1. Report No. FHWA/TX-07 / 0-1774-4		2. Government Accession No.		3. Recipient's Catalog No.	
4. Title and Subtitle Performance of Fiber Composite Wrapped Columns and Beams in a Corrosive Environment				5. Report Date October 2006

## **Performance of Fiber Composite Wrapped Columns and Beams in a Corrosive Environment**

The procedures used to assess the condition were described in Report 0-1774-3. The purpose of this report is to document the performance of all remaining tests and to propose design guidelines for use of wrapping techniques to protect bridge structures in a corrosive environment.

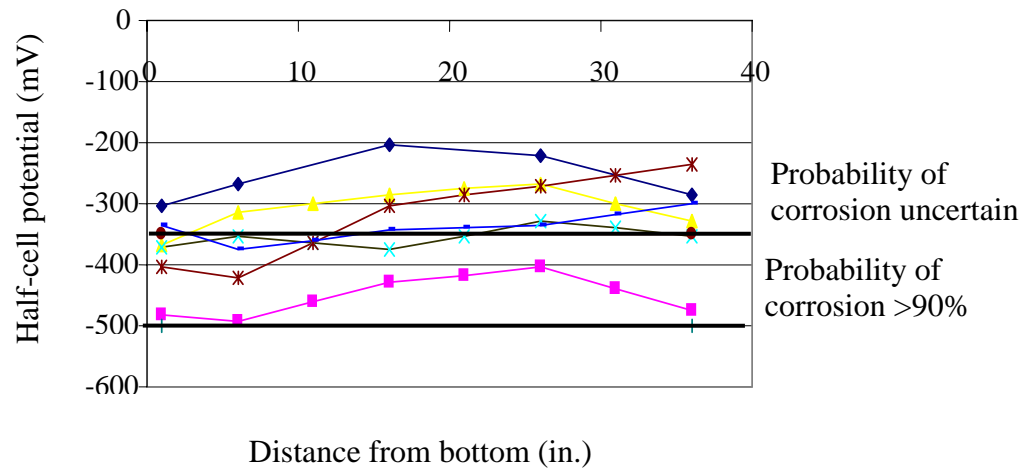
Figure 3.2 Half-cell potential profile for some of the fully wrapped specimens

Figure 3.1 shows half-cell profiles for unwrapped column specimens and Figure 3.2 shows the half-cell profiles for some of the fully wrapped specimens. For the unwrapped columns, the potentials lie primarily between -350 mV and -500 mV, indicating a very high probability of corrosion. For the fully wrapped specimens, the potentials range from -200 mV to -500 mV, indicating that after many cycles in the corrosion tank, it becomes increasingly difficult to predict the level of corrosion based only on half-cell readings. The half-cell readings, though, are very effective in indicating whether the probability of corrosion is very high or low. The half-cell potential profiles also provide a strong indication that the addition of FRP wrap reduces the likelihood of corrosion.

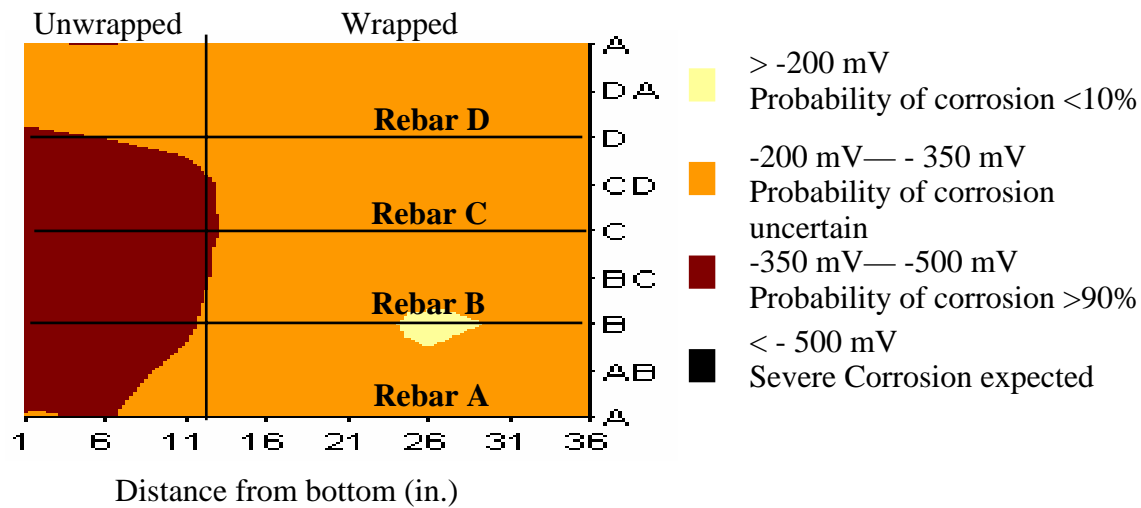
Figure 3.3 Half-cell potential contour for specimen CNC3

Figure 3.3 shows the half-cell potential contour of a specimen CNC3, that was wrapped over the top 24 in. The half-cell readings clearly indicate that the FRP wrapping has reduced the likelihood of corrosion. Similar conclusions can also be drawn by looking at half-cell contour maps of other specimens such as CC1, CC8, CC9, CC19, CNC4, CNC18, S3, S5, S7, S11, S13 and S14. The details are given in Appendix A.

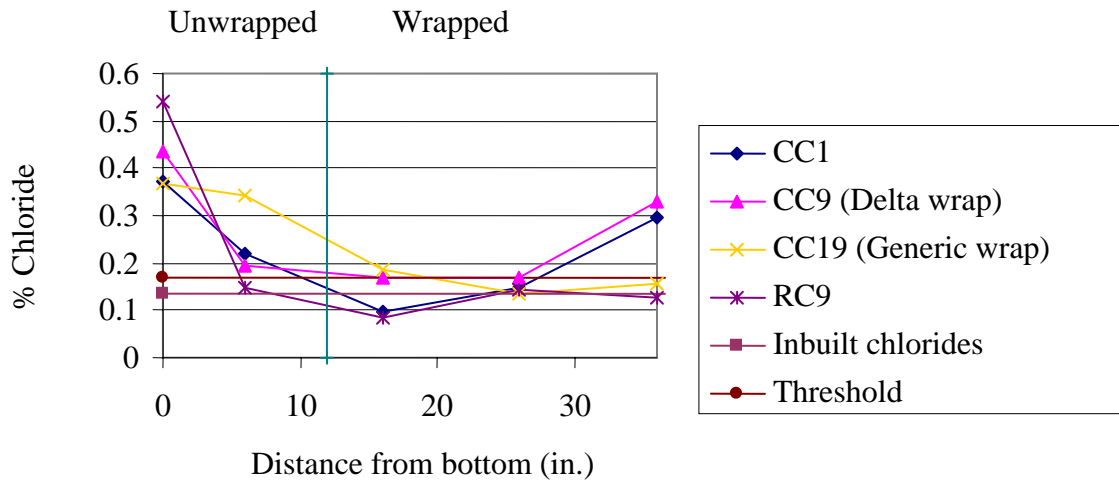
Figure 3.5 Chloride content profiles of specimens wrapped over top 24 in.

A threshold value of 0.03% chloride content as a percentage of weight of concrete is indicated in the figures. For the specimens containing inbuilt (added to the fresh concrete) chlorides (0.137% by weight of concrete), the threshold is considered as an additional 0.03% of migrating chlorides. For the unwrapped specimens, the chloride contents are much higher than the threshold value (Figure 3.4). For the partially wrapped columns, the chloride contents are high in the unwrapped portion but below the threshold in the wrapped portion (Figure 3.5). High chloride contents were found in the exposed upper end of the columns.

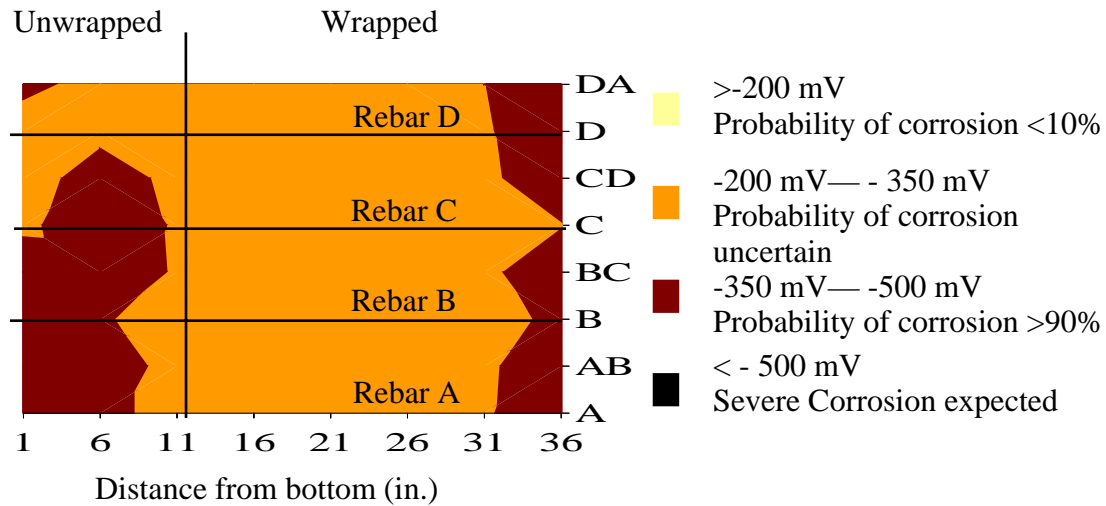
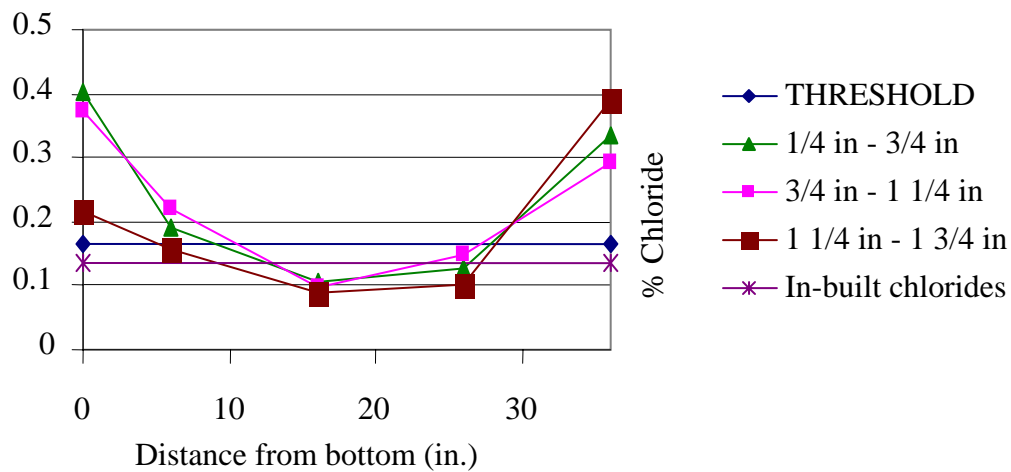
- 1) No corrosion was observed except on the bottom few inches of rebars C and D.
- 2) Though the bottom 12 in. was not wrapped, there was hardly any corrosion in those areas. This is in contrast to other specimens where heavy rusting was observed in unwrapped areas. This could be due to the presence of corrosion inhibitor Ferrogard.

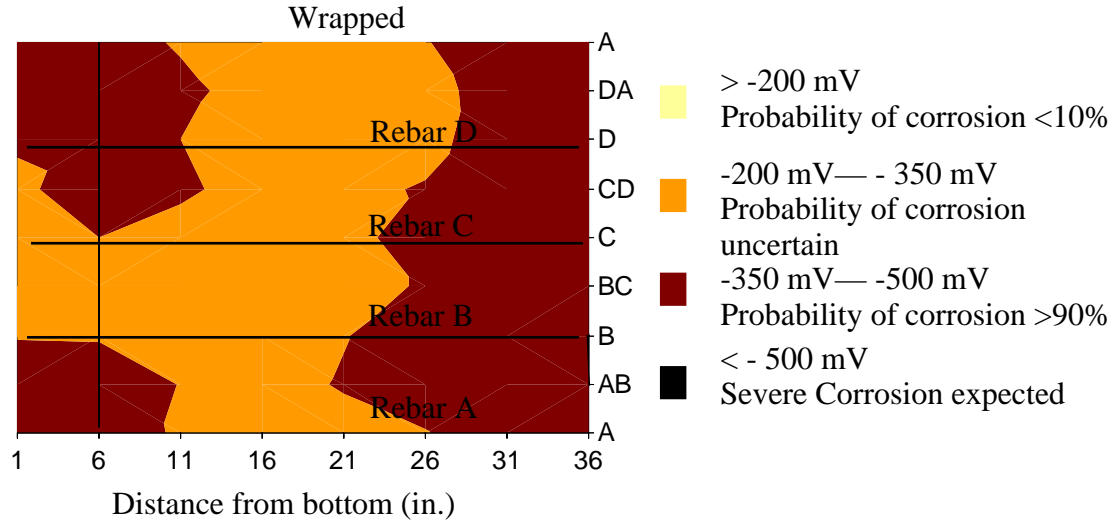
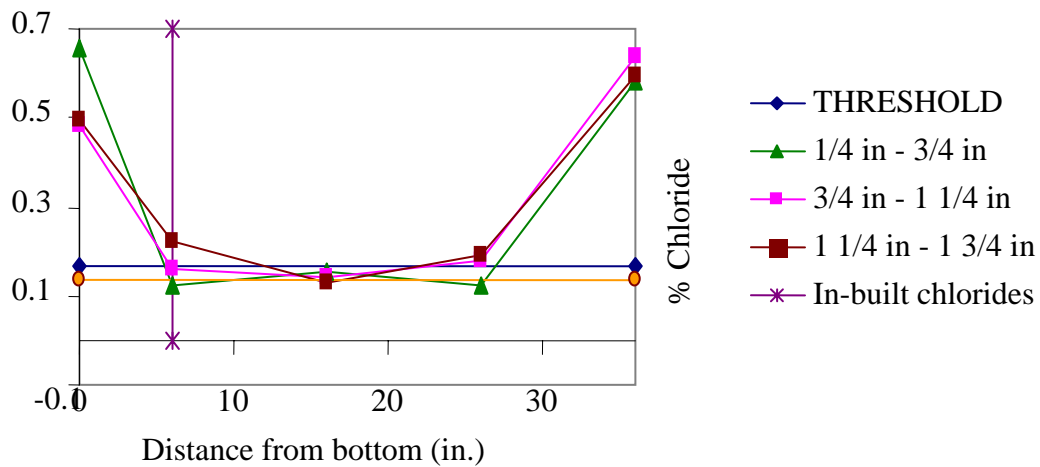
- 1) The cylinder was wrapped over top 30 in.
- 2) The wrap was intact at all places.
- 3) A vertical crack of width 0.016 in. was observed over 0 in- 2 in. over rebar D.
- 4) A rust spot (3 in.× 2 in.) was found over rebar A.
- 5) A vertical crack of width 0.08 in. was observed over 0 in- 3 in. over rebar B.
- 6) After removal of wrap, repair patch was visible over bottom 18 in. at area DC-C-B and till 8 in. at areas BA-A-D-DC.

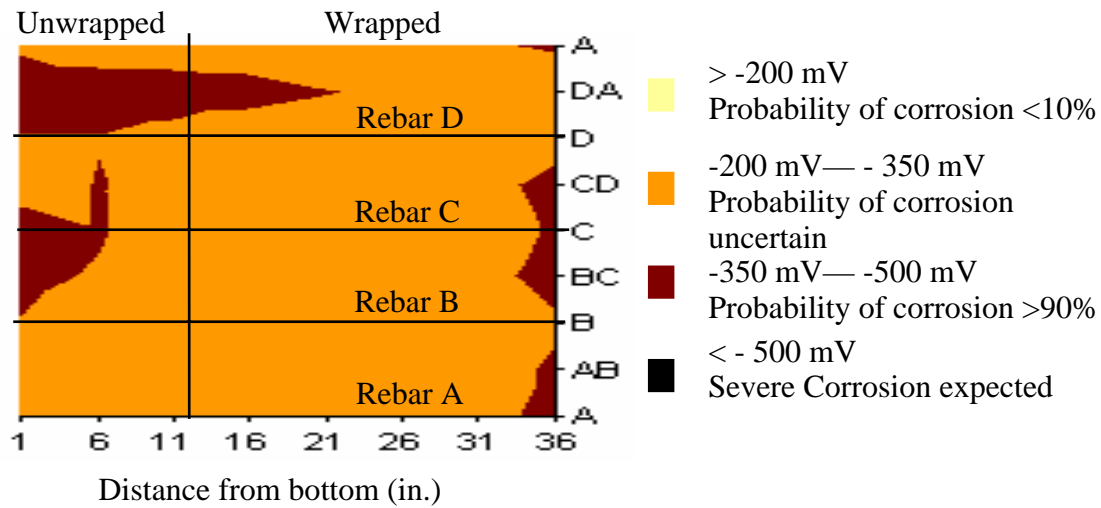
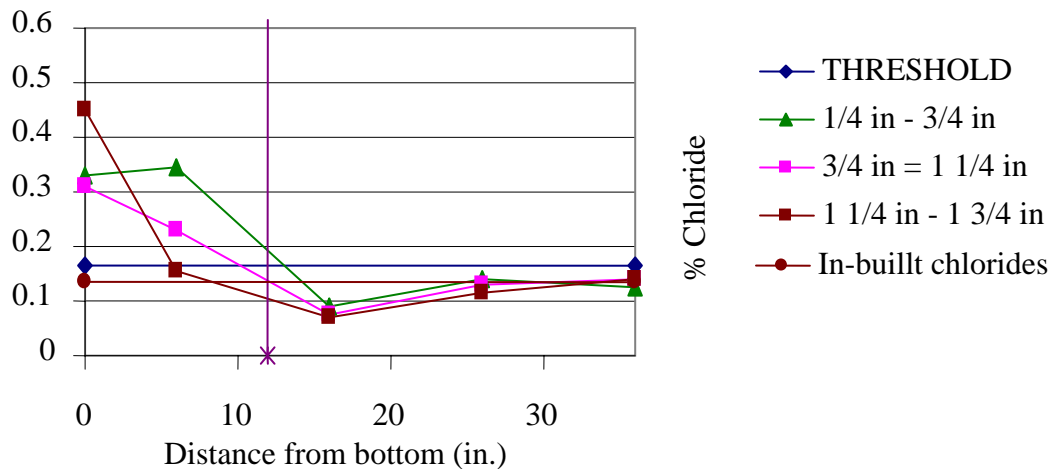
- 2) The half-cell potential contour and the chloride content profile corroborated with the corrosion observed on the extracted rebar.

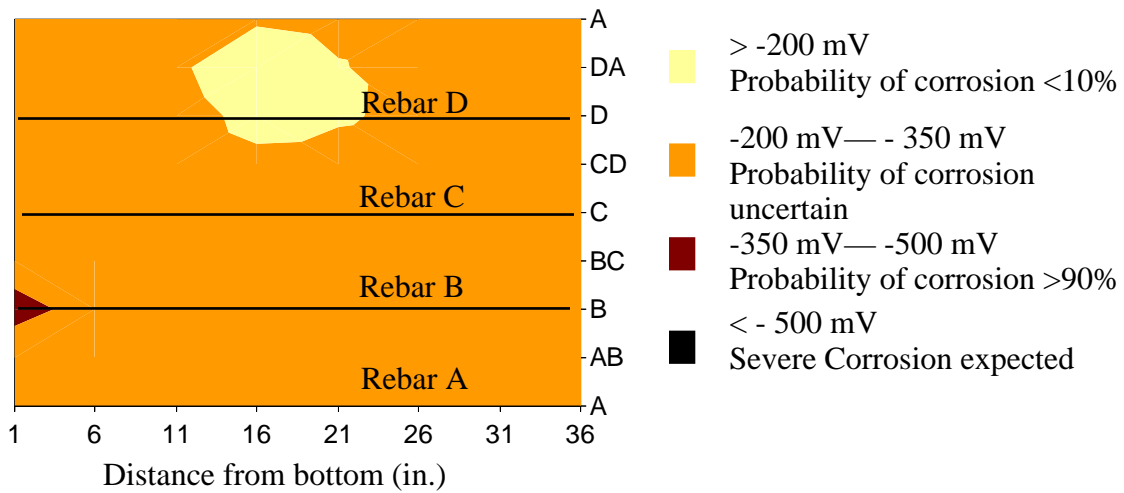
- 1) Rebars in cylinder CC8 were not corroded. The chloride content is below the threshold level. The wrap has been effective in inhibiting corrosion.

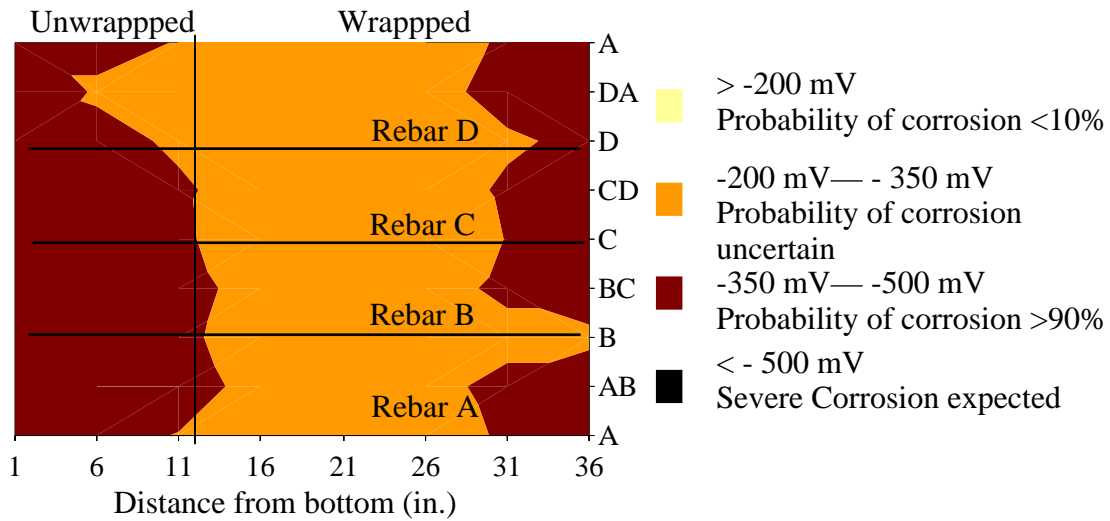
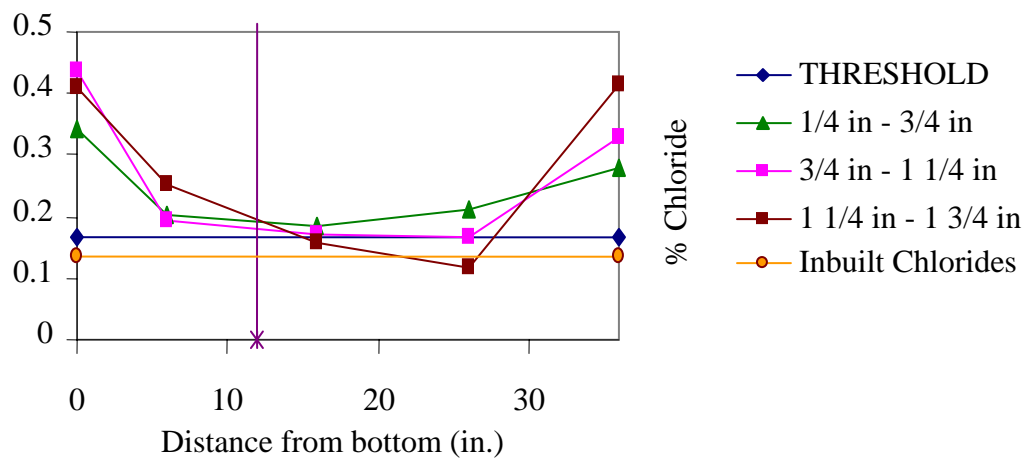
- 1) The cylinder was wrapped over top 24 in.
- 2) The wrap was intact at all places.
- 3) Concrete had spalled-off in the bottom region over rebar A. Rust stains were visible underneath.
- 4) A horizontal crack of width 0.03 in. was observed 2 in. above bottom over area CD-B-BA.

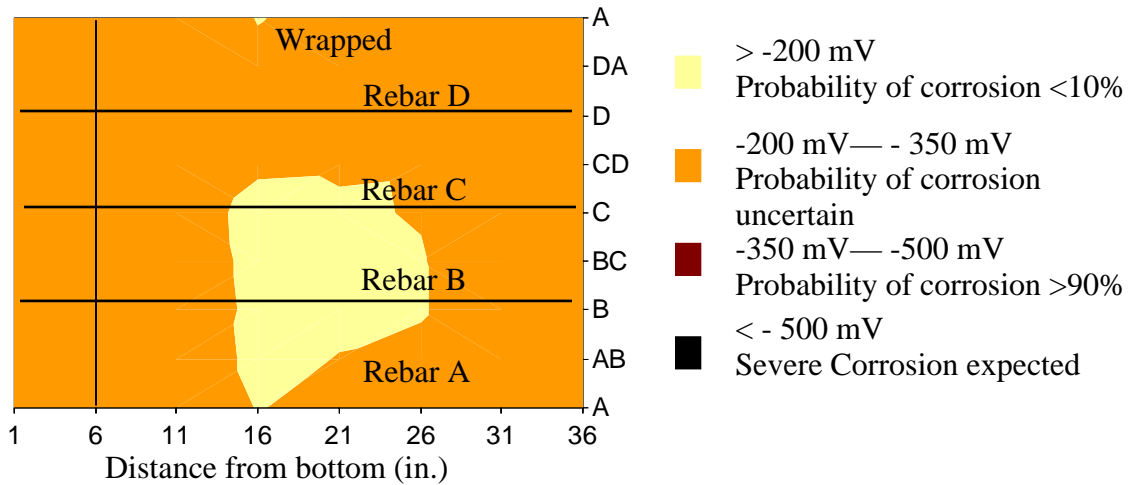
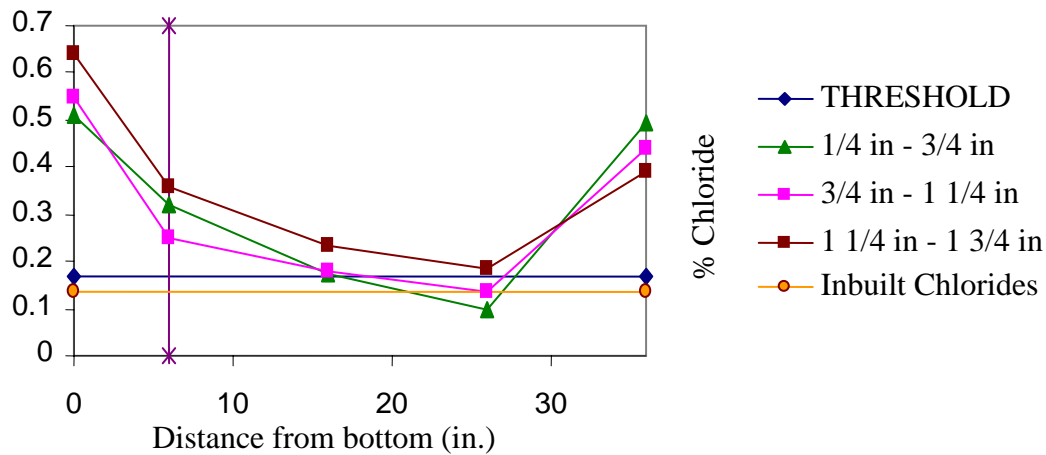
- 1) The specimen was covered with wrap over top 30 in.
- 2) The wrap was intact at all places.
- 3) A horizontal crack of width 0.04 in. was observed over area D-A-B at 2 in. above bottom.
- 4) Concrete over bottom 2 in. over rebar A was spalled.

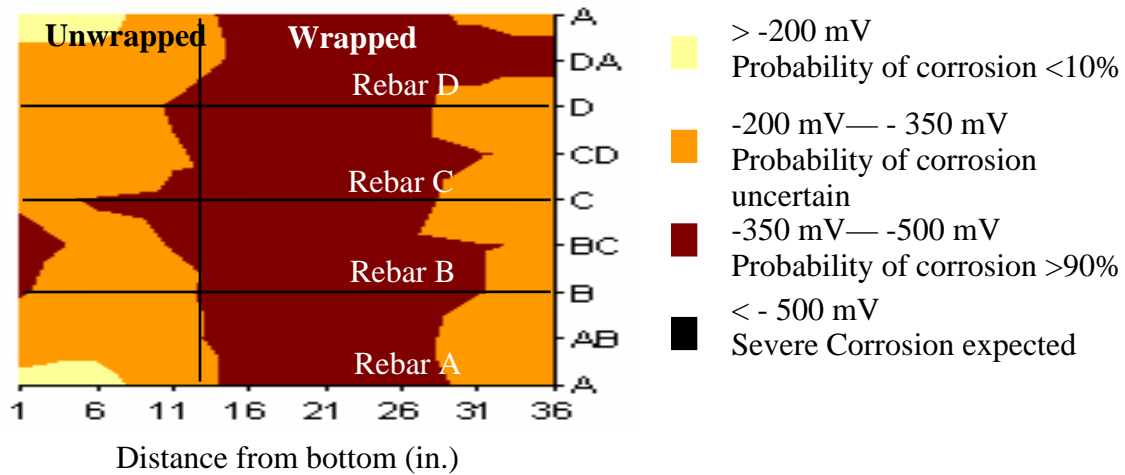
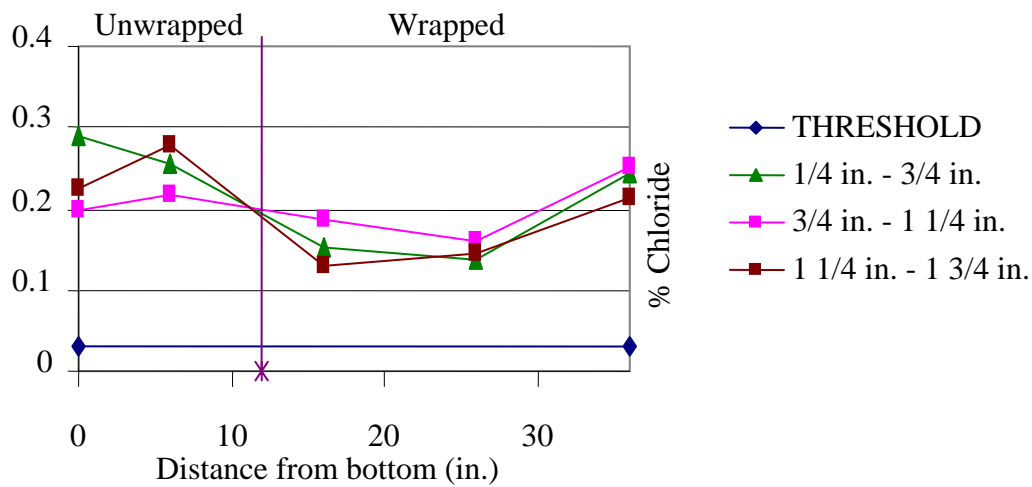
- 2) In rebar A, the unwrapped area ( 0 in. to 12 in.) was heavily corroded while the wrapped area (12 in. to 36 in.) was not corroded at all.

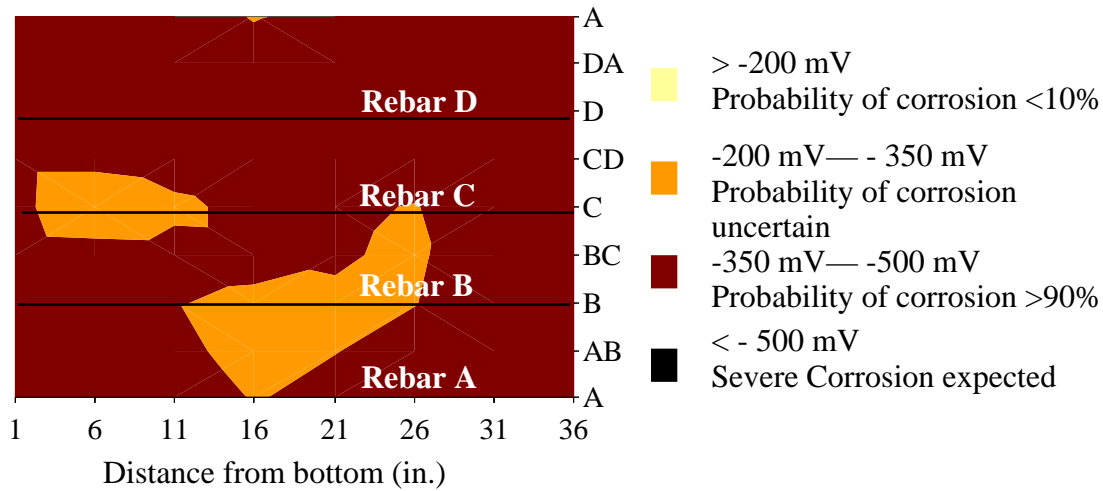
- 1) Unlike in other specimens where the repair material were successful in inhibiting corrosion completely, rebars under the repair material were corroded, mostly only on one side. The amount and level of corrosion under the repair material was lesser than the areas with no repair material.
- 2) All the other rebars were heavily corroded since the cylinder was not wrapped.

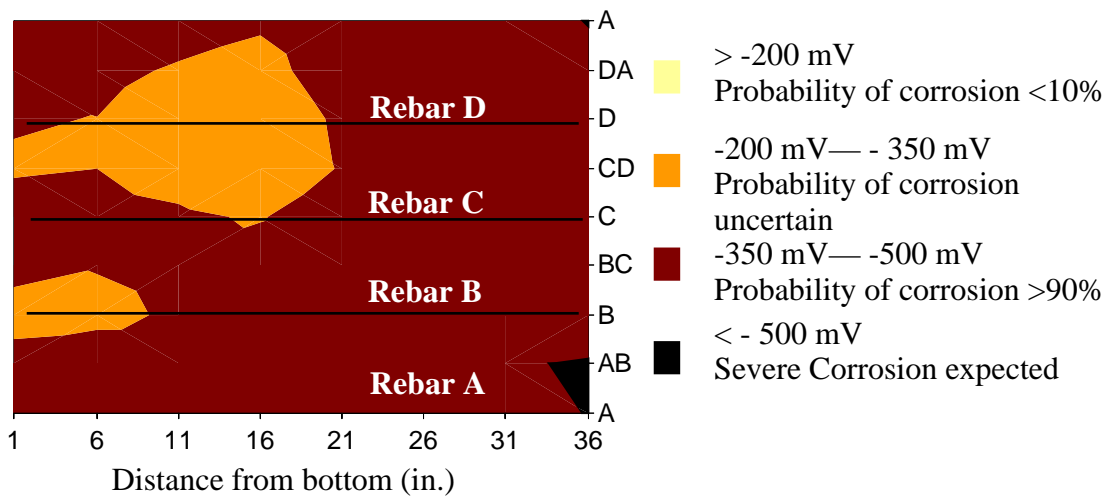
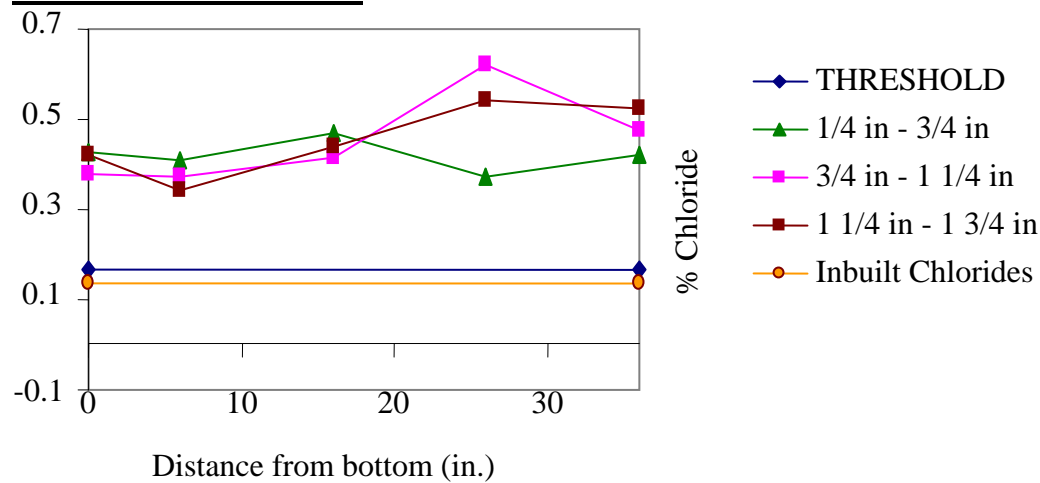
- 1) Though it was not wrapped, corrosion was not as extensive as other unwrapped specimens (for example, CC16). This could be due to the presence of inhibitor Ferrogard. The inhibitor, though, is not very effective in the “splash zone” i.e. 0 in. – 12 in. from bottom.

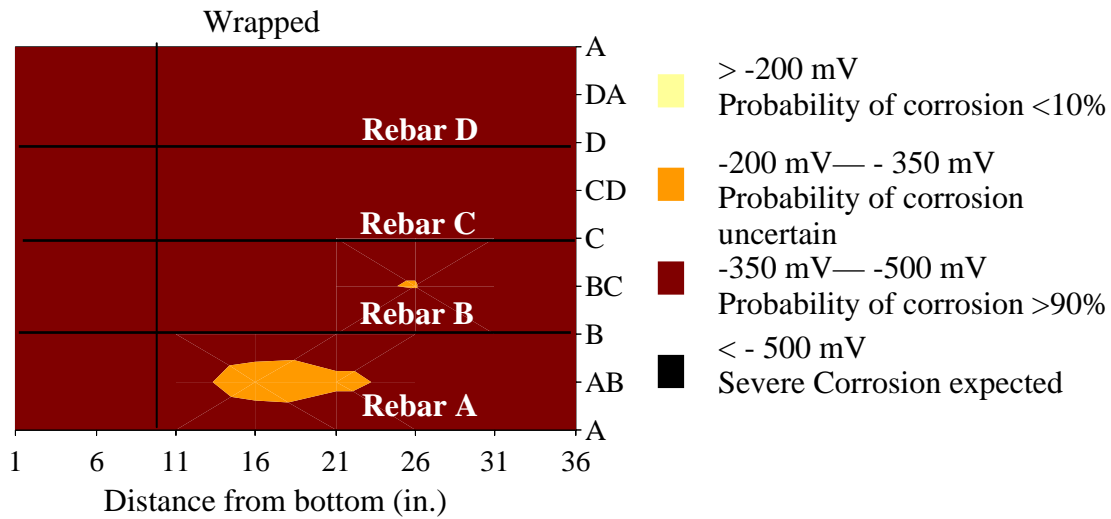
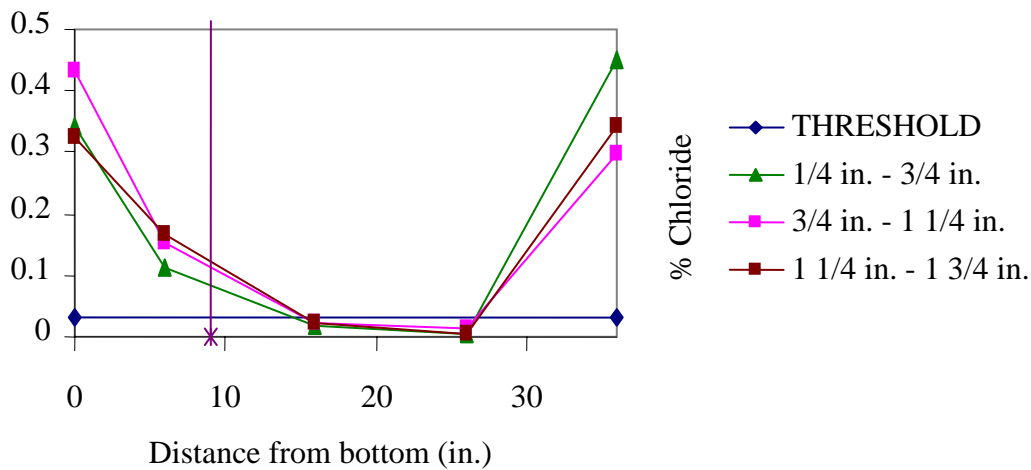
- 1) Though the bottom 9 in. were not wrapped heavy corrosion was not observed on the rebar.
- 2) No corrosion was observed under the wrapped region.
- 3) Heavy corrosion was observed over bottom 8 in. of rebar B

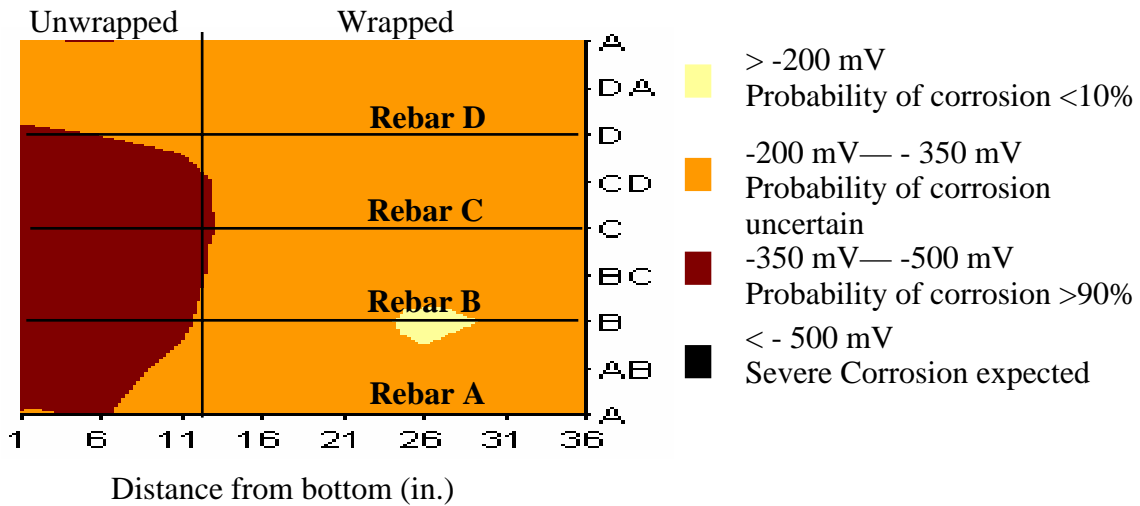
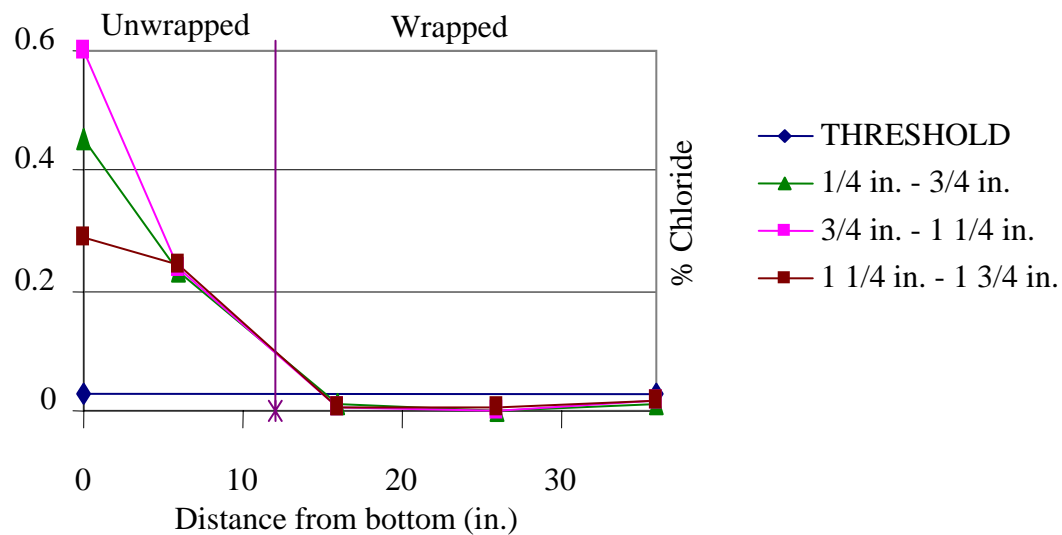
- 1) Bottom 12 in. of rebars A, C and D was heavily corroded while rebar B was not corroded.
- 2) Wrapped areas were not corroded at all.

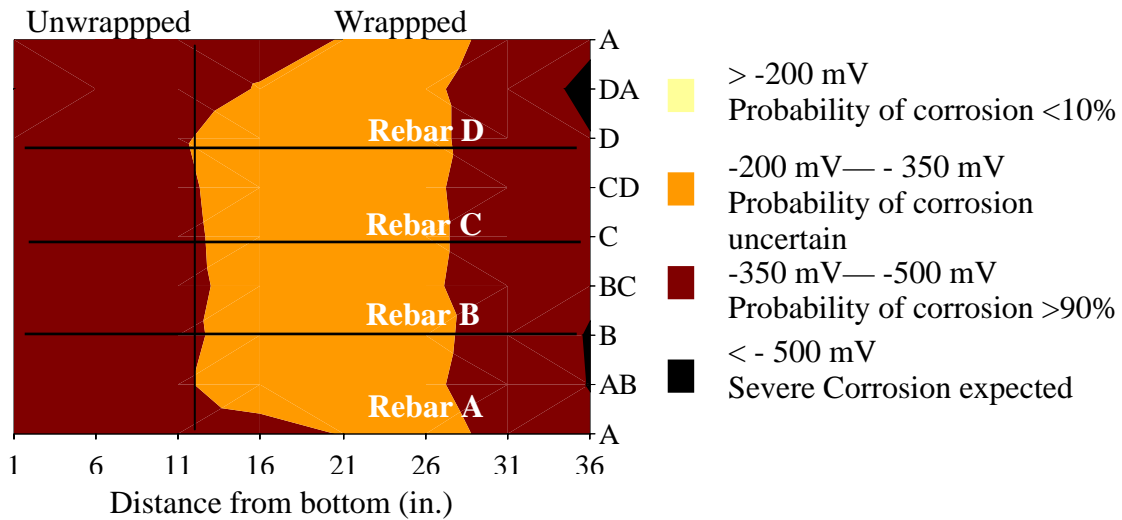
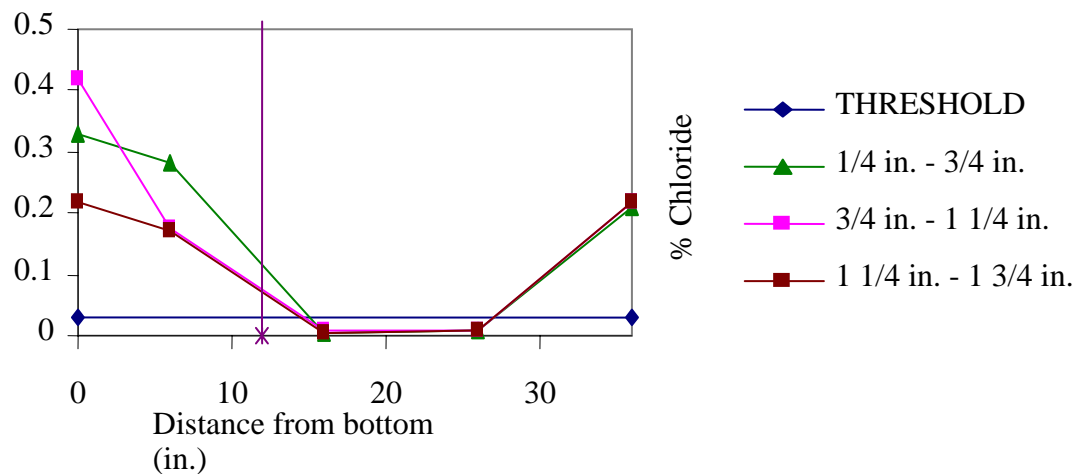
- 1) The cylinder is wrapped over top 24 in.
- 2) The wrap is intact at all places.
- 3) Rust stains were observed over the bottom unwrapped region.
- 4) When the wrap was removed, chunks of concrete came off with it, exposing rust stains lying underneath the surface.

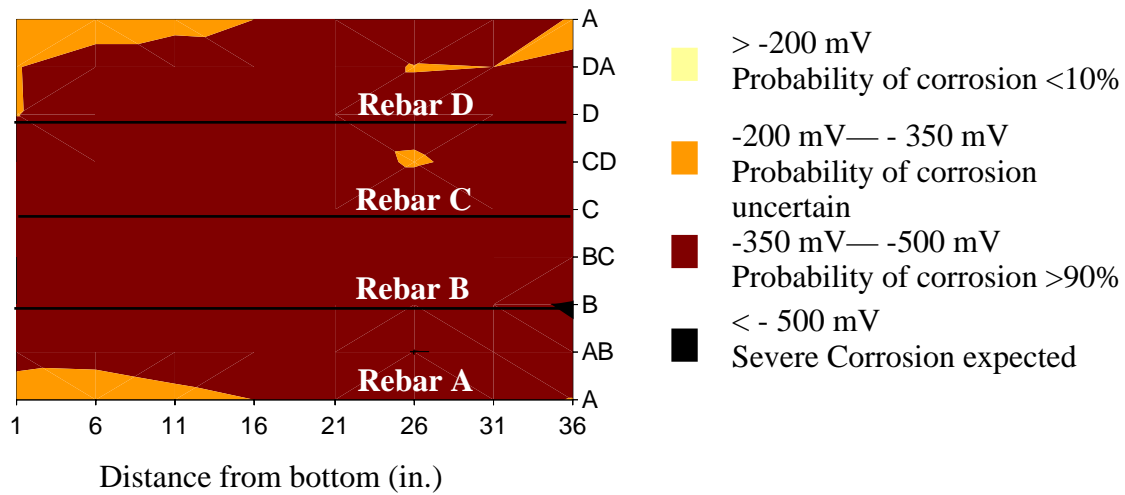
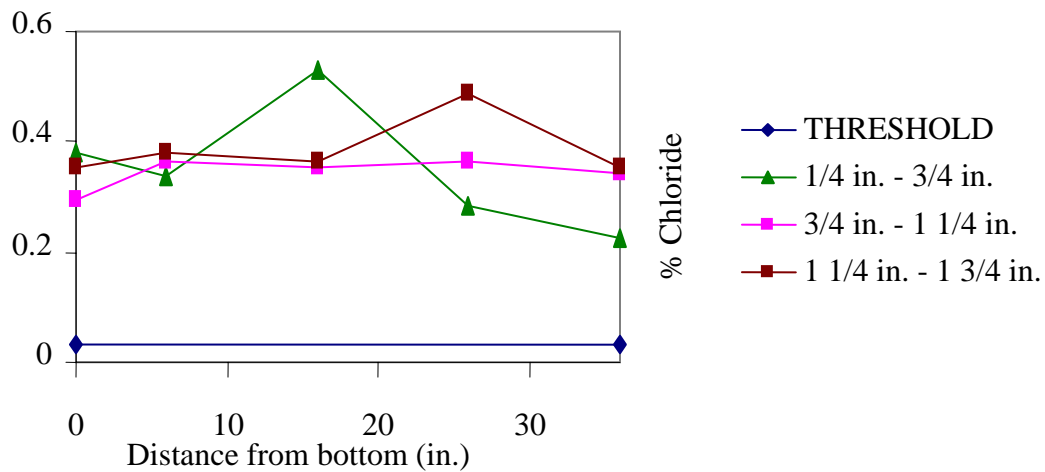
- 1) The specimen was not wrapped.
- 2) A vertical crack of width 0.04 in. was observed over rebar A extending the complete height of the cylinder.
- 3) A vertical crack of width 0.02 in. was observed over rebar B extending the complete height of the cylinder.
- 4) A vertical crack of width 0.03 in. was observed over rebar C extending from 16 in. to 31 in.
- 5) A vertical crack of width 0.016 in. was observed over rebar D extending from 7 in. to 36 in.
- 6) Large rust stains were observed all over the specimen.

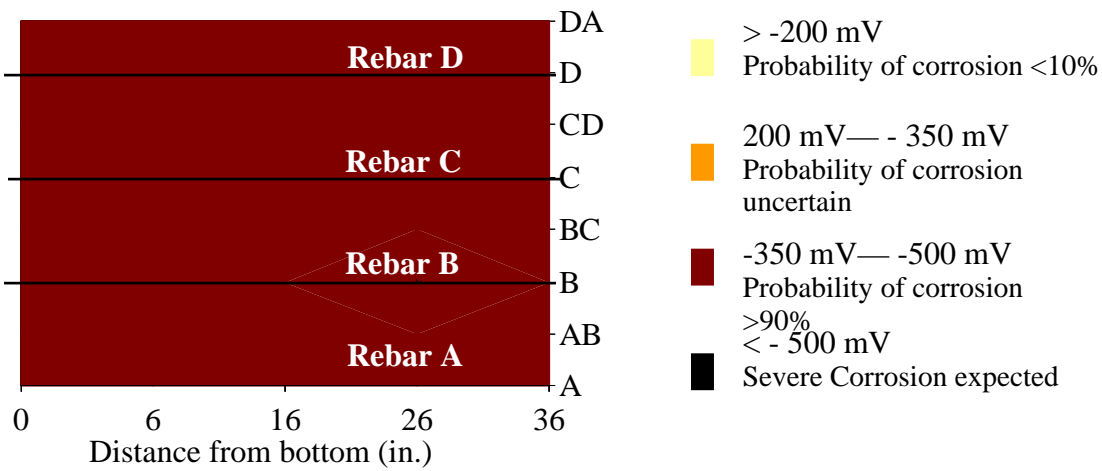
- 1) A vertical crack of width 0.06 in. occurred over rebar A, extending from top to 7.5 in. from bottom.
- 2) A vertical hairline crack occurred over rebar B, extending from 6.5 in. to 14 in. from top.
- 3) A vertical crack of width 0.04 in. occurred over rebar B, extending from 14 in. to 26 in. from top.
- 4) A few vertical hairline cracks occurred in area AB, extending from 12 in. to 20 in. from top.
- 5) A vertical crack of width 0.04 in. occurred over rebar C, extending from top to 33 in. from top.
- 6) A vertical crack of width 0.06 in. occurred over rebar D, extending from top to 32 in. from top.
- 7) A Stain spot (2 in. in diameter) was located in area CD, at 9 in. above bottom.
- 8) A Stain spot (0.5 in.  $\times$  2 in.) was located over rebar C, at 9 in. above bottom.
- 9) A Stain spot (1 in.  $\times$  1 in.) was located in area AB, at 17 in. above bottom.

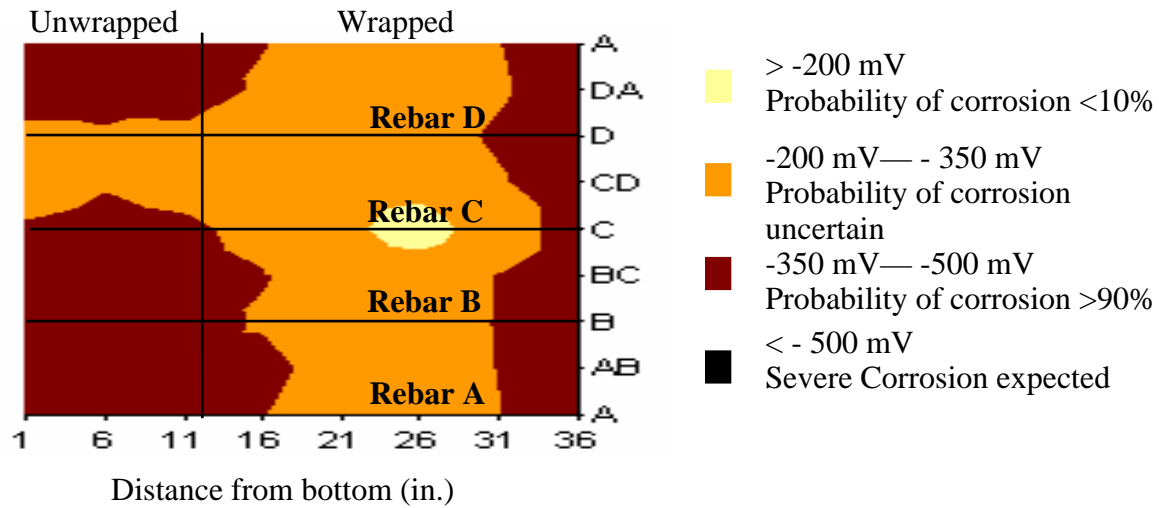
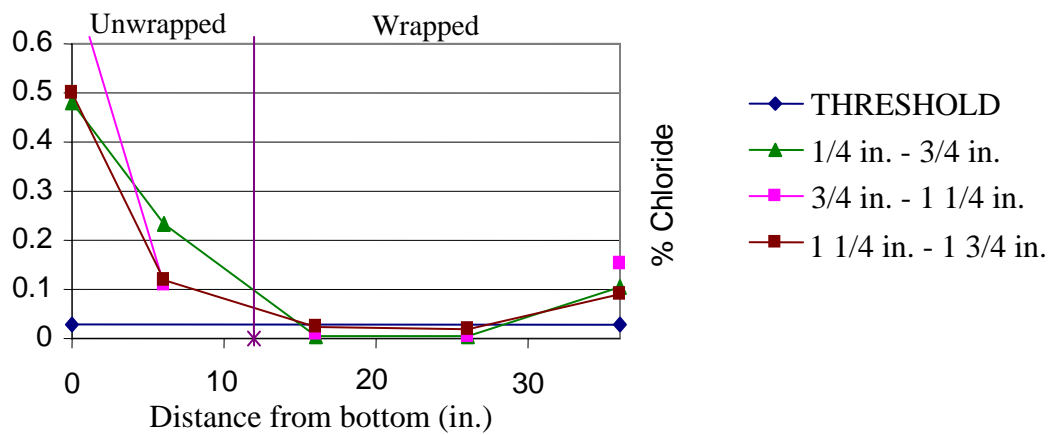
- 1) Unwrapped portions of rebar A and B were corroded while those of rebars C and D were not. This was likely due to the presence of repair material over rebars C and D.
- 2) No corrosion was observed in the wrapped regions.

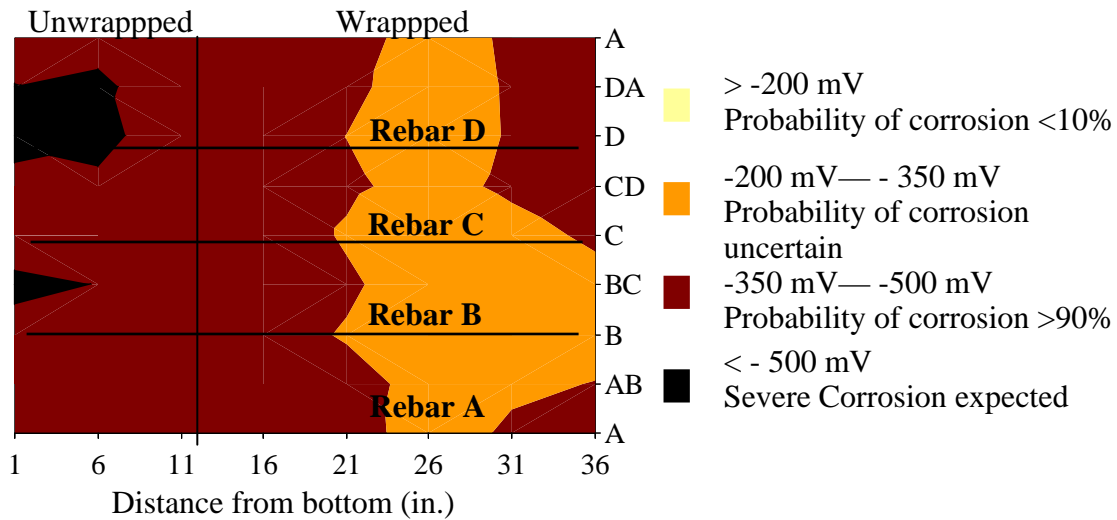
- 1) The cylinder was covered with wrap over the top 24 in.
- 2) The wrap was intact at all places.
- 3) A vertical crack of width 0.03 in. was observed over rebar A, extending from 0 in. to 12 in., accompanied with rust stains.
- 4) A vertical crack of width 0.016 in. was observed over rebar B, extending from 0 in. to 10 in., accompanied with rust stains.
- 5) A vertical crack of width 0.02 in. was observed over rebar C, extending from 4 in. to 12 in.

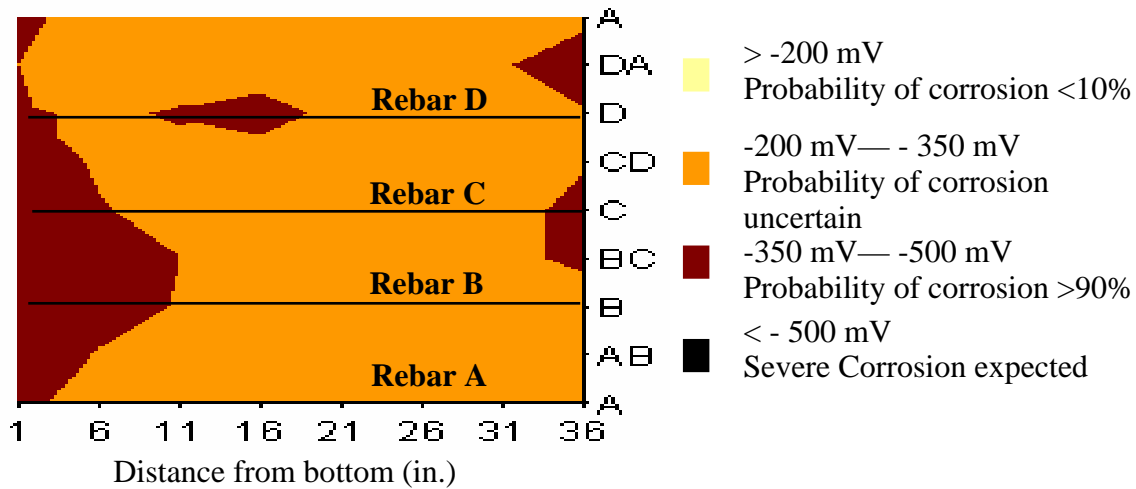
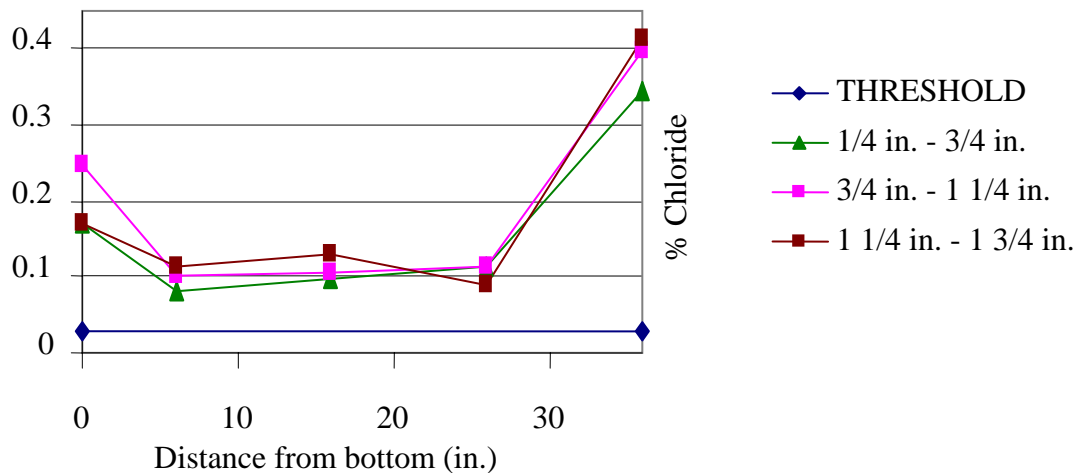
- 1) The column was completely wrapped. The wrap was intact at all places.
- 2) No cracks or rust stains were observed after the wrap was removed.

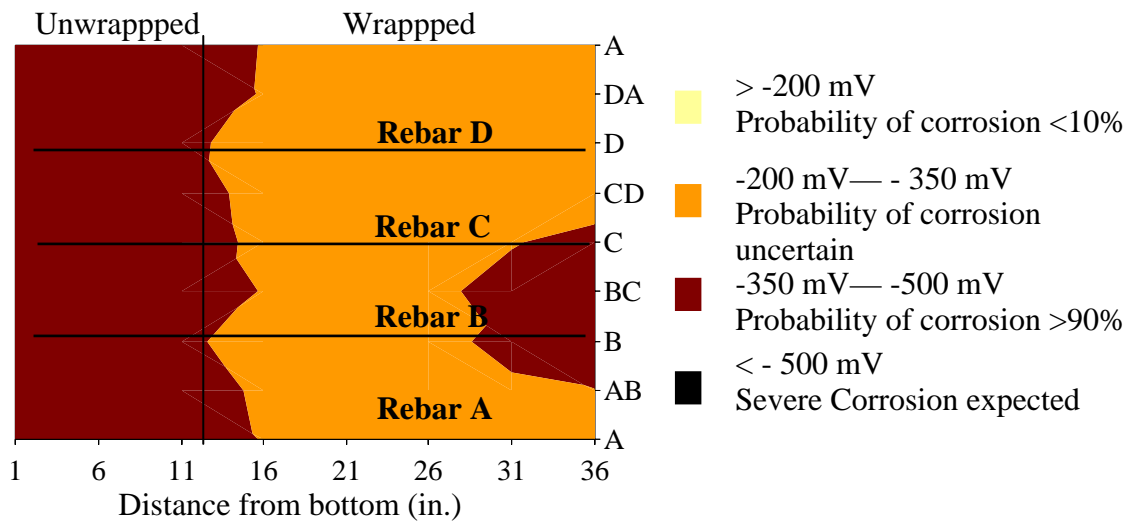
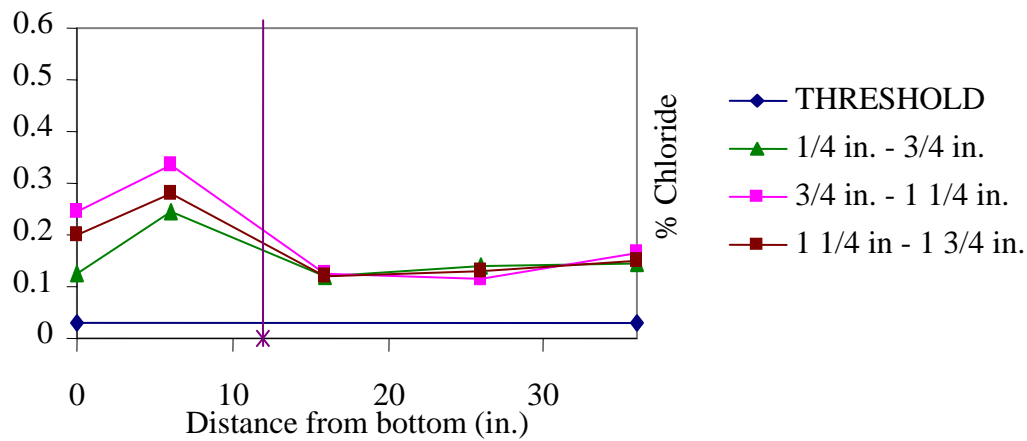
- 1) The cylinder was wrapped over the top 24 in.
- 2) The wrap was intact at all places.
- 3) A vertical crack of width 0.013 in. was observed over rebar A, extending from 0 in. to 12 in., accompanied with rust stains.
- 4) A vertical crack of width 0.03 in. was observed over rebar B, extending from 3 in. to 12 in., accompanied with rust stains.
- 5) A vertical hairline crack of width 0.01 in. was observed over rebar C, extending from 2 in. to 12 in., accompanied with rust stains.

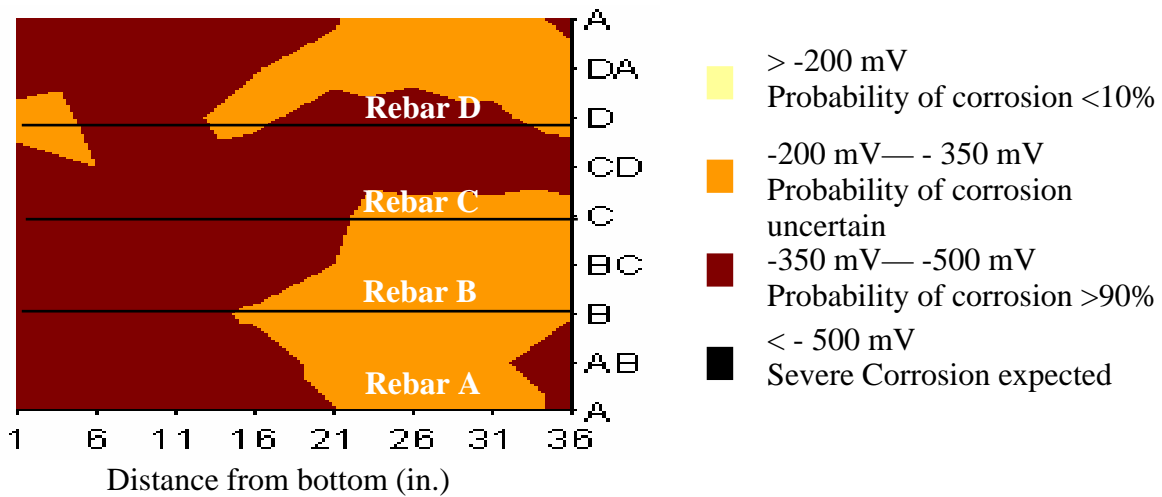
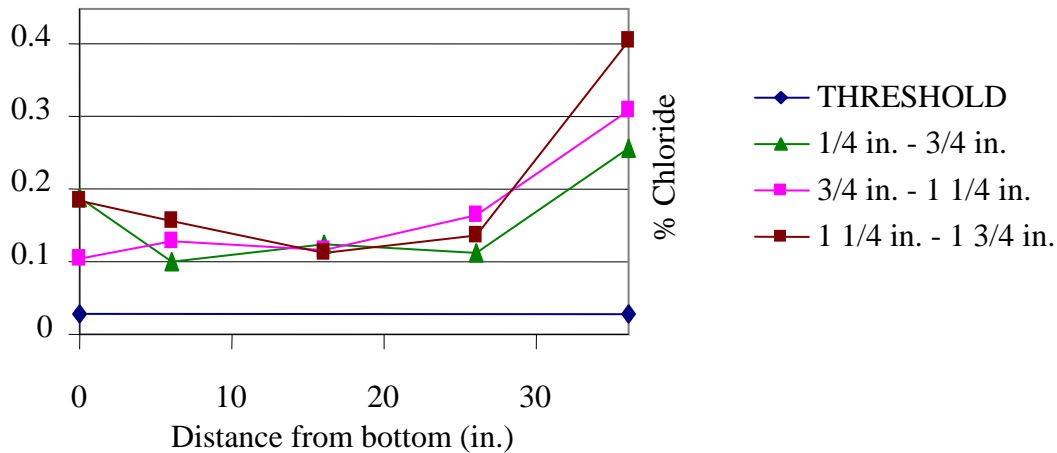
- 1) The column was completely wrapped. The wrap was intact at all places.
- 2) No cracks or rust stains were observed after the wrap was removed.

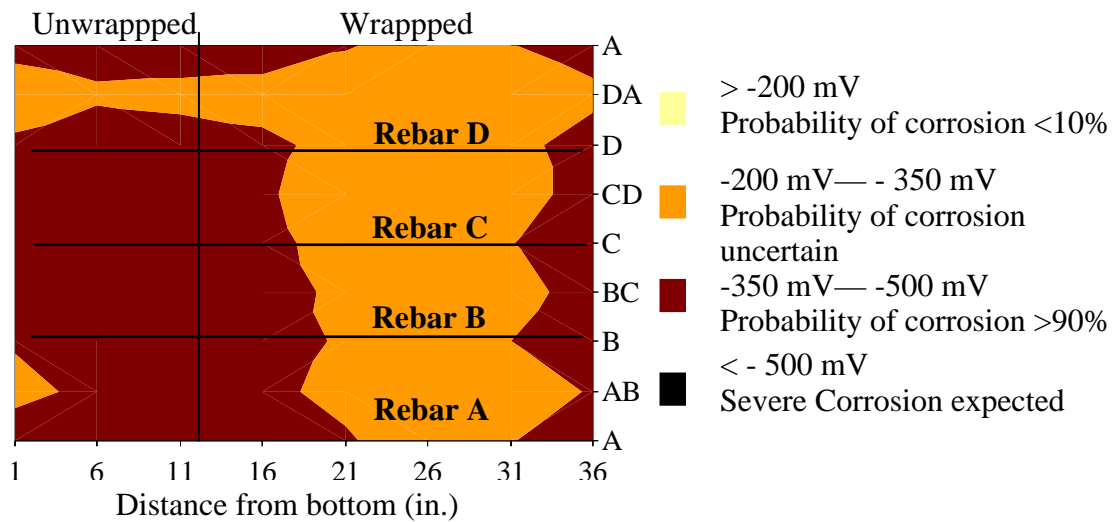
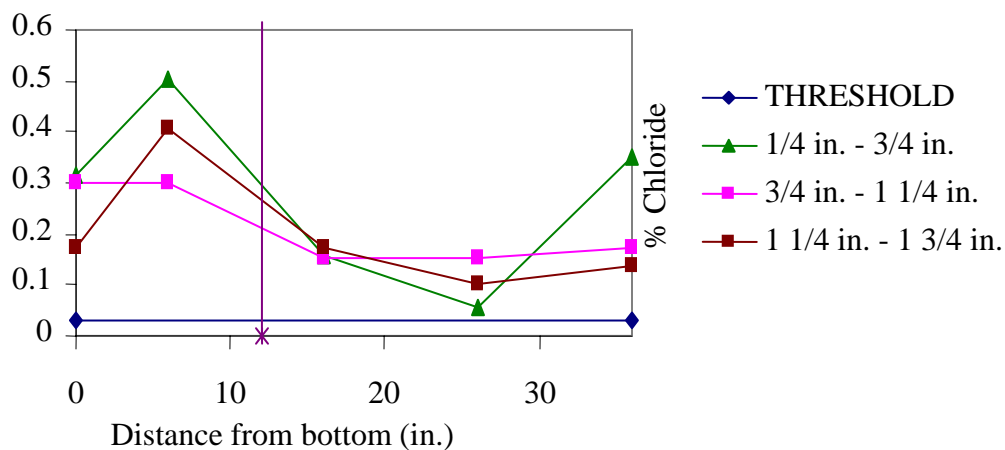
- 1) The cylinder was wrapped over the top 24 in.
- 2) The wrap was intact at all places.
- 3) A vertical crack of width 0.016 in. was observed over rebar A, extending from 5 in. to 9 in.
- 4) A vertical crack of width 0.016 in. was observed over rebar B, extending from 0 in. to 12 in.
- 5) Rust stains were observed in the unwrapped region.
