1. Report No. FHWA/TX-07 / 0-1774-4		2. Government Accession No.		3. Recipient's Catalog No.	
4. Title and Subtitle Performance of Fiber Composite Wrapped Columns and Beams in a Corrosive Environment				5. Report Date October 2006

## **Performance of Fiber Composite Wrapped Columns and Beams in a Corrosive Environment**

The procedures used to assess the condition were described in Report 0-1774-3. The purpose of this report is to document the performance of all remaining tests and to propose design guidelines for use of wrapping techniques to protect bridge structures in a corrosive environment.

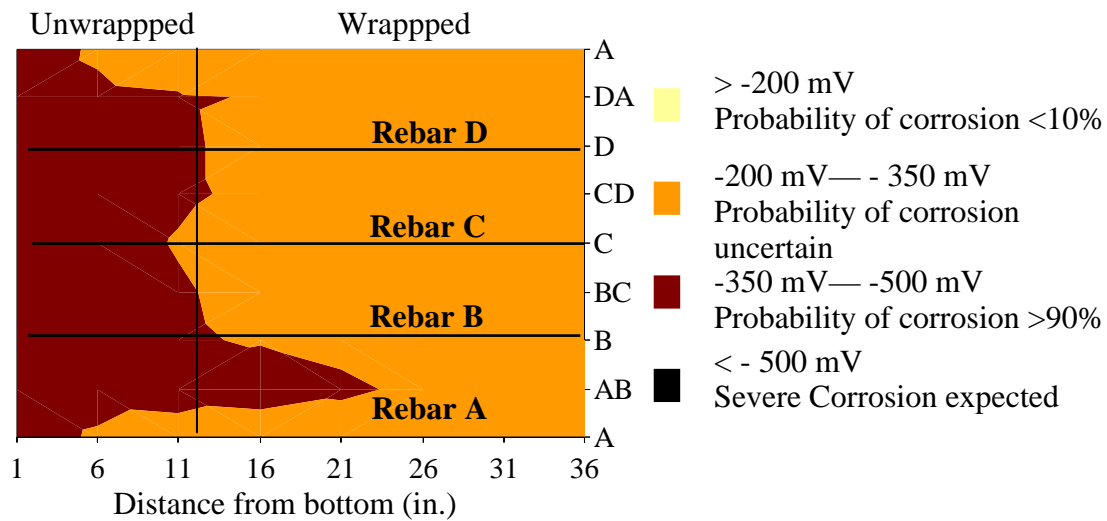
- 1) The cylinder was wrapped over the top 24 in.
- 2) The wrap was intact at all places.
- 3) A vertical crack of width 0.013 in. was observed over rebar B, extending from 0 in. to 6 in.
- 4) A vertical crack of width 0.02 in. was observed over rebar C, extending from 0 in. to 10 in.
- 5) A few rust stains were observed in the unwrapped region.

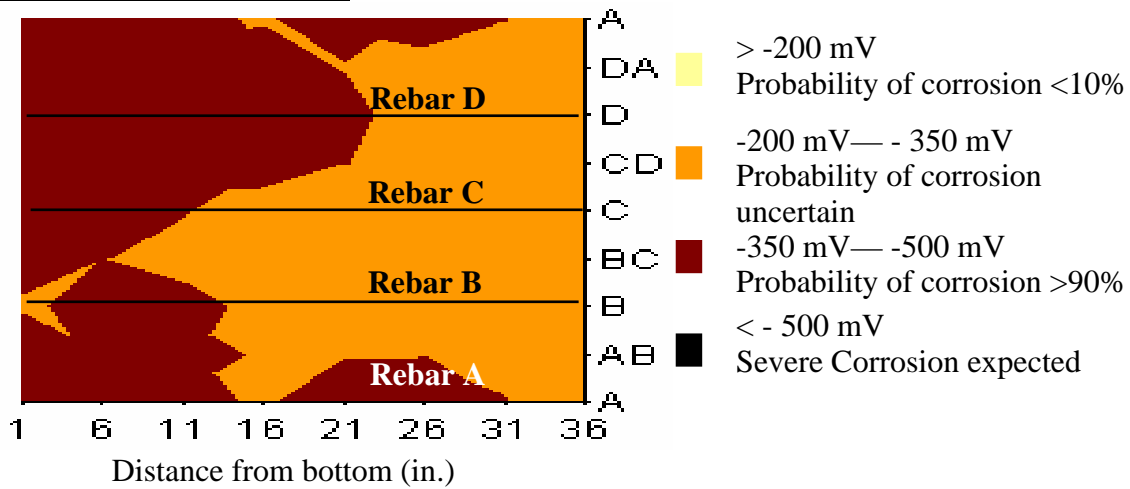
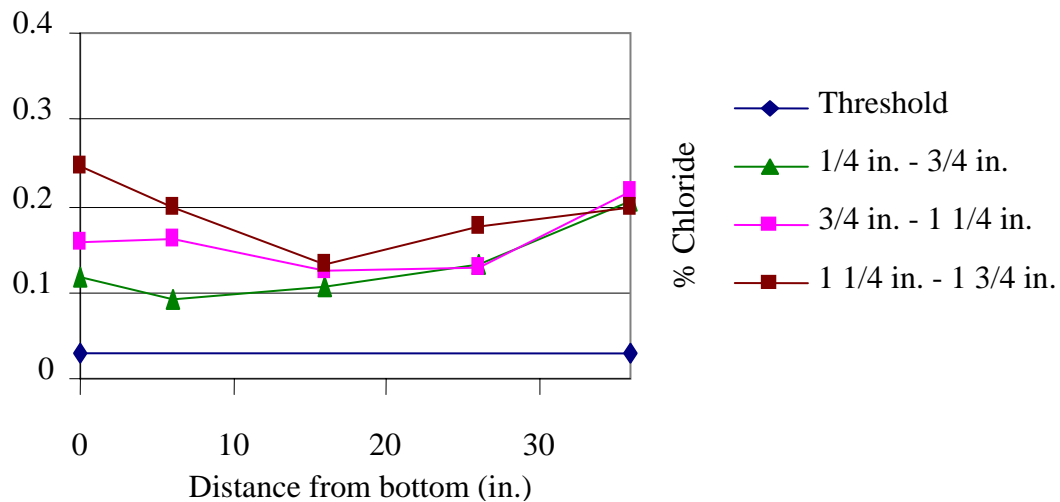
- 1) Though the column was fully wrapped, heavy corrosion was observed in certain areas and light corrosion in some, as marked.
- 2) The inhibitor used, Cortec, does not seem to be beneficial in preventing corrosion.

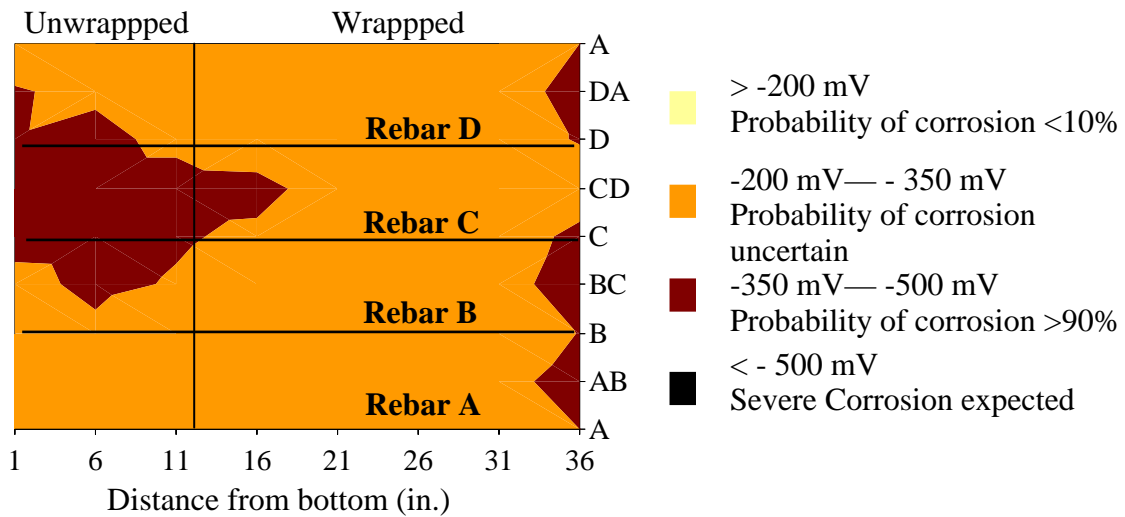
- 1) The cylinder was wrapped over the top 24 in.
- 2) The wrap was intact at all places.
- 3) A vertical crack of width 0.02 in. was observed over rebar B, extending from 9 in. to 12 in.
- 4) A vertical crack of width 0.02 in. was observed over rebar C, extending from bottom to 12 in.

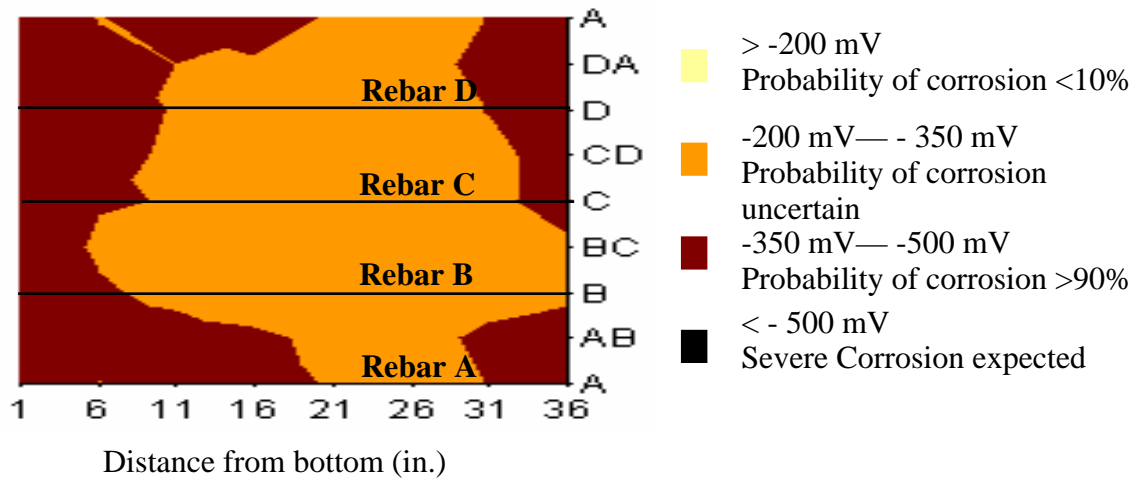
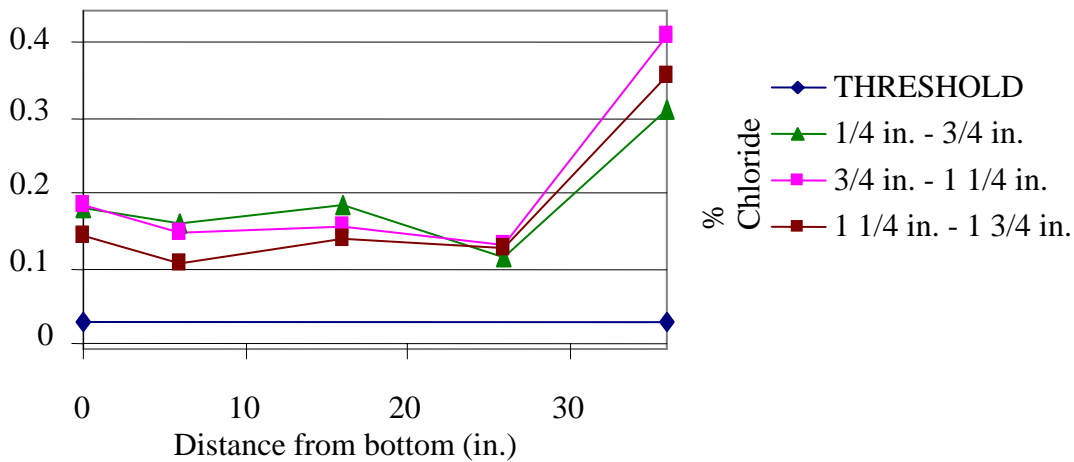
- 1) The level and amount of corrosion is lesser when compared to specimens S6 and S8.

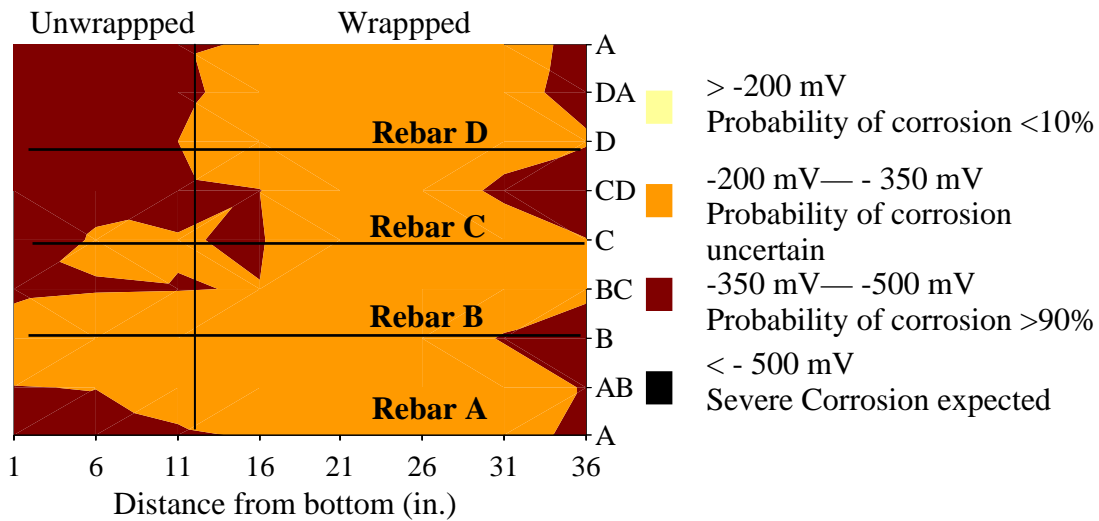
- 1) The cylinder was wrapped over the top 24 in.
- 2) The wrap was intact at all places.
- 3) A vertical crack of width 0.04 in. was observed over rebar C, extending from 0 in. to 12 in.
- 4) A vertical crack of width 0.016 in. was observed over rebar B, extending from 2 in. to 12 in. accompanied with rust stains.
- 5) A vertical crack of width 0.016 in. was observed over rebar D, extending from 0 in. to 10 in.
- 6) Bottom (4 in.  $\times$  2.5 in.) chunk of concrete had fallen in area CD.

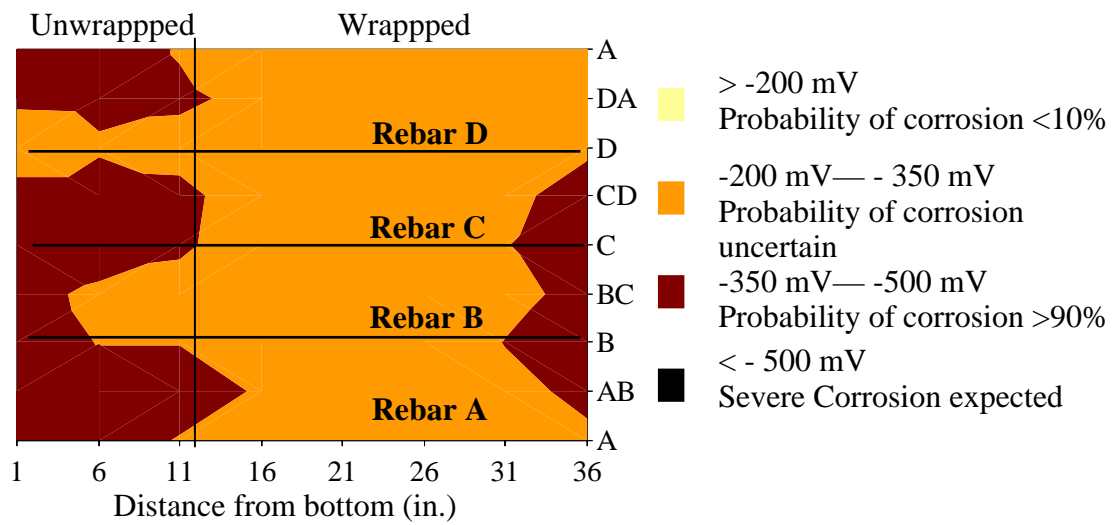
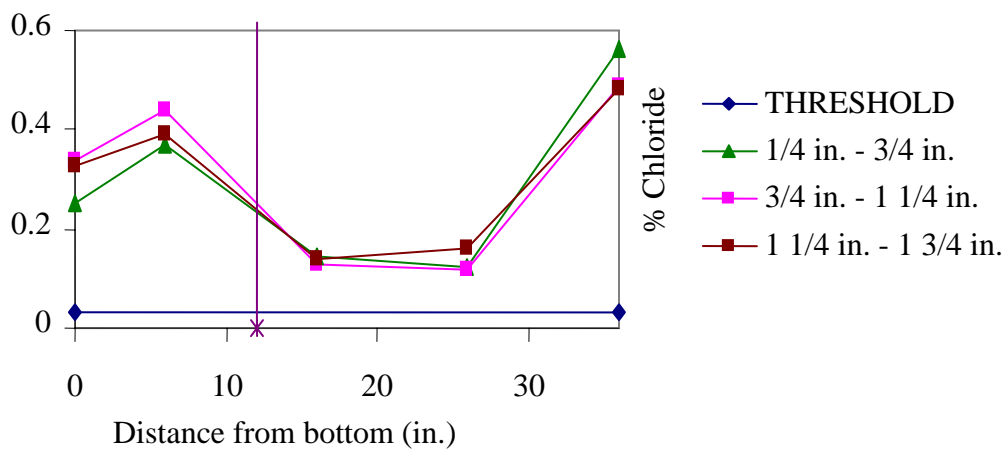
- 1) The cylinder is wrapped over the top 24 in.
- 2) The wrap was intact in all places.
- 3) A vertical crack of width 0.013 in. was observed over rebar A, extending from 6 in. to 12 in.
- 4) A vertical crack of width 0.03 in. was observed over rebar B, extending from 0 in. to 12 in.
- 5) A vertical crack of width 0.03 in. was observed over rebar D, extending from 0 in. to 12 in.
- 6) Rust stains were observed in the unwrapped region.

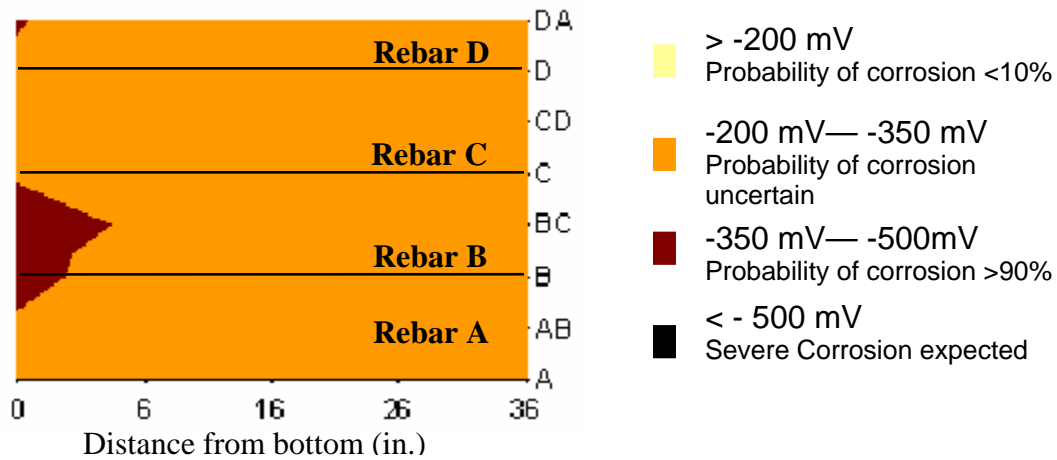
- 1) The level of corrosion was higher than that of cylinder S16, possibly since cylinder S14 was cracked while S16 was uncracked. Overall the amount of corrosion was much lesser than that of unwrapped specimens.
- 2) Very less loss of cross-section was observed on the rebars.
