1. Report No. FHWA/TX-08/0-4562-2		2. Government Accession No.		3. Recipient's Catalog No.	
4. Title and Subtitle Durability Evaluation of Post-Tensioned Concrete Beam Specimens after Long-Term Aggressive Exposure Testing			5. Report Date November 2007

Durability Evaluation of Post-Tensioned Concrete Beam Specimens after Long-Term Aggressive Exposure Testing

Center for Transportation Research
The University of Texas at Austin
3208 Red River
Austin, TX 78705

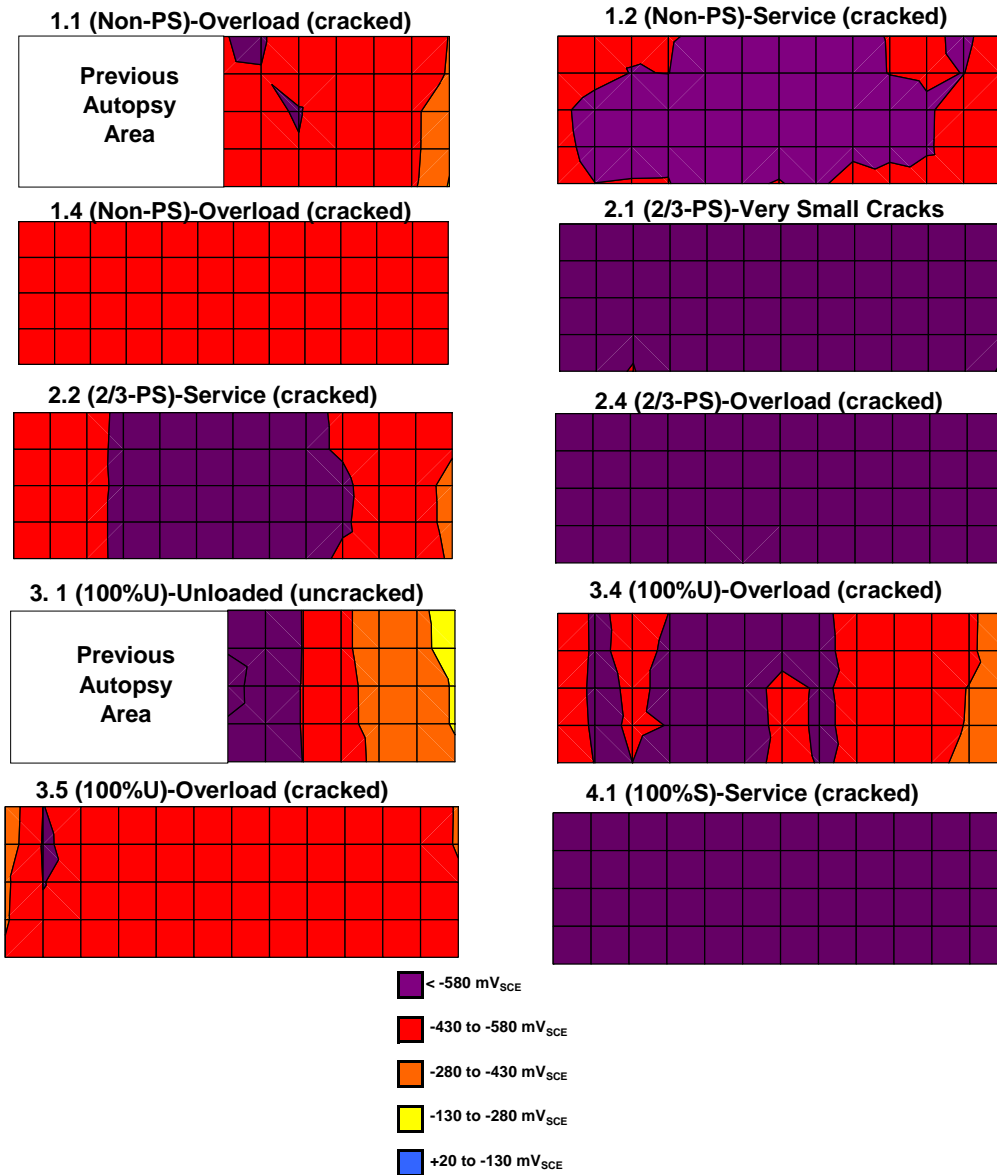
Figure 4.3: Half-Cell Potential Contours at 3,107 Days for Phase I Beams

All Phase I specimens show high probabilities of corrosion. Only a small area of beam 3.1 falls in the uncertain range, while the rest of the beam shows a high probability of corrosion. Based on the -280 mV threshold for 90 percent probability of corrosion, the half cell data can also serve as a means to estimate the time of initiation of corrosion. This is done by examining the most negative monthly reading for each specimen. The estimated time to initiation of corrosion for the Phase I specimens is shown in Figure 4.4.

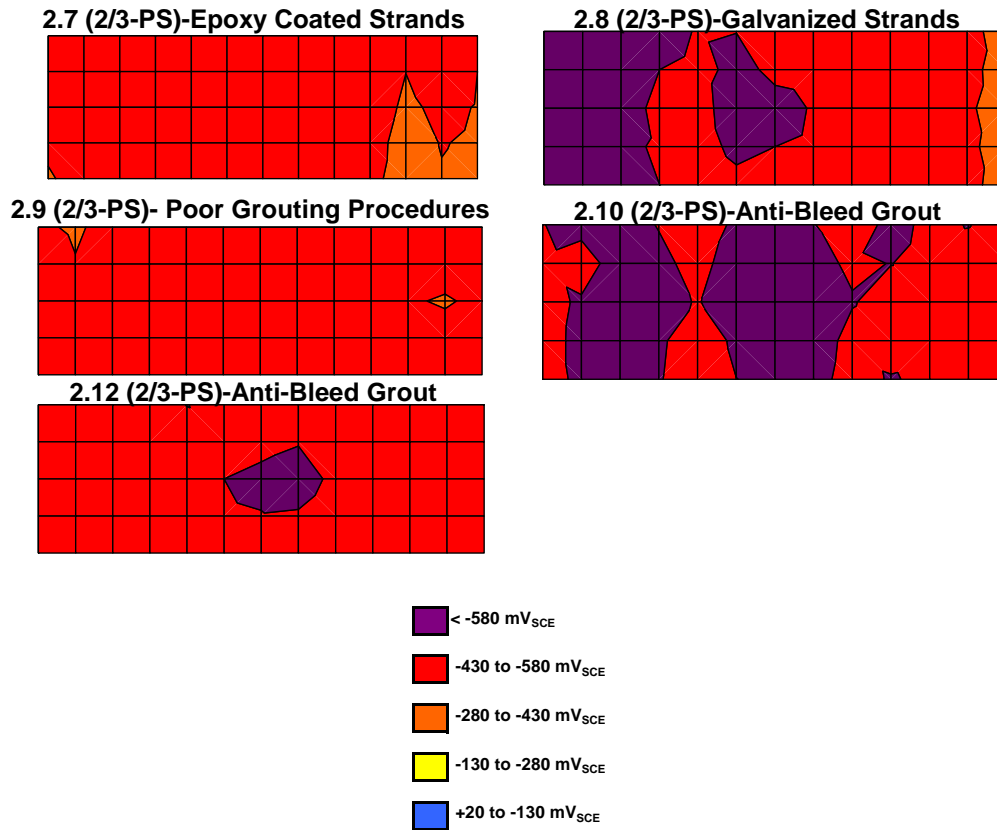
Figure 4.5: Half-Cell Potential Readings at 2,894 Days for Phase II Beams

In Figure 4.5 the final half-cell contours for the Phase II beams are shown. All Phase II beams were partially prestressed, were cracked under service load, and had high probabilities of corrosion at the end of exposure testing. The time to initiation of corrosion for the Phase II beams is shown in Figure 4.6.

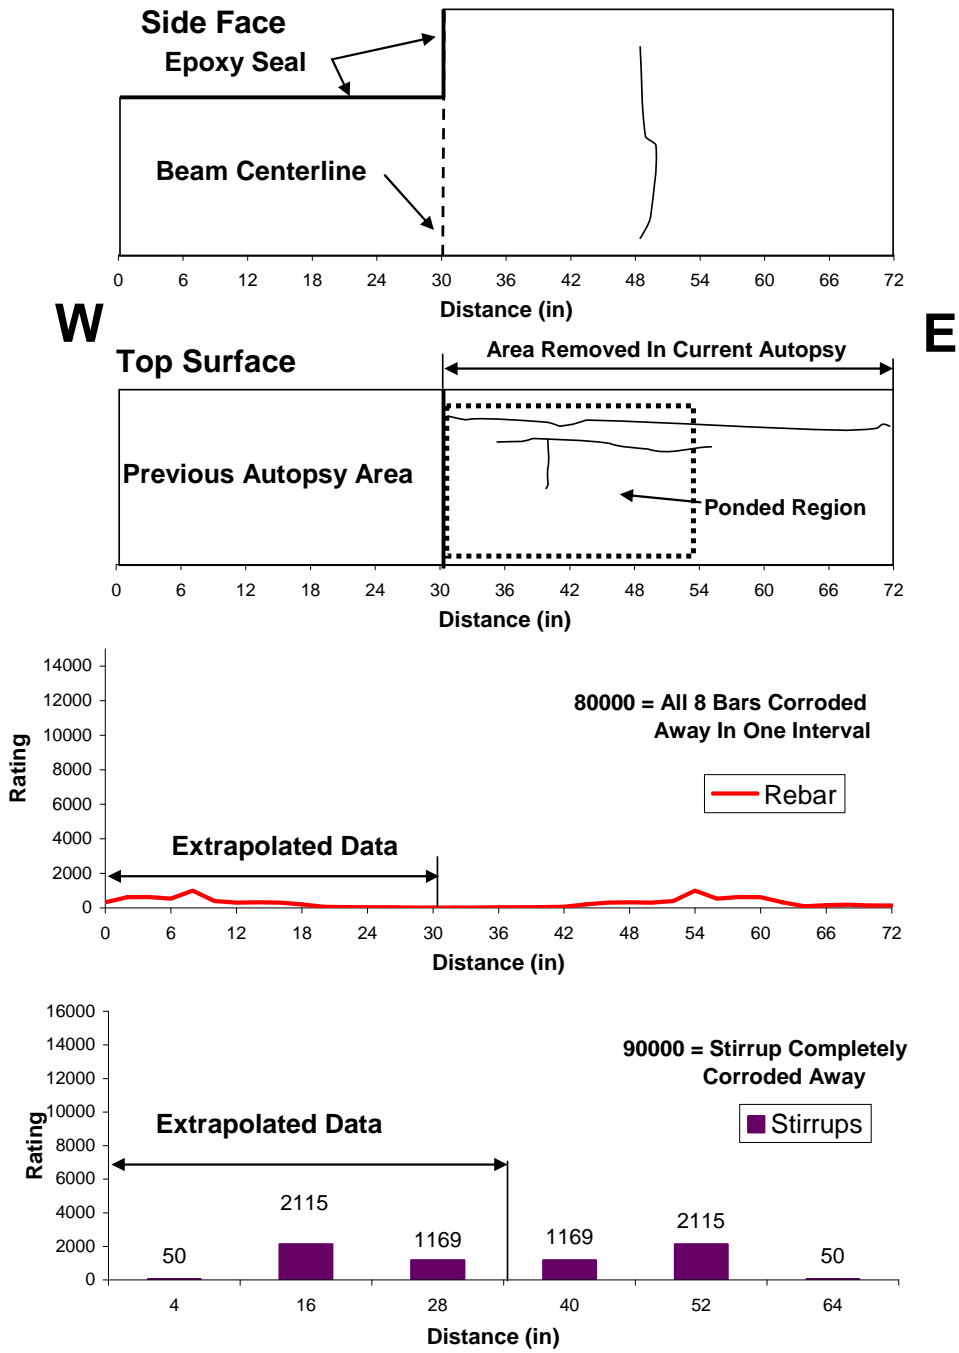
Figure 5.7: Beam 1.1-Crack Patterns and Corrosion Rating Graphs

There was pitting and some cross-sectional area loss on all longitudinal bars and most of the stirrups. The stirrup, which was outside the ponded region, exhibited pitting on its top portion but only moderate corrosion on its legs. The stirrups and bars are shown in Figure 5.8. The ratings for the stirrups and bars, along with the beam crack maps are shown in Figure 5.7. In these plots the sum of the ratings for all longitudinal bars in each 2-in. interval is plotted. The total of the ratings for each stirrup along the length of the autopsy area is also shown. The corrosion ratings for the stirrups and bars are summarized in Table 5.4. In order to compare this beam with the other beams, additional stirrup and bar data were extrapolated in order to have a full 72 in. worth of data. This was done by “mirroring” the data from the section currently autopsied.

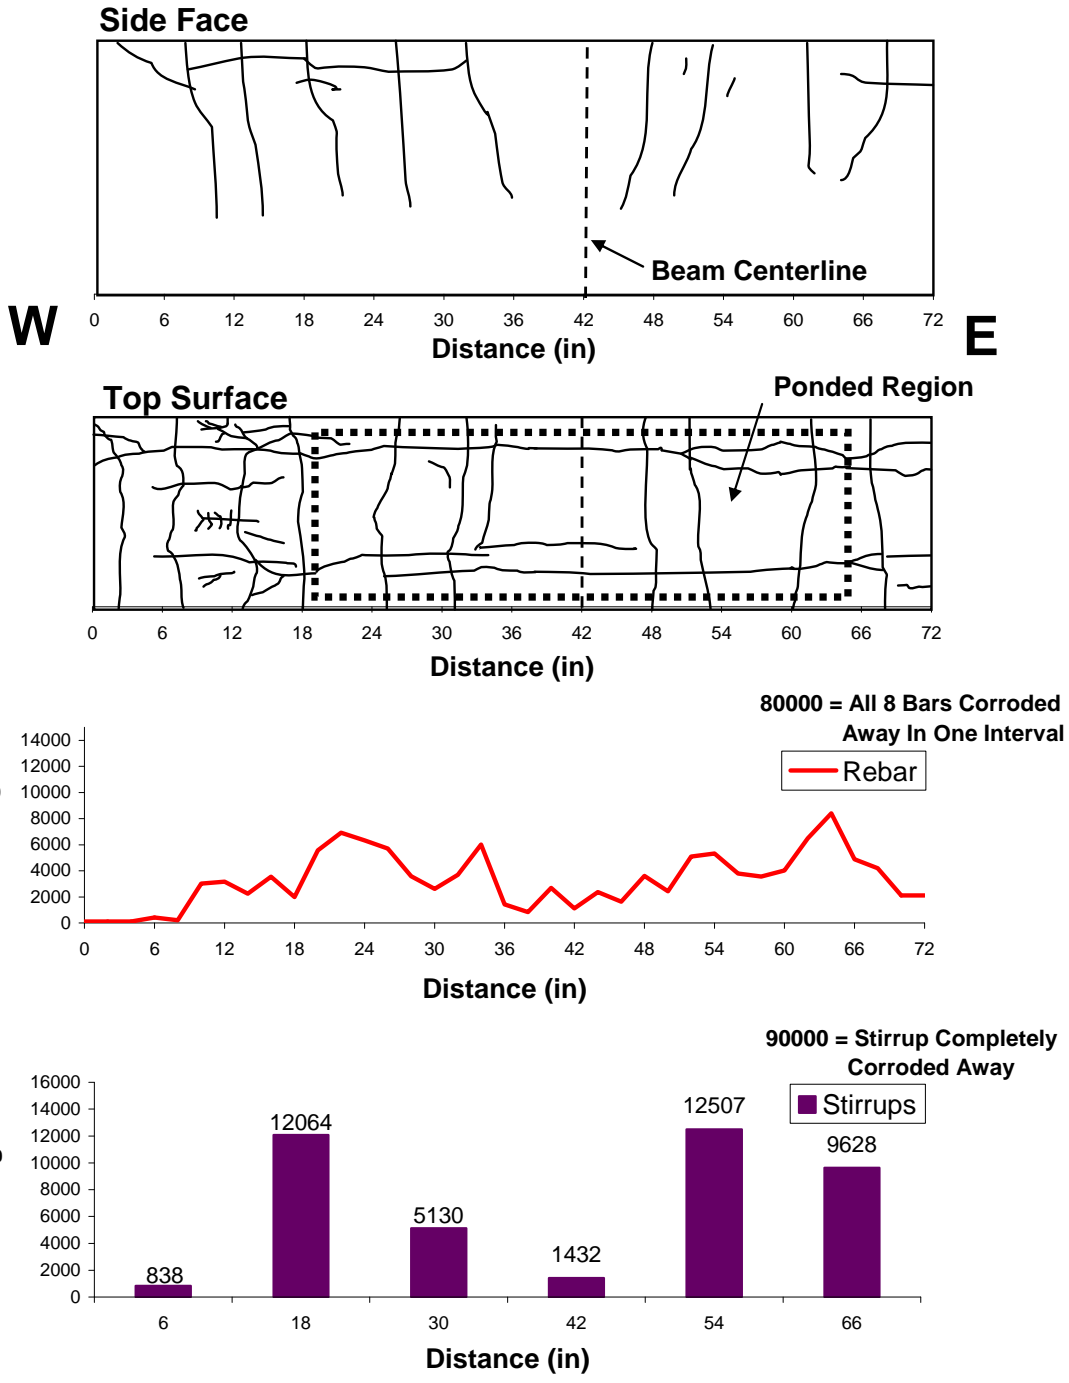
Figure 5.9: Beam 1.2-Crack Patterns and Corrosion Rating Graphs

As shown in Figure 5.9, there was cracking both inside and outside the ponded region. There were large 1/8-in. cracks running from the west end of the salt bath through the entire remaining length of the autopsy area. Bolster strip corrosion was found in multiple locations in the ponded region. Some of the flexural cracks coincided with stirrup locations, while flexural cracks were found in other locations as well. Severe staining was found in the area of these flexural cracks. Also, there was longitudinal cracking on the side face of the beam. The combination of longitudinal cracking on the top and side of the beam would suggest severe bar corrosion, since the expansive effect of the corrosion products is essentially pushing the top corners of the beam off. The crack width data are given in Figure 5.10. After cutting of the beam, it was observed that the longitudinal 1/8-in. cracks actually formed a crack plane right through the level of the severely corroded bars. Thus, corrosion of the bars is responsible for the longitudinal cracking. As the bars corroded, the expansive effects of the corrosion products cracked the concrete. This is shown in Figure 5.11. Note that the block is upside down compared with its position during exposure testing.

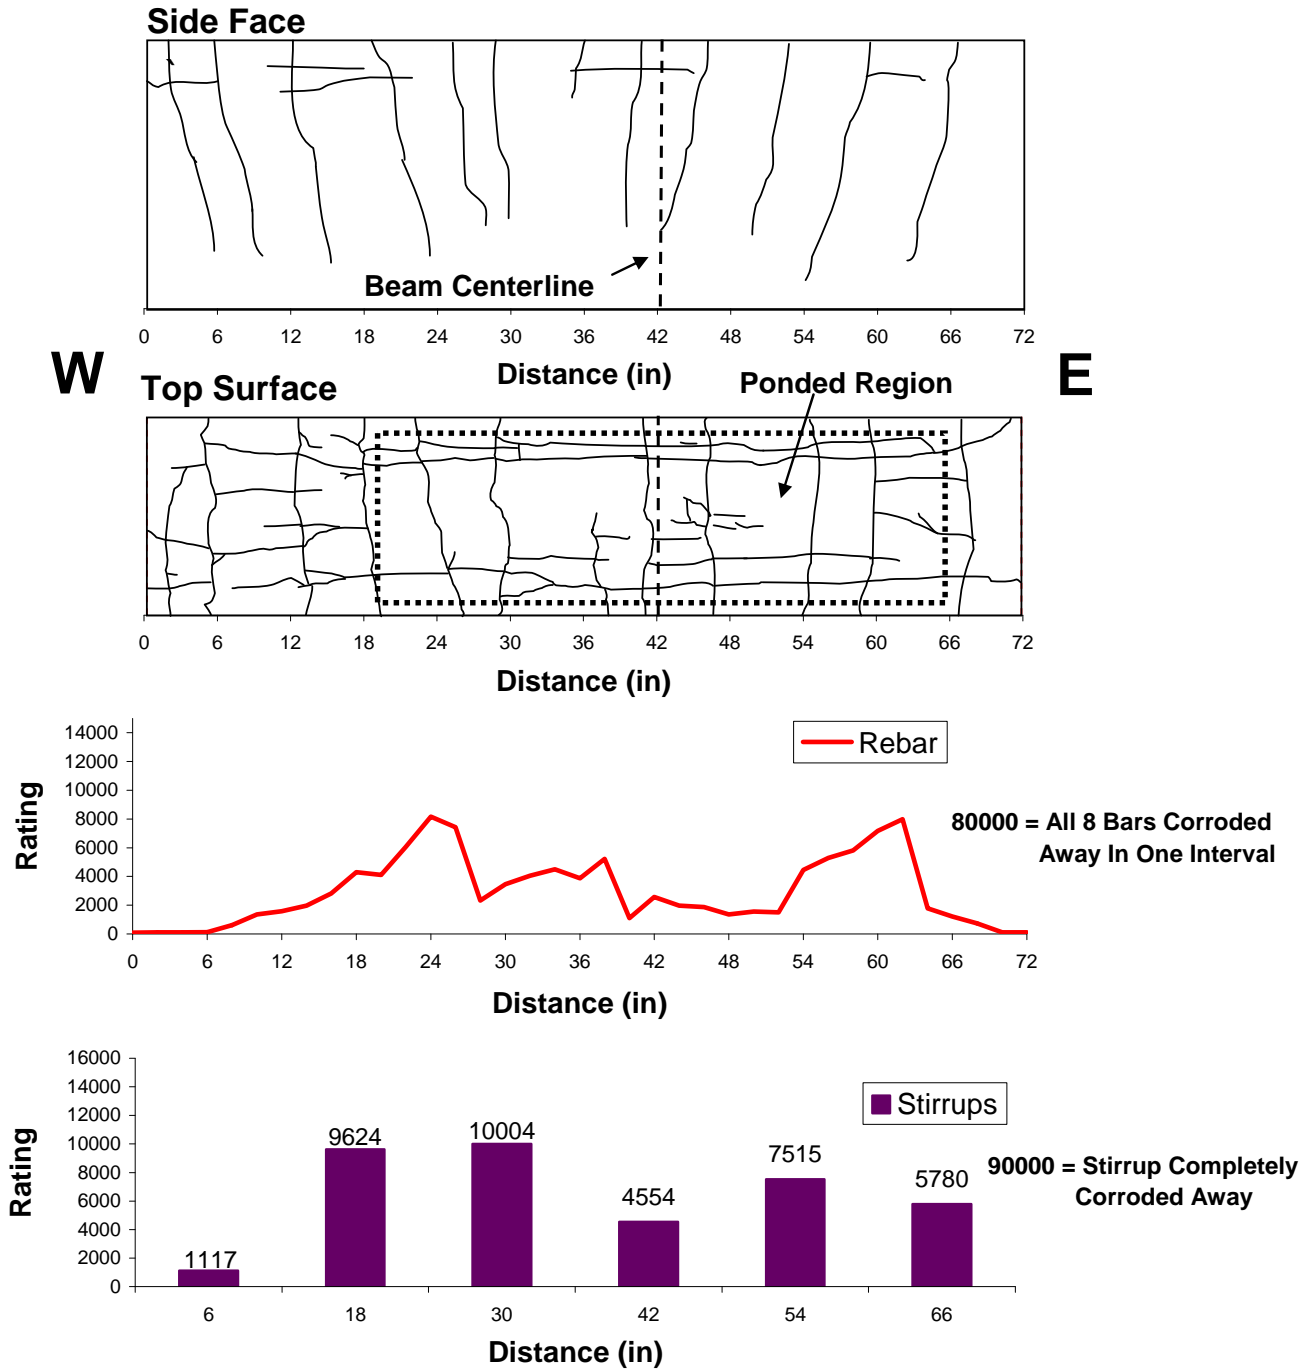
Figure 5.13: Beam 1.4-Crack Patterns and Corrosion Rating Graphs

Considerable cross-sectional area loss and pitting was found on all bars and most of the stirrups, with the most severe area loss in the bars corresponding to the locations of flexural cracks. The worst damage seen on the stirrup was essentially a reduction in diameter from 1/2 in. to approximately 3/8 in. Crack patterns and corrosion rating graphs are given in Figure 5.13 and corrosion ratings are summarized in Table 5.6.

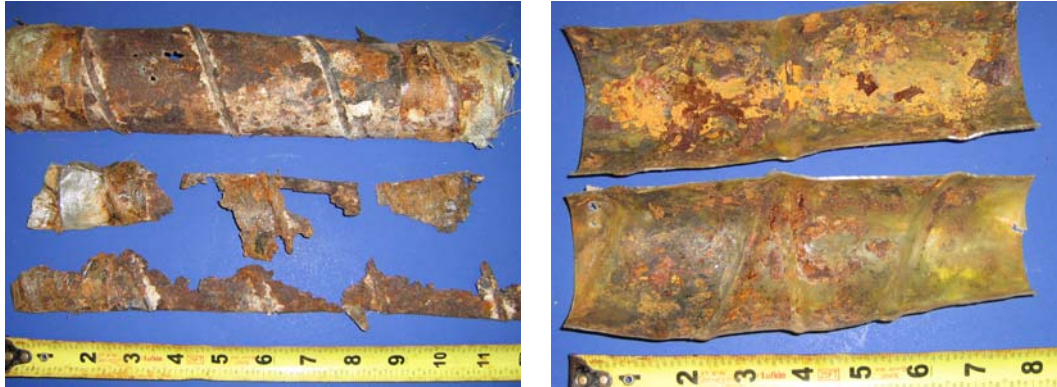
Figure 5.15: Beam 2.1 Duct Splices-South Duct Industry Standard Splice (Left) and North Duct Heat Shrink Splice (Right)

The south duct was fitted with an industry standard splice, while the north duct had a heat shrink splice. The industry standard splice suffered tremendous area loss to its top portion and pitting corrosion was found on the remains of the inside surface of the splice. The duct beneath had large holes and pitting. The heat-shrink splice on the south duct showed severe staining and corrosion deposits on the inside. The section of duct beneath the splice was found to be heavily pitted and holed. In this case the holes were smaller than those in the splice zone of the south duct. The splices are shown in Figure 5.15.

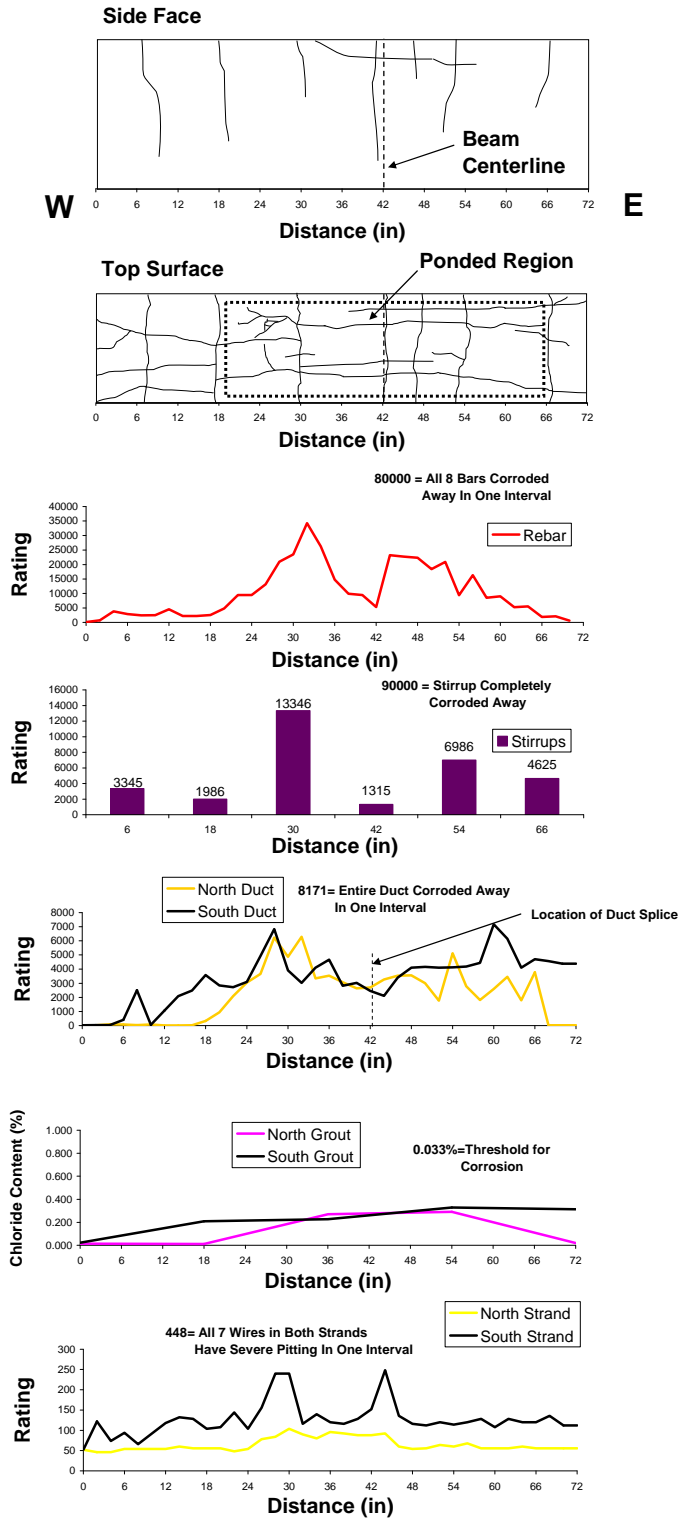
Figure 5.17: Beam 2.2- Crack Patterns and Corrosion Rating Graphs

It is significant that the most severe duct damage observed in the south duct was where the large bleed water void occurred. The presence of the void allowed for moisture to reach the inside of the duct more easily. This is also where the maximum chloride content was observed for this duct. The more severe strand damage in the south duct is likely due to the presence of the bleed water void as well, since the duct corroded away and less grout “cover” was available to the strand. The presence of the industry standard splice likely allowed an initial entry of moisture, but as is clear from the chloride content data, in the end the presence of the splice became negligible as rest of the duct began to corrode away.
