1. Report No. FHWA/TX-11/0-4562-4		2. Government Accession No.		3. Recipient's Catalog No.	
4. Title and Subtitle Evaluation of Corrosion Resistance of Improved Post-tensioning Materials after Long-term Exposure Testing				5. Report Date October 2011

Evaluation of Corrosion Resistance of Improved Post-tensioning Materials after Long-term Exposure Testing

CTR Technical Report:	0-4562-4
Report Date:	October 2011
Project:	0-4562
Project Title:	Corrosion Resistance of Grouted Post-Tensioning Systems
Sponsoring Agency:	Texas Department of Transportation
Performing Agency:	Center for Transportation Research at The University of Texas at Austin

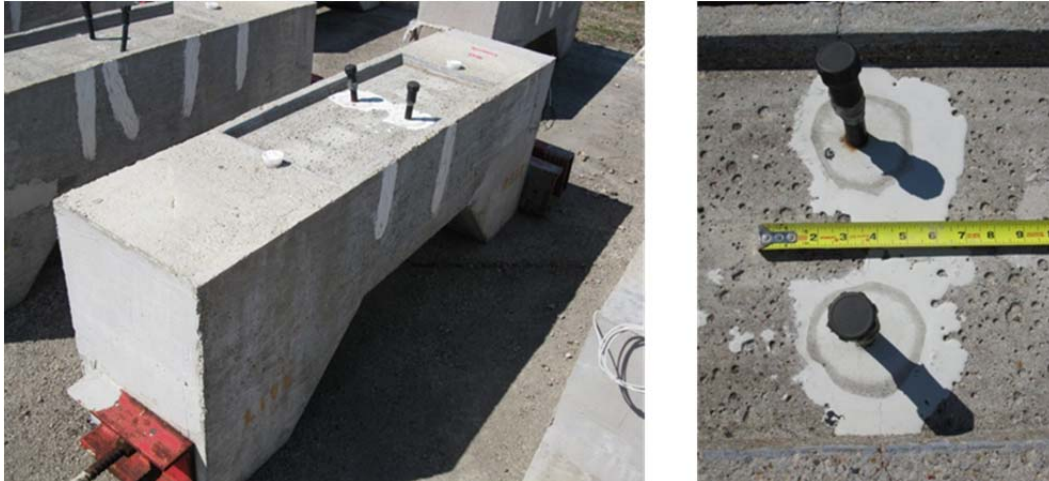
Figure 5.8: Specimen T.1 Overall (Right) and Grout Vents (Left)

This specimen was the first of two trial specimens that were cast prior to the others so that the project team could practice their construction methods. It did not receive anchorage exposure during the testing period. Component corrosion ratings are summarized in Table 5.5.

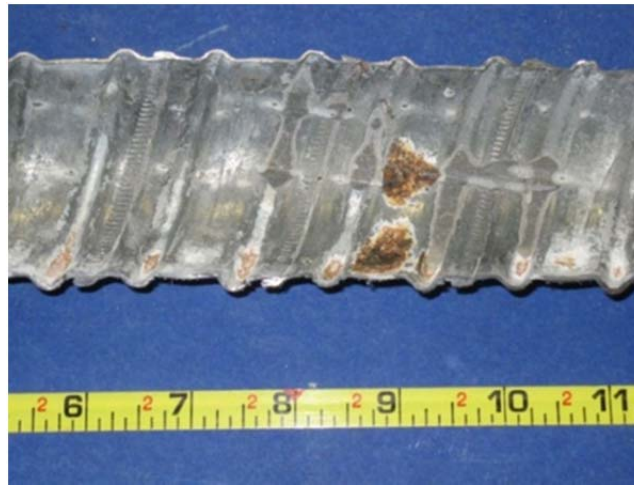
The north and south ducts both had localized severe corrosion damage as shown in Figure 5.10. Most damage on the north duct occurred at midspan and at the live end quarter point. Pitting and corrosion were more extensive on the inside of the duct. The shape and extent of the damage indicate the presence of small grout voids along the top of the entire duct. Significant corrosion and pitting also extended along the bottom inside surface. Here, the location of damage suggests that voids may have formed under the strands during grouting (see Figure 5.9).

Figure 5.9: Specimen T.1, Corrosion Along Gouges on Bottom Half of North Duct

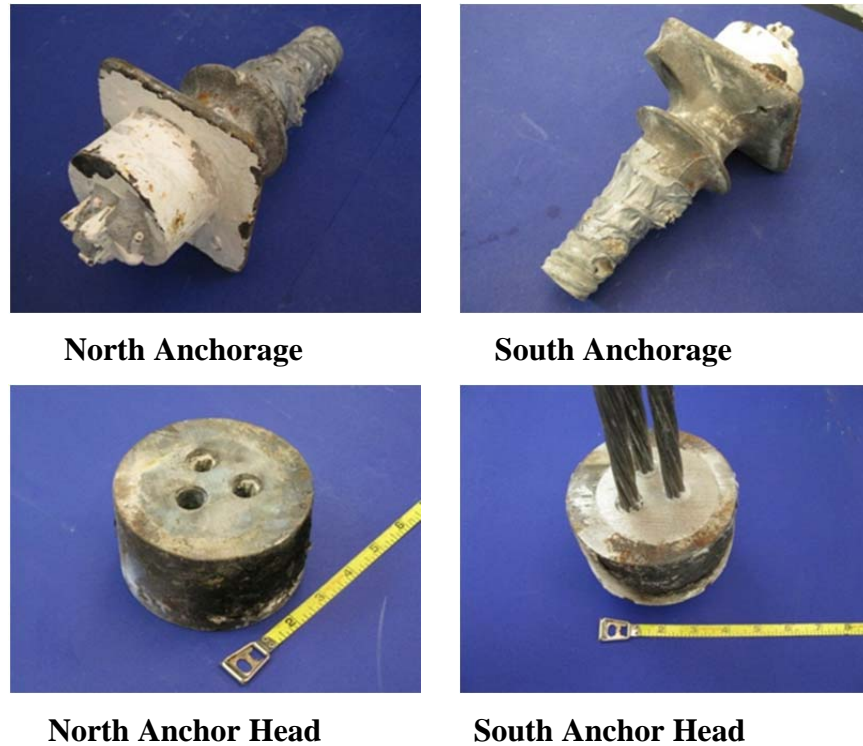
discoloration on all epoxied surfaces. The duct tape used to seal the bearing plate-duct connection was intact on both anchorages. Extensive surface corrosion was found on the surfaces covered by the duct tape. The north and south anchorages and anchor heads are shown in Figure 5.12 and corrosion ratings are given in Table 5.6.

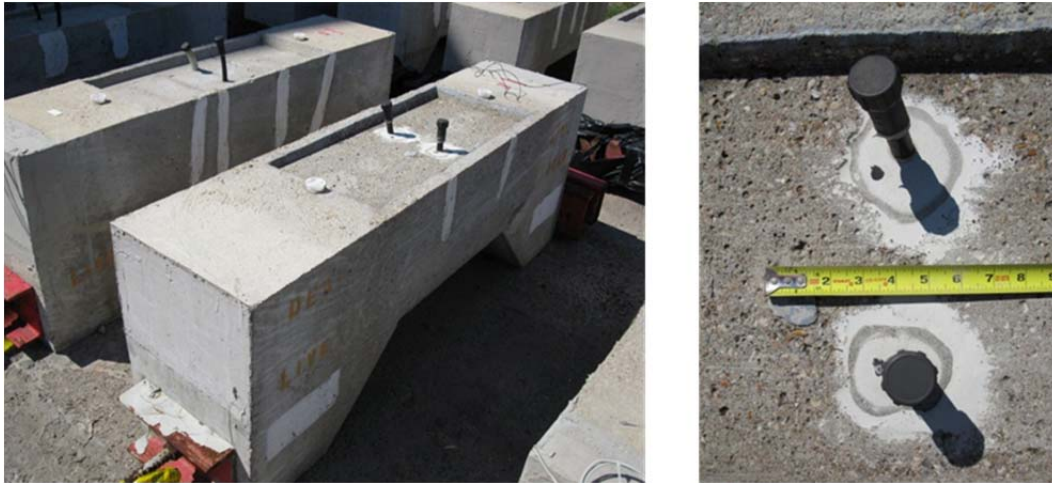
Figure 5.14: Specimen T.2 Overall (Left) and Grout Vents (Right)

This specimen was the second of two trial specimens that were cast prior to the others so that the project team could practice their construction methods. It did not receive anchorage exposure during the testing period. Component corrosion ratings are summarized in Table 5.7.

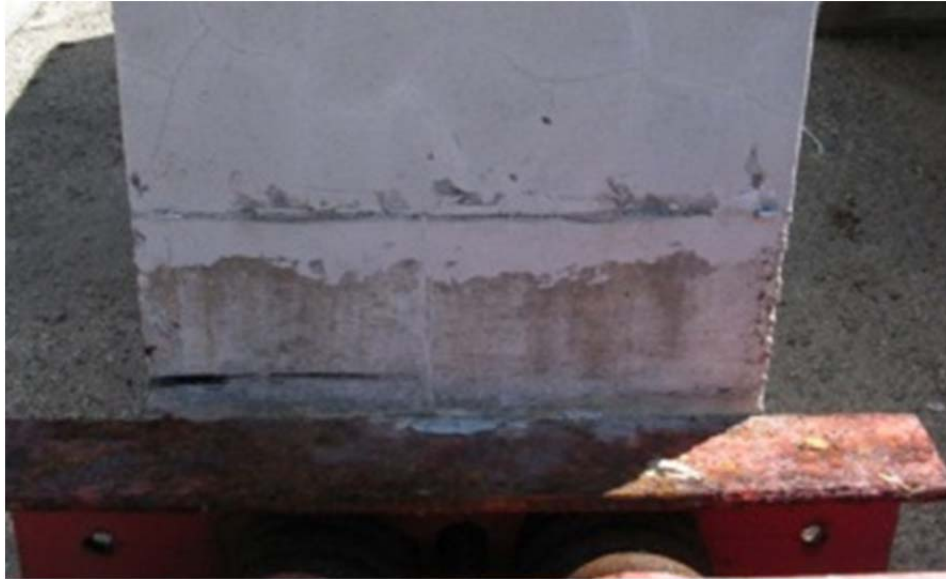
The specimen had two large transverse cracks running along its top face and down its north and south faces, each with an average width of 0.03 inches. The epoxy used to seal the vertical portions of these cracks to prevent leakage was intact. The dead end anchorage pourback showed significant separation as well as some delamination near its interface with the rest of the specimen. This is shown in Figure 5.15. The crack diagram is shown in Figure 5.19.

Figure 5.15: Specimen T.2, Separation and Delamination Around Dead End Pourback

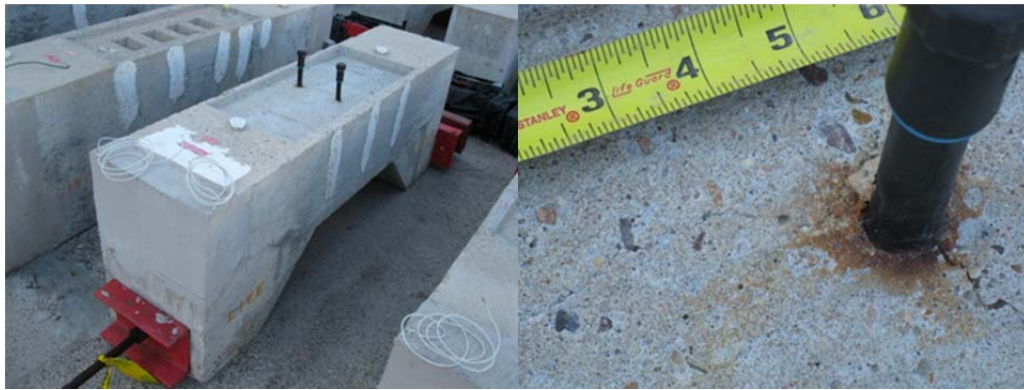
Figure 5.29: Specimen 2.2 Overall (Left) and Corrosion Stains Near Grout Vent (Right)

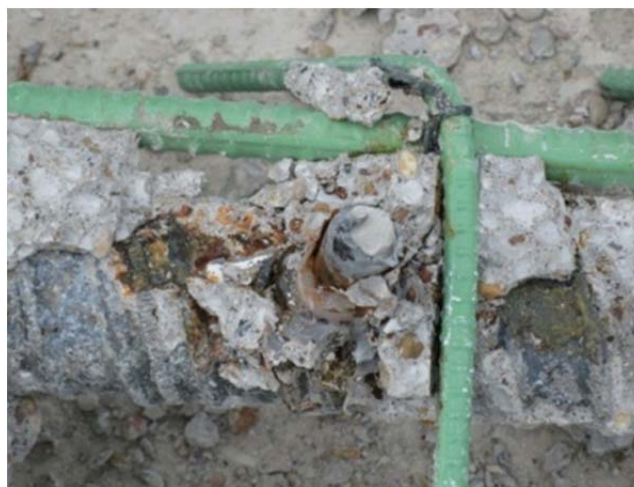
Figure 5.30: Specimen 2.2, Corrosion Staining Under North Grout Vein

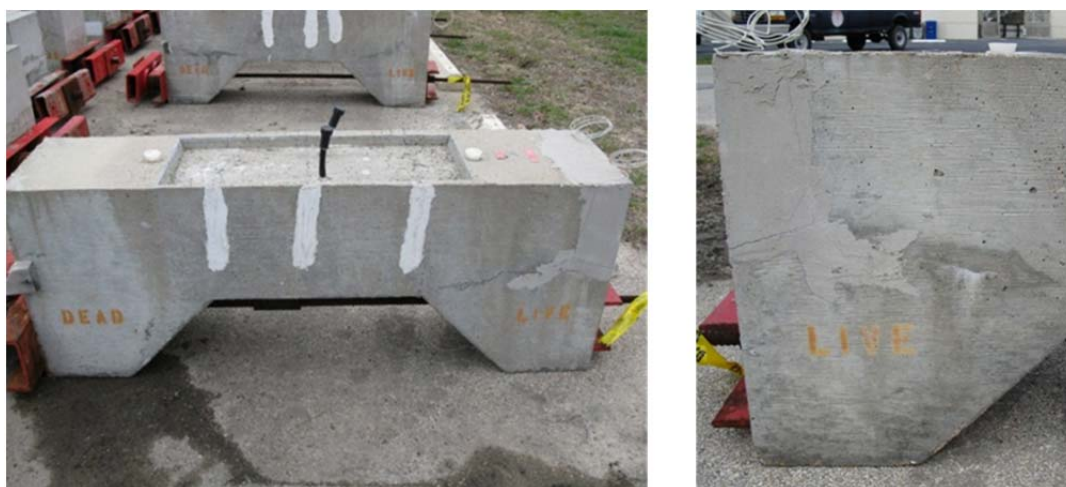
Figure 5.50: Specimen 3.2 Overall (Left) and Efflorescence at Live End Corbel Crack

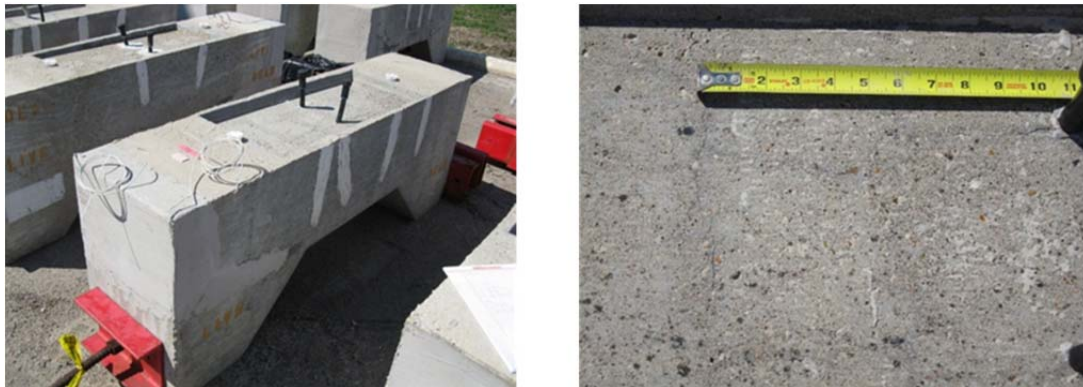
Figure 5.59: Specimen 3.4 Overall (Left) and Discoloration around Surface Cracks (Right)

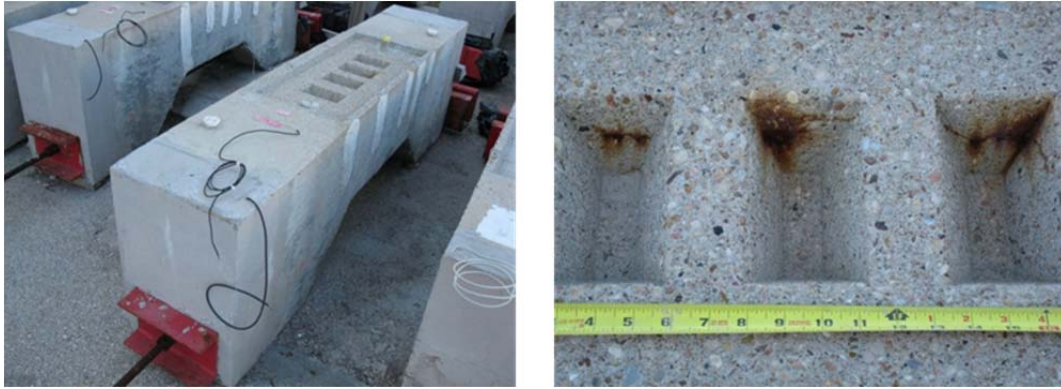
Figure 5.71: Specimen 7.1 Overall (Left) and Corrosion Staining in Saltwater Tray Wells (Right)
