# **Assessment and Rehabilitation Methods for Longitudinal Cracks and Joint Separations in Concrete Pavement**

CTR Technical Report:	0-5444-2
Report Date:	October 2008
Project:	0-5444
Project Title:	Assessment and Rehabilitation Methods for Longitudinal Cracks and Joints Separations in Concrete Pavement
Sponsoring Agency:	Texas Department of Transportation
Performing Agency:	Center for Transportation Research at The University of Texas at Austin

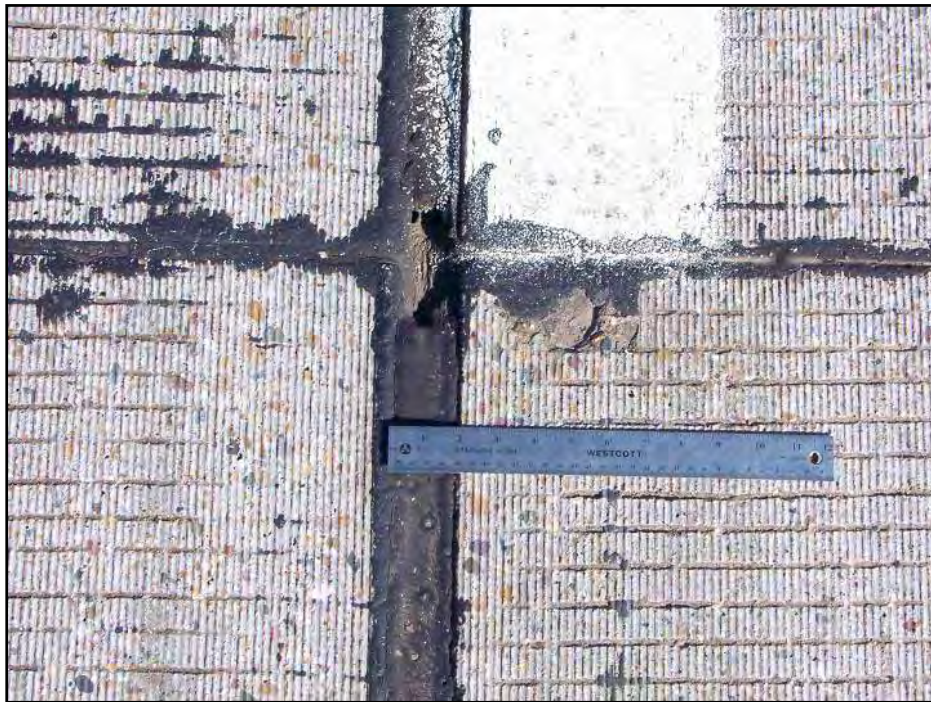
The distance between joint monitoring pins was measured on both trips. Table 3.1 shows the joint width data from both trips. The outside joint grew in width by an average of 0.4 mm, while the middle joint decreased by an average of 0.26 mm over time. The changes indicate at the very least that the roadway crown no longer exists. Further conclusions cannot be drawn because of the limited data set; more frequent measurements leading to a time-history plot of joint movement would be beneficial for TxDOT to pursue in the future. The method used to monitor joint width was very inexpensive and has been utilized by other states (CDOT 2003). The disadvantage is that traffic control is required when measurements are made.

*Figure 3.7: 2-Inch Longitudinal Joint Separation*

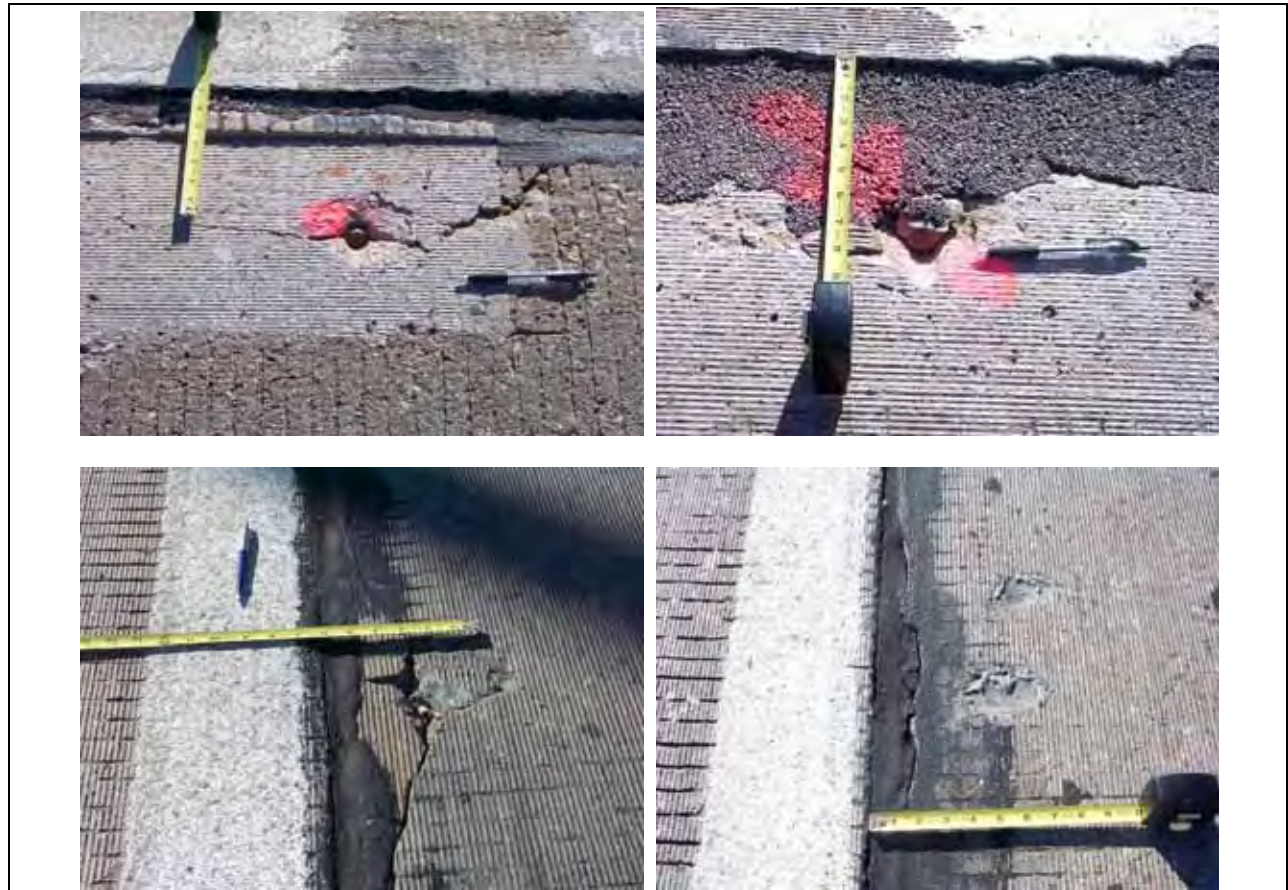
*Figure 3.18: Distressed Stitching in Area Three*

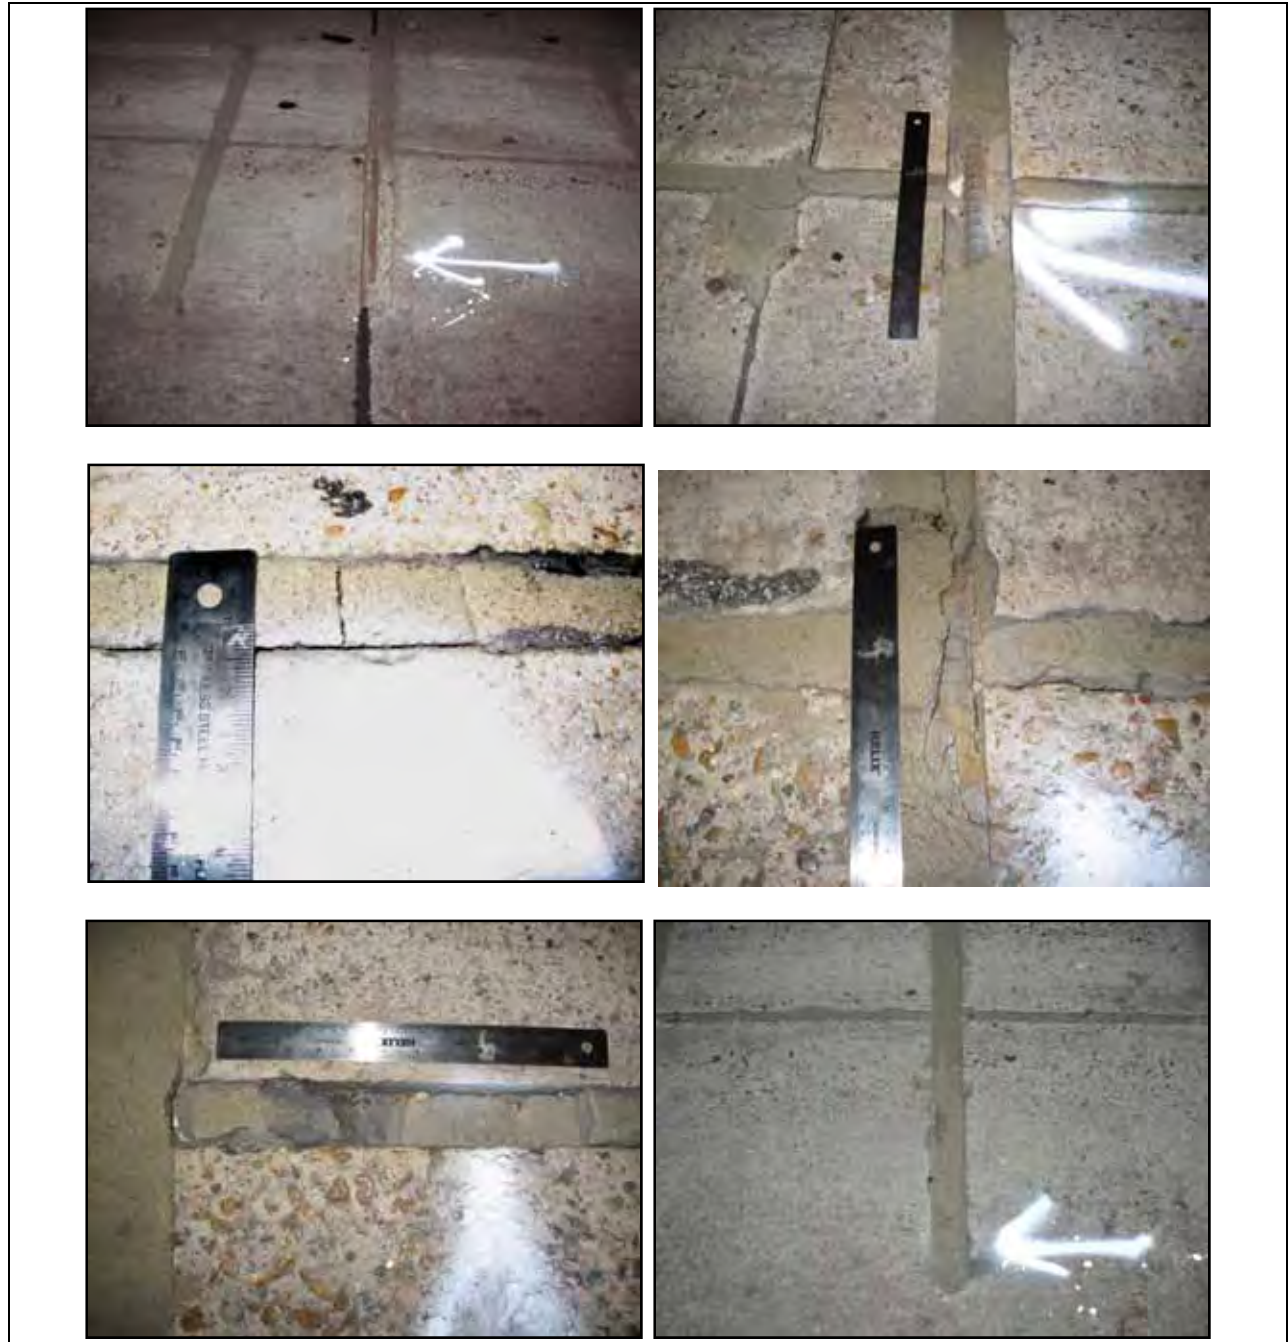
Several areas showed extensive cracking and spalling of the joint filler material; both in the staple slots and in the longitudinal joint (Figure 3.21). Non-compressible material had invaded the joint or slot in those areas. Some joints also showed debonding of the joint filler material with the side walls of the joint.

*Figure 3.21: Deteriorated Stapling Repair Material*

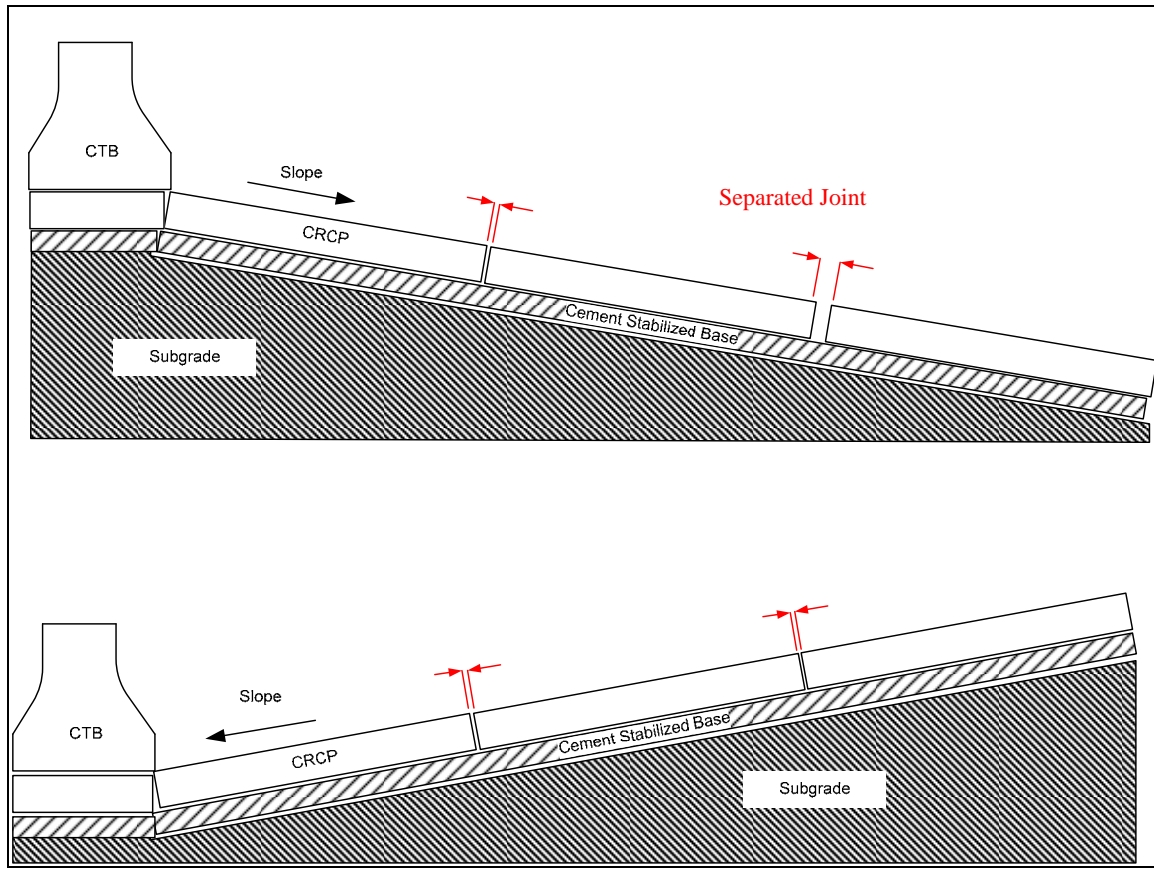
Observation of the pavement slope revealed a pattern in the width of longitudinal joints; in areas where the pavement sloped downward from the concrete traffic barrier (CTB) toward the shoulder, joint separations were larger than in areas where the pavement sloped from the shoulder towards the CTB (Figure 3.76).

*Figure 3.76: Effect of Pavement Slope on Joint Separation*

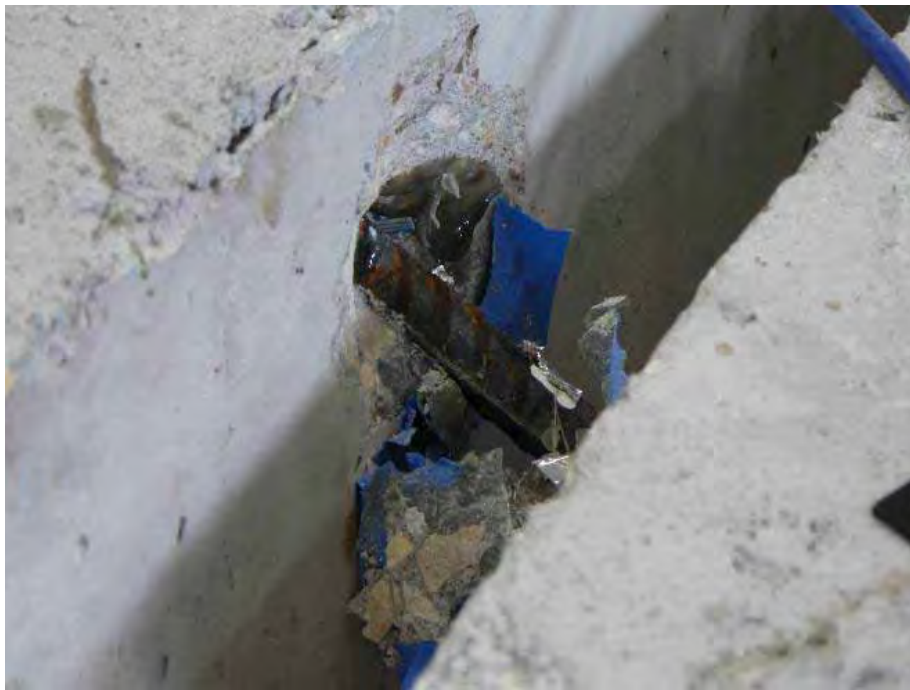
Note: the spalling on the face of the concrete where the bar entered the specimen as seen in Figure 4.46 was not due to testing, but occurred during installation of the stitch bars during hammer drilling of the holes. The bar shown is loaded primarily in flexure, as can be seen from its curvature.

*Figure 4.46: Right Cross Stitch Bar at End of Test*

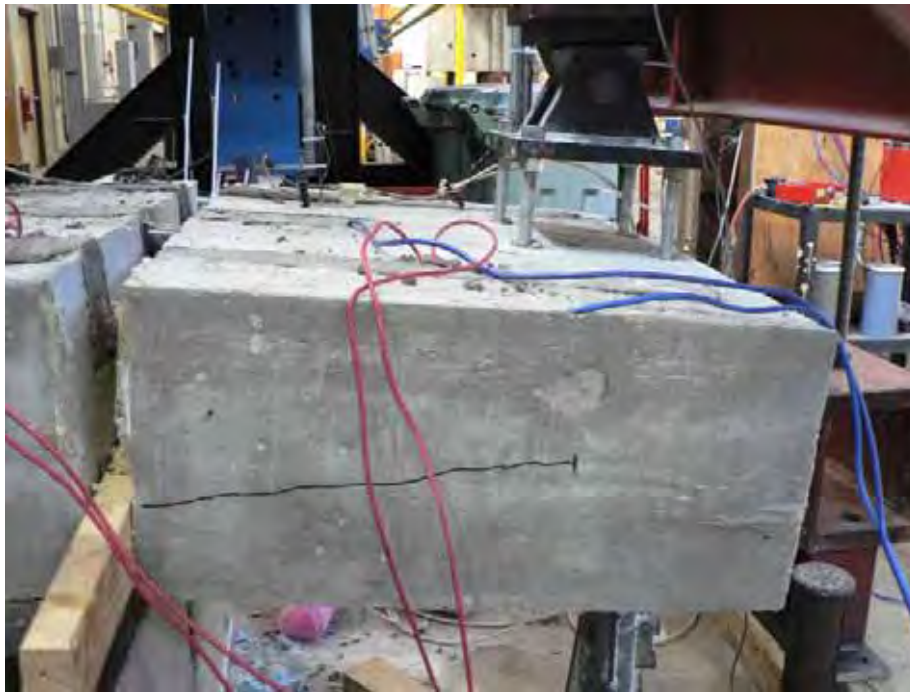
*Figure 4.56: Right Side of Slot Stitch Specimen at Failure*

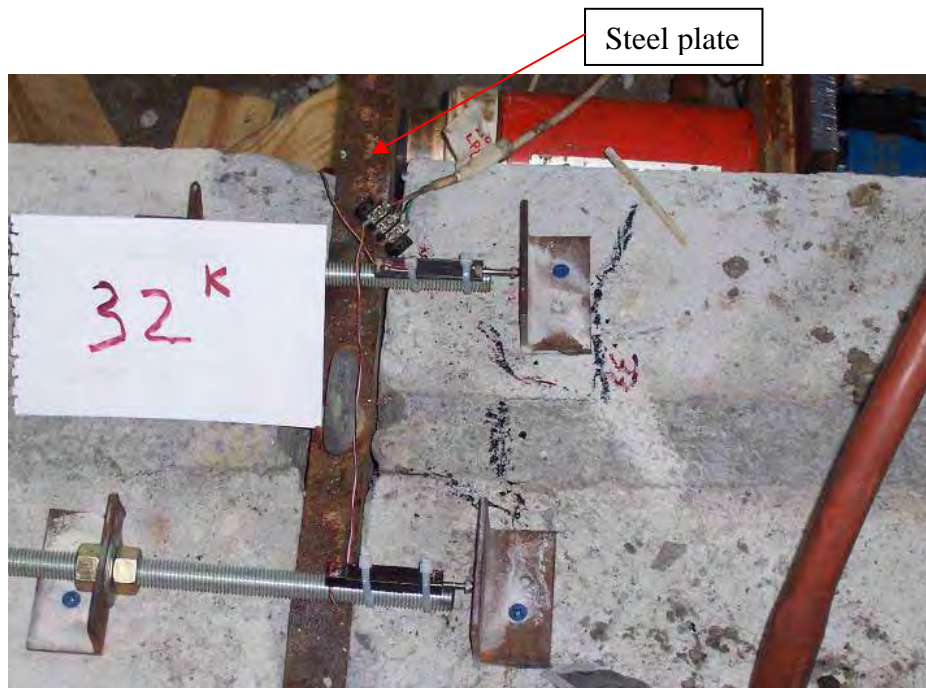
*Figure 4.60: Headed Bar Specimen Cracking at 32 k*

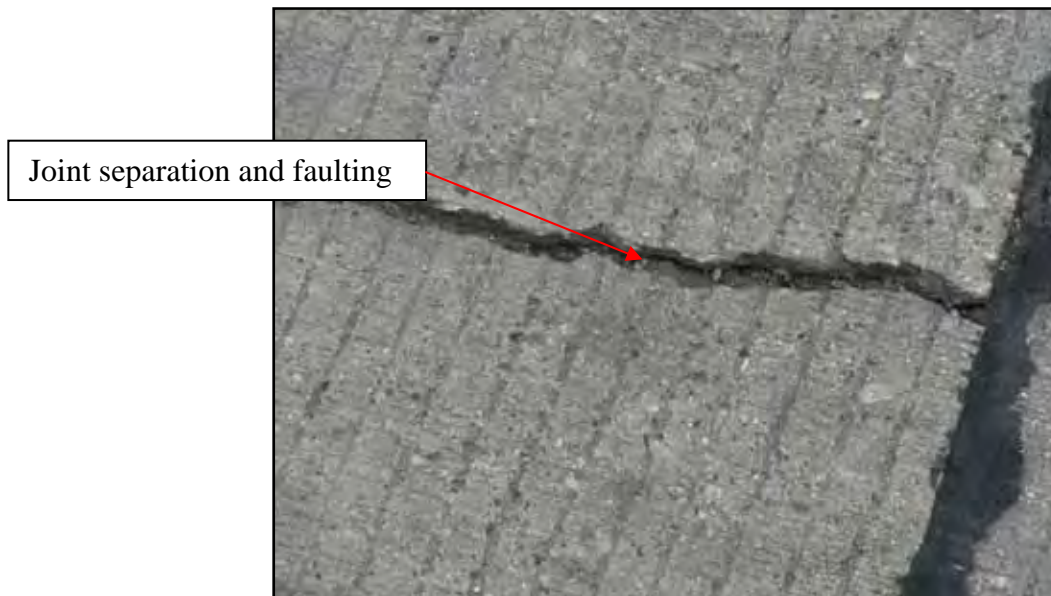
*Figure 4.74: Dallas SH 66 Longitudinal Joint Separation and Faulting*

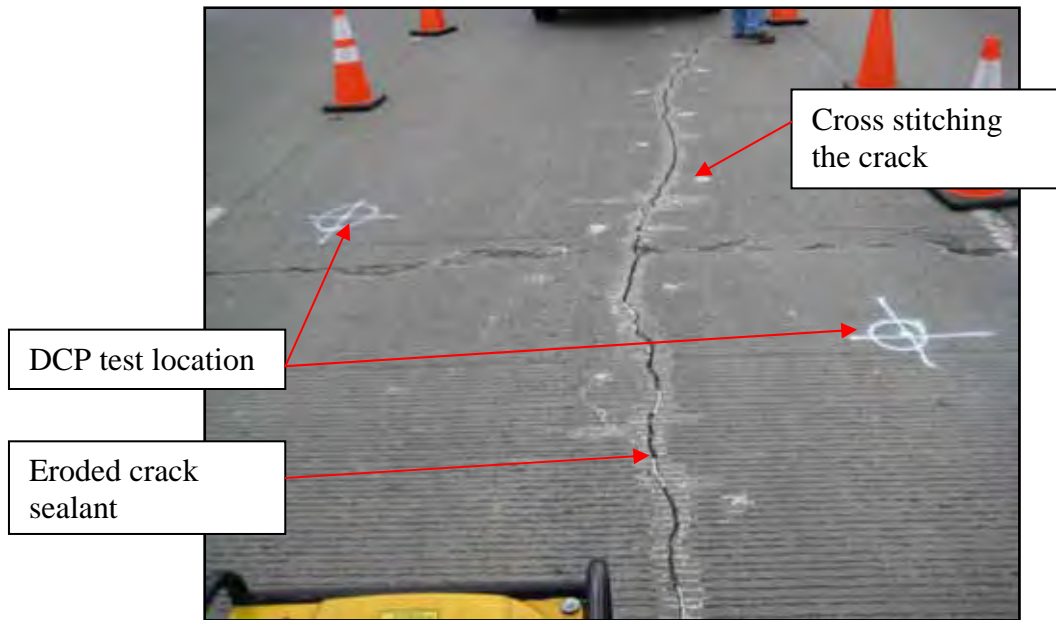
Figure 4.75: Dallas SH 289 DCP Test Location with Cracking
