**CORROSION PERFORMANCE OF EPOXY-COATED
REINFORCEMENT–MACROCELL TESTS**

Research Report No. 1265-3

STRUCTURAL INTEGRITY OF EPOXY-COATED BARS

November 1998

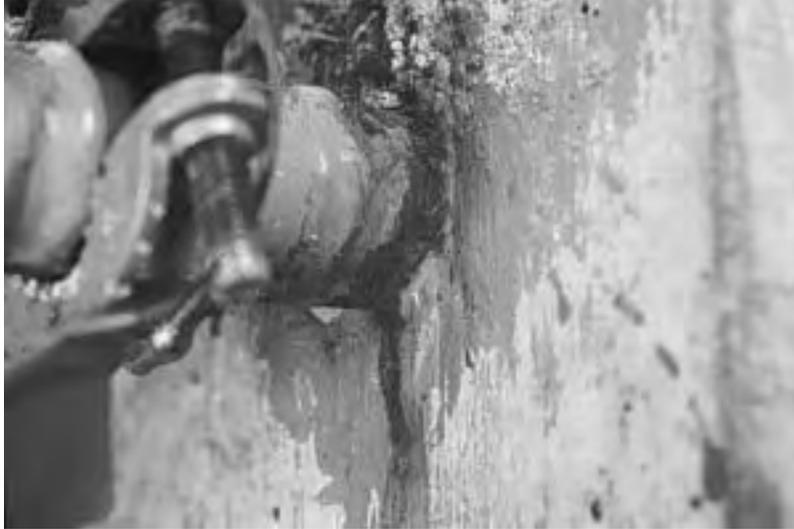
Figure 2.10 Brown solution exuding from protruding bar at front face of specimen.

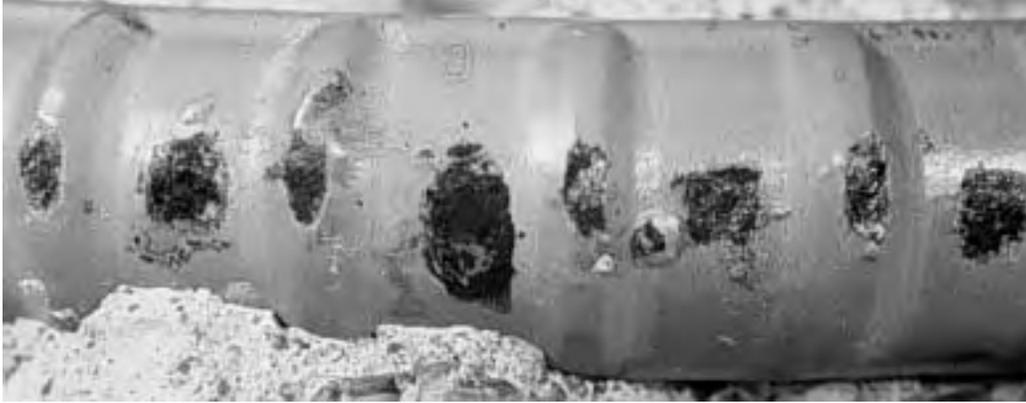
The large bars showed relatively more corrosion activity; however, metal loss was minor as shown in Figure 2.18. Rust spotting at some patched areas was visible. On the majority of the large bars, many variable size blisters distributed on the coated surface were noted. The blisters formed at spots facing air voids in concrete as shown in Figure 2.19. Based on appearance, the worst bars, from both series, were those with exposed damaged areas slightly exceeding 2% of the bar surface area.

Figure 2.18 Example of 25-mm (#8) coated bar specimens after one year of exposure.

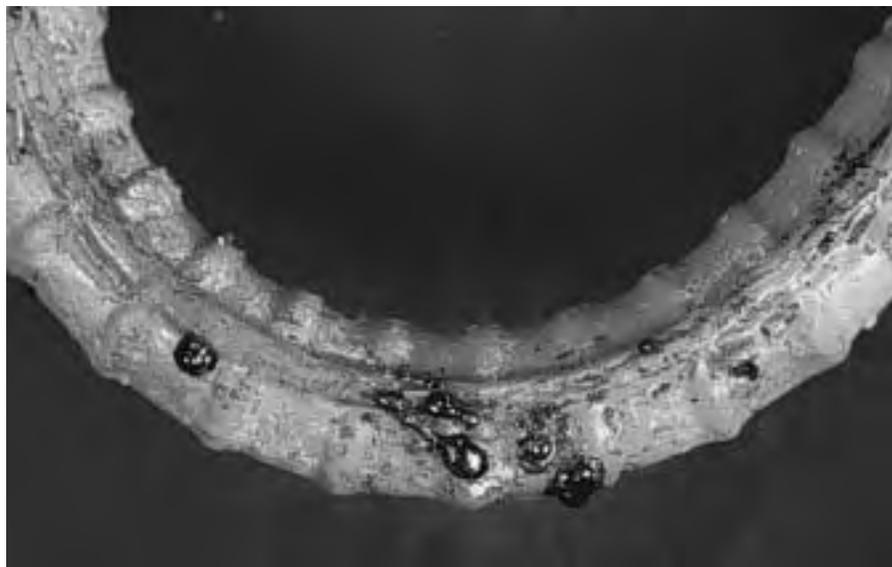
Figure 2.30 Brownish, liquid solution exuded on surface of epoxy-coated bars.

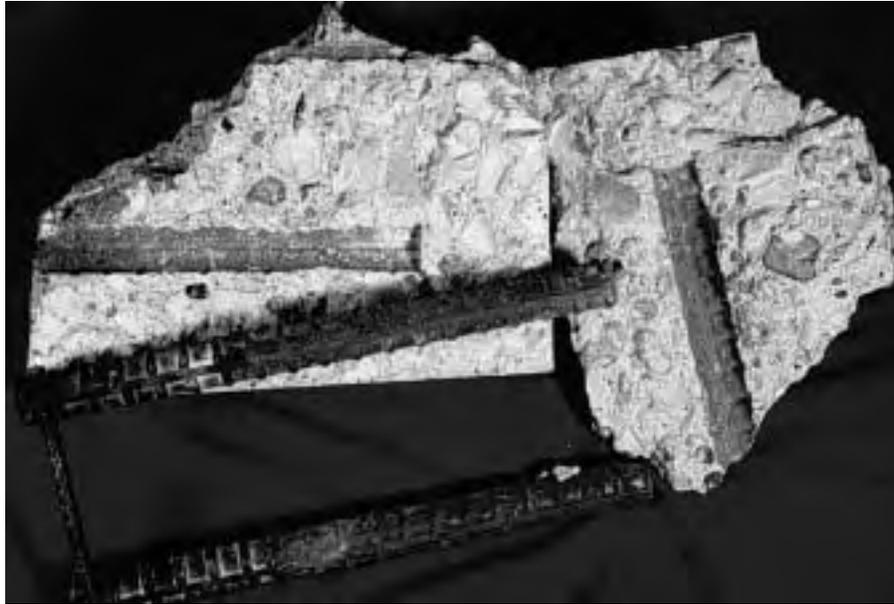
Figure 2.31 Cathodic uncoated bars at bottom of macrocell specimens.

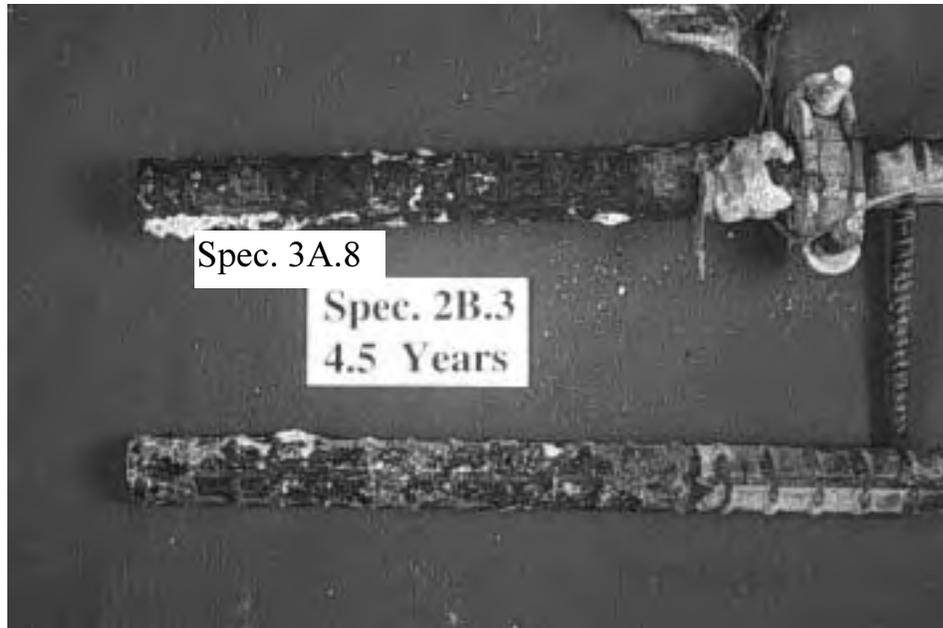
concrete showed extensive dark and reddish-brown rust staining, similar to the corrosion observed on the bars. Sites adjacent to pitted locations in the bars showed accumulation of solid rust products, usually inside concrete voids.

Figure 2.32 Corrosion at bottom side of cathodic, bottom bars of specimen 3A.8.

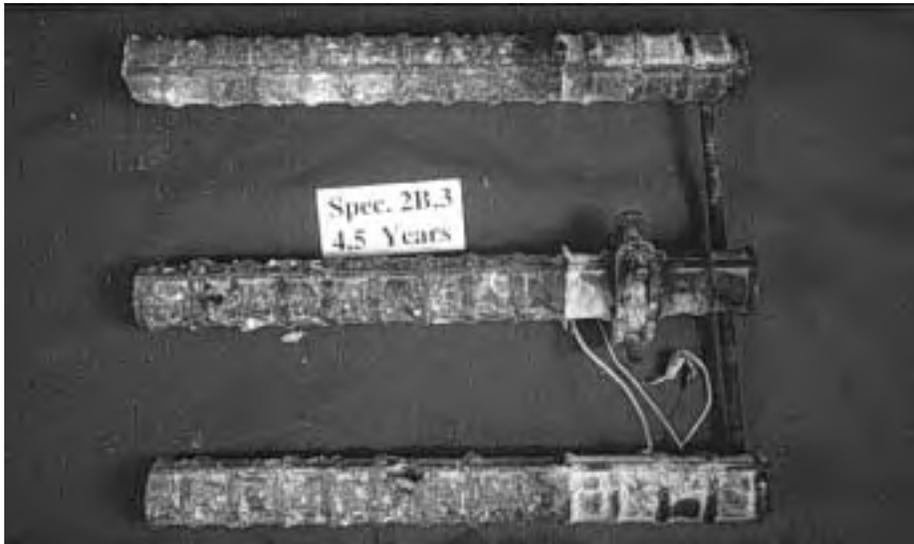
dark stains appeared at the uncorroded portion on the bottom side (a 11.5-cm long zone closer to the front face of the specimen). Laitance was present at the adjacent bar trace in concrete, suggesting that something occurred at the metallic surface (ions that were generated by the cathode may have reacted with concrete). Macrocell currents in specimen 3B.5 experienced incidental large drops between cyclic high and low peaks after 2 years. This suggests that corrosion of the cathodic bar started to affect the currents measured.

Figure 2.33 Appearance of bottom side of cathodic, bottom bars of specimen 2B.3.

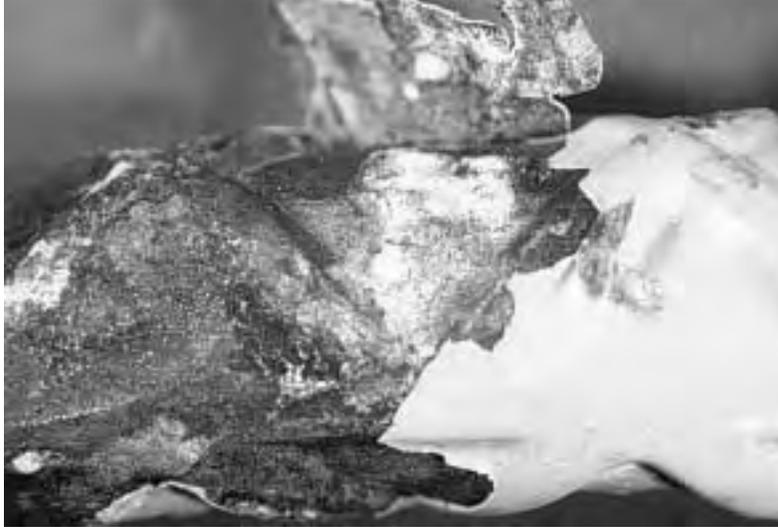
After two years, specimens showed moderate underfilm activity and pitting. There was a clear distinction between the appearance of the top and bottom sides of the bar. The top side was black, and sometimes moist, while the bottom side was dull with sporadic rust spotting as shown in Figure 2.38. Even the patched large bars showed surface darkening with minor metal loss or slight pitting as shown in Figure 2.39. Whitish and orange residue was occasionally observed in some pockets forming alongside the bottom continuous rib as shown in Figure 2.40. The blisters were often full of corrosion products and some had an acidic (pH 2 to 4) trapped solution. Figure 2.41 shows a close up of the solution detected underneath the coating.

Figure 2.37 Underfilm corrosion (undercutting).

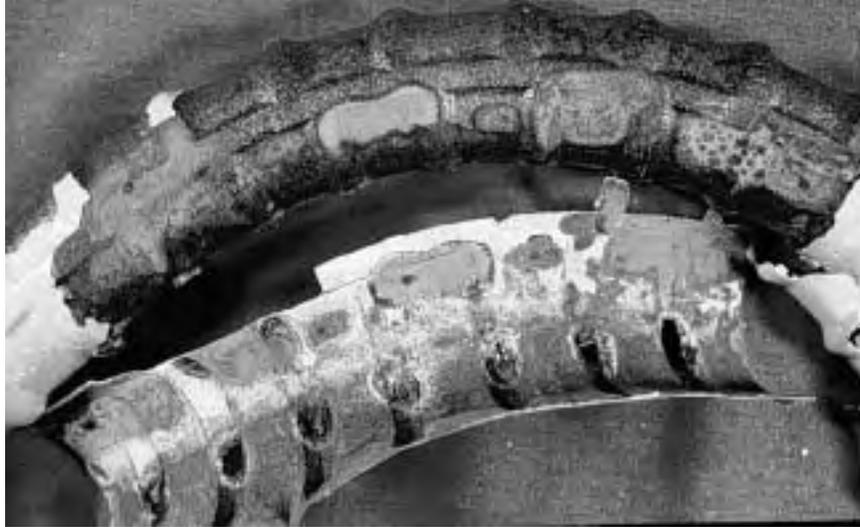
Figure 2.40 Corrosion deposits on bottom side of steel surface.

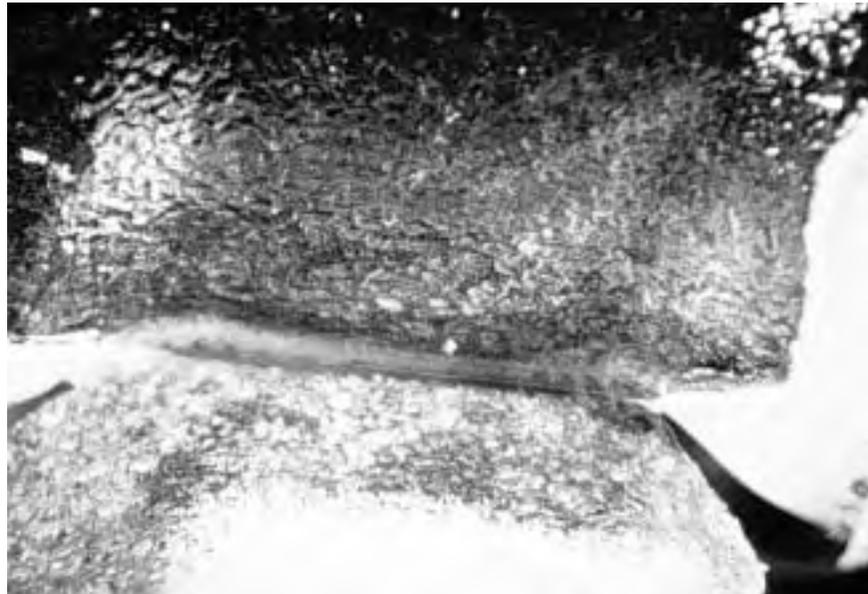
Figure 2.41 Trapped solution beneath epoxy coating.

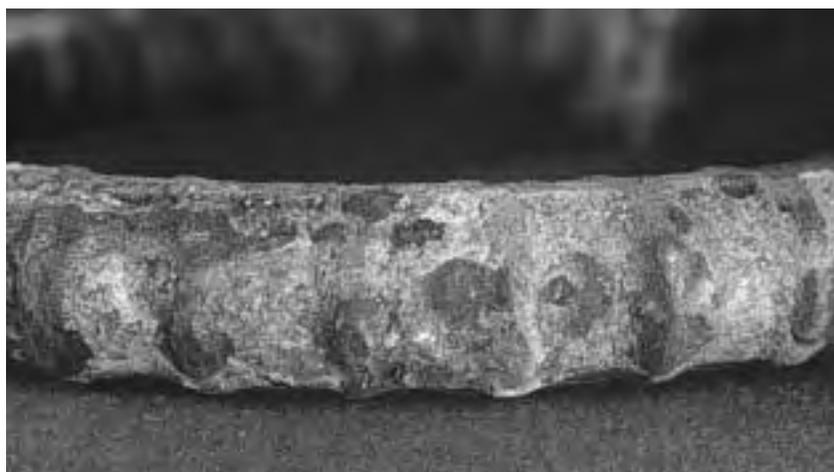
Areas with rust deposits or pockets of varying size, shape, appearance, color, and amount were usually present along the bar surface above the uniform black rusted surface (Figures 2.42 and 2.43). The size of such rust spots ranged from very large, occupying large areas of the bar surface, to small flecks. Appearance of rust spots was dependent on rust concentration, varying from a light film of rust, similar to a stain, to thicker layers of rust deposits. Rust layers at some spots were bulky enough to cause a bulge in the coating, but in most instances, rust amounts in such areas were light. At the time of autopsy, whitish products were the most prevalent. After a few days of being exposed to air, more commonly found colors were light-brown, reddish-brown, orange-brown, and yellowish-brown. Many of the larger and medium-sized rust stains often had shapes with clearly delineated boundaries, giving the appearance of traces or remains of a solution (Figure 2.43). Several rust spots or stains appeared to be wet. In one case (bar 3B.5), a silver-colored stain was detected (top side of bar between bent zone and right straight leg) immediately after removing the coating. One hour later its color changed to whitish, and 2 days later changed to dull-brown and orange-brown. At the bottom side of bar 1A.5, a whitish substance found alongside a longitudinal lug (bent zone and straight right leg) turned yellowish-brown a few hours after coating removal. Such matter was deposited along a strip, giving the appearance of a solution trace (Figure 2.44).

Figure 2.42 Various rust products above uniformly black corroded surface under the coating.

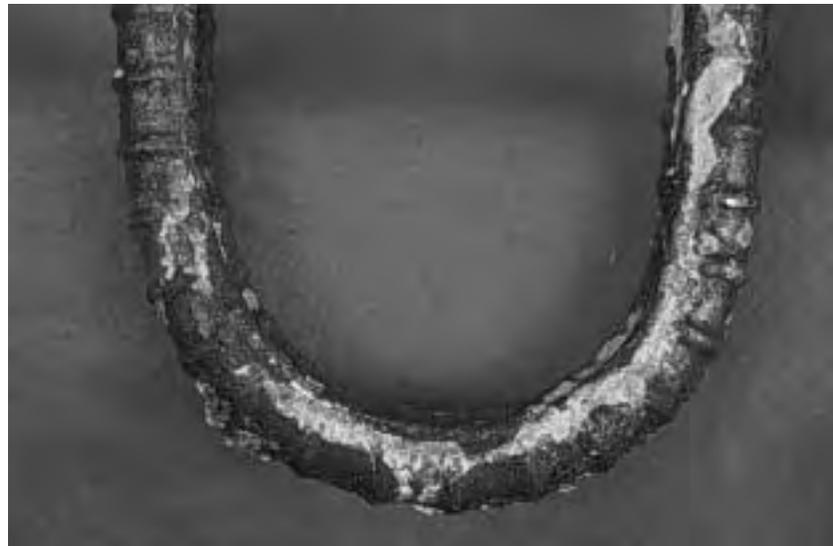
Figure 2.44 Whitish products alongside longitudinal lug at bottom side of bar 1A.5.

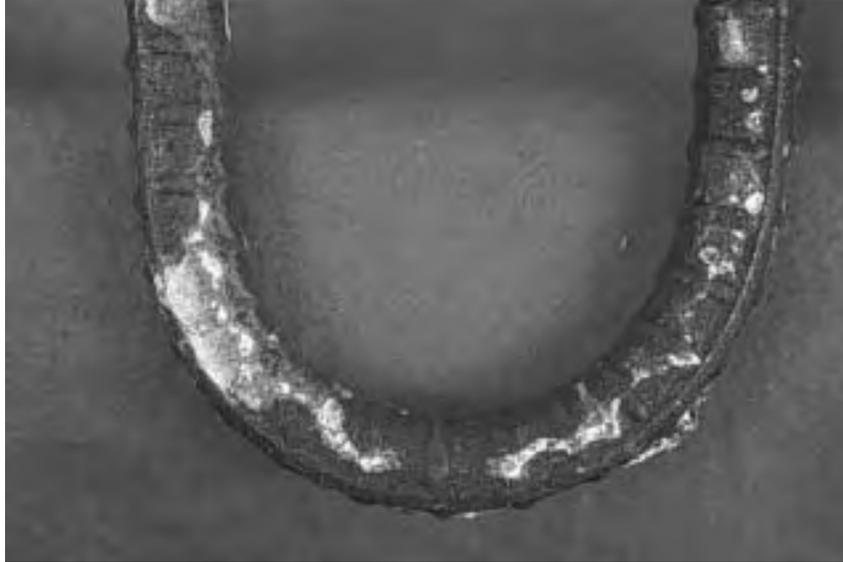
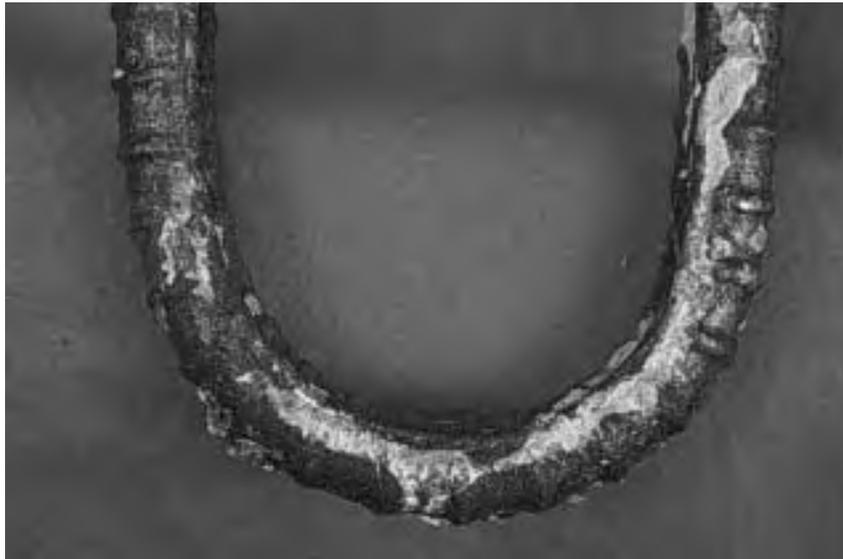
Among smaller bars, specimen 1A.5 (damage > 2%) suffered the worst corrosion (Figure 2.45), followed by bars 2A.6 (cracks with damage < 1%) and 1A.10 (damage > 6x6 mm). The bar with best condition was, amazingly, 3A.3 (damage > 6x6 mm) (Figure 2.46), followed by bar 3A.7 (damage < 2%). Among larger bars, specimen 3B.5 (damage > 2%) suffered the worst corrosion (Figure 2.47), followed closely by bar 3B.4 (damage > 2%, patched). The extent and severity of corrosion was similar for the remaining bars. Interestingly, in bars with damage greater than 6x6 mm, corrosion spread much more on the repaired bar (3B.2) than on the unrepaired bar (2B.3).

Figure 2.45 Whitish and yellowish-brown corrosion products on bar 1A.5.

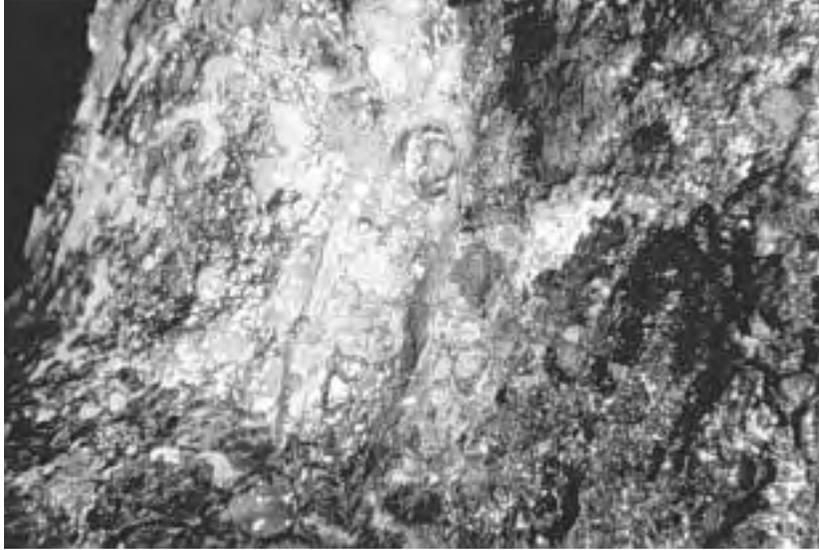
Forensic examination of bar specimens, in general, confirmed the findings of the rate of corrosion analysis. All epoxy-coated bar specimens experienced less steel corrosion than control specimens. Figures 3.16 and 3.17 show close ups of surface corrosion of an uncoated bar and a damaged coated bar specimens, respectively. The figures illustrate severe surface degradation of the uncoated bar relative to superficial corrosion on the exposed steel of the coated bar.

Figure 3.16 Surface corrosion of uncoated bar after one year of exposure.

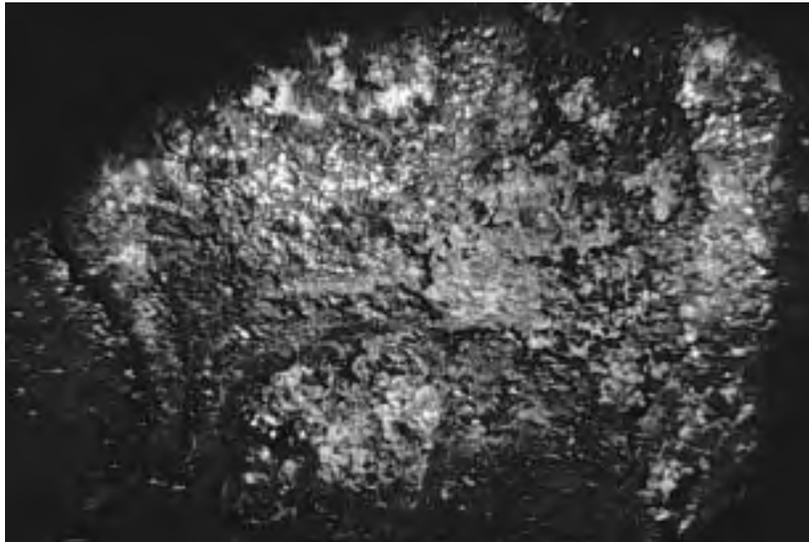
Figure 3.17 Surface corrosion of coated bar after one year of exposure.

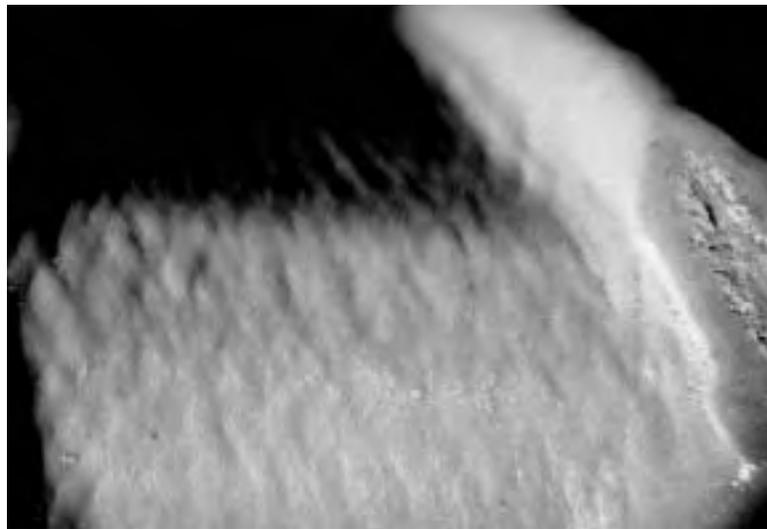
Damage on the inside of bend is usually neglected mainly because the region is compressed instead of stretched. However, coating debonding may still occur. Bending a coated bar generates high shear stresses at the steel/coating interface on both sides of the bend. The stresses may break the adhesion creating paths for oxygen and water migration to the debonded region. Figure 3.19 shows the microscopic ripples that form on a compressed coated surface. Localized compressive residual stresses at the metal surface have been recognized as a factor to initiate corrosion at the inside of bends.³⁷ Such a phenomenon explains why sheet steel often rusts first at bent edges.

Figure 3.19 Compressed coating surface.

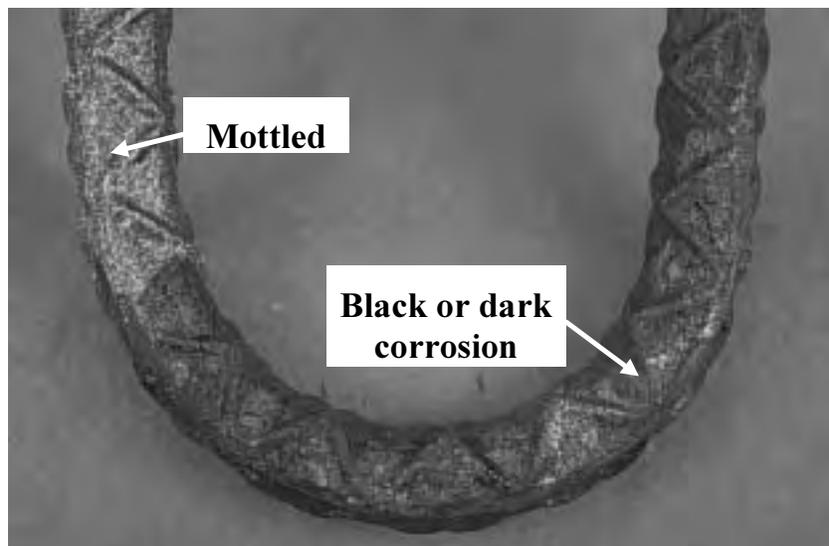
(b) Black or dark corroded surface.

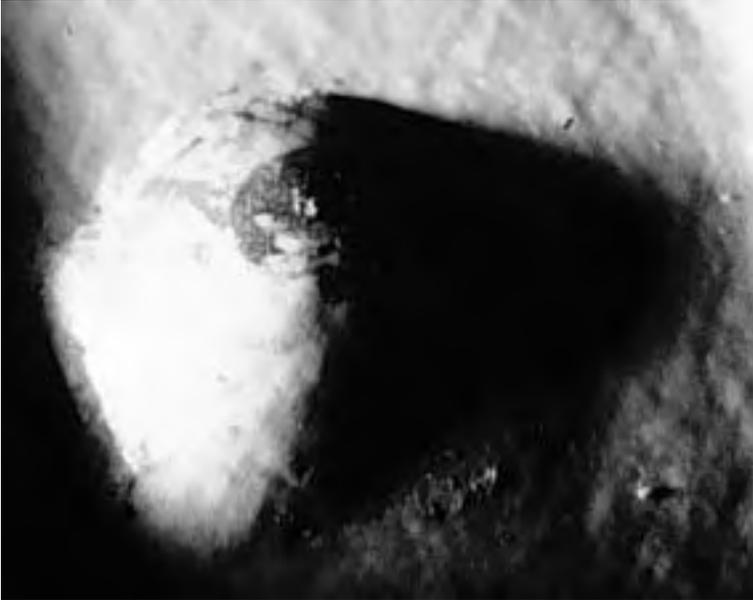
(a) Blister on Coating Surface

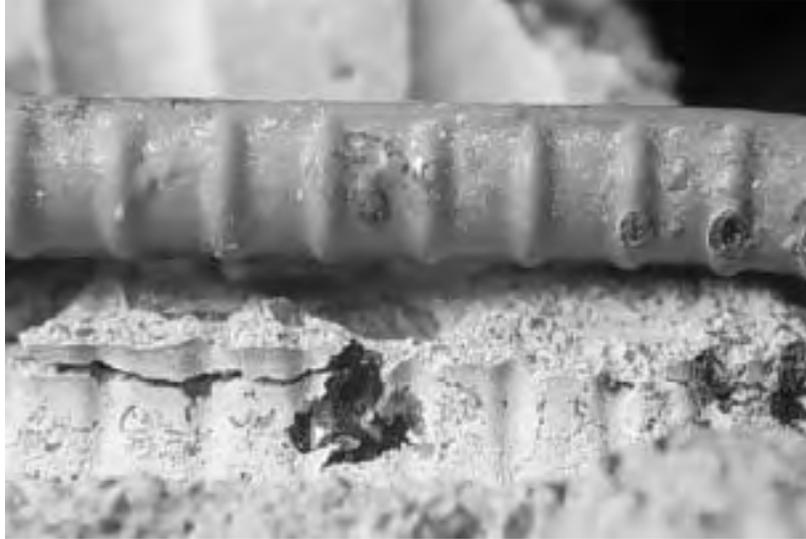
Figure 3.24 *Blisters always formed adjacent to concrete voids.*

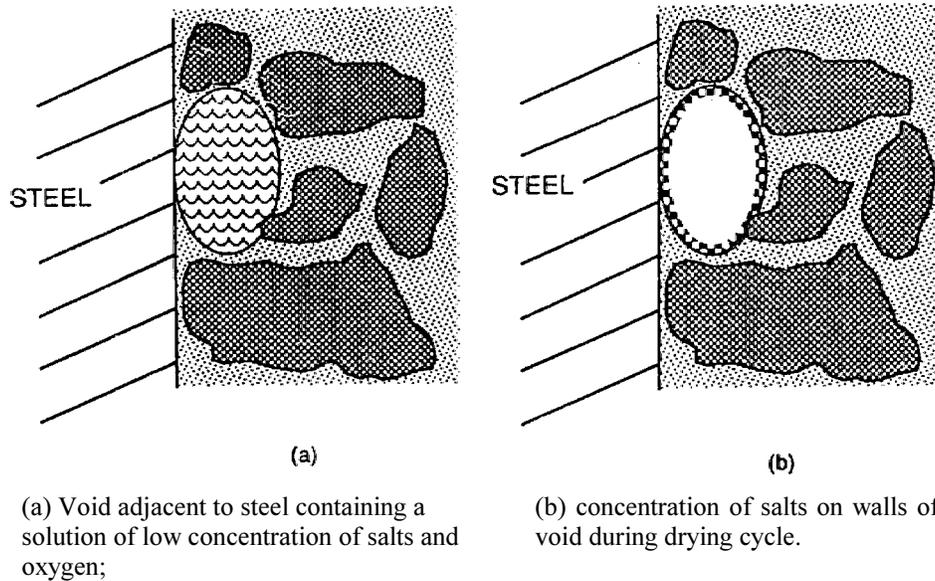
Figure 3.28 Voids promoting steel corrosion in concrete.

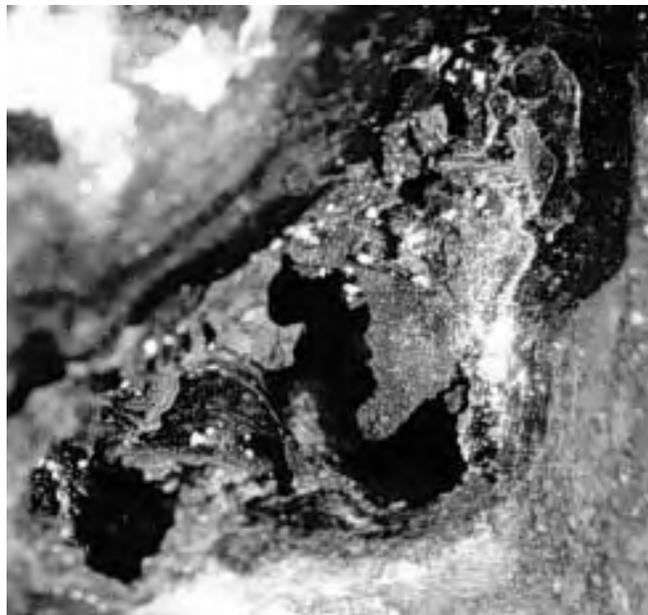
Figure 3.29 Corrosion products found in voids at coated bar surface.

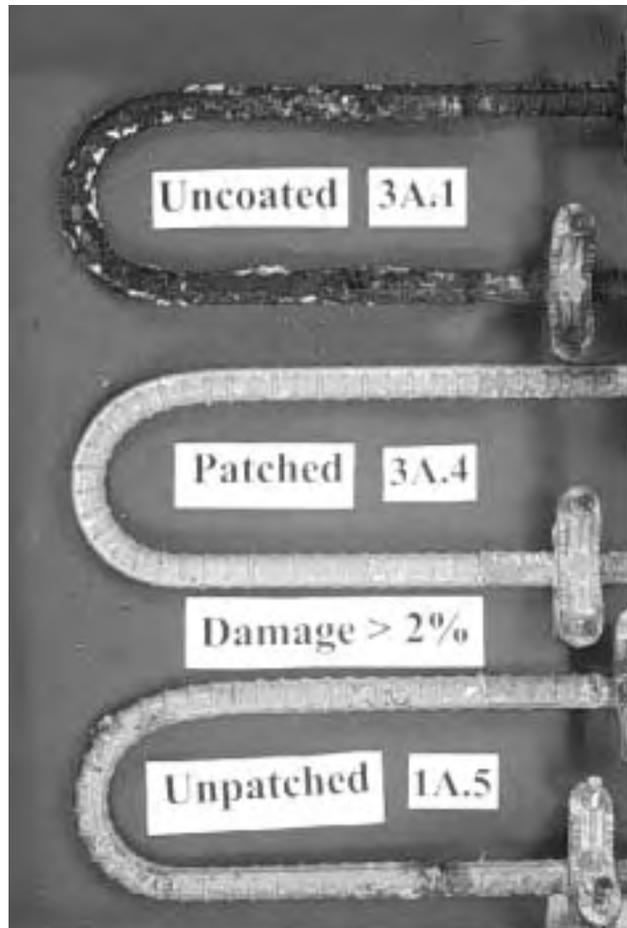
Figure 3.35 Comparative performance of uncoated and coated bars after 4.5 years of exposure.

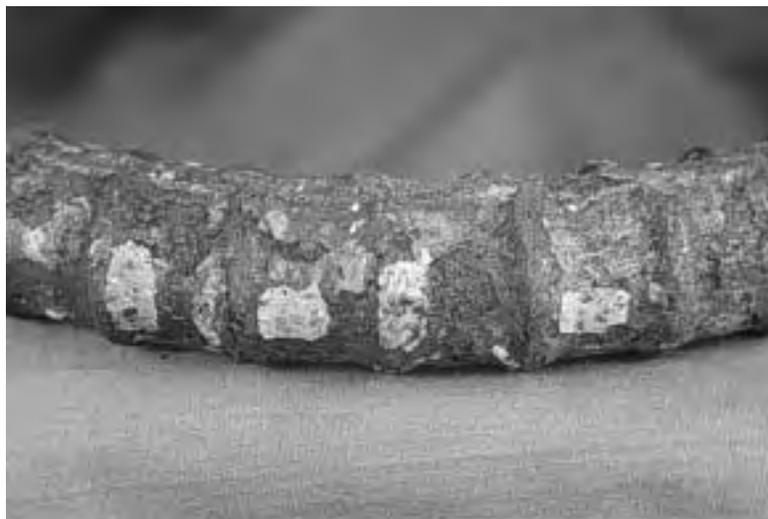
(a) Patched bar 3B.2, outside bend.

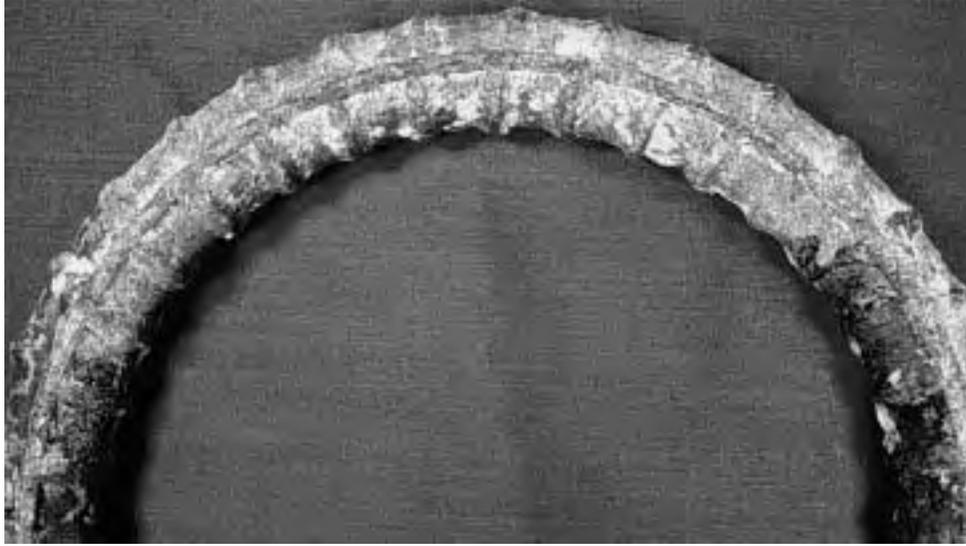
(a) Uncoated bar free of rust at bend

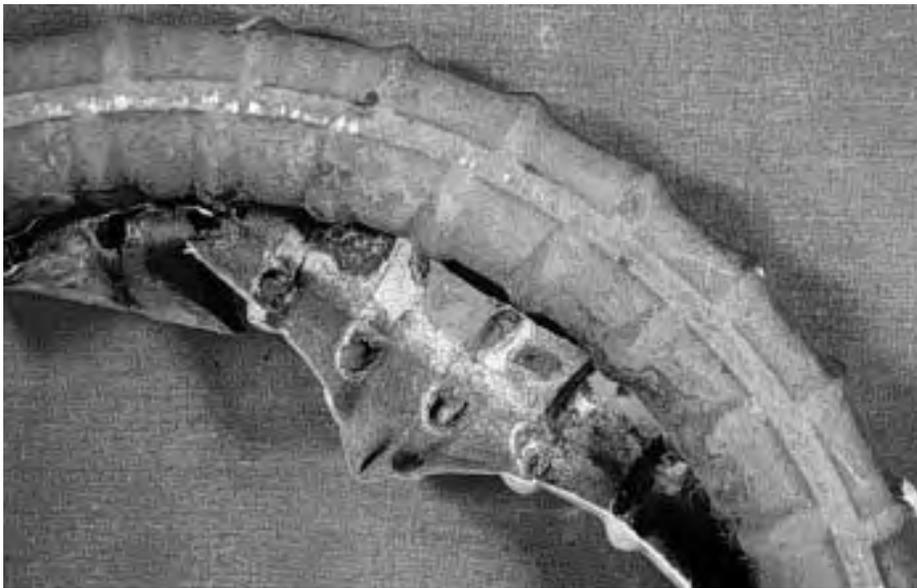
(b) Coated bar with corroded bend

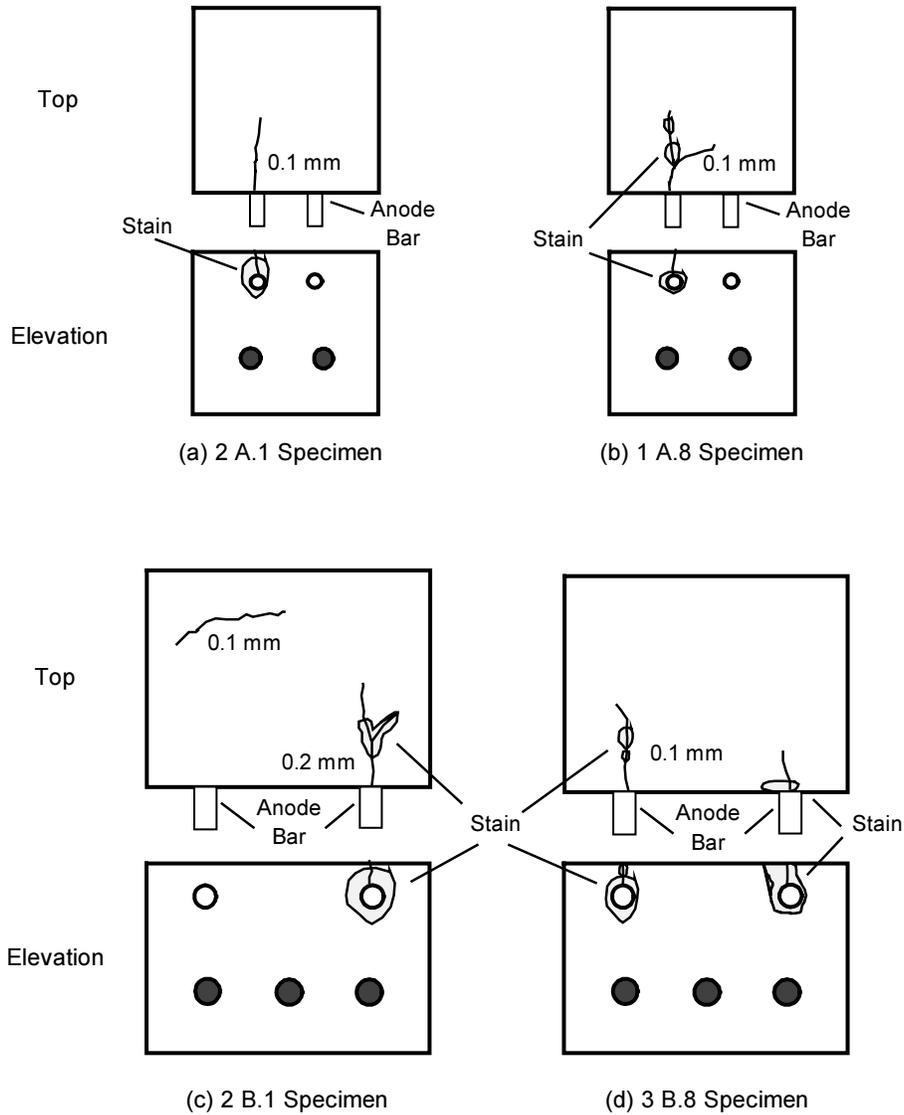
Figure A.21 Cracks and stains on macrocell specimens autopsied after one year of exposure.

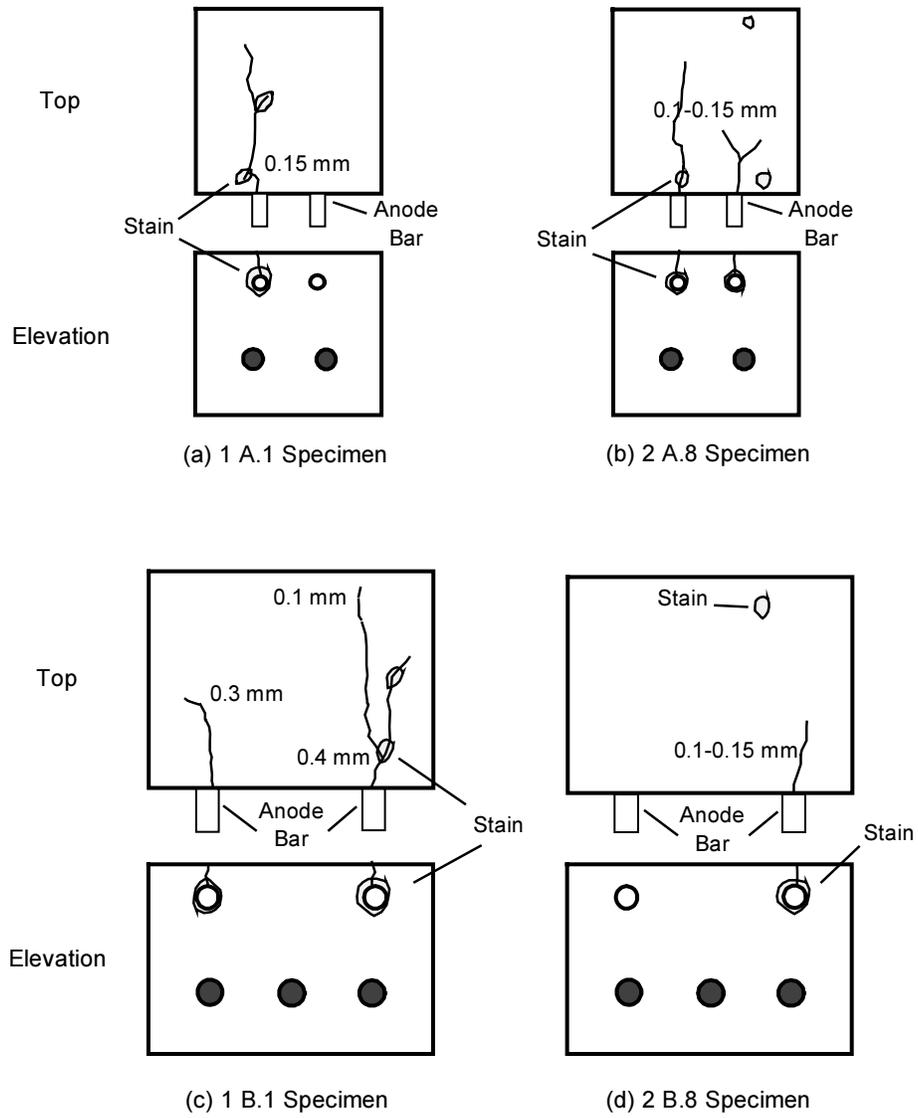
Figure A.22 Cracks and stains on macrocell specimens autopsied after two years of exposure.

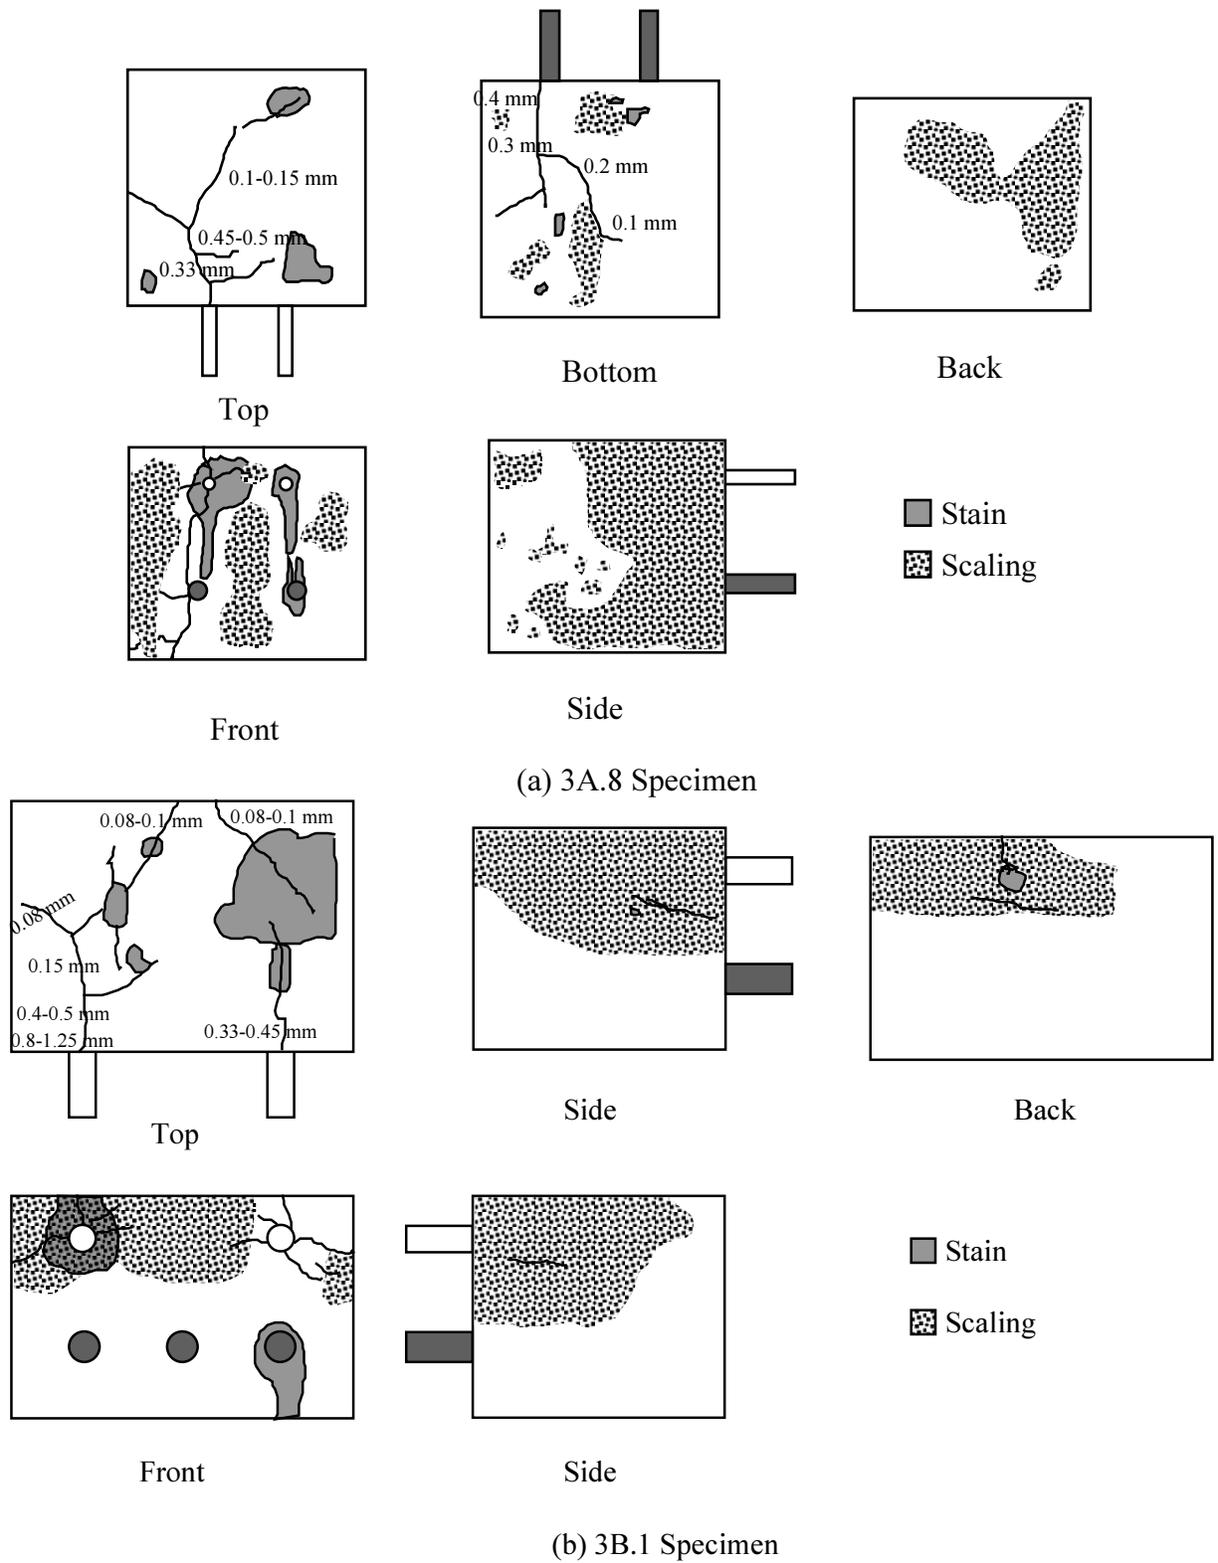
Figure A.24 Cracks and stains on macrocell specimens 3A.8 and 3B.1 inspected after 4.5 years of exposure.

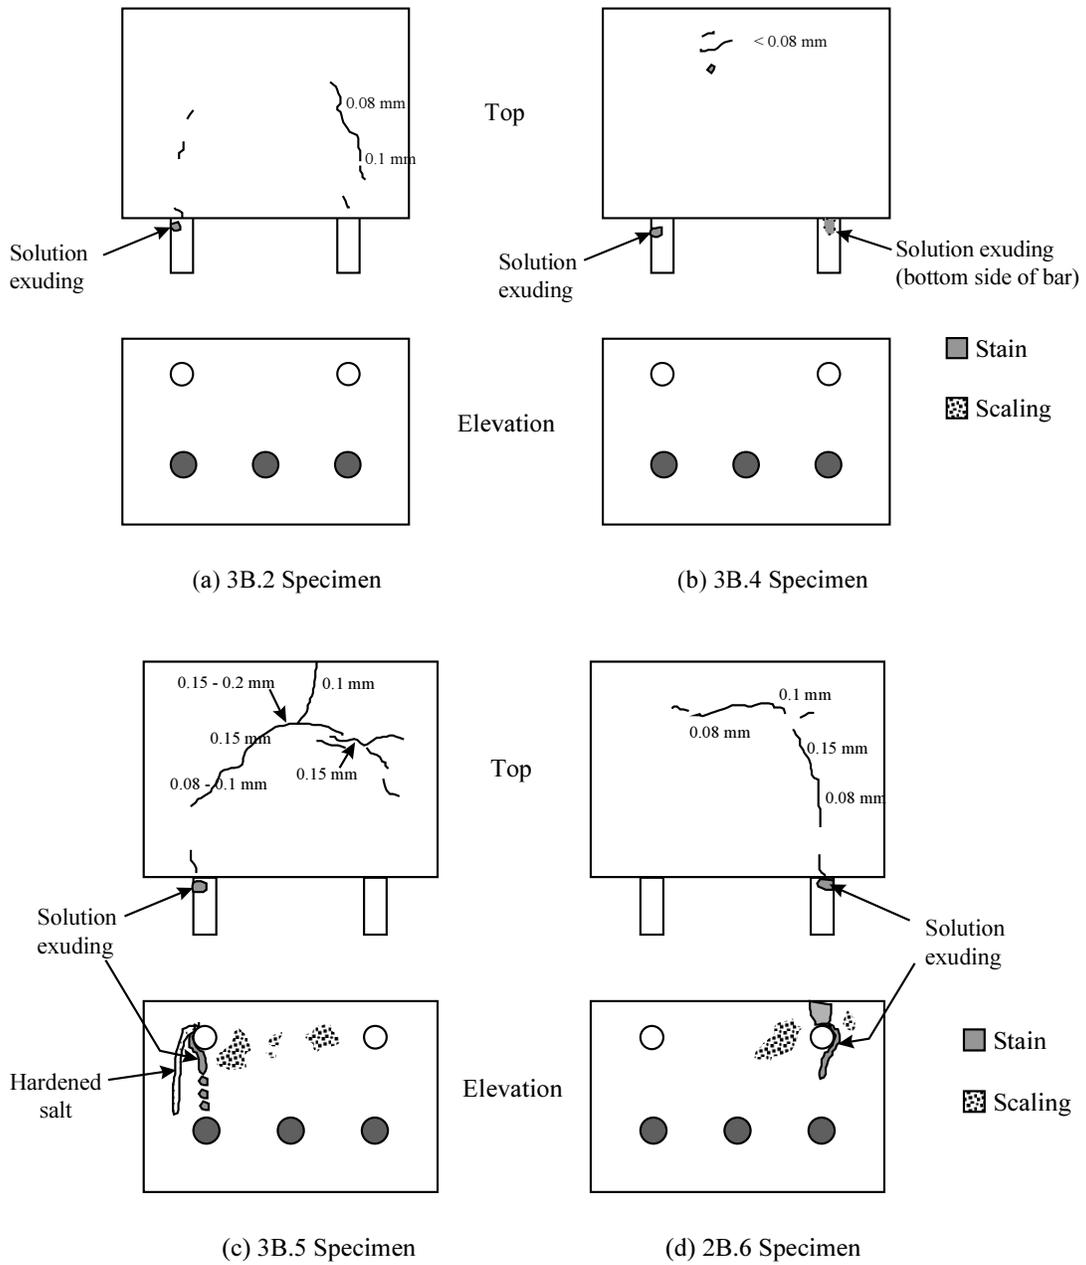
Figure A.25 Cracks and stains on macrocell specimens 3B.2, 3B.4, 3B.5, and 2B.6 inspected after 4.5 years of exposure.
