16. Abstract This report documents a field test to determine the stresses at areas where fatigue cracks had formed in the bridges. Two bridges were instrumented and subjected to controlled truck traffic. In addition, the service fatigue stresses were evaluated by monitoring the stresses for a 1 week period after the controlled truck testing. A three dimensional finite element model was constructed of each bridge. The stresses from the field tests and the model were compared. The floor beams were found to behave as composite with the bridge deck when the truck loads were near floor beams. The local stress at the critical sections was in reasonable agreement between the field and analytical results. Proposed retrofit schemes were evaluated in the analytical model. In general, the proposed schemes appear to reduce the stresses at the critical locations, however high stresses are generated in other areas that have not cracked. The unsymmetrical support conditions of some of the girder units cause twisting of bridge section. Adding of additional supports to make the bridge support symmetrical will also improve fatigue performance of the bridge.

Field Test and Finite Element of I-345 Br

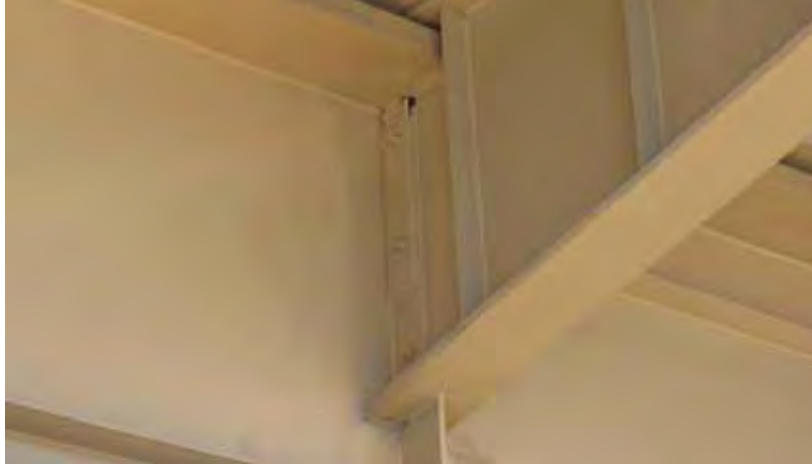
Figure 1.6: Retrofitted Connection

A retrofit was performed in 2004 in an attempt to mitigate the cracking. Many of the cracks were welded and arrestor holes were drilled at the crack tips to relieve the stress. This repair can be seen in Figure 1.3. The retrofit also consisted of adding retrofit stiffeners on top of the stiffeners connecting the floor beams to the girders. These stiffeners were welded to the top flange of the girder in order to close the previously mentioned gap where cracking had occurred. Figures 1.5 and 1.6 show a detail and picture of a retrofitted connection. Some of the welds were also subjected to ultrasonic impact treatment to improve their fatigue performance.
