| 4. Title and Subtitle<br>Repair of Galvanizing After UIT Application | | | 5. Report Date<br>June 2005 | |
| 15. Supplementary Notes<br>Project performed in cooperation with the Texas Department of Transportation and the Federal Highway Administration. Project Title: Ultrasonic Impact Treatment (UIT) for Traffic Signal Structure Fatigue Details | | | | |

## **Repair of Galvanizing After UIT Application**

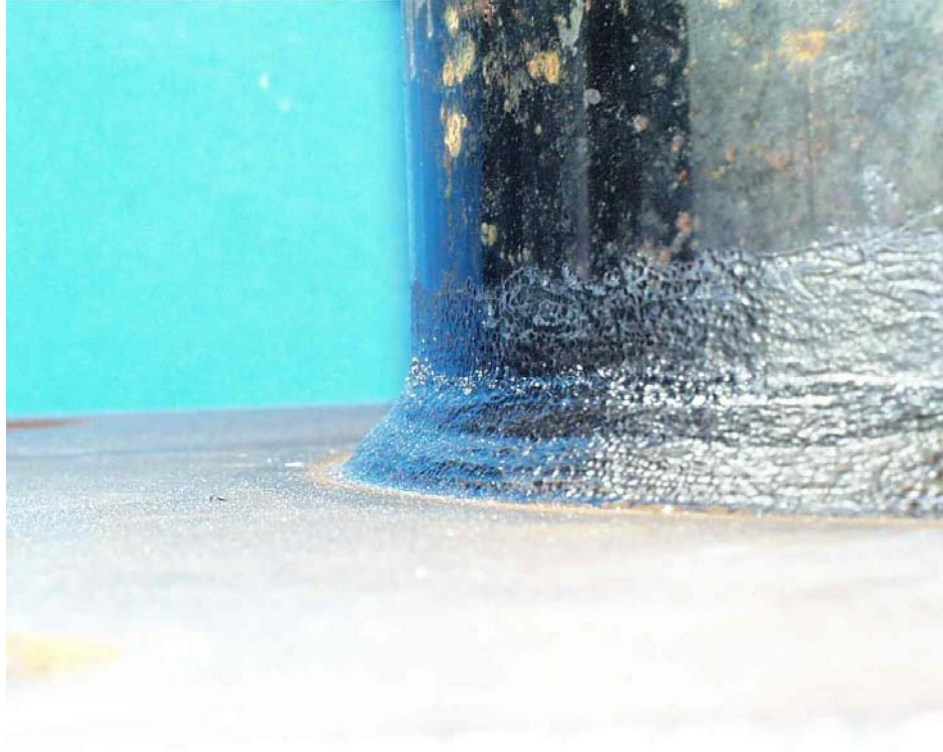
The effects of UIT when it is applied before and after hot-dip galvanization was examined in full size mast arm specimens in a previous research project. An attempt was made to compensate for the influence of hot-dip galvanization on the mast arm welds by using a modified treatment procedure. After a UIT technician performed the standard UIT application under loaded conditions using the 3mm diameter pins in the multi-pin tool along the toe of the socket weld, the same settings were used for an additional treatment to an area around the socket weld. The resulting condition of the socket weld after the heat affected area treatment is shown in Figure 1.

*Figure 1: UIT Application to Both Weld Toes and the HAZ on TXuCLGP*

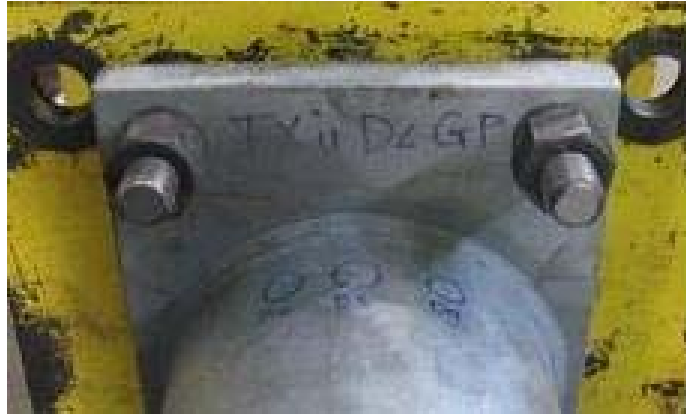
The temperature was measured with a non-contact thermometer prior to heating at five locations on each mast arm. All five temperature reading locations were 1.5 in. from the mast arm weld toe. Two temperature reading locations were at either end of the UIT application line along the weld toe. The other three temperature reading locations were at the middle most area of UIT application. The temperature reading locations are shown in figure 2. The average temperatures for each specimen are shown in Table 1 with the maximum temperature for the central location also noted. The specimens were heated using an oxygen-acetylene torch with a rosebud style heating tip. Care was taken not to exceed the maximum temperature of 750° F specified by TxDOT and to not jeopardize the UIT treatment. It was arbitrarily decided that mast arm TXuCLGP would be heated to the maximum allowed repair temperature of 750° F, and mast arm TXuDLGP would be heated to the minimum allowed repair temperature, 600° F, in an attempt to cover the extremes of possible field conditions. As noted in the table slightly higher maximum temperatures were recorded on the specimens.

*Figure 2: Location of the Middle-Most Temperature Reading Locations (Circles Labeled D2, D3, and D4; The Endmost Temperature Reading Locations are Not Visible in this Picture)*

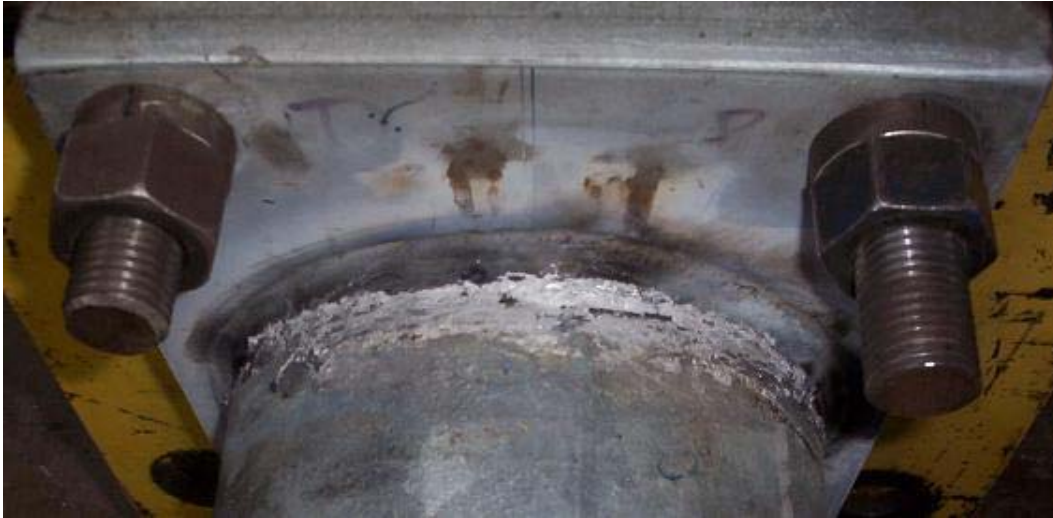
The application of the solder to the mast arms was difficult. In order to limit the heat input and to simulate what would be the anticipated field procedure, the heat was applied only to the arm and not to the end plate. The large mass of the end plate relative to the thin mast arm absorbed the heat quickly when the heating torch was removed to apply the solder. Consequently, the solder did not flow well on the arm since the temperature of the surface of the arm dropped quickly below the solder's melting point when the heating torch was removed. The coated area had a pasty look, as shown in figure 3, not the smooth look of a properly applied solder. A higher initial temperature and heating of the end plate might have produced a better application of the solder; however, the higher temperature would be more likely to reduce the effect of UIT upon the fatigue performance.

*Figure 3: Test Arm C After Application of Solder*

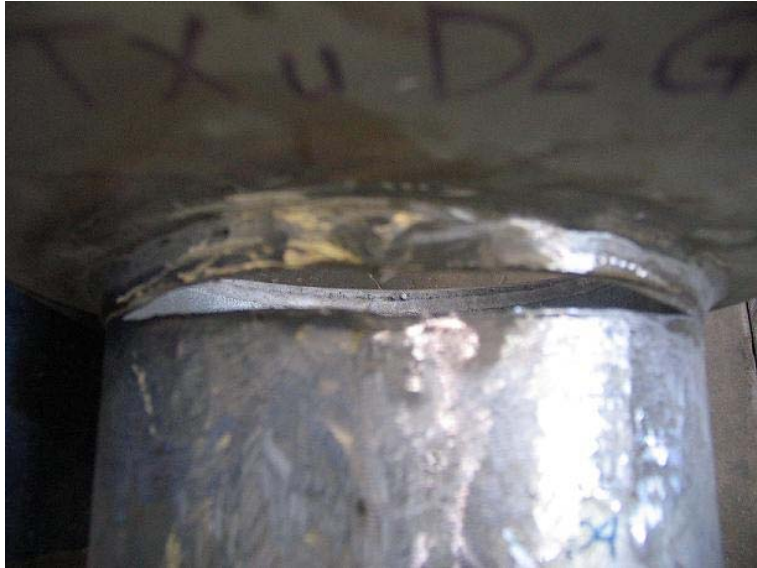
The test reached the controller limits after 85,214 cycles of loading. The mast arms were visually inspected for cracks, and none were detected. At this point the controller had unknowingly been re-set, probably due to a brownout. When the test was restarted, the inadvertently re-set controller induced a deflection of 2.5 in., which caused a large fracture along the mast arm weld toe of TXuDLGP. A picture of this fracture after grinding to remove the galvanizing is shown in Figures 4 and 5. Figure 5 shows the angle created by the bending of the base plate of TXuDLGP during the loading. The fracture started from a fatigue crack at the weld toe of the specimen which had evidently caused the system to shut down.

*Figure 4: Top View of Crack at Weld Toe of TXuDLGP*

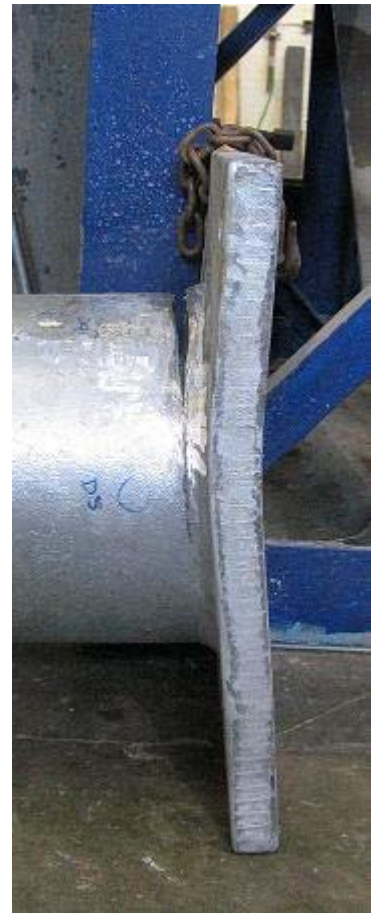
*Figure 5: Side View of Mast Arm TXuDLGP After Cracking*

Due to the extreme cracking and base plate bending, TXuDLGP was irreparable and could not be put back in the test setup to continue the fatigue test. Mast arm TXuBLGP had almost identical dimensions and fabrication conditions as TXuDLGP. TXuBLGP was put into

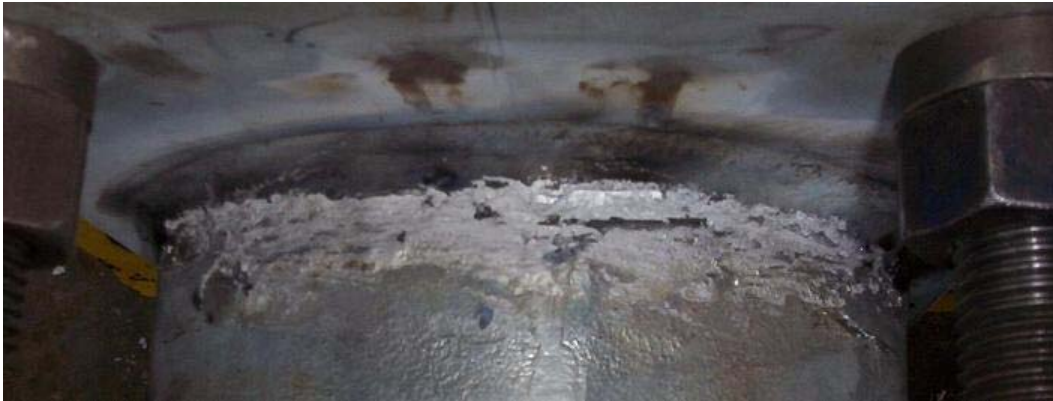
The controller shut down after reaching the control limits 101,865 cycles. A picture of mast arm TXuCLGP at this point is shown in Figure 6. Visual inspection revealed no fatigue cracks. However, the thick galvanized repair along the weld toe prevented good inspection. Since no fatigue cracks were visible in TXuCLGP, the controller was reset, and dynamic testing continued.

*Figure 6: Mast Arm TXuCLGP After 101,865 Cycles*

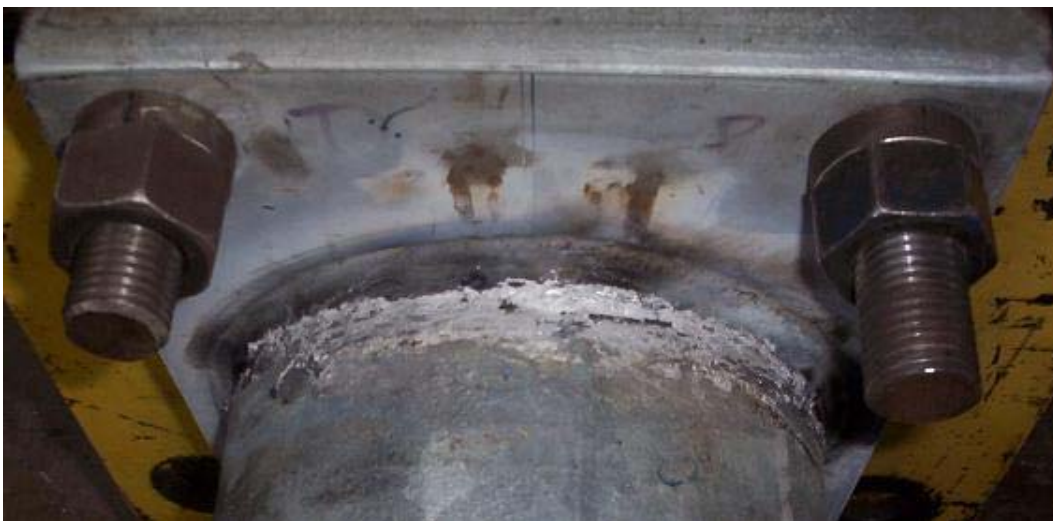
The controller reached a limit again after only 7,546 cycles at 109,411 cycles. A picture of mast arm TXuCLGP at this point is shown in Figure 7. Visual inspection revealed cracking in the thick solder repair. The solder was removed by scrapping with a screwdriver in the area of the cracking. No cracks were observed at the mast arm weld toe or surrounding metal. The controller was reset and dynamic testing continued.

*Figure 7: Mast Arm TXuCLGP After 109,411 Cycles*

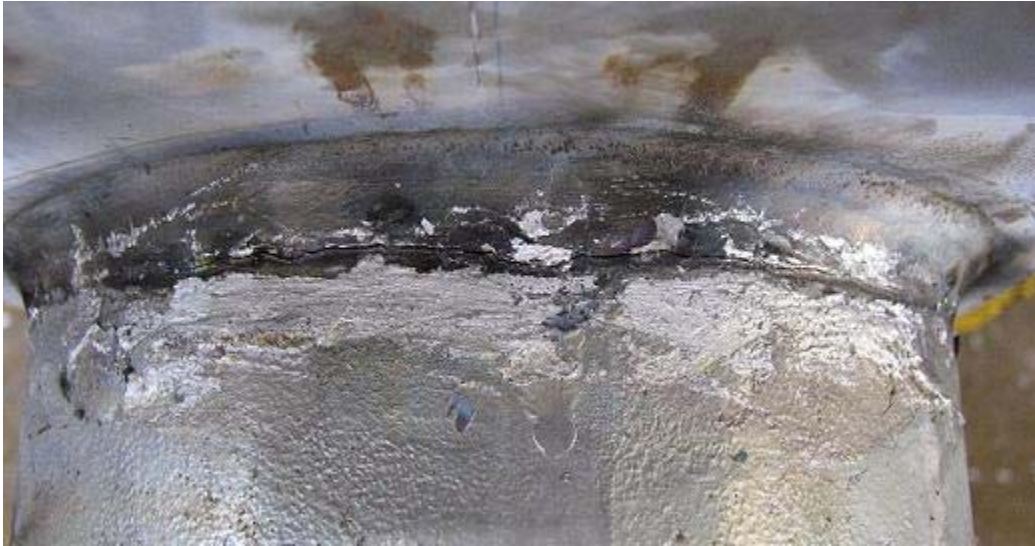
The controller shut down a third and final failure for mast arm TXuCLGP 8,050 cycles later at 117,461 cycles. Visual inspection showed extensive cracking in the thick solder repair. Further removal of the solder with a screwdriver revealed visible cracking along TXuCLGP's mast arm weld toe. Removal of the entire thick repair with a screwdriver revealed the extent of fatigue cracking along the weld toe, as shown in Figure 8. The crack is highlighted in figure 9.

*Figure 8: Mast Arm After 117,461 Cycles and After Removal of All the Repair Coating*

The inability to see the fatigue crack in specimen TXuDLGP after 85,214 cycles was probably due to masking of the crack by the solder used to repair the galvanizing. The crack on specimen TXuCLGP was not visible until it was very large and after the system had shut off 3 times from a change in specimen stiffness. It is interesting that TXuDLGP failed first, because this mast arm was heated to the minimum heat of about 600° F, while mast arm TXuCLGP was heated to 770° F.

The use of galvanizing solder repair to connections treated with UIT is not recommended. The application of the solder repair reduced the improvement in fatigue life associated with the application of UIT. The solder was also difficult to apply due to the difference in thickness and mass of the mast arm and the attached end plate. The large end plate absorbed the heat applied to the mast arm making it difficult to melt the solder. The solder also masked the fatigue crack and made the cracks very difficult to see.

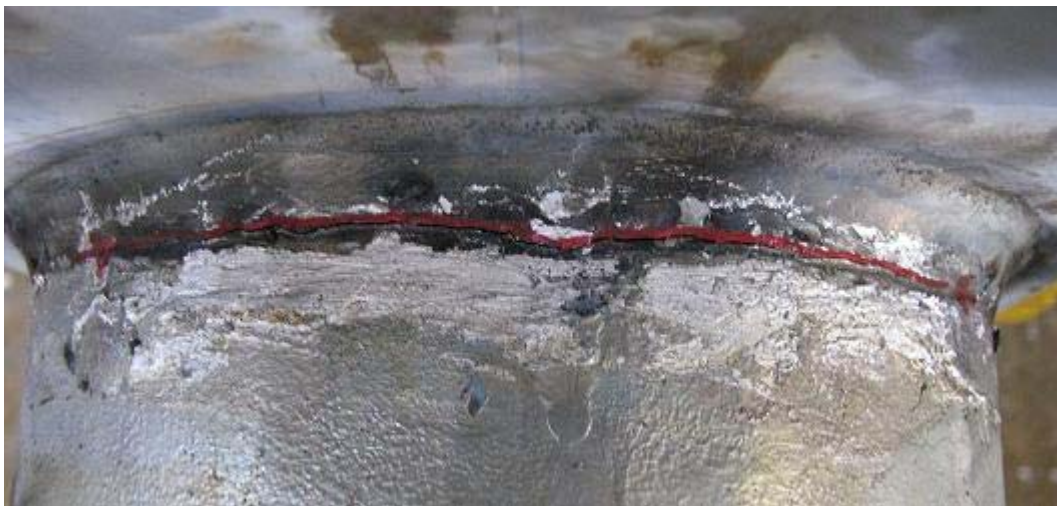
*Figure 9: Highlighted Fatigue Crack at Weld Toe*

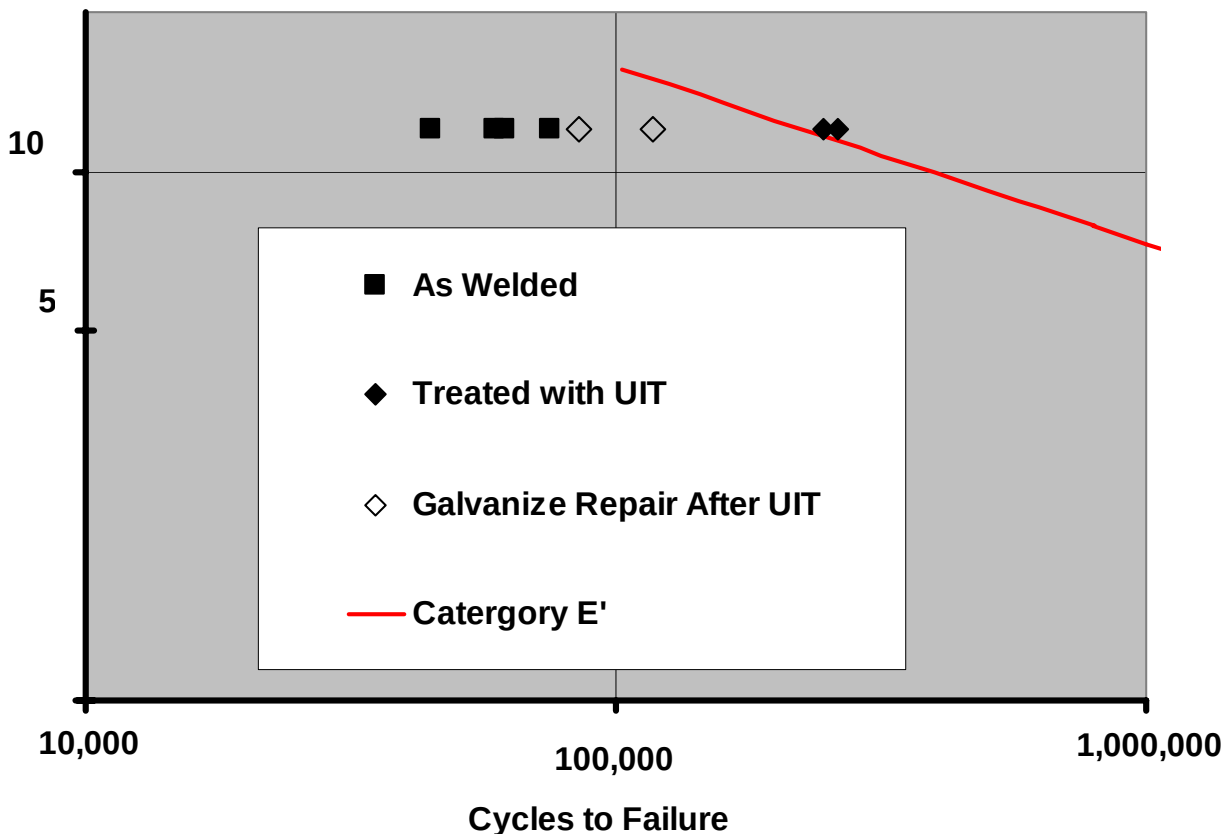
Figure 10: Fatigue Test Results

The results of these two fatigue tests are compared with the identical specimens that had not been treated with UIT in Figure 10. The fatigue lives of the specimens repaired with galvanizing repair solder after UIT are slightly better than the specimens that had not been treated. However, their fatigue lives are much less than the specimens treated with UIT and not repaired with solder. Consequently, the heating of the specimens during the application of the galvanizing repair solder reduced the effectiveness of the UIT treatment. Note the thin end plates used in these specimens and the location of the longitudinal seam welds at the top of the arms produced a very low fatigue lives in all of the tests conditions relative to previous tests.
