## **Application of Ultrasonic Impact Treatment to In-Service Signal Mast Arms**

Amanda H. Palmatier  
Karl H. Frank

CTR Research Report:	5-4178-01-2
Report Date:	June 2005
Research Project:	5-4178-01
Research Project Title:	Ultrasonic Impact Treatment (UIT) for Traffic Signal Structure Fatigue Details
Sponsoring Agency:	Texas Department of Transportation
Performing Agency:	Center for Transportation Research at The University of Texas at Austin

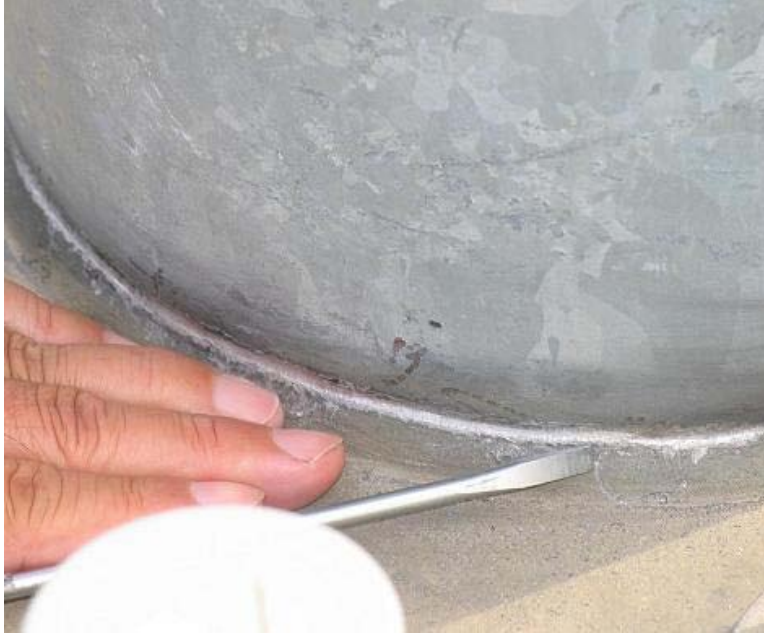
*Figure 2.8 UIT Application at the bottom of Mast 2*

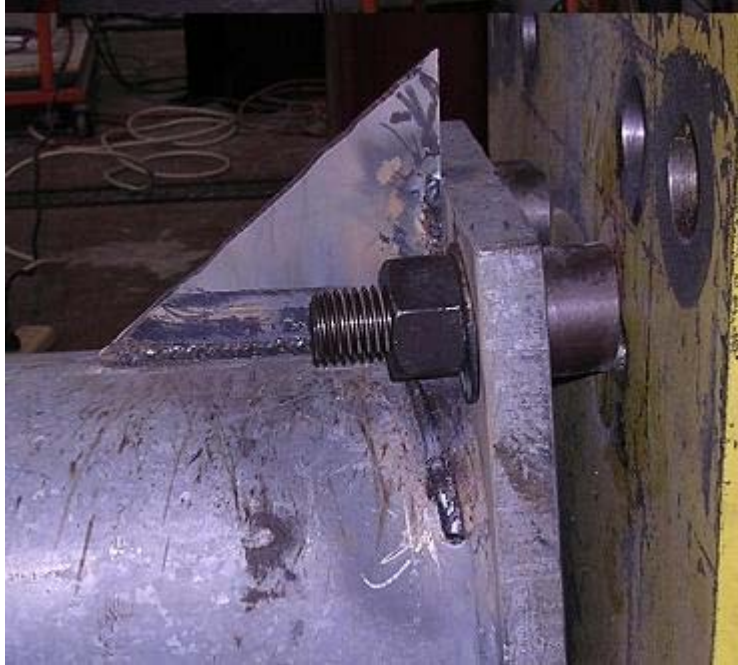
After the failure of the weld repair on mast arm DU, it was decided to add a stiffener to mast arm DU, to reinforce the weld and prevent further fatigue cracking. Figure 3.12 shows the stiffener added to mast arm DU before Phase 3 dynamic testing.

*Figure 3.12 Stiffener Added to Mast Arm DU After 116,876 Cycles*
