CONCLUSIONS, RECOMMENDATIONS AND DESIGN GUIDELINES FOR CORROSION PROTECTION OF POST- TENSIONED BRIDGES

Research Report 0-1405-9

*DURABILITY DESIGN OF POST-TENSIONED
BRIDGE SUBSTRUCTURE ELEMENTS*

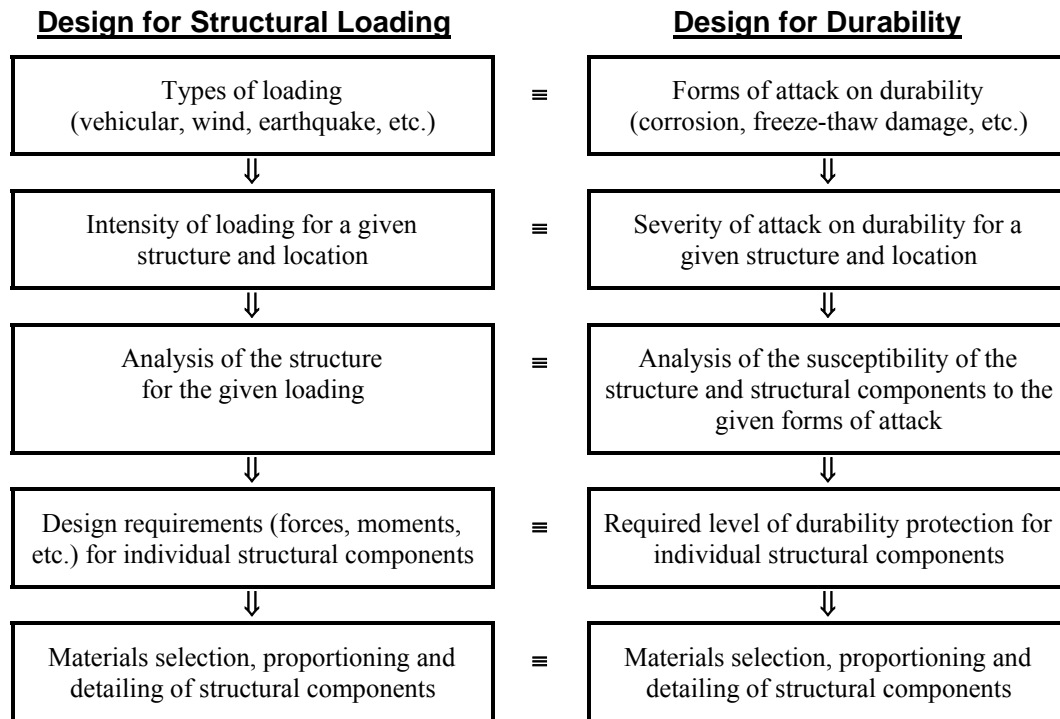
Figure 1.1 Simplified Analogy between Design for Structural Loading and Durability

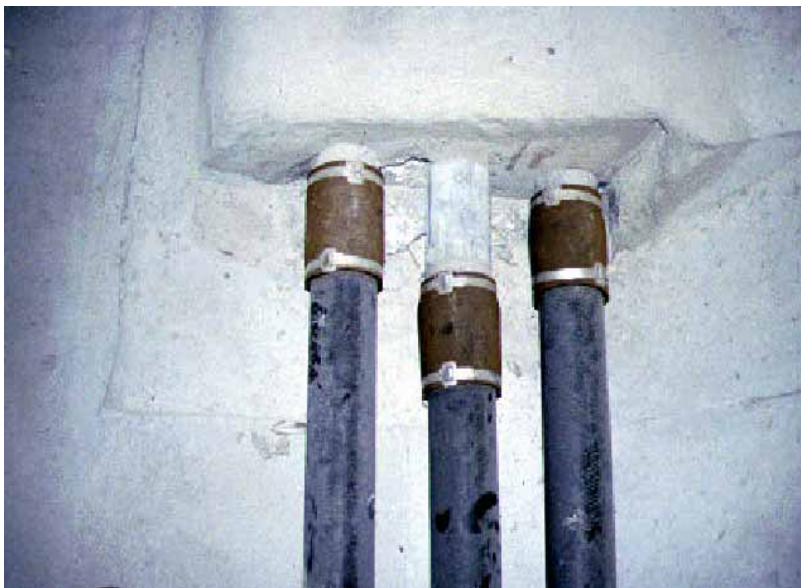
Figure 2.5 Plan View of Slipped Tendon at Deviation Saddle Niles Channel Bridge¹⁶

Recently, some tendon failures and corrosion related problems have come to light, especially in the state of Florida.^{6,16} In 1999, one of the external tendons in the Niles Channel Bridge built in 1983, failed due to corrosion at an expansion joint. A 9-inch movement of the tendon through one of the deviation saddles was noticed first. When the tendon was removed for replacement, a void in the grout and heavy pitting in the prestressing strands inside the anchor head were found. (See Figures 2.5 and 2.6). In 2000, eleven tendons out of a total of 846 were replaced in the Mid-Bay Bridge built in 1993. Ten of the eleven tendons that were replaced were located at expansion joints. (See Figures 2.7, 2.8 and 2.9) Also, in 2000, several corroded tendons were discovered in segmental piers of the Sunshine Skyway Bridge, built in 1986, where the corrosion resulted from seawater in ducts, permeable concrete anchorage protection at the top of piers and splitting of polyethylene ducts.⁶ (See Figures 2.10 and 2.11)

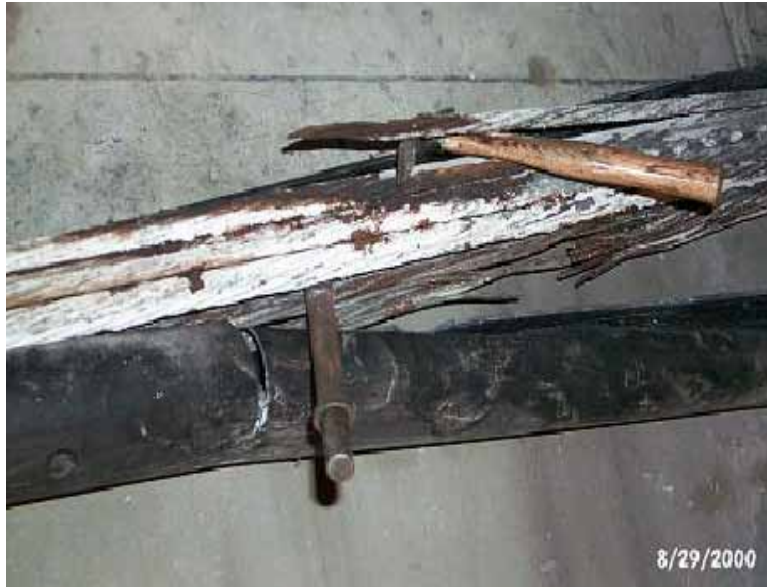
Figure 2.8 Failure of Tendon 28-6 on the Mid-Bay Bridge¹⁶

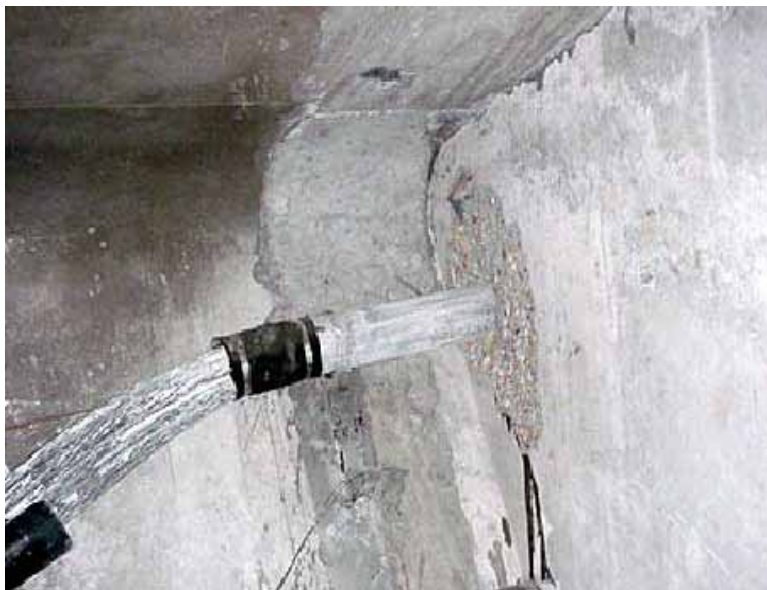
Figure 2.9 Failure of Tendon 57-1 on the Mid-Bay Bridge at Expansion Joint Diaphragm¹⁶

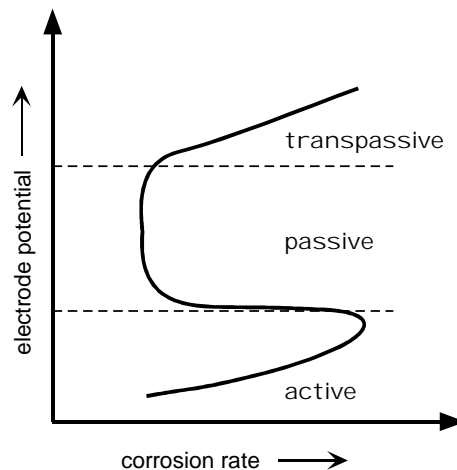
Figure 2.12 Passive-Active Behavior in Steel³⁴

Steel is an active-passive metal, and therefore its corrosion rate depends on potential as shown in Figure 2.12. Under typical conditions, steel in concrete is in a passive state and a passive protective film is found on the steel surface. Chlorides (and lowered pH) in the surrounding concrete have been shown to cause a breakdown of the passive film at potentials that should be well within the passive region.⁶²

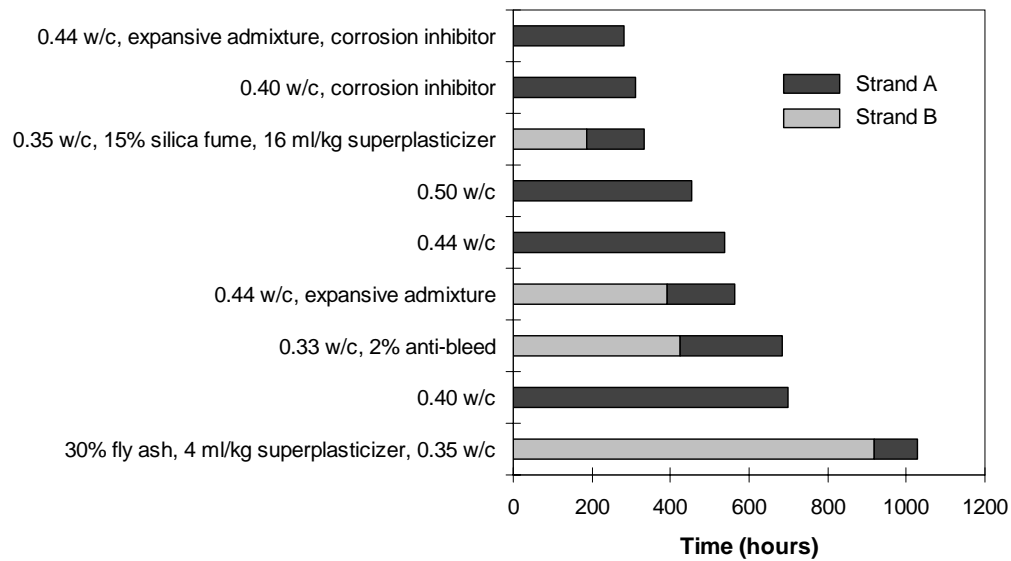
Figure 3.4 Comparison of ACTM Average Times to Corrosion³⁴

- The standard TxDOT grout had below average performance (average time to corrosion was lower than for a plain grout at the same water-cement ratio).
- Using prestressing strand from different spools can alter the test results. When comparing grout designs, the strand used should be consistent among all grouts.

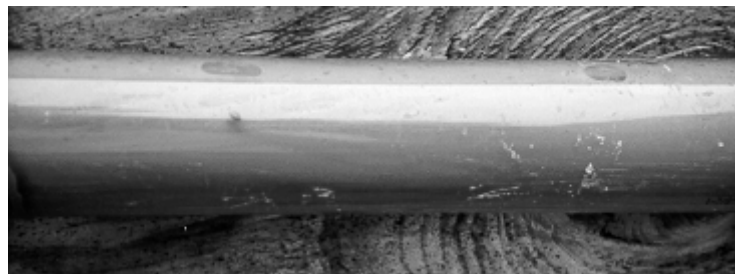
Figure 3.5 TxDOT Grout – Bubbles Traveling Toward Intermediate Crest³⁴

Observation of grouts during pumping and setting (See Figures 3.5 and 3.6) as well as examination of slices cut from the large scale grouted ducts (See Figure 3.7) indicated:

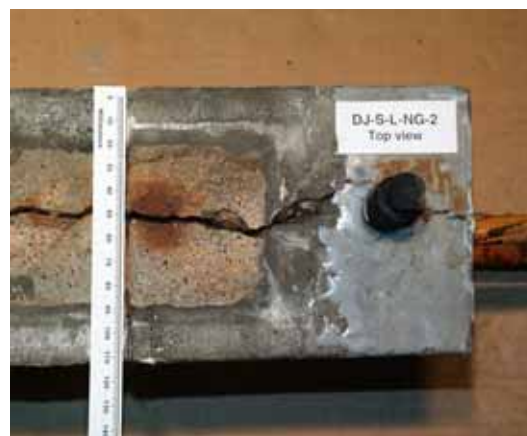
Figure 3.10 Example of Specimen Condition Prior to Autopsy Specimen DJ-S-L-NG-2⁸³

Thirty eight macrocell specimens were used to investigate the corrosion protection of internal tendons at segmental joints (See Figures 3.8 and 3.9). Half of the specimens were autopsied after approximately four and a half years of highly aggressive exposure and preliminary conclusions were reported.³⁰ The variables analyzed during the testing program included: joint type (dry or epoxy), duct type (galvanized steel or plastic), grout type (3 grouts with differing additives) and level of joint compression (3 different levels). The second half of the specimens were autopsied with over eight years of very aggressive exposure. Example of macrocell condition prior to autopsy is shown in Figure 3.10. Numerous conclusions can be drawn.

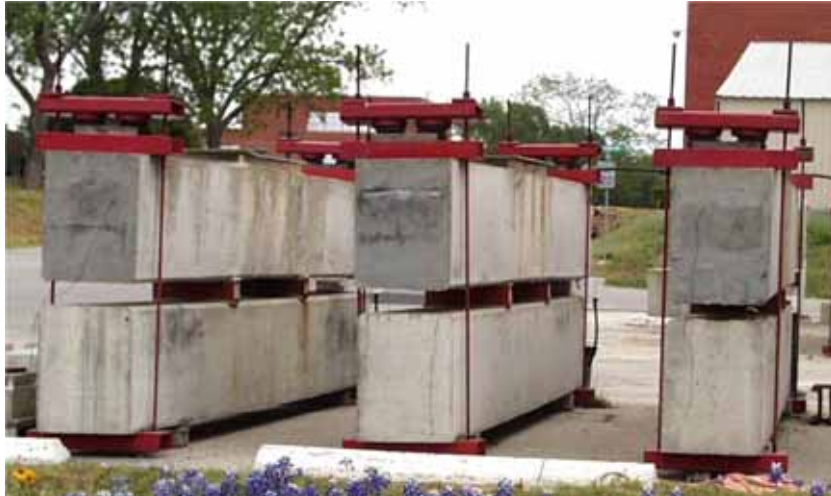
Figure 3.11 Beam Test Setup at North End of Ferguson Laboratory³⁷

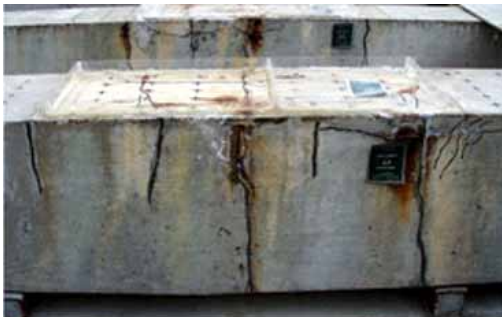
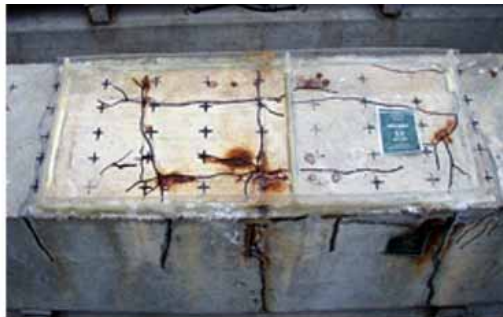
Lateral (South) View

Top View (from South Side)

Figure 3.13 Example of Specimen Condition Prior to Autopsy
Specimen 2.3 - Mixed Reinforced Beam under Constant Service Load^{37,38}

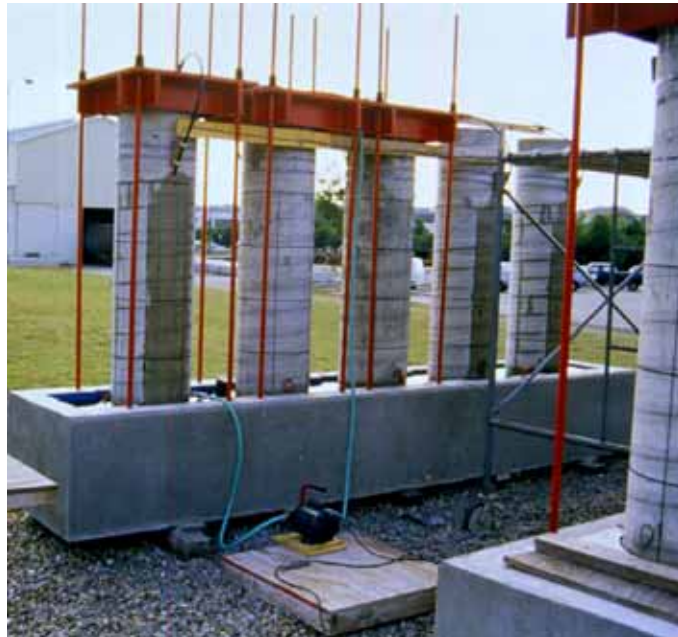
Figure 3.14 Column Test Setup³⁷

Five non-prestressed and five post-tensioned columns specimens were used to investigate corrosion mechanisms and chloride ion transport (“wicking effect”) in various column connection configurations and to evaluate column corrosion protection measures (See Figures 3.14 and 3.15). Variables included column to foundation connection (no dowel joint, doweled joint and post-tensioned joint), loading (no loading and service load – with combined moment and axial load), concrete type (TxDOT Class C concrete, and Class C Fly Ash concrete – 35% replacement by volume), prestressing bar coatings (uncoated, galvanized PT-bars, and epoxy coated PT-bars), and post-tensioning ducts (plastic and galvanized steel). Trickle water was used on one face of each column to determine the effect of salt water spray or dripping. Test specimen exposure started in July of 1996 and ended in January of 2003, after six and a half years. Full autopsies were performed at the end of testing (See Figure 3.16), and conclusions are as follows.

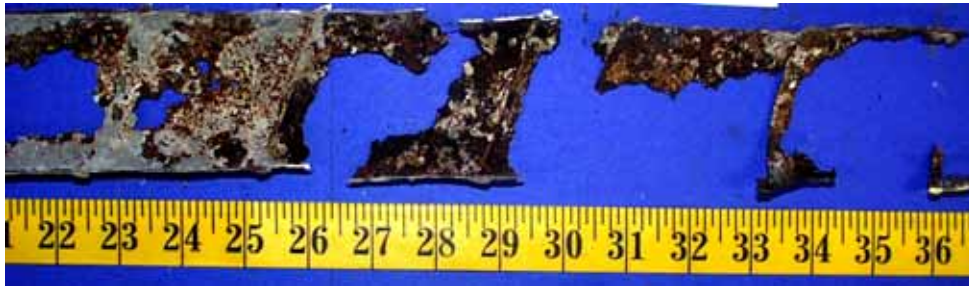
Figure 3.17 Large Galvanized Steel Duct Destruction Due to Corrosion^{37,38}

- The use of galvanized steel ducts appears unwise. Severe duct destruction and pitting was found in most specimens with this type of duct, as seen in Figure 3.17. From macrocell and column corrosion test results the superiority of plastic ducts was evident. The use of encapsulated anchorage protection systems appear very promising but cannot be conclusively evaluated until after final autopsies of the remaining beam specimens. However, in view of the substantial corrosion found with galvanized ducts, it seems like a prudent step to use plastic duct in any application that has even a moderate risk of exposure to chlorides.

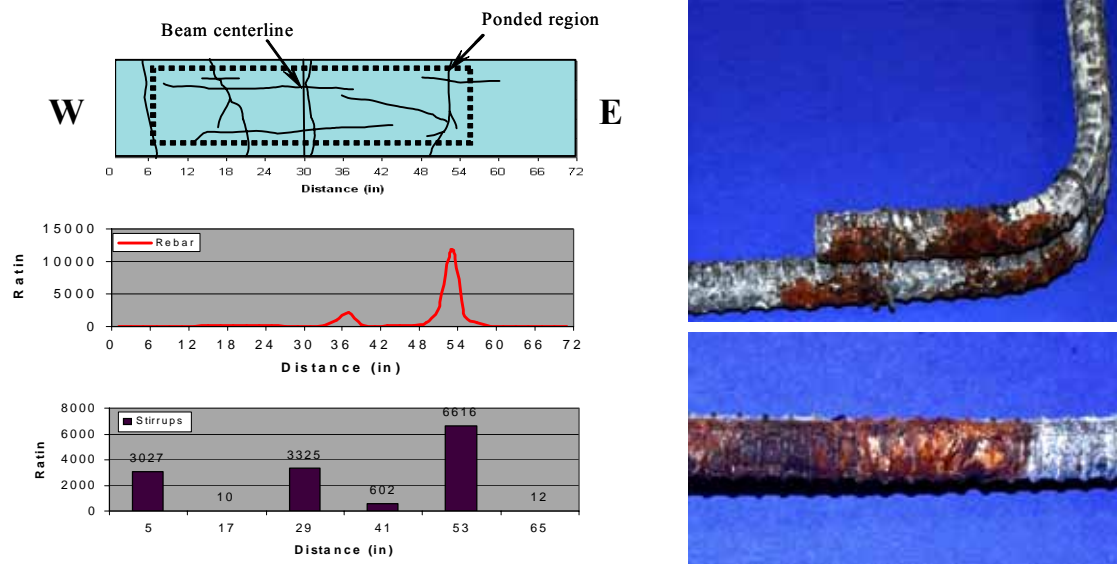
Figure 3.18 Effect of Transverse Concrete Cracking Due to Service Loading on Reinforcement Corrosion^{37,38}

- Transverse cracking due to loading had a definite effect on corrosion damage. As cracking increased, reinforcement corrosion increased. Larger crack widths and crack density were found to be the cause of very severe localized and uniform reinforcement corrosion activity. (See Figure 3.18)
- Longitudinal or splitting cracks always indicated very severe corrosion within the member, as shown in Figure 3.19.
- Sound epoxy joint filling is mandatory to prevent moisture and chloride ingress. Dry joints and incompletely filled epoxy joints in the macrocell specimens showed very poor performance. (See Figure 3.20) Similar results were observed in the column tests at the column bases for the non-doweled specimens. Dry joints performed as preset cracks.

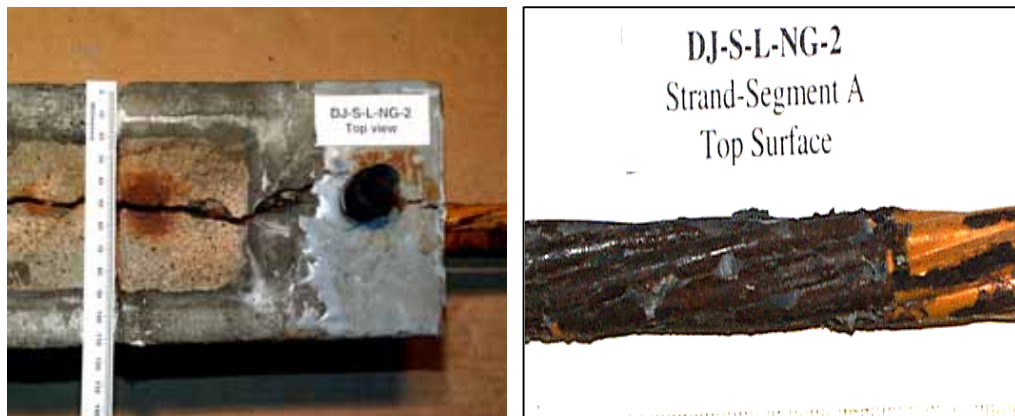
Figure 3.19 Example of Longitudinal (Splitting) Crack in Macrocell Specimen⁸³
