| 4. Title and Subtitle<br><br>Mitigation Techniques for In-Service Structures with Premature Concrete Deterioration: A Literature Review | | 5. Report Date<br>September 2004 | |
| 7. Author(s)<br><br>Amy E. Eskridge, Richard E. Klingner, Michael E. Kreger, and Timothy J. Fowler | | 8. Performing Organization Report No.<br>Research Report 0-4069-1 | |

# **Mitigation Techniques for In-Service Structures with Premature Concrete Deterioration: A Literature Review**

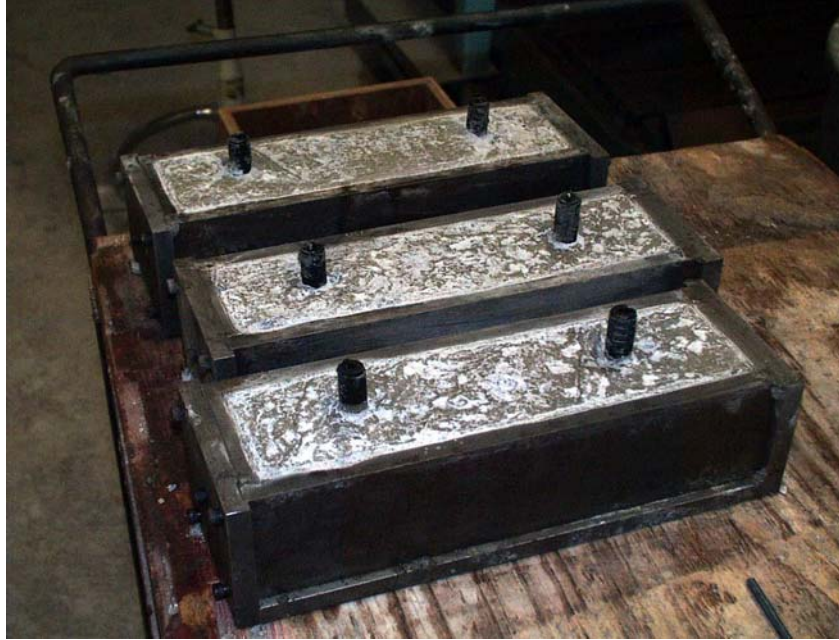
**Figure 3-1 Specimens in molds**

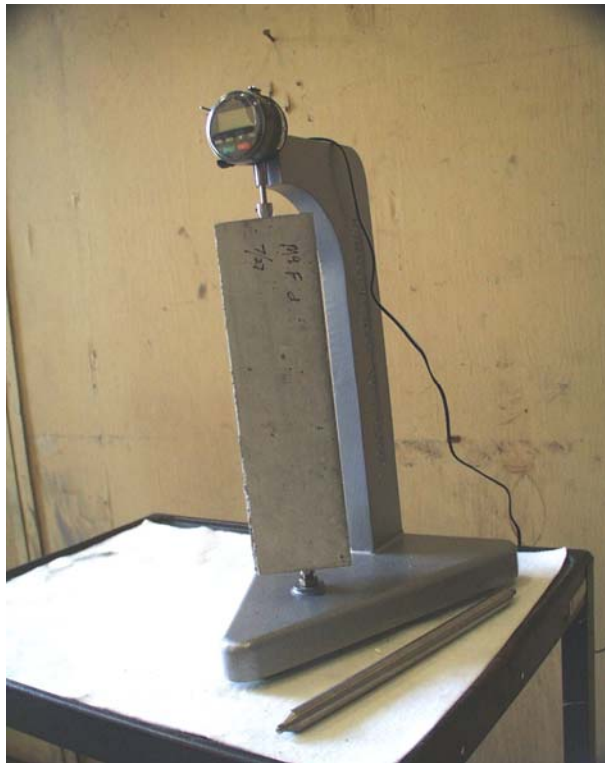
**Figure 3-2 Length reading taken with length comparator**

Length readings for each specimen were taken using a length comparator (Figure 3-2) at 1 week, 2 weeks, 4 weeks, 8 weeks, and 13 weeks after fabrication. Readings were taken immediately after removing the specimens from the storage containers. Specimens were promptly returned to the storage containers and placed in the storage environment after completing the length readings.

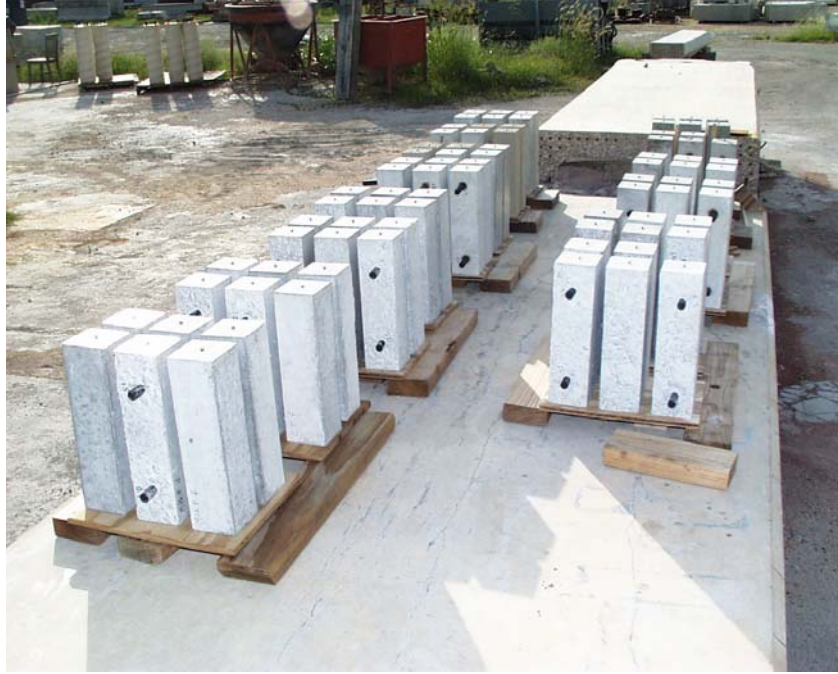
**Figure 3-3 Specimens of outdoor series behind FSEL**

After coating, the specimens of the outdoor series were placed on racks outside Ferguson Structural Engineering Laboratory (FSEL), as shown in Figure 3-3. The purpose of the outdoor series is to subject the specimens to conditions as similar as possible to actual field conditions. For this series, mitigation treatments were applied outside, during midday of the summer, and the specimens remained outside for curing.

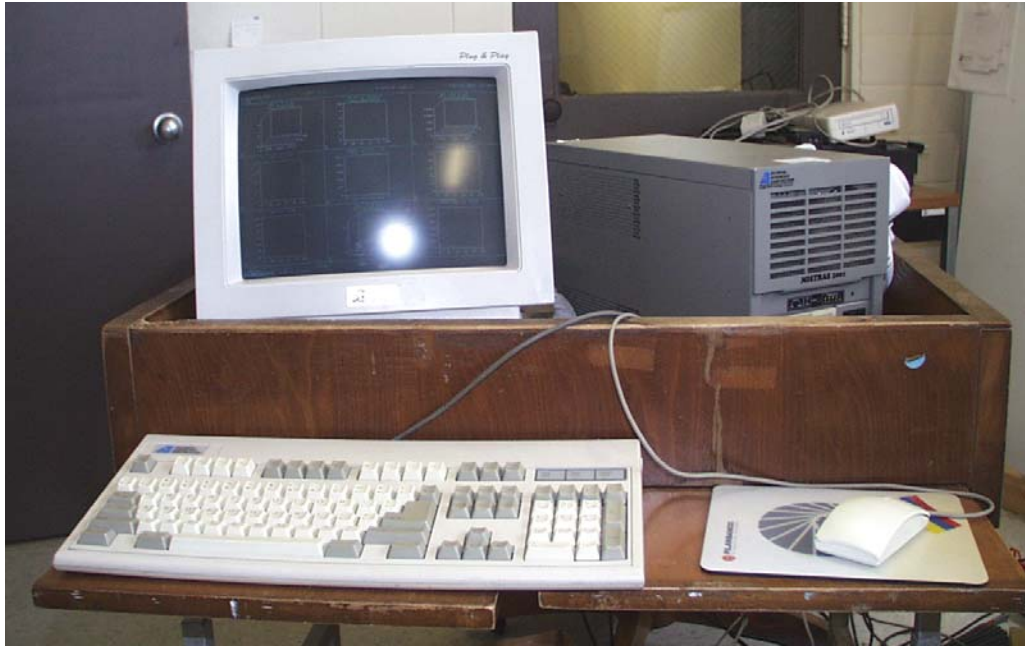
**Figure 3-5 MISTRAS 2001 instrument**

The instrumentation for the AE testing included a six-channel MISTRAS 2001 instrument manufactured by Physical Acoustic Corporation (PAC). Two PAC R6I resonant sensors were mounted with a couplant material to the prisms at 2.5 in. (6 cm) from the ends. The R6I sensor has a resonant frequency of 60 kHz and incorporates an integral 40 dB preamplifier (Chotickai 2001). The electric signal from a 5 kip (22 kN) load cell was used to record the applied load as part of the MISTRAS data file.

The prisms were loaded under third-point bending, per ASTM C 78. Load was applied with a hand-operated hydraulic ram. The testing frame, ram, and instrumentation are shown in Figure 3-4 and Figure 3-5.

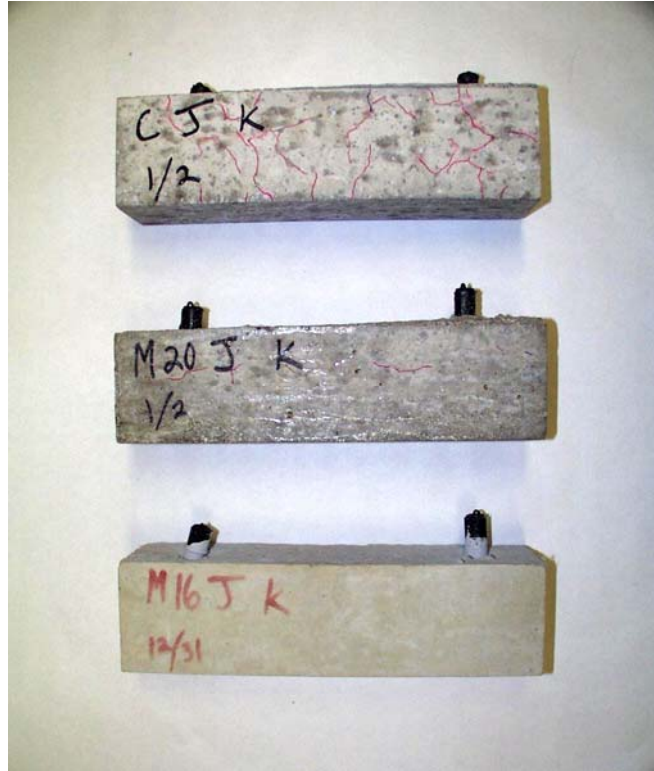
Figure 5-2 Sketches of cracks on specimens of wet/dry series

Figure 5-2 shows sketches of the cracks used to calculate damage indices for a control specimen, a Type IV epoxy (M20) specimen, and a silane+742 (M16) specimen. Very little surface cracking is observed on the silane+742 and Type IV epoxy specimens, as seen in Figure 5-2. Silane+742th, silane+PCM, and polyurethane also exhibit small damage indices, while silane+latex is slightly greater than the previous five mitigation techniques. These six mitigation techniques prevent or retard surface cracking by preventing rapid moisture loss from the surface. Also, cracks were observed under the surface of the painted specimens, but were not included in the damage indices because the paint itself had not cracked.

Both the  $\text{LiNO}_3$  and  $\text{LiNO}_3+742$  specimens exhibited cracking equivalent to or greater than the control specimens. The lithium nitrate, which may only penetrate slightly into the surface by brush application, increases surface cracking.
