1. Report No. FHWA/TX-06/0-4176-1		2. Government Accession No.		3. Recipient's Catalog No.	
4. Title and Subtitle Anchorage Requirements for Grouted Vertical-Duct Connectors in Precast Bent Cap Systems				5. Report Date May 2006

ANCHORAGE REQUIREMENTS FOR GROUTED VERTICAL-DUCT CONNECTORS IN PRECAST BENT CAP SYSTEMS

CTR Research Report:	4176-1
Report Date:	May 2006
Research Project:	0-4176
Research Project Title:	Development of Precast Bridge Construction Systems
Sponsoring Agency:	Texas Department of Transportation
Performing Agency:	Center for Transportation Research at the University of Texas at Austin

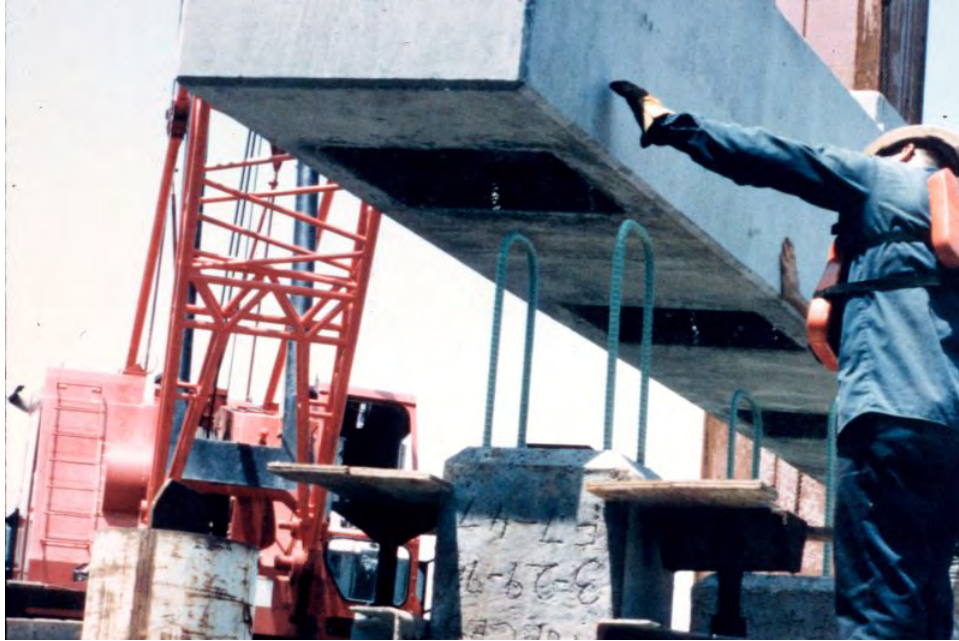
Figure 1.1 Red Fish Bay Project

The contractor suggested using precast bent caps on the Redfish Bay Project to minimize concrete operations over water (Wolf and Friedman 1994, Medlock et al. 2002). Connections involved large voids or pockets preformed into the caps to house connectors (Figure 1.1). U-shaped, epoxy-coated #9 dowels were grouted into embedded sleeves that were cast in trestle piles. Precast caps were then lowered over the dowels, and concrete was cast inside the voids to complete the connections. Construction time for the project was reduced by one third compared with the estimated construction time for cast-in-place bent caps.

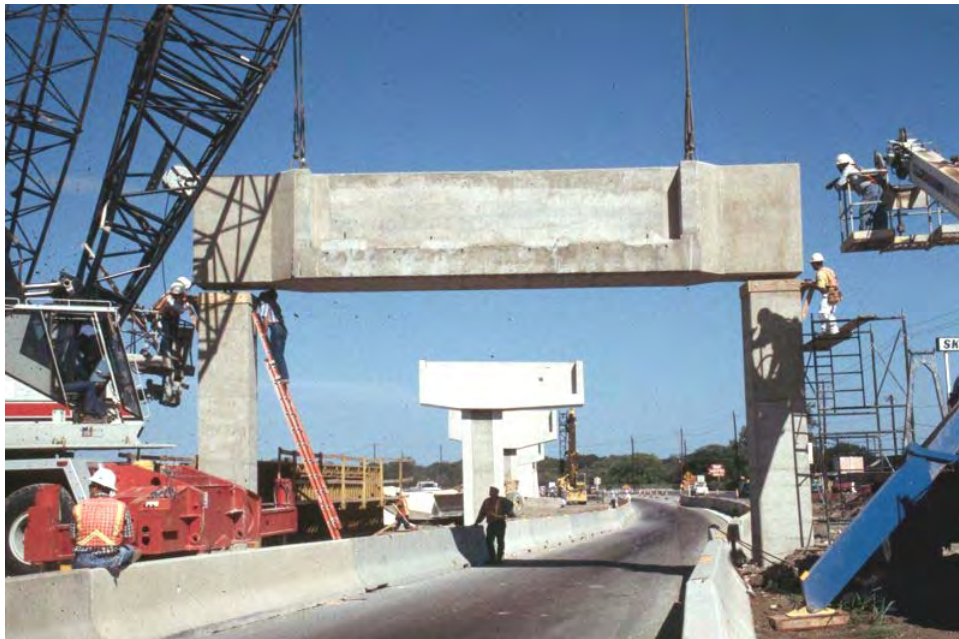
Figure 1.2 US 290 Ramp E-3 Project

The US 290 Ramp E-3 Project in Austin (Figure 1.2) was originally conceptualized as cast-in-place construction. The bent cap design for this ramp was changed to precast when it was found that estimated closure time of the ramp to traffic due to construction would be reduced from weeks to only hours (Medlock et al. 2002). The cap was cast adjacent to the erection site. Two vertical sleeves made of corrugated steel duct were formed on each end of the cap. Dywidag threaded bars that protruded from the columns below passed through the entire cross section and post-tensioned at the top. Grout was then poured into the sleeves to complete the connection.

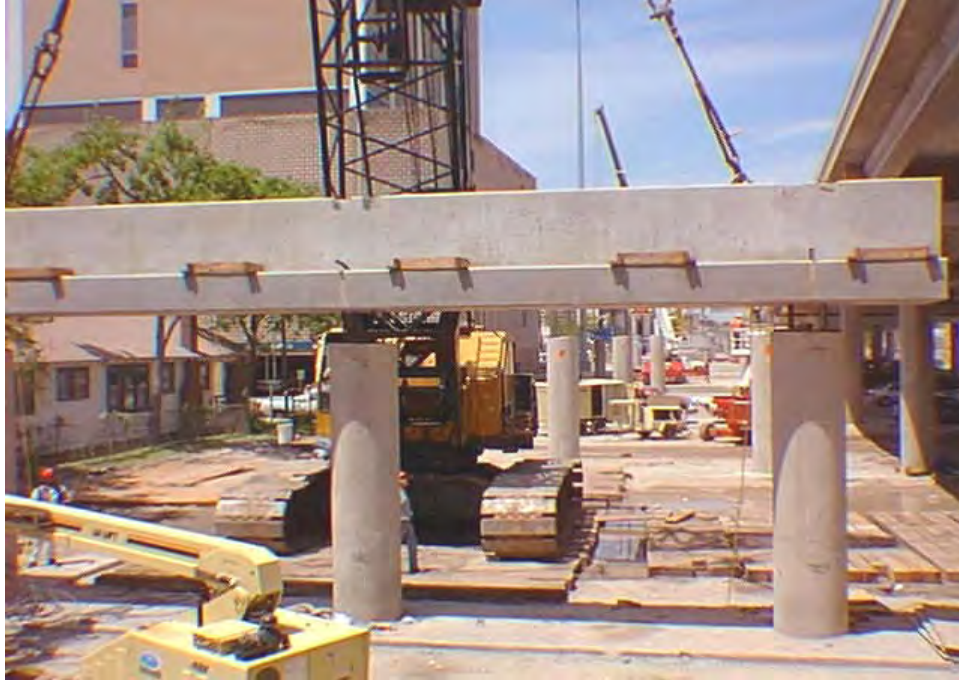
Figure 1.3 Pierce Elevated Project

The use of prefabricated bent caps on the Pierce Elevated Project in downtown Houston allowed the project to be completed in 95 days instead of the estimated 548 days needed for conventional cast-in-place construction (Medlock et al. 2002, Wigington 1997). This replacement project used the existing foundations and columns and only replaced the bent caps, girders, and bridge deck. After removal of the original deteriorated superstructure and bent caps, post-tensioning bars were epoxied into the top of the columns. The new precast caps, which contained preformed sleeves made of corrugated steel duct, were then lowered into position (Figure 1.3). Bars were anchored through plates at the top of the cap, and sleeves were filled with grout.

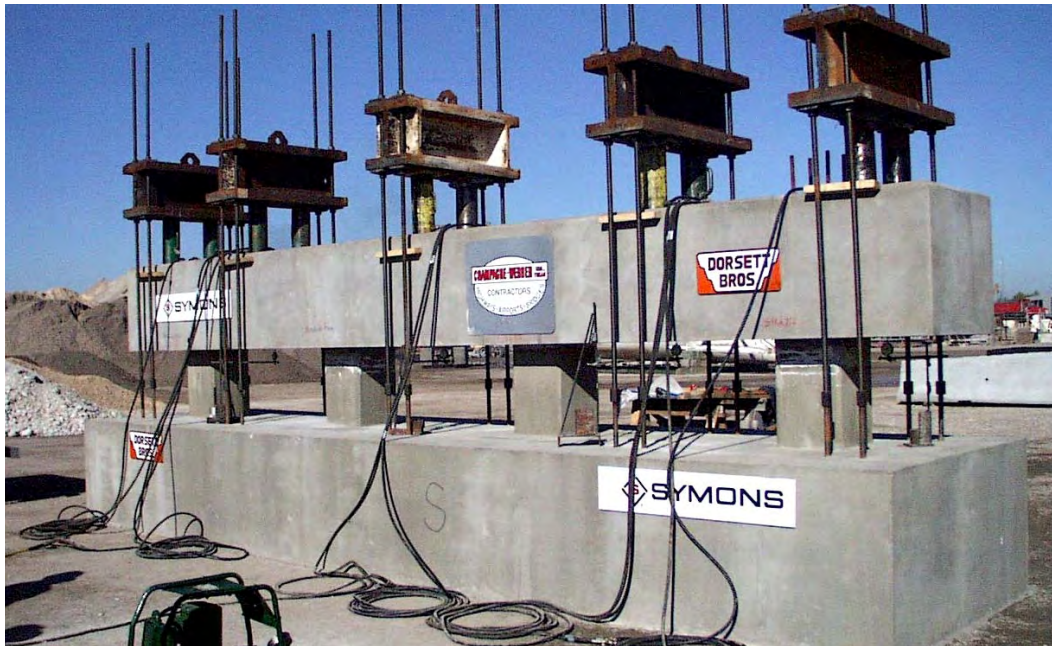
Figure 1.7 Full-Scale Multi-Column Bent (Matsumoto et al. 2001)

Two multi-column bents were constructed in the field by a contractor (Figure 1.7) during the third phase of the project. The main purpose of this phase was to assess the constructability of the different connection types in the field. Behavior of connections was also examined. The researchers made observations on use of plans by the contractor, construction tolerances, setting of the caps, and grouting practices.

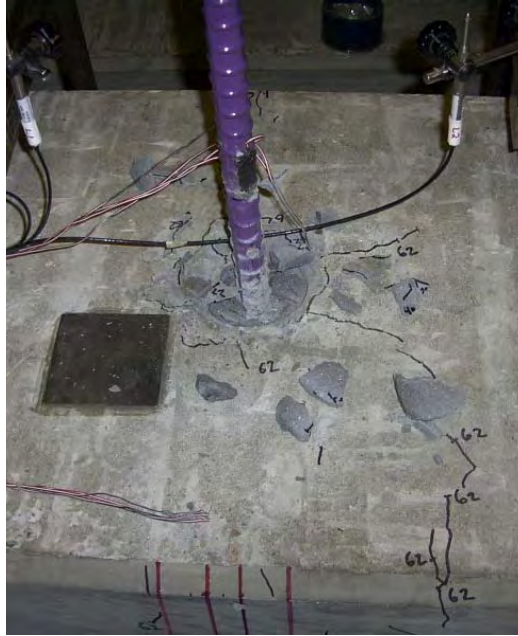
Figure 2.4 Test of Connector Embedded $10d_b$ (Mandawe et al. 2002)

Tests underway at California State University in Sacramento are investigating the seismic response of precast bent caps with grouted vertical-duct connectors. The first phases of testing have examined the cyclic behavior of single epoxy-coated #9 bars embedded in galvanized steel ducts (Mandawe et al. 2002, Matsumoto 2003). Connectors embedded $10d_b$ achieved yielding before failure by pull-out, while connectors embedded $16d_b$ failed by fracture. Figure 2.4 shows a photograph of a test involving a connector embedded $10d_b$. No significant bond degradation due to tension cycles was reported when bars were anchored to achieve yield and the strength of the grout was at least 1000 psi greater than the strength of the concrete. The preliminary results indicate that grouted vertical-duct connections are a viable alternative for use in precast bent cap systems in seismic regions.

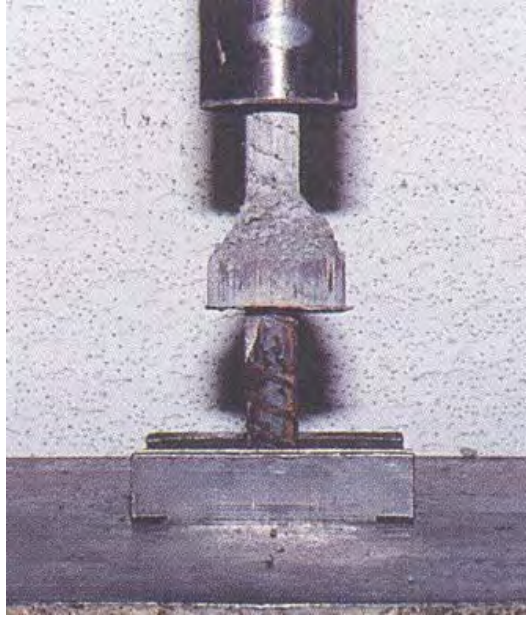
Figure 2.5 Pullout Failure of Generic Grout-Filled Splice Sleeve (Einea et al. 1995)

Einea et al. (1995) tested a series of generic grout-filled reinforcing bar splices monotonically in tension utilizing standard steel pipe as the sleeve material (Figure 2.5). Four different types of splice specimens were tested using both lap splice and butt splice arrangements, and with different steel pipe end details. Details included welding steel rings on the ends of pipes to mobilize confinement action in the grout. Tests involved #5, #6, and #9 bars with embedded lengths between 5 and $11d_b$. Most specimens failed at an axial stress higher than the specified yield strength of the reinforcement.

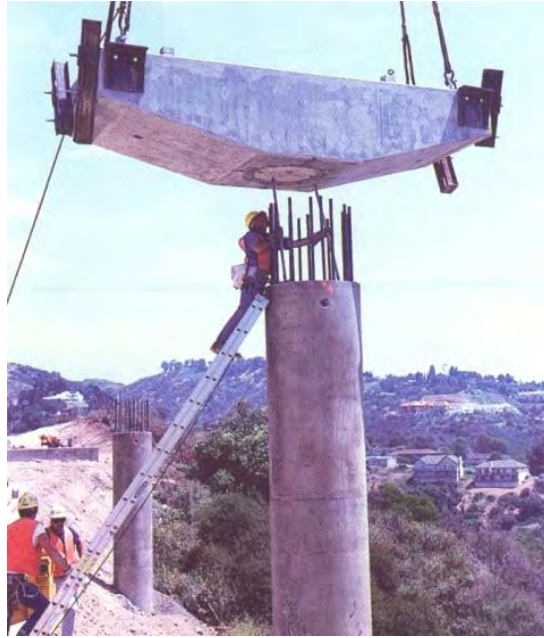
Figure 2.6 Precast Crossheads Used in the Getty Center People-Mover System Project (Josten et al. 1995)

The Getty Center People-Mover System in Los Angeles was built using precast concrete crossheads with grouted vertical-duct connections (Josten et al. 1995). The precast crosshead elements provided an efficient construction system in an environmentally sensitive site along steep hillsides (Figure 2.6). The columns of the tram system were cast-in-place and included a double reinforcing bar template to ensure adequate alignment of the vertical reinforcement that projected above the tops of the columns into the precast crosshead elements. The connection configuration typically consisted of 16 reinforcing bars, as large as #11s, in a 3'-0" diameter circular pattern. The protruding column bars were housed inside 1.5-in. diameter corrugated sleeves cast into the crossheads. High-strength grout was then poured into the sleeves to complete the connections. The sleeve diameter was restricted to 1.5 in. so that it would not interfere with the crosshead reinforcing. Construction of the crosshead elements also made use of templates in the formwork that aligned and maintained the corrugated sleeves at the proper location. Although clearances were extremely tight, all crossheads aligned correctly when erected in the field.

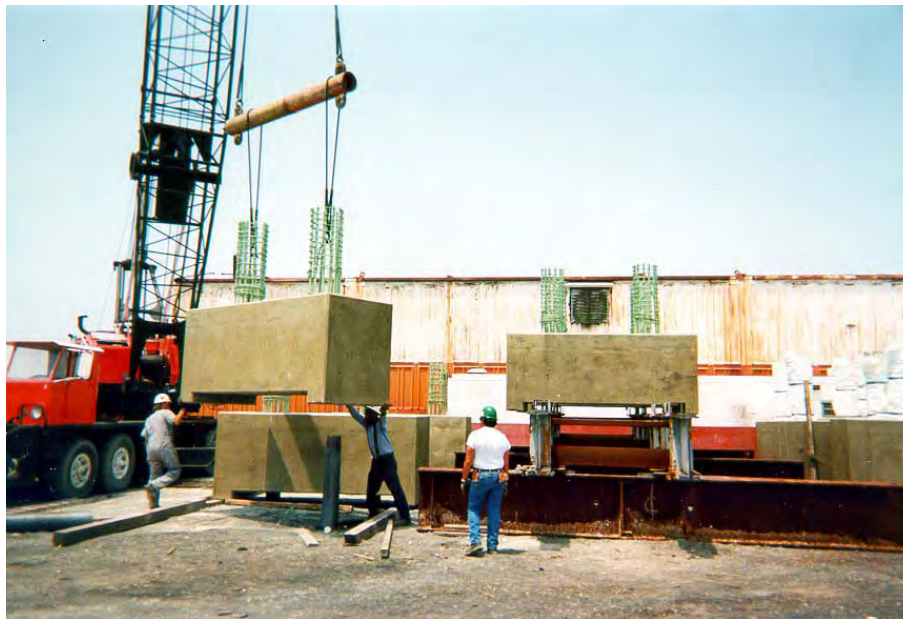
Figure 2.8 Beaufort and Morehead Railroad Trestle Bridge Bent Caps (FHWA 2005a)

Precast bent caps were used in the Beaufort and Morehead Railroad Trestle Bridge Project in North Carolina. Pier caps were cast upside down with protruding top pile reinforcement (Figure 2.8). As caps were placed into position, top pile reinforcement was positioned inside steel pipe piles, and concrete was then pumped into the pipes to make the moment connections between caps and piles (FHWA 2005a). The use of precast bent caps improved constructability and minimized traffic disruption. Trestles were

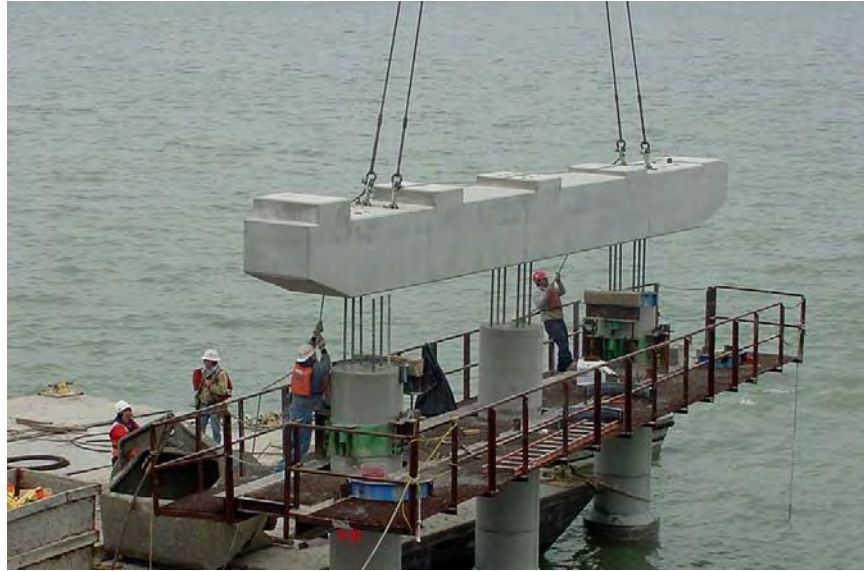
Figure 3.7 Lake Ray Hubbard Bridge Project

Three-column bents supported on drilled shaft foundations make up the substructure system of the replacement bridge. At the initial stages of the project, all substructure elements were constructed using cast-in-place concrete. However, before beginning construction of the westbound bridge, the contractor asked TxDOT for permission to use precast bent caps in order to accelerate construction, avoid the difficulties of handling formwork and materials over water, and to minimize exposure of the workers to power lines that were located very close to the site (Medlock et al. 2002, Freeby et al. 2003). Figure 3.6 shows a photograph of the construction site. The initial precast bent cap design by TxDOT involved a grout void connection detail. Although this detail facilitated construction tolerances, the amount of grout needed for completing the connections was cost prohibitive. TxDOT then designed a connection detail that would utilize grouted vertical ducts instead of grout pockets (Figure 3.7). This change in design led to a 60% reduction in the volume of grout needed (Freeby et al. 2003).

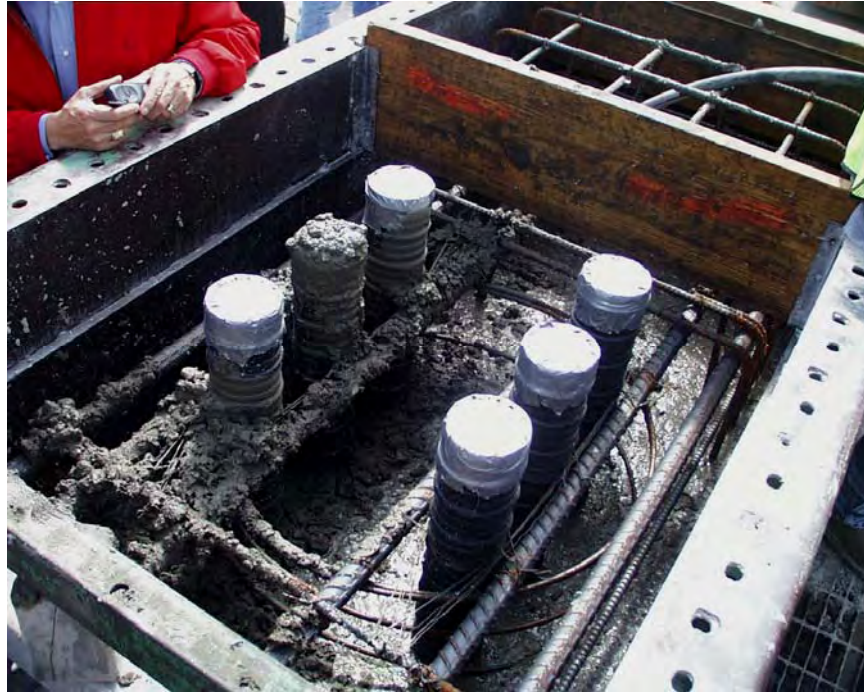
Figure 3.8 Bent Cap Connection Zone under Construction

The final precast bent cap connection detail consisted of six #11 straight reinforcing bars, each housed inside a 4-in. diameter duct. Spiral reinforcement was provided around the connector group to control cracking and enhance ductility. Clear spacing between ducts was 4 in. (or one duct-diameter spacing) in the longitudinal direction of the cap. A photograph of a bent cap connection zone under construction is shown in Figure 3.8.

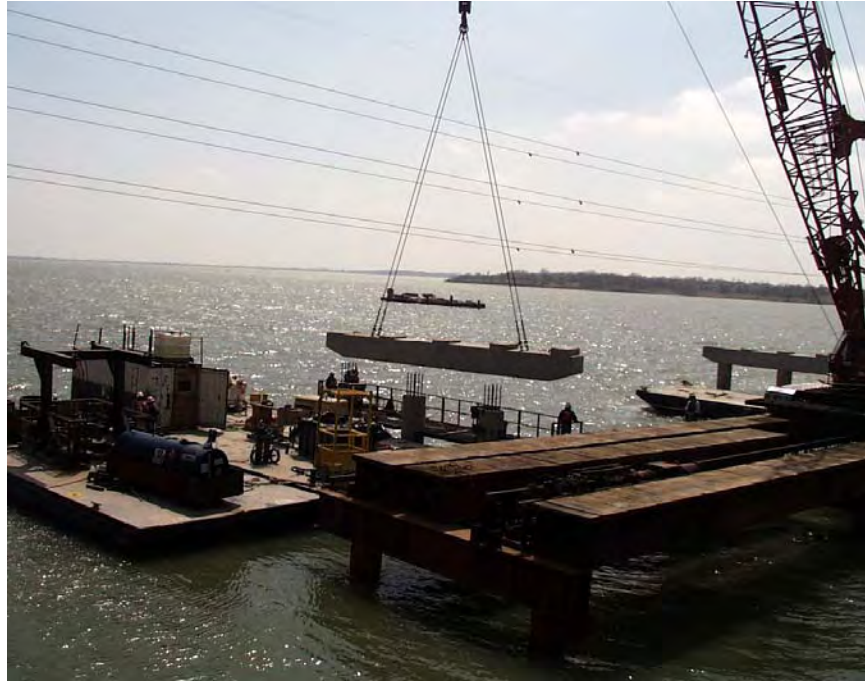
Figure 3.9 Bent Cap Placement Operations

Drilled shaft and column construction were conducted while bent caps were being constructed at a casting yard setup at the eastern end of the bridge. Templates were used at the top of the columns during casting to position the connectors properly to match the sleeves formed in the bent cap element. Bent caps were loaded onto barges and transported for erection. Figure 3.9 shows a bent cap being hoisted for placement on top of the columns. Friction collars were placed on the columns to provide temporary support for the cap during the placement and grading operations. Grout was pumped from the bedding layer into each connection; three vents were provided in the forms of the bedding layer to ensure a successful grouting operation. Flow of grout up the ducts was monitored from the top.

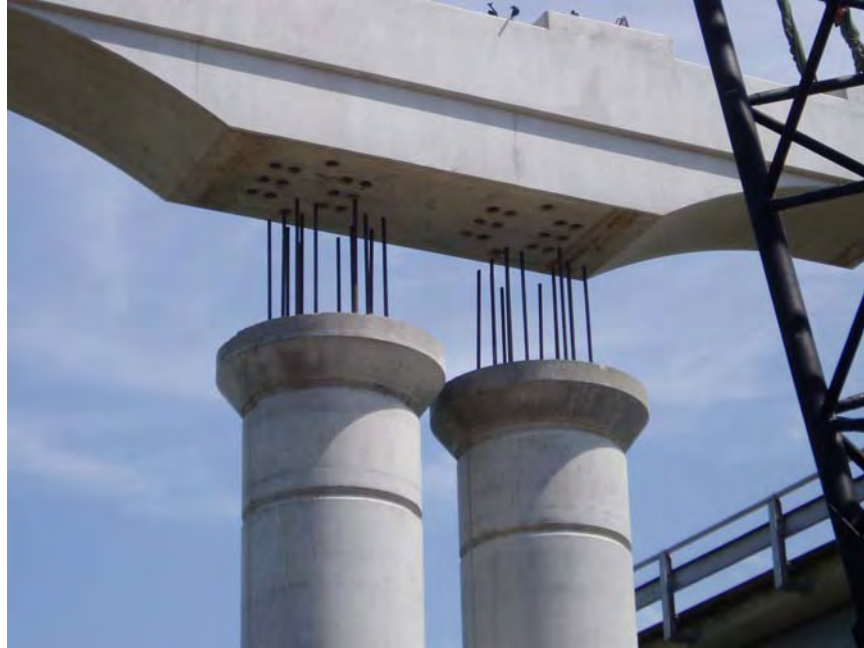
Figure 3.12 Lake Belton Bridge Project

Each of the two connection zones (one for each column) involved the anchorage of fourteen #11 Grade 60 reinforcing bars in 4.5 in. diameter galvanized steel ducts (Figure 3.12). The connectors were embedded 4'-2" into the cap, and the ducts that housed them did not extend to the top of the cap. Discontinuing the ducts prevented interference with the negative moment reinforcement in the cap and also limited the area of grout that was exposed to the atmosphere.

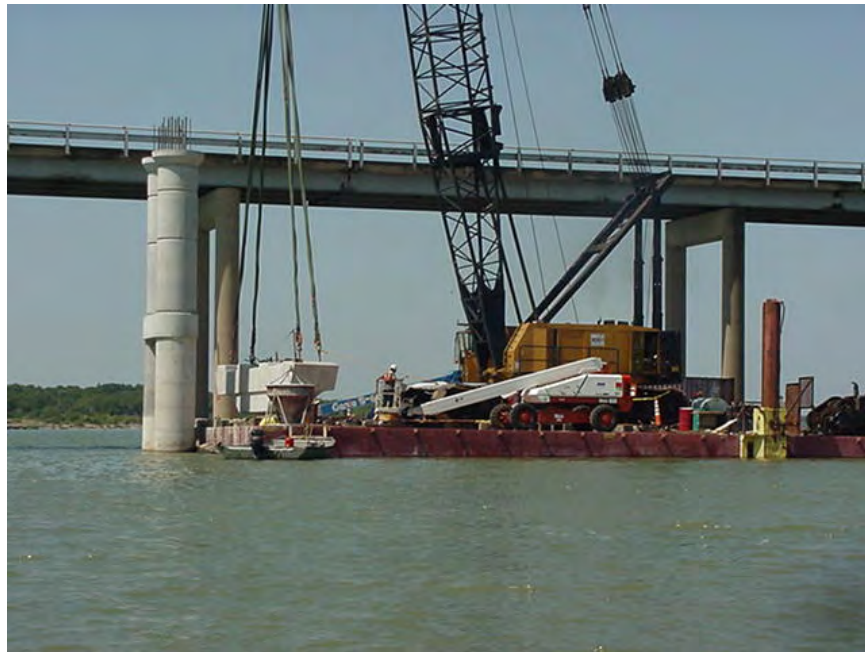
Figure 3.14 Bent Cap Placement Operation with Barge-mounted Crane

Each of the precast caps weighed approximately 75 kips. The caps were transported by truck from a precasting yard located 140 miles south of the construction site. After arriving at the site, caps were mounted on a barge with an integrated the crane used for lifting and placing the caps (Figure 3.14). A 2-in. thick bedding layer was formed between the cap and the columns that included dry-pack grout placed in the periphery of the connection zones. The bedding layer and the ducts were then filled with grout that was pumped at high pressure from below.

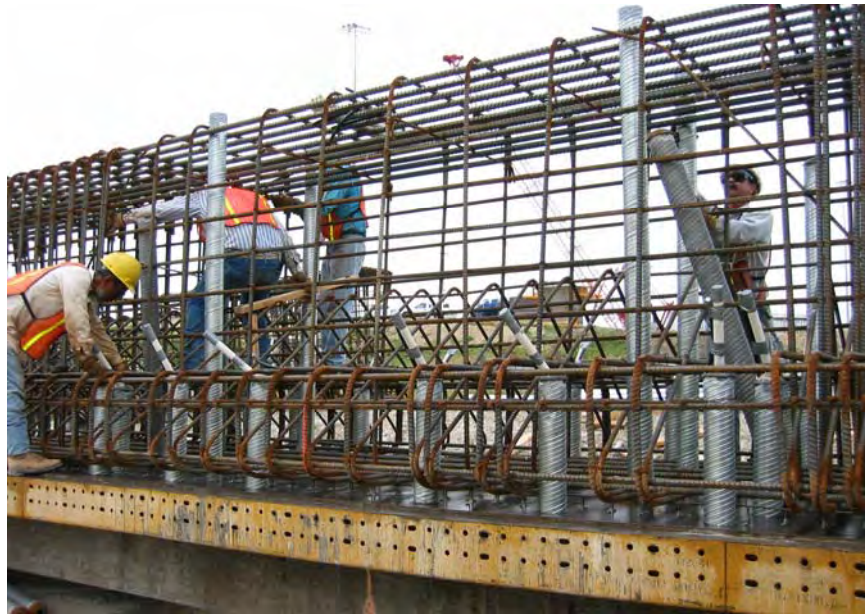
Figure 3.17 Placement of Bent Cap Reinforcement and Ducts

Caps were fabricated on the construction site (Figure 3.17). A typical detail of the inverted-T cap cross section is shown in Figure 3.18. A total of 18 - #11 bars (approximately 60% of the longitudinal reinforcing steel in the column) extended beyond the column and were grouted in the corrugated steel ducts provided in the caps. Ducts were located in the stem and in both ledges of each cap. Column bars that were anchored in the ledge regions of the cap had a short embedment length of around 18 in. ($13d_b$ for a #11 bar). Connections (bedding layer and ducts) were pressure grouted from the ground (Figure 3.19). Four threaded bars anchored at the top of the cap provided support during grouting operations. Except for those ducts housing the erection bolts, all other ducts were terminated before reaching the top surface of the cap.

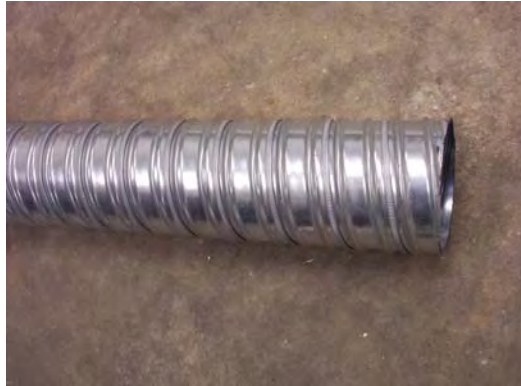
Figure 4.1 Corrugated Galvanized Steel Duct

A large portion of the testing program dealt with comparing the performance of connections configured with different duct materials. Three different duct types were selected for the investigation. The first type was made of a corrugated galvanized strip steel material conforming to ASTM A653 with a 26-gage thickness (Figure 4.1). The other two duct types were made from different plastic materials: one was made of high-density polyethylene (Figure 4.2), and the other was made of polypropylene (Figure 4.3). Because the bond transfer mechanism between the plastic duct and the concrete/grout depends mainly on friction and mechanical interlock, the influence of the rib pattern on behavior can be of great consequence. Only duct with a 4-in. nominal diameter was used in the tests. The geometric properties of each type of duct are summarized in Table 4.1.

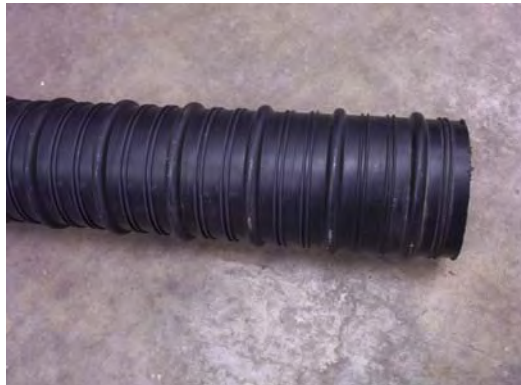
Figure 4.2 Corrugated High-Density Polyethylene Duct

Two kinds of plastic duct were used in this investigation: one was made of high-density polyethylene, and the other was made of polypropylene. All ducts had a 4-in. nominal diameter. Corrugations for both types of ducts were circular and intermittent, as shown in Figure 4.2 and Figure 4.3. The duct made of polypropylene had an additional corrugation pattern in the longitudinal direction, designed to improve bond properties. Because the two plastic duct types have equal wall thickness, and because the tensile properties for both materials are similar, differences in behavior were expected to be due to variation in corrugation patterns. The geometric properties of the plastic ducts are summarized in Table 4.1.

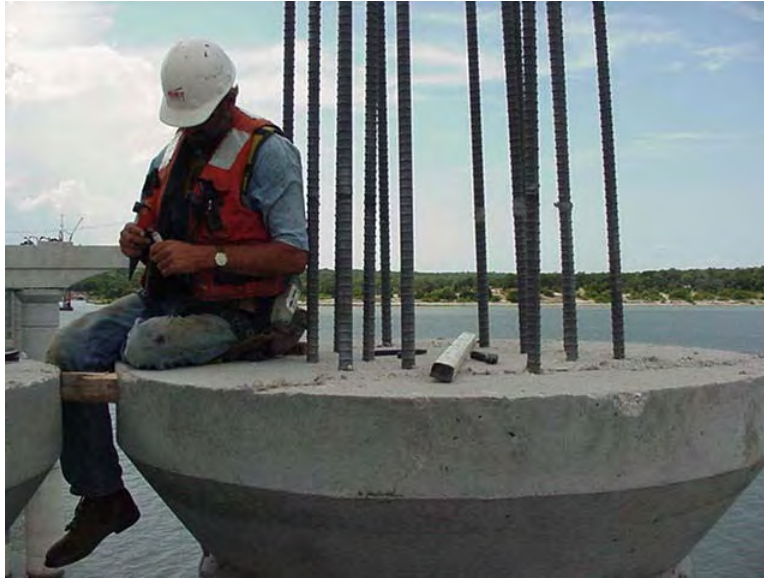
Figure 4.4 Observed Alignment of Connectors – Lake Belton Bridge Project

Precast bent cap connections are currently being designed in Texas using grouted vertical ducts with connectors positioned in close proximity to each other. The clear spacing between the ducts is often equal to the diameter of the duct. To explore the effect of connector spacing, duct clear spacing from one to two duct diameters was examined. For the 4-in. nominal diameter of the ducts used, this meant center-to-center distances between the connectors of 8 and 12 in.

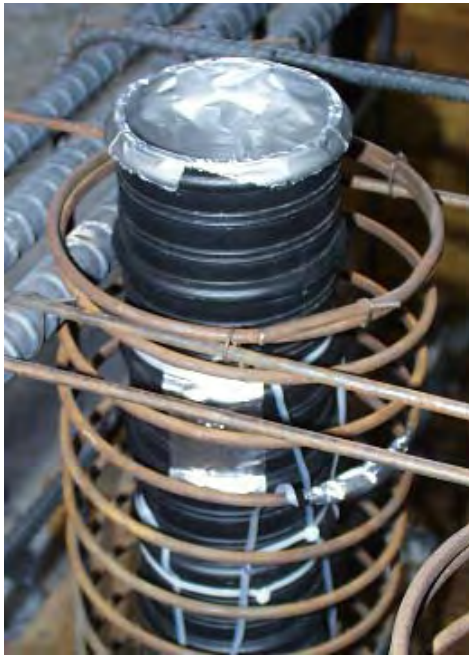
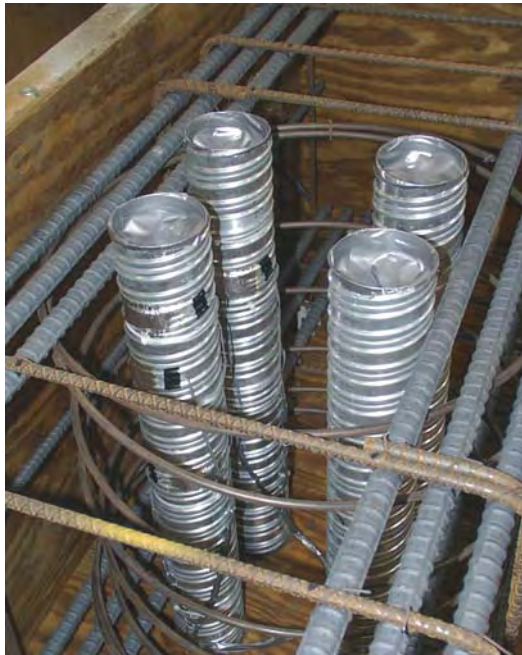
Figure 4.9 Spirals Used as Transverse Reinforcement

The beam specimen reinforcement is shown in Figure 4.7. Longitudinal reinforcement consisted of 6-#8 reinforcing bars at both the top and bottom of the beam. Stirrups were #4 open stirrups at 6-in. spacing. Some specimens included transverse reinforcement around the ducts. Spiral reinforcement is shown in Figure 4.9. Large spirals, which surrounded groups of connectors, had a diameter of 24 in. and a pitch of 6 in.; whereas the small spirals, which surrounded individual ducts, had a diameter of 7.5 in. and a pitch of approximately 1.5 in. Bar diameters were 0.375 in. for the large spirals, and 0.25 in. for the small spirals.

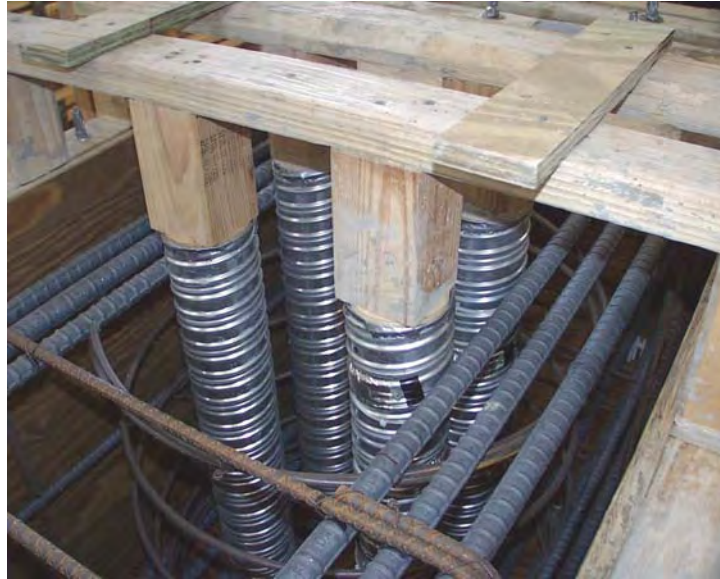
Figure 4.10 Vertical Alignment of Ducts during Concrete Placement

Test specimens were constructed two at a time. After reinforcing cages were placed inside the formwork, ducts were ready to be placed. Ducts were sealed with duct tape at both ends to prevent penetration of concrete during casting. Duct locations were carefully laid out, and ducts were held in place by small, round, plywood block-outs at both ends to maintain proper alignment during concrete placement (Figure 4.10). Proper positioning and vertical alignment of ducts in the formwork was important because it ensured that the connector would be within tolerance to fit in the space allocated in the test setup.

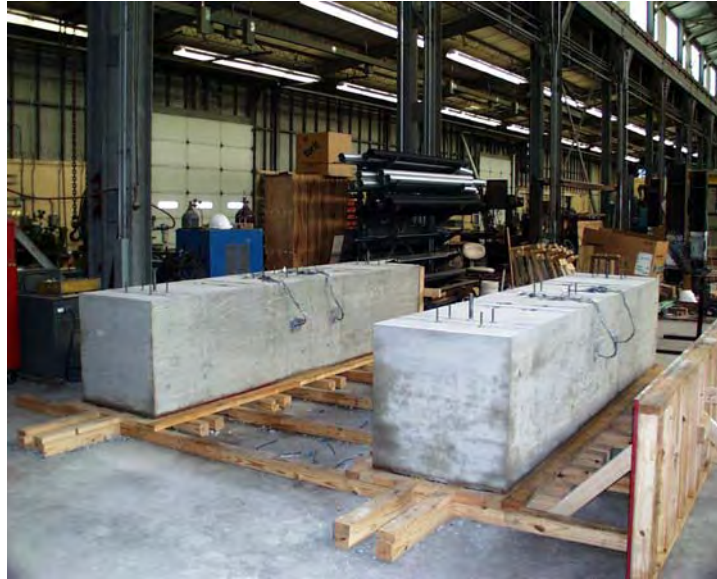
Figure 4.11 Beam Specimens after Formwork Removal

Three or four days after concrete placement, the forms were removed, and the beams were left to gain strength for approximately two weeks (Figure 4.11). It is worth noting that at this point, a precast concrete bent cap in the field would be prepared to be hoisted and positioned into its final position on top of a bridge pier, followed by grouting operations to complete the connection. In contrast, the test specimens used in this investigation do not have accompanying piers to complete the connections. Instead, beams were moved to the testing area where they were set on neoprene pads and leveling shims on three concrete support blocks.

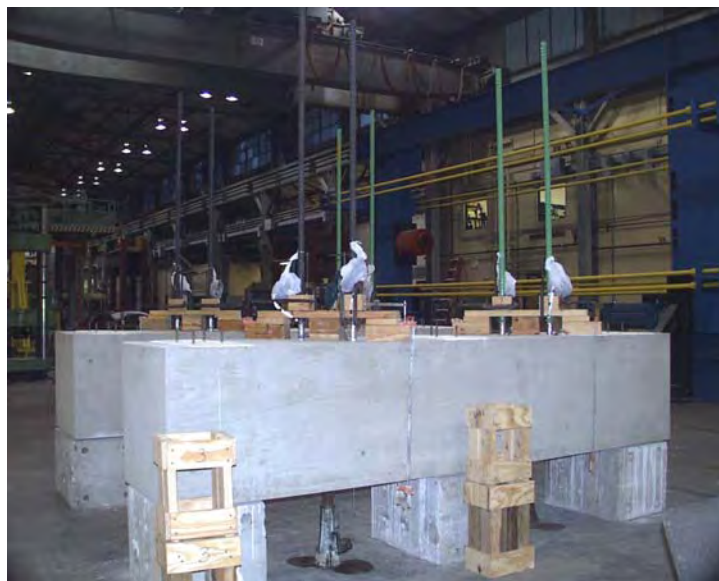
Figure 4.12 Positioning and Vertical Alignment of Connectors in Preparation for Grouting Procedures

Individual connectors were then positioned within the ducts. The required embedment depth was measured from the top of the beam to the bottom of the connector and each connector was carefully aligned (Figure 4.12). The ducts were then filled with grout. Most of the connection zones had a square four-duct configuration, but usually, connectors were only placed in one or two of these ducts. However, all ducts were filled with grout.

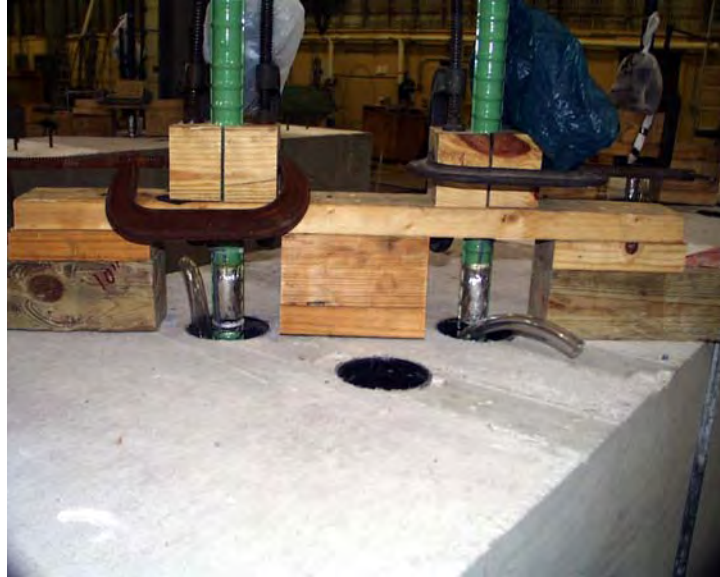
Figure 4.13 Formwork to Hold Connectors Aligned during Grouting

The formwork required for filling the ducts with grout was simple. The bottom of the connection area was sealed with a square plywood panel, held firmly in position by a jacking device from below. At the top of the specimens, connectors were restrained and positioned using a combination of clamps, small shims, and wood blocks (Figure 4.13). Vertical alignment of the connectors was checked using surveying equipment.

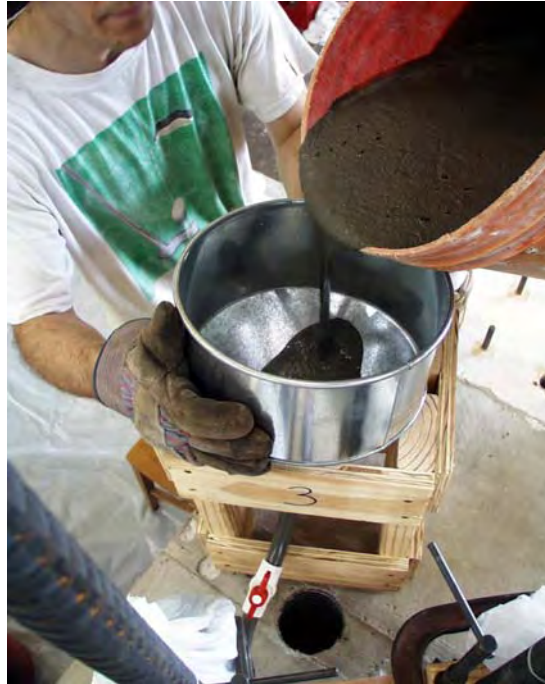
Figure 4.14 Gravity Tremie-tube Technique to Fill Ducts with Grout

Grout was placed using a gravity tremie-tube method. Grout was poured from buckets into large funnels, which had a 0.625 in. clear plastic hose that extended from the base of the funnel to the bottom of the duct (Figure 4.14). Ducts were thus filled from the bottom up, in a continuous, uninterrupted fashion to avoid the inclusion of air in the grout. A series of 2-in. grout cubes were also prepared. After the ducts were filled, and the grout was beginning to show signs of hardening, normally two to three hours after placement, a curing compound was applied on top of the grout surface, and wet cloth rags were then applied and kept moist for 24 hours.

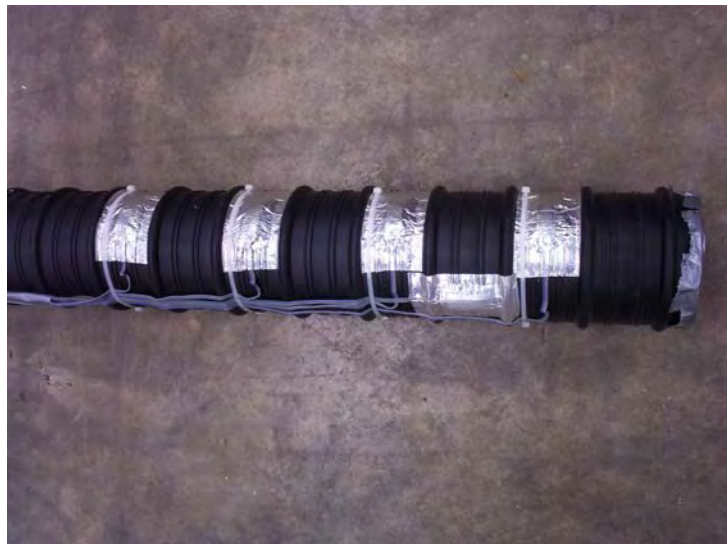
Figure 5.6 Completed Gage Installations on HD Polyethylene Duct

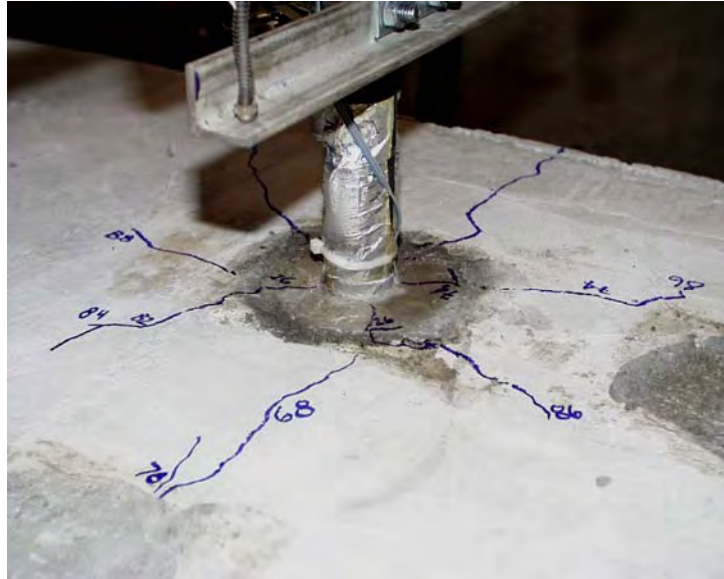
Figure 6.1 Widespread Splitting in Test 10

Crack patterns in specimens constructed using galvanized steel duct are illustrated using Tests 10, 13, and 23. A single, plain bar with an embedded depth of $12d_b$ was loaded during Test 10. The first signs of cracking in the grout were observed at a load of 26 kip (17 ksi). As load increased, radial cracks were observed in the concrete at a load of approximately 68 kip (45 ksi). A widespread pattern of radial splitting (Figure 6.1) formed at a load of approximately 88 kip (57 ksi). The pattern of radial splitting in single connectors was generally axisymmetric, meaning cracks were usually spread equally in all directions. The cracks typically extended over a large portion of the top surface of the specimens.

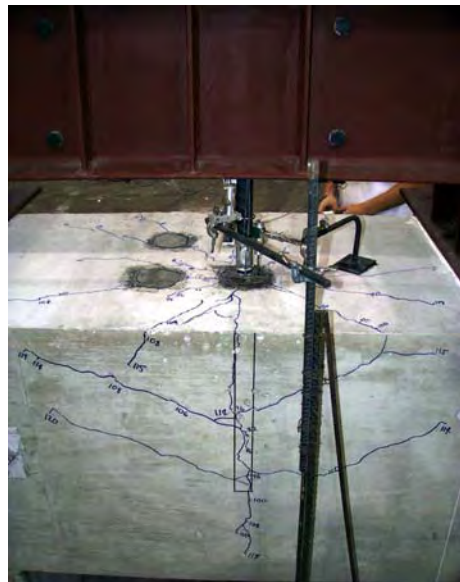
Figure 6.2 Crack Pattern at Failure – Test 10

Figure 6.2 shows the crack pattern at failure (121 kip (80 ksi)). The V-shaped cracks that formed on the side of the specimen corresponding to the smallest cover indicate that the connector, grout, duct, and concrete were working together to resist the applied load. The orientations of these diagonal cracks indicate the presence of inclined compression struts in the concrete, which are a primary component of the resisting mechanism in the grouted vertical connections.

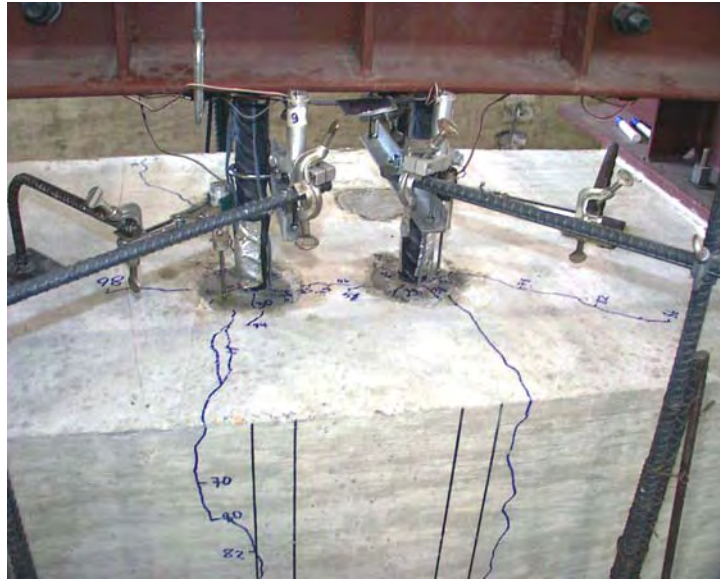
Figure 6.3 Widespread Splitting in Test 13

The crack patterns at failure were similar for tests with multiple connectors. Two, plain bars with embedded depths of $16d_b$, were loaded during Test 13. The first signs of cracking in the grout were observed at a load of 24 kip (16 ksi), and radial cracks in the concrete were observed at a load of 86 kip (57 ksi). The crack patterns around the two connectors were similar throughout the test (Figure 6.3). The close proximity of connectors (clear spacing of $1D$ between ducts) caused extensive interaction between the connectors. Both connectors failed together as a unit at a load of approximately 132 kip (87 ksi) (Figure 6.4).

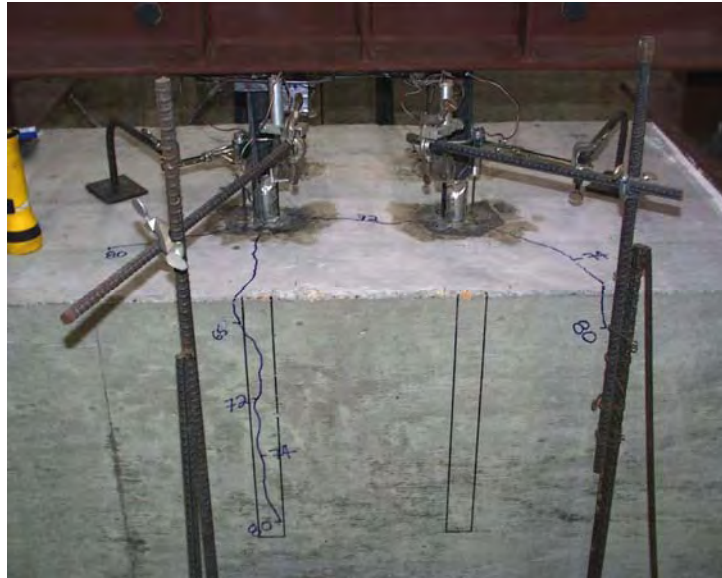
Figure 6.5 Widespread Splitting in Test 23

Two connectors were also tested in Test 23. The connectors were embedded $12d_b$ and the clear spacing between ducts was $2D$. The increased duct clear spacing reduced the interaction between the connectors and different crack patterns were observed for each connector (Figure 6.5). In this test, cracks were first observed in the grout at a load of approximately 19 kip (13 ksi) and widespread splitting was observed at a load of 74 kip (49 ksi). As loading approached failure, the connectors acted as a unit. Figure 6.6 shows the crack pattern at failure, which included V-shaped cracks.

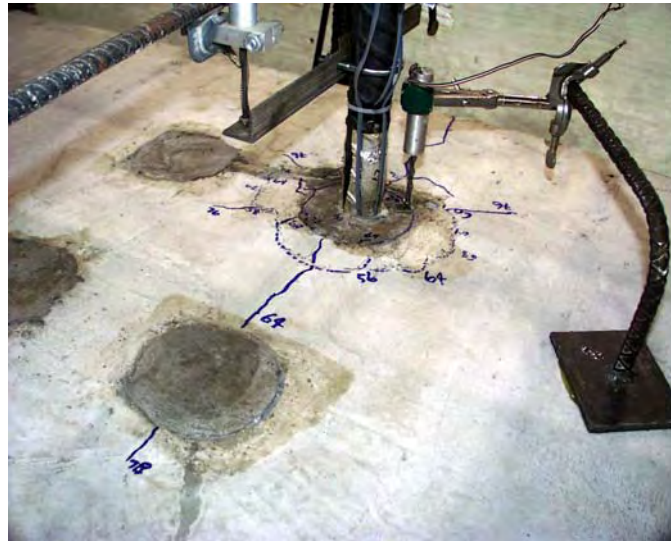
Figure 6.7 Splitting Cracks in Test 9

Crack patterns in specimens constructed using polyethylene duct are illustrated using Tests 9 and 14. A single, plain bar with an embedded depth of $12d_b$ was loading during Test 9. The first signs of cracking in the grout were observed at a load of 20 kip (13 ksi). As load increased, radial cracks were observed in the concrete at a load of approximately 64 kip (42 ksi). Figure 6.7 shows the cracking pattern at a load of 78 kip (51 ksi). Fewer radial cracks were observed in this specimen compared with the specimens constructed using galvanized steel duct. In addition, the cracks occupied a much smaller area on the top surface of the beam. Figure 6.8 shows the crack pattern at failure (82 kip (54 ksi)). V-shaped crack formations did not form in this specimen.

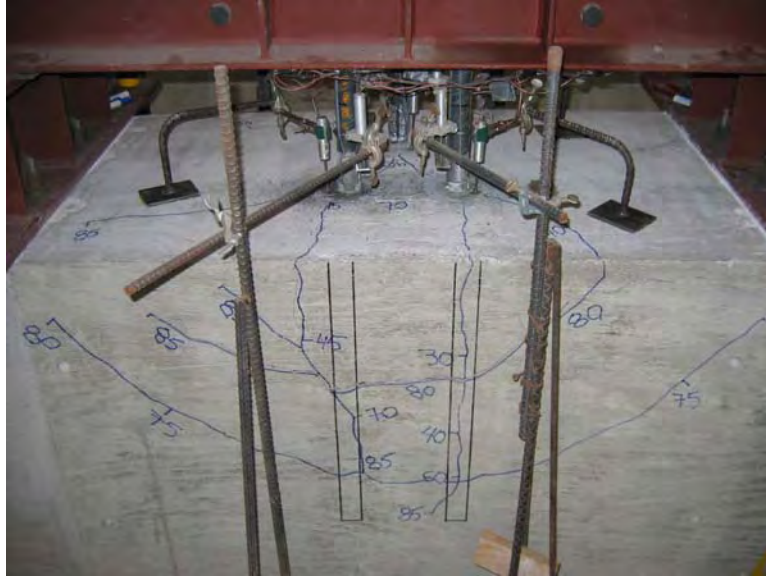
Figure 6.13 Formation of V-Shaped Cracks in Test 32

Three connectors, arranged in a triangular pattern and embedded $16d_b$, were loaded during Test 32. Cracking of the grout was observed at a load of 15 kip (10 ksi), while radial splitting cracks in the concrete started to develop at a load of 30 kip (20 ksi). V-shaped cracks, shown in Figure 6.13, formed at a load of 75 kip (50 ksi). Failure occurred at a load of 101 kip (67 ksi).

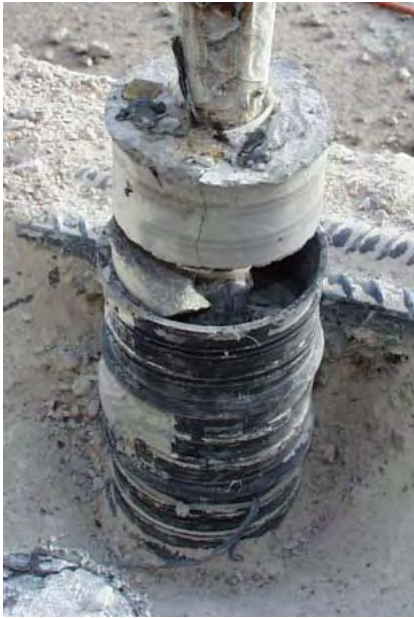
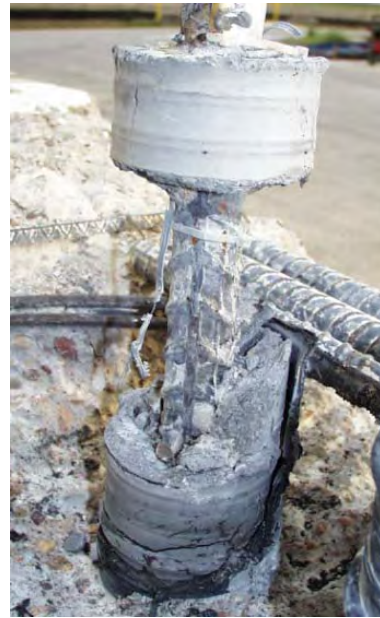
Figure 6.28 Observed Failure of Test 7 (Single Connector, Polyethylene Duct)

Connector embedment depth and the number of connectors per connection influenced the type of pullout failure (Table 6.8). Single connectors with shallow embedded depths tended to fail in the first mode, while single connectors with deeper embedded lengths and multiple connectors tended to fail in the third mode. In tests involving more than one connector, different pullout failure modes were sometimes observed. Figure 6.28 and Figure 6.29 show pictures of Tests 7 and 8, respectively, before and after the damaged duct was removed from the grout.

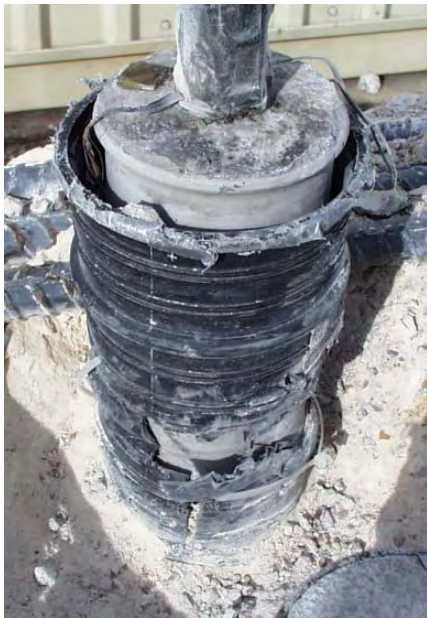
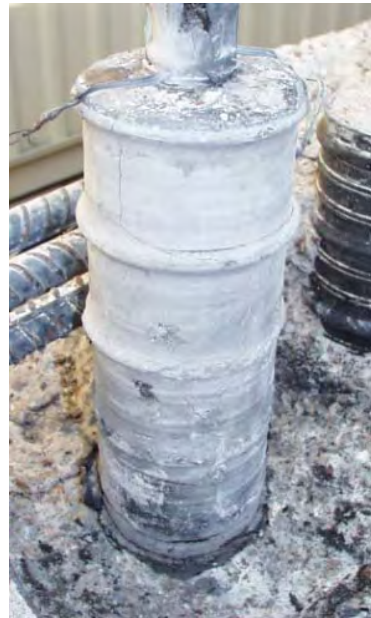
Figure 6.29 Observed Failure of Test 8 (Single Connector, Polyethylene Duct)

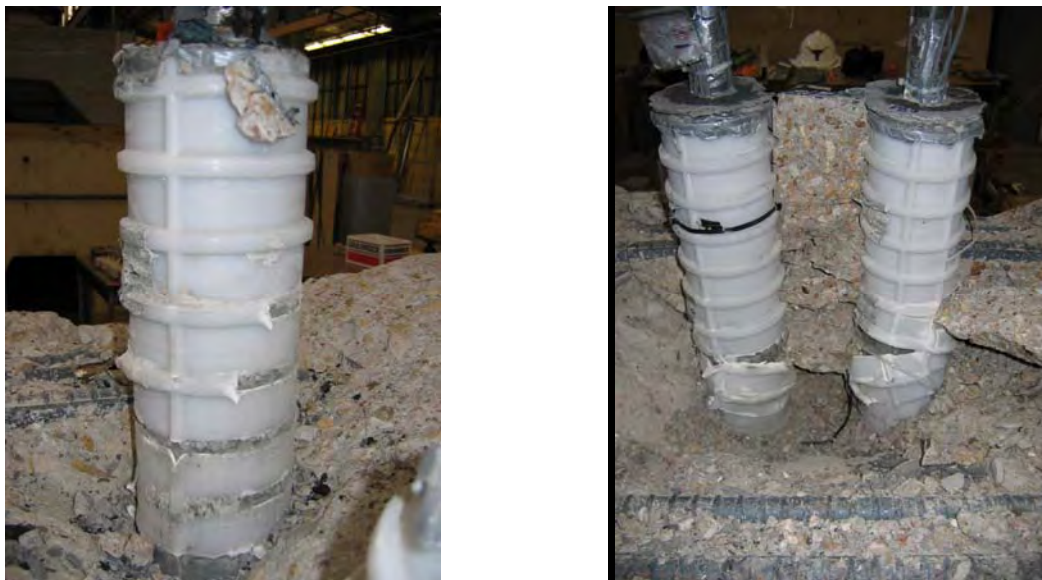
Figure 6.30 Observed Failure of Tests 30 and 28 (Polypropylene Duct)

All four specimens constructed with polypropylene ducts exhibited plug failures of the connector and grout with the top portion of the duct attached to the grout (Figure 6.30). Unlike the polyethylene duct, the polypropylene duct prevented the grout from slipping relative to the duct. The length of the top segment of the duct attached to the grout depended on the depth of the cone-shaped concrete breakout zone that formed in the connection area at failure. This top segment of the duct was intact in all cases. The remainder of the duct remained attached to the grout in some cases, with only the duct/grout ribs getting sheared off as the grout and connector pulled out. No differences were observed in modes of failure of the connections as a result of variation in embedment depth or in the number of connectors. The three connectors removed from Test 32 are shown in Figure 6.31 before and after the duct was removed.

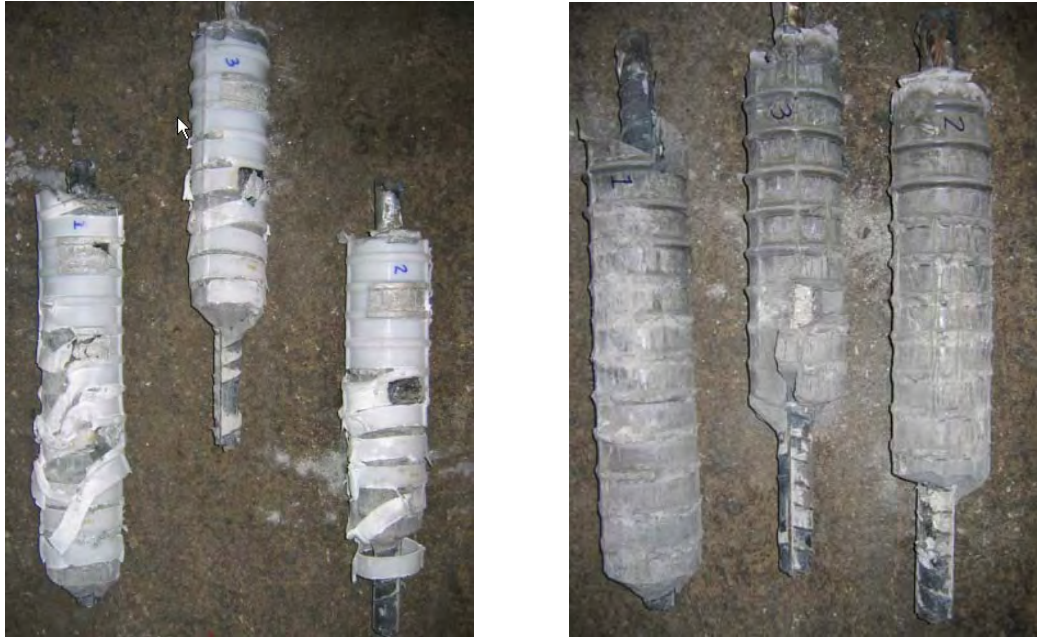
Figure 6.31 Connectors from Test 32 after Pullout (Polypropylene Duct)
