1. Report No. FHWA/TX-06/0-4176-1		2. Government Accession No.		3. Recipient's Catalog No.	
4. Title and Subtitle Anchorage Requirements for Grouted Vertical-Duct Connectors in Precast Bent Cap Systems				5. Report Date May 2006

ANCHORAGE REQUIREMENTS FOR GROUTED VERTICAL-DUCT CONNECTORS IN PRECAST BENT CAP SYSTEMS

CTR Research Report:	4176-1
Report Date:	May 2006
Research Project:	0-4176
Research Project Title:	Development of Precast Bridge Construction Systems
Sponsoring Agency:	Texas Department of Transportation
Performing Agency:	Center for Transportation Research at the University of Texas at Austin

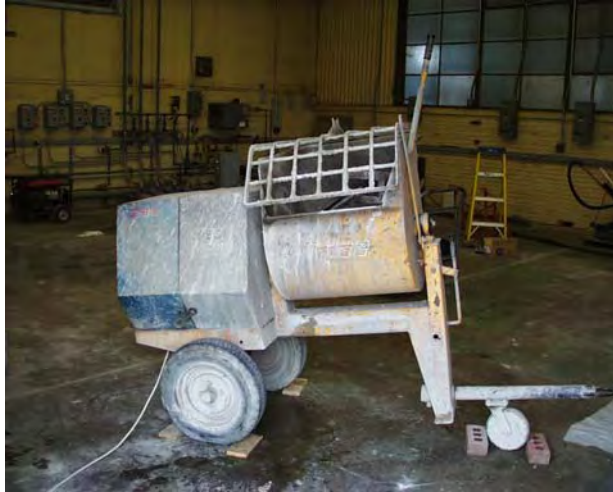
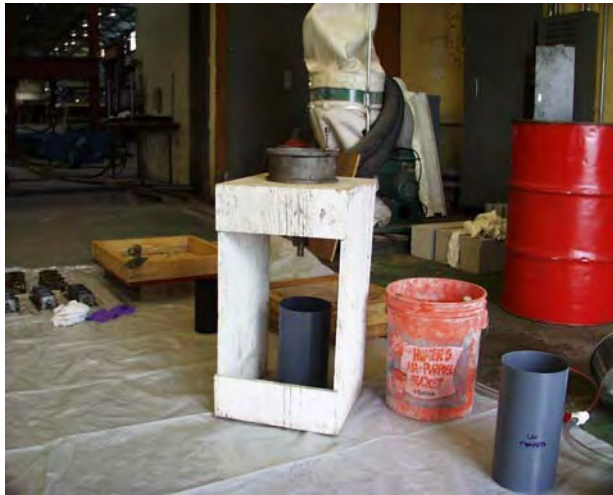
a. Mortar Mixer Used to Mix Grout

b. Flow Cone

Figure A.2 Equipment Used during Grout Operations

Figure A.2 shows the equipment used during the grouting operations: mortar mixer, flow cone, funnels, plastic hoses, and cube forms.

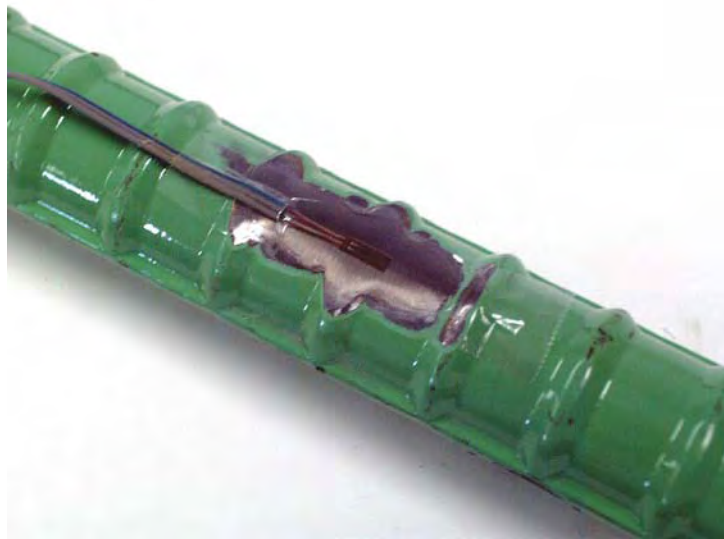
Figure B.1 Surface Preparations on a Connector for Bonding a Strain Gage

Surfaces of the materials were carefully prepared and cleaned before strain gages were applied. In the case of the reinforcing bars, a small portion of a bar lug was ground away to leave a flat surface, which was long enough to bond the gage and apply the water-proofing and protective coatings. Care was taken to grind only the amount of metal necessary to achieve this flat surface. Figure B.1 shows the surface preparation of the rebar.

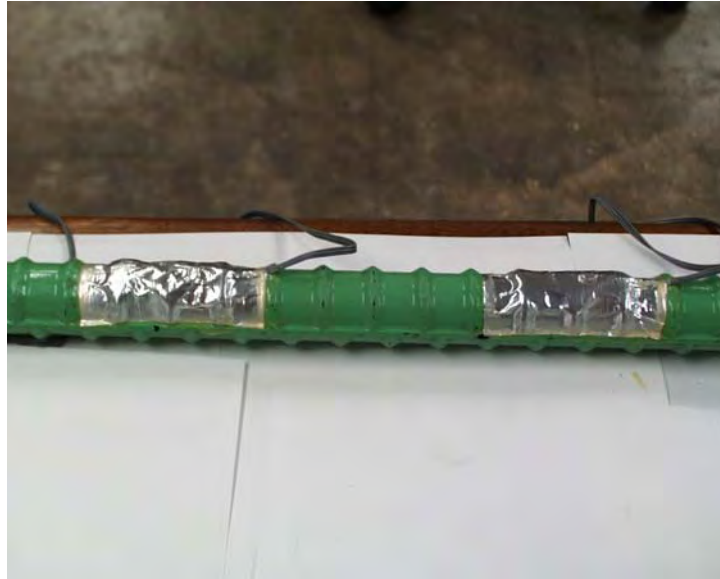
Figure B.3 Two Completed Strain Gage Installations
