Applicability of Asphalt Concrete Overlays on Continuously Reinforced Concrete Pavements

CTR Research Report:	4398-1
Report Date:	March 2003
Research Project:	0-4398
Research Project Title:	<i>Applicability of Asphalt Concrete Overlays on Continuously Reinforced Concrete Pavements</i>

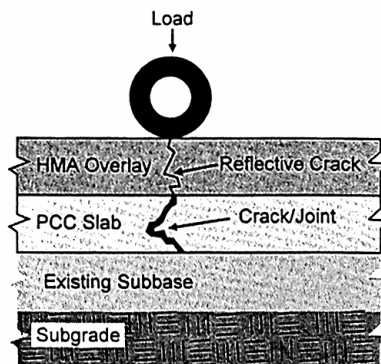
Figure 2.1 Reflective crack distress mechanism

Reflective cracking is a well-documented phenomenon. It occurs in pavement overlays that were placed over unprepared PCCP in poor condition. The pavements expand and contract as the concrete slab temperatures increase and decrease. As the cracks or joints open they induce tension on the bottom of the asphalt overlay. When the tensile stress exceeds the strength of the asphalt overlay, a reflective crack is initiated in the AC overlay at the PCCP interface (Figure 2.1). The cracks will ultimately propagate to the surface. Left unsealed, the crack will allow moisture into the aggregate base and subgrade resulting in premature failure.

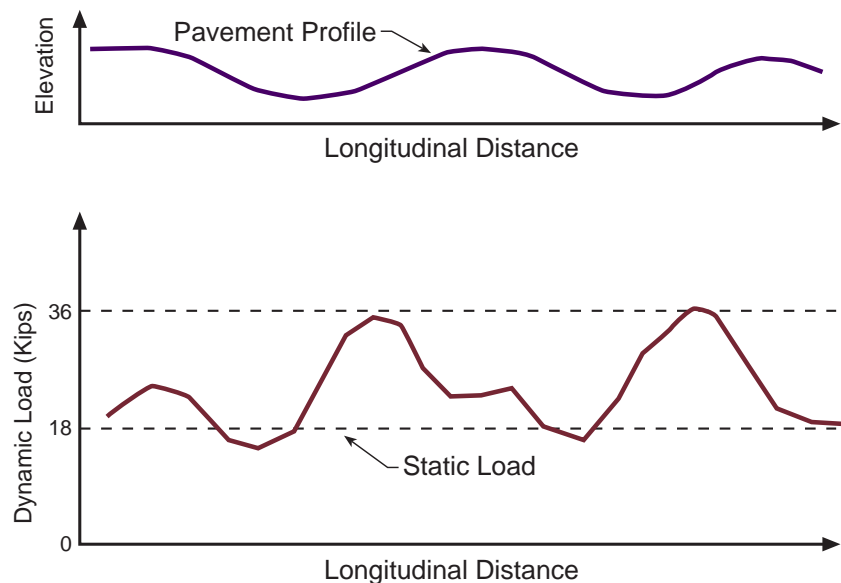
Figure 3.1 The relationship between pavement profile and dynamic loading

Even though pavements are designed based on static loading conditions, the effects of dynamic loading do accelerate the deterioration of a pavement. In particular, because of the relatively high stiffness of rigid pavement slab, any extra roughness on the pavement slab will produce a significant amount of dynamic loading on the pavement. The dynamic load can go as high as twice that of the applied static load on a pavement, as illustrated by the relationship between pavement profile and dynamic loading in Figure 3.1. Research has shown that even lightly loaded trucks can generate 18 kips of dynamic load; yet they are generally ignored in traffic counts.

The higher dynamic loads definitely produce additional stresses in the pavement that can accelerate the deterioration rate of the pavement. Unfortunately, the deterioration rate is not a linear function, but rather a geometric function to the fourth power or greater, for instance, if the load is doubled, the deterioration would be on the order of sixteen times

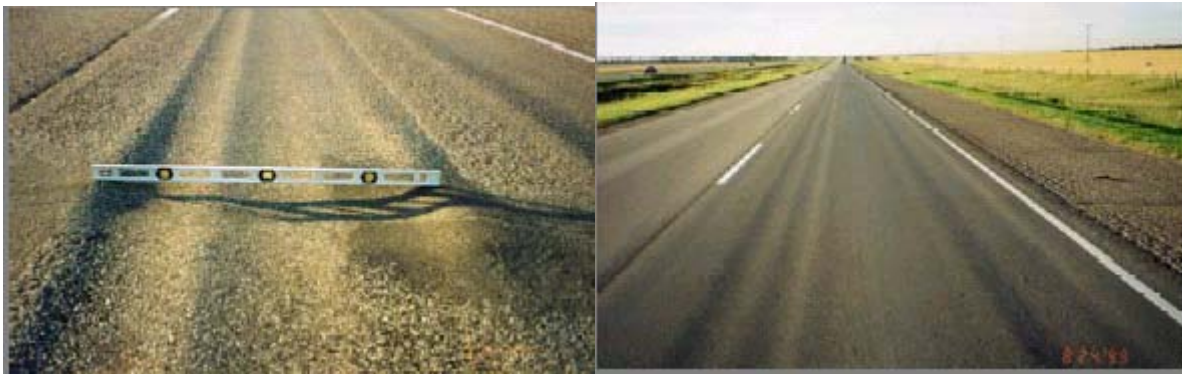
Figure 3.2 Rutting

Definition of the problem: Rutting stems from the permanent deformation of the AC overlay, usually caused by the densification or lateral movement of the materials, that is, shoving due to traffic loads.

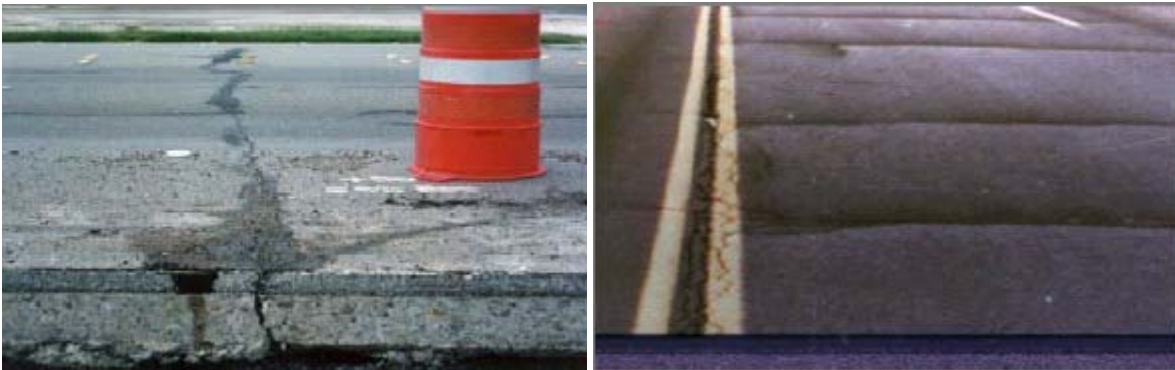
Figure 3.3 Reflection cracking

Definition of the problem: Reflection cracking is defined as a crack that is initiated by discontinuity such as a joint crack or punchout in the underlying PCC layers, which propagates through the HMA surface due to vertical and/or horizontal movement of the crack.

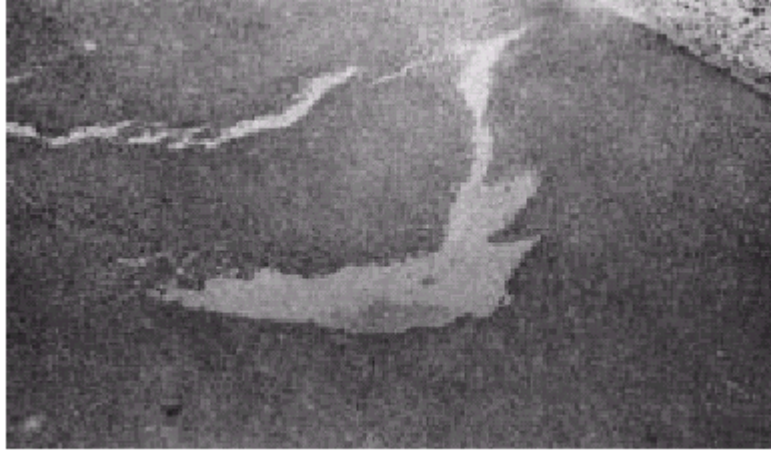
Figure 3.4 Slippage cracking

Definition of the problem: Slippage cracks are crescent- or U-shaped cracks with the bottom of the U pointing in the direction of applied force. Cracks are mainly due to poor bond between the surface and the next layer of the pavement structure and/or low strength of the surface mix. They are generally observed on paths where vehicles brake, accelerate, or turn. Cracks can be repaired by removing the slipped part and replacing with new material.

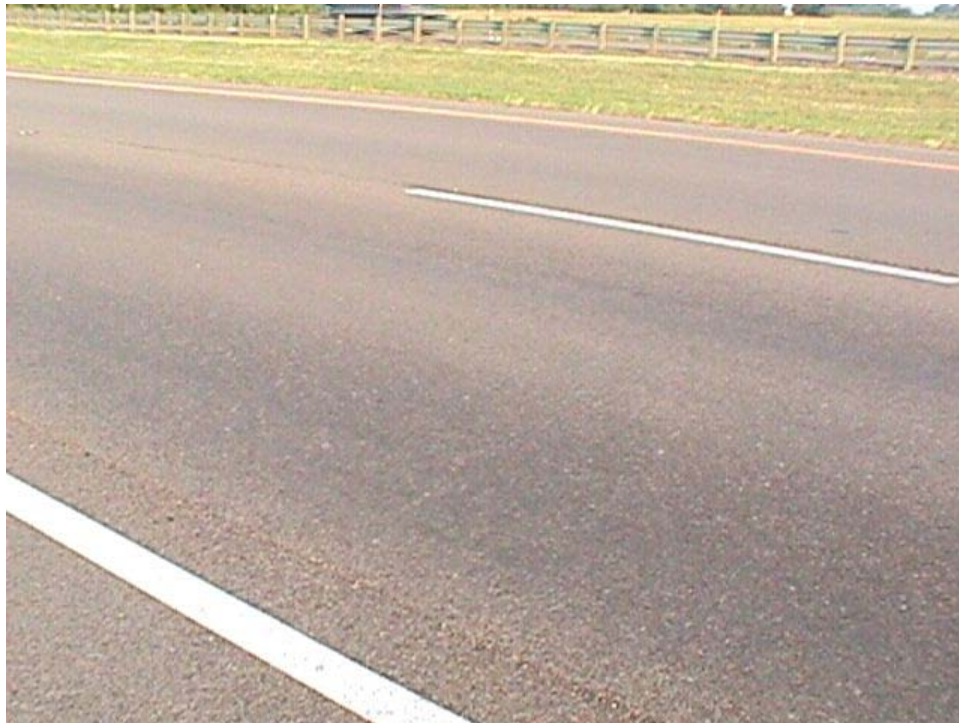
Figure 5.1 Shallow rutting (<0.5 in.) and flushing of asphalt on section 13010-1

The distressed asphalt overlay shows mainly surface rutting and flushing at both wheel paths of the outside lane. In some cases, both lanes show signs of distress, but the outside lane is considerably more distressed than the inside lane. No cracking was found in the sections. Figures 5.1 to 5.4 display the conditions in which the pavement sections were found during the surveys.

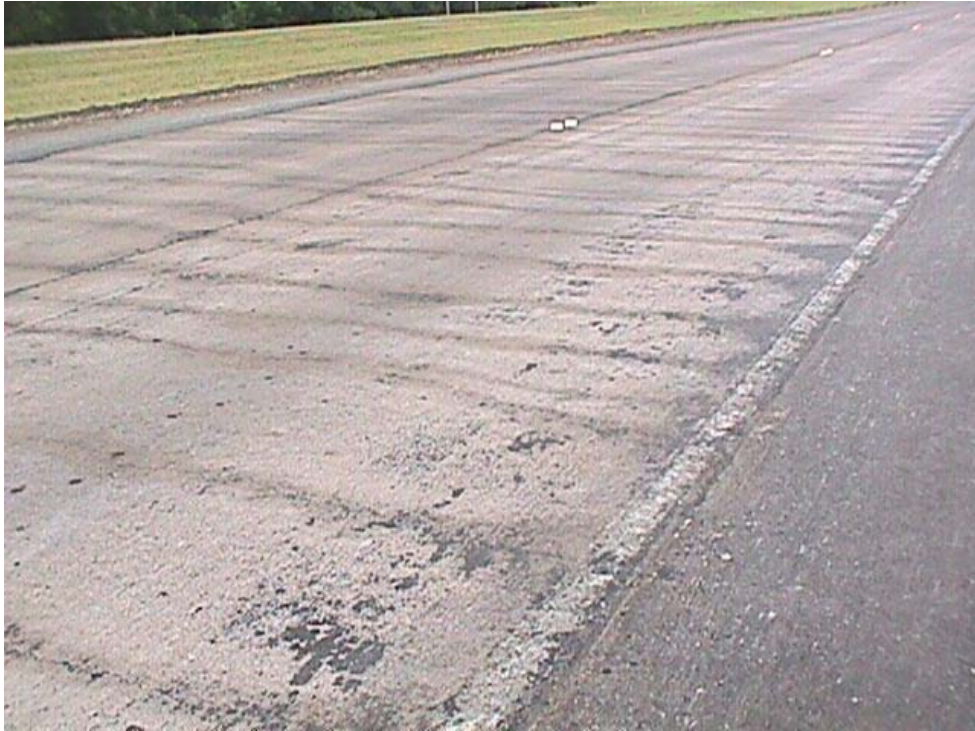
Figure 5.2 Image of CRCP underneath the AC layer that was milled off

The overall condition of sections 13010-2, 13010-3, and 13010-4 exemplifies poor-performing asphalt overlays built on top of CRCP. In some areas the AC overlay has been milled off, and a new AC overlay has been placed as scheduled by TxDOT.

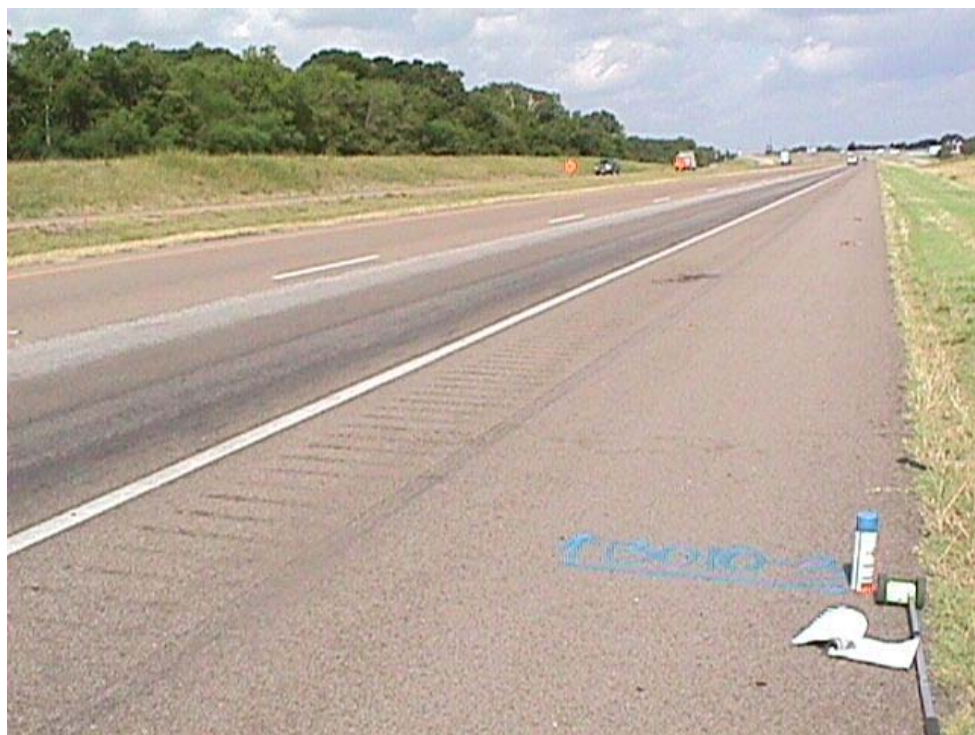
Figure 5.3 Image of rutted and flushed wheel paths of the outside lane

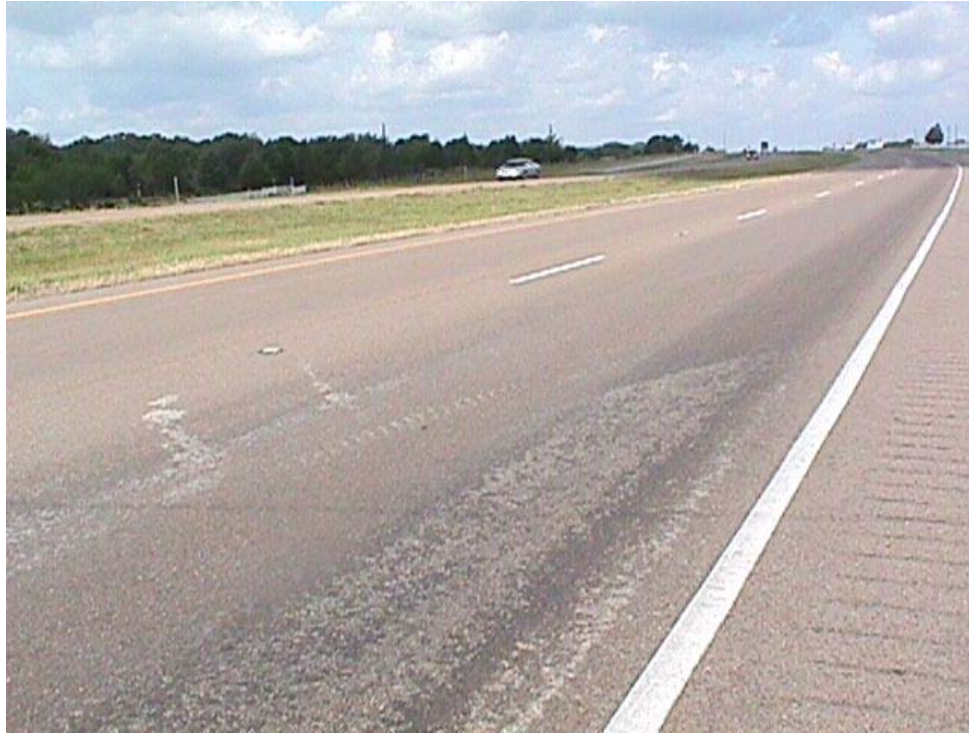
Figure 5.4 End of distressed asphalt layer area, section 13010-4

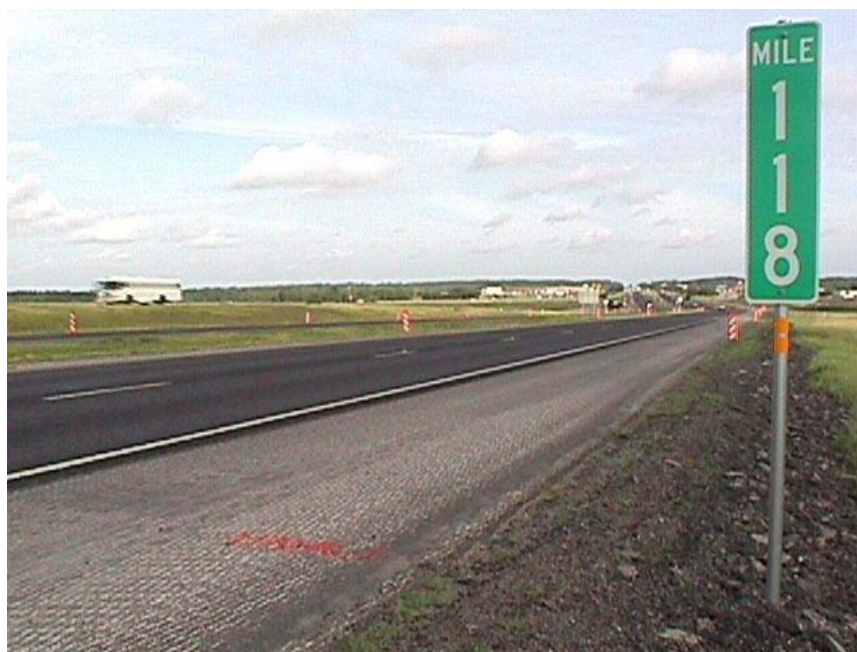
Figure 5.5 Beginning of section 17045-1 on northbound IH-45

All of the sections in Walker County on IH-45, except for one section (17045-2), had just been overlaid when the CTR field crew surveyed the pavement. In fact, the traffic control devices were still in place, which facilitated the surveyors' work, and part of the TxDOT crew was at the site. Being a brand new overlay, the condition was excellent, as shown in Figures 5.5, 5.6, and 5.7, where the old overlay on top of the CRCP shoulder has been milled off.

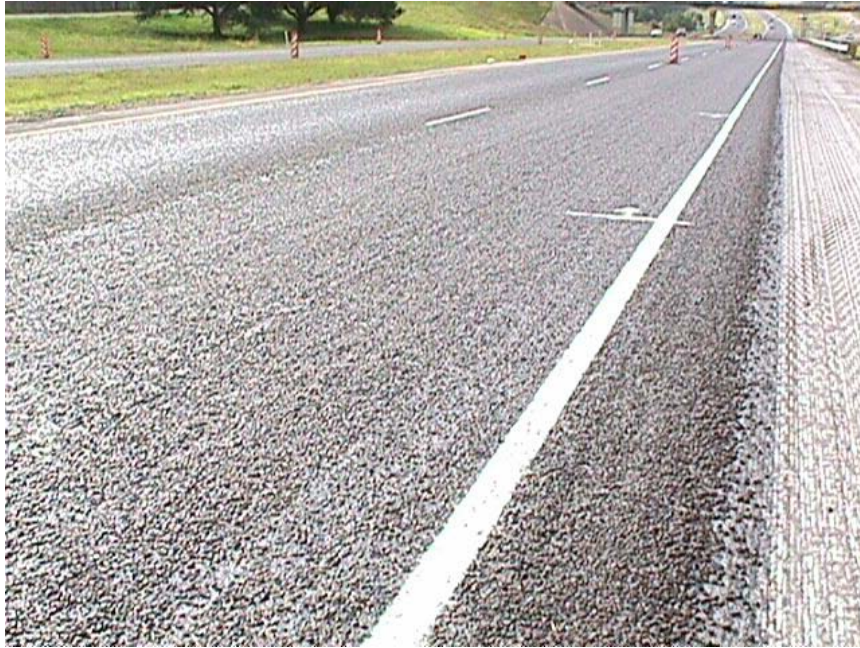
Figure 5.6 Section 17045-1, recently overlaid

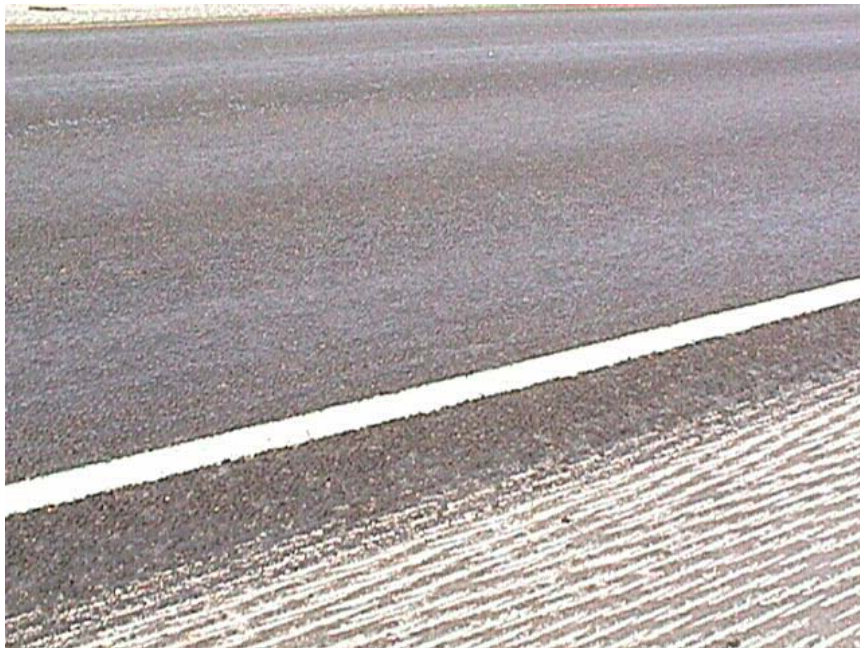
Figure 5.7 Section 17045-3, still showing non-resurfaced shoulder

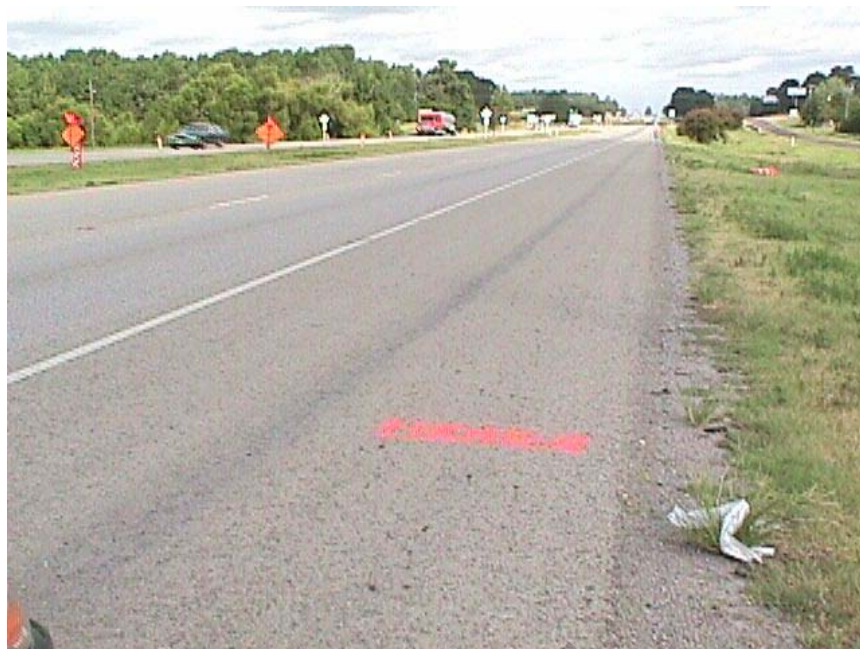
Figure 5.8 Beginning of section 17045-2

Section 17045-2 has not been recently overlaid. Nevertheless it is in very good shape, as shown in Figure 5.8.

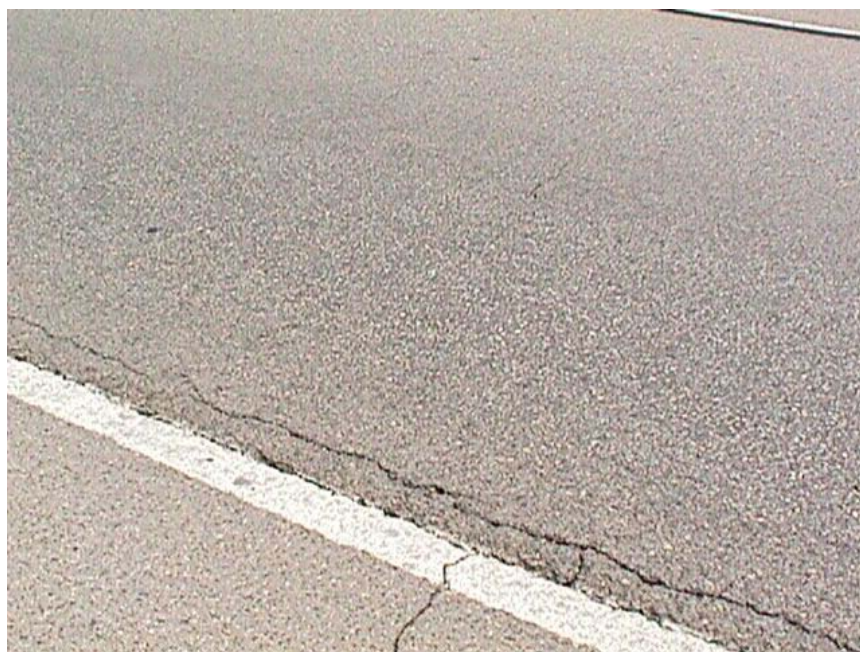
Figure 5.9 Longitudinal crack next to the shoulder in section 17006-1 on SH 6 in Brazos County

The two sections on SH 6 south in Brazos County did not exhibit a very good performance, with both presenting several distresses. Section 17006-1 had 25 transverse cracks with 5 spalls, while section 17006-2 had 2 transverse cracks (Figures 5.9 and 5.10).

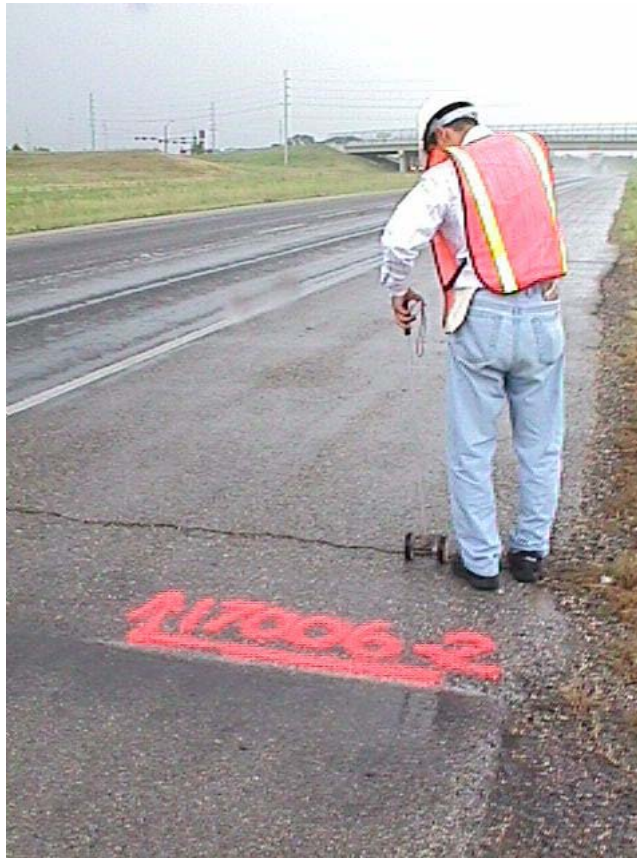
Figure 5.10 Beginning of section 17006-2 with a transverse crack on southbound SH 6

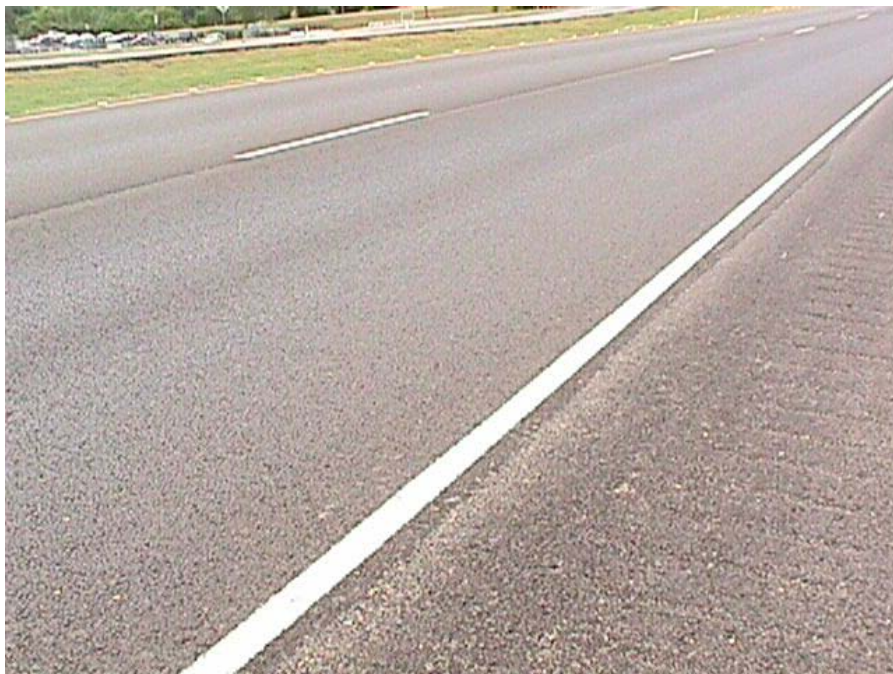
Figure 5.11 Section 17290-1 on eastbound US290

There are three sections in Washington County, all of which are on US290, all of which looked in good shape, showing no distresses. The AC looks relatively new and it offers a good riding surface, as Figures 5.11 and 5.12 illustrate.

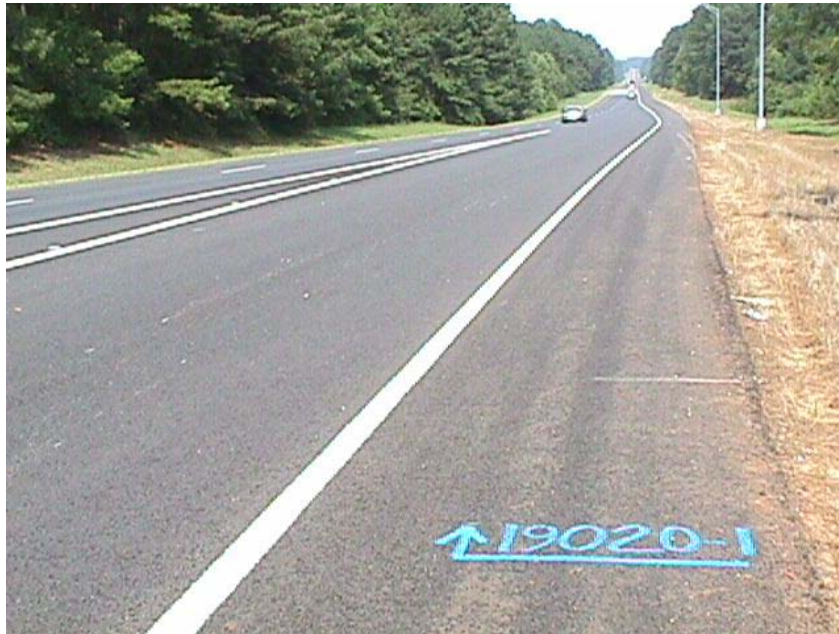
Figure 5.13 Section 19020-1

In general, the sections are in very good condition with no distresses, rutting, or signs of wear. The AC appears to be fairly new, given the smooth riding surface shown in Figures 5.13 to 5.16. The few minor distresses found in these sections are discussed below.

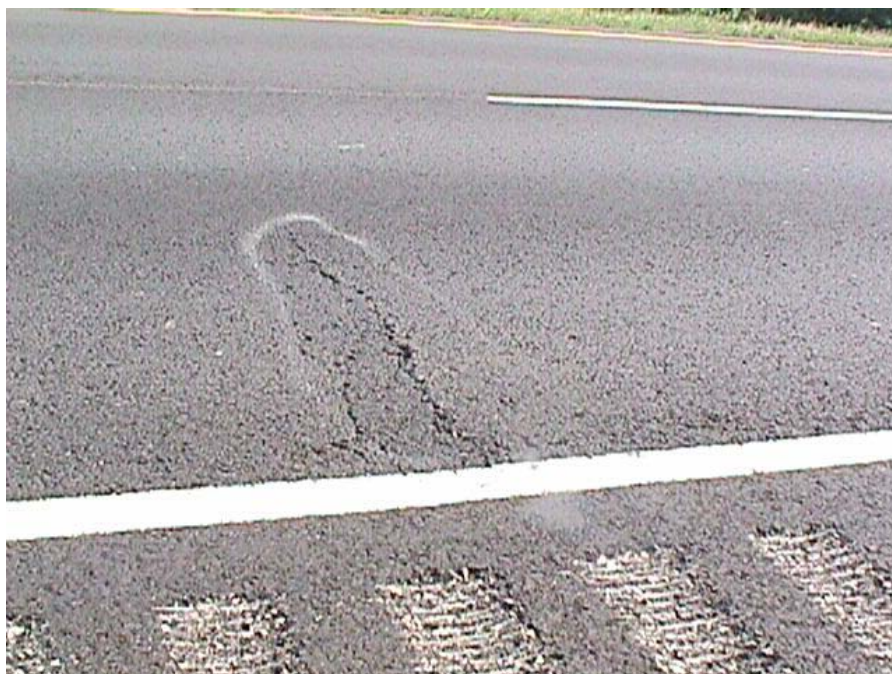
Figure 5.17 AC overlay delamination in section 19020-8

Section 19020-4 has a few small patches and one transverse crack, while section 19020-5 presents three cracks. None of these distresses is severe. There is a small delaminated area in section 19020-8; the delamination starts at the edge of the lane next to the shoulder, as shown in Figure 5.17.

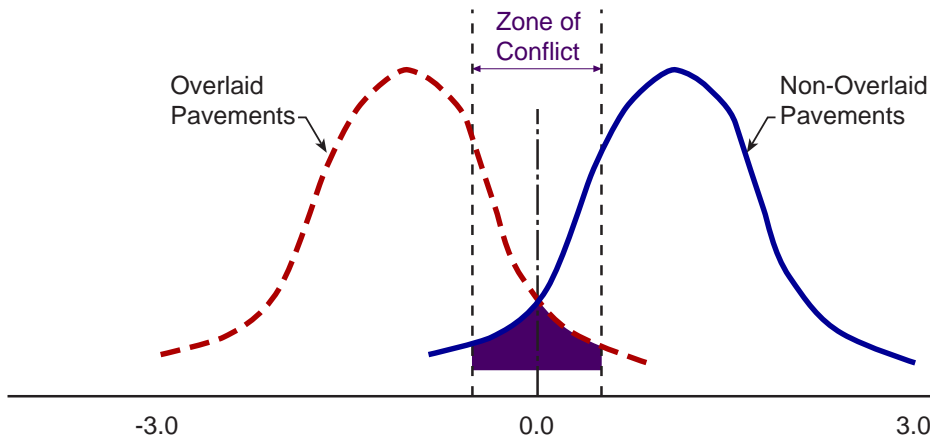
Figure 6.1 Discriminant analysis based on PDI

The purpose of calculating the PDI is to enable the designers to decide whether a section is suited for an AC overlay rehabilitation, in other words, to help discriminate between pavement sections in need of an AC overlay and those that do not need it. Therefore, once the PDI is computed for pavement sections, a discriminant analysis may be conducted to distinguish between those two types of sections, as exemplified in Fig 6.1, where the distributions of both are assumed normal, but with a different mean value, which will be established by a discriminant score based on their PDI.

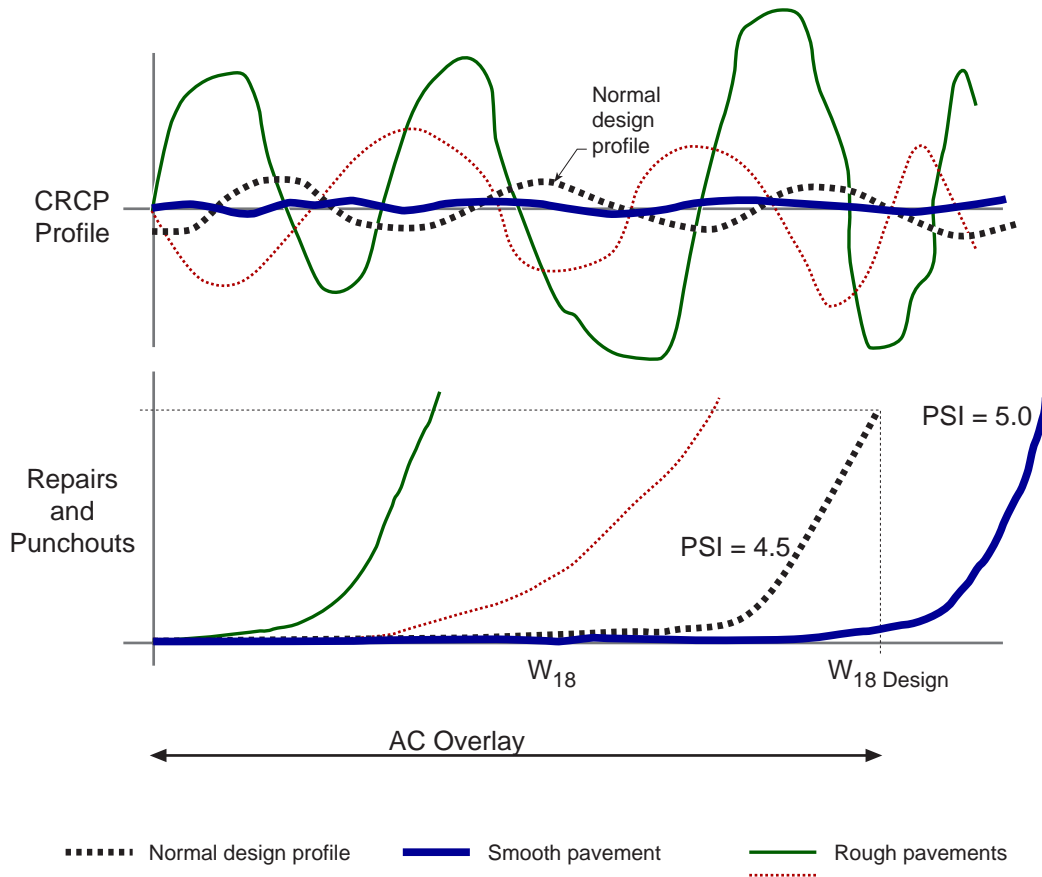
Figure 6.2 Pavement profile, serviceability, and design traffic

On the other hand, if the CRCP does not show profile problems, then the thin AC overlay may be unnecessary. The following charts in Fig 6.2 illustrate how the pavement profile affects the attainment of the original design life and the appearance of distresses. A pavement structure with a normal design profile, illustrated by the dashed line, will have a present serviceability index (PSI) of 4.5 and will be able to attain its designed life, carrying the design traffic (W_{18}) before reaching a specified number of distresses. A smoother pavement, such as that represented by the bold line, will be able to withstand a higher number of load applications before reaching that predetermined number of distresses and repairs. Given the smoothness of its profile, this pavement will likely have a PSI of 5. Conversely, rougher pavements like those represented by the thinner dotted lines, probably will not fulfill their design life, reaching the failure level at an earlier stage, before carrying the specified design traffic, and thus, deteriorating at a higher rate. The PSI values for

these pavements will be lower than 4.5, unless the structure is rehabilitated. This criterion, which will be developed with experimental field data from selected projects, would be a useful aid in deciding when a thin AC overlay should be placed to provide the maximum benefit to the life of the structure. Overlay placement may occur anytime in the lifespan of the pavement as illustrated in the bottom chart of Fig. 6.2, and the development of this criterion will determine the ideal timing for the rehabilitation.

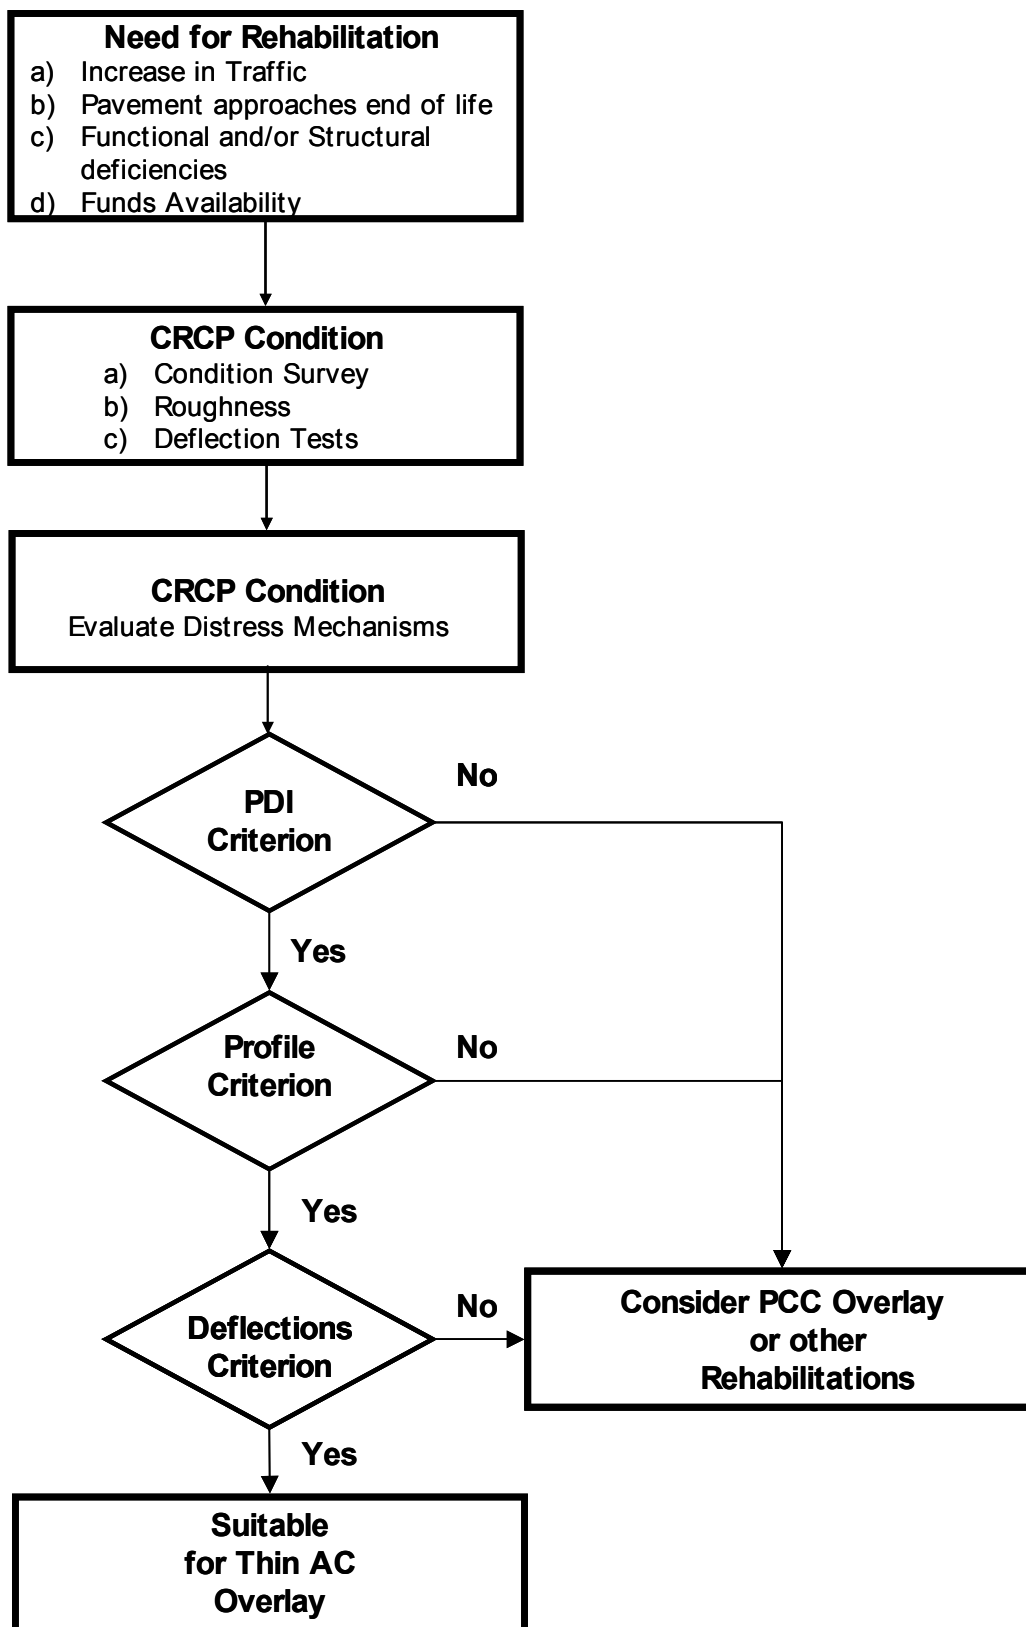
Figure 6.3 Decision tree for AC overlays on CRCP

This chapter is summarized with the illustration of the decision tree for thin AC overlays on CRCPs, depicted in Fig 6.3. This chart shows every step that has been considered, although new additions may improve the concept as this research project progresses. The establishment of the decision criteria is still in development. Thus, this is a preliminary version.

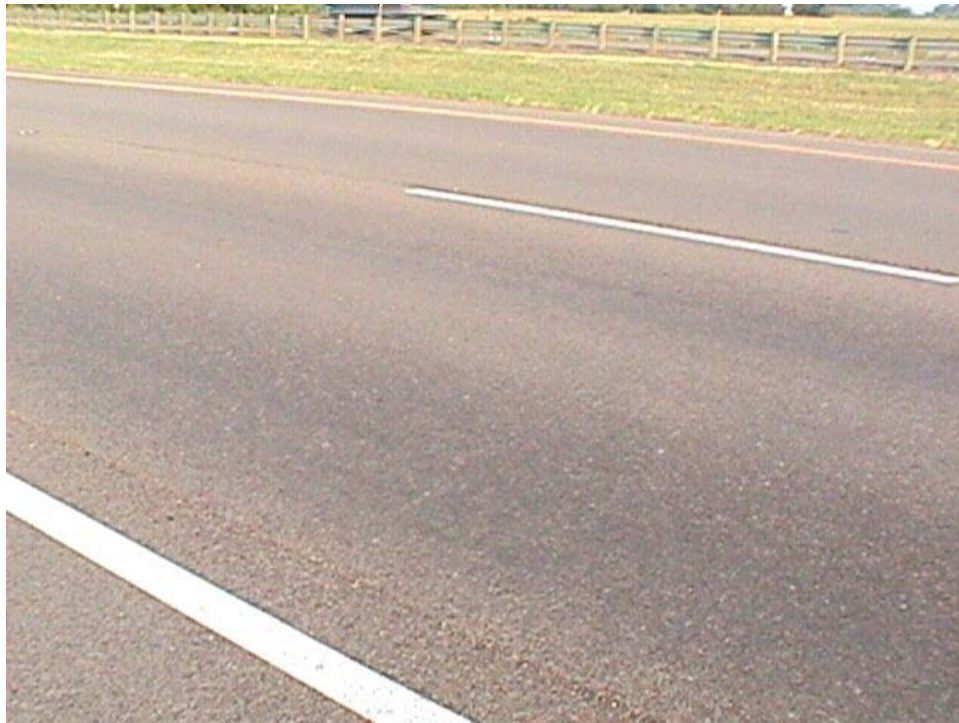
Figure B.1 Shallow rutting (<0.5 in) and flushing of asphalt on section 13010-1

The distressed AC overlay shows mainly surface rutting and flushing on both wheel paths of the outside lane. In some cases, both lanes show signs of distress, but the outside lane is considerably more distressed than the inside lane. No cracking was found in the sections.

Figs B.1 to B.4 display the conditions in which the pavement sections were found on June 19, 2002, when the condition survey was done.

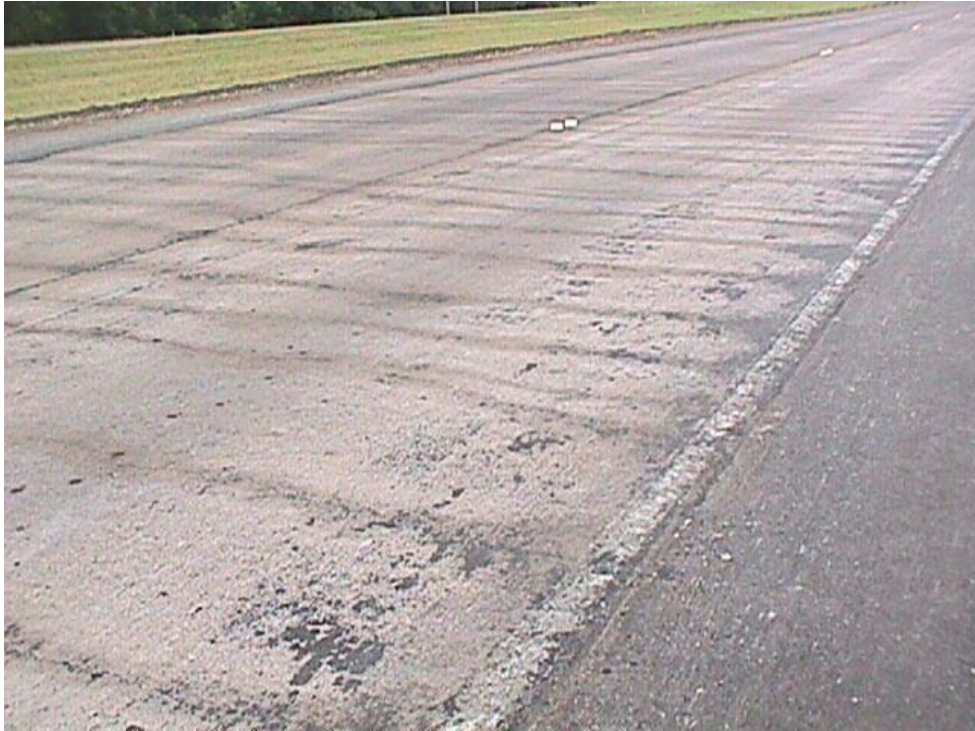
Figure B.2 Image of CRCP underneath the AC layer that was milled-off

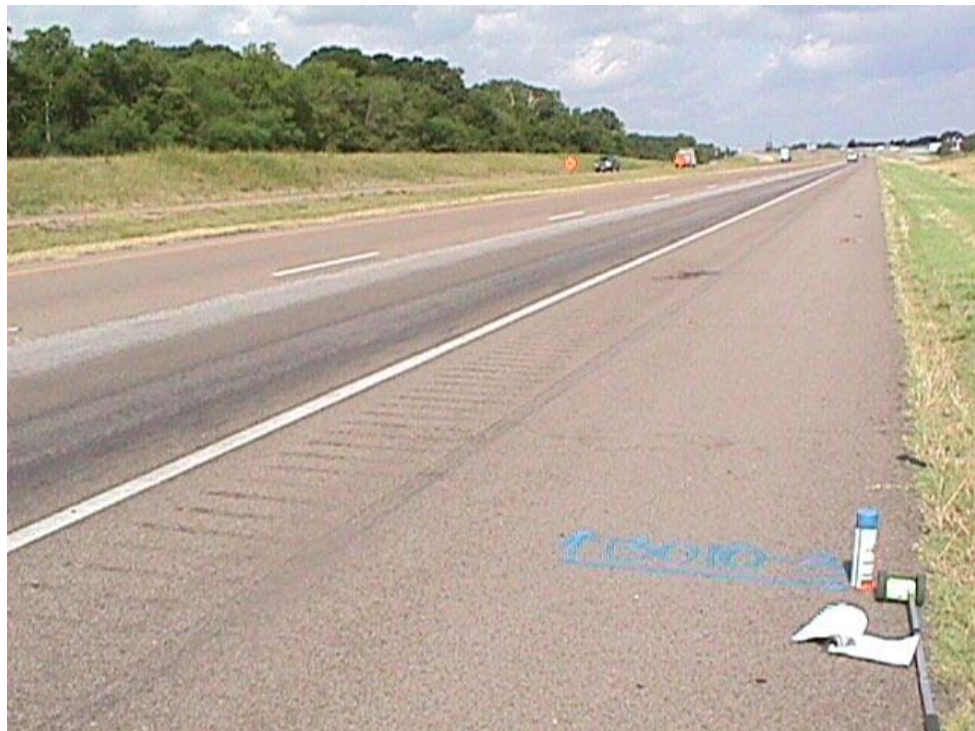
Figure B.3 Image of rutted and flushed wheel paths of the outside lane

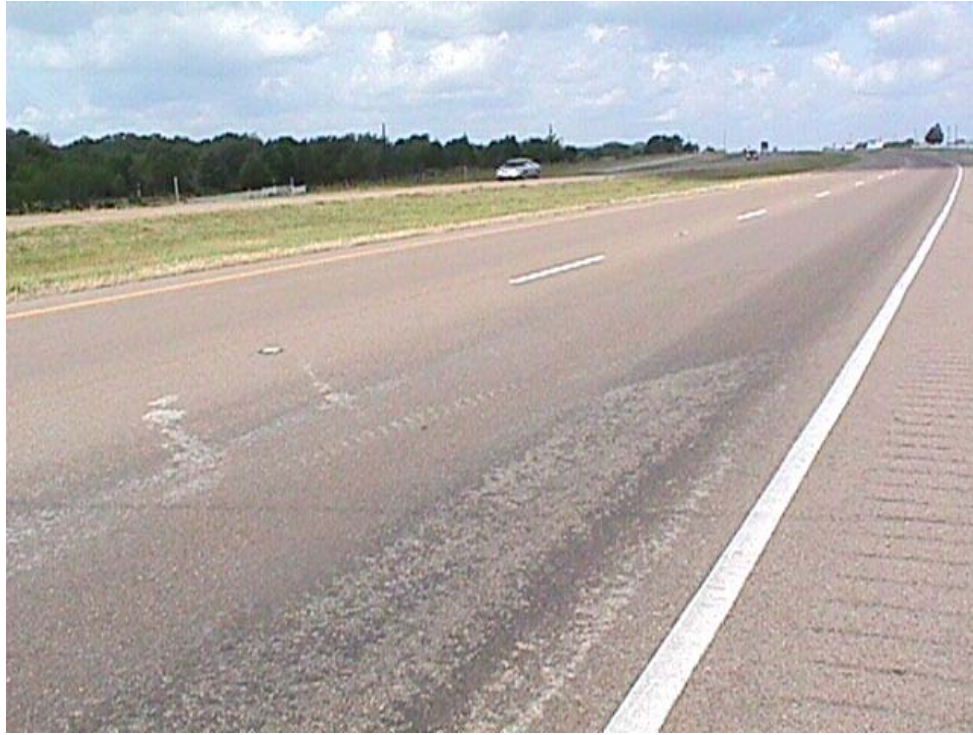
Figure B.4 End of a distressed asphalt layer area, section 13010-4
