1. Report No. FHWA/TX-05/0-4418-1	2. Government Accession No.	3. Recipient's Catalog No.	
4. Title and Subtitle Bridge Slab Behavior at Expansion Joints		5. Report Date October 2004, Rev. March 2006

BRIDGE SLAB BEHAVIOR AT EXPANSION JOINTS

Research Report 0-4418-1

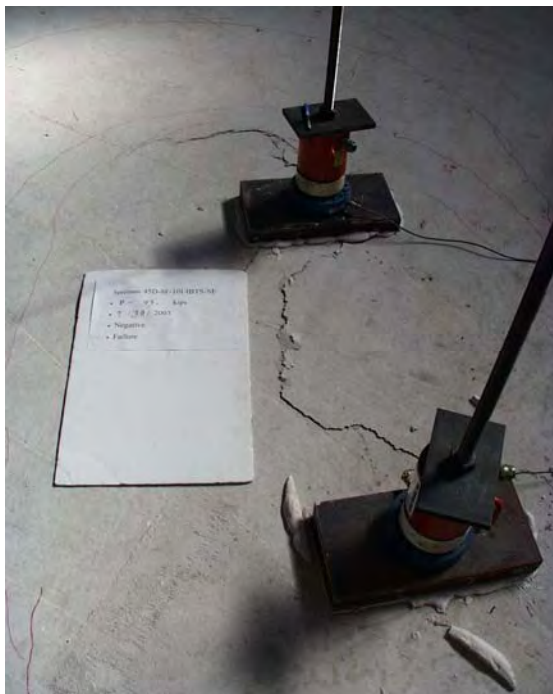
- loading plate where first punching shear failure occurred
- loading plate where secondary punching shear failure occurred
- failure surface as seen from top of slab
- - - failure surface as seen from bottom of slab

Figure 3.2 Locations of punching shear failures: IBTS negative-moment tests

Figure 3.2 shows the locations of major cracks at failure in both maximum negative moment tests. In the 0° skewed specimen, a punching shear failure occurred at the end load plate of the interior bay. In the 45° skewed specimen, a punching-shear failure initiated at the interior load plate of the interior bay, where the slab depth was 8 in. The failure surface formed at this interior plate, and then propagated toward the end plate.

In the areas where negative moment was maximized, failure mechanisms were similar. Punching shear failure occurred on the side of the load points closest to the girder. Skew had no effect on the failure loads (7.5DT, 94 kips) of the negative-moment test areas. Design provisions for punching shear capacity and calculated capacities for all tests are discussed in Chapter 6.

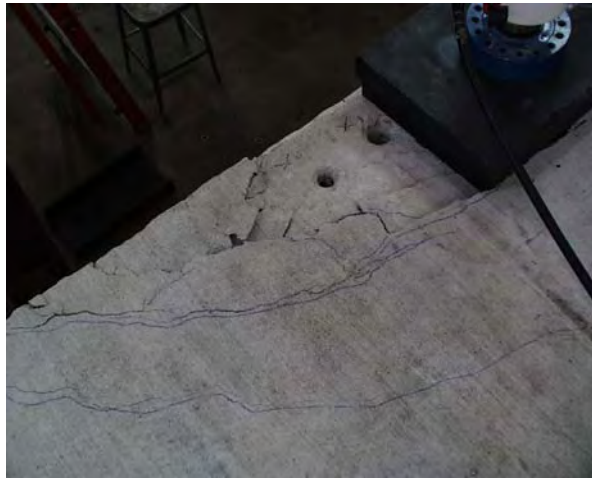
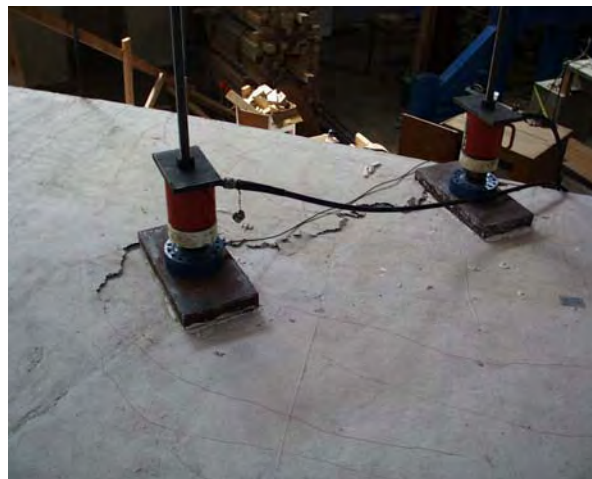
Figure 3.4 Locations of failure surfaces: IBTS positive-moment region

Figure 3.4 shows the locations of major cracks at failure in both positive moment tests. In the 0° skewed specimen, a punching shear failure occurred at 7.7DT (96 kips) the end load plate of the interior bay. In the 45° skewed specimen, a one-way shear failure occurred at 3.8DT (48 kips). Only one test area failed in one-way shear, and test data from the one test area is too limited to provide a precise explanation for the different failure mode and capacity. However, two possible factors for influencing the failure loads of the test section are the geometry of the test specimen, the location of the critical section for shear and the predicted shear stress at that critical section, which is discussed further in the Section 3.3.1.

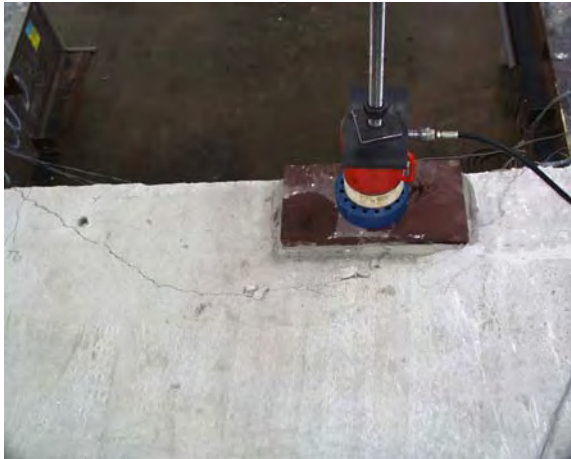
- loading plate where first punching shear failure occurred
- loading plate where secondary punching shear failure occurred
- failure surface as seen from top of slab
- failure surface as seen from bottom of slab

Figure 4.2 Locations of punching shear failure: UTSE negative-moment tests

Figure 4.2 shows the locations of major cracks at failure in both negative moment tests. In the 0° skewed specimen, a punching shear failure occurred at the end load plate of the interior bay. In the 45° skewed specimen, a punching-shear failure occurred around the loaded point in the interior bay. Of all of the locations where load was applied in this test area, this load plate was closest to the end and had the smallest shear perimeter calculated in accordance with AASHTO LRFD Bridge Design Specifications and ACI 318-02 provisions.

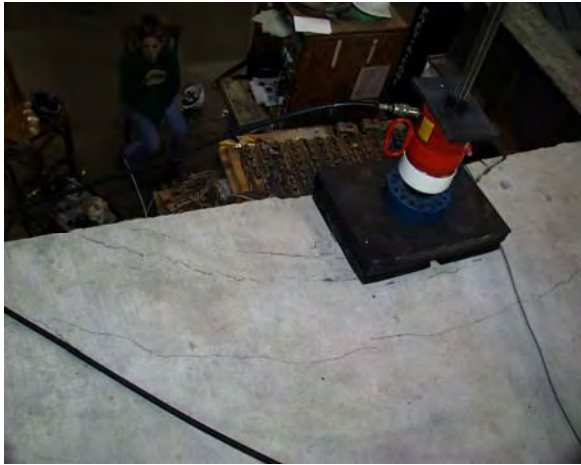
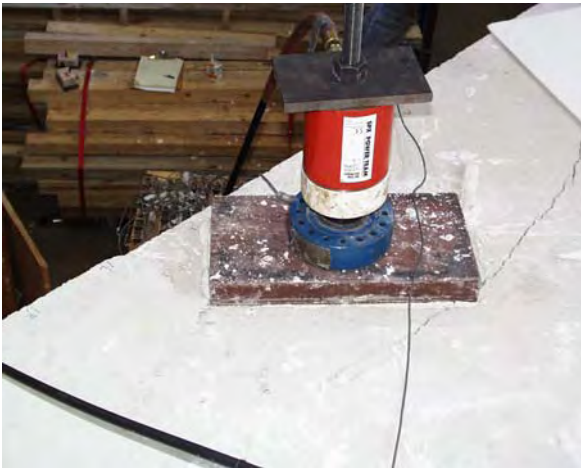
Figure 4.4 shows the locations of major cracks at failure in both specimens for the UTSE positive moment test areas. In the areas where negative moment was maximized, failure mechanisms were similar. Slab end skew angle had an effect on the failure loads with an approximately 35% lower load at the skewed end. Punching shear failures occurred at 6.6DT (83 kips) in the 0° skewed specimen and 4.4DT (55 kips) in the 45° skewed specimen.

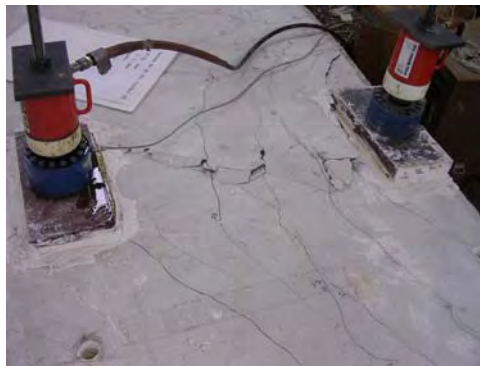
(a) 3-7/8 in. top reinforcement spacing

Figure 5.2 shows the locations of major cracks in the two negative moment regions that were taken to failure. For the 8-ft girder spacing, 3-7/8 in. top reinforcement spacing, a punching shear failure initiated at the end load plate of the interior bay at 6.0DT (75 kips). The failure surface formed at the end load and then propagated toward the interior plate.

Figure 5.2 Locations of punching shear failures of PCPE specimens: Negative-moment tests

Failure mechanisms were similar for the negative moment loadings. Punching shear failure occurred in the region between the load points and the closest girder. With an armor joint test area, punching shear failure began at the load point away from the end. There was a 20% difference between the failure loads for the two test areas.

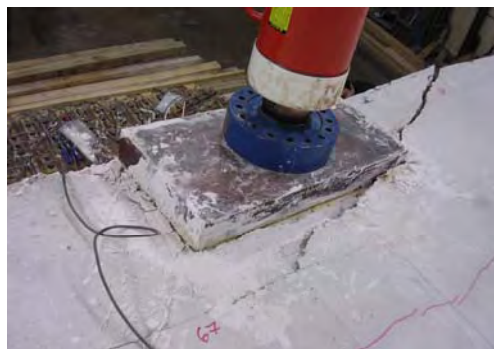
(a) 6-in. top reinforcement spacing

Figure 5.4 shows the locations of major cracks at failure in both of the test areas where positive moment was maximized. Both test areas failed in punching shear, at 5.4DT (68 kips) for the test area without SEJ and 6.8DT (85 kips) for the test area with SEJ.

Figure 5.4 Locations of punching shear failures of PCPE specimens: Positive-moment tests

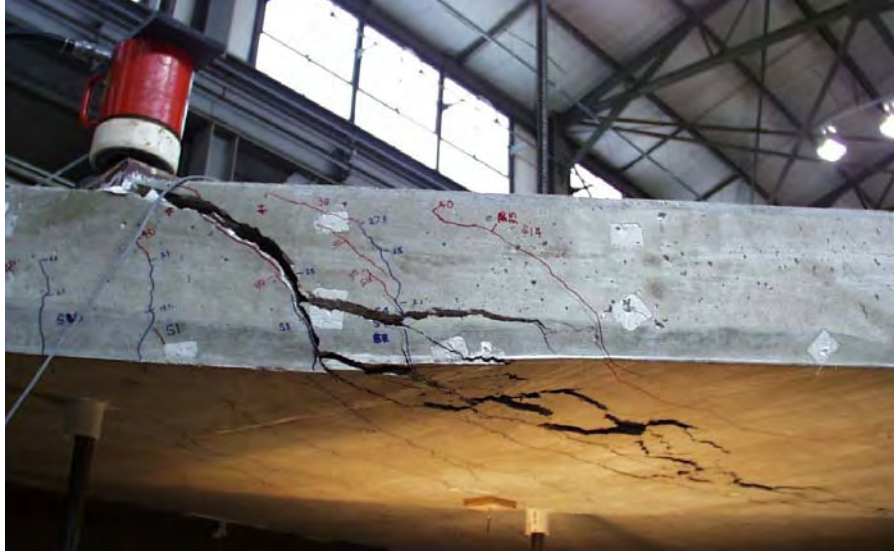
Figure 6.1 Shear failure: IBTS detail, positive-moment test, 45° skew

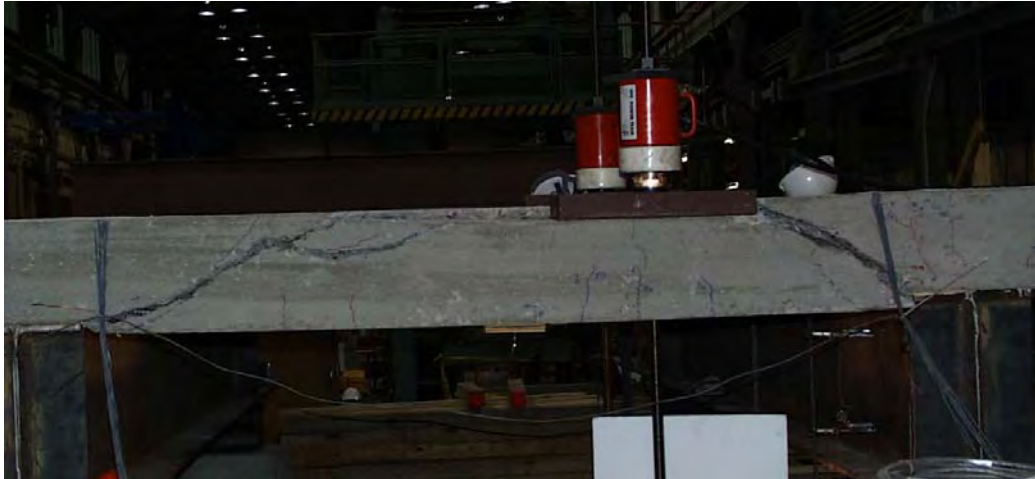
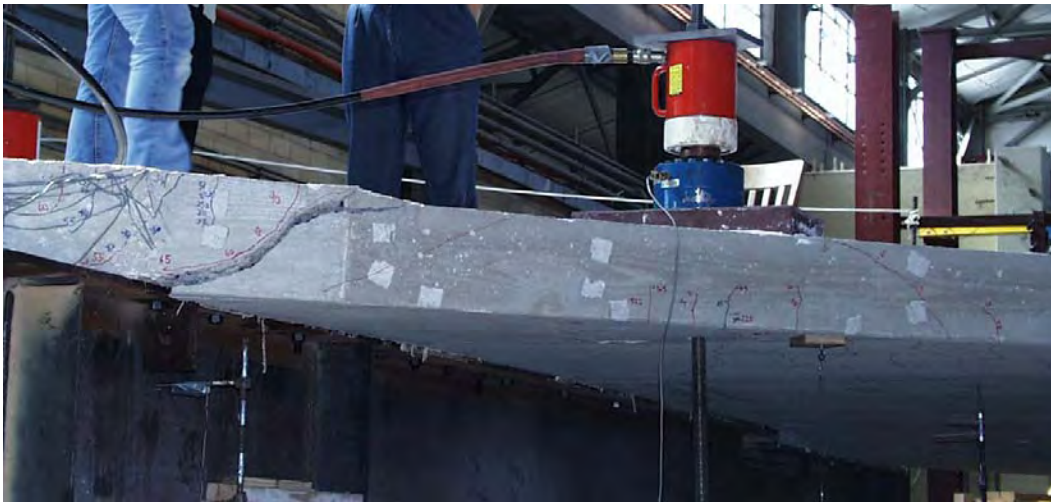
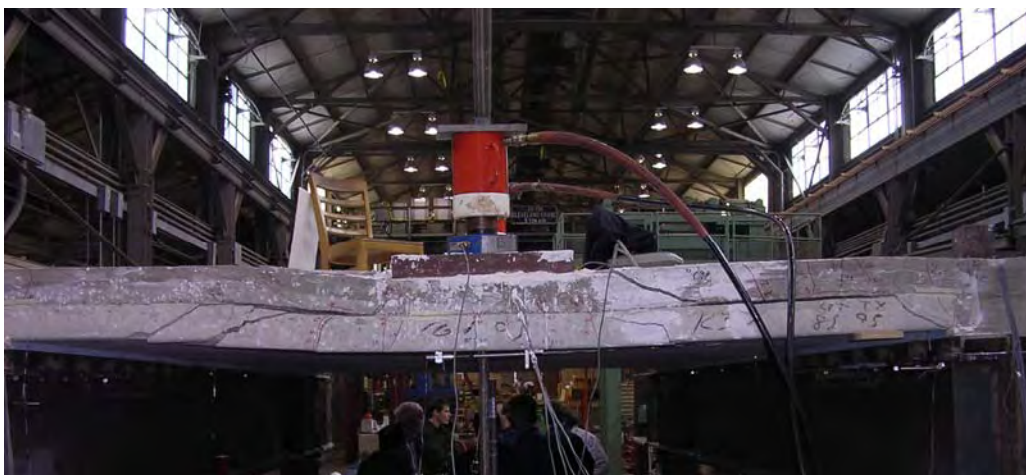
(a) 0° skew

(b) 45° skew

(c) PCP specimen

Figure 6.5 Failure pictures from test specimens: Side view of slab

The shape of the critical section assumed in the analysis above for punching shear did not adequately predict the shape of the failure surface for the end loading configuration in the three specimens. Figure 6.4 shows the shape of a typical failure surface, as observed from the top of the slab. Figure 6.5 shows the failure surfaces as observed from the side of the slab. In the observed failure surfaces, the critical perimeter is longer than that used in the previous calculations. ACI 318-02 uses an eccentric shear model to account for this, assuming that a portion of the unbalanced moment is transferred through an eccentricity of shear around the loaded area. A conservative prediction of ultimate strength might be attained by varying the shape of the critical perimeter and applying the eccentric shear model.

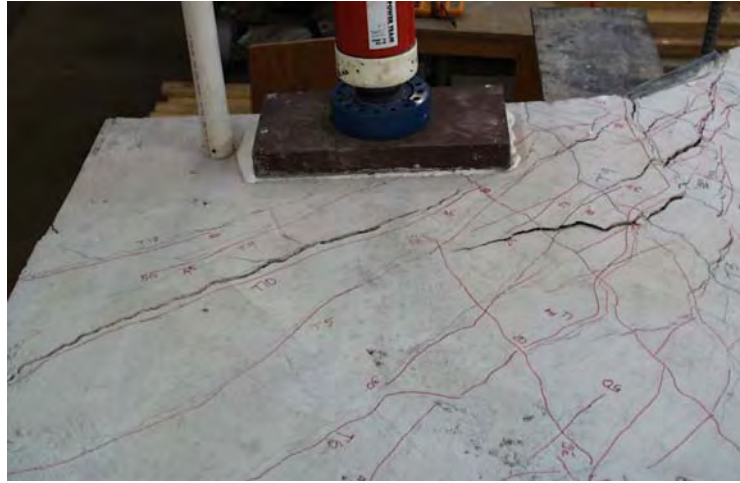
Figure 7.10 Failure of simulated 0° skewed UTSE overhang: Top view of slab, facing north
