Summary: Factors Affecting Bond and Friction Losses in Multi-Strand Post-Tensioning Tendons Including the Effect of Emulsifiable Oils

The main objectives of the first phase (2005-2006) of Project O-4562 were to assess the corrosion-inhibiting performance of emulsifiable oils, to investigate how the oils affect friction losses during post-tensioning, and to determine the impact of the oils on bond strength in multi-strand tendons. The second, ongoing phase is evaluating a variety of new materials that could improve durability in post-tensioned concrete systems. This document summarizes the first phase only.

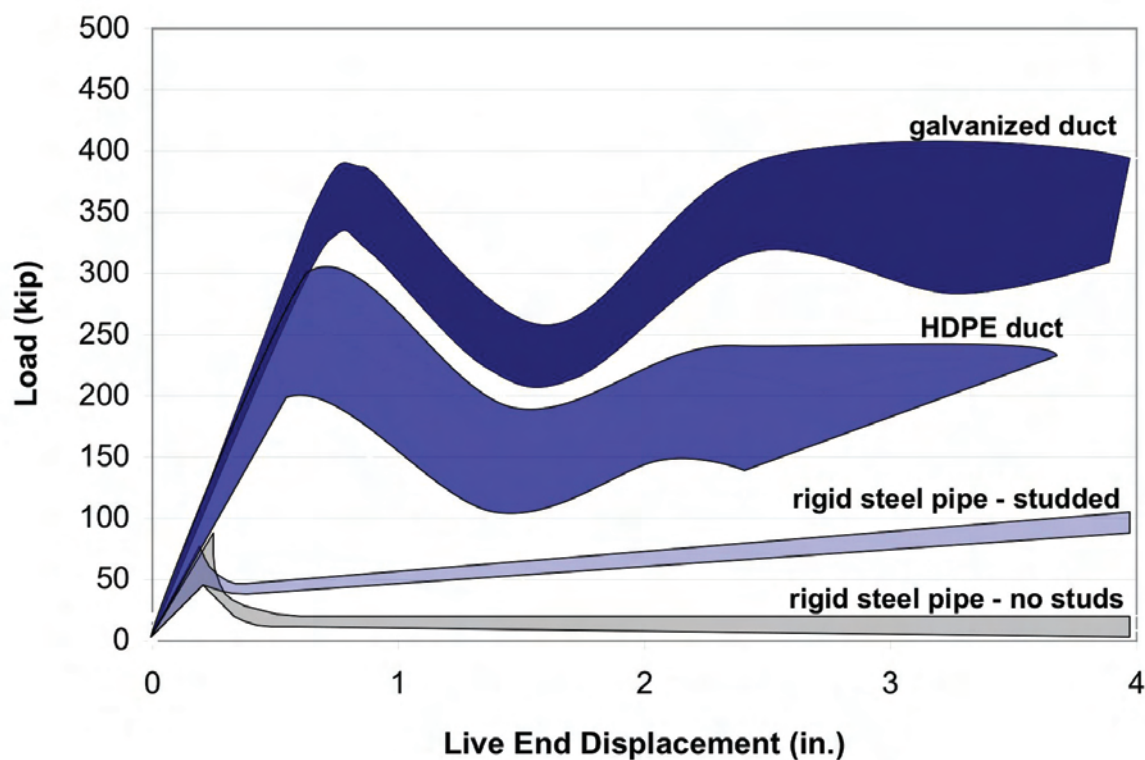
Figure 1 – Live End Load-Displacement Behavior, Uncoiled Tendons

Peak loads for specimens with galvanized ducts were 20% to 40% higher than peak loads for specimens with HDPE ducts, as shown in Figure 1. Galvanized ducts therefore allow bonded tendons to be developed in shorter lengths than HDPE ducts.

Peak loads for specimens with rigid steel pipes were 70% to 90% lower than peak loads for specimens with galvanized or HDPE ducts, as shown in Figure 1. This poor behavior was due to failure at the interface of the concrete and the smooth steel pipe. Shear

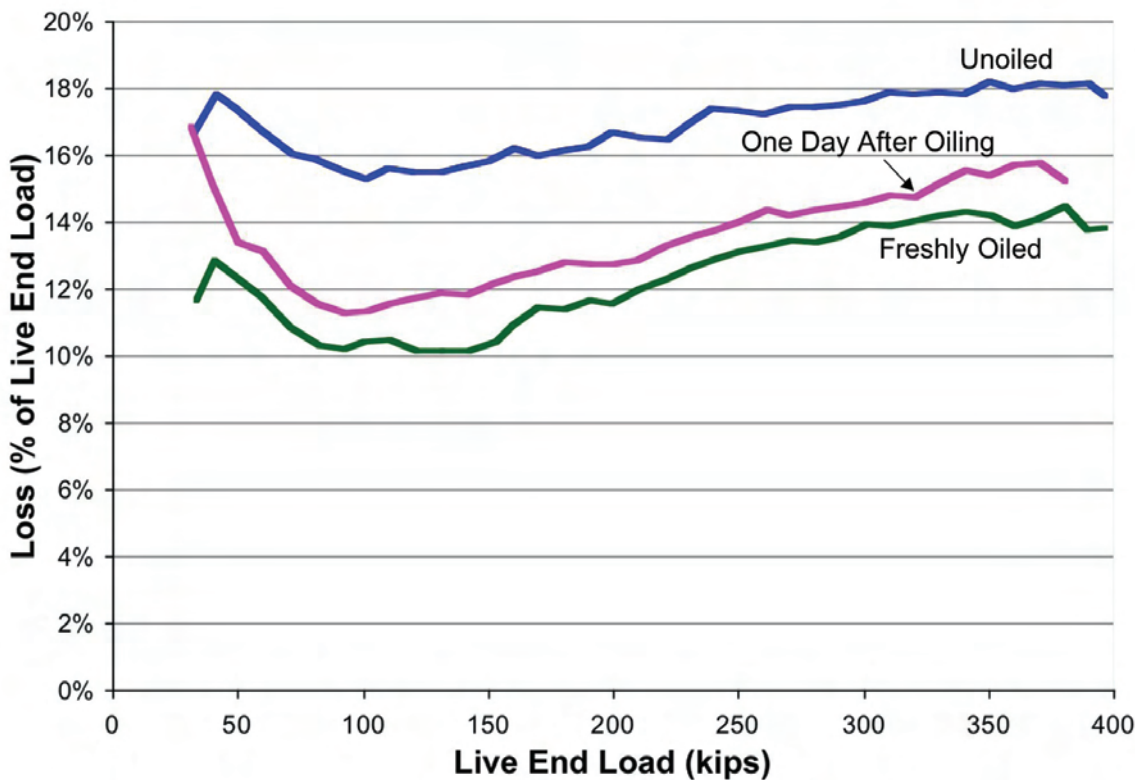
Figure 2 – Average Friction Losses, HDPE Duct, 10 ft Radius, Oil NC205

Tendons which were lubricated with oil and stressed immediately after oiling experienced lower friction losses than uncoiled tendons, as shown in Figure 2. Oiling caused the greatest reductions in the friction coefficient for steel pipe specimens, on the order of 20% to 30%. Reductions for HDPE duct specimens were smaller but still significant, on the order of 20%. Reductions for galvanized ducts specimens were the least significant, on the order of 10%.

For tendons stressed one day after oiling, the data was highly scattered. The results indicate that dried oil is less effective in reducing friction losses than fresh oil, as shown in Figure 2, but
