| 4. Title and Subtitle<br><br>Fatigue Life of Steel Base Plate to Pole Connections for Traffic Structures | | | | 5. Report Date<br>January 2011; Revised July 2011 | |
| 7. Author(s)<br><br>Andrew Stam, Nicholas Richman, Charles Pool, Craig Rios, Thomas Anderson, and Karl Frank | | | | 8. Performing Organization Report No.<br>9-1526-1 | |
| 16. Abstract<br>This is a final report of an extensive experimental and analytical examination of the fatigue behavior of the welded end connection used on high-mast light structures and traffic signal masts. The weld details commonly used for these connections produce very poor fatigue performance. Their performance is a function of base plate stiffness, weld type and geometry, and number of anchor bolts. Older connection designs produced very poor fatigue performance far below the lowest AASHTO fatigue category. These connections can be improved by increasing the base or end plate thickness, improving weld details, and other geometric considerations. Due to the interaction of the overall connection geometry upon fatigue performance, the fatigue performance of the connection cannot be classified by simply the type of connection. The fatigue li

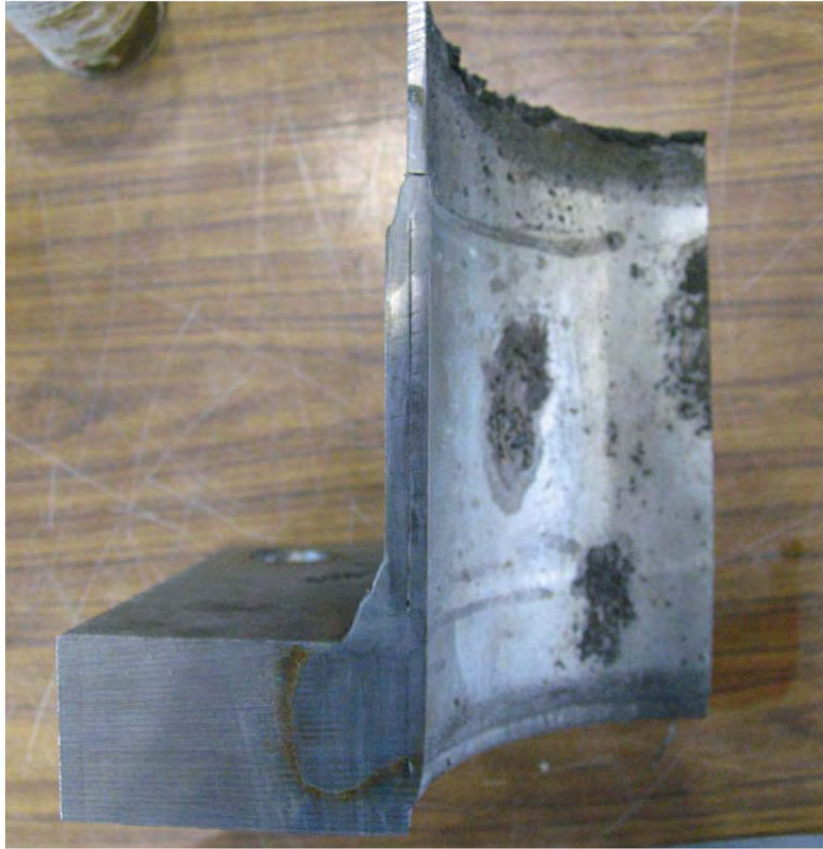
*Figure 3.8: A Cross Section of a Typical External Collar Detail*

Etched cross sections of a typical external collar detail are given in Figures 3.8 and 3.9.
