1. Report No. FHWA/TX-07 / 0-1774-4		2. Government Accession No.		3. Recipient's Catalog No.	
4. Title and Subtitle Performance of Fiber Composite Wrapped Columns and Beams in a Corrosive Environment				5. Report Date October 2006

## **Performance of Fiber Composite Wrapped Columns and Beams in a Corrosive Environment**

The procedures used to assess the condition were described in Report 0-1774-3. The purpose of this report is to document the performance of all remaining tests and to propose design guidelines for use of wrapping techniques to protect bridge structures in a corrosive environment.

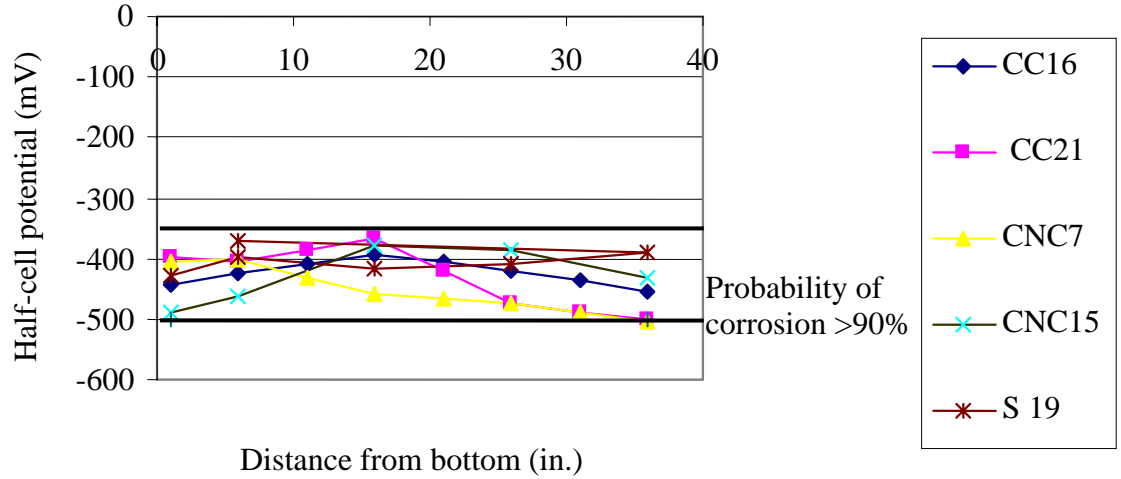
Figure 3.1 Half-cell potentials for unwrapped columns

Figure 3.1 shows half-cell profiles for unwrapped column specimens and Figure 3.2 shows the half-cell profiles for some of the fully wrapped specimens. For the unwrapped columns, the potentials lie primarily between -350 mV and -500 mV, indicating a very high probability of corrosion. For the fully wrapped specimens, the potentials range from -200 mV to -500 mV, indicating that after many cycles in the corrosion tank, it becomes increasingly difficult to predict the level of corrosion based only on half-cell readings. The half-cell readings, though, are very effective in indicating whether the probability of corrosion is very high or low. The half-cell potential profiles also provide a strong indication that the addition of FRP wrap reduces the likelihood of corrosion.

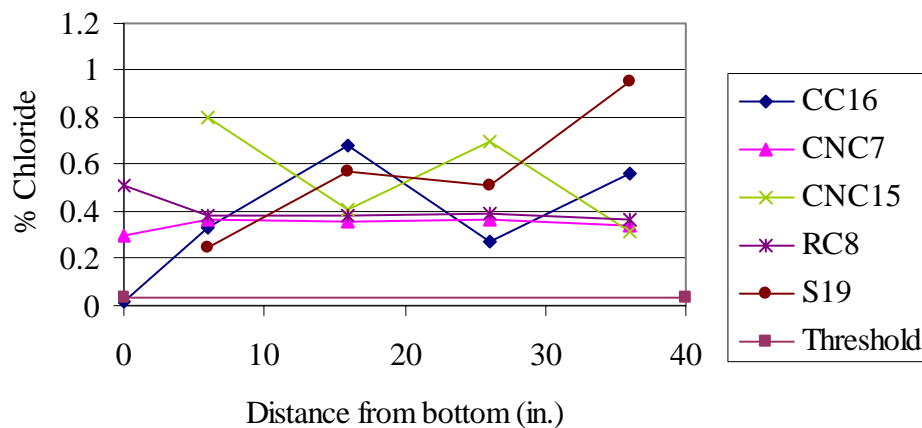
Figure 3.4 Chloride content profiles of unwrapped specimens

The chloride contents of wrapped and unwrapped specimens clearly indicate that the FRP wrapping acts as a barrier to ingress of chlorides. Figure 3.4 shows the chloride content profiles of unwrapped specimens and Figure 3.5 shows the chloride profiles of some specimens wrapped over the top 24 in.

A threshold value of 0.03% chloride content as a percentage of weight of concrete is indicated in the figures. For the specimens containing inbuilt (added to the fresh concrete) chlorides (0.137% by weight of concrete), the threshold is considered as an additional 0.03% of migrating chlorides. For the unwrapped specimens, the chloride contents are much higher than the threshold value (Figure 3.4). For the partially wrapped columns, the chloride contents are high in the unwrapped portion but below the threshold in the wrapped portion (Figure 3.5). High chloride contents were found in the exposed upper end of the columns.

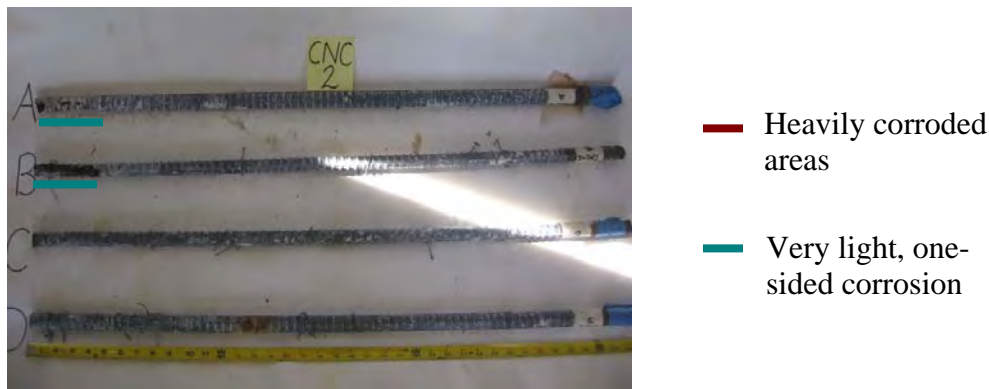
Figure 3.6 Extracted bars from CNC2

Half-cell potential readings were lower for specimens that had no chlorides cast in the concrete (Table 3.1). This indicated that the presence of cast-in chlorides may have reduced the effectiveness of the wrap. But after extracting the reinforcing bars it was observed that corrosion was not extensive. The FRP wrap was almost equally effective for concrete with and without cast-in chlorides. The FRP acts as a barrier to the ingress of chlorides, moisture and oxygen, and was effective in reducing corrosion. Figure 3.6 shows the extracted reinforcing bars from specimen CNC2 that had in-built chlorides and was wrapped completely. Figure 3.7 shows the extracted rebars from specimen CC8 that had no in-built chlorides and was completely wrapped. As seen from the figures, FRP wrapping was effective for both specimens. Other specimens show similar results.

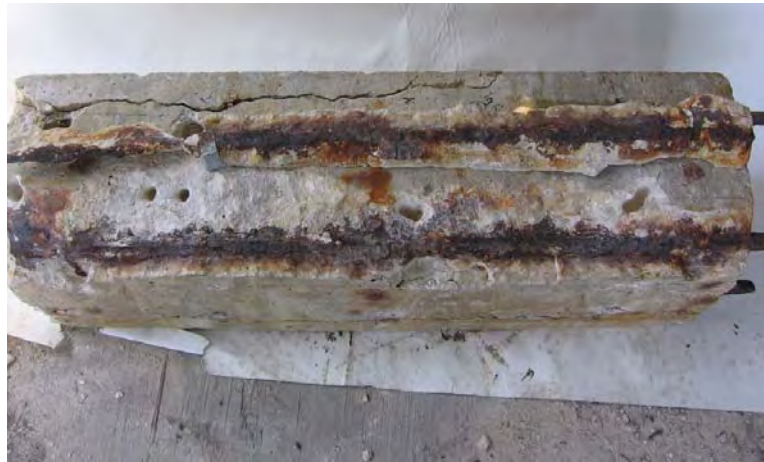
migrating chlorides was lower than the threshold, indicating that the FRP wrap acted as a barrier to the ingress of chlorides. The bars were badly corroded and showed a loss of cross-section. Figure 3.8 shows the extent and level of corrosion in an unwrapped specimen.

*Figure 3.8 Corrosion of bars in unwrapped specimen*

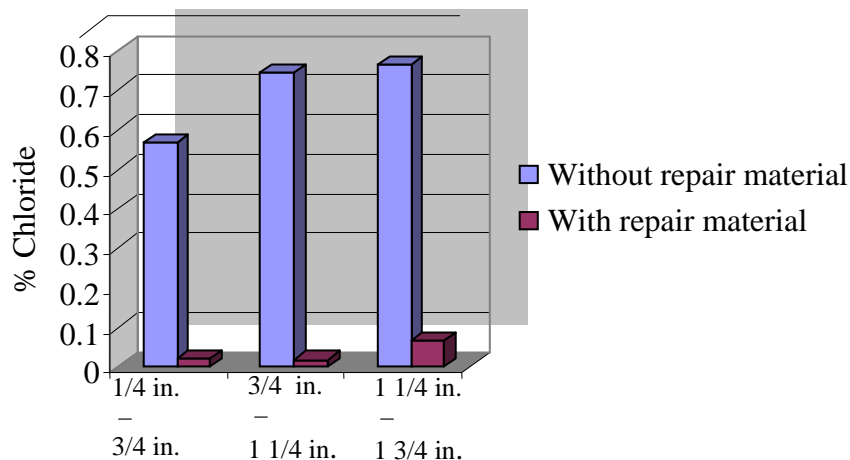
All the repaired specimens that were autopsied had been repaired using Latex-Modified Concrete. LMC repair material is less permeable than ordinary concrete, and it was observed that the chloride content levels below the repair material were very low. After removal of the reinforcing bars, it was observed that no corrosion had taken place below the repair material even in unwrapped regions. The LMC also acted as a barrier for the ingress of chlorides. Figure 3.9 shows the difference in the chloride contents below LMC repaired concrete and areas that were not repaired for specimen CNC9. Figure 3.10 shows the corrosion on reinforcing bars below the repair material. Similar results were observed in specimens CC2, CC4, CNC9 and CNC18.

*Figure 3.9 Chloride contents of concrete covered with repair material*

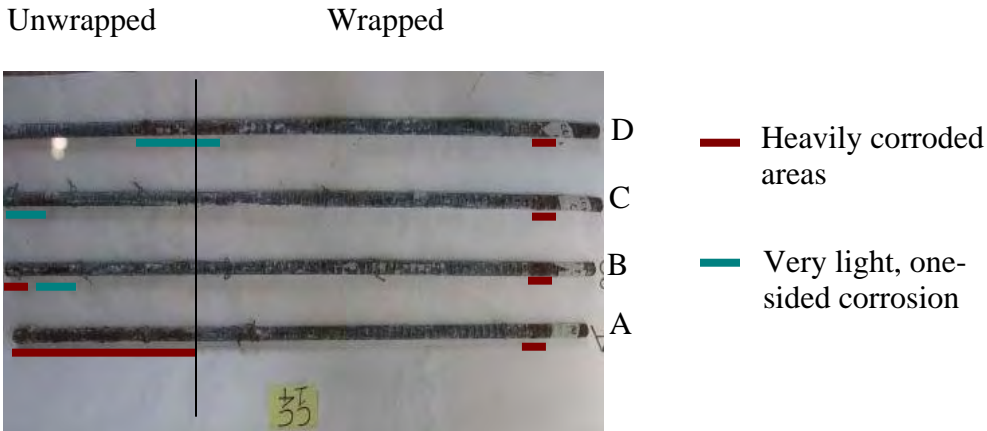
Some specimens were treated using Ferrogard corrosion inhibitor. The inhibitor was generally ineffective in preventing corrosion in the unwrapped region. Specimen CC21 was not wrapped and was treated with Ferrogard. The level and amount of corrosion in CC21 was less compared with other unwrapped specimens. Ferrogard also seemed to be effective in the unwrapped regions of specimens CC1 and CC14. Figure 3.11 shows bars extracted from specimen CC15. Bars in the unwrapped portion were not corroded, possibly due to the presence of Ferrogard. However, there is insufficient data to assess the effectiveness of the Ferrogard corrosion inhibitor.

*Figure 3.11 Bars extracted from specimen CC14*

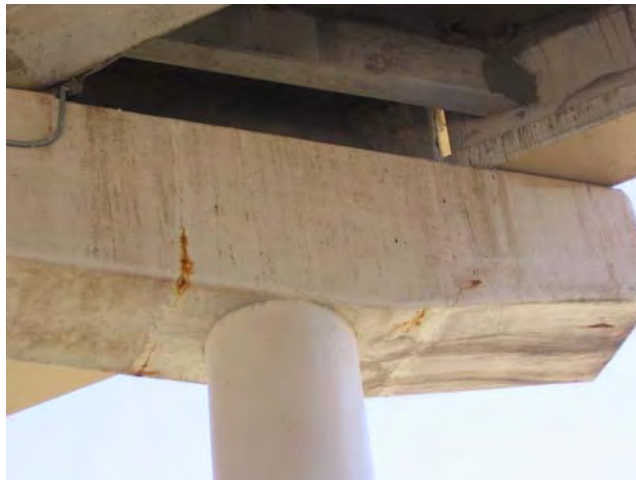
*Figure 4.3 Rust staining on bent*

*Figure 4.4 Rust staining on bent, Structure 1*

Rust staining was observed on the bent cap on Structure 1 (Figure 4.3 and Figure 4.4). Rusting had also been observed on this bent in an earlier report (1774-2), but it seems to have increased and spread to more areas. The rust stains were observed near the end of the bent cap, near the column joint and on the underside of the bent. No probes had been embedded in this structure. Chloride samples were extracted and the results are shown in Table 4.3

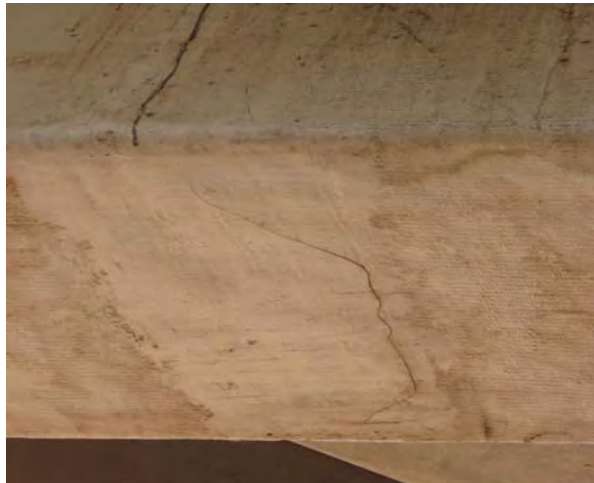
A crack was observed on the under-side of the bent on Structure 5 where the FRP fabric sheets overlap (Figure 4.6). No rust staining was observed near the crack or anywhere else on the bent.

*Figure 4.6 Crack on underside of bent on Structure 5*

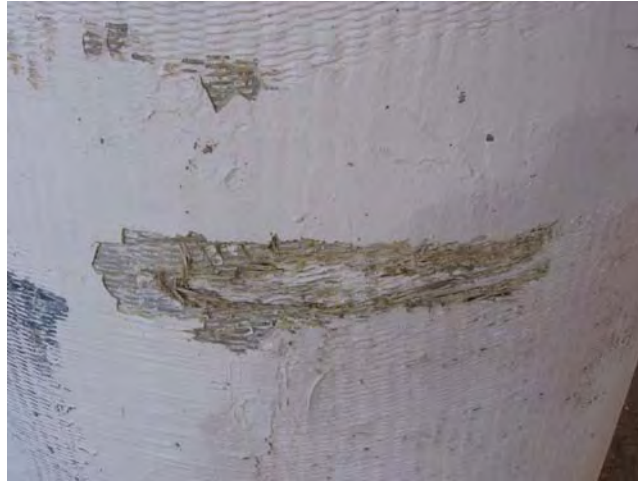
No cracking or rust stains were observed on Structure 7. The upper layer of FRP wrap has been damaged in one of the columns, but the inner layers were intact (Figure 4.7). Results from the embedded probes are shown in Table 4.4.

*Figure 4.7 Damage on the upper layer of FRP wrap, Structure 7*

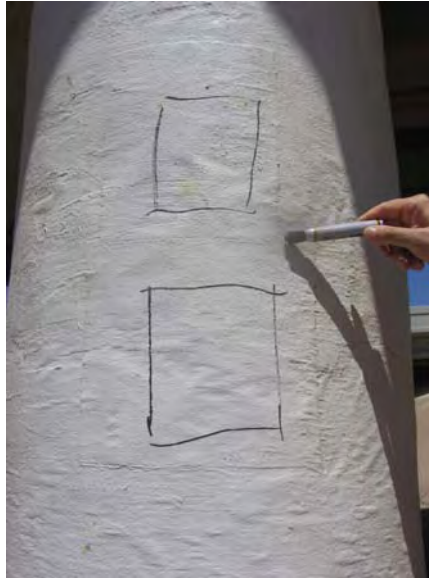
Some of the columns in this structure were wrapped with carbon fibers instead of the glass fibers as used in all the other structures. Air bubbles were observed under these carbon wraps along with small rust stains all over the column (Figure 4.10). No rust stains or cracks were observed on other columns wrapped with the glass fibers. Readings from the embedded probes are shown in Table 4.6.

*Figure 4.10 Air bubbles under the carbon fiber wrap along with rust stains, Structure 12*

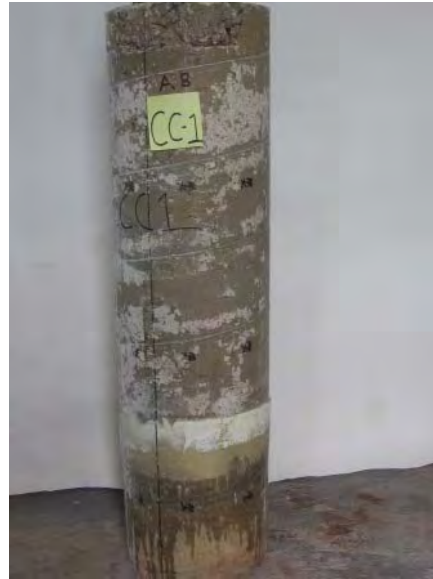
Cylinder CC1 after removal of wrap. Top 3 in. not consolidated properly.

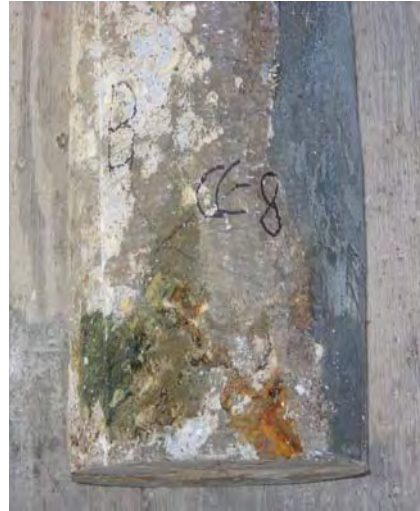
Moisture under the wrap over bottom region of rebar B.

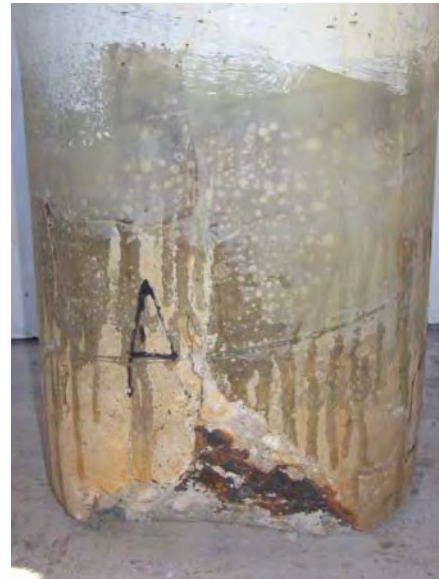
Detail of unwrapped region over rebar A.

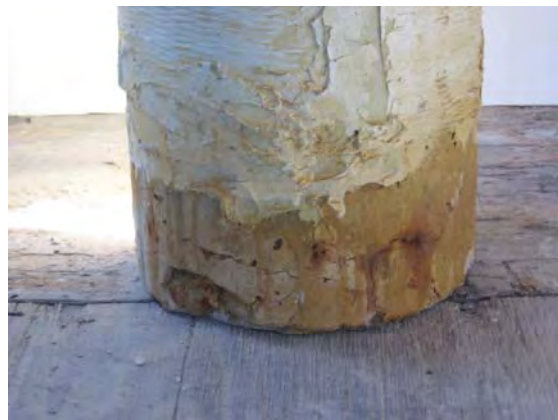
Detail of cracks and rust stains in unwrapped.

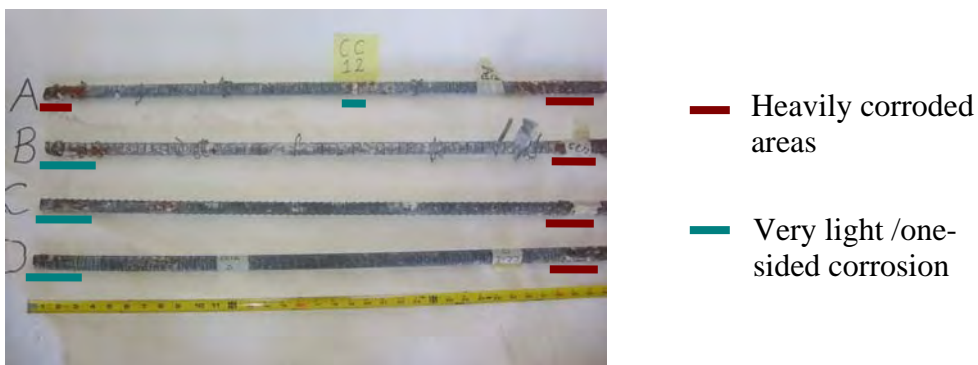
### Corrosion of rebars:

- 1) The rebars in unwrapped region were corroded whereas no corrosion was observed under the wrapped region.
- 2) Corrosion was especially heavy on rebars A and B, where the concrete had been spalled and cracks were observed.
- 3) Heavy corrosion was observed on one side of rebar D accompanied by a green colored residue.

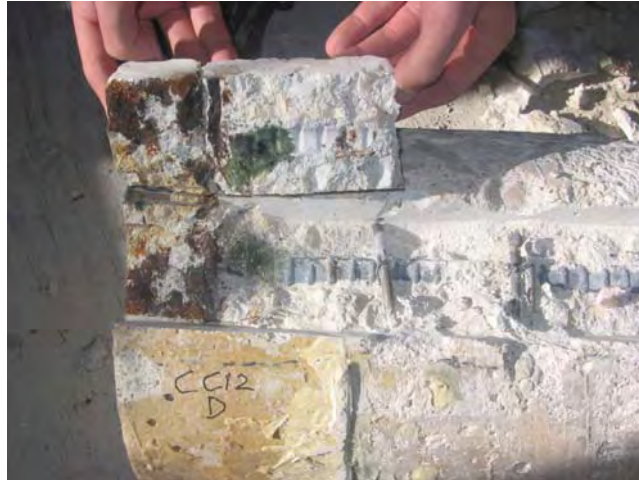
Heavy corrosion near bottom of rebar D. It can be clearly seen that the rest of the bar was not corroded.

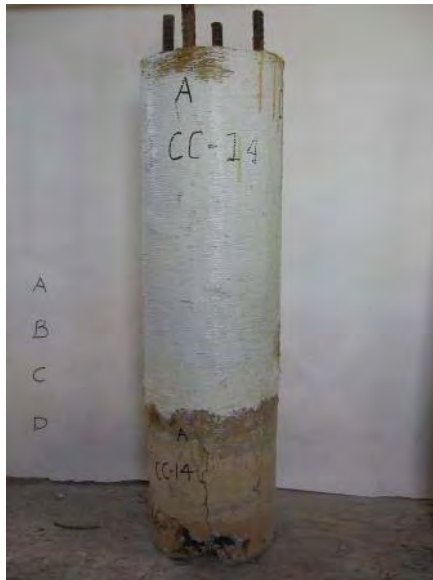
Cylinder CC14 wrapped over upper 24 in.

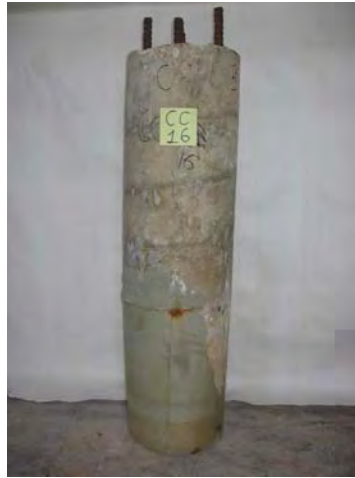
Cylinder CC16 with repair material over bottom region.

- 1) The specimen was not wrapped.
- 2) Repair material was observed over lower 16 in. on area A-AD-D-DC-C and over bottom 6 in. on area CD-D-DA.
- 3) A vertical crack of width 1/8 in. was observed over rebar D extending from 20 in. to 36 in.
- 4) A vertical crack of width 1/8 in. was observed over rebar A extending from 6 in. to 36 in.
- 5) A vertical crack of width 0.06 in. was observed over rebar B extending from 6 in. to 36 in.
- 6) A vertical crack of width 0.07 in. was observed over rebar C extending from 16 in. to 36 in.
- 7) Bottom region over rebar B was not consolidated properly.

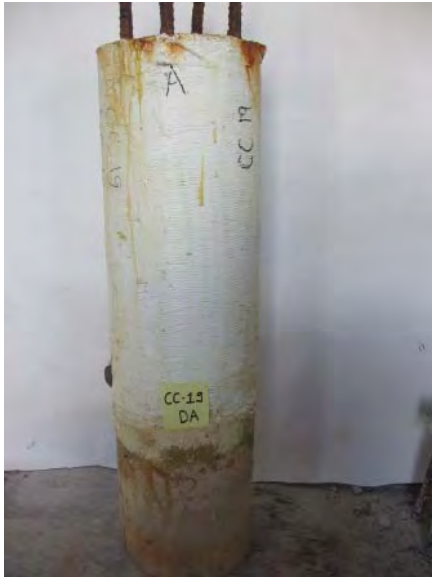
Cylinder CC19 wrap ped over top 24 in.

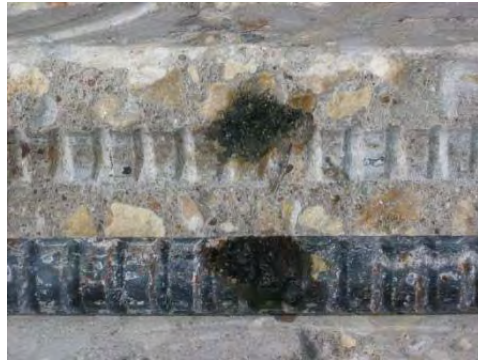
- 1) Heavy black corrosion residue was observed on rebar A at 13 in. from bottom and on rebar B at 34 in. from bottom.

Heavy localized rusting on rebar A.

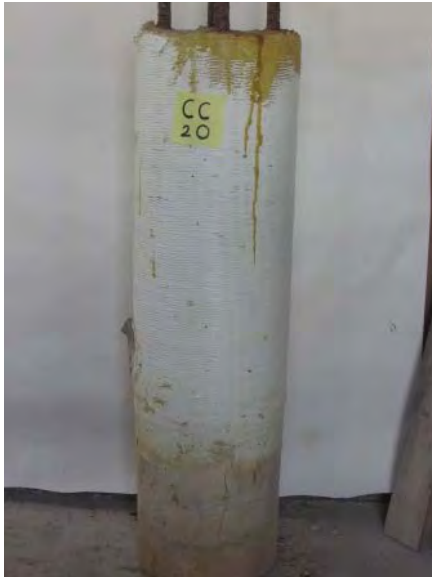
Cylinder CC20 wrapped over top 24 in.

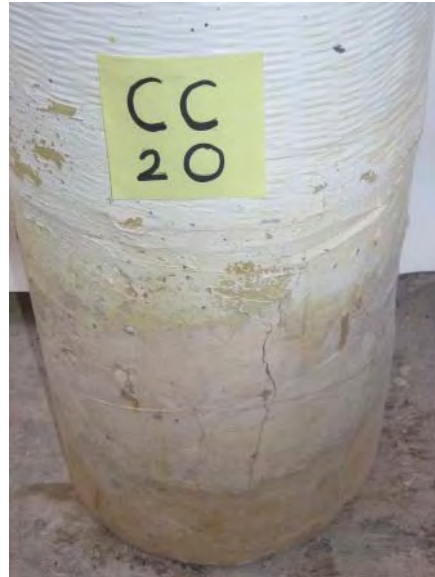
Crack over rebar A in unwrapped region.

- 1) The column was wrapped over the top 24 inches.
- 2) A vertical crack of width 0.03 in. occurred over rebar A extending from 25 in. to 34 in. from top.
- 3) A vertical crack of width 0.02 in. occurred over rebar B extending from 26 in. to 34 in. from top.

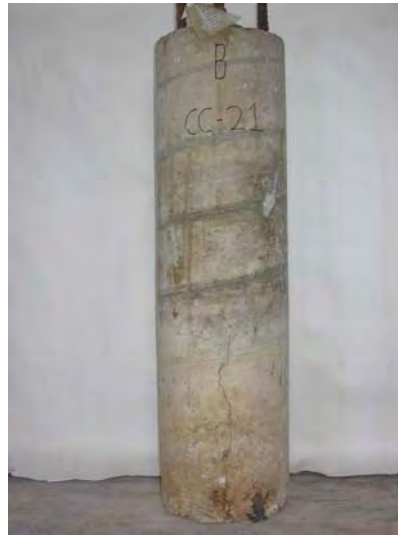
Cylinder CC21.

- 1) The specimen was not wrapped.
- 2) Two vertical cracks of width 0.03 in. were observed over rebar D extending from 12 in. to 24 in. from bottom.
- 3) A vertical crack of width 0.04 in. was observed over rebar C extending from 0 in. to 20 in.
- 4) Two vertical cracks were observed over rebar B, first 0.02 in. wide extending from 25 in. to 36 in. and the second of width 0.04 in. extending from 0 in. to 20 in.
- 5) Rust stain (5 in. × 7 in.) was observed near bottom of rebar B.

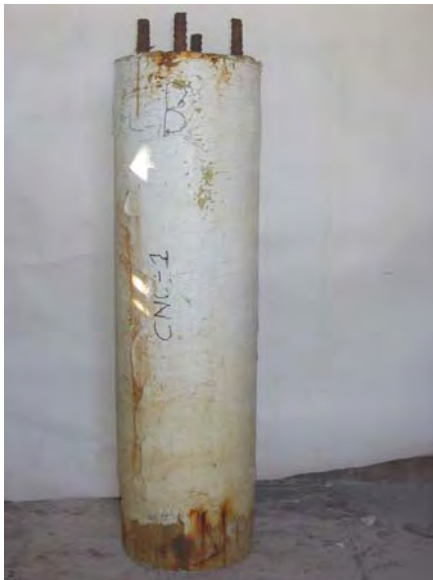
Cylinder CNC1 wrapped over top 27 in.

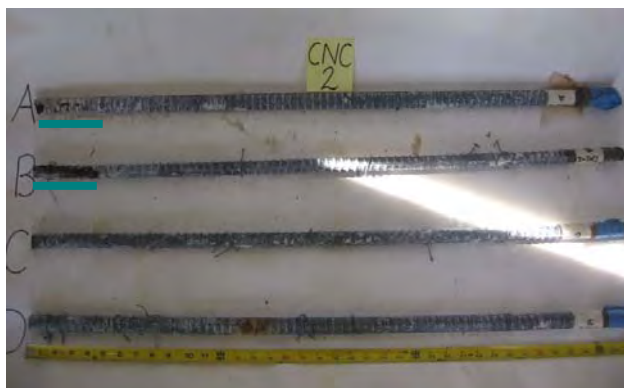
- Heavily corroded areas
- Very light, one-sided corrosion

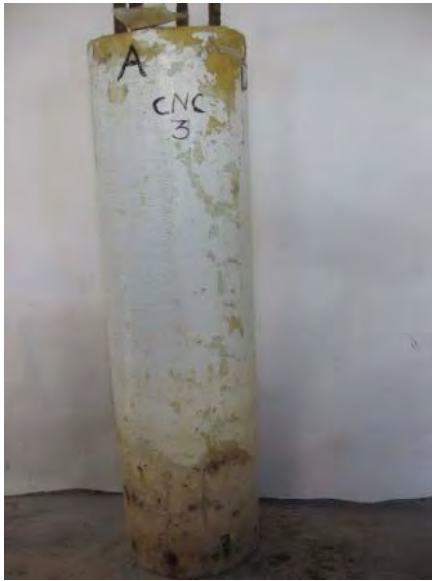
Cylinder CNC3 wrapped over top 24 in.

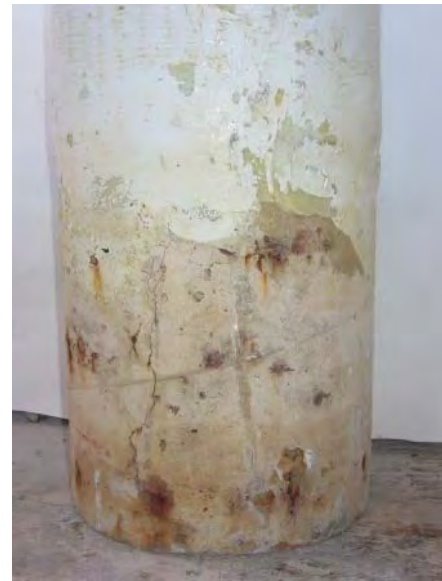
Crack and rust stains over rebar A.

- 1) The cylinder was wrapped over the top 24 in.
- 2) A 0.02-in. vertical crack over rebar A extended from the end of wrap to bottom.
- 3) Rust stains were observed on unwrapped regions in area AD and AB.

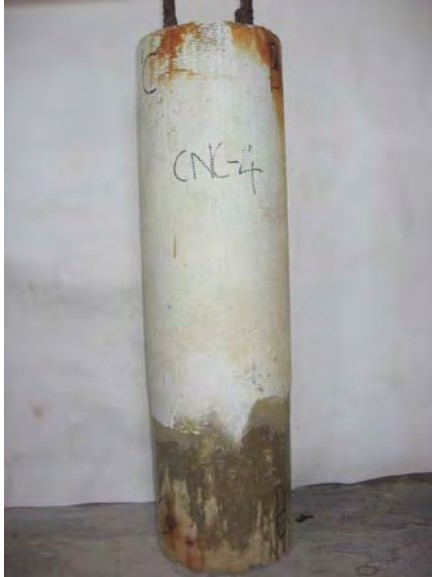
Cylinder CNC4, wrapped over top 24 in.

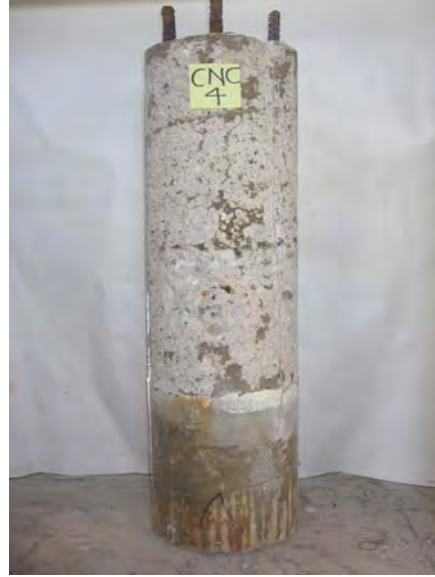
Cylinder CNC4, after removal of wrap.

- 1) The cylinder is wrapped over top 24 in.
- 2) The wrap is intact at all places.
- 3) Rust stains were observed over the bottom unwrapped region.
- 4) When the wrap was removed, chunks of concrete came off with it, exposing rust stains lying underneath the surface.

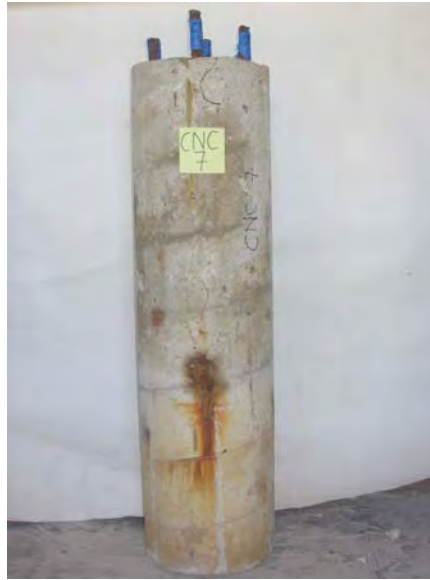
Cylinder CNC7 with large rust stain over rebar C.

- 1) The specimen was not wrapped.
- 2) A vertical crack of width 0.04 in. was observed over rebar A extending the complete height of the cylinder.
- 3) A vertical crack of width 0.02 in. was observed over rebar B extending the complete height of the cylinder.
- 4) A vertical crack of width 0.03 in. was observed over rebar C extending from 16 in. to 31 in.
- 5) A vertical crack of width 0.016 in. was observed over rebar D extending from 7 in. to 36 in.
- 6) Large rust stains were observed all over the specimen.

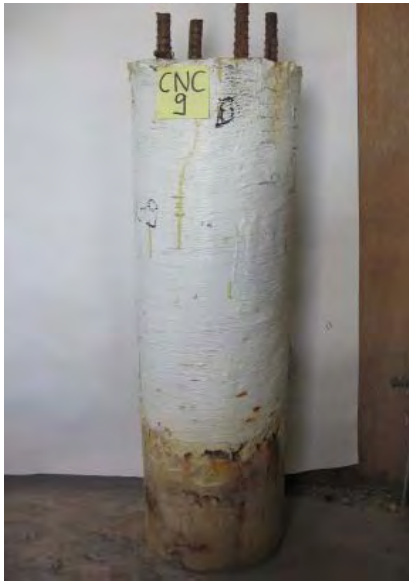
Cylinder CNC9 wrapped over top 24 in.

- 1) The cylinder was wrapped over the top 24 in.
- 2) Concrete was not consolidated properly just below the wrap edge in areas AD and DC and over the bottom 2 in. in area AD.
- 3) Unconsolidated portions extending from 14 in. to 16 in. from top over rebars D and A were filled with repair material.
- 4) A dark stain of width 7 in. was observed over rebar D extending from 21 in. to 24 in. from the top and of width 4 in. over rebar B extending from 14 in. to 16 in. from top.
- 5) Staining was observed over the unwrapped region due to wash-out/ rust.
- 6) Repair patch as shown in the figure below.

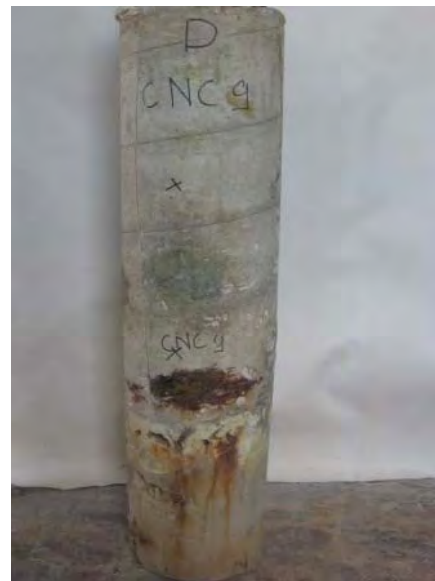
Rust stains and unconsolidated parts over rebar D.

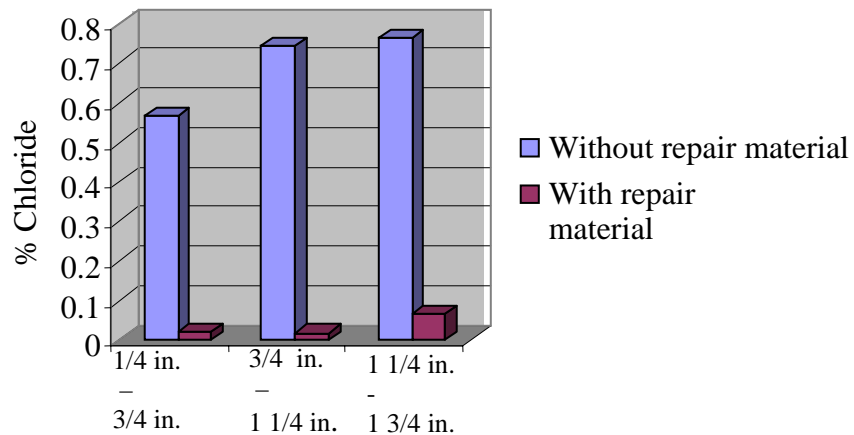
- 1) Rebars A and D were corroded in the bottom unwrapped area only with no corrosion under the wrapped region.
- 2) Rebars B and C were not corroded even in the unwrapped portions due to the presence of LMC repair patch.
- 3) The chloride test results correlated well with the amount of corrosion observed on the rebars.
- 4) The chloride content was calculated for areas covered with repair material and areas not covered with repair material at 6 in from bottom. The results are shown graphically.

Comparison of chloride content.

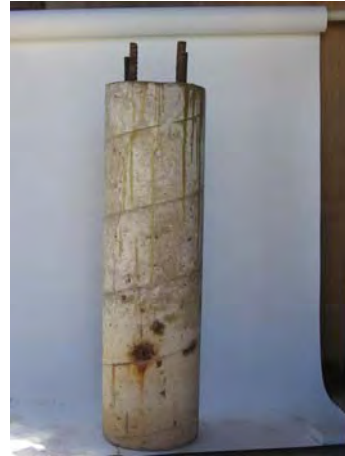
CNC15 full view with rebar A  
in front.

CNC15 Area DC.

- 1) A vertical crack of width 0.06 in. occurred over rebar A, extending from top to 7.5 in. from bottom.
- 2) A vertical hairline crack occurred over rebar B, extending from 6.5 in. to 14 in. from top.
- 3) A vertical crack of width 0.04 in. occurred over rebar B, extending from 14 in. to 26 in. from top.
- 4) A few vertical hairline cracks occurred in area AB, extending from 12 in. to 20 in. from top.
- 5) A vertical crack of width 0.04 in. occurred over rebar C, extending from top to 33 in. from top.
- 6) A vertical crack of width 0.06 in. occurred over rebar D, extending from top to 32 in. from top.
- 7) A Stain spot (2 in. in diameter) was located in area CD, at 9 in. above bottom.
- 8) A Stain spot (0.5 in.  $\times$  2 in.) was located over rebar C, at 9 in. above bottom.
- 9) A Stain spot (1 in.  $\times$  1 in.) was located in area AB, at 17 in. above bottom.

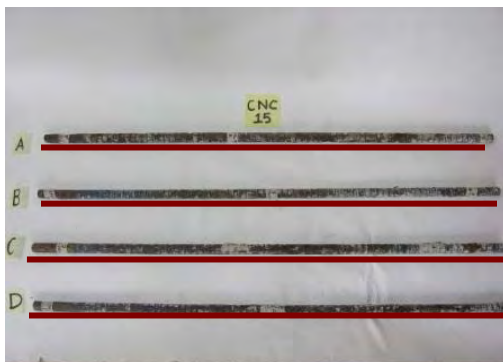
— Heavily corroded areas.

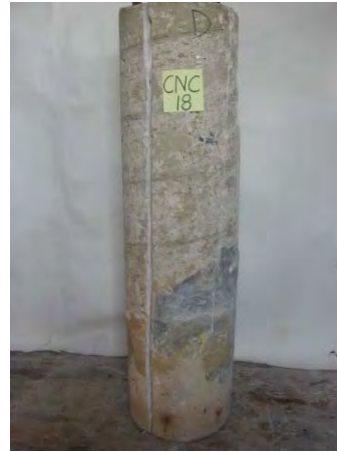
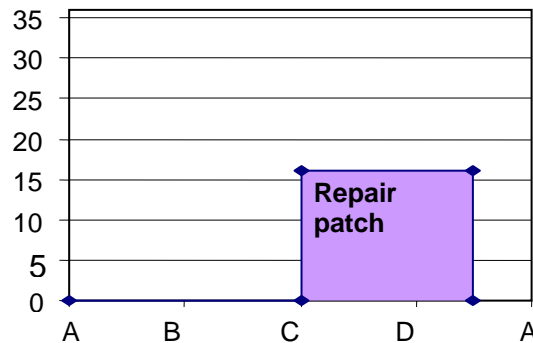
Repair patch and rust stains over rebar D.

- 1) Unwrapped portions of rebar A and B were corroded while those of rebars C and D were not. This was likely due to the presence of repair material over rebars C and D.
- 2) No corrosion was observed in the wrapped regions.

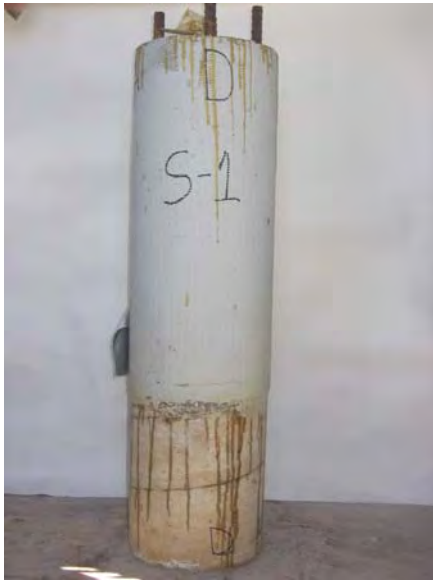
Cylinder S1 wrapped over top  
24 in.

Cylinder S1 after removal of  
wrap.

- 1) The cylinder was covered with wrap over the top 24 in.
- 2) The wrap was intact at all places.
- 3) A vertical crack of width 0.03 in. was observed over rebar A, extending from 0 in. to 12 in., accompanied with rust stains.
- 4) A vertical crack of width 0.016 in. was observed over rebar B, extending from 0 in. to 10 in., accompanied with rust stains.
- 5) A vertical crack of width 0.02 in. was observed over rebar C, extending from 4 in. to 12 in.

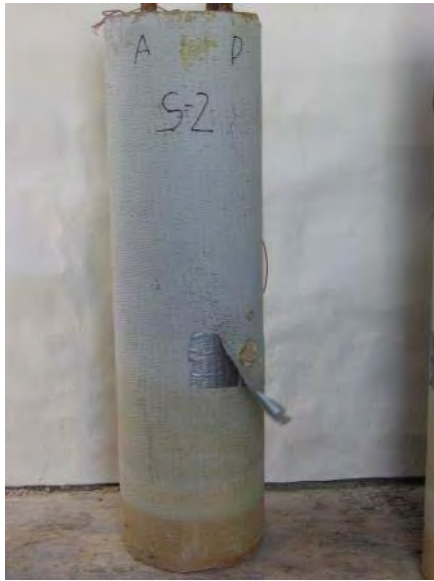
Column S2 Completely wrapped.

Column S2 after removal of wrap.

- 1) The column was completely wrapped. The wrap was intact at all places.
- 2) No cracks or rust stains were observed after the wrap was removed.

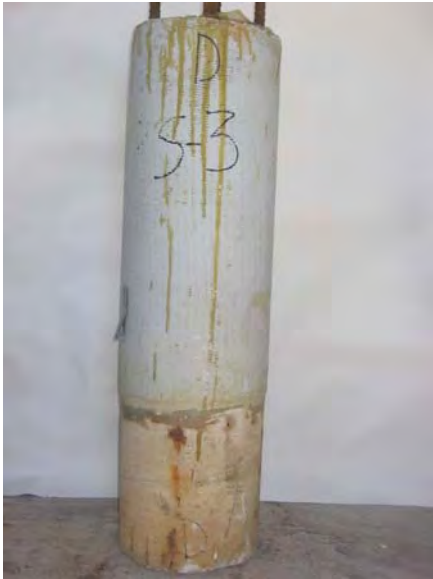
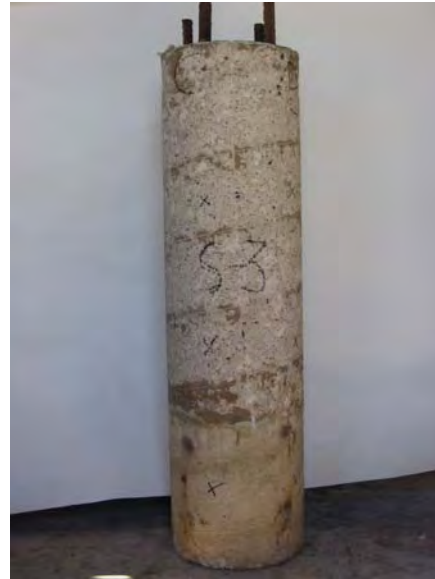
Cylinder S3 wrapped over  
top 24 in.

Cylinder S3 after removal of  
wrap.

- 1) The cylinder was wrapped over the top 24 in.
- 2) The wrap was intact at all places.
- 3) A vertical crack of width 0.013 in. was observed over rebar A, extending from 0 in. to 12 in., accompanied with rust stains.
- 4) A vertical crack of width 0.03 in. was observed over rebar B, extending from 3 in. to 12 in., accompanied with rust stains.
- 5) A vertical hairline crack of width 0.01 in. was observed over rebar C, extending from 2 in. to 12 in., accompanied with rust stains.

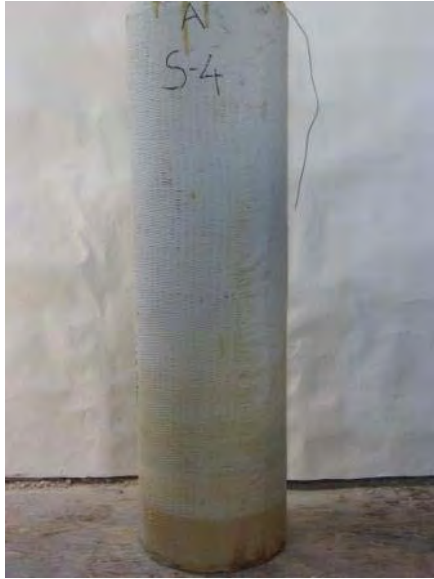
Column S4 Completely wrapped.

Column S4 after removal of wrap.

- 1) The column was completely wrapped. The wrap was intact at all places.
- 2) No cracks or rust stains were observed after the wrap was removed.

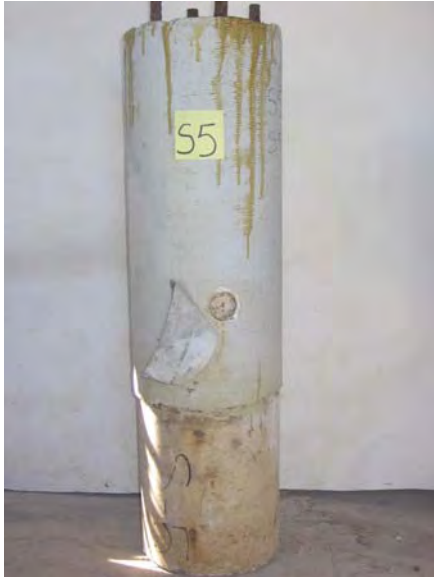
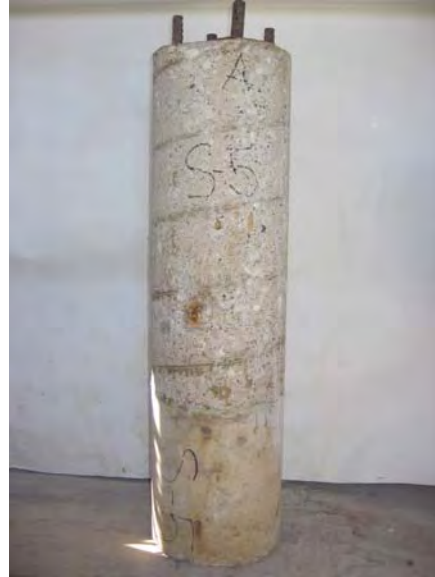
Cylinder S5 wrapped over top  
24 in.

Cylinder S5 after removal of  
wrap.

- 1) The cylinder was wrapped over the top 24 in.
- 2) The wrap was intact at all places.
- 3) A vertical crack of width 0.016 in. was observed over rebar A, extending from 5 in. to 9 in.
- 4) A vertical crack of width 0.016 in. was observed over rebar B, extending from 0 in. to 12 in.
- 5) Rust stains were observed in the unwrapped region.

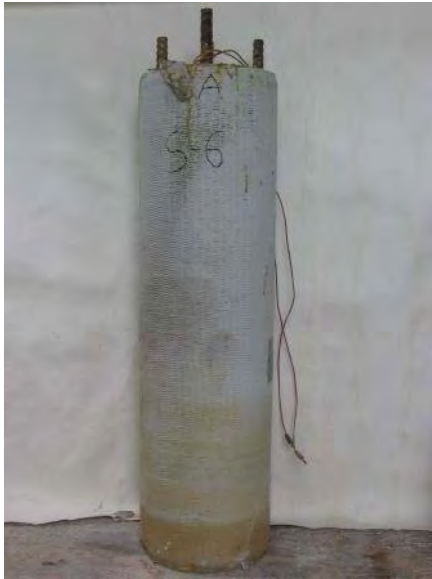
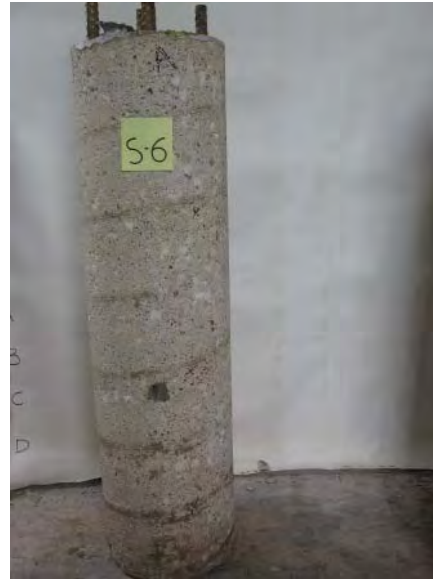
Column S6 completely wrapped.

- 1) The column was completely wrapped. The wrap was intact at all places.
- 2) Rust stains were observed at 6 in. above bottom over area DA and area AB, 1.5 in. above bottom over area BC and 26 in. above bottom over rebar C.

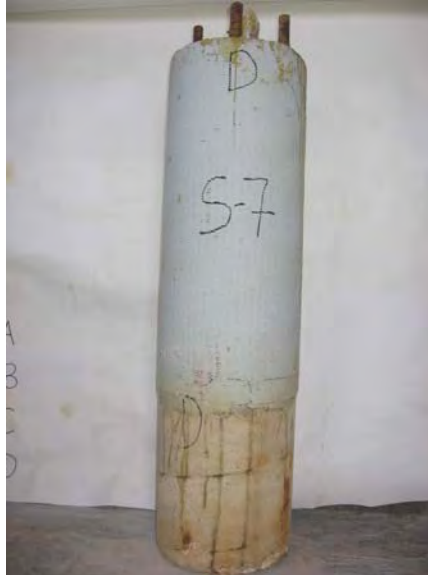
Cylinder S7 wrapped over top  
24 in.

- 1) The cylinder was wrapped over the top 24 in.
- 2) The wrap was intact at all places.
- 3) A vertical crack of width 0.013 in. was observed over rebar B, extending from 0 in. to 6 in.
- 4) A vertical crack of width 0.02 in. was observed over rebar C, extending from 0 in. to 10 in.
- 5) A few rust stains were observed in the unwrapped region.

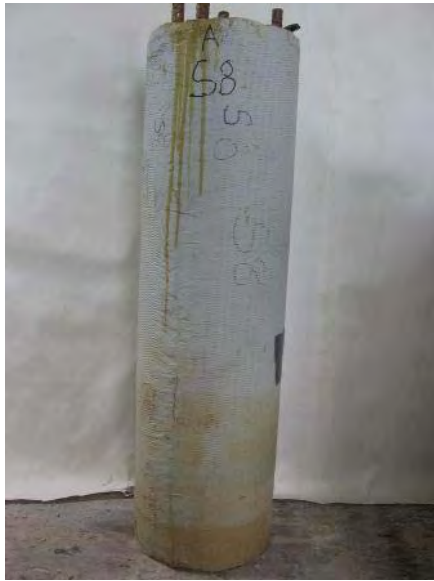
Column S8 completely wrapped.

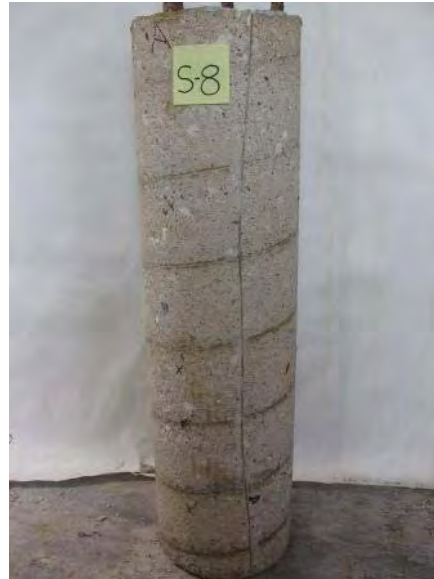
No cracks or rust stains after removal of wrap.

- 1) The cylinder was completely wrapped. The wrap was intact at all places.
- 2) No rust stains or cracks were visible after removal of wrap.
- 3) The surface of concrete was finished properly.

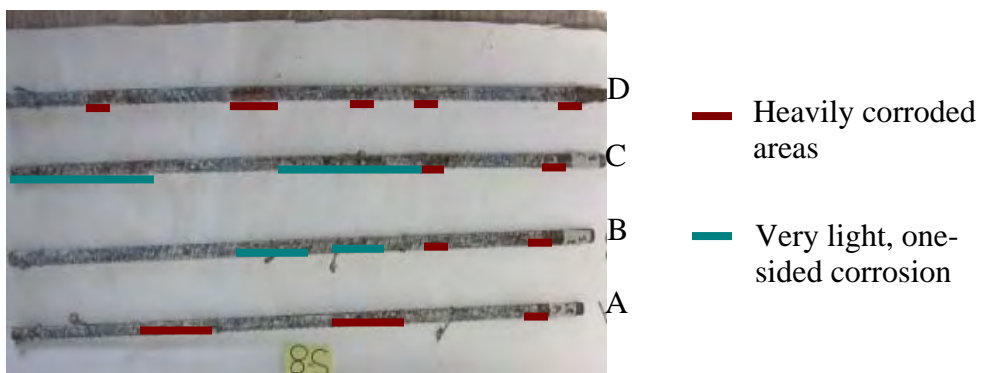
### Corrosion of rebars:

- 1) Though the column was fully wrapped, heavy corrosion was observed in certain areas and light corrosion in some, as marked.
- 2) The inhibitor used, Cortec, does not seem to be beneficial in preventing corrosion.

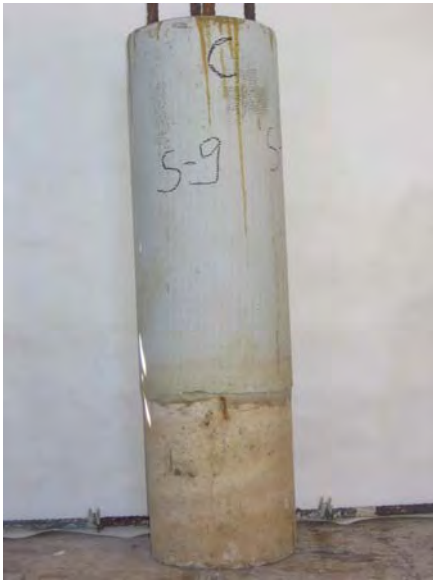
Cylinder S9 wrapped over top 24 in.

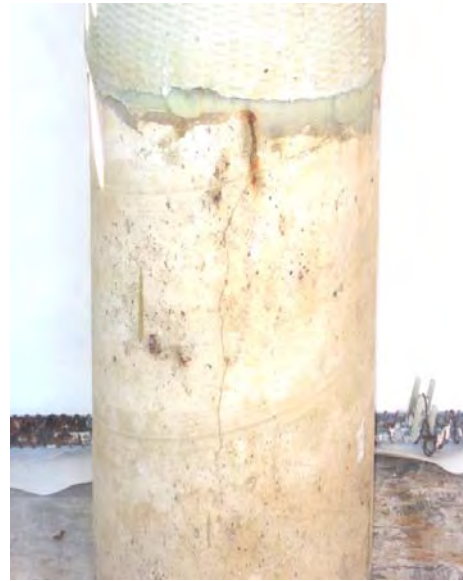
Crack over rebar C, starting where the wrap ends.

- 1) The cylinder was wrapped over the top 24 in.
- 2) The wrap was intact at all places.
- 3) A vertical crack of width 0.02 in. was observed over rebar B, extending from 9 in. to 12 in.
- 4) A vertical crack of width 0.02 in. was observed over rebar C, extending from bottom to 12 in.

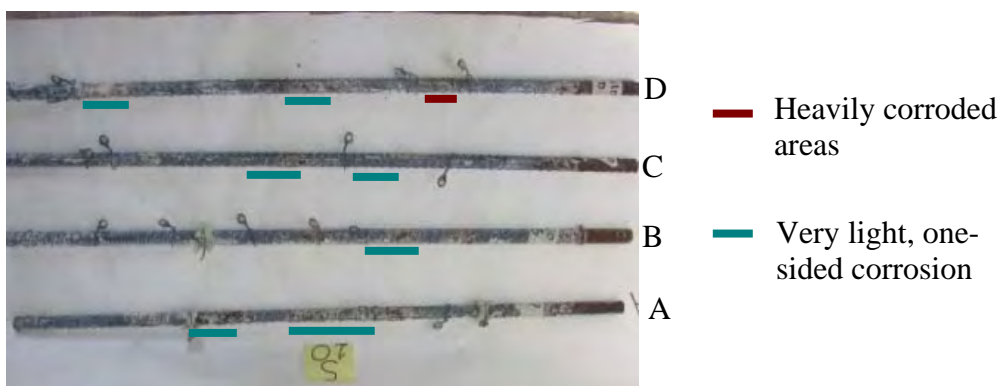
### Corrosion of rebars:

- 1) The level and amount of corrosion is lesser when compared to specimens S6 and S8.

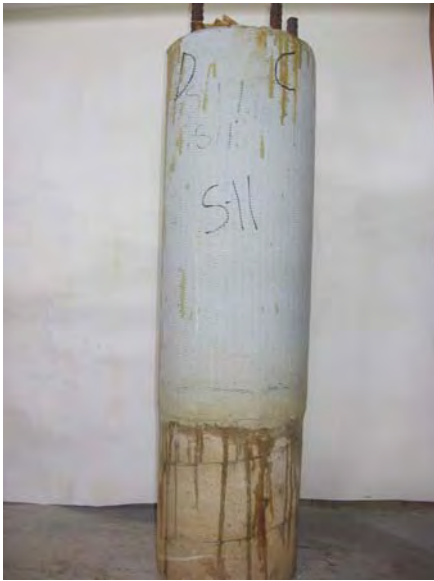
Cylinder S11 wrapped over top  
24 in.

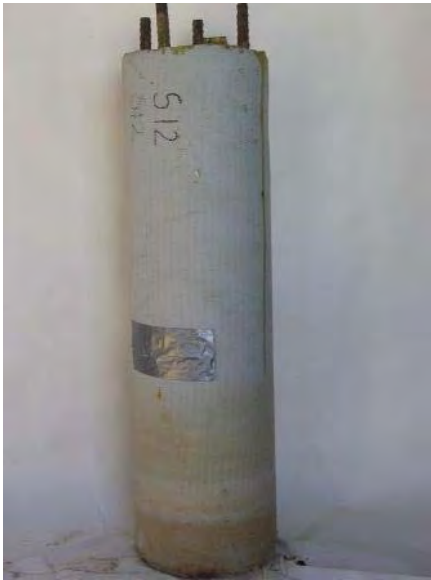
Specimen S12 with wrap intact.

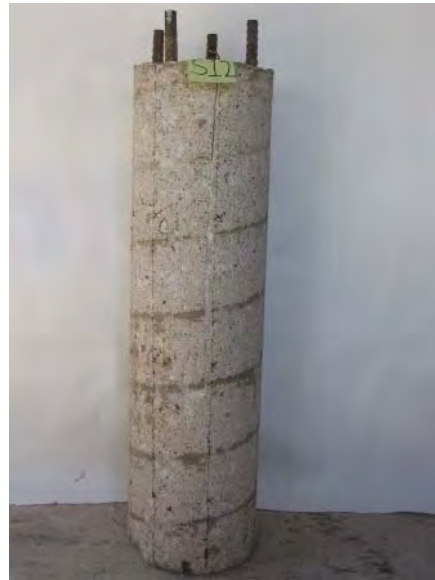
Specimen S12 after removal of wrap.

- 1) The cylinder was wrapped over the full length. The wrap was intact in all places.
- 2) No rust stains or cracks were observed before or after removal of wrap.

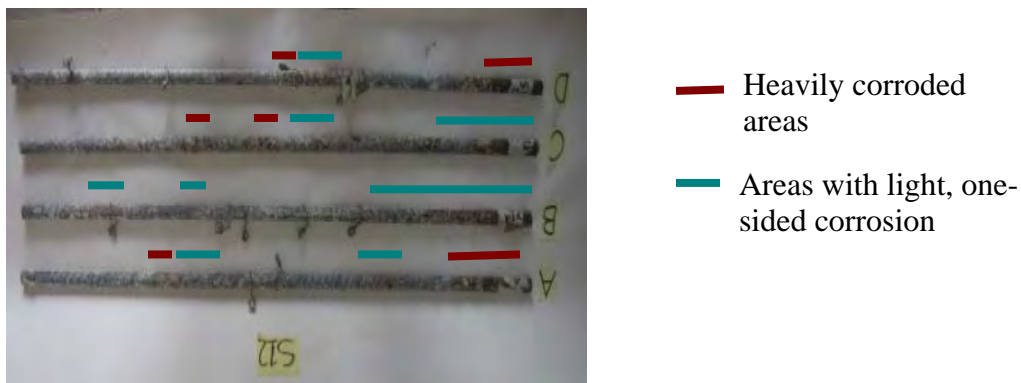
### Corrosion of rebars:

- 1) The amount of corrosion was very low throughout, except on rebar C which was more corroded than the others.
- 2) Very little loss of cross-section was observed on the rebars.
- 3) Compared to cylinder S16, which had the same parameters except that it did not contain any corrosion inhibitor, corrosion was lower in cylinder S12 which contained the corrosion inhibitor Sika.

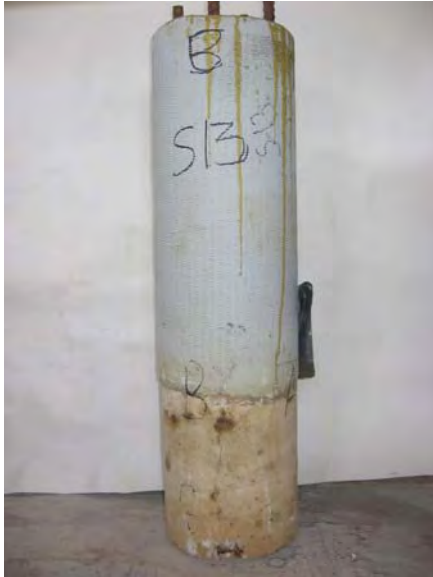
Cylinder S13 wrapped over top 24 in.

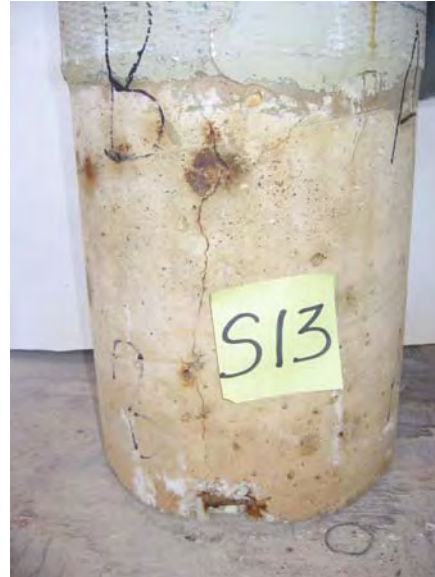
Crack and rust stains over rebar B on cylinder S13.

- 1) The cylinder is wrapped over the top 24 in.
- 2) The wrap was intact in all places.
- 3) A vertical crack of width 0.013 in. was observed over rebar A, extending from 6 in. to 12 in.
- 4) A vertical crack of width 0.03 in. was observed over rebar B, extending from 0 in. to 12 in.
- 5) A vertical crack of width 0.03 in. was observed over rebar D, extending from 0 in. to 12 in.
- 6) Rust stains were observed in the unwrapped region.

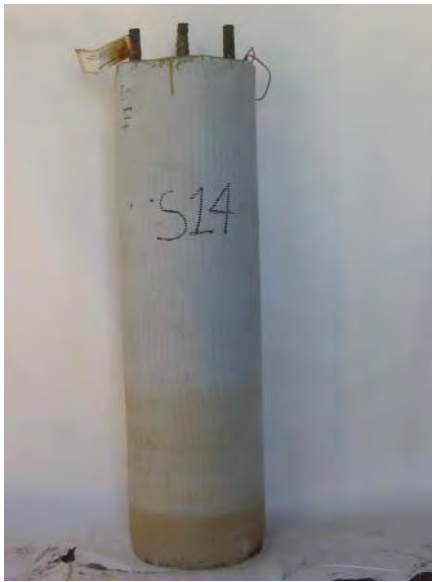
Specimen S14 with wrap intact.

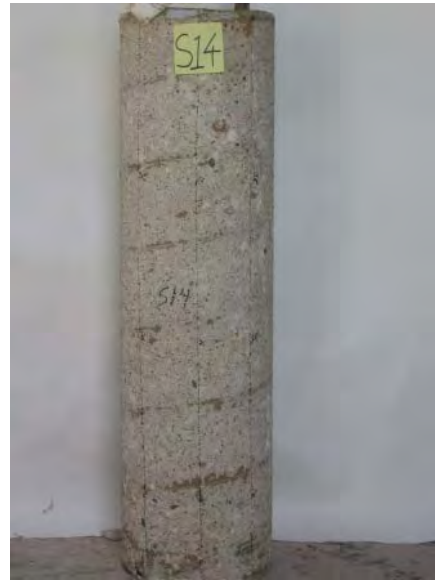
Specimen S14 after removal of wrap.

- 1) The cylinder was completely wrapped. The wrap was intact in all places.
- 2) No rust stains or cracks were observed before or after removal of wrap.

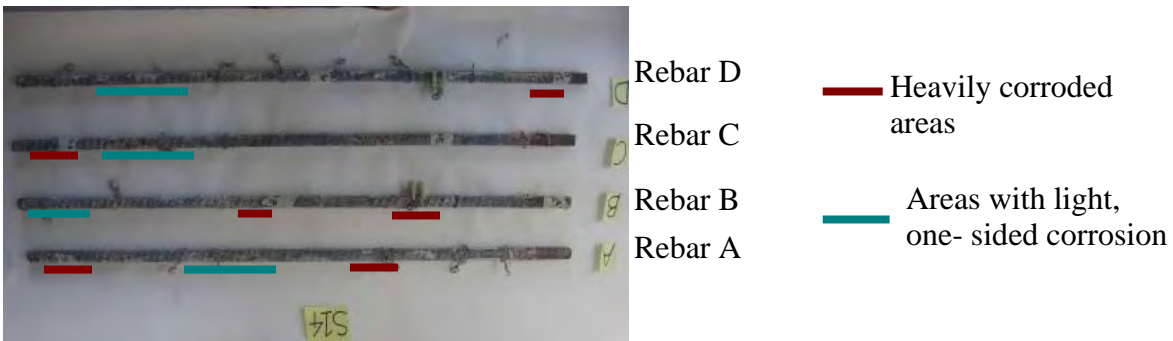
### Corrosion of rebars:

- 1) The level of corrosion was higher than that of cylinder S16, possibly since cylinder S14 was cracked while S16 was uncracked. Overall the amount of corrosion was much lesser than that of unwrapped specimens.
- 2) Very less loss of cross-section was observed on the rebars.

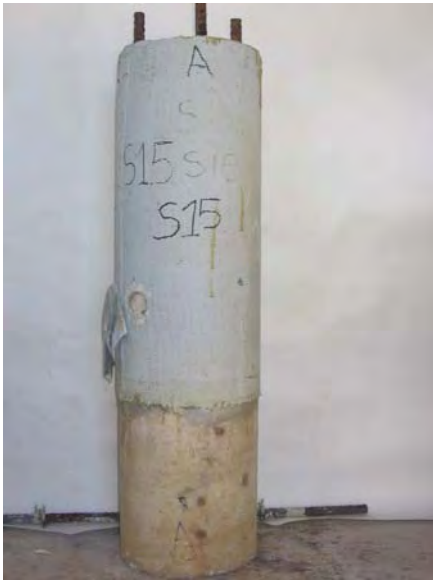
Cylinder S15 wrapped over  
top 24 in.

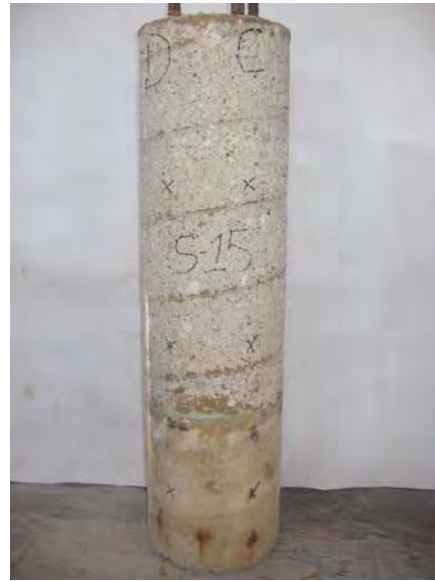
Cylinder S15 after removal of  
wrap.

- 1) The cylinder is wrapped over the top 24 in.
- 2) The wrap is intact in all places.
- 3) A vertical hairline crack (width 0.01 in.) was observed over rebar D and rebar C, extending from 0 in. to 12 in., accompanied with rust stains.
- 4) Small rust stains were observed all over the unwrapped region.
