1. Report No. FHWA/TX-07 / 0-1774-4		2. Government Accession No.		3. Recipient's Catalog No.	
4. Title and Subtitle Performance of Fiber Composite Wrapped Columns and Beams in a Corrosive Environment				5. Report Date October 2006

## **Performance of Fiber Composite Wrapped Columns and Beams in a Corrosive Environment**

The procedures used to assess the condition were described in Report 0-1774-3. The purpose of this report is to document the performance of all remaining tests and to propose design guidelines for use of wrapping techniques to protect bridge structures in a corrosive environment.

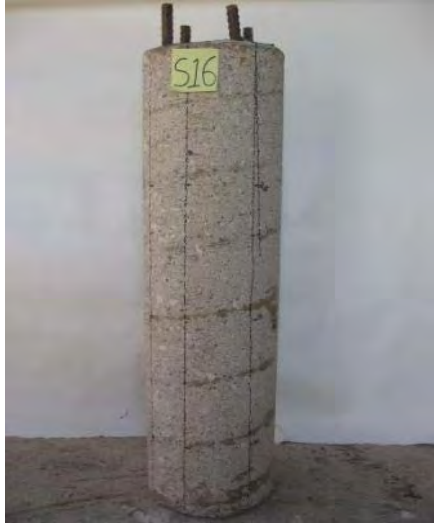
Cylinder S16 with wrap removed.

- 1) The cylinder was completely wrapped. The wrap was intact in all places.
- 2) No rust stains or cracks were observed before or after removal of wrap.

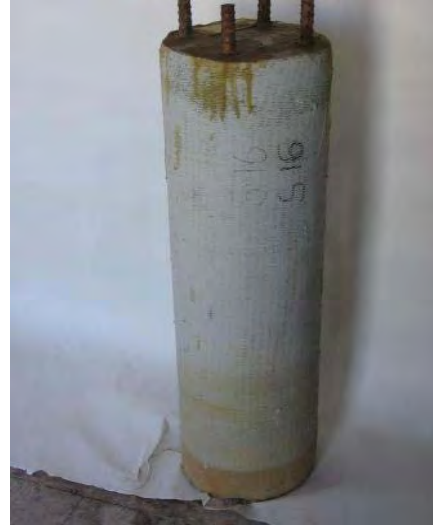
Cylinder S16 completely wrapped.

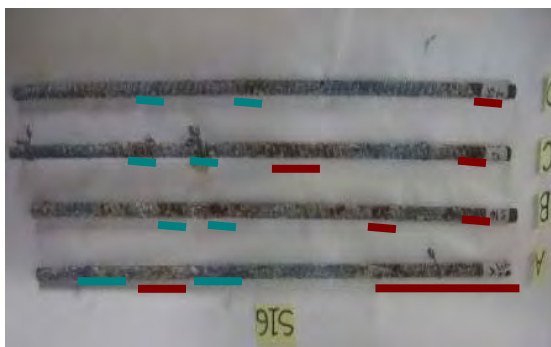
### Corrosion of rebars:

- 1) Rebar A was corroded only near the top. No major corrosion was observed anywhere else.
- 2) Rebar B, C, D were lightly corroded intermittently. Very less corrosion was observed on rebar D.
- 3) There was a marked difference in the level of corrosion of unwrapped and wrapped specimens.
- 4) It was observed in nearly all the specimens that the top 1 in. to 1 1/2 in. of rebar, just below the surface on the exposed upper end, was always corroded. The portions of the rebars that were extended out underwent heavy corrosion, and the corrosion extended to the covered portions as well.

- Highly corroded areas.
- Areas with light, one sided corrosion

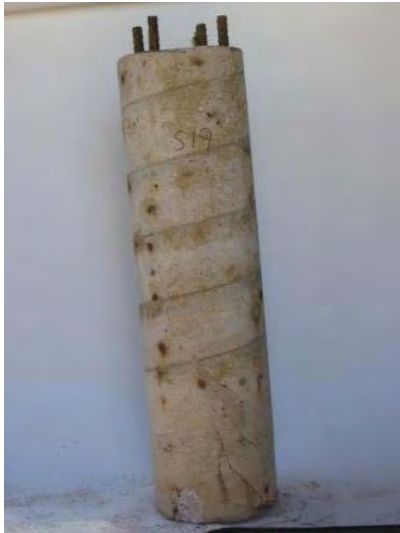
Specimen S19, Rebar A in front.

- 1) A vertical crack of width 0.013 in. occurred over rebar A, extending from the top to 22 in. from top. Wider cracks of width 0.03 in. occurred near bottom.
- 2) A vertical crack of width 0.02 in. occurred over rebar B that turned diagonal after 20 in. from top. Approximately 3/4 in. diameter stain spots were located at top near rebar B.
- 3) A vertical crack of width 0.02 in. occurred from top to bottom over rebar C. Stain spots of approximately 3/4 in. diameter were located along the crack.
- 4) A vertical crack of width 0.016 in. occurred from top to bottom over rebar D.
- 5) The concrete was spalled over bottom area AD.

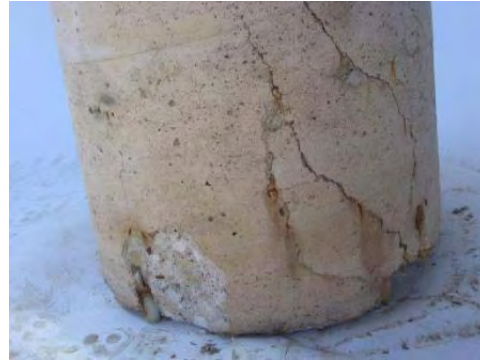
Spalling and cracking at bottom of Area AD.

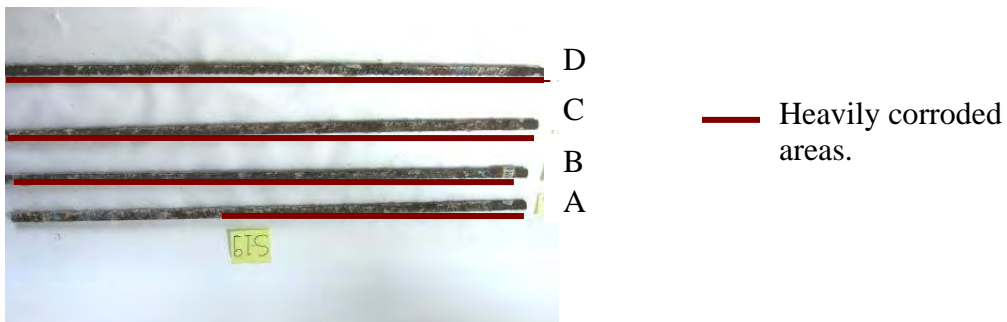
### Corrosion of rebars:

- 1) Rebar A was much less corroded than rebar D, even though the half-cell readings indicate otherwise.
- 2) Bars were not corroded where spacers were embedded.
- 3) Rebar A was lesser corroded over bottom 11 in., especially on one side; and was intermittently corroded above that.
- 4) Rebars C and D were highly corroded, especially at the bottom. (Spalling and large cracks had been observed near the bottom.)

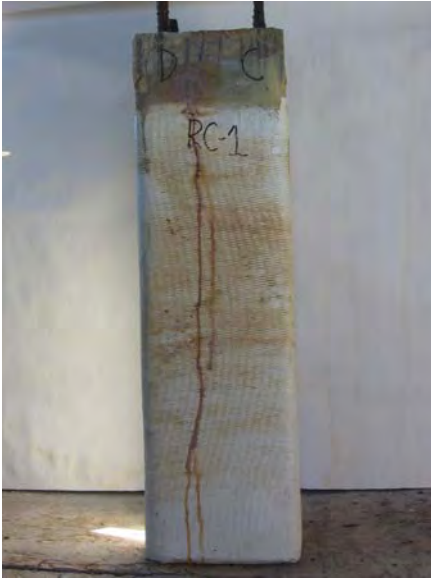
Specimen RC1 wrapped over the top 27 in.

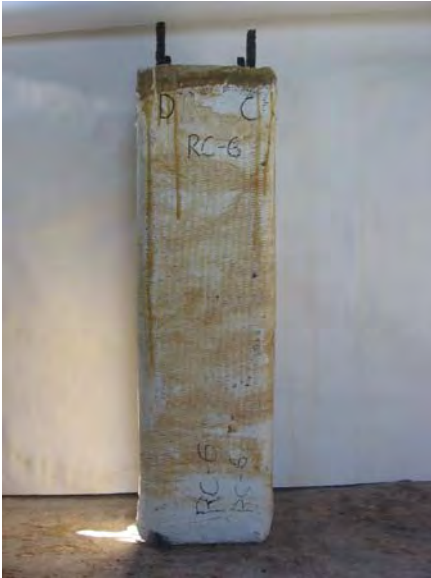
Specimen RC6 wrapped over the top 33 in.

Specimen RC6 after removal of wrap

- 1) The specimen was covered with repair material extending from 20 in. to 36 in. over face DA and half each of face AB and DC.
- 2) Vertical cracks of width 0.03 in. and 0.013 in. were observed over rebar D extending from 0 in. to 4 in. on face DA and from 0 in. to 7 in. on face CD respectively.
- 3) Vertical cracks of width 0.02 in. were observed over rebar A extending from 0 in. to 2.5 in. on face AB and from 0 in. to 4 in. on face AB.
- 4) Vertical cracks of width 0.016 in. were observed over rebar B extending from 0 in. to 5 in. on face AB and from 0 in. to 7 in. on face BC.
- 5) Vertical cracks of width 0.01 in. were observed over rebar C extending from 0 in. to 6 in. on face BC and face CD.

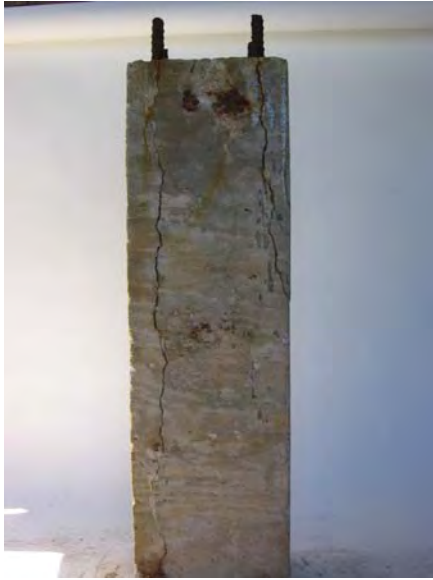
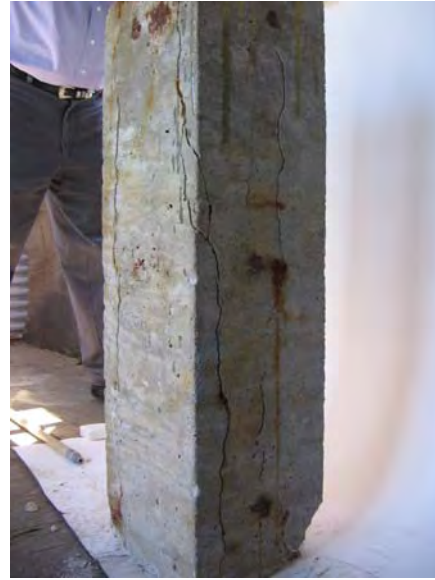
Specimen RC8 with no wrap.

- 1) Large vertical cracks of width 1/8 in. were observed on each side on each rebar extending over the full length of the specimens.
- 2) The cracks were accompanied with large rust stains.
- 3) Concrete had spalled-off over the lower end of rebar B.

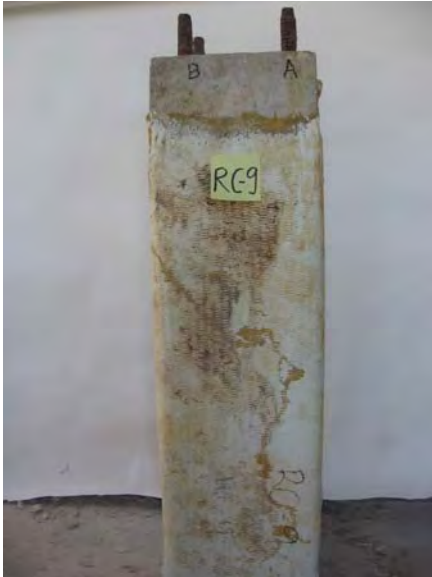
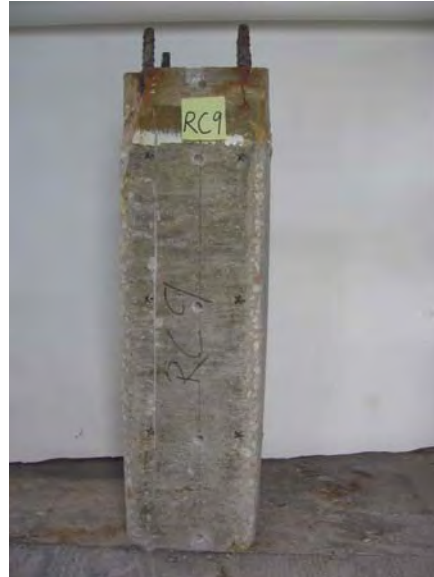
Specimen RC9.

- 1) A vertical crack of width 0.07 in. was observed over rebar C extending from 0 in. to 4 in. on face CD.
- 2) Vertical cracks of width 0.02 in. and 0.06 in. were observed over rebar D extending from 0 in. to 4 in. on face CD and face DA respectively.
- 3) A vertical crack of width 0.04 in. was observed over rebar A extending from 0 in. to 4 in. on face DA.

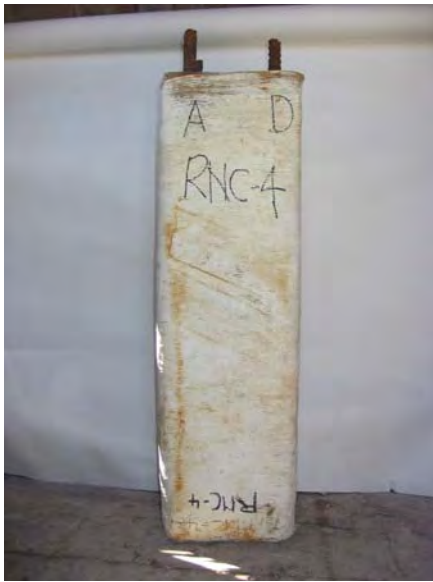
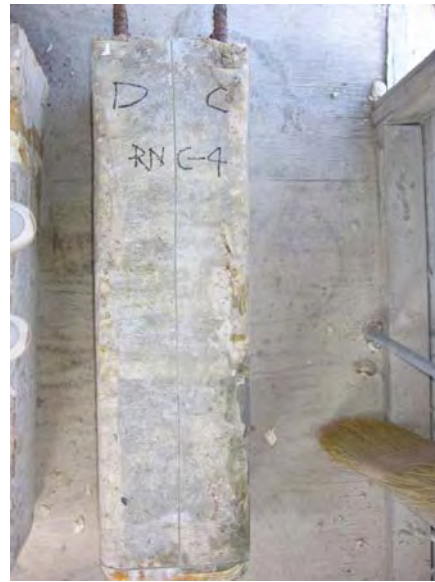
Specimen RNC4 before and after removal of wrap.

- 1) The specimen was completely wrapped and the wrap was intact in all places.
- 2) No cracks or stain spots were visible on the wrap.
- 3) The specimen was covered with repair material extending from 0 in. to 17 in. over face BC and CD.
- 4) A rust stain was observed on the lower end of rebar A.

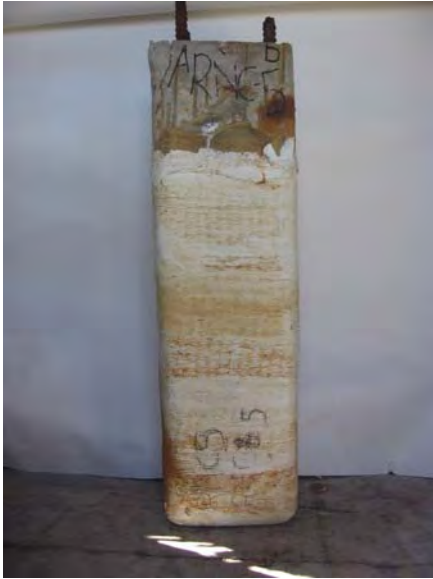
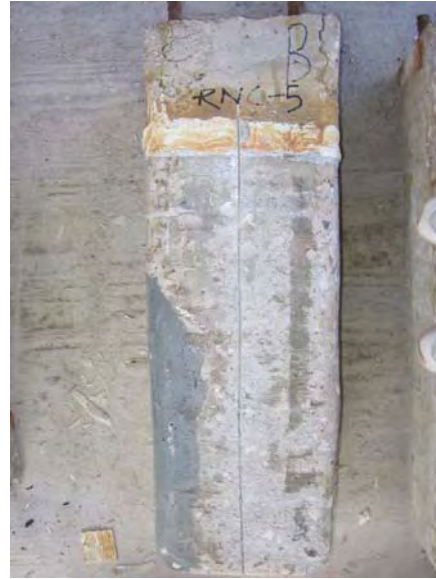
Specimen RNC5 before and after removal of wrap.

- 1) A vertical crack of width  $\frac{1}{8}$  in. was observed over rebar A extending from 0 in. to 6 in. on face DA.
- 2) A vertical crack of width  $\frac{1}{8}$  in. was observed over rebar D extending from 0 in. to 6 in. on face CD.
- 3) A vertical crack of width  $\frac{3}{16}$  in. was observed over rebar C extending from 0 in. to 6 in. on face CD.
- 4) A vertical crack of width  $\frac{3}{16}$  in. was observed over rebar B extending from 0 in. to 7 in. on face BC.
- 5) The specimen was covered with repair material extending from 16 in -36 in. over face CD.

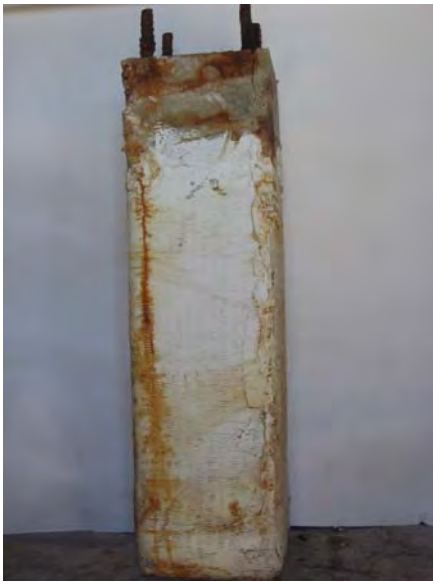
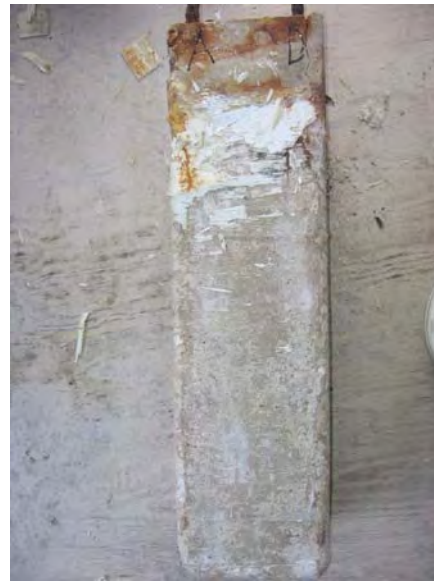
Specimen RNC8 before and after removal of wrap.

- 1) A vertical crack of width  $\frac{1}{8}$  in. was observed over rebar B extending from 0 in. to 6 in. on face AB.
- 2) A vertical crack of width 0.08 in. was observed over rebar A extending from 0 in. to 7 in. on face AB.
- 3) A vertical crack of width  $\frac{3}{16}$  in. was observed over rebar C extending from 0 in. to 7 in. on face CD.
- 4) A vertical crack of width 0.06 in. was observed over rebar D extending from 0 in. to 7 in. on face CD.
- 5) A vertical crack of width 0.06 in. was observed over rebar D extending from 0 in. to 7 in. on face DA.
