1. Report No. FHWA/TX-08/0-4562-2		2. Government Accession No.		3. Recipient's Catalog No.	
4. Title and Subtitle Durability Evaluation of Post-Tensioned Concrete Beam Specimens after Long-Term Aggressive Exposure Testing			5. Report Date November 2007

Durability Evaluation of Post-Tensioned Concrete Beam Specimens after Long-Term Aggressive Exposure Testing

Center for Transportation Research
The University of Texas at Austin
3208 Red River
Austin, TX 78705

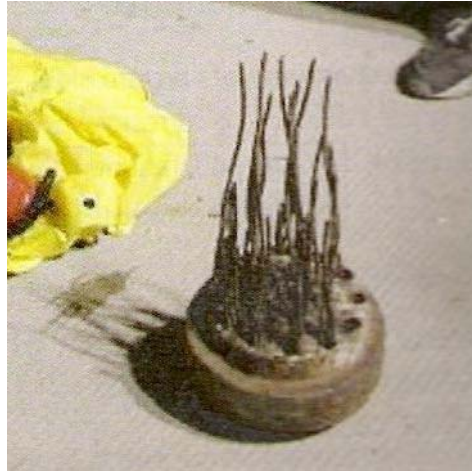
One major area of concern in post-tensioning systems is the anchorage. During stressing of the strands, the post-tensioning force is held by hydraulic rams. Upon completion of stressing, tapered wedges are driven into the holes into the anchorhead typically using a power-seating system on the jack. Upon release of the force in the jack, the strand attempts to “jump” back into the duct but the metal teeth in the wedges “bite” into the strand and bear against the tapered holes in the anchorhead, maintaining the post-tensioning force. A detrimental effect from the wedges is a reduction in the cross sectional area of the strand wires, resulting in higher stresses than would be found along the length of the strand. Typically, post-tensioning anchorage areas are sealed with grout after stressing. However, if the chlorides penetrate the grout, either through cracks or because of high grout permeability, they can enter the rest of the post-tensioning system through the interstitial areas of the strand at the anchors. In addition, once the strands in the anchorage begin to corrode, the strand stress levels increase because of their smaller effective cross sectional area. Thus the strand can fail at the anchorage. Failures of this type have been observed in Florida.¹¹ A corroded anchorage is shown in Figure 1.2.

Figure 1.2: Corroded Anchorage (Bearing Plate with Strand Tails)⁴

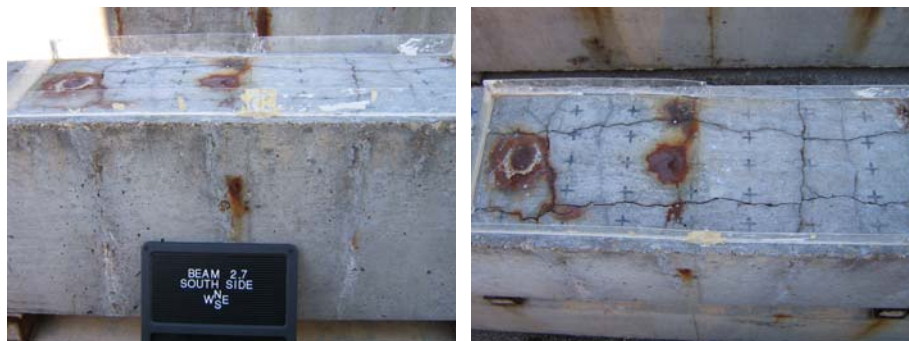
Cracking on the specimens was generally widespread and often very wide. As shown in Figure 3.4, at the end of 8 years of aggressive exposure there were often very wide longitudinal cracks (numerous cracks were in the 1/8-in. range) running along the line of the post-tensioning ducts in addition to the original transverse flexural cracks. The surfaces of the beams were often heavily stained with corrosion products. The wide cracking was due to the splitting forces set up by the corroding ducts and reinforcement as the volume of the corrosion products is substantially greater than the original volume of the materials.

Figure 3.4: Beam 2.7-Side View (Left) and Top View (Right)

As shown in Figures 3.4 and 5.29, staining and longitudinal cracking was found in the ponded region. One major area of staining was at the flexural crack at the beam centerline. The other was at the west end of the autopsy area. At this location the staining was concentrated around a flexural crack and where the hole had been drilled to create a grout vent during beam

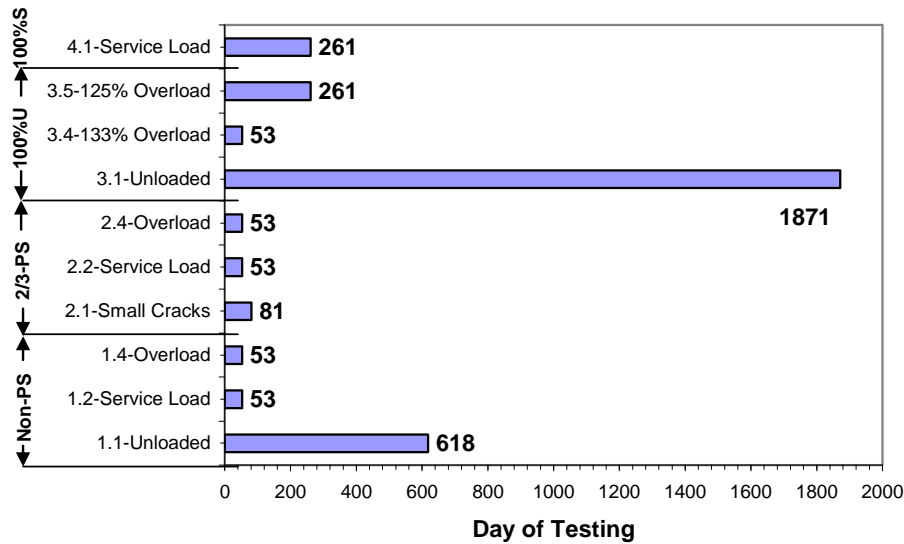
Figure 4.4: Estimated Time of Initiation of Corrosion: Phase I Beams

- All of the loaded specimens indicated corrosion within the first year of exposure testing, while the two unloaded specimens, 1.1 (Non-Prestressed) and 3.1 (100 percent Prestressed), showed a time to initiation of corrosion of 1.7 years and 5.1 years, respectively. The delay in corrosion was likely due to the absence of cracking in these specimens.
- Among specimens with identical loading, the time to corrosion increased when the specimen was fully prestressed (4.1). Both the partially prestressed (2/3-PS) specimens and the non-prestressed specimens at service load began corroding at the same time.

- Among the partially prestressed and non-prestressed specimens, the overloaded and service load specimens began corroding at the same time. The partially prestressed specimen with small cracks (2.1) and the unloaded non-prestressed specimen (1.1) had a longer duration to initiation of corrosion.

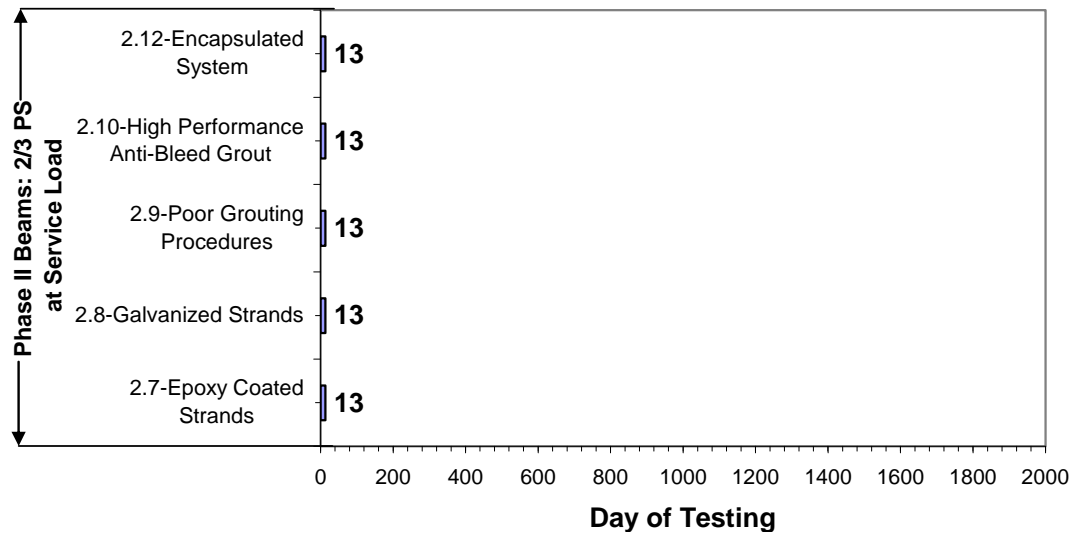
Figure 4.6: Estimated Time of Initiation of Corrosion: Phase II Beams

All Phase II Beams began corroding after only 13 days of testing. Even though all Phase II specimens had different post-tensioning details (either strand type, duct type, or grout type), the presence of cracking likely initiated the corrosion of the reinforcing bars at the same time in all five specimens.

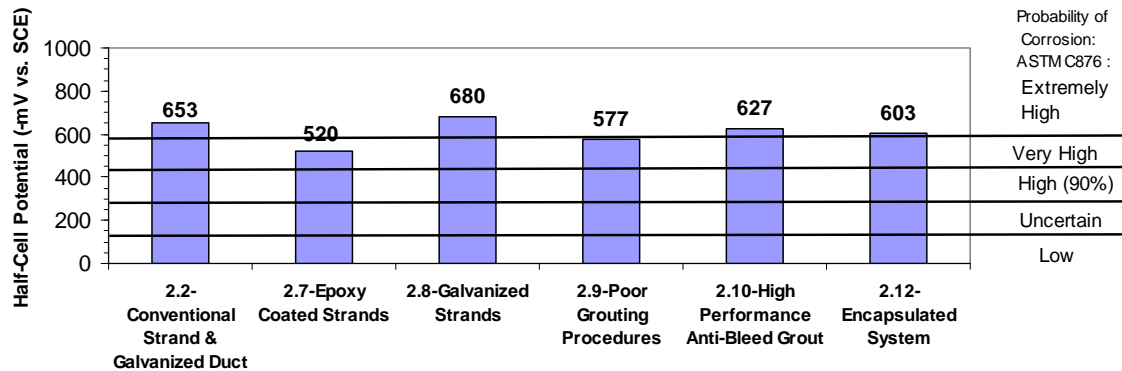
Figure 4.8: Maximum Final Half-Cell Potential Readings for Phase II Beams, Including Phase I Beam 2.2

Only the specimen with epoxy coated strands (2.7) had a probability of corrosion in the very high range. The remainder of the Phase II specimens were in the extremely high range. Beam 2.9 was essentially at the extremely high threshold (580 mV). It is interesting to note that according to the half-cell data, the use of the plastic duct (2.12) did not decrease the probability of corrosion in relation to the other specimens. However, it needs to be stressed that the half cell readings include the conventional bars and metal ducts, since all the steel elements in the beam form a circuit. Therefore, the relative performance of only the post-tensioning hardware (namely the strand) cannot be readily estimated from the half-cell potential data.

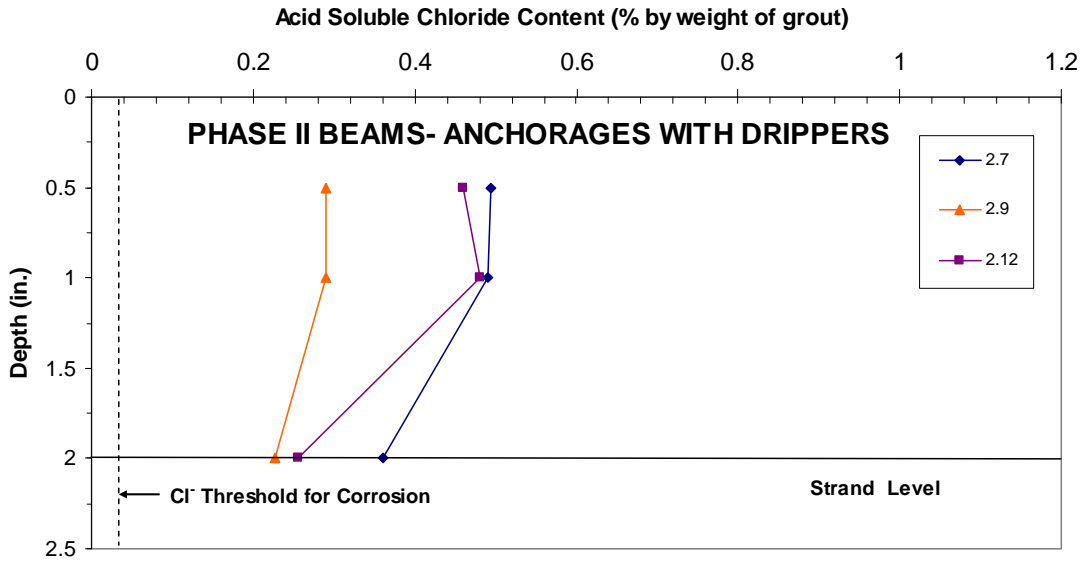
Figure 4.12: Chloride Penetration for Anchorages of Phase II Beams Subjected to End Anchorage Exposure

According to these data, the anchorage exposure cycles were rigorous enough to produce corrosion in the anchorages. For all three specimens, the chloride content at the level of the strand tails is far above the threshold for corrosion. The presence of any corrosion in the anchorages will be determined in the forensic analysis in Chapter 5.

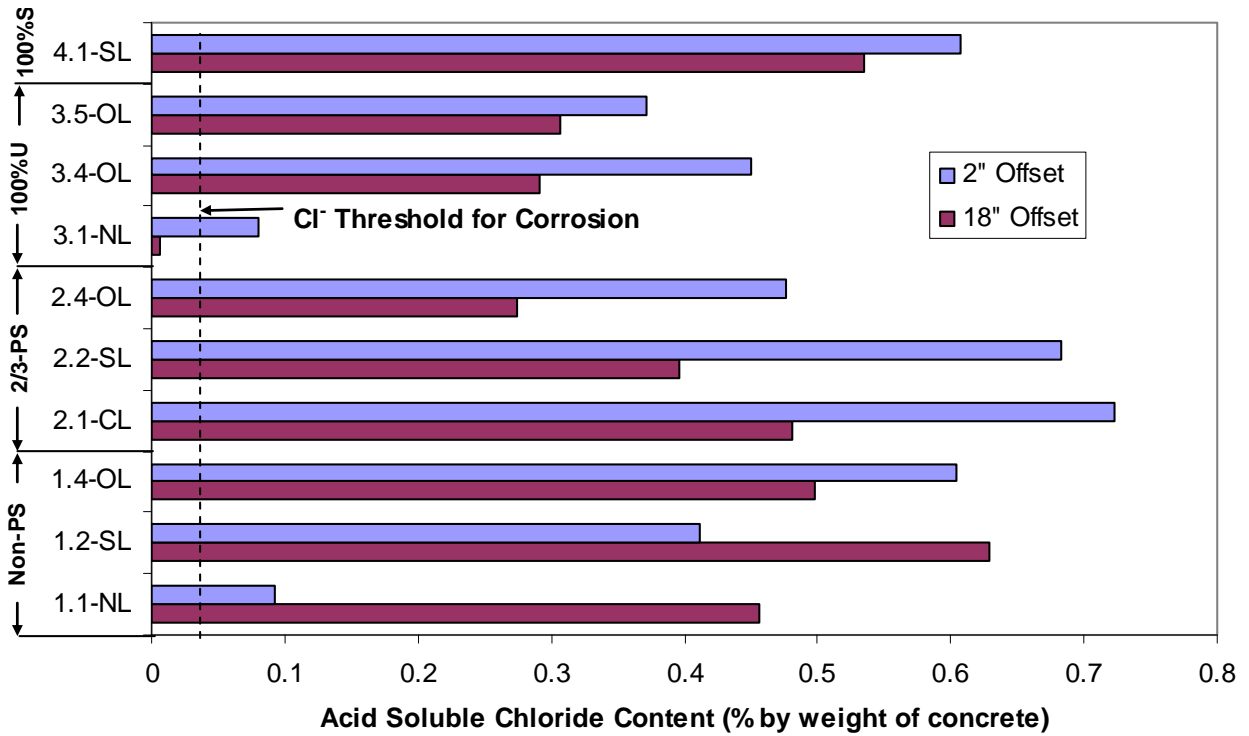
Figure 4.13: Chloride Penetration at Reinforcing Bar Depth-Phase I Beams

Except for the 18-in. offset in the unloaded fully prestressed specimen 3.1, all chloride levels exceeded the threshold for corrosion—even the reinforced concrete unloaded specimen. While the contents at the 2-in.offsets were not always the same, in all loaded specimens the contents were far above the threshold, so the difference in values is irrelevant. The only trend observed when comparing specimens with the same level of prestress is with the fully prestressed beams: Beam 3.1 clearly demonstrated the effect of an uncracked section when compared to beams 3.4 and 3.5.

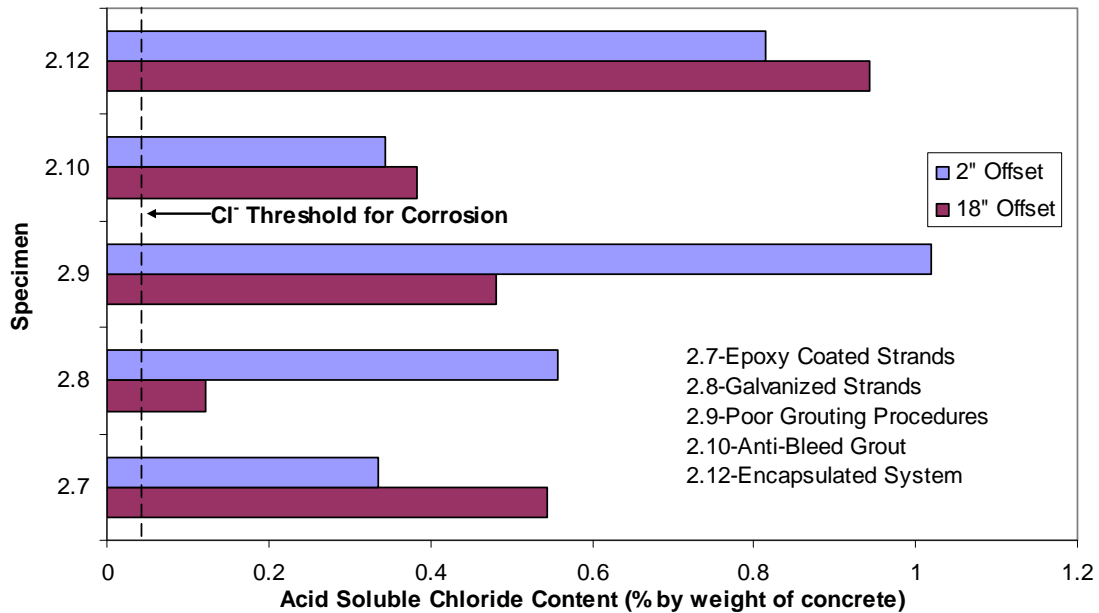
Figure 4.14: Chloride Penetration at Bar Depth-Phase II Beams

All values are well above the threshold for corrosion. The fact that the threshold is exceeded is most likely due to corrosion of the steel reinforcing bars and galvanized ducts. Thus the difference in values among specimens does not reveal any information about the effects of different grouts, strand, or duct type. The values only indicate the potential for corrosion at the levels of the bars and ducts.

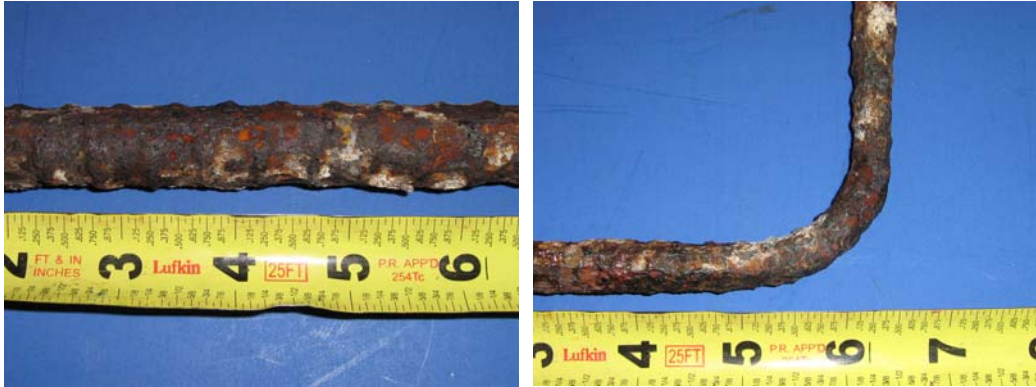
Figure 5.8: Beam 1.1 Autopsy Elements-Longitudinal Bar (Left) and Stirrup (Right)

There was pitting and some cross-sectional area loss on all longitudinal bars and most of the stirrups. The stirrup, which was outside the ponded region, exhibited pitting on its top portion but only moderate corrosion on its legs. The stirrups and bars are shown in Figure 5.8. The ratings for the stirrups and bars, along with the beam crack maps are shown in Figure 5.7. In these plots the sum of the ratings for all longitudinal bars in each 2-in. interval is plotted. The total of the ratings for each stirrup along the length of the autopsy area is also shown. The corrosion ratings for the stirrups and bars are summarized in Table 5.4. In order to compare this beam with the other beams, additional stirrup and bar data were extrapolated in order to have a full 72 in. worth of data. This was done by “mirroring” the data from the section currently autopsied.

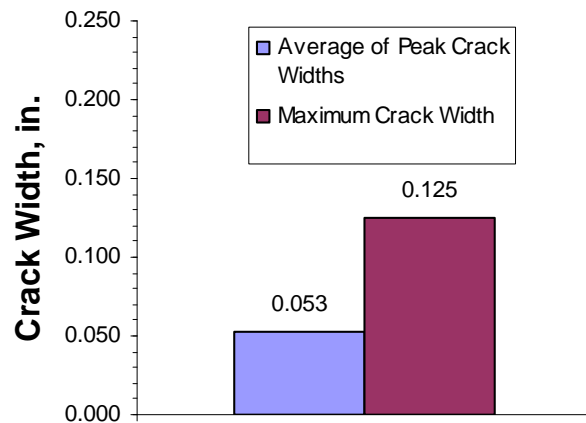
Figure 5.10: Beam 1.2 Crack Widths

As shown in Figure 5.9, there was cracking both inside and outside the ponded region. There were large 1/8-in. cracks running from the west end of the salt bath through the entire remaining length of the autopsy area. Bolster strip corrosion was found in multiple locations in the ponded region. Some of the flexural cracks coincided with stirrup locations, while flexural cracks were found in other locations as well. Severe staining was found in the area of these flexural cracks. Also, there was longitudinal cracking on the side face of the beam. The combination of longitudinal cracking on the top and side of the beam would suggest severe bar corrosion, since the expansive effect of the corrosion products is essentially pushing the top corners of the beam off. The crack width data are given in Figure 5.10. After cutting of the beam, it was observed that the longitudinal 1/8-in. cracks actually formed a crack plane right through the level of the severely corroded bars. Thus, corrosion of the bars is responsible for the longitudinal cracking. As the bars corroded, the expansive effects of the corrosion products cracked the concrete. This is shown in Figure 5.11. Note that the block is upside down compared with its position during exposure testing.

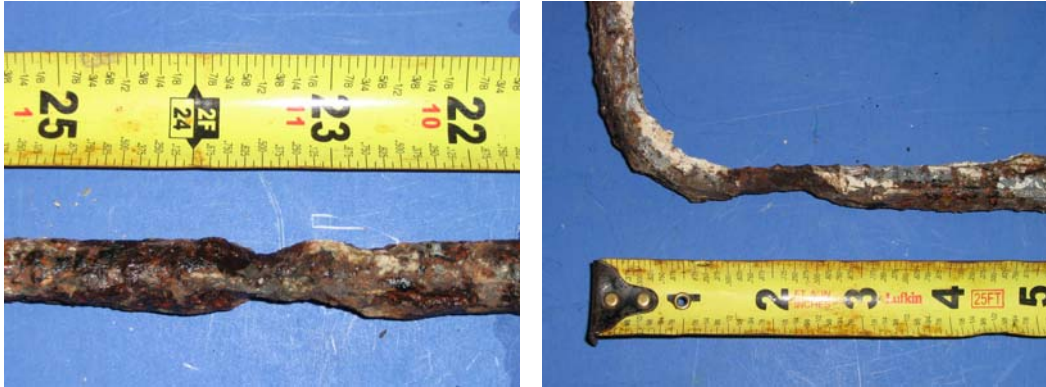
Figure 5.12: Beam 1.2 Autopsy Elements-Longitudinal Bar (Left) and Stirrup (Right)

During autopsy, pitting and cross-sectional area loss was found throughout all the longitudinal bars and the stirrups. The most severe section loss in the bars was found in the area of the flexural cracks. The most corroded stirrup was that located 54 in. from the west end of the autopsy area. The corroded bars and stirrups are shown in Figure 5.12. Bar and stirrup corrosion ratings are given in Figure 5.9, and the corrosion ratings are summarized in Table 5.5.

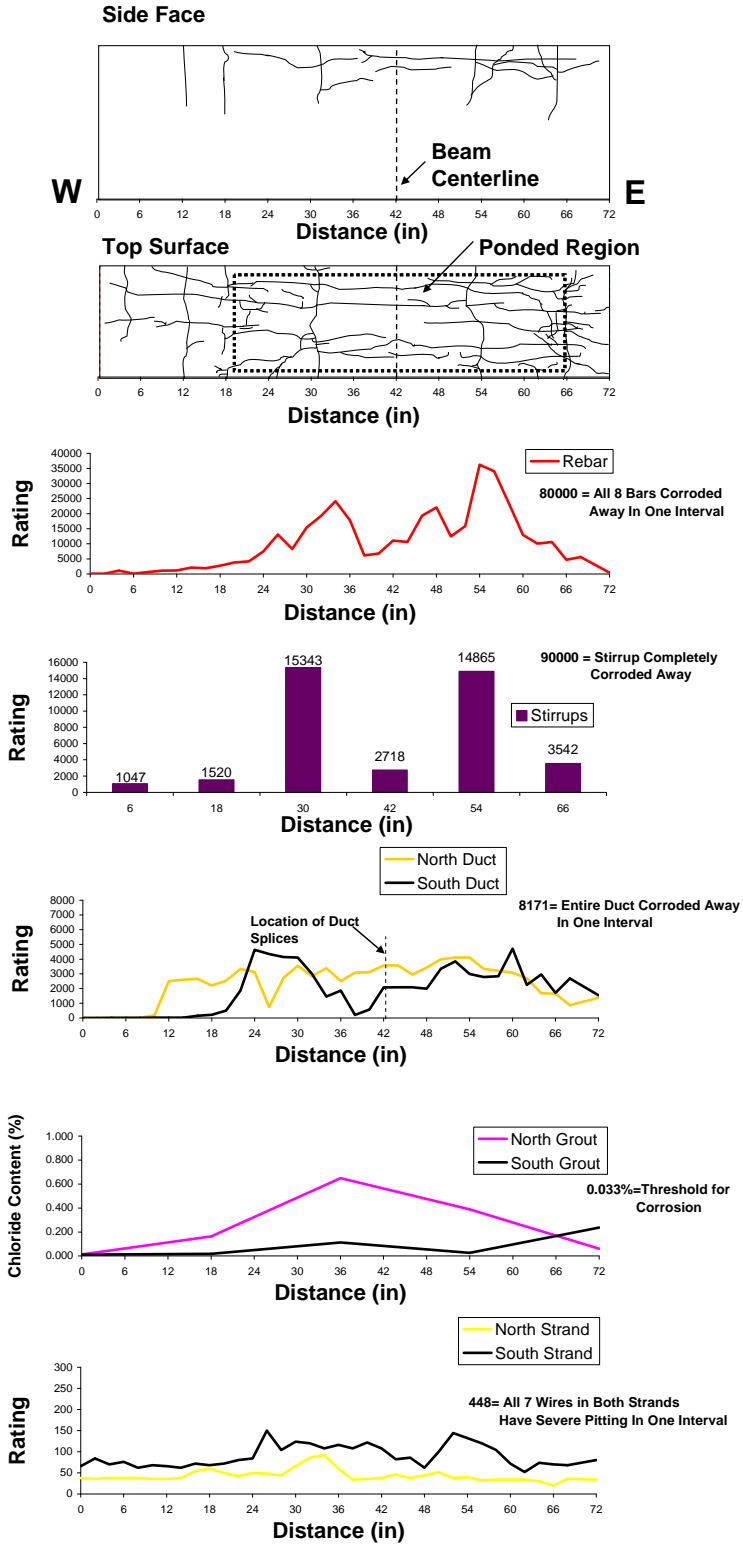
Figure 5.14: Beam 2.1-Crack Patterns and Corrosion Rating Graphs

As shown in the crack maps in Figure 5.14, heavy cracking was observed in the ponded region. Inside the ponded region, longitudinal cracks following the bolster strips measured about 0.01 in. in width. Severe staining was seen in the area of these cracks. The flexural cracks also showed severe staining on the top of the beam. The largest crack width was from a longitudinal crack about 18 in. to the east of the beam centerline. This crack measured 1/8 in. in width. On the side faces of the beam, the flexural cracks had severe staining emanating from them, which was likely from the corrosion of stirrups because all flexural crack locations corresponded with stirrup locations. Longitudinal cracks with staining were also found on the side of the beam as well. The large number of longitudinal cracks suggest severe corrosion within the beam. Indeed, when the autopsy block was removed from the center of the beam, cracking through the bars was seen similar to that in the Non-PS beams.

Upon autopsy, it was found that all stirrups and bars suffered severe pitting and cross-sectional area loss (See Figure 5.15). In the area of the flexural cracks, the smaller bars completely corroded away, some losing almost 2 in. in length. The stirrups also had severe pitting and area loss, with the worst stirrup 12 in. to the west of the beam centerline. The ratings along the length of the beam for the bars and stirrups, as well as the other elements of the beam, are given in Figure 5.14. The corrosion ratings are summarized in Table 5.7.

It is interesting to note from Figure 5.14 that the reinforcing bar ratings, duct and strand ratings all reach peak ratings at the same locations, which correspond with the location of cracks. Also, the strands from the south duct show more corrosion than the north duct strand. However, according to the chloride content data, the south duct had smaller grout chloride contents than the north duct. It is possible that the industry standard splice allowed more moisture in initially than the heat shrink splice, resulting in more strand corrosion. However, once the ducts corroded away more heavily, the splice type became irrelevant, as chlorides could then enter through the large holes in the ducts.

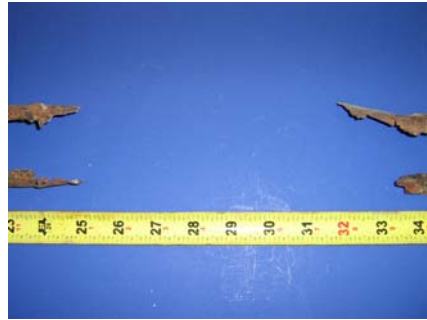
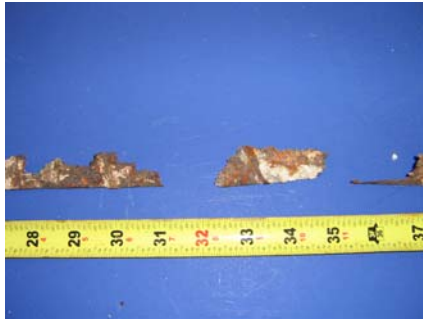
Figure 5.16: Beam 2.1 Autopsy Elements

The south duct was fitted with an industry standard splice, while the north duct had a heat shrink splice. The industry standard splice suffered tremendous area loss to its top portion and pitting corrosion was found on the remains of the inside surface of the splice. The duct beneath had large holes and pitting. The heat-shrink splice on the south duct showed severe staining and corrosion deposits on the inside. The section of duct beneath the splice was found to be heavily pitted and holed. In this case the holes were smaller than those in the splice zone of the south duct. The splices are shown in Figure 5.15.

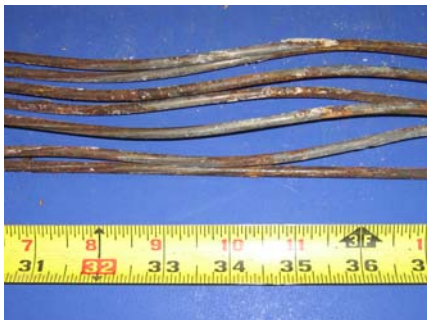
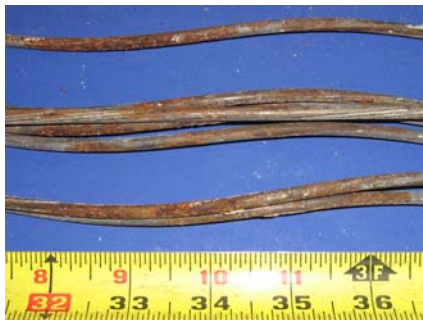
The strands in both ducts were pitted. The two south duct strands showed mild pitting throughout, and moderate to severe pitting on a few wires within the ponded region. Mild pitting was also found on portions of the strands outside the ponded region. The north duct strands had much less pitting than the south duct strand, with only mild pitting found at the three flexural crack locations near the beam centerline. The strands are shown in Figure 5.16. Corrosion ratings for the strand are plotted in Figure 5.14 and are summarized in Table 5.7.

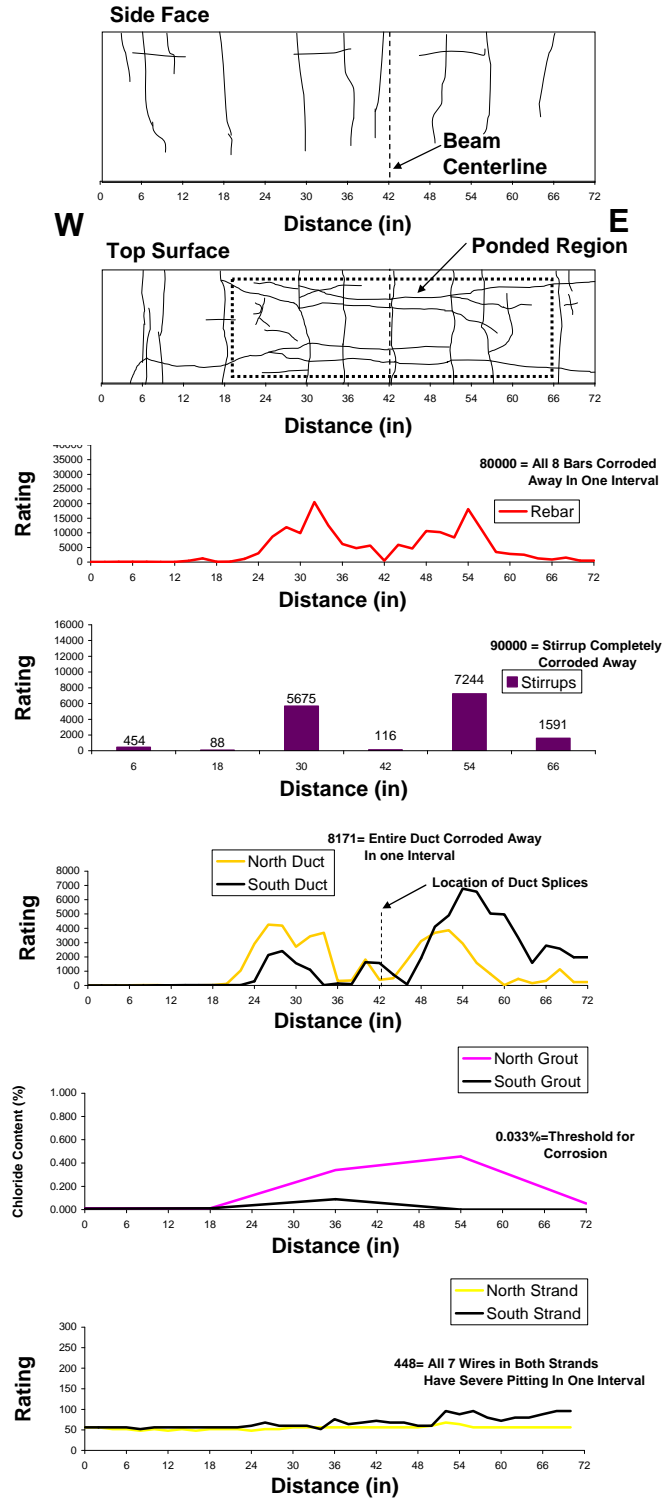
Figure 5.19: Beam 2.4 - Crack Patterns and Corrosion Rating Graphs

As expected, more flexural cracks were observed on this beam than in 2.1 and 2.2 because of the temporary overloading, which was done at the beginning of exposure testing. As is apparent in Figure 5.19, severe longitudinal cracking was observed inside the ponded region. The largest crack width observed for these longitudinal cracks was 1/8 in. This was at the extreme east end of the ponded region. These cracks continued even outside the ponded region. The cracks seemed to run parallel to the steel bolster strips.

Upon autopsy, all bars and stirrups were found to be heavily pitted and reduced in the cross-sectional area (See Figure 5.20). The most severe bar damage corresponds to 30 in. on the crack maps and rating graphs shown in Figure 5.19. This coincides with the location of a flexural crack as well as severe patches of staining. The bar damage consisted of the total loss of approximately 4 in. of two of the #3 bars, and the loss of around half the cross-sectional area of one of the other nearby #3 bars. The two most heavily corroded stirrups were those located at 12 in. to the west and east of the beam centerline, which were reduced in diameter by nearly 25 percent in one interval. The stirrups and bars are shown in Figure 5.20. The bar and stirrup corrosion ratings along the length of the beam are shown in Figure 5.19 and are summarized in Table 5.9.

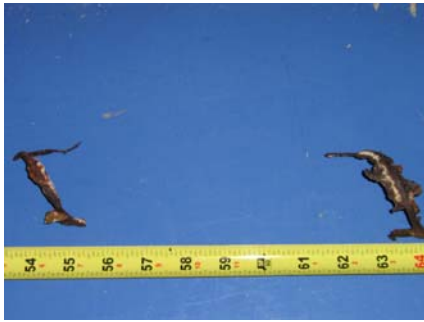
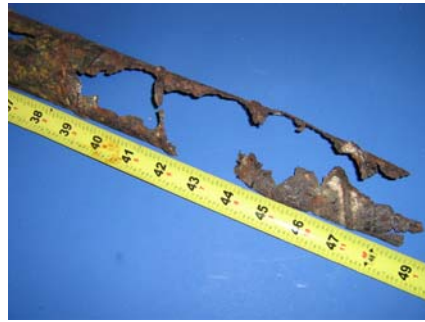
Both ducts were heavily holed and thus had large surface area loss. In the case of the south duct, severe surface area loss was seen 12 in. to the west and east of the beam centerline (corresponding to flexural crack locations). The last 2 feet of the top portion of the duct was nearly corroded away, and only fragments of the duct ribbing were recovered. The north duct

showed similar performance, except that the last 2 ft were more intact than the south duct, with large holes instead of complete duct loss. For both ducts, pitting was observed inside the duct in the vicinity of the holes. The ducts are shown in Figure 5.20. The duct corrosion ratings are plotted in Figure 5.19 and summarized in Table 5.9.

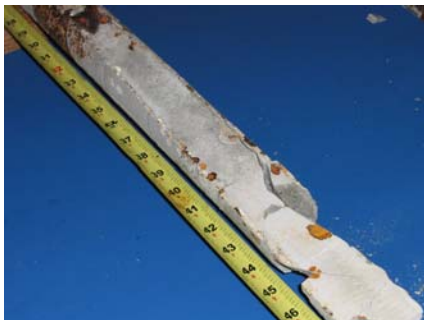
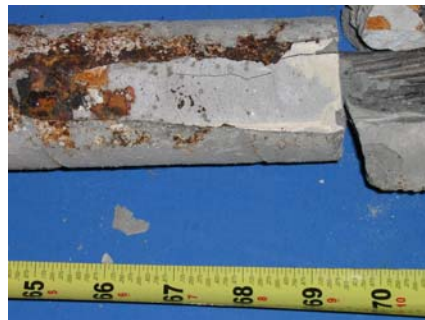
The south duct grout had corrosion deposits throughout from the duct corrosion. Bubbles indicating porosity were evident. The grout was cracked and staining was found in some areas. At about 22 in. from the west end of the autopsy area, a large bleed water void was found. This void became deeper moving east; finally, the grout essentially terminated at about 27 in. from the east of the autopsy area, with only fragments found beyond that point. The highest chloride content measured in the south duct was 0.089 percent, and was found 6 in. to the west of the beam centerline. The threshold for corrosion is 0.033 percent. The north duct had a small bleed water void starting at about 7 in. from the east end of the autopsy area. Therefore, the north duct had better grouting than the south duct. The north duct grout had maximum chloride content of 0.455 percent, which was at location 12 in. to the east of the beam centerline. The grout from both ducts is shown in Figure 5.20, with the chloride contents plotted in Figure 5.19.

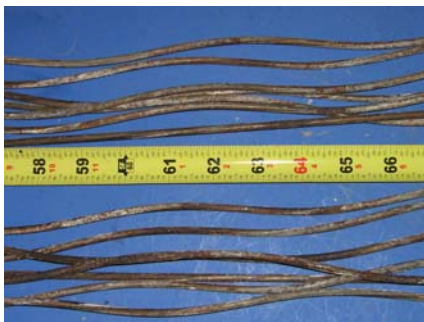
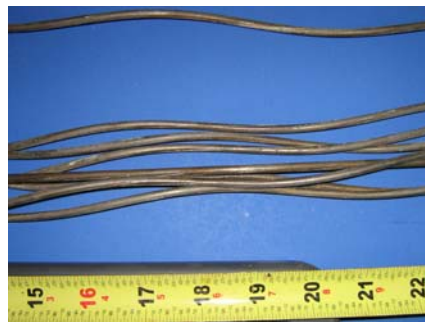
South Duct Strands (Both Strands shown) North Duct Strand

The strands in both ducts varied had varied amounts of corrosion. The north duct strands showed light to moderate corrosion in the area outside the ponded region. Inside the ponded region, moderate corrosion was observed on more wires. At 8 to 12 in. east from the centerline (corresponding to 54 in. on the corrosion rating graphs), mild pitting was observed on both the outer wires and on the center wires on one of the two strands. No pitting was seen on the second strand. This area of pitting corresponds to the location of a flexural crack and where very severe surface area loss was observed in the duct itself. The south duct strand was more severely corroded, with pitting first observed in the center wire at 18 in. to the west of the beam centerline. At 26 in. from the west end of the autopsy area, moderate pitting was seen on the center wire. Pitting was seen on the outer wires starting at the beam centerline, and mild strand pitting continued through to the end of the autopsy area. The strands are shown in Figure 5.20, with the corrosion ratings shown in Figure 5.19, and summarized in Table 5.9.

It is very significant to note that the lack of grout at the end of the south duct resulted in more severe damage to the duct and to the strand (in comparison to the north duct) at the end of the duct.

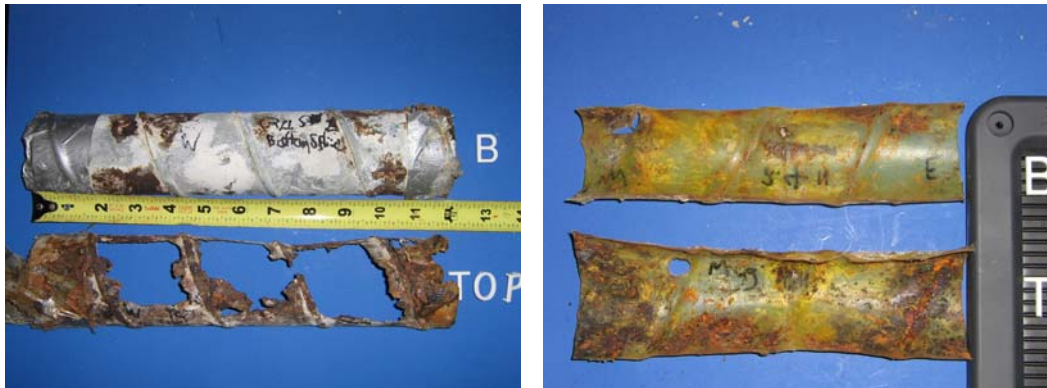
Figure 5.21: Beam 2.4 Duct Splices-South Duct Industry Standard Splice (Left) and North Duct Heat Shrink Splice (Right)

Both ducts in the beam were spliced at the beam centerline. The south duct had an industry standard splice, while the north duct had a heat shrink splice. Most of the top half of the south duct splice corroded away, while the remainder was pitted. The inside surface had severe pitting adjacent to the holes. The bottom portion of the splice did not have any holes but was pitted on the exterior in a few locations. The duct portion directly beneath the splice showed large holes and pitting. The north duct heat shrink splice showed discoloration on its inside surface. The portion of duct beneath it had large holes and pitting. Therefore, in this instance both splices performed very poorly in keeping moisture out of the splice zone. The heavy duct corrosion in the splice zone suggests large moisture ingress. The splices are shown in Figure 5.21.

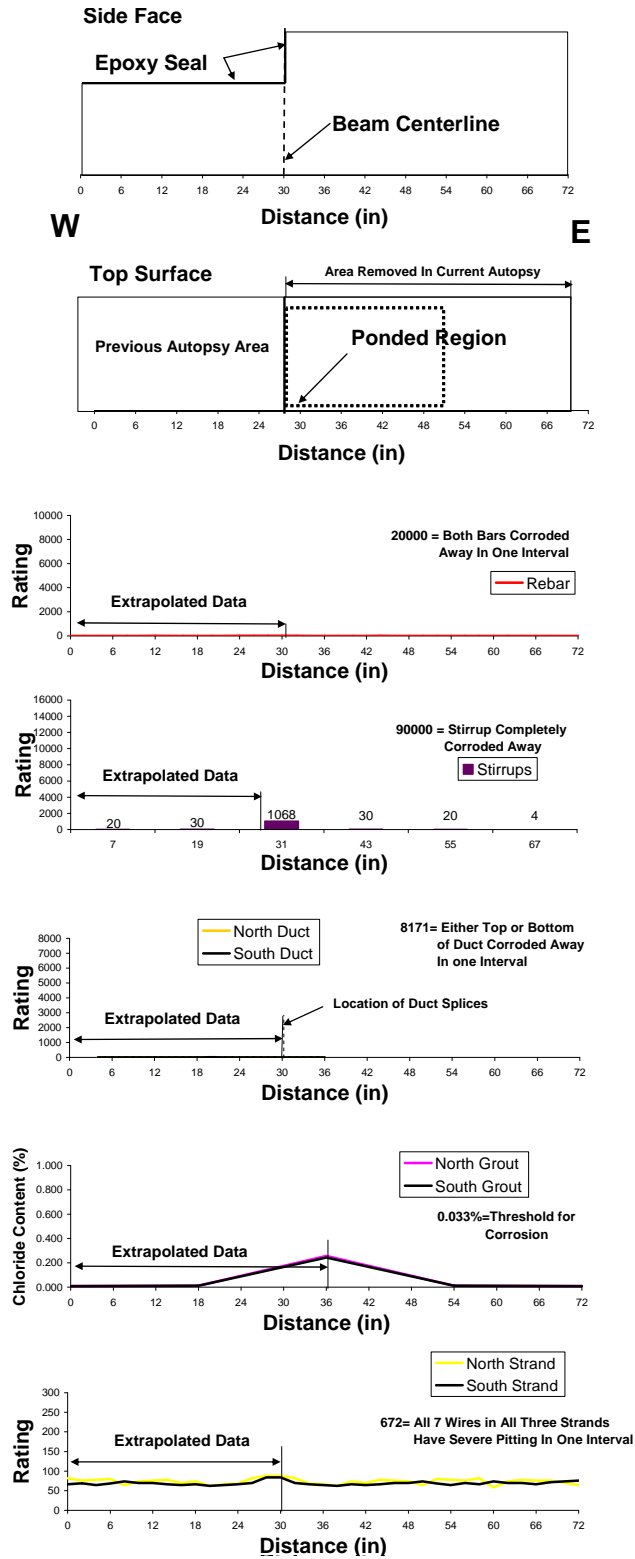
Figure 5.22: Beam 3.1-Crack Maps and Corrosion Rating Graphs

As shown in Figure 5.22, no actual cracking was seen on the specimen.

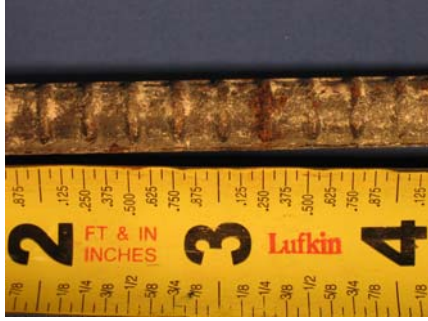
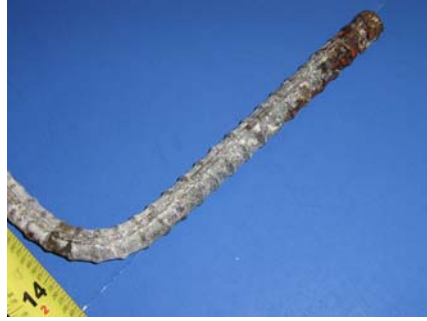
In general, except at the face of the cutting area from the previous autopsies, the longitudinal bars only showed slight discoloration. The stirrups were slightly discolored with only a few instances of light to moderate corrosion. The stirrups and bars are shown in Figure 5.23, with the corrosion ratings plotted in Figure 5.22 and summarized in Table 5.10. In order to have a full 72 in. worth of data for comparison to the other beams, additional data was extrapolated by “mirroring” the data about the beam centerline.

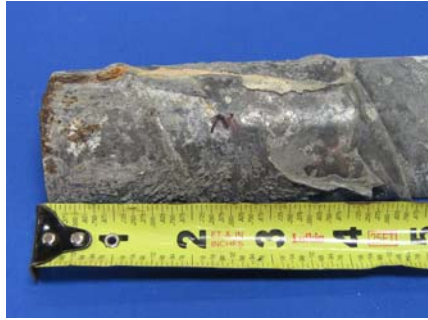
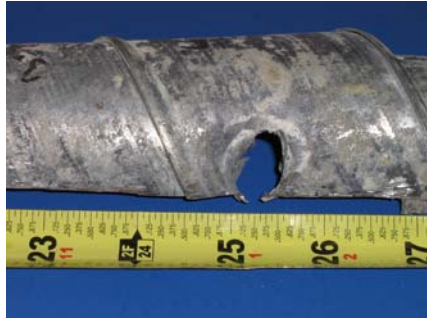
Both ducts were only slightly corroded. Except near the previous autopsy area, only a few instances of light corrosion were found on the inside and outside of the remainder of the ducts. The ducts are shown in Figure 5.23, with the ratings plotted in Figure 5.22 and summarized in Table 5.10.

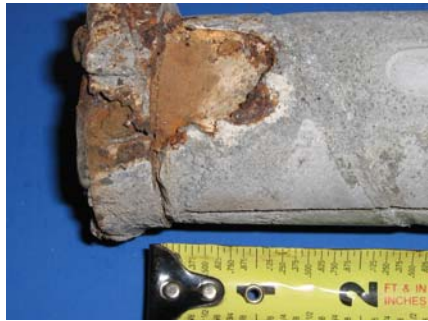
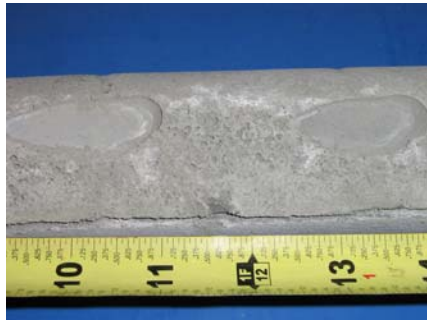
The south duct grout showed evidence of a shallow bleed water void on the west end, right at the previous autopsy cutting area. The void was only about 2 in. long and was stained on the inside. Smaller bleed water voids were also seen at the top of the grout, spaced about every 8 in. These voids terminated about 2 feet from the west end of the autopsy area. The grout also showed bubbles which indicate porosity. The north duct had several small, shallow bleed water voids. The largest was 2 in. long and about 1/4 in. deep. This void was located about 10 in. from the west end of the autopsy area. The grout is shown in Figure 5.23. The maximum chloride content for the south duct grout was 0.243 percent, while for the north duct 0.257 percent. These two values were found at the far west of the autopsy area, near the cut face from the previous autopsies. The chloride content data is plotted in Figure 5.22.

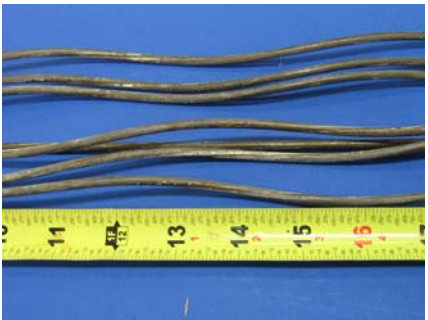
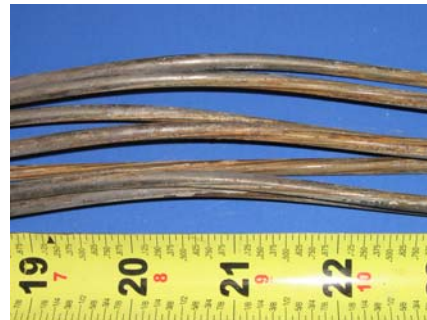
The strands from both ducts showed light to moderate corrosion throughout. At the cutting area on the west end of the autopsy area, the exteriors of the strand had a large buildup of corrosion products. The light to moderate corrosion for the remainder of the autopsy was concentrated in the interstitial zones. The strand is shown in Figure 5.23, and the corrosion ratings are plotted in Figure 5.22 and summarized in Table 5.10.

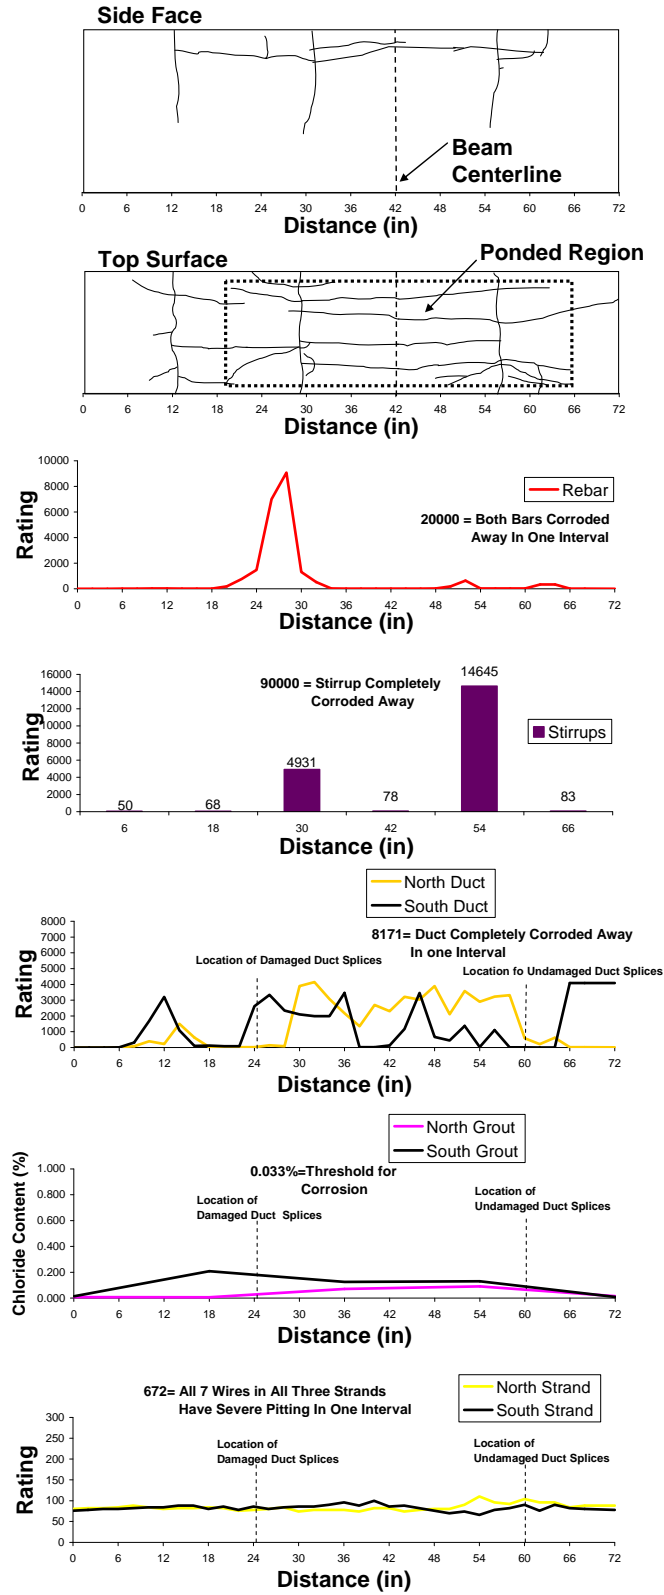
Figure 5.24: Beam 3.4-Crack Patterns and Corrosion Rating Graphs

This beam was originally intended to be at constant service load, but in order to crack the beam, the previous researchers were forced to overload it. As shown in Figure 5.24, severe cracking was found within the ponded region. Longitudinal cracks ran parallel with the bolster strips, and the maximum crack width was 0.06 in., which was measured from one of the longitudinal cracks. The cracks continued outside the ponded region. Longitudinal cracks were also observed on the side of the beam, in the vicinity of the flexural cracks as well. This suggests a large amount of corrosion within the beam.

From the plots in Figure 5.24, there is no overall trend between either strand damage or chloride content when comparing the data in the vicinities of the “damaged” or “undamaged” splices in both ducts. It is likely that the severe duct corrosion made the damage to the splices insignificant as the ducts began to corrode away.

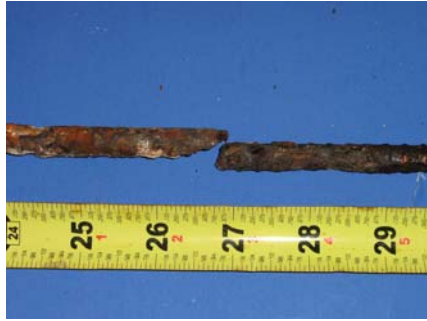
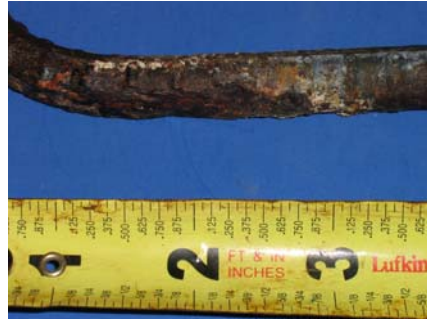
Upon autopsy, it was found that within the ponded region, the bars were mostly pitted with area loss at flexural crack locations (See Figure 5.25). The stirrups were also heavily pitted with cross-sectional area loss. The most severe bar corrosion was at the flexural crack 12 in. to the west of the beam centerline, where one of the bars was reduced in diameter by over 2/3. The bar broke in half at this location upon removal from the beam during autopsy. The other bar had moderate area loss at this location. The bars and stirrups are shown in Figure 5.25, with the ratings plotted in Figure 5.24 and summarized in Table 5.11.

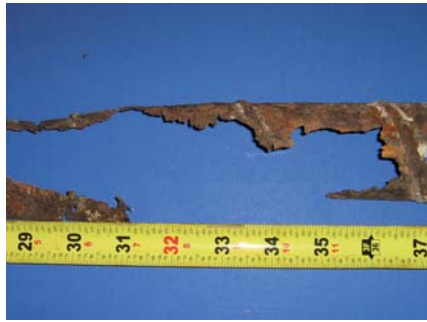
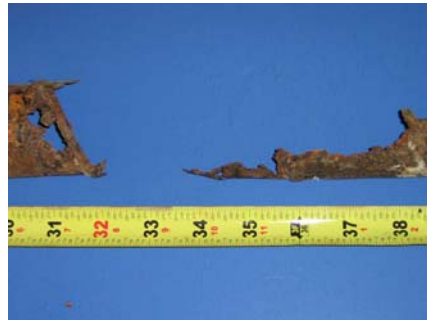
Both ducts were severely holed and pitted, thus they had large surface area loss. The south duct was severely pitted and holed within the ponded region. Discolorations to moderate corrosion with some pitting were observed in the duct portion outside the ponded region. Some of the worst damage duct was approximately 12 in. to the west of the beam centerline—corresponding to the location of one of the flexural cracks. In this location the top portion of the duct was nearly corroded away in several intervals. The bottom portion was also heavily corroded with holes and pitting. Another area of major damage was the loss of 6 in. of the top portion of the duct at the end of the autopsy area (east end). The north duct was also holed and pitted, with some of the worst damage located, again, 12 in. to the west of the centerline. At this location the top part of the duct was almost completely corroded away in several intervals. The bottom portion had large holes. However, the worst damage to the south duct overall was the loss of 6 in. of length of the entire top of the duct at the east end of the autopsy area. The ducts are shown in Figure 5.25, with the corrosion ratings plotted in Figure 5.24 and summarized in Table 5.11.

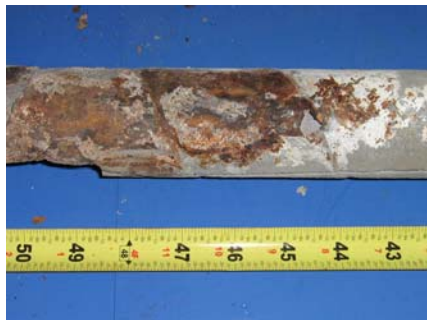
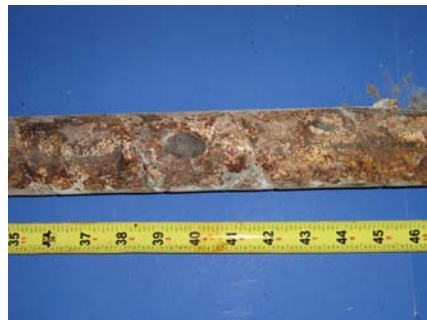
The south duct grout had large deposits of corrosion products throughout. The grout was also cracked at numerous locations. Small bleed water voids were observed in many locations. Many of the voids had corrosion products inside. Most of the voids were around 1/2 in. in diameter and 1/4 in. deep. There was a large bleed water void at the extreme east end of the autopsy area. This void was wide and 3/8 in. deep maximum. The maximum chloride content in the south duct grout was 0.209 percent, measured at 18 in. to the west of the beam centerline. The north duct grout was similar, with corrosion products deposited on it throughout. Bleed water voids were seen, with similar sizes to the voids in the north duct. These also had corrosion products in them. The maximum chloride content measured in the north duct grout was 0.091 percent, found at 12 in. to the east of the beam centerline. The grout for each duct is shown in Figure 5.25. The chloride contents for the grout in each duct are plotted in Figure 5.24.

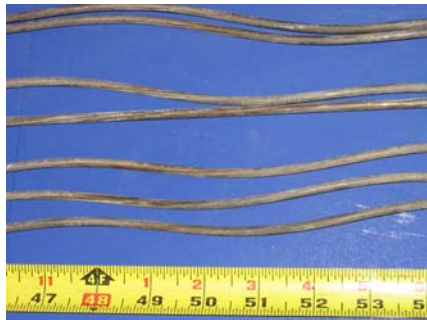
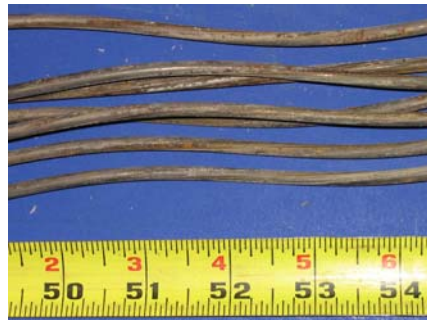
The three south duct strands were moderately corroded with instances of pitting. Mild pitting was observed on wires just outside the ponded region, with pitting also found on the center wire (this location corresponds to 12 in. on the corrosion rating graphs.) The fact that there was pitting on the center wire suggests that the pitting in the ponded region is due to moisture traveling down the strands from the ponded region. Mild pitting with one instance of moderate pitting was found in the vicinity of the flexural crack 12 in. to the west of the beam centerline. Other instances of mild pitting were found near the centerline of the beam. The strands are shown in Figure 5.25 and the corrosion ratings are plotted in Figure 5.24 and summarized in Table 5.11.

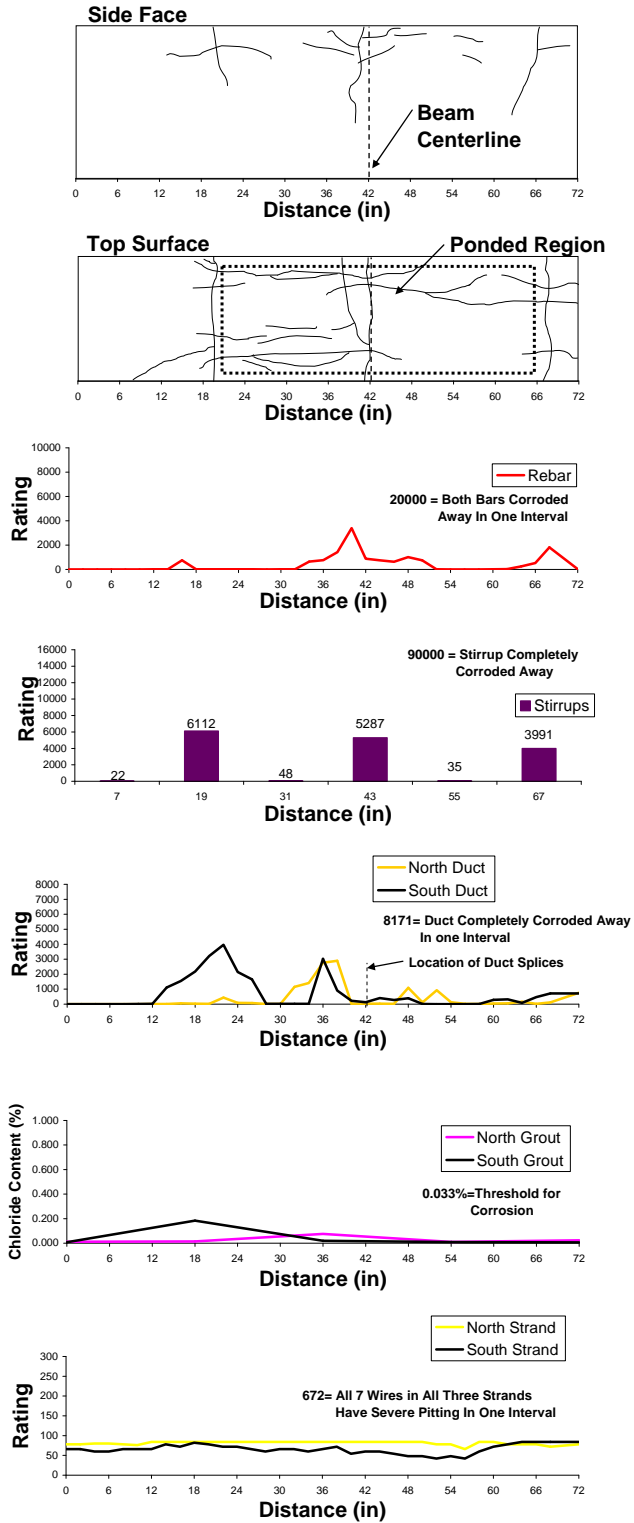
Figure 5.26: Beam 3.5-Crack Patterns and Corrosion Rating Graphs

As shown in Figure 5.26, the beam was heavily cracked. There were longitudinal cracks with a maximum width of 0.06 in. running parallel to the bolster strips. Staining was observed emanating from these cracks. Minor longitudinal cracking was also observed on the sides of the beam, in the vicinity of the flexural cracks. The large amounts of staining and cracking suggest large amounts of corrosion within the specimen.

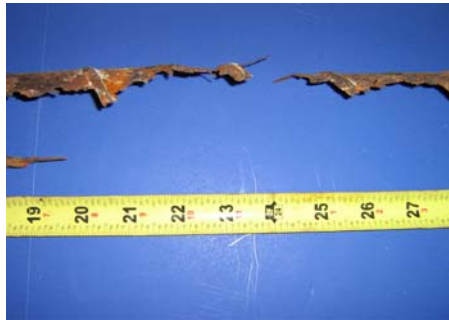
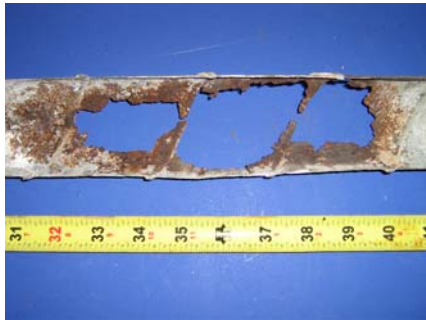
Both ducts were heavily pitted and holed. The large number of holes produced large section loss in the ducts. The south duct was lightly corroded outside the ponded region. Inside the ponded region the duct was heavily pitted and heavily holed. The ducts are shown in Figure 5.27, with the ratings plotted in Figure 5.26 and summarized in Table 5.12.

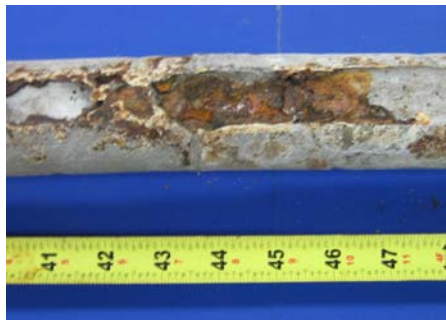
North Duct Grout

The south duct grout had small voids at the west end of the autopsy area. These voids were approximately 3/4 in. in diameter and a 1/4 in. deep. The most significant void was 12 in. from the end of the autopsy area. At approximately 23 in. to the west of the beam centerline, transverse cracks were observed with staining on their faces. When this grout was separated from the strand, corrosion could be seen on the strand directly beneath these cracks. A large bleed water void was found in the vicinity of the beam centerline. It was more than 16 in. long and about 3/8 in. deep. Corrosion products from the duct were found inside portions of the void. The maximum chloride content measured in the south duct grout was 18 in. from the west end of the autopsy area. The chloride content was 0.184 percent, far above the threshold for corrosion of 0.033 percent. The grout from both ducts is shown in Figure 5.27. The grout chloride content along the length of the autopsy area is plotted in Figure 5.26.
