1. Report No. FHWA/TX-08/0-4562-2		2. Government Accession No.		3. Recipient's Catalog No.	
4. Title and Subtitle Durability Evaluation of Post-Tensioned Concrete Beam Specimens after Long-Term Aggressive Exposure Testing			5. Report Date November 2007

Durability Evaluation of Post-Tensioned Concrete Beam Specimens after Long-Term Aggressive Exposure Testing

Center for Transportation Research
The University of Texas at Austin
3208 Red River
Austin, TX 78705

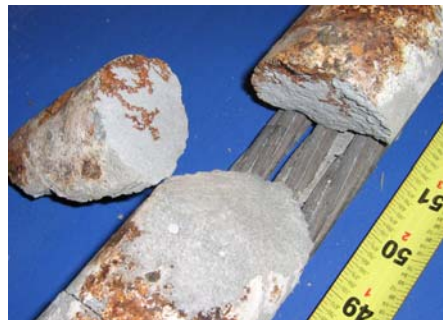
South Duct Strand

The south duct grout had small voids at the west end of the autopsy area. These voids were approximately 3/4 in. in diameter and a 1/4 in. deep. The most significant void was 12 in. from the end of the autopsy area. At approximately 23 in. to the west of the beam centerline, transverse cracks were observed with staining on their faces. When this grout was separated from the strand, corrosion could be seen on the strand directly beneath these cracks. A large bleed water void was found in the vicinity of the beam centerline. It was more than 16 in. long and about 3/8 in. deep. Corrosion products from the duct were found inside portions of the void. The maximum chloride content measured in the south duct grout was 18 in. from the west end of the autopsy area. The chloride content was 0.184 percent, far above the threshold for corrosion of 0.033 percent. The grout from both ducts is shown in Figure 5.27. The grout chloride content along the length of the autopsy area is plotted in Figure 5.26.

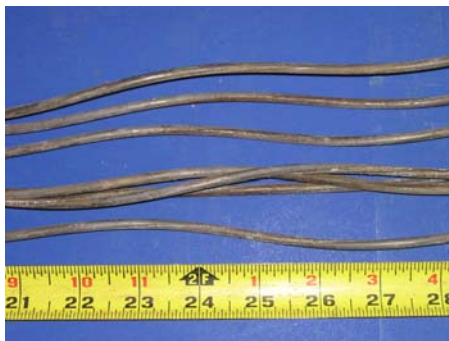
North Duct Strand

The three strands in the south duct showed light to moderate corrosion overall, with some instances of mild pitting. The mild pitting was found on the center wire of one of the strands at 24 in. to the west of the beam centerline (18 in. on the corrosion rating graphs.) In addition, at approximately 4 in. to the west of the beam centerline, mild pitting was also found on a single wire from one of the strands. The three strands in the north duct showed light to moderate corrosion as well, but no pitting. Strands from both ducts are shown in Figure 5.27. The corrosion ratings for the strand along the length of the autopsy area are shown in Figure 5.26, and are summarized in Table 5.12.

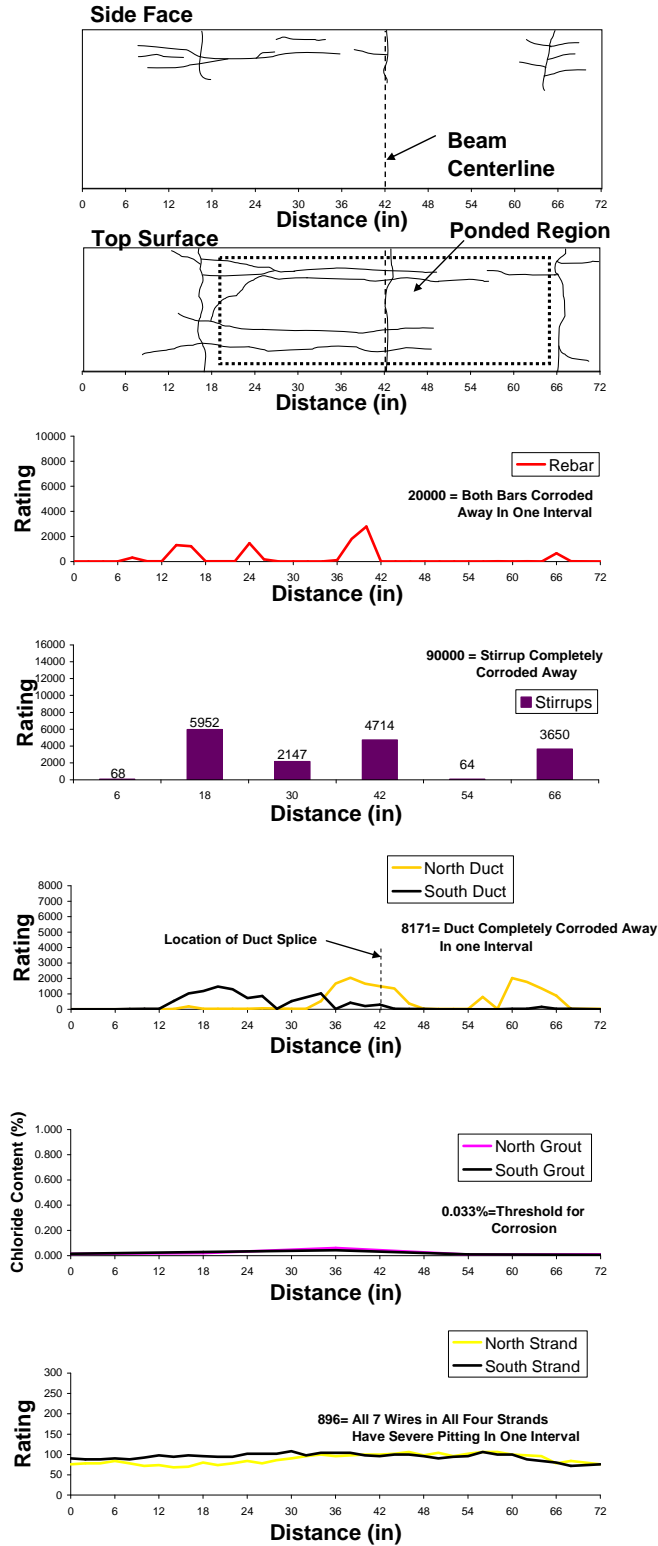
Figure 5.28: Beam 4.1-Crack Patterns and Corrosion Rating Graphs

As shown in Figure 5.28, the beam was substantially cracked. Patches of staining were found in the ponded region. The staining was concentrated around longitudinal cracks, which seemed to follow the bolster strips/longitudinal bars. These cracks were typically between 0.002 and 0.009 in. in width, while the largest longitudinal crack width was 0.016 in. Longitudinal cracks were also found on the side of the beam, with staining emanating from one of these cracks just outside the west end of the autopsy area. This crack continued almost to the beam centerline. Flexural cracks were also found on the beam. This is significant for this beam because it was designed not to crack under long term loading at service load. Three flexural cracks were found, one at the beam centerline and two additional cracks, each 24 in. to the east and west of the

centerline. In general these flexural cracks were wider than the aforementioned longitudinal cracks. Staining was found emanating from the side of the flexural crack at the beam centerline. This crack continued almost to the beam centerline. The largest crack width measured was from the flexural crack just outside the east end of the ponded region. This crack was 0.04 in. in width. This was the only beam where the largest crack width was measured at an actual flexural crack.

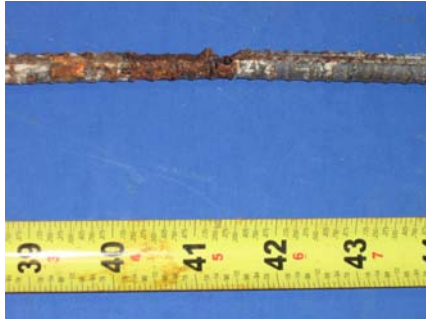
Longitudinal Bar

When the beam was autopsied, both the longitudinal bars and stirrups were found to have considerable corrosion (See Figure 5.29). The longitudinal bars were found to be pitted and have cross-sectional area loss near the locations of the flexural cracks in the ponded region. Significant cross-sectional area loss was also found at the location of the flexural crack just outside the west end of the ponded region. Staining was seen at this crack previously. The worst longitudinal bar damage was at the centerline flexural crack, where one of the #3 bars was reduced to about a 1/4 in. in diameter. At this location the other bar had moderate uniform corrosion. Pitting was also found in areas where there were no flexural cracks, but where longitudinal cracks were located. The stirrups and bars are shown in Figure 5.29, and the corrosion ratings are plotted in Figure 5.28 and summarized in Table 5.13.

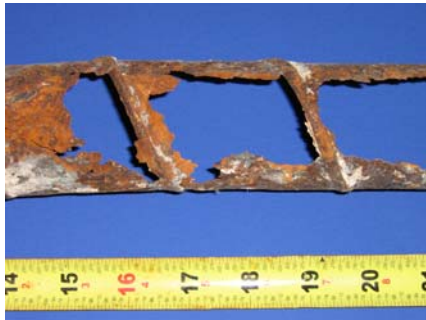
Top of South Duct

The south duct was fitted with an industry standard splice, while the north duct was not spliced. The top portion of the south duct splice was severely holed and pitted. The bottom portion of the splice was also pitted in some locations. Pitting was also found on the inside of both the top and bottom portions of the splice. Pitting and holes were found on the portion of the south duct directly beneath the splice, with pitting also found on the inside of the duct at this location.

Both ducts were pitted and holed, thus causing large amounts of surface area loss. In the case of the south duct, the surface area loss was concentrated in the area between the western most flexural crack and the centerline flexural crack. Pitting was also found on the inside of the duct in this area. The north duct was only pitted with some minor holes until about the beam centerline, where the top portion of the duct was almost completely corroded away across several inches. The ducts are shown in Figure 5.29, and the corrosion ratings are plotted in Figure 5.28 and summarized in Table 5.13.

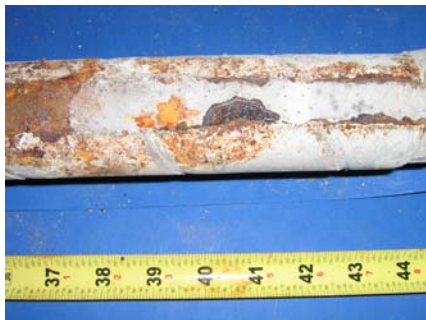
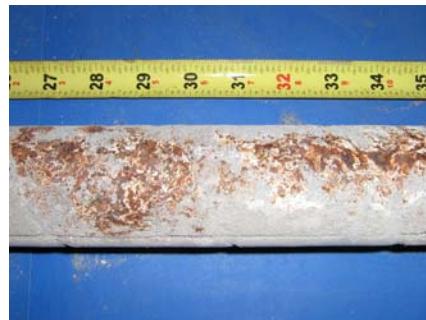
Both the south and north grouts were cracked. The south duct grout had a large bleed water void from 30 in. to about 46 in. from the west end of the autopsy area. At its deepest, the void was 0.25 in. deep. The largest chloride content at strand level for the south duct grout was 0.04 percent, close to the corrosion threshold for 0.033 percent. This value was at 6 in. to the west of the beam centerline. The north duct grout had a large bleed water void from 12 to 28 in. (again, in reference to the west end of the autopsy area), and corrosion products were found inside the void. At approximately 12 in. from the east end of the autopsy area, staining was found on the face of one of the transverse cracks. Many small bubbles were found on the top of the grout as well. The highest chloride content measured in the north duct grout was 0.06 percent, also at 6 in. to the west of the beam centerline. This is far above the threshold of 0.033 percent. The grout from both beams is shown in Figure 5.29. The chloride content along the length of the autopsy area for the grout from both ducts is shown in Figure 5.28.

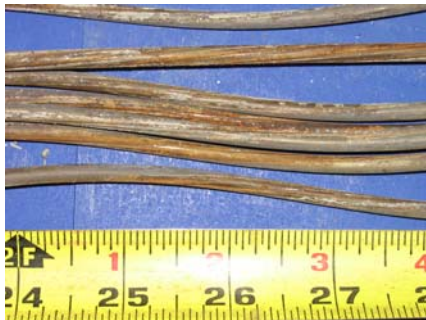
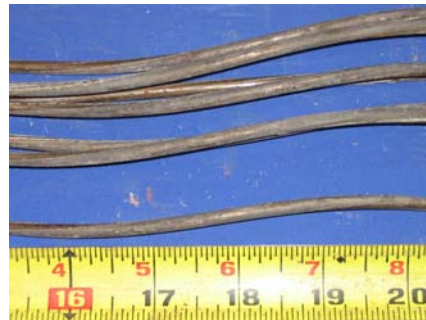
The four strands in the south duct had light to moderate corrosion. The four strands in the north duct had light to moderate corrosion as well. The strand from both ducts is shown in Figure 5.29. The strand ratings along the length of the beam are shown in Figure 5.28 and are summarized in Table 5.13.

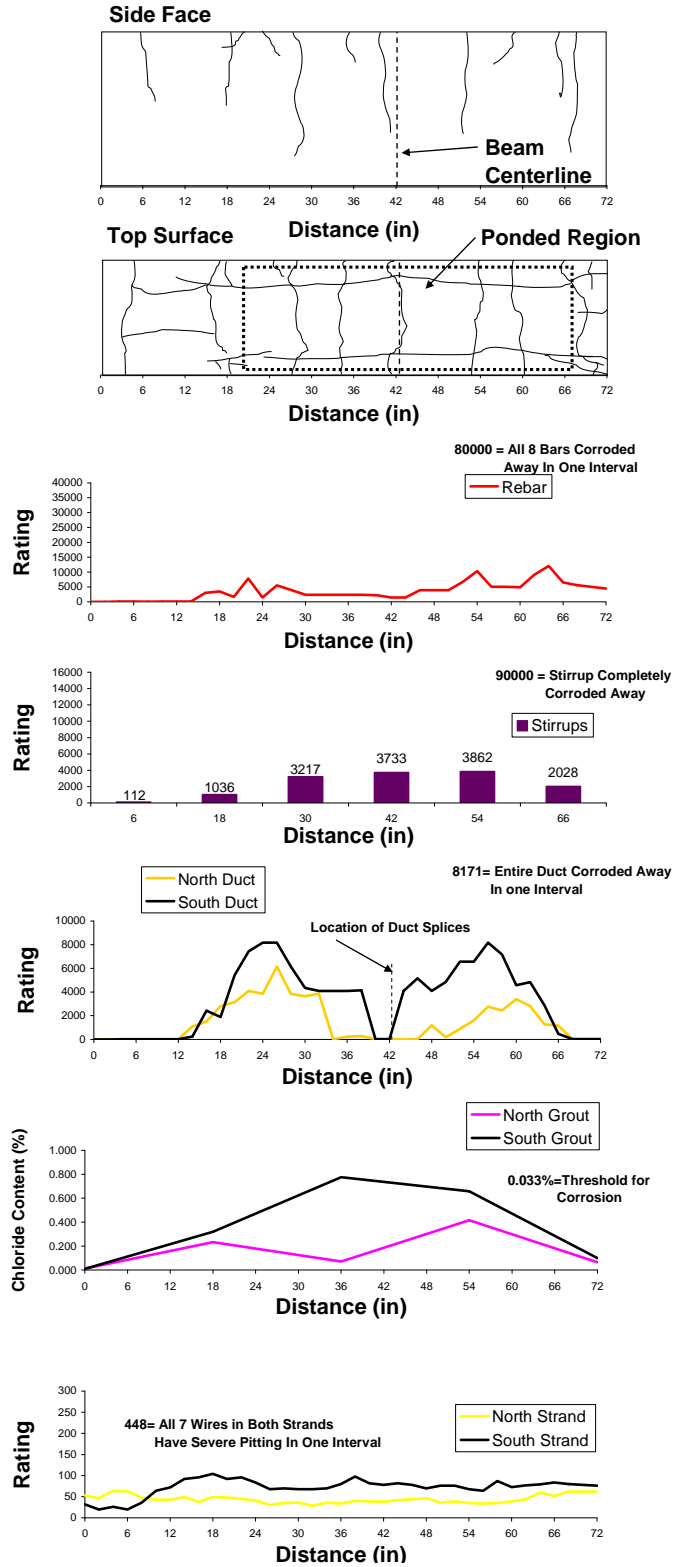
Figure 5.30: Beam 2.7 - Crack Maps and Corrosion Rating Graphs

As shown in Figures 3.4 and 5.29, staining and longitudinal cracking was found in the ponded region. One major area of staining was at the flexural crack at the beam centerline. The other was at the west end of the autopsy area. At this location the staining was concentrated around a flexural crack and where the hole had been drilled to create a grout vent during beam

construction. The hole had been sealed with epoxy after grouting. Staining was also seen on the flexural crack just to the west of the ponded region. Staining was also seen on the side of the beam corresponding with the location of the centerline flexural crack. The maximum crack width was from a longitudinal crack and measured 0.14 in. This value was measured near the beam centerline. Very little staining was observed from these longitudinal cracks.

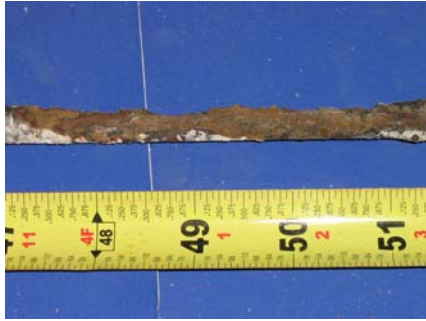
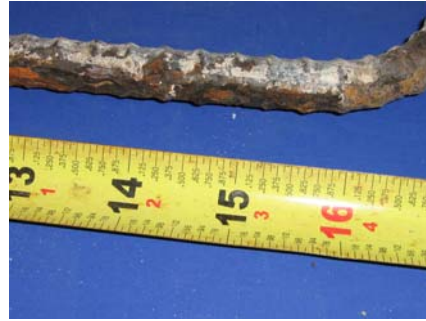
Upon autopsy, pitting and large cross-sectional area loss was found on the longitudinal bars and stirrups throughout the ponded region (See Figure 5.31). The worst damage to an individual bar was at 12 in. to the east of the beam centerline. At this location one of the #3 bars was reduced in diameter to 0.19 in. The stirrups beneath the ponded region were also heavily pitted with large section loss. The stirrup and bar ratings in the autopsy area are plotted in Figure 5.30, and are summarized in Table 5.14.

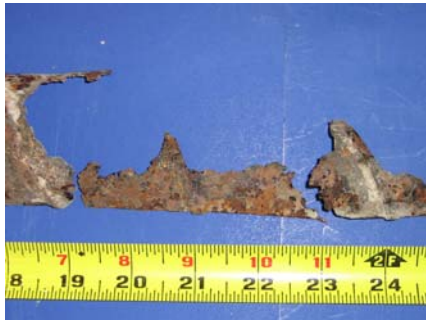
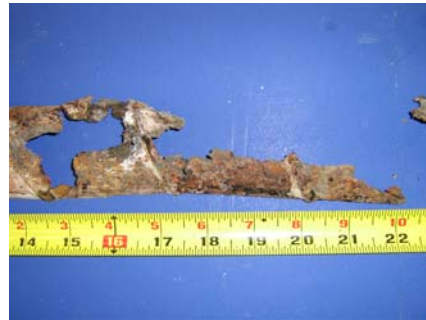
Both the north duct and south duct had industry standard splices at the beam centerline. The south duct splice was severely corroded with very large area loss. The top section of the south duct directly beneath the splice was almost completely corroded away. Only fragments were found at the beam centerline. The north duct industry standard splice was also severely corroded. The top portion of the splice was almost completely corroded away, and only fragments were recovered.

Both ducts were severely pitted and holed, resulting in large surface area loss, as shown in Figure 5.31. Starting at approximately 19 in. from the west end of the autopsy area, several in. of the duct were completely corroded away. At approximately 12 in. from the east end of the autopsy area, several in. of duct were also corroded away. Upon inspection of the inside of the bottom of the duct, evidence of abrasion of the epoxy on the strand was found at 14 in. from the west end of the autopsy area. Corrosion deposits, which were likely from the strand, were found in this area. This is shown in Figure 5.32. This may have occurred at other locations as well, but the severe duct corrosion further east of this location made any other abrasion evidence on the duct impossible to find. The duct damage along the length of the beam is shown in Figure 5.30 and is summarized in Table 5.14.

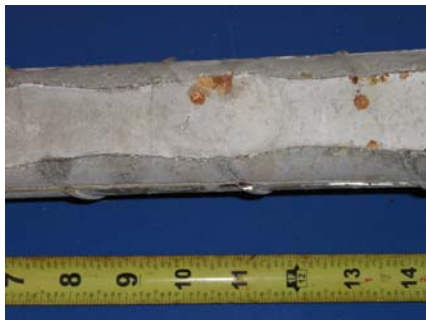
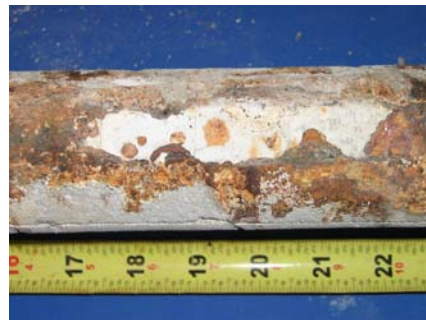
The south duct grout had a 3-ft long bleed water void from the far west end of the autopsy area to about 6 in. short of the centerline. In this area, large corrosion deposits from the duct were found in the bleed water void. The grout was cracked at multiple locations, and at the grout crack 12 in. from the east end of the autopsy area, a large amount of staining was found on the crack face. The maximum chloride content found in the south duct was 6 in. west of the beam centerline, where the chloride content was 0.775 percent. This is very far above the corrosion threshold of 0.033 percent. The north duct grout had a shallow bleed water void from about 17 to 21 in. west of the end of the autopsy area. From 46 to 48 in., a shallow white-colored void was also observed. Transverse cracks were found at multiple locations, and staining was found at the cracks 25 and 27 in. west of the autopsy area. The grout also had many small bubbles indicating a large amount of porosity. The maximum chloride content was 0.415 percent, measured at 54 in. from the west end of the autopsy area. This is far above the threshold for corrosion. The grout is shown in Figure 5.31, and the chloride content data is plotted in Figure 5.30.

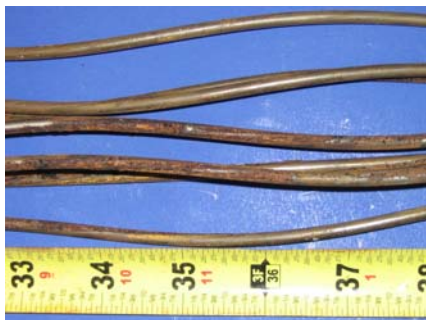
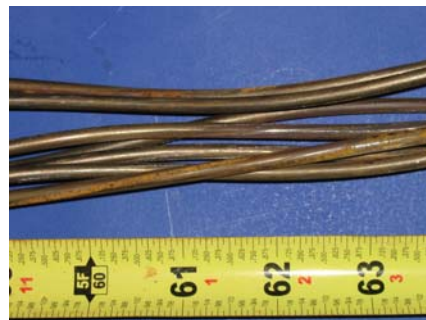
A small amount of epoxy coating on the bottom of the south ducts strands was missing at about 14 in. from the west end of the autopsy area. This confirms the evidence of epoxy abrasion observed on the bottom of the duct. Starting at about 24 in. from the west end of the autopsy area, a large amount of corrosion products as well as damage to the bottom of the strand coating was observed. This is shown in Figure 5.33. The coating on the strand was then chipped off and the strand examined. The coating seemed very brittle and easily cracked when pierced with a screwdriver. After removal of the coating, large amounts of light to moderate corrosion and mild pitting were found on the strands exterior throughout their length. Moderate pitting was found on one of the wires at 18 in. from the west end of the autopsy area. The strand after removal of the coating is shown in Figure 5.33. When the strands were unwound, pitting was also found on the center wire of one of the strands. The unwound strand from the south duct is shown in Figure 5.31.

Upon autopsy, corrosion deposits were found on the epoxy next to the unpatched holes. Abrasion damage to the epoxy was found 7 in. from the east end of the autopsy area, where the strand actually made contact with the bottom of the duct. Pitting was found on the exposed strand surface at this location. Upon removal of the coating, light corrosion was found adjacent to the hole locations. Mild pitting was found on the west end of the strands, with instances of pitting found on the center wires. Additional instances of mild pitting were found adjacent to the abrasion damage at the east end of the autopsy area. The strand that was patched also had mild pitting on the west and east ends, as well as light to moderate corrosion. Not as many instances of pitting were observed as in the unpatched strand. Abrasion damage was also found at the same location as the other strand. Light corrosion was found in the vicinity of one of the patched holes, but otherwise the exterior of the strand had little corrosion in the vicinity of the other patched holes. The corrosion ratings for the strand are plotted in Figure 5.30 and are summarized in Table

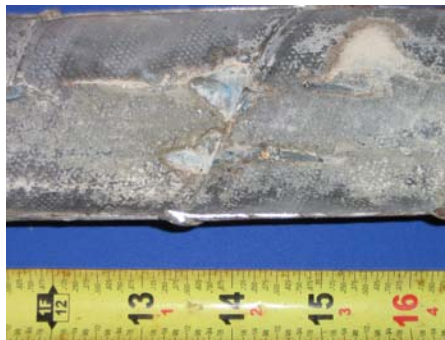
Figure 5.32: Beam 2.7-Evidence of Abrasion of Epoxy Coating from Strand on Bottom of South Duct

Overall, it would appear that the primary source of moisture ingress for the epoxy-coated strand is from abrasion damage caused by contact between the strand and the bottom of the duct during prestressing.

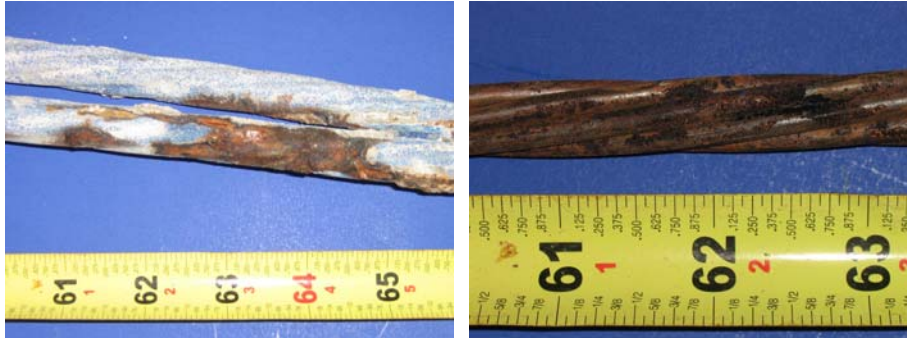
Figure 5.33: Beam 2.7-South Duct Strand with Coating (Left) and After Removal of Coating (Right)

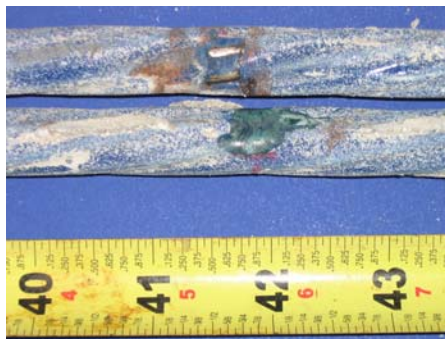
In contrast to the south duct strand, the coating of north duct strand was intentionally damaged by the previous researchers in order to test the effectiveness of epoxy repair kits. As explained in Chapter 2, numerous small holes were made in the epoxy coating on the two strands at five locations: at the beam centerline and four holes at approximately 12 in. spacing to the right and left of the centerline. One of the strands had these holes repaired with a standard epoxy repair kit before installation in the beam. An example of one of the holes is shown in Figure 5.34.

Figure 5.34: Beam 2.7-Example of Strand Coating Damage to North Duct Strand-Patched Strand (Bottom) and Unpatched Strand (Top)

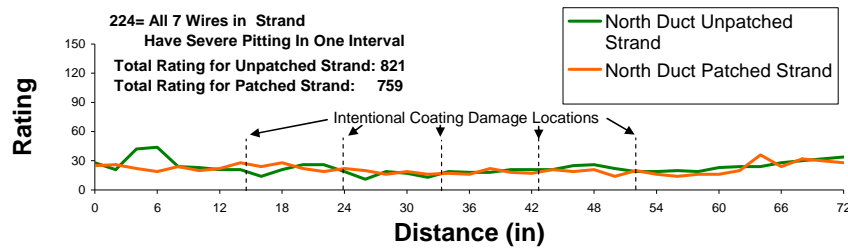
Figure 5.35: Beam 2.7- North Duct Strand Damage Ratings

As shown in Figure 5.35, the total rating for the unpatched strand was slightly larger than the patched strands. However, there is no significant difference between the ratings for the two strands in the vicinity of the holes. The visual inspection of the strand showed no significant corrosion in the vicinity of four of the five patches on the exterior of the strand. So the performance of the patches is fair.

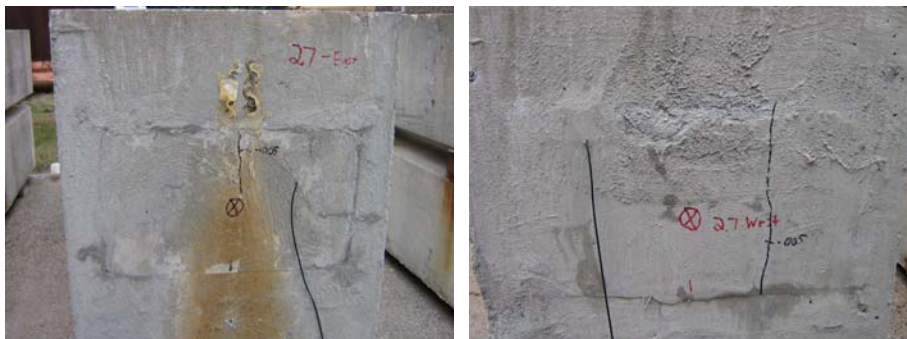
As shown in Figure 5.36, the east end anchorage zone, which had been subjected to exposure testing with a saltwater dripper, had a small patch of staining. There was a 0.005-in. crack found on the grout which formed the pocket. This was likely a shrinkage crack. The west end anchorage, which had not been subjected to a dripper, also had a 0.005-in. shrinkage crack. As previously stated in Chapter 4, chloride samples revealed no chlorides at the west end, while high chloride content was found at strand tail depth on the east (dripper) end. Approximately 2 ft of each tendon was removed from each end of the beam ends during autopsy.

Figure 5.36: Beam 2.7 Anchorage Zones-East End (Left) with Dripper, and West End (Right) without Dripper

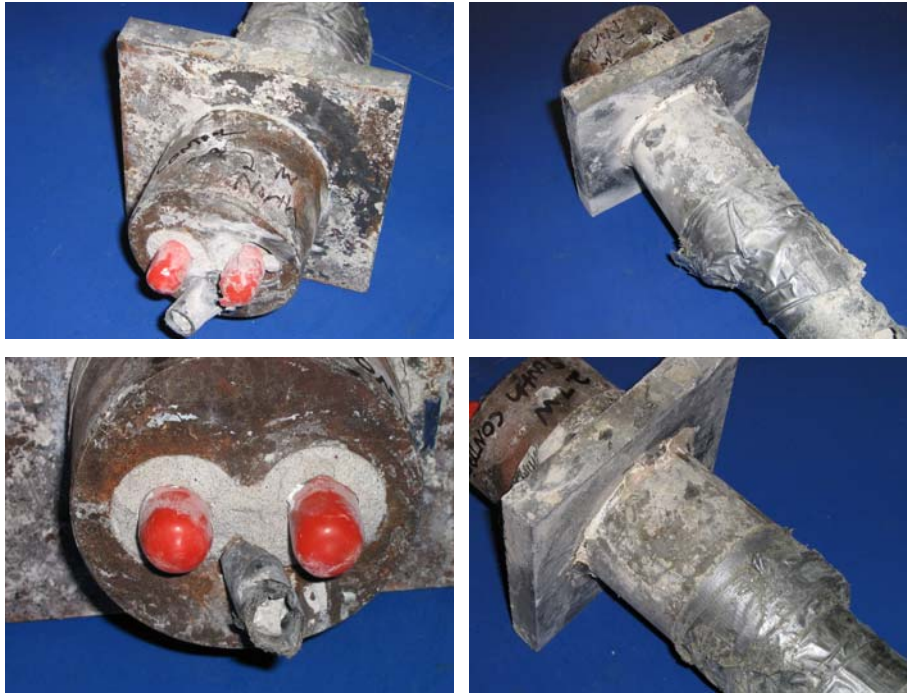
Figure 5.37: Beam 2.7 West End Anchorages After Removal (Controls): North Duct Anchorage (Top, Left and Right), and South Duct Anchorage (Bottom, Left and Right)

As shown in Figure 5.37, the front of the bearing plate and the anchorhead in both tendons were slightly corroded, while the back of the bearing plates showed no corrosion. The fronts of the wedges also showed some slight corrosion as well. The portion of the north duct in the anchorage zone had light corrosion directly underneath the duct tape seal between the duct and the back of the anchorhead. Light corrosion was also found on the inside of the duct surface in this area. Otherwise the rest of the duct showed no evidence of corrosion. The south duct was similar. The ducts are shown in Figure 5.38. Note that the white substance on the south duct is zinc oxide, which is from the corrosion of the galvanized coating on the duct. The corrosion ratings for the ducts in the anchorage are given in Figure 5.41 and are summarized in Table 5.15.

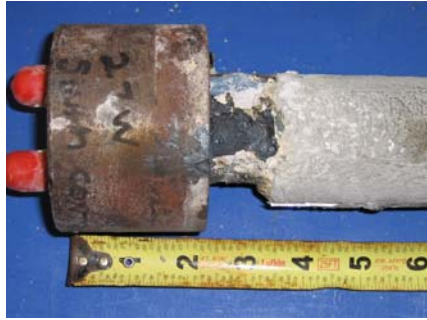
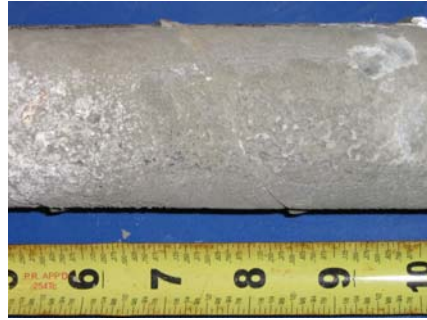
The north duct grout showed bubbles indicating porosity, but otherwise nothing else significant was observed in the appearance of the grout. Chloride samples of the grout taken at strand depth revealed negligible chloride content from the back of the anchorhead (where the first sample was taken), all the way to end of the portion of the duct removed from the anchorage zone. The south duct grout showed evidence of bleed water accumulation for a length of 1 in. behind the anchorhead. Similar to the north duct grout, negligible chloride content was found at strand depth along the length of the duct at the anchorage. The grout from both ducts is shown in Figure 5.38.

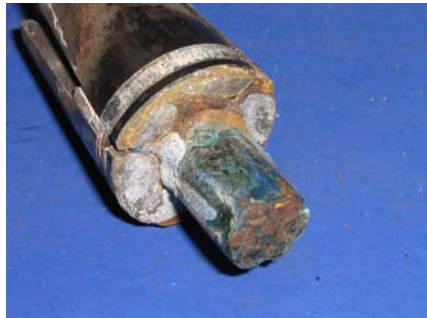
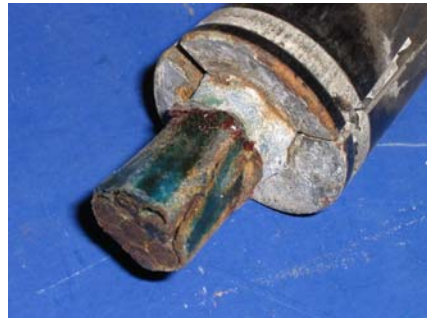
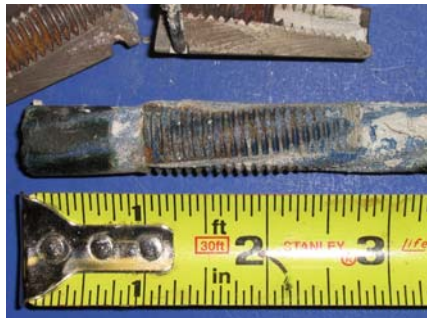
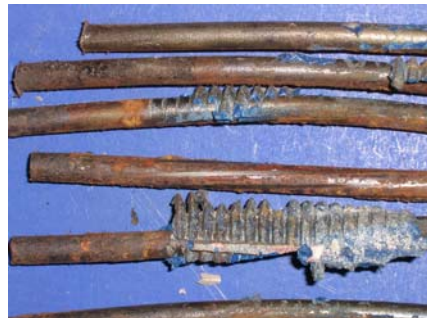
Mostly light to moderate corrosion was found in all the strands from both ducts. However, in the vicinity of where the wedges “bit” into the epoxy-coated strand, full penetration of the coating was found in all the strands. In the north duct, pitting was found on a single strand on both the center wire as well as some of the outer wires in this vicinity. A single strand in the south duct showed similar mild pitting. The likely source of the corrosion is moisture from the center of the beam that found its way through the interstices into the anchorages. The autopsy elements removed from the anchorage are shown in Figure 5.39. The strand ratings for the anchorage are given in Figure 5.41 and are summarized in Table 5.15.

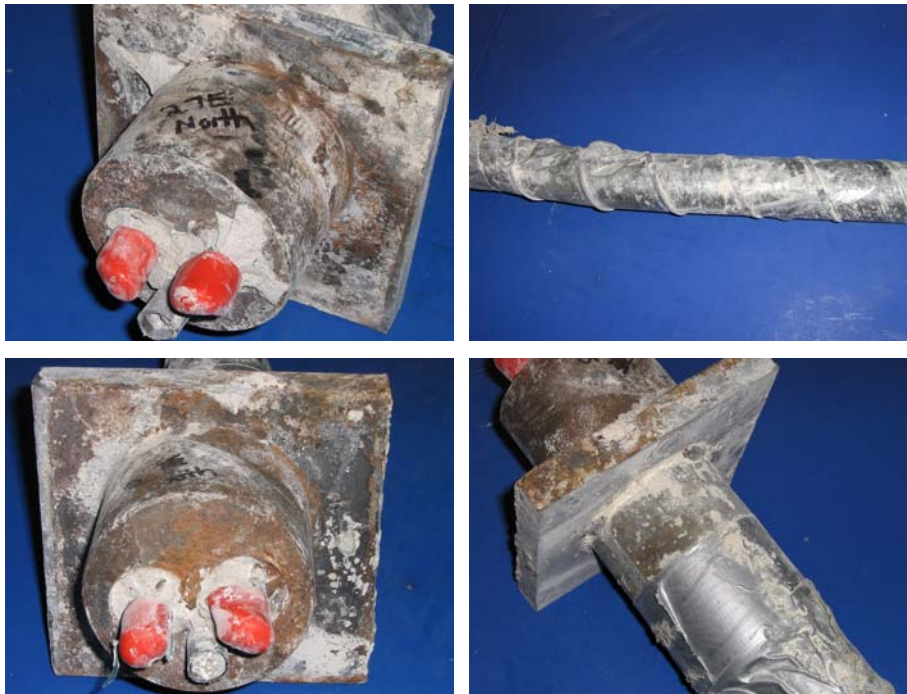
Figure 5.39: Beam 2.7 East End Anchorages (Dripped End): North Duct Anchorage (Top, Left and Right), and South Duct Anchorage (Bottom, Left and Right)

As shown in Figure 5.39, both bearing plates and the anchorheads were slightly corroded. As shown in Figure 5.40, the ends of three of the four wedges were heavily corroded. One of the wedges in the south duct had pitting on its front surface. The north duct had pitting on its top inside and outside surfaces in the area right behind the bearing plate, with some light corrosion observed on the inside and outside surfaces of the bottom of the duct in this area. All other portions of the duct showed no evidence of corrosion. The south duct had light corrosion on both the top and bottom portions on the inside and outside surfaces. All other parts of the duct showed no evidence of corrosion. The ducts are shown in Figure 5.40. The duct ratings in the anchorage zones are plotted in Figure 5.41 and are summarized in Table 5.15.

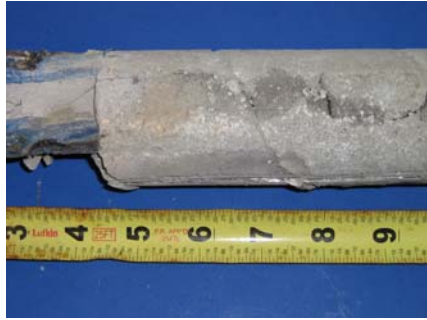
South Duct Grout

The north duct grout was slightly stained from the pitting corrosion on the inside of the duct. There was evidence of bleed water accumulation directly behind the anchorhead. Further towards the interior of the beam there were very small voids indicating a small amount of bleed water accumulation. The chloride content samples taken at strand level showed negligible chlorides in the grout. The south duct grout showed shallow voids which may have been the result of segregation and/or bleed water accumulation during pumping of the grout. The possibility of segregation is mentioned because the voids did not appear similar to bleed water voids observed previously. A definite bleed water void was seen directly behind the anchorhead. Like the north duct, no chlorides were found at strand depth in the south duct. The grout from both ducts is shown in Figure 5.40.

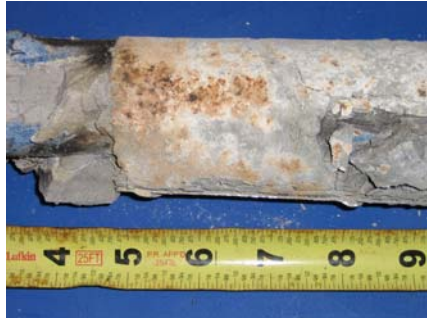
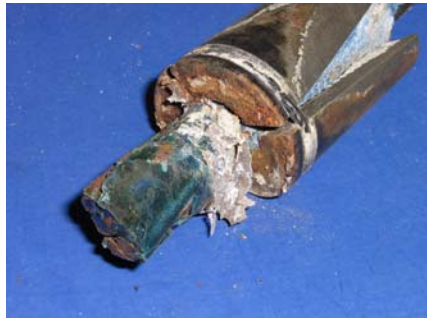
North Duct Grout

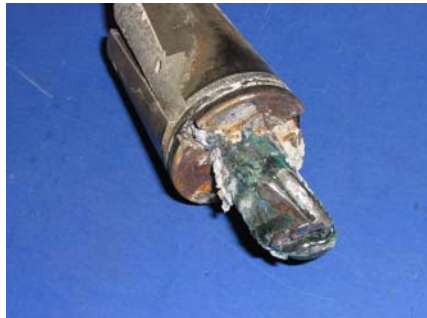
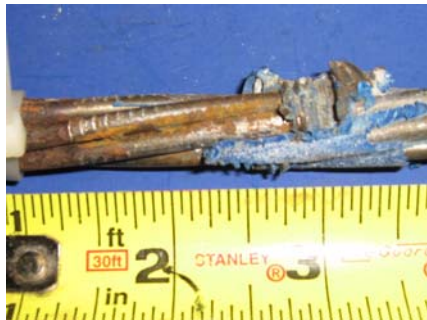
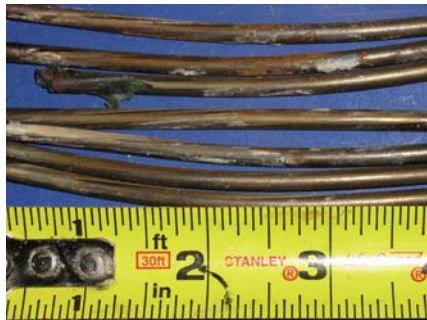
South Duct Strand With Wedges

North Duct Strand With Wedges

South Duct Strand (Coating Removed)

The north duct strand was lightly to moderately corroded throughout the anchorage, including the portion outside the anchorhead. The south duct strand was similar, except there was mild pitting at the tips of one of the strands outside the anchorhead. At this location, five of the six outer wires had moderate pitting, as well as the center wire. Beyond this point, only light to moderate corrosion was found on the center wire. In the case of both the north and south strands, moderate corrosion was observed directly beneath the locations where the wedges “bit” into the strand and punctured the epoxy coating. The strands are shown in Figure 5.40. The ratings for the strand in the anchorage are shown in Figure 5.41 and are summarized in Table 5.15.

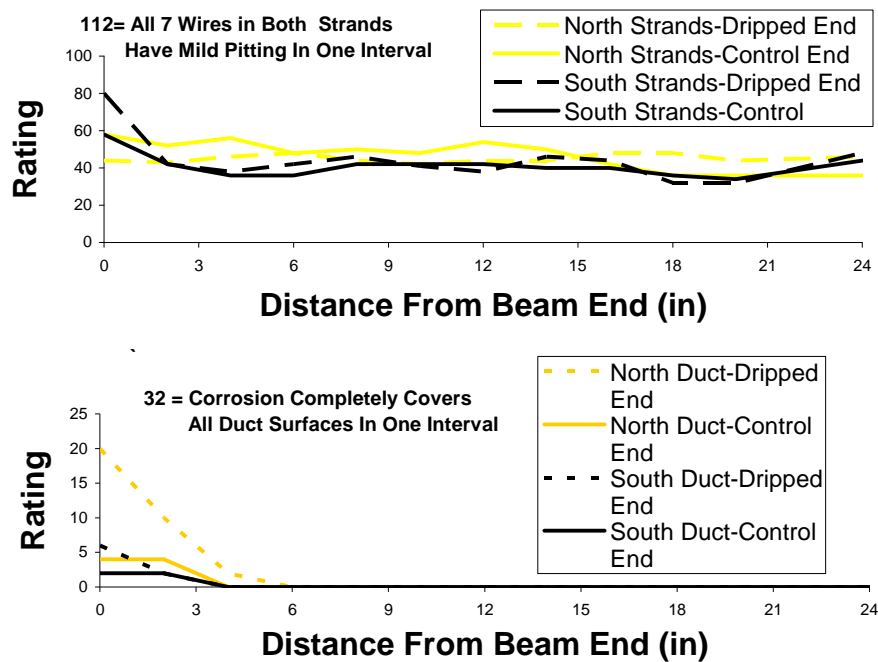
Figure 5.41: Beam 2.7-Corrosion Rating Graphs for Anchorages

In Figure 5.41, the corrosion ratings for both the ducts and strand for the west end and east end anchorages are shown plotted together for comparison. Note that “Distance from Beam End” is the distance from the respective end of the beam for each respective anchorage. Because the corrosion from the center of the beam spread to both anchorages, in order to detect any corrosion caused by the end dripper, the data from the dripped end is compared to the control end

to see if there is any increase in corrosion between the two. Thus it is assumed that the corrosion from the center of the beam had an equal effect on both ends of the beam. In Table 5.15, the corrosion ratings for both anchorages are summarized.

By comparing the data from each tendon in Figure 5.41 and Table 5.15, there is no overall trend between the total strand damage and whether the anchorage has a dripper or not. The corrosion on the strand in the south duct did increase dramatically at the very end of the beam. But since this was observed on both ends of the beam, it cannot be attributed to the dripper. It is likely that what occurred in both ducts is that the large chloride/moisture ingress from the severe corrosion at the center of the beam found its way to the anchorages by way of the strand interstices, since the anchorage is only 7 ft, 6 in. from the central area of the beam, where, as previously mentioned, very large chloride contents were observed. This is also supported by the fact that no chlorides were found in the grout in the tendons within the anchorage. Subsequently, the effect on the strand from the moisture/chloride ingress from the beam centerline made the chloride ingress caused by the dripper negligible. In contrast, both Figure 5.41 and Table 5.15 clearly demonstrate that the duct damage did increase with the presence of the dripper. All of the major corrosion observed in the ducts was in the vicinity of the duct tape seal or slightly closer to the anchorhead. This is also the location where the steel collar at the back of the anchorhead comes into contact with the galvanized duct. The corrosion was located right inside this area. Therefore, it is possible that a form of galvanic or “two metal corrosion” has taken place, which is when two dissimilar metals are placed together and one of them is corroded due to the difference in electrochemical potential between the two metals.²⁴ However, in order for this to occur, the two metals must already be in a corrosive environment. At the control end, bleed water accumulation from behind the anchorhead may have helped initiate this. Meanwhile, at the dripper end, the same occurred but in addition, small amounts of chloride ingress from the dripper may have helped accelerate the galvanic corrosion process, resulting in greater corrosion than the control end. These chlorides may have found their way through the anchorhead and on to the duct surface. However, the chlorides may not have reached the actual level of the strands within the grout. This would explain the lack of chlorides at the level of the strands at the dripped end.

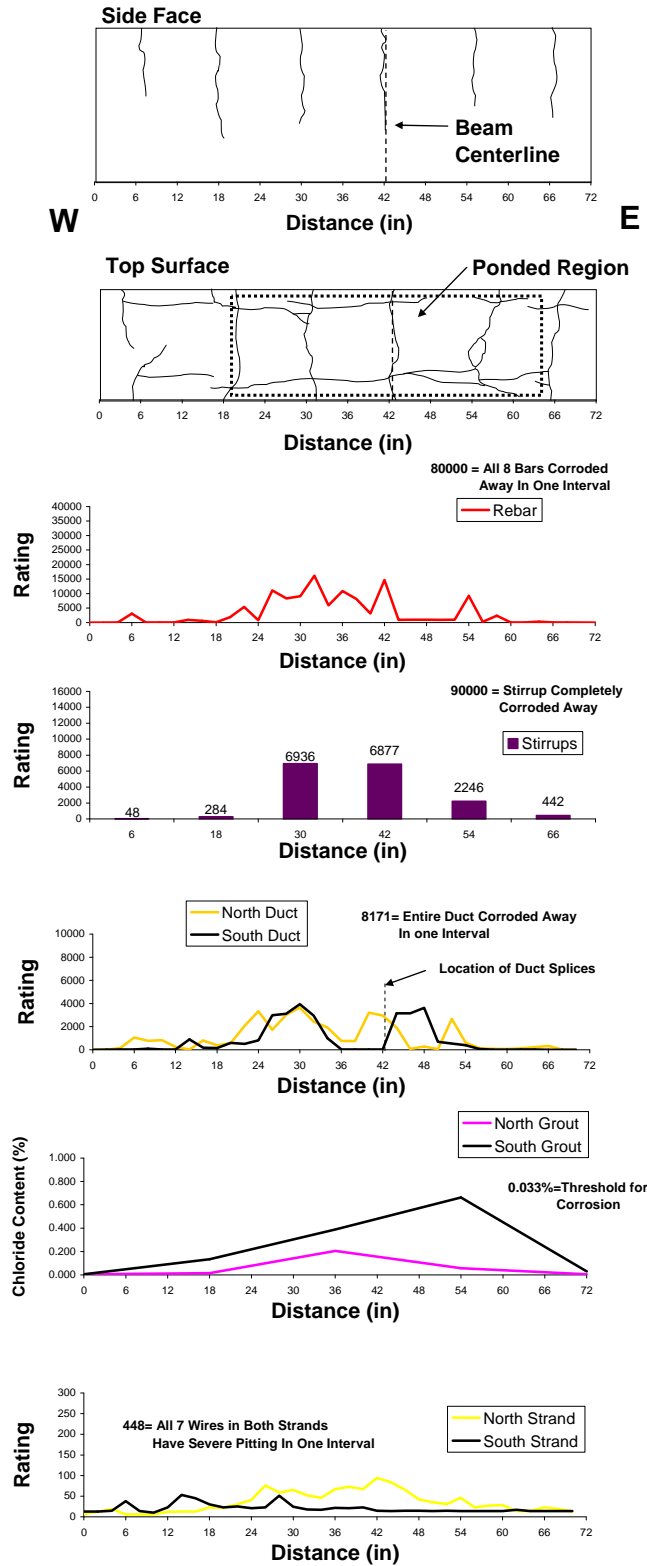
Figure 5.42: Beam 2.8-Crack Patterns and Corrosion Rating Graphs

As shown in Figure 5.42, there was substantial longitudinal cracking. As observed in all the other loaded beams, the flexural cracks corresponded with stirrup locations. The maximum

crack width was from one of the longitudinal cracks in the ponded region, near the centerline. The crack measured nearly 0.0115 in. in width. There was heavy staining at the beam centerline around one of the longitudinal cracks. Patches of staining were also seen outside the ponded region as well.

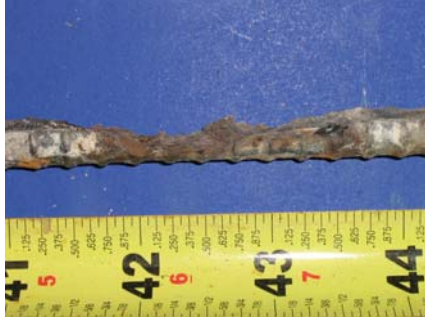
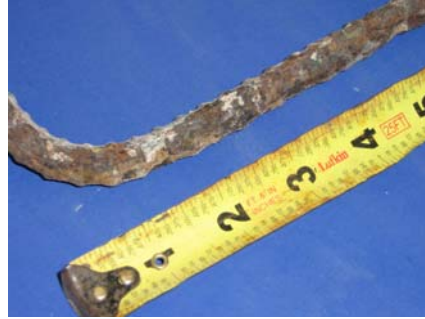
Once the beam was autopsied, pitting and cross-sectional area loss were found on the longitudinal bars and stirrups in the ponded region (See Figure 5.43). The worst reinforcing bar damage was 10 in. to the west of the beam centerline, where one of the #3 bars was completely corroded away in one interval. This corresponded to a flexural crack location. The most corroded stirrup was that at the beam centerline. Here the stirrup was heavily pitted, and at one location the stirrup bar diameter was reduced from 1/2 in. to 3/8-in. The stirrups and bars are shown in Figure 5.43, with the corrosion ratings shown in Figure 5.42 and summarized in Table 5.16.

Longitudinal Bar

Stirrup

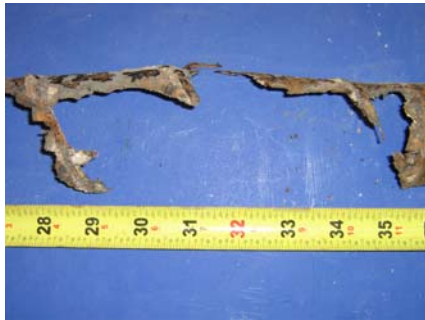
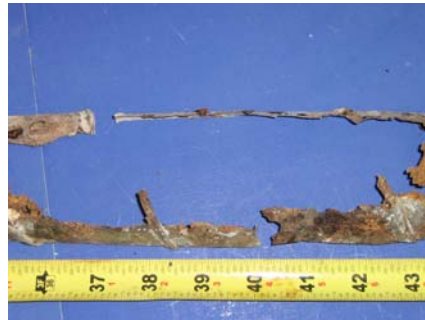
Both ducts were heavily pitted and holed and thus had large surface area loss. The top portion of both north and south duct were nearly corroded away at places as shown in Figure 5.43. The duct corrosion ratings along the length of the beam are shown in Figure 5.42 and are summarized in Table 5.16.

Top of South Duct

Top of North Duct

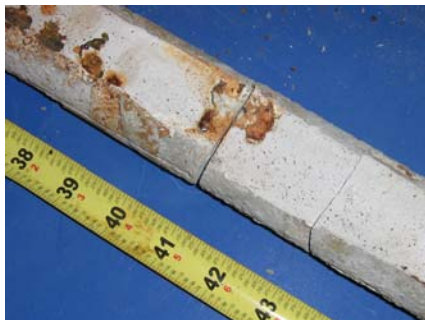
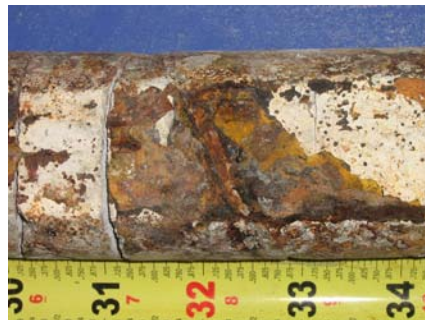
The south duct grout had multiple large bleed water voids. The largest was at 26 in. to the west of the beam centerline. The bleed water void at this location was nearly 3/4 in. wide. The grout was also transversely cracked, with staining found on several crack faces. The maximum chloride content measured in the north duct grout was 0.662 percent, far above the threshold for corrosion of 0.033 percent. This was measured 12 in. to the east of the beam centerline. The north duct grout had two large bleed water voids. The largest was 8 in. long and 1.25 in. wide and was just west of the beam centerline. Here duct corrosion products were found in the void. The north duct grout was transversely cracked in multiple locations with staining found on some crack surfaces. The largest chloride content found in the north duct grout was 0.205 percent, at 6 in. west of the beam centerline. This value is, again, far above the threshold for corrosion. The grout from both ducts is shown in Figure 5.43, and the chloride contents are plotted in Figure 5.42.

South Duct Grout

North Duct Grout

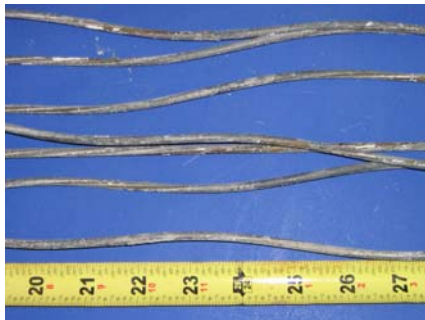
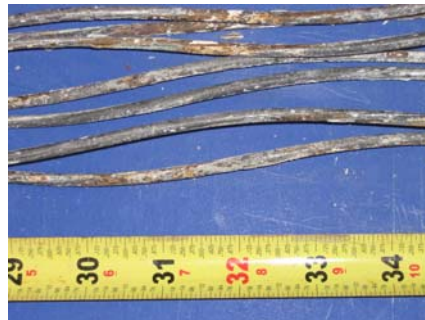
South Duct Galvanized Strand

North Duct Galvanized Strand

The two south duct galvanized strands had a wide range of corrosion. Both strands were discolored with instances of light to moderate corrosion. There were some instances of mild pitting on only a few wires. Whitish powder, likely zinc oxide, was found in the interstices between several of the wires. The amount of discoloration in the galvanized strand is shown in Figure 5.45. Here, new galvanized strand, which was in environmentally controlled storage at FSEL, is shown with the galvanized strand removed from the beam. The north duct strand was similar but with many more instances of mild pitting in multiple locations. The strand from both ducts is shown in Figure 5.43, while the corrosion ratings along the length of the autopsy area are shown in Figure 5.42 and are summarized in Table 5.16.

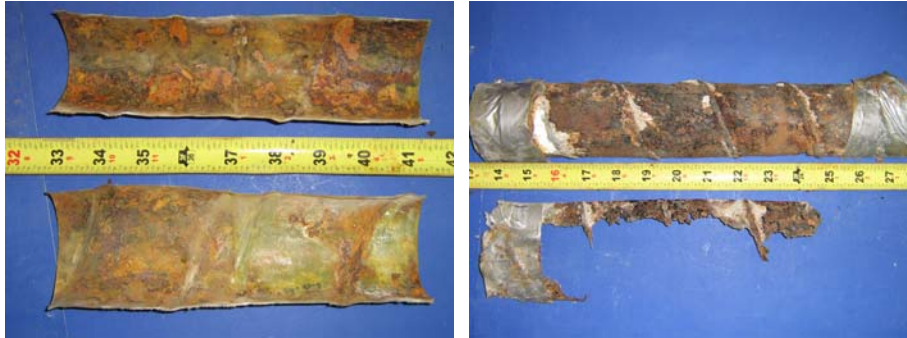
Figure 5.44: Beam 2.8 Duct Splices-South Duct Heat Shrink Splice (Left) and North Duct Industry Standard Splice (Right)

The splice configuration in this beam was an industry standard splice on the north duct at the beam centerline, with a heat shrink splice on the south duct also located at the beam centerline. As shown in Figure 5.44, the south duct heat shrink splice had a large amount of corrosion deposits on both the inside and outside surfaces, with the duct portion beneath the splice heavily pitted. The top portion of the industry standard splice was essentially corroded away, with a pitted fragment recovered. In this case the heat shrink splice was certainly superior.

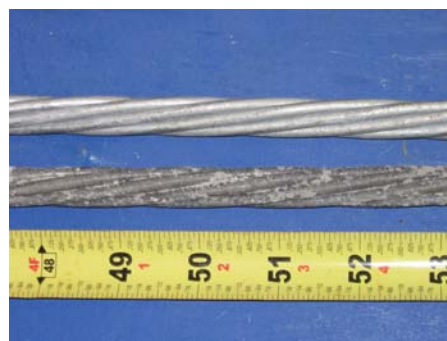
Figure 5.45: Autopsied Galvanized Strand (Bottom) versus New Galvanized Strand (Top)

It is significant that pitting and other heavy corrosion was found on the galvanized strand. The overall discoloration of the strand as well as the presence of zinc oxide suggests that the zinc coating had almost corroded away on all the strands, and that the actual steel in the strand was under attack. This is similar to what occurred to the galvanized ducts, where the galvanization only delayed the onset of corrosion in the actual steel.

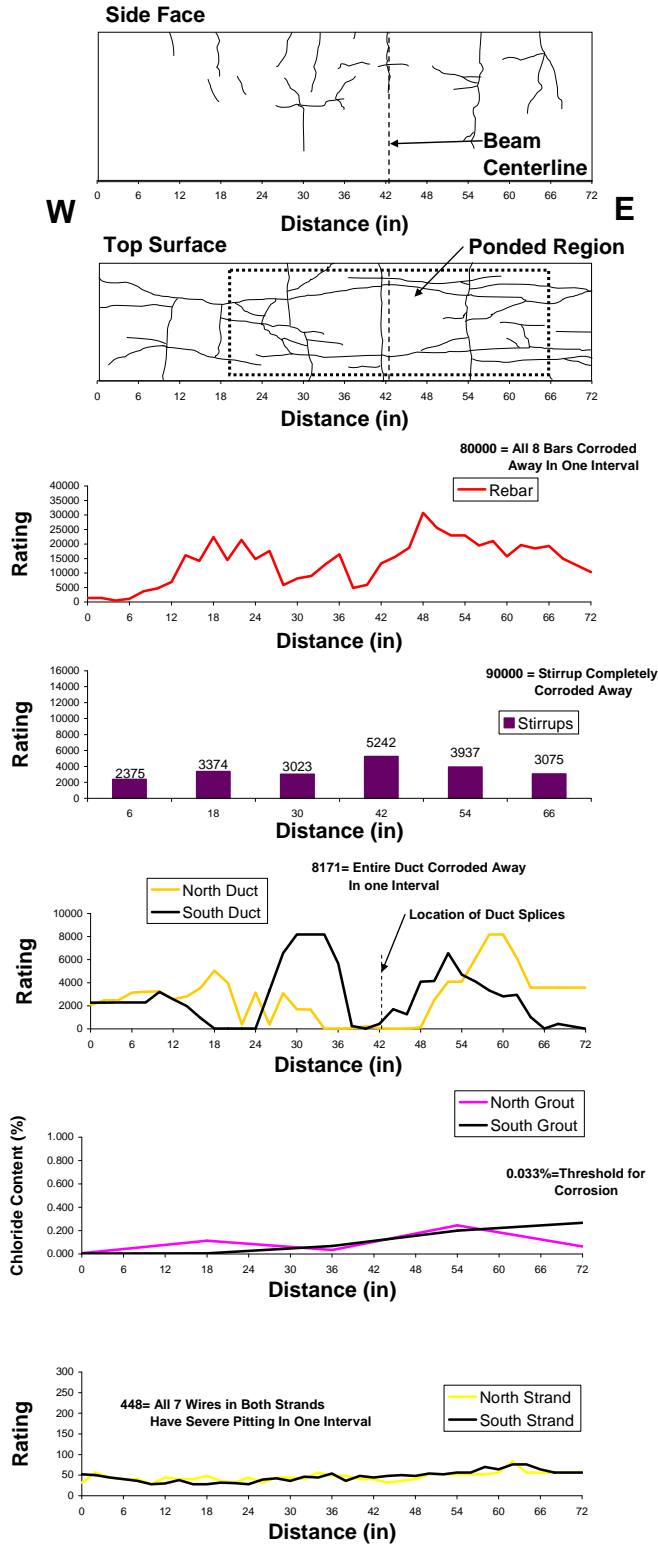
Figure 5.46: Beam 2.9-Crack Patterns and Corrosion Rating Graphs

As shown in Figure 5.46, there was extensive longitudinal cracking in the ponded region. The largest crack width was recorded near the centerline of the beam, where one of the longitudinal cracks was 0.09 in. in width.

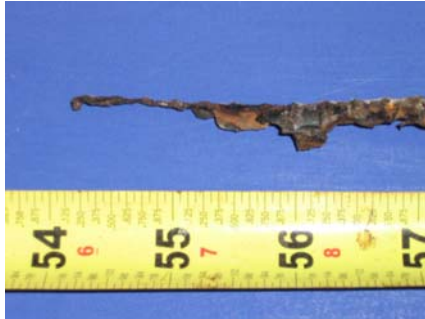
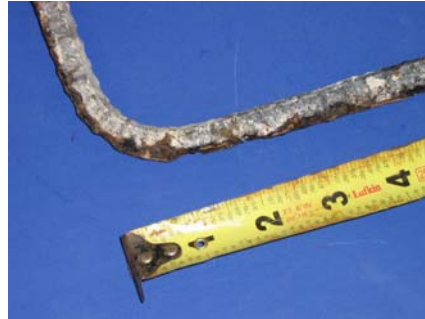
Upon autopsy of the center portion of the beam, large amounts of pitting and cross-sectional area loss were found on all longitudinal bars and stirrups (See Figure 5.47). In some instances, the #3 longitudinal reinforcing bars were completely corroded away for several in. of length. This occurred over a broad area centered about 18 in. west of the beam centerline, where in one 2-in. interval two of the #3 bars were completely corroded away. Loss of bar lengths also occurred intermittently in an area about 18 in. long, which was just to the east of the beam centerline. Again, in this area two of the four #3 bars were completely corroded away for several 2-in. intervals. The worst stirrup damage was just outside the east end of the ponded region, corresponding to a location of heavy staining. The stirrup at this location suffered significant section loss in several 2-in. intervals and was also heavily pitted. The stirrups and bars are shown in Figure 5.47, while the corrosion ratings for the stirrups and bars within the autopsy area are plotted in Figure 5.46 and are summarized in Table 5.17.

Longitudinal Bar

Stirrup

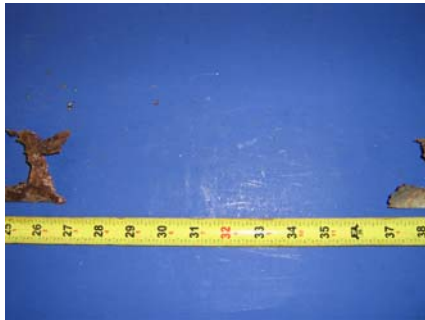
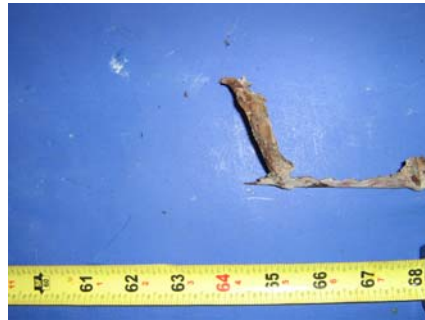
As shown in Figure 5.47, both ducts had large surface area loss. The tops of the ducts had virtually disappeared in some areas. The duct corrosion ratings along the length of the beam are shown in Figure 5.46, are summarized in Table 5.17.

Top of South Duct

Top of North Duct

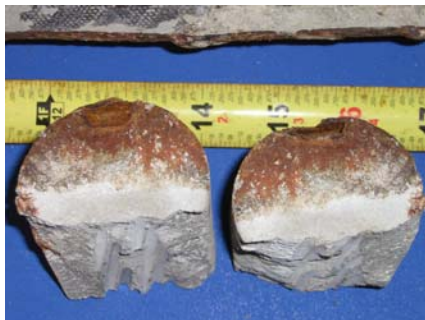
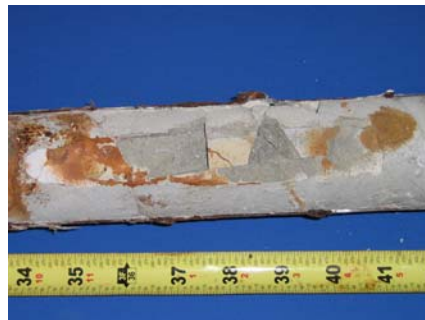
South Duct Grout

North Duct Grout

As described in Chapter 2, this beam was intended to be used to evaluate the effect of poor grouting procedures. The poor procedures included delays of up to 10 minutes during pumping of the grout, letting air into the pump, and capping the grout vents at the first sign of grout at the vents. Upon autopsy of the tendons, the south duct grout was found to have larger surface bubbles than compared to the beams with the “proper” grouting procedures. Bleed water voids of various sizes were present, and some evidence of segregation of the grout mix was found when examining the faces of the transverse cracks in the grout. This may have been caused by the 10-minute delays in pumping. Many of these transverse crack faces were also heavily stained. An example of the segregation and staining is shown in Figure 5.47. Note the small bleed water voids at the tops of the grout sections. The maximum chloride content measured in the north duct was 0.267 percent; this was at the extreme east end of the autopsy area. The north duct was similar, with a large bleed water void near the beam centerline, which was 1 in. wide and almost 1/2 in. deep. The maximum chloride content measured in the north duct was 0.245 percent and was located 12 in. to the east of the beam centerline. Thus the maximum chloride content for both ducts was far above the threshold for corrosion. The grout from both ducts is shown in Figure 5.47. The chloride content in the grout along the length of the autopsy area is plotted in Figure 5.46.
