1. Report No. FHWA/TX-08/0-4562-2		2. Government Accession No.		3. Recipient's Catalog No.	
4. Title and Subtitle Durability Evaluation of Post-Tensioned Concrete Beam Specimens after Long-Term Aggressive Exposure Testing			5. Report Date November 2007

Durability Evaluation of Post-Tensioned Concrete Beam Specimens after Long-Term Aggressive Exposure Testing

Center for Transportation Research
The University of Texas at Austin
3208 Red River
Austin, TX 78705

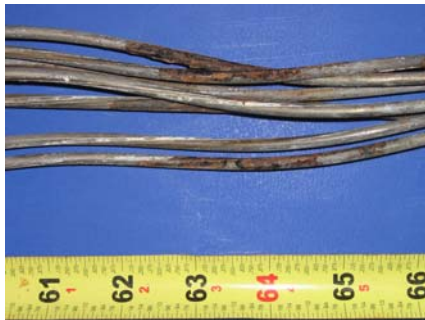
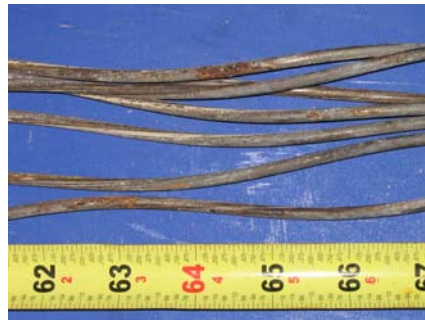
South Duct Strand

North Duct Strand

The two south duct strands had instances of light to moderate corrosion throughout, with some instances of mild and moderate pitting found on one strand in a zone about 20 in. long at the east end of the autopsy area. Here mild pitting was found on some wires, with one case of moderate pitting on one wire at 16 in. to the east of the beam centerline. The other strand had only two instances of mild pitting. One was at the beam centerline and the other was about 18 in. to the west of the beam centerline, in the same general vicinity as was the moderate pitting found on the other strand in the duct. Both strands in the north duct had mild pitting in the same general areas as the south duct strands, but no instances of moderate pitting were found in either of the strands. The strand is shown in Figure 5.47, and the corrosion ratings for the strand in the autopsy area are given in Figure 5.46 and are summarized in Table 5.17.

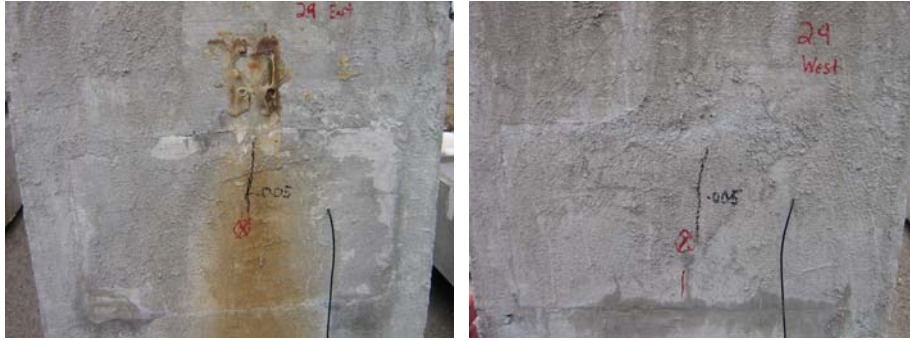
Figure 5.48: Beam 2.9 Anchorage Zones-East End (Left) with Dripper, and West End (Right) Without Dripper

As shown in Figure 5.48, there were 0.005-in. wide shrinkage cracks on both ends of the beam, where the anchorage pockets had been backfilled. On the east (dripped) end anchorage, there was a large patch of staining right beneath where the saltwater exited from the dripper.

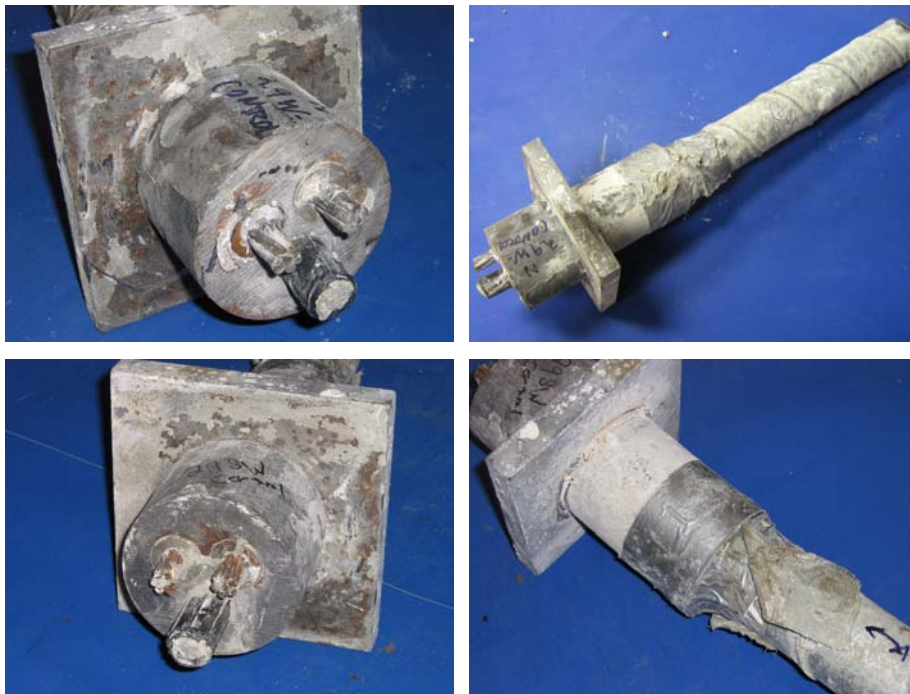
Figure 5.49: Beam 2.9 West End Anchorages (Controls) After Removal-North Duct Anchorage (Top, Left and Right), and South Duct Anchorage (Bottom, Left and Right)

As shown in Figure 5.49, the front of the bearing plate and anchorhead in both tendons were only slightly corroded. The fronts of the wedges also showed slight corrosion as well. The portion of the north duct in the anchorage zone had moderate corrosion on its outside surface inside the duct taped connection between the back of the bearing plate and the duct. Otherwise, no other evidence of corrosion was found on the north duct. The south duct had moderate corrosion in the same location as the north duct, and, some small instances of light corrosion were found on the inside of the duct as well, near where the duct met the bearing plate. The

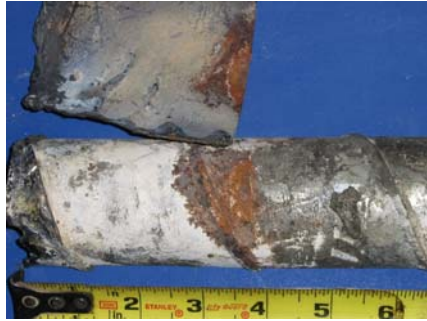
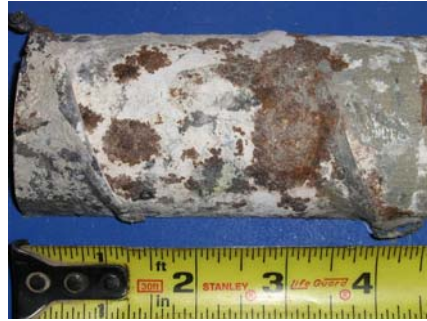
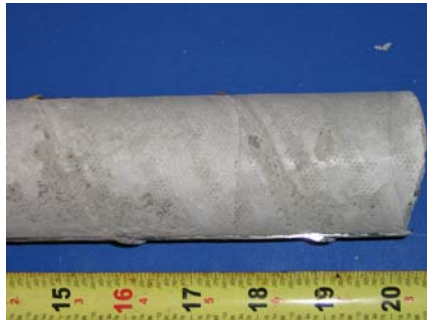
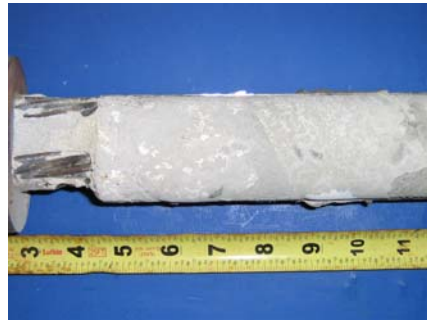
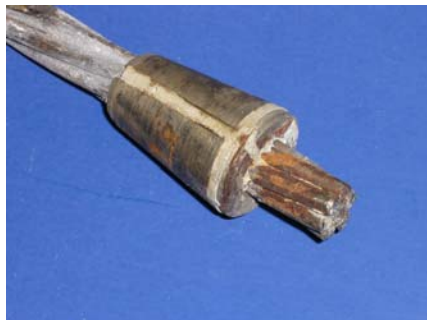
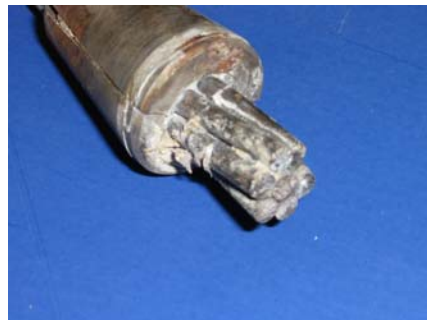
Figure 5.50: Beam 2.9-West End Anchorage Zone (Control) Autopsy Elements

corrosion ratings for the ducts in the anchorage are given in Figure 5.53 and are summarized in Table 5.18. The ducts removed from this anchorage are shown in Figure 5.50. Note that in the latter figure the duct is shown next to the top half of the back of the bearing plate, which it was in contact with during the test. Notice that there are corrosion deposits on that component from the corrosion of the duct.

The north duct grout showed evidence of bleed water accumulation just behind the anchorhead and deep, but small in diameter, bubbles in the top of the grout. Negligible chlorides were found at the level of the strand in the grout. The south duct had a transverse crack at about 18 in. from the back of the anchorhead. However, the south duct grout did not have the deep bubbles that the north duct grout had. No evidence of bleed water accumulation was found behind the anchorhead in this duct. Similar to the north duct grout, the south duct grout had negligible chlorides at the level of the strands. The grout from both ducts is shown in Figure 5.50. Light to moderate corrosion was found on the strands in the north and south ducts in the anchorage zone. Most of the moderate corrosion was concentrated in the interstices, but in the south duct strands, moderate corrosion was observed on the outside of the strand at the ends of both tendons outside the anchorhead. The likely source of this corrosion is that corrosion from the center of the beam spread through the interstices down to the anchorages. No corrosion was found where the wedges “bit” into the wires. The strands from both ducts in the west end anchorage are shown in Figure 5.50. The strand ratings in the anchorage are given in Figure 5.53 and are summarized in Table 5.18.

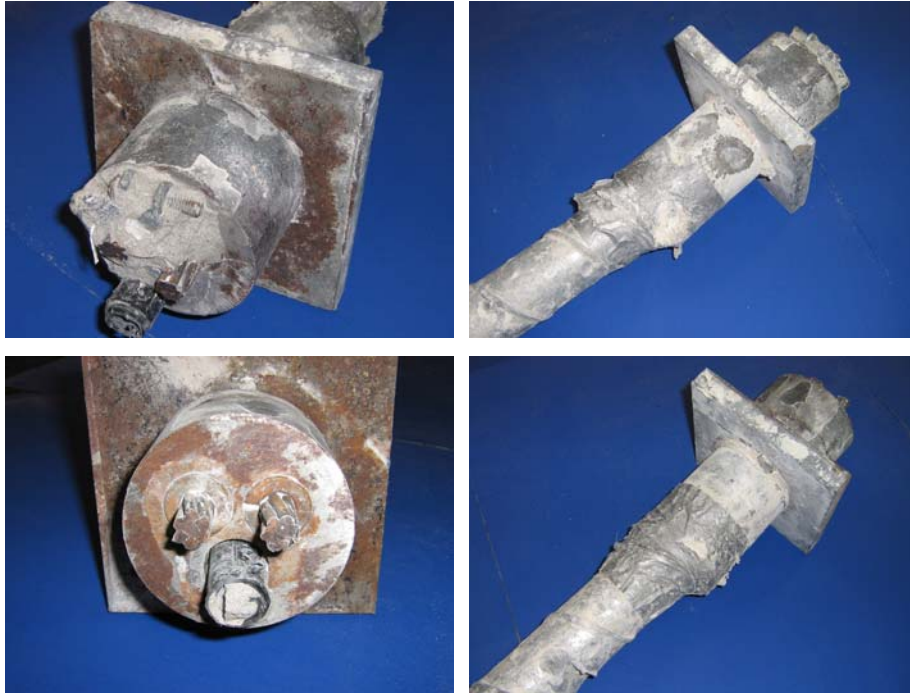
Figure 5.51: Beam 2.9 East End Anchorages (Dripped End)-North Duct Anchorage (Top, Left and Right), and South Duct Anchorage (Bottom, Left and Right)

As is evident by comparison of Figure 5.51 with Figure 5.49, in the case of both tendons more corrosion was found on the face of the bearing plate and anchorhead at the dripped end of the beam than at the control end. However, there was no evidence of corrosion in the area behind the bearing plate. The outside of the top portion of the south duct had severe corrosion in the vicinity of the duct tape connection and instances of light corrosion on both the outside and inside of the bottom portion of the duct right at the end of the duct at the anchorhead. Light corrosion was also found underneath the duct tape at the duct/bearing plate interface. It is known from the aforementioned industry standard splices that duct tape does not act as an effective barrier for moisture ingress. But the absence of corrosion on the exposed portion of the duct behind this area suggests that failure of the duct tape was not the likely culprit for the corrosion on the duct behind the anchorhead. The outside of the north duct had light corrosion at the end of the duct behind the anchorhead, on the top surface. At the same end of the duct, light corrosion was found on the outside of the bottom surface of the north duct. The ducts from the anchorage are shown in Figure 5.52. The corrosion ratings for the ducts in the anchorages are given in Figure 5.53 and are summarized in Table 5.18.

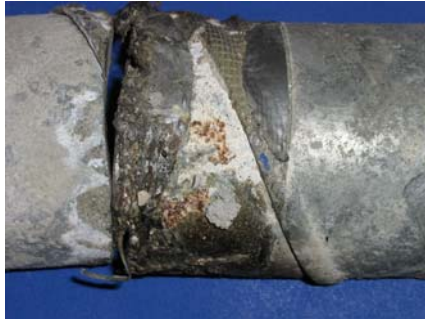
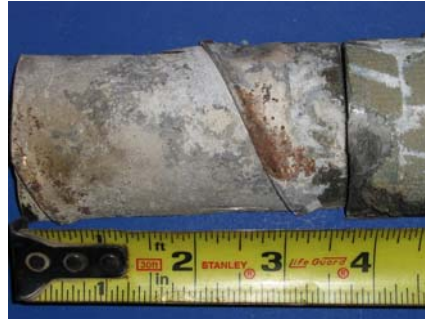
The south duct grout was cracked in a similar fashion to the grout at the center of the beam. No evidence of staining was found on the crack faces. The north duct grout was also cracked, but again, no evidence of staining was observed on the crack faces. In both ducts the grout chloride content at strand depth was negligible. The grout from both ducts in the anchorage is shown in Figure 5.52.

Moderate corrosion was found on all the strand wires in both ducts. Behind the anchorhead the moderate corrosion was generally found in the interstices. However, in front of the anchorhead, instances of moderate corrosion were found on the outside of the strands in both ducts. No evidence of corrosion was found inside the “bite” marks caused by the wedges in either duct. The strand from both ducts is shown in Figure 5.52. The strand ratings for the anchorages are given in Figure 5.53 and are summarized in Table 5.18.

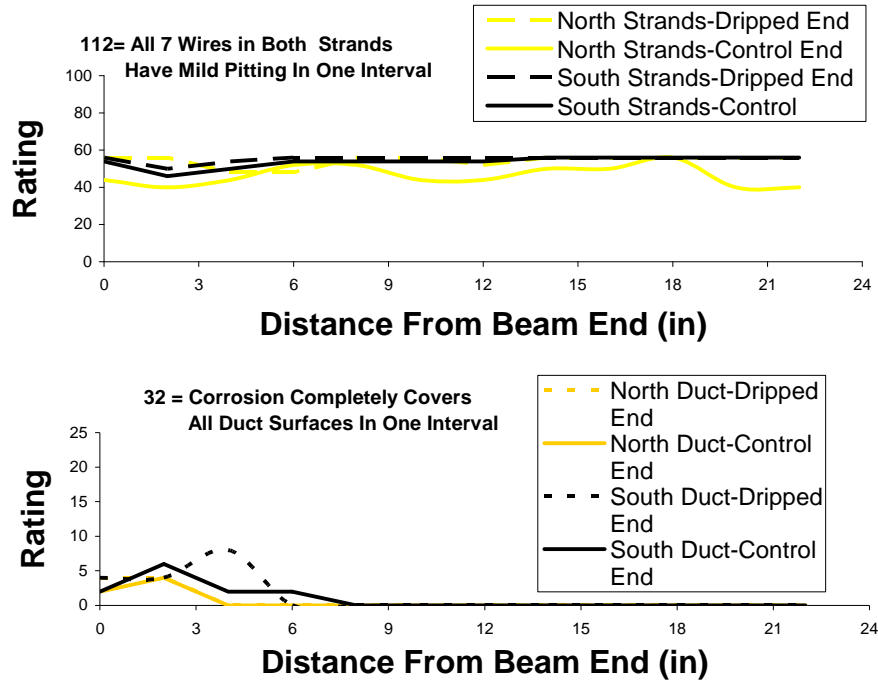
Figure 5.53: Beam 2.9-Corrosion Rating Graphs for Anchorages

In Figure 5.53, the corrosion ratings for the ducts and strands in both the end anchorage zones are plotted. This data is also summarized in Table 5.18. The data from both ends are plotted together so that a direct comparison can be made between the control end and the dripped end. The x axis value “Distance From Beam End” is the distance from the respective ends of the beam for each anchorage element. For this analysis it is assumed that the corrosion at the center of the beam had an equal effect on both end anchorages.

In Figure 5.53 there is no increase in strand corrosion at the very ends of the beam (which is “0” on the x axis) in either the dripped end of the beam or the control end of the beam. However, from the same plot and from Table 5.18, an increase in the total strand corrosion for both ducts between the dripped and the control end is apparent. In the case of the ducts the significant corrosion was found at the bearing plate/duct interface. As demonstrated in Beam 2.7 (Epoxy Coated Strand), the corrosion of the duct at its interface with the bearing plate is likely a form of galvanic corrosion. In Figure 5.53 and Table 5.18 it is clear that the corrosion in the ducts is greater in the end with the dripper. It is possible that chlorides entered through the strand holes in the anchorhead. While this did not penetrate the grout deep enough to produce significant chloride content at the level of the strand in the grout, it still may have found its way to the interface between the galvanized steel of the duct and the regular steel of the anchorhead. The presence of these chlorides would then accelerate the galvanic corrosion process between the galvanized duct and the steel bearing plate.

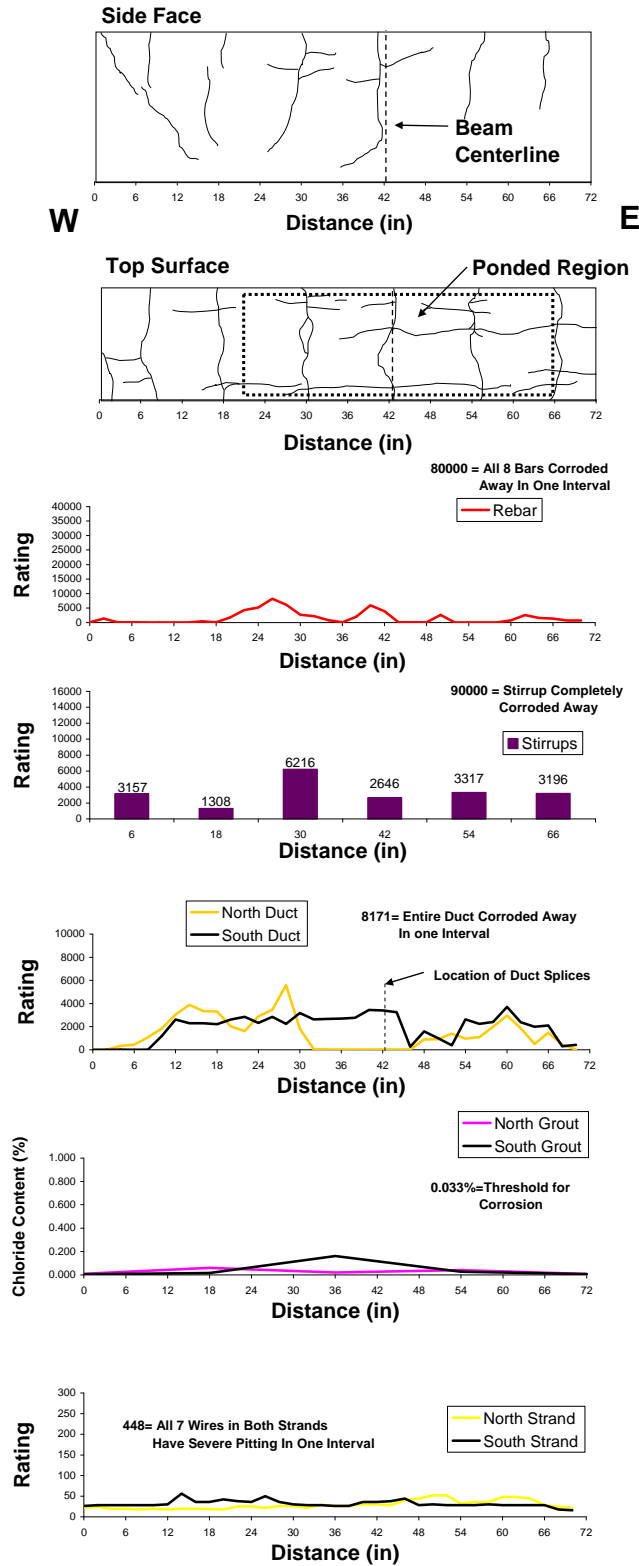
Figure 5.54: Beam 2.10-Crack Patterns and Corrosion Rating Graphs

As shown in the crack maps in Figure 5.54, there was heavy longitudinal cracking in the ponded region. The largest crack width was 0.094 in. and was measured at one of the longitudinal cracks near the beam centerline. There were a few small patches of staining outside the ponded region, but no wide longitudinal cracking.

Both the south duct grout and north duct grout were an anti-bleed grout mix designed by Schokker.² The grout mix was described in Chapter 2. Upon autopsy of both tendons, a large degree of segregation was found in the grout in both ducts. This resulted in shallow voids that ran almost the entire length of the autopsied ducts. Therefore, it appears that the anti-bleed admixture did not fully engage. When viewing the cross section of the grout (see Figure 5.55), directly beneath the shallow void was a distinct layer of more whitish grout, then grout which was more normal in appearance. The grout at the level of the strands appeared to be better quality than that seen with the grout in the other autopsied beams. The segregation and thus the anti-bleed admixture not engaging may have been caused by the mixing method used, which was mixing the grout for a short period in a bucket with a hand mixer instead of using a dedicated grout mixer/pump assembly.* In the south duct, the maximum chloride content at strand level was 0.162 percent, which was at 36 in. from the west end of the autopsy area. This is far above the threshold of 0.033 percent. The maximum chloride content in the north duct was 0.06 percent, which was at 18 in. from the west end of the autopsy area. The chloride contents in the grout in the autopsy area are plotted in Figure 5.54.

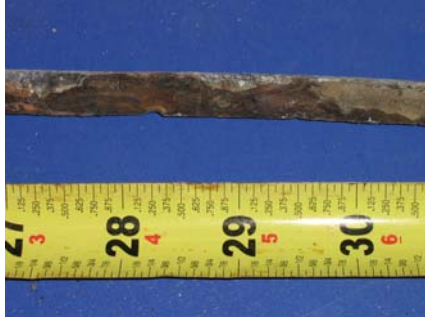
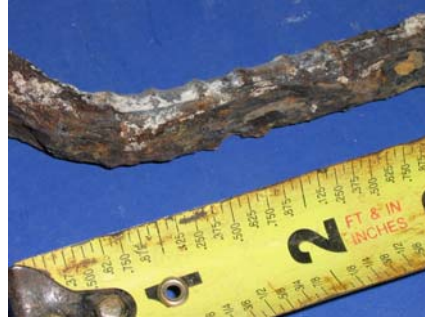
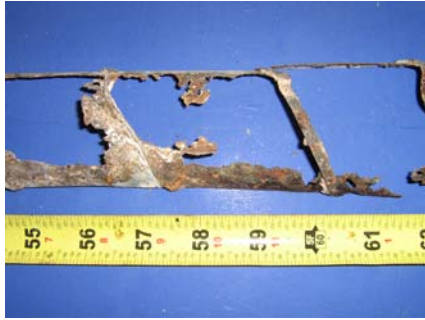
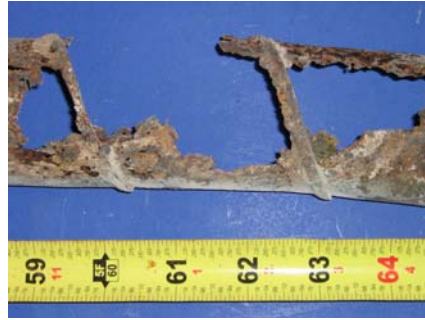
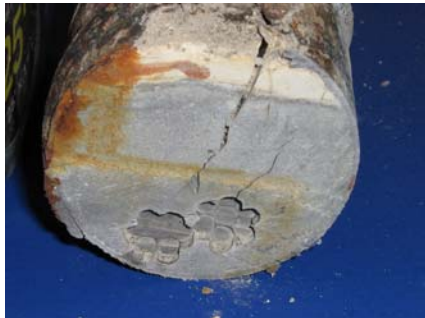
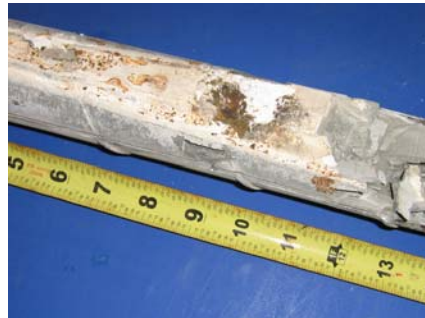
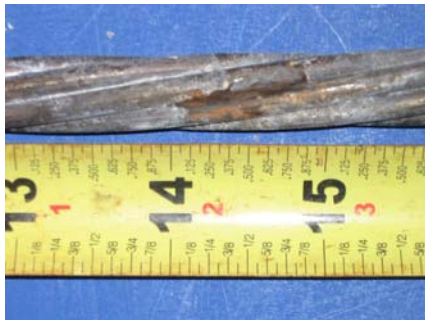
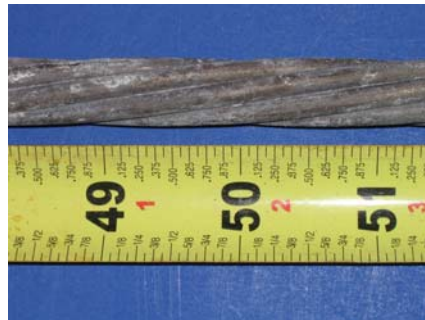
Figure 5.55: Beam 2.10 Autopsy Elements

Upon autopsy of the beam, pitting and cross-sectional section loss was found on the stirrups and longitudinal bars (See Figure 5.55). The worst longitudinal bar corrosion was at 16 in. to the west of the beam centerline, where one of the #3 bars was reduced in diameter to 0.25 in. In the same location, the four #4 bars also had considerable area loss. The most highly corroded stirrup was also in this vicinity and had a reduction in diameter from 0.5 in. to 0.4 in. The stirrup and longitudinal bar corrosion ratings are given in Figure 5.54 and are summarized in Table 5.19.

Both ducts were spliced at the beam centerline. Both splices were industry standard splices, and were heavily corroded. The top portion of the south duct splice was almost completely corroded away. The top portion of the duct beneath it was nearly corroded away.

As shown in Figure 5.55, both ducts were heavily pitted with large surface area loss. Corrosion rating graphs for the ducts are given in Figure 5.54 and are summarized in Table 5.19.

The south duct strand had light to moderate corrosion, with a few instances of pitting at 14 and 26 in. from the west end of the autopsy area. The north duct strand also had light to moderate corrosion, but with no pitting. The strands from both ducts are shown in Figure 5.55, with the corrosion ratings plotted in Figure 5.54 and summarized in Table 5.19.

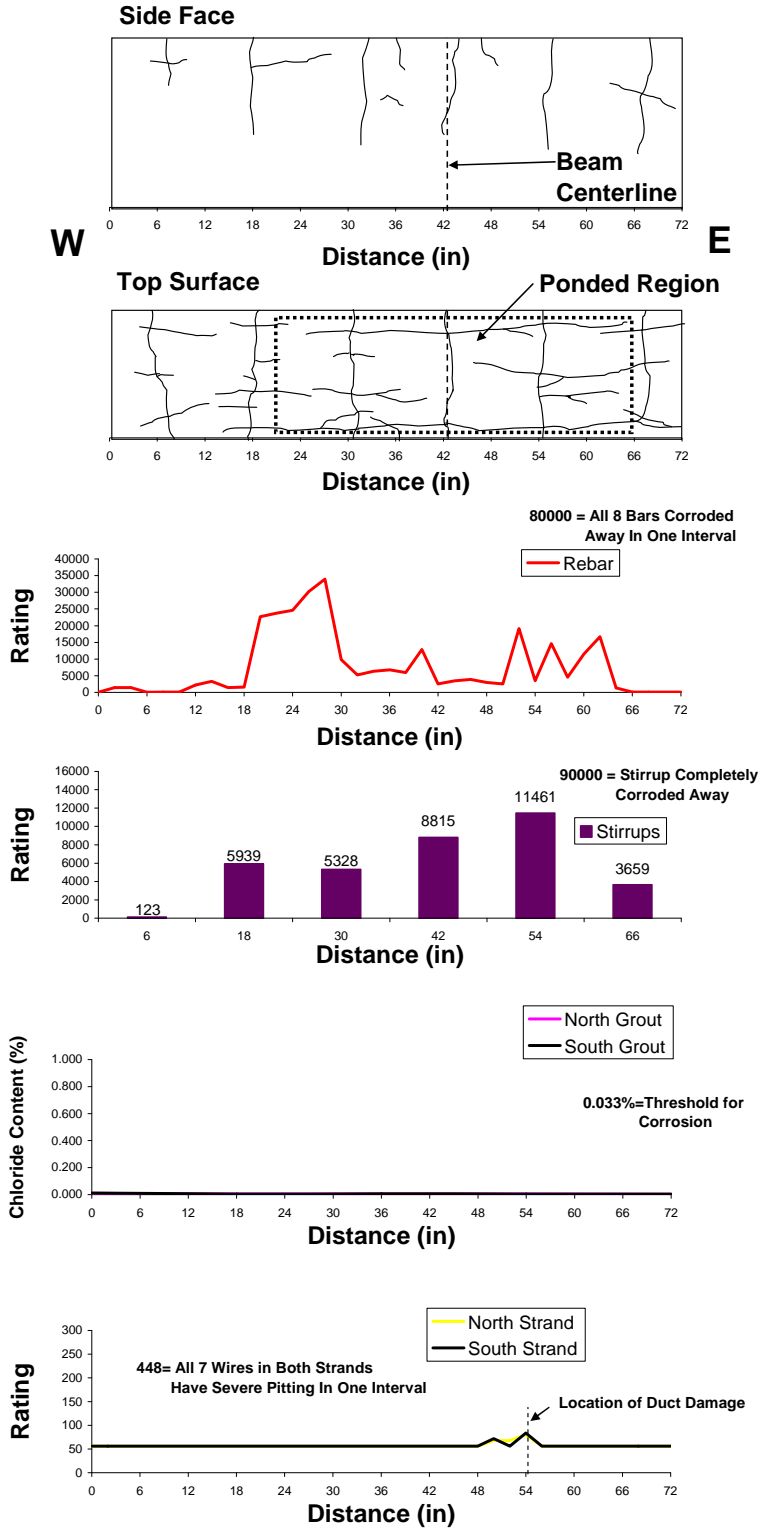
Figure 5.56: Beam 2.12-Crack Patterns and Corrosion Rating Graphs (Center Portion of Beam)

As shown in the crack patterns in Figure 5.56, wide longitudinal cracks were seen on the top surface of the beam within the ponded region, with staining also emerging from the flexural cracks on the side of beam. The largest amount of staining on the top of the beam was centered around the intersection of the centerline flexural cracks and the pair of wide longitudinal cracks that ran the length of the ponded region. The largest overall crack width was at 14 in. east of the centerline, where one of the longitudinal cracks was 0.13 in. in width.

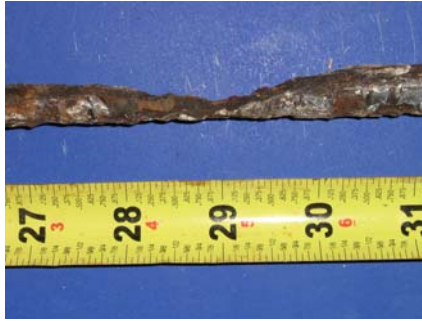
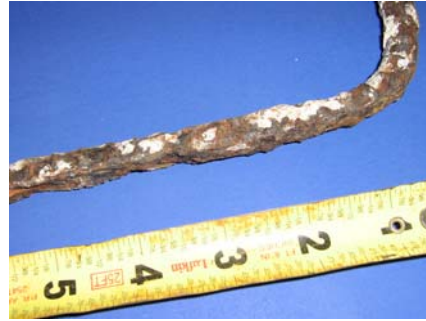
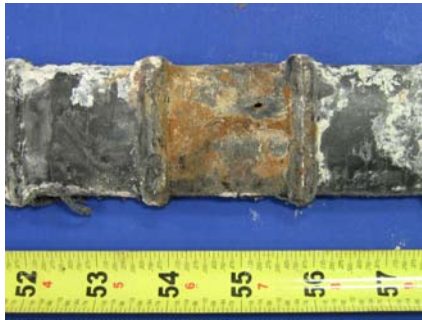
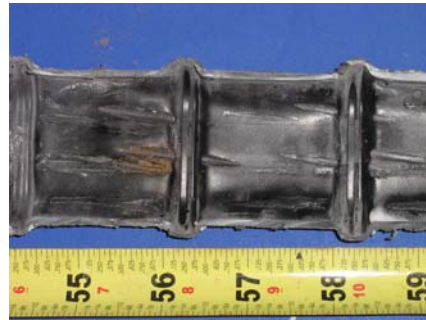
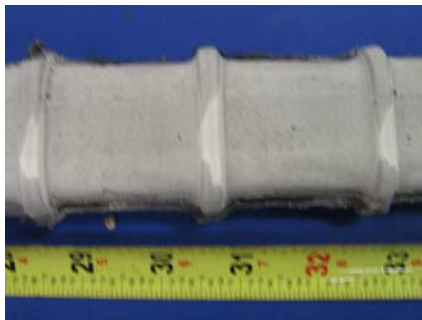
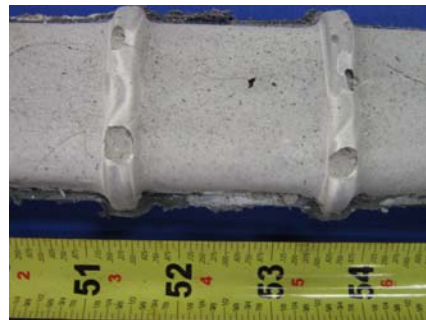
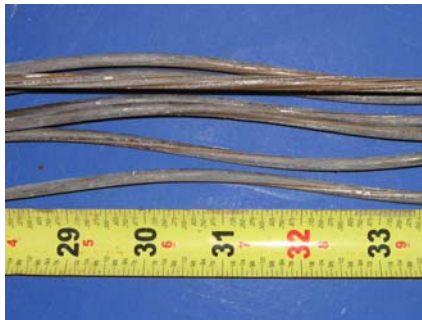
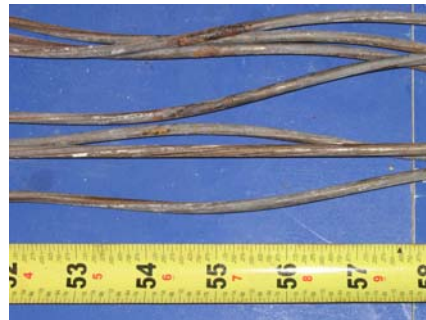
Figure 5.57: Beam 2.12 Autopsy Elements (Center Portion of Beam)

All longitudinal bars and stirrups were pitted with large amounts of cross-section loss (See Figure 5.57). The worse longitudinal bar damage was in an area about 18 in. to the west of the beam centerline, where nearly 6 in. of two of the #3 bars were completely corroded away. The worst stirrup damage was at 12 in. to the east of the beam centerline, where the top portion of the stirrup had its diameter reduced from 1/2 in. to around 0.375 in. The longitudinal bars and stirrups are shown in Figure 5.57. The corrosion ratings for the bars and stirrups are plotted in Figure 5.56 and are summarized in Table 5.20.

As seen in Figure 5.57, both ducts were well grouted. The bleed water accumulated on the peaks of the ribs along the length of the duct, preventing large bleed water voids from forming, as seen in the galvanized ducts. The evidence for bleed water accumulation at the peaks of the ducts was large bubbles on the tops of many of the ribs. Negligible chlorides were found in the grout right at the level of the strand. This is surprising considering the aforementioned damage to the duct. What likely happened was the chlorides entered the strands directly and did not absorb into the grout. This is also likely because obviously there was no grout between the damaged areas of the ducts and the strand, so unlike typical strand damage seen in the other autopsies, the chlorides did not have to pass through the grout to get to the strand. The chloride contents along the length of the ducts in the autopsy area are shown in Figure 5.56.

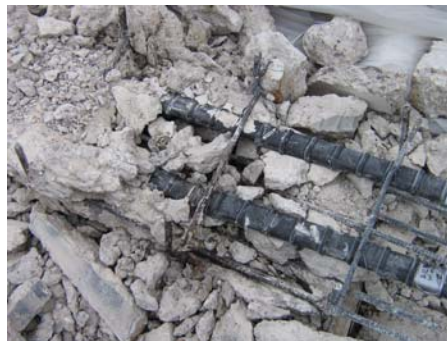
Figure 5.58: Beam 2.12 During Autopsy

The ribbed plastic ducts were continuous in both ducts, so no splices were present to be evaluated. During the breaking up of the block from the beam centerline, it was found that bracing bars had been placed across the bottoms of the stirrups during construction to hold the ducts up. The ducts had then been tied to these bars. This is shown in Figure 5.58. Note that the block is upside down, so the surface on the bottom of the block, facing the ground, was where the saltwater was ponded upon during exposure testing.

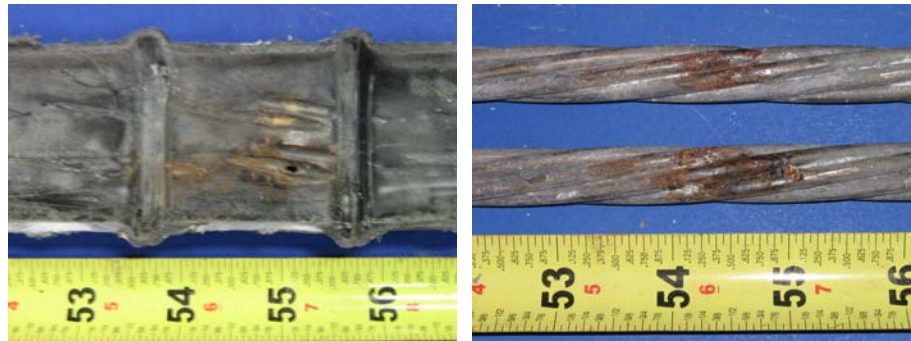
Figure 5.59: Beam 2.12-Abrasion Damage to Interior of North Duct (Left) and Strand from Same Location (Right)

At multiple locations, including all the stirrup locations, heavy corrosion deposits were seen on the top of the plastic ducts along the length of the autopsy block. Once the ducts were opened, evidence of abrasion was found between the strand and the bottom of the ducts. The abrasion was in the form of deep gouges in the bottom of the duct (See Figure 5.59). The damage was similar to fretting. At a point 12 in. to the west of the beam centerline (54 in. on the corrosion rating graphs), a small hole was found on the bottom of the north duct inside one of these gouges, with corrosion products inside. This was directly over one of the bracing bars, which contributed to the damage. Corrosion products were found on the outside of the duct in this area. Severe pitting was found on the strand wire surface that had caused this gouge. Mild pitting was found on two other wires in this vicinity. The other strand in the north duct had mild to moderate pitting on three wires at the same location. Mild pitting was also found on the center wire of this strand, suggesting that the chlorides that had entered the duct had made their way into the interstices of the strand. While at first the remainder of the strand appeared unaffected on the outside, once the strand was unwound moderate corrosion was found on all wires in both strands for rest of the autopsy area. This damage to the north duct is shown in Figure 5.59.

Very small cracking was found in one of the strand gouges on the bottom of the south duct in the exact same location along the length of the beam as the damage to the north duct. This resulted in basically the same situation as that in the north duct. Corrosion products were found in the gouge where the crack was located and mild to moderate pitting was found on three of the outer strand wires, with moderate pitting found on the center wire as well. The other strand had mild pitting on two of its wires in the same area. The strand from both ducts is shown in Figure 5.57, with the corrosion ratings for the strand shown in Figure 5.56 and summarized in Table 5.20. Corrosion ratings for the ducts are not plotted because the ducts are plastic. However, the location of the damage to the ducts is marked on the plot of strand rating. An explanation for this damage is as follows: when the strand was prestressed, it actually pushed down onto the duct, causing damage similar to fretting. Consequently, at a point 12 in. to the west of the beam centerline, the plastic ducts had been “squeezed” between the strand and the bracing bar, and as a result the ducts failed mechanically. This damage must have occurred right when the beams were prestressed, even before exposure testing began. As shown in Figure 5.56, once the beam was loaded a flexural crack formed at the point where the ducts were damaged, since a stirrup was located there. Chlorides in the salt bath found their way through the flexural crack and corroded the bracing bar that held the ducts up. The corrosion then spread through the holes in the duct into the strand.

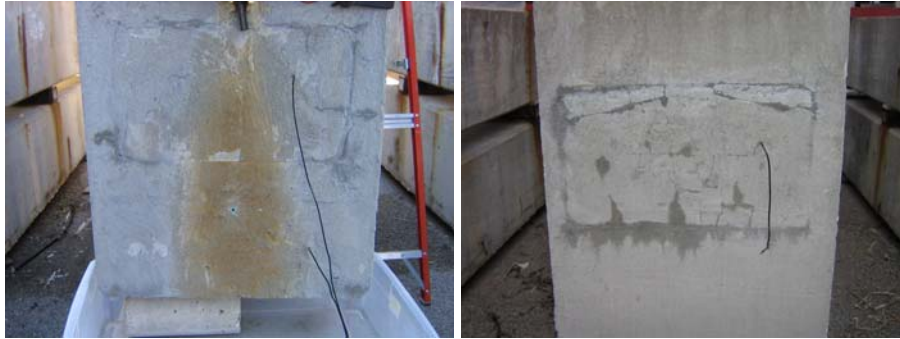
Figure 5.60: Beam 2.12 Anchorage Zones: East End Anchorage With Dripper (Left) and West End Anchorage Without Dripper (Right)

As shown in Figure 5.60, there was staining on the dripped end of the beam where the saltwater had exited from the dripping system. There was no staining on the west end anchorage. No shrinkage cracks were seen on the grout pockets in either anchorage zone.

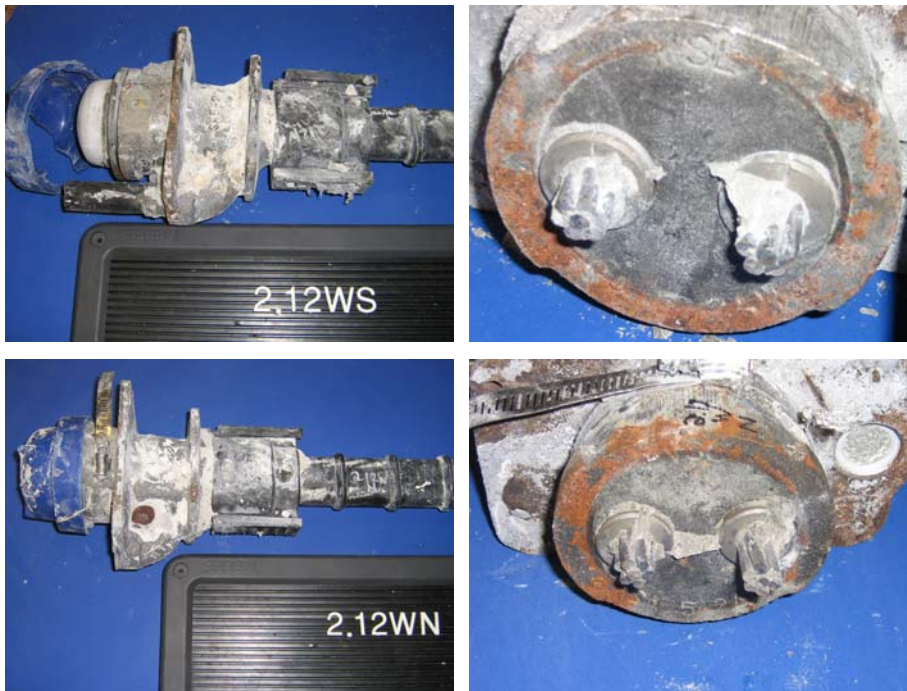
Figure 5.61: Beam 2.12 West End Anchorages (Control End)-South Duct Anchorage (Top, Left and Right) and North Duct Anchorage (Bottom, Left and Right)

In Figure 5.61, the entire south duct anchorage is shown with the grout cap removed and the grout underneath revealed. The damage to the grout cap occurred during its removal from the anchorhead. The photograph to the right is the face of the anchorhead after the grout was removed. The corrosion seen on both anchorheads is just outside the perimeter of the seal of the rubber ring behind the grouting cap. This corrosion may have caused by bleed water trapped in this area. However, within the perimeter of the seal, the anchorhead had no corrosion and the

outside of the strands and wedges were nearly pristine in appearance. When the collars behind the anchorheads were opened, the area beneath them was found to be filled with grout and in good condition.

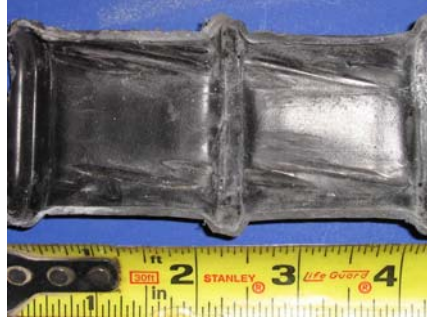
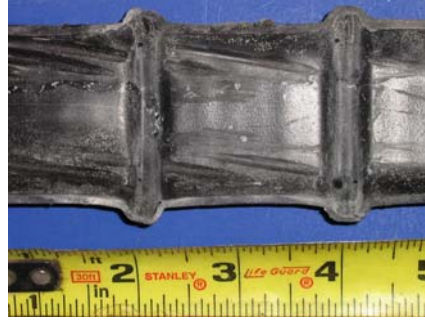
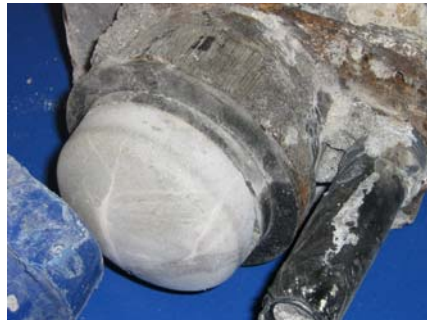
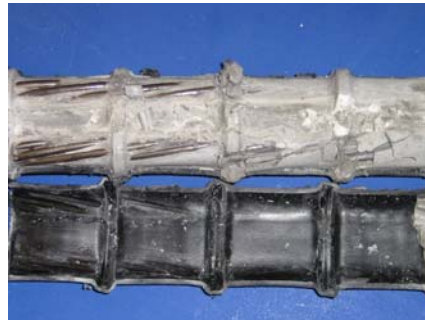
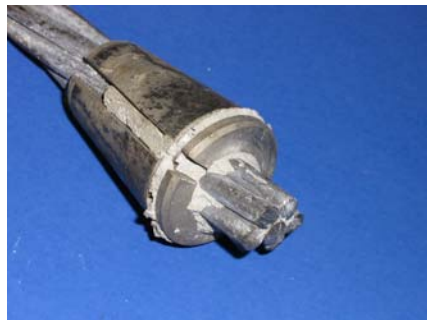
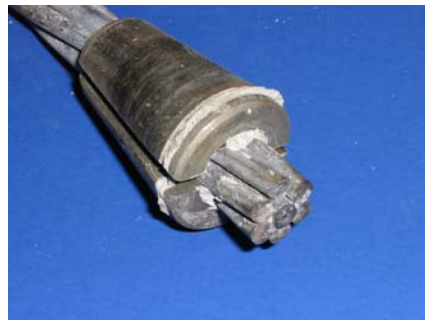
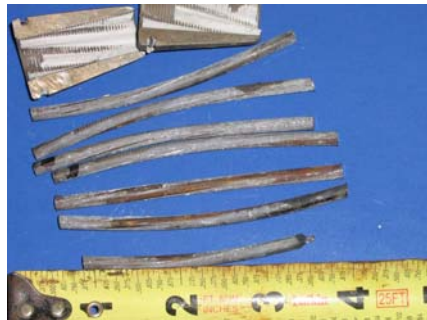
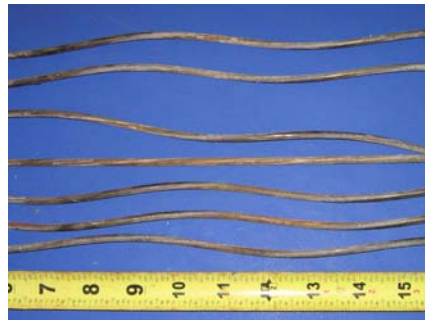
Figure 5.62: Beam 2.12 West End Anchorage (Control End) Autopsy Elements

The portion of the south duct and north ducts within the anchorage were in good condition. Some evidence of strand abrasion was found on both ducts, but no punctures or cracks were found in the ducts. The duct portions from the anchorage are shown in Figure 5.62. Corrosion damage ratings for the ducts are not plotted because they are plastic.

Both ducts were well grouted, and no evidence of bleed water accumulation was found. The grout completely filled the end caps in both ducts, and as previously mentioned, filled the area under the collar. Chloride content testing of the grout in both ducts showed negligible chlorides. Grout from the caps and the collars also showed negligible chlorides. The grout from both ducts is shown in Figure 5.62.

The exterior of the strands from both ducts were in excellent condition, but when the strands were unraveled, light to moderate corrosion was found in the interstices throughout the anchorage. What likely occurred was corrosion from the center of the beam spread down the length of the strand through the interstices. The wedges from both ducts had only some instances of slight discoloration inside the anchorhead. The strand from the anchorage is shown in Figure 5.62. The strand corrosion ratings in the anchorage are plotted in Figure 5.66 and are summarized in Table 5.21.

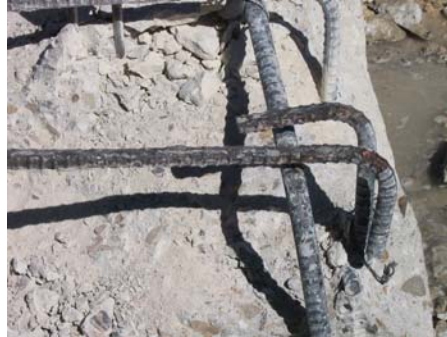
Figure 5.63: Beam 2.12-Corroded Stirrup in East End Anchorage Zone (Dripped End)

During autopsy of the end block containing the east end anchorages, moderate corrosion was found on the stirrups above the cracks in the anchorage as mentioned previously. The stirrup is shown in Figure 5.63.

The stirrup was likely corroded by saltwater splash from the drip pan when the dripper system was run, since the crack was directly beneath the stirrup and above the drip pan for the saltwater.

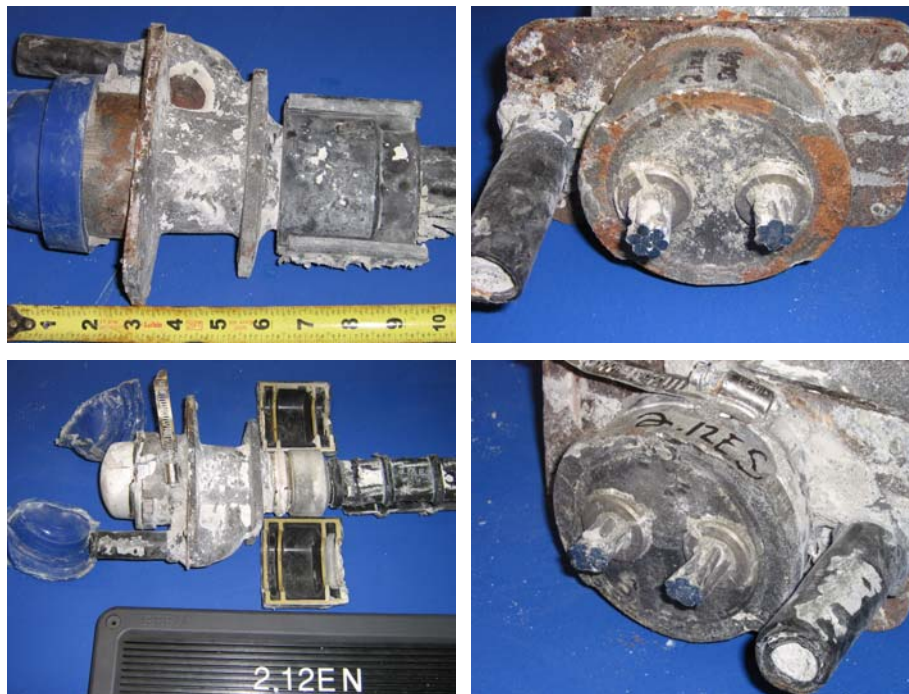
Figure 5.64: Beam 2.12 East End Anchorages (Dripped End)-South Duct Anchorage (Top, Left and Right), and North Duct Anchorage (Bottom, Left and Right)

As shown in Figure 5.64, the north duct anchorhead and bearing plate had some corrosion, while in the case of the south duct there was very little corrosion on the bearing plate or the anchorhead. The north duct anchorhead had corrosion around the o-ring seal, like the anchorages from the other end of the beam. However, the south duct anchorhead had no such corrosion. In the case of both ducts the strand and wedges appeared to be in pristine condition at the anchorhead. When the collars behind the bearing plates were removed, no significant corrosion was found on the bearing plates beneath the collars.

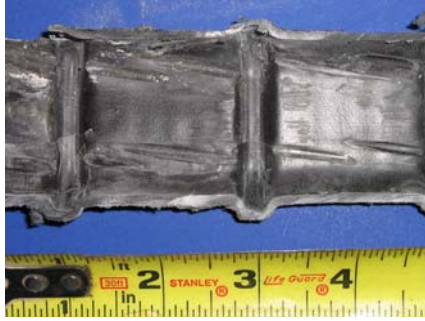
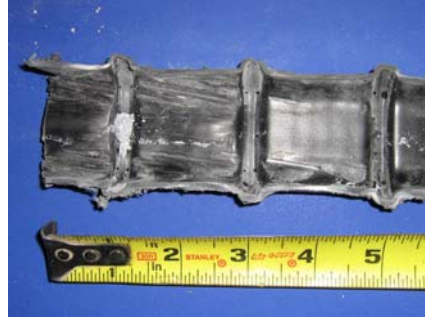
Figure 5.65: Beam 2.12 East End Anchorage Zone (Dripped End) Autopsy Elements

Both the north and south duct portions in the anchorage zone were in good condition. Evidence of abrasion in the plastic duct was found where the strands were in contact with the ducts, but no cracks or holes were found in the ducts. The ducts from the anchorage are shown in Figure 5.65.

Both ducts were well grouted at the anchorage. Very small bleed water voids were seen at some of the peaks of the duct ribs, similar to what occurred in the center of the beam. Grout also completely filled the end cap and the area beneath the collar in the south duct. There was a small void at the top of the cap in the north duct cap. The area beneath the collar was completely filled with grout in the north duct. Chloride content testing of the grout from the cap and collar as well as the duct showed negligible chlorides in both the north and south tendons. The grout from both tendons is shown in Figure 5.65.

The strands in both ducts had light to moderate corrosion, with the corrosion essentially only in the interstices, similar to the strand from the control end of the beam. The wedges in both ducts only had some very light corrosion. The strands from the anchorage are shown in Figure 5.65. The corrosion ratings for the strand in the anchorages are plotted in Figure 5.66 and are summarized in Table 5.21.

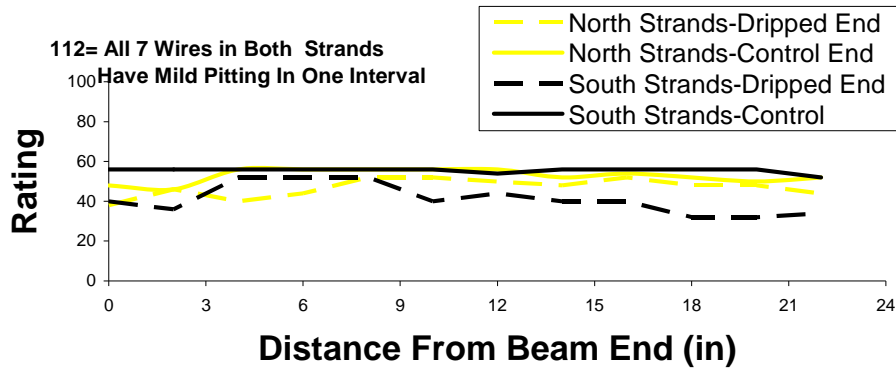
Figure 5.66: Beam 2.12-Strand Corrosion Ratings for Anchorages

In Figure 5.66, the strand corrosion ratings are plotted. Data from both beam ends are plotted together so that a comparison can be made between the dripped end and control end of the beam. It is assumed that the influence of the corrosion of the strands at the center portion of the duct had the same influence on either beam end. The x value "Distance From Beam End" indicates the distance from the respective beam end. The corrosion ratings for the anchorages are summarized in Table 5.21.

From Table 5.21 and Figure 5.66 it is clear that the strand corrosion did not increase between the control end and the dripped end. In addition, the lack of chlorides in both the caps and collars suggest that the encapsulated system prevented chlorides from entering the duct at all. In addition, the tips of the strands outside the anchorhead in both ends of the beam were in much better condition than the strand tips in the non-encapsulated anchorages (Beam 2.7 and Beam 2.9). This demonstrated the fine contribution of the plastic caps used to encapsulate the system.

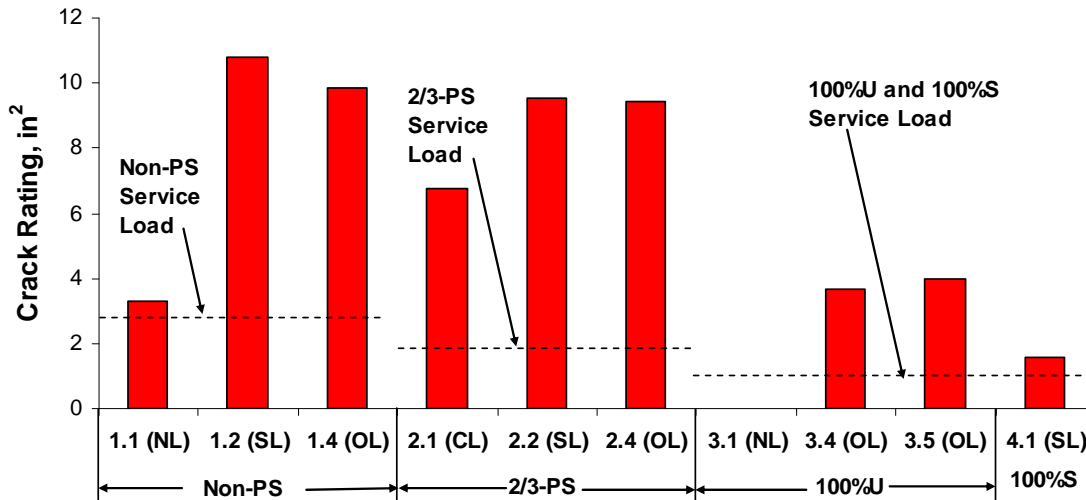
Figure 6.1: Phase I Beams- Crack Ratings

The rating is essentially the surface area of the cracks in the autopsy area. In Figure 6.1, the crack ratings for each of the beams from Phase I are plotted. Note that “NL” indicates no applied load, “CL” indicates small crack load, “SL” indicates service load, and “OL” indicates overload. In order to obtain a relative sense of the amount of cracking in the beams, a baseline service load rating is shown as a dashed line for each section type. This baseline rating represents the crack rating that a fully cracked beam would have under AASHTO maximum allowable service load cracking. It is computed using the typical number of flexural cracks found in the autopsy area in each beam type at service load (nine cracks for Non-PS, six cracks for 2/3-PS, and three cracks for 100% U and 100% S), and the Class 1 crack width from AASHTO of 0.017 inches.²⁰ The cracking rating for beam 1.1 was scaled up to account for the fact that only 42 in. were removed during autopsy. This was not necessary for beam 3.1 since it had no visible cracking.

In all loaded beams except 4.1 (100% S), the crack ratings are much higher than the baseline, due to the extensive longitudinal cracking from the duct and bar corrosion. Beam 1.1, which was never loaded, actually exceeded the crack rating for service load

just from the effect of the bar corrosion. When comparing specimens with similar loading, it is clear that the long-term cracking was only reduced for the beams that were fully prestressed (100% U and 100% S), since the loaded Non-PS beams and the loaded 2/3-PS beams had essentially the same level of cracking.

When comparing specimens with the same levels of prestress, it is evident from the 2/3-PS beams and the Non-PS beams that once the specimen reaches service load cracking levels there is no real difference in the long-term cracking behavior. However, the 2/3-PS specimen, which was initially loaded to only a small crack width, did have a considerably lower long-term cracking rating. Even though all the 2/3-PS specimens had wide longitudinal cracks, the somewhat lower rating in this beam was caused by the fact that the flexural cracks were smaller in width than the other 2/3-PS beams.

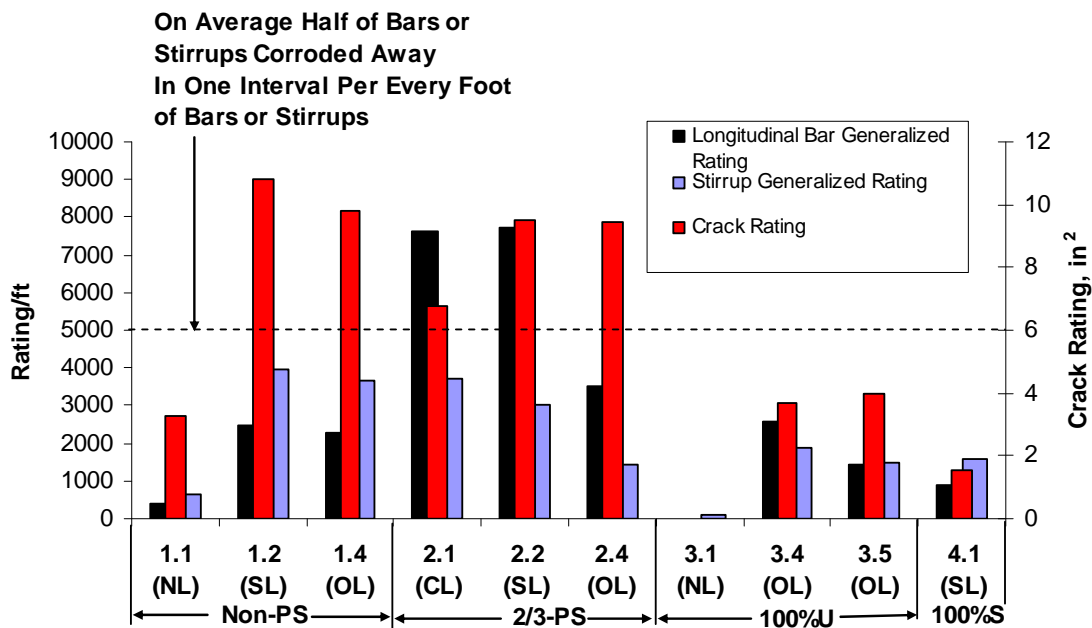
Figure 6.2: Phase I Beams- Stirrup and Longitudinal Bar Generalized Ratings versus Crack Ratings

The longitudinal bar and stirrup generalized ratings for the Phase I beams are plotted in Figure 6.2, along with the crack ratings. In order to obtain a relative sense of the amount of corrosion of the uncoated reinforcement components, a baseline generalized corrosion rating is shown as a dashed line on the plot. It corresponds to extremely heavy corrosion in which half of the reinforcement would be completely corroded over at least one 2-in. interval in each ft of bar or stirrup.

Figure 6.2 shows that, when comparing specimens with same level of applied load, the stirrup and longitudinal bar damage was substantially less for fully prestressed specimens. The high ratings in the 2/3-PS beams are caused by the fact that the #3 bars were completely corroded away in many locations. The damage was not as severe in the Non-PS beams because the bars were larger (#4's and #5 bars).

Increasing the initial level of loading did not have any appreciable effect on the bar or stirrup damage in the Non-PS or 2/3-PS beams. Of course, the unloaded Non-PS beam (1.1) had little damage due to the lack of an applied load.

Only in the Non-PS beams do the crack ratings follow the trend of the bar corrosion. In the prestressed beams, the duct corrosion as well as bar corrosion are contributing to the longitudinal cracking. This explains why the crack ratings do not follow the trend of bar damage in the prestressed beams.

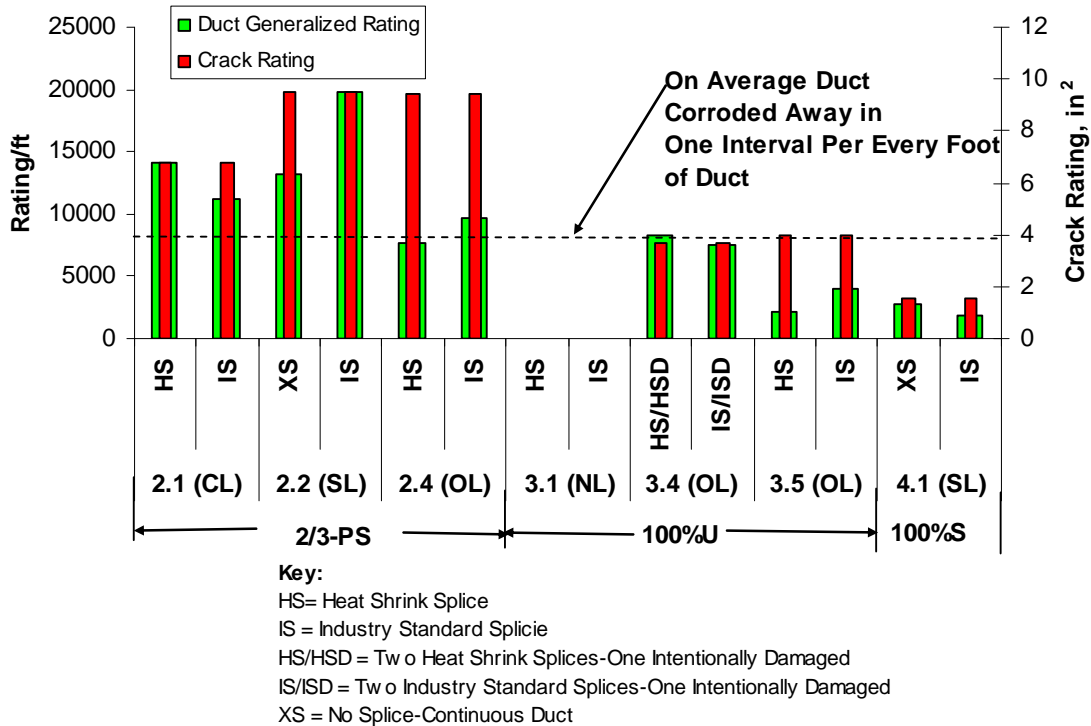
Figure 6.3: Phase I Beams-Generalized Duct Ratings (Organized by Splice Type)

The duct ratings for the Phase I beams are plotted in Figure 6.3, along with the crack ratings. The ducts in each beam are identified by splice type for proper comparison. Again, a baseline generalized rating is provided as a dashed line to indicate the rating corresponding to very severe corrosion where an entire 2-in. interval of duct is corroded away in each ft of duct.

When comparing specimens/ducts with similar loadings and with the same splice types, it is clear that the amount of damage in the ducts clearly decreased once the beam was fully prestressed.

Increasing the level of loading, which can be only be analyzed with the 2/3-PS beams, had no significant effect on the amount of damage in the duct.

There is no trend between the crack ratings and duct corrosion when comparing beams with similar levels of prestress. This is likely from the fact that bar corrosion, not just duct corrosion, is contributing to the cracking.

It is also clear the presence of the splice was not a significant factor in the amount of duct corrosion, since large portions of duct were corroded away even in areas where there were no splices.
