1. Report No. FHWA/TX-08/0-4562-2		2. Government Accession No.		3. Recipient's Catalog No.	
4. Title and Subtitle Durability Evaluation of Post-Tensioned Concrete Beam Specimens after Long-Term Aggressive Exposure Testing			5. Report Date November 2007

Durability Evaluation of Post-Tensioned Concrete Beam Specimens after Long-Term Aggressive Exposure Testing

Center for Transportation Research
The University of Texas at Austin
3208 Red River
Austin, TX 78705

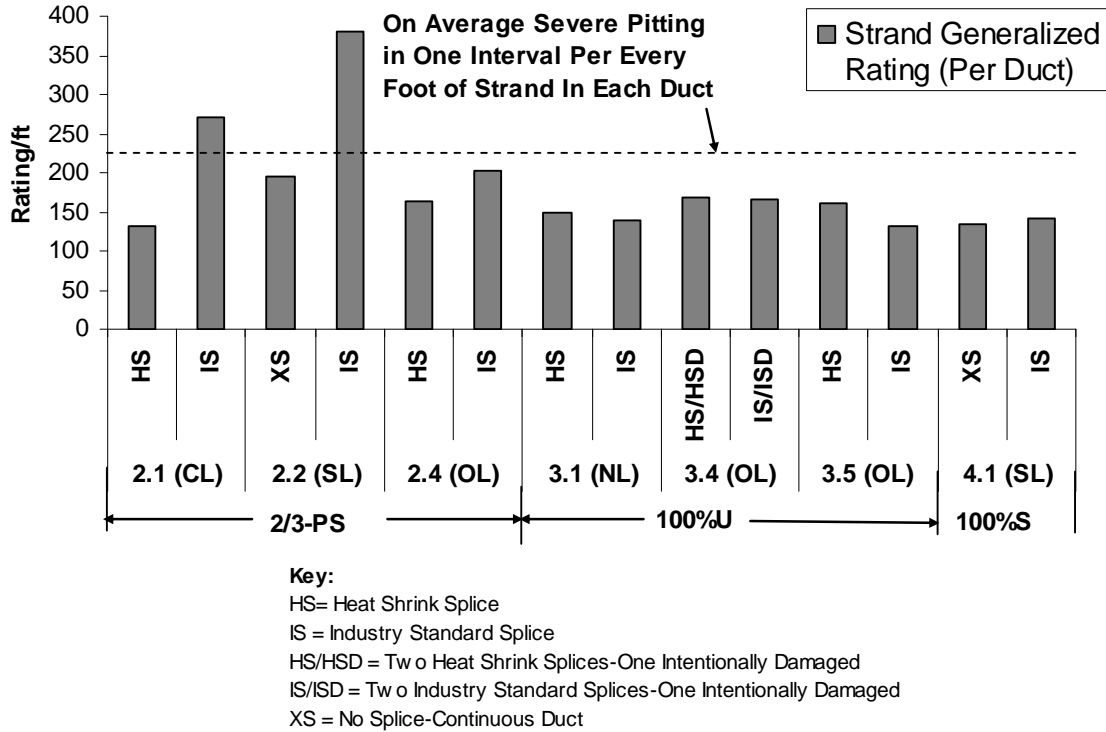
Figure 6.4: Phase I Beams-Strand Generalized Ratings

The generalized strand ratings for each duct are plotted in Figure 6.4. Again, a baseline generalized rating is provided as a dashed line representing severe pitting occurring in one 2-in. interval for each ft of strand in each duct.

In Figure 6.4, when ducts with similar loadings and splices are compared, there is, in general, a decrease in strand corrosion with increased levels of prestress. This is especially true when comparing beams 2.2 and 4.1. However, when comparing the specimens at overload, beams 2.4 and 3.5, there is no difference between the ducts with the heat shrink splices. In general, the differences in strand corrosion are not as dramatic as the differences in bar and stirrup and in duct corrosion. Given the large amount of interstitial corrosion in the strands (mentioned in Chapter 5), it is likely that once a single part of the strand is corroded, then the chlorides can be transmitted through the interstices and thus corrode the entire length of strand.

When comparing the identical ducts in the 2/3-PS beams, there is no clear trend between strand damage and the level of applied load.

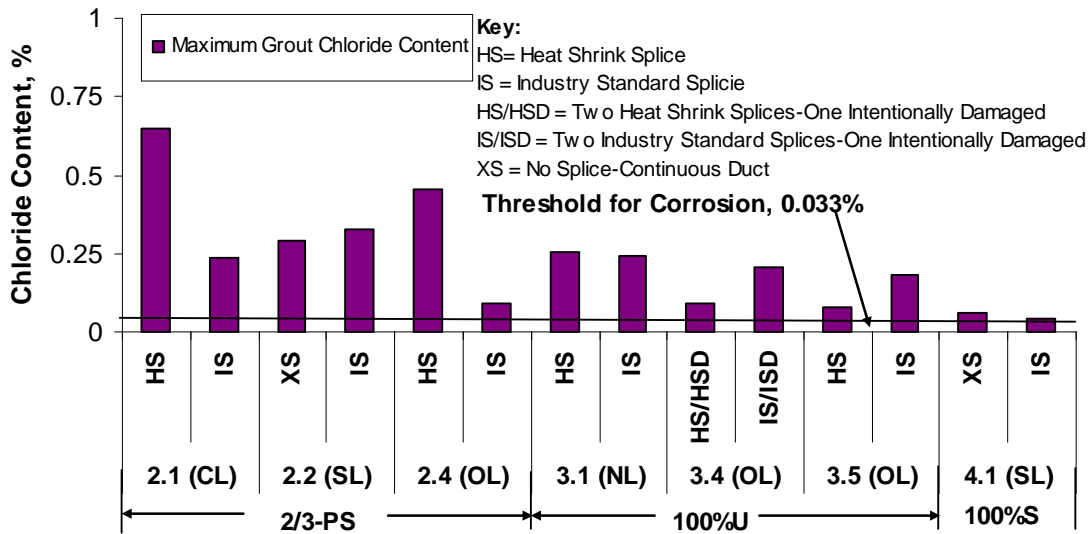
Figure 6.5: Phase I Beams-Maximum Grout Chloride Content in Each Duct

As shown in Figure 6.5, and as mentioned repeatedly in Chapter 5, the maximum chloride contents in all the tendons were higher than the threshold for corrosion of 0.033 percent. Therefore, any differences between specimens with similar loadings or prestress are inconsequential.

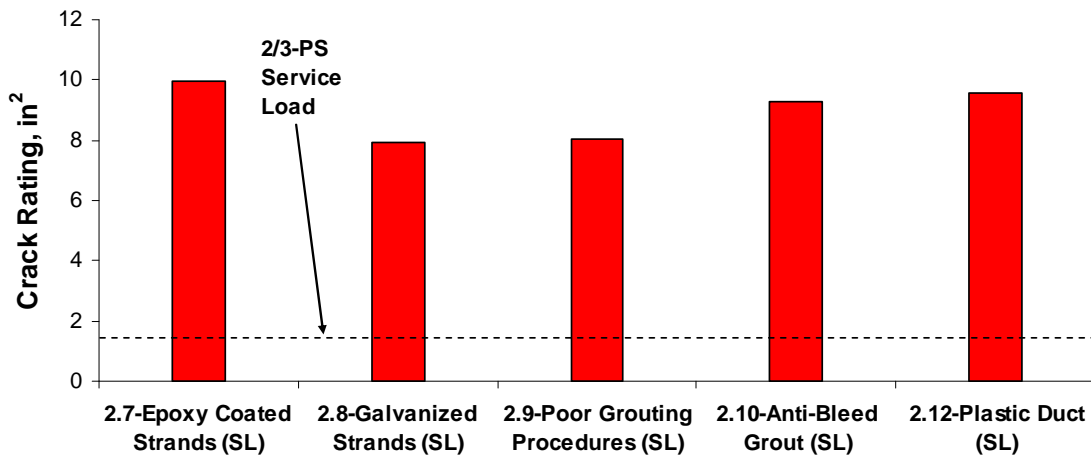
Figure 6.6: Phase II Beams-Crack Ratings

As shown in Figure 6.6, all the Phase II beams exhibited similar very poor long-term cracking behavior. Their cracking behavior is comparable to the 2/3-PS service load beam from Phase I (Beam 2.2).

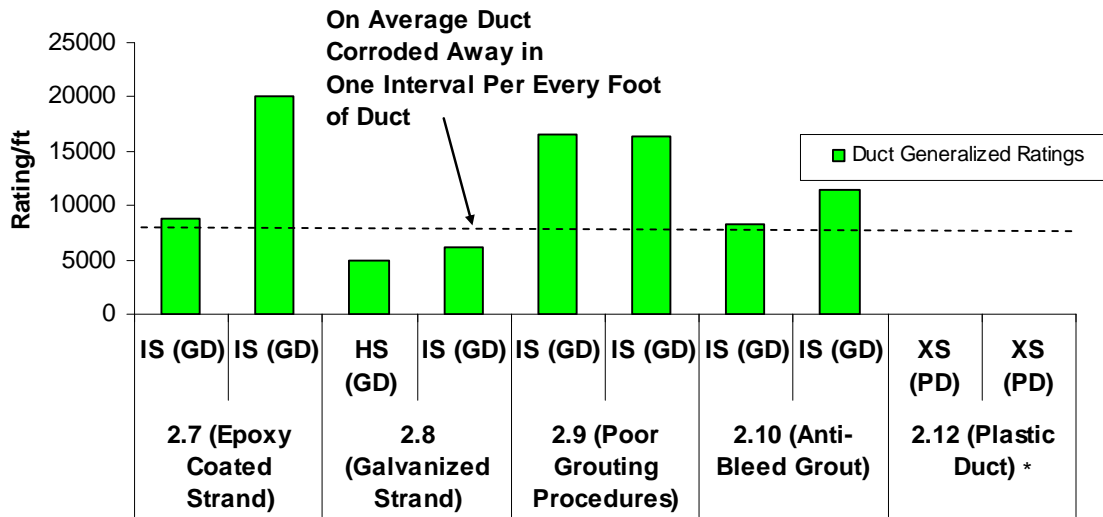
Figure 6.8: Phase II Beams-Duct Generalized Ratings

As shown in Figure 6.8 and as was found previously with the Phase I beams, the galvanized ducts performed extremely poorly. As mentioned in Chapter 5, the plastic ducts in beam 2.12 were punctured due to mechanical failure. As shown in Figure 6.9, this resulted in greater strand damage than with the comparable specimen with galvanized duct, beam 2.9 (the proper comparison is with beam 2.9 since it has the same grout type in addition to conventional strand.) As shown in Figure 6.10, the chloride content in the plastic duct specimen was still lower than the threshold for corrosion. As explained in Chapter 5, this is likely from the fact that the chlorides entered the strand almost directly through the punctures, and as a result, only a small amount of chloride may have been

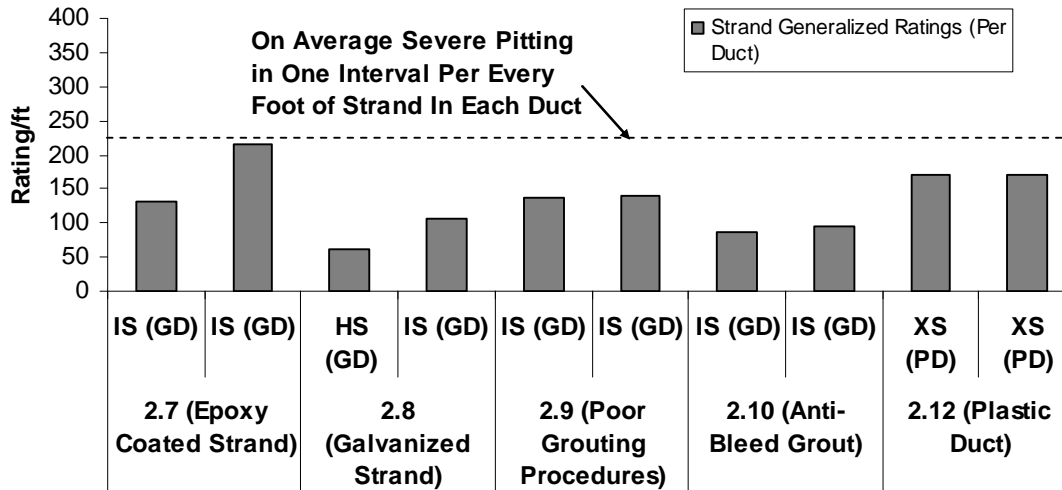
Figure 6.9: Phase II Beams-Strand Generalized Ratings

As shown in Chapter 5 and clearly shown in Figure 6.9, the non-flow filled epoxy coated strand used in this study performed poorly in comparison to conventional strand (this comparison is made between beams 2.7 and 2.9 since both have the same type of grout). Abrasion damage to the brittle epoxy coating as a result of prestressing operations allowed chloride ingress onto the strand surface. Because the coating did not also fill the interstices of the strand, the moisture was able to spread throughout the length of the strand. The damage might have been minimized if the epoxy had filled the interstices, so-called “flowfilled” epoxy strand. It would also be preferable if the epoxy had better mechanical properties to resist abrasion and wedge tooth penetration.

As presented in Chapter 5 and as shown in Figure 6.9, galvanized strand performed only slightly better than conventional strand. Thus, it still performed poorly. The presence of the galvanized coating only delayed the onset of corrosion.

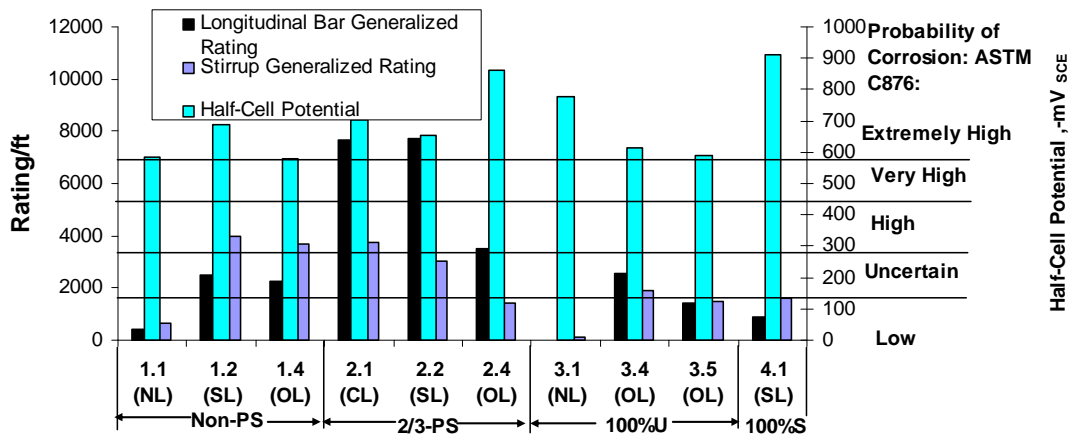
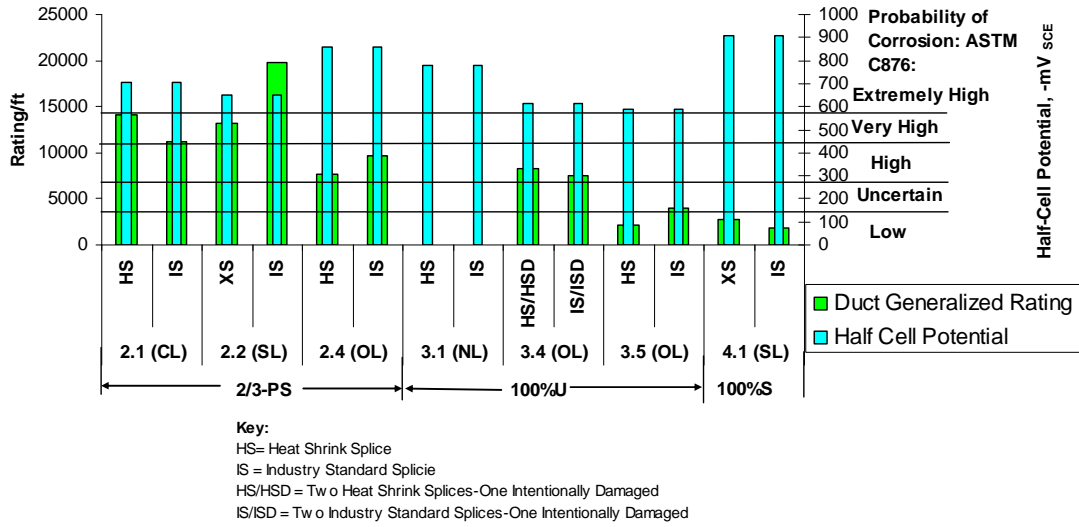
In Figure 6.11 and Figure 6.12 the half-cell data essentially indicate a greater than 90 percent probability of corrosion (extremely high probability) for all beams. Indeed, all bars, stirrups, and ducts were at the very least significantly corroded in all specimens. Thus, the half-cell potentials were correct in this matter. However, it is also clear that half-cell readings do not give a good estimate of the relative corrosion damage in the specimens. This is exemplified in Figure 6.11 by beams 3.1 and 4.1, where the relative bar and stirrup damage was low but these two beams had some of the highest half-cell potential readings. This is also true in Figure 6.12 for the duct ratings for these beams as well. Only in the Non-PS beams do the half-cell data show the same trend as the stirrup and longitudinal bar data. This is significant because the bars and stirrups are the only elements corroding in the Non-PS beams since the Non-PS beams have no tendons. Because the galvanized ducts are in metal to metal contact with reinforcing bar cage in the prestressed specimens, a circuit is formed between the tendons and the bars and stirrups. Thus there is a large amount of interaction which may be causing the behavior shown in the half-cell potential data. The reinforcing bar, stirrup and duct ratings for the Phase II beams are plotted with the half-cell potential data in Figure 6.13.

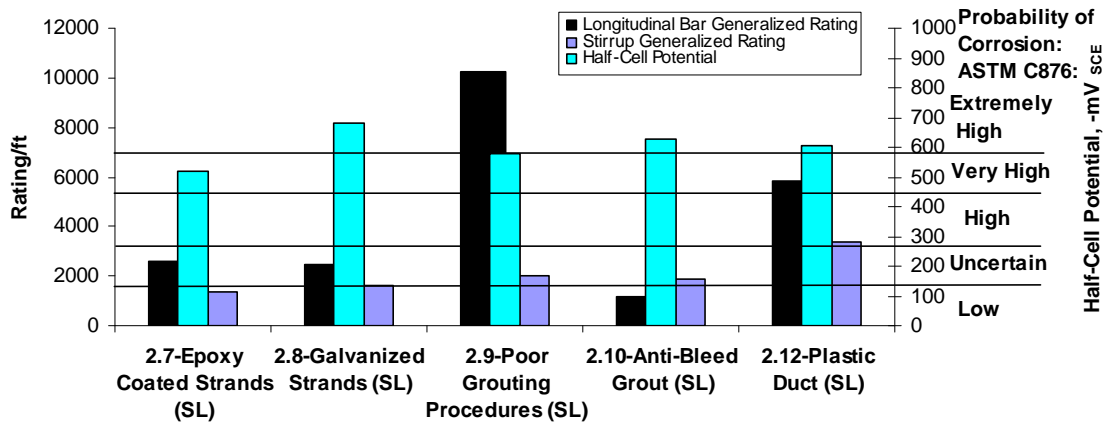
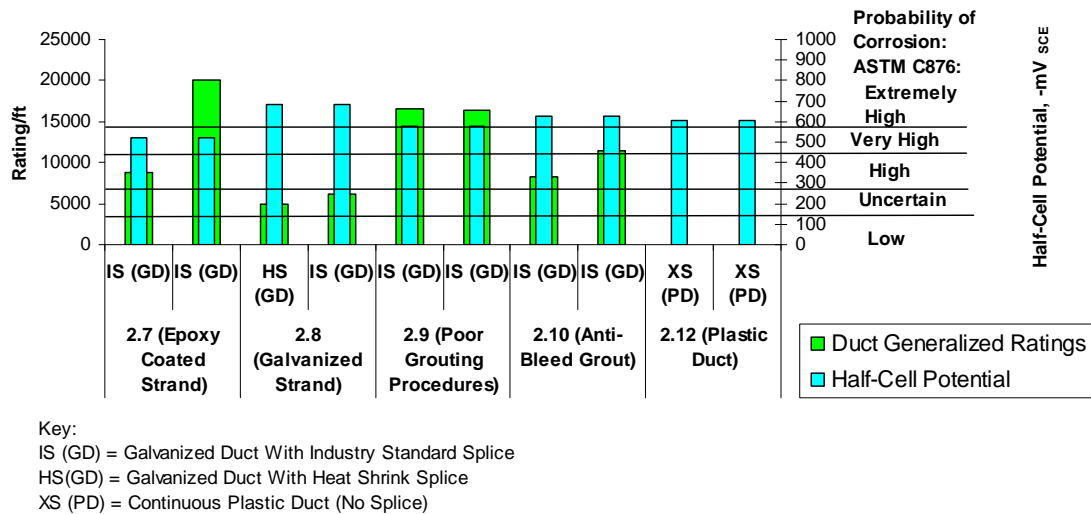
In Figure 6.13 all the half-cell potential data from all phase II beams suggested at least a very high probability of corrosion for all beams (all beams except for 2.7 were in the extremely high range.) Indeed, the stirrups and the bars in all the beams were heavily corroded. So using the half-cell data to conclude that corrosion was present was accurate. However, there is no clear trend between the amount of the bar and stirrup corrosion damage and the half-cell potential readings. Careful examination of Figure 6.14 reveals that, in general, the half-cell potential data actually decreased (in absolute value) with increased duct corrosion, but only slightly. All the galvanized ducts in the Phase II beams were heavily corroded at the end of testing. Of course, beam 2.12 (plastic ducts), which had half-cell potential values in the same range as the rest of the beams, had no duct corrosion. As mentioned for the Phase I beams, the two beams with the least amount of duct corrosion (beams 4.1 and 3.1) had some of the highest half-cell potential readings. Also, the half-cell potentials in the Phase I Non-PS beams were the only readings that agreed with the relative levels of damage in the beams. It is also known from electrochemistry in corrosion that any interaction between zinc and regular steel will result in more negative potentials in the circuit between the ducts and the bars. Therefore, this would all suggest that the zinc in the galvanized ducts is what is causing the incorrect relative behavior of the half-cell data. The interaction of the zinc and the steel reinforcing cage causes very negative values, but once the zinc has sacrificed itself and the duct begins to corrode away the corrosion of the reinforcing bars begins to dominate the half-cell readings. This suggests that the use of half-cell potentials to determine corrosion of ducts and strands is problematic.

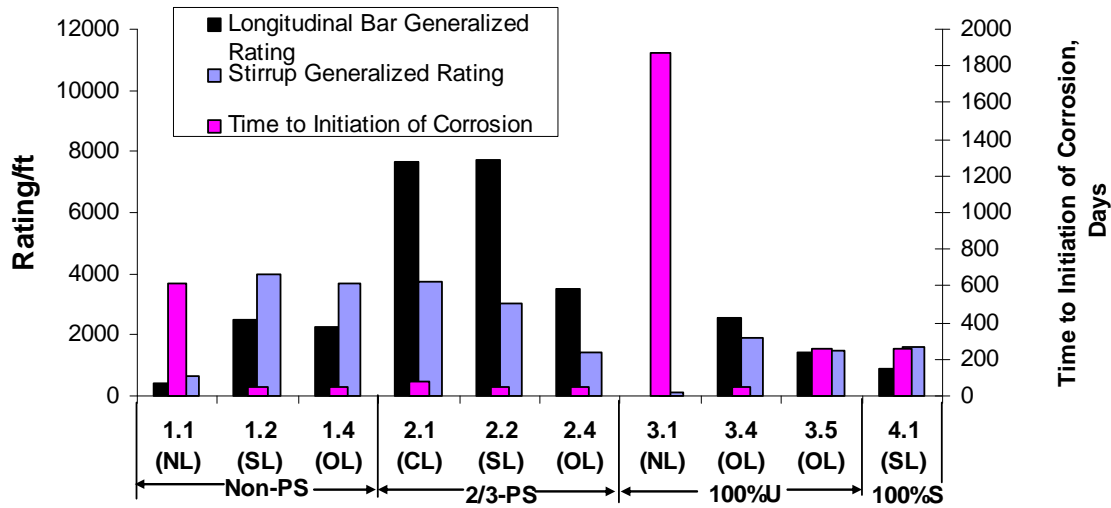
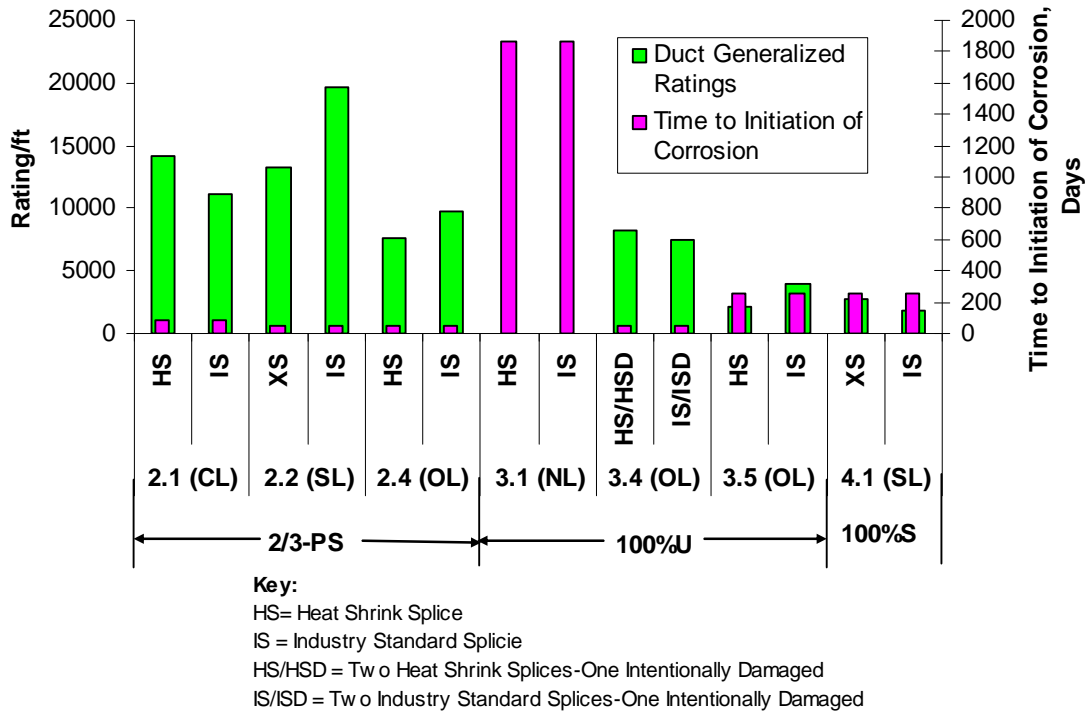
As stated in Chapter 4 and as shown in Figure 6.15 and Figure 6.16, the two unloaded beams (1.1 and 3.1) showed much longer times to initiation of corrosion than the other specimens. In the case of the 2/3-PS beams, maintaining the load at small crack levels delayed the onset of corrosion. Also, the time to initiation of corrosion was significantly delayed when the beams were fully prestressed (the service load and overload Non-PS beams and 2/3-PS beams began corroding at the same time). It is clear from Figure 6.15 and Figure 6.16 that the delay in the time to initiation of corrosion had no real effect overall on the final amount of corrosion in the beams. Of course, beams 1.1 and 3.1 had little corrosion due to the lack of cracking due to an applied load, which also delayed the onset of corrosion. This is not surprising considering the fact that all the loaded beams began to corrode within 1 year, which is insignificant considering that the length of exposure testing was a little over 8 years. In Figure 6.17 the Phase II beam stirrup and longitudinal bar ratings are plotted along with the time to initiation of corrosion.

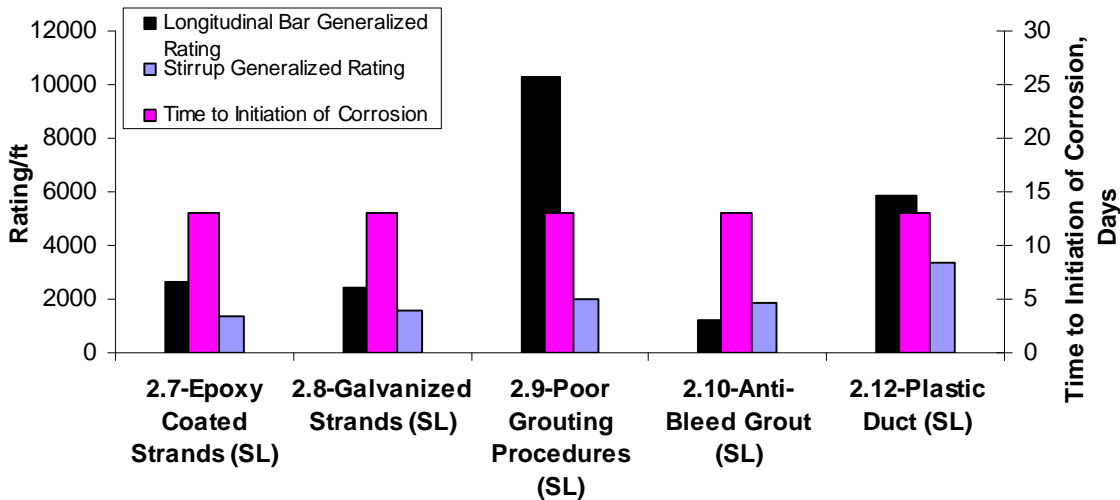
Figure 6.17: Phase II Beams-Stirrup and Bar Generalized Ratings versus Time to Initiation of Corrosion

As mentioned in Chapter 4 and shown in Figure 6.17, all the Phase II beams indicated corrosion when the first set of readings was taken at 13 days. The bar and stirrup ratings varied among the specimens (as well as the duct ratings, shown in Figure 6.8), but all were very severe. This also suggests that the time to initiation of corrosion in cracked loaded beams has no effect on the final amount of corrosion, since the time to

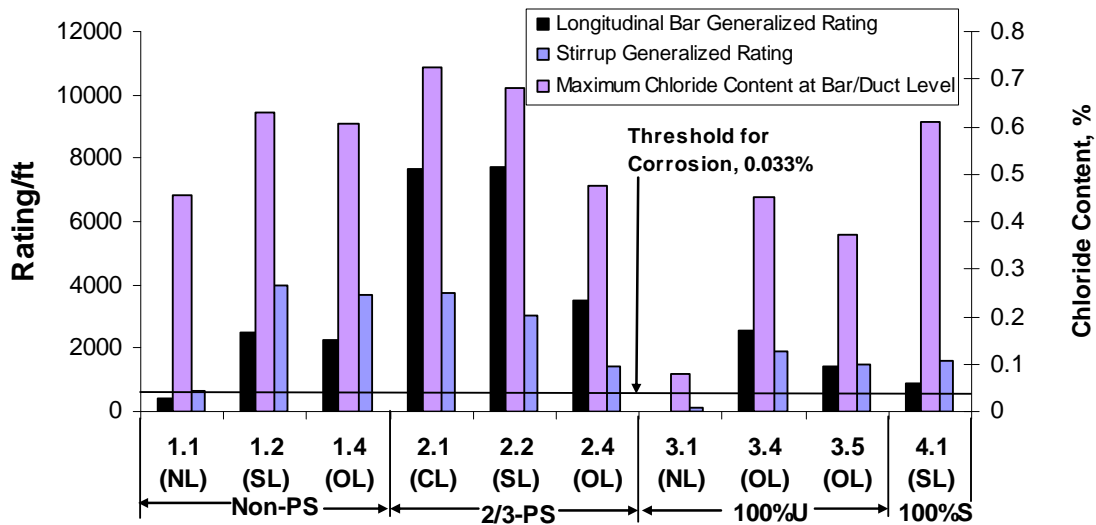
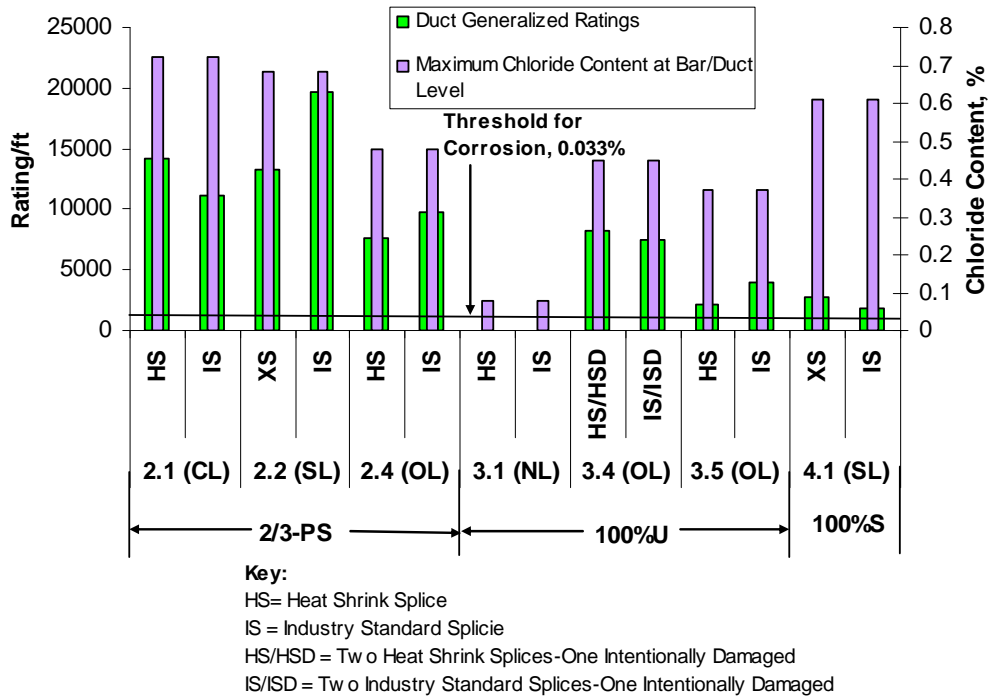
As shown in Figure 6.18 and Figure 6.19, and as mentioned in Chapter 4, the threshold for corrosion was reached at bar/duct level in the ponded region in all beams. During autopsy, the bars and stirrups in all beams were found to be severely corroded. While the corrosion was typically the highest in the areas of the flexural cracks, it was also significant in areas where there was no flexural cracking (from the longitudinal cracking). In Chapter 5 it was also noted that many of the beams had wide longitudinal splitting cracking, which was from severe bar corrosion. As mentioned in Chapter 4, in several instances the concrete ponding blocks were found to have reached the threshold for corrosion. Therefore, it would appear that chloride ingress due to high concrete permeability was beginning to become significant. The corrosion this caused on the bars and ducts and in the Phase I beams steel bolster strips likely initiated the longitudinal cracking. This is also supported by the fact that the unloaded beam 3.1, which had a very low chloride content (but still above the threshold), had no longitudinal cracking. The

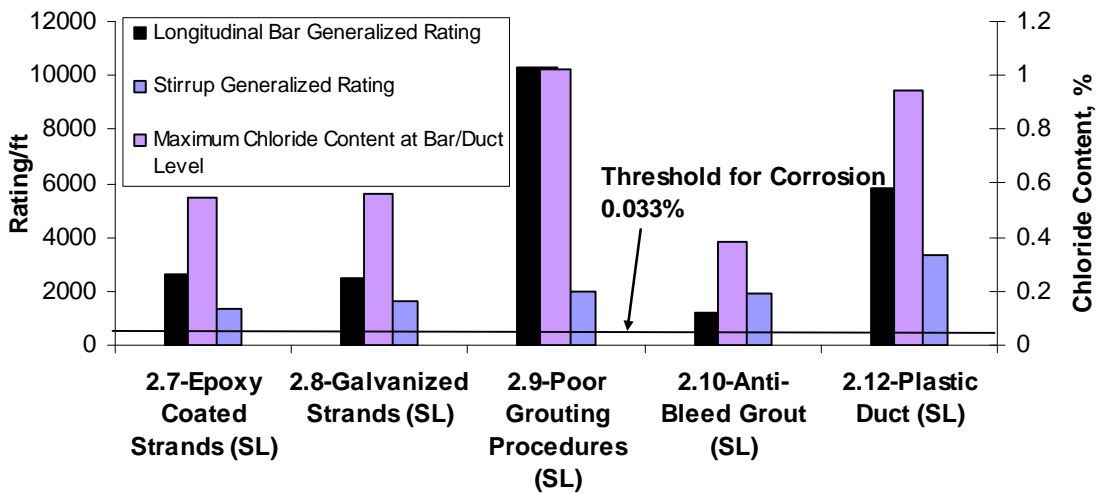
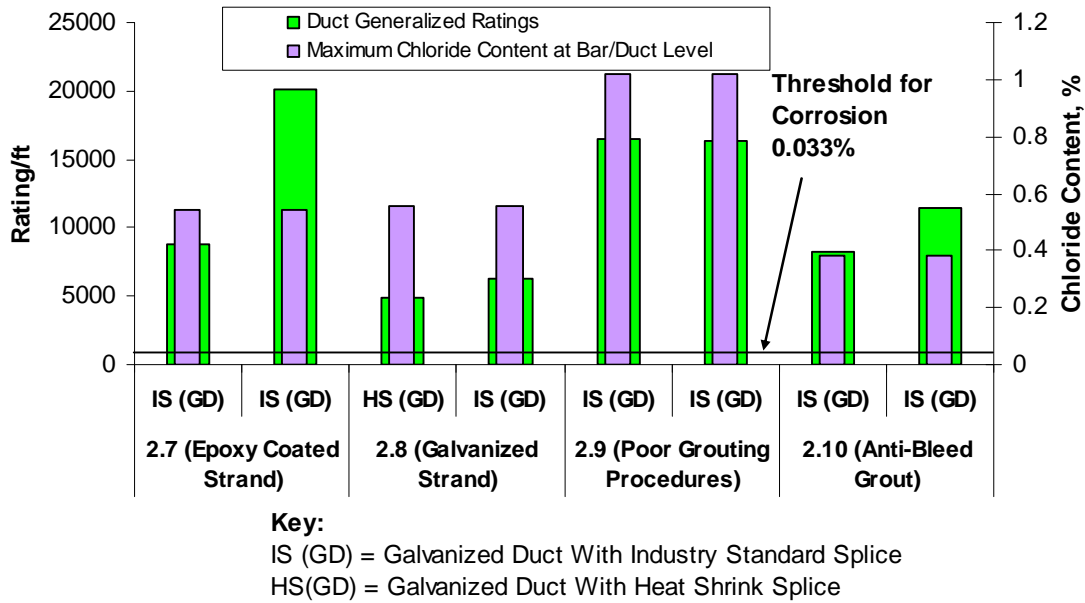
Again, the threshold for corrosion was reached in all beams and severe bar, stirrup and duct corrosion were found. It is interesting to note in Figure 6.20 that the relative bar ratings coincide with relative chloride content. However, the stirrups do not. In Chapter 5 it was noted that in the Phase II beams flexural cracks would form at stirrup locations. So, the stirrups are corroded by chlorides entering at the flexural cracks for the most part. The fact that the relative values of the chloride contents and the longitudinal bar ratings coincide further suggests that concrete permeability, not just flexural cracks, was playing a major role in the corrosion damage of each beam after the long period of exposure.

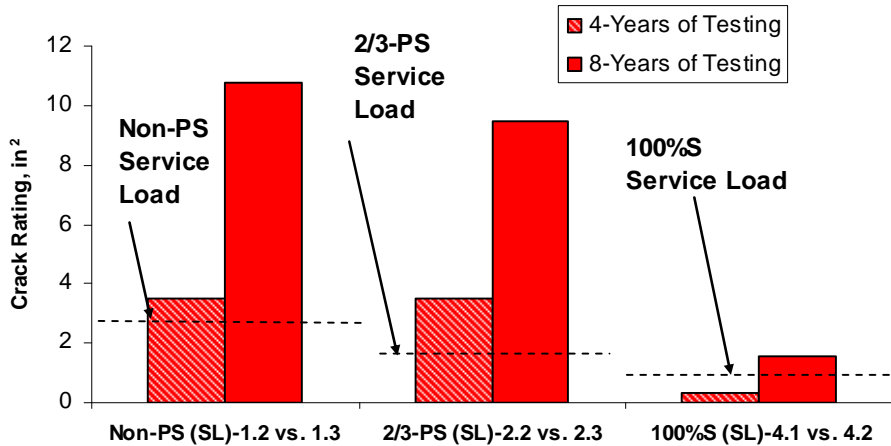
Figure 6.22: Phase I Beams- 8-Year Crack Ratings versus 4-Year Crack Ratings¹⁴

The crack ratings increased tremendously after an additional 4 years of testing. Details of the autopsies of the 4-years beams are found in Salas.¹⁴ The trends among the beams are similar, but more pronounced with the longer exposure time. In Figure 6.23 the duct ratings for the equivalent 4-year and 8-year prestressed beams are plotted. The strand ratings are plotted in Figure 6.24.

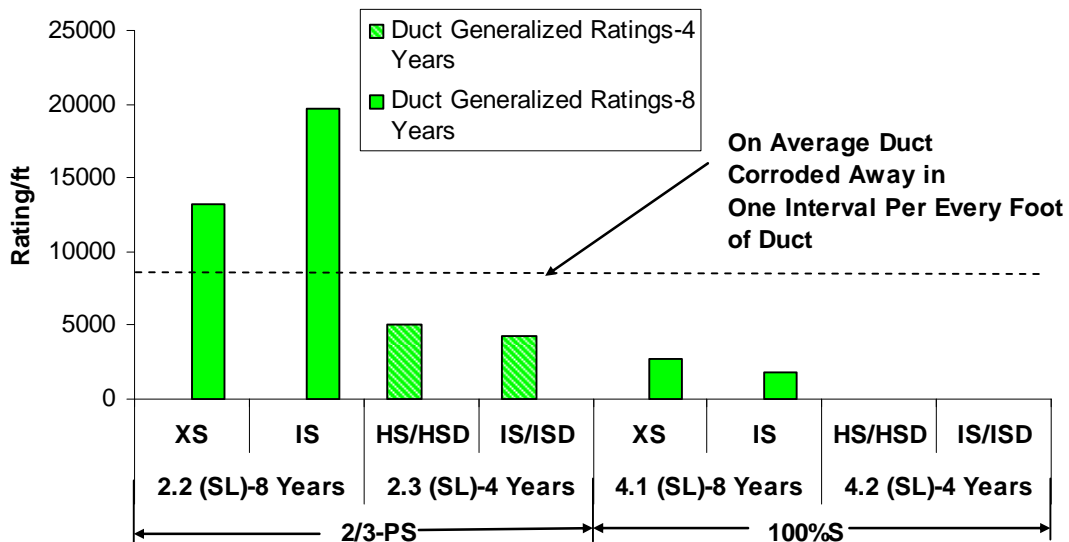
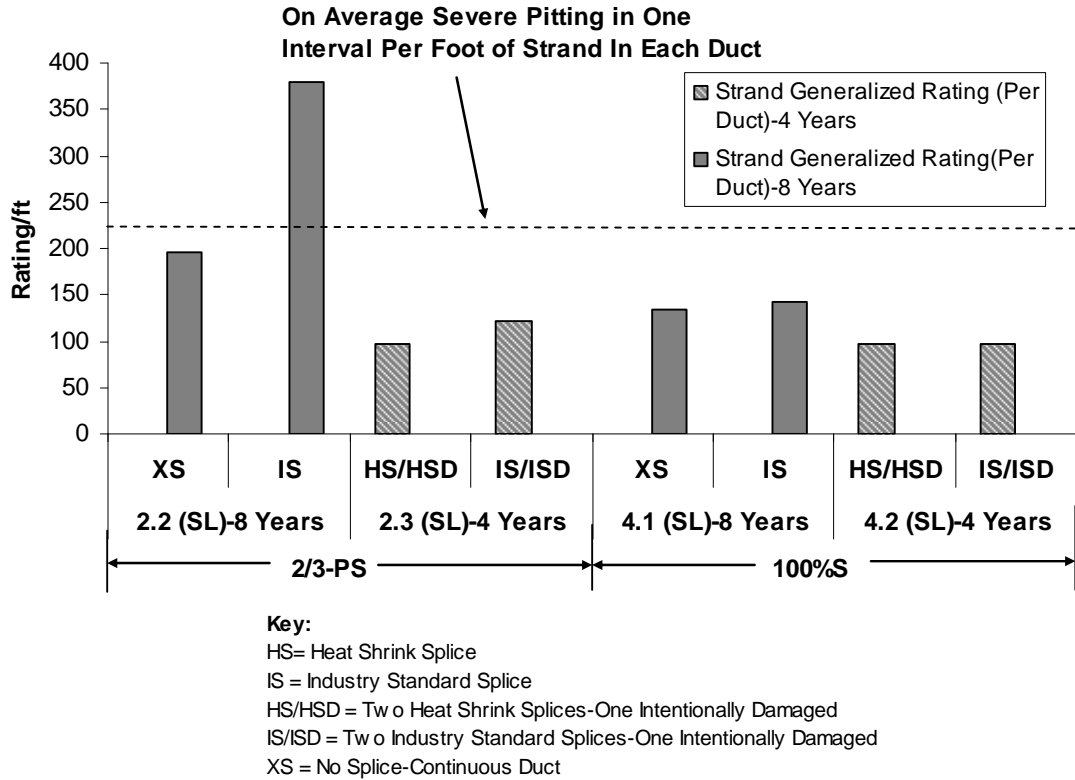
From Figure 6.23, it is clear that the duct corrosion increased dramatically after an additional 4 years of exposure. This is especially evident in the 100%S beams (4.1 versus 4.2). In the 4-year autopsies, there was little corrosion evident in the ducts, but at 8 years, the ducts were heavily holed. The strand ratings in Figure 6.24 show that strand corrosion increased significantly in both the beam types with the additional testing time. It is even more prevalent with the 2/3-PS beams. However, in making this comparison, the fact that different duct splices are used must be ignored.

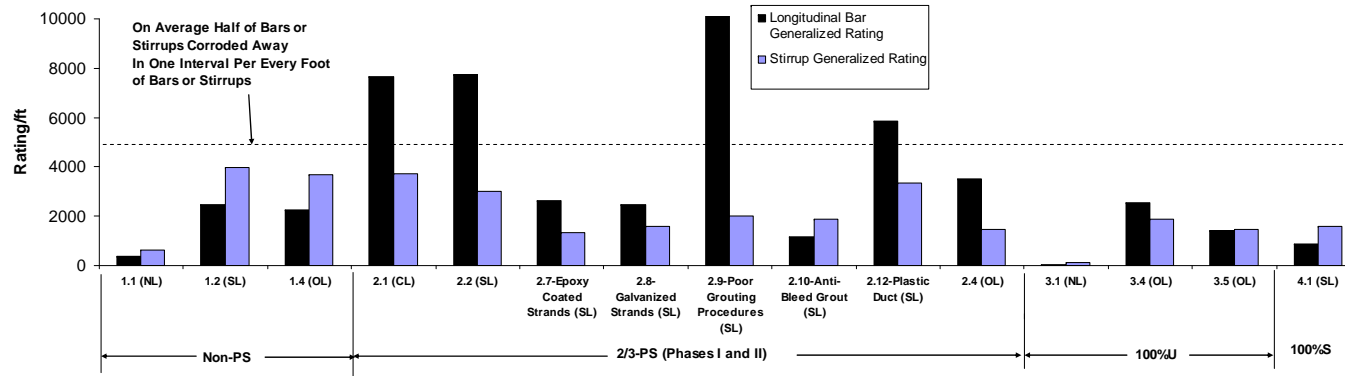
Figure 6.25: Phase I and Phase II Beams-Generalized Bar and Stirrup Ratings

In Figure 6.25, the bar and stirrup ratings for the Phase I and Phase II beams are plotted together for comparison. The Phase II beams are placed alongside the equivalent 2/3-PS beam from Phase I (Beam 2.2). The duct and strand ratings are plotted in Figure 6.26 and Figure 6.27, respectively.

It is clear that Phase II beams (All 2/3-PS at Service Load) performed similarly to the 2/3-PS beams of Phase I. Thus, the relatively small difference in testing time between the two phases was negligible and the beams are comparable.
