1. Report No. FHWA/TX-11/0-4562-4		2. Government Accession No.		3. Recipient's Catalog No.	
4. Title and Subtitle Evaluation of Corrosion Resistance of Improved Post-tensioning Materials after Long-term Exposure Testing				5. Report Date October 2011

Evaluation of Corrosion Resistance of Improved Post-tensioning Materials after Long-term Exposure Testing

CTR Technical Report:	0-4562-4
Report Date:	October 2011
Project:	0-4562
Project Title:	Corrosion Resistance of Grouted Post-Tensioning Systems
Sponsoring Agency:	Texas Department of Transportation
Performing Agency:	Center for Transportation Research at The University of Texas at Austin

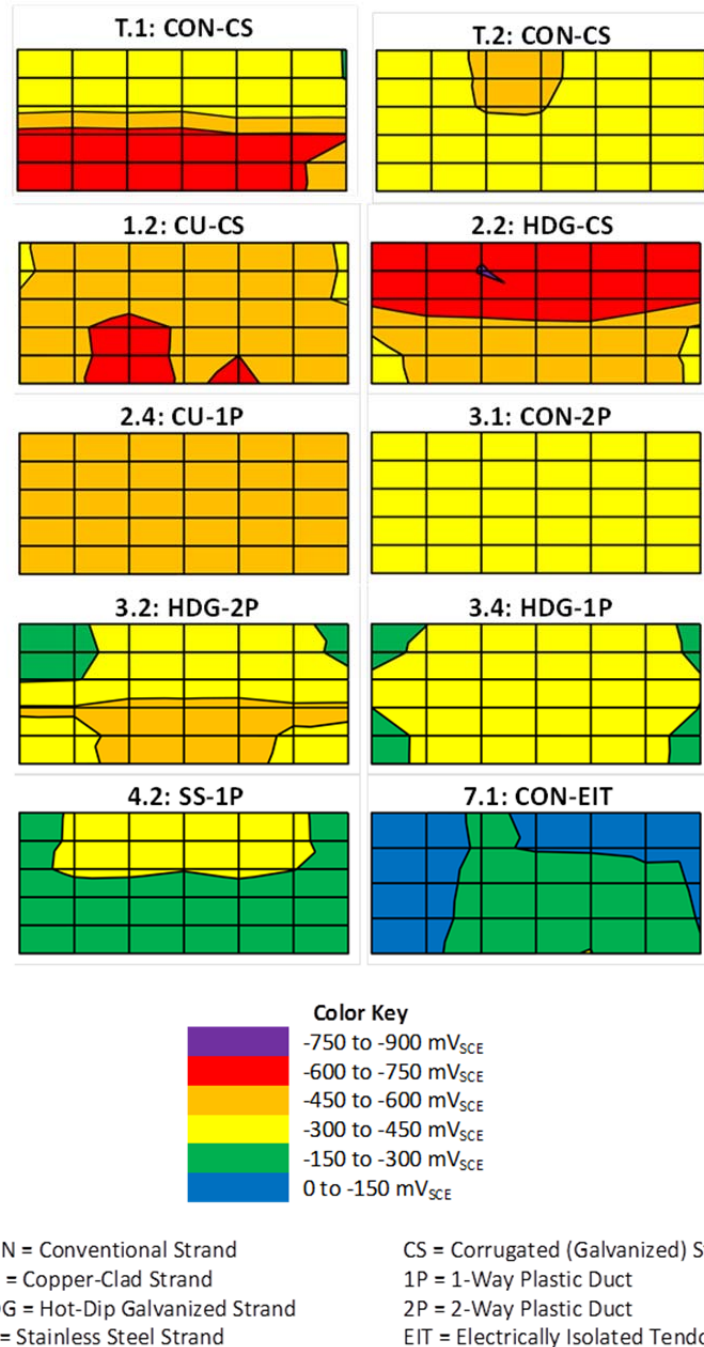
Figure 4.1: Final Half-Cell Reading Contour Maps

Spatially, there are some discernible patterns visible in the contour maps. For specimens T.1, 2.2, 3.2, and 4.2, the potentials were noticeably different between the north and south tendon regions, implying that damage may have been more severe in one tendon. For other specimens, the difference was not as clear. Specimens 4.2 and 7.1 had the least negative readings overall, indicating that they had experienced less corrosion than the other specimens. In addition, it appears from nearly all the contour maps that potentials were least negative at the live and dead ends of the monitoring region. This may have occurred because the tendons are draped, making

them slightly deeper within the specimen at the end regions. This is important because as depth to steel increases, so does the inaccuracy of the half-cell potential measurement¹⁴. The average final half-cell reading for each specimen is plotted in Figure 4.2.

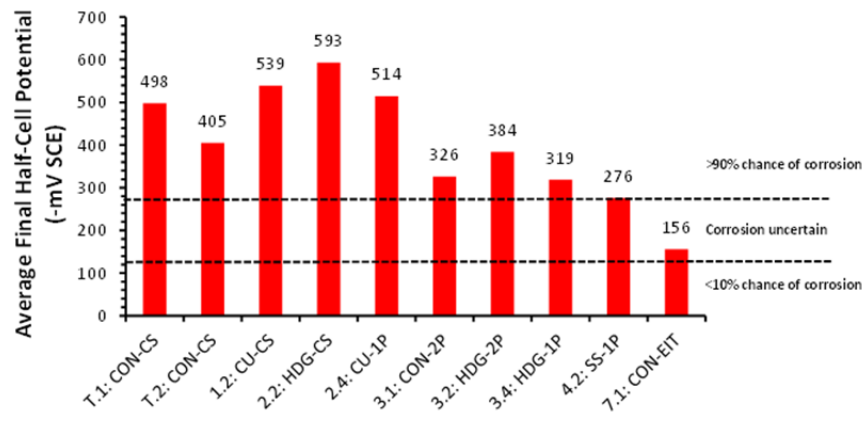
Figure 4.2: Average Final Half-Cell Readings

Specimen 2.2 had the most negative final average potential, while specimen 7.1 had the least negative potential. This probably indicates the effectiveness of the electrically isolated system used in specimen 7.1. Specimens with galvanized steel ducts had an average final half-cell potential of $-509 \text{ mV}_{\text{SCE}}$, while those with plastic ducts had an average final potential of $-329 \text{ mV}_{\text{SCE}}$. This suggests that specimens with plastic ducts had less corrosion at the time of autopsy. Average final potential for specimens with conventional strand was $-346 \text{ mV}_{\text{SCE}}$, while the average for specimens with any other type of strand was $-437 \text{ mV}_{\text{SCE}}$, indicating that the specimens with conventional strand were actually less corroded than the specimens with novel strand types at autopsy. This seems highly counterintuitive but can be explained. Averaging the final readings in this manner ignores the individual contributions of each element to corrosion. The higher potentials of the specimens with novel strand types may have occurred due to a higher degree of corrosion in the specimens' reinforcing steel or ducts. Also, different types of strand are likely to corrode in ways that produce different potentials. Analysis of the final half-cell potentials alongside the results of the forensic analysis will shed more light on the corrosion within each specimen.

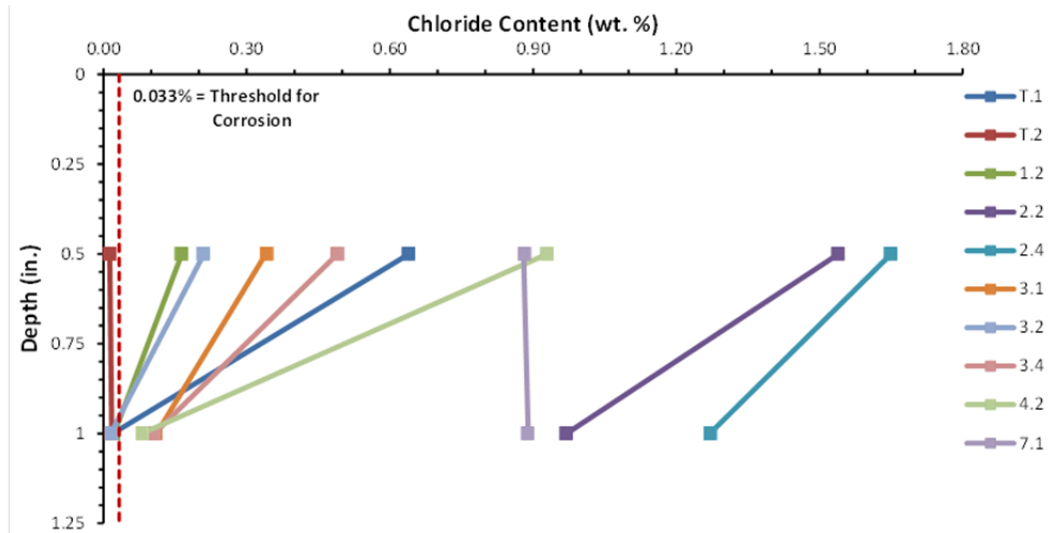
Figure 4.8: Specimen Chloride Content at Top Surface, 2-Inch Offset

Chloride content decreased with depth for all specimens except for Specimen 7.1. It is possible that the presence of additional indentations within that specimen's saltwater tray caused a chloride distribution in which concentrations were actually higher at 1 inch depth than at 0.5 inches. At a depth of 0.5 inches, chloride content was well above the corrosion threshold for every specimen except for T.2. At 1 inch depth, chloride content was above the threshold for six of the ten specimens.

The high level of chlorides within the top surface of the specimens may indicate one of two things. Either the concrete was relatively porous and allowed chlorides to permeate to a depth of at least one inch, or several samples were inadvertently extracted from a small crack. The former is certainly plausible. The surface of the specimens' saltwater trays generally appeared to be in poor condition upon autopsy, and the subsurface concrete condition could have been affected as well. The latter case is also possible, although care was taken to examine the drilling site prior to extraction to ensure that no visible cracks were present there. Had control blocks been cast alongside the post-tensioned specimens at the start of the project, there would be a better understanding of the transport of chlorides through the concrete.

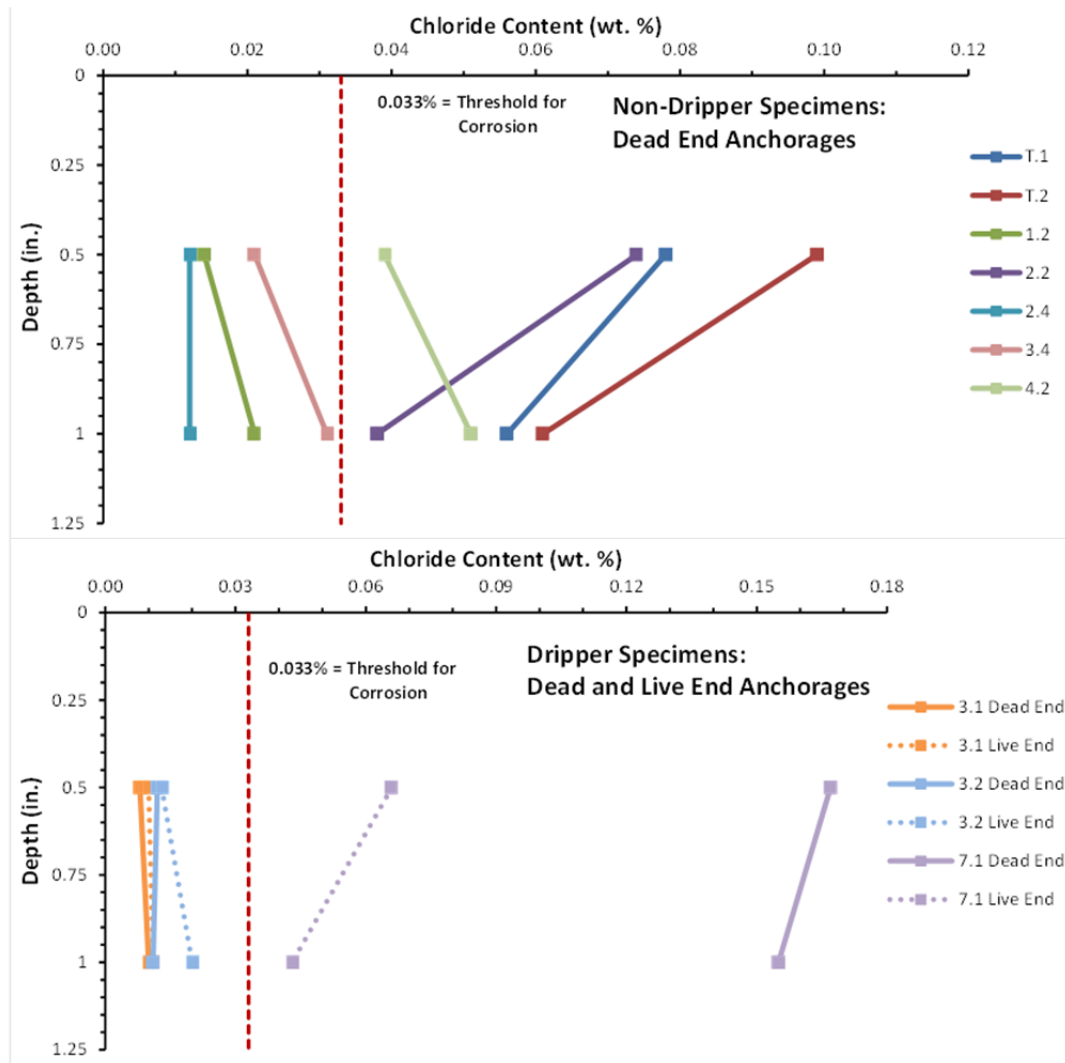
Figure 4.9: Specimen Chloride Content at Anchorages

Overall, concentrations were much lower at the dead end anchorages than at the top surfaces of the seven non-dripper specimens. Maximum chloride content for any non-dripper specimen was 1.65% (Specimen 2.4) at the top surface and 0.099% (Specimen T.2) at the dead end anchorage. Three of the seven non-dripper specimens showed chloride concentrations below the corrosion threshold at both depths. The other four specimens were above the threshold at both depths. In addition, chloride content only decreased with depth for three specimens.

Chloride content was below the corrosion threshold at the live and dead ends of dripper specimens 3.1 and 3.2. The concentrations also increased with depth at both ends for these specimens. For Specimen 7.1, chloride content decreased with depth and was above the corrosion threshold at both ends. In addition, concentrations decreased with depth for this specimen. For the exposure specimens, anchorage region concentrations were much lower in magnitude than top surface concentrations.

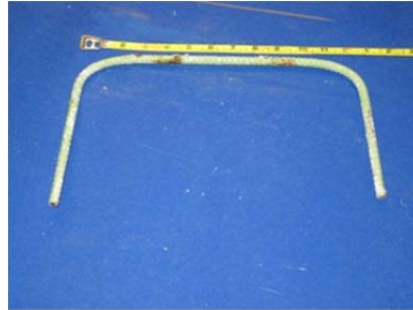
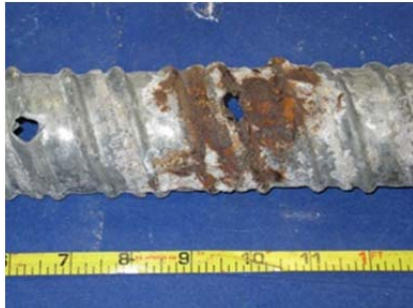
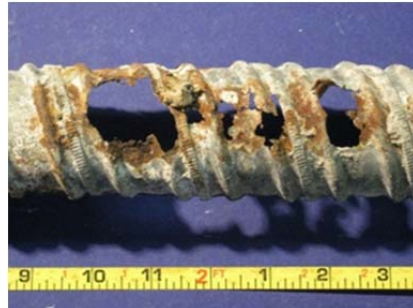
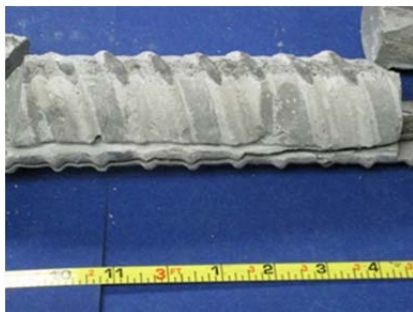
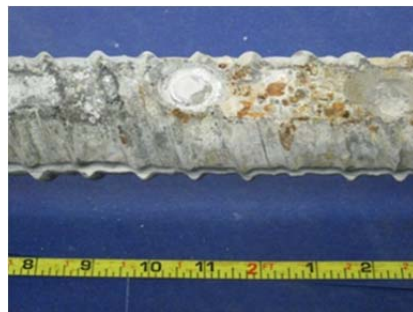
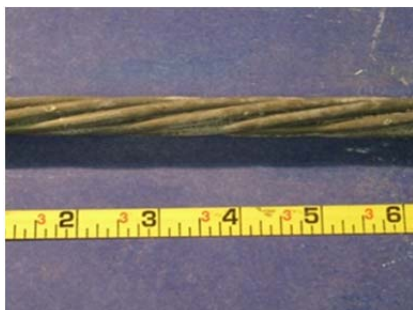
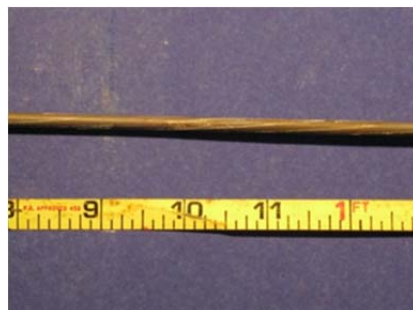
Figure 5.10: Specimen T.1 Main Autopsy Region Elements

Both longitudinal bars were only lightly damaged, as shown in Figure 5.10. Discoloration was present at several spots along the top side of both bars, mostly coinciding with the locations where the stirrups were tied. The stirrups showed more damage than the longitudinal bars. Six stirrups had corrosion that could not be completely scoured away along at least one interval, as pictured in Figure 5.10. Corrosion ratings were highest for stirrups #2 and #4, which were located underneath the two large transverse cracks. Stirrup #4 showed the worst damage with approximately 5% area loss at the location where the north duct was tied to it.

The north and south ducts both had localized severe corrosion damage as shown in Figure 5.10. Most damage on the north duct occurred at midspan and at the live end quarter point. Pitting and corrosion were more extensive on the inside of the duct. The shape and extent of the damage indicate the presence of small grout voids along the top of the entire duct. Significant corrosion and pitting also extended along the bottom inside surface. Here, the location of damage suggests that voids may have formed under the strands during grouting (see Figure 5.9).

Damage was somewhat more extensive in the south duct. Moderate to severe area loss occurred on the top of the duct at midspan, and much smaller holes were found on top of the duct near the dead end quarter point. These holes tended to form inside the helical flutes of the duct, as seen in Figure 5.10. Duct corrosion ratings are shown in Figure 5.11 and summarized in Table 5.5.

The strands in the south tendon were somewhat more severely affected. On the outer wires, discoloration and light corrosion were present on many intervals. Corrosion that could not be scoured off occurred at a few points along each strand. The inner wires had light corrosion spots on almost all intervals. Corrosion ratings were mostly uniform over the entire tendon, although strand corrosion ratings were higher for the south tendon than for the north. A typical strand and inner wire are shown in Figure 5.10. Strand corrosion ratings are shown in Figure 5.11 and are summarized in Table 5.5.

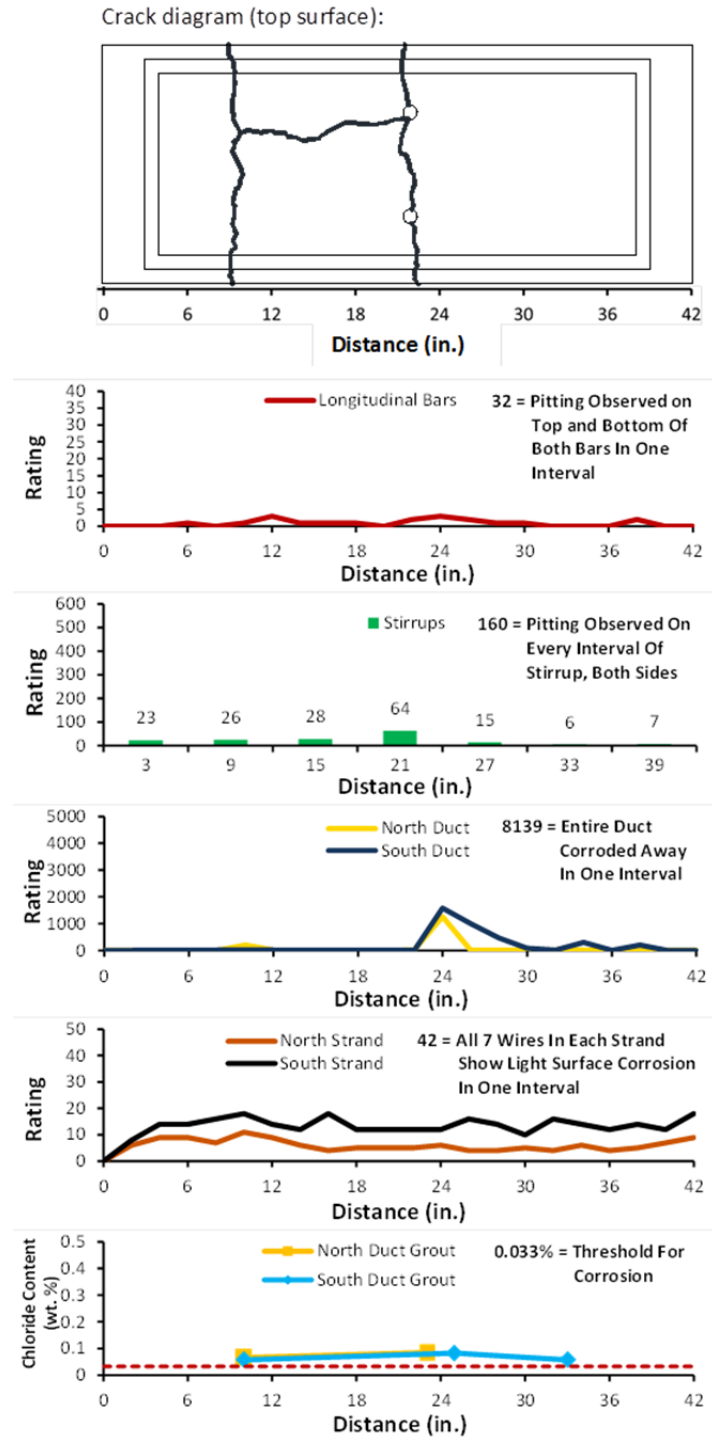
Figure 5.11: Specimen T.1 Crack Map and Corrosion Rating Plots

The specimen had two large transverse cracks running across its top face, each with an average width of 0.03 inches. These cracks extended down the north and south faces of the specimen. There was one longitudinal crack with an average width of 0.004 inches running perpendicular from the north grout vent to the transverse crack near the live end of the specimen. The crack diagram is shown in Figure 5.11.

The tendon grout had very few discernible transverse cracks and no longitudinal cracks. Corrosion staining could be seen near midspan and the live end quarter point, coinciding with the corrosion observed in the duct at those locations. Orange-yellow staining was also visible at seemingly random points along the grout. Maximum chloride content was 0.085% at midspan, well above the corrosion threshold. Chloride content distributions are shown in Figure 5.11.

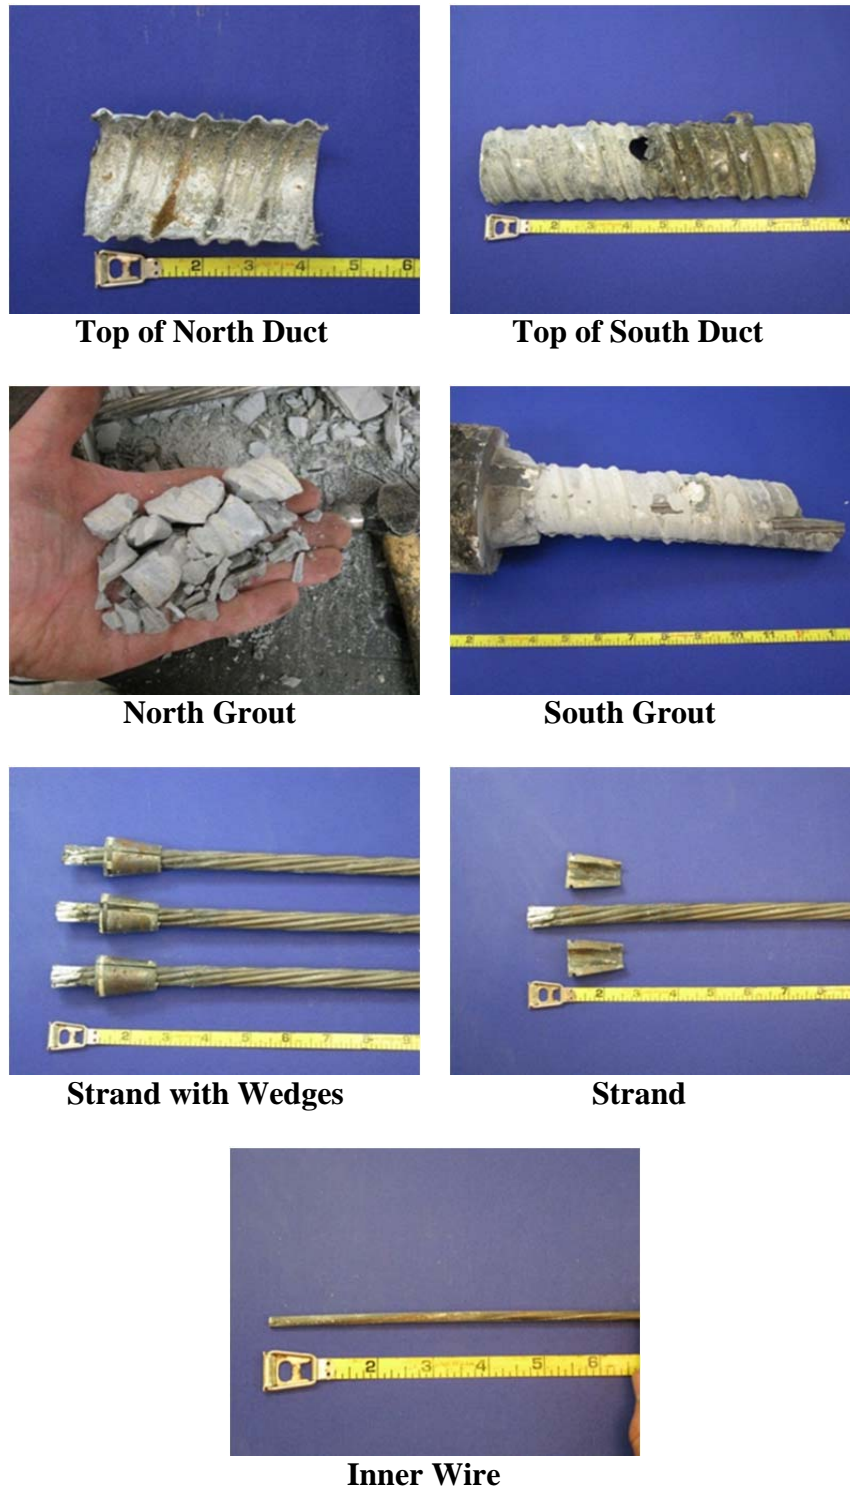
Figure 5.13: Specimen T.1 Anchorage Region Elements

The strands in the anchorage zones of both the north and south tendons experienced light localized corrosion and discoloration scattered across their lengths. As with the main specimen tendons, the center wire of all strands was slightly more damaged than the outer wires. Damage to both sets of strands was most severe at the ends that were outside the anchor head. One strand in each duct experienced moderate corrosion on several wires in its outermost interval. All wedges were substantially intact with only light localized corrosion. The appearance of a typical

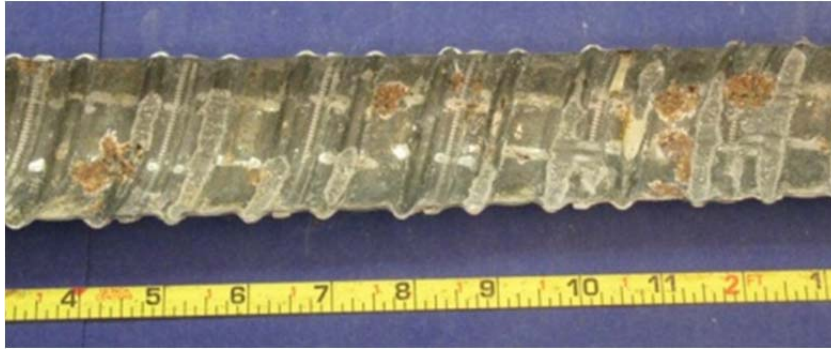
Both ducts were severely damaged. The north duct had substantial area loss on its top portion amounting to over half of the total cross-sectional area in several intervals. This damage occurred mostly in the intervals between transverse cracks on the beam's surface (see Figure 5.18). The overall shape of the area loss and pitting inside the duct indicates the presence of a very large void extending over most of the duct's length. The bottom portion of the north duct was less damaged. Inside, there was widespread discoloration and light localized corrosion, mostly occurring on the same intervals as the area loss on the top half. Most of the corrosion inside the duct occurred where the strands had rubbed against it. This is shown in Figure 5.16.

Figure 5.16: Specimen T.2, Corrosion Along Gouges on Bottom Half of North Duct

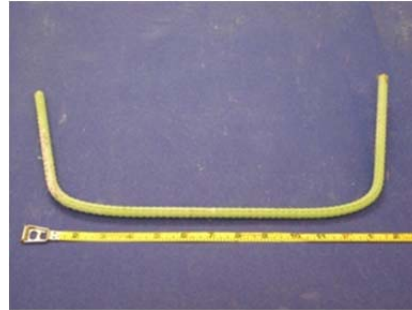
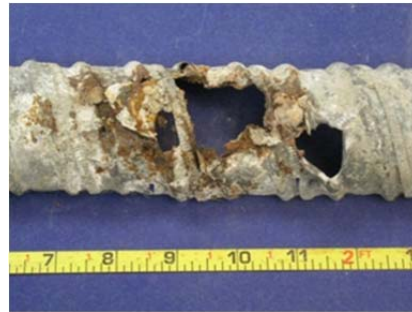
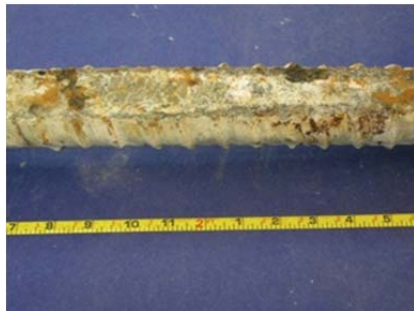
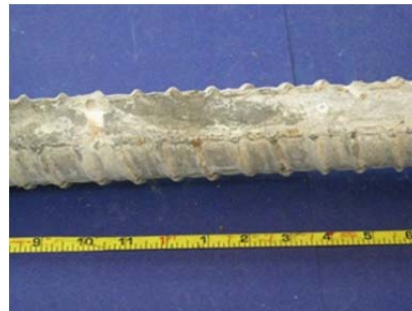
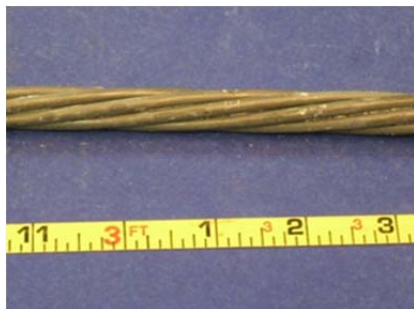
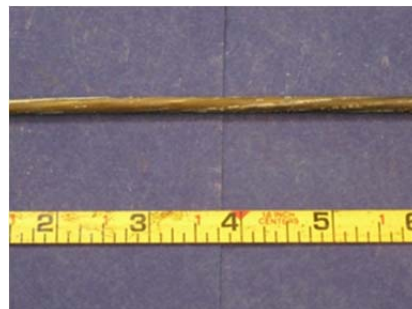
Figure 5.18: Specimen T.2 Main Autopsy Region Elements

The south tendon grout had voids over most of its length. The largest void extended from near the live end of the grout to just past midspan (see Figure 5.18). This void was approximately 1.25 inches wide. The grout vent at midspan left a deep impression in the grout. This may indicate that the grout vent was not properly seated at the top of the duct and consequently slipped downward, possibly interfering with the flow of grout through the tendon. The underside of the south tendon grout was poorly consolidated. Like the north grout, there was at least one strand exposed over the entire length of the tendon. Chloride levels were much lower in the south duct grout but still above the corrosion threshold. The maximum chloride concentration was 0.094% at midspan. Chloride content for grout in both tendons is given in Figure 5.19.

The three south duct strands all showed similar levels of damage, and were more severely corroded than the north duct strands. Spots of light to moderate corrosion occurred at the location of the live end transverse surface crack on all three strands, with light localized corrosion and discoloration occurring on other intervals. The inner wires were uniformly damaged, with light surface corrosion occurring on almost all intervals. Corrosion ratings in the south duct strands showed peaks at crack locations, and were uniform and higher than the north duct strands. A typical strand and inner wire are shown in Figure 5.18. Strand corrosion ratings are shown in Figure 5.19 and summarized in Table 5.7.

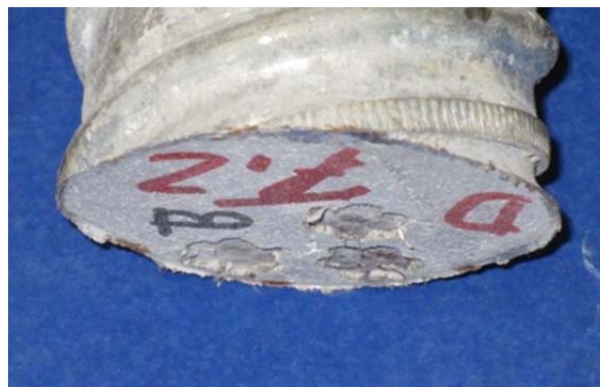
The south tendon strands shortened by approximately 0.1 inches after the anchorage had been removed from the specimen, as shown in Figure 5.20. Strands in both tendons experienced light to moderate corrosion at their exposed ends and more localized light corrosion or discoloration elsewhere. The wedges showed some surface corrosion but were substantially intact. The appearance of a typical strand, with and without wedges, is shown in Figure 5.21. Corrosion ratings for the anchorage zone strands are and summarized in Table 5.8.

Figure 5.20: Specimen T.2, Debonded Strands in South Anchorage

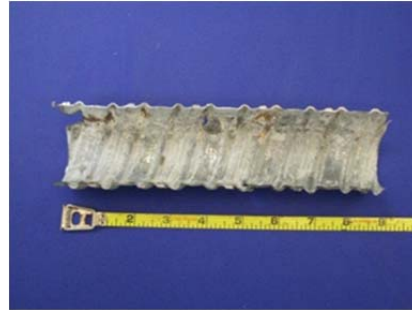
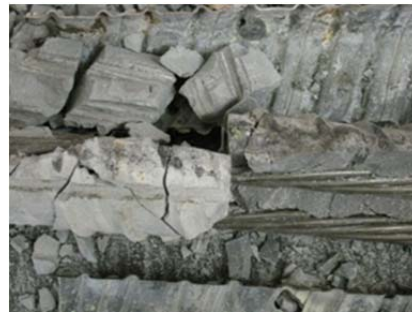
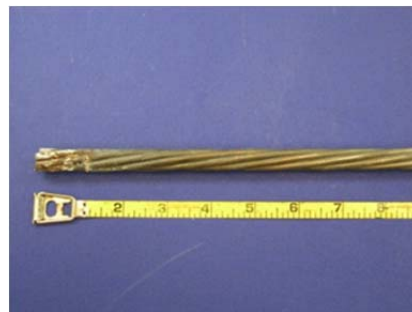
Figure 5.21: Specimen T.2 Anchorage Region Elements

The anchorage zone ducts were only mildly damaged. Corrosion ratings for the anchorage zone ducts are summarized in Table 5.8.

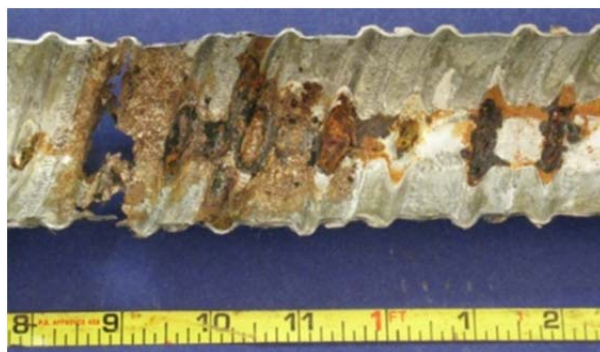
Both galvanized steel ducts showed severe localized corrosion damage. The outside top half of the north duct experienced area loss and extensive pitting over several intervals near midspan and its quarter points, as shown in Figure 5.26. Inside the top half, pitting and area loss were just as severe. The void appeared to be continuous between 8 inches and 22 inches from the live end of the autopsy region. Corrosion may have initiated at midspan and traveled outward over this void (see Figure 5.23). The pattern of the discoloration on the bottom of the duct suggests that the grout was cracked over much of its length and that at least two of the strands had rubbed against it during its life. Among large areas of discoloration, some regions of the inside even showed the characteristic sheen of new metal.

Figure 5.23: Specimen 1.2, Area Loss and Large Void on Top Inner Surface of North Duct

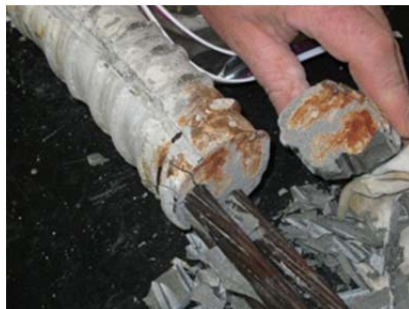
Figure 5.24: Corrosion Staining Within South Grout

The south tendon grout was also cracked transversely every few inches along its length. Staining occurred at the locations corresponding to area loss and pitting of the surrounding duct. This staining permeated from the top of the grout down to the level of the strands (see Figure 5.24). Localized yellow-orange discoloration spots were also observed on all sides of the grout. Some portions of strand were exposed on the bottom of the grout, but not nearly to the extent of the north grout. The south grout was extremely well-consolidated compared to the north grout. Maximum chloride concentration in the grout was 0.112% at midspan. Measurements taken at 8 and 32 inches from the live end were approximately at the threshold for corrosion. Chloride content for grout in both tendons is given in Figure 5.27.

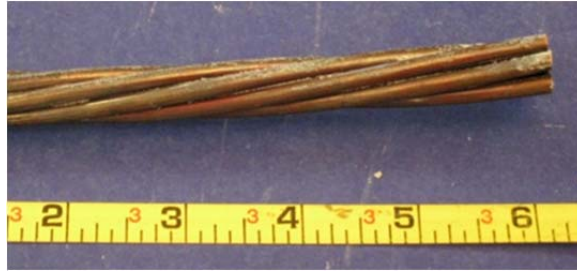
Strand damage was minor and extremely uniform in both tendons. The copper-clad strands did not show any corrosion on any wire within any interval. Instead, the strands assumed a dark black patina over their entire length. The patina was darkest and glossiest on the inner wire of each strand, but could be scoured off of the outer wires more easily than the inner wires. The patina as seen on the inner and outer wires of the strands is shown in Figure 5.26. The ends of each strand took on a slightly lighter patina than the areas within the autopsy region. The distinctive orange color of copper was even visible in spots at the ends of some strands. At the ends of several strands, a bright red color was observed, as shown in Figure 5.25. This may have been a phenomenon known as dezincification. This is a type of selective corrosion in which zinc leaches out from copper alloys and oxidizes, forming a characteristic red color²². The zinc content of the copper-clad strand is unknown. Transverse lines were visible on many outside wires of the strands in both ducts. These lines coincide with the locations of cracks in the north duct grout. Strand corrosion ratings are shown in Figure 5.27 and summarized in Table 5.9.

Figure 5.25: Specimen 1.2, Possible Dezincification

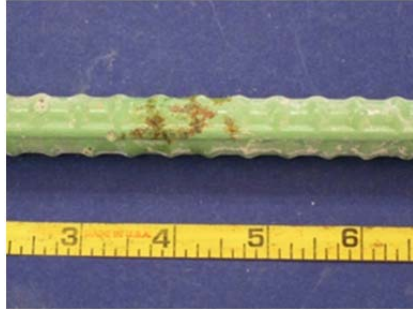
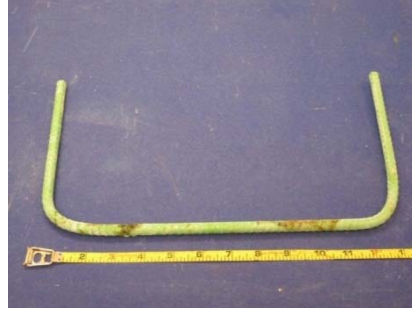
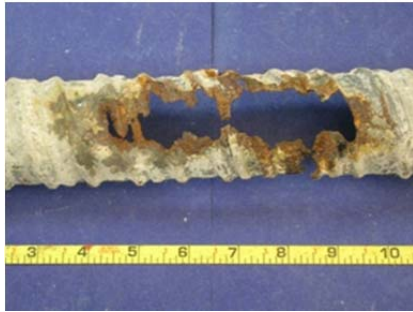
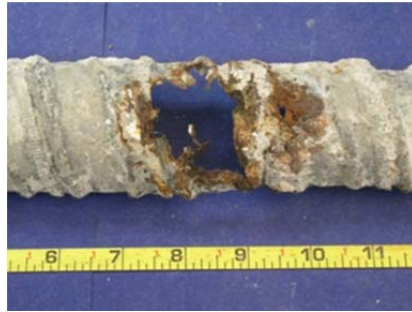
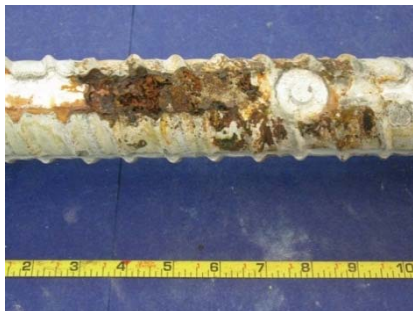
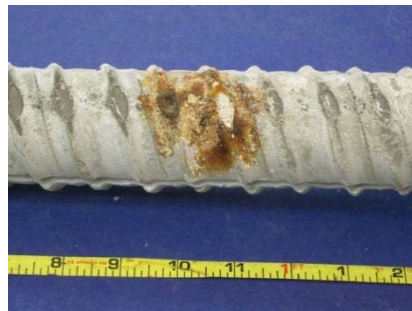
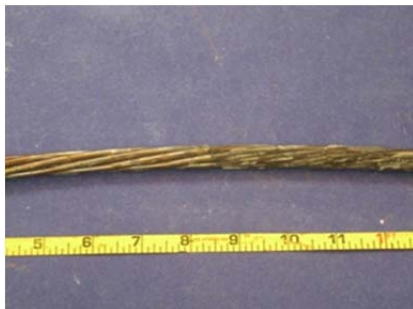
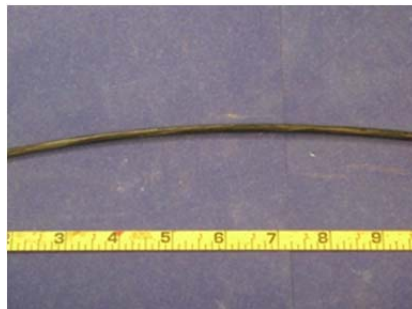
Figure 5.26: Specimen 1.2, Main Autopsy Region Elements

Damage to both longitudinal bars was minor. Spots of discoloration and light surface corrosion occurred on the top and bottom of both bars at the locations where stirrups were tied. Typical longitudinal bar corrosion for this specimen is shown in Figure 5.26. Longitudinal bar corrosion ratings are shown in Figure 5.27 and summarized in Table 5.9.

The south duct was similarly damaged. Its area loss was more extreme than the north duct at the live end quarter point. Pitting and area loss occurred over only a few intervals near each quarter point and midspan. The remainder of the duct was only slightly discolored or lightly corroded, as shown in Figure 5.26. Overall, the discoloration within both ducts was much darker than expected. This may be due to the dark patina of the copper-clad strand in this specimen. Duct corrosion ratings are shown in Figure 5.27 and summarized in Table 5.9.

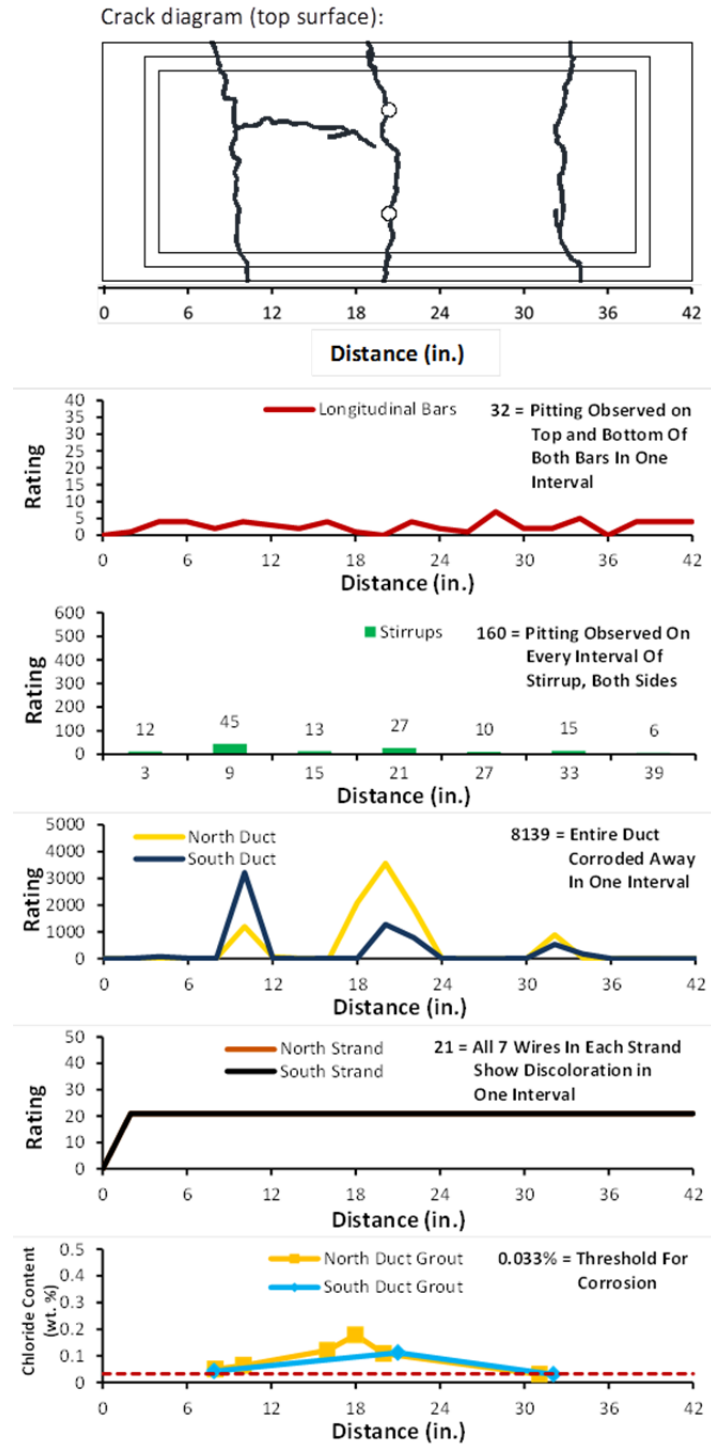
Figure 5.27: Specimen 1.2 Crack Map and Corrosion Rating Plots

There were three large transverse cracks that crossed the top of the specimen and extended down its north and south faces. These cracks were located roughly at the quarter points of the specimen. Their average width was 0.02 inches. One longitudinal crack extended from near the middle transverse crack to the live end transverse crack approximately six inches from the north edge of the specimen, and its width was 0.004 inches. The crack diagram is shown in Figure 5.27.

ducts had been tied. The three stirrups with the highest corrosion ratings were located underneath each of the three transverse cracks on the specimen surface. Stirrup corrosion ratings are shown in Figure 5.27 and summarized in Table 5.9.

Both tendon grouts had similar chloride distributions. However, the north tendon grout had a long continuous void on its top surface, while the south did not. This means that chlorides are transported through strand interstices and grout voids at approximately the same rate, achieving the uniform distributions shown in Figure 5.27.

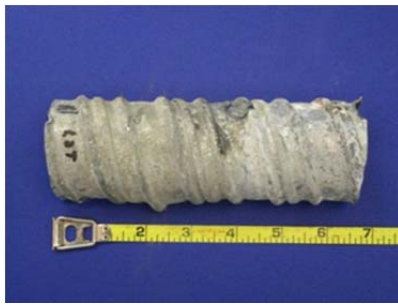
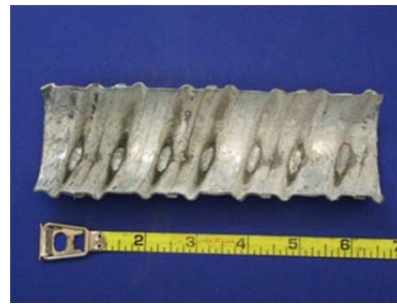
Figure 5.28: Specimen 1.2 Anchorage Region Elements

Discoloration on the anchorage zone strands was not as uniform as in the main autopsy region. The black patina was intermittent over most of each anchorage zone strand. Multi-colored staining and some extremely localized corrosion were found in the wedge region. This suggests that the wedges may have damaged the copper coating and exposed the regular steel below. Damage to the inner wires was comparable to that of the outer wires for all strands. All wedges were found to be intact. The appearance of a typical strand, with and without wedges, is shown in Figure 5.28. Corrosion ratings for the anchorage zone strands are in Table 5.10.

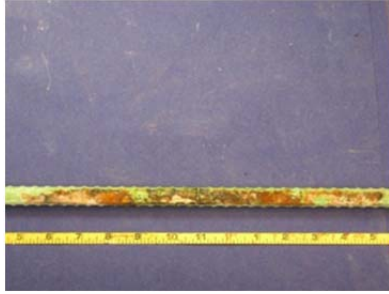
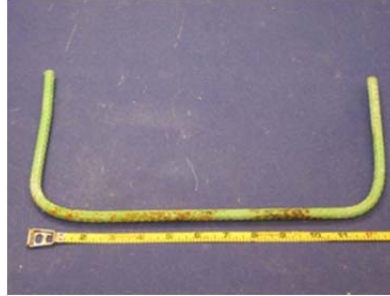
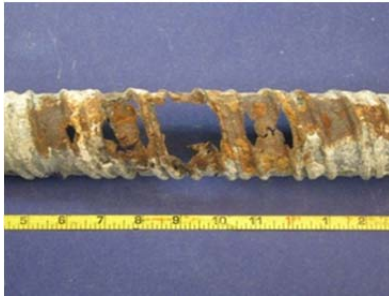
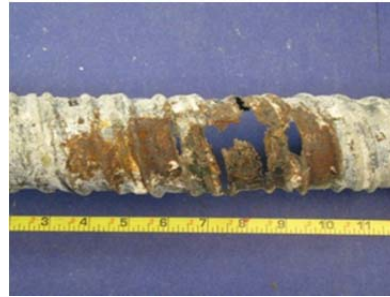
Figure 5.31: Specimen 2.2 Main Autopsy Region Elements

The stirrups also experienced moderate but consistent damage (see Figure 5.31). Only two stirrups experienced pitting on any interval. The three most severely damaged stirrups were the ones located beneath each of the specimen's transverse surface cracks. Stirrup corrosion ratings are shown in Figure 5.32 and summarized in Table 5.11.

The north and south ducts showed severe localized corrosion damage. The north duct had significant area loss over the intervals corresponding to the locations of the specimen's transverse surface cracks (see Figure 5.31). Damage to the south duct was comparable to that of the north duct. Duct corrosion ratings are shown in Figure 5.32 and summarized in Table 5.11.

The north tendon grout was cracked transversely every few inches along its entire length. Significant staining was present in the areas corresponding to duct corrosion and area loss. This staining seeped down the grout through its transverse cracks, though not to the level of the strands (see Figure 5.31). The grout appeared not to have consolidated well around the lowest strands in the tendon. At least one strand was partially exposed over much of the duct's length. Maximum chloride concentration in the grout was 0.084%, occurring 20 inches from the live end. Elsewhere in the north grout, the chloride levels were at or just above the corrosion threshold.

The south tendon grout was similar in appearance to the north tendon grout. A large, continuous void was present from about 8 inches to about 20 inches from the live end. This void was approximately 1 inch wide (see Figure 5.31). Extensive corrosion staining was found corresponding to the regions of the duct that experienced the most severe corrosion and area loss. Like the north duct, this staining seeped downward through the grout's transverse cracks. The maximum chloride content of 0.43% occurred 18 inches from the live end of the grout. Beneath the live end transverse surface crack, the chloride concentration was 0.14%. Beneath the dead end crack, chloride levels were just above the corrosion threshold. Chloride content for grout in both ducts is given in Figure 5.32.

discoloration at worst. Damage to the south tendon strands was comparable to the north duct strands. A typical strand and inner wire are shown in Figure 5.31. Strand corrosion ratings are shown in Figure 5.32 and summarized in Table 5.11.

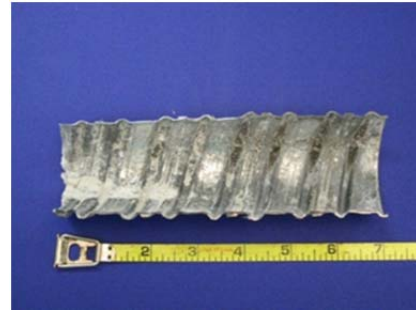
Figure 5.33: Specimen 2.2 Anchorage Region Elements

Both the north and south anchorage zone ducts experienced very mild corrosion damage. Lines visible in the duct surface discoloration suggest that the grout was cracked transversely. North and south ducts are shown in Figure 5.33. Anchorage zone duct corrosion ratings are shown in Figure 5.32 and summarized in Table 5.12.

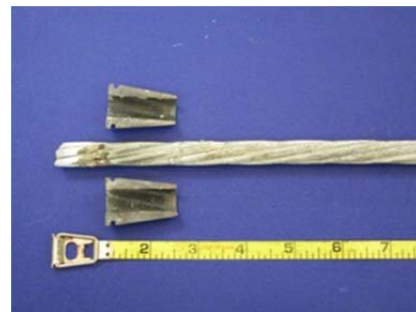
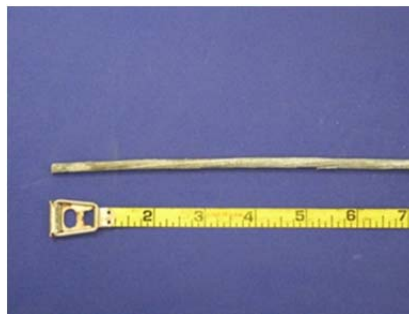
In the anchorage zone, all strands were found to have an extremely strong bond with the surrounding grout, just as was observed in the main autopsy region. Damage to all anchorage zone strands was limited to discoloration or light surface corrosion for all wires in all intervals. All wedges were found to be intact. Some localized light corrosion was found on their exteriors as well as slight discoloration in their inner regions. Typical strands, with and without wedges, are shown in Figure 5.33. Anchorage zone strand corrosion ratings are summarized in Table 5.11.

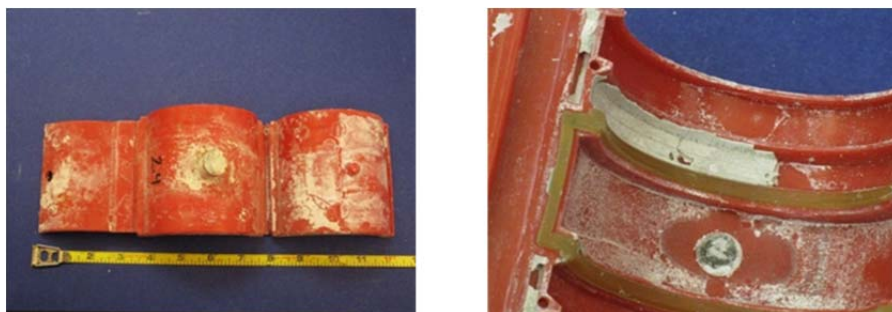
Figure 5.36: Specimen 2.4 North Duct Coupler Exterior (Left) and Gasket (Right)

The north duct coupler appeared undamaged. There were some small orange-brown flecks present on and around the coupler's grout vent outlet, and the same chalky white residue

that was observed on the ducts was also present on the exterior of the coupler. The coupler's mechanical connections and gaskets were intact. The latter did not appear to be affected by the widespread scratching that occurred in the duct itself (see Figure 5.36). Cement paste was present inside the coupler but outside the gasket. Inside the gasket were grout residue and the white crystals that were present inside both ducts. There was also evidence of a small void in the vicinity of the coupler's grout vent. The south duct was continuous and did not have a coupler. The epoxy used to seal the south duct grout vent was slightly detached from the duct at midspan.

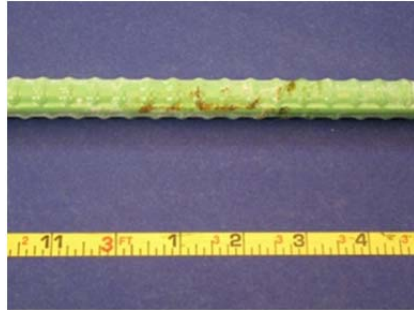
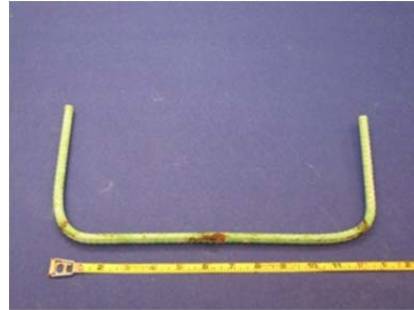
Figure 5.38: Specimen 2.4 Main Autopsy Region Elements

Damage to the north and south longitudinal bars was moderate and localized, mostly where stirrups were tied (see Figure 5.38). Damage was more severe to the underside of the bar than to the top. The extent of corrosion was similar in the south bar, although somewhat more severe. Localized pitting was observed over one interval near the live end of the bar. Longitudinal bar corrosion ratings are shown in Figure 5.39 and summarized in Table 5.13.

Stirrups in this specimen were moderately damaged. Six of the seven stirrups had moderate corrosion or pitting over at least one interval. The worst damage tended to occur at the bend points of the stirrups and at locations where ducts were tied. Stirrup #5 suffered the heaviest damage. This stirrup lost over 20% of its cross sectional area over a small length at midspan of its horizontal portion (see Figure 5.38). Damage did not correspond clearly to surface crack location. Although stirrup #5 was located beneath a transverse surface crack, corrosion ratings for the other six stirrups were relatively independent of location. Stirrup corrosion ratings are shown in Figure 5.39 and summarized in Table 5.13.

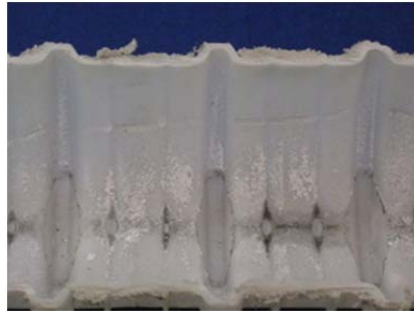
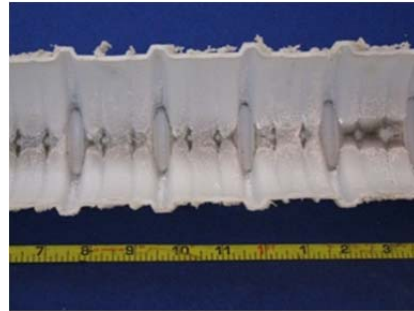
The north and south plastic ducts were in near-perfect shape upon autopsy. The top of the inside of the north duct had scratches along approximately 36 inches of its length. These scratches had a depth of between 5 and 10 percent of the duct's wall thickness (see Figure 5.38). The top of the inside of the south duct was similarly damaged, although the scratches were shallower and shorter in length. Duct damage ratings are shown in Figure 5.39 and summarized in Table 5.13.

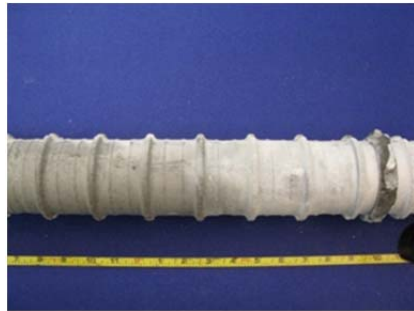
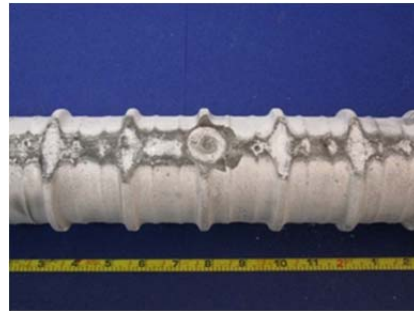
The north tendon grout was cracked transversely every few inches along its entire length. One longitudinal crack was visible on the underside of the grout. This crack appeared to terminate within approximately 6 inches of each end of the grout (see Figure 5.38). Chloride concentration at midspan was 0.2% in the north tendon.

The south tendon grout was also cracked every few inches along its length. One longitudinal crack was observed at roughly midheight of the grout. This crack extended along the grout's entire length. While intact, this grout was much smoother to the touch over its entire exposed surface than any grout encountered thus far. This may indicate that pressure was high and uniform during the grouting process. One strand was exposed on the underside of the grout from approximately 16 inches to 24 inches from the live end. Chloride concentration at midspan was 0.25% in the south duct. Chloride content for grout in both ducts is shown in Figure 5.39.

The chloride content at midspan of the grout in each tendon was well above the corrosion threshold despite the lack of any meaningful damage to the ducts themselves. The coupler also showed no signs of a breach. Thus, the chlorides could not have entered through either the duct or coupler. Similarly, there was no evidence to suggest that chlorides entered through the anchorage region on either end of the specimen. The only remaining means of chloride ingress would be the grout vent located at midspan of the south tendon and on top of the coupler located at midspan on the north tendon. The detached epoxy at the south duct grout vent supports the idea that chlorides entered the duct at a central location on the tendon. Chlorides entered through small imperfections in the grout vent-duct or grout vent-coupler interface and penetrated the grout through its transverse cracks. Because the copper-clad strand was uniform in appearance over the entire length of both tendons, it appears that the chlorides traveled along the tendons through the strand interstices, as well.

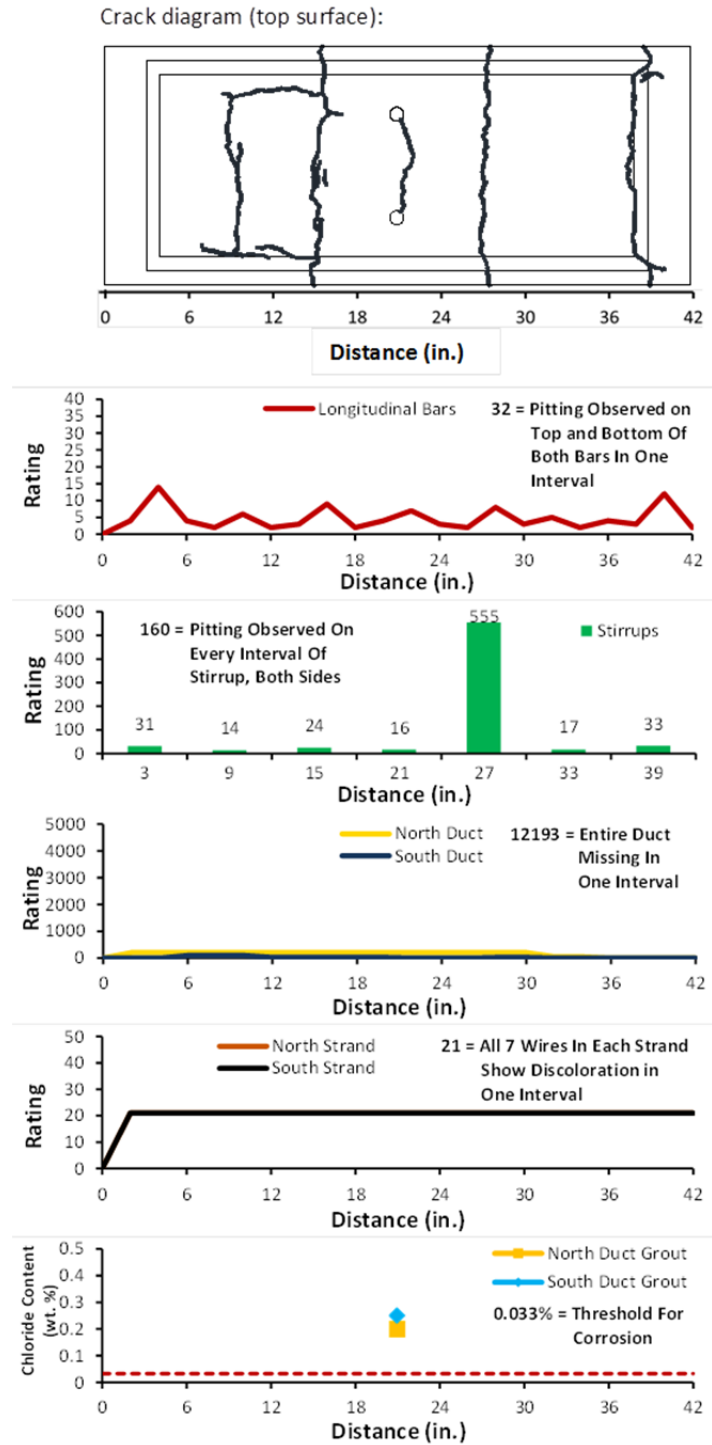
Figure 5.39: Specimen 2.4 Crack Map and Corrosion/Damage Rating Plots

leakage was still intact. These transverse cracks had an average width of 0.04 inches. Two secondary transverse cracks were also visible. These did not cross the entire specimen and had an average width of 0.035 inches. Two longitudinal cracks were found that connected the two transverse cracks nearest to the specimen's live end. The average width of these cracks was 0.015 inches. Most of the cracks on the specimen had more than one branch. Overall, the top of this specimen was the most cracked of any seen up to this point. The crack diagram is shown in Figure 5.39.

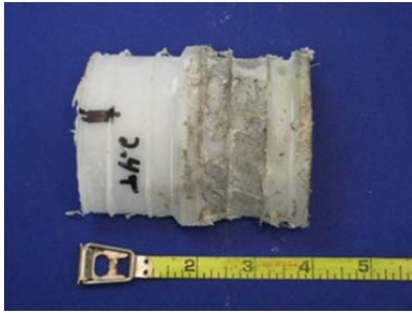
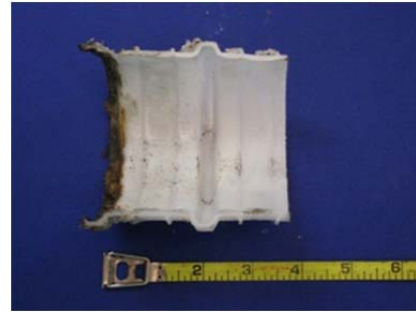
Figure 5.40: Specimen 2.4 Anchorage Region Elements.

Both anchorage zone ducts showed evidence of voids in their upper flutes, as well as traces of the same white crystals found in the ducts of the main autopsy region. In addition, the outside of the ducts were covered with traces of the same chalky white residue that had been found on the outside of the ducts in the main autopsy region. North and south anchorage zone ducts are shown in Figure 5.40. No scratches or gouges were found inside the ducts. Anchorage zone duct corrosion ratings summarized in Table 5.14.

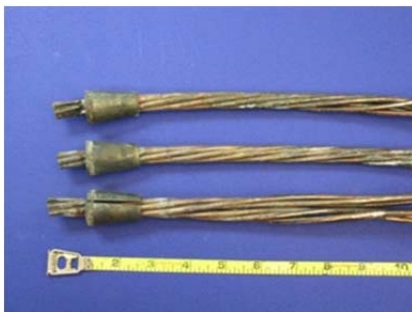
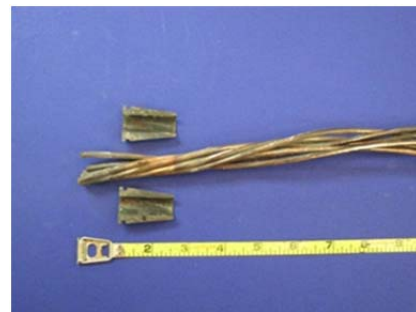
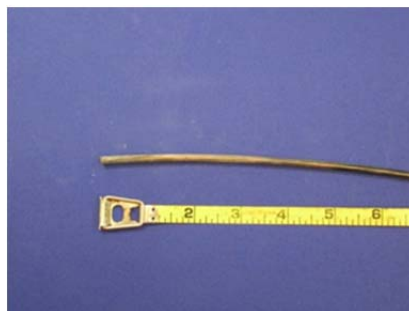
Within the first four inches from the end of the specimen of all six strands, the distinctive green color of corroding copper was visible in very localized spots. No sign of steel corrosion was found in this region on any strand. Moving in toward the specimen interior, the same patina that covered the strands in the main autopsy region was found, although the patina covered much less of the strands' overall area. Two of the specimen's dead end wedges were cracked, and some spots of moderate corrosion were found on both the inside and outside surfaces of all six wedges. Typical strands, with and without wedges, are shown in Figure 5.40. Anchorage zone strand corrosion ratings are summarized in Table 5.14.
