1. Report No. FHWA/TX-11/0-4562-4		2. Government Accession No.		3. Recipient's Catalog No.	
4. Title and Subtitle Evaluation of Corrosion Resistance of Improved Post-tensioning Materials after Long-term Exposure Testing				5. Report Date October 2011

Evaluation of Corrosion Resistance of Improved Post-tensioning Materials after Long-term Exposure Testing

CTR Technical Report:	0-4562-4
Report Date:	October 2011
Project:	0-4562
Project Title:	Corrosion Resistance of Grouted Post-Tensioning Systems
Sponsoring Agency:	Texas Department of Transportation
Performing Agency:	Center for Transportation Research at The University of Texas at Austin

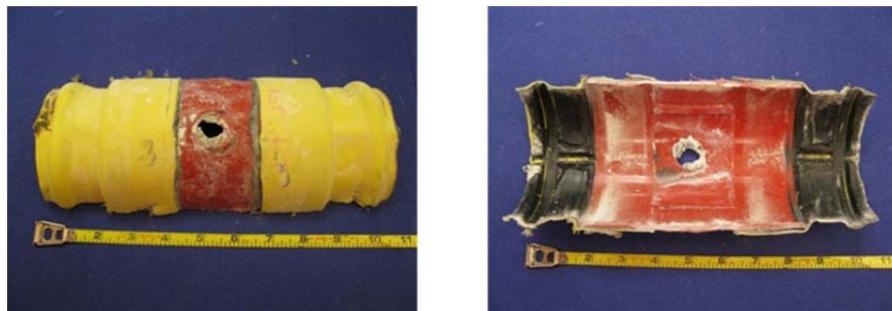
The heat shrink coupler applied to the north duct was mostly intact at the time of autopsy. Both the inside and outside surfaces of the coupler showed similar discoloration and evidence of more voids than what was observed on the north duct itself. The seam between the dead end heat shrink and the coupler appeared somewhat detached around its entire circumference. This may have occurred during the autopsy process. The heat shrink tubing was somewhat brittle and easy to peel back from the duct surface. There may not have been a perfect heat shrink seal around both ducts. The coupler is pictured in Figure 5.42.

Figure 5.42: Specimen 3.1 North Duct Coupler Outer Surface (Left) and Inner Surface (Right)

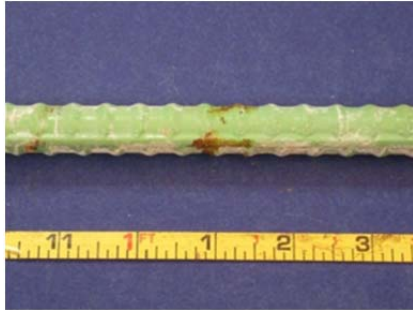
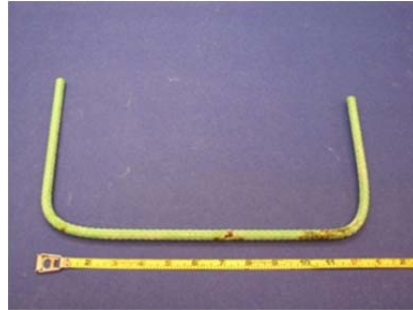
Figure 5.44: Specimen 3.1 Main Autopsy Region Elements

Both the north and south longitudinal bars showed only minor corrosion damage, mostly at the locations where stirrups had been tied, as shown in Figure 5.44. Corrosion ratings for both bars were highest underneath the location of the specimen's transverse surface cracks. Longitudinal bar corrosion ratings are shown in Figure 5.45 and summarized in Table 5.15.

The stirrups showed relatively minor damage. Only two stirrups showed pitting in any interval. Most corrosion and discoloration were observed at the inner and outer surfaces of the stirrups' bend radii, as well as at midspan of their horizontal regions (see Figure 5.44). The stirrups with the highest corrosion ratings were those found directly beneath the specimen's three transverse surface cracks. Stirrup corrosion ratings are shown in Figure 5.45 and summarized in Table 5.15.

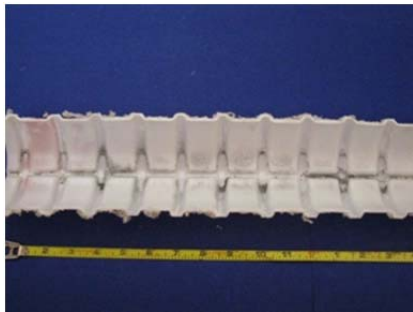
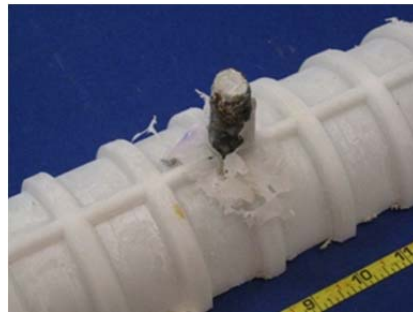
The entire north plastic duct had a chalky white residue over its entire exterior, along with several localized corrosion stains. Many of these spots were located near the heat shrink splice at midspan. The top interior portion of the north duct showed evidence of small voids that had formed in the duct's top flutes over its entire length. These voids were somewhat larger near the live end of the duct than the dead end, and all of the voids were made continuous by the duct's top longitudinal rib (see Figure 5.44). Damage to the south duct was similar to that of the north duct. The epoxy that sealed the grout vent at midspan appeared to have detached from the duct somewhat. It is unknown whether this occurred during autopsy or some time before (see Figure 5.44). The bottom interior portion of the duct had some light gouges between midspan and the dead end. It appeared that one strand had been bearing directly on the duct there. Duct damage ratings are shown in Figure 5.45 and summarized in Table 5.15.

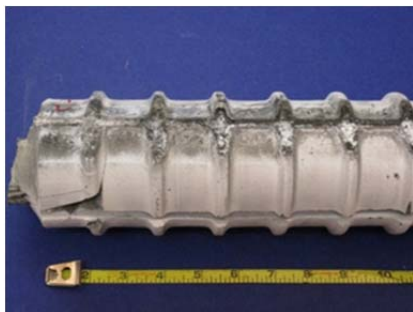
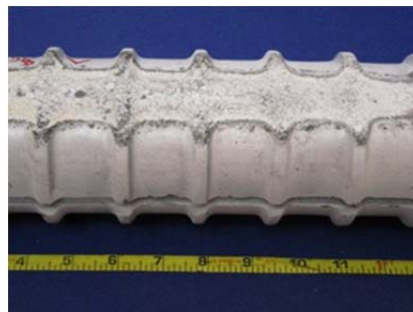
The south tendon grout was cracked transversely every few inches along its length. No longitudinal cracks were found. One continuous void, approximately 1.25 inches wide, was found on the top of the grout extending from the live end to near midspan. The remainder of the grout showed smaller voids, about 0.5 inches across, on its top surface, connected by the top longitudinal rib of the duct. The surface of the large void was white in color with a gray perimeter and many small gray craze cracks. The smaller voids were uniformly gray in color, as shown in Figure 5.44. Chloride content for north and south grouts is shown in Figure 5.45.

The presence of chloride concentrations above the corrosion threshold in both tendons indicates that chlorides entered by way of leaks. Breaches appeared to have occurred around the south duct grout vent interface and at the north duct coupler. The presence of cement paste and aggregate inside the coupler confirm that it was not watertight. It is possible that chlorides may have also entered through the north duct grout vent, but this was broken off during autopsy. No evidence was found to suggest that chlorides entered the tendon through either anchorage. The presence of strand corrosion along the entire north and south tendons suggests that chlorides were able to travel the entire length of duct from their midspan entry point through the strand interstices.

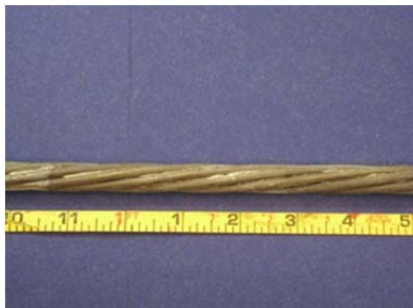
Corrosion damage to the north and south tendon strands were minor. The outer wires of all strands showed isolated flecks of light surface corrosion or somewhat more widespread discoloration. Over many intervals, no damage was observed at all.

Corrosion ratings were nearly uniform along the strands' length. No clear correlation with crack location was observed. A typical strand and inner wire are shown in Figure 5.44. Strand corrosion ratings are summarized in Table 5.15.

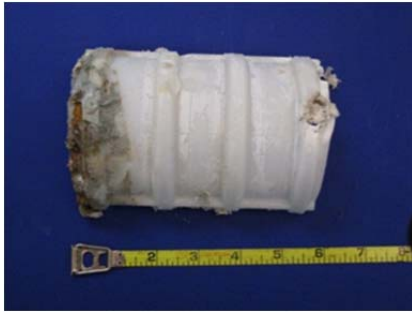
Top of North Duct

The outside of both the north and south ducts showed the same chalky white residue that was found on the ducts in the main autopsy region. In addition, prominent corrosion stains were found on the outer surface of the ducts where they had been spliced with the anchorages. Some very light gouges were observed in the interior of the south duct. However, the ducts were moderately damaged during the autopsy process, so the damage may have occurred at that time. The bottom interior surfaces of both ducts showed traces of the white crystals that were found in

the main autopsy regions, but to a much lesser extent. North and south ducts are shown in Figure 5.47. Dead end anchorage zone duct corrosion ratings are summarized in Table 5.16.

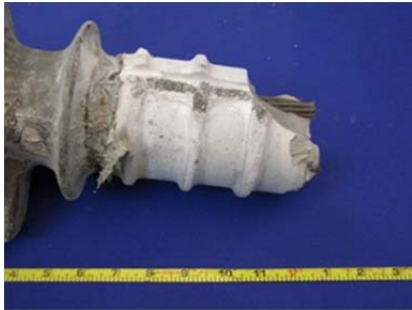
North Grout

Both the north and south tendon grout had small voids corresponding to the top of the transverse duct flutes. Heavy corrosion staining was visible on the edge of the grout nearest to the corroded anchorage-duct splices. Both grouts were damaged during the duct removal process, so the extent of cracking could not be determined. North and south grouts are shown in Figure 5.47.

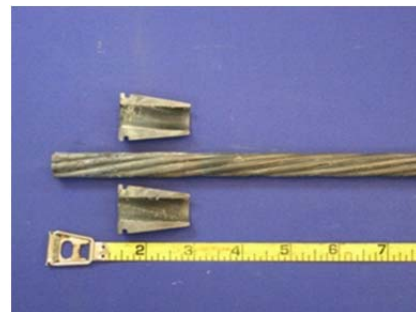
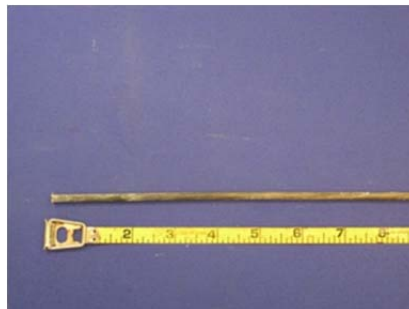
Figure 5.47: Specimen 3.1 Dead End Anchorage Region Elements

Damage to the strands in both ducts was most severe in the regions outside the anchor head and inside the wedges. Light to moderate surface corrosion spots were found on several outer wires per strand in these regions. Further into the specimen, the outer wires were far less damaged, showing light discoloration and the occasional light corrosion spot. The inner wires of all strands were much more uniformly damaged, with light surface corrosion spots on most intervals. All 6 sets of wedges showed light to moderate corrosion on their outer surfaces and some discoloration spots inside. Damage to the wedges tended to be more extreme near their narrow end. Typical strands, with and without wedges, are shown in Figure 5.47. Dead end anchorage zone strand corrosion ratings are summarized in Table 5.16.

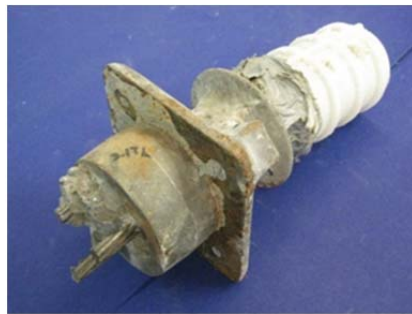
North Anchorage

North and south anchorages and anchor heads are shown in Figure 5.48. The epoxy used to seal the exposed surfaces of both live end anchorages was almost entirely missing. The exposed front of the bearing plates were mostly covered with widespread moderate surface corrosion and some localized pitting. This damage tended to be more severe toward the bottom of the bearing plates. All outer surfaces showed some isolated surface corrosion, but widespread surface corrosion was found on the bottom surfaces of both bearing plates. This was most pronounced on the north bearing plate, whose bottom surface was nearly covered with corrosion. Some isolated damage occurred on the interior edges of both bearing plates, as well. The duct tape used to seal the bearing plate-duct connections was mostly intact on the north anchorage but mostly missing on the south anchorage. Heavy corrosion and some pitting were found underneath the duct tape. The inside surfaces of both anchor heads showed widespread moderate to heavy corrosion, while the outside surfaces were only slightly discolored. Corrosion on the sides of the anchor heads was more severe in the vicinity of the bearing plates.

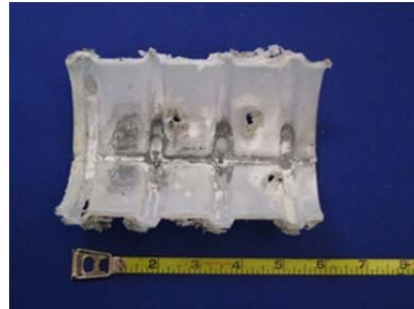
Top of North Duct

North and south ducts are shown in Figure 5.49. Anchorage zone duct corrosion ratings are summarized in Table 5.16.

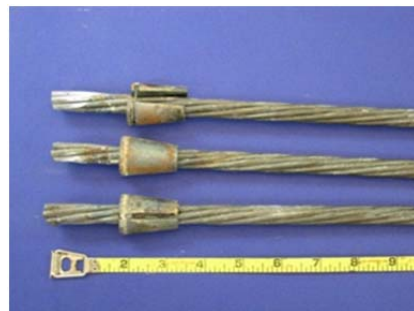
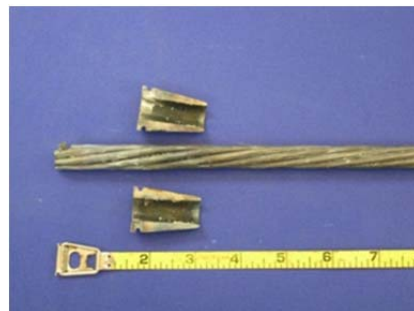
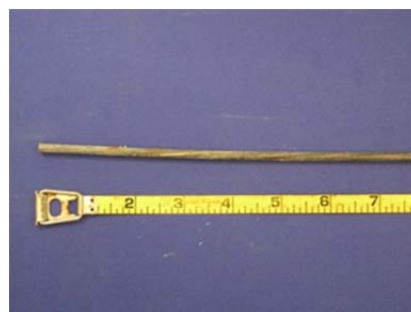
Figure 5.49: Specimen 3.1 Live End Anchorage Region Elements

Damage to the anchorage zone strands was minor. Only two strands showed any corrosion spots that could not be scrubbed away. In general, the most severe corrosion occurred underneath the wedges and outside the anchor head. Corrosion spots were found on several wires per strand in these intervals. The outer wires on the remainder of the strands showed only minor surface corrosion spots or discoloration. The damage was only slightly more severe on the inner wires away from the anchor head region. All 6 wedges showed light to moderate surface corrosion on their outer surfaces and spots of discoloration on their inner surfaces. Typical strands, both with and without wedges, are shown in Figure 5.49. Anchorage zone strand corrosion ratings are summarized in Table 5.16.

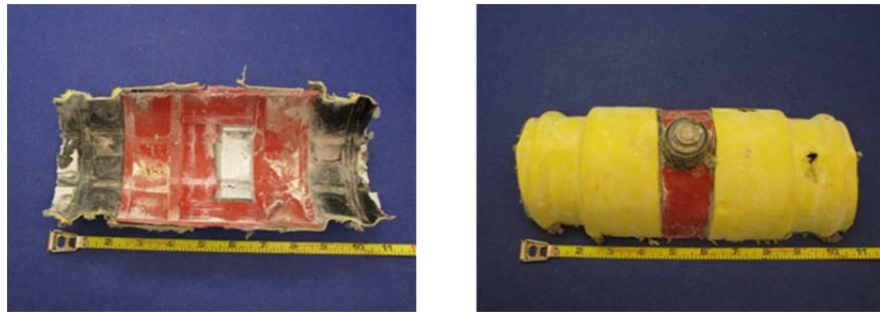
Figure 5.51: Specimen 3.2 North Duct Coupler Inner Surface (Left) and Outer Surface (Right)

The outer surfaces of the heat shrink splice showed the same chalky white residue as the rest of the north duct. The interfaces between the heat shrinks and the plastic coupler were somewhat detached (see Figure 5.51). This damage may have occurred during the autopsy process. The heat shrink tubing seemed somewhat brittle and was easy to peel back from the plastic coupler. The splice's seals may not have remained intact during the specimen's exposure.

Concentrations were well above the corrosion threshold in both tendons, indicating that breaches allowed chlorides to enter. The north tendon had a higher chloride content than the south, suggesting that the breach in the north duct coupler was more extensive than the breach in the south duct grout vent. Chlorides may have entered the north tendon through the coupler's grout vent, although damage incurred during autopsy does not allow this to be determined. Nothing suggests that chlorides entered the tendons through the anchorages. The extent of chloride travel along the tendon is not known because only one measurement per tendon was taken. However, the presence of strand corrosion along the entire strand suggests that chlorides traveled the entire length of both tendons through the strand interstices.

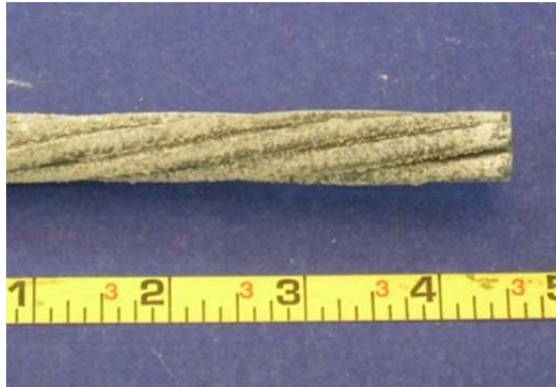
Figure 5.52: Specimen 3.2, Bubbles in Interstices of Galvanized Strand

Similar to Specimen 2.2, the galvanized strand in this specimen was observed to have a much stronger bond with the surrounding grout than other types of strand. In addition, small bubbles were observed in the interstices of several strands, most prominently within a few inches of the end of the strands, as shown in Figure 5.52. This may be a sign that a chemical reaction occurred between the strands' zinc coating and the surrounding grout.

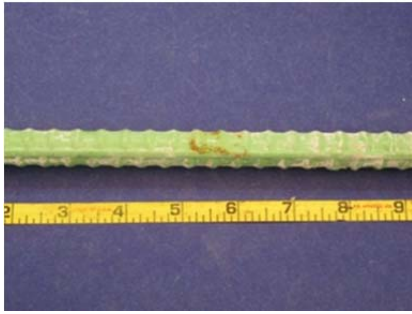
Longitudinal Bar

Both longitudinal bars experienced very minor corrosion damage (see Figure 5.53). The highest corrosion ratings occurred beneath the transverse surface crack nearest the live end of the autopsy region. Longitudinal bar corrosion ratings are shown in Figure 5.54 and summarized in Table 5.17.

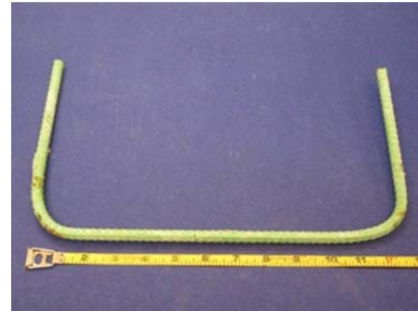
All stirrups showed localized corrosion damage as shown in Figure 5.53. Stirrup #1 showed the worst corrosion damage with localized pitting at the midpoint of its horizontal span. In general, corrosion ratings decreased across the autopsy region from live end to dead end. Stirrup corrosion ratings are shown in Figure 5.54 and summarized in Table 5.17.

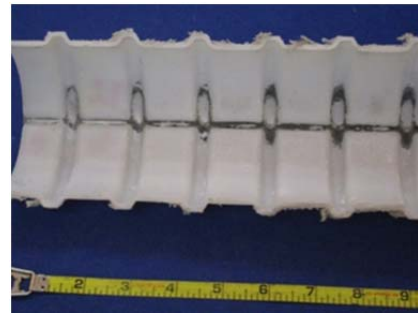
Top of South Duct

Chalky white residue and dull corrosion staining was observed on the outside of the south duct. The epoxy used to seal the joint between the duct and grout vent had separated somewhat from the duct surface. It is uncertain whether this occurred during autopsy or during construction. The inner top portion of the duct showed signs of voids within its upper transverse ribs. These voids were uniform in size along the duct's length and were made continuous by the duct's longitudinal rib, as shown in Figure 5.53. White crystals were observed near the upper ribs and on the bottom of the duct's interior. The bottom half of the duct had widespread light gouging over more than a foot of its length, centered at midspan. It appeared that one strand had

been bearing directly on the duct in that region. Duct damage ratings are shown in Figure 5.54 and summarized in Table 5.17.

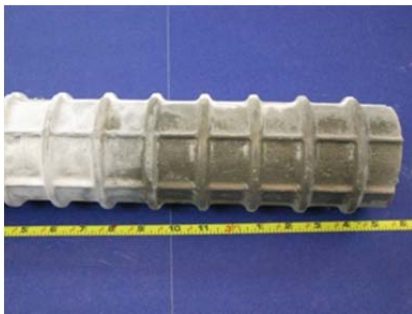
North Grout

The north tendon grout had transverse cracks every few inches along its length. No longitudinal cracks were found. Small voids, approximately 0.75 inches across, were found on the top surface of the grout. The grout as a whole was very difficult to crack open, and its entire surface was very smooth to the touch. These observations suggest that the grout was very well consolidated. Segments of strand were visible along the bottom of the grout over much of its length. Chloride content at midspan of the grout was 0.48%.

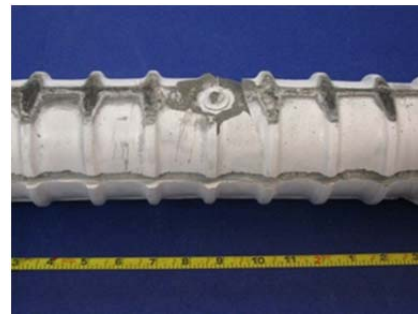
South Grout

The south tendon grout showed transverse cracks, but these cracks were only visible every few inches near midspan of the grout. Voids were observed in the top portion of the grout. These voids were approximately 1 inch in width along the entire length of grout and were connected by the duct's top longitudinal rib (see Figure 5.53). Like the north duct grout, this grout was difficult to break in order to extract the strands within. In addition, the grout was very smooth to the touch and shiny in appearance, especially on its bottom surface. These observations suggest that the south duct grout was extremely well consolidated. Chloride content at midspan was 0.188%. Chloride content for grout in both ducts is shown in Figure 5.54.

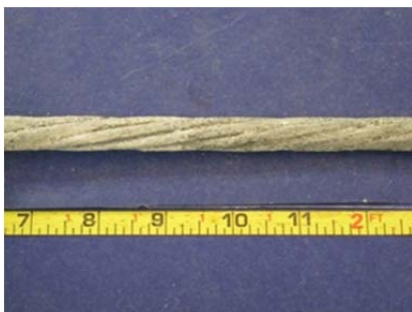
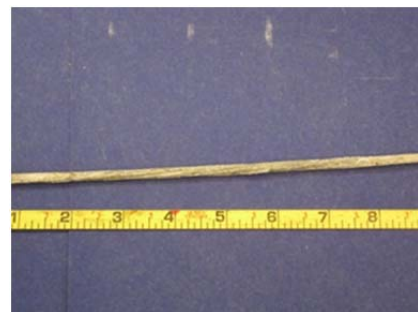
Figure 5.53: Specimen 3.2 Main Autopsy Region Elements

The north and south tendon strands were only slightly damaged. Small, isolated flecks of light corrosion or discoloration were found on one or more outer wires on some intervals, although the outer wires showed no damage at all on many intervals. The inner wires were slightly more damaged. Corrosion ratings were generally uniform along the entire length of the tendons.

A typical strand and inner wire are shown in Figure 5.53. Strand corrosion ratings are shown in Figure 5.54 and summarized in Table 5.17.

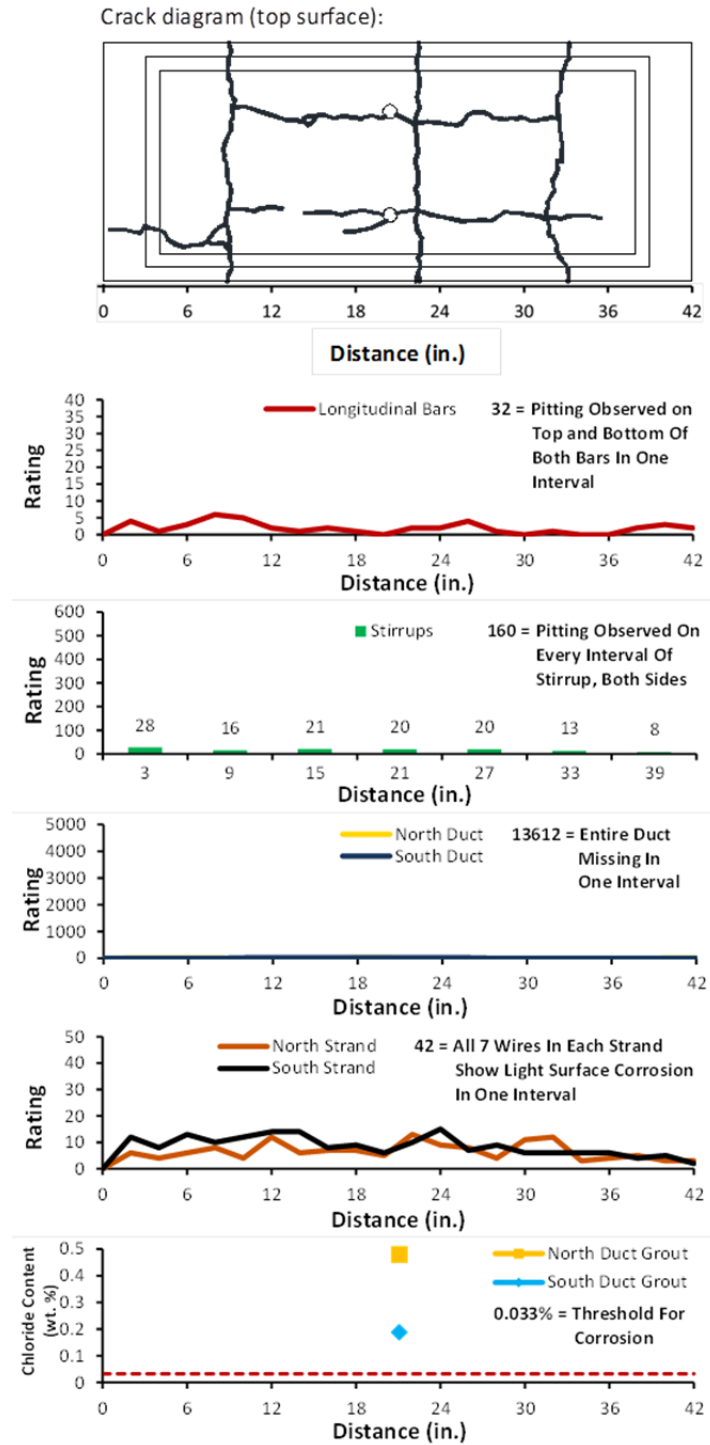
Figure 5.54: Specimen 3.2 Crack Map and Corrosion/Damage Rating Plots

Three primary transverse cracks crossed the top face of the specimen and extended down its sides. The average width of these cracks was 0.015 inches. Several longitudinal cracks extended along various portions of the top surface. These were mostly located above the specimen's ducts. Average width of the longitudinal cracks was 0.004 inches. The crack diagram is shown in Figure 5.54.

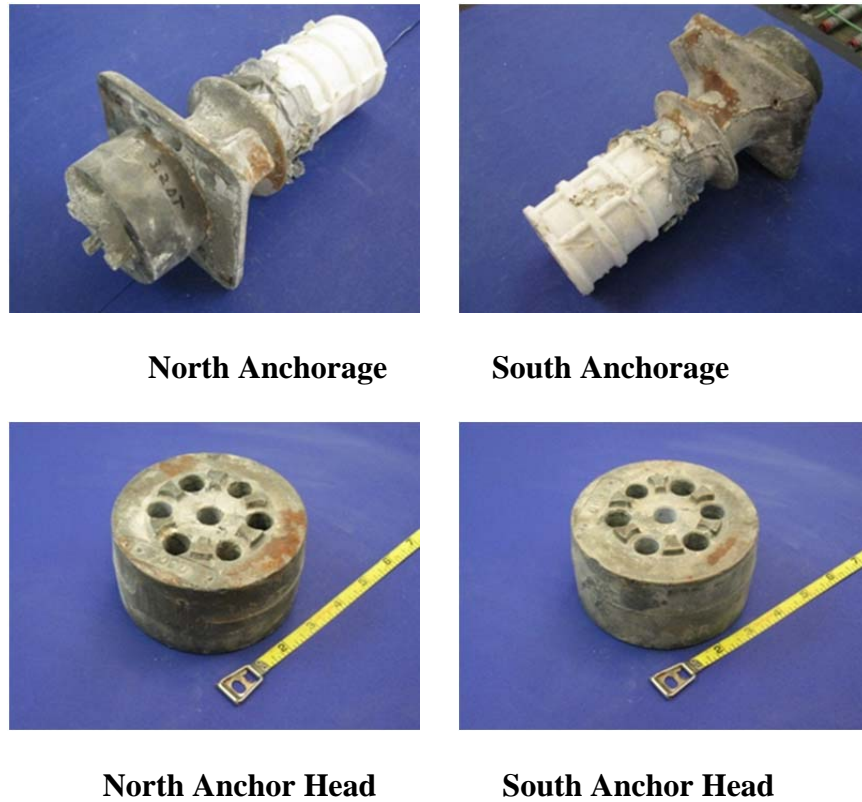
Figure 5.55: Specimen 3.2 Dead End Anchorages and Anchor Heads

The epoxy used to seal the exposed surfaces of both dead end anchorages was mostly intact on the bearing plates and mostly missing on the anchor heads. Both bearing plates showed

only localized light to moderate corrosion over a small portion of their exposed area. Corrosion was much more widespread on the underside and along the lower interior edges of the bearing plates. The duct tape used to splice the ducts to the anchorages was mostly intact at the time of autopsy. Only one small spot of corrosion was observed on the interior side of the south anchor head. The level of discoloration on the other surfaces was comparable to the north anchor head. The north and south anchorages and anchor heads are shown in Figure 5.55.

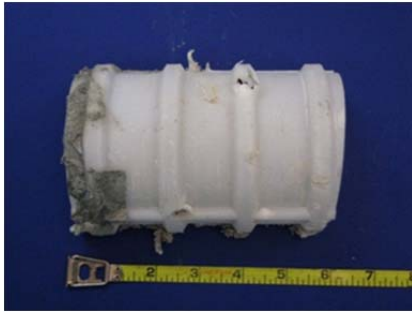
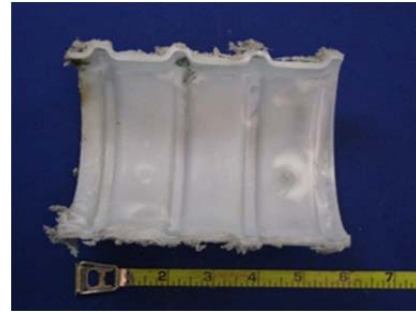
The exterior of both anchorage zone ducts showed traces of chalky white residue. Isolated corrosion staining was also observed on both ducts where they were spliced to the anchorages. Scattered patches of shiny white crystals were found on the interior portions of both ducts. Evidence of small voids was also seen on the top interior portion of both ducts. The north duct had some light gouging due to strands rubbing near the anchorage splice. There was no such damage observed in the south duct. North and south ducts are shown in Figure 5.56. Anchorage zone duct corrosion ratings are summarized in Table 5.18.

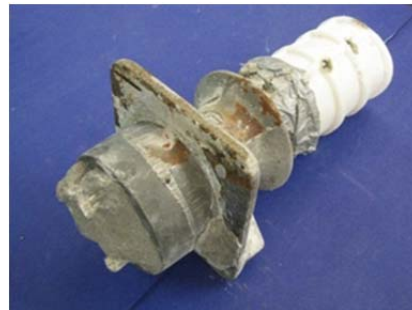
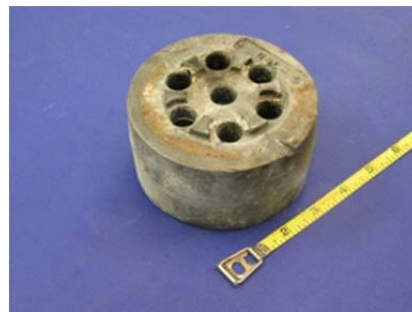
Figure 5.57: Specimen 3.2 Live End Anchorages and Anchor Heads

Most of the epoxy on the exposed surfaces of the live end anchorages was gone. The south bearing plate experienced light corrosion on some of its exposed surface, while the north bearing plate had moderate corrosion over the majority of its exposed area. The north and south bearing plates were moderately corroded on their bottom surfaces and on all inside edges of the bearing plates. This damage was more severe on the north anchorage than the south anchorage. Although the duct tape splices were mostly intact on both anchorages, there was extensive moderate corrosion and some pitting found underneath the duct tape. The north anchor head experienced widespread moderate corrosion on its inner surface and lighter localized corrosion on much of its other surfaces. The south anchor head was much less damaged, with light to moderate localized corrosion on its inside surface and extremely localized light corrosion or discoloration elsewhere. The north and south anchorages and anchor heads are shown in Figure 5.57.

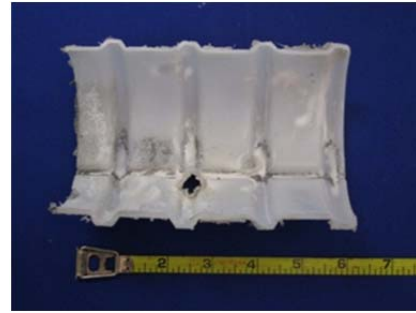
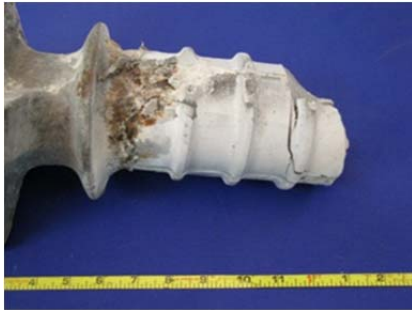
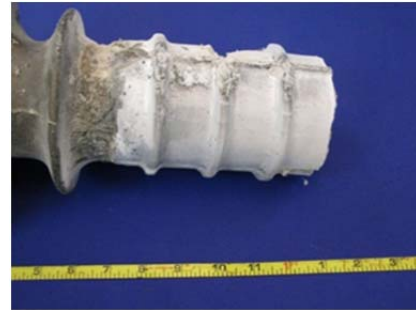
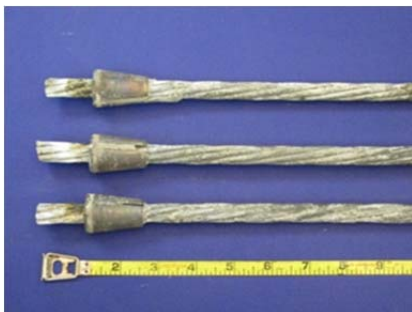
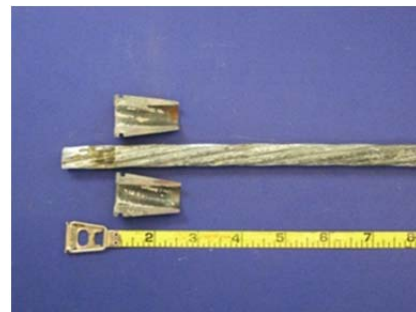
Figure 5.58: Specimen 3.2 Live End Anchorage Region Elements

The outer surfaces of both ducts showed a chalky white residue. Additionally, the outer surface of the north duct was significantly stained at the duct's interface with the bearing plate due to the corrosion that had occurred there. Inside the duct, evidence of small voids was found in the duct's upper ribs. The voids appeared to be connected by the duct's narrow longitudinal rib. Patches of shiny white crystals were found on the inside surfaces of the duct. In addition, several light scratches were found on the inside of the south duct. These most likely occurred while the strands were being threaded through the duct. Light scratches were seen in the north duct, but these were not nearly as extensive and occurred over only one interval. North and south

ducts are shown in Figure 5.58. Live end anchorage zone corrosion ratings are summarized in Table 5.18.

Damage to the live end anchorage zone strands was light to moderate. The outer wires of all strands showed some discoloration and localized light corrosion in most intervals. The inner wires showed similar damage, although corrosion was somewhat more widespread in the inner wires. Spots of corrosion that could not be scrubbed away were found on the inner wires of two of the north duct strands. Overall, corrosion ratings were highest where the strands had been exposed and where they had been inside the anchor heads. All wedges were intact, showing only localized light corrosion and discoloration. Most of this damage was observed on the outer surfaces of the wedges. Typical strands, with and without wedges, are shown in Figure 5.58. Live end anchorage zone strand corrosion ratings are summarized in Table 5.18.

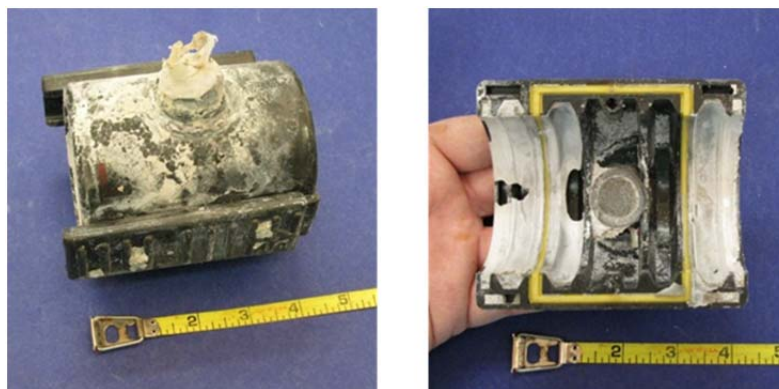
Figure 5.61: Specimen 3.4 North Duct Coupler Outer Surface (Left) and Breach in Upper Gasket (Right)

The north duct coupler was physically intact, and its two mechanical fasteners were functional at the time of autopsy. Similar discoloration to that of the north duct was observed on both the inner and outer surfaces of the coupler. Evidence of one small void was observed near the grout vent on the top inner surface of the coupler. The gasket on the bottom half of the coupler was mostly intact, and a clear boundary between cement paste and grout residue was observed over most of its length. One breach in the gasket was found on the live end of the coupler, indicated by cement paste leaking through the gasket. The top gasket was in worse condition. The live end half of the gasket was breached and had allowed cement paste to fill almost 1/3 of the coupler's sealed area (see Figure 5.61). These breaches suggest that the gasket was not firmly applied to the full perimeter of the duct before concrete was cast around it.

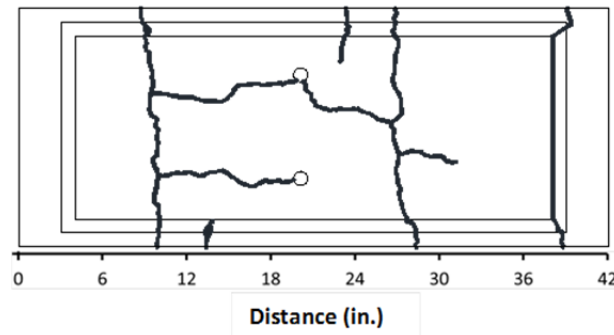
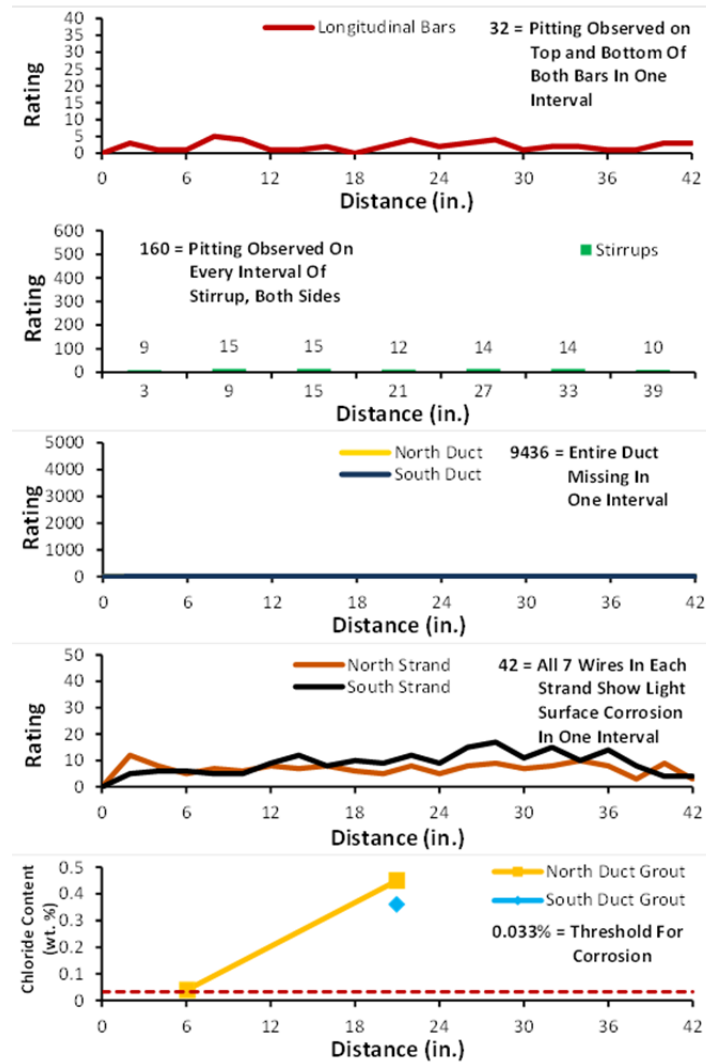
Figure 5.63: Specimen 3.4 Crack Map and Corrosion/Damage Rating Plots

The specimen had 5 transverse cracks. Three of these were continuous across the top surface, while the other 2 only extended a few inches into the saltwater tray. Average width of the transverse cracks was 0.02 inches. Two longitudinal cracks were observed on the specimen's top face. Both passed through one grout vent, and the crack closer to the north face of the specimen was the longer of the two. Average width of the longitudinal cracks was 0.008 inches. The crack diagram is shown in Figure 5.63.

Corrosion observed in the stirrups was similarly mild. Stirrup corrosion ratings are shown in Figure 5.63 and summarized in Table 5.19.

The south tendon grout was similar in appearance to the north tendon grout. The south tendon grout was cracked every few inches along its length. No longitudinal cracks were found. One continuous void, about 1.5 inches wide, was observed along most of the live end half of the grout. On the dead end half of the grout, all voids were approximately 1 inch wide and isolated to the ribs of the duct. All voids were somewhat smaller than in the north grout, although their color was comparable. All three strands were visible on the underside of the grout along most of its length, and at least one strand was visible along the entire length of the grout. Chloride content was 0.36% at midspan. Chloride content for both ducts is shown in Figure 5.63.

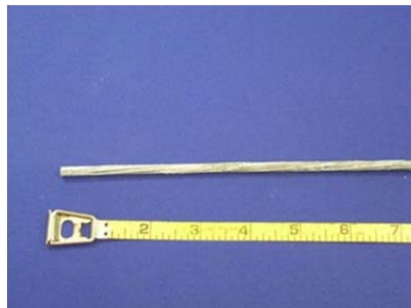
Figure 5.64: Specimen 3.4 Anchorage Region Elements

The outside surface of both ducts showed the same chalky white residue that was found on the ducts in the main autopsy region. Large deposits of cement paste were found in the splice region of both ducts. This occurred because the ducts are slightly smaller than the anchorage opening, which allowed paste to enter and adhere to the ducts. North and south ducts are shown in Figure 5.64. Anchorage zone corrosion ratings are summarized in Table 5.20.

The south tendon grout was severely damaged during extraction, so no meaningful observations could be made. The north tendon grout showed signs of small voids on its top surface and a long void within the anchorage itself. Over the region that had been covered by the north duct, the grout appeared to be well consolidated. The grout in this region was very dark and very hard to break. Two strands were visible on the grout's bottom surface over the entire duct region. The grout was not observed to be cracked. North and south tendon grouts are shown in Figure 5.64.

The anchorage zone strands in both tendons showed similar levels of corrosion. Small flecks of light surface corrosion and discoloration were observed over the entire length of strand, generally on more than one wire per interval. Outer wire damage was greatest in the region that had been inside the wedges. Inner wire damage was uniform, with discoloration and light surface corrosion spots found along the entire length of wire on every strand. All wedges were physically intact, showing only mild surface corrosion on their outer surfaces and isolated spots of discoloration inside. Typical strands, with and without wedges, are shown in Figure 5.64. Anchorage zone strand corrosion ratings are summarized in Table 5.20.

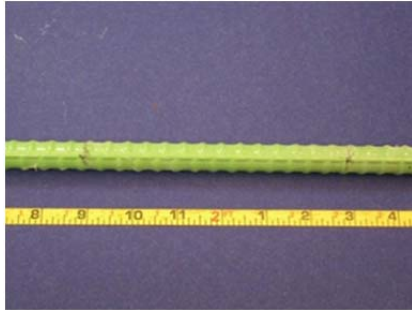
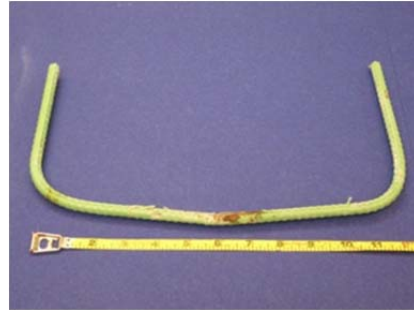
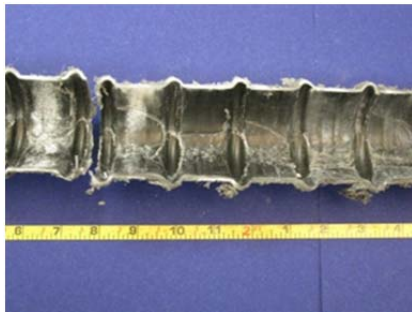
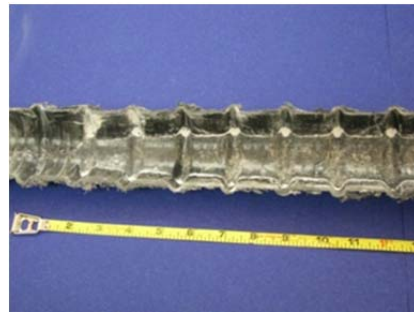
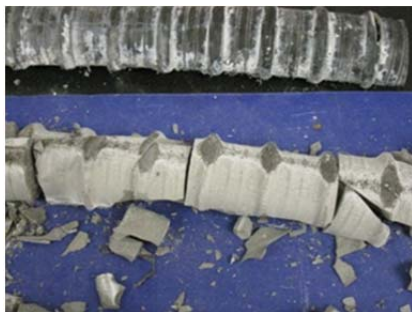
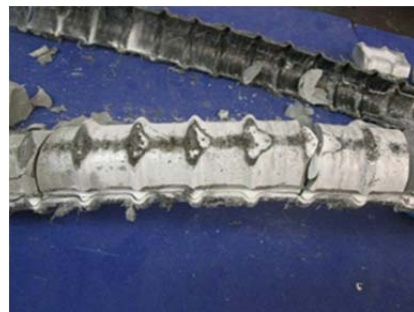
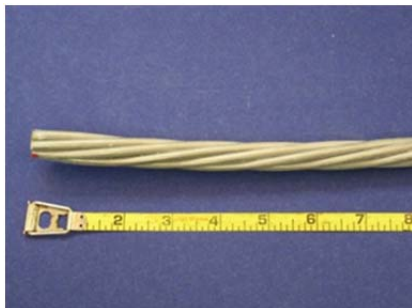
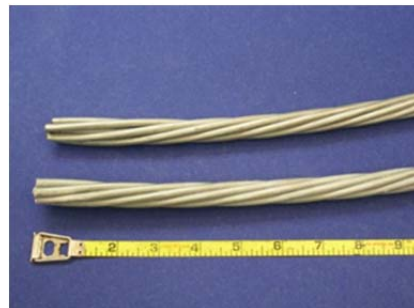
Figure 5.68: Specimen 4.2 Main Autopsy Region Elements

Both the north and south longitudinal bars experienced no corrosion and very little discoloration, as shown in Figure 5.68. Longitudinal bar corrosion ratings are shown in Figure 5.68 and summarized in Table 5.21. Corrosion damage to the stirrups was mild. However, stirrup #5, shown in Figure 5.68, showed pitting over one interval at its center. The highest corrosion ratings were observed in the stirrups underneath the specimen's transverse surface cracks. Stirrup corrosion ratings are shown in Figure 5.69 and summarized in Table 5.21.

The north plastic duct showed a large amount of chalky white residue on its outer surface. This residue formed small swirls near the live end of the duct, suggesting that small pockets of moisture may have been present there. Patches of shiny white crystals were found inside the duct. Evidence of a large, continuous void was found on the inner top portion of the duct, extending from the live end of the duct to the splice at midspan. Smaller voids were observed on the dead end half of the duct. These appeared to be confined to the top ribs of the duct. Gouges were observed on the duct's bottom interior surface, suggesting that at least one strand had been bearing on the duct over its entire length. Deep scratches, amounting to approximately 10% of the duct's thickness, were seen on the top interior surface of the duct along almost its entire length. This damage was likely caused by the highly curved strands as they were threaded through the duct prior to stressing (see Figure 5.68).

The large curvature of the strands caused both the north and south grout to fracture along their lengths as the ducts were removed. Large, continuous voids, approximately 2 inches across, were present on the live end half of each grout, and smaller voids were seen on the dead end half (see Figure 5.68). These voids were approximately 0.75 inches in width. Chloride content was 0.39% at midspan of the north grout and 0.32% at midspan of the south grout. Chloride content for north and south grouts is shown in Figure 5.69.

All stainless steel strands in both the north and south tendons were nearly immaculate upon inspection. No corrosion or corrosion staining was found on the outer wires of any strand. The only discoloration observed was a light coating of white-gray grout residue (see Figure 5.68). This could easily be rubbed off over all intervals. When compared to a length of stainless steel strand that had been stored indoors for the duration of the exposure period, the strands extracted from the specimen showed no discernible difference in appearance, as shown in Figure 5.68. Small flecks of light surface corrosion were found at the dead end of every strand's inner wire, but this may have been due to water intrusion during the autopsy process. Strand corrosion ratings are summarized in Table 5.21.

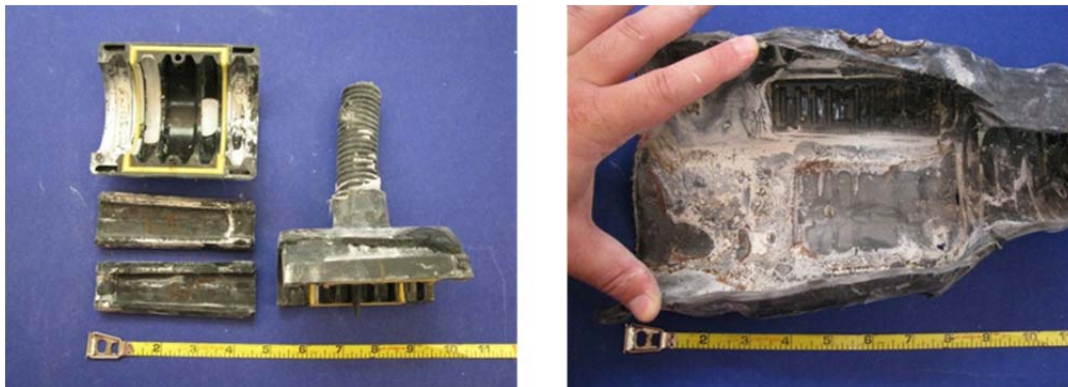
Figure 5.72: Specimen 7.1 Live End Coupler (Left) and Live End Sheath (Right)

The outside of the duct was extensively coated with chalky white residue. Some traces of corrosion products were found near the live end of the duct underneath the heat shrink sleeve. Inside, a shinier white residue was found, along with evidence of voids in the top inner ribs of the duct. These voids were uniform in size and did not appear to be continuous along the length of the duct (see Figure 5.73). Isolated light gouges were found on the duct's inner surface at various points along its length. It appeared that at least one strand had been bearing on the duct at those locations. Duct corrosion ratings are shown in Figure 5.74 and summarized in Table 5.23. The dead end and live end couplers were completely intact. Both sets of fasteners were fully functional at the time of autopsy, and no cement paste appeared to have breached the gaskets at any point of either coupler (see Figure 5.72). The outer and inner surfaces of both couplers showed similar discoloration to that which was seen on the duct. Both primary heat shrink sleeves were also intact. Extensive paste intrusion was observed near the outer end of each sleeve, along with some corrosion staining, as shown in Figure 5.72. The sleeves had a somewhat loose fit on the ducts. It is unknown how much of the cement paste was introduced during construction and how much was a byproduct of the autopsy process. At the dead end coupler, an additional heat shrink sleeve had been applied to the top of the duct because the primary sleeve had split during its application. This additional sleeve was observed to be loose at the time of autopsy, although it may have been jarred loose during the extraction process.

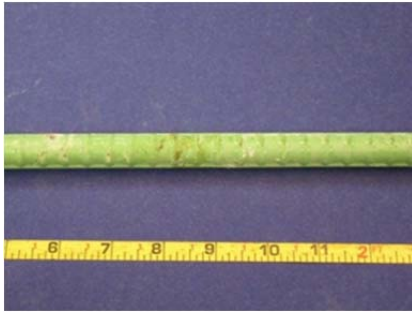
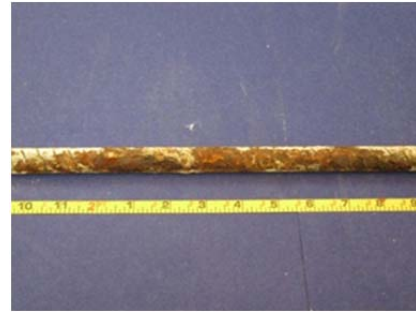
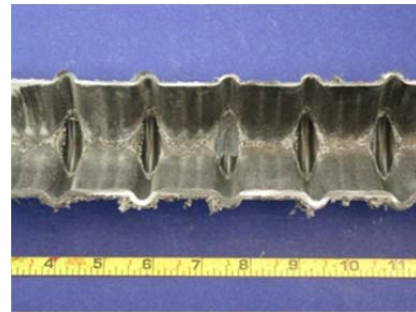
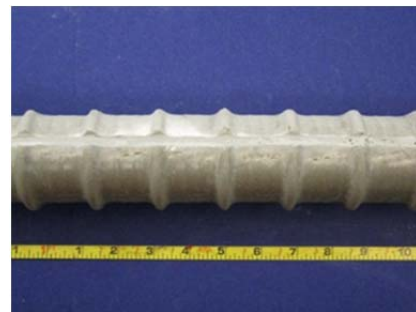
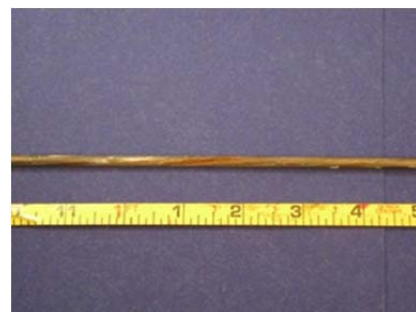
Figure 5.73: Specimen 7.1 Main Autopsy Region Elements

Damage to the epoxy-coated longitudinal bars was minor, as shown in Figure 5.73. The uncoated longitudinal bars provided for resistance monitoring showed moderate to severe corrosion damage. Spots of corrosion were observed along most of the bars' length. Near midspan, both bars were also pitted over several intervals (see Figure 5.73). The south uncoated bar was substantially more damaged than the north bar. It showed pitting on almost half of its total length. Longitudinal bar corrosion ratings are shown in Figure 5.74 and summarized in Table 5.23.

The stirrups were mildly damaged, as shown in Figure 5.73. It is possible that much of the discoloration at these locations was transported there from the uncoated bars. Stirrup #3 was

the most damaged, with nonremovable corrosion visible on top of its horizontal region over several intervals. This stirrup was located directly beneath the specimen's largest transverse surface crack. Stirrup corrosion ratings are shown in Figure 5.74 and summarized in Table 5.23.

Corrosion damage to the strands was uniform and minor. The outer wires of each strand showed spots of discoloration and light surface corrosion over most intervals. All corrosion could be removed with a scouring pad (see Figure 5.73). The inner wire on each strand was somewhat more damaged. Corrosion that could not be removed was found in several intervals along each strand. Strand corrosion ratings are shown in Figure 5.74 and summarized in Table 5.23.

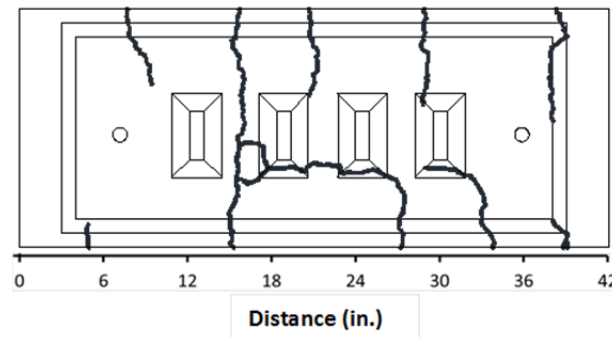
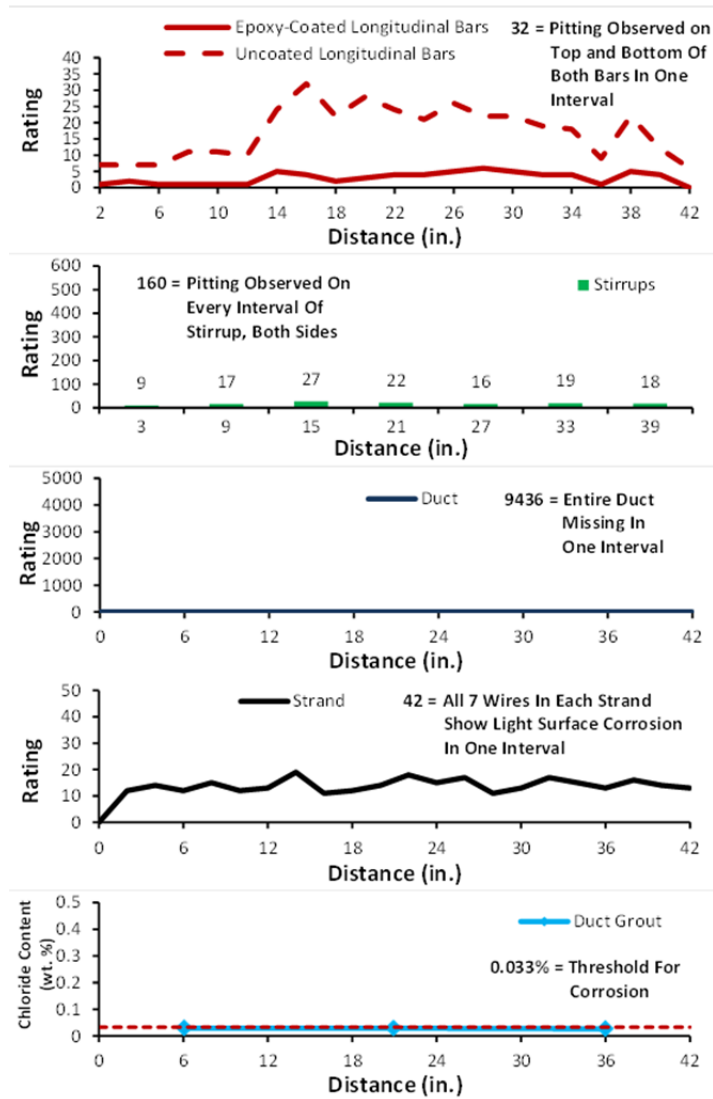
Figure 5.74: Specimen 7.1 Crack Map and Corrosion/Damage Rating Plots

Several transverse cracks were present on the top face of the specimen. Although only one crossed the full width of the specimen, five of the cracks extended down both the north and south faces. Two of the transverse cracks were connected to longitudinal cracks that ran approximately 6 inches from the south face of the specimen. Average crack width for all surface cracks was 0.015 inches. Some separation was found at the joint between the live and dead end pourbacks and the surrounding concrete. The crack diagram is shown in Figure 5.74.

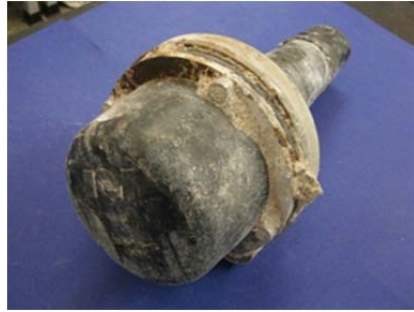
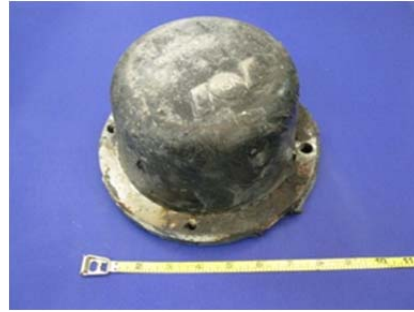
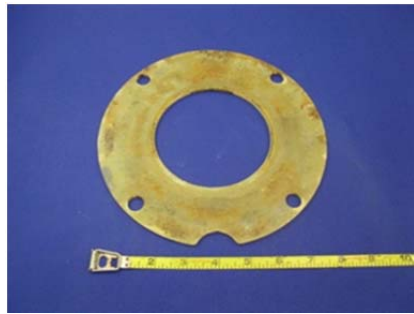
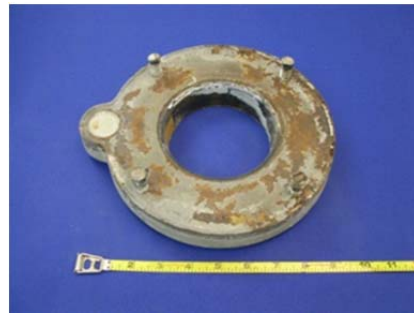
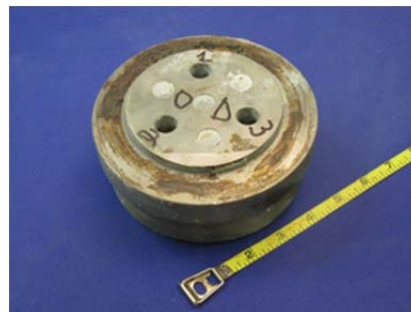
Figure 5.76: Specimen 7.1 Dead End Anchorage Cap Components

The VSL CS-2000 anchorage system contained several cap components that will be described here in order from the end of the specimen toward the inside. See Figure 5.75 for the layout and names of these components. The outside of the grout cap was covered in chalky white residue. Some light corrosion staining was also observed on the top of its outer surface and along its outer lip. The retaining ring was severely pitted around the top of its outer face. Localized pitting and corrosion was found elsewhere on the retaining ring, mostly on or near its outer edges. The insulation plate showed widespread corrosion staining on both of its faces. The discoloration was most severe near the top of the plate. The bearing plate showed widespread moderate surface corrosion on the surface in contact with the insulation plate. Lighter corrosion was also observed around the bearing plate's forward edge. Some light to moderate surface corrosion was observed on the rear of the bearing plate. The anchor head was lightly discolored over much of its exposed surfaces. The surface that had been bearing on the bearing plate showed widespread moderate corrosion and some pitting. Also, a small "window" of corrosion was observed on the top, outer surface of the anchor head. A grout void that was similar in shape to the "window" appeared to have been located there. This may have been a chloride ingress point. Anchorage components are shown in Figure 5.76.

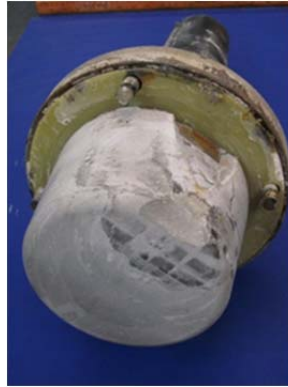
Figure 5.77: Specimen 7.1 Dead End Grout Cap Showing Grout Discontinuity

The grout inside the grout cap was not cracked. The top third of the grout cap was slightly darker than the rest, and a clear boundary was visible between these regions, as shown in Figure 5.77. This may have occurred because grouting was completed in stages. It is possible that the time between stages was too great. A void was observed on the top of the grout within the grout cap adjacent to the insulation plate. The corroded “window” of the anchor head was visible beneath the void. Some corrosion products were found around the perimeter of the void,

and the void appeared to terminate at the location of the grout cap vent. The grout within the trumpet was also uncracked, contradicting evidence found to the contrary inside the dead end trumpet. The grout was darker on its bottom surface along its whole length, as shown in Figure 5.78. This indicates that segregation may have occurred. A small void surrounded by dark bubbling was found on the top of the grout.

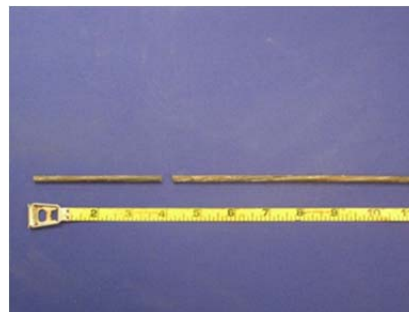
Figure 5.78: Specimen 7.1 Dead End Anchorage Region Elements

The trumpet was completely intact at the time of autopsy. Chalky white residue was observed on the outer surface of the trumpet. Some localized corrosion staining was observed near the bearing plate. Inside the trumpet, lines were visible in the shiny grout residue that suggested that the grout was cracked longitudinally there. The trumpet is pictured in Figure 5.78. Trumpet damage ratings are summarized in Table 5.24.

The dead end anchorage zone strands were somewhat damaged but overall in good condition. The outer wires of each strand showed spots of discoloration or light surface corrosion over most of their length. All corrosion could be scrubbed away with a scouring pad. The inner wires were more damaged, with light to moderate surface corrosion occurring over all intervals, as shown in Figure 5.78. On the inner wires of two strands, the heaviest corrosion occurred on the intervals that had been located inside the anchor head. Light to moderate surface corrosion was found on the exterior of all three wedges. The interior of each wedge was not damaged. A typical strand is shown with and without wedges in Figure 5.78. Dead end anchorage zone strand corrosion ratings are summarized in Table 5.24.
