1. Report No. FHWA/TX-11/0-4562-4		2. Government Accession No.		3. Recipient's Catalog No.	
4. Title and Subtitle Evaluation of Corrosion Resistance of Improved Post-tensioning Materials after Long-term Exposure Testing				5. Report Date October 2011

Evaluation of Corrosion Resistance of Improved Post-tensioning Materials after Long-term Exposure Testing

CTR Technical Report:	0-4562-4
Report Date:	October 2011
Project:	0-4562
Project Title:	Corrosion Resistance of Grouted Post-Tensioning Systems
Sponsoring Agency:	Texas Department of Transportation
Performing Agency:	Center for Transportation Research at The University of Texas at Austin

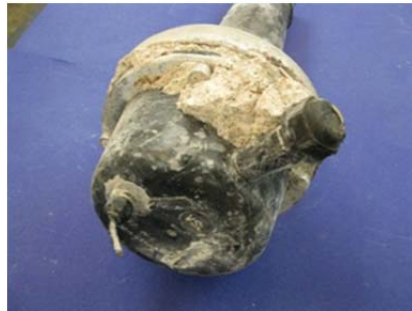
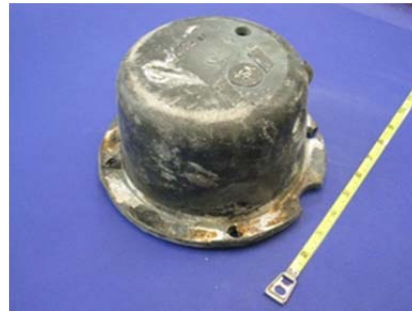
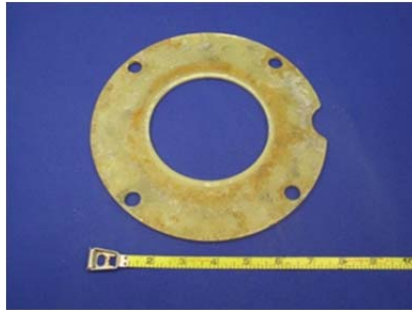
Figure 5.79: Specimen 7.1 Live End Anchorage Cap Components

The orientation of the components within the live end anchorage cap is shown in Figure 5.75. The grout cap was covered in white, chalky residue and showed moderate corrosion staining along its outer lip. Localized moderate corrosion and pitting were found on all surfaces of the retaining ring. The most severe damage occurred near the top of the ring. The insulation plate was lightly stained on both sides. Staining was most severe in the vicinity of its inner edge. The bearing plate showed widespread moderate corrosion and some localized pitting on the surface it shared with the insulation plate. The corrosion near the middle of this outer surface was burnt orange in color, while the corrosion around the bearing plate's outer edge was a much darker red. The inboard side of the bearing plate had localized light to moderate surface corrosion, mostly occurring on its upper portion. Many small spots of light surface corrosion were observed on the outer surfaces of the anchor head, while moderate surface corrosion

covered much of the surface that had rested on the bearing plate. A small “window” of moderate corrosion was found on the upper surface of the anchor head. This appeared to coincide with the location of small grout void there and may have been another chloride ingress point for the tendon. Anchorage cap components are shown in Figure 5.79.

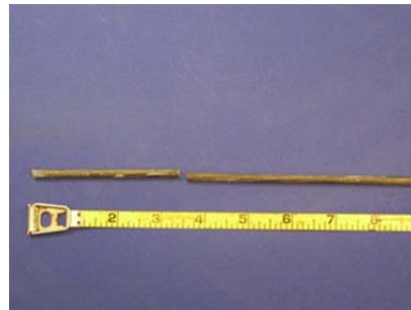
Figure 5.80: Specimen 7.1 Live End Anchorage Region Elements

The live end trumpet was similar in appearance to the dead end trumpet. Chalky white residue was found on its outer surface, along with small areas of corrosion staining on the portion of the trumpet that had been inside the bearing plate. Shiny white residue was present on the inner surfaces of the trumpet. Lines in this residue suggested that the grout may have been cracked there. The live end trumpet is pictured in Figure 5.80. Trumpet damage ratings are summarized in Table 5.24.

The live end anchorage strands were somewhat less damaged than the dead end strands. Discoloration spots were visible along many of the outer wires’ length in all three strands, as shown in Figure 5.80. Occasional spots of light surface corrosion were observed on the outer wires. These did not occur solely in the anchor head regions of each strand. The inner wires were more corroded. Localized light surface corrosion was present on all intervals (see Figure 5.80). With the exception of one interval on one of the outer wires, this corrosion could be removed with a scouring pad. All three wedges were substantially intact, although spots of moderate surface corrosion were found on their outer surfaces. Typical live end anchorage region strands, with and without wedges, are shown in Figure 5.80. Live end anchorage zone strand corrosion ratings are summarized in Table 5.24.

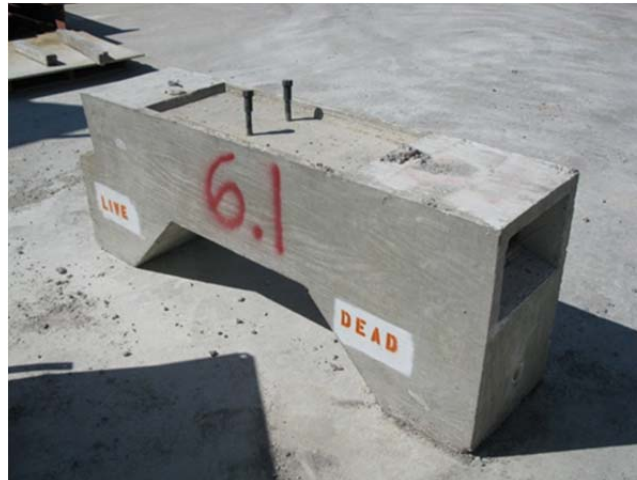
Figure 5.81: Control Specimen Overall Appearance

The beam was in near-immaculate condition at the time of autopsy, as shown in Figure 5.81. Some light scaling had taken place along the edges of the saltwater tray. Small surface air voids were visible on the north and south faces of the specimen, as well as within the saltwater tray. No cracks were observed at any location on the specimen, as it had never been stressed.

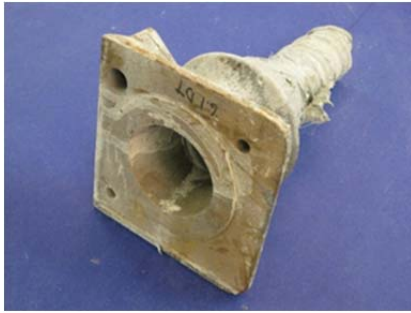
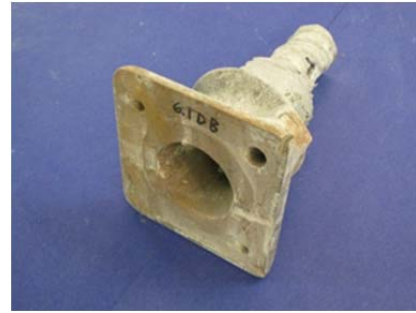
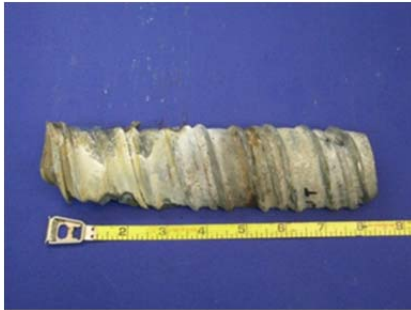
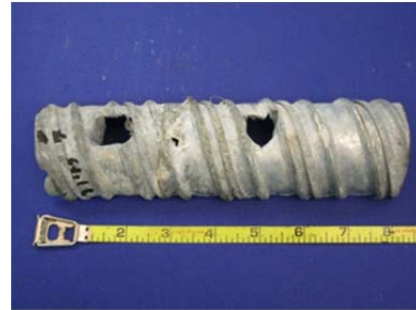
Figure 5.84: Control Specimen Anchorages and Ducts

A uniform layer of light surface corrosion was present on the exposed surface of the bearing plates. Localized light to moderate surface corrosion was found along the outside edges of the bearing plates, as well as on the portions of the anchorages around that concrete had been cast. The duct tape used to make the connection between the ducts and bearing plates was intact. A small amount of light surface corrosion was found beneath the duct tape on both bearing plates. North and south anchorages are shown in Figure 5.84.

Some spots of discoloration were present on the outside of the north and south ducts in the area where the duct tape had been applied. This is shown in Figure 5.84. The inner surfaces of the ducts were not evaluated because they had spent several years exposed to air. Anchorage zone duct corrosion ratings are summarized in Table 5.26.

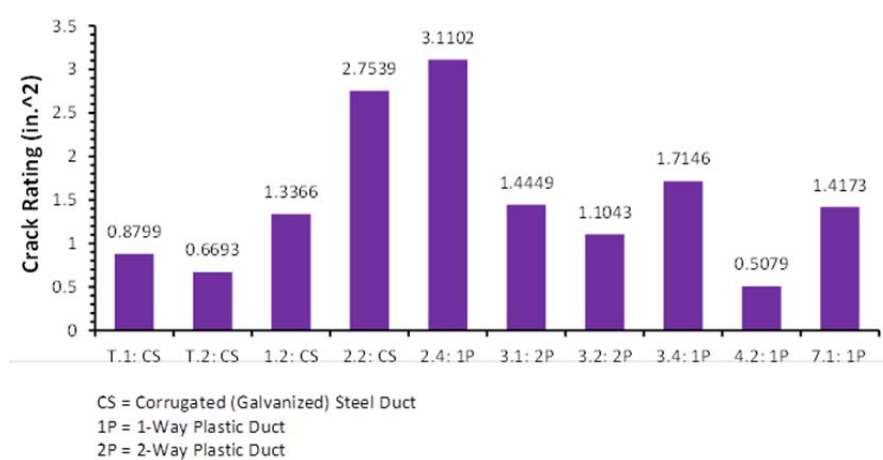
Figure 6.1: Crack Ratings

The surface concrete of all specimens developed scaling in and around the saltwater tray. Corrosion staining was visible on the top surface of several specimens, most often near the base of one or both grout vents. Most specimens displayed wider and more numerous top surface cracks than had been observed immediately after live load application. Crack ratings for all specimens are shown in Figure 6.1. The highest crack ratings occurred in Specimens 2.2 and 2.4, while the lowest crack ratings were computed for Specimens T.2 and 4.2. Crack ratings do not show a strong correlation with duct type. In fact, the two highest and two lowest crack ratings were found in one specimen with plastic ducts and one with galvanized steel, respectively. This suggests that galvanized duct corrosion, while quite extensive, was not extensive enough to cause surface cracking.

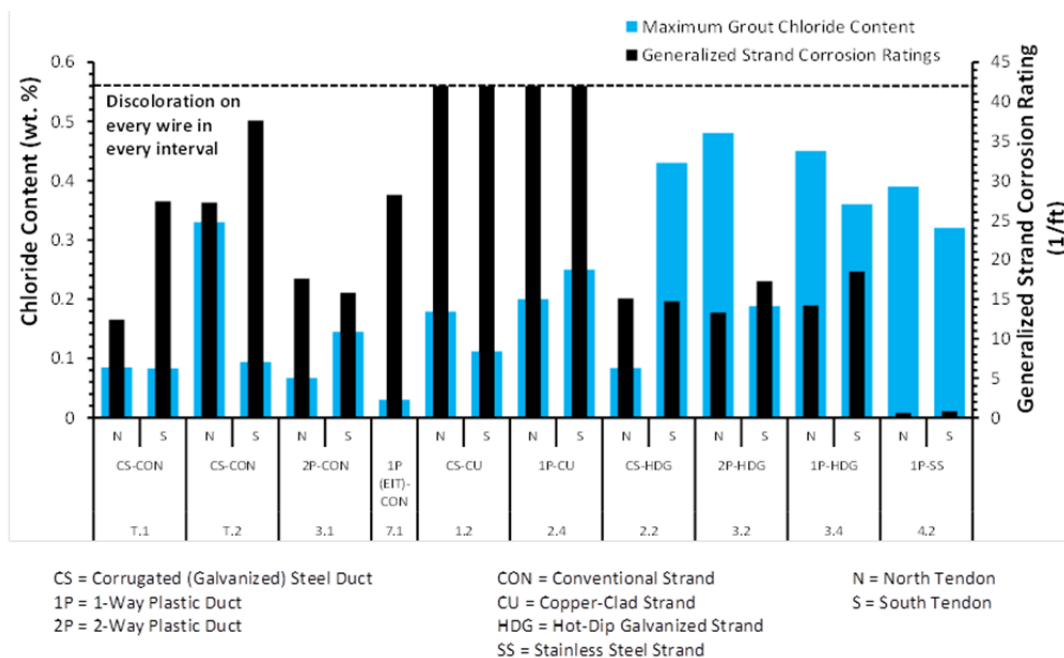
Figure 6.3: Generalized Strand Corrosion Ratings and Maximum Tendon Chloride Content, Organized by Strand Type

Because the different strand types corroded in different ways, direct comparison among them is difficult. Generalized strand corrosion ratings are plotted with maximum chloride content for both tendons in each autopsy specimen in Figure 6.3. Note that the plots are organized by strand type.

For tendons with conventional strand, only Specimen 7.1 (electrically isolated tendon) had a maximum chloride content below the corrosion threshold. The north duct of Specimen T.2 had the highest strand corrosion rating but one of the lowest grout chloride concentrations. The south tendon of Specimen T.1, the north tendon of T.2, and the tendon in Specimen 7.1 all had similar generalized strand corrosion ratings. However, the maximum chloride content of these tendons varied dramatically, showing that corrosion rating is not dependent on chloride concentrations once the corrosion threshold has been exceeded.

The copper clad strands all took on a uniform black patina during their life. As a result, their generalized strand ratings were identical. However, all maximum chloride concentrations were above the corrosion threshold, varying from 0.11% to 0.25%. Therefore, corrosion of

copper-clad strand was independent of chloride content above the corrosion threshold for copper-clad strand.

For the specimens with hot-dip galvanized strand, generalized corrosion ratings were relatively uniform. However, chloride concentrations ranged from 0.08% to 0.48%. Again, this suggests that corrosion of galvanized strand was independent of chloride concentration past the corrosion threshold.

Only one specimen with stainless steel strands was autopsied. Generalized strand corrosion ratings were very low in both tendons of Specimen 4.2, while maximum chloride concentrations were about ten times higher than the corrosion threshold. This shows that the stainless steel strands were extremely corrosion resistant. None of the specimens autopsied had epoxy coated or stainless clad strands.

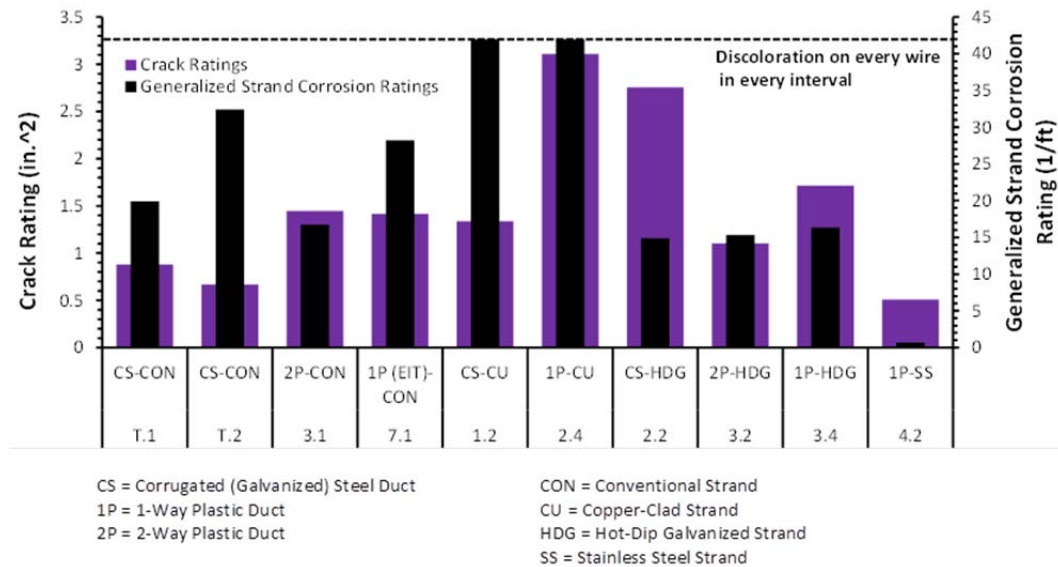
Figure 6.4: Average Generalized Strand Corrosion Ratings and Crack Ratings, Organized by Strand Type

Figure 6.4 shows generalized strand corrosion ratings plotted with crack ratings for each specimen. The corrosion ratings shown represent the average of the tendons in each specimen. For each individual strand type, there is no clear correlation between strand corrosion rating and crack rating. High crack ratings do not necessarily correspond to high corrosion ratings. If cracking is assumed to indicate the extent of chloride ingress, this data confirms that strand corrosion does not depend on chloride content above the corrosion threshold.

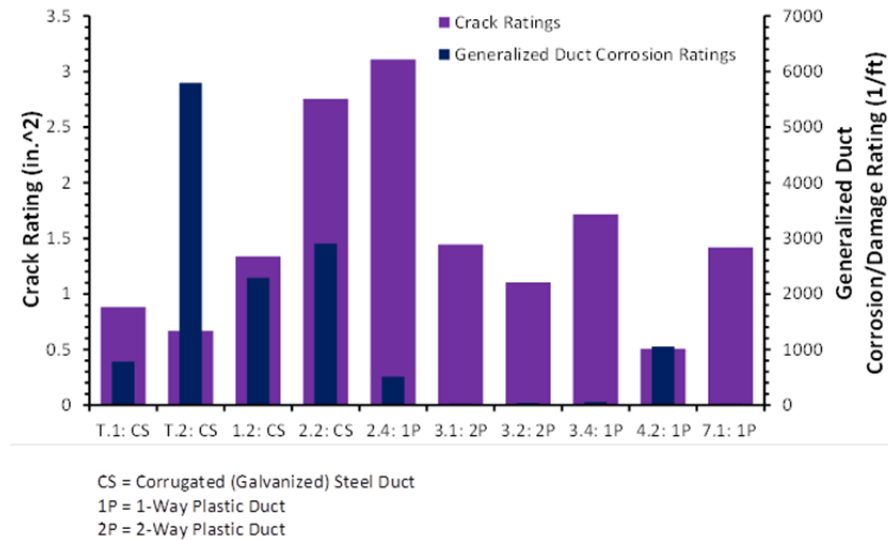
Figure 6.5: Average Generalized Duct Corrosion/Damage Ratings and Crack Ratings

The autopsy specimens contained galvanized steel duct or one of three types of plastic duct from two suppliers. Specimen 7.1, which was electrically isolated, contained the same type of one-way plastic duct as Specimens 3.4 and 4.2. In Figure 6.5, average generalized duct corrosion or damage ratings for each specimen are plotted with crack ratings.

Among the four specimens with galvanized steel ducts, corrosion ratings increased with crack ratings for Specimens T.1, 1.2, and 2.2. However, the highest duct corrosion ratings occurred for Specimen T.2, which had the lowest crack rating. This suggests a correlation between crack rating and duct corrosion rating, but other factors must also influence the extent of corrosion. From the forensic analysis, it was clear that corrosion initiated in the galvanized steel ducts at locations corresponding to each specimen's transverse surface cracks. For Specimen T.2, cracking allowed duct corrosion to initiate at crack locations, then travel along the length of the large voids as chlorides continued to enter the tendons. Therefore, crack location and the presence of grout voids are just as important as crack rating in determining the extent of duct corrosion.

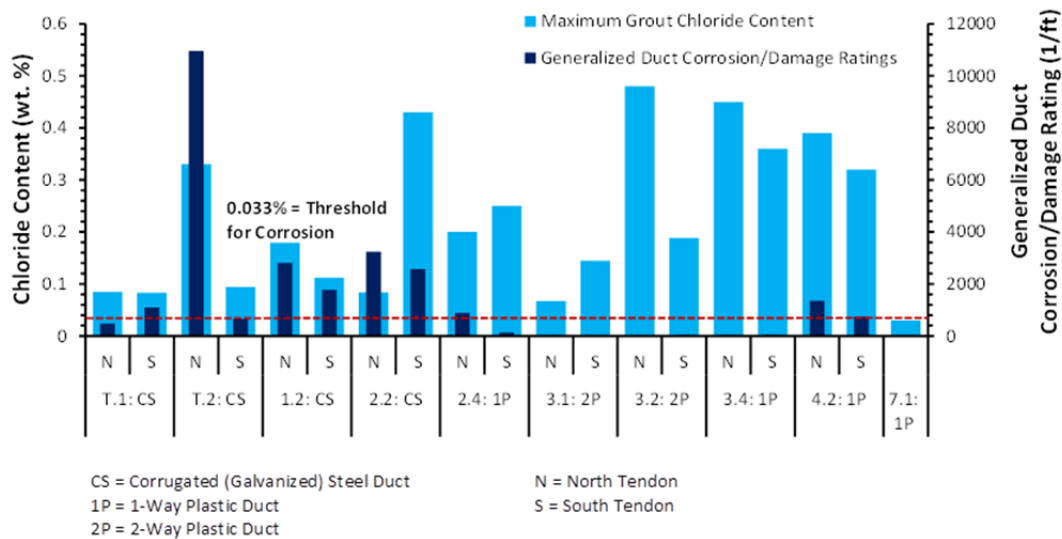
Figure 6.6: Generalized Duct Corrosion/Damage Ratings and Maximum Grout Chloride Content

Figure 5.66 shows generalized duct corrosion and damage ratings plotted with maximum chloride content in each tendon. For the steel ducts, chloride content seemed to increase in each tendon along with the generalized corrosion rating in the surrounding duct. However, the highest overall chloride contents occurred in tendons with plastic ducts. This is a puzzling result, given the extensive area loss in the steel ducts. However, it confirms the presence of leaks in the couplers of the north plastic ducts and the grout vents of the south plastic ducts, as observed during the autopsy process. Plastic duct damage ratings showed no correlation to the grout chloride content.

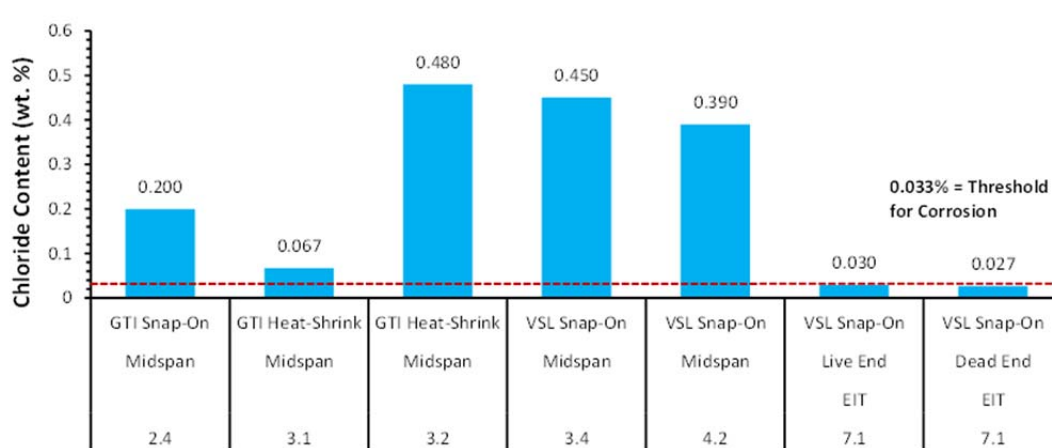
Figure 6.7: Grout-Chloride Contents at Coupler Locations

The specimens with galvanized steel ducts did not contain couplers. In each specimen with plastic ducts, the two halves of the north duct were connected with one of three couplers: GTI slip-on, GTI snap-on, or VSL snap-on. For each specimen, Figure 6.7 shows the chloride content within the tendon grout at the location of each coupler.

The highest grout chloride concentration was found inside the GTI heat shrink coupler within Specimen 3.2. The lowest concentrations were found in both VSL snap-on couplers inside Specimen 7.1, although these couplers had the benefit of being covered with an additional plastic sheath. Both chloride concentrations in Specimen 7.1 were below the corrosion threshold. The presence of chlorides within the couplers confirms that breaches had occurred, as observed during autopsies. For each coupler that was installed in more than one specimen, chloride concentrations vary significantly. This suggests that the integrity of the couplers depends more on workmanship during construction than on coupler type and manufacturer. The inexperience of the project team at construction time may have resulted in couplers that were not properly installed and that allowed chloride ingress during exposure.

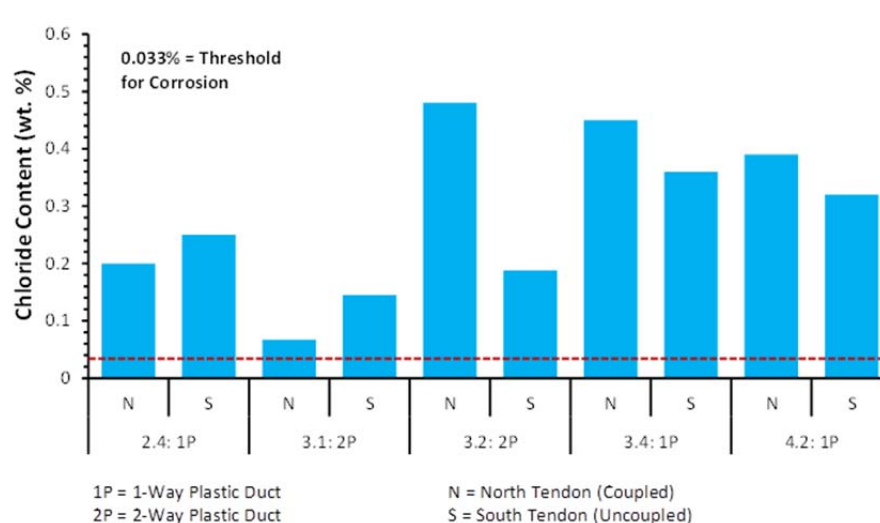
Figure 6.8: Midspan Grout Chloride Contents for Specimens with Two Plastic Ducts

For all specimens with one coupled and one uncoupled plastic duct, grout chloride concentrations at midspan are plotted in Figure 5.68. From this figure, it is clear that chloride levels at midspan were well above the corrosion threshold in both tendons of each specimen. While chloride levels were generally higher in the north tendons, concentrations were of similar magnitude in the corresponding south tendons. This is most clear for Specimens 2.4, 3.4, and 4.2, for which both chloride concentrations were nearly equal. This trend confirms that the grout vents at midspan of the south ducts were indeed breached by chlorides during the exposure period.

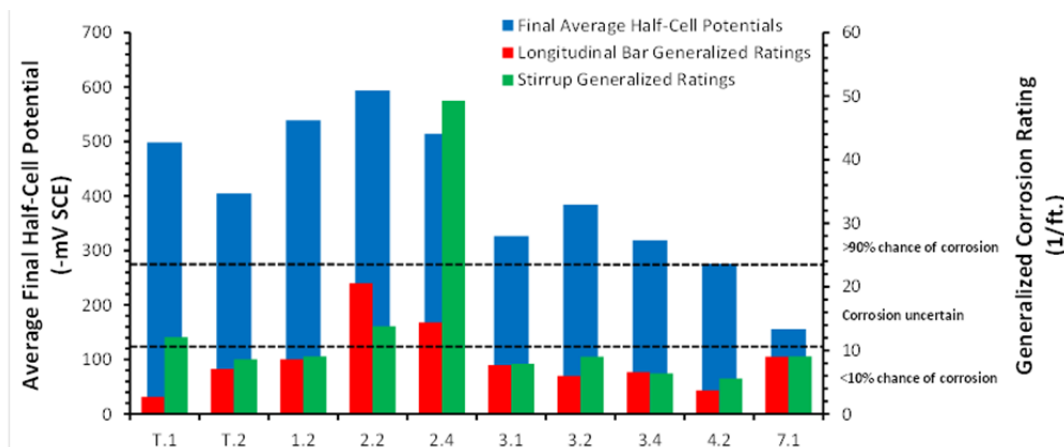
Figure 6.10: Average Final Half-Cell Potentials and Generalized Longitudinal Bar and Stirrup Corrosion

Average final half-cell potentials for each specimen are shown in Figure 6.10 with generalized longitudinal bar and stirrup corrosion ratings. All specimens except for 7.1 ended the test period with an average half-cell potential within the 90% chance of corrosion region, indicating that corrosion is very likely to be present¹⁴. Specimen 7.1 ended the test period in the uncertain corrosion category. Corrosion was present to some extent on the bars and stirrups in all specimens. In the sense of predicting the presence of corrosion, the final half-cell potential method was accurate. However, the half-cell potentials did not correlate well to the magnitude of the stirrup and longitudinal bar generalized corrosion ratings. Thus, the half-cell method did not accurately predict the relative severity of corrosion for the mild steel components in the autopsy specimens.

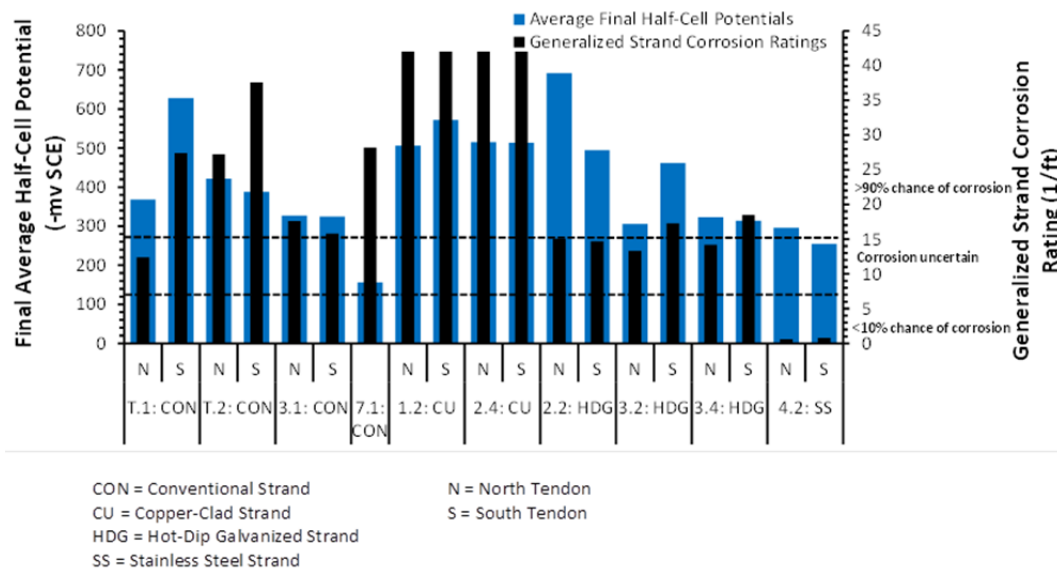
Figure 6.12: Average Final Half-Cell Potentials and Generalized Strand Corrosion Ratings

Figure 6.12 shows average final half-cell potentials plotted with generalized strand corrosion ratings for north and south tendons of each Specimen, grouped by strand type. Final half-cell potentials for all seven tendons with conventional strand indicated that corrosion was uncertain or more than 90% likely. Because all conventional strands had some corrosion, the half-cell method was accurate in this regard. However, no relationship can be seen between the final half-cell potential and generalized corrosion rating.

The three specimens with hot-dip galvanized strands all showed similar generalized corrosion ratings. Final average half-cell potentials were all above the 90% threshold and generally decreased from Specimen 2.2 to 3.2 to 3.4. In this case, a slight correlation can be seen between half-cell potential and strand corrosion rating.

Almost no corrosion was found on the stainless steel strands in Specimen 4.2. However, the final average half-cell potentials for the two tendons in that specimen indicated that corrosion was uncertain or more than 90% likely. The half-cell method was not accurate for stainless steel strands and probably was meaningless for detecting strand corrosion at all.

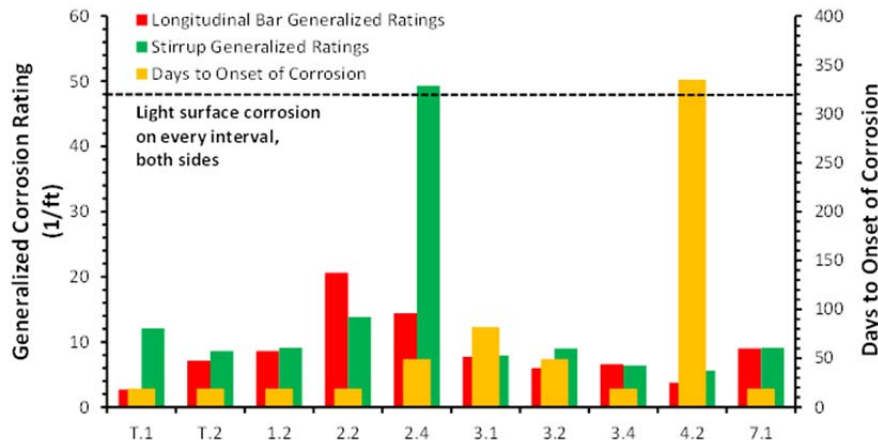
Figure 6.13: Longitudinal Bar and Stirrup Generalized Corrosion Ratings and Days to Onset of Corrosion

In Chapter 4, corrosion was assumed to initiate when the most negative half-cell reading within a specimen exceeded the 90% chance of corrosion threshold. The number of days to onset of corrosion for each specimen is shown in Figure 6.13 along with generalized longitudinal bar and stirrup corrosion ratings.

There was not much variation in the time to onset of corrosion among most autopsy specimens, which makes comparison difficult. Times to corrosion onset tended to be lower for specimens with higher bar and stirrup corrosion ratings, although this trend is not universal. The longest time to corrosion onset was observed in Specimen 4.2, which also had the least amount of corrosion on its bars and stirrups.

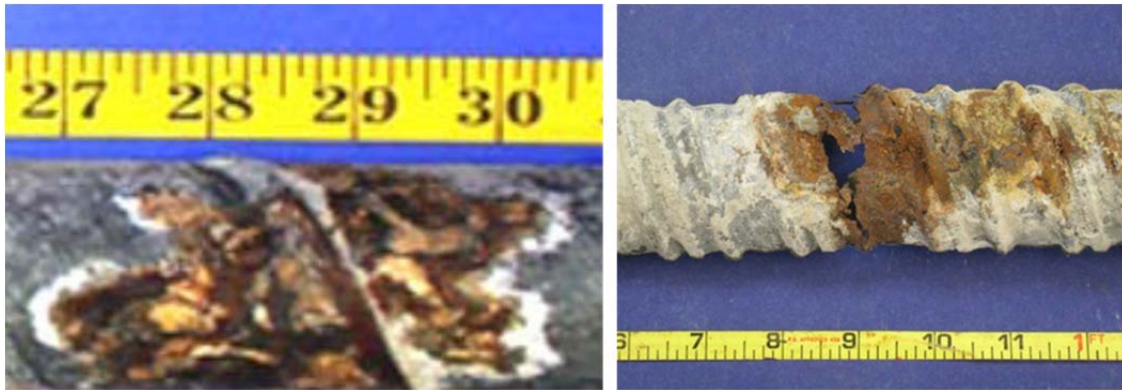
Figure 6.20: Typical Galvanized Steel Duct from Project 0-14058 (Left) and Project 0-4562 (Right)

Typical steel ducts from both projects are shown in Figure 6.20. The comparable damage in the ducts indicates that the testing conditions were generally compatible in both projects. The galvanized steel ducts experienced pitting and area loss in several 0-1405 specimens, with the worst corrosion occurring at locations of grout voids. “Industry standard” (duct tape) and heat shrink splices performed very poorly, allowing chloride ingress at splice locations. Salas did not include any specimens with plastic ducts in his autopsies.

Galvanized duct corrosion was comparable in the 0-4562 specimens. Despite very little visible corrosion on the outer surface of the specimens, the galvanized duct within experienced substantial area loss and some pitting. This damage occurred mostly around transverse surface cracks and the locations of grout voids.

Galvanized steel duct performed very poorly and should not be used in aggressive environments. The plastic ducts studied herein were robust enough to prevent significant damage during casting and post-tensioning. Their use is recommended in aggressive environments. However, chlorides were able to enter continuous plastic ducts through grout vent openings that had been drilled on-site and inadequately sealed. Therefore, it is recommended that all grout vents be installed at couplers equipped with integral grout vents and positively attached grout hoses for maximum watertightness.
