# **Assessment and Rehabilitation Methods for Longitudinal Cracks and Joint Separations in Concrete Pavement**

CTR Technical Report:	0-5444-2
Report Date:	October 2008
Project:	0-5444
Project Title:	Assessment and Rehabilitation Methods for Longitudinal Cracks and Joints Separations in Concrete Pavement
Sponsoring Agency:	Texas Department of Transportation
Performing Agency:	Center for Transportation Research at The University of Texas at Austin

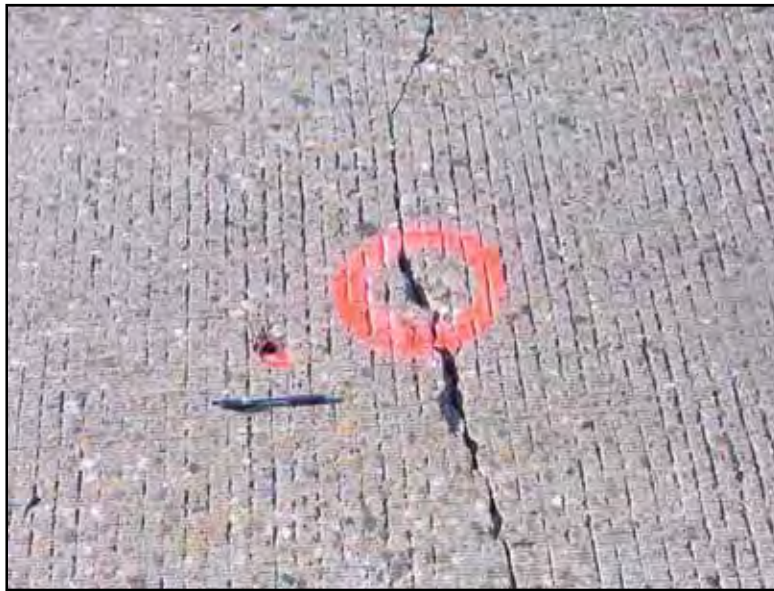
Slabs generally appeared to be in good condition, except for those with edge spalling and cracking as noted above. The only significant transverse crack that was observed is shown in Figure 3.6. No major longitudinal cracks were observed.

*Figure 3.6: Transverse Slab Crack in Area Two*

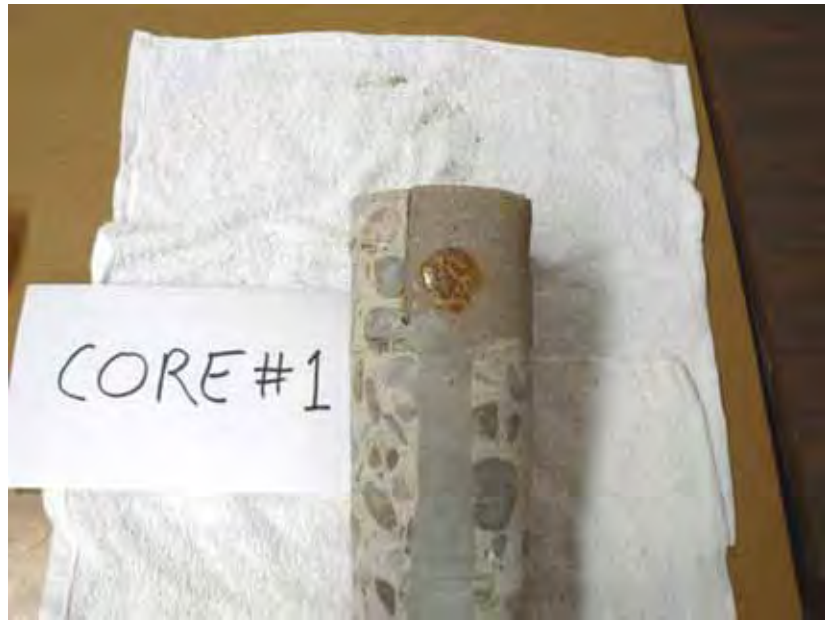
All staple bars appeared to be rigidly connected to the pavement as originally installed. No pullouts or bar ruptures were observed. Some exposed bars showed evidence of corrosion, which was confirmed by examining core #1 (Figures 3.19 and 3.20).

*Figure 3.19: Staple Corrosion (Core #1)*

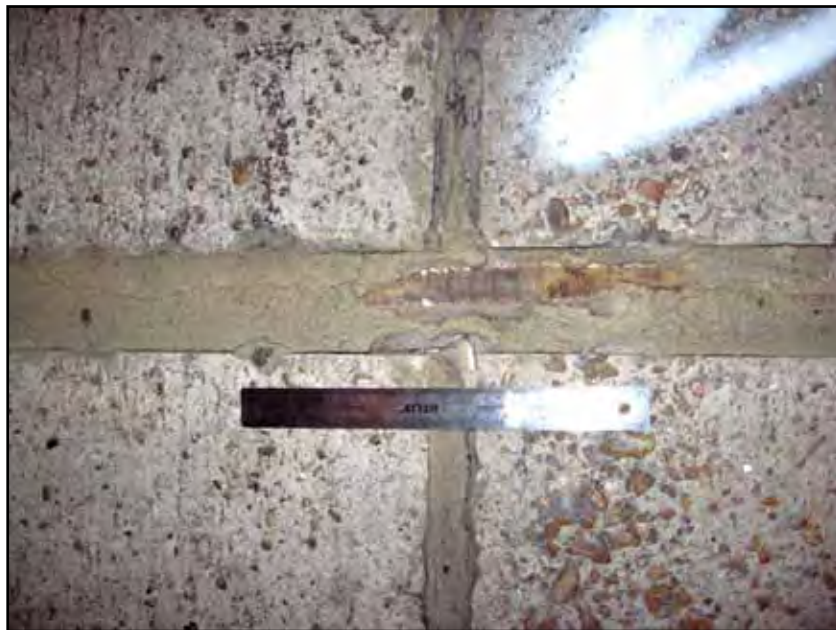
*Figure 3.20: Staple Corrosion*

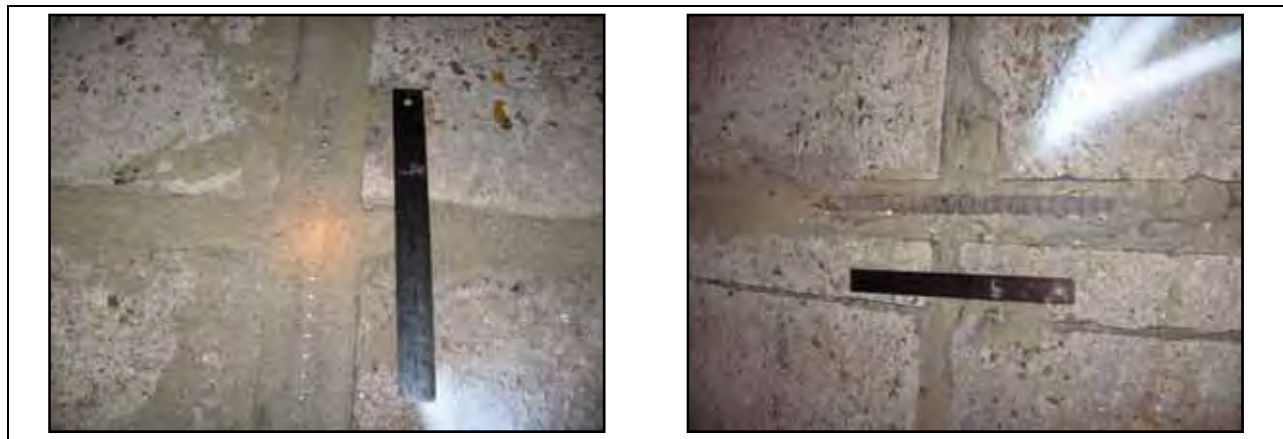
Several staples were protruding through the joint filler material (Figure 3.23). It appeared that the staples were not installed with sufficient clear cover above the bar (much less than the 2 in. required by the specification), and the elastomeric material was worn over time by traffic.

*Figure 3.23: Protruding Staple Bars*

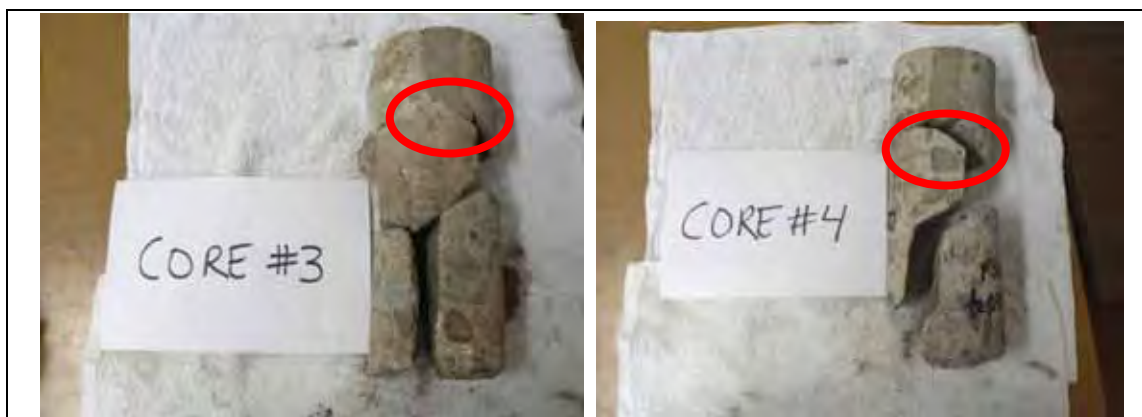
Examination of the cores revealed the absence of backer rod in the longitudinal joint as called for in the stapling specification (Figure 3.24). While not a critical construction error, the backer rod prevents the repair material from intruding into the joint farther than desired. This not only saves money on repair material, but could also cause better performance of the repair material. For low-modulus materials subjected to large strain demands, the effect of Poisson's ratio begins to negatively affect the strain capacity of the material if it is very thick.

*Figure 3.24: Absence of Backer Rod in Longitudinal Joint Cores*

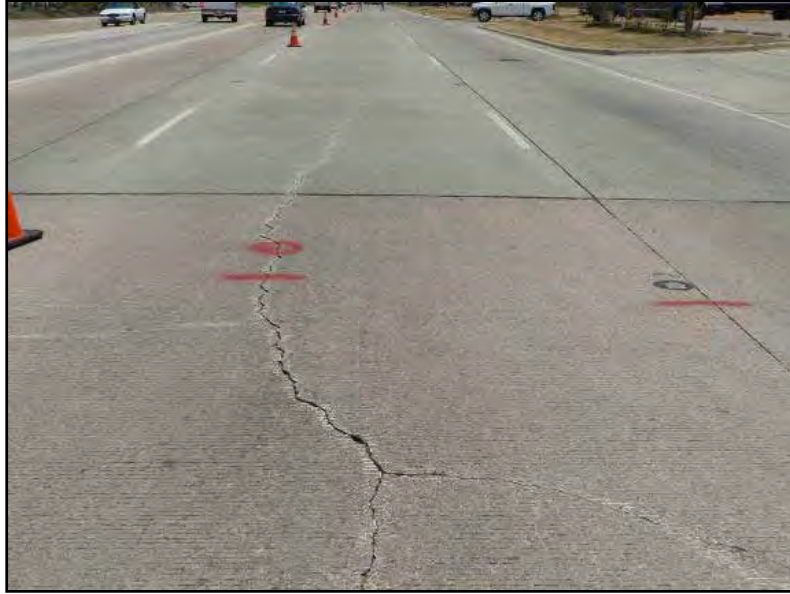
*Figure 3.25: Longitudinal Cracking (1)*

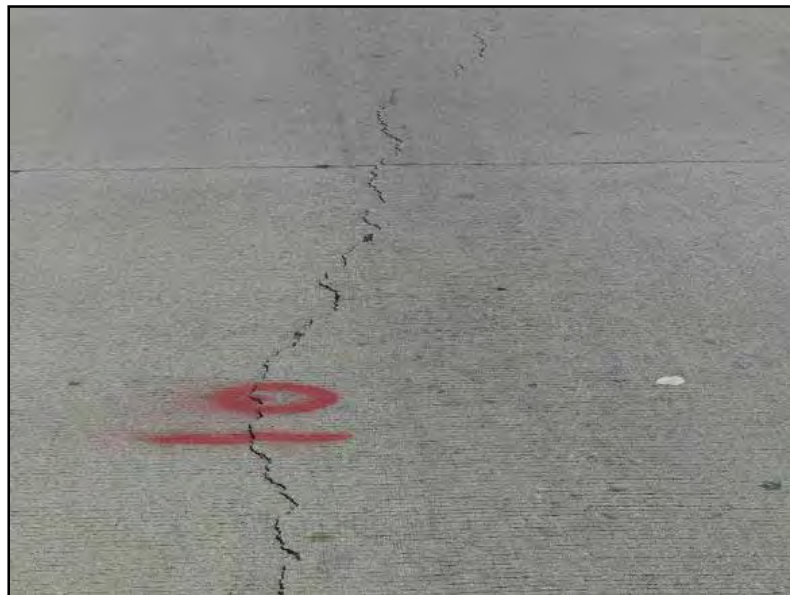
*Figure 3.26: Longitudinal Cracking (2)*

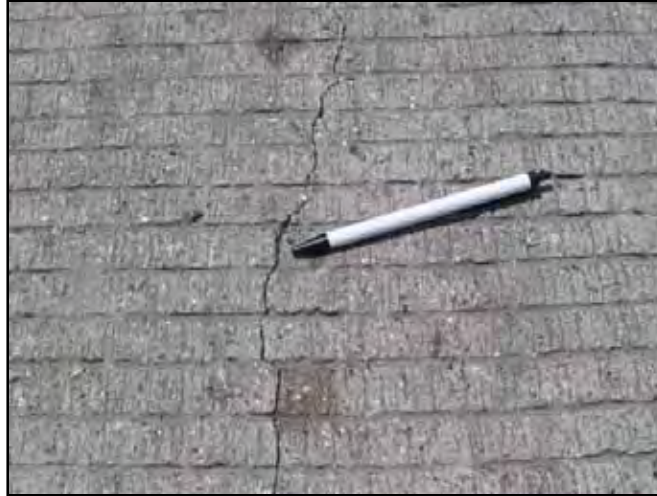
Crack widths from 0.025 to 0.5 in. were measured in the test section. Limited slab faulting of up to 0.25 in. was also observed (Figures 3.27 and 3.28).

*Figure 3.27: Narrow Crack*

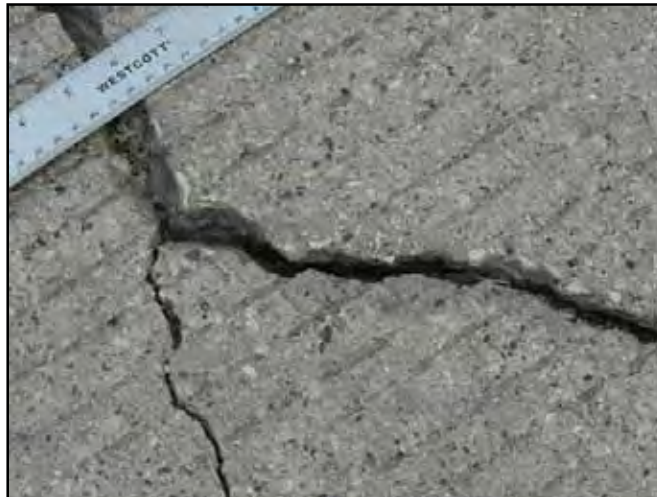
*Figure 3.28: Wide Crack with Faulting*

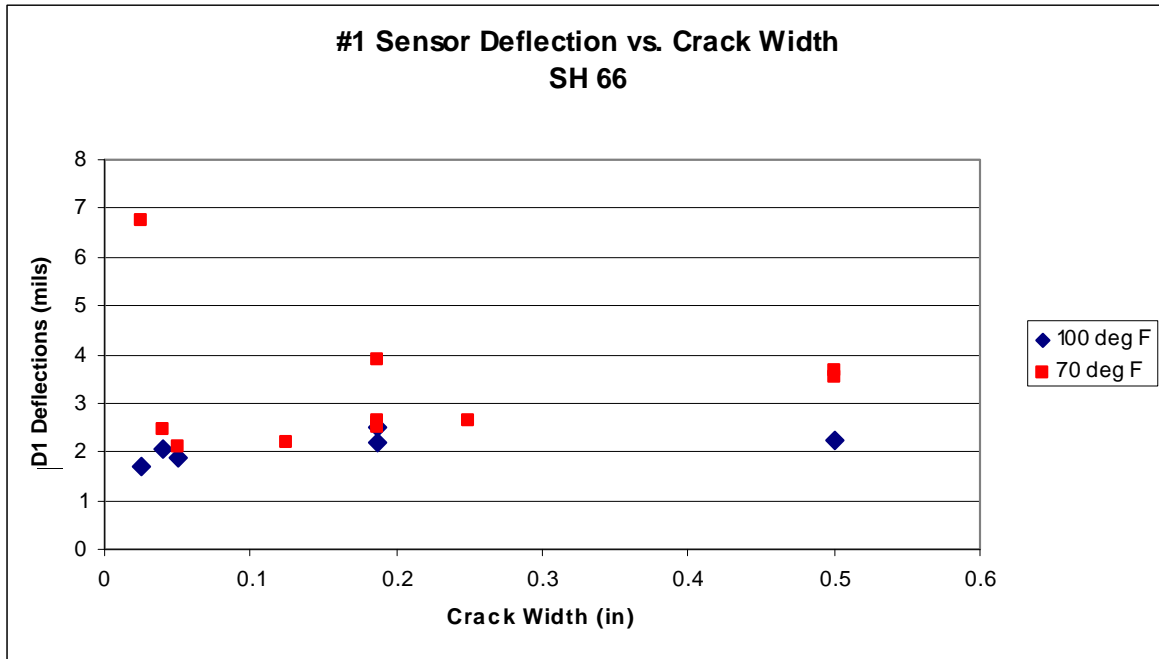
*Figure 3.33: #1 Sensor Deflection vs. Crack Width*

Data did not indicate a strong correlation between deflection and crack width. Deflection did not vary significantly for different crack widths (only a slight increase in the deflection was seen as crack width increases). The low average deflection indicated that the pavement system is in generally good condition. Base and subgrade were likely robust.

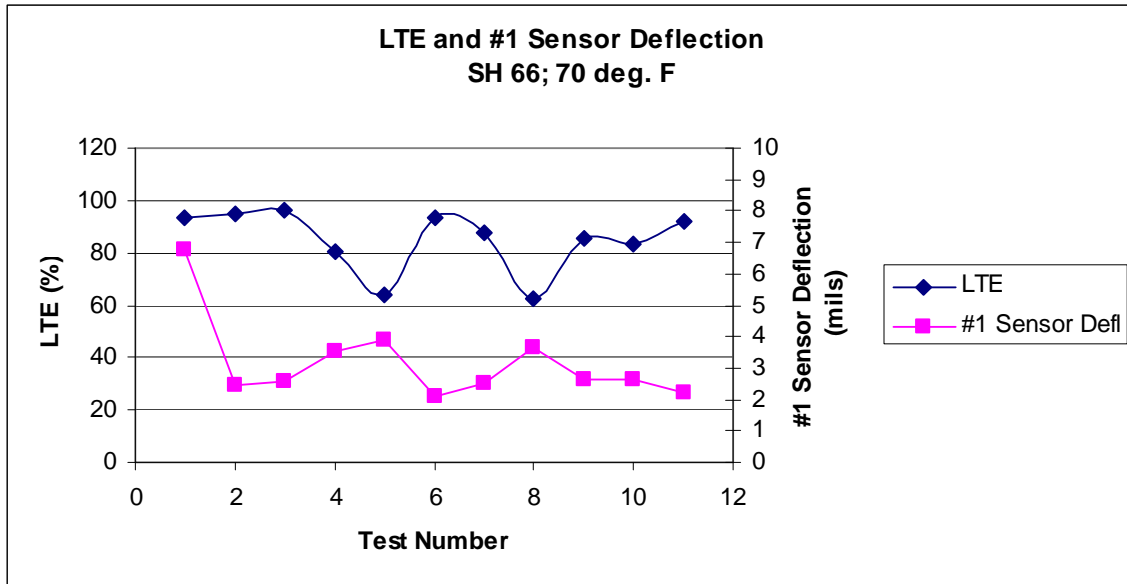
Figure 3.34: LTE and #1 Sensor Deflection

Figure 3.34 shows that there was a clear correlation between LTE and #1 sensor deflection. With the exception of the first data point, LTE was inversely proportional to deflection. Data show that (relatively) large deflections correspond to (relatively) low LTE and vice versa.

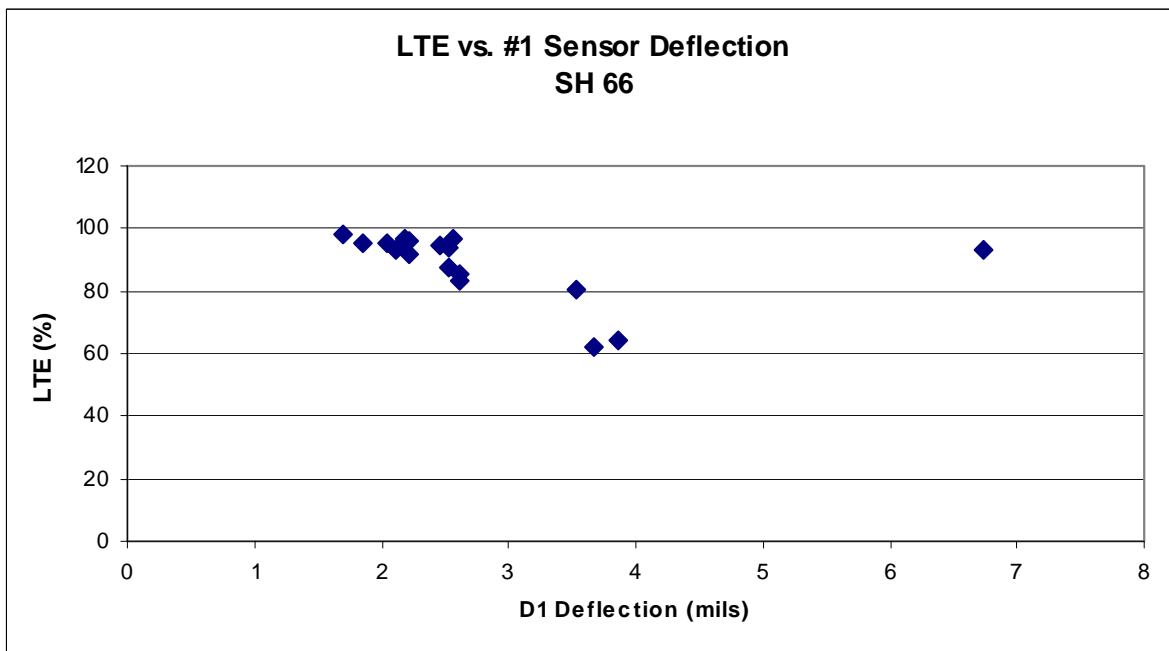
Figure 3.35: LTE vs. #1 Sensor Deflection

Figure 3.35 confirms that LTE decreased as deflection increased. As Figure 3.33 demonstrates that deflection was not strongly dependent on crack width, this shows that general

pavement integrity, as indicated by #1 sensor deflection, had a strong impact on LTE of longitudinal cracks.

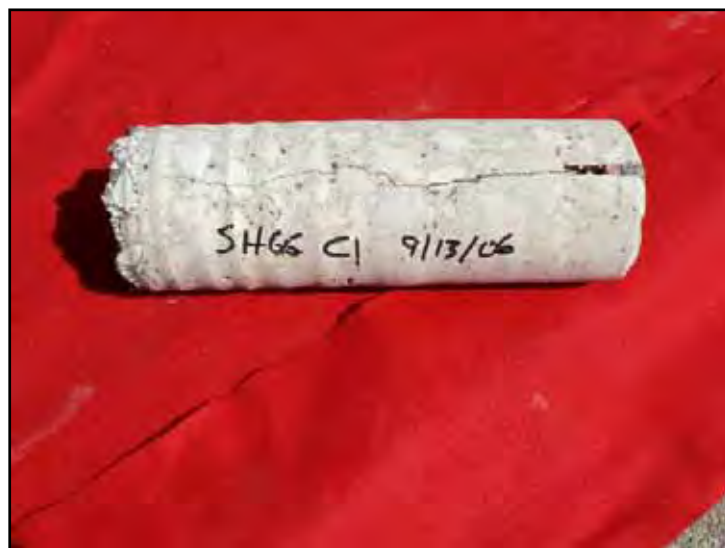
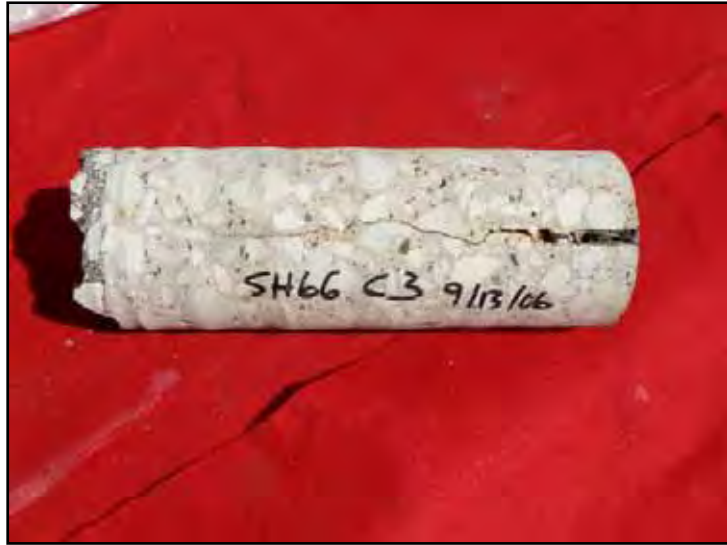
Cores through the longitudinal contraction joint showed that the likely cause of longitudinal cracking was the shallow (and possibly late) saw cutting of the joint. Figures 3.36 and 3.37 below show cores taken through the joint adjacent to cracked slabs. Figures 3.38 and 3.39 show cores taken through the joint adjacent to an uncracked slab. On average, the crack widths beneath the joint adjacent to the cracked slabs were smaller and did not go through the base, whereas the cracks adjacent to uncracked slabs were wider, showed more evidence of erosion, and had invaded the asphalt stabilized base. In addition, saw cuts were significantly shallower than specified (cuts as shallow as 1.5 in. were observed; T/4, or 2.25 in, is required by the CPCD specification).

In the event that saw cutting operations are begun late or the saw cuts are shallower than specified, excess stresses may accumulate in the pavement due to temperature curling, warping, and drying shrinkage. Before contraction joint cracks are cut, these stresses can accumulate not only at the contraction joint, but elsewhere in the slab. Shallow saw cutting serves to delay the cracking of the contraction joint, which in turn causes higher stress levels than if the contraction joint cracked early per the design. The contraction joint did eventually crack, as is evidenced by the cores. After the contraction joint cracked, longitudinal cracking occurred, probably due to the excess stresses caused by the late cracking of the contraction joint. Carbonation tests were performed on the cores taken over the longitudinal cracks and the contraction joints in order to determine the relative age of the cracks. Test results were inconclusive, but the contraction joints likely cracked before the longitudinal cracking occurred.

*Figure 3.36: Core Through Contraction Joint Adjacent to Cracked Slabs (1)*

*Figure 3.37: Core Through Contraction Joint Adjacent to Cracked Slabs (2)*

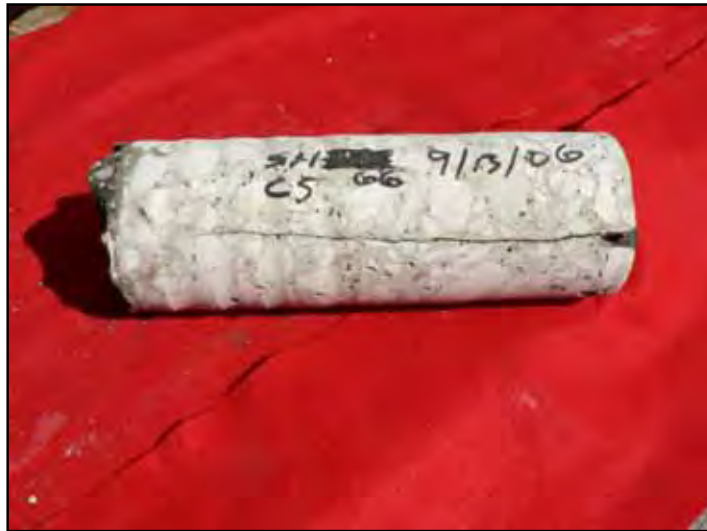
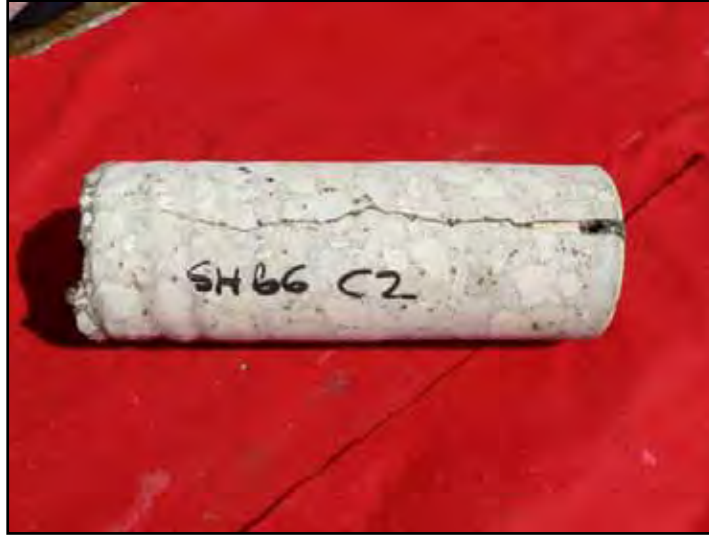
*Figure 3.38: Core Through Contraction Joint Adjacent to Uncracked Slabs (1)*

*Figure 3.39: Core Through Contraction Joint Adjacent to Uncracked Slabs (2)*

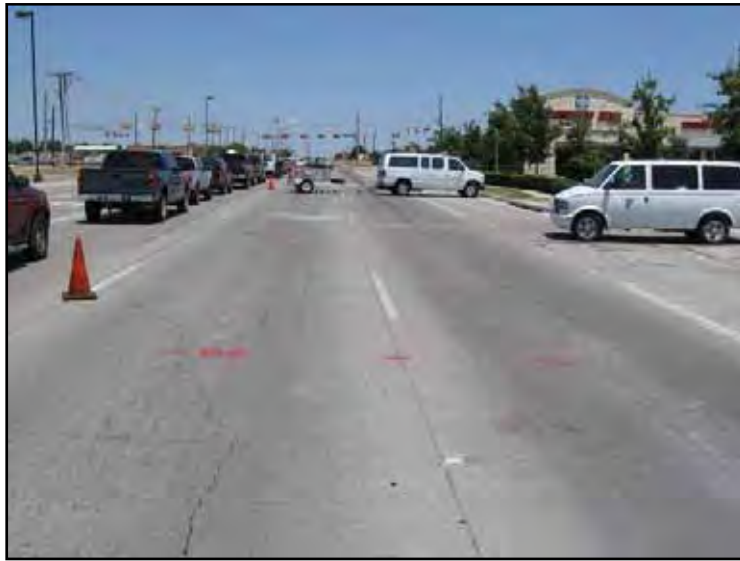
*Figure 3.40: Longitudinal Cracking (1)*

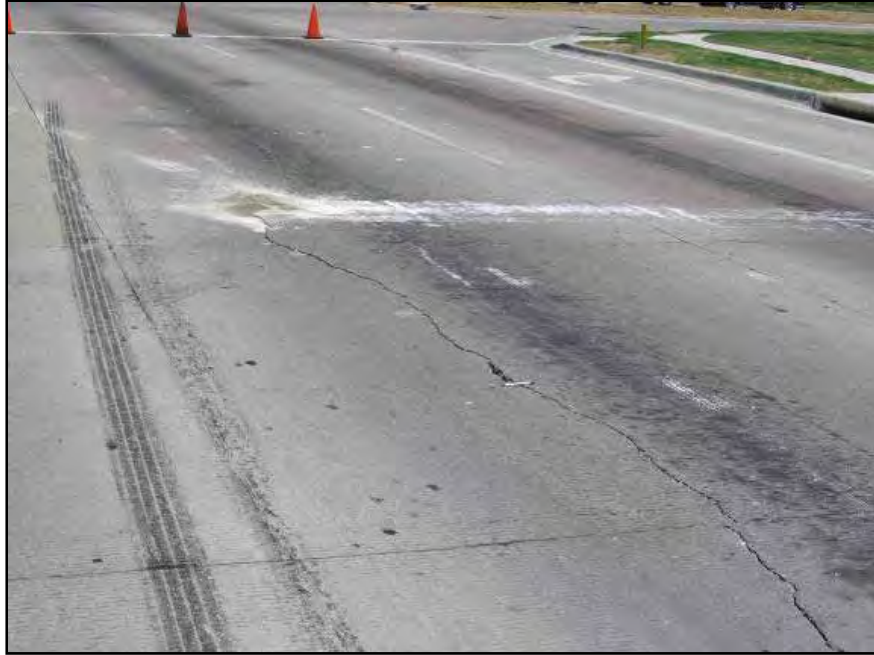
*Figure 3.41: Longitudinal Cracking (2)*

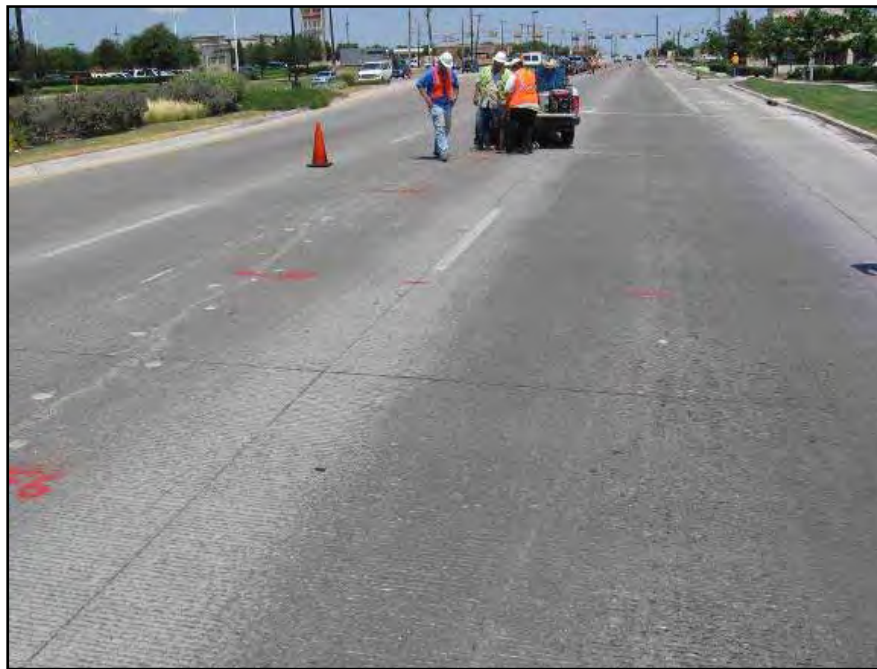
*Figure 3.42: Cross-Stitch Repair (1)*

Concrete around the stitch bars appeared to be in good condition, with no evidence of cracking or spalling. No evidence of further crack separation or slab faulting was found.

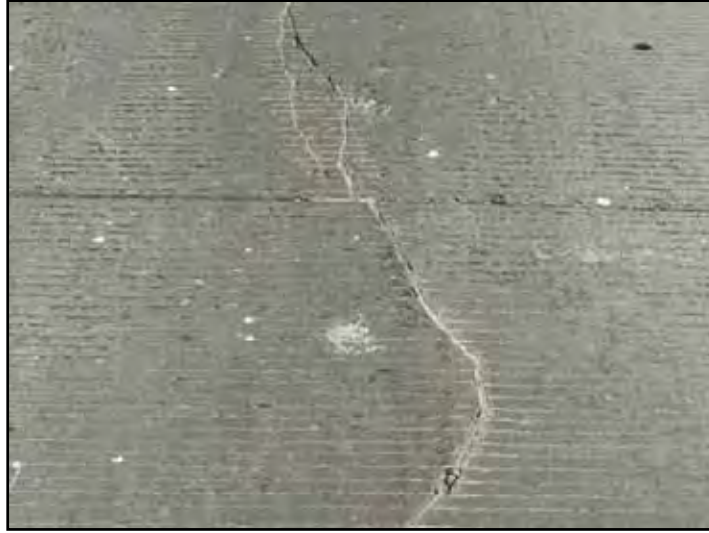
*Figure 3.43: Cross Stitch Repair (2)*

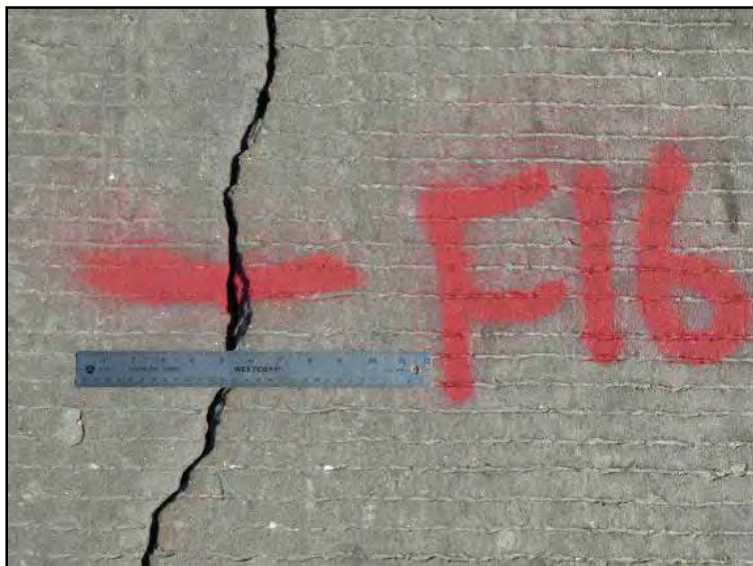
Crack widths between 0.030 in. and 0.625 in. were measured (Figures 3.44 and 3.45). Isolated slab faulting of up to 0.5 in. was measured (Figure 3.46). Figures 3.51 and 3.52 show cores taken through the cracks. Cores showed that the cracks remained tight beneath the surface of the pavement, and thus had a high degree of aggregate interlock.

*Figure 3.44: 0.625 in. Crack*

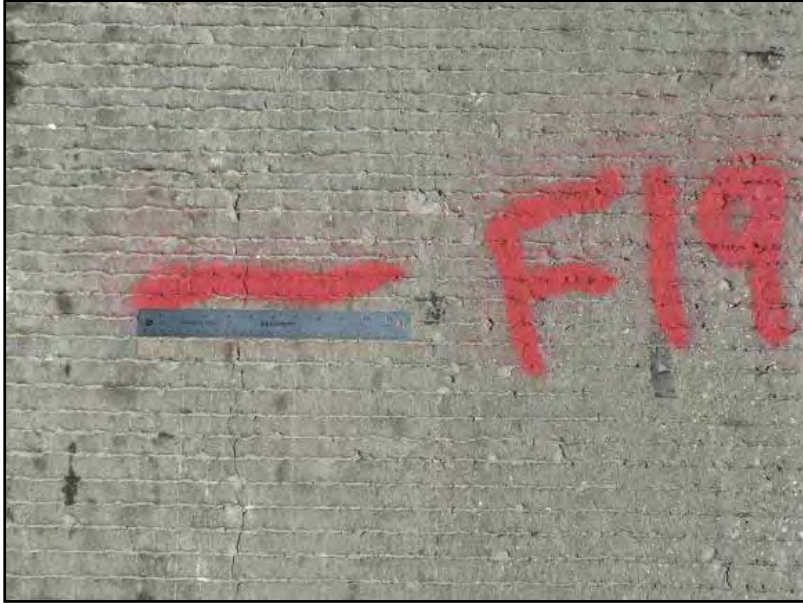
*Figure 3.45: 0.030 in. Crack*

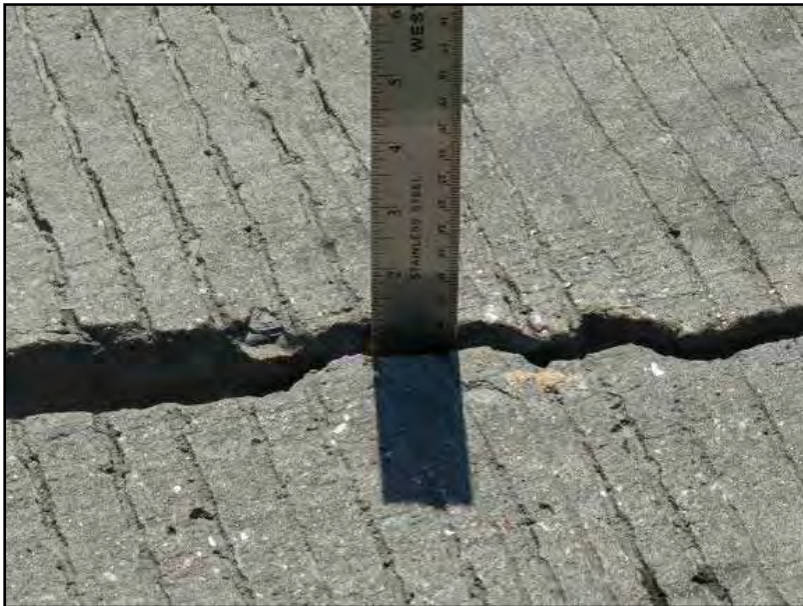
*Figure 3.46: Faulted Crack*

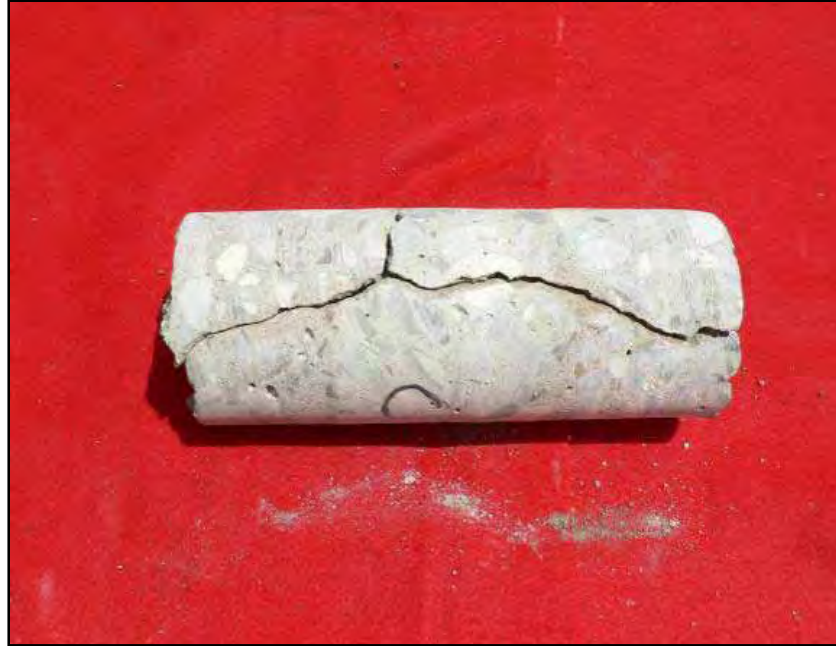
*Figure 3.47: Core through Longitudinal Crack (1)*

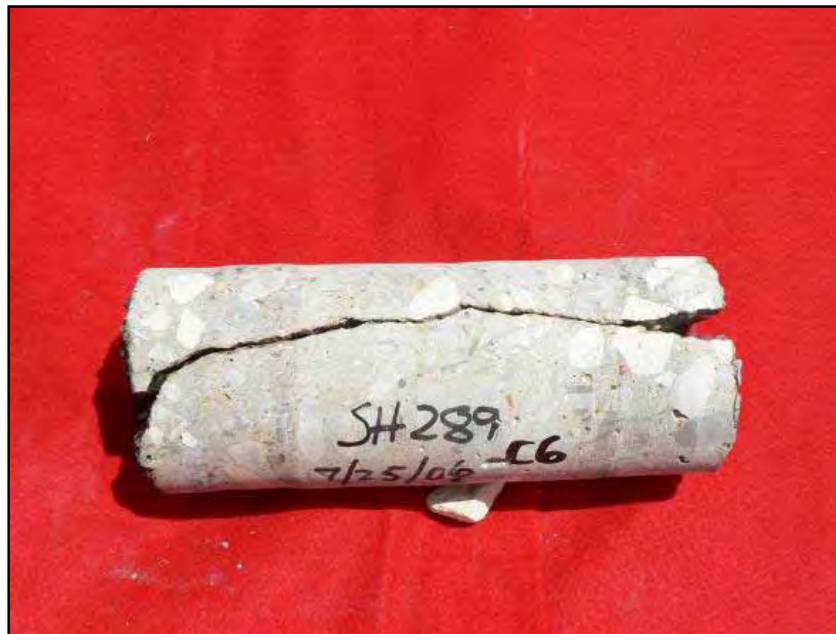
*Figure 3.48: Core through Longitudinal Crack (2)*

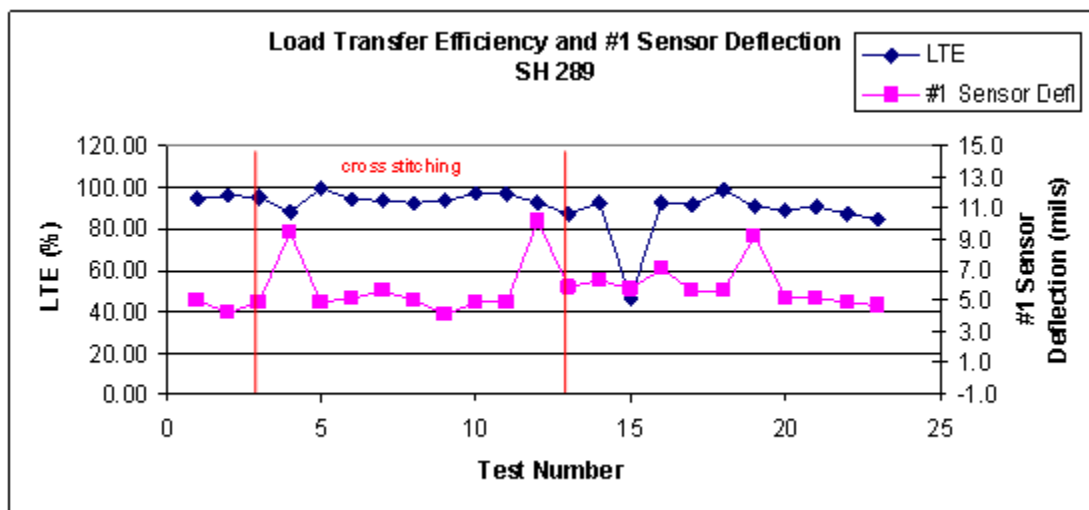
Figure 3.49: LTE and #1 Sensor Deflection

sensor deflection for each test location in the order they were taken in the field. Data for unrepaired and cross-stitched cracks had similarities in LTE and deflection. Consequently, data were combined to make observations about load transfer trends.

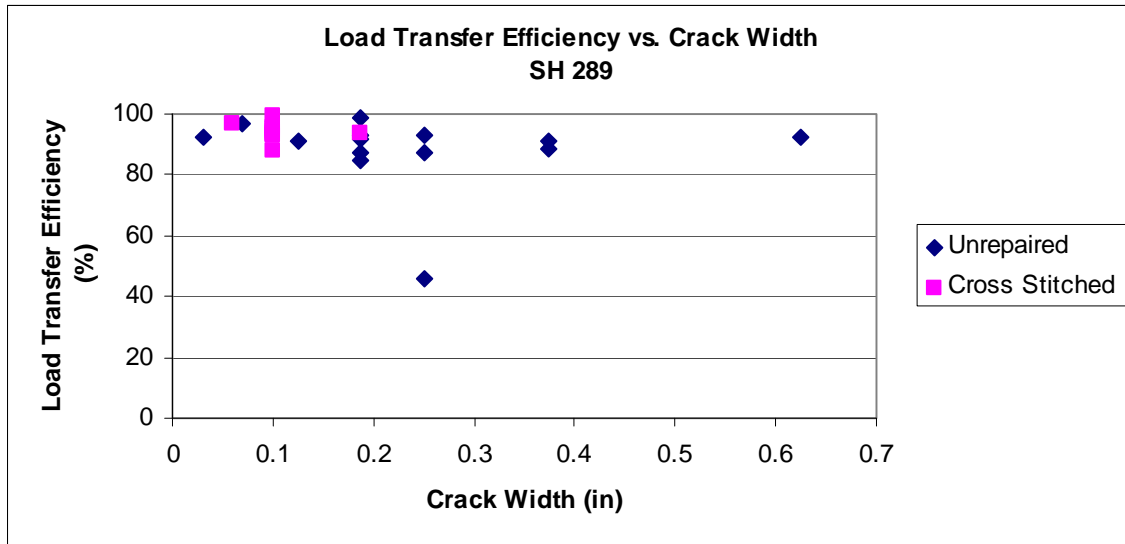
Figure 3.50: LTE vs. Crack Width

LTE did not appear to be dependent upon crack width in this case (Figure 3.50). High levels of load transfer were seen for a wide range of crack widths, which indicates that the cracks were tight enough to engage aggregate interlock. Data seemed to indicate that the aggregate interlock mechanism was fully at work in the range of crack widths tested. What is unclear is whether, as cracks widen until aggregate interlock is no longer engaged, LTE would drop sharply or gradually. Another indication that aggregate interlock was at work was the strong similarity between the data for the unrepaired crack and the cross stitched crack. If aggregate interlock was not at work, then the cross-stitched area would (based on the good visible condition of the repairs) have exhibited higher LTE.

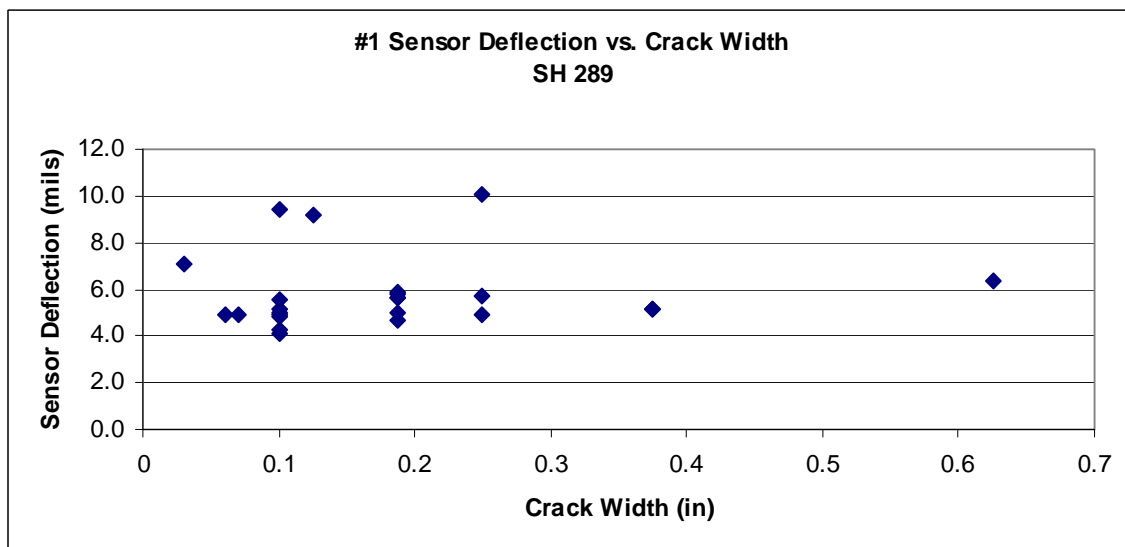
Figure 3.51: #1 Sensor Deflection vs. Crack Width

Data shown in Figure 3.51 indicate that #1 sensor deflection was not strongly dependent upon crack width for the section of pavement tested. This indicates two things: (1) aggregate interlock was contributing to load transfer for the entire range of crack widths; and (2) base/subgrade conditions were fairly consistent over the test area. If base conditions varied greatly, a corresponding variation in deflections would have been observed. Likewise, if aggregate interlock had disengaged at larger crack widths, an increase in deflection would have been seen.

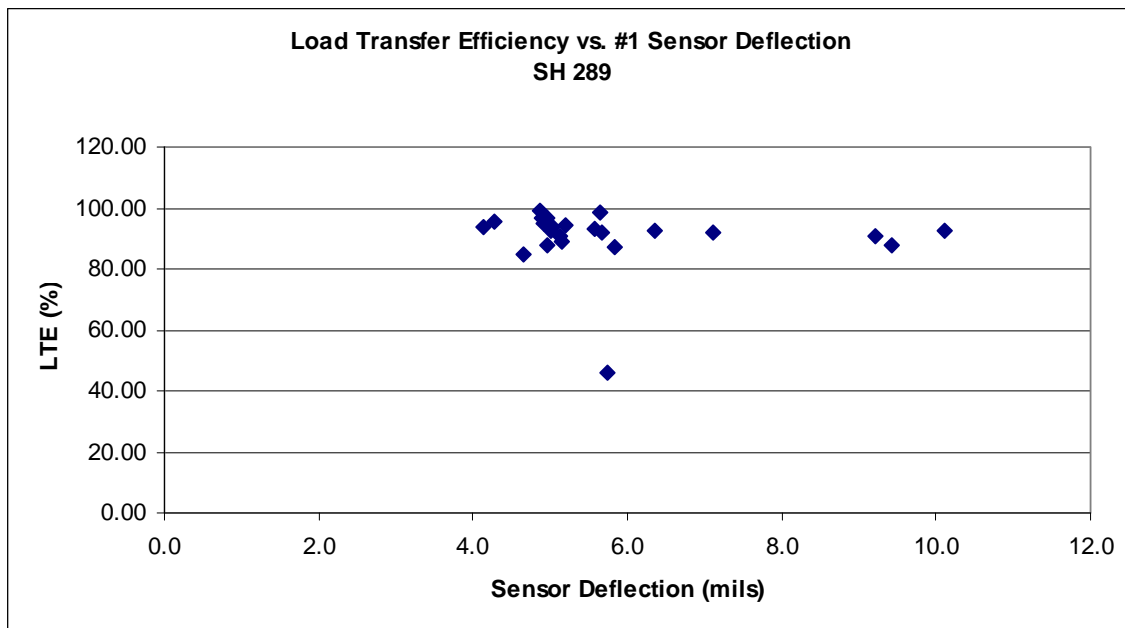
Figure 3.52 shows that LTE was not dependent on #1 sensor deflection. With the exception of one point of very low LTE, all the data points showed very high LTE over the entire range of deflection. This would seem to be inconsistent with data from several other field investigations (which showed that LTE decreases with increasing deflection) so the exact reason for the relationship seen on SH 289 is unclear. This may again indicate that aggregate interlock was the primary mechanism providing load transfer. If it was not, then the primary load transfer mechanism would have been the base and subgrade (which #1 sensor deflection indicates) and LTE would have varied with deflection.

*Figure 3.52: LTE vs. #1 Sensor Deflection*

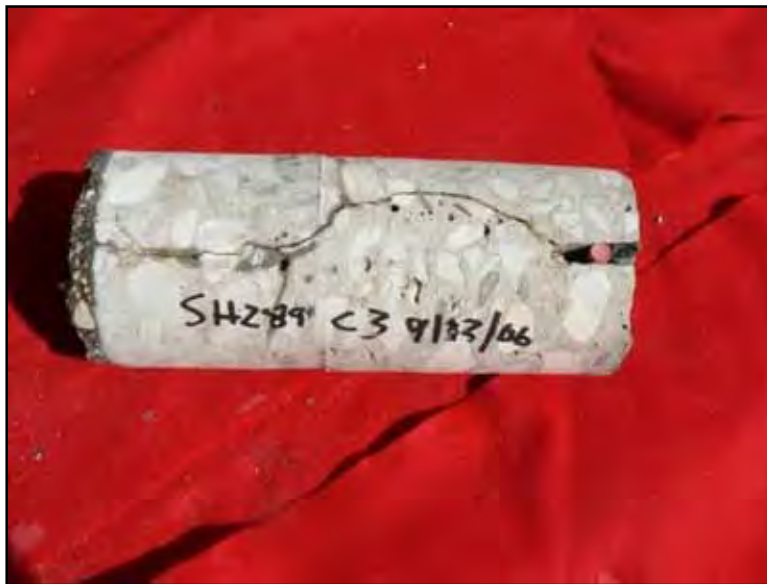
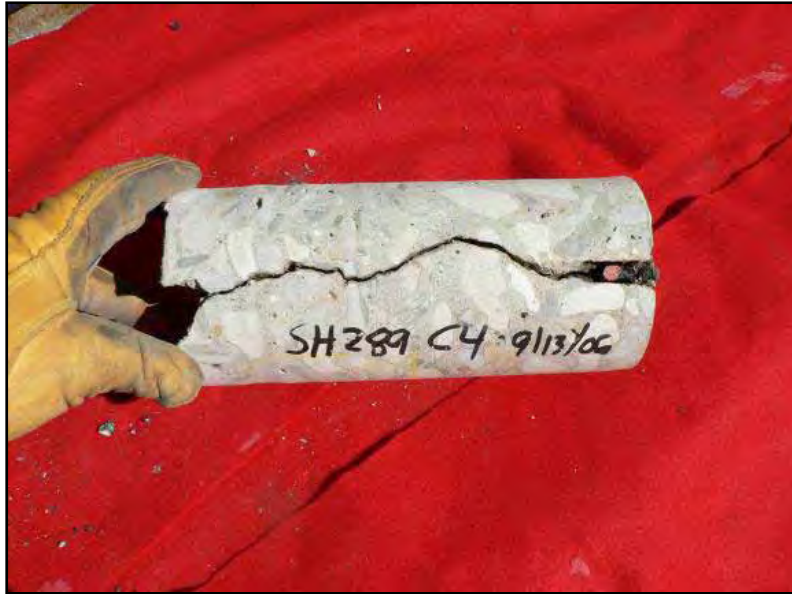
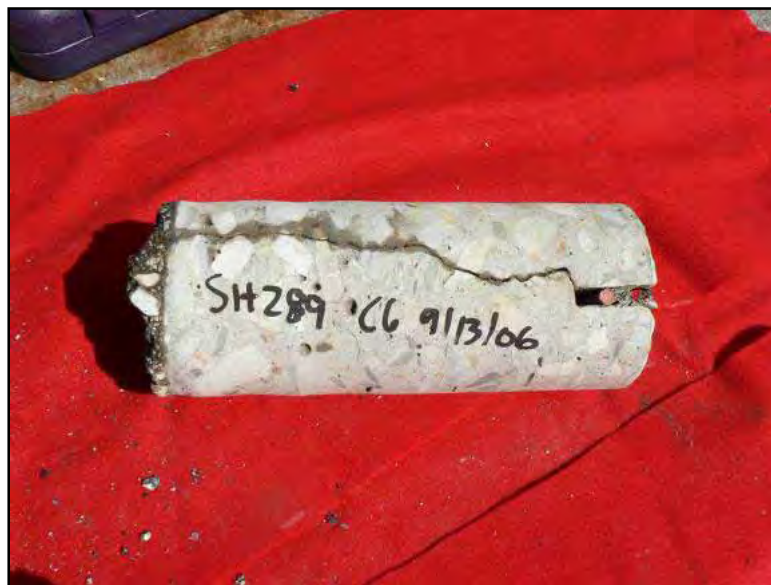
Figures 3.54 through 3.56 show cores taken through the contraction joint adjacent to cracked slabs, while Figure 3.57 show cores taken through the same joint but adjacent to uncracked slabs. Due to the highly variable character of the cracks, one single measurement of crack width was not made for each core, but qualitative visual inspection showed that the crack beneath the contraction joint was smaller in areas where the adjacent slabs are uncracked and larger in areas where longitudinal cracking is present. As in the case with the longitudinal cracking on SH 66 (reviewed in previous section), these observations indicate that late and possibly shallow saw cutting delayed formation of cracks beneath the longitudinal contraction joint, thereby increasing the stresses elsewhere in the slab and causing cracking at those locations over time.

*Figure 3.54: Core Through Contraction Joint (1)*

*Figure 3.55: Core Through Contraction Joint (2)*

*Figure 3.56: Core Through Contraction Joint (3)*

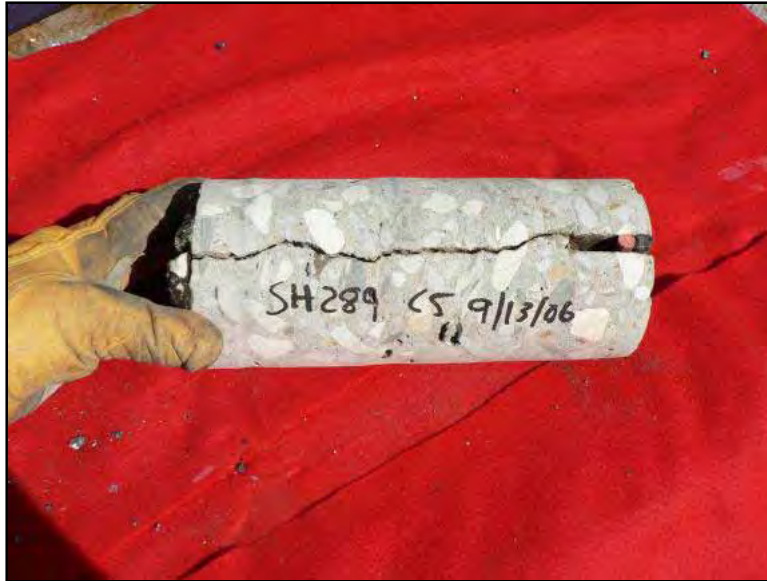
*Figure 3.57: Core Through Contraction Joint (4)*

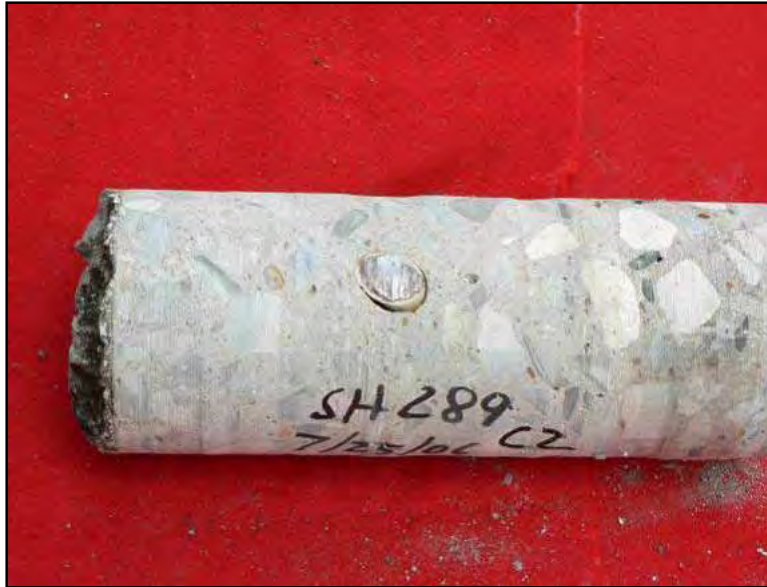
The core taken through one of the stitch bars showed the bar to be in good condition, with no evidence of corrosion (Figure 3.58). Epoxy injected into the stitch hole from the pavement surface appeared to have flowed down the hole and into the crack without filling the hole opposite the crack (Figure 3.59). Figure 3.64 also shows the dry hole with the stitch bar.

*Figure 3.58: Core Through Cross Stitching (1)*

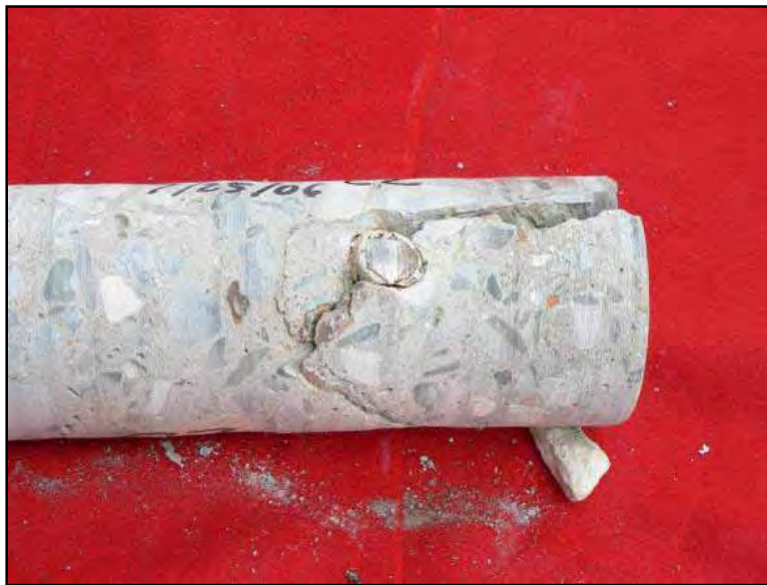
*Figure 3.59: Core Through Cross Stitching (2)*

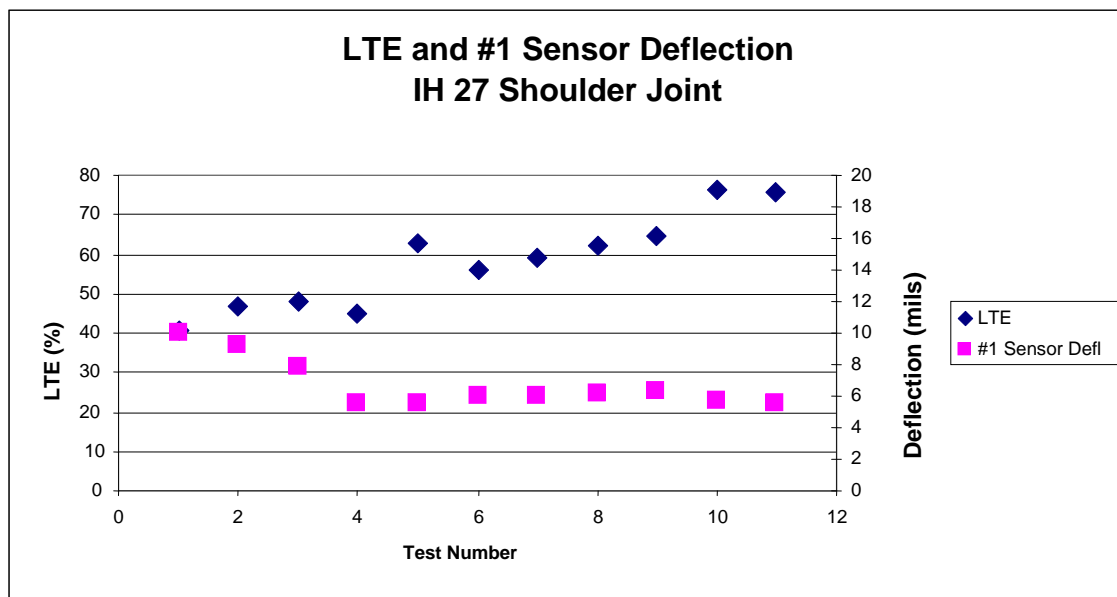
Shoulder joint separations between 0.5 in. and 1.25 in. were observed. Average joint width over the area tested was 1.0 in. Slab faulting of up to 0.25 in. was observed. Load transfer

efficiency varied from 41 to 76%, with an average of 58%. Number one sensor deflections averaged 6.7 mils (Figure 3.62).

*Figure 3.62: LTE and #1 Sensor Deflection (Shoulder Joint)*

Data showed a progressive increase in LTE and decrease in #1 sensor deflection throughout the test. At the location of the first test, the joint was approximately 4 to 6 ft. from the edge of the pavement. At the location of the last test, the joint was about 12 ft. from the edge. Figure 3.63 (from Won 2006b) summarizes #1 sensor deflection data taken at different distances from the longitudinal free edge of another pavement. Deflections generally decreased as the test was moved farther from the pavement free edge. The shape of the curve was unique to the pavement tested, and was influenced by the overall stiffness of the pavement, base and subgrade conditions, etc. The general tendency applies, however.

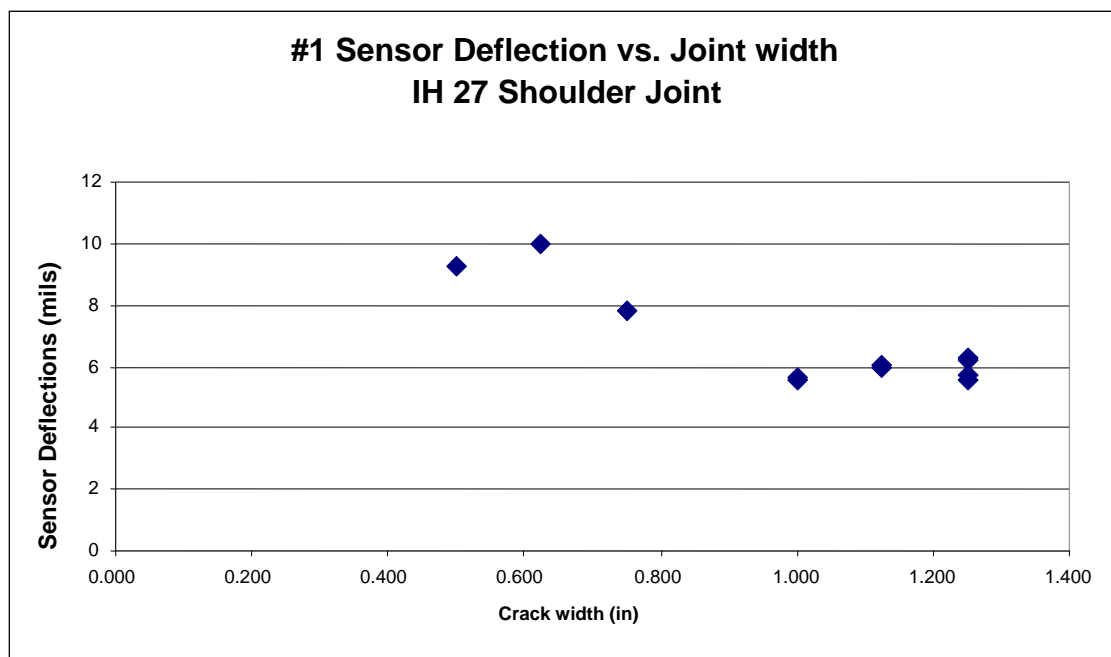
Figure 3.64 shows a general trend of a decrease in #1 sensor deflection as joint width decreased. This seems to be inconsistent with not only theoretical behavior but also with results from other field investigations. However, the three points with the highest deflection corresponded to the first three tests where the joint was the closest to the pavement free edge. Because of the data given in Figure 3.63 and in the preceding paragraph, the data in Figure 3.64 are not reliable because the deflections for the first three tests are artificially high.

*Figure 3.64: #1 Sensor Deflection vs. Joint Width (Shoulder Joint)*

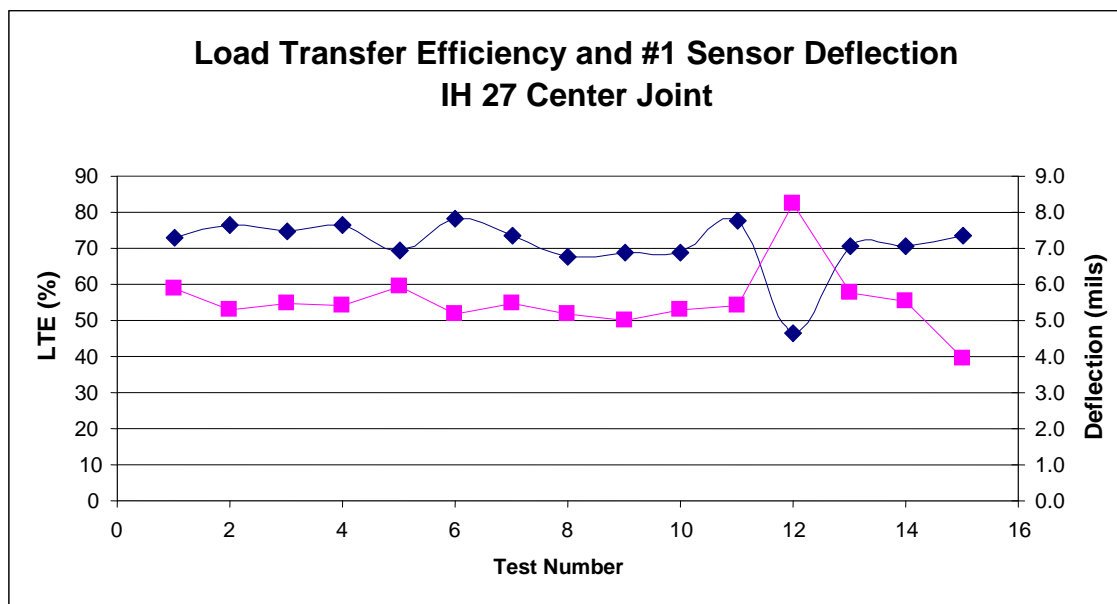
Figure 3.65: LTE and #1 Sensor Deflection (Center Joint)

Figure 3.65 shows the LTE and #1 sensor deflection for all the FWD tests along the (unrepaired) center joint. Data show a consistent pattern in which higher LTE corresponds to lower deflection and lower LTE to higher deflection.
