# **Assessment and Rehabilitation Methods for Longitudinal Cracks and Joint Separations in Concrete Pavement**

CTR Technical Report:	0-5444-2
Report Date:	October 2008
Project:	0-5444
Project Title:	Assessment and Rehabilitation Methods for Longitudinal Cracks and Joints Separations in Concrete Pavement
Sponsoring Agency:	Texas Department of Transportation
Performing Agency:	Center for Transportation Research at The University of Texas at Austin

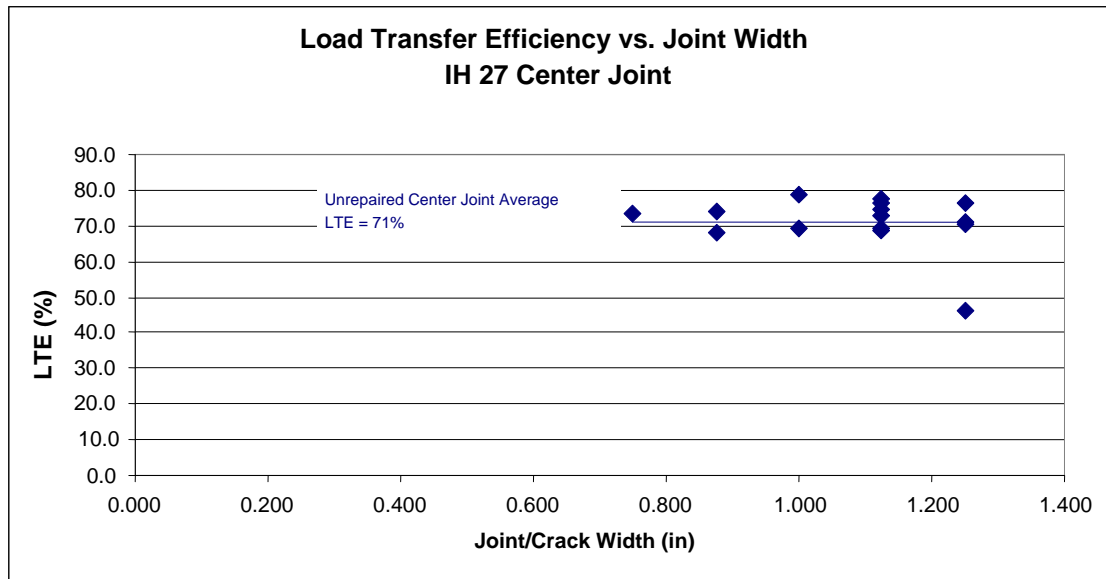
Figure 3.66: LTE vs. Joint Width (Center Joint)

Figure 3.66 shows that there was little correlation between LTE and joint width for the section of pavement tested. This was not surprising, as the joint had separated to the point that little or no aggregate interlock could be engaged to provide load transfer. Consequently, other mechanisms not reliant upon joint width provided the load transfer. In other words, once the joint separated to the point that no aggregate interlock was present, further separations did not reduce LTE. The high value of LTE was suspicious, though, because of the lack of aggregate interlock across the joint. One contributing factor might be that the FWD sensor array (as it was used for this series of tests) can give artificially high LTE values (see Appendix A for more detail). In addition, the base and subgrade could have been contributing more to the LTE than originally thought possible. Temperature is not thought to have affected LTE on this section of IH 27,

given the large joint separations. Cracks and tighter joints may be sensitive to temperature because aggregate interlock can play a primary role in the load transfer mechanism, but the joint widths observed on IH 27 were so large they likely would not be affected by even very large temperature changes.

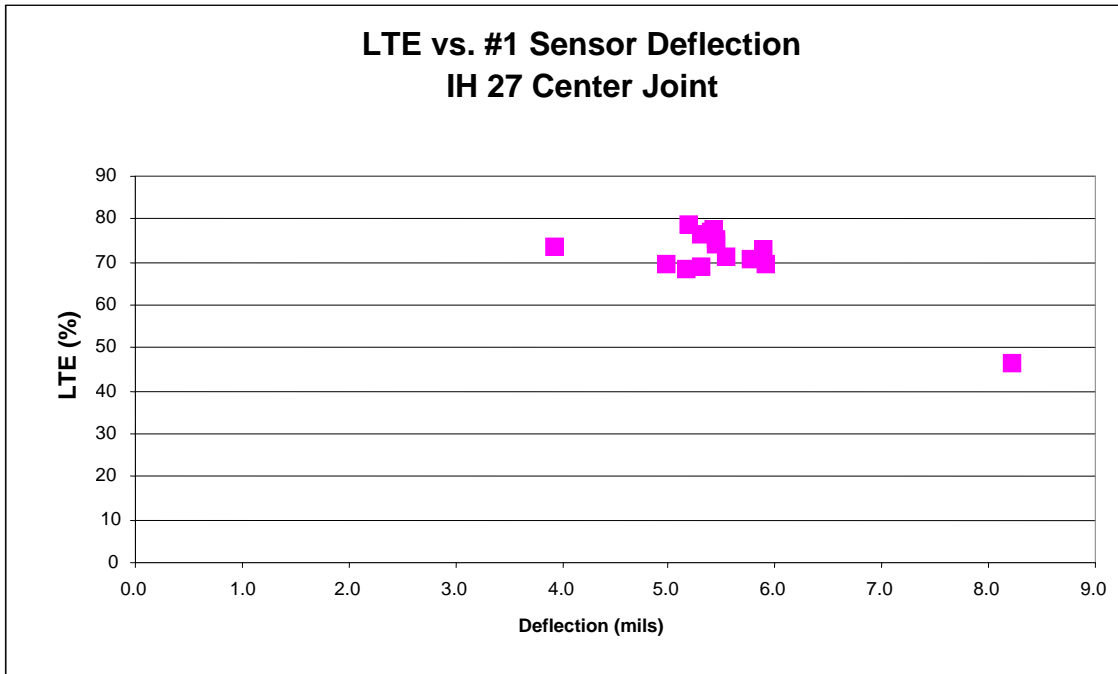
Figure 3.67 shows that a good correlation between LTE and #1 sensor deflection was hard to determine. With the exception of one point, all the data were clustered within a tight range of deflection values. In other field investigations, where more representative data were available, the general trend was for LTE to decrease with increasing sensor deflection. Because sensor deflection is a measure of general pavement integrity (which depends on, among other things, condition of base and subgrade), LTE is also dependent on the same.

*Figure 3.67: LTE vs. #1 Sensor Deflection (Center Joint)*

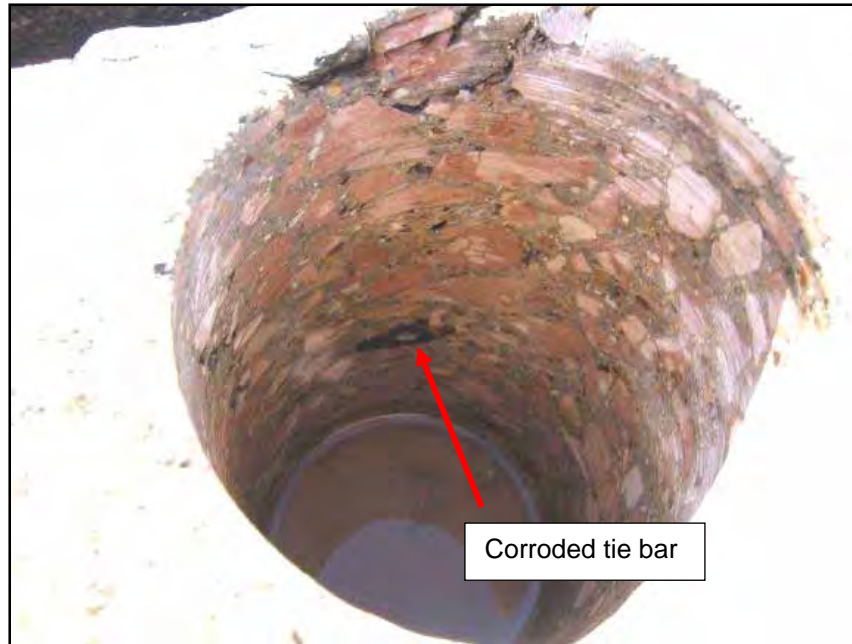
*Figure 3.72: Core Hole Over Tie Bar*

Figure 3.72 shows the core hole at the tie bar, directly adjacent to the separated longitudinal construction joint. At the face of the construction joint, the bar was completely corroded (no steel was present). At the face of the core hole nearest the joint, the tie bar was approximately 50 percent corroded. At the inside face of the core itself (Figure 3.72), the bar was approximately 30 percent corroded. At the outside face of the core (Figure 3.73), the bar was not corroded at all. Thus it appeared that the corrosion was concentrated within a few inches of the joint. Tie bar corrosion likely contributed to joint separation. However, it is not certain that tie bar corrosion was the initial factor that caused separation. Excess strain on the steel tie bars due to thermally-induced stresses in the pavement could have caused the joint to open, allowing air and moisture to penetrate into the joint, and initiating the corrosion. Conversely, worn joint sealant may have allowed air and water to penetrate and begin corrosion, as the (relatively) smooth faces of the construction joint offer little physical resistance to such penetration. In either case, tie bar corrosion would have contributed to joint separation.

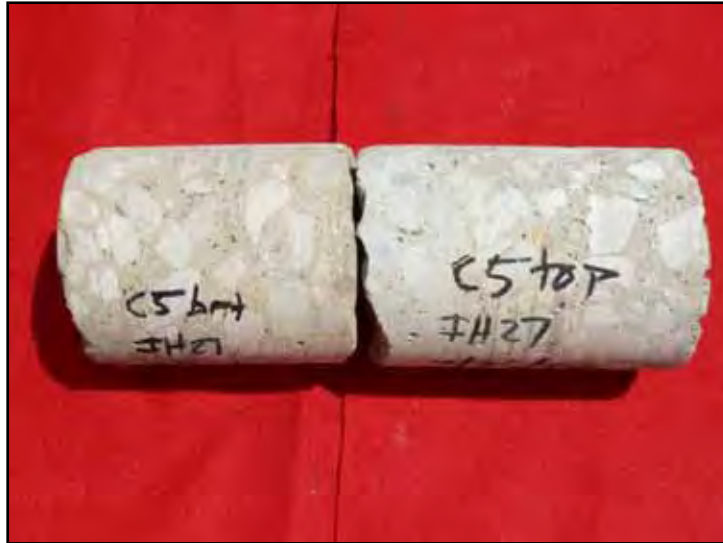
*Figure 3.75: Core Through Full Depth Repair*

Approximately 50 ft. of repaired joint was inspected. No cracking, spalling, joint separation or slab faulting was observed. One core was taken through the repaired area (shown in Figure 3.75 below).

At a depth slightly below mid-slab, a weathered crack could be seen in the core. Other than this crack, the repair appeared to be in good condition, with no visible external distress.

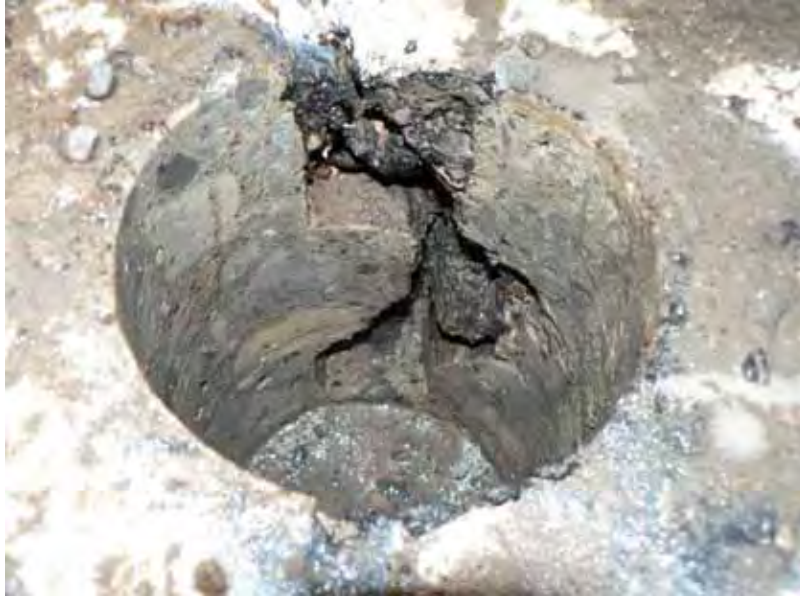
*Figure 3.79: Core hole through joint (1)*

Another factor contributing to joint separation was the lack of tie bars across the joint. Cores showed that the pavement was constructed with untied, keyed joints Figures 3.79 and 3.80. GPR was used to locate the transverse steel (see Figure 3.78 for a picture of the GPR screen), then cores were taken directly adjacent to the joint at the location of the transverse steel (Figure 3.77) as well as over the joint itself in the same location. The purpose of taking cores at these locations was to determine if tie bars had been used and had completely corroded (as seen in other field investigations) or if tie bars were not used.

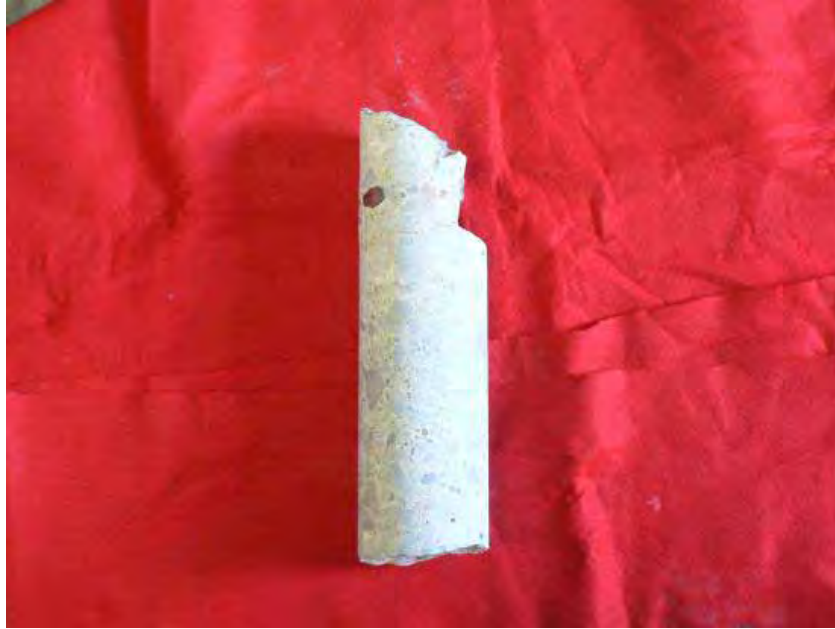
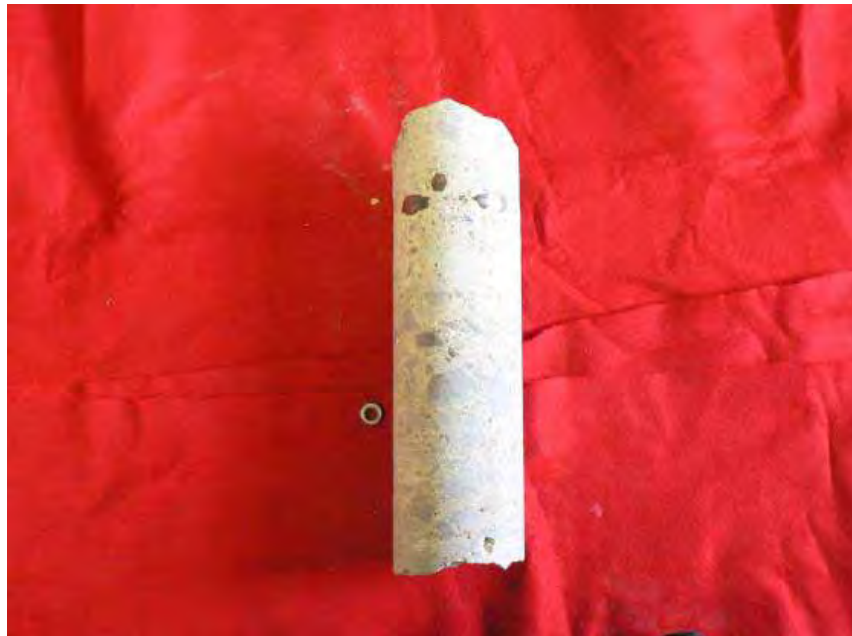
Figures 3.81 through 3.83 show the keyed joint with no evidence of tie bars. Figure 3.83 shows one of the cores taken through the longitudinal joint. The key could clearly be seen, but no evidence of a tie bar existed.

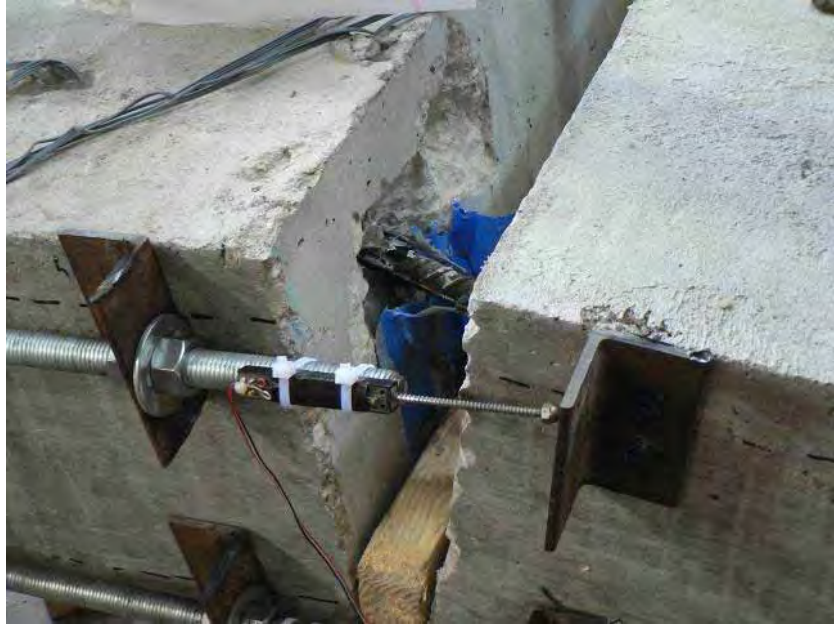
*Figure 4.45: Left Cross Stitch Bar at End of Test*

Note: the spalling on the face of the concrete where the bar entered the specimen as seen in Figure 4.46 was not due to testing, but occurred during installation of the stitch bars during hammer drilling of the holes. The bar shown is loaded primarily in flexure, as can be seen from its curvature.

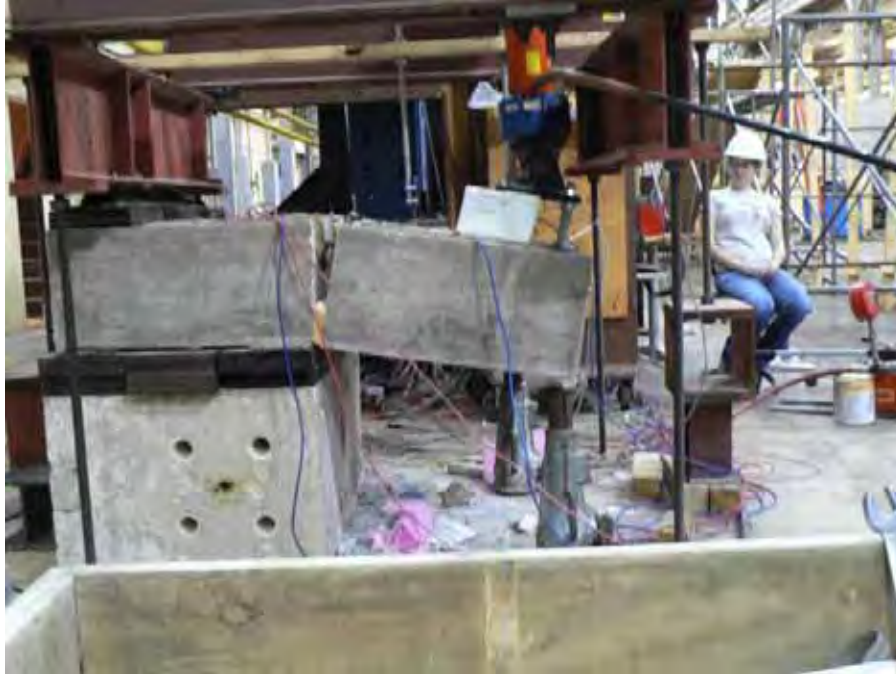
*Figure 4.48: Staple Specimen at End of Flexure Test (1)*

Figures 4.48 and 4.49 below show the staple specimen at the termination of testing. The specimen never actually “failed”; no cracks or spalls in the repair material or concrete were observed and the specimen continued to carry increasing load at the end of the test. The test was terminated because the large amount of deflection of the loaded side of the specimen introduced unsafe geometry into the testing frame. Field repairs would likely never experience such deflections, so to continue the test would have been superfluous.

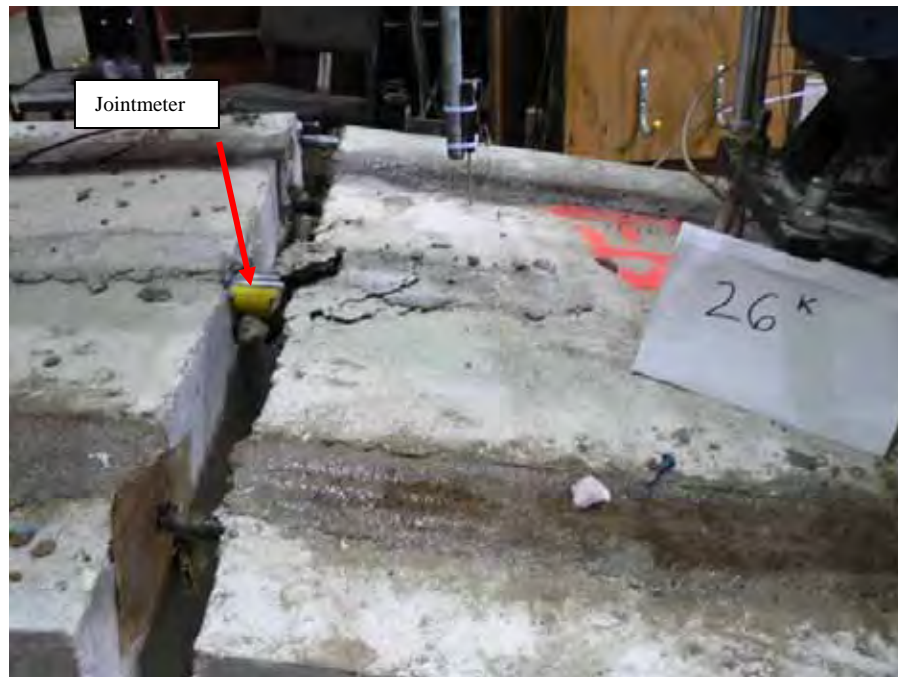
*Figure 4.49: Staple Specimen at End of Flexure Test (2)*

Figure 4.49 shows the top of the staple specimen at the end of testing. No obvious distress was observed in the repair materials. Material used to fill the jointmeter slot spalled and began to break off at large deflections. See Figure 4.50 for load-deflection behavior of the specimen.

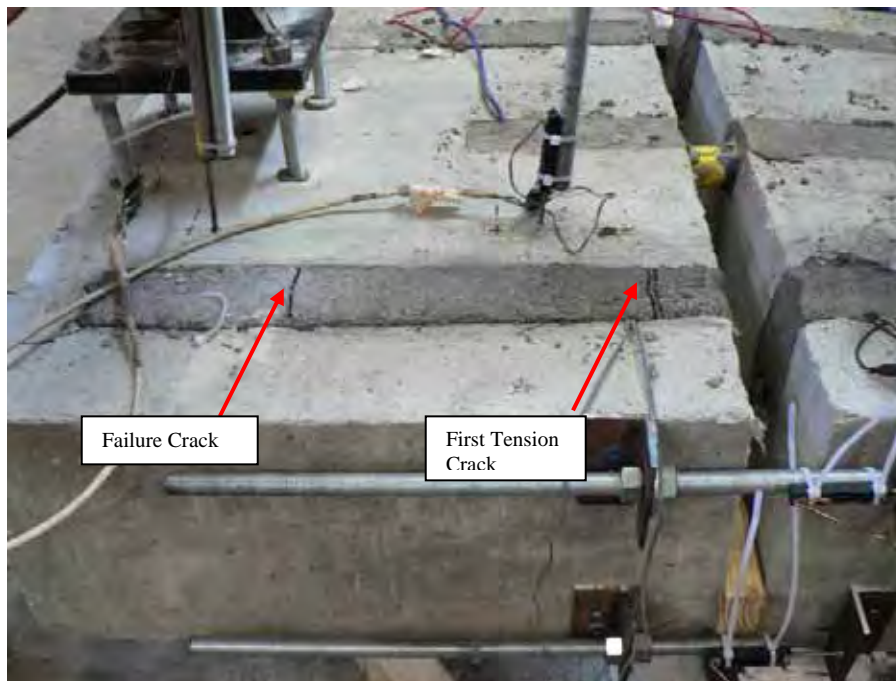
*Figure 4.54: Cracks at Failure in Slot Stitch Specimen*

The “first tension crack,” labeled in Figure 4.54, likely occurred around 7 k (the exact load was not recorded because the crack was not identified until it was fairly wide). The premature failure of this portion of the repair material was attributed to poor bonding to the walls of the slot. As the slots were being filled with repair material, a foam dam was installed in the simulated construction joint to prevent the repair material from leaking into the joint. This dam was somewhat flexible, and may have allowed the repair material to move away from the sides of the slot during curing, which would create poor bonding between the repair material and the concrete. As the specimen was loaded, the repair material lost bond, and the full value of stress present in the bar would have been transferred deeper into the slot (similar to the bond performance of steel bars in reinforced concrete beams as they crack). The bar would have been subjected to full tension strain at that point. Because the rigid repair material had very low tensile strength (like conventional portland cement concrete), it then cracked. A maximum load was reached at a coupled force of approximately 40 k, after which the load carrying capacity dropped sharply. Another tension crack formed in the repair material approximately two-thirds of the way into the slot at the maximum load. Additional cracking on the sides of the specimen were visible at failure, thought to be induced by radial bond stresses exerted by the repair bar on the repair material and propagating into the concrete.

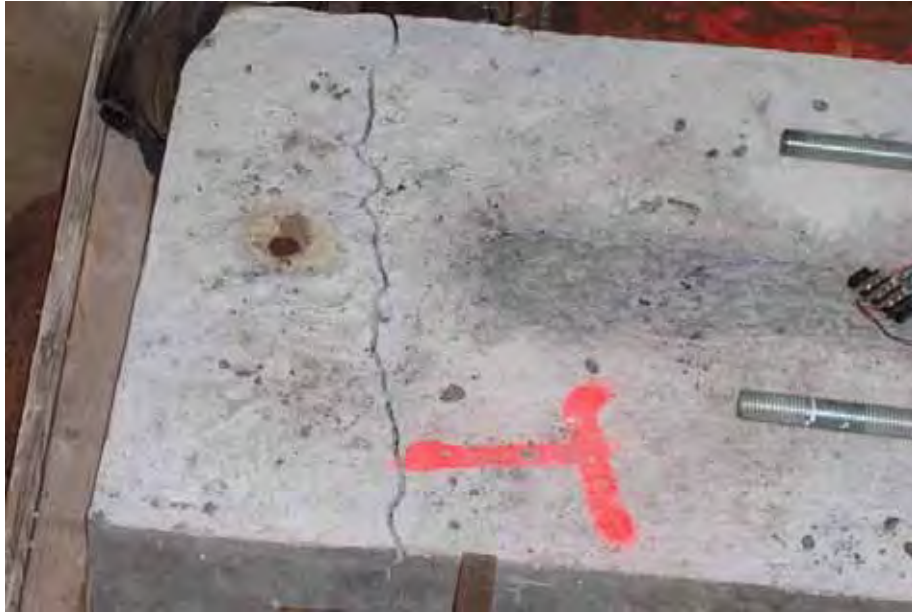
*Figure 4.59: Cracking of Specimen at Loading Brackets*

Shortly after commencing loading on the headed bar specimen (before yielding began), cracking occurred around the loading brackets on one end of the specimen. The test was stopped and a steel plate was installed in the simulated joint between the two ends of the specimen (Figure 4.60). The rams were re-set and loading restarted. Figure 4.58 shows the test data with the second test setup.

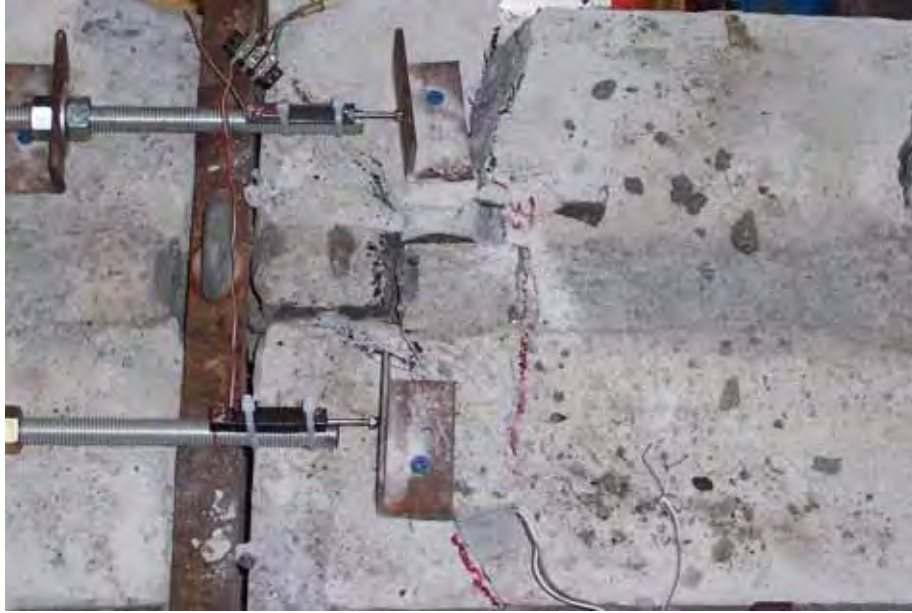
*Figure 4.61: Headed bar Specimen at Failure*

the bar. Cracks widened and eventually the concrete ruptured at a failure load of 40 k. See Figure 4.61 and 4.62 for the specimen at failure.

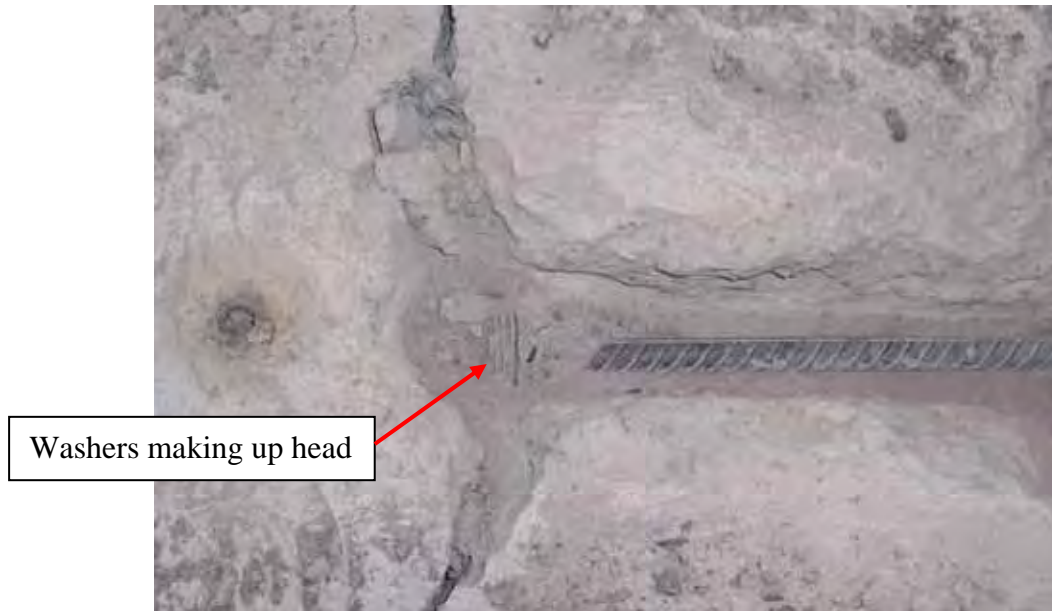
*Figure 4.63: Exposed Head after Testing*

The specimen could likely have carried more load after test termination. After the completion of the test, the repair material was chipped out with a jackhammer in order to examine the condition of the bar heads. Figure 4.63 shows that they were in excellent condition. Had loading continued, the bar would likely have gone into strain hardening, and the heads would have increased capacity even further. However, the concrete around the remaining set of loading brackets ruptured at the same time as the concrete around the bar, so the test could not continue.

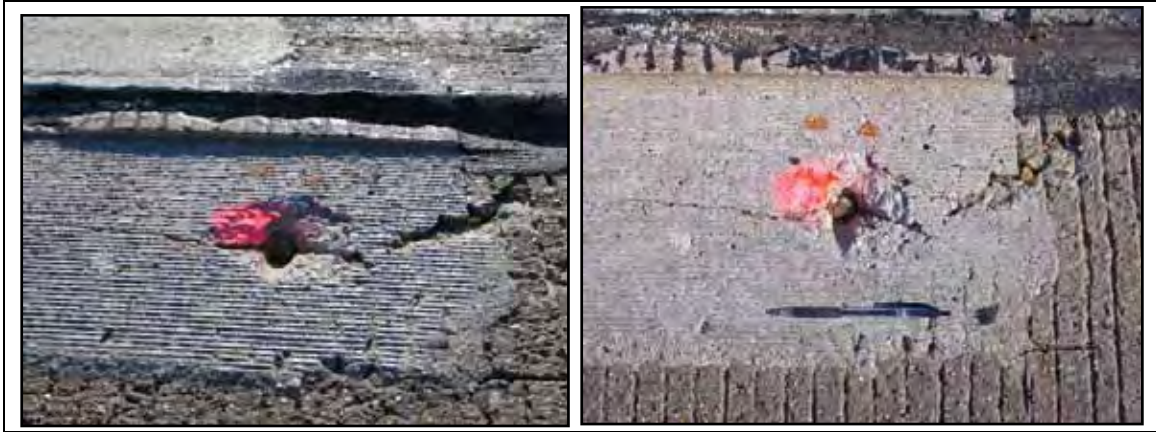
*Figure 4.68: Cross Stitching Distress on US 59*

Data from the field suggest that the cross stitching experimental results are not representative of the global performance of the repair method in the field. Failures observed on US 59 in Queen City showed that breakout of the compression bars, which created spalling and cracking on the pavement surface, were the governing failure mechanism (Figure 4.68). This behavior highlights one of the primary differences between pavement in the field and laboratory specimens and illustrates the boundary conditions of in-place pavement. In the lab, specimens were not restrained because the width of the specimens and the loading and support conditions permitted relative translation and rotation of the segments across the joint. Much longer segments of the pavement containing at least 4 bar crossing the joint should have been tested.

Quality control with regard to construction practices is likely a contributing factor in the failures seen on US 59. Many of the bars holes were drilled closer to the joint than that required. The closer the hole is to the joint, the higher the concrete stress and the likelihood of cracking and spalling. Cross stitching on SH 289 did not show this kind of distress. Construction practices there appeared to be more consistent, and although it cannot be conclusively stated that this is the sole cause of differing performance in the two areas, it is likely that it significantly contributed to the behavior.

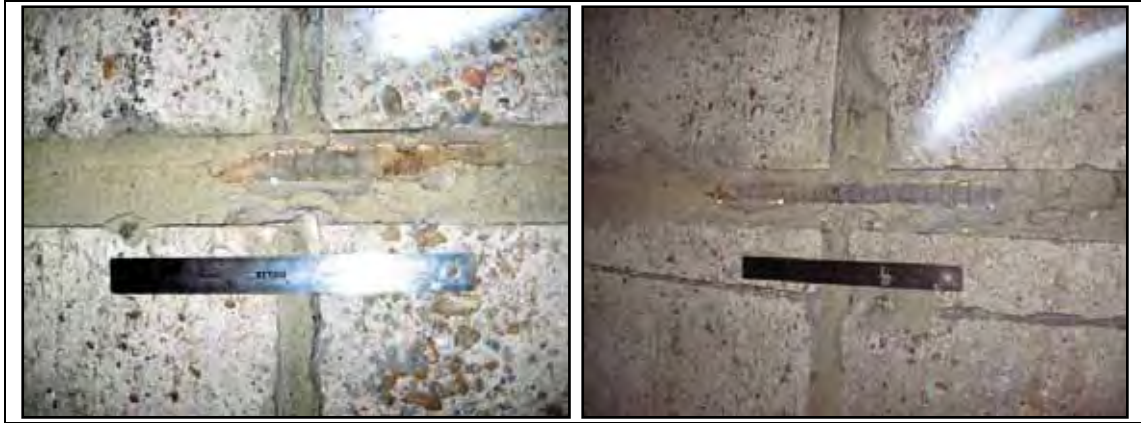
*Figure 4.69: Deterioration of Stapling on US 290*

Field investigations did not uncover the kind of staple repair failures that were observed in the lab. Figure 4.69 below show bars on US 290 in Houston. The repair material appeared to have been worn off by traffic, but no evidence of further longitudinal joint separation was observed. No major faulting in the area was observed, and the pavement had 6 in. of asphalt-stabilized base when originally constructed, so the vertical loading condition simulated in the lab does not directly correlate with this particular section of pavement.

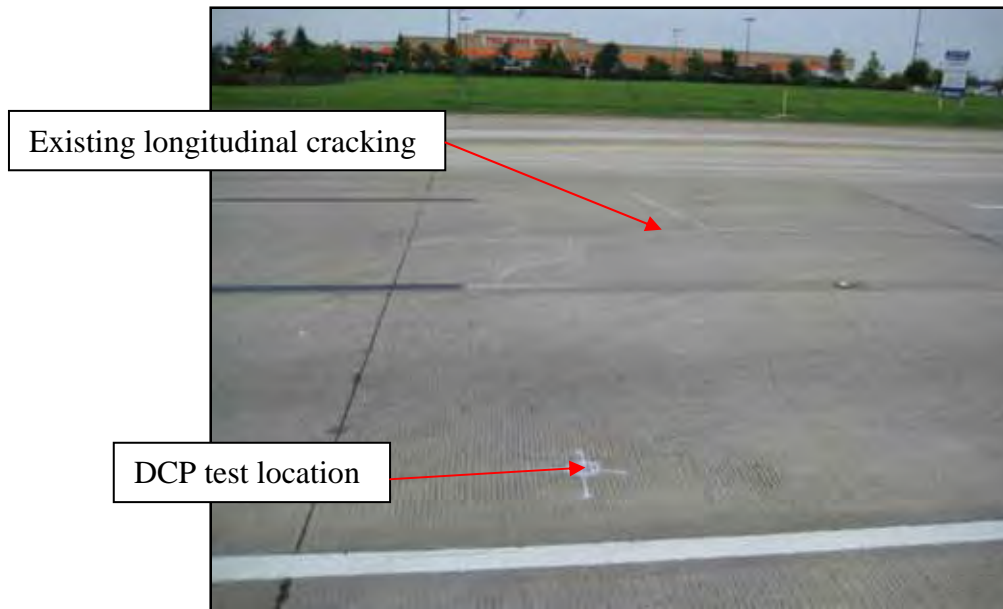
*Figure 4.73: Dallas SH 66 DCP Test Location with Cracking Adjacent to Slab*

Researchers performed a field investigation on September 13, 2007 along SH 66 at Centerville Road and on SH 289 at Preston Road. DCP tests were run in numerous locations along both highways in locations where the longitudinal cracking was bad and on the slabs adjacent to the longitudinal cracks (Figure 4.73). Along 289 longitudinal cracks were previously cross stitched, but the repaired cracks do not appear to be in good form. The epoxy sealing the longitudinal crack has eroded away (Figure 4.75).

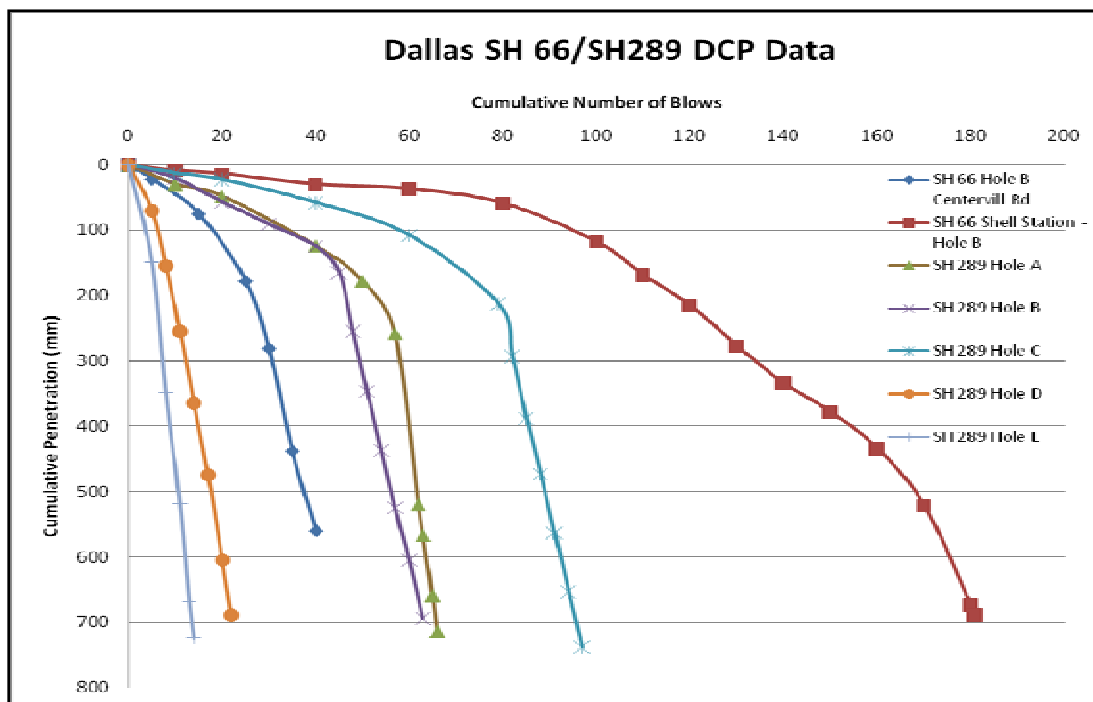
Figure 4.76: Dallas DCP Data

Tests indicated, for the most part, very poor subgrade material and wet subbase material was found at both locations. The graphs indicating number of blows vs. penetration depth and the subgrade modulus chart are shown in Figures 4.76 and 4.77.

The DCP tests along SH 66 and 289, with the exception of one test along SH 66, showed very poor subgrade modulus values (below 10,000 psi). Along SH 66, crack widths from about 0.025 to 0.5 in. were observed as well as limited slab faulting (Figure 4.74). Researchers found one very good subgrade modulus value and one very poor value. These results are not necessarily conclusive due to the singular nature of DCP tests; DCP tests offer just a snapshot of the base material at a particular time (seasonal moisture condition) and location. Also, subgrade is only one of many factors affecting pavement conditions. After completing a visual study of SH 289, it was evident that the pavement was in poor condition. The pavement has numerous transverse and longitudinal cracks. The longitudinal cracks were previously repaired but the condition of the repair is poor. The modulus values calculated show very poor subgrade conditions. This and/or the wet subbase could be the cause of the concrete's extensive cracking problems. The modulus values were lower than those for SH 66, and this may be the reason that the crack widths and slab faulting observed were greater than the crack widths and slab faulting observed on SH 66.

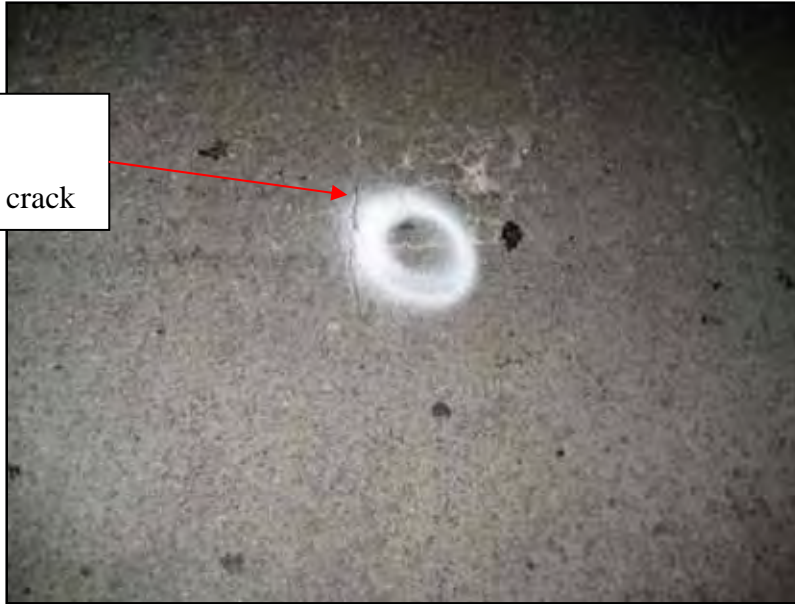
*Figure 4.78: El Paso DCP Test Location*

Field tests were performed November 14, 2007 on I10 near exit 22B along the eastbound outside lane. Multiple tests were run in locations with longitudinal cracks (Figures 4.78 and 4.79) or small joint separations and in locations without.

Fine, non-  
separating  
longitudinal crack

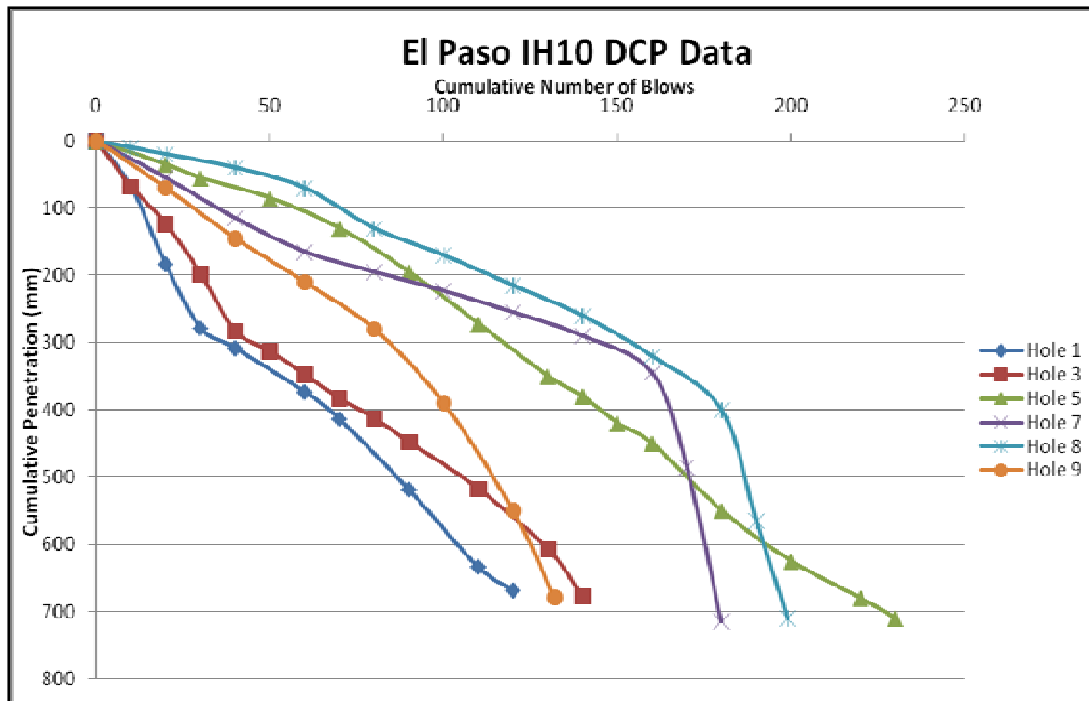
Figure 4.80: El Paso DCP Data

IH 10 showed very good subgrade modulus values (above 20,000 psi). Minimal faulting was observed, and the longitudinal cracks and separations observed in the test locations were relatively small. Although the concrete pavement on I10 in El Paso is mostly over 40 years old it

is still in pretty good condition. This probably is because good base conditions and good subgrade modulus values were found.

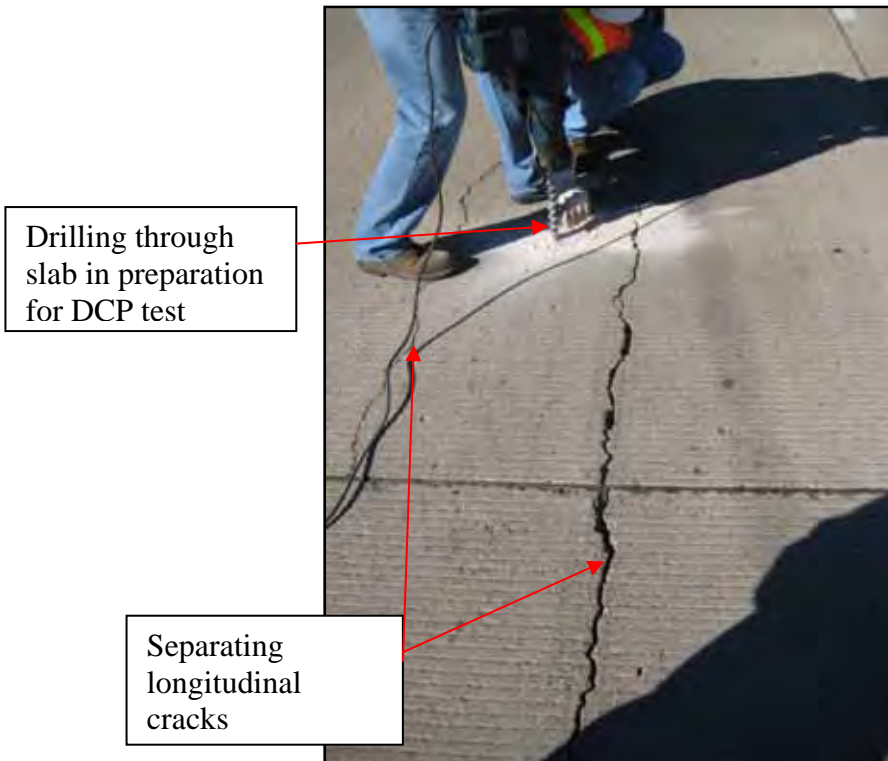
*Figure 4.82: Childress DCP Test Location*

Researchers performed field tests in Childress and Quanah on December 4, 2007 along IH287 at 3<sup>rd</sup> Street Avenue in Childress and at Main Street and Star Road in Quanah. In Childress, tests were run in locations where longitudinal cracks were present (Figure 4.82) and in locations without cracks. In Quanah, dowel bar retrofit was installed along the transverse joints (Figure 4.83) and the DCP tests were taken along the repaired portion of IH 287.

Childress and Quanah both have very bad longitudinal cracking along IH 287. DCP tests indicated for the most part poor subgrade material and both sections of IH 287 had poor subgrade modulus values. In Quanah researchers found slightly higher subgrade modulus values than in Childress (14,000 psi average in Quanah and 10,000 psi average in Childress).

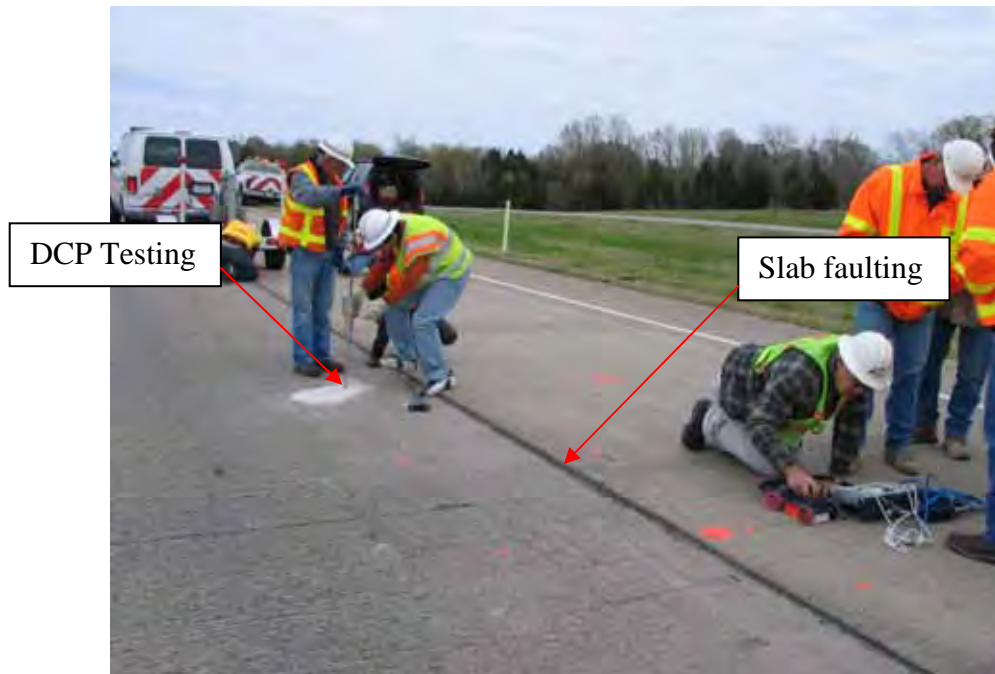
Figure 4.86: Sherman Slab 3 DCP Test Location

DCP tests were run during the field investigation (see Chapter 6) on March 31<sup>st</sup>–April 2, 2008. Longitudinal joint separations, faulting, and some cracking were evident. The field investigation began after an entrance ramp and just prior to exit ramp 68 along US 75 northbound on the two right-hand lanes. DCP tests were run in locations within the 14 contiguous slabs studied (Figure 4.86). DCP data and modulus graphs are shown in Figures 4.87 and 4.88.

Subgrade modulus values for US 75 were poor with the exception of the modulus at slab 5 (about 21,000 psi). Despite the good and bad modulus values, Slabs 5 and 6 had the worst faulting of the slabs investigated. At those locations, the open construction joint allowed water to penetrate to the base. As a result pumping and faulting began to occur. This pumping of the slab is evident from the clean gravel (no fine materials) found at the base and resulted in an approximately 3 in. deep by 5 in. wide void under Lane 2's slab, see Chapter 6 for details and figures. DCP tests offer just a snapshot of the base material at a particular time and location. The DCP's singular nature can explain why poor pavement conditions can be observed despite good subgrade modulus values and illustrates that subgrade modulus is one of many factors affecting the condition of the pavement. This can explain the high subgrade modulus value calculated at Slab 5. There was a crack along Slab 3, which can explain the poor modulus value determined there. Slab 14 was in the best state of the slabs investigated (about 14,500 psi subgrade modulus value). It was also one of two slabs to have a keyed longitudinal construction joint. This keyed longitudinal joint offered more resistance to slab vertical movement and enhanced the slab's stability. Keyed joints do not allow the two ends of the slabs to deflect differently. They also allow less water penetration to the base compared to an un-keyed joint which in turn reduces the likelihood for slab pumping.

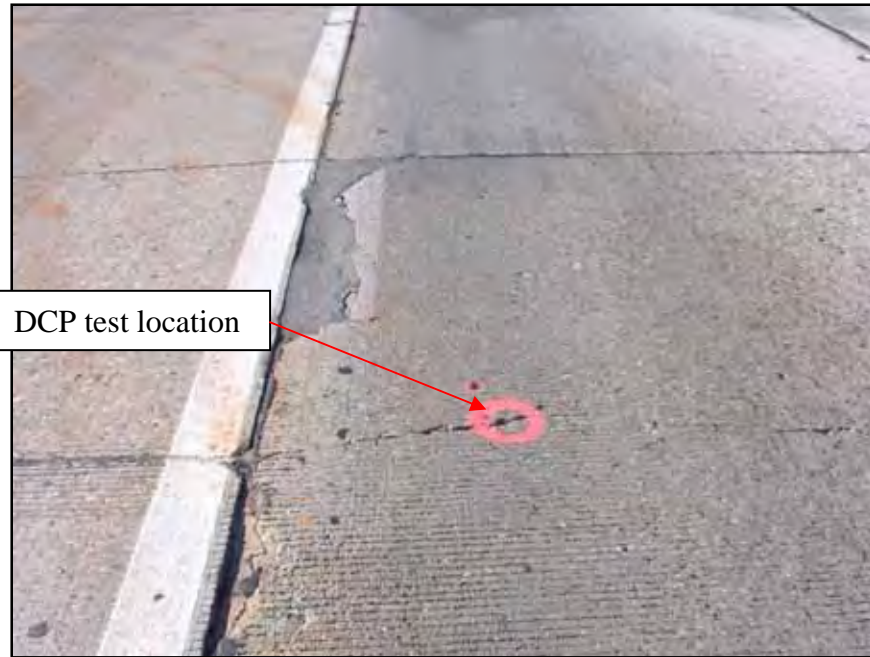
*Figure 4.89: Queen City US 59 DCP Test Location*

DCP data were collected from Queen City and Houston by researchers and local TxDOT offices. In Queen City the data was taken on US 59 in front of Ken's Sporting Goods, near the intersection with Hickory Street on August 15, 2007 (Figure 4.89). In Houston data were taken along US290 near the Magnum exit. The data collected are shown in Figures 4.91 and 4.92.

Queen City has had some major pavement issues along US59 and was repaired in 1997 and 2004. Repairs have included slab jacking, installation of pipe underdrain, joint sealing and cleaning, dowel bar retrofit, cross stitching and diamond grinding. A major cause of US 59's

problems is logging trucks that pass through the city that cause entire lanes to depress. Despite the pavement problems caused by the trucks, the base modulus values calculated in Queen City were very high (above 30,000 psi). These tests, however, were not run to the full depth; tests were stopped after penetrating approximately 8 in. into the base and do not give indications of subgrade conditions beneath the treated base. In Houston very wet climate conditions are encountered and good base preparation is always performed prior to any paving operations. The well-compacted base explains the high subgrade modulus values discovered. Also attributing to this is the fact that US 290 has keyed longitudinal joints and previous longitudinal crack repairs. The stapling method was used across the longitudinal joints to prevent further joint separation. Typical joint separation found along US 290 is shown in Figure 4.90.

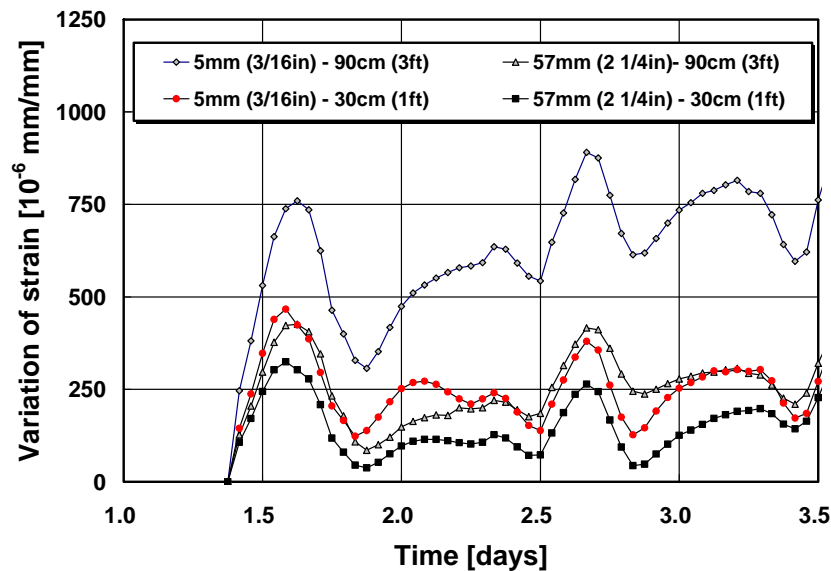
Figure 5.7: Effect of tie bar spacing on tie bar strain

Figure 5.7 shows strains in tie bars placed at 1-ft spacing and 3-ft spacing. In the legend, the first number denotes the distance of the measured steel strain from LCJ, and the second number is tie bar spacing. It shows that much higher steel strain was obtained at LCJ in a tie bar with 3-ft spacing than that at LCJ in a tie bar with 1-ft spacing. It is as expected as tie bars placed at closer spacing have more steel cross-sectional area per unit length of concrete slab, which will result in lower steel stress.

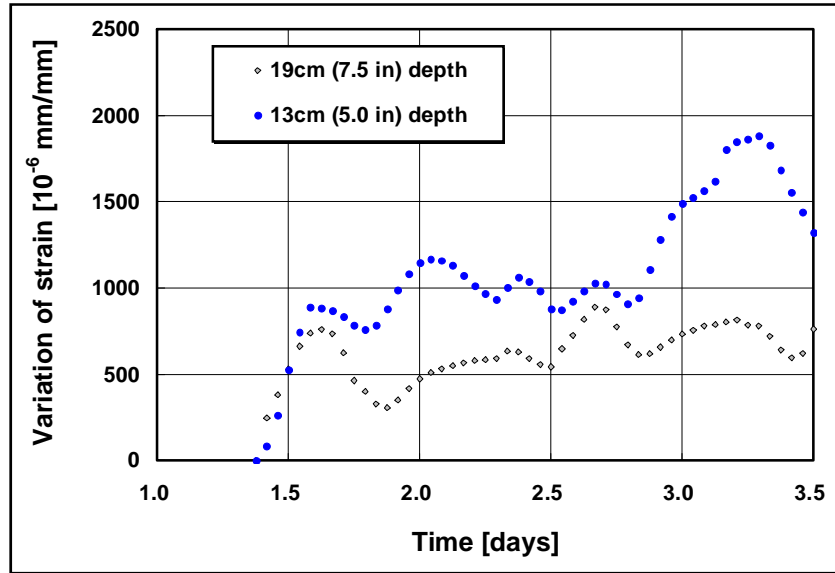
Figure 5.8: Effect of tie bar depth on tie bar strain

Figure 5.8 shows strains in tie bars that were placed at two different depths. One was placed at 5 in from the top of the slab, and the other at 7.5 in from the concrete surface. It shows larger strain values in a tie bar placed at 5 in. from the concrete surface. These two bars were

within 12 ft, and it is considered that the only difference was the vertical location of the tie bars. The information in Figure 5.8 cannot be explained by SGGT. Rather, it can be explained only when the curling effect is taken into account. As will be discussed later in more detail, curling behavior at the LCJ could result much higher stresses in tie bars if they are placed closer to the slab surface.

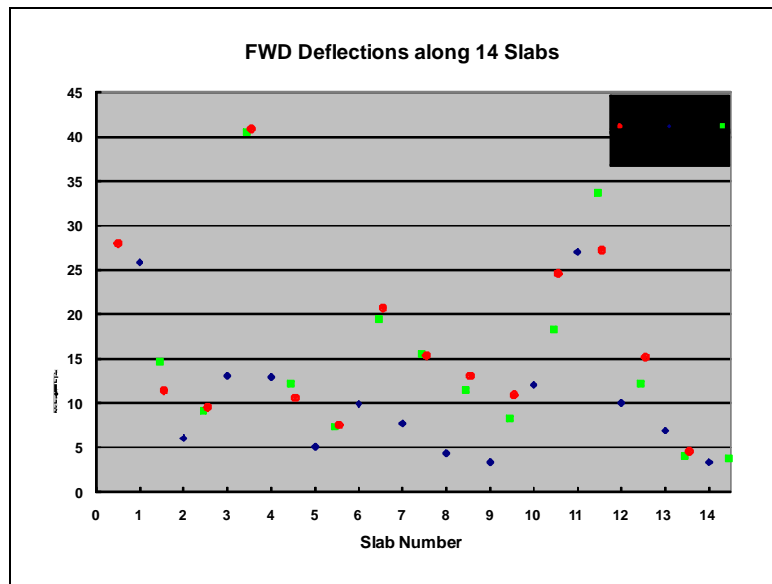
Load deflections and load transfer efficiency along the longitudinal joint of each slab was measured using the FWD in several locations along each slab: at the left transverse joint, at the tie bar, and at the right transverse joint, see Figure 6.3. The deflections plot in Figure 6.4 shows that the dowel bars at the transverse joint are mostly providing good load transfer (red circle and green square for two adjacent slabs are close together) and it illustrates the curling effect occurring along each slab. The curling effect causes the slab ends to deflect (curl) vertically upward or downward depending on the temperature (time of day) and moisture content at the particular slab's location. When the top and bottom of the slab are at different temperatures one side wants to contract while the other wants to expand. If the top of the slab is warmer than the bottom of the slab it will want to expand and will curl downwards (creating an upside down

*Figure 6.4: FWD Deflections Along Slabs*

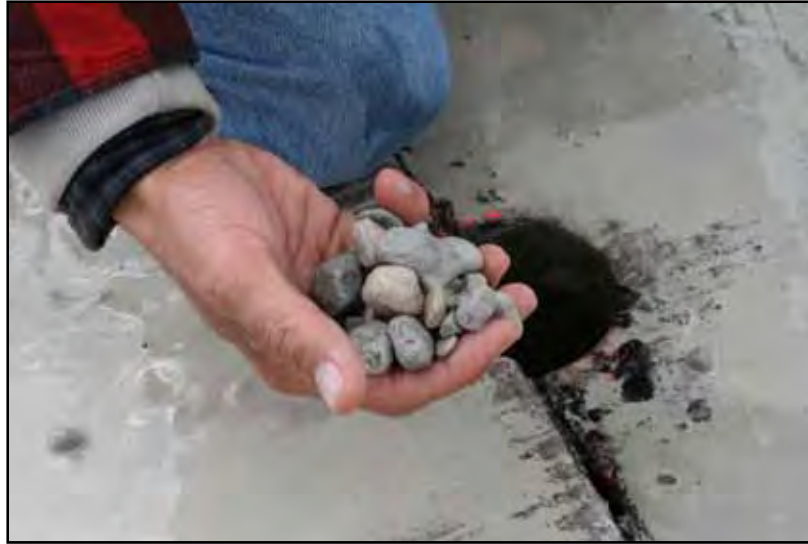
voids under the longitudinal joint. Where the faulting was greatest (Slabs 5 and 6) (Figure 6.7), the subbase material obtained from the hole was clean gravel, with almost no fine materials indicating pumping of the slab (Figure 6.5). In contrast, the subbase material obtained from core holes in non-faulted areas contained both gravel and fine materials (Figure 6.6).

*Figure 6.5: Subbase Material Resulting from Slab Pumping at Slab 5*

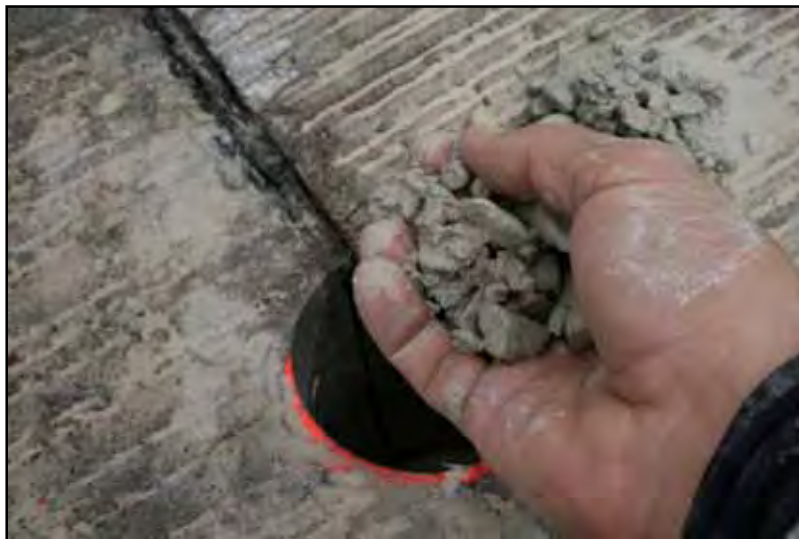
*Figure 6.6: Good Subbase Material at Slab 14*

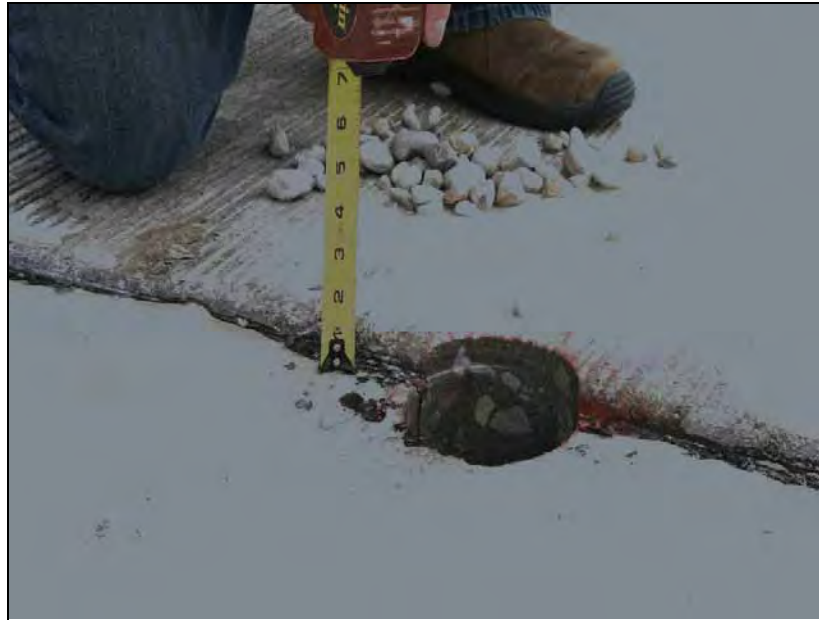
Figure 6.7 shows a section through the pavement along the longitudinal construction joint. This condition was observed where faulting was the greatest. A core was taken at the joint and the base material was observed. The construction joint had allowed water to penetrate to the base and pumping began to occur from the faulted slab in Lane 2. This pumping of the slab is evident from the clean gravel (no fine materials) found at the base and the approximately 3 in. deep by 5 in. wide void detected under the Lane 2 slab (Figure 6.86).

The mechanics of the slab faulting is an iterative process. The faulting is a result of joint separation, which leads to water infiltrating into the joint. The water infiltration leads to deteriorated base and softening of the subgrade which leads to deflection of the slab. This deflection leads to pumping out of fine materials from the base and that leads to the creation of voids under the slabs. The voids allow larger slab deflections which leads to cracking, spalling and larger separations.

*Figure 6.7: Faulted Slab 5*
