# **Assessment and Rehabilitation Methods for Longitudinal Cracks and Joint Separations in Concrete Pavement**

CTR Technical Report:	0-5444-2
Report Date:	October 2008
Project:	0-5444
Project Title:	Assessment and Rehabilitation Methods for Longitudinal Cracks and Joints Separations in Concrete Pavement
Sponsoring Agency:	Texas Department of Transportation
Performing Agency:	Center for Transportation Research at The University of Texas at Austin

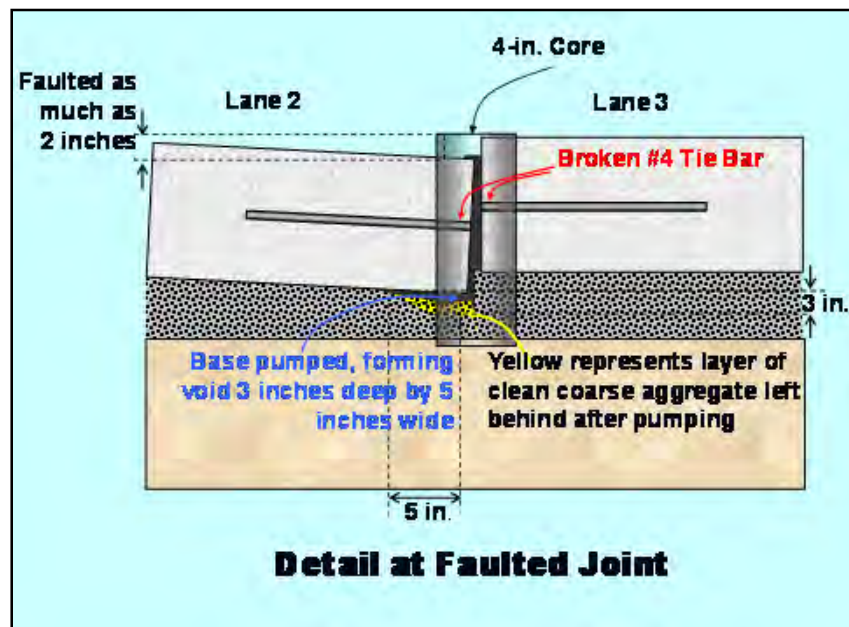
Figure 6.7 shows a section through the pavement along the longitudinal construction joint. This condition was observed where faulting was the greatest. A core was taken at the joint and the base material was observed. The construction joint had allowed water to penetrate to the base and pumping began to occur from the faulted slab in Lane 2. This pumping of the slab is evident from the clean gravel (no fine materials) found at the base and the approximately 3 in. deep by 5 in. wide void detected under the Lane 2 slab (Figure 6.86).

*Figure 6.8: Faulted Joint Detail*

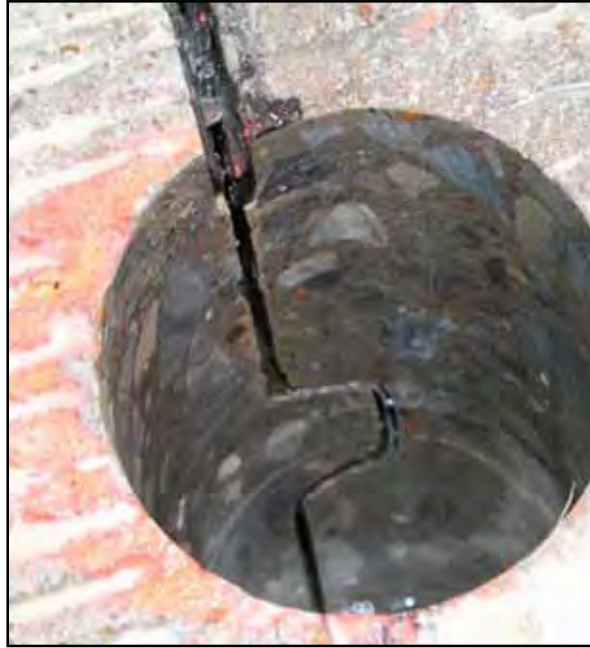
Researchers additionally found keyed joints where faulting was minimal or non-existent, but none where faulting was greatest. These keyed joints occurred at Slabs 13 and 14 and cores were taken at a tie bar. At the Slab 13 joint, a small separation had occurred and the tie bar at that location has corroded as shown in Figures 6.9 and 6.10. In contrast, the Slab 14 joint is much tighter and its tie bar is in much better condition. The cracking around the Slab 14 keyed joint shows signs of imminent failure. The cracking around the key way can be seen in Figure 6.11.

*Figure 6.9: Slab 13 Keyed joint*

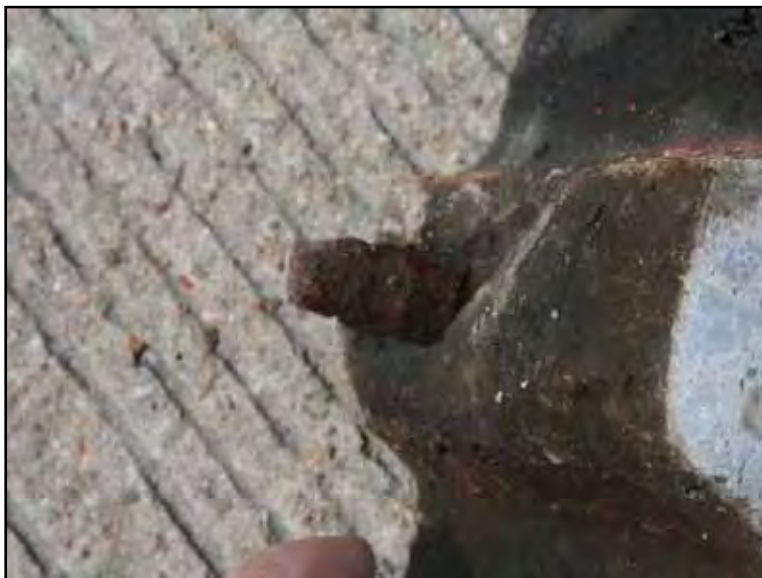
*Figure 6.10: Slab 13 Corroded tie bar in keyed joint*

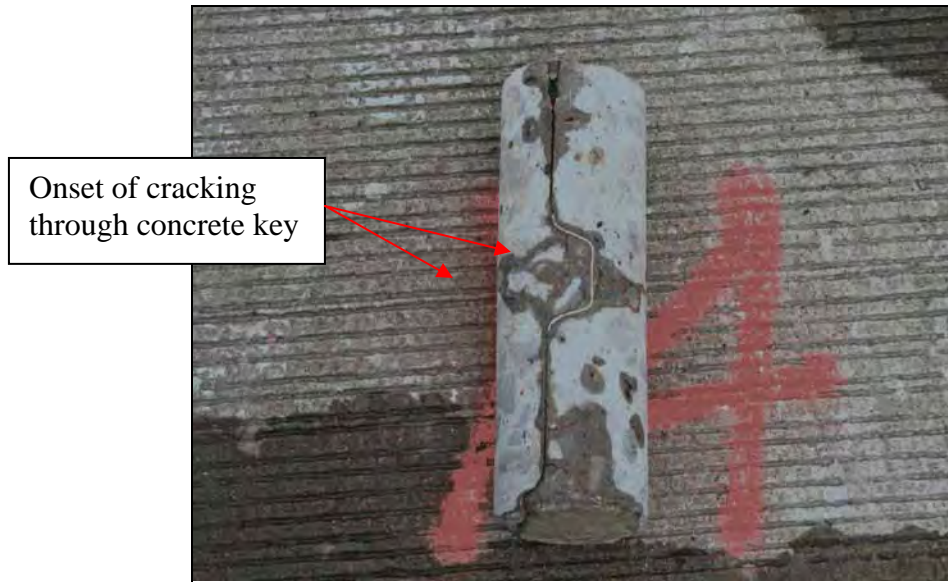
Figure 6.11: Slab 14 tight keyed joint

Slab 14 had the highest LTE of all the slabs observed. Currently it is in good form but it is starting to deteriorate, as evident by the cracking to the left of the key. The keyed joint provides the tie bars extra vertical resistance and strength. Support conditions are very important to integrity of the keyed joint, if there is a loss in support, aggregate interlock will be the only factor preventing the key from shearing off. Once that happens the performance of Slab 14 will begin to deteriorate and resemble the middle slabs (Slabs 5 to 9). It is important to restore slab 14 before its LTE drops significantly before it causes more problems along US 75 and becomes very costly to repair. Figure 6.15 shows the current LTE values and corner deflections for each slab and where the LTE and corner deflections of slab 14 will end up if the pavement issues along US 75 are not addressed properly and in a timely manner. The failing longitudinal joints were between the outside travel lane and the paved shoulder. The section examined was just north of the entrance ramp from Loy Lake Road onto northbound US 75 north of Sherman, TX (south of northbound US 75 Exit 68, Crawford Street).

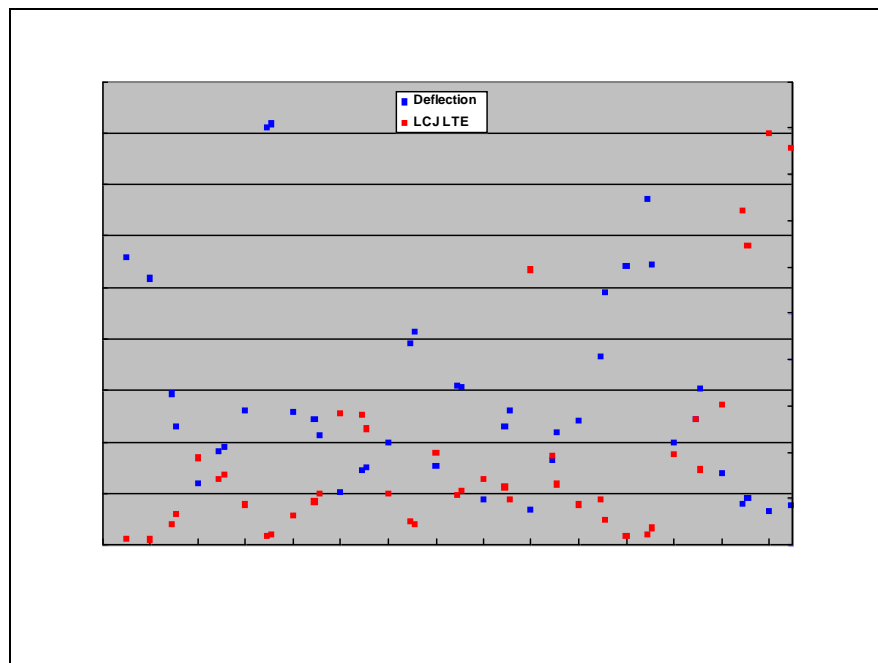
The condition of the section analyzed along US 75 is summarized in the following deflection and LTE graph (Figure 6.12). There is a direct relationship between FWD deflections and LTE; the higher the LTE observed the lower the deflection and vice versa. This relationship was confirmed upon testing; when there was good LTE across the longitudinal joint there was minimal slab deflection observed.

Figure 6.12: FWD Deflections and LTE at LCJ

Average LTE was very low (less than 30%) along the longitudinal joint but was quite high along all transverse joints. Slabs 5 and 6 had the worst faulting. Slab 5 had a good subgrade modulus (approximately 21,000 psi) while Slab 6 did not (approximately 11,500 psi). Despite the good subgrade modulus at slab 5, LTE was not good (approximately 30%). Slab 13 and 14 both have keyed joints and exhibit the best LTE of the slabs tested. Slab 14 shows higher LTE than Slab 13 (80 to 90% vs. 65 to 75%) because of a small separation of the construction joint occurring at Slab 13, see Figure 6.9. The high LTE at Slabs 13 and 14 is a direct result of the keyed joints. The high deflection found at Slab 3 was due to the large crack running across the slab. The LTE at Slab 9 is much higher than the previous slabs because the tie bars were not broken (LTE is about 60%). While LTE was not very high at Slab 9, it was at least twice as much as the LTE at Slabs 1 to 8 and 10 to 12. This shows the effect tie bars have in pavement performance and illustrates the importance of well placed and working bars.

- Rehab with minimal slab replacement
- Restore LTE at longitudinal joints to improve the performance.
- Utilize new tie bar design concept
- Restore base support
