**CORROSION PERFORMANCE OF EPOXY-COATED
REINFORCEMENT–MACROCELL TESTS**

Research Report No. 1265-3

STRUCTURAL INTEGRITY OF EPOXY-COATED BARS

November 1998

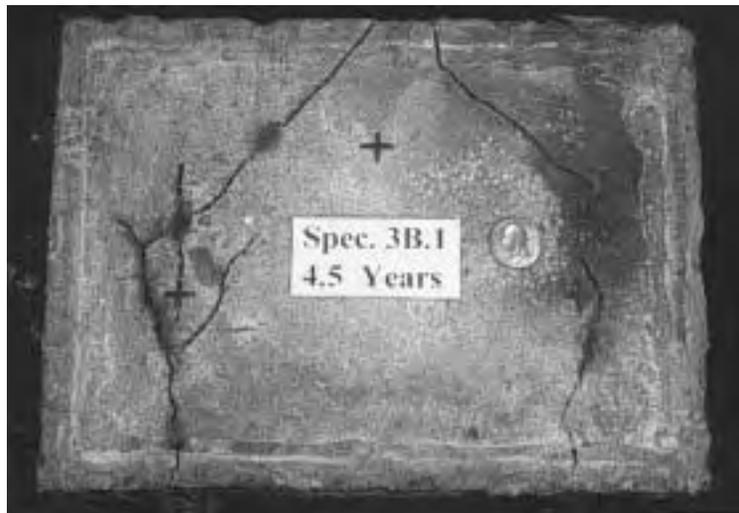
Figure 2.7 Surface condition of specimen with uncoated bar.

All specimens with uncoated bars underwent extensive deterioration after 4.5 years of exposure, including concrete cracking, rust staining, and surface scaling, as shown in Figures 2.7 and 2.8. The first outward signs of corrosion became apparent after about 100 days of exposure. The large bar specimens, in particular, showed minor brown spots on the concrete surface around the protruding ends of top bars. After about 170 days of exposure, larger brown stains were apparent at the same locations. Rust staining on the top concrete surfaces was visible after about 200 days of exposure. The small bar specimens

showed staining on the top concrete surfaces after about 330 days of exposure. Rust stains were of different sizes and colors (light to dark brown, reddish and orange brown) and generally formed along cracks on the top surface. Their appearance constantly changed during exposure. At different periods during the third and fourth years, fine orange brown rust powder exuded on the surface, especially on cracks. The top surface of all control specimens had an overall yellowish appearance, probably due to contamination by dissolved rust products in the solution.

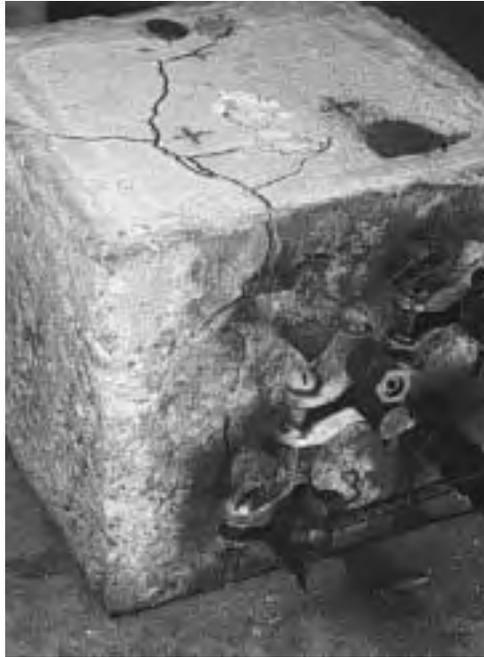
Figure 2.8 Surface condition of specimen with uncoated bar.

Fine corrosion-induced cracks showed up on the top concrete surfaces of some of the large bar specimens at approximately 210 days. The fine cracks gradually developed larger areas of rust staining and widened. The cracks generally formed parallel to the embedded bars and along the straight portions of the bars. Cracking was first evident on the top surfaces of the smaller bar specimens after about 340 days of testing. None of the specimens developed early cracking due to plastic shrinkage. Cracking generally occurred along the path of the top bar, starting at the straight regions of the bar next to the front face and later extending towards the bent zone of the bar.

In all cases, cracks propagated on the front face above the protruding bar legs. In specimen 3A1 (13-mm bar with parallel ribs) horizontal cracking developed on the front face between the 2 bar legs, which is a symptom of concrete delamination. In specimen 3A8 (13-mm bar with cross ribs), the crack above the left bar leg propagated on the front face all the way down to the bottom of the specimen and was visible at the bottom surface, along the left cathodic bar (Figure 2.8). Horizontal cracks appeared on the two lateral surfaces of specimen 3B1 (25-mm bar with parallel ribs) at a section slightly below the top bar location. The maximum crack width was 1.0 mm in specimens with 13-mm bars and 1.25 mm in specimens with 25-mm bars.

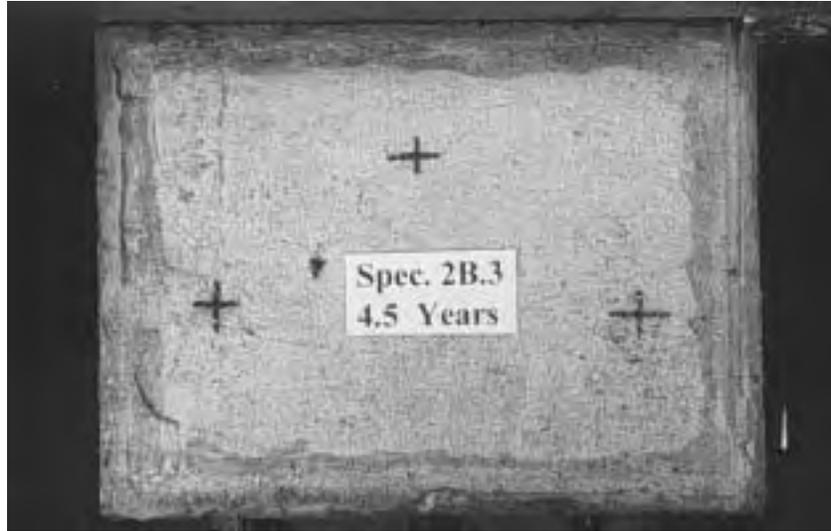
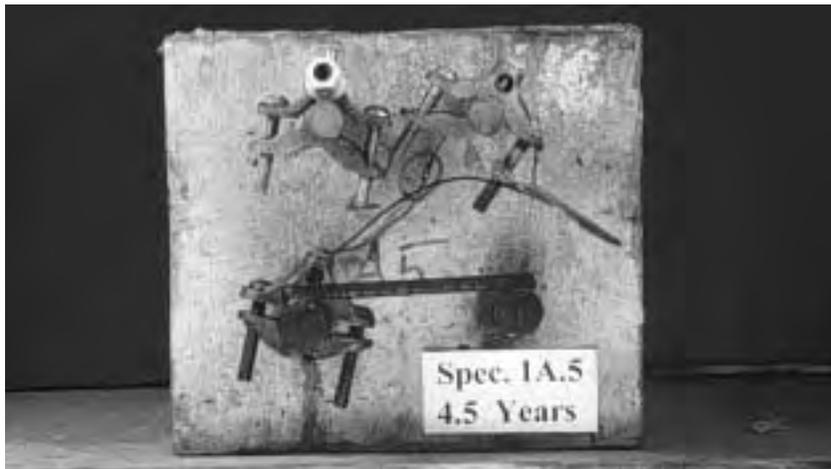
Figure 2.9 Surface condition of specimens with coated bars.

Unlike specimens with uncoated bars, specimens with coated bars maintained very good surface conditions after 4.5 years (Figure 2.9). Some specimens cracked but widths were narrower than in control specimens. Twenty percent of specimens with 13-mm bars and 80% of specimens with 25-mm bars developed cracking. In the first two years of exposure, none of the epoxy-coated bar specimens showed surface staining or cracking beyond the plastic settlement and shrinkage cracks detected at the beginning of the test. These initial cracks are described in Appendix A.

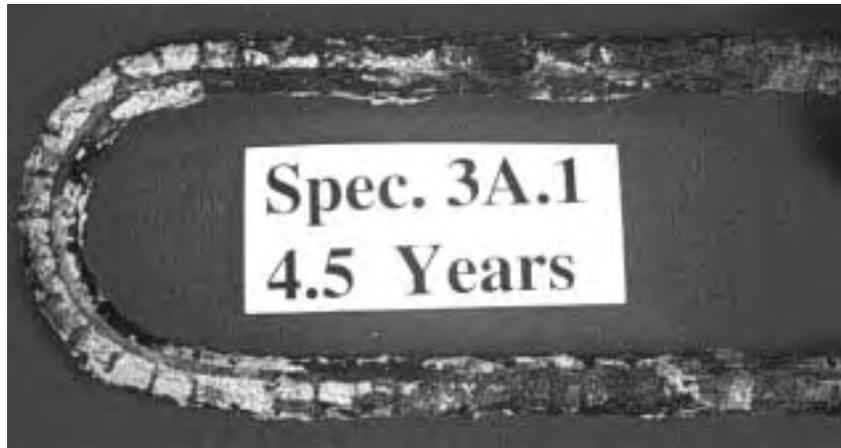
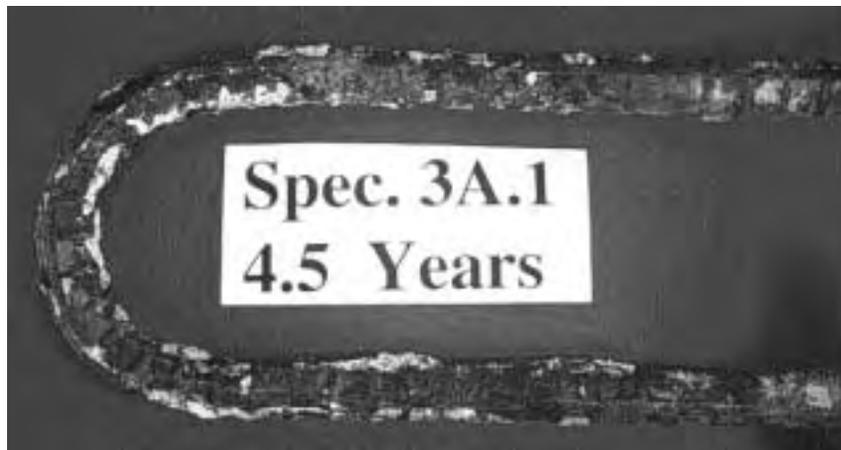
Figure 2.15 Uncoated bars after autopsy.

The uncoated bars showed relatively high levels of corrosion with discernible extensive degradation and localized loss in section, especially after 4.5 years. Figure 2.15 shows the top and bottom sides of one uncoated bar after removal. Immediately after opening the specimens, corroded metal had a black or dark appearance with randomly distributed areas of reddish-brown rust and several smaller areas of dark-green and bluish-green rust. After being exposed to oxygen, all dark- and bluish-green areas changed to bright orange-brown or yellowish-brown rust.

The accumulation and build-up of rust products was evident in the most corroded areas. Corrosion was concentrated mostly at the straight portions of the bar, exhibiting appreciable loss of metal and pitting (Figure 2.16). On bent areas, a relatively clean, non-corroded metallic surface was visible over most of the top half of the bar and over a portion of the bottom side. After 1 and 2 years, more pitting corrosion occurred on the top side than the bottom side of the bar. However, corrosion spread more on the bottom side than on the top side of the bars after 4.5 years. Larger bars were more severely attacked than the smaller bars.

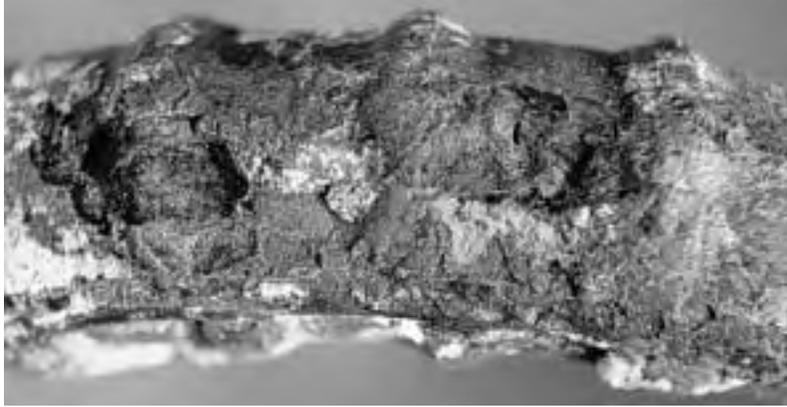
(a) Severe pitting on 25-mm (#8) uncoated bar after 2 years of exposure.

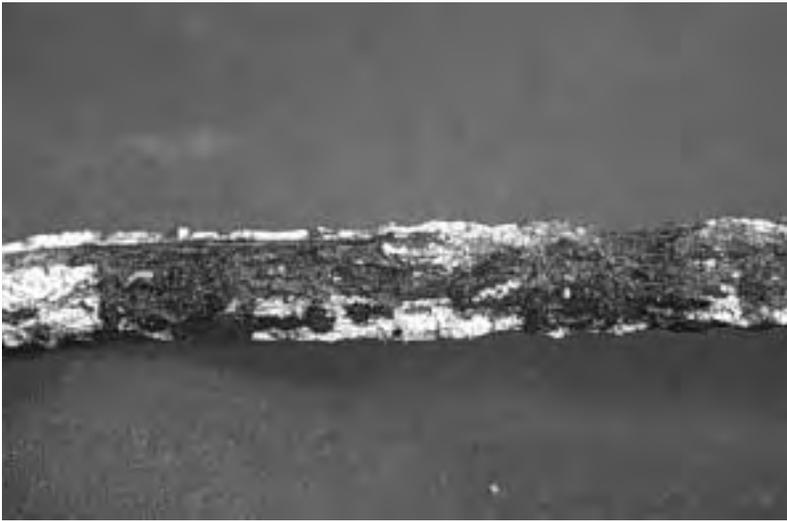
Pitting corrosion worsened after 4.5 years of exposure. Several large pits, ranging from 0.5 to 2.0 mm deep, developed on the straight legs of both 13-mm bars [(Figure 2.16(b)], outside of the bent portion on a 13-mm bar with cross ribs, and on the right side of the bent portion in a 25-mm bar with parallel ribs. A large, deep pit on the top side of a 13-mm bar with parallel ribs caused a significant reduction in bar area at that location.

(b) Severe metal loss and pitting at straight leg of 13-mm (#4) uncoated bar after 4.5 years of exposure.

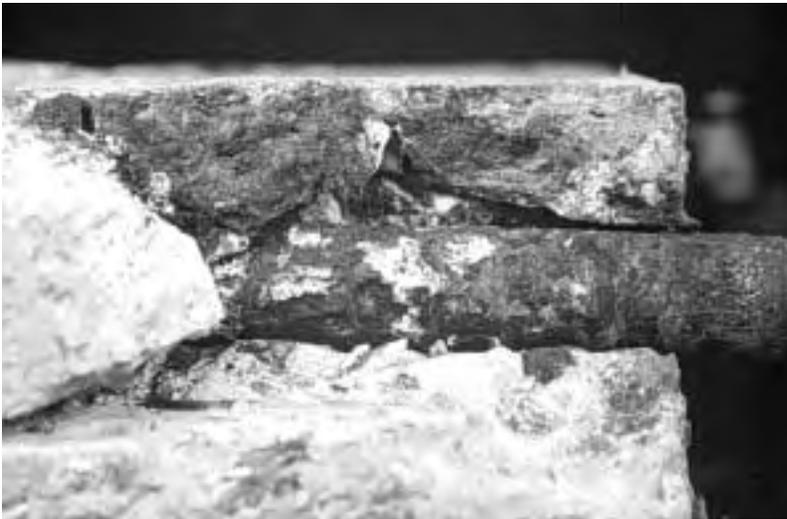
(c) Pitting at straight leg of 25-mm (#8) uncoated bar after 4.5 years of exposure.

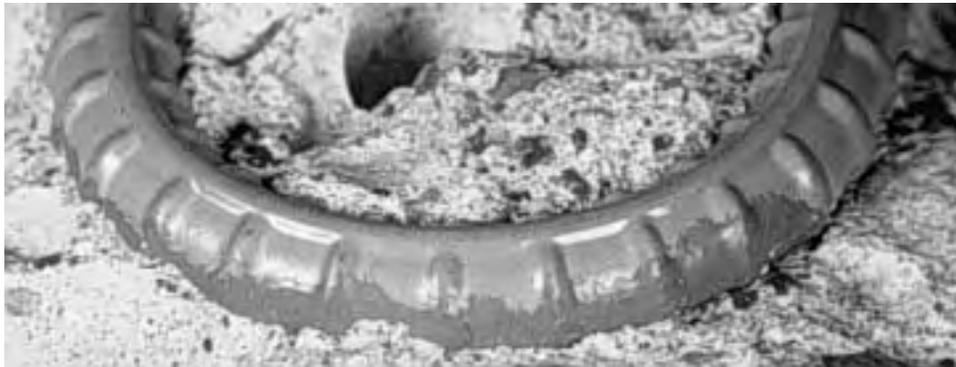
(a) Specimen 1A.4

After one year of exposure, the small coated bars showed either no apparent corrosion or minor surface corrosion on the introduced damage and other defective areas of coating (inside and outside of bend). Figure 2.17 shows two examples of the 13-mm (#4) bars exposed for one year. At the damaged locations, steel was only discolored or had suffered minor (shallow) loss of metal.

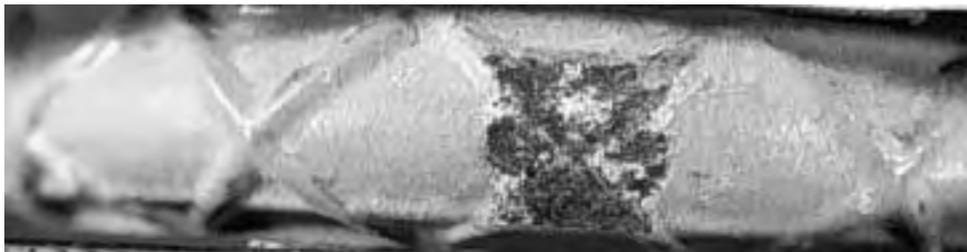
(b) Specimen 3A.10

Figure 2.17 Examples of 13-mm (#4) coated bar specimens autopsied after one year of exposure.

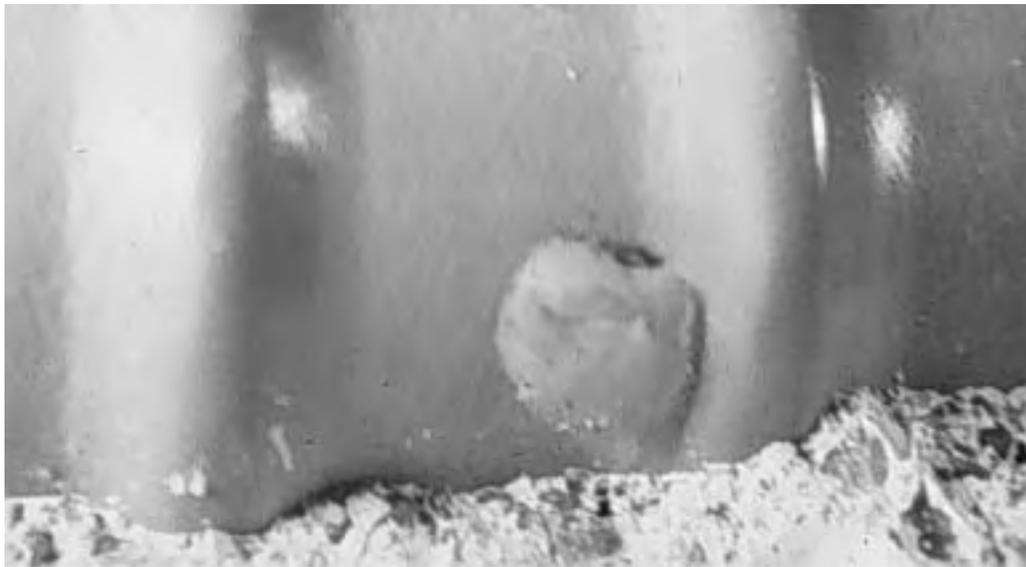
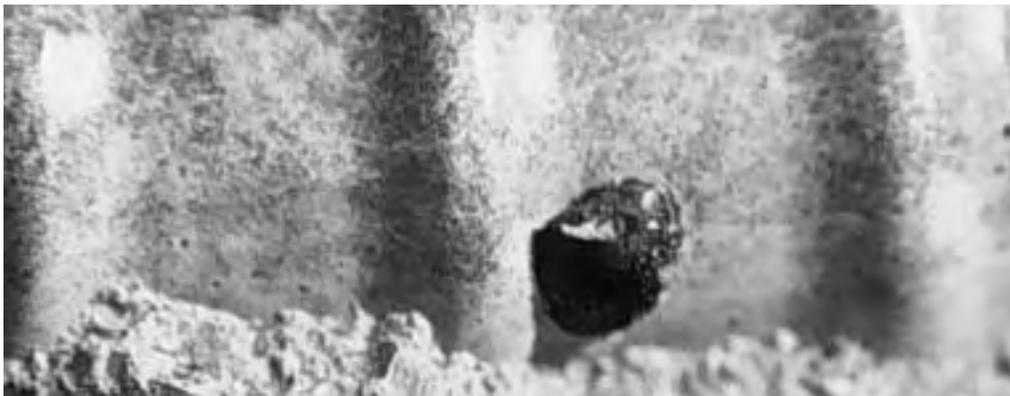
The large bars showed relatively more corrosion activity; however, metal loss was minor as shown in Figure 2.18. Rust spotting at some patched areas was visible. On the majority of the large bars, many variable size blisters distributed on the coated surface were noted. The blisters formed at spots facing air voids in concrete as shown in Figure 2.19. Based on appearance, the worst bars, from both series, were those with exposed damaged areas slightly exceeding 2% of the bar surface area.

(a) Blister on a coated bar surface

(b) Void in concrete at blister formation

Figure 2.19 Coating blistering at voids in concrete.

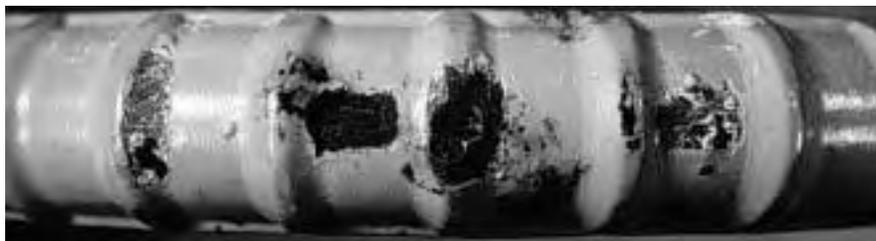
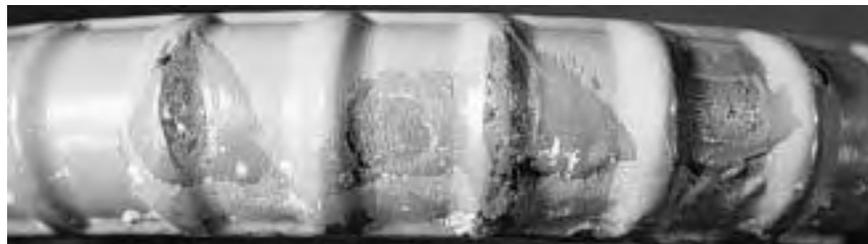
More corrosion activity was visible after two years than after one year. After two years, it was clear that pitting corrosion was occurring on the exposed areas of some specimens. Rust spotting at some patched areas was also observed, particularly on the larger size bars. These observations are illustrated in Figure 2.20. Again, blisters of variable sizes formed on the coated bar surface at locations facing voids in concrete. These voids were more concentrated on the underside of the bar as shown in Figure 2.21. The blisters were also much more apparent after two years than after one year for the corresponding specimens indicating further breakdown of the coating with longer exposure. Figure 2.21 shows a bar with many blisters formed on the bottom side.

(a) Pitting corrosion on specimen 3B.3

(b) Rust spotting on specimen 1B.2

Figure 2.20 Examples of 25-mm (#8) coated bar specimens after two years of exposure.

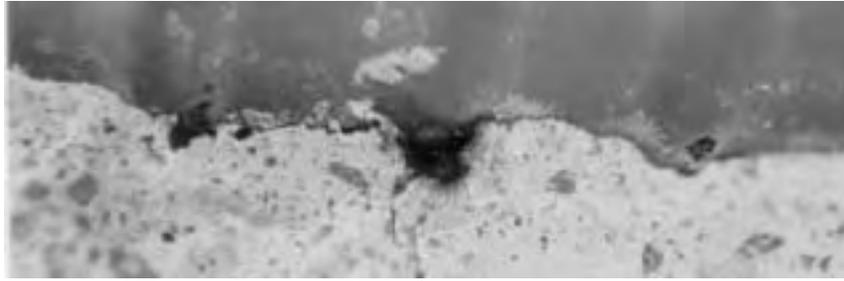
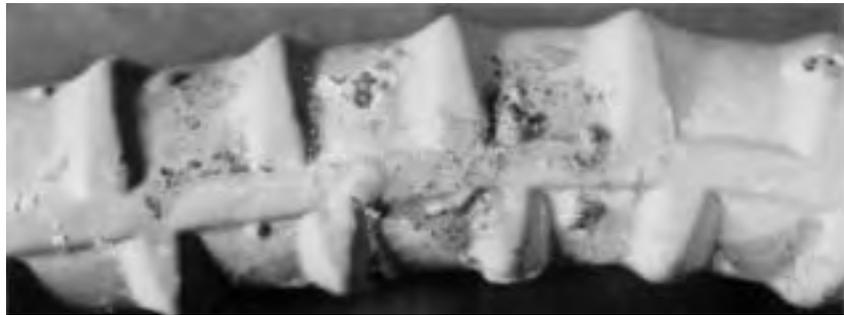
(a) Specimen 3B.7

(b) Specimen 2B.5

Figure 2.21 *Blister formation at bottom side of coated bars after two years of exposure.*

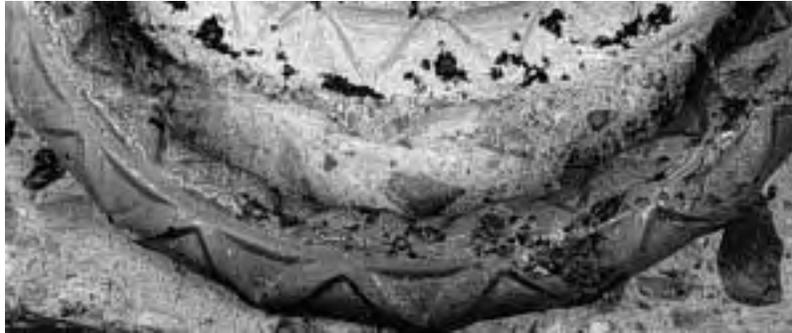
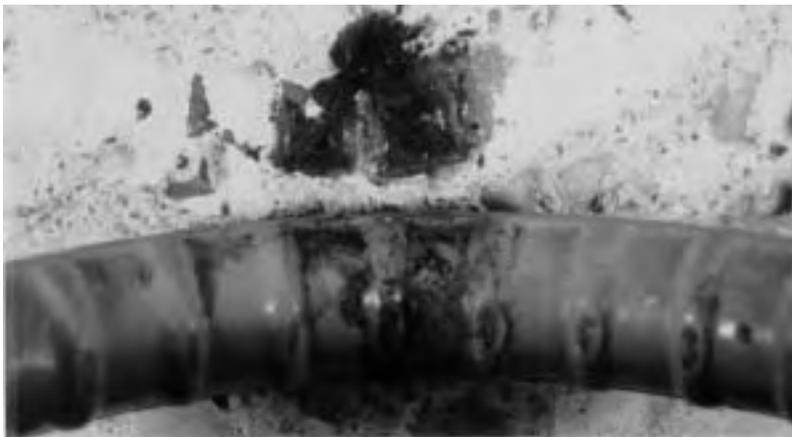
(a) Specimen 3B.10 (bottom side facing up)

(b) Specimen 2B.5 (inside of bend facing up)

Figure 2.22 *Rust spotting on bottom sides of coated bars coincident with voids in concrete.*

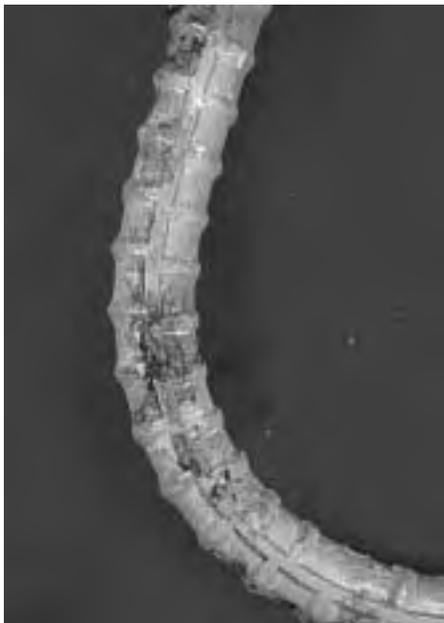
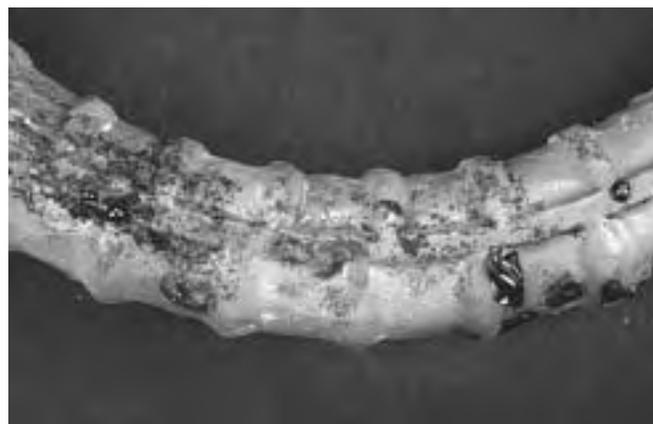
As expected, corrosion of coated bars progressed with time. Corrosion was more extensive after 4.5 years, especially in larger bars. Rust staining, coating blistering, and corrosion of exposed areas were noted (Figure 2.23). The color of rust stains ranged from dark to light brown, and their appearance varied from dense to tenuous. Blisters of different sizes formed but small ones were prevalent. In some bars, a few small stain lines with dull appearance (indicating coating distress or cracking) were detected next to longitudinal lugs. Corrosion did not always occur at the damaged, exposed areas of smaller bars. In contrast, all exposed areas of larger bars corroded severely. Rust at damaged spots on the outside of the bend was uniformly dark. Traces of bright or dull reddish-brown rust were found inside the darkly rusted damaged areas. At some of the damaged spots, metal depletion was evident. Traces of acidic (pH = 3) brown solution were observed on several damaged areas. In contrast, generally minor corrosion was observed on patched areas. Patched areas were frequently discolored, had medium-sized to small dark-brown or reddish-brown rust spotting, and tiny blisters (See Figure 2.29 later in Chapter). Fine reddish-brown rust products (in small amounts) were deposited at several patched spots.

(a) Rust staining and blistering on epoxy-coated bar.

(b) Rust staining and exudation of brown liquid on epoxy-coated bar.

Figure 2.23 *Corrosion of epoxy-coated bars after 4.5 years of exposure.*

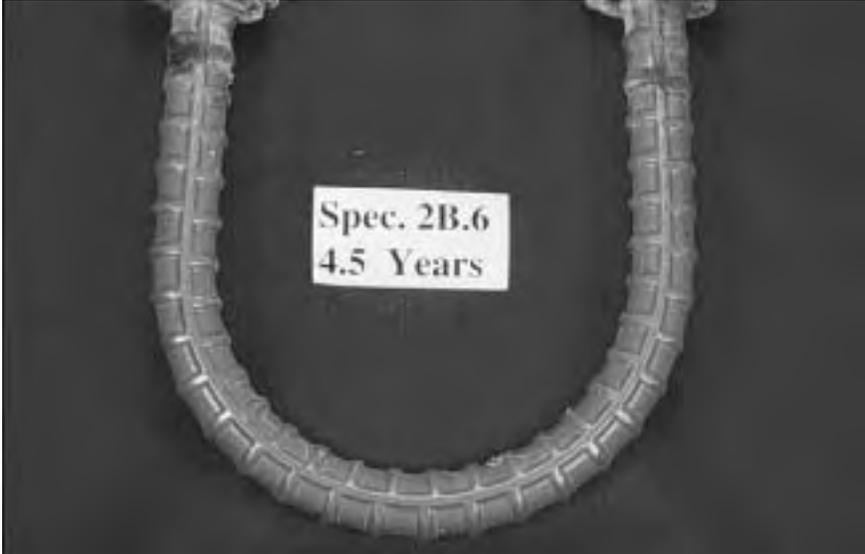
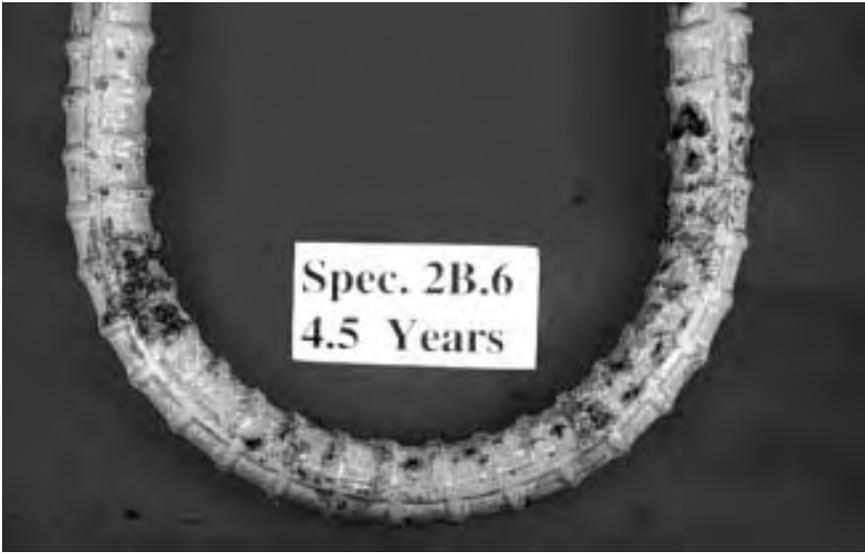
Except for bar 3B.5 (25-mm bar with damage greater than 2%), all bars experienced more rust staining or spotting and blistering on the bottom surface than on the top (Figure 2.24). In most cases, more corrosion developed on the bent area than on the straight portions. Blistering and rust staining tended to concentrate next to the longitudinal lugs. Most damaged areas on the inside of the bend (produced by the mandrel during fabrication) did not show much corrosion, only superficial rusting. There was almost always a void in the concrete where a blister formed. However, corrosion did not occur at all voids. As with 1-year and 2-year specimens, smaller bars corroded less than large bars.

Figure 2.24 *Appearance of top and bottom sides of epoxy-coated bars.*

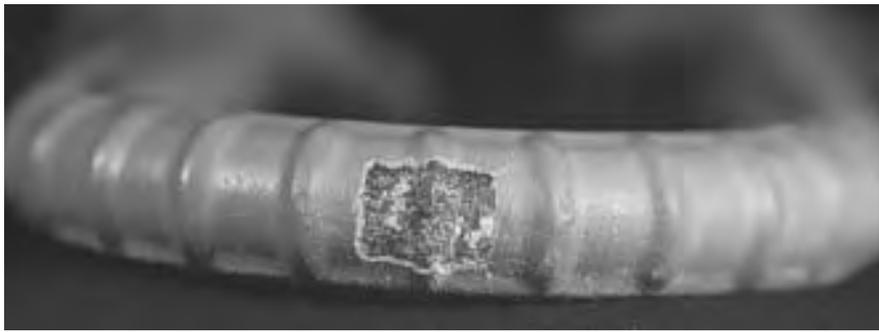
Figure 2.25 Clean, uncorroded damaged area after 4.5 years of exposure (Bar 3A.3).

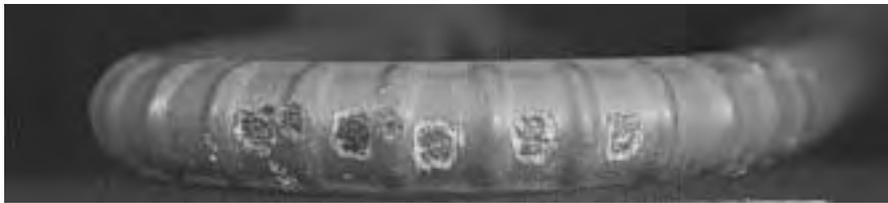
Figure 2.26 Clean, uncorroded damaged areas after 4.5 years of exposure.

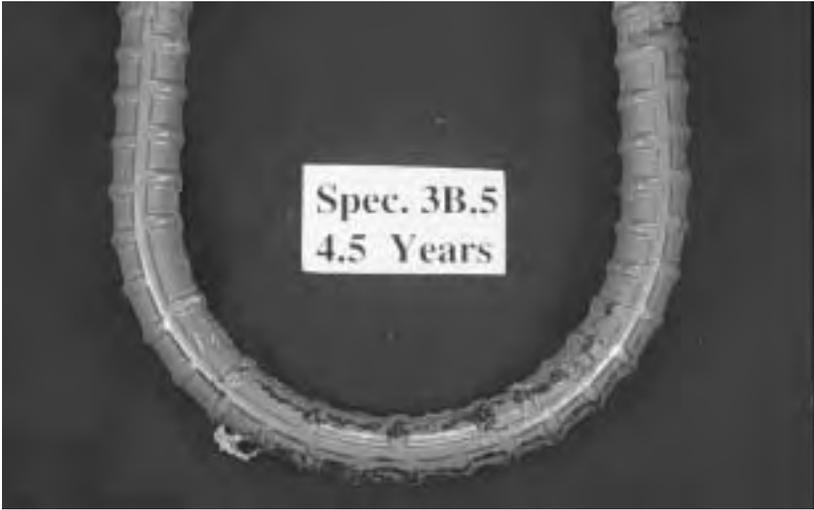
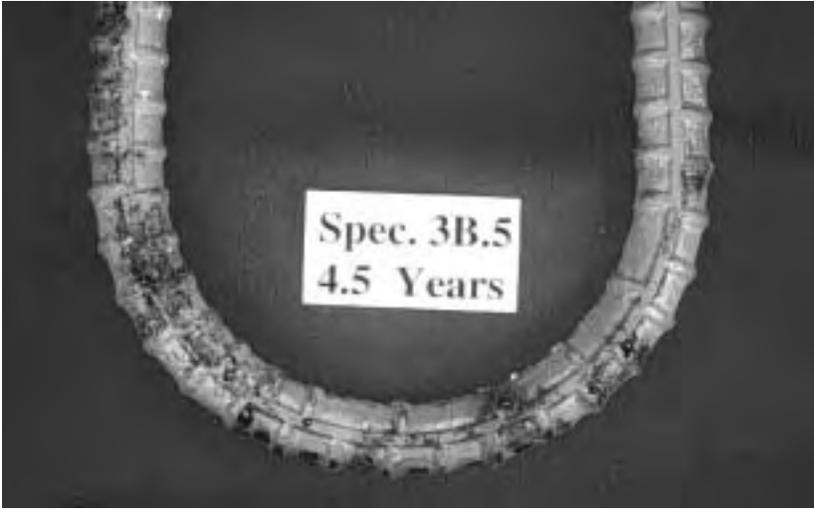
In group B (larger bars), bars 2B.3 (damage > 6x6 mm), 3B.5 (damage > 2%), and 1B.7 (damage < 2%) exhibited the highest corrosion. Dark, dense stains formed on the top portion of bar 3B.5 [Figure 2.27(a)]. Diluted, dark and brownish stains appeared at the bottom side around the bent zone and on one bar leg [Figure 2.27(b)]. Damaged areas at the outside of the bend had a dark rust accumulation (Figure 2.28). For comparison, Figure 2.29 shows the appearance of patched areas at the outside of the bend on box 3B.4.

Figure 2.27 Bar 3B.5 after 4.5 years of exposure.

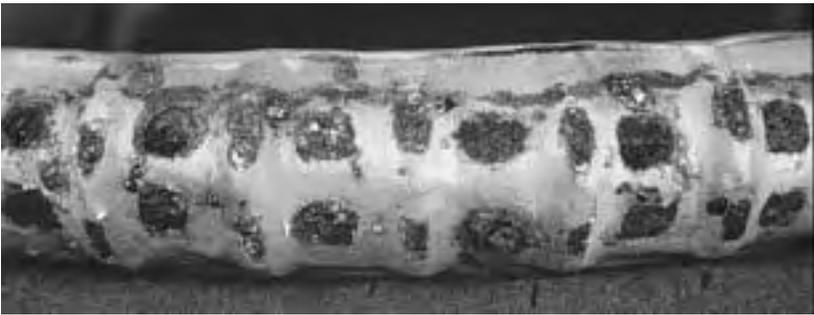
Figure 2.28 Corrosion of damaged areas at outside bend on bar 3B.5.

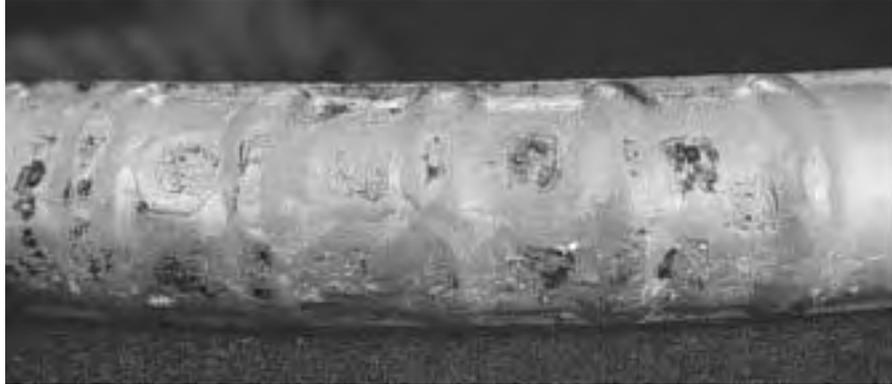
Figure 2.29 Corrosion of patched areas at outside bend on bar 3B.4.

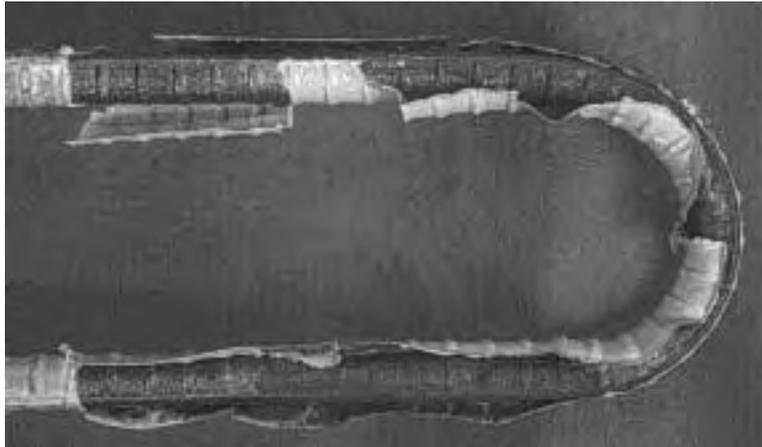
Scraping the coating after two years was easier than after one year and resulted in larger chipped off pieces. The extent of coating debonding after 4.5 years was slightly greater than after 2 years. Extensive adhesion loss was observed more frequently on large bars than on small bars. Four small bars developed complete coating debonding throughout their whole length (bent and straight zones). At the remaining

small bars, debonded areas included the bent zone and an adjacent portion of the straight bar legs. Coating adhesion was preserved in the portion of straight bar legs closer to the protruding ends, away from the bent zone (a 4- to 7.5-cm stretch extending from the front face). In contrast, all large bars experienced complete loss of adhesion throughout their length. Only in bar 1B.7, a short piece of coating (about 2.5 cm long) adjacent to the protruding end of one leg remained adhered to the steel substrate.

Figure 2.34 Coating debonding on 13-mm (#4) bar.

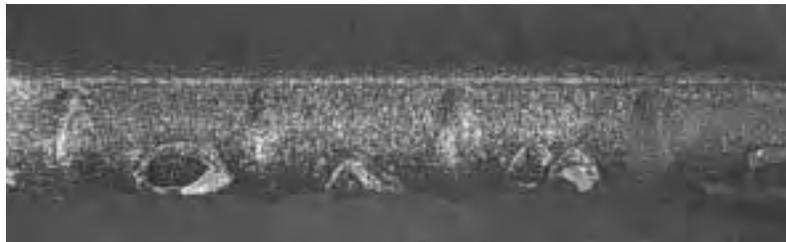
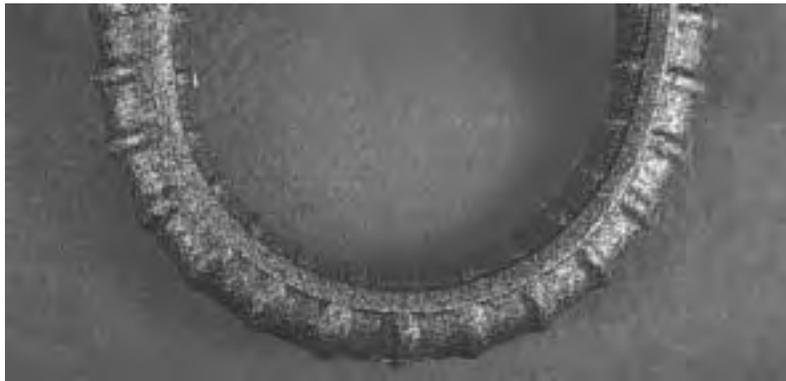
The designation of “non-corroded” is possibly a misnomer because corrosion may be in an initial stage. The steel surface showed a very unique characteristic: A sort of a mottled, glittery or twinkling appearance with a golden-brown or similar brownish color. An example of such a surface is illustrated in Figure 2.35. The condition of such steel surfaces was very good, with no discernible pitting or metal attack. The term “non-corroded” was used to describe the good condition of the steel. The loss of coating adhesion, though, may indicate that corrosion may already be in early stages. Mottled surfaces were found mainly in the less corroded small bars and occurred more often at straight bar legs than at bent zones. Debonded areas with mottled surfaces underneath were suspected to have undergone cathodic disbondment, as will be explained later.

(a) Left leg of bar 3A.2.

(b) Top side of bar 3A.3.

Figure 2.35 Mottled, glittery surface with golden-brown (or similar brownish) appearance under the coating.

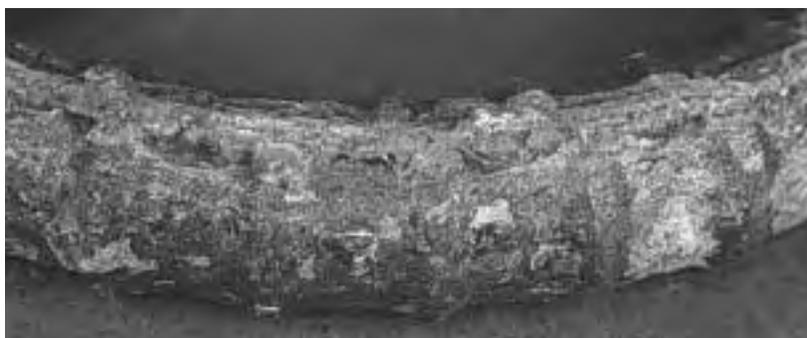
The appearance of corroded surfaces varied from bar to bar. In most cases, a uniformly black or dark rusted surface developed. The degree of darkness varied from specimen to specimen and it also changed with time for the same specimen. In several bars, the corroded surface looked darker one or two days after the coating was removed. Depending on the length of exposure and severity of corrosion, shallow pitting and metal depletion, rust volume increase, and blistering may have developed in varying degrees (Figure 2.36). In many specimens, spots of whitish matter with pasty consistency, sometimes combined

Figure 2.36 Shallow pitting and accumulation of rust products on steel surface under the coating (outside bend).

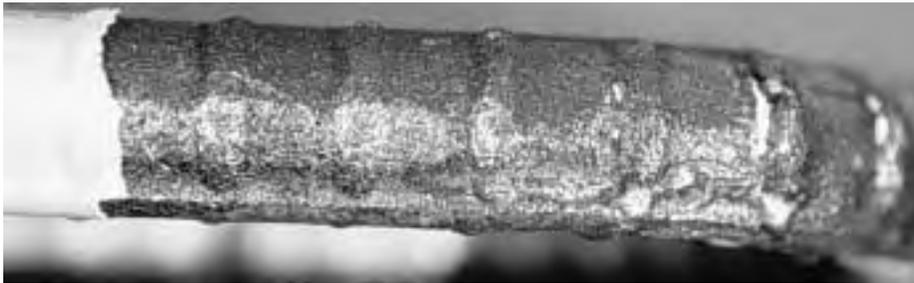
After two years, specimens showed moderate underfilm activity and pitting. There was a clear distinction between the appearance of the top and bottom sides of the bar. The top side was black, and sometimes moist, while the bottom side was dull with sporadic rust spotting as shown in Figure 2.38. Even the patched large bars showed surface darkening with minor metal loss or slight pitting as shown in Figure 2.39. Whitish and orange residue was occasionally observed in some pockets forming alongside the bottom continuous rib as shown in Figure 2.40. The blisters were often full of corrosion products and some had an acidic (pH 2 to 4) trapped solution. Figure 2.41 shows a close up of the solution detected underneath the coating.

Figure 2.38 Thin black layer on top side of steel surface.

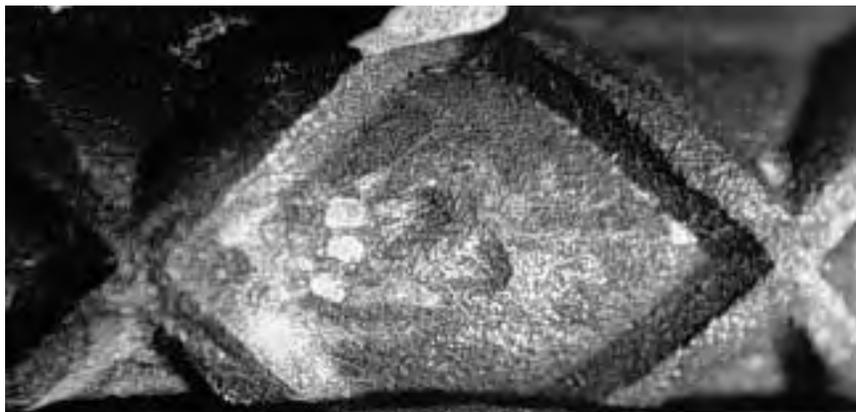
Figure 2.39 Darkening and pitting underneath patching.

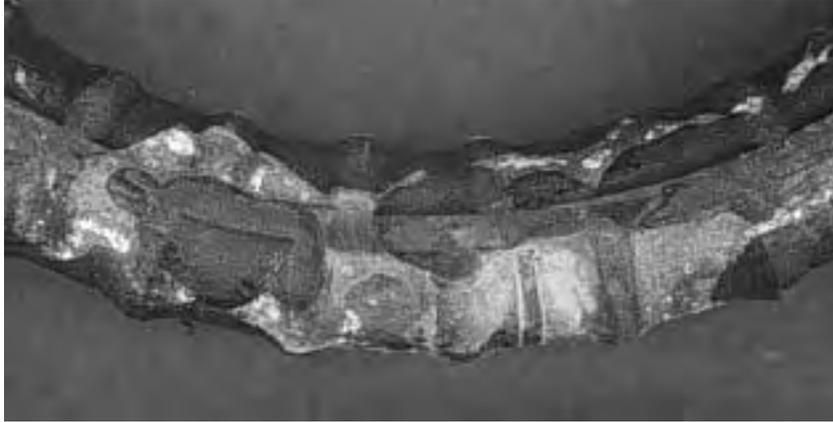
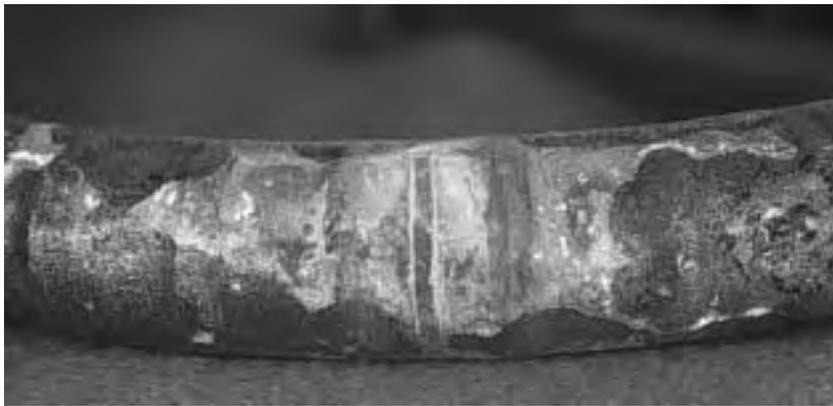
Areas with rust deposits or pockets of varying size, shape, appearance, color, and amount were usually present along the bar surface above the uniform black rusted surface (Figures 2.42 and 2.43). The size of such rust spots ranged from very large, occupying large areas of the bar surface, to small flecks. Appearance of rust spots was dependent on rust concentration, varying from a light film of rust, similar to a stain, to thicker layers of rust deposits. Rust layers at some spots were bulky enough to cause a bulge in the coating, but in most instances, rust amounts in such areas were light. At the time of autopsy, whitish products were the most prevalent. After a few days of being exposed to air, more commonly found colors were light-brown, reddish-brown, orange-brown, and yellowish-brown. Many of the larger and medium-sized rust stains often had shapes with clearly delineated boundaries, giving the appearance of traces or remains of a solution (Figure 2.43). Several rust spots or stains appeared to be wet. In one case (bar 3B.5), a silver-colored stain was detected (top side of bar between bent zone and right straight leg) immediately after removing the coating. One hour later its color changed to whitish, and 2 days later changed to dull-brown and orange-brown. At the bottom side of bar 1A.5, a whitish substance found alongside a longitudinal lug (bent zone and straight right leg) turned yellowish-brown a few hours after coating removal. Such matter was deposited along a strip, giving the appearance of a solution trace (Figure 2.44).

(a) Top side of bar 1B.7

(b) Outside bend of bar 1B.7

Figure 2.43 Rust products or stains with clearly delineated boundaries, with the appearance of solution trace.

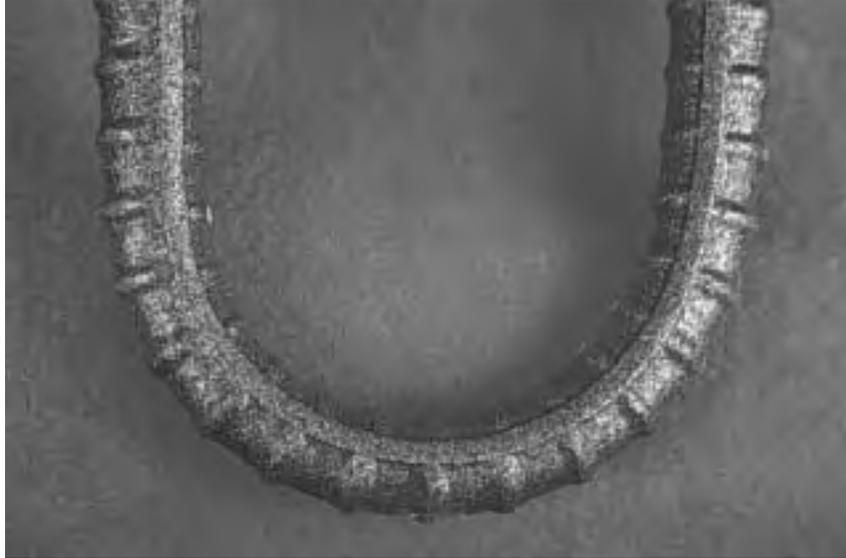
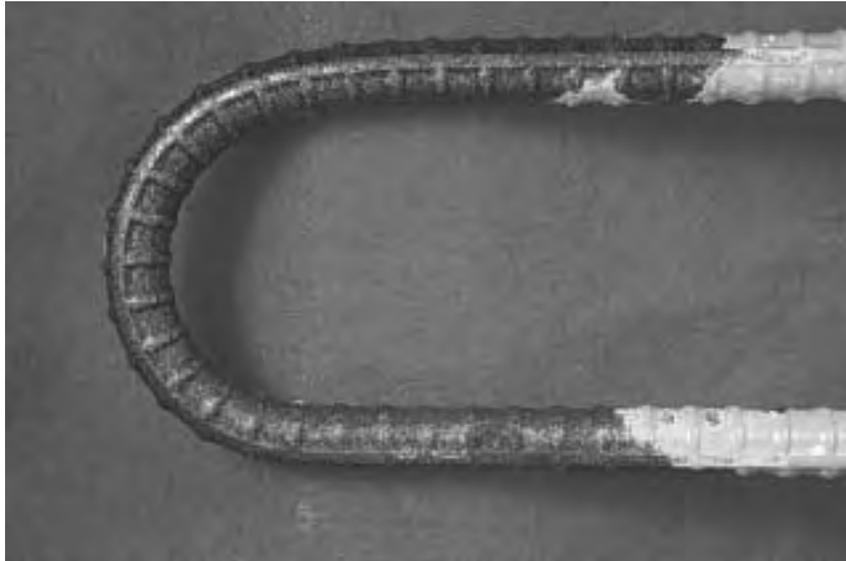
Among smaller bars, specimen 1A.5 (damage > 2%) suffered the worst corrosion (Figure 2.45), followed by bars 2A.6 (cracks with damage < 1%) and 1A.10 (damage > 6x6 mm). The bar with best condition was, amazingly, 3A.3 (damage > 6x6 mm) (Figure 2.46), followed by bar 3A.7 (damage < 2%). Among larger bars, specimen 3B.5 (damage > 2%) suffered the worst corrosion (Figure 2.47), followed closely by bar 3B.4 (damage > 2%, patched). The extent and severity of corrosion was similar for the remaining bars. Interestingly, in bars with damage greater than 6x6 mm, corrosion spread much more on the repaired bar (3B.2) than on the unrepaired bar (2B.3).

Figure 2.46 Steel surface condition beneath the coating of bar 3A.3.

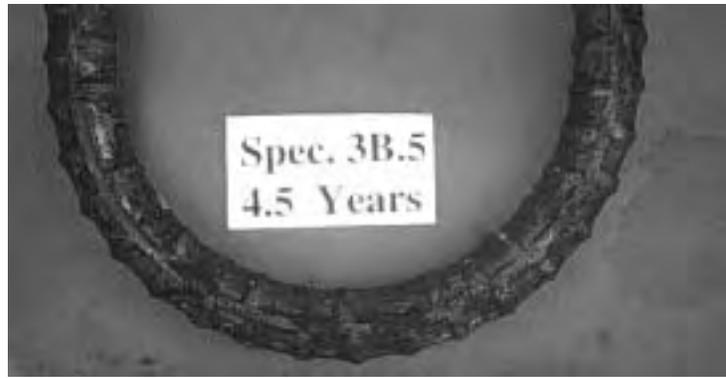
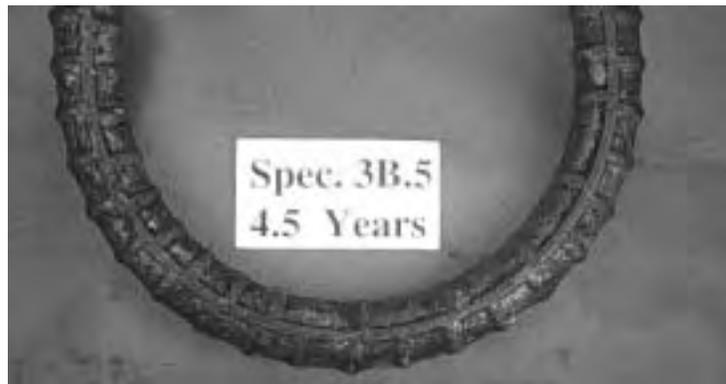
Figure 2.47 Steel surface condition under the coating of bar 3B.5.

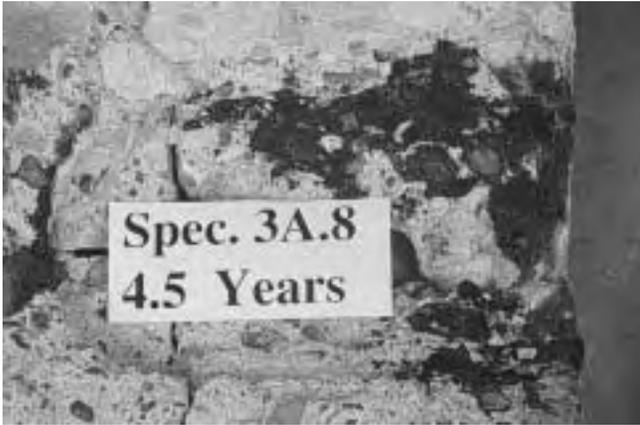
Concrete surrounding the top bar (above and below the bar) was extensively rust stained (Figure 2.48). Rust stains were very large, mostly black or dark and reddish-brown colored. Sometimes, reddish-brown stains had a black rim. Other observed stains were bluish, bright orange, brownish, yellowish-brown, and whitish. In specimen 3B.1, a few dark-greenish spots were observed immediately after autopsy, and hours later turned bluish or dark. In specimens with small bars, concrete around straight bar legs experienced more rust staining than concrete around the bend zone. Black and reddish-brown rust usually accumulated and hardened in concrete above straight bar legs. Staining distribution seemed more uniform in concrete around large bars. Rust staining was more extensive in concrete above smaller bars, especially in the portion closer to the front face of the specimen, where stains penetrated the concrete far beyond the bar location at either side or both sides of bar legs (Figure 2.48). Rust staining was more extensive in concrete below large bars. In general, rust stains penetrated the concrete far beyond the bar location along different portions of the bar. Stains penetrated cracks and expanded towards the top concrete surface (Figure 2.49). Rust staining was mostly reddish-brown and orange-brown at areas closer

Figure 2.48 *Rust staining on surrounding concrete under uncoated bar 3A.8.*

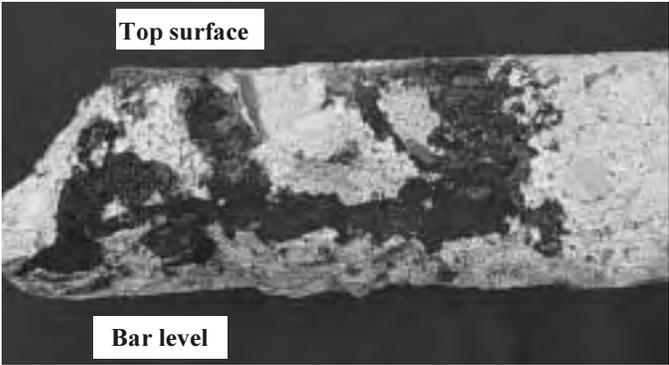
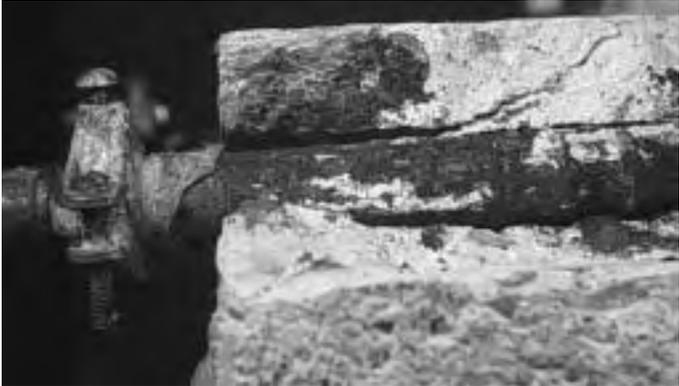
(a) Rust inside crack surfaces in concrete cover.

(b) Another aspect of rust inside crack surface.

Figure 2.49 *Rust products penetrated through cracks and rose to the upper surface in specimens with uncoated bars.*

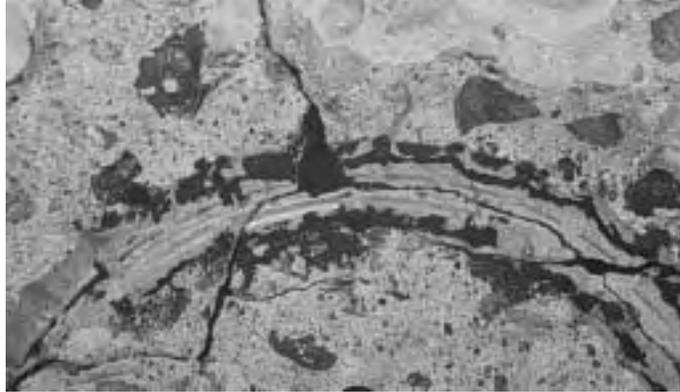
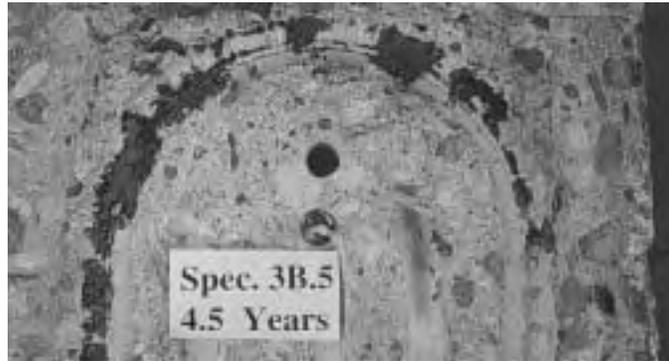
Figure 2.50 Bar trace in concrete of specimens 3B.5.

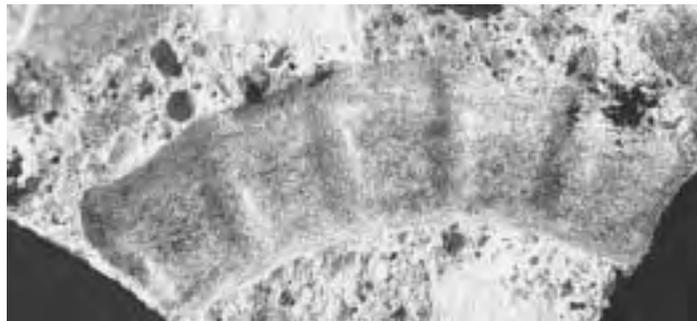
The bar trace in concrete above epoxy-coated bars consisted of a smooth, shiny, glossy surface with a grayish-like appearance, the rib imprints were clearly defined, and there were few voids (Figure 2.51). The bar trace in concrete below epoxy-coated bars had a whitish-like appearance, looked more dusty and porous with presence of laitance, and had much more voids of different size (Figure 2.52). Sometimes white deposits, probably salt, accumulated on the underside bar trace as shown in Figure 2.53. Chemical adhesion to concrete was lost, as evidenced by the ease with which the bar was removed from the concrete and lack of concrete adhering to the bar. Only a film of white dust from the concrete paste adhered to the bottom of the bars.

Figure 2.51 Bar trace on top of coated bar in concrete.

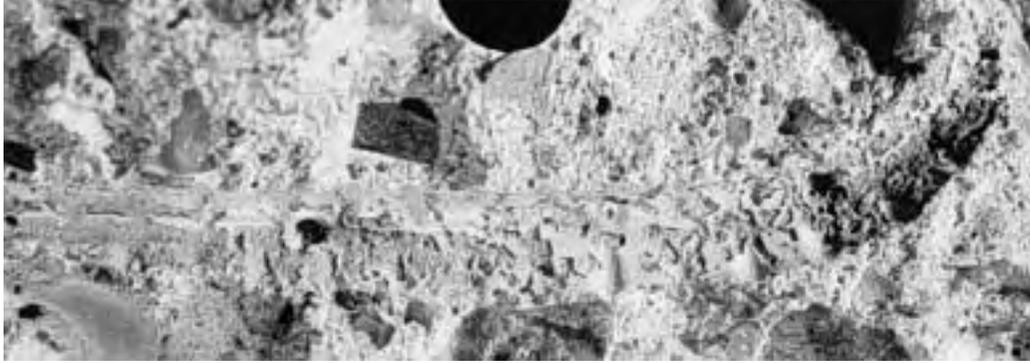
Figure 2.52 Bar trace on bottom of coated bar in concrete.

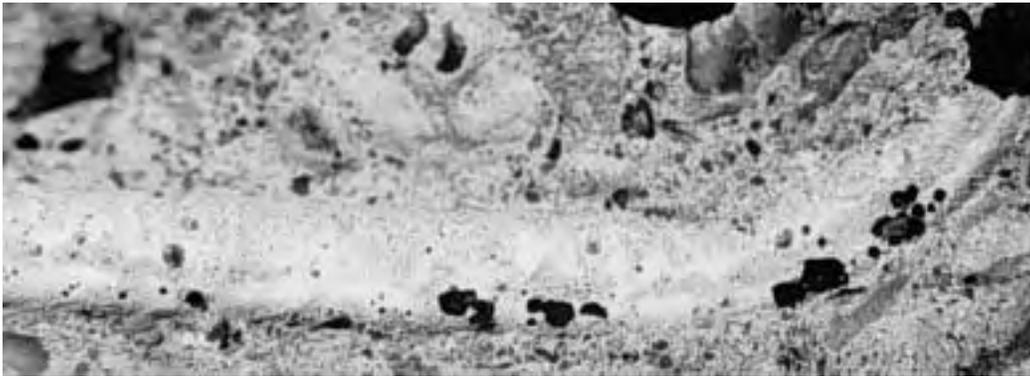
Figure 2.53 White deposits accumulated under coated bar.

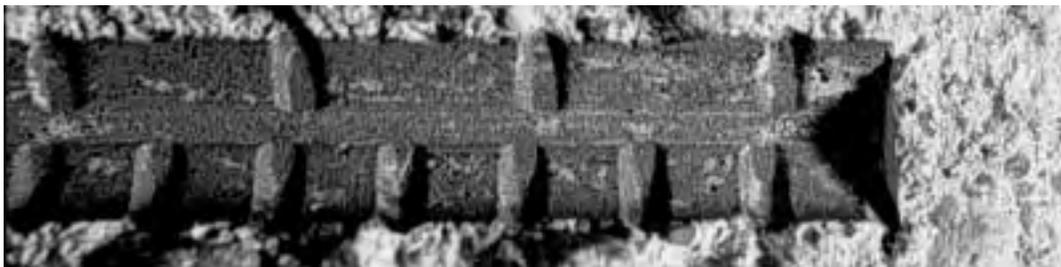
The trace of uncorroded bars in concrete had a grayish-like appearance, with a darker gray within 1.0 to 2.0 cm from the front face. This appearance was probably the result of the alkalinity produced by cathodic activity at the steel surface. Concrete at the top side of the bar was smoother with few concrete voids. Concrete on the bottom of the bars was more porous with many more voids. Figure 2.54 shows the cathodic bar imprint in concrete.

Figure 2.54 Cathodic bar trace in concrete

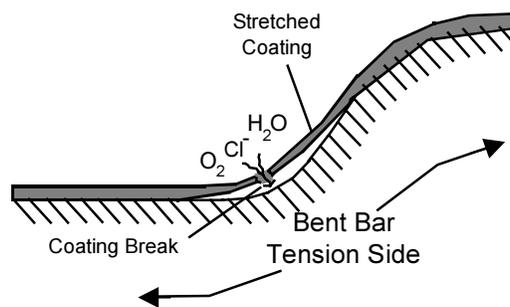
There are indications that coating bond strength to steel is weakened by fabrication. Bending coated bars causes stretching of the coating at the rib bases (rib-bar intersections) on the outer surface of bend. The regions at the rib bases of the test bars seemed slightly discolored which indicated thinning of the coating and a tendency for debonding. A study has demonstrated that coating films are consistently thinner at deformation edges than in the areas between the deformations.³⁶ The difference in coating thickness averaged about 23 μm (0.9 mils) for straight bars, and about 55 μm (2.2 mils) for bent bars.

The initiation of corrosion activity in thin film regions is a consequence of holidays. This is a common observation in corrosion studies.³⁶ A thin film spot is a point of weakness where holiday formation is most likely to occur. The indicators to debonding are the micro-tears in the coating and the more noticeable cracking. Cracks in the coating on specimens from groups A.6 and B.6 were produced during fabrication. Even if the film remained unbroken, it probably allowed oxygen and water to cross the film. With debonding, the condition became worse; moisture and oxygen were retained beneath the coating and corrosion was more likely to initiate. Fabricated bars became more vulnerable and susceptible to corrosion at the bent zones. Figure 3.18 illustrates stretching and debonding in the rib base region on the outside of bend.

Figure 3.18 Coating thinning and debonding at rib/bar interface.
