**CORROSION PERFORMANCE OF EPOXY-COATED
REINFORCEMENT–MACROCELL TESTS**

Research Report No. 1265-3

STRUCTURAL INTEGRITY OF EPOXY-COATED BARS

November 1998

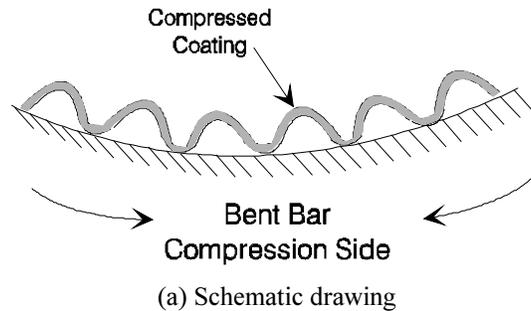
Damage on the inside of bend is usually neglected mainly because the region is compressed instead of stretched. However, coating debonding may still occur. Bending a coated bar generates high shear stresses at the steel/coating interface on both sides of the bend. The stresses may break the adhesion creating paths for oxygen and water migration to the debonded region. Figure 3.19 shows the microscopic ripples that form on a compressed coated surface. Localized compressive residual stresses at the metal surface have been recognized as a factor to initiate corrosion at the inside of bends.³⁷ Such a phenomenon explains why sheet steel often rusts first at bent edges.

Figure 3.19 Compressed coating surface.

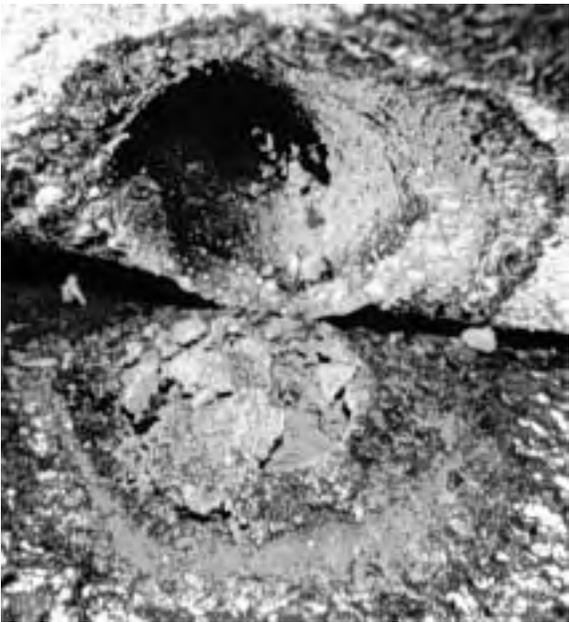
In bars examined after 2 years, blisters spread on the coating surface and indicated pitting corrosion. The pits were generally very slight (shallow depth) covered with black and brown brittle corrosion products. Figure 3.23 shows a blister under microscopic examination. At some locations, the buildup of corrosion products breached the epoxy film. At other locations, the blisters were soft and full of liquid. Blisters had varying sizes and small blisters (up to 5 mm) were more abundant than large blisters (greater than 5 mm). A concrete void was always present adjacent to a blister in the coating (Figure 3.24). Concrete voids provided an ideal environment for the formation of blisters, because chlorides, water and oxygen could

(b) Corrosion product buildup in blister

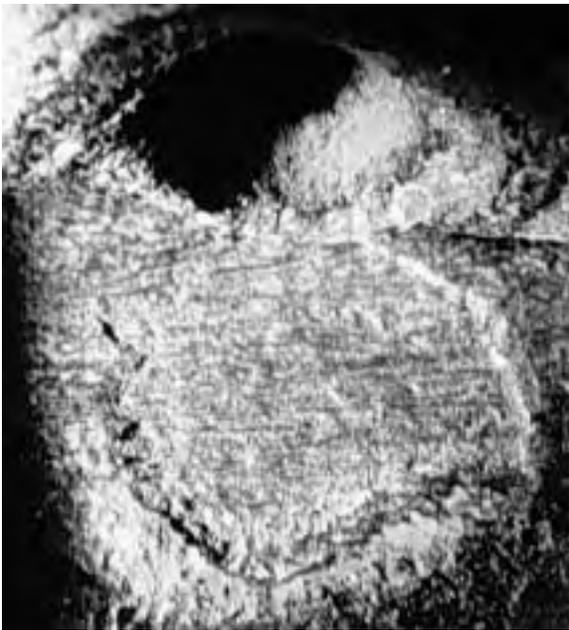
(c) Pitting Inside Blister

Figure 3.23 Blister under microscopic examination.

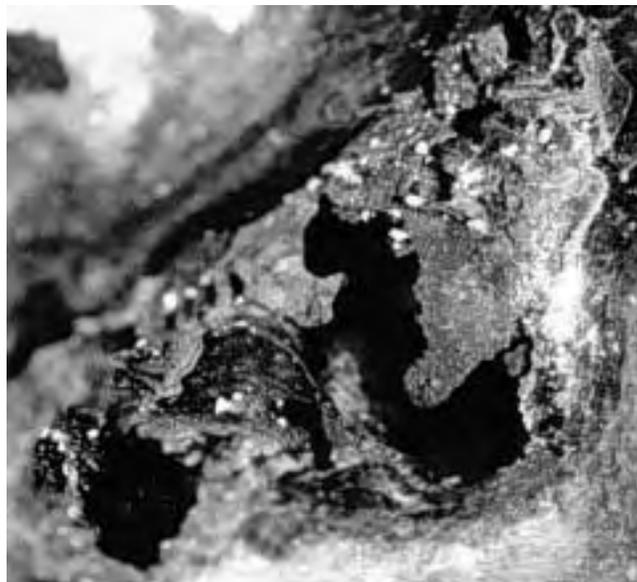
During concrete consolidation and setting, water migrates towards the top concrete surface. Some of the bleed water is trapped under the horizontal epoxy-coated bars. As fresh concrete settles, small gaps are formed under the coated bar. Gap formation is enhanced by lack of interlock and cohesion between cement mortar and coated bar surface. Free water may then accumulate in that zone underlying the bar. When water eventually evaporates, it leaves voids or air pockets adjacent to bar surface. These voids will not be filled during hydration similar to the voids forming around the aggregates due to bleeding and inefficient packing of the cement mortar. As a result, a weak porous zone, with possible interconnected cavities, forms underneath the bar. This zone is characterized by a dull, light gray appearance as shown in Figure 3.25.

Figure 3.25 Concrete below coated bar.

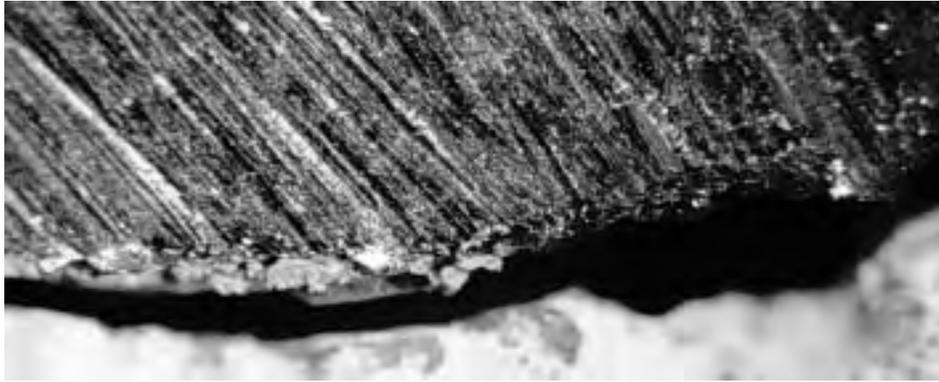
Based on observations from the opened macrocell specimens, initial efforts were made in this study to investigate the possibility of gap formation beneath the coated bars. One concrete prism of similar dimensions to the macrocell specimens was cast with an individual coated bent bar typical of those bars used in series B. Concrete was vibrated as in a normal casting procedure. The prism was sawcut after few days in a plane perpendicular to the bar axis. The condition of concrete above and below the bar was microscopically inspected. Although concrete was compacted well above the bar, a gap was found underneath the bar. A view of the gap is shown in Figure 3.26.

Figure 3.26 Gap formation below coated bar.

The zone under the bar may trap relatively large amounts of harmful substances very close to the bar surface. Moisture, oxygen, and chlorides are the specific agents necessary for corrosion. With time, these agents penetrate to the metal surface mainly through damaged spots, coating defects, and holidays. Salt solution may also accumulate under the bar and beneath the coating bridging between concrete and the corroded sites. Corrosion commences and progresses causing widespread undercutting.

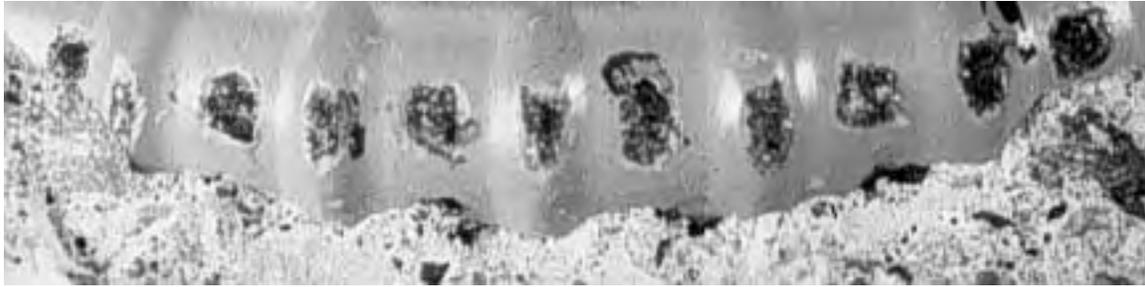
In addition, photographs of the exposed steel areas on bar specimens retrieved after one year of testing were re-examined. The purpose was to confirm that corrosion initiated generally at the edges of the open areas, *i.e.* around the perimeter of the cut in coating (as shown in the example in Figure 3.31). It is possible that while casting concrete, the cement paste filled these open areas but bridged over the sharply cut edges. If so, both the gaps that were formed and the crevice effect at the coating edges encourage corrosion initiation as shown in Figure 3.32.

Figure 3.31 Corrosion initiation around exposed steel areas on damaged coated bars embedded in concrete.

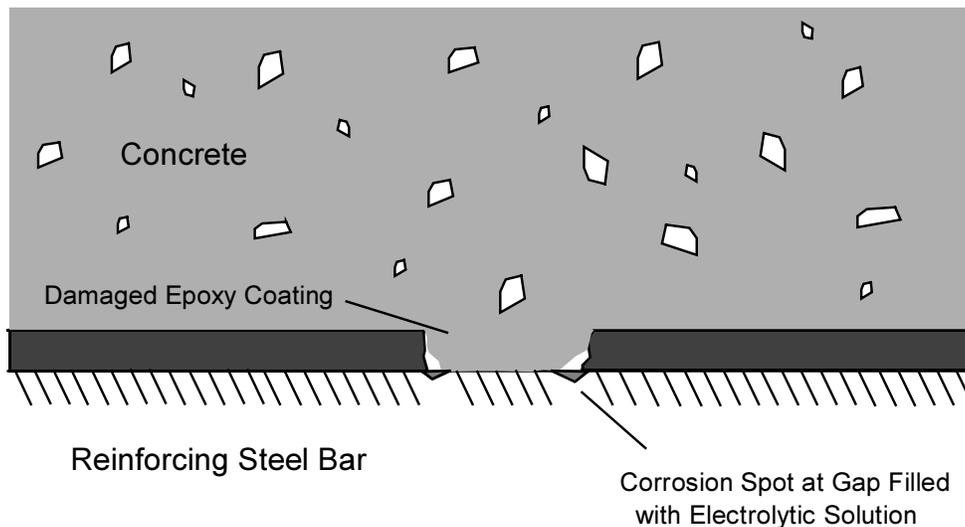
Figure 3.32 Schematic diagram of corrosion initiation around exposed steel areas on damaged coated bars embedded in concrete.

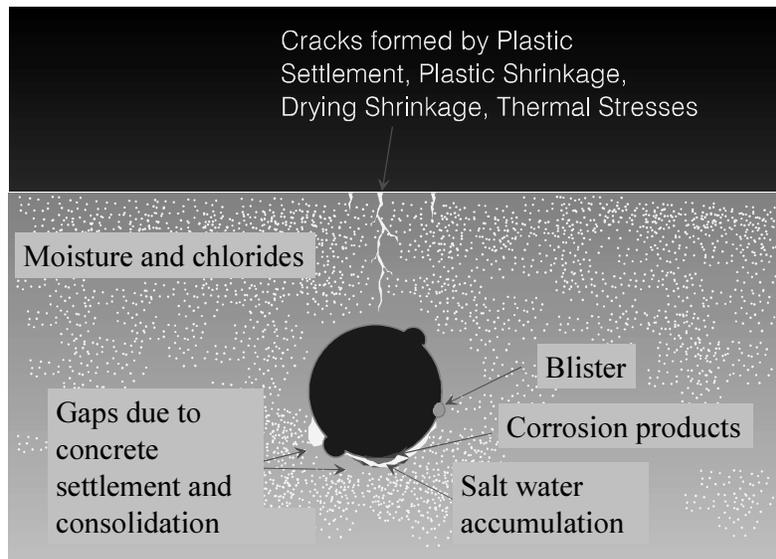
From the preceding sections, it seems that many unfavorable conditions may combine where epoxy-coated bars are used. Wide plastic settlement cracks may form, there may be frequent gaps beneath the bar, adhesion to concrete may be lacking and, as a result, there is instantaneous contamination by intruding chlorides. From the standpoint of preparing for the worst case, epoxy-coated steel used as top reinforcement in slabs, may develop the conditions depicted in Figure 3.33 (with exaggeration for clarity).

Figure 3.33 Conditions conducive to corrosion for coated bars embedded in concrete.

A few interesting key points emerge from the preceding diagram. First, corrosion products that develop on the lower half of the coated bar may turn brownish if moisture and oxygen were available in the voids to further oxidize the initial black corrosion products. In addition, the availability of *space* in these voids allows friable corrosion products to build up. Conversely, the steel substrate at the upper half of the bar, where concrete is well consolidated, remains in an air-tight zone suffering from oxygen starvation. As a result, a very thin black layer forms underneath the coating. Moisture may also reach to the upper surface by means of capillary action or “web effect,” or simply permeation through the coating.

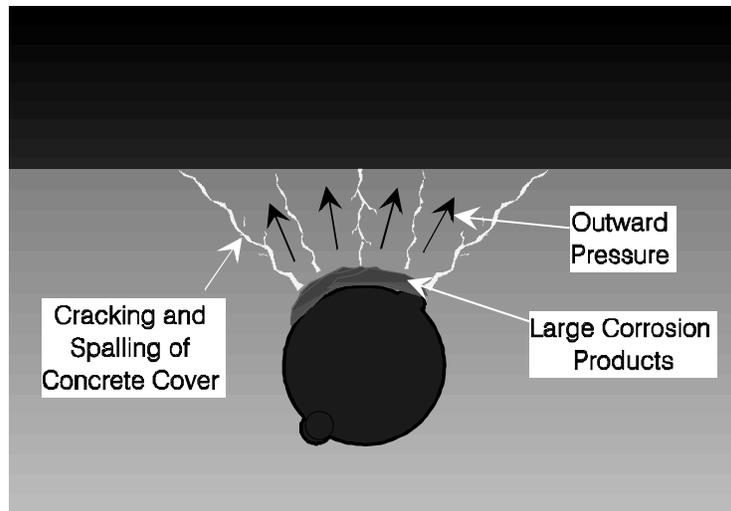
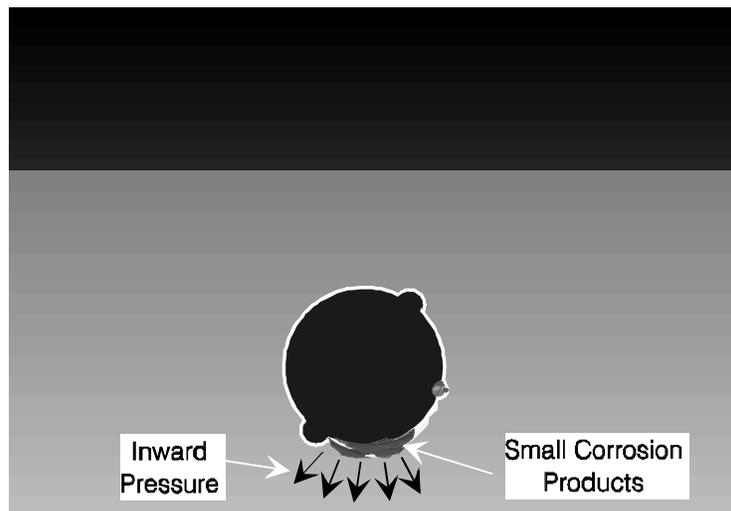
Second, a fundamental difference in corrosion behavior between epoxy-coated bars and uncoated bars can be deduced. With all other variables being equal, the uncoated bars tended to suffer more corrosion at the upper half of the bar after one and two years of exposure, where intruding chlorides attack first. Corrosion builds up voluminous solid products that exert radial pressure against concrete cover causing early cracking (as illustrated in Figure 3.34. However, with prolonged periods of exposure, corrosion eventually spread more on the bottom side than on the top side, as evidenced by the bars inspected after 4.5 years.

(a) Uncoated bar

(b) Coated bar

Figure 3.34 Differences of corrosion behavior between uncoated and coated bars in concrete.

The opposite is true for the epoxy-coated bars placed near the top concrete surface. Unless the coated bars are heavily damaged at random, corrosion tends to commence at the lower half of the bar. Corrosion remained worse on the bottom side at all periods of exposure, although the difference in condition between top and bottom sides became less significant with time. The corrosion products remain in a low state of oxidation and may diffuse through concrete pores; the volume of the corrosion products is nearly always small. Consequently, the generated internal pressure is low and in an inward direction (as illustrated in Figure 3.34). Therefore, the risk of developing corrosion-induced cracking and deterioration is lower for coated bars than uncoated bars. This explains again why concrete specimens containing coated bars with large amounts of lost steel underwent limited cracking during the macrocell test.

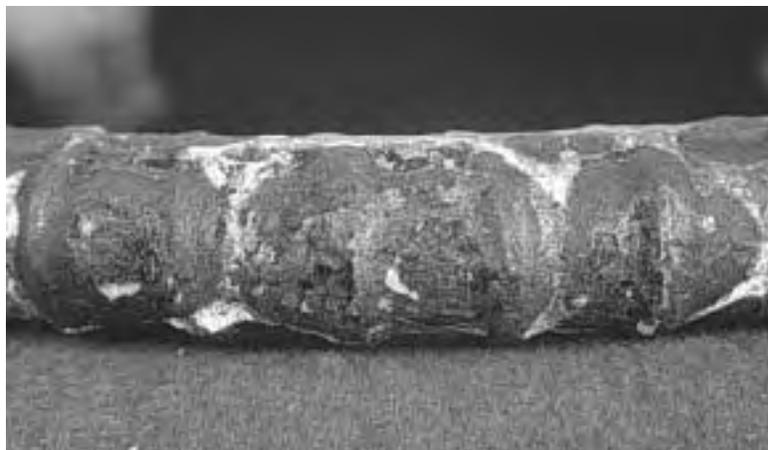
In general, corrosion in bars with exposed areas tended to be slightly more severe and corrosion in bars with repaired areas tended to be more widespread. Patching damaged areas on the outside of the bend only was not sufficient. Corrosion also propagated from mandrel indentations at the inside of the bend and at the outside of one straight leg (at point of support for bending operation). The only case where a bar with patched coating presented a substantially improved steel surface condition relative to a bar with exposed areas after 4.5 years was provided by the small bars with parallel ribs and damaged spots greater than 2% of the bar surface.

(b) Bar 2B.3 with unpatched damage at outside bend.

Figure 3.36 Comparative steel corrosion under the coating at outside bend of bars with damaged coating, with and without repair.

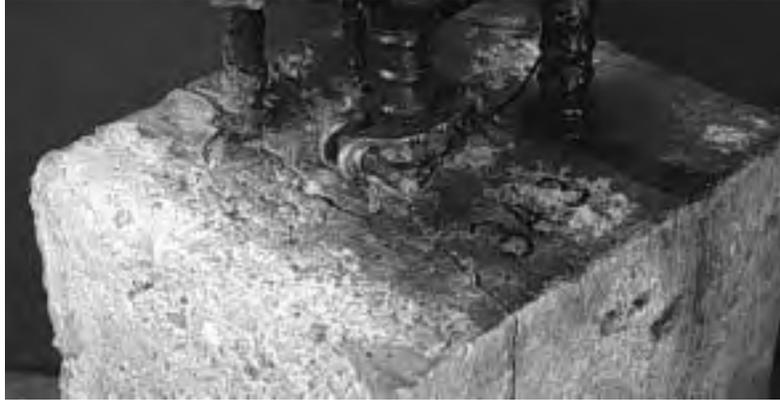
The effect of disruptive forces by expansive hydrated crystals was visible in the lateral surfaces of the specimens in the form of concrete scaling. At scaled areas, the hardened cement paste and embedded fine aggregate particles were removed, leaving behind protruding coarse aggregate particles (Figure 3.37). Large deposits of salt crystals were visible at scaled surfaces. The lateral surfaces with more extensively scaling were near the concrete cracks on the top surface, reinforcing the notion that cracks facilitated percolation of salts towards the inside. Both processes of salt weathering and corrosion-induced cracks interacted with each other to further propagate deterioration. Specimens with coated bars also experienced concrete scaling on their lateral surfaces, but the scaling was much less extensive and not severe. Undoubtedly, the lack of extensive concrete cracking greatly reduced the amount of salt weathering in specimens with coated bars.

Figure 3.37 Severe concrete scaling on specimen 3A.8 with uncoated bars.

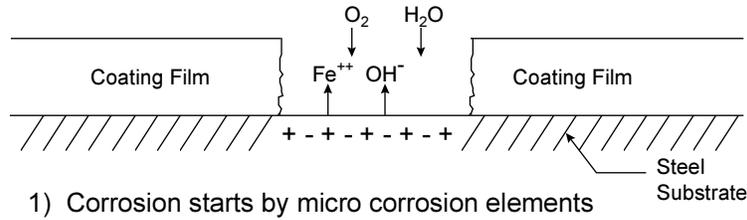
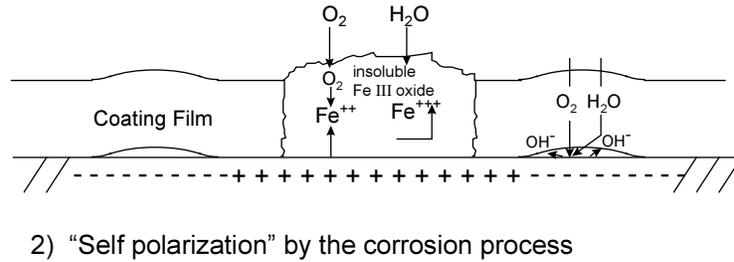
The mechanism for corrosion initiation at local exposed areas or defects in the coating is illustrated in Figure 3.38. Corrosion started at exposed areas, with anodes and cathodes developing locally, in a process similar to the Evans water drop experiment. As corrosion progressed locally and the exposed area was covered by corrosion products, a self-polarization of the exposed area occurred. This induced a polarization in the opposite direction in the adjacent areas covered by the coating, and a cathodic reaction (with consequent cathodic disbondment) may take place at such areas.⁴³ Corrosion spread at the small crevices under the coating at the edges of exposed areas or discontinuities. Adjacent debonded coating (by cathodic disbondment, water action, or a combination of both) formed very thin crevices and corrosion propagated under the coating in a mechanism similar to that of crevice corrosion.

Figure 3.38 Corrosion initiation mechanism in coated bars.⁴³

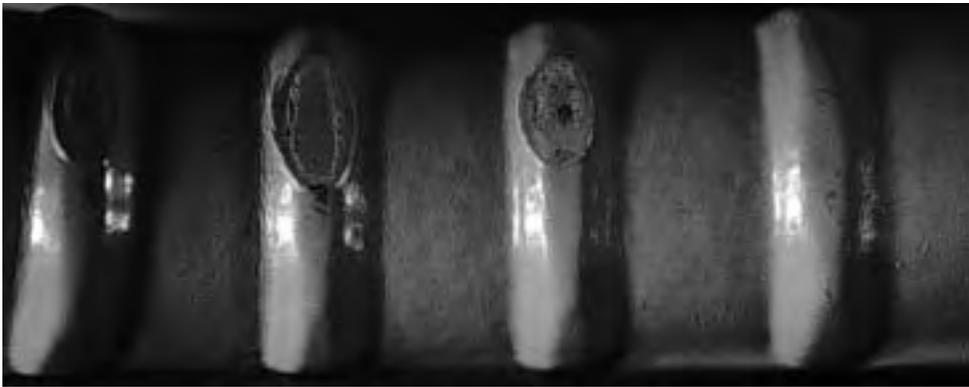
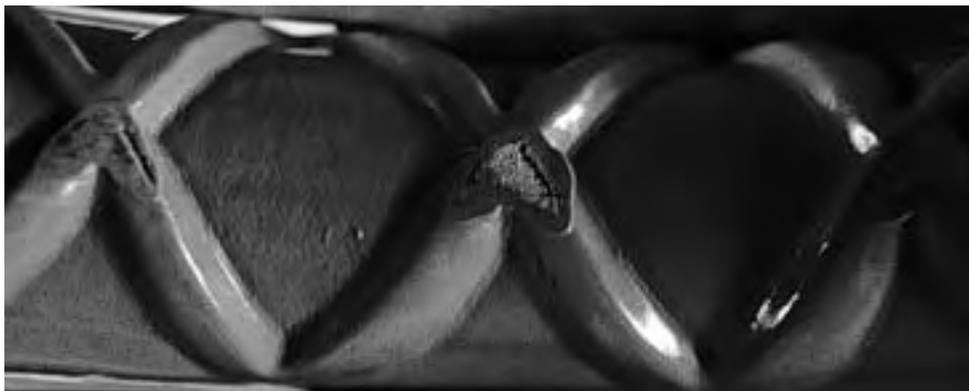
Figure A.12 Typical damage on the inside of bend.

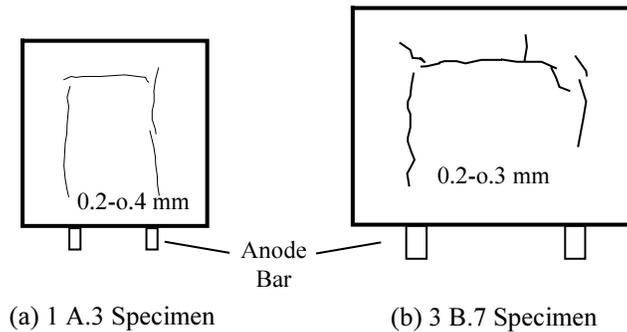
Figure A.18 Examples of initial cracks detected on top surfaces of macrocell specimens.

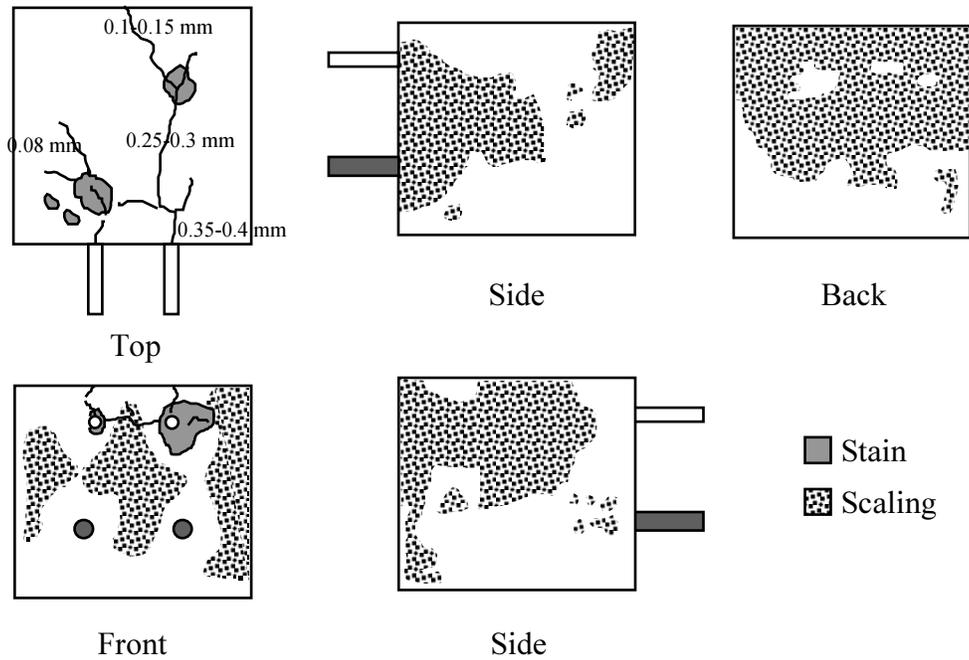
(a) 3A.1 Specimen

Figure A.23 Cracks and stains on macrocell specimens 3A1, 3A.4, and 2A.6 inspected after 4.5 years of exposure.

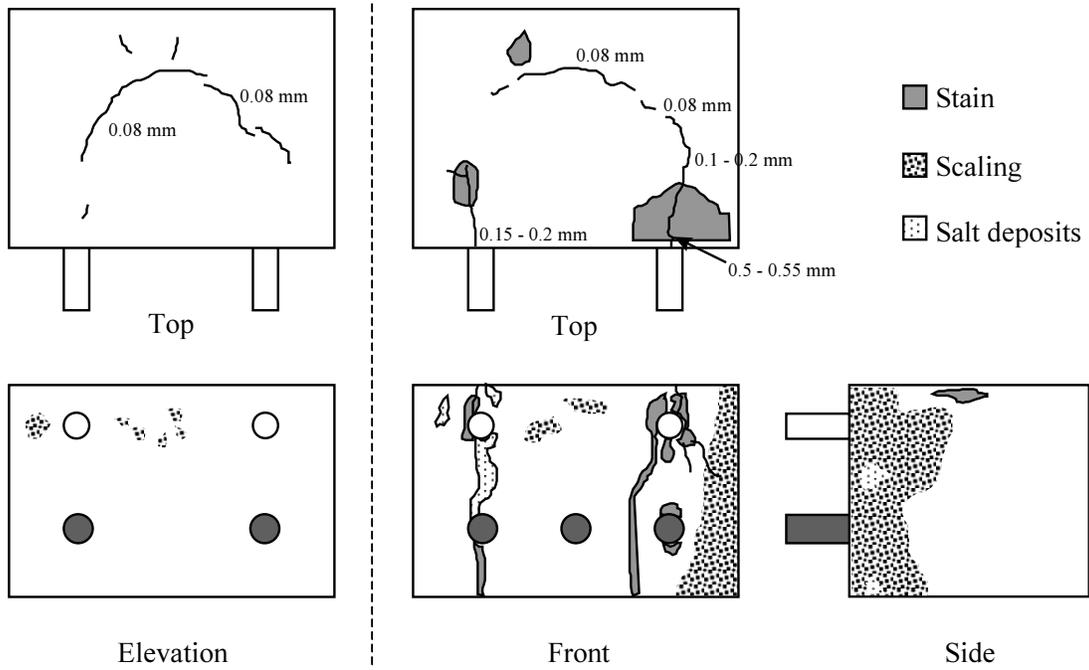
(a) 1B.7 Specimen

Figure A.26 Cracks and stains on macrocell specimens 1B.7, 1B.8, 3B.9, and 2B.11 inspected after 4.5 years of exposure.
