16. Abstract This report documents a field test to determine the stresses at areas where fatigue cracks had formed in the bridges. Two bridges were instrumented and subjected to controlled truck traffic. In addition, the service fatigue stresses were evaluated by monitoring the stresses for a 1 week period after the controlled truck testing. A three dimensional finite element model was constructed of each bridge. The stresses from the field tests and the model were compared. The floor beams were found to behave as composite with the bridge deck when the truck loads were near floor beams. The local stress at the critical sections was in reasonable agreement between the field and analytical results. Proposed retrofit schemes were evaluated in the analytical model. In general, the proposed schemes appear to reduce the stresses at the critical locations, however high stresses are generated in other areas that have not cracked. The unsymmetrical support conditions of some of the girder units cause twisting of bridge section. Adding of additional supports to make the bridge support symmetrical will also improve fatigue performance of the bridge.

Field Test and Finite Element of I-345 Br

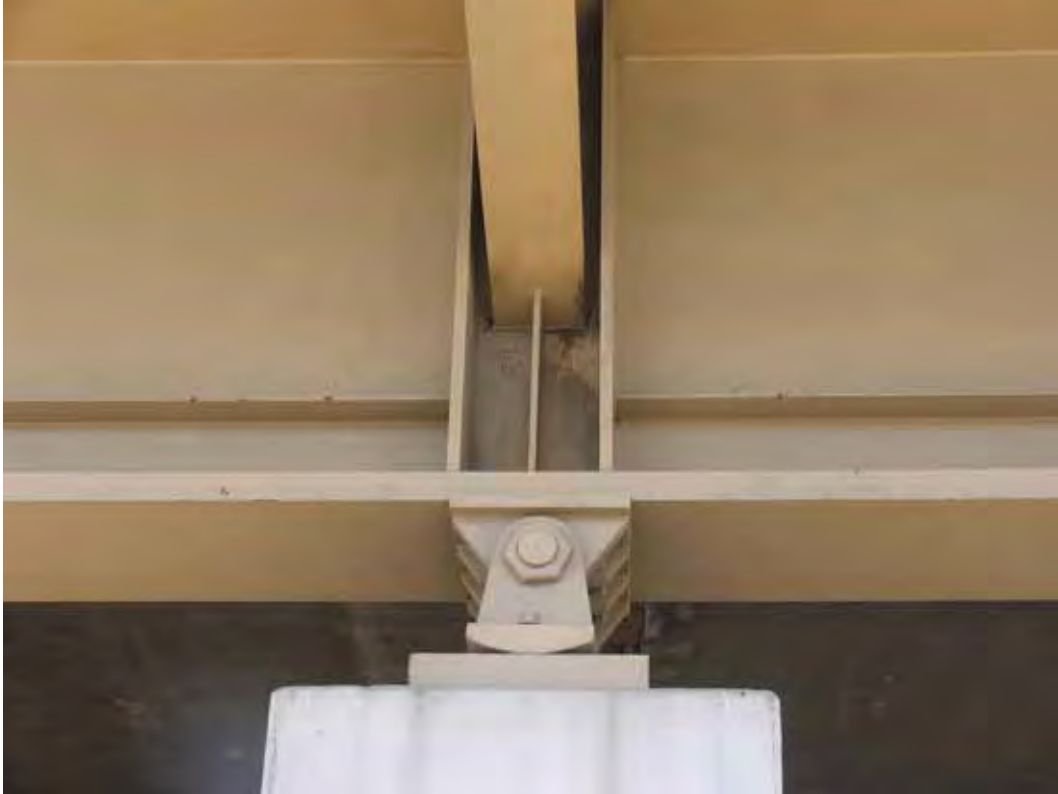
Figure 1.2: Floor Beam to Girder Connection at Pier

Cracking occurred in the girder web where the bottom floor beam flange is welded to the girder web. When the floor beam is at a pier the floor beam flanges frame into the web between the bearing stiffeners (Figure 1.2). The resulting small gap between the stiffener and flange welds causes high stresses to occur at the weld toes from displacement of the floor beam flange. These cracks typically formed an arc shape in the girder web around the edges of the bottom floor beam flange. Figure 1.3 shows the cracking that occurred at these locations. Cracking also occurred on the girder web in the gap between the top flange of the girder and the web of the connecting floor beam. The stiffener connecting the floor beam and girder webs is not attached to the top flange of the girder. This creates a small gap in the girder web where differential deflection between the two girders causes the floor beam to rotate creating very high stresses. Figure 1.4 shows an example of cracking at this location.

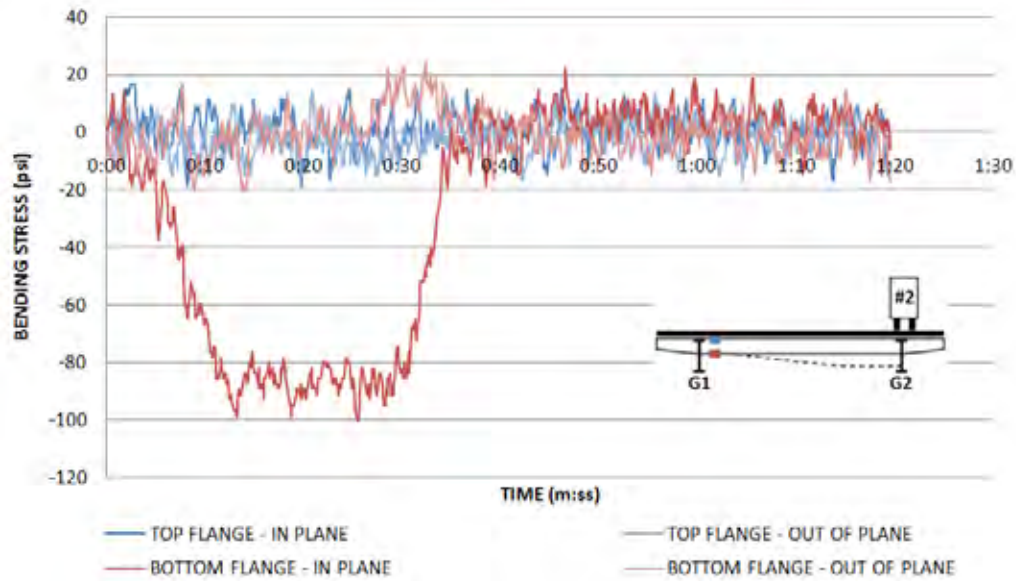
Figure 4.3: In-Plane and Out-of-Plane Stress of the Floor Beam near Girder 1 due to one Truck on the Right

To gain a better understanding of how the floor beam is moving under the truck load, the in-plane and out-of-plane stresses were determined as discussed in Section 3.2 and plotted. Figure 4.3 shows the stresses in the top and bottom flange near Girder 1. It can be seen that there is a large in-plane compressive stress in the bottom flange. There is very little in-plane bending of the top flange or out-of-plane bending of either flange. Figure 4.4 shows the stresses in the top and bottom flange near Girder 2. For this case, there is in-plane bending in both the top and bottom flanges as well as relatively large out-of-plane bending in the bottom flange. The top flange is restrained by the deck, so it is expected that there would be little to no lateral movement of the top flange. The out-of-plane bending of the bottom flange suggests that the floor beam is deflecting laterally as the truck moves over the bridge. This lateral movement of the floor beam under the truck seems to alleviate some of the in-plane bending stress, which could be one of the reasons why the in-plane bending stress in the bottom flange of the floor beam near Girder 2 is less than the stress near Girder 1. Overall, the stresses in the floor beam due to one truck in the right lane are relatively small, reaching a maximum of 0.1 ksi. When the truck leaves the floor beam, the stresses in the floor beam flanges go to zero.

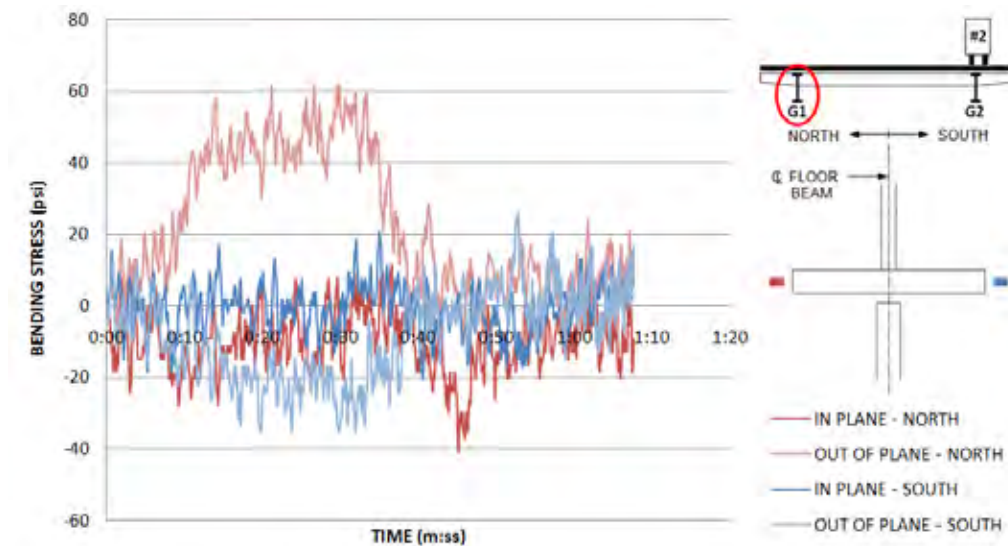
Figure 4.5: In-Plane and Out-of-Plane Bending Stresses of Girder 1 Web due to one Truck on the Right

Figures 4.5 and 4.6 show the in-plane and out-of-plane bending stress of the girder web due to one truck in the right lane at Girder 1 and Girder 2, respectively. At Girder 1, it can be seen that there is very little in-plane bending of the girder web when the truck is on the opposite side. This suggests that this girder is not deflecting vertically. The plot shows slight positive out-of-plane bending of the girder web on the north side of the floor beam and negative out-of-plane bending on the south side. These stresses, however, are relatively small in magnitude when compared to the stresses in Girder 2 under the truck, as seen in Figure 4.6.

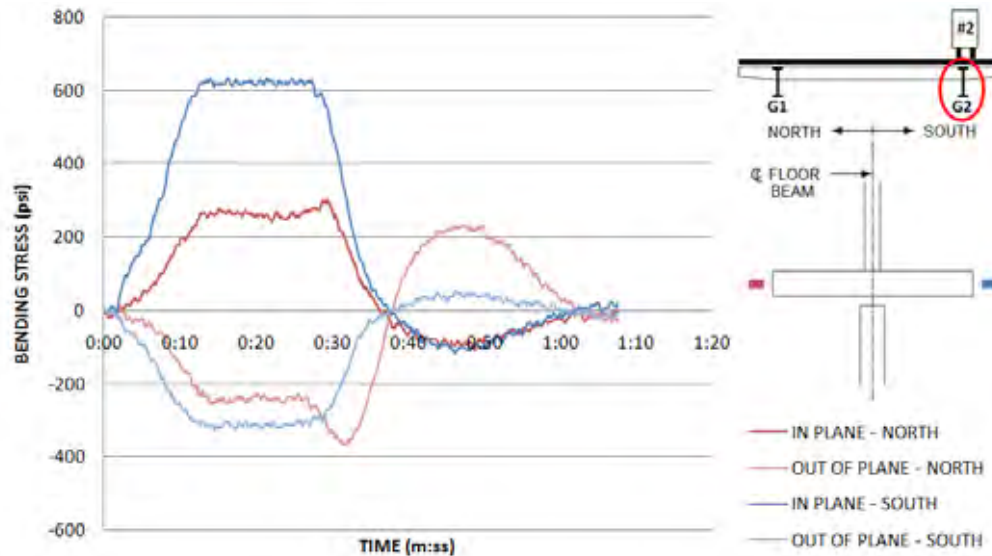
Figure 4.6: In-Plane and Out-of-Plane Bending Stresses of Girder 2 Web due to one Truck on the Right

Figure 4.6 shows significant positive in-plane bending of Girder 2, which means it is deflecting downward under the weight of the truck, as discussed in Section 3.3.3. There is also out-of-plane bending of the web toward the exterior of the bridge. Note that there is a distinct point at which the stresses reverse in sign. This is believed to happen when the truck moves onto the next span.

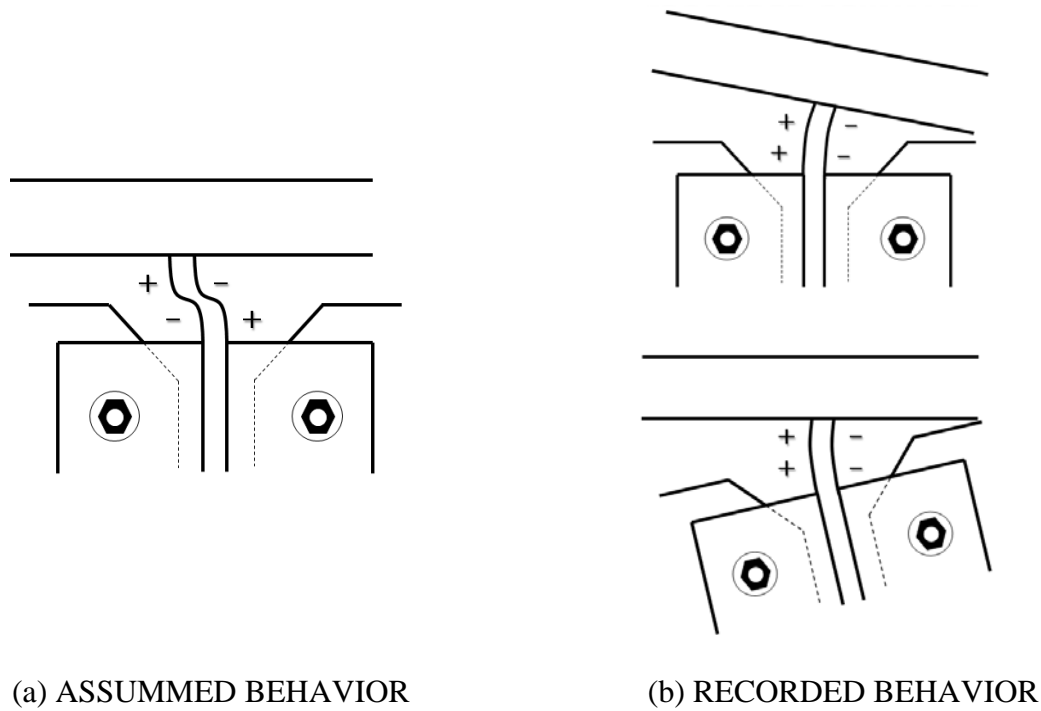
Figure 4.7: Assumed versus Recorded Behavior of Web Gap

The expected behavior of the web gap was that the top flange of the girder and the connection stiffeners would behave as rigid constraints for this small gap. Therefore, if there was bending in this area, it would be in double curvature as seen in Figure 4.7(a). If this was the case, the gages on opposite sides of the girder web and the gages on the same side of the web would have opposite signs. This, however, is not what was recorded. The gages on the same side of the girder web showed the same sign, meaning the gap was bending in single curvature. This could only be possible if the top flange of the girder was rotating or the movement of the floor beam was causing the web to bend as seen in Figure 4.7(b).

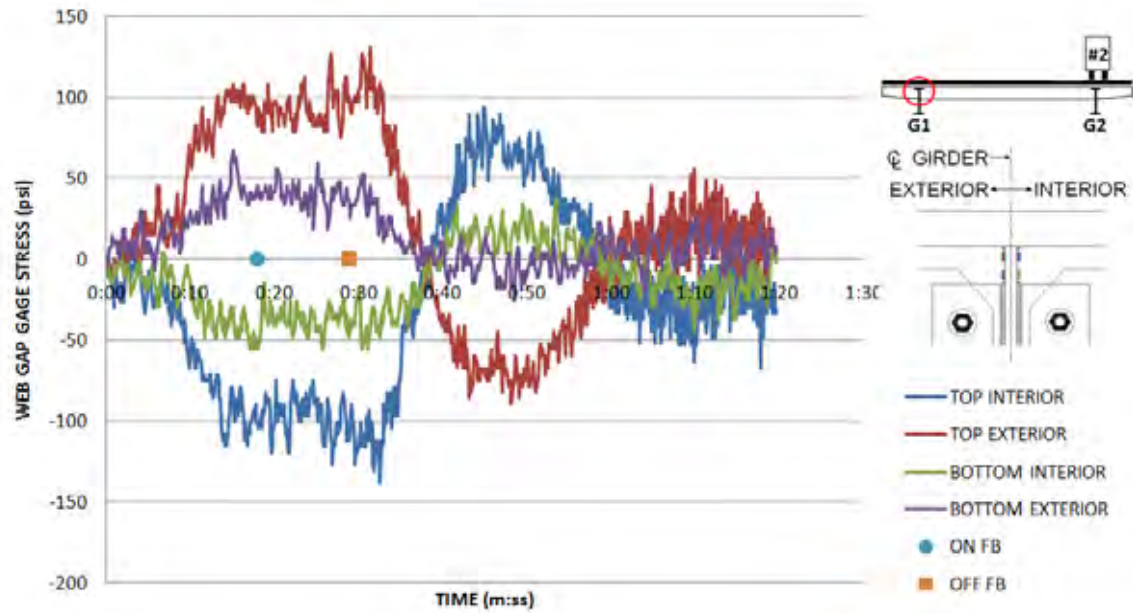
Figure 4.8: Stress in Web Gap Gages on Girder 1 due to one Truck on the Right

Figure 4.8 shows the stress in the web gap gages on Girder 1 when the truck is on the right side of the bridge. It can be seen that the gages on the interior side of the web have compressive static stress values and the gages on the exterior side of the web have tensile static stress values. This suggests that the web gap is bending in single curvature toward the exterior of the bridge. The gages in the top of the web gap recorded higher stresses than the gages in the bottom of the gap meaning there is more bending in the top of the gap. There are three distinct sections in this plot created by stress reversals in the gages. It is believed that the gages experience reversals in stress as the truck moves over the three spans of the bridge.

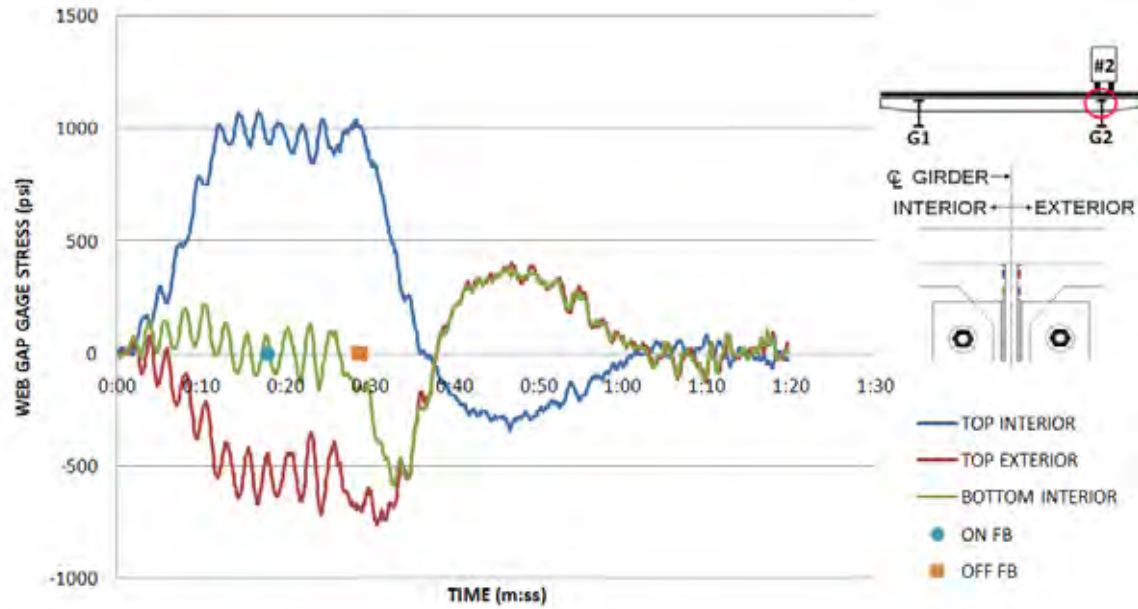
Figure 4.9: Stress in Web Gap Gages on Girder 2 due to one Truck on the Right

Figure 4.9 shows the stress in the web gap gages on Girder 2 under the truck. The bottom gage on the exterior side of the web was found to be defective; therefore it is not shown on the plot. The three sections caused by stress reversals are apparent in this plot as well. The top gages show that the web gap is bending in single curvature toward the interior of the bridge when the truck is on the floor beam. However, once the truck leaves the floor beam, it looks as though the gap begins to bend in double curvature. This starts when the green line, representing the bottom interior gage, begins to follow the red line, representing the top exterior gage. It should also be noted that the stresses in the web gap are much higher in the girder under the truck than they are in the other girder.

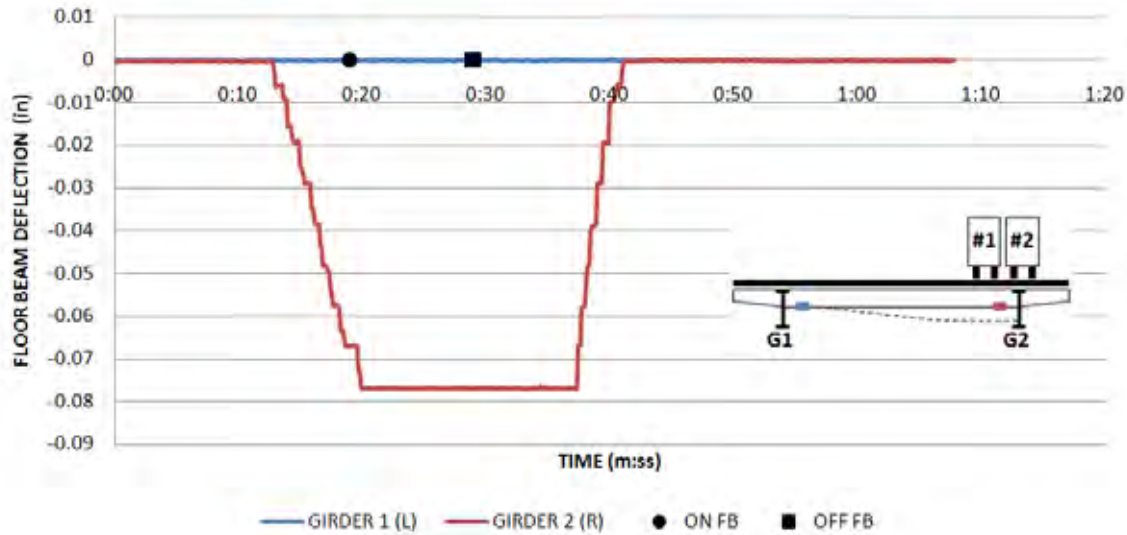
Figure 4.10: Deflection of Floor Beam due to Two Trucks on the Right

Figure 4.10 shows the deflection of both ends of the floor beam due to two trucks on the right side of the bridge. The right side of the bridge deflects downward under the weight of the trucks while the left side remains stationary. The total static deflection of the right side is small, measuring only 0.08 inches. This is twice the deflection that was seen with the single truck. The assumed deflected shape of the floor beam under static loads is represented by the dashed line on the detail of the floor beam within Figure 4.10. Once the trucks leave the floor beam, it returns to its original undeflected status.

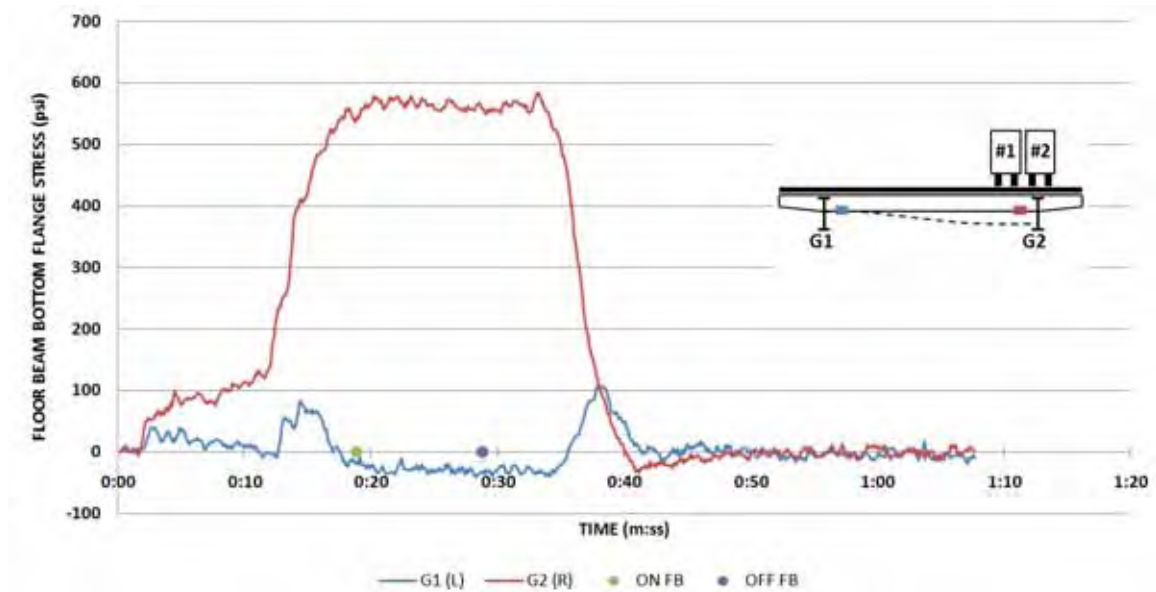
Figure 4.11: Stress in the Bottom Flange of the Floor Beam due to 2 Trucks on the Right

Figure 4.11 shows the stresses in the bottom flange of the floor beam when two trucks were in the two right-most lanes. It would be expected that doubling the load would double the stress in the floor beam. However, if Figure 4.11 is compared to Figure 4.2, it can be seen that the static tensile stress in the floor beam under two trucks is ten times the value under one truck. The behavior of the left side of the floor beam is very interesting. It has little to no stress until just before the truck reaches the floor beam at which point it experiences tensile stresses. Therefore, right before the trucks reach the floor beam, the floor beam seems to be bending in single curvature. Once the truck is on the floor beam, the left side shows a small compressive stress, suggesting it is bending in double curvature. To determine why the tensile stress under the trucks is much greater than the compressive stress on the other side of the floor beam, the in-plane and out-of-plane bending stresses were calculated and are plotted in Figures 4.12 and 4.13.

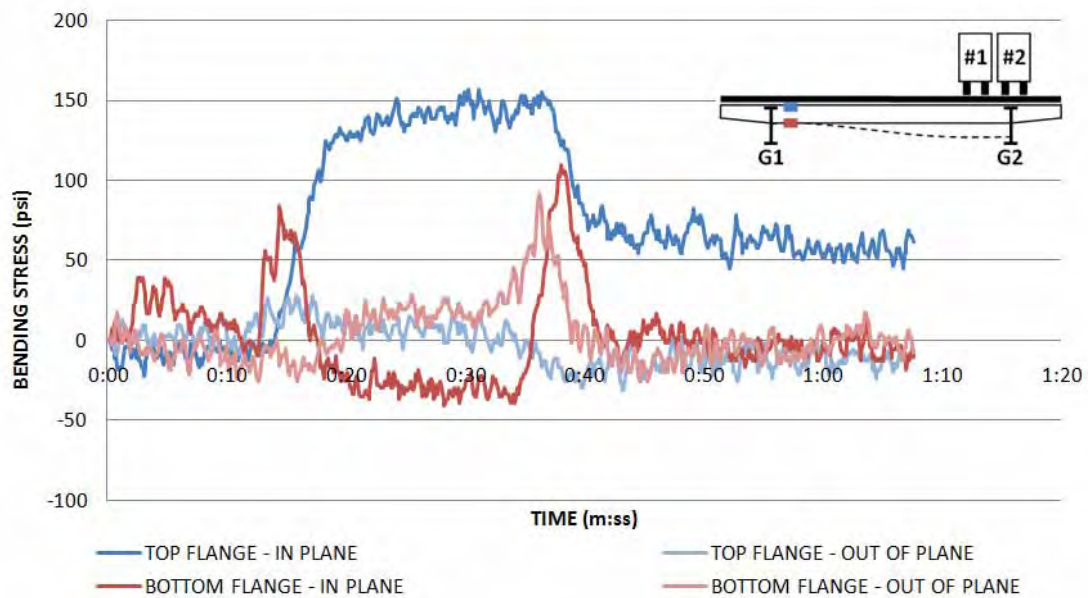
Figure 4.12: In-Plane and Out-of-Plane Stress of the Floor Beam near Girder 1 due to two Trucks on the Right

Figure 4.12 shows the in-plane and out-of-plane bending stresses in the floor beam near Girder 1 due to two trucks in the right lanes and Figure 4.13 shows the stresses near Girder 2. The plots show that there is practically no out-of-plane bending of the floor beam on the side opposite the trucks, but there is out-of-plane bending of the bottom flange under the trucks. This doesn't seem to explain why the stress on the side opposite the trucks is much less than under the trucks. Another possible explanation for this could be rotation of the girder as will be discussed in the following section with the bottom flange and web gap gage results.

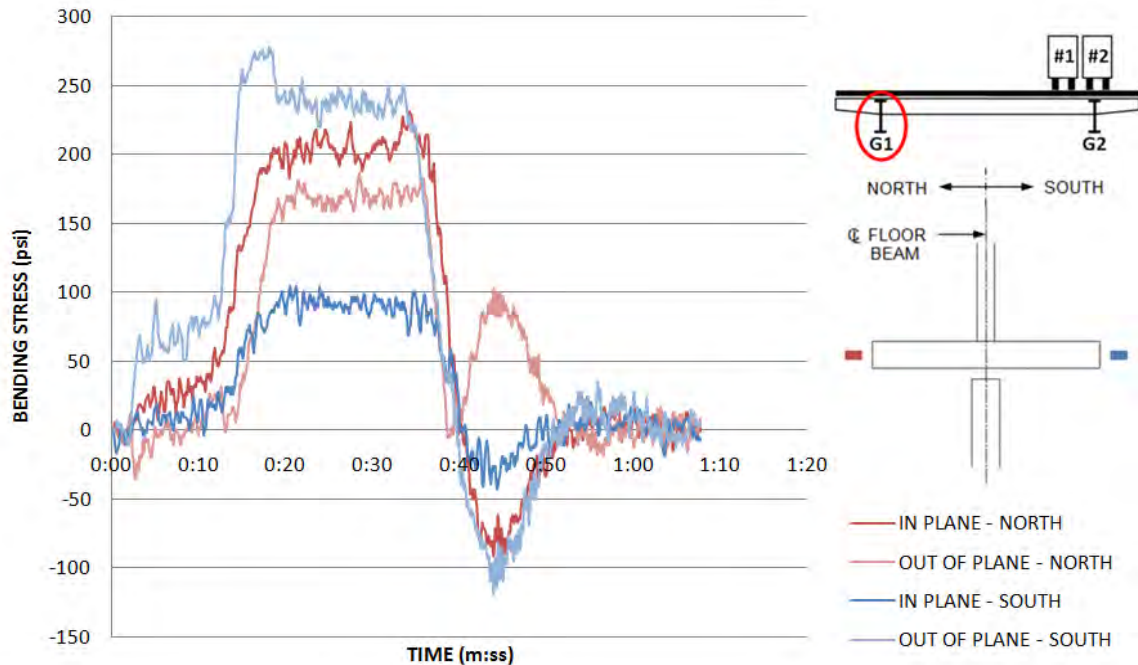
Figure 4.14: In-Plane and Out-of-Plane Bending Stresses of Girder 1 Web due to two Trucks on the Right

Figure 4.14 shows the in-plane and out-of-plane bending stresses in Girder 1 on either side of the floor beam framing into the girder. The in-plane stresses are positive while the truck is over the floor beam indicating that the girder is deflecting downward. The out-of-plane stresses are also positive, which suggests that the girder is bending inward toward the center of the bridge. When these results are compared with Figure 4.5, which shows the results from the single truck test for Girder 1, it can be seen that the stresses are much higher. One truck in the right lane caused little to no stress in Girder 1 whereas doubling the load to two trucks caused Girder 1 to bend both in and out of plane. After the truck leaves the floor beam, the gages show that the girder is bending out of plane in different directions on either side of the floor beam. On the north side of the floor beam, the girder is bending inward and on the south side, the girder is bending outward. This is most likely caused by lateral bending of the floor beam. The out-of-plane bending of Girder 1 could explain why the stress on the left side of the floor beam was much smaller than the stress on the right side, as seen in Figure 4.11. The out-of-plane rotation of the floor beam-to-Girder 1 connection could have alleviated some of the stress in the bottom flange of the floor beam near that connection.

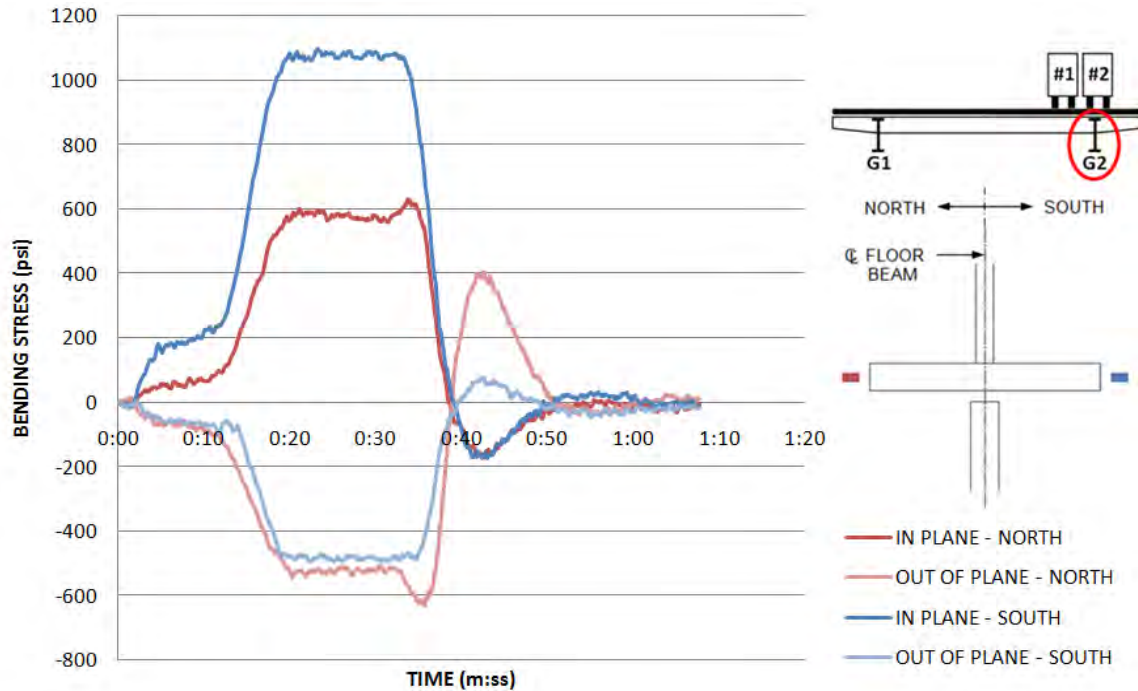
Figure 4.15: In-Plane and Out-of-Plane Bending Stresses of Girder 2 Web due to two Trucks on the Right

Figure 4.15 shows the in-plane and out-of-plane bending stresses in Girder 2 on either side of the floor beam framing into the girder due to two trucks in the right lanes. This plot shows the three sections seen in the web gap plots created from stress reversals as the trucks move over the three spans of the section. During this test, the trucks were directly over Girder 2. The plot shows that while the trucks were over the floor beam, the girder is deflecting downward creating tensile stresses in the gages. The out-of-plane bending stresses were negative indicating that the girder is bending outward toward the exterior of the bridge. When the trucks move onto the second span, the in-plane stresses are negative suggesting the girder is deflecting upward and the out-of-plane stresses are positive suggesting the girder is bending inward toward the interior of the bridge. These stresses are then reversed as the trucks move over the third span.

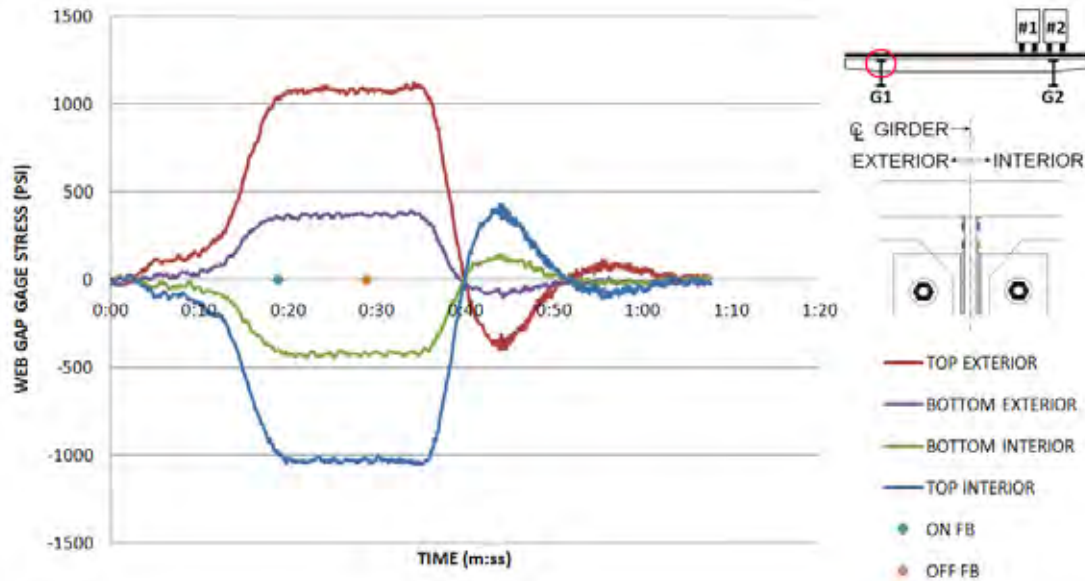
Figure 4.16: Stress in Web Gap Gages on Girder 1 due to 2 Trucks on the Right

Using the data from the gages installed in the web gap, it is possible to determine how this area of the girder responds to traffic loads. The following two figures show the stress in the web gap gages as a function of time for the tests with two trucks in the right lanes. Figure 4.16 shows the stresses for the web gap gages on Girder 1. The plot shows the stress reversals that were seen in previous plots caused by movement of the truck over the three spans. As the trucks are on the first span, which includes floor beam two, the exterior gages produced tensile stresses and the interior gages produced compressive stresses. This suggests that the girder web is bending out of plane toward the exterior of the bridge. This bending is reversed once the trucks are on the middle span, and then reversed again when the trucks reach the third span.

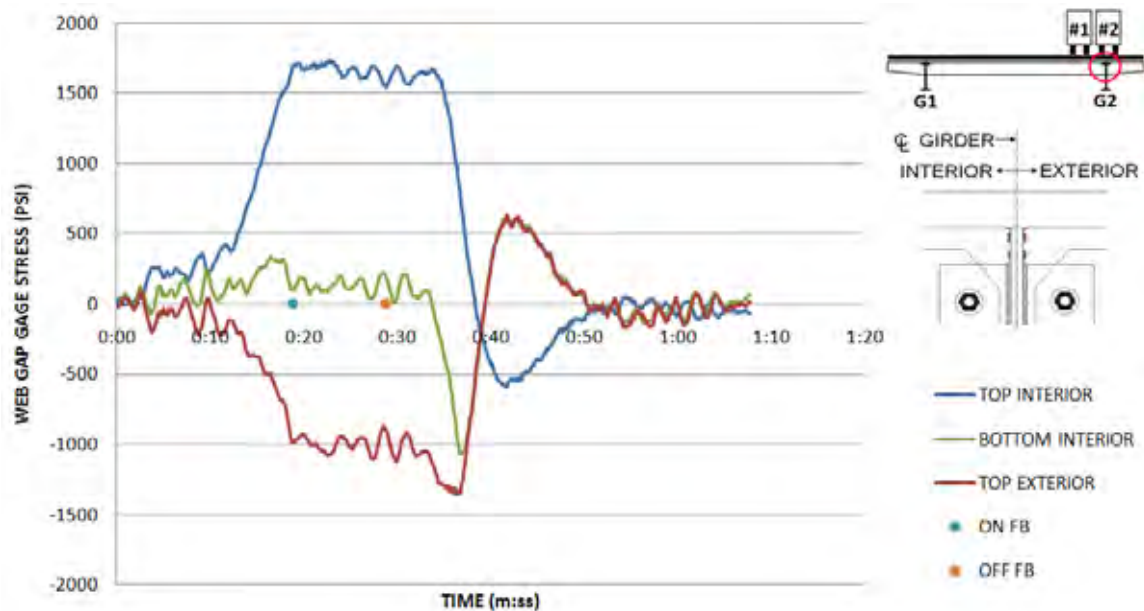
Figure 4.17: Stress in Web Gap Gages on Girder 2 due to 2 Trucks on the Right

Figure 4.17 shows the stresses in the web gap gages on Girder 2 while two trucks are in the right lanes. This plot also shows the three sections created from stress reversals as the trucks move over the three spans. Looking at the gages at the top of the web gap when the trucks are over floor beam two, the interior gage produces tensile stresses and the exterior gage produces compressive stresses. This suggests that the girder web is bending out of plane toward the interior of the bridge. Once the trucks move into the middle span, the top exterior and the bottom interior gages show the same stresses. This implies that the web gap is bending in double curvature. When comparing the static stresses in the two girders due to the two trucks, it can be seen that the stresses in the top of the gap of Girder 2 are slightly higher than in Girder 1. This is because the trucks are directly over Girder 2.

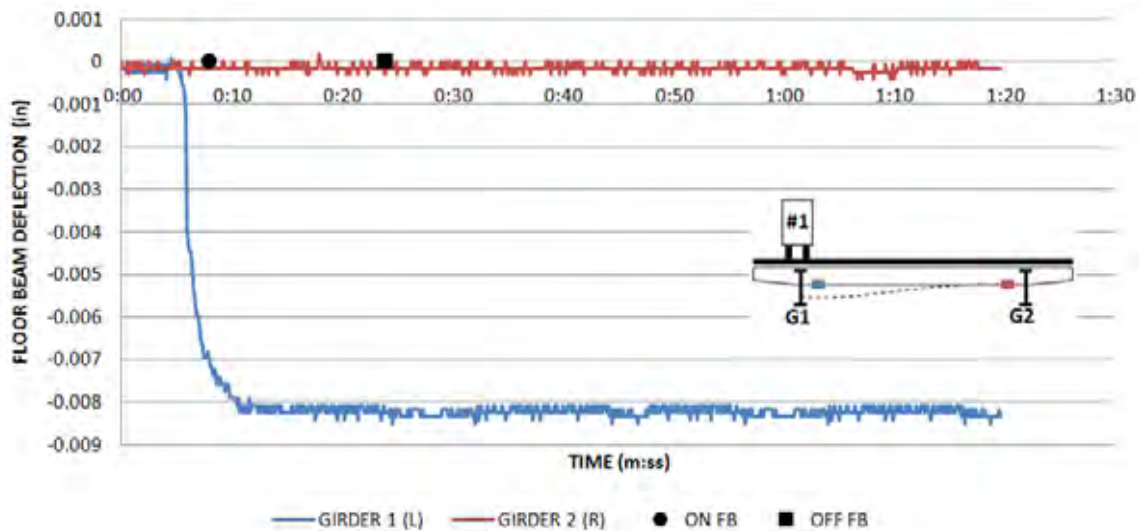
Figure 4.18: Deflection of Floor Beam due to One Truck on the Left

Figure 4.18 shows the deflection at either end of the floor beam due to one truck on the left side of the bridge. The left side of the bridge deflects downward a total of 0.008 inches under the weight of the truck while the right side of the bridge remains undeflected. The assumed deflected shape of the floor beam under static loads is represented by the dashed line on the

detail of the floor beam within Figure 4.18. The left side of the floor beam seems to stay deflected even after the truck leaves the floor beam. This could have been caused by the deflection gage sticking in the deflected position.

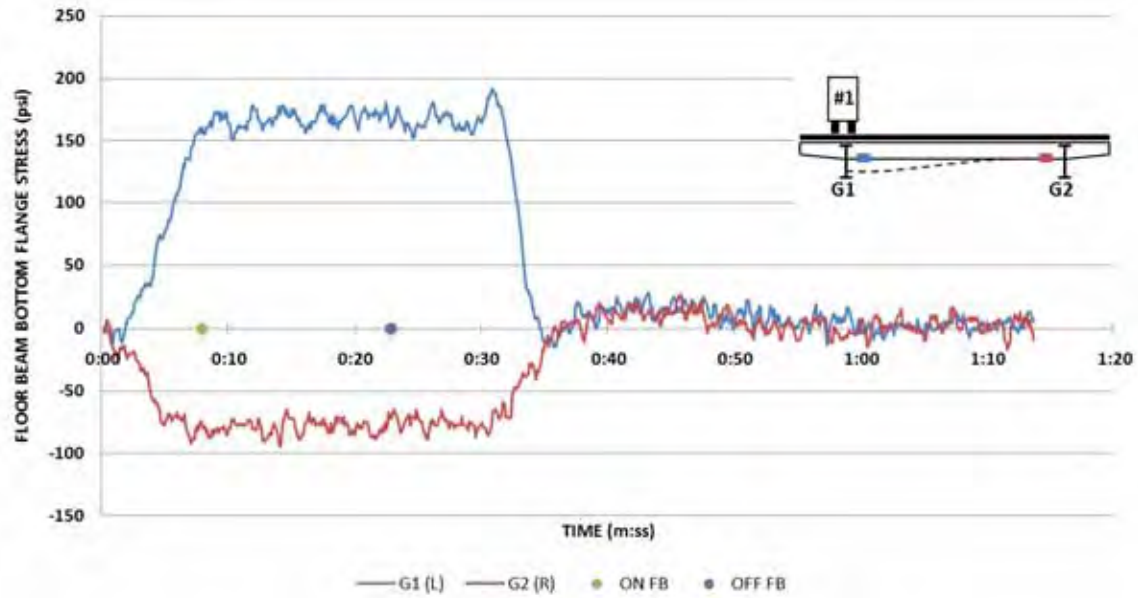
Figure 4.19: Stress in the Bottom Flange of the Floor Beam due to 1 Truck on the Left

Figure 4.19 shows the stress at both ends of the bottom flange of the floor beam due to one truck in the left lane. It can be seen that the truck causes the left side of the floor beam to deflect downward creating tensile stresses in the bottom flange. The right side of the beam is in compression, which creates double curvature in the beam. When comparing Figures 4.2 and 4.19, it would be expected that with the symmetry of the bridge, the stresses caused by the two single truck tests would be opposite, but similar in magnitude. This was not the case. It can be seen that the tensile stresses caused by the two single truck tests are quite different. The stress in the left side of the beam caused by one truck on the left is almost three times the stress in the right side of the beam due to one truck on the right. The reason for this could be partially due to the fact that the truck that was run on the left side weighed about one ton more than the truck on the right side. Also, the left girder (Girder 1) is along the outer edge of the horizontal curve of the bridge. This creates a larger tributary area for Girder 1, which would increase the stress in the floor beams on that side of the bridge.

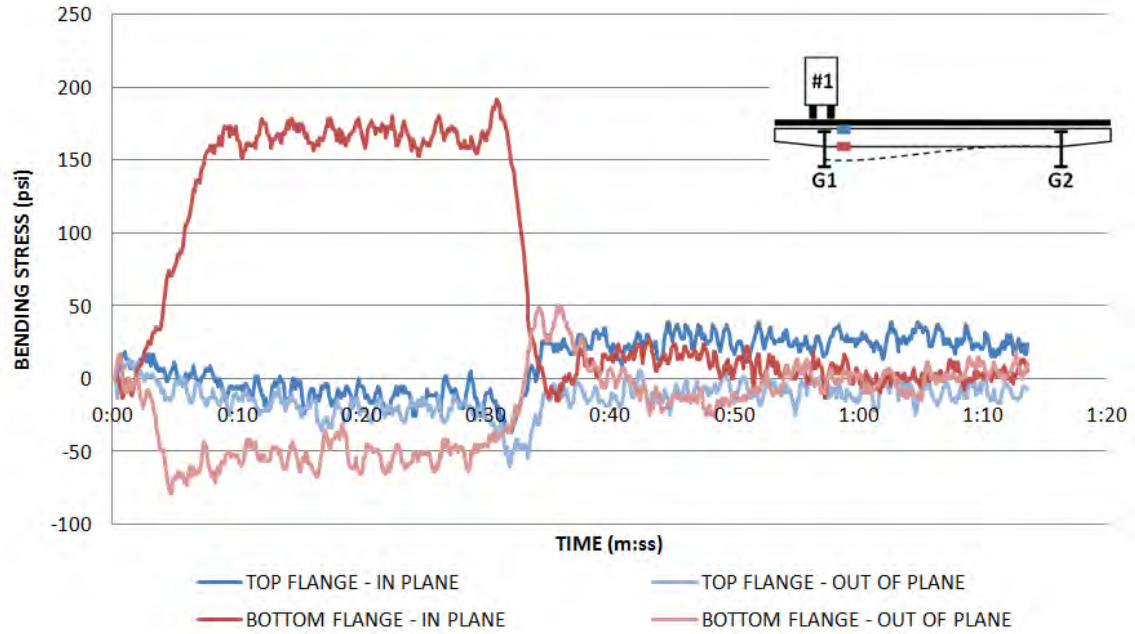
Figure 4.20: In-Plane and Out-of-Plane Stress of the Floor Beam near Girder 1 due to one Truck on the Left

The discrepancies between the two single truck tests could also be a result of the lateral bending of the floor beam. Figures 4.20 and 4.21 show the in-plane and out-of-plane bending of the floor beam due to one truck on the left side. If Figures 4.4 and 4.20, which plot the bending stresses underneath the single trucks, are compared, it can be seen that there is much more out-of-plane bending when the truck is on the right side. The out-of-plane bending of the floor beam due to one truck on the right seems to have alleviated some of the in-plane bending, which would explain the difference in values between the single truck tests.

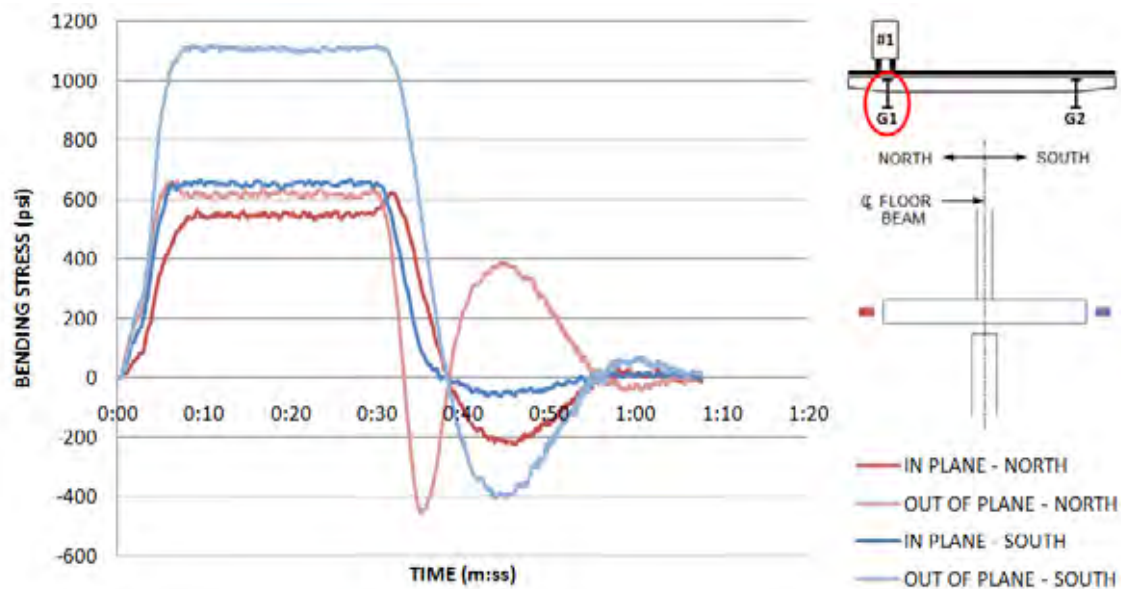
Figure 4.22: In-Plane and Out-of-Plane Bending Stresses of Girder 1 Web due to one Truck on the Left

Figures 4.22 and 4.23 show the in-plane and out-of-plane bending measured in Girder 1 and Girder 2, respectively, due to one truck on the left side of the bridge. The plots show that Girder 1 has positive in-plane bending, which suggests it is deflecting downward and positive out-of-plane bending, which suggests it is also bending inward toward the center of the bridge. Once the truck leaves the floor beam, the girder shows negative in-plane stresses, indicating that there is uplift of the girder when the truck is over the middle span. At this point, the girder also starts to bend out-of-plane in different directions on either side of the floor beam indicating that there is lateral movement of the floor beam. Girder 2 has a relatively large out-of-plane bending stress on the south side of the floor beam and practically no in-plane stresses. These stresses, however, are very small when compared to the stress in the girder under the truck.

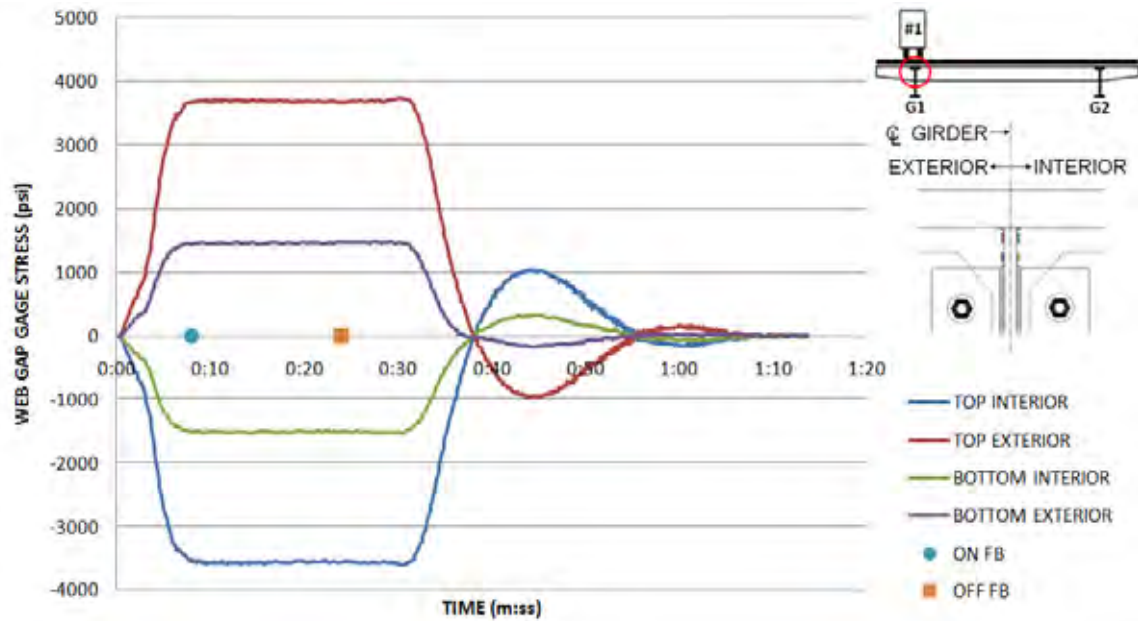
Figure 4.24: Stress in Web Gap Gages on Girder 1 due to 1 Truck on the Left

Figure 4.24 shows the stress in the web gap of Girder 1 due to one truck on the left side of the bridge. For this run, the truck is directly over the girder, which creates high stresses in the gap. The exterior gages experienced tensile stresses while the interior gages experienced compressive stresses. Therefore, the gap is bending in single curvature toward the exterior of the bridge. The stress recorded by the top gages is more than twice that of the bottom gages, which means there is more bending toward the top of the gap. The three sections signifying the three spans of the bridge are also apparent in this plot. The web gap bends in the opposite direction when the truck is on the middle span and bends back the other way when the truck is on the last span.

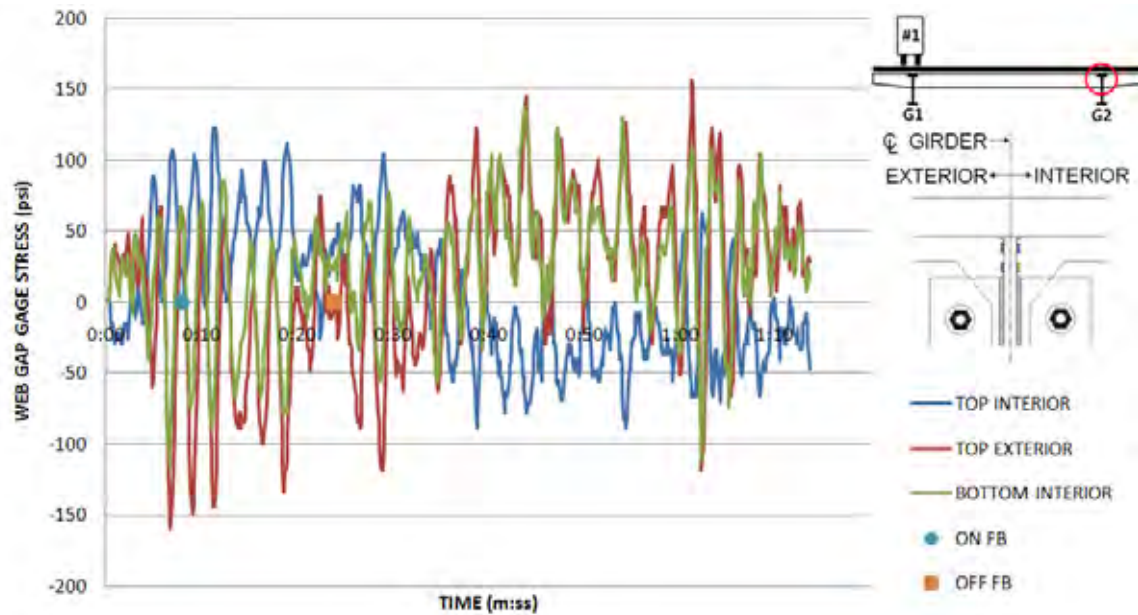
Figure 4.25: Stress in Web Gap Gages on Girder 2 due to 1 Truck on the Left

Figure 4.25 shows the stress in the web gap of Girder 2 due to one truck on the left side of the bridge. The plot shows significant noise in the data. However, the values of the stress that were recorded were very low. Therefore, the web gap experiences very little stress when the truck is on the other side of the bridge.

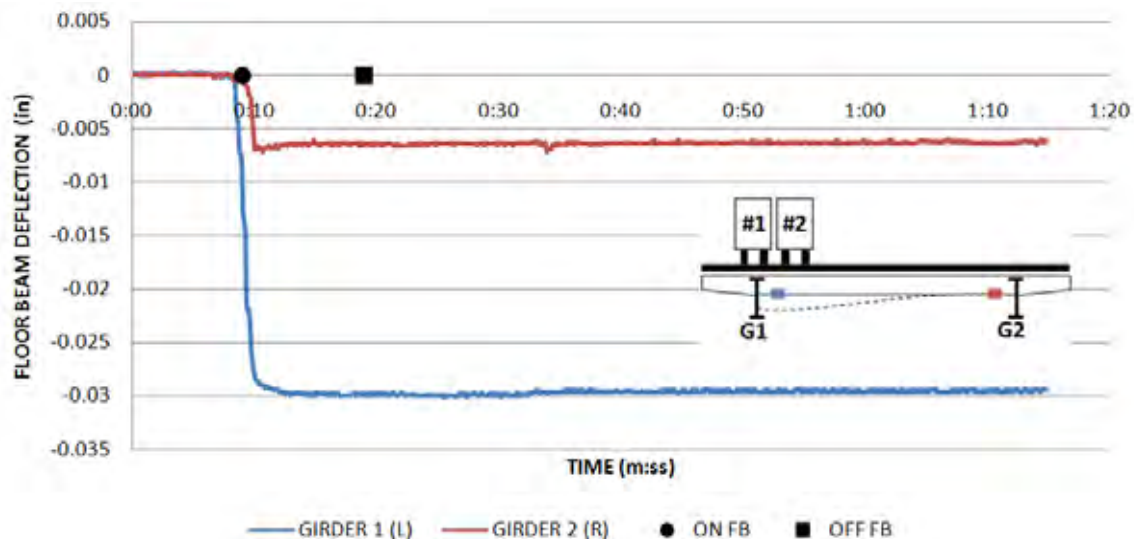
Figure 4.26: Deflection of Floor Beam due to Two Trucks on the Left

Figure 4.26 shows the deflection at either end of the floor beam due to two trucks on the left side of the bridge. The left side of the bridge deflects downward a total of 0.03 inches under the weight of the trucks. This deflection is almost four times the deflection seen with one truck

on the left. The figure also shows that the right side of the floor beam deflects downward a very small amount. The floor beam seems to stay deflected even after the trucks leave the floor beam, which could have been caused by a sticky deflection gage.

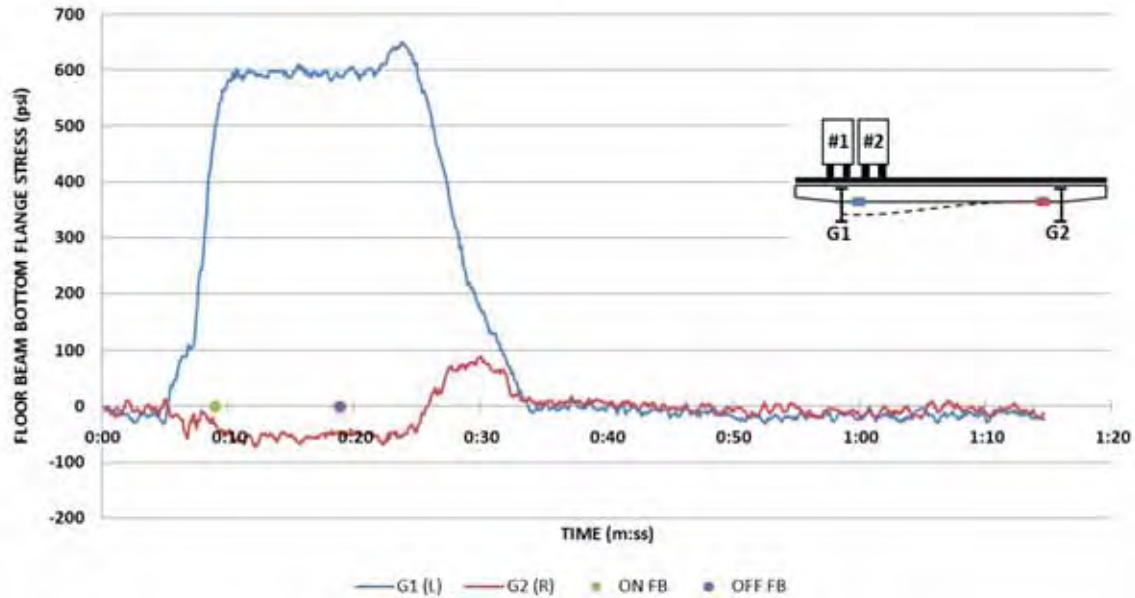
Figure 4.27: Stress in the Bottom Flange of the Floor Beam due to 2 Trucks on the Left

Figure 4.27 shows the stress at both ends of the bottom flange of the floor beam when two trucks are in the two left-most lanes. The trucks cause the left end of the floor beam to deflect vertically downward, creating tensile stresses in the bottom flange. The static tensile stress on the left side of the floor beam is almost four times the value due to one truck. The plot shows the same change to single curvature after the truck leaves the floor beam as was seen with the two trucks on the right. It can also be seen that there is a slight decrease in the compressive stress in the bottom flange of the floor beam on the side opposite the trucks from the single left truck test.

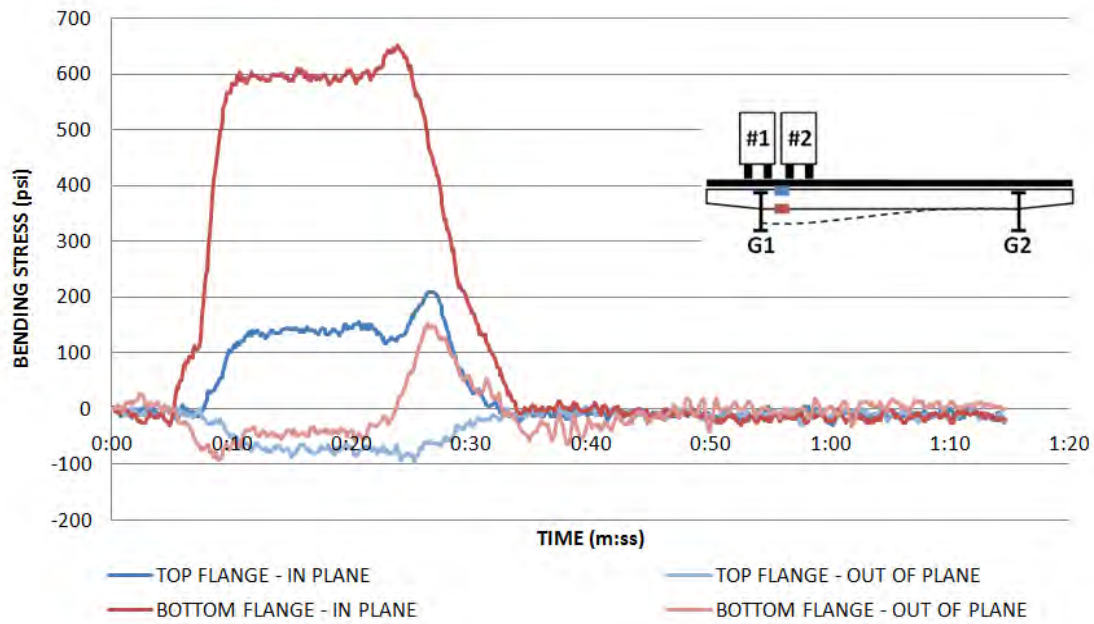
Figure 4.28: In-Plane and Out-of-Plane Stress of the Floor Beam near Girder 1 due to two Trucks on the Left

Figures 4.28 and 4.29 show the in-plane and out-of-plane bending of the floor beam due to two trucks on the left side of the bridge. As can be seen, the in-plane stress in the bottom flange dominates the other stresses and there is very little out-of-plane bending on either side of the floor beam. Therefore, the decrease in the compressive stress in the bottom flange of the floor beam on the side opposite the trucks is most likely not due to lateral bending of the floor beam. Another explanation could be out-of-plane bending of the girder at the floor beam to girder connection. To determine if this is the case, the results from the bottom flange gages will be discussed.

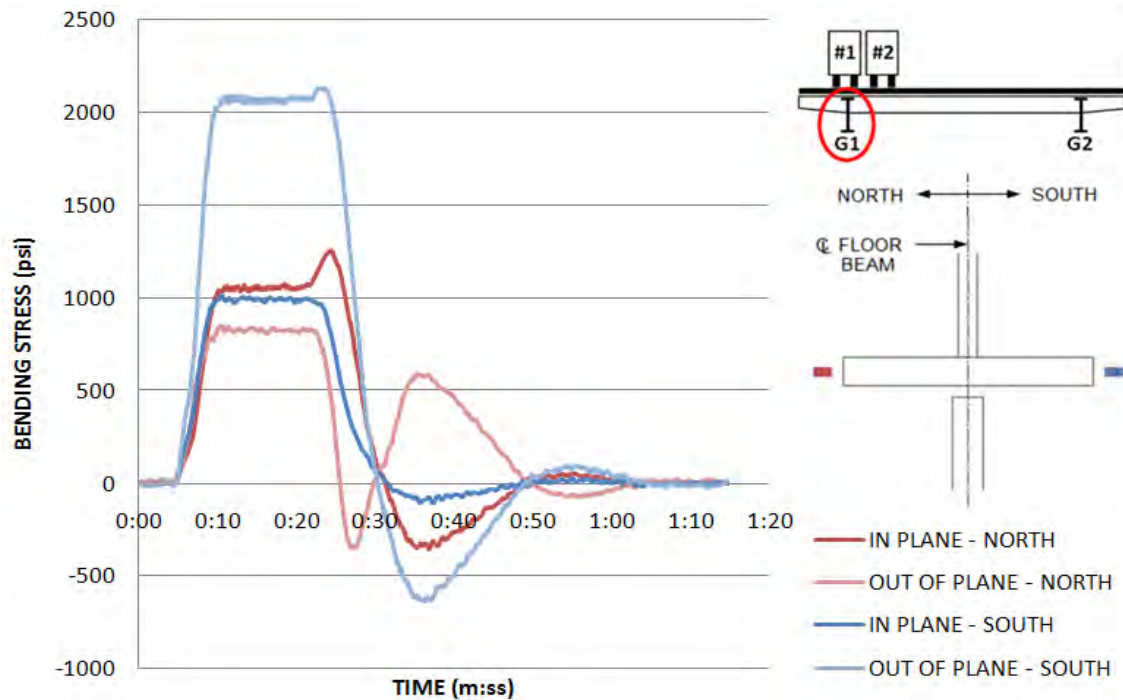
Figure 4.30: In-Plane and Out-of-Plane Bending Stresses of Girder 1 Web due to two Trucks on the Left

Figure 4.30 shows the stress in the bottom flange gages on the web of Girder 1 due to two trucks on the left side of the bridge. Both in-plane and out-of-plane stresses are positive when the trucks are over the floor beam, which means the girder is deflecting both downward and inward toward the center of the bridge. When the trucks are on the middle span, the girder deflects upwards and bends out-of-plane in different directions on either side of the floor beam. On the last span, the girder reverses the directions in which it bends.
