16. Abstract This report documents a field test to determine the stresses at areas where fatigue cracks had formed in the bridges. Two bridges were instrumented and subjected to controlled truck traffic. In addition, the service fatigue stresses were evaluated by monitoring the stresses for a 1 week period after the controlled truck testing. A three dimensional finite element model was constructed of each bridge. The stresses from the field tests and the model were compared. The floor beams were found to behave as composite with the bridge deck when the truck loads were near floor beams. The local stress at the critical sections was in reasonable agreement between the field and analytical results. Proposed retrofit schemes were evaluated in the analytical model. In general, the proposed schemes appear to reduce the stresses at the critical locations, however high stresses are generated in other areas that have not cracked. The unsymmetrical support conditions of some of the girder units cause twisting of bridge section. Adding of additional supports to make the bridge support symmetrical will also improve fatigue performance of the bridge.

Field Test and Finite Element of I-345 Br

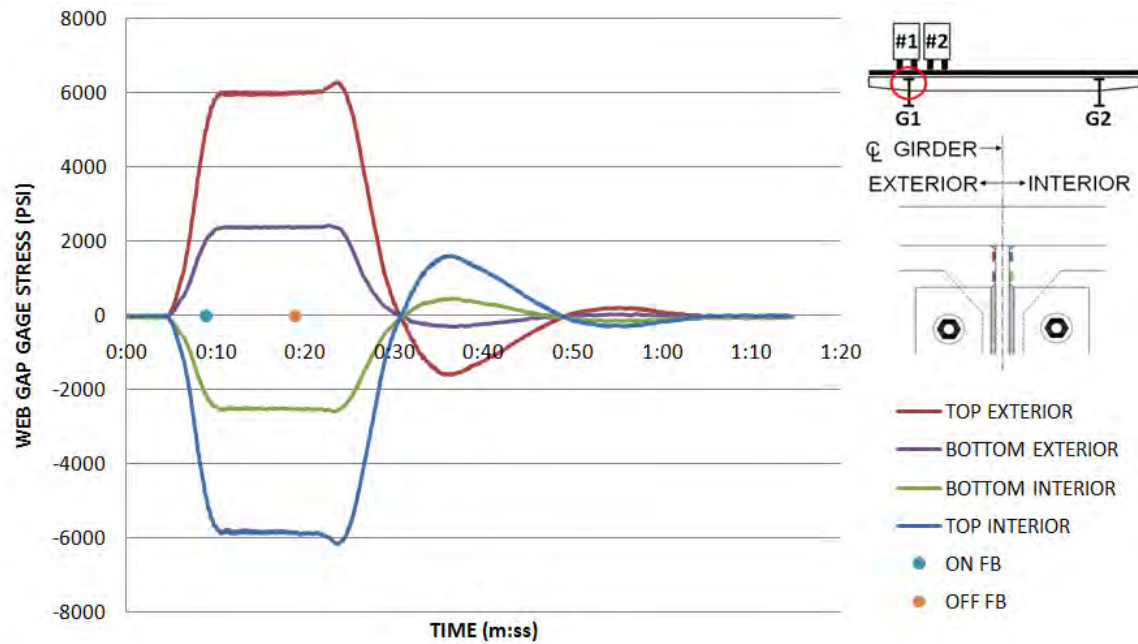
Figure 4.32: Stress in Web Gap Gages on Girder 1 due to 2 Trucks on the Left

Figure 4.32 is a plot of the stress in the web gap of Girder 1 due to two trucks on the left. The exterior gages show tensile stresses and the interior gages show compressive stresses. This indicates that the web gap is bending in single curvature toward the exterior of the bridge. When the truck is on the middle span, the web gap bends toward the interior of the bridge and bends back toward the exterior of the bridge on the last span. The stresses measured in the web gap of Girder 1 were the largest stresses measured anywhere along this floor beam and the girder connections.

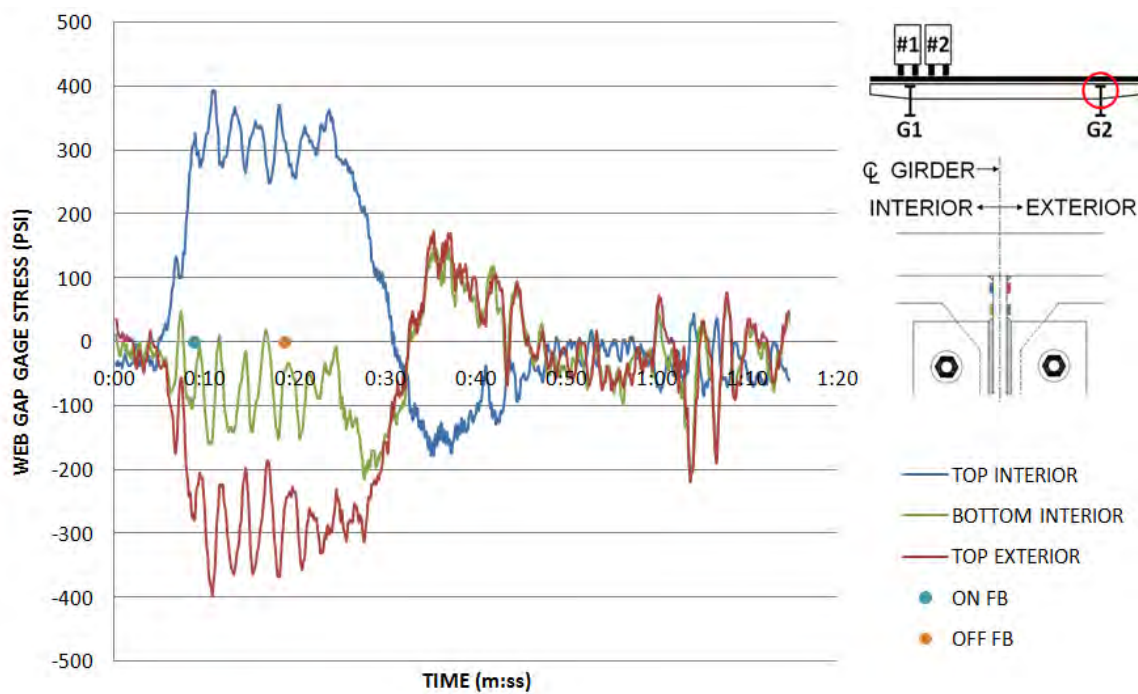
Figure 4.33: Stress in Web Gap Gages on Girder 2 due to 2 Trucks on the Left

Figure 4.33 shows the stresses in the web gap of Girder 2 due to two trucks on the left. The top gages show that the web gap is bending inward toward the center of the bridge. Again, the bending is reversed every time the trucks move onto the next span.

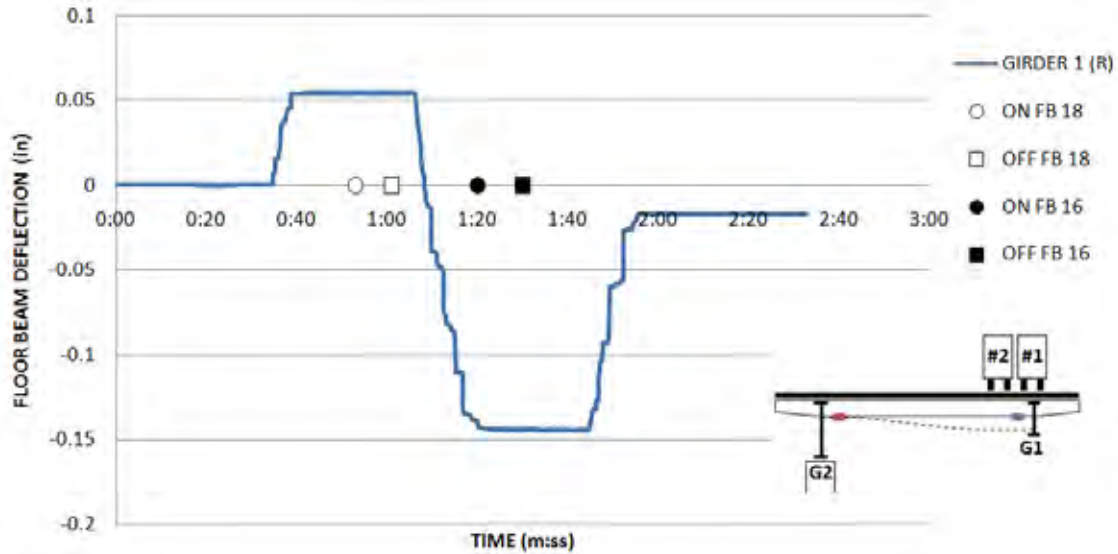
Figure 5.1: Deflection of Floor Beam due to Two Trucks on the Right

Deflection gages, also referred to as string potentiometers, were placed on the bottom flange of the floor beam at each end near the connection to the girder. These were used to determine how much the floor beam deflected under the weight of the trucks. The string pot that was placed near Girder 2 was determined to be defective. However, because this location was near the supported girder, it was not expected to deflect significantly. Figure 5.1 shows the deflection on the right side of the floor beam due to two trucks on the right side of the bridge. The right side of the floor beam deflected upward when the trucks were nearing Floor Beam 18 and deflected downward when the trucks were over Floor Beam 16. From this data, the deflected shape of Floor Beam 16 due to the stationary trucks can be determined and is represented by the dashed line in the detail of the floor beam within Figure 5.1. The right side of the floor beam deflects downward under the weight of the trucks while the left side is restrained from deflecting by the column.

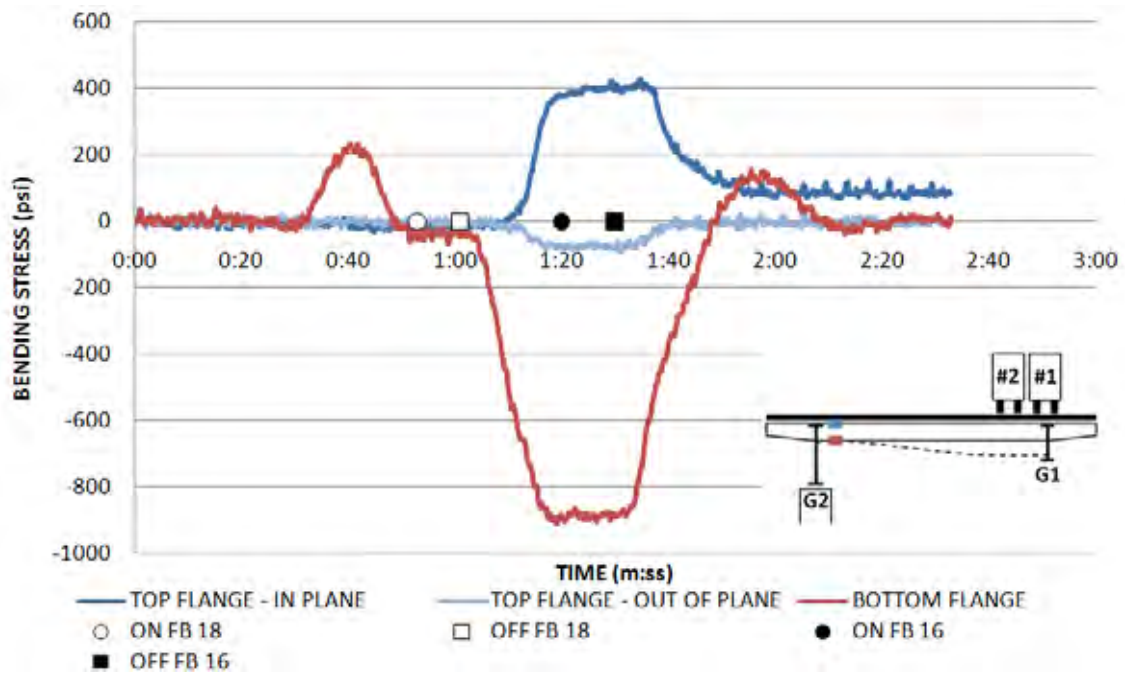
Figure 5.3: In-Plane and Out-of-Plane Stress of the Floor Beam near Girder 2 due to two Trucks on the Right

One of the gages placed on the bottom flange of the floor beam near Girder 2 was defective. Therefore, it is not possible to determine whether the stress in the floor beam flange at this location is in plane or out of plane. Figure 5.3 shows the in-plane and out-of-plane bending stresses in the top flange near Girder 2 as well as the stress on one side of the bottom flange due to two trucks on the right side of the bridge. Before the trucks reach Floor Beam 18, the bottom flange of Floor Beam 16 shows a slight tensile stress. The left side of the floor beam is restrained from deflecting due to the column. Therefore, this tensile stress is most likely caused by the right side deflecting upward from the weight of the trucks on the previous span. When the trucks are stationary over Floor Beam 16, there is tensile stress in the top flange and compressive stress in the bottom flange. This is consistent with the assumed deflected shape determined from Figure 5.1. The left side is restrained from deflecting due to the support from the column and the right side is deflecting downward under the weight of the trucks. This results in the floor beam bending in double curvature. After the trucks leave the floor beam, the bottom flange shows a slight tensile stress.

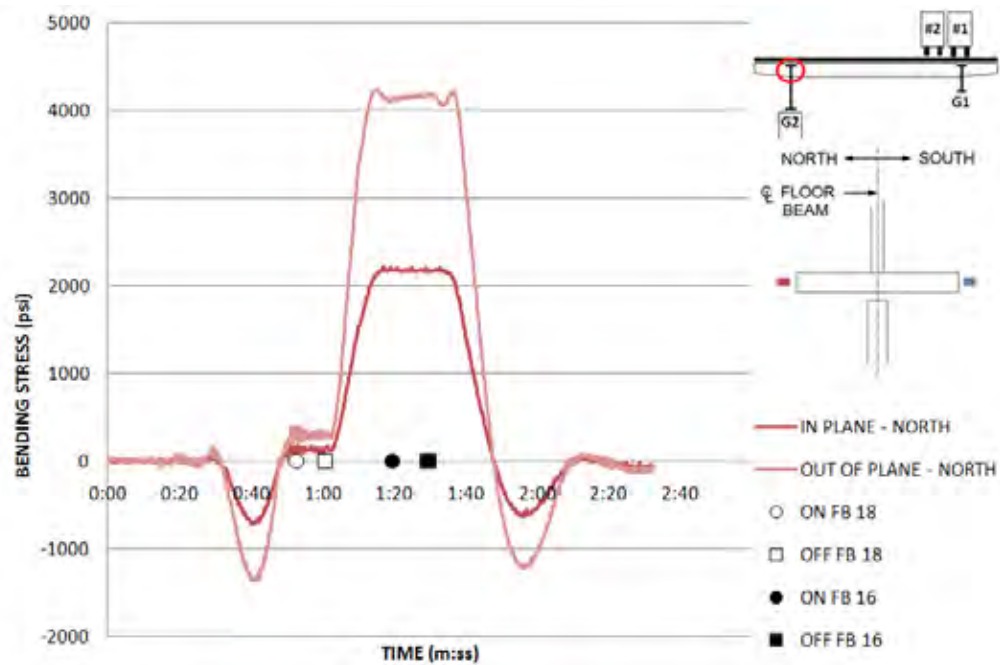
Figure 5.5: In-Plane and Out-of-Plane Bending Stresses of Girder 2 Web due to two Trucks on the Right

Figure 5.5 shows the stress in Girder 2 adjacent to the bottom flange of the floor beam due to two trucks in the right lanes. Girder 2 is haunched and supported by a column at this location. The girder has bearing stiffeners on either side of the floor beam that create a very small gap in which to place the strain gages. Because of this and the presence of repair welds, it was not possible to place gages on the interior or exterior side of the girder on the south side of the floor beam. The haunch of Girder 2 causes the bottom flange of the floor beam to frame into the girder above the girder's neutral axis. Figure 5.5 shows that the girder is experiencing in and out-of-plane stresses just before the trucks reach Floor Beam 18. Again, the stresses are practically zero when the trucks stop over Floor Beam 18. When the trucks stop over Floor Beam 16, the girder experiences tensile in-plane and out-of-plane stresses. This suggests that the girder is deflecting downward on either side of the column creating tension at the location where the floor beam frames into the girder above the column. The positive out-of-plane stress suggests that the girder is also bending inward toward the center of the bridge. The out-of-plane stress is significantly higher than the in-plane stress at this location. This is most likely due to the fact that the girder is supported by the column and is, therefore, restrained from deflecting vertically. The increased height of the girder due to the haunch creates a more slender web that may be more susceptible to out-of-plane bending. Comparing Figures 5.4 and 5.5, it can be seen that the stress in Girder 2 is much greater than the stress in Girder 1. This is due to the presence of bearing stiffeners on Girder 2. The bearing stiffeners create a very small gap next to the bottom flange of the floor beam, which results in very high stress concentrations in this area. These stress concentrations are most likely the cause of cracking at this location.

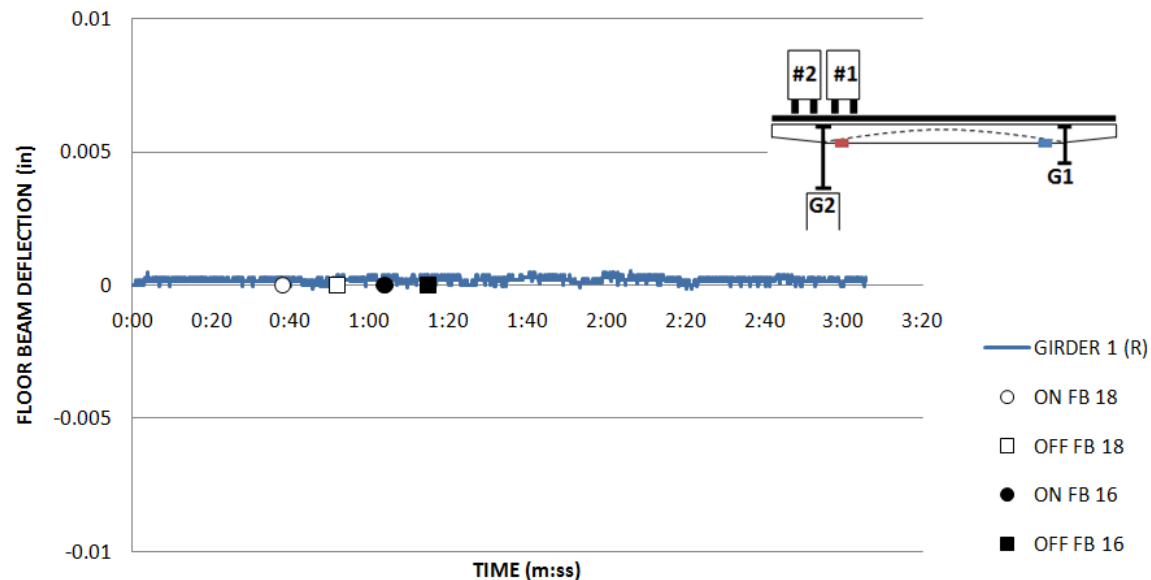
Figure 5.8: Deflection of Floor Beam due to Two Trucks on the Left

Figure 5.8 shows the deflections measured at the right side of the floor beam due to two trucks on the left side of the bridge. The string pot on the left side was defective, but it is assumed that the left side does not deflect due to the support of the column. The figure shows that the right side of the floor beam does not deflect. Because of the narrow shoulder on the left side of this bridge, the two trucks are centered over Girder 2 as can be seen in the detail within

Figure 5.8. Therefore, the trucks are completely supported by Girder 2 and do not cause the right side of the floor beam to deflect.

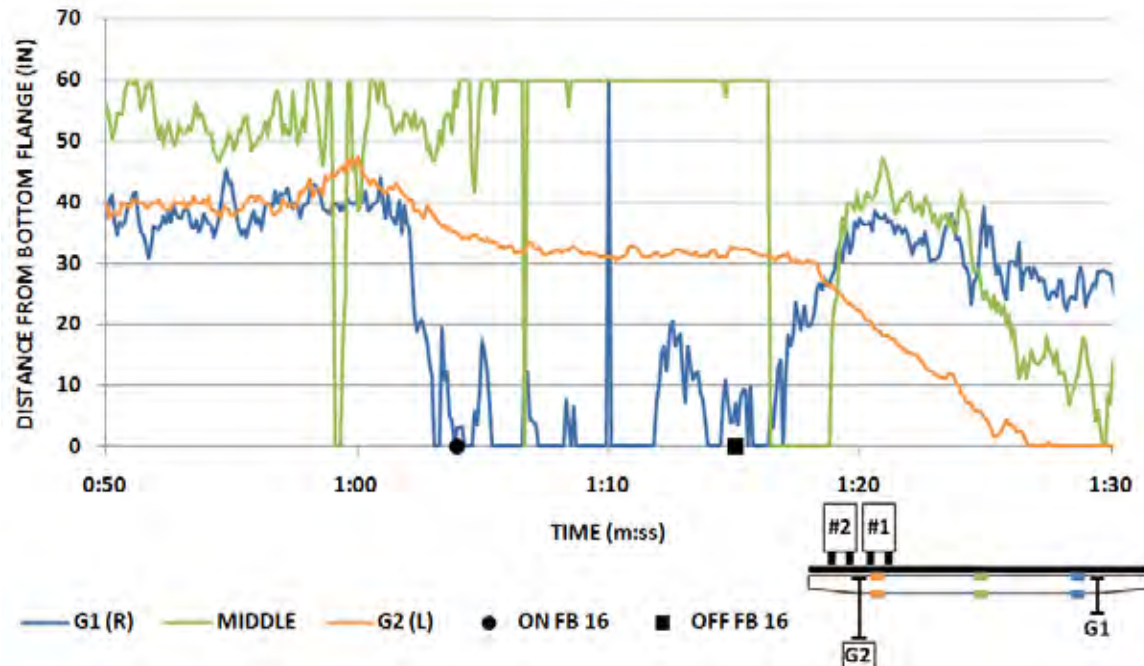
Figure 5.16: Neutral Axis of the Floor Beam versus Time due to Two Trucks on the Left

Figure 5.16 shows the location of the neutral axis of the floor beam versus time as two trucks move along the left side of the bridge. During this run, the two trucks were directly over Girder 2, which is supported by a column at Floor Beam 16. Due to the support of the column, there was very little stress transferred to the middle and right side of the floor beam. When the stress values are very small, the calculation of the neutral axis is very sensitive to any changes in stress. This makes the location of the neutral axis highly variable. This is the reason for the

scatter in the data of Figure 5.16 for the middle and right side of the floor beam. On the left side of the floor beam, directly under the trucks, the neutral axis was calculated to be about 32 inches above the bottom flange, which is slightly above the centroid. This suggests very minor composite action between the floor beam and slab. Because the supported girder is taking much of the stress from the trucks, there is little weight transferred to the floor beams. Therefore, there is very little friction to cause the floor beam and slab to act compositely.

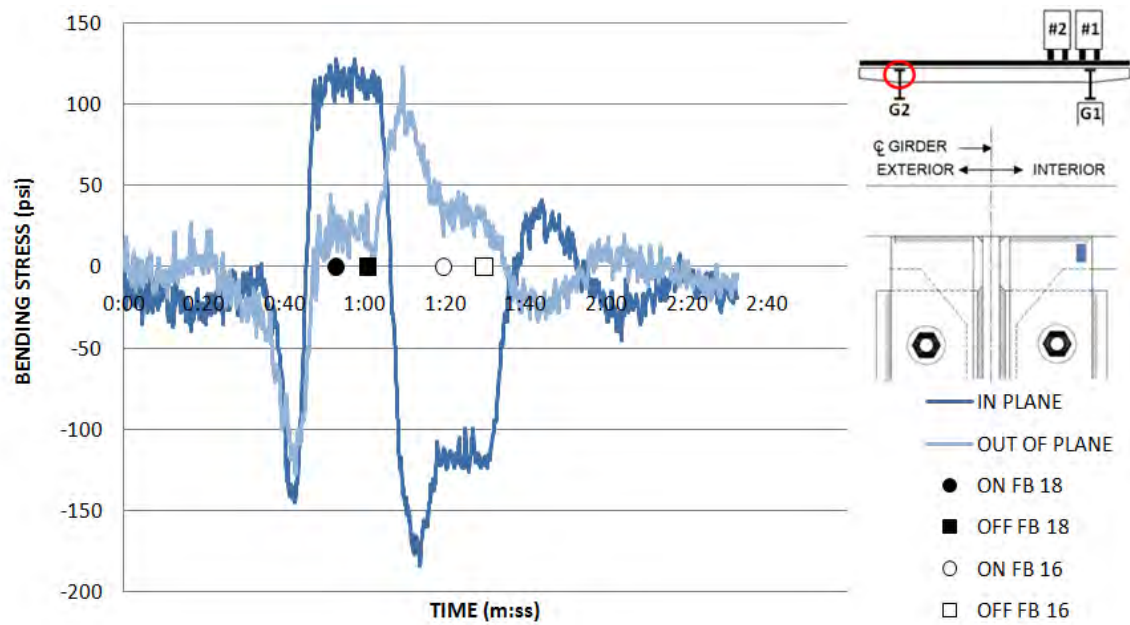
Figure 6.7: Stress in Girder 2 Retrofit Stiffeners due to two Trucks on the Right

Figure 6.7 shows the in-plane and out-of-plane bending stresses of the Girder 2 retrofit stiffeners due to two trucks on the right side of the bridge. The stiffeners bend both in and out of plane before the trucks reach the floor beam. When the trucks are on the floor beam, the stiffeners bend mostly in plane. When the trucks are over Floor Beam 16, the stiffeners bend in plane in the opposite direction with slight out-of-plane bending.

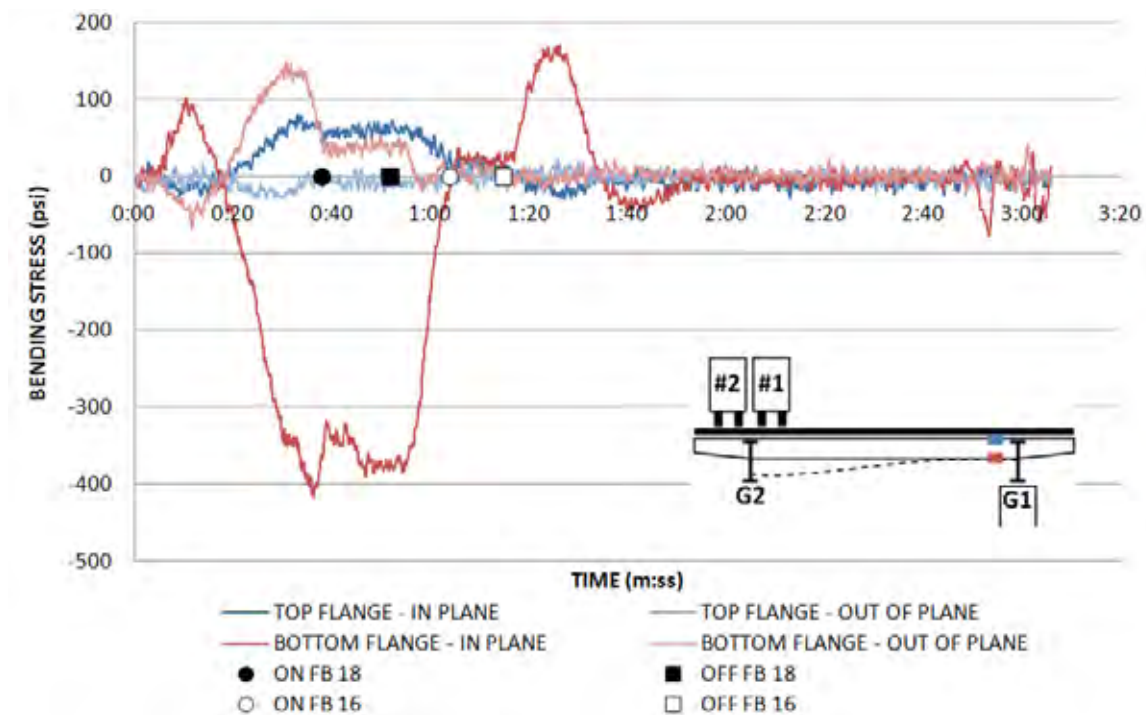
Figure 6.9: In-Plane and Out-of-Plane Stress of the Floor Beam near Girder 1 due to two Trucks on the Left

Figure 6.9 shows the in-plane and out-of-plane bending of the floor beam near Girder 1 due to two trucks on the left side of the bridge. There is slight in-plane and out-of-plane bending of the bottom flange before the trucks reach the floor beam. When the trucks are stationary over the floor beam, there is a relatively large in-plane compressive stress in the bottom flange with very little out-of-plane bending. The top flange has a small tensile in-plane stress. After the trucks leave Floor Beam 16, the bottom flange experiences tensile stresses. This data correlates with the deflection data from Figure 6.8, which shows that the left side of the bridge deflects downward under the weight of the trucks and causes compressive stresses in the bottom flange on the opposite side of the floor beam. When the trucks move past Floor Beam 16, the left side of Floor Beam 18 deflects upward as seen in Figure 6.8, which creates tensile stresses in the bottom flange on the opposite side of the floor beam.

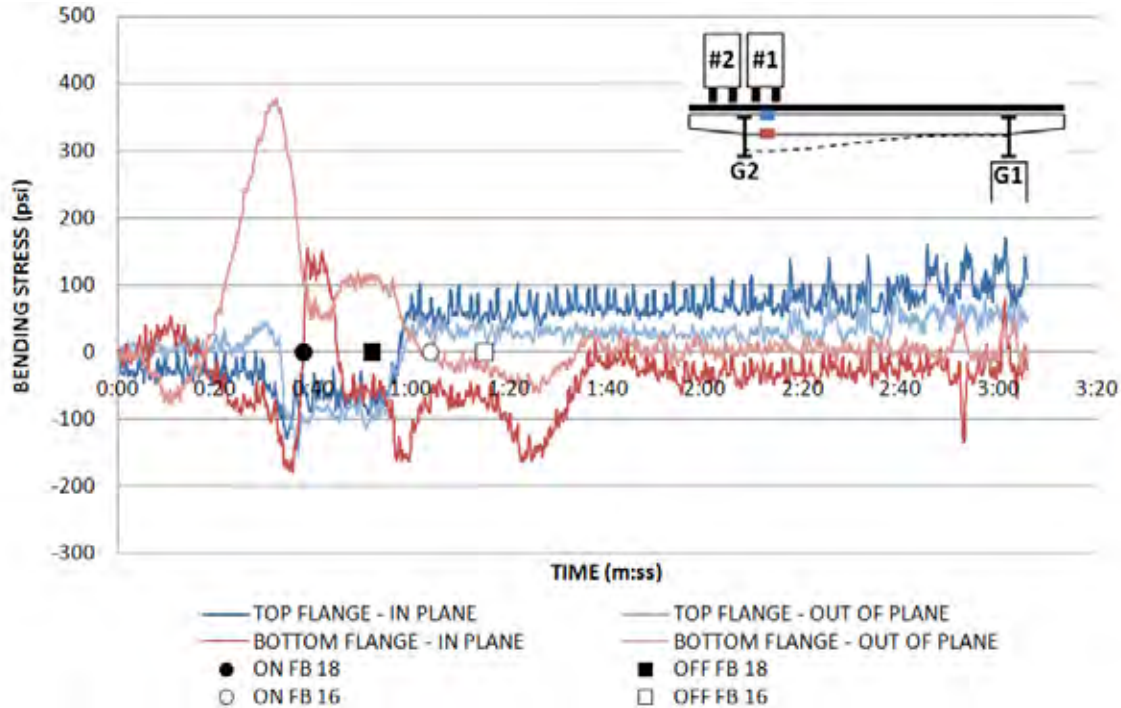
Figure 6.10: In-Plane and Out-of-Plane Stress of the Floor Beam near Girder 2 due to two Trucks on the Left

Figure 6.10 shows the in-plane and out-of-plane bending stresses in the floor beam near Girder 2 due to two trucks on the left. Before the trucks reach the floor beam, there are high out-of-plane bending stresses in the bottom flange, which suggest that the floor beam is deflecting laterally. When the trucks are over the floor beam, this out-of-plane stress is decreased as the in-plane bending stress increases. The in-plane stress is positive on the bottom flange when the trucks move onto the floor beam indicating that the floor beam is deflecting downward under the weight of the trucks. This data correlates well with the deflection data from Figure 6.8 that shows that the left side of the floor beam is deflecting downward due to the trucks. The stress in the bottom flange on the left side of the floor beam is generally less than that on the right side of the floor beam. This seems to suggest that the supporting column is attracting the majority of the stress caused by the trucks even when they are on the other side of the bridge.

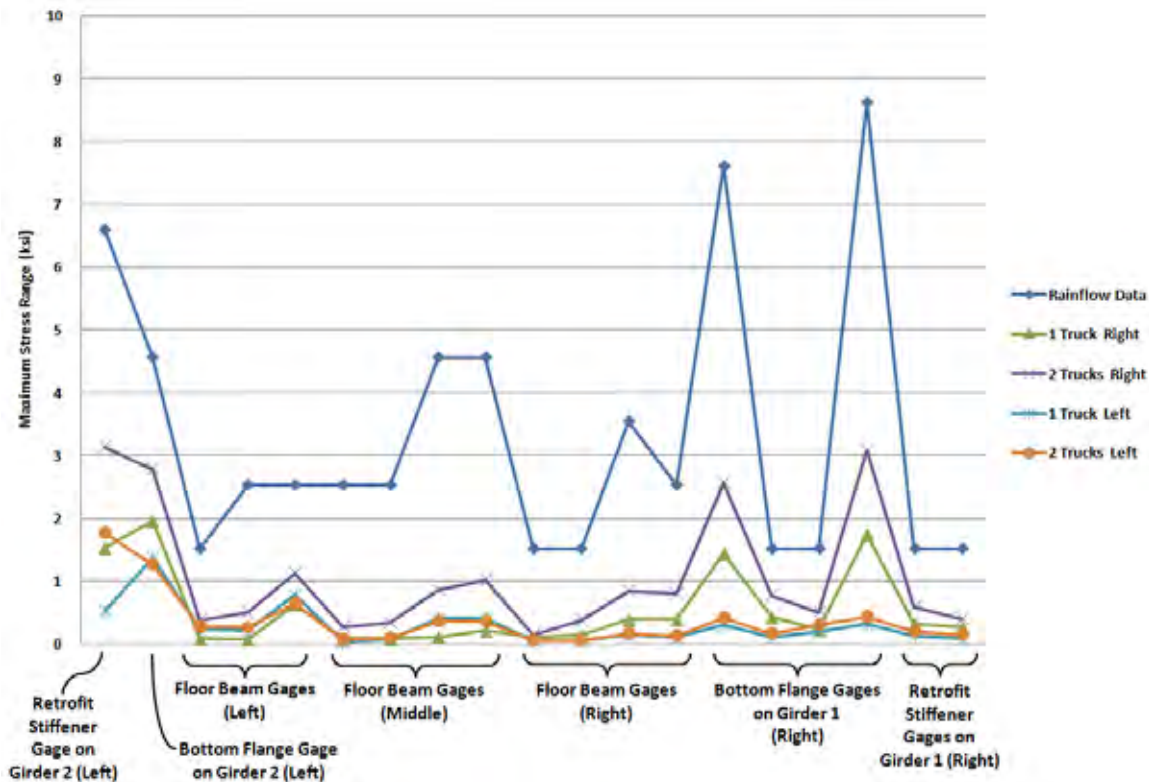
Figure 7.7: Comparison of Rainflow Data to Live Load Test Data for Floor Beam 16

Figure 7.7 shows the maximum stress ranges recorded for each gage from both the rainflow counting program as well as the four controlled live load tests. The gages on the horizontal axis are arranged such that the gages on the left side of the bridge are shown on the left side of the plot and gages on the right side of the bridge are shown on the right.

It can be seen that the general trends in the stress ranges for the gages are similar for all of the tests. The largest stress ranges for the live load tests were recorded during the run with two trucks on the right side of the bridge. This is because the girder on the right side of this floor beam was not supported by a column. For each of the tests, the largest stress ranges were experienced by the bottom flange gages and the retrofit stiffener gage on Girder 2.

As discussed for Floor Beam 2, the stress ranges recorded by the rainflow counting program are significantly higher than the stress ranges calculated from the live load tests because of the dynamic effect created by the fast-moving traffic recorded during the fatigue tests.

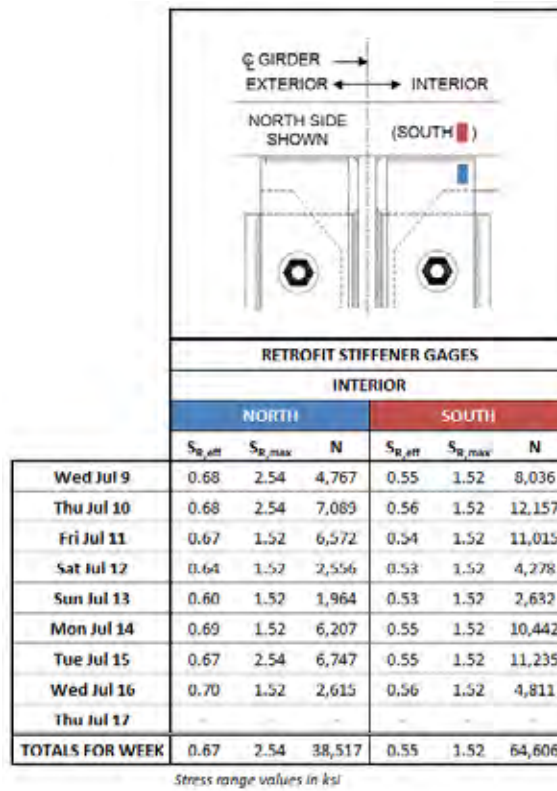
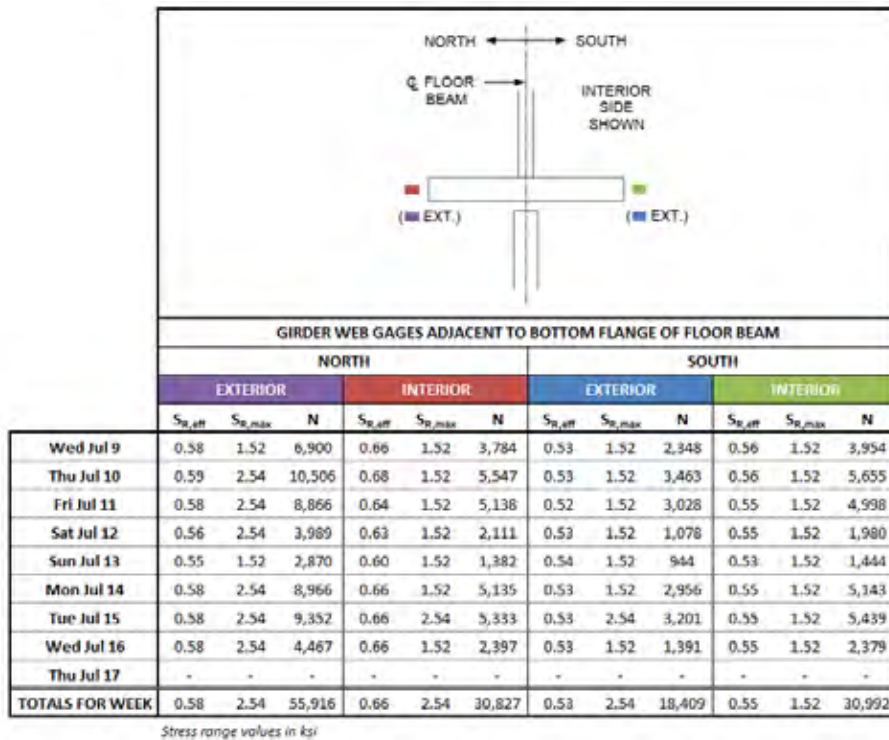
Figure 7.8: Stress Range Summary for Gages Near Connection of Floor Beam 18 to Girder 2

Figures 7.8 through 7.10 show a summary of the effective stress range, maximum stress range, and number of cycles for each of the gages on Floor Beam 18. Figure 7.8 shows the gages located at the connection of Floor Beam 18 to Girder 2, which is on the left side of the bridge. The first are the retrofit stiffener gages. The maximum stress range recorded by these gages

averaged about 2 ksi and the effective stress range averaged about 0.6 ksi. If compared to the retrofit stiffeners on Girder 1, which is shown in Figure 7.10, it can be seen that the stiffeners on Girder 1 experienced higher stress ranges. The average maximum and effective stress ranges for these gages were about 6.6 ksi and 0.9 ksi, respectively. This is due to the fact that Girder 1 is supported by a column and able to attract greater stress than Girder 2.

The bottom flange gages on Girder 2, shown in Figure 7.8, experienced average maximum and effective stress ranges of about 2.3 ksi and 0.58 ksi, respectively. These values are less than those on Girder 1, shown in Figure 7.10, whose values averaged 7.1 ksi and 1.1 ksi. Again, this is due to the fact that Girder 1 is supported by a column and is able to attract greater stresses.

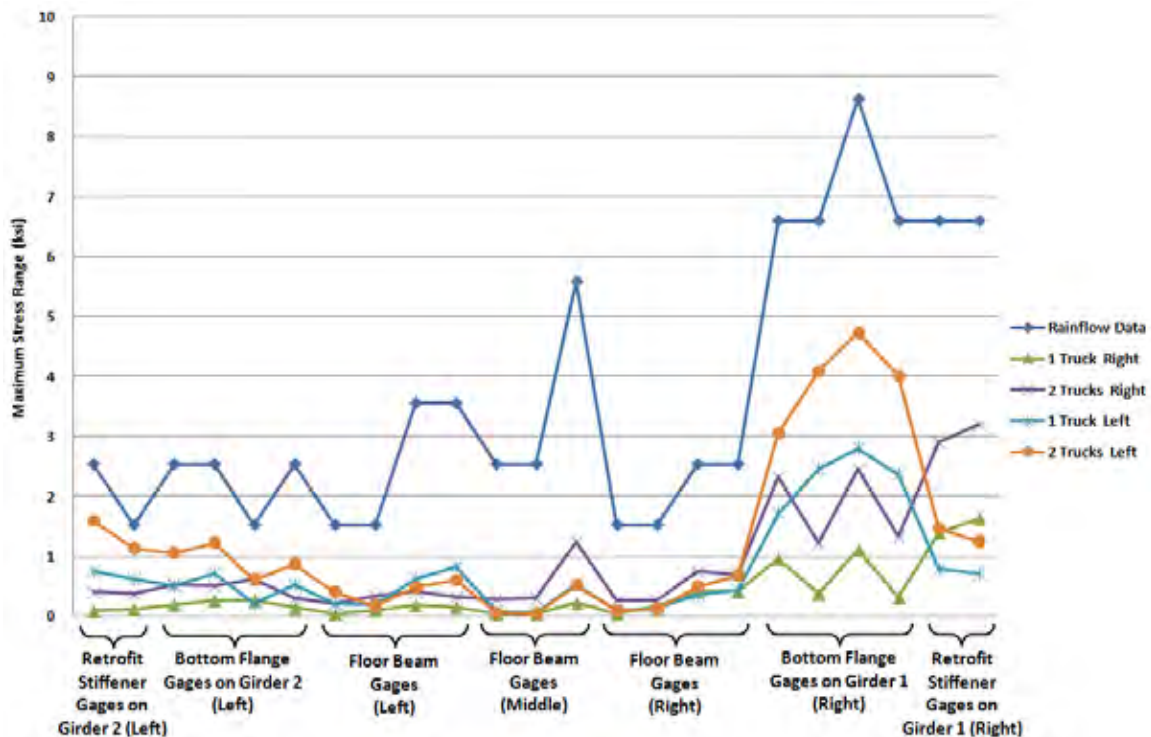
Figure 7.11: Comparison of Rainflow Data to Live Load Test Data for Floor Beam 18

Figure 7.11 shows the maximum stress ranges recorded for each gage from both the rainflow counting program as well as the four controlled live load tests. The gages on the horizontal axis are arranged such that the gages on the left side of the bridge are shown on the left side of the plot and gages on the right side of the bridge are shown on the right. It can be seen that the general trends in the stress ranges for the gages are similar for all of the tests. The largest stress ranges for the controlled live load tests were generally recorded during the run with

two trucks on the left side of the bridge. This is because the girder on the left side of the floor beam was not supported by a column. The plots show that the largest stress ranges were generally experienced by the bottom flange gages on Girder 1, which is the supported girder.

As discussed for the two floor beams above, the stress ranges recorded by the rainflow counting program are significantly higher than the stress ranges calculated from the live load tests because of the dynamic effect created by the fast-moving traffic recorded during the fatigue tests.

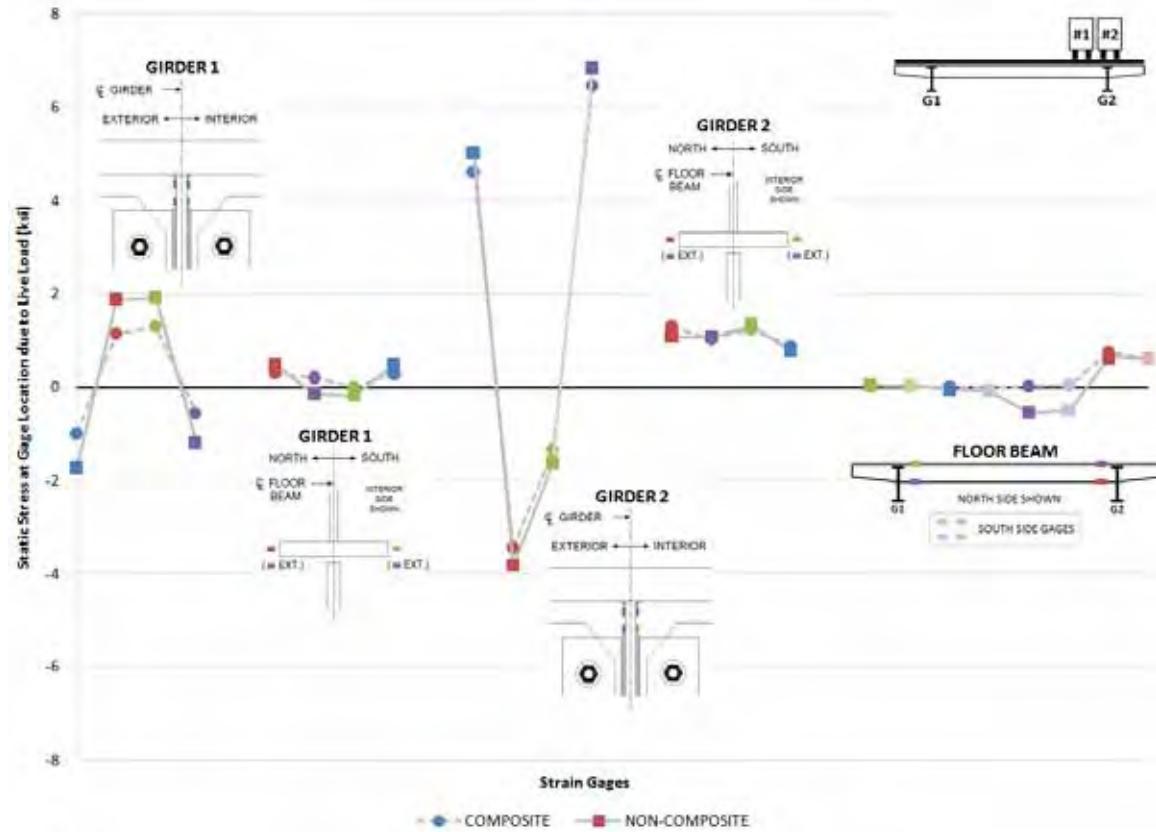
Figure 8.6: Comparison of Composite and Non-Composite Models for the Load Case with 2 Trucks on the Right

As can be seen in both figures, the results from both of the models were close. The composite model does show a smaller stress in the web gap areas, which results from a smaller rotation of the floor beam due to the higher stiffness of the composite floor beam. Also, the non-composite model shows a larger stress in the top flange of the floor beam near the trucks, which would be expected with non-composite elements. However, the differences between the values from the two models are small at the locations of interest. The results from the partially composite model showed stress values that were typically between the fully-composite and non-composite values.

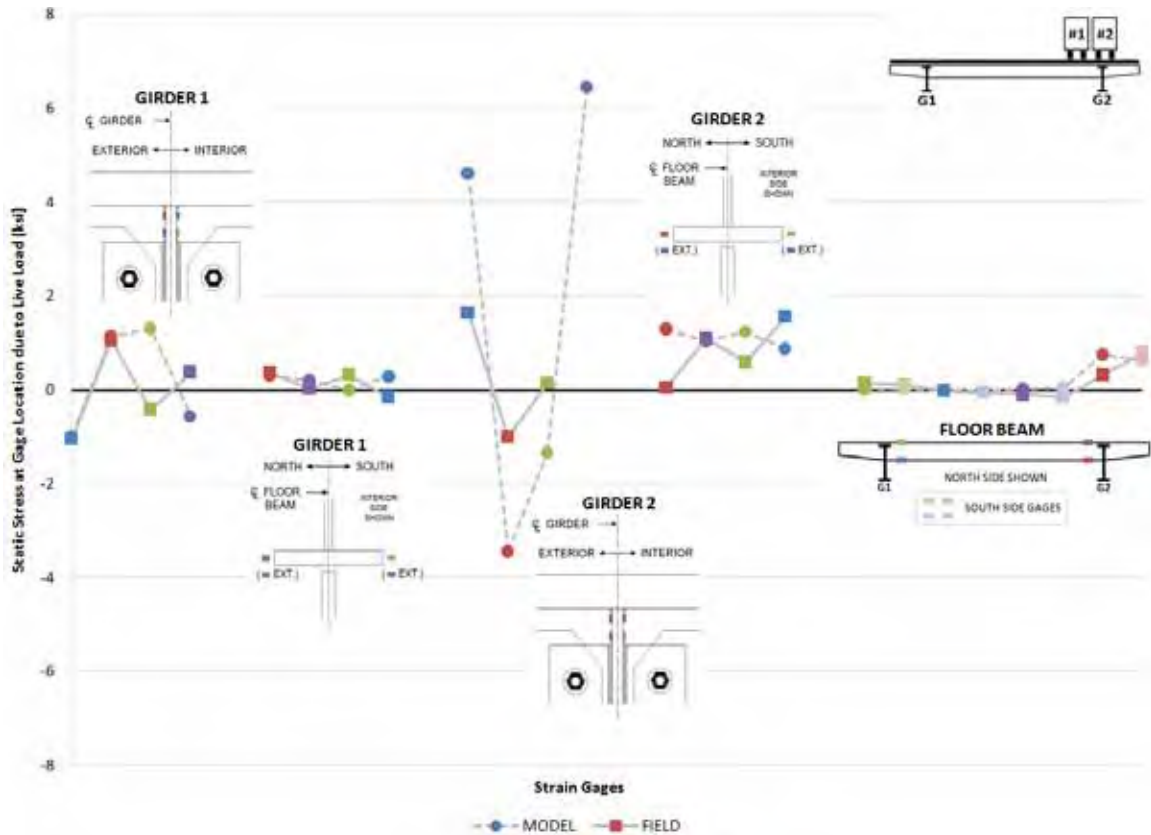
Figure 8.8: Comparison of Composite Model with Field Test Results for the Load Case with 2 Trucks on the Right

Figure 8.8 shows the comparison of the model to the field data for the test with two trucks on the right side of the bridge. One difference between the model and field data is that the model shows the web gap bending in double curvature. As was discussed in Chapter 4, this is what was expected to happen, but was not what was recorded during the field testing. All of the field test results showed the web gap bending in single curvature with the top of the gap recording higher stresses than the bottom of the gap. Another difference between the model and field data is that the model does not show as much out-of-plane bending of the girder web at the location where the bottom flange of the floor beam frames into the girder. The stresses in the gages on opposite sides of the web are much closer in value, which suggests that the majority of the stress is due to in-plane bending of the web. These differences are more prevalent at the connection of the floor beam to girder 2, which is where the trucks were located. The stress values measured in the floor beam during the field test were similar to the results from the computer model.

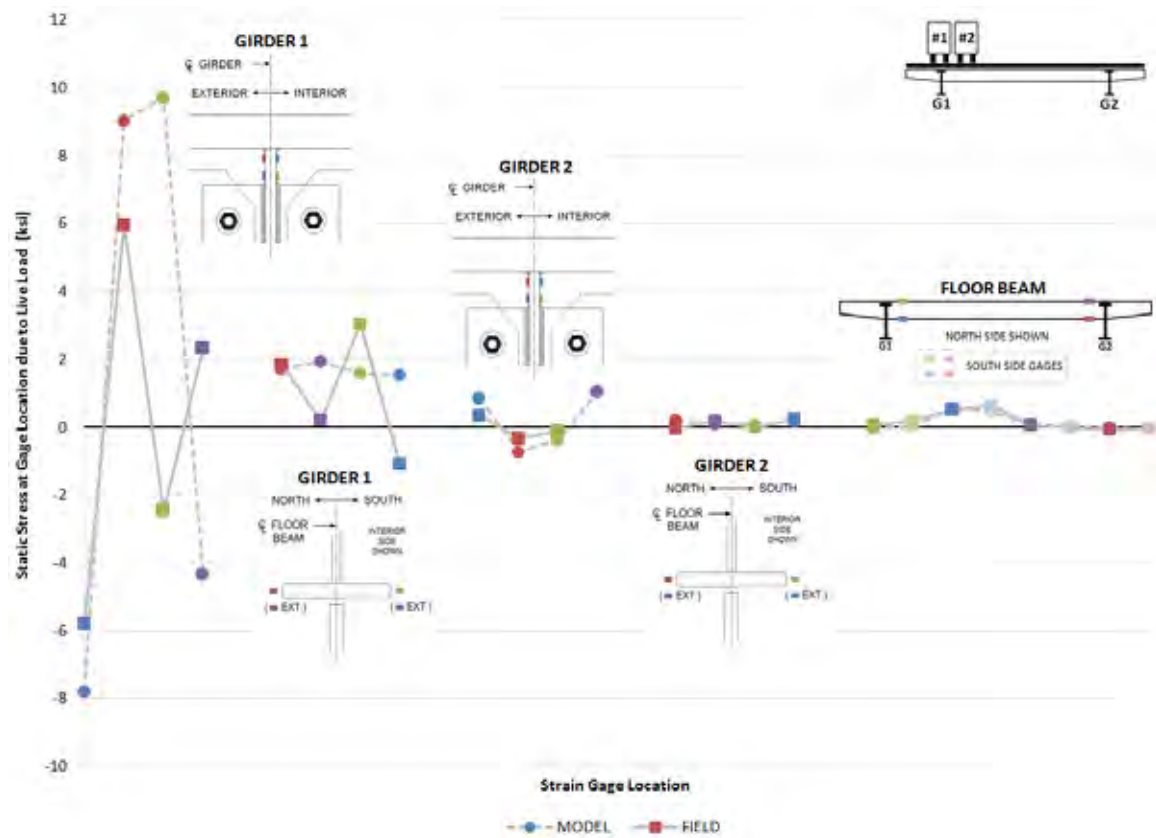
Figure 8.11: Comparison of Composite Model with Field Test Results for the Load Case with 2 Trucks on the Left

Figure 8.11 shows the comparison of the model to the field data for the test with two trucks on the left side of the bridge. These results show the same differences that were seen in the previous test. The model is showing double curvature in the web gap and virtually no out-of-plane bending in the girder web due to the movement of the floor beam in the connection under

the trucks. At the connection of the floor beam to the other girder, the results from the model closely resemble the field test results as do the results from the floor beam.

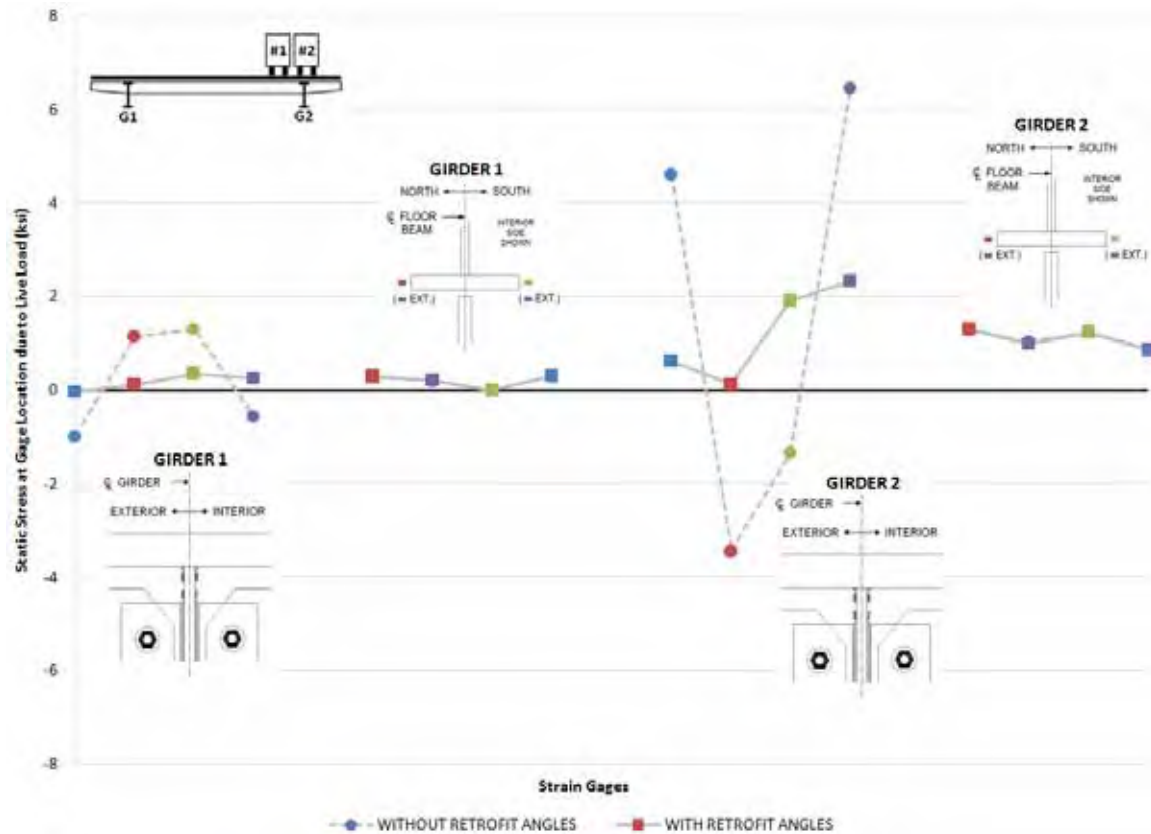
Figure 8.12: Comparison of Model Results with and without Retrofit Angles for Load Case with 2 Trucks on the Right

The results from the composite model before and after adding the retrofit angles will be compared to determine if this retrofit is effective in reducing the stress at the connection. Figures 8.12 and 8.13 show the results for the test with two trucks on the right and two trucks on the left, respectively. As can be seen from both figures, the retrofit angles are effective in reducing the stress in the web gaps. However, the stress in the girder web near the bottom flange of the floor beam is not affected by the angles.

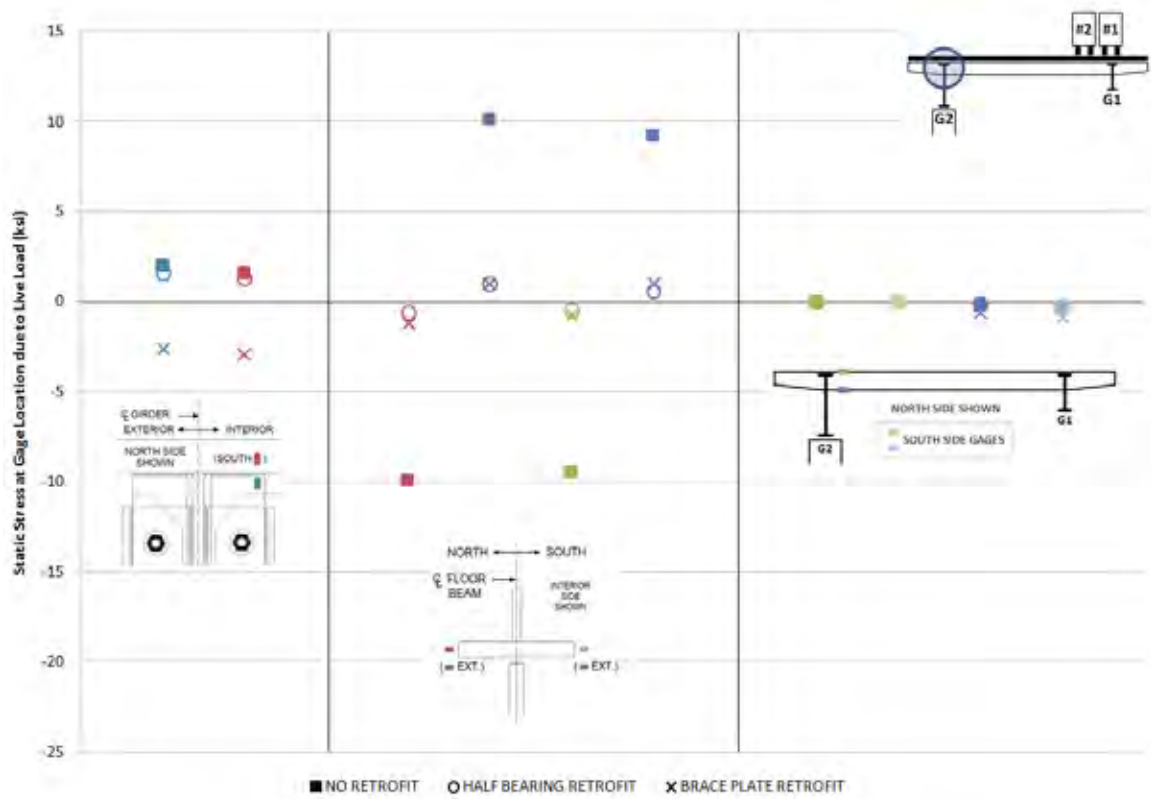
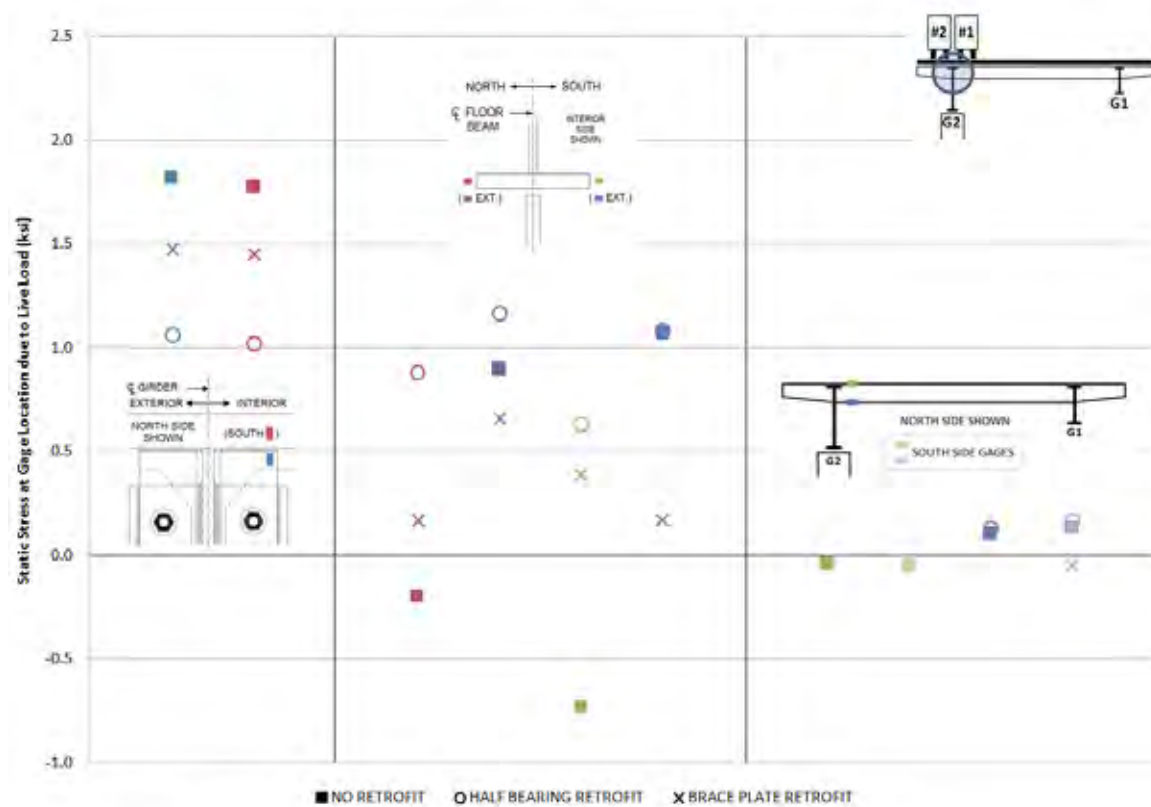
The results from the composite model with and without the previously mentioned retrofits will be compared to determine if these retrofits are effective in reducing the stress at the connection. Figure 9.11 and Figure 9.12 show the results for the test with two trucks on the right and two trucks on the left, respectively. The squares in the plots represent that stress values from the model with no retrofits. The circles correspond to the stress values with the retrofit where the bearing stiffeners are cut in half and the Xs correspond to the retrofit with the knee brace plates and angle brackets. As can be seen from both figures, both retrofits were effective in reducing the stresses in most locations. When the trucks are over girder 1, the stresses in the web of girder 2 are significantly reduced with both retrofits. When the trucks are over girder 2, the stresses measured on opposite sides of the web of girder 2 are much closer in value with the retrofits, which means that the out-of-plane bending that was seen without the retrofits was reduced.

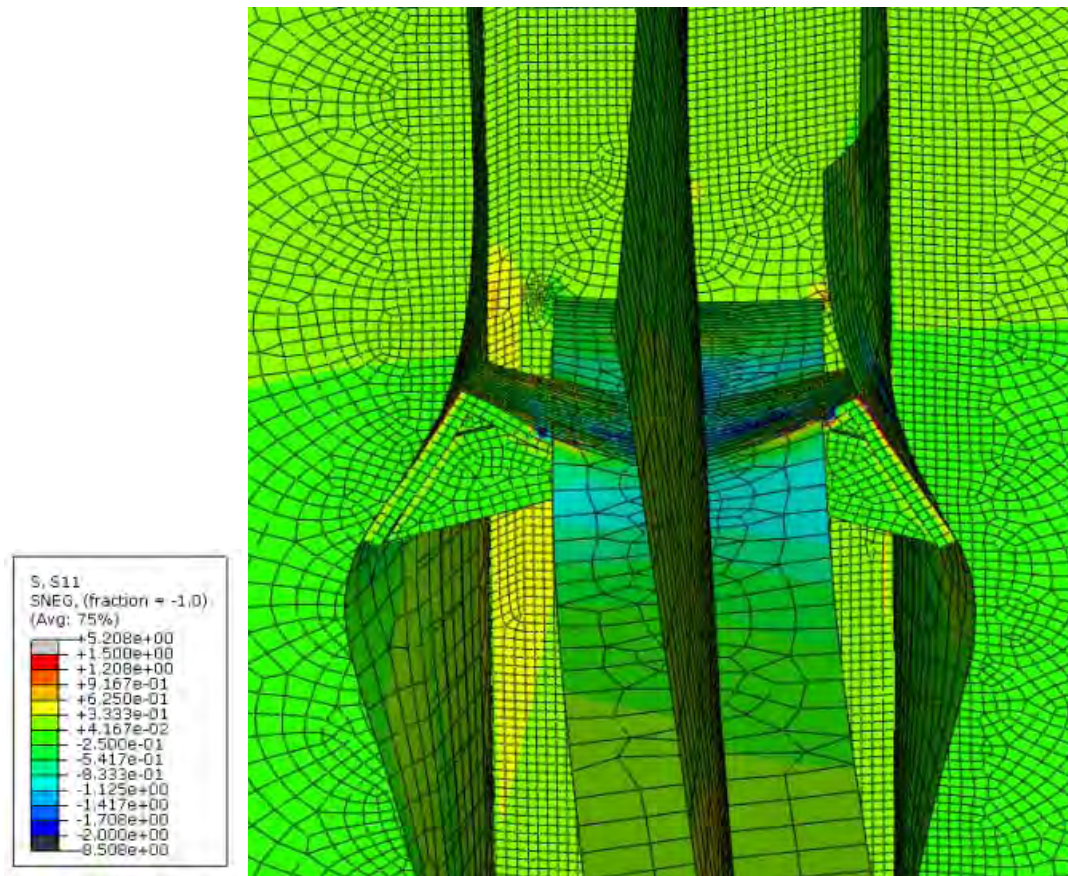
Figure 9.13: View of Connection in Deformed State with Retrofit Braces

Figure 9.13 shows a view of the connection in the deformed state with the retrofit braces and brackets. The stress contours in the gap between the bearing stiffeners and the bottom flange of the floor beam show that the magnitude of the stress in this area has decreased compared to Figure 9.9, which shows the connection without the retrofit. There are increased stresses in the bottom flange of the floor beam where the brackets are connected. These stresses are a result of the truck loads rotating the floor beam downward and the brackets pushing back up on the bottom flange. One possible way to reduce these stresses would be to place a continuous plate above both angle brackets between the brackets and the bottom floor beam flange. This would spread the stresses out and reduce the distortion that is seen in the bottom flange.
