## **Application of Ultrasonic Impact Treatment to In-Service Signal Mast Arms**

Amanda H. Palmatier  
Karl H. Frank

CTR Research Report:	5-4178-01-2
Report Date:	June 2005
Research Project:	5-4178-01
Research Project Title:	Ultrasonic Impact Treatment (UIT) for Traffic Signal Structure Fatigue Details
Sponsoring Agency:	Texas Department of Transportation
Performing Agency:	Center for Transportation Research at The University of Texas at Austin

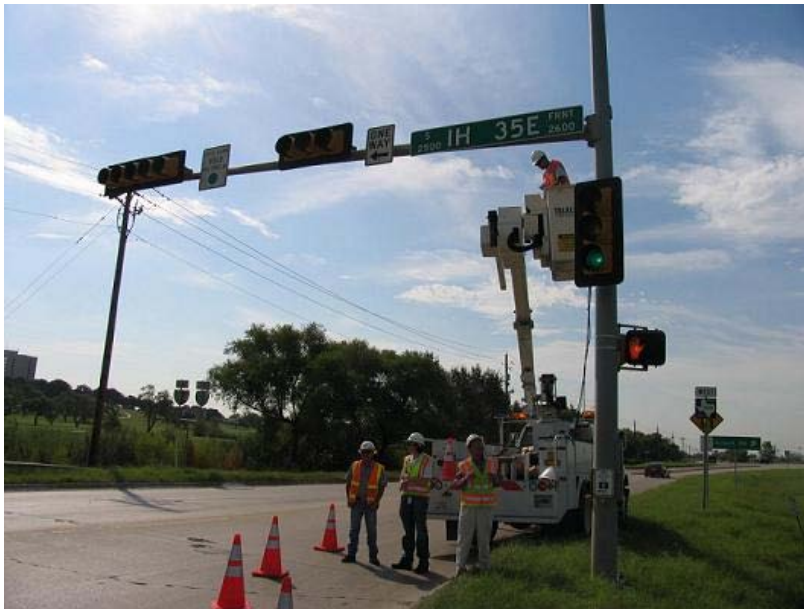
Mast arm 1, shown in Figure 2.2, is 24 feet long 7.5 inch diameter with an end plate bolt spacing of 6" x 10". Mast arm 2, shown in Figure 2.3, is 8 inch diameter 28 feet in length with an end plate bolt spacing of 7" x 11". Mast arm 2 has been in service for approximately 10 years. Mast arm 1 was replaced after a recent fatigue failure, and had been in service approximately one year at the time of treatment.

*Figure 2.3 Mast Arm 2 at the Southwest Corner of the South Intersection of I-35E and Bonnie Brae Street in Denton, TX*

The bolts used on Mast arm 2 interfered with UIT application, so the technician applied UIT as best as possible, and the TxDOT inspector found the application to be adequate. The UIT should be applied at a 45° angle each side of vertical, however this was not always possible and the UIT was applied as closely to a 45° angle as possible. The TxDOT inspector suggested using the UIT tool with a 15° angle that is available, but it was decided that technicians in the field would be unlikely to switch to a 15° angle UIT tool; therefore, the straight UIT machine was used in an effort to simulate typical field applications as accurately as possible.

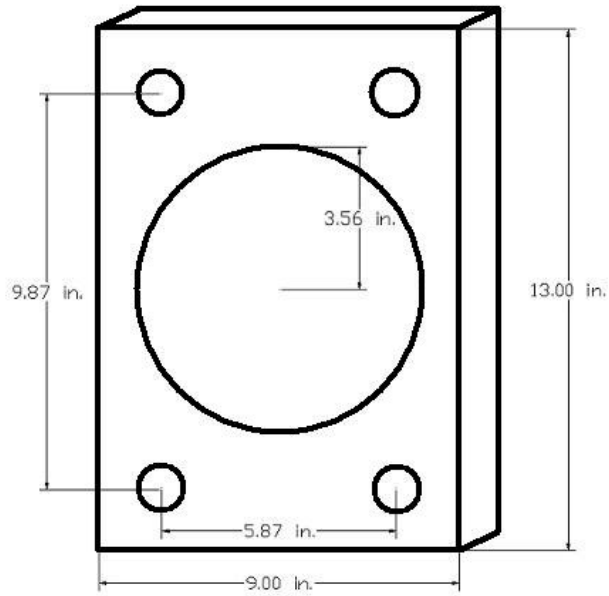
Mast arm DU was a 24-foot mast arm with thickness of 0.152 inch after removal of galvanizing, and a diameter of 7-1/2 inch at the 1 in. end plate. Mast arm DN was a 28-foot mast arm with thickness of 0.148 inch after removal of galvanizing, and a diameter of 8 inch at the 1-1/4 in. end plate. Figure 3.1 shows the dimensions of the mast arm DU endplate, and Figure 3.2 shows the dimensions of the mast arm DN endplate. The difference in end plate thickness and hole pattern as well as the difference in the arm diameters made comparison of the test results difficult.

*Figure 3.1 DU Mast Arm Endplate Dimensions, 1 in. Thick*

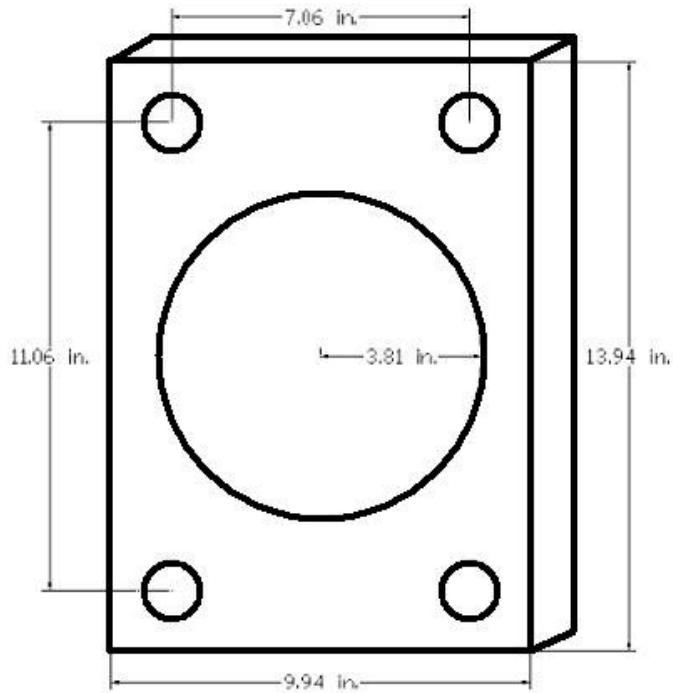
*Figure 3.2 DN Mast Arm Endplate Dimensions, 1-1/4 in. Thick*

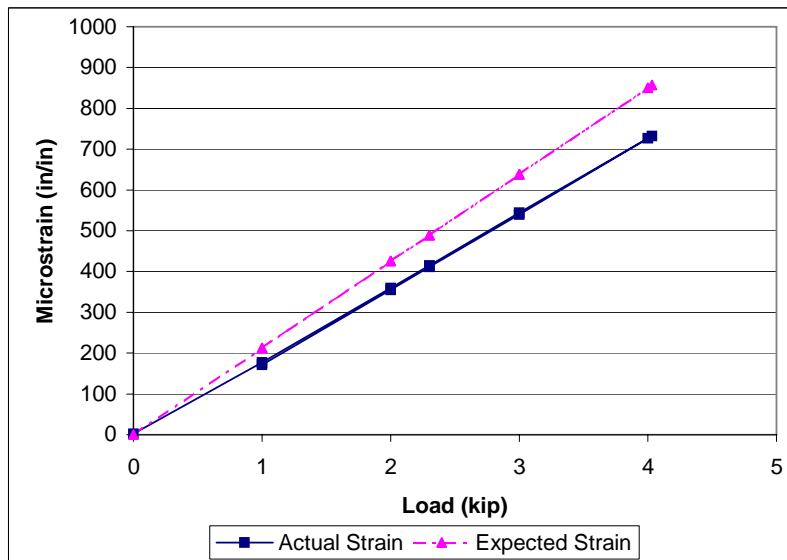
The results of the strain measurements at 3 inches from the mast arm-base plate weld were within 7.8% of the expected strains for the DU specimen and within 15.8% of the expected strains for the DN specimen. Figure 3.5 is a plot of load vs. strain for the DU static test, showing both measured and expected strains. Figure 3.6 is a plot of load vs. strain for the DN static test, showing both the measured and expected strains. Since the strain gauges were attached 3 inches from the mast arm weld toe, expected strains were calculated using the moment arm and diameter at the location of the strain gauge. The variation of the measured strain from the calculated strains is due to the local bending of the mast arm tubing wall due to the deformation in the end plate.

Figure 3.6 Actual and Expected Strain at 3 Inches from the Mast Arm Weld Toe of Specimen DN

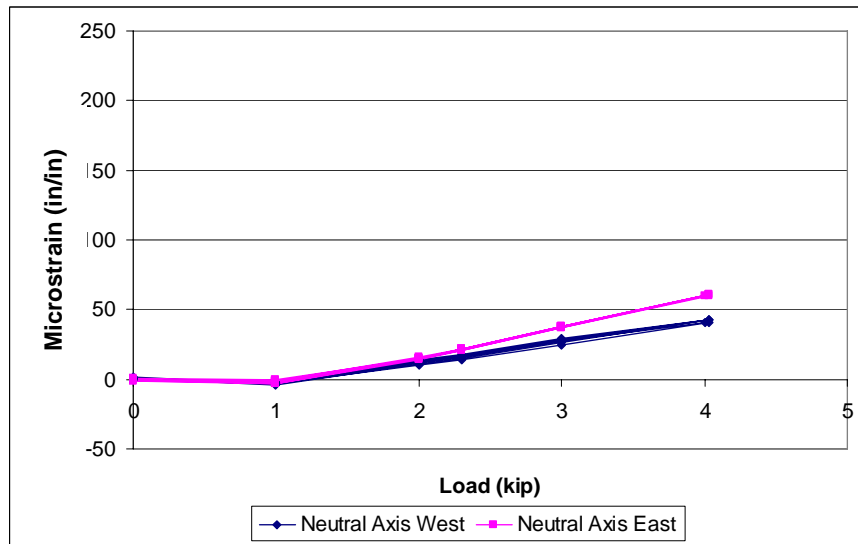
Figure 3.8 shows the strains on both the East and West side of the neutral axis of the DN end plate. Notice that the DU end plate has strains ranging to 225 in/in at 4.03 kip, while the thicker DN end plate has strains ranging to only about 61 in/in at 4.03 kip. The DU end plate was only 1 inch thick, while the DN end plate was 1-1/4 inches thick. The additional 1/4 inch of the DN end plate increases the stiffness of the end plate that reduces the stress at the mast arm weld toe.

Figure 3.8 Strain at the Mid-Height of Baseplate DN

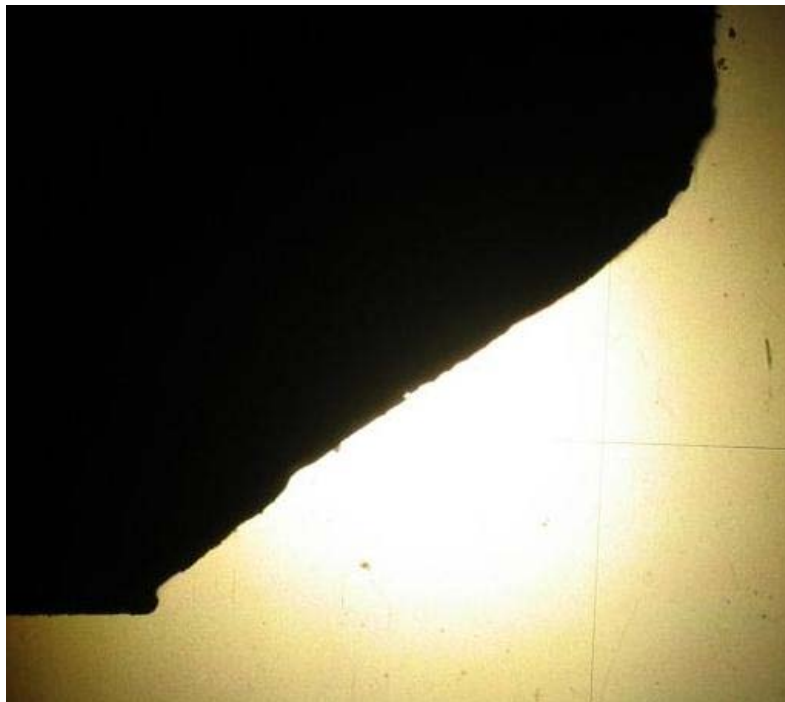
Molds were made of mast arm weld profiles before and after UIT application. The molds were made as described in reference 1. Figure 3.18 shows a typical weld, pointing out the locations of the long and short leg. All measurements of the weld legs were made with the Mitutoyo Profile Projector, Model PJ250. The Profile Projector projected a 10x magnification of the weld mold onto a screen with cross hairs. From this projection, a digital readout with accuracy of 0.0001 inch was used to measure the lengths of the weld legs. Figure 3.19 shows the weld profile of a typical mast arm at 10x magnification.

*Figure 3.19 10x Magnification of Mast Arm Weld Before UIT*
