| 4. Title and Subtitle<br><br>TEXAS MODEL BORDER CROSSING PROJECT:<br>RETROFIT REPORT | | 5. Report Date<br>February 2003 | |
| 12. Sponsoring Agency Name and Address<br>Texas Department of Transportation<br>Research and Technology Implementation Office<br>P.O. Box 5080<br>Austin, TX 78763-5080 | | 13. Type of Report and Period Covered<br>Implementation Report<br>September 2000–February 2003 | |

## Texas Model Border Crossing Project: Retrofit Report

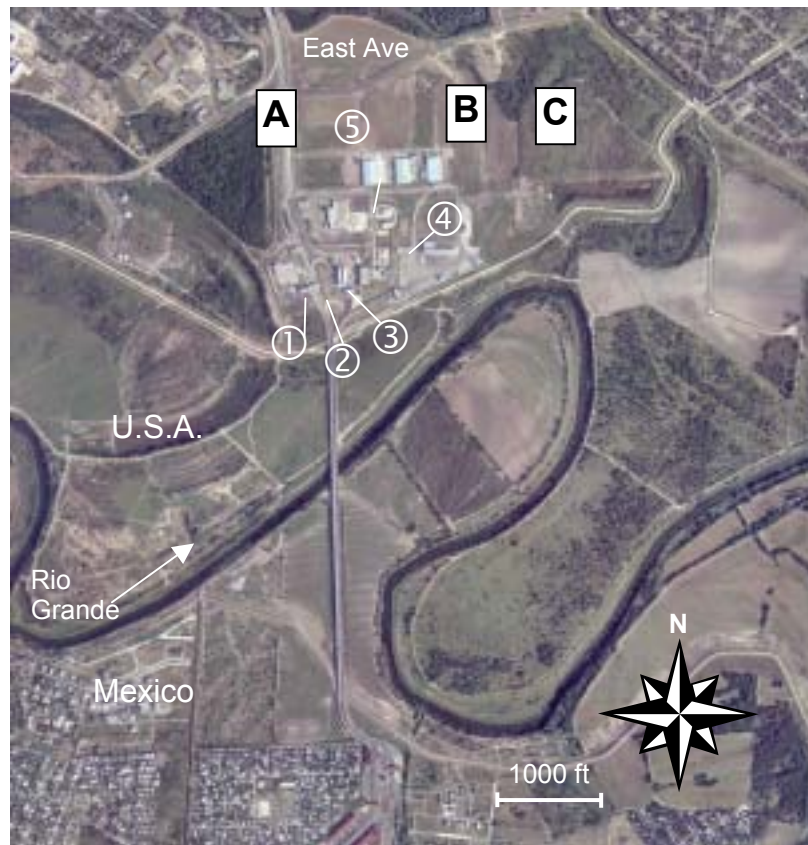
**Figure 2-1. Veterans International Bridge at Los Tomates**

The Veterans International Bridge at Los Tomates border crossing is located at the south terminus of US 77/83 in Brownsville, Texas. The bridge provides four lanes (two in each direction). The federal compound is surrounded by the Rio Grande on the south side and by a mix of undeveloped and planned industrial land on the remaining sides. Details of the border crossing facility are shown in Figures 2-1 to 2-6.

TxDOT has explored three options for the location of the state safety inspection facility. Figures 2-1, 2-2, 2-5, and 2-6 show the potential locations that TxDOT is currently evaluating.

Letters indicate potential location of the state safety inspection facility ("Site Selection Study" 2001). Numbers indicate locations for automated processing on the prototype border crossing model (see Fig 1-1).

\* (see Figs 2-1 and 2-2)

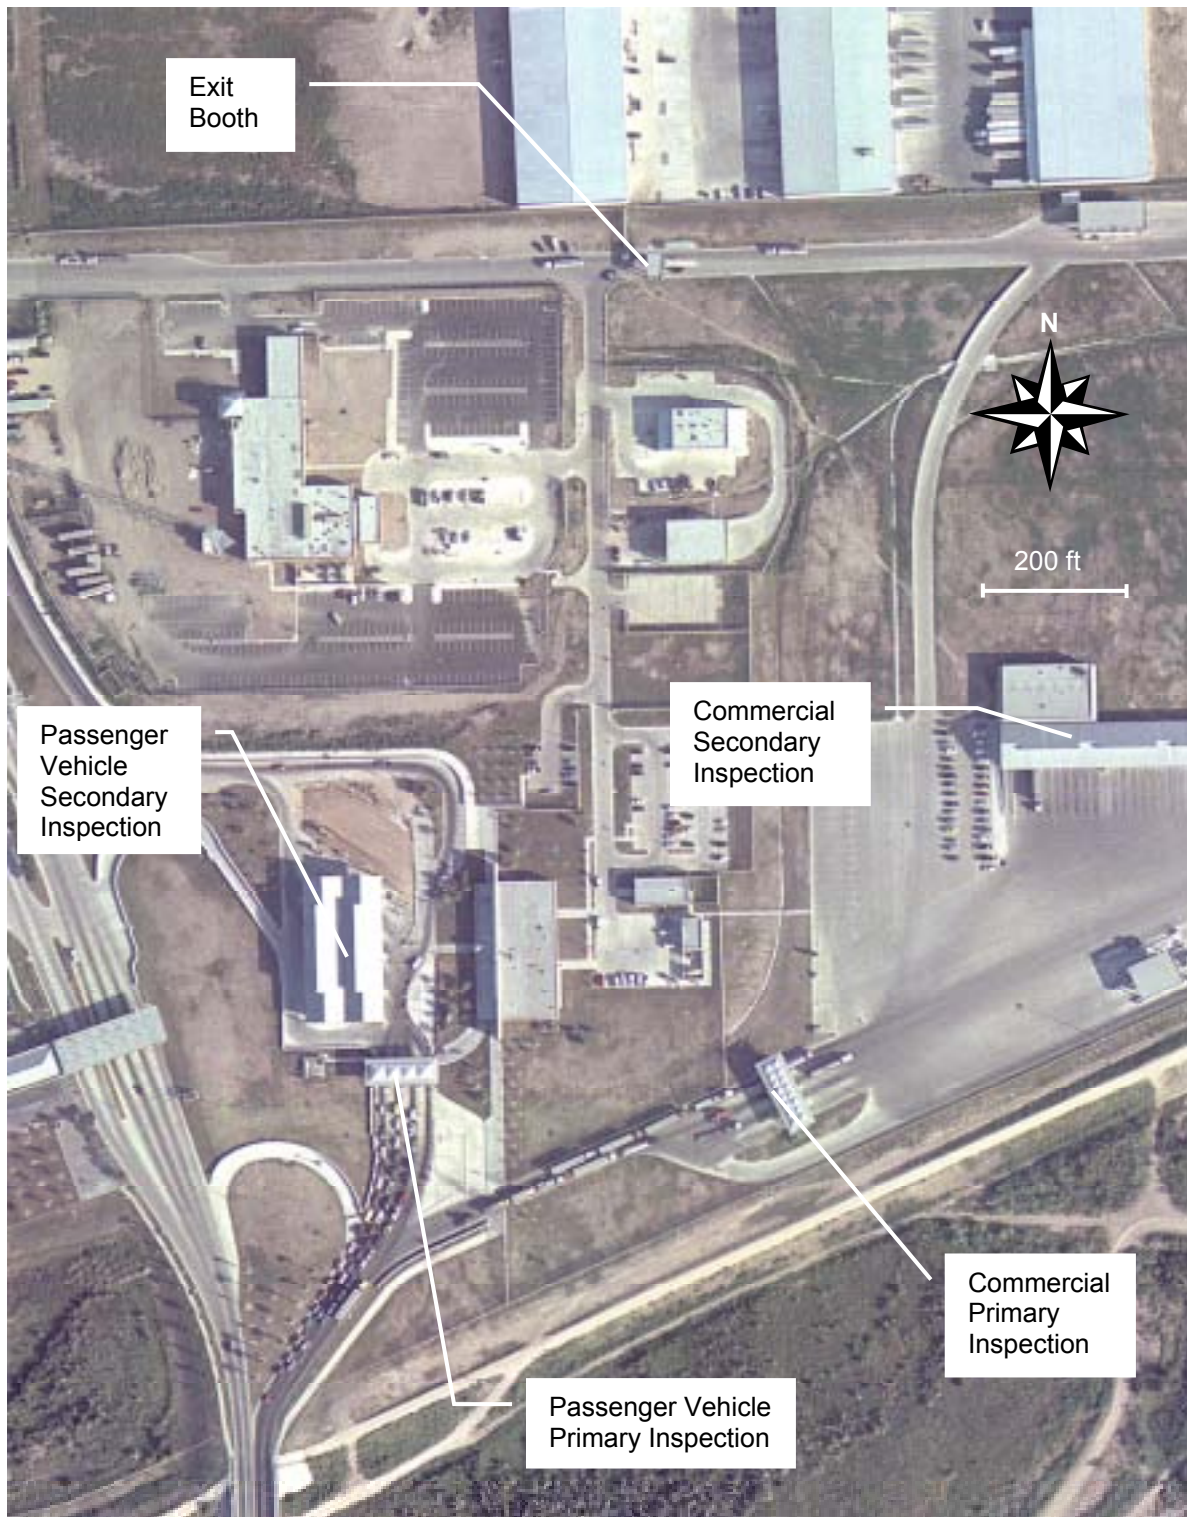
**Figure 2-3. Veterans International Bridge at Los Tomates: primary and secondary inspection stations**

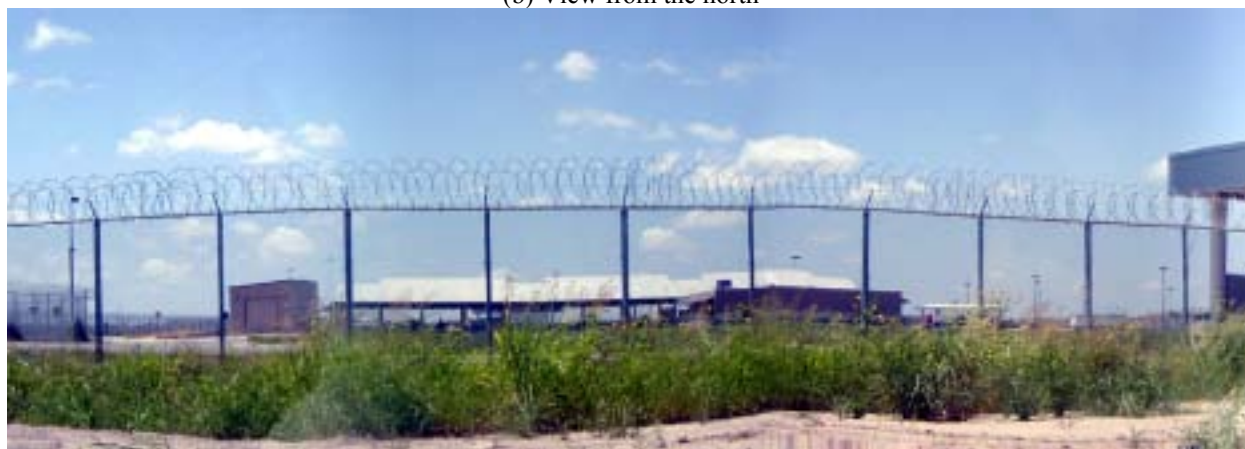
(a) Plan view \*

(b) View from the north

**Figure 2-4. Veterans International Bridge at Los Tomates:  
secondary inspection station and X-Ray facility**

\* Note: In this and all subsequent figures, the presence of a camera icon indicates the location from which an accompanying ground-level picture was taken.

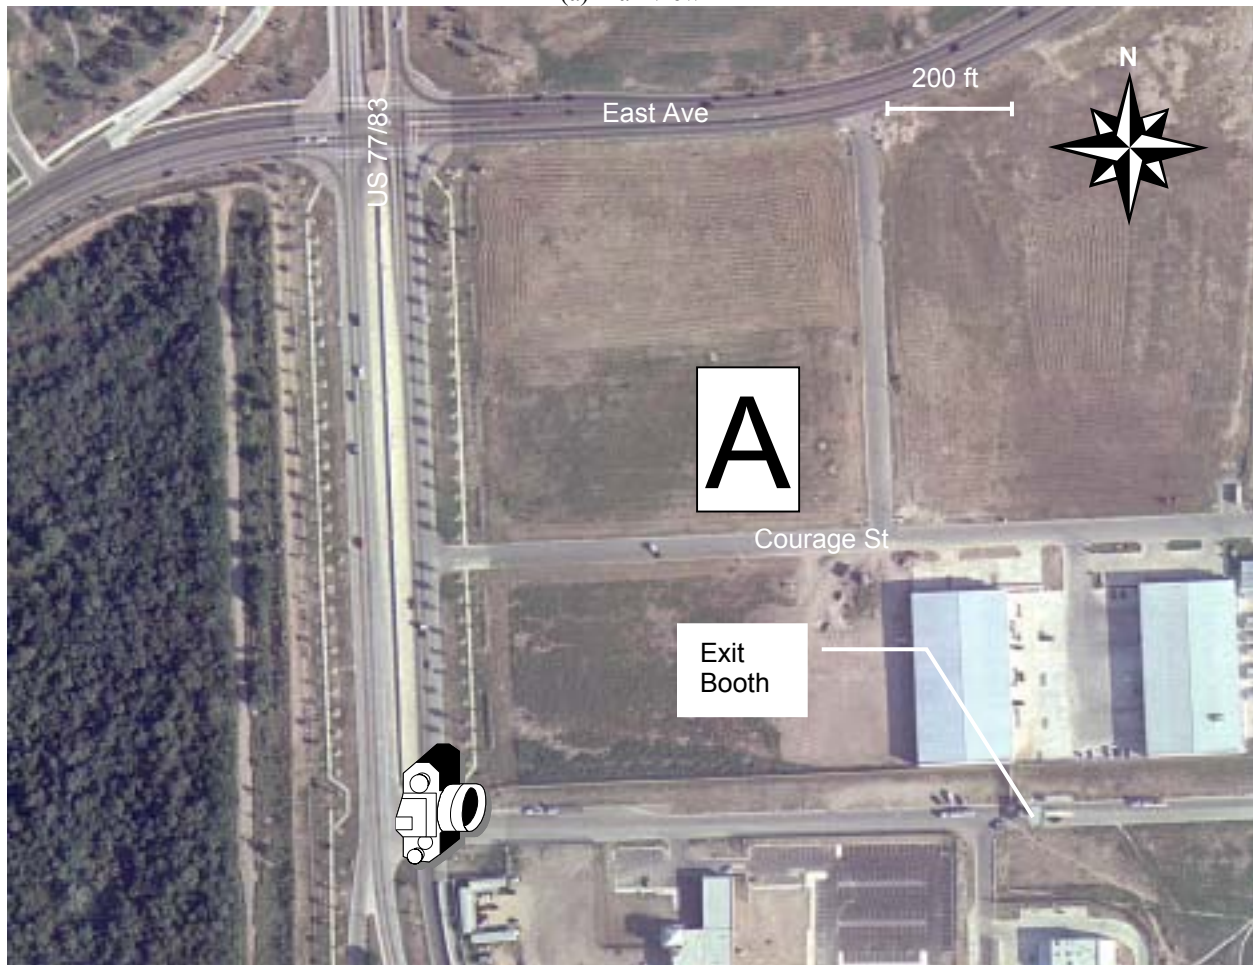
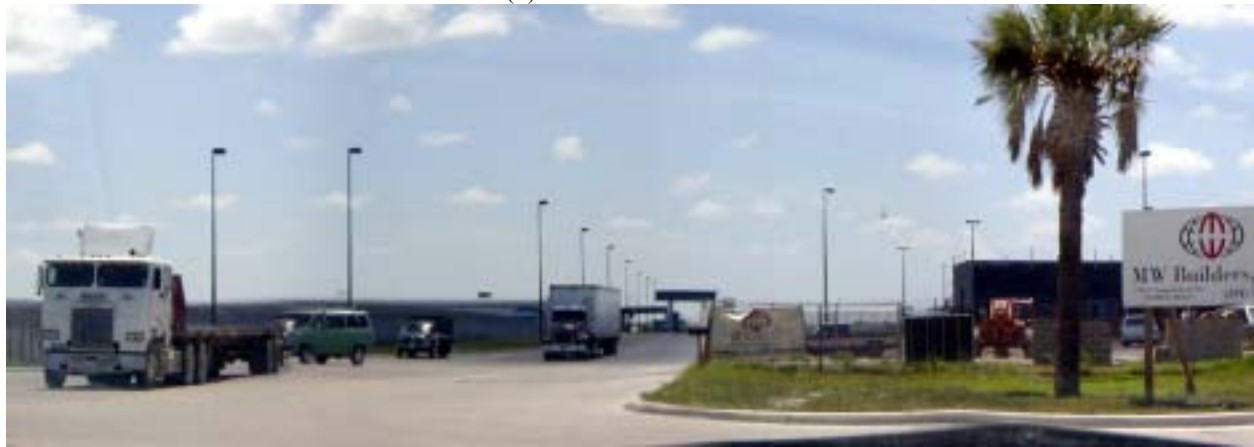
Letter "A" indicates potential location of the state safety inspection facility ("Site Selection Study" 2001).

(b) View from the west

**Figure 2-5. Veterans International Bridge at Los Tomates: commercial vehicle exit**

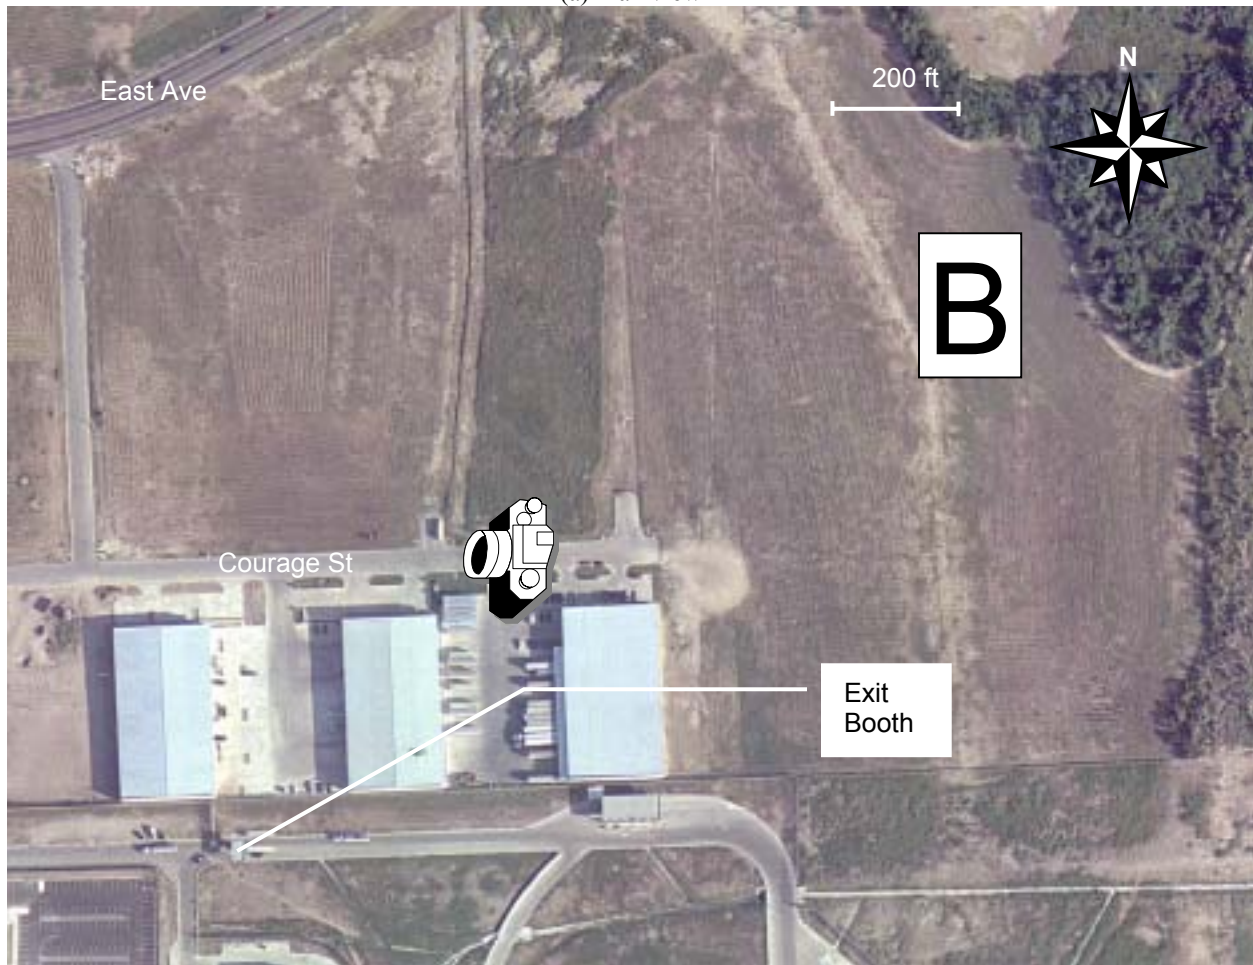
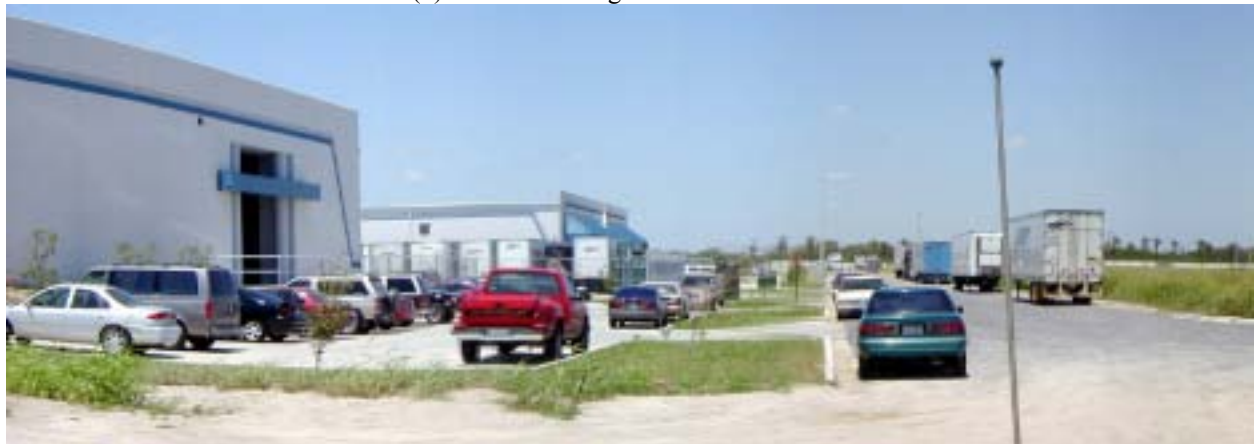
Letter “B” indicates potential location of the state safety inspection facility (“Site Selection Study” 2001).

(b) View of Courage Street from the east

**Figure 2-6. Veterans International Bridge at Los Tomates: area around commercial exit booth**

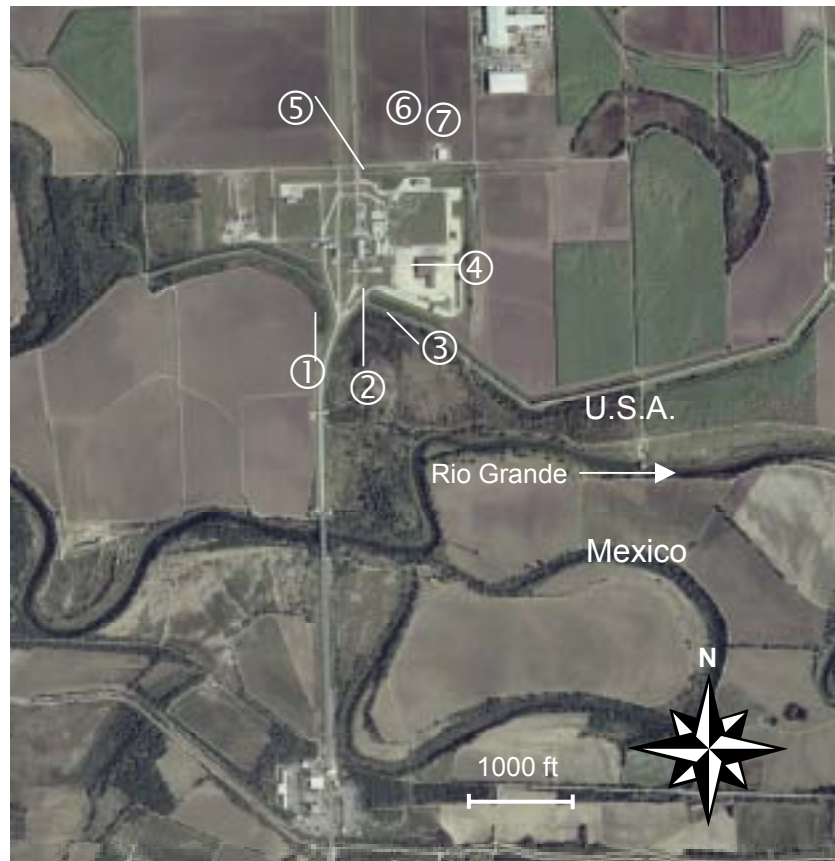
**Figure 3-1. Free Trade Bridge at Los Indios**

The Free Trade Bridge border crossing is located on FM 509, roughly 0.2 miles south of US 281. The bridge is about 0.3 miles long and has a four-lane cross section (two in each direction). The federal compound is surrounded by a levee parallel to the Rio Grande on the south side, by Rio Grande Avenue on the north side, and by agricultural land on the west and east sides. North of Rio Grande Avenue the land use is largely agricultural with some scattered warehouse development. Details of the border crossing facility are shown in Figures 3-1 to 3-6.

Numbers indicate locations for automated processing on the prototype border crossing model (see Fig 1-1).

A comparison between the actual layout of the Free Trade Bridge at Los Indios border crossing facility (Figs 3-1 and 3-2) and the prototype border crossing (Fig 1-1) leads to the following observations (Table 3-1):

\* (see Figs 3-1 and 3-2)

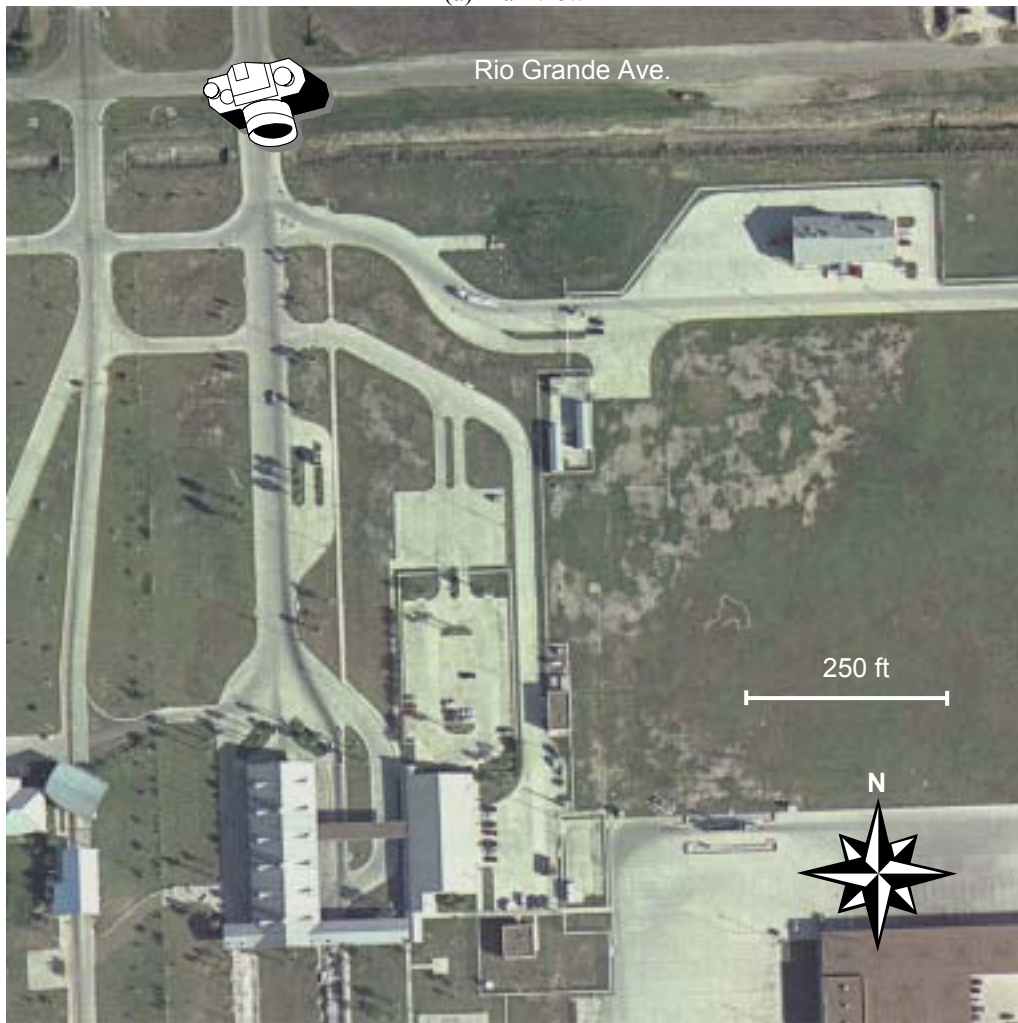
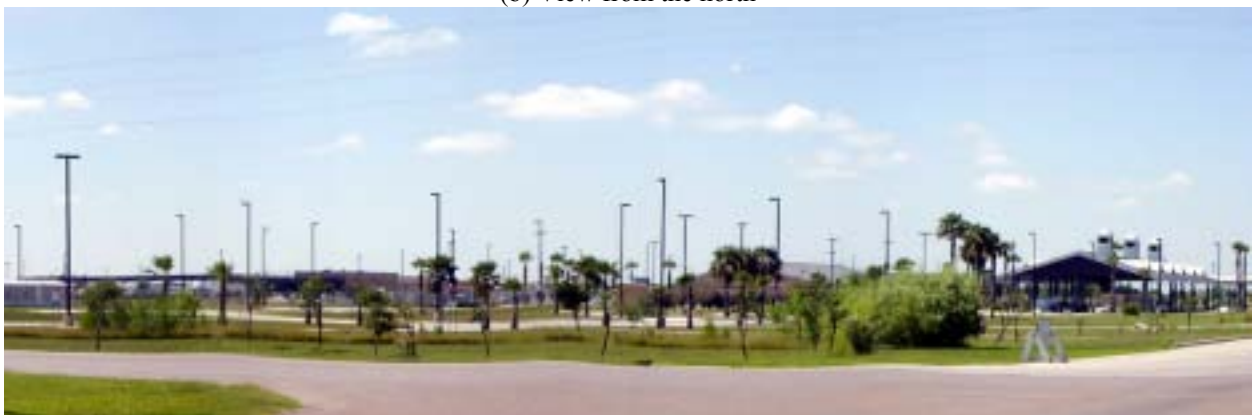
(a) Plan view

(b) View from the north

**Figure 3-3. Free Trade Bridge at Los Indios: exit from federal compound**

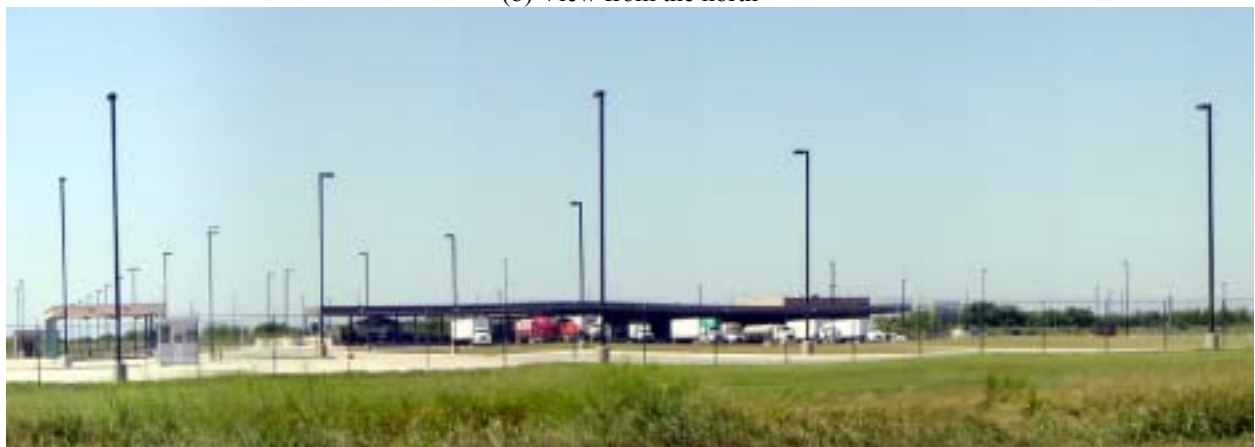
(a) Plan view

(b) View from the north

**Figure 3-4. Free Trade Bridge at Los Indios: secondary inspection station**

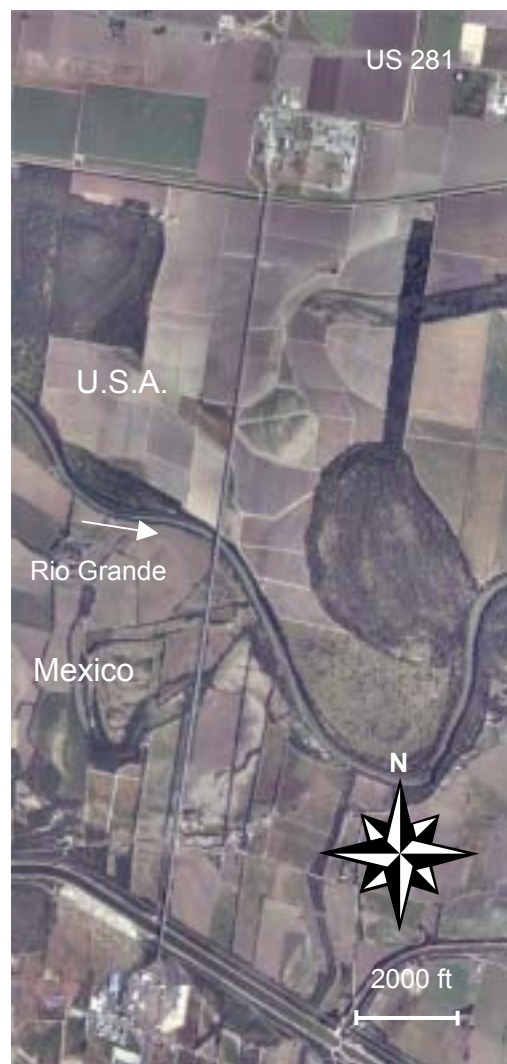
**Figure 4-1. Pharr-Reynosa International Bridge on the Rise**

The Pharr-Reynosa International Bridge on the Rise border crossing is located on Spur 600, roughly 1,500 ft south of US 281. The bridge is a viaduct about 3 miles long and has a four-lane cross section, with three northbound lanes and one southbound lane. The federal compound is surrounded by agricultural land on all sides. Details of the border crossing facility are shown in Figures 4-1 to 4-5.

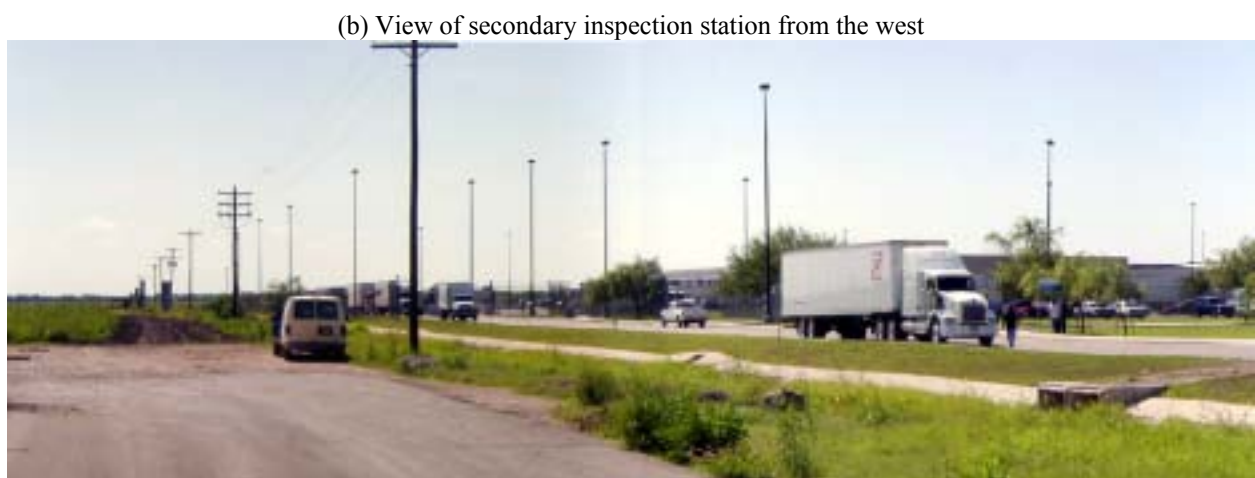
**Figure 4-4. Pharr-Reynosa International Bridge on the Rise: commercial secondary inspection station and exit booth**

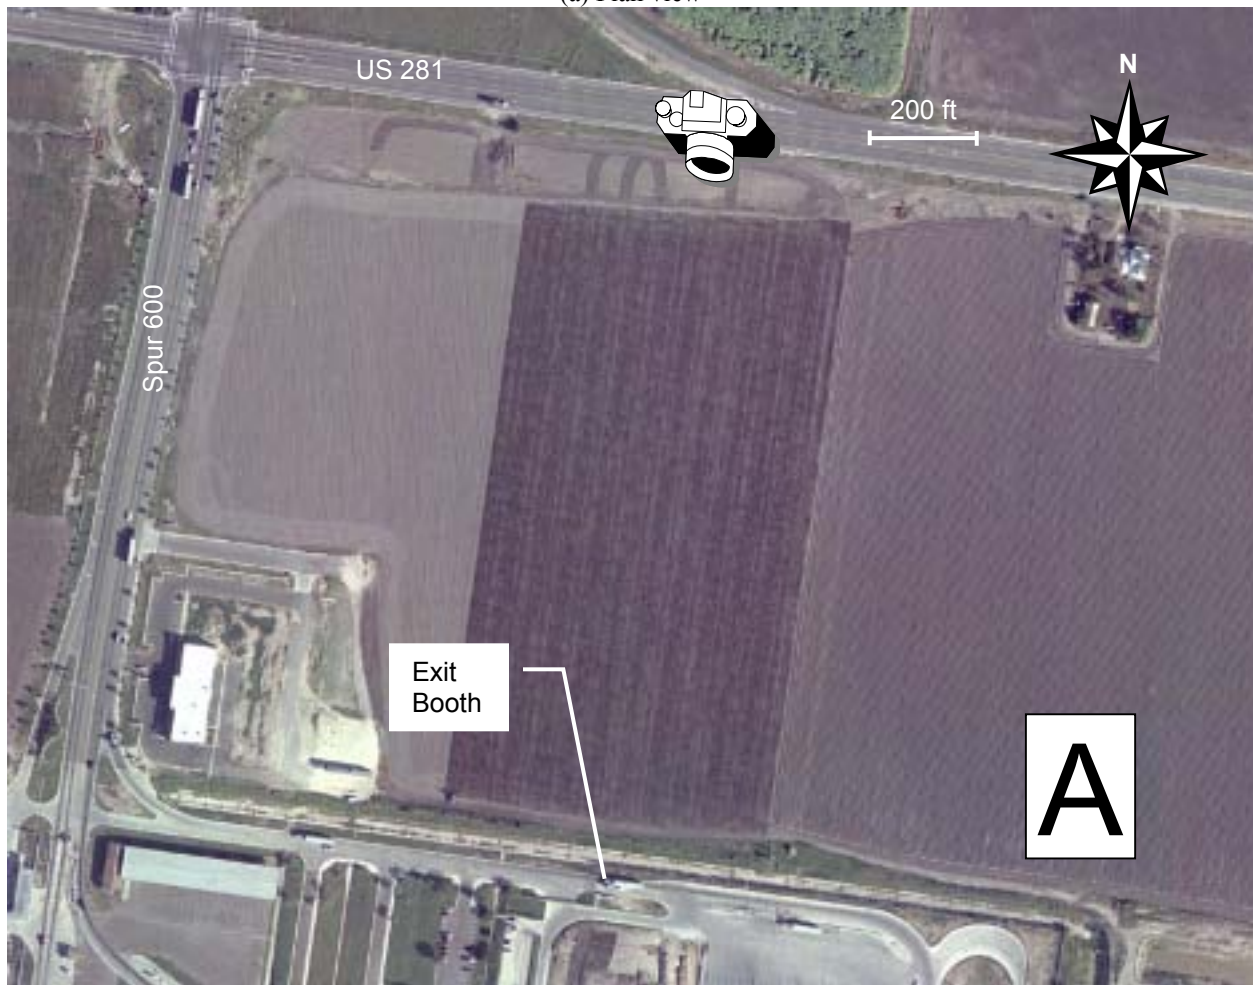
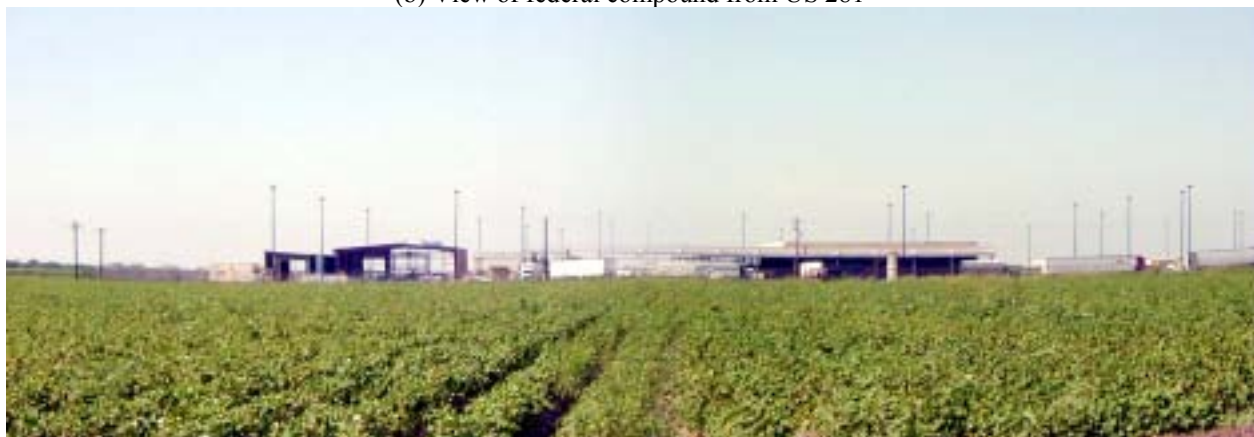
(a) Plan view

(b) View of federal compound from US 281

**Figure 4-5. Pharr-Reynosa International Bridge on the Rise: exit booth and potential location of the state safety inspection facility (“Site Selection Study” 2001)**

TxDOT has explored several options for the location of the state safety inspection facility. Figures 4-2 and 4-5 show the potential locations that TxDOT is currently evaluating.

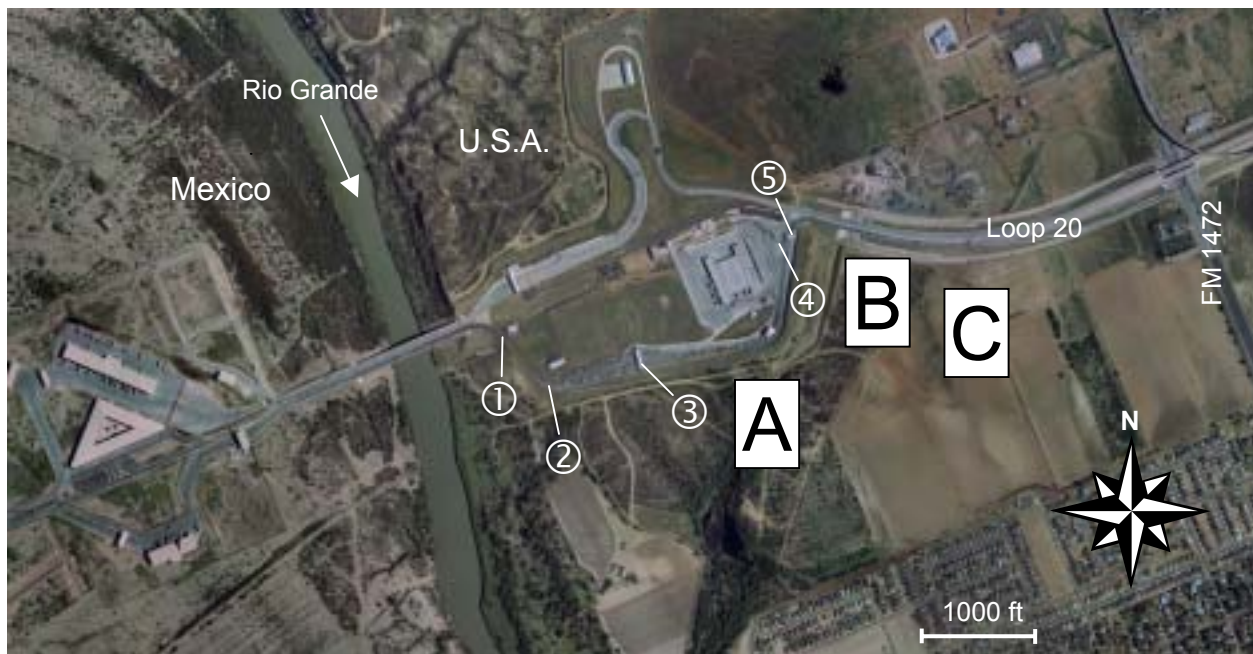
**Figure 5-1. World Trade Bridge in Laredo**

The World Trade Bridge border crossing is located at the west terminus of Loop 20 in northwest Laredo. The bridge is located about 1.5 miles west of FM 1472. The bridge provides eight lanes (four in each direction) that are currently dedicated to commercial traffic. The federal compound, which is located on top of an earth fill is surrounded by the Rio Grande on the west side, and by a mix of industrial facilities and undeveloped areas on the north, south, and east sides. Details of the border crossing facilities are shown in Figures 5-1 to 5-5.

TxDOT is considering three alternatives for locating a state safety inspection facility. Figures 5-1, 5-2, 5-5, and 5-6 show the alternative locations that currently are being evaluated.

Letters indicate potential locations of the state safety inspection facility (“Site Selection Study” 2001). Numbers indicate locations for automated processing on the prototype border crossing model (see Fig 1-1).

\* (see Figs 5-1 and 5-2)

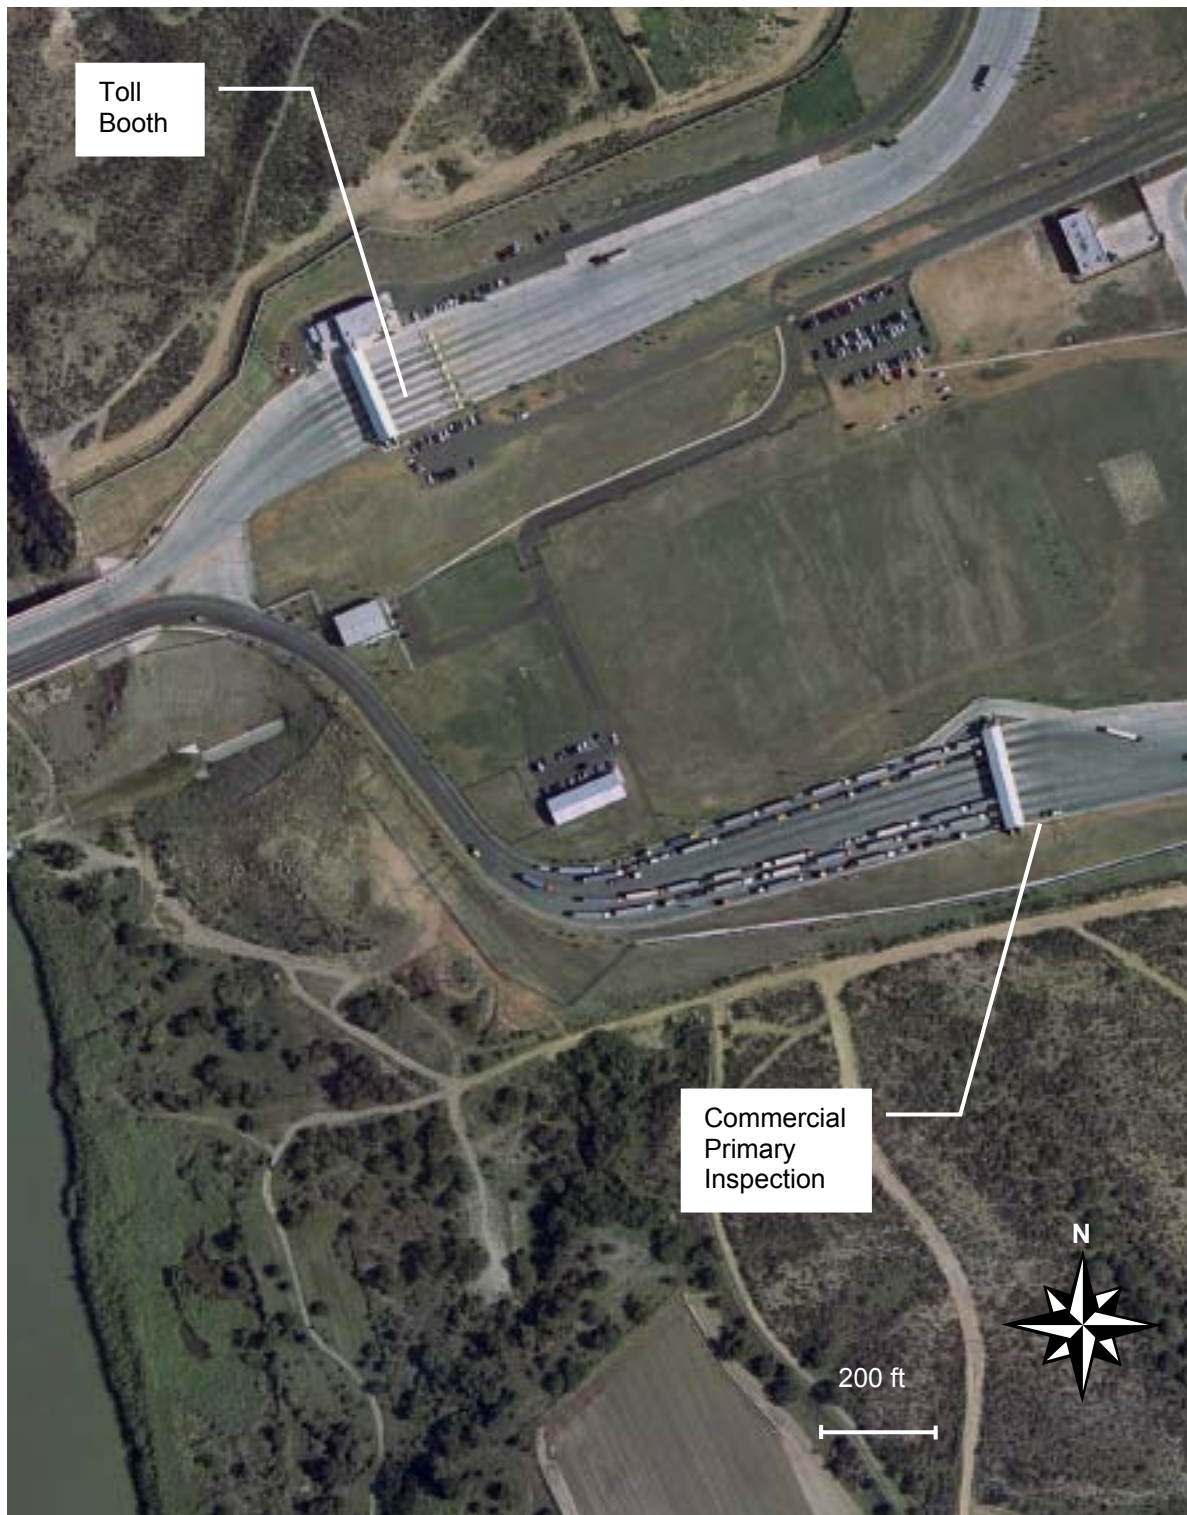
**Figure 5-3. World Trade Bridge: primary inspection station**

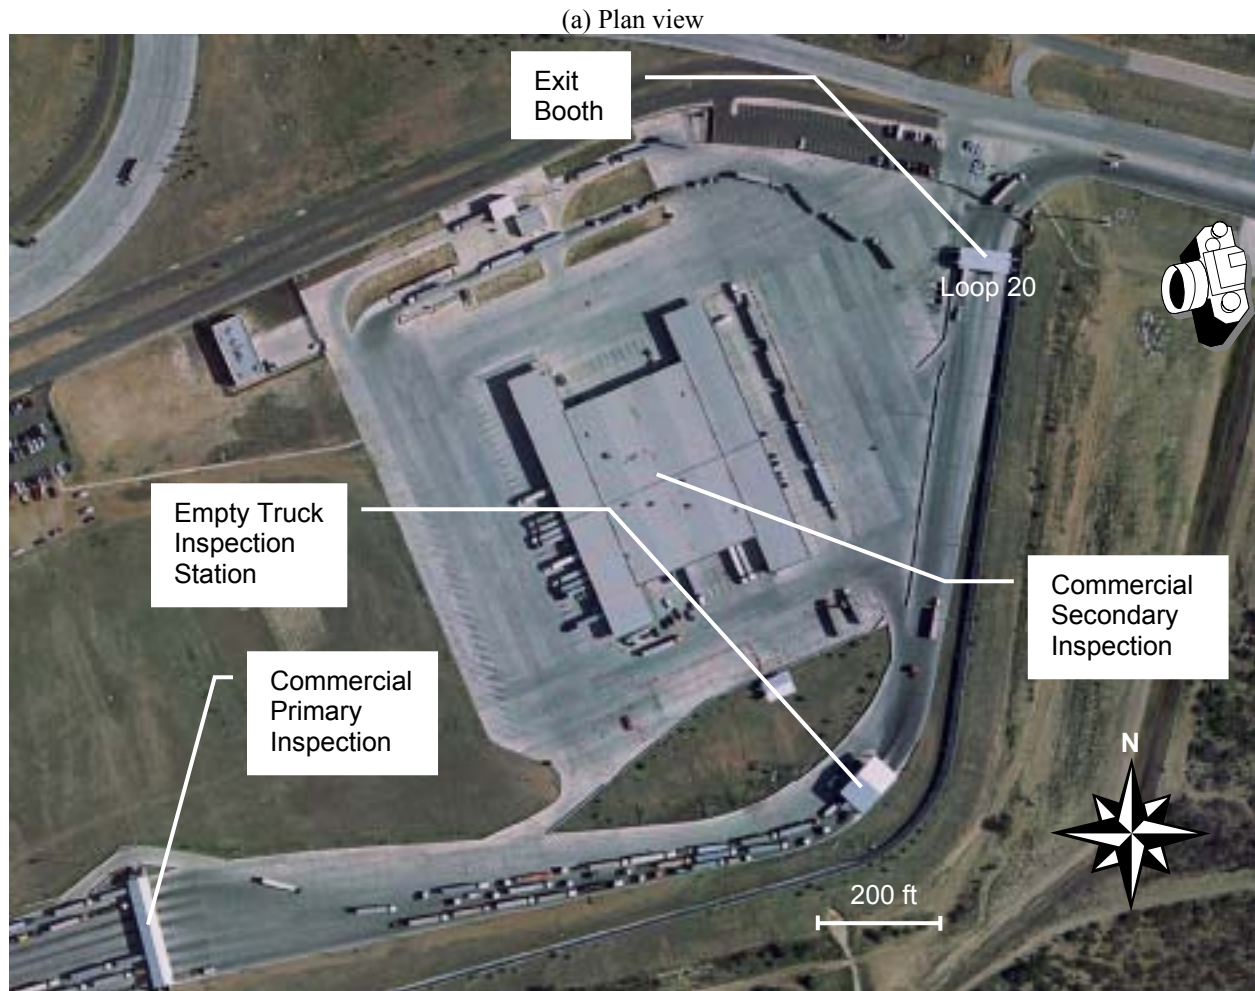
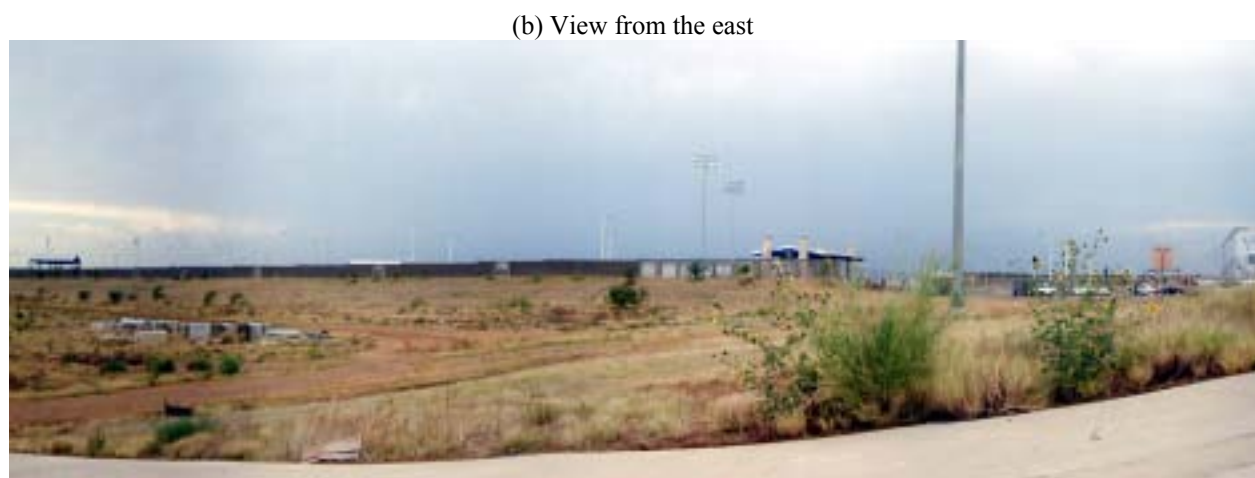
**Figure 5-4. World Trade Bridge: empty truck inspection station, secondary inspection station, and exit booth**

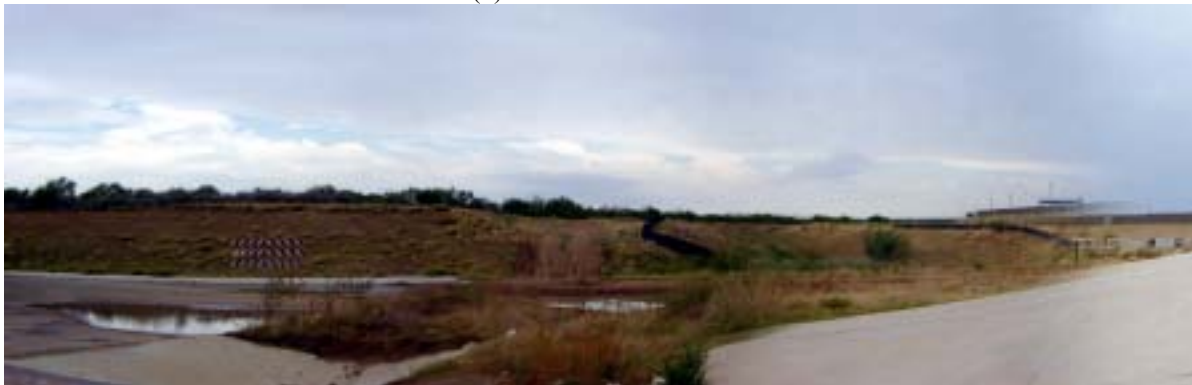
(a) Plan view

(b) View from the north

**Figure 5-5. World Trade Bridge: drainage channel and low area east of the federal compound, and potential sites “B” and “C” for state safety inspection facility (“Site Selection Study” 2001)**

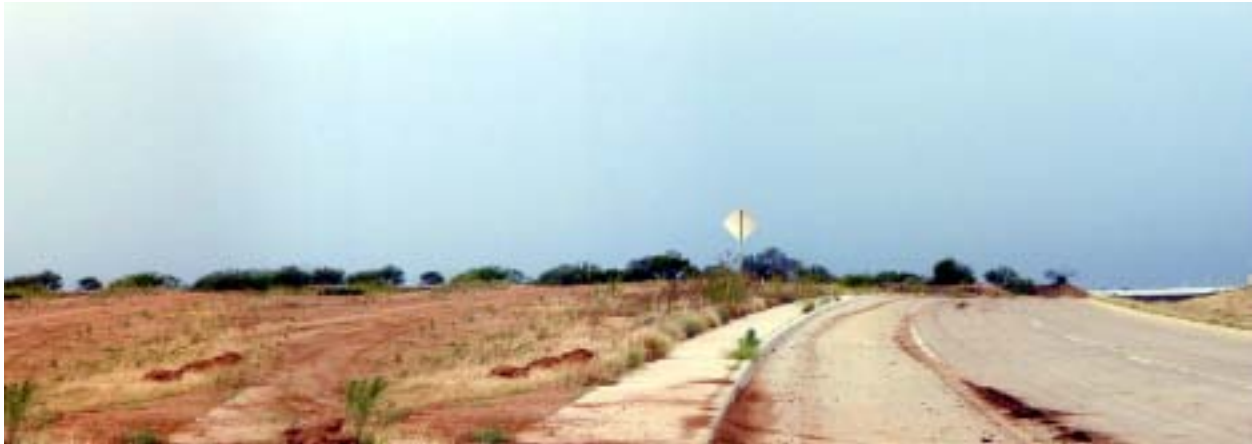
View from the northeast

**Figure 5-6. World Trade Bridge: potential site “C” for state safety inspection facility (“Site Selection Study” 2001)**

- Unlike other border crossing locations, there seems to be strong local opposition to the idea of building a state safety inspection facility in the immediate vicinity of the federal compound. According to TxDOT Laredo District officials, the opposition is particularly strong from the owner of the tract of land located on the southwest corner of the Loop 20 and FM 1472 interchange, who already has plans for developing the land (as shown in Fig 5-6).

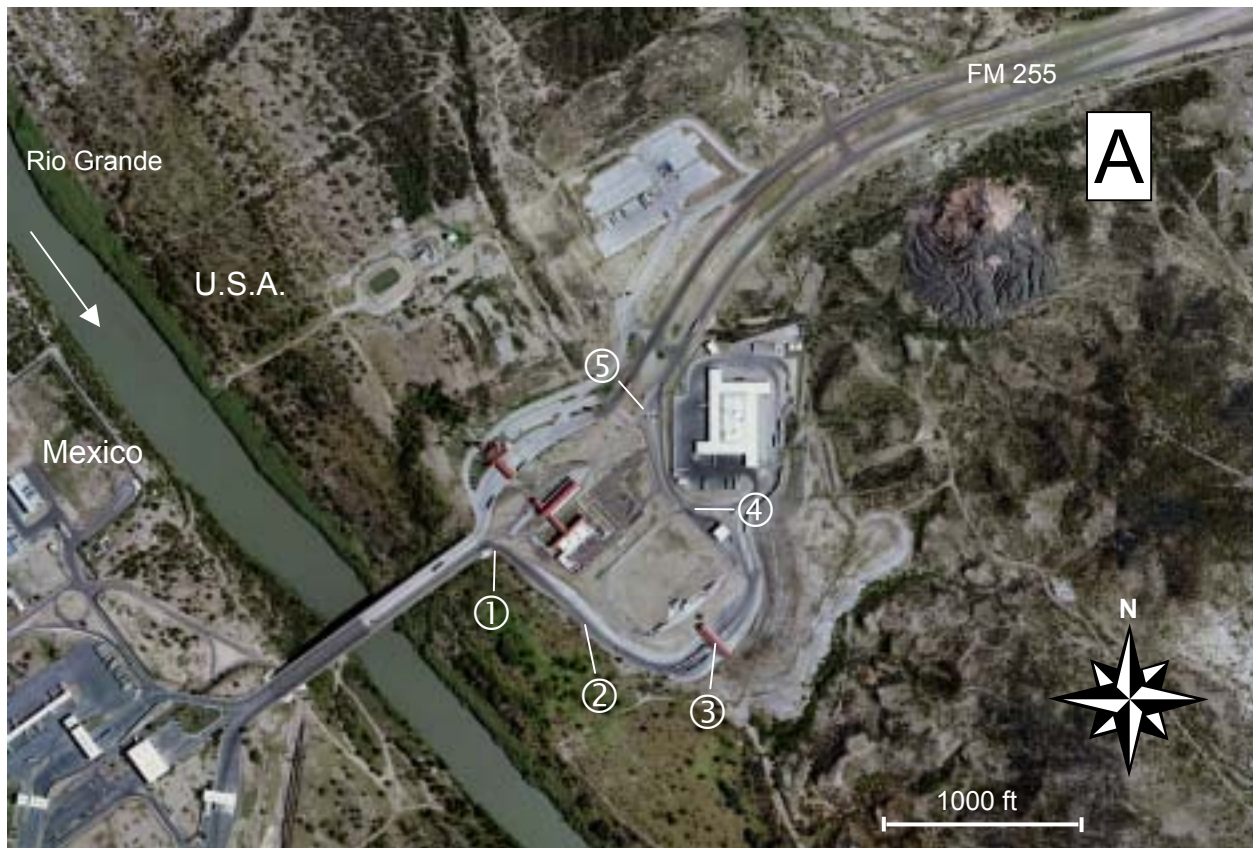
**Figure 6-1. Laredo-Colombia Solidarity Bridge in Laredo**

The Laredo-Colombia Solidarity Bridge border crossing is located 25 miles northwest of Laredo, slightly over a mile southwest of FM 1472. FM 255 connects the border crossing with FM 1472 and the recently built Camino Colombia toll road. The bridge provides eight lanes (four in each direction). The two right lanes in the northbound direction feed the commercial vehicle federal inspection facility. The federal compound is surrounded by the Rio Grande on the southwest side and by undeveloped land on the remaining sides. Details of the border crossing facility are shown in Figures 6-1 to 6-5.

TxDOT has explored several options for the location of the state safety inspection facility. Because of the existence of mine tailings and tunnels in the area, the number of potential locations appears to be limited. Figures 6-1 and 6-5 show a potential location that TxDOT is currently evaluating.

Numbers indicate locations for automated processing on the prototype border crossing model (see Fig 1-1).  
Letter "A" indicates potential location of the state safety inspection facility ("Site Selection Study" 2001).

- Figures 6-1 and 6-5 show the location of a potential state safety inspection facility being considered by TxDOT. According to information provided by TxDOT officials, this location minimizes the amount of earth work required for the construction of the facility while still providing access to both FM 1472 and the Camino Colombia toll road. A secure link from the federal inspection compound to Site “A” would require either a parallel road along the east side of FM 255 or, given the wide right-of-way occupied by FM 255, relocating the FM 255 roadbeds to the northwest to provide additional space within the right-of-way for the link to the state safety inspection facility. If the main lanes on FM 255 could be moved to the northwest, there is a possibility the state safety inspection facility could be located right next to the federal compound (Alternative “B” in Figure 6-5). This alternative would reduce the length of the secure link between the two facilities and the amount of land to acquire for the state safety inspection facility.

\* (see Figs 6-1 and 6-2)

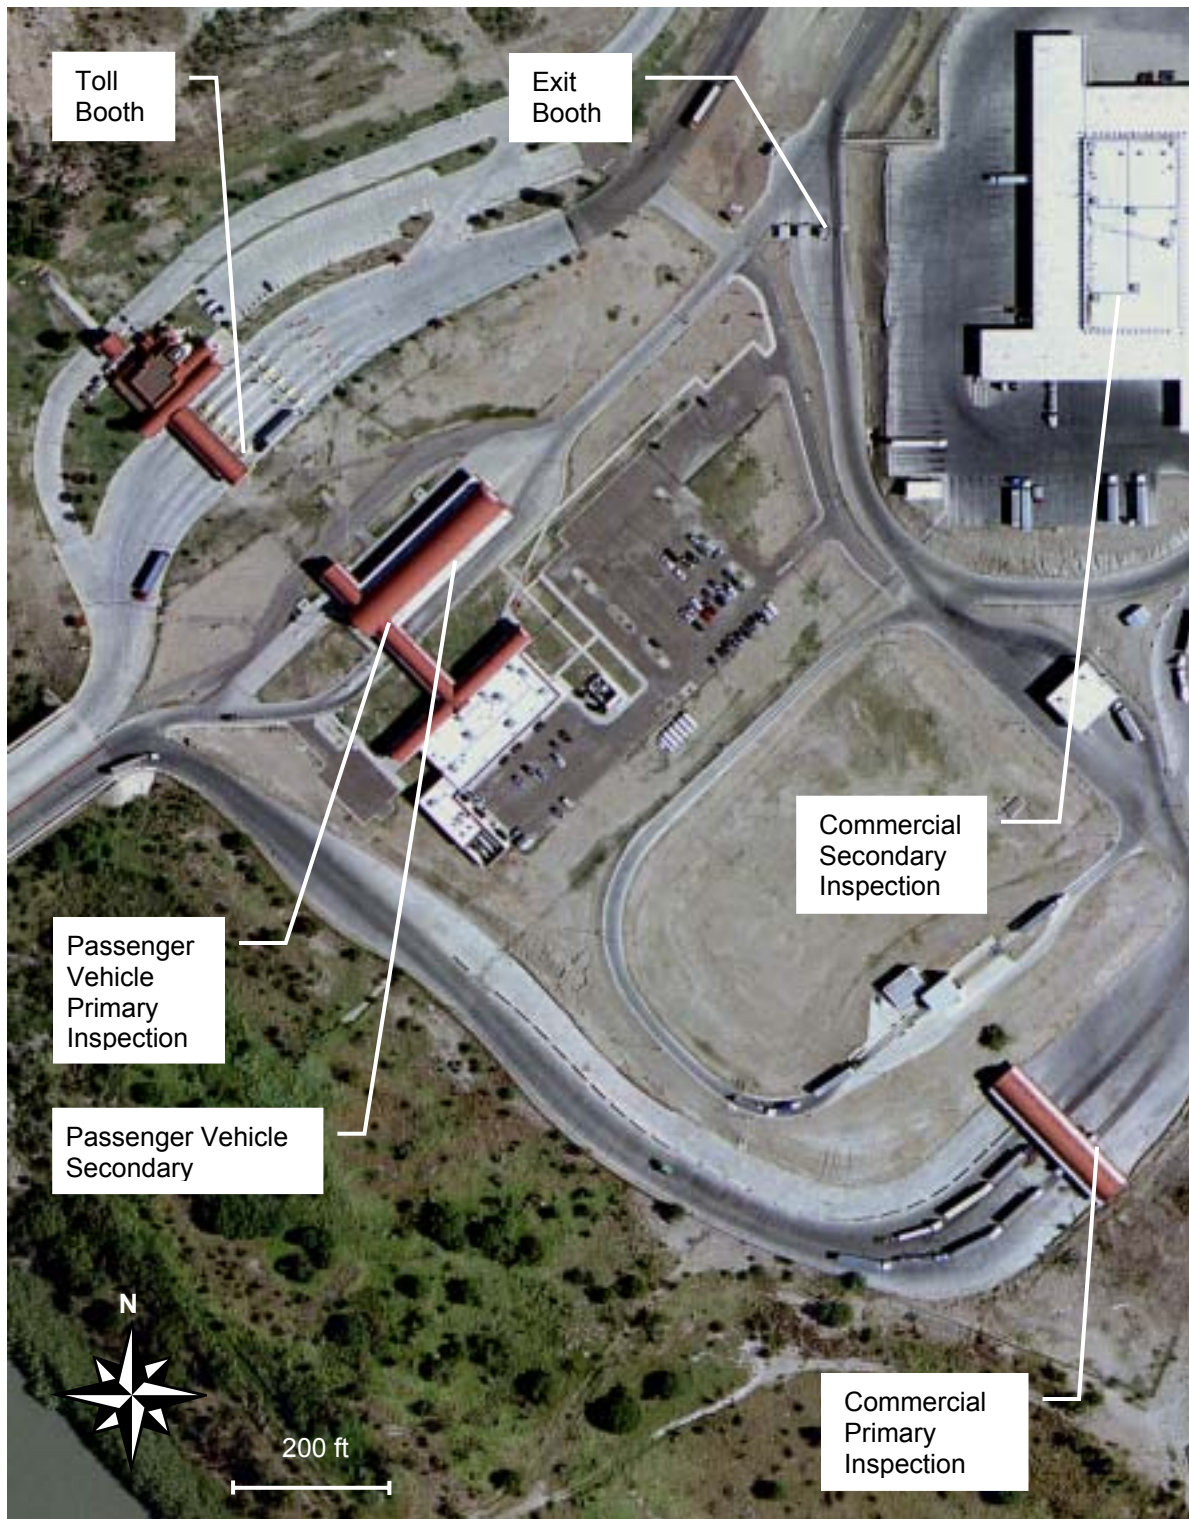
**Figure 6-3. Laredo-Colombia Solidarity Bridge: primary and secondary inspection stations**
