| 4. Title and Subtitle<br><br>TEXAS MODEL BORDER CROSSING PROJECT:<br>RETROFIT REPORT | | 5. Report Date<br>February 2003 | |
| 12. Sponsoring Agency Name and Address<br>Texas Department of Transportation<br>Research and Technology Implementation Office<br>P.O. Box 5080<br>Austin, TX 78763-5080 | | 13. Type of Report and Period Covered<br>Implementation Report<br>September 2000–February 2003 | |

## Texas Model Border Crossing Project: Retrofit Report

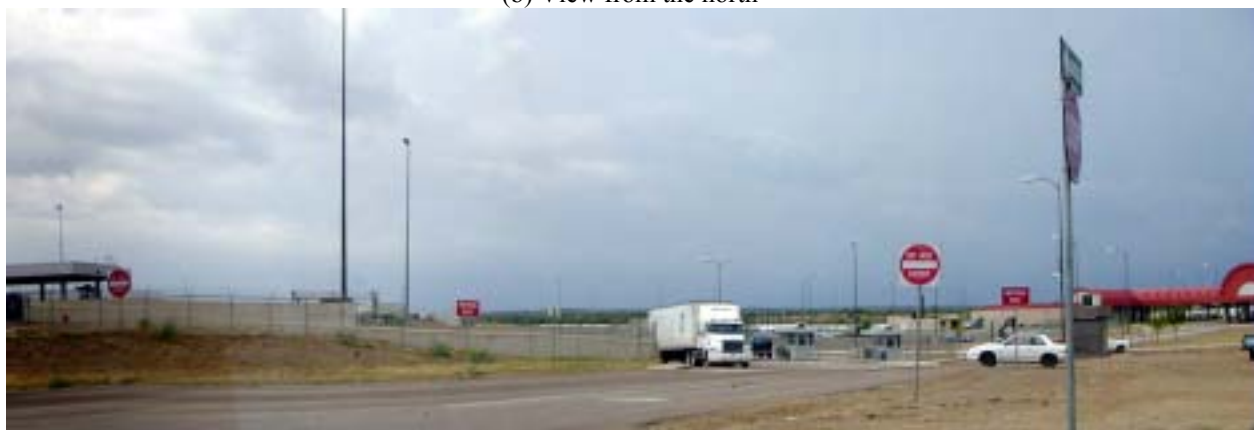
(a) Plan view

(b) View from the north

**Figure 6-4. Laredo-Colombia Solidarity Bridge: secondary inspection station and exit booth.**

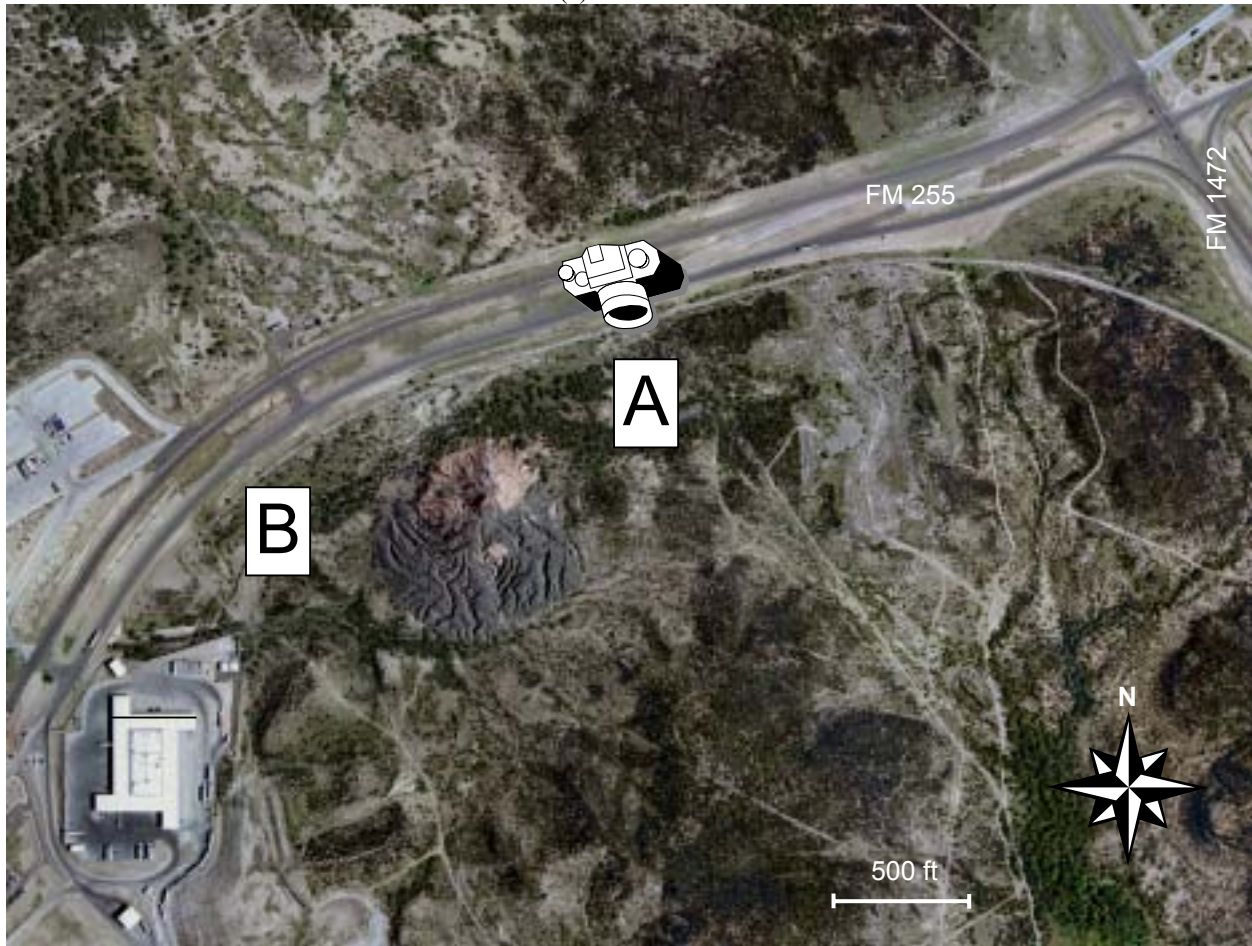
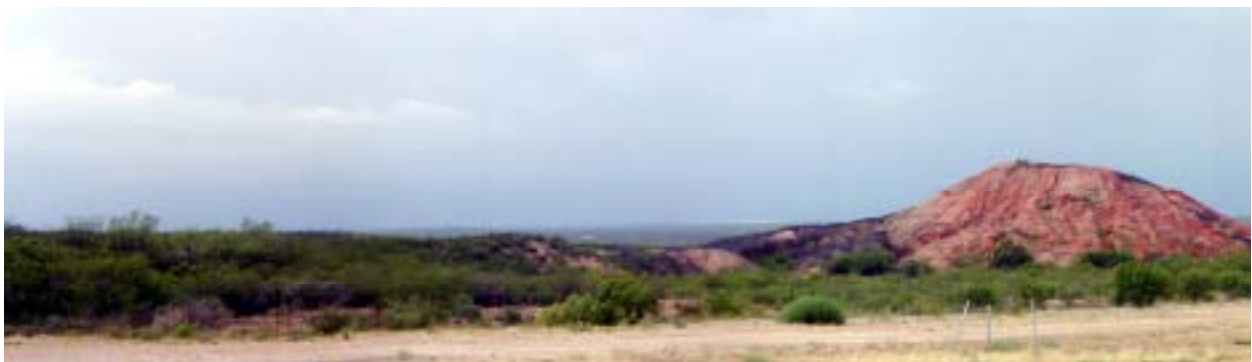
**Figure 6-5. Laredo-Colombia Solidarity Bridge: potential sites “A” and “B”**

Letter “A” indicates site currently considered by TxDOT for the state safety inspection facility (“Site Selection Study” 2001). Letter “B” indicates alternative site that could be considered by TxDOT in combination with relocating one or both main lanes on FM 255.

- Figures 6-1 and 6-5 show the location of a potential state safety inspection facility being considered by TxDOT. According to information provided by TxDOT officials, this location minimizes the amount of earth work required for the construction of the facility while still providing access to both FM 1472 and the Camino Colombia toll road. A secure link from the federal inspection compound to Site “A” would require either a parallel road along the east side of FM 255 or, given the wide right-of-way occupied by FM 255, relocating the FM 255 roadbeds to the northwest to provide additional space within the right-of-way for the link to the state safety inspection facility. If the main lanes on FM 255 could be moved to the northwest, there is a possibility the state safety inspection facility could be located right next to the federal compound (Alternative “B” in Figure 6-5). This alternative would reduce the length of the secure link between the two facilities and the amount of land to acquire for the state safety inspection facility.

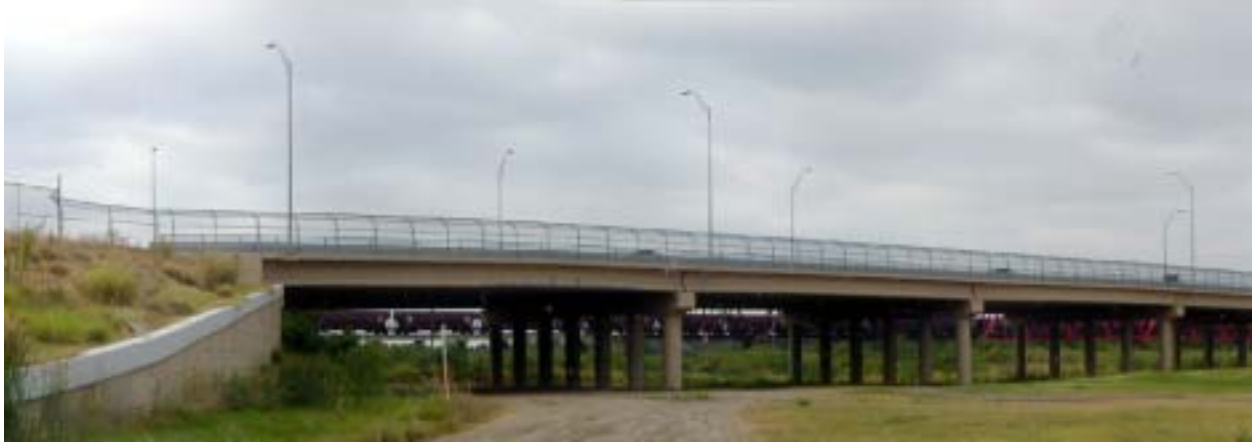
**Figure 7-4. Camino Real International Bridge: view of international bridge from the north**

Path follows approximate alignment of proposed Outer Loop. Federal compound is on the left behind the fence.

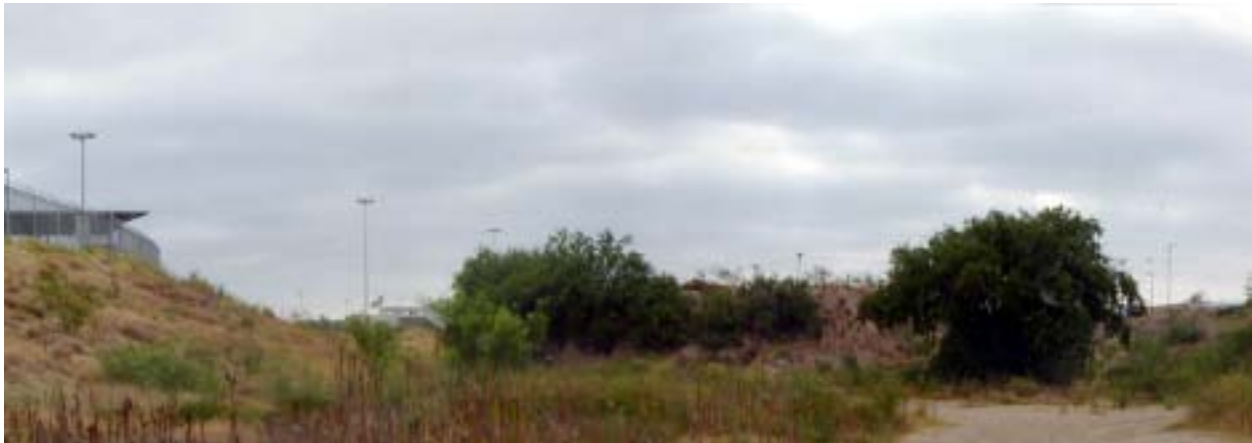
**Figure 7-5. Camino Real International Bridge: view from the southwest**

Federal compound is on the left (north) side. Railroad track is on the right (south) side.  
Notice difference in elevation between the federal compound and this area.

Terrain in the immediate vicinity of the federal compound is characterized by significant differences in elevation, with the west side being much lower than the east side. While the federal compound itself is located on high ground (most likely raised by earth fill on the west side), the surrounding area appears to be prone to river flooding. The proposed alignment of the Outer Loop under the international bridge would be affected by that flooding.

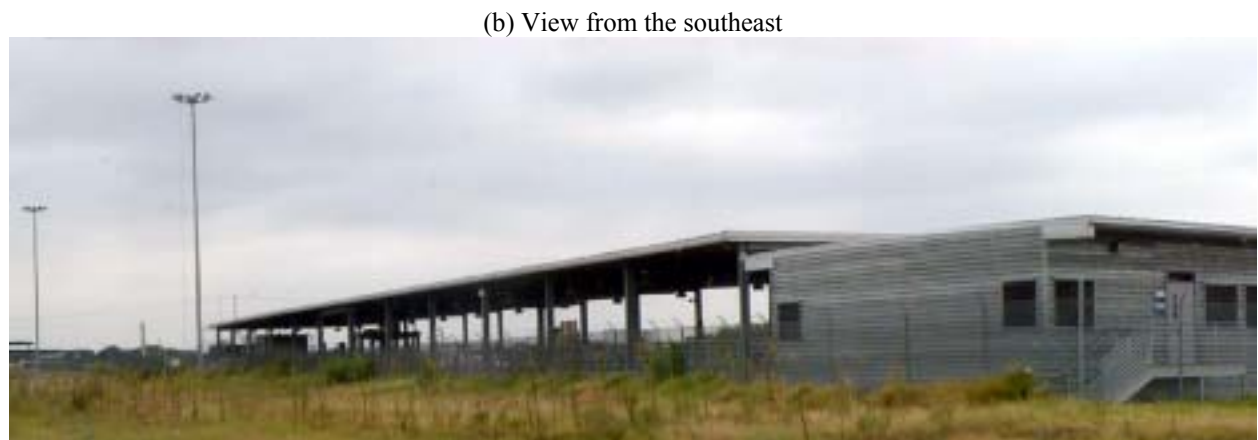
**Figure 7-6. Camino Real International Bridge: view of secondary inspection station**

Letter "A" indicates potential location of the state safety inspection facility ("Site Selection Study" 2001).

- Given the current alignment of the proposed Outer Loop, none of the four TxDOT alternatives proposed for a state safety inspection facility presents an ideal location to provide a secure link from the federal compound to the state safety inspection facility. For example, location "A" (Figs 7-1, 7-2, and 7-6) would be located on the north side of the Outer Loop, i.e. across the street from the federal compound. In this case, a city ordinance would need to force all inbound commercial vehicles to make a left turn once they leave the federal compound. A secure connection could not be provided between the federal and state compounds. Location "A" also has the disadvantage of being located in a park and recreational area owned by the City of Eagle Pass. Location "B" (Figs 7-1, 7-2, and 7-9) would require a new dedicated secure link from the federal inspection facility. This road could be adjacent to the

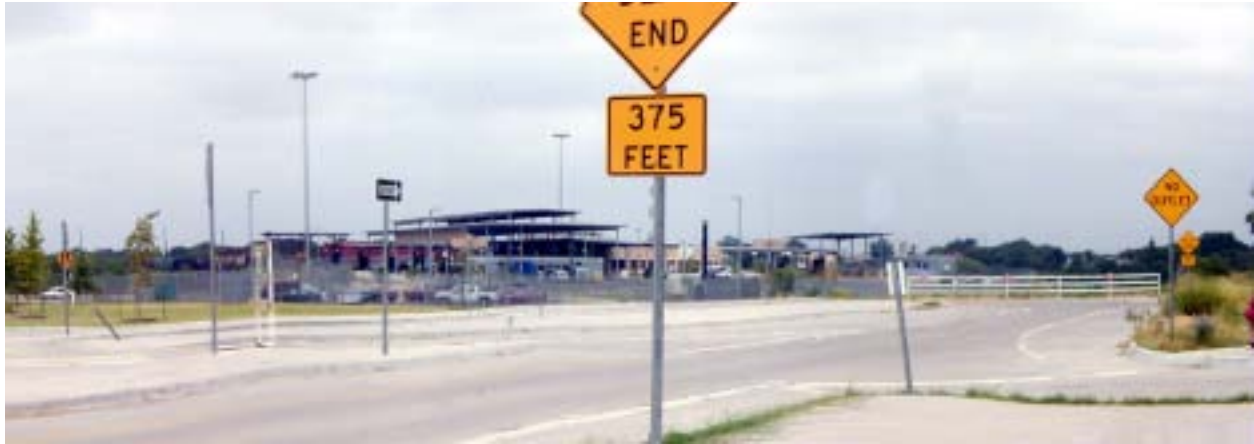
**Figure 7-7. Camino Real International Bridge: view of federal compound from the northeast**

Export lot is in foreground; dead end is where the proposed Outer Loop would begin.

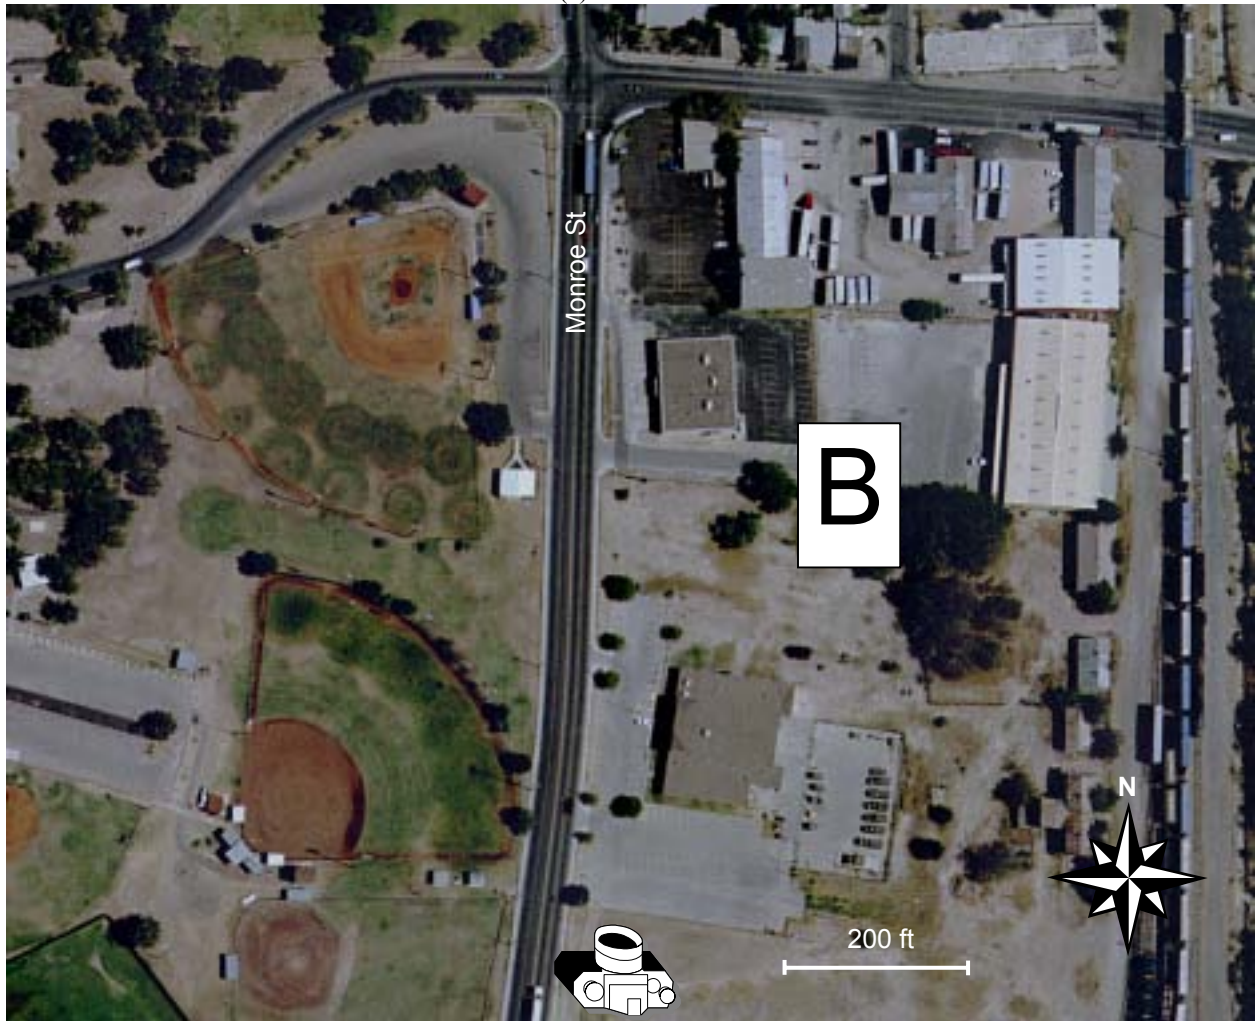
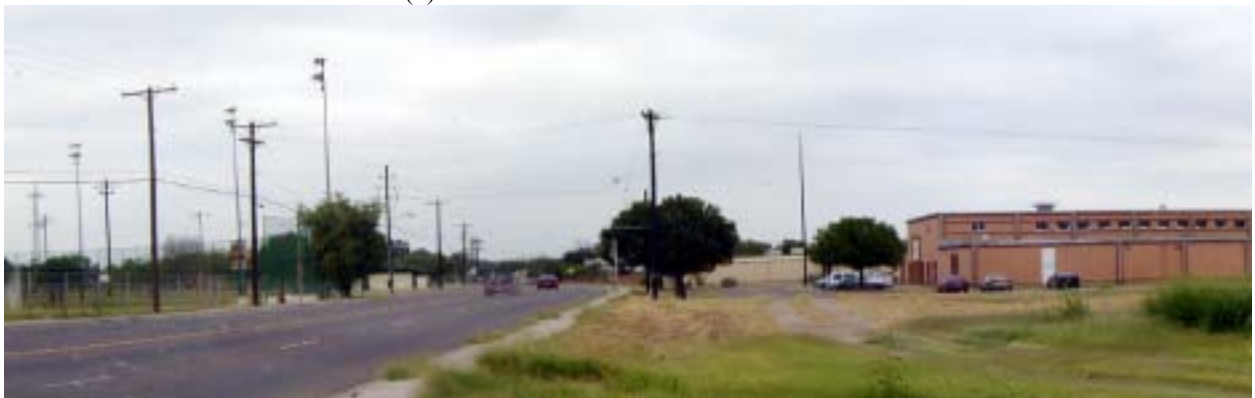
**Figure 7-9. Camino Real International Bridge: view of Monroe Street**

Letter “B” indicates potential location of the state safety inspection facility (“Site Selection Study” 2001).

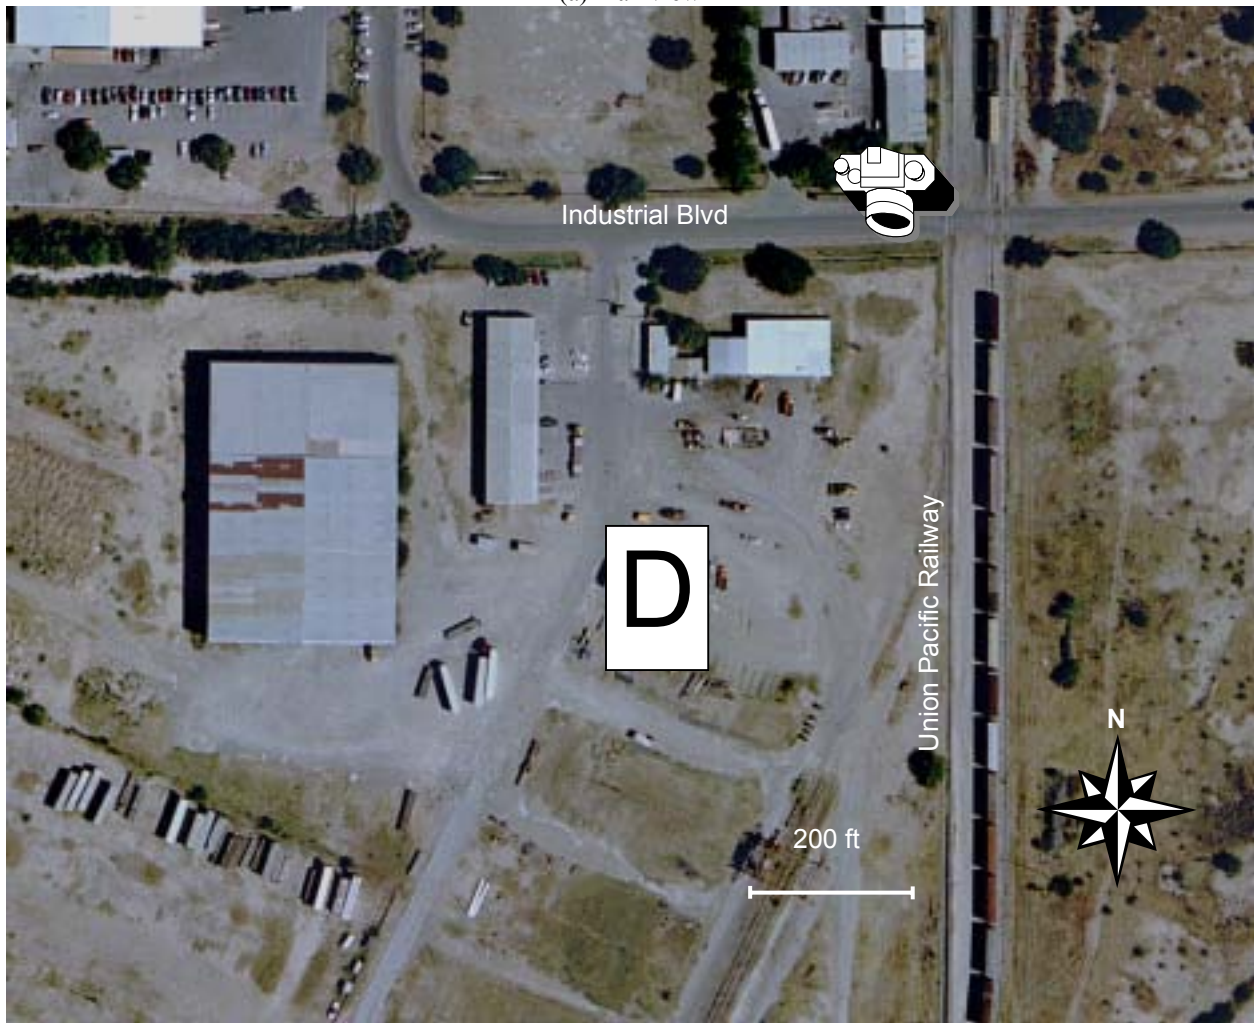
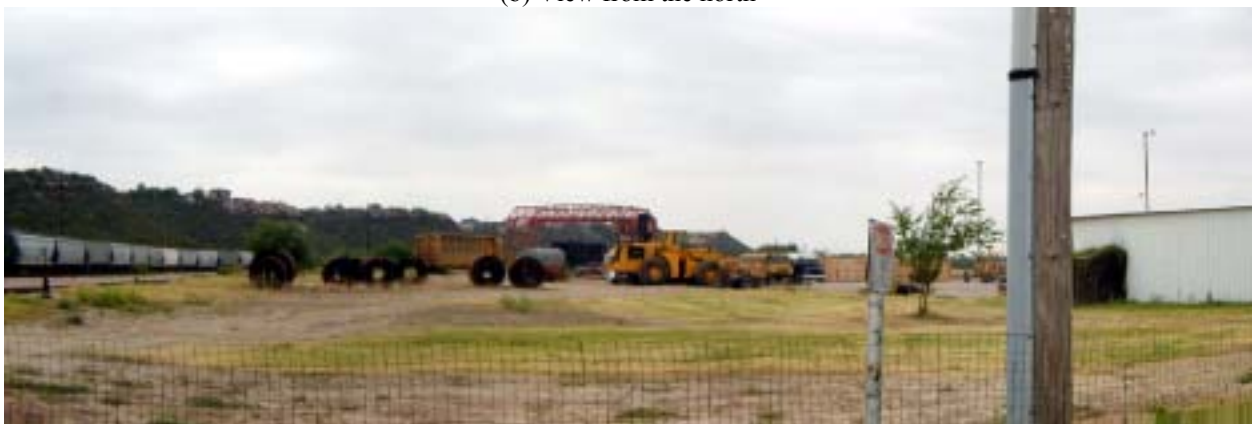
**Figure 7-11. Camino Real International Bridge: potential location of inspection facility**

Letter "D" indicates potential location of the state safety inspection facility ("Site Selection Study" 2001).

railroad track or Monroe Street. Egress would need to be on Monroe Street. Locations “C” and “D” (Figs 7-1, 7-2, 7-10, and 7-11) are located even further away from the federal compound exit booths. Inbound commercial vehicles would be required to make a left turn at the Outer Loop once they leave the federal compound. A secure link between the federal and state compounds could not be provided if the state safety inspection facility is at either location “C” or “D.” In addition, Alternative “D” is located too far away from the Outer Loop. Egress from Alternative “C” and “D” would need to use the Outer Loop or the proposed FM 375 Extension and Industrial Blvd. to connect with US 57 or US 277.

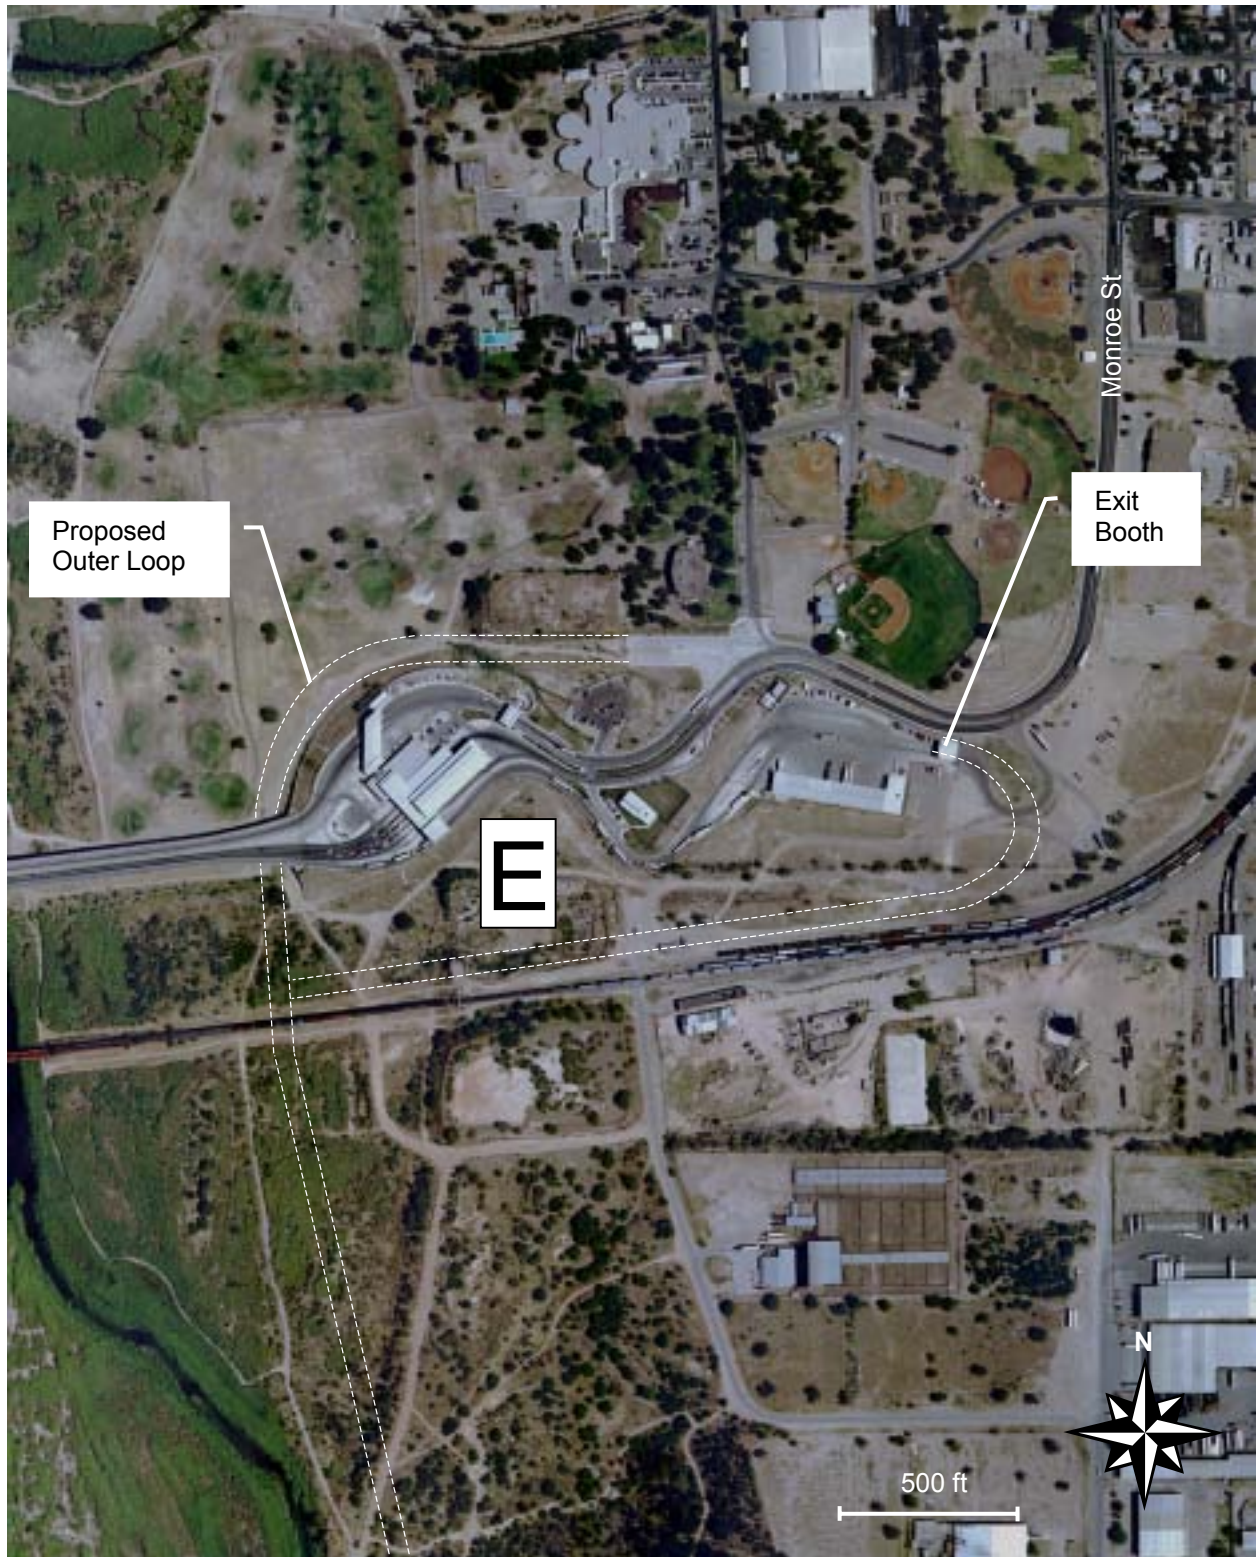
**Figure 7-12. Camino Real International Bridge in Eagle Pass: alternative location of inspection facility**

Letter "E" indicates alternative location of state safety inspection facility.

- Because of the disadvantages of locations “A” to “D,” it may be necessary to evaluate other potential sites. For example, Figure 7-12 shows an additional potential state safety inspection site located on the south side of the federal compound, north of the railroad track (Alternative “E”). This alternative might require some earth fill and moving the railroad alignment slightly to the south. Commercial vehicles would make a sharp turn to the right as soon as they leave the federal compound and would drive a short distance over a secure link to access the state safety inspection facility. Commercial vehicles leaving or bypassing this facility would access the Outer Loop between the railroad track and the international bridge.

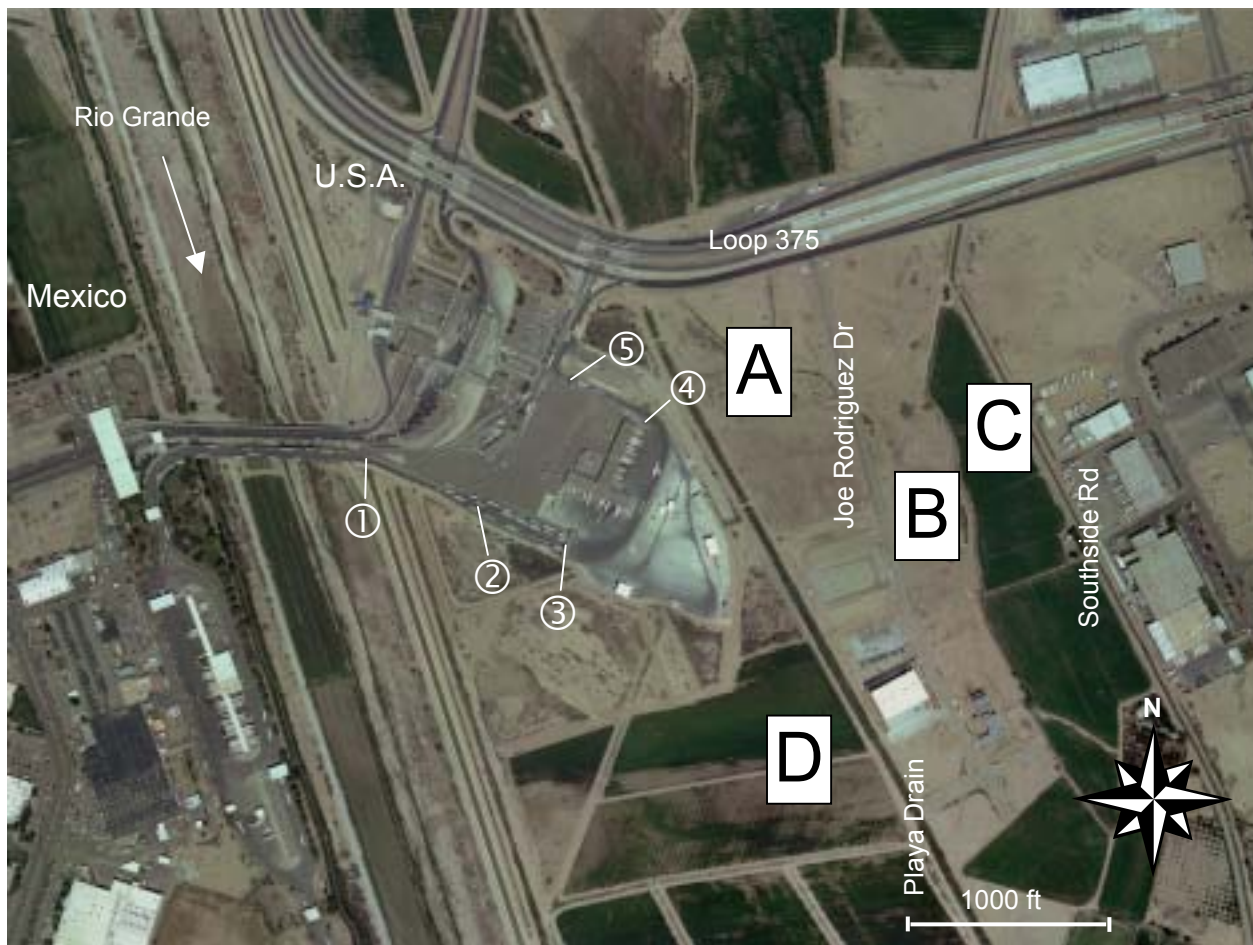
**Figure 8-1. Ysleta-Zaragoza Bridge**

Numbers indicate locations for automated processing on the prototype border crossing model (see Fig 1-1). Letters "A"-"C" indicate potential locations of the state safety inspection facility ("Site Selection Study" 2001). Letter "D" indicates a fourth option now being considered by TxDOT.

The Ysleta-Zaragoza Bridge border crossing is located near State Loop 375 on the southeast side of El Paso, Texas. The bridge is composed of two separate structures, one for commercial traffic, and the other one for noncommercial traffic. The truck bridge is a four-lane facility with two lanes for each direction. The federal compound is surrounded by the Rio Grande on the west and southwest sides, agricultural fields on the south side, and a currently vacant lot on the east side. This vacant lot is being developed as an industrial park. TxDOT is considering several options for the state safety inspection facility, including the agricultural field adjacent to the federal compound and the northwest corner of the industrial park. Details of the border crossing facilities are shown in Figures 8-1 to 8-5.

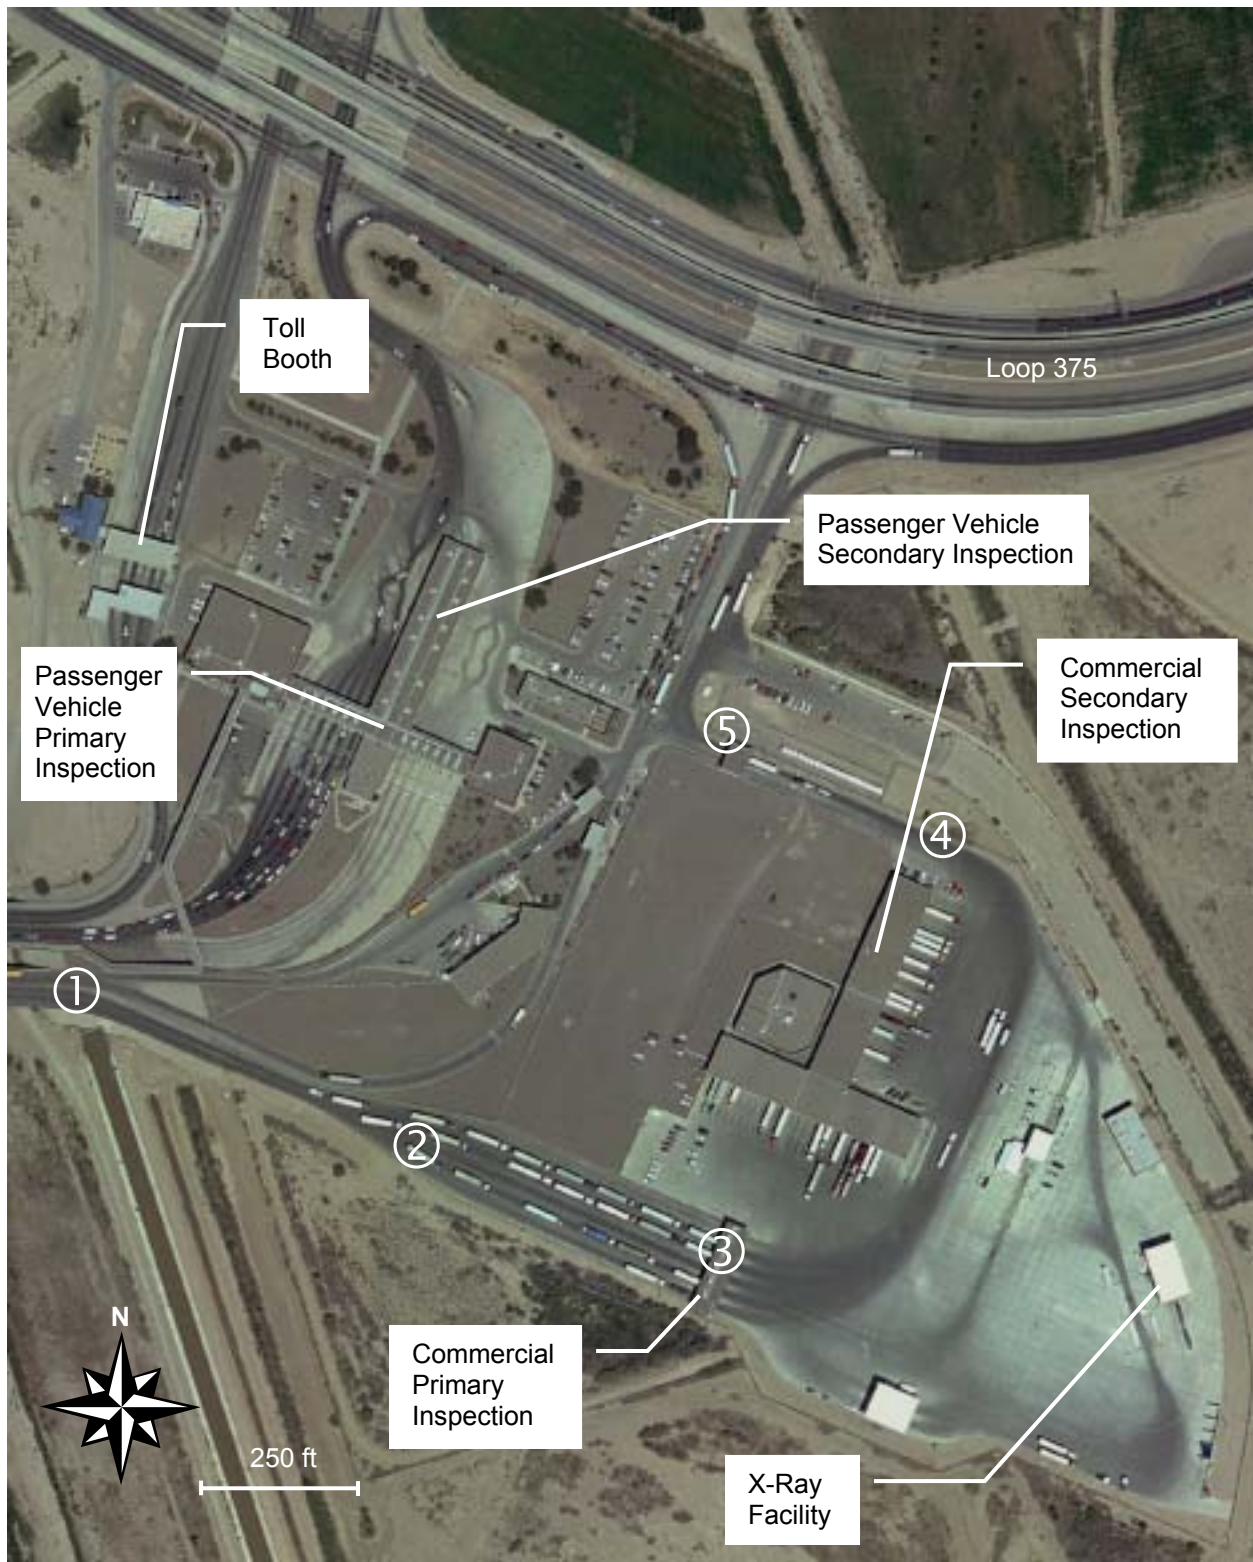
**Figure 8-2. Ysleta-Zaragoza Bridge**

Numbers indicate locations for automated processing on the prototype border crossing model (see Fig 1-1).

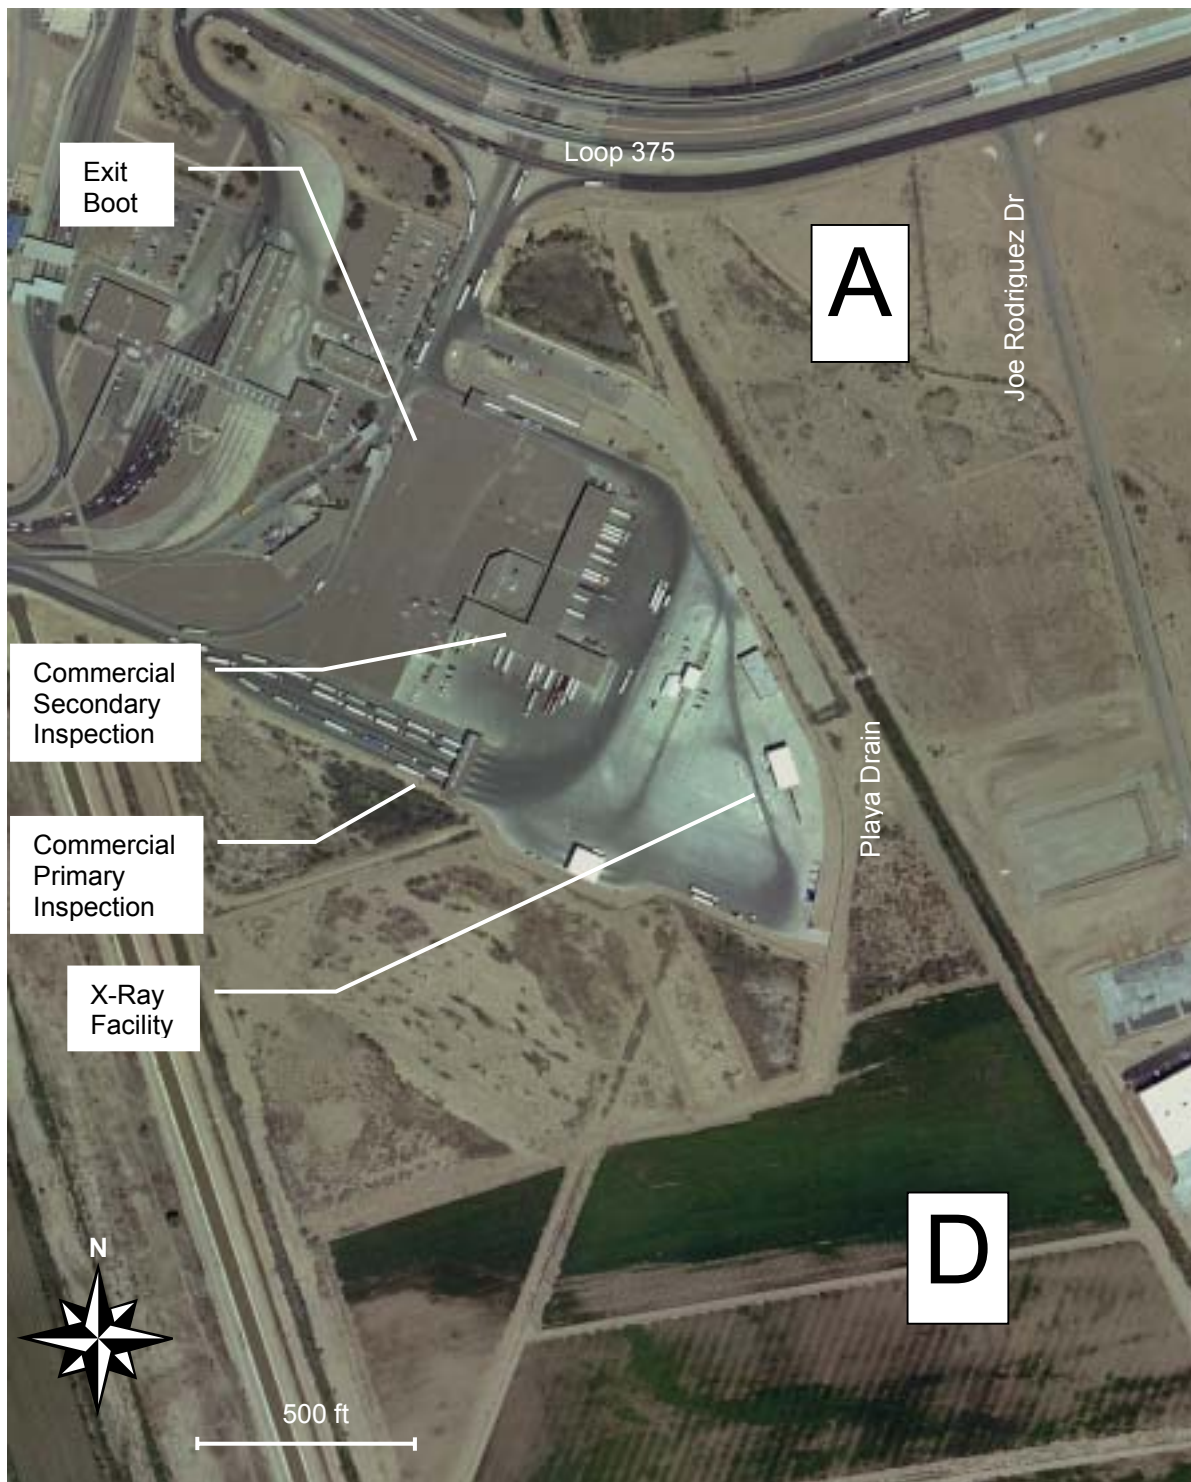
**Figure 8-3. Ysleta-Zaragoza Bridge: potential sites “A” and “D”**

Letter “A” indicates potential locations of the state safety inspection facility (“Site Selection Study” 2001). Letter “D” indicates additional alternative location being considered by TxDOT.

- The location of the state safety inspection facility is flexible. As indicated previously, TxDOT is considering the vacant lot on the east side of the federal compound as one of the potential sites for the state safety inspection facility (see Figs 8-3 and 8-4, Alternatives “A,” “B,” and “C”). With the current layout, Alternative “A” seems to be the most advantageous location because it is closest to the existing exit from the federal compound and would not need a relocation of the exit. A secure link south of the eastbound frontage road would provide access from the federal compound to the state safety inspection facility. Egress from the state inspection site would be possible through the eastbound frontage road or Joe Rodriguez Drive. In this case, it might be necessary to upgrade Joe Rodriguez Drive. Westbound truck traffic would need to travel about a mile on the eastbound frontage road and take the turnaround lane at Pan American Drive, because the exit from the safety inspection facility would not have a grade separation to access westbound Loop 375. If westbound traffic is directed towards the Pan American Drive interchange, a capacity analysis would need to be conducted to determine whether the interchange can handle the increased volume in commercial vehicles. If the federal compound exit location is changed, Alternative “A” would still be feasible. For Alternatives “B” and “C,” located to the east of the federal compound, it would be useful to relocate the exit of the federal compound to the south of the X-ray facility. In this case, the secure link would cross the Playa Drain, and egress from the state safety inspection facility would use Joe Rodriguez Drive. If the exit of the federal compound could not be relocated, the secure link to the state safety inspection facility would be about twice as long as the link to Alternative “A.” Unfortunately, the secure link from the federal compound to both locations “B” and “C” would block through traffic on Joe Rodriguez Drive. Currently, there is no connection from Joe Rodriguez Drive to Southside Road. A road connecting those two roads would be needed for location “B” or “C” to remain feasible.

- Alternative “D” is now being considered by TxDOT as an additional potential location for the state safety inspection facility (Figure 8-3). It is located to the south of the federal compound and west of the Playa Drain. This location would also benefit from the relocation of the federal compound’s exit to the southeast corner of the facility. Egress from the state safety inspection facility would exit slightly to the north of the current exit of the federal compound to enable westbound traffic to use the Loop 375 underpass. If use of the current exit continued, traffic towards the state safety inspection facility would use a newly constructed link to the east of federal compound and parallel to the Playa Drain. Egress would use the same link exiting to the north of the federal compound’s old exit. It is likely that the exit from the federal compound will be moved to the new location because U.S. Customs is interested in using the existing exit only as an emergency exit. If the federal compound exit is relocated, Alternative “D” would be an excellent location for the state safety inspection facility.

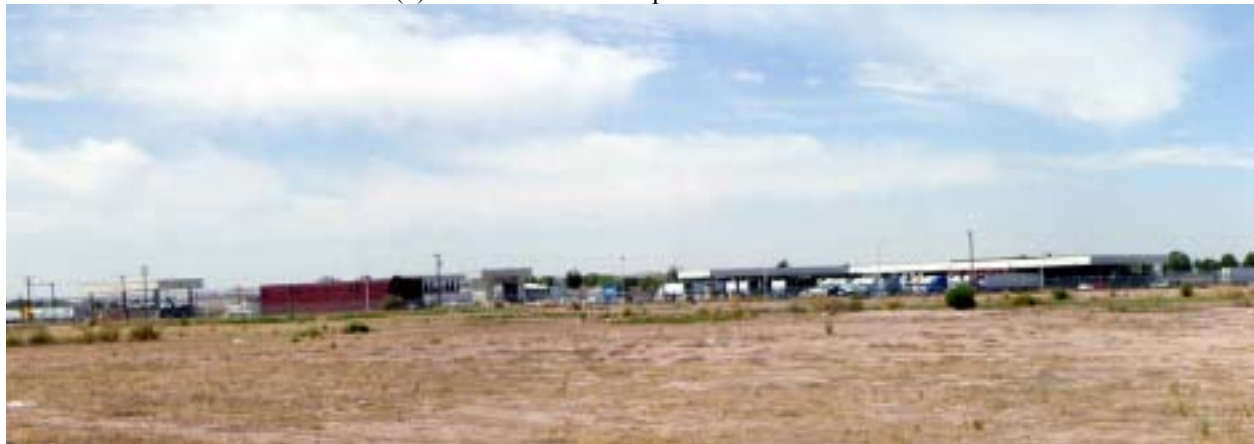
**Figure 8-4. Ysleta-Zaragoza Bridge: potential sites "A", "B", and "C"**

Letters indicate potential locations of the state safety inspection facility ("Site Selection Study" 2001).

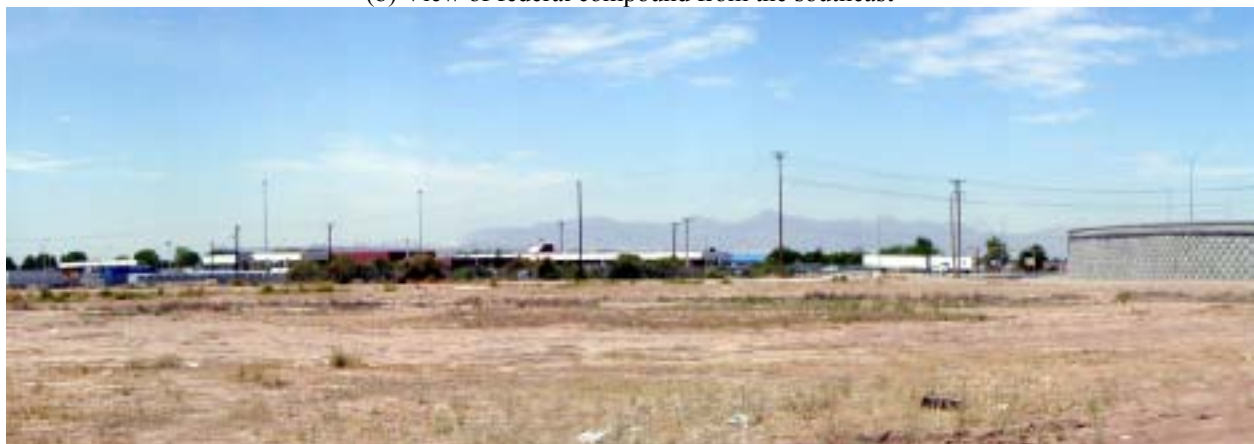
**Figure 8-5. Ysleta-Zaragoza Bridge: industrial park east of federal compound**

Letters indicate potential locations of the state safety inspection facility ("Site Selection Study" 2001).

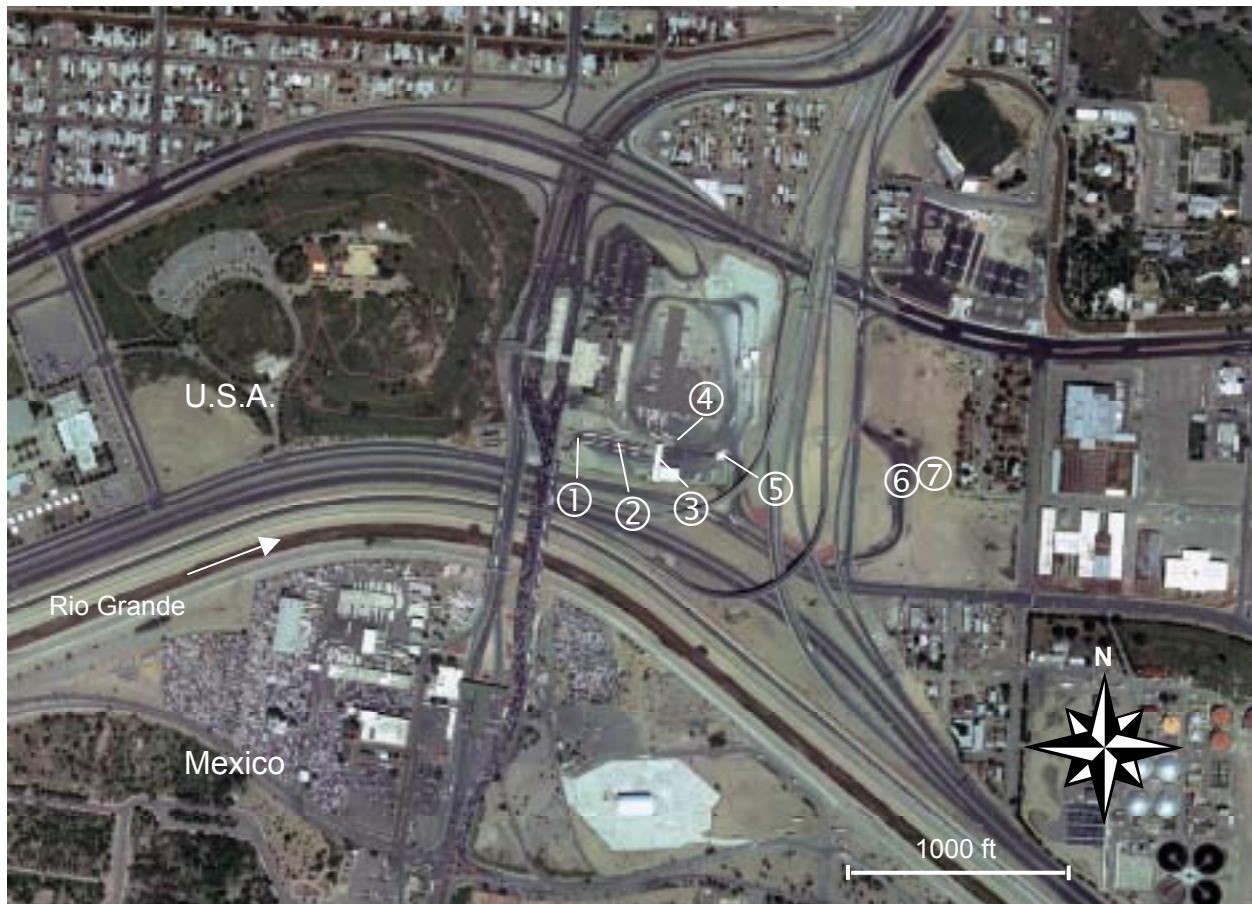
**Figure 9-1. Bridge of the Americas (BOTA)**

Numbers indicate locations for automated processing on the prototype border crossing model (see Fig 1-1).

TxDOT has already selected the location of the state safety inspection facility. As shown in Figures 9-1 and 9-2, this facility will be located on the east side of the US-54 northbound frontage road (No. 7). A former turnaround lane will provide a secure link between the federal compound and the state safety inspection facility. To ensure that the link between the federal and state compounds is secure, TxDOT has now closed access to the US-54 northbound frontage road from Delta Drive.

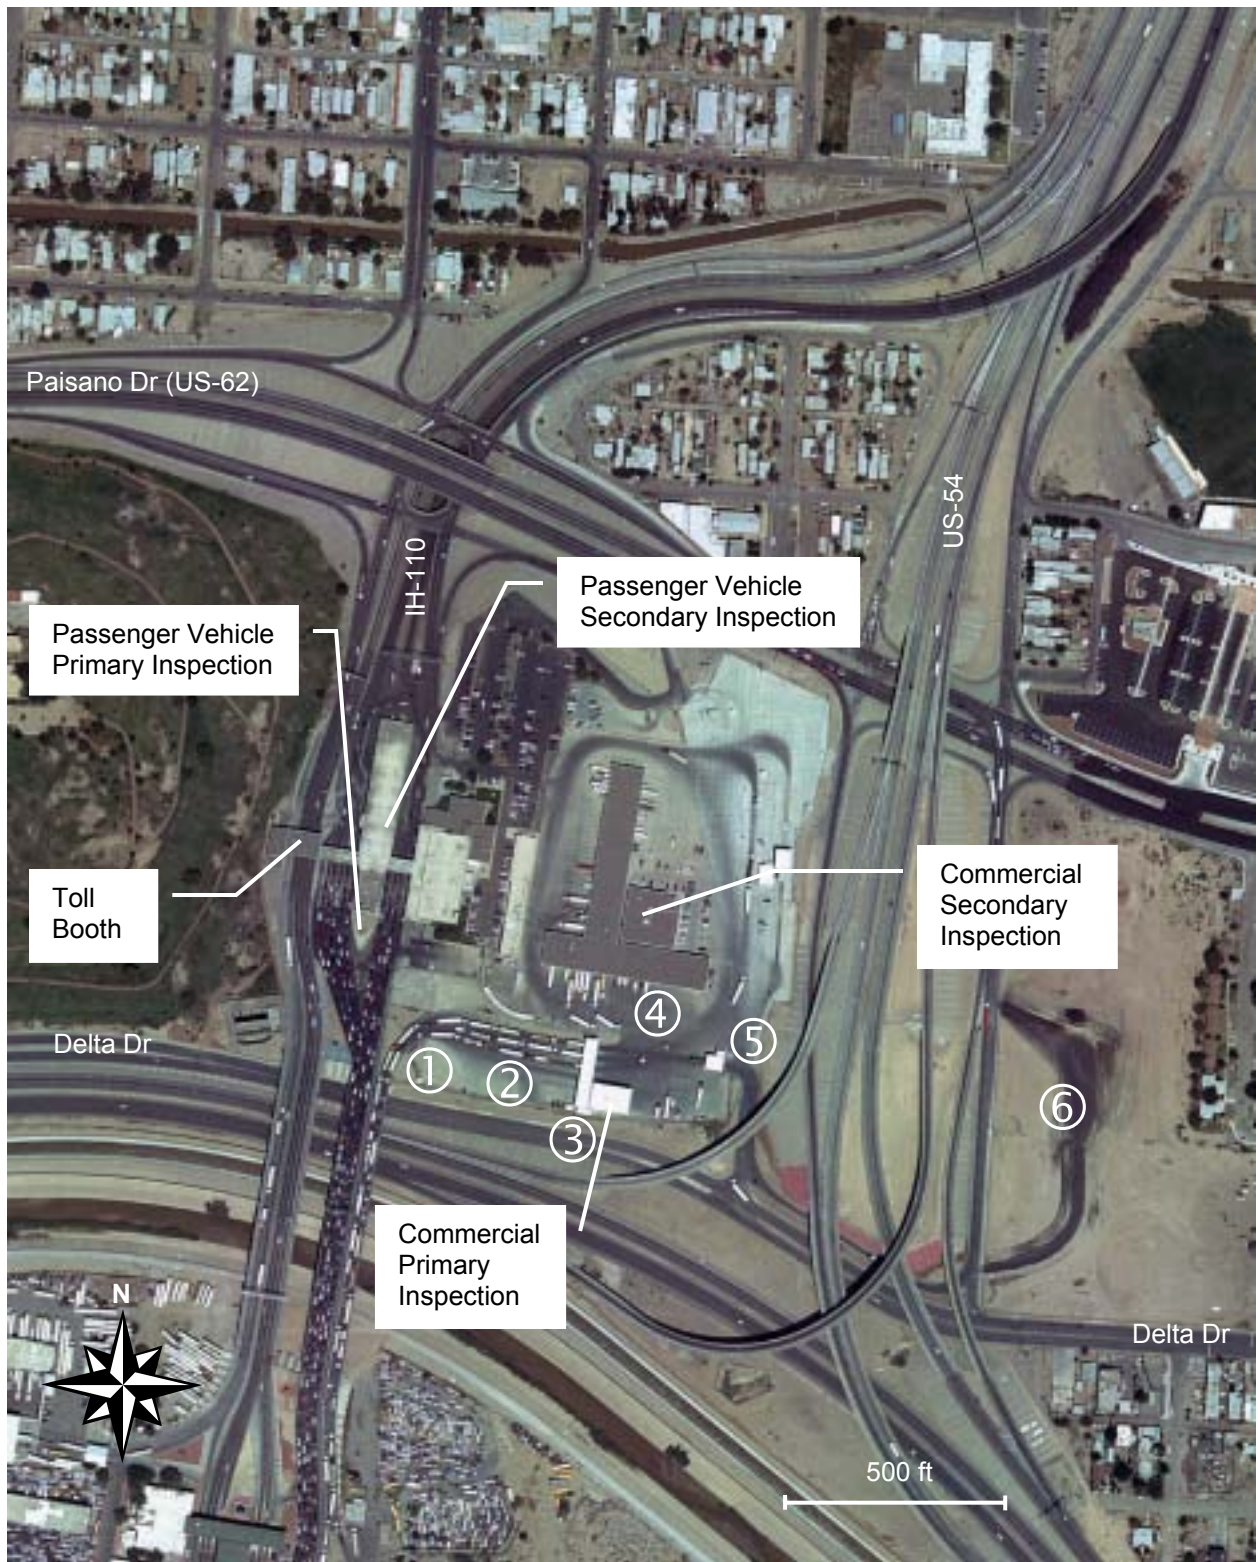
**Figure 9-2. Bridge of the Americas (BOTA)**

Numbers indicate locations for automated processing on the prototype border crossing model (see Fig 1-1).
