| 4. Title and Subtitle<br><br>TEXAS MODEL BORDER CROSSING PROJECT:<br>RETROFIT REPORT | | 5. Report Date<br>February 2003 | |
| 12. Sponsoring Agency Name and Address<br>Texas Department of Transportation<br>Research and Technology Implementation Office<br>P.O. Box 5080<br>Austin, TX 78763-5080 | | 13. Type of Report and Period Covered<br>Implementation Report<br>September 2000–February 2003 | |

## Texas Model Border Crossing Project: Retrofit Report

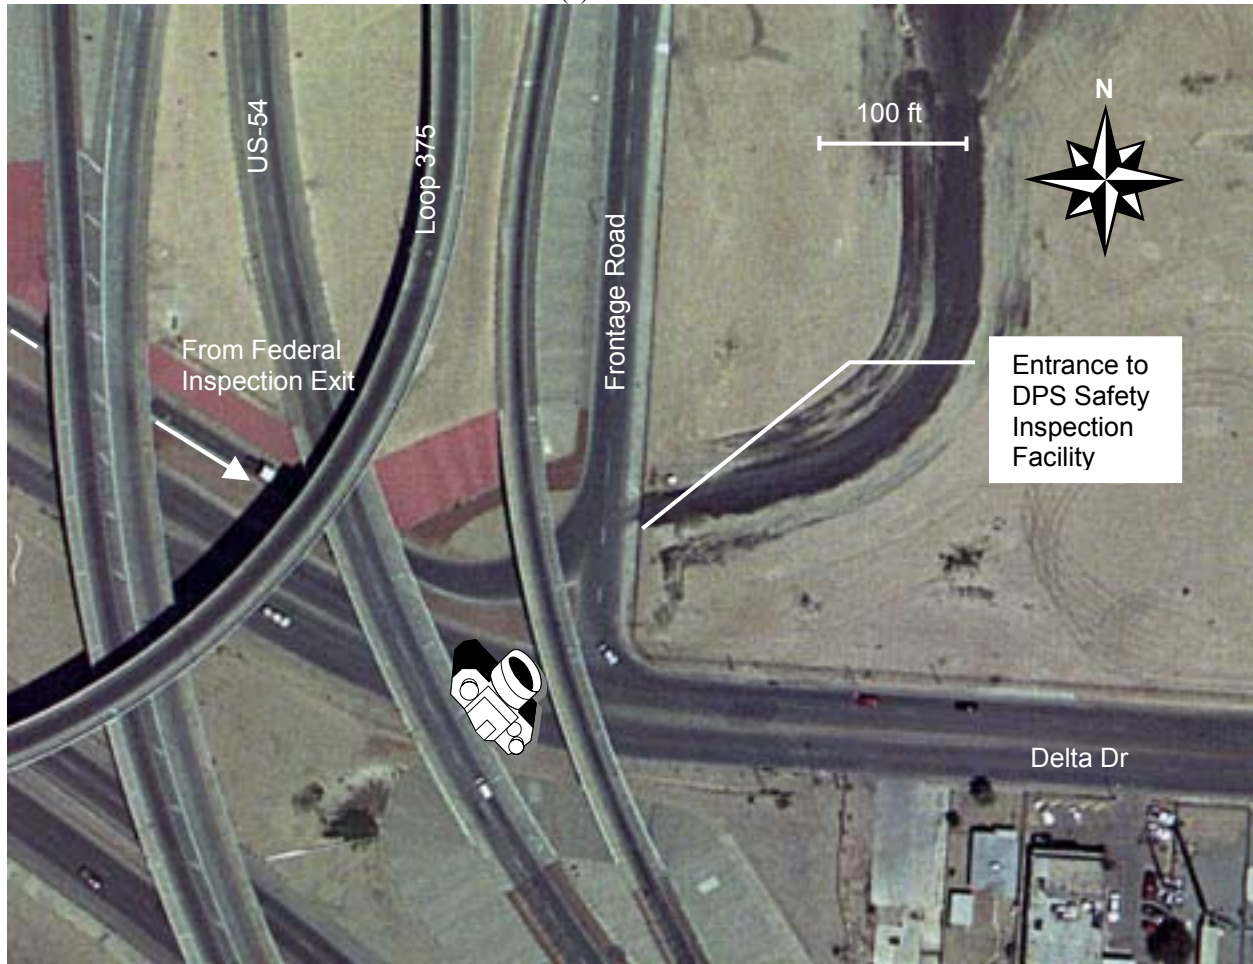
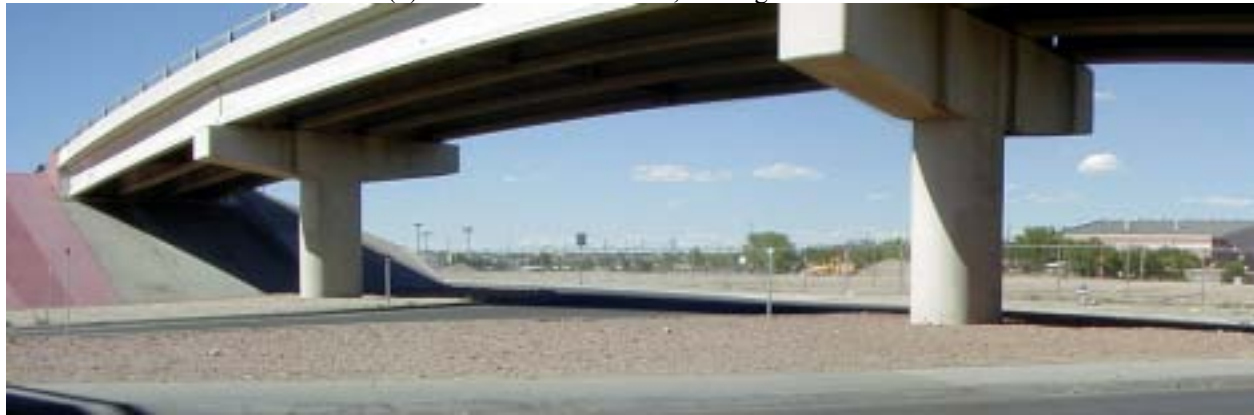
**Figure 9-5. Bridge of the Americas (BOTA): entrance to state safety inspection facility**

Note: Access to frontage road from Delta Drive has been closed.

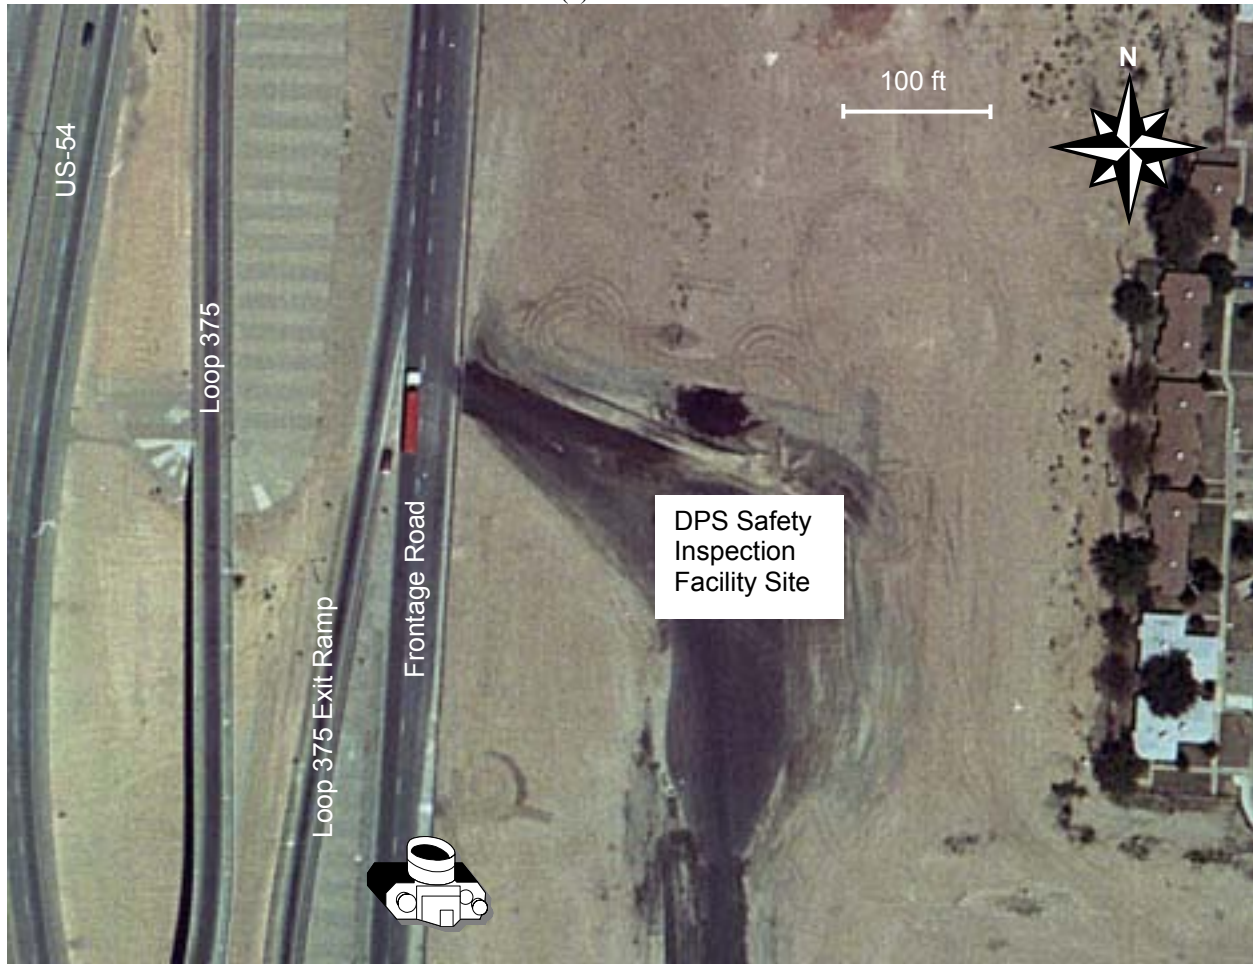
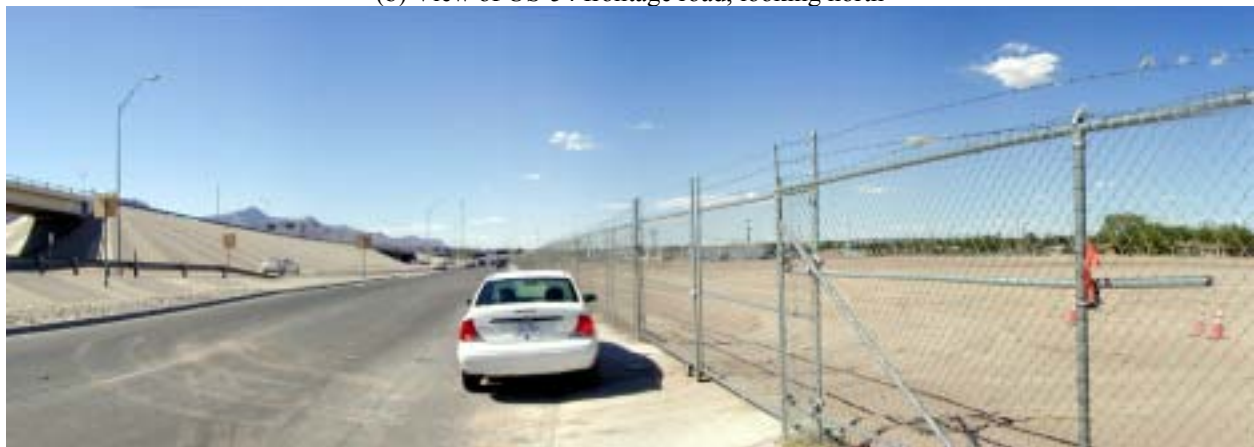
State safety inspection facility location is on the right.
