Mitigation Techniques for In-Service Structures with Premature Concrete Deterioration: Synthesis Report

Research Report 0-4069-3

Research Project 0-4069

October 2004

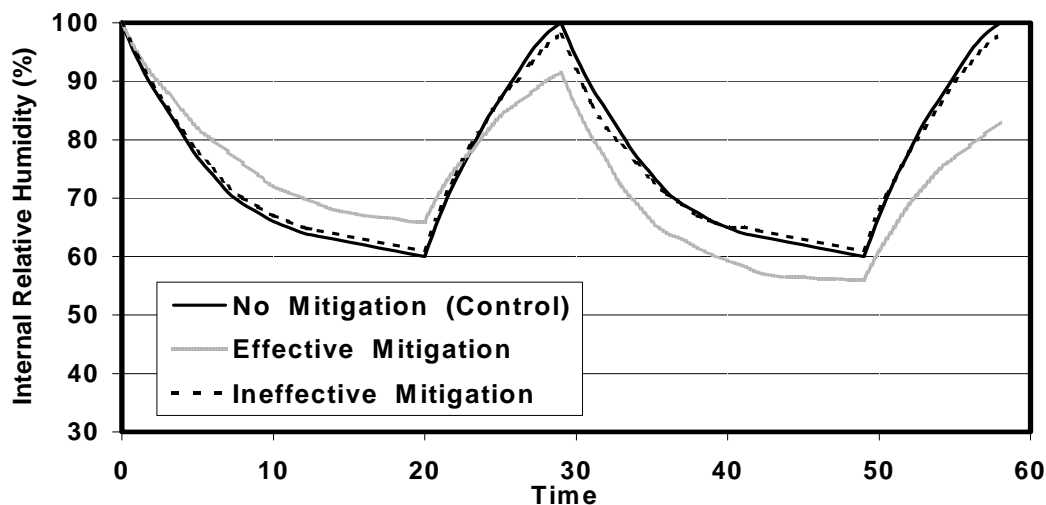
This logic is shown schematically in Figure 4.1 for a control specimen and two hypothetical mitigation treatments, one effective and the other ineffective. As ambient relative humidity is cycled from wet to dry and back again, the effectively treated specimen loses moisture at about the same rate as an untreated specimen, and gains moisture more slowly. The ineffectively treated specimen, in contrast, does not differ significantly from the untreated specimen as it is cycled.

Figure 4.1 Hypothetical application of test method

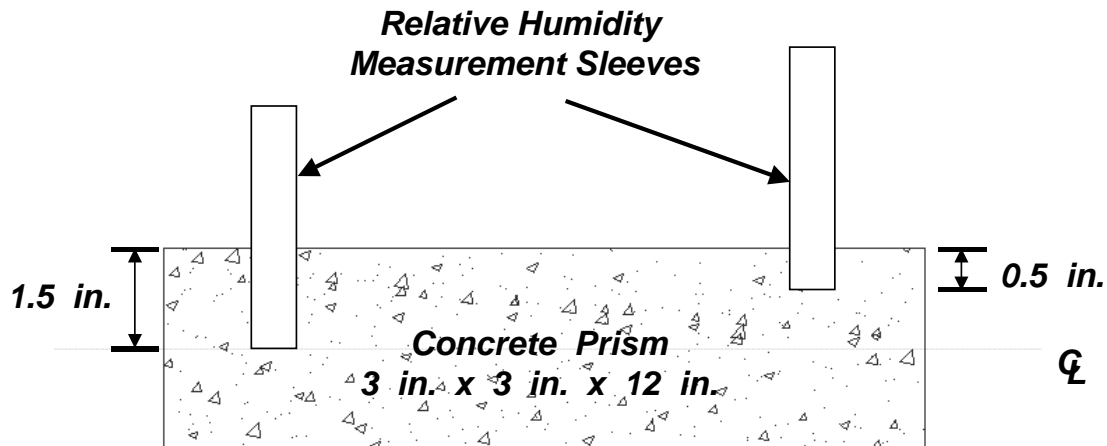
humidity measurement sleeves (plastic sleeves allowing insertion of a probe to measure internal relative humidity of concrete) were cast into the specimens with a nominal gage length between sleeves of 10 in. Each specimen has a measurement sleeve placed at a depth of 0.5 in. and another at a depth of 1.5 in. (at the longitudinal axis of the specimens). The specimens were allowed to cure for 7 days in a moist room. The drawing in Figure 4.2 shows a specimen with two measurement sleeves cast at depths of 0.5 in. and 1.5 in., representative of the specimens used in this study.

Figure 4.2 Fabricated specimen with measurement sleeves

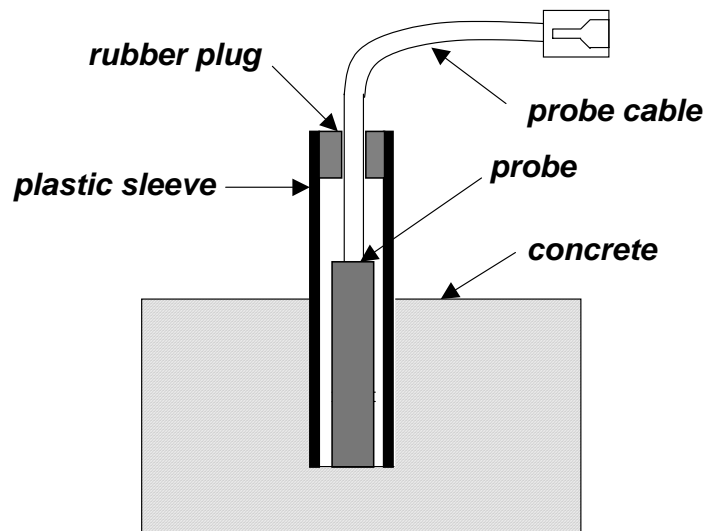
3. Seal the measurement sleeve with the manufacturer's rubber plug, leaving the small central hole open for the wire from the probe.
4. Allow 30 minutes for the probe to reach hygral equilibrium with the small surrounding air volume at the lower end of the sleeve, and presumably with the concrete at the bottom of the sleeve.
5. Plug the electronic connector from the rear of the probe into the digital indicator (designation HMI41).
6. Turn on indicator and record relative humidity and temperature.
7. Turn off indicator and unplug the electronic connector.
8. Remove the manufacturer's rubber plug and probe from the open end of the sleeve.
9. Seal the measurement sleeve by re-inserting the manufacturer's rubber plug into opening, this time with the small central hole closed.

Figure 4.3 Cast-in-place sleeve with probe inside

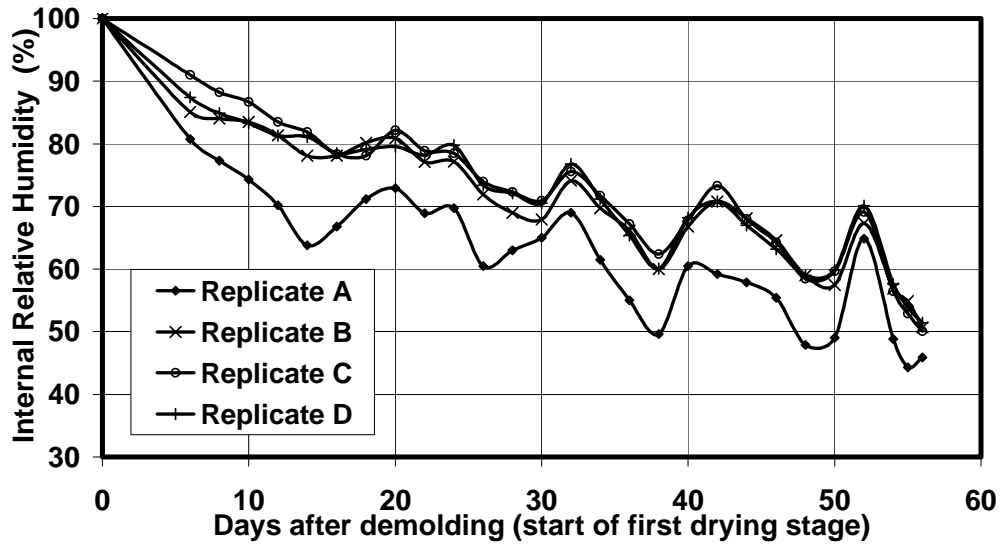
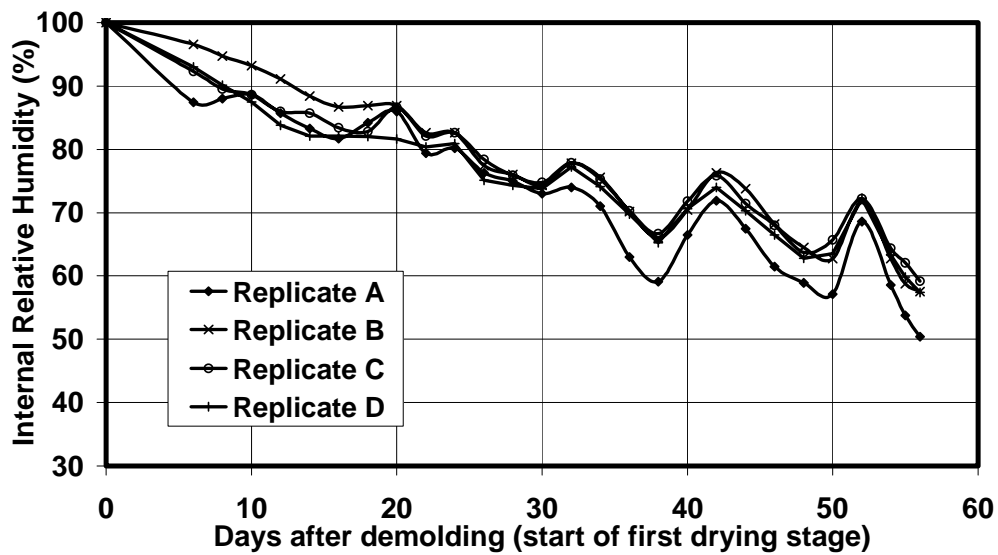
The internal relative humidity of the specimens behaved erratically during the drying stage, fluctuating significantly instead of decreasing monotonically (Figure 4.4 and Figure 4.5).

Figure 4.4 Internal RH at 0.5 in. depth during drying stage, uncontrolled pilot tests

Figure 4.5 Internal RH at 1.5 in. depth during drying stage, uncontrolled pilot tests

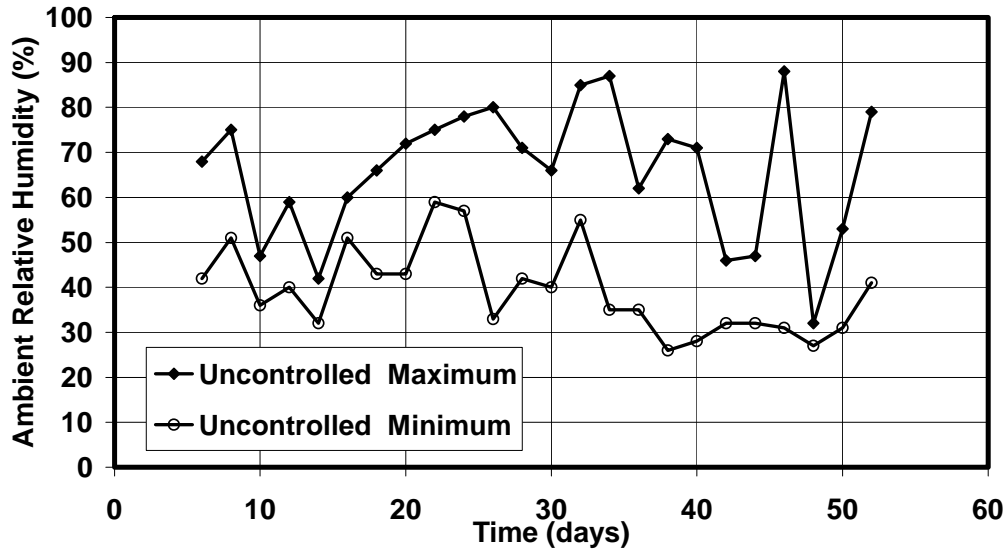
The erratic behavior of the specimens during the drying stage might be attributed to the ambient relative humidity. If the ambient relative humidity fluctuates significantly, the internal relative humidity of the specimens might never reach a stable equilibrium value. Figure 4.6 shows the maximum and minimum recordings of ambient relative humidity during the drying stage.

Figure 4.6 Ambient relative humidity during drying stage, uncontrolled pilot tests

Ambient relative humidity varied from as low as 26% to as high as 88% during the drying stage, and by as much as 55 percentage points over a two-day interval. The internal relative humidity of the specimens reacted to each large change in ambient relative humidity (daily maximum, daily minimum, or both.) The replicates' reactions to ambient relative humidity are seen in Figure 4.7, which plots the relative humidity of the replicates along with the ambient relative humidity. The former follows the latter. Significant increases in ambient RH were followed soon after by a slowing in the descent of the internal RH of the specimens, or even an increase in that internal RH. Correspondingly, when ambient RH decreased, the internal RH of the specimens decreased faster. Clearly, the internal relative humidity of the specimens during the drying stage was directly related to the ambient relative humidity of the air-conditioned space used for the drying stage.

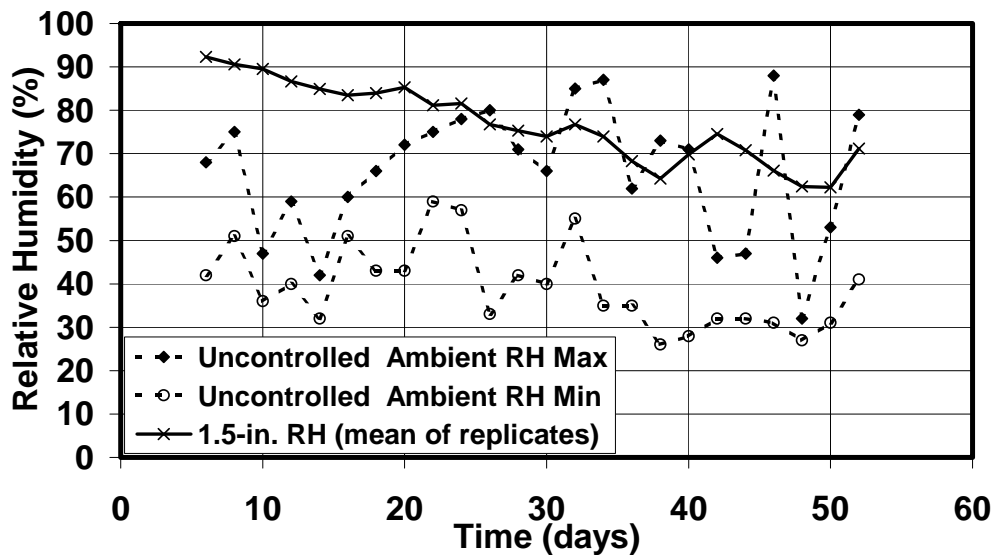
Figure 4.7 Average internal RH of replicates at 1.5 in. depth and ambient RH during drying stage

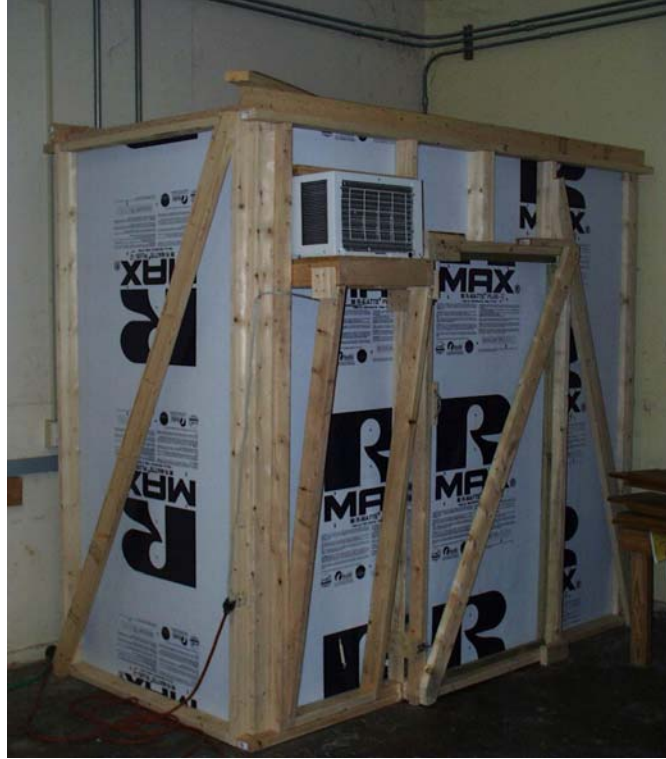
During the drying stage, the specimens were placed in the environmental chamber, set to maintain a relative humidity of 30% and a temperature of 21°C. During the wetting stage, the specimens were submersed in water. The environmental chamber was not necessary during the wetting stage since the ambient relative humidity was a constant 100%, and the ambient temperature was almost constant at 21°C.

Figure 4.8 Environmental chamber used in controlled pilot tests

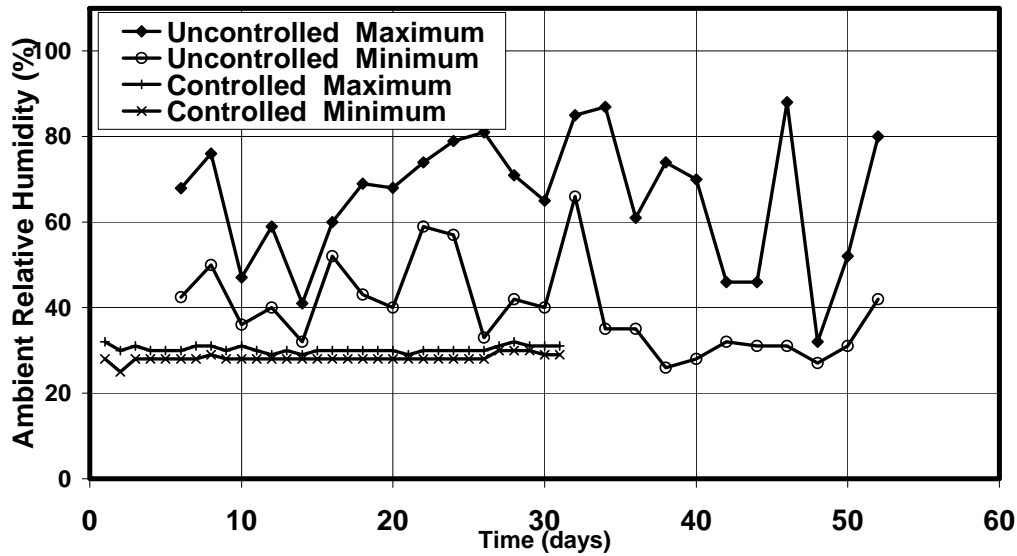
During the controlled pilot tests, the ambient relative humidity and temperature in the environmental chamber was essentially constant, and the humidity was well below 60% (Figure 4.9). Because the ambient RH and ambient temperature were carefully controlled, the results of the drying stages and wetting stages were consistent from replicate to replicate within each cycle, and repeatable from cycle to cycle as well.

Figure 4.9 Ambient RH outside chamber (uncontrolled) and inside chamber (controlled)

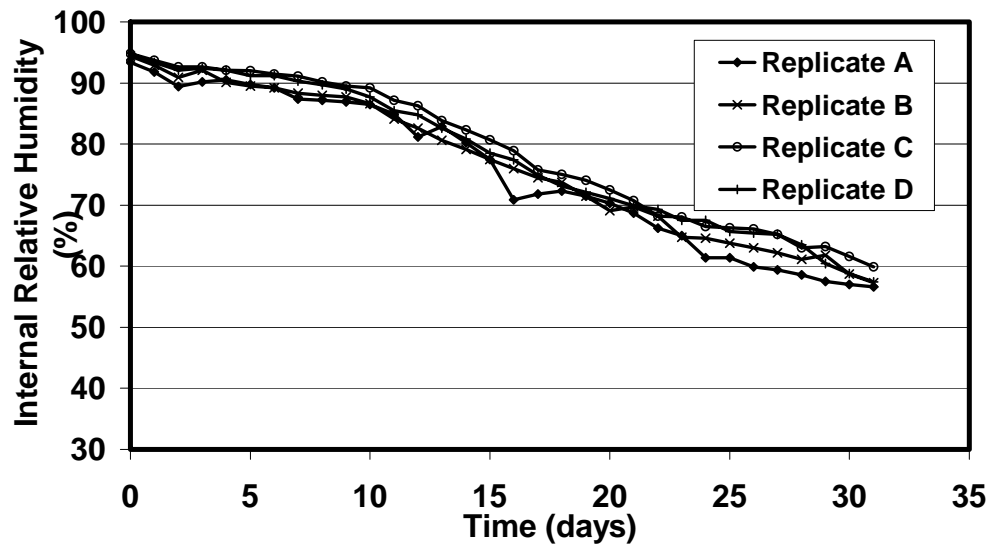
A total of three complete cycles were imposed on the specimens. During each drying stage each replicate had relatively the same response as the other replicates (consistent behavior), and essentially the same response as in other drying stages (repeatable behavior). All specimens decreased in internal relative humidity monotonically throughout the drying stage. Figure 4.10 shows the internal relative humidity of the specimens at the 0.5-in. depth during the first drying stage. The specimens had similar behavior during the following drying stages (Appendix ***).

Figure 4.10 Internal RH at 1.5 in. depth during drying stage, controlled pilot tests

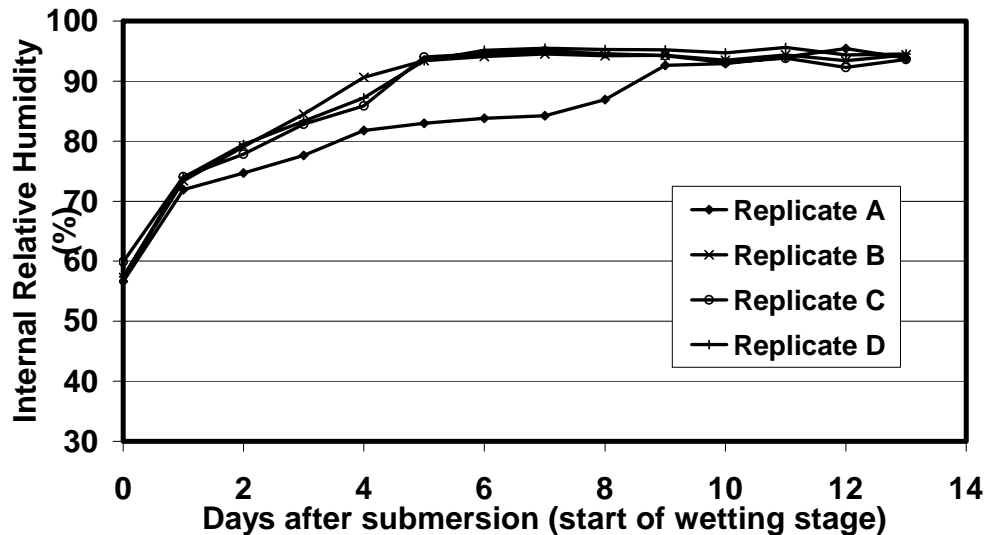
Similarly consistent and repeatable behavior was observed during the wetting stages. The internal relative humidity of the specimens increased monotonically during each wetting stage. Figure 4.11 shows the internal relative humidity of the specimens at the 1.5-in. depth during a wetting stage. The specimens had similar behavior during the other wetting stages, which are shown in Appendix ***B.

Figure 4.11 Internal RH at 1.5 in. depth during wetting stage, controlled pilot tests

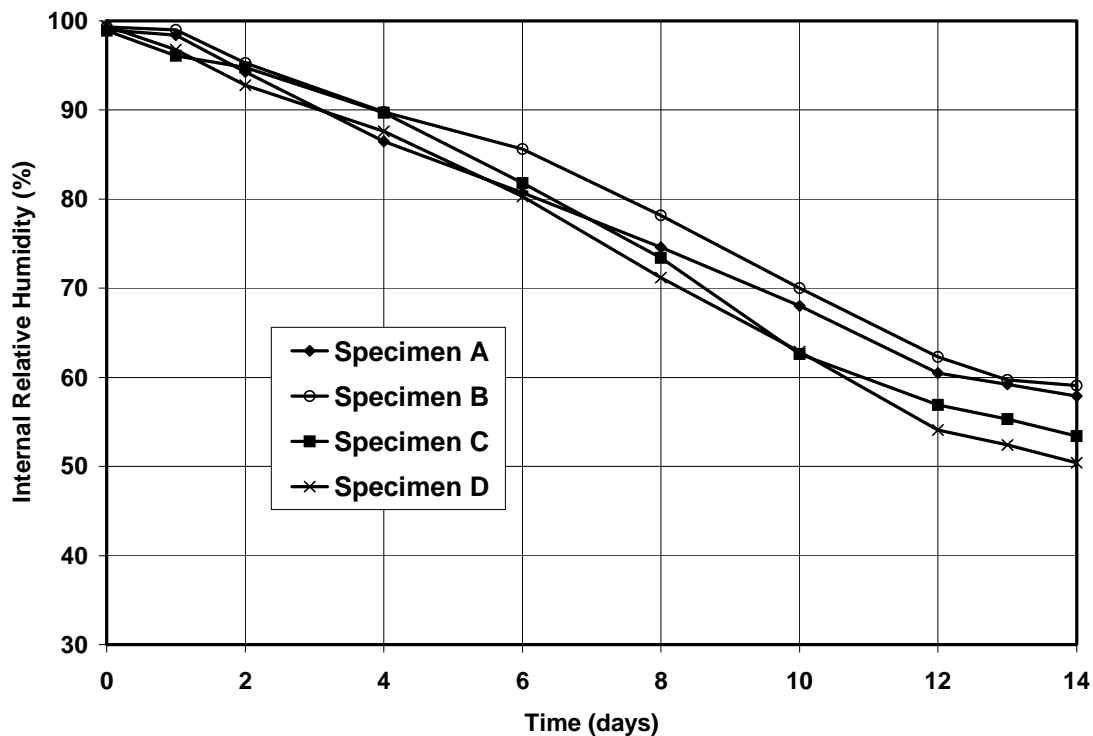
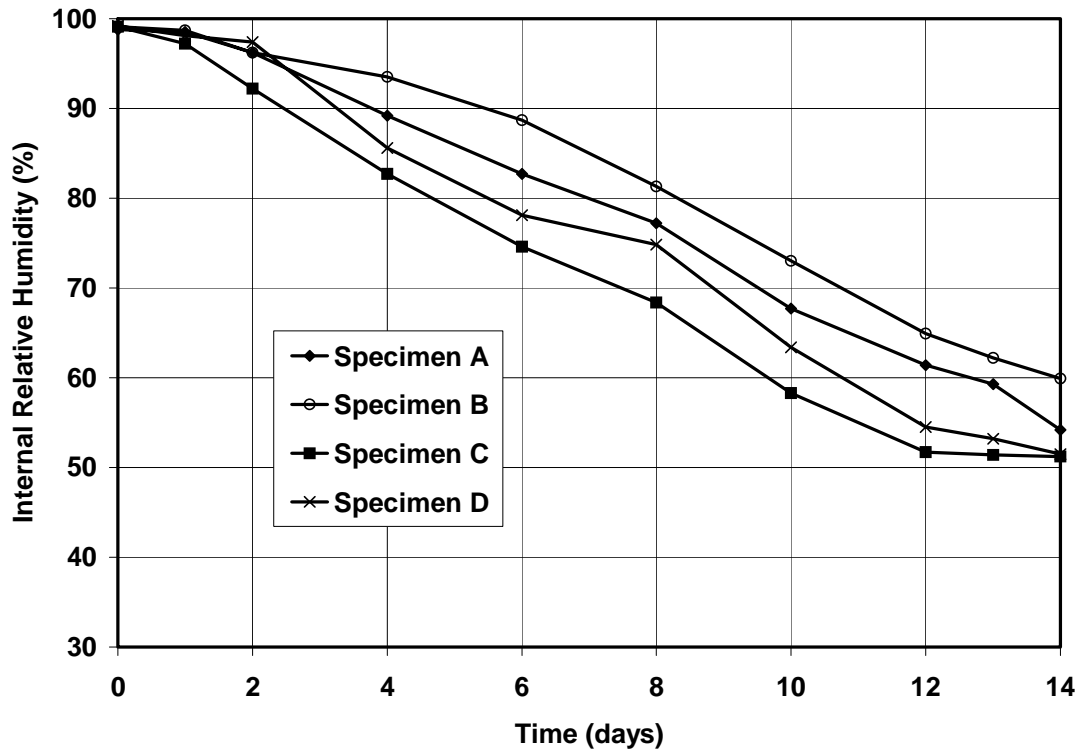
Figure 6.1 Measured internal relative humidity of control specimens at 0.5 in. depth during Drying Stage #1 (Confirmatory Test)

Figure 6.2 Measured internal relative humidity of control specimens at 1.5 in. depth during Drying Stage #1 (Confirmatory Test)

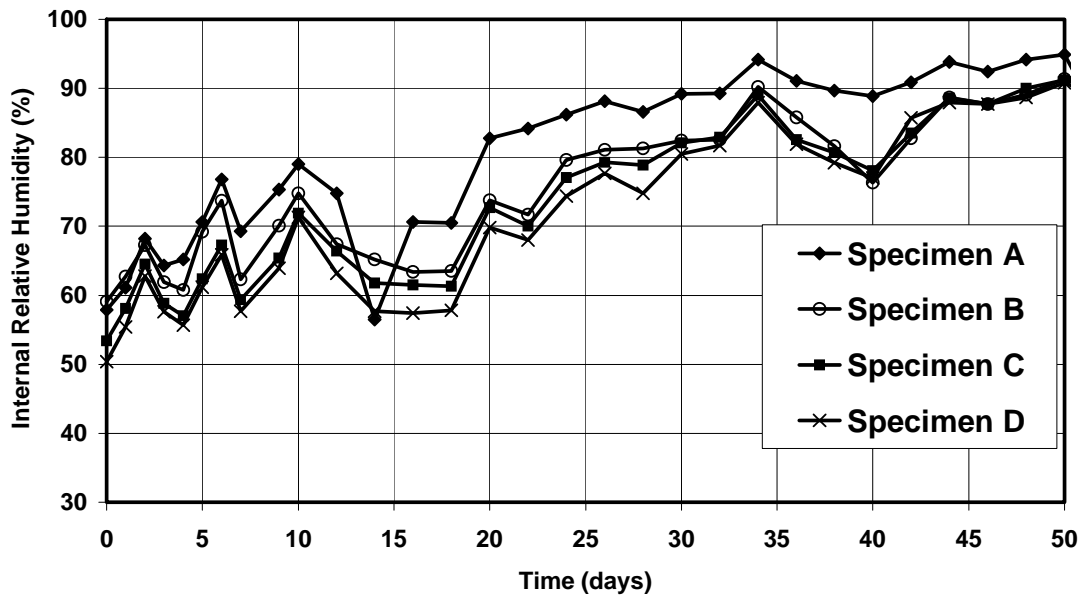
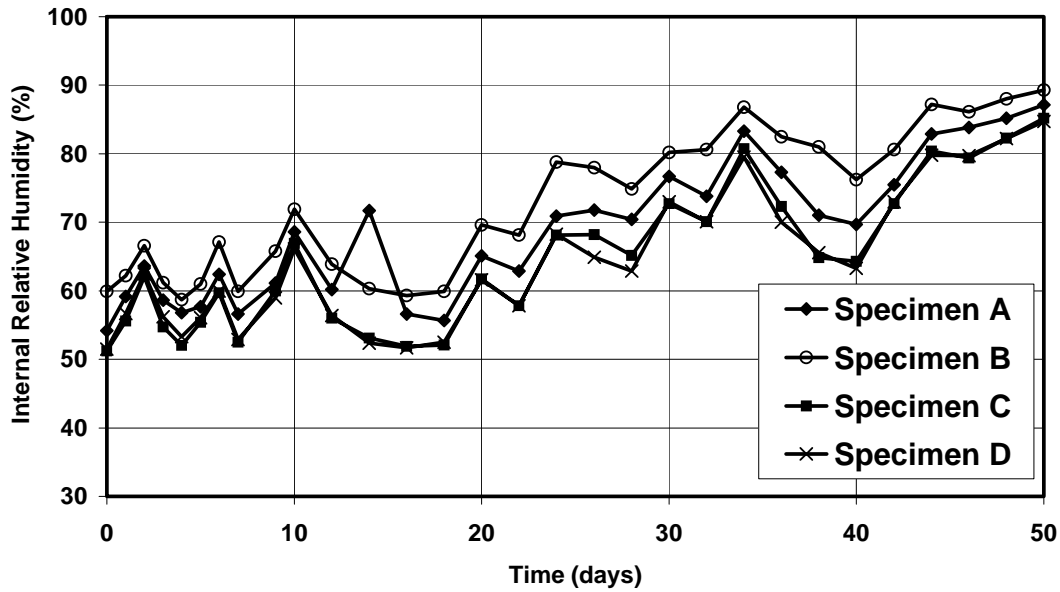
When all control specimens in the confirmatory tests reached a measured internal relative humidity of 60% at a depth of 1.5 in., the specimens were submersed in water, starting the first wetting stage. During this first wetting stage the measured internal relative humidity of the specimens did not increase monotonically, but rather fluctuated significantly over the next two months of observation (Figure 6.3 and Figure 6.4).

Figure 6.3 Measured internal relative humidity of control specimens at 0.5 in. depth during Wetting Stage #1 (Confirmatory Test)

Figure 6.4 Measured internal relative humidity of control specimens at 1.5 in. depth during Wetting Stage #1 (Confirmatory Test)

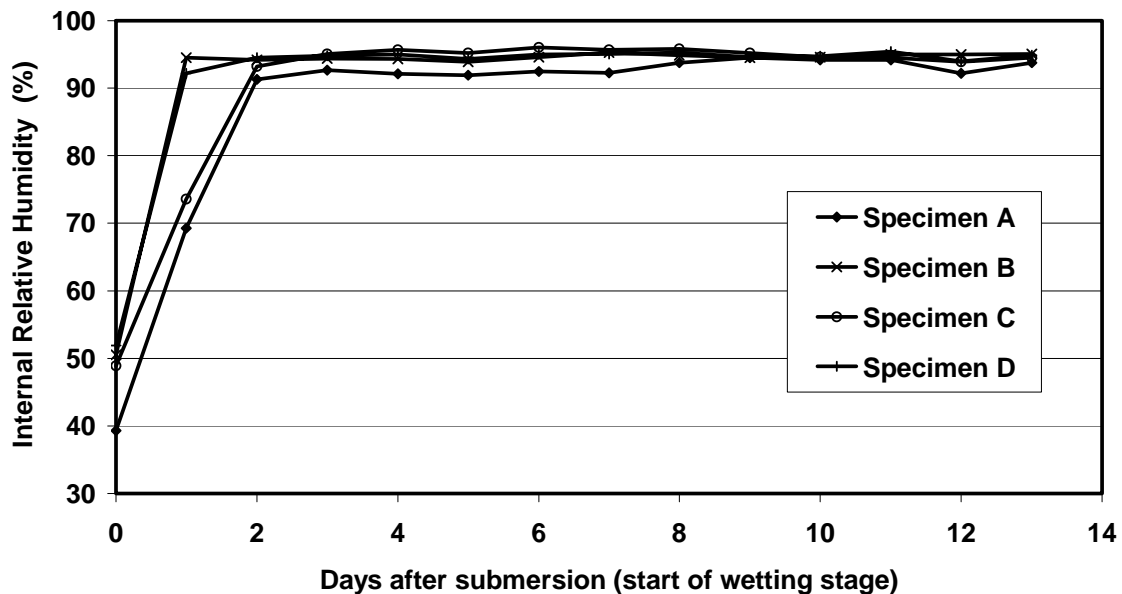
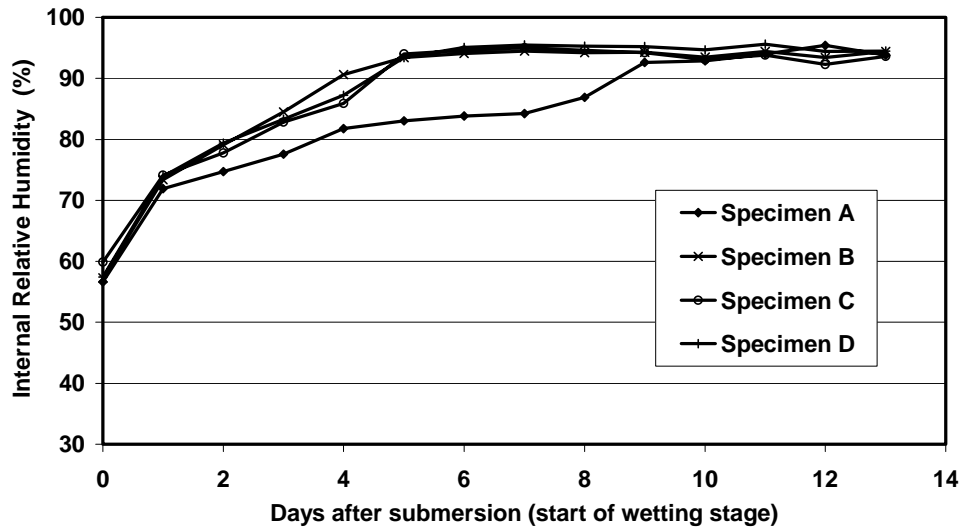
This behavior in the wetting stage of the confirmatory tests contrasted with that previously observed in the refined pilot tests, in which the measured internal relative humidity of the control specimens increased monotonically to a high value (around 95%) within 10 days (Figure 6.5 and Figure 6.6).

Figure 6.5 Measured internal relative humidity of control specimens at 0.5 in. depth during Wetting Stage #2 (Pilot Test)

Figure 6.6 Measured internal relative humidity of control specimens at 1.5 in. depth during Wetting Stage #2 (Pilot Test)

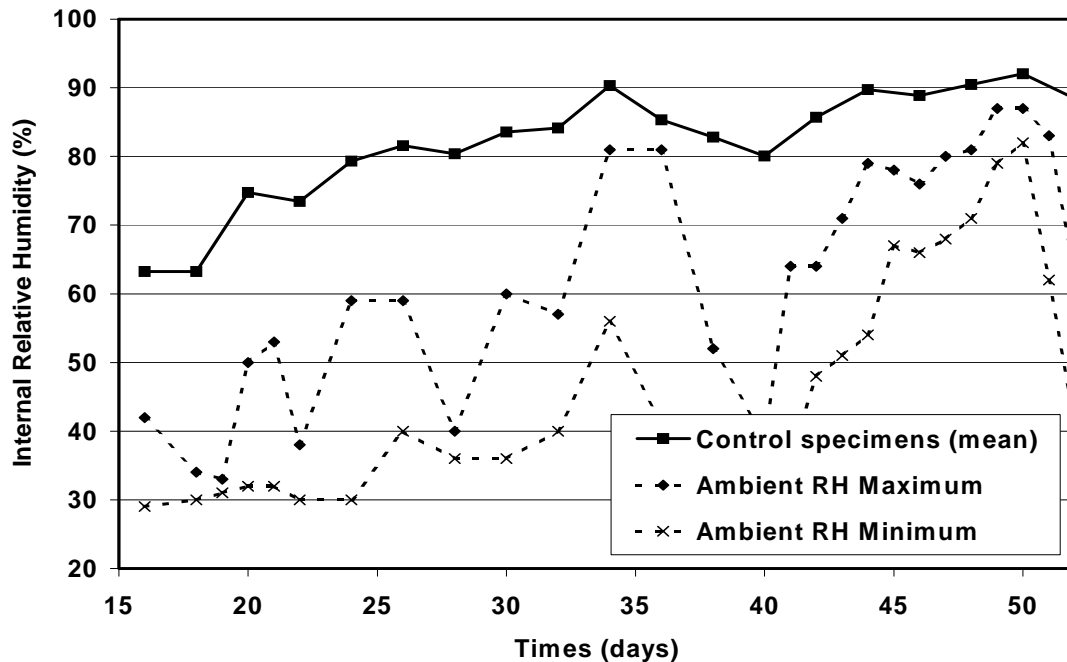
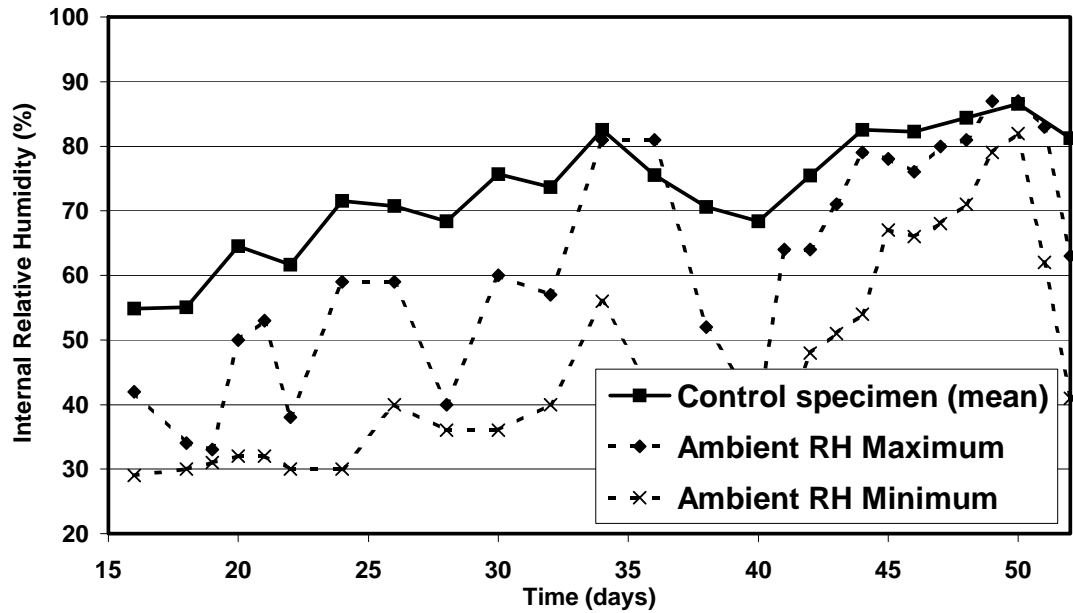
During the wetting stage of the confirmatory test, another trend was evident in the data. The measured relative humidities of all specimens (treated and untreated alike) fluctuated together. When one specimen dropped in measured relative humidity, all other specimens would also drop. During this wetting stage, ambient relative humidity varied from as low as 30% to as high as 90%. When ambient relative humidity decreased, the measured relative humidity of the concrete specimens decreased as well. When ambient relative humidity increased, the specimens reacted analogously, increasing in measured relative humidity (Figure 6.7 and Figure 6.8). This was puzzling, because the specimens were submerged during the wetting stage, and their internal relative humidity should not have fluctuated with changes in ambient relative humidity.

Figure 6.7 Average internal RH of control specimens at 0.5-in. depth and ambient RH during Wetting Stage #1 (Confirmatory Test)

Figure 6.8 Average internal RH of control specimens at 1.5 in. depth and ambient RH during Wetting Stage #1 (Confirmatory Test)

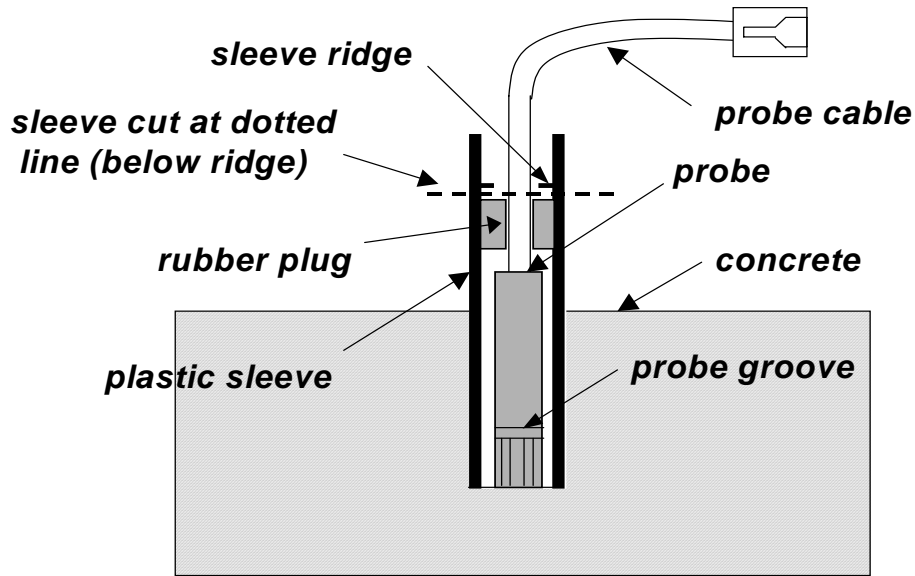
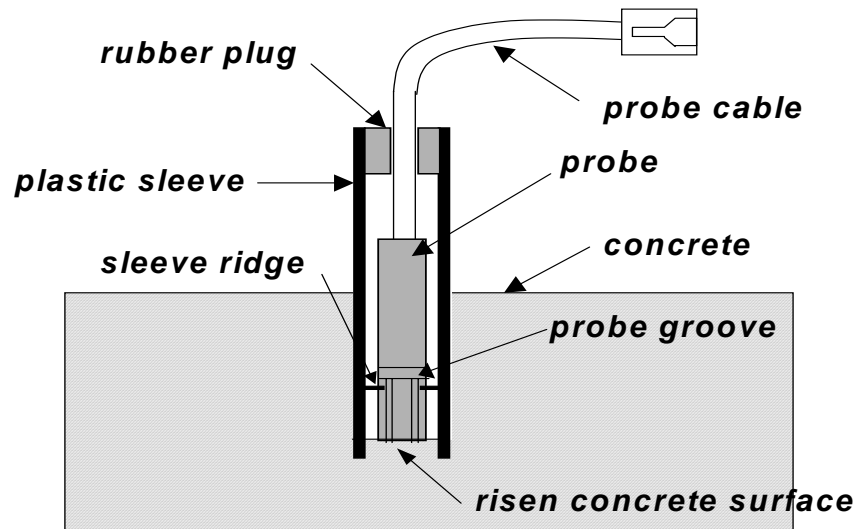
The only identifiable difference between the two sets of specimens was the orientation of the cast-in-place gage sleeves. The pilot test specimens had inadvertently been cast with the plastic sleeves oriented upside-down. This presented a problem, because the measuring probes did not fit down the sleeves due to the presence of an internal sealing ridge near the top inside of the sleeves. To solve this problem in the pilot tests, the sleeves were cut just under the ridge to allow the probes to slide down into the sleeves (Figure 6.9). The confirmatory test specimens, in contrast, were cast with the gage sleeves in correct orientation, and it was not necessary to cut them (Figure 6.10).

Figure 6.9 Orientation of sleeves in Pilot Tests

Figure 6.10 Orientation of sleeves in Confirmatory Tests

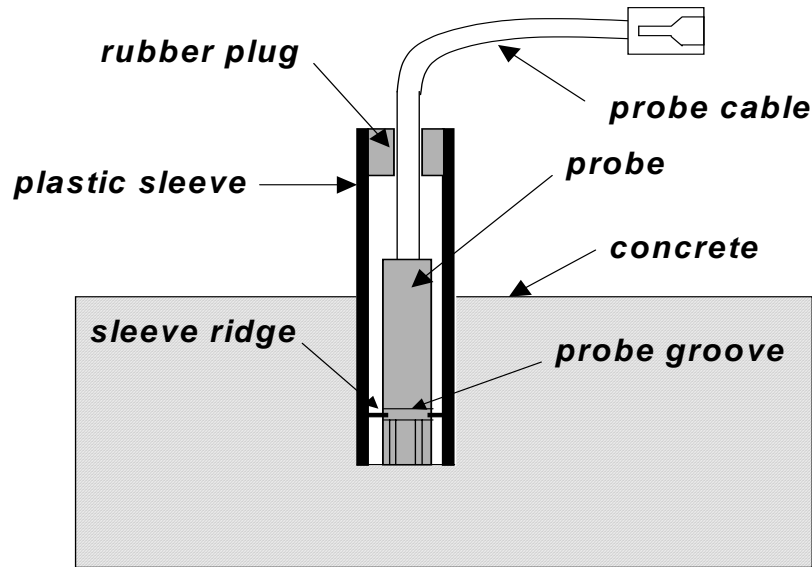
The manufacturer of the measuring equipment and sleeves (Vaisala Inc.) was contacted regarding this behavior. According to the manufacturer, the rubber plug was not intended to create an airtight seal with the plastic sleeve. Rather, the airtight seal was intended to be created when the measuring probe was inserted into the tube the internal ridge in the tube would mate with a corresponding groove in the probe (Figure 6.11).

Figure 6.11 Manufacturer's suggested sleeve orientation

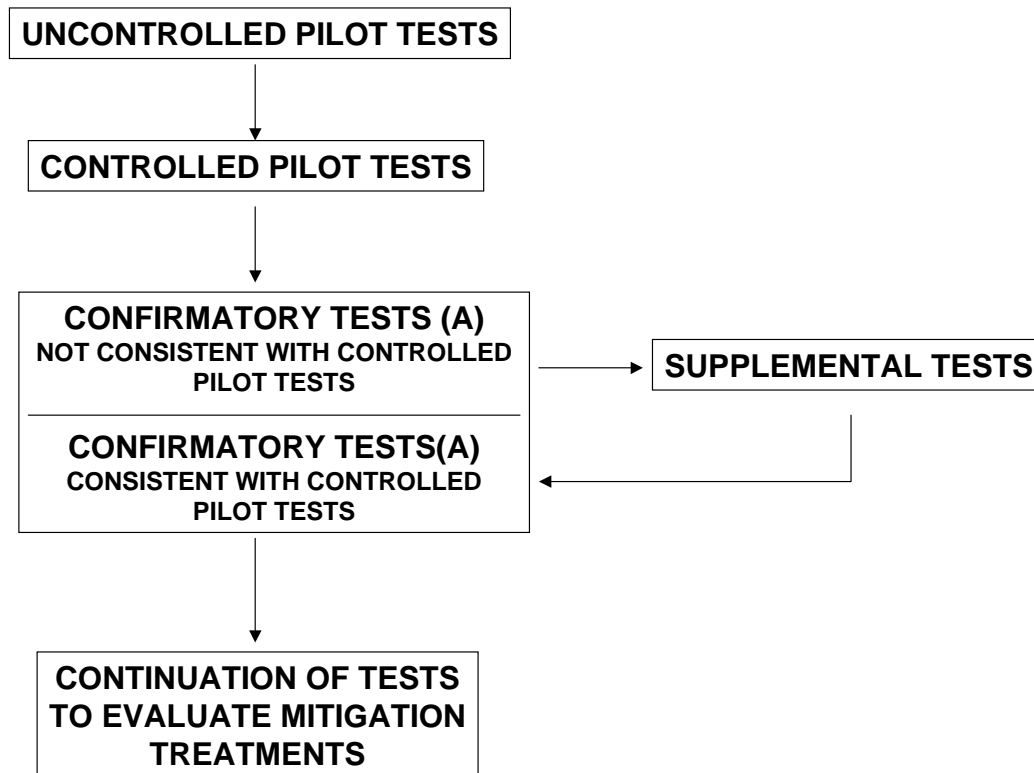
To ensure that the micro-environment inside the plugged sleeve is not directly affected by ambient relative humidity, it is necessary to use an effective seal between the plug and sleeve. Because of the measured variation in relative humidity within the sleeve during the wetting stage, the method used previously during the confirmatory test was determined to be ineffective, necessitating the development of a modified method. Three supplemental experiments were conducted to evaluate several sleeve-sealing methods. A sleeve-sealing method that proved to be effective in the supplemental experiments would be tested further by applying the method in confirmatory tests. Should those confirmatory tests be consistent with the controlled pilot tests, the test method, modified to use that sleeve-sealing method, would then be expected to be successful in comparing proposed mitigation treatments (Figure 6.12).

Figure 6.12 Flow chart of tests conducted in this phase of Study 4069

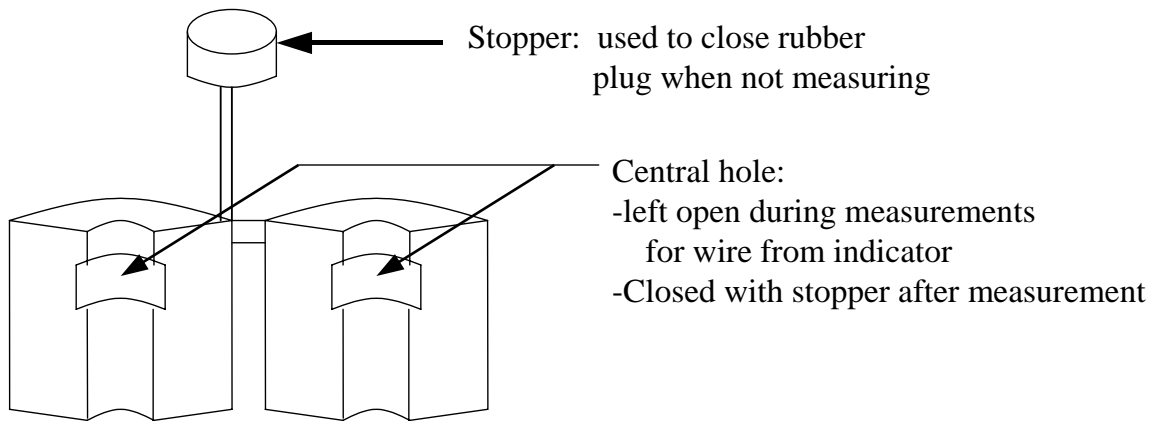
A supplemental experiment was conducted to evaluate the effectiveness of three different sleeve-sealing methods. Each sealing method was used to seal the sleeves, cast at depths of 0.5 in. and 1.5 in., into two concrete specimens. The first sleeve-sealing method consisted of applying electrical tape to the circumference of the manufacturer’s rubber plug (Figure 6.13). This was intended to increase slightly the diameter of the plug and therefore increase the tightness of the sleeve seal.

Figure 6.13 Manufacturer's rubber plug

The third and last sleeve-sealing method consisted of cutting the sleeves and sealing them with the manufacturer's rubber plugs (Figure 6.13). Since the sleeves in the confirmatory test specimens are orientated correctly, the open ends of the sleeves have a larger inside diameter than the end in the concrete. Cutting the sleeves changes the height at which the plugs seal the sleeves. Since the inside diameter of the sleeve tapers along its height, the plug should create a tighter seal than the plug at the end of an uncut sleeve. The results of this test show that the properly oriented and cut sleeves, and the tapered plugs, follow the ambient humidity to a greater extent than the tapered rubber plugs (Figure 6.15 and Figure 6.16), and are therefore less desirable than the tapered rubber plugs as a means of stabilizing the relative humidity within the measurement sleeves.

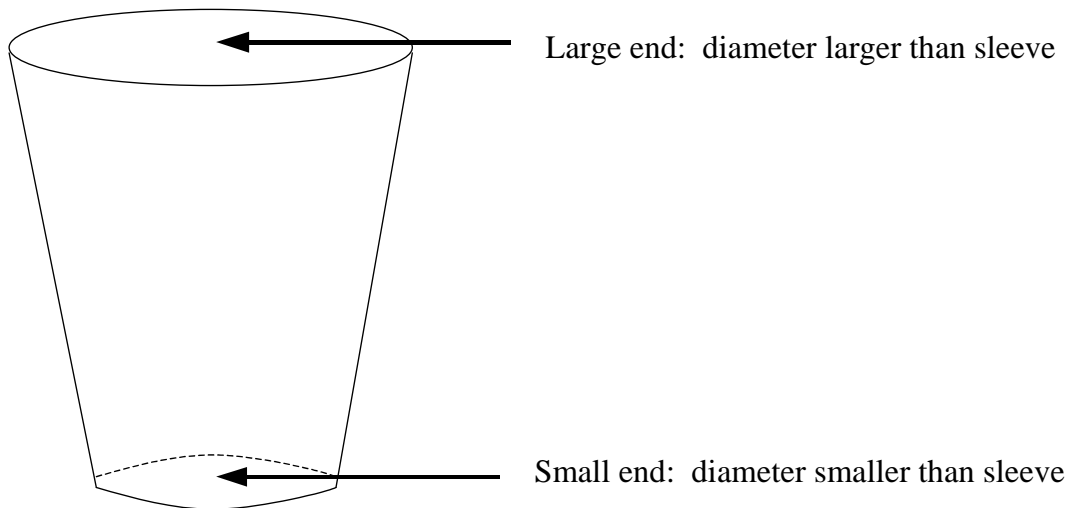
The second sleeve-sealing method consisted of using tapered rubber plugs (Figure 6.14). One end of tapered plug has a diameter smaller than the sleeve opening, while the other end has a diameter larger than the opening. The tapered plug, in theory, creates an airtight seal when inserted into the sleeve. When the measuring probe is in the sleeve during the 30-minute equilibrium period, the tapered plug cannot be used to seal the sleeve. Instead, a tapered rubber plug was used to seal the sleeve during the 30-minute measurement period. Further testing to evaluate the effectiveness of the tapered rubber plug during the 30-minute measurement period is the subject of another supplemental experiment.

Figure 6.14 Tapered rubber plug

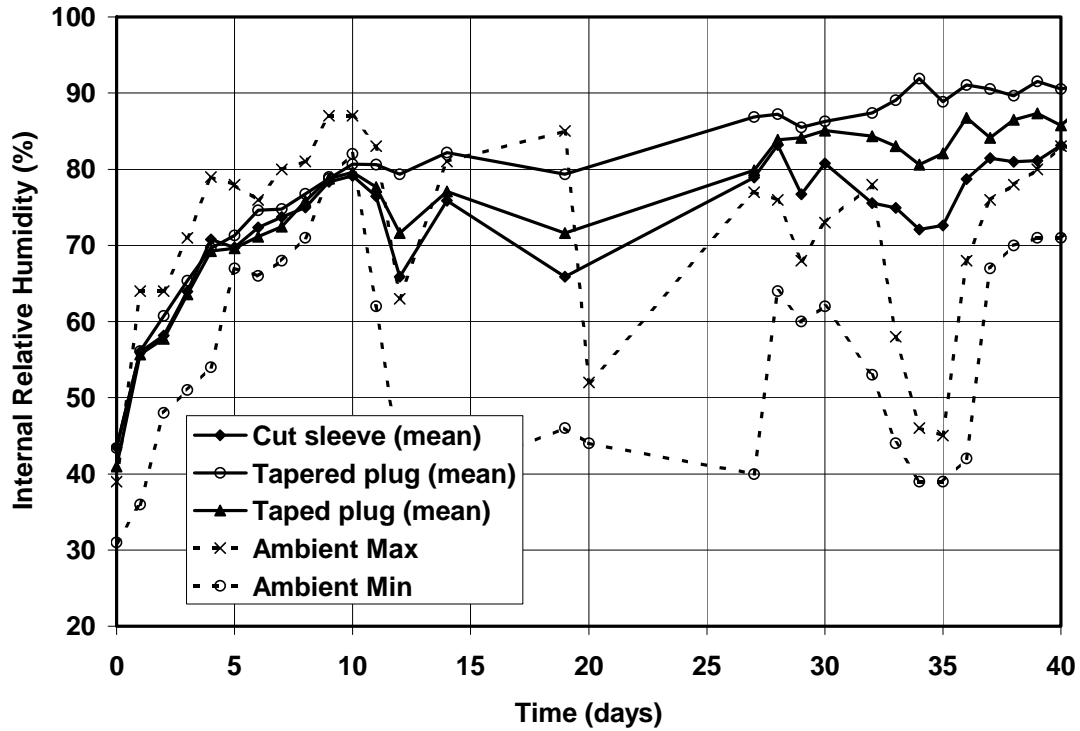
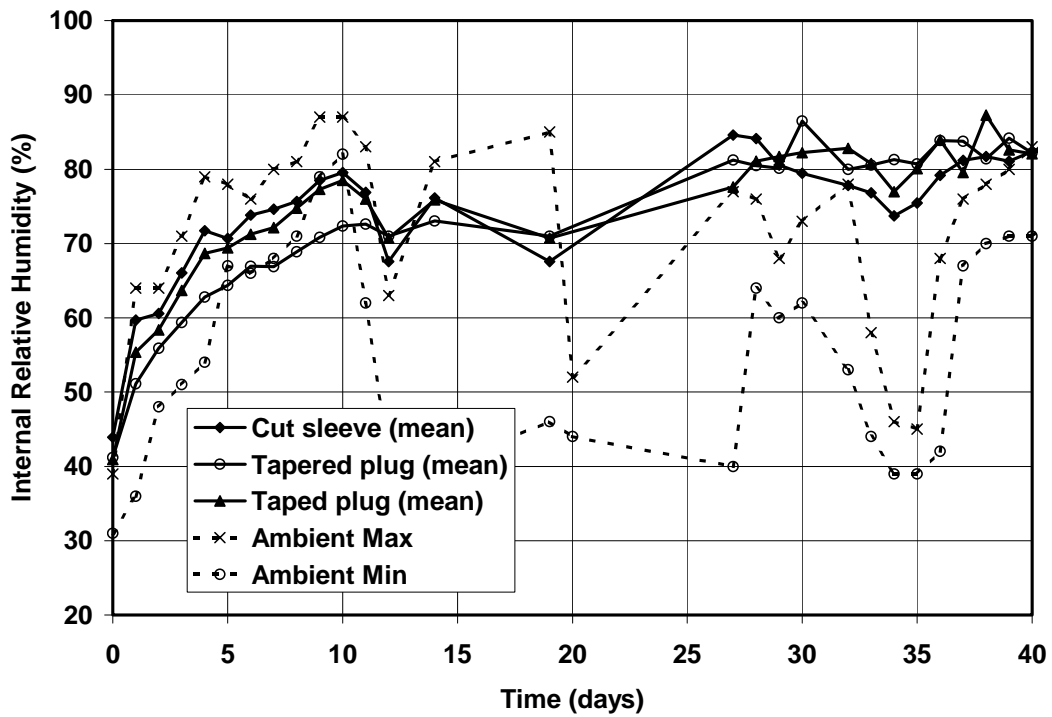
Figure 6.15 Average internal RH of control specimens with cut sleeves, taped sleeves, and tapered plugged sleeves at 0.5-in. depth (Supplemental Experiment #1)

Figure 6.16 Average internal RH of control specimens with cut sleeves, taped sleeves, and tapered plugged sleeves at 1.5-in. depth (Supplemental Experiment #1)

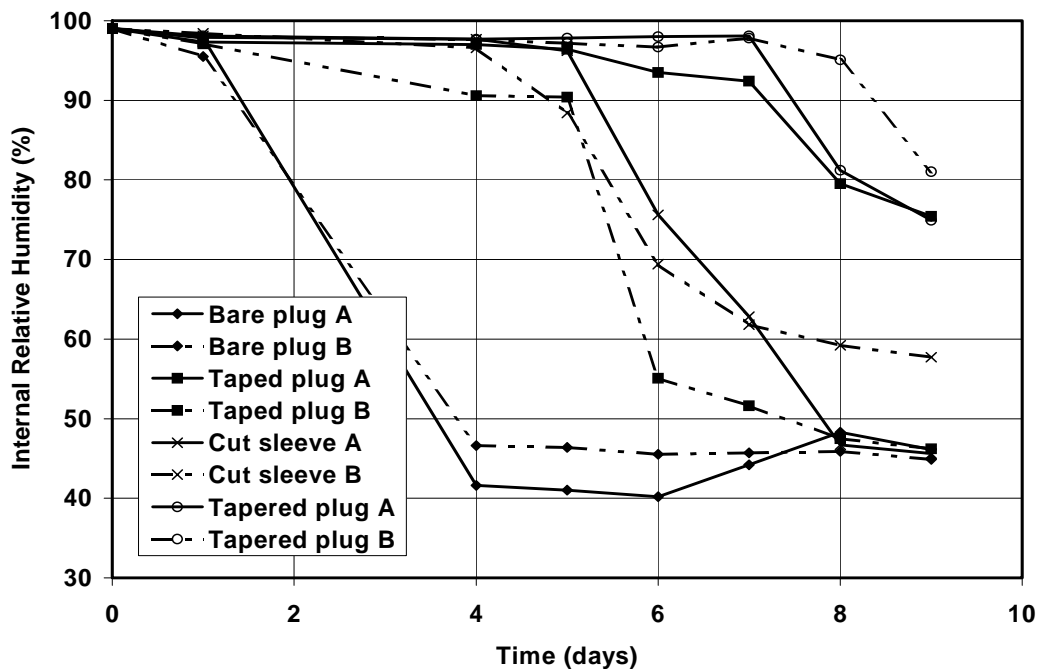
During the first test cycle, the sleeves whose larger end was sealed with the manufacturer’s plug decreased the fastest in relative humidity, showing that this was the least effective sealing method for the first test cycle. The sleeves whose smaller end was cut and sealed with the manufacture’s plug decreased the slowest in relative humidity, indicating that this was the most effective sealing method for the first test cycle (Figure 6.17).

Figure 6.17 Relative humidity of sleeves without concrete (Supplemental Experiment #2, Test #1)

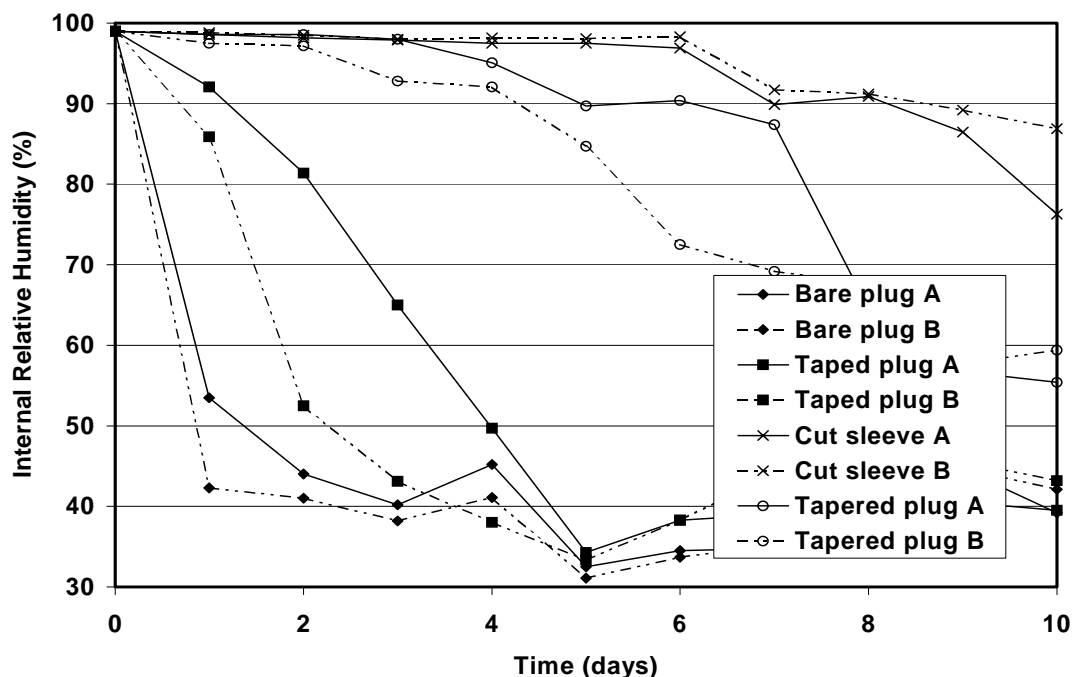
The sleeve-sealing method using the manufacturer's plug was the least effective during the first test cycle and also the second test cycle. The sleeve-sealing method involving the use of a tapered plug to seal the sleeve's larger end proved to be the most effective during the second test cycle (Figure 6.18).

Figure 6.18 Relative humidity of sleeves without concrete (Supplemental Experiment #2, Test #2)
