Mitigation Techniques for In-Service Structures with Premature Concrete Deterioration: Synthesis Report

Research Report 0-4069-3

Research Project 0-4069

October 2004

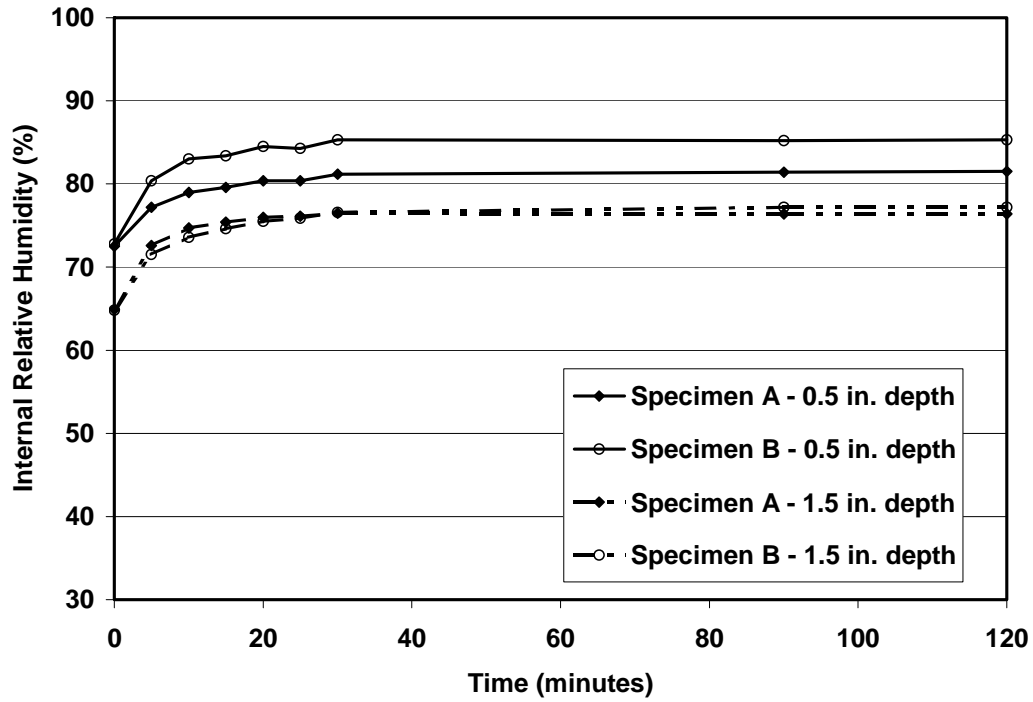
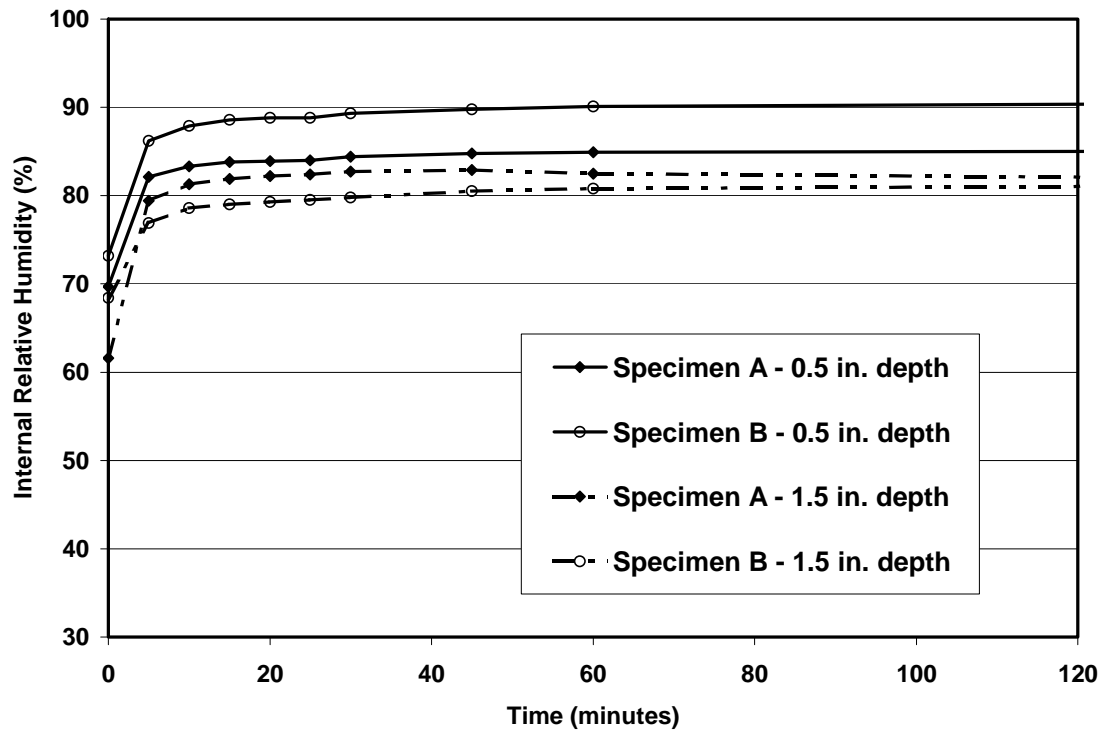
Figure 6.19 Internal RH of control specimens during measurement period with low (44%) ambient RH (Supplemental Experiment #3)

Figure 6.20 Internal RH of control specimens during measurement period with high (73%) ambient RH (Supplemental Experiment #3)

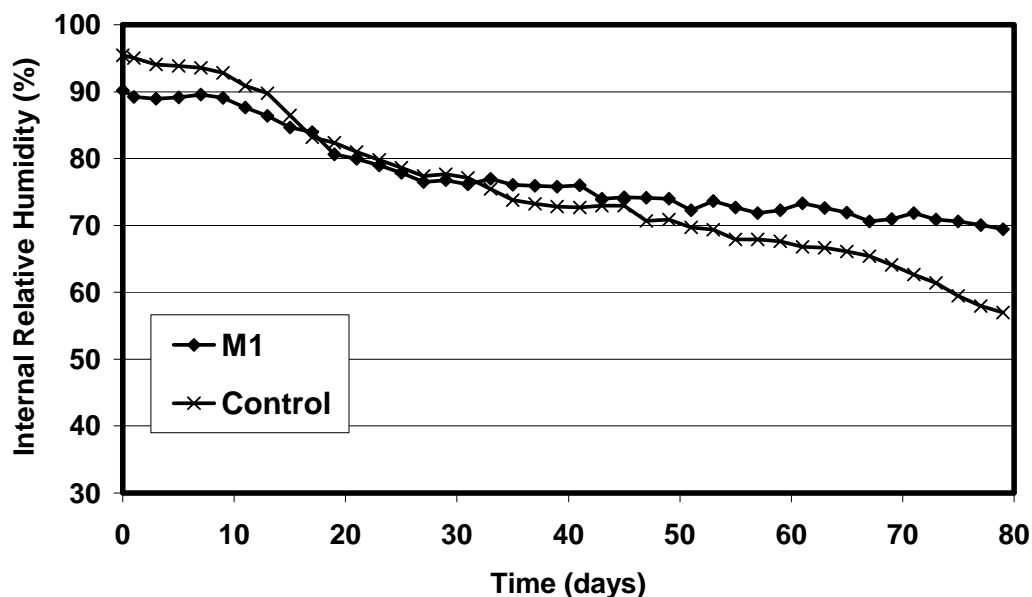
Figure 7.1 and Figure 7.2 show the average internal relative humidity of a typical set of treated specimens (M1) and the corresponding set of control specimens, at depths of 0.5 and 1.5 in. respectively, during the drying stage. In contrast to the results from Confirmatory Tests A, the internal relative humidity decreases monotonically, showing that the sealing methods developed in the Supplemental Tests were satisfactory.

Figure 7.1 Average internal RH of M1 replicates and control replicates at 0.5-in. depth during the drying stage, Confirmatory Tests B

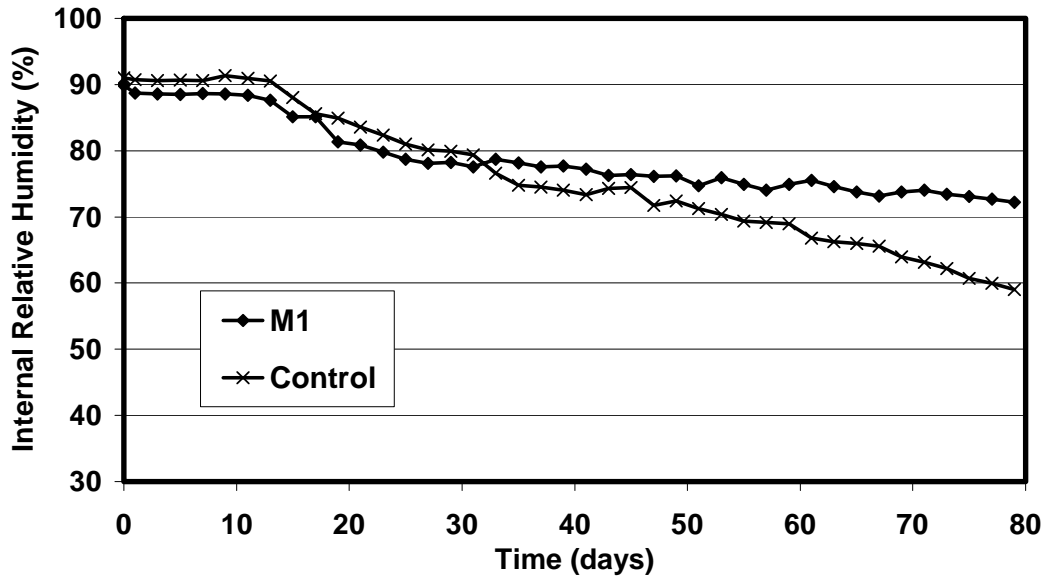
Figure 7.2 Average internal RH of M1 replicates and control replicates at 1.5-in. depth during drying stage, Confirmatory Tests B

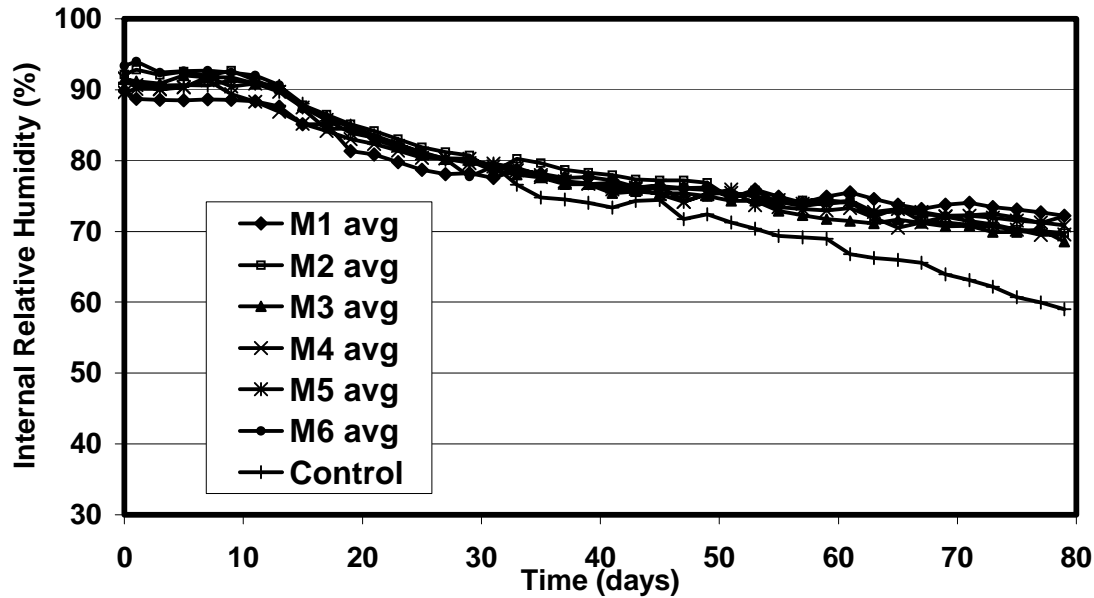
Figure 7.3 and Figure 7.4 show the average internal relative humidity of each set of specimens (treated and control), at depths of 0.5 and 1.5 in. respectively, during the drying stage. Results are consistent among sets of specimens, showing that the sealing methods developed in the Supplemental Tests were satisfactory.

Figure 7.4 Average internal RH of each treated and untreated set of specimens at 1.5-in. depth during drying stage, Confirmatory Tests B

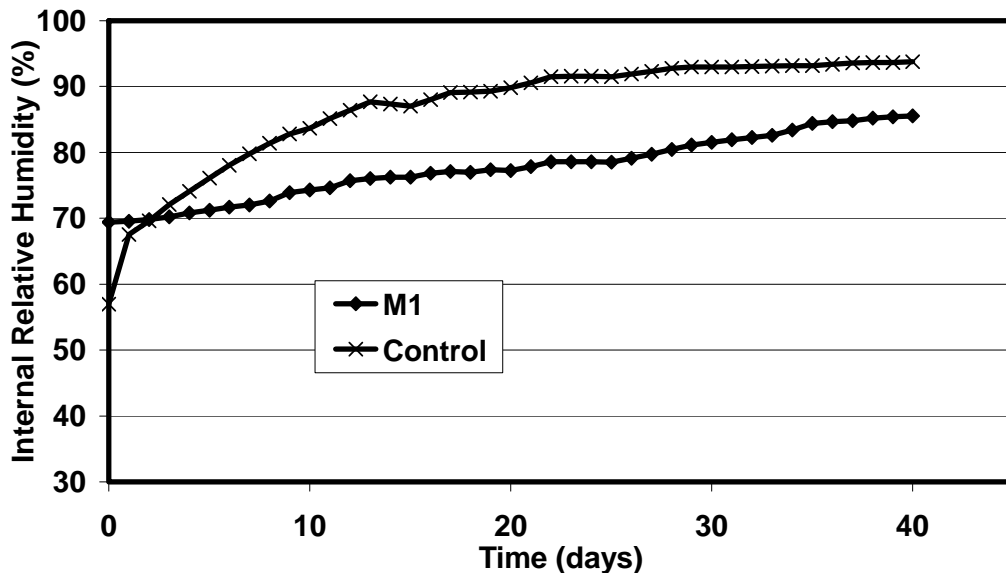
Figure 7.5 and Figure 7.6 show the average internal relative humidity of a typical set of treated specimens and the control set of specimens, at depths of 0.5 and 1.5 in. respectively, during the wetting stage. Unlike the results from Confirmatory Tests A, the internal relative humidity increases monotonically, showing that the sealing methods developed in the Supplemental Tests were satisfactory.

Figure 7.5 Average internal RH of M1 replicates and control replicates at 0.5-in. depth during wetting stage, Confirmatory Tests B

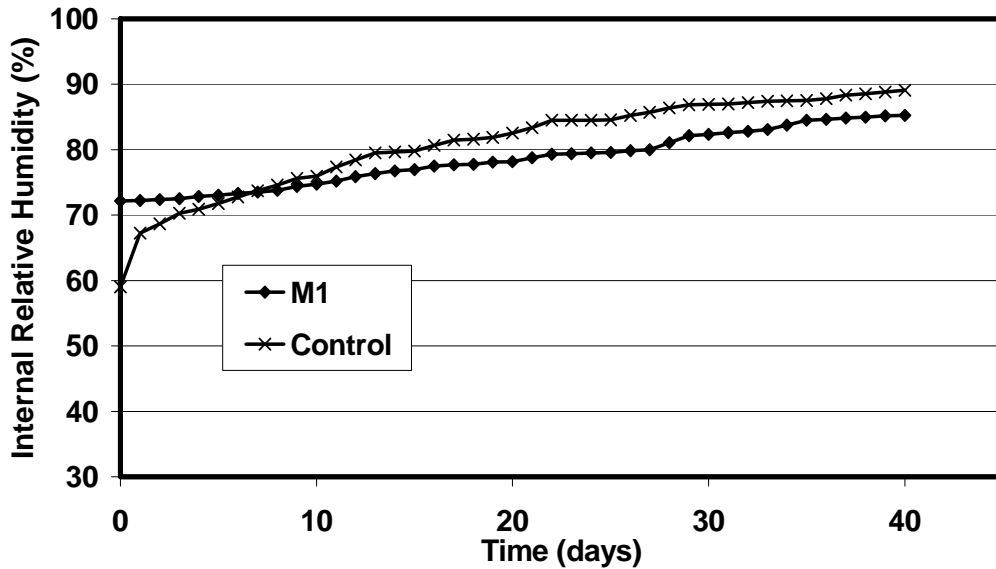
Figure 7.6 Average internal RH of M1 replicates and control replicates at 1.5-in. depth during wetting stage, Confirmatory Tests B

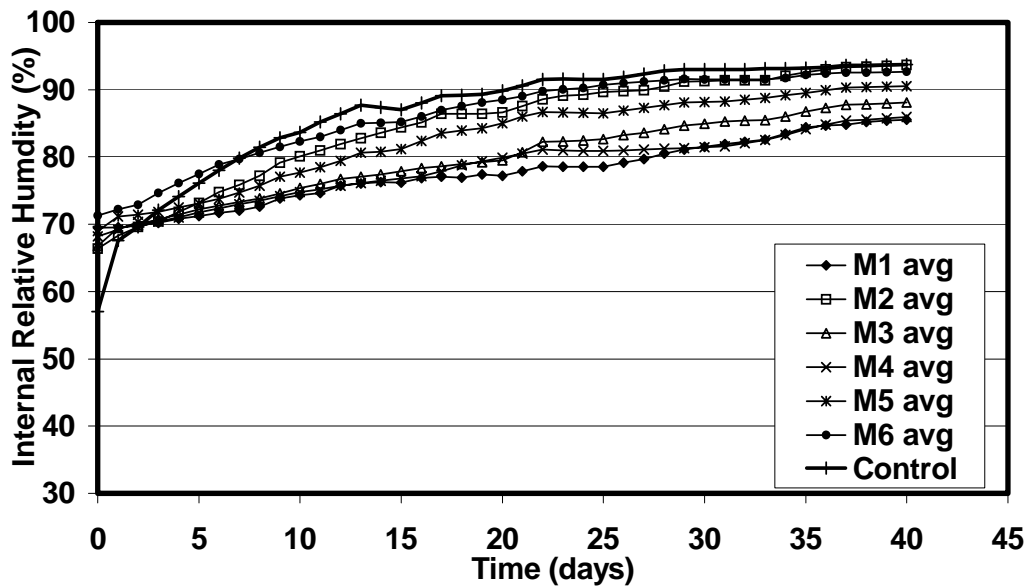
Figure 7.7 and Figure 7.8 show the average internal relative humidity of each set of specimens (treated and control) during the wetting stage, at depths of 0.5 and 1.5 in. respectively. Results are consistent among sets of specimens, showing that the sealing methods developed in the Supplemental Tests were satisfactory.

Figure 7.7 Average internal RH of each treated and untreated set of specimens at 0.5-in. depth during wetting stage, Confirmatory Tests B

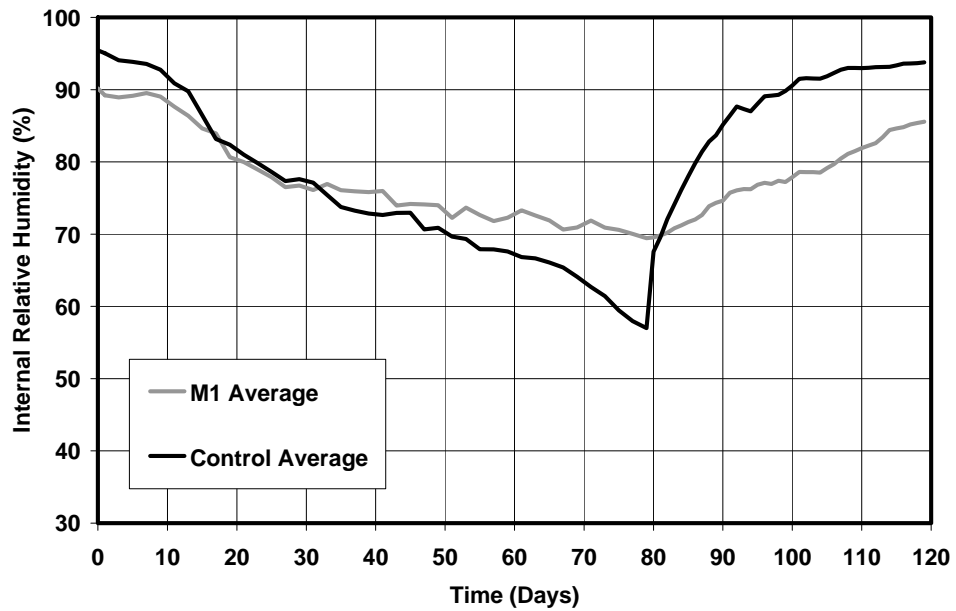
In Figure 7.9 and Figure 7.10 are shown, for depths of 0.5 and 1.5 in. respectively, the variation of average internal relative humidity, during a complete cycle of a drying stage followed by a wetting stage, for the M1 treated replicates and for the untreated (control) replicates. During the drying stage, the internal relative humidity of the M1 treated replicates decreases about the same as that of the untreated control specimens; during the wetting stage, it increases more slowly than that of the controls.

Figure 7.9 Average internal RH of M1 replicates and control replicates at 0.5-in. depth during entire cycle, Confirmatory Tests B

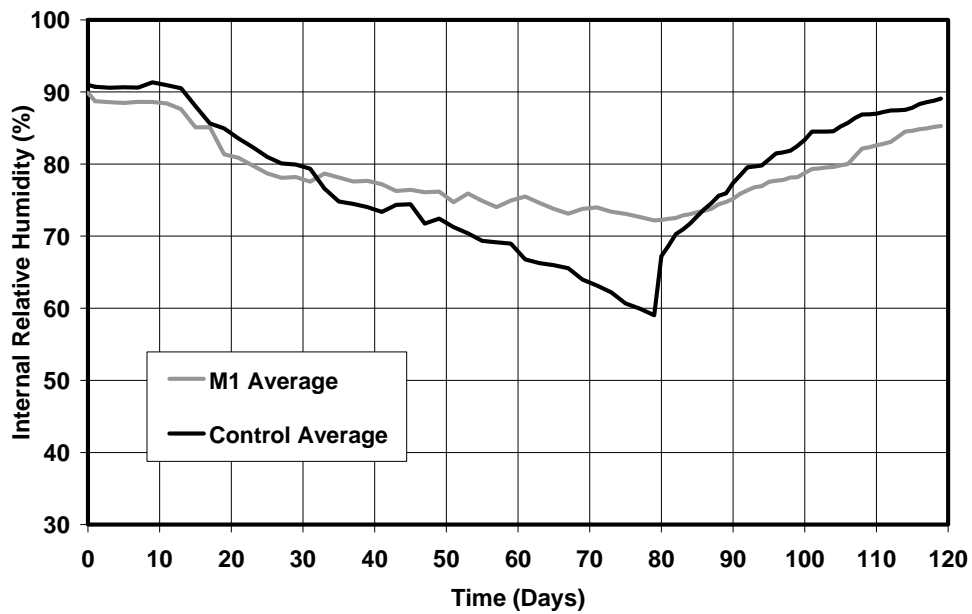
Figure 7.10 Average internal RH of M1 replicates and control replicates at 1.5-in. depth during entire cycle, Confirmatory Tests B

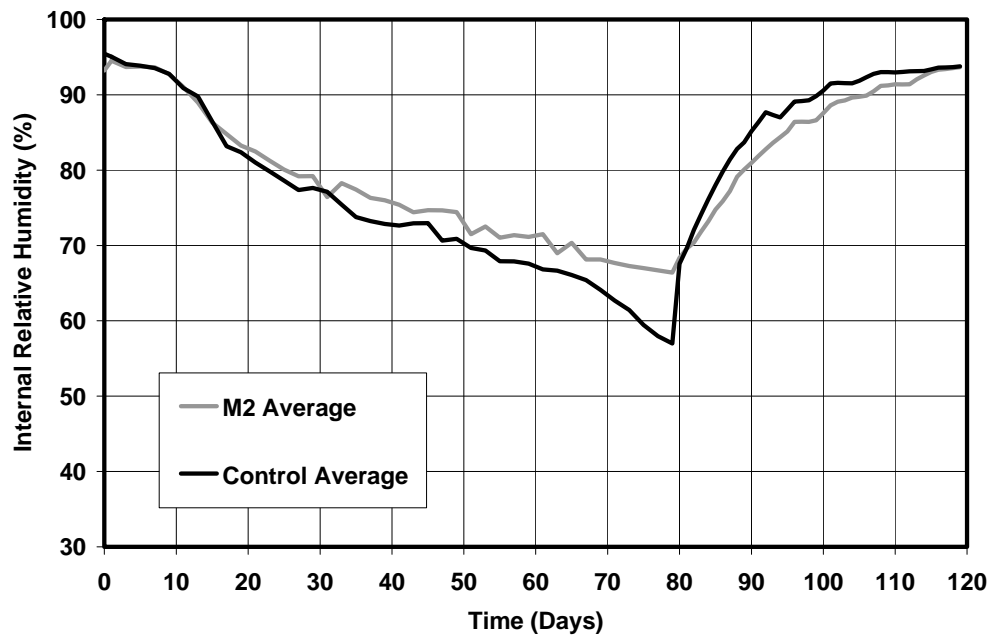
Figure 7.11 Average internal RH of M2 replicates and control replicates at 0.5-in. depth during entire cycle, Confirmatory Tests B

Corresponding information for Mitigation Treatments M2 through M6 is presented in Figure 7.11 through Figure 7.20.

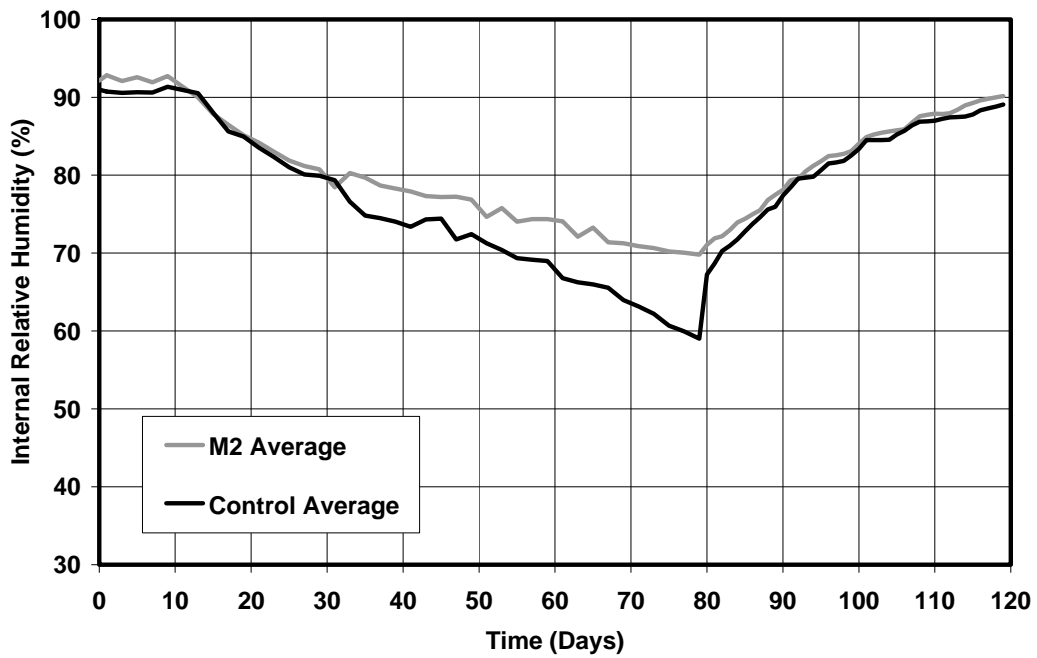
Figure 7.12 Average internal RH of M2 replicates and control replicates at 1.5-in. depth during entire cycle, Confirmatory Tests B

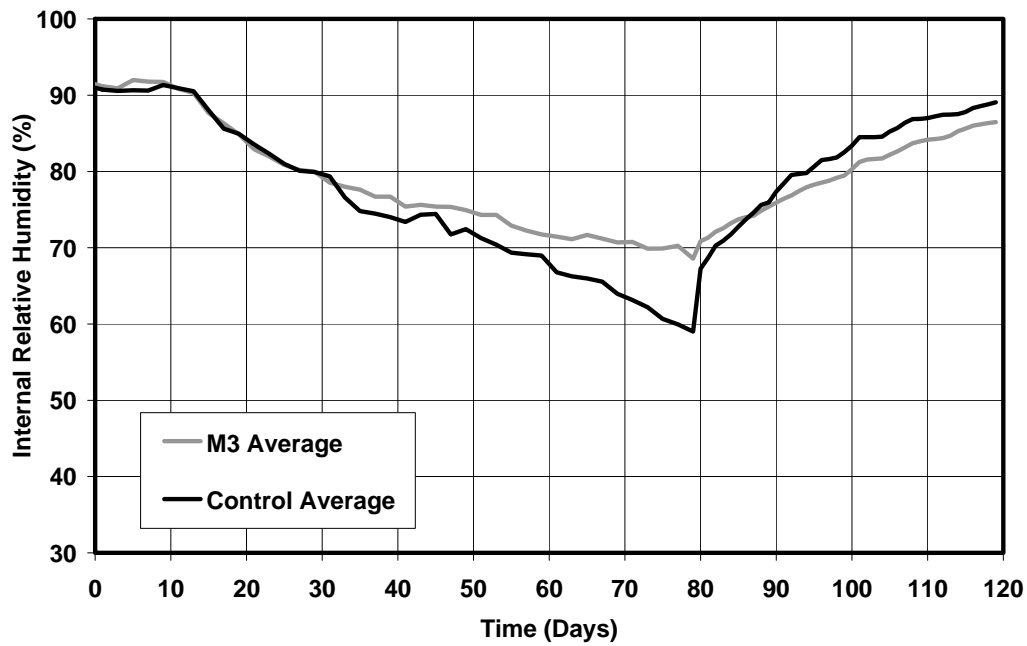
Figure 7.14 Average internal RH of M3 replicates and control replicates at 1.5-in. depth during entire cycle, Confirmatory Tests B

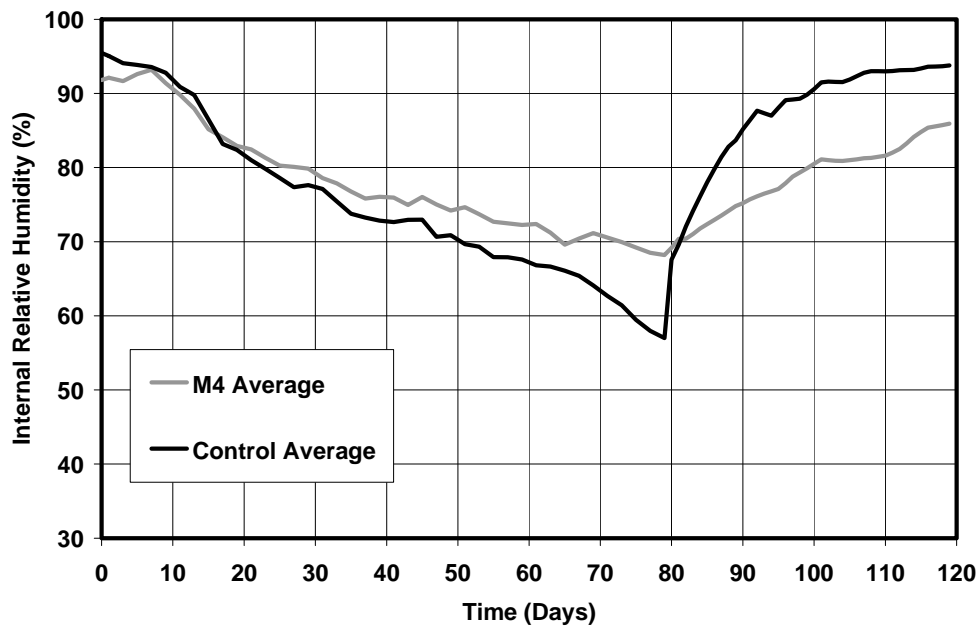
Figure 7.15 Average internal RH of M4 replicates and control replicates at 0.5-in. depth during entire cycle, Confirmatory Tests B

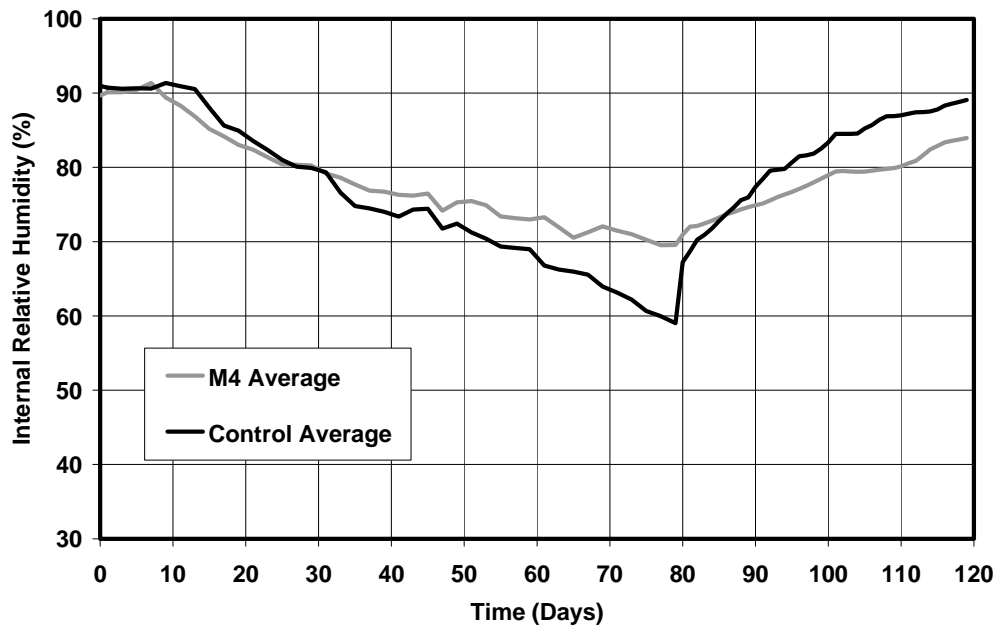
Figure 7.16 Average internal RH of M4 replicates and control replicates at 1.5-in. depth during entire cycle, Confirmatory Tests B

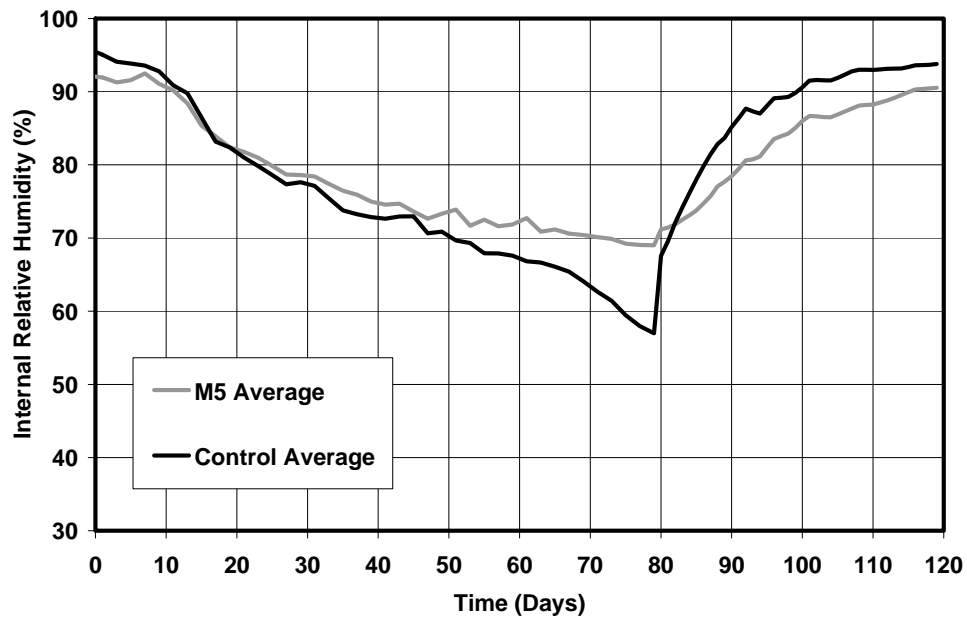
Figure 7.17 Average internal RH of M5 replicates and control replicates at 0.5-in. depth during entire cycle, Confirmatory Tests B

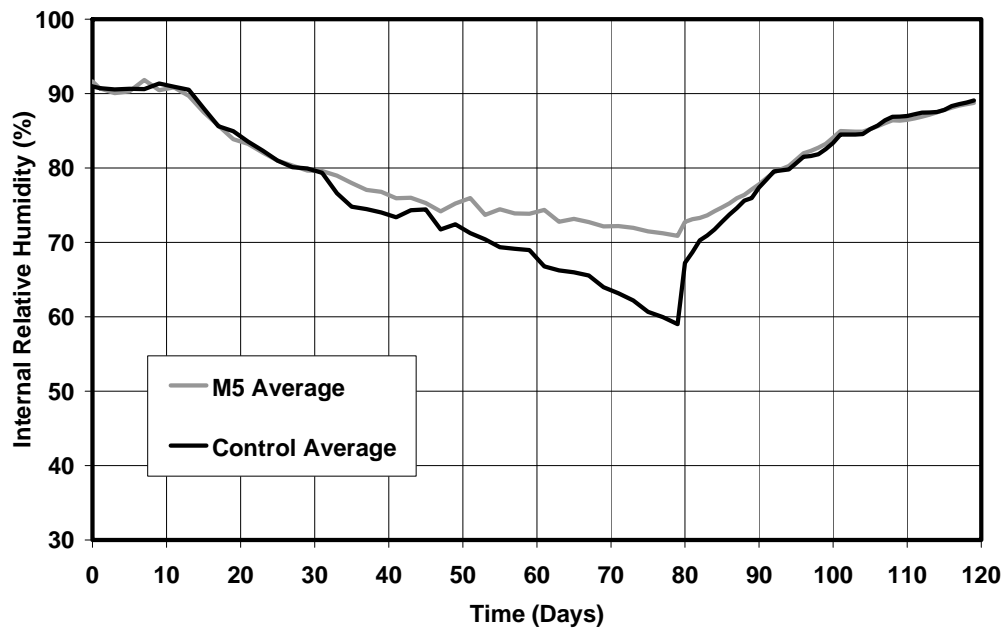
Figure 7.18 Average internal RH of M5 replicates and control replicates at 1.5-in. depth during entire cycle, Confirmatory Tests B

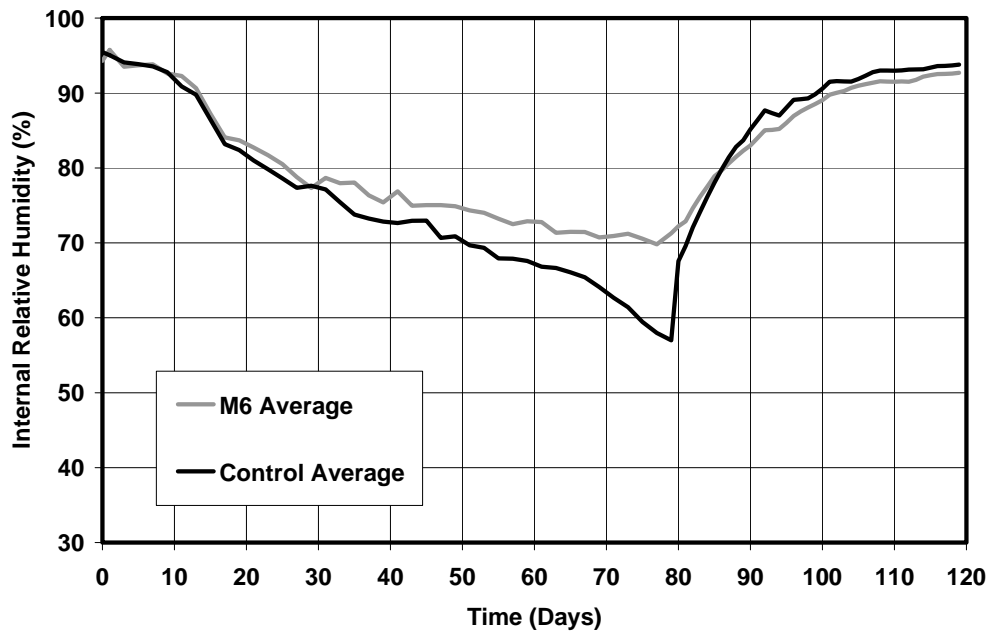
Figure 7.19 Average internal RH of M6 replicates and control replicates at 0.5-in. depth during entire cycle, Confirmatory Tests B

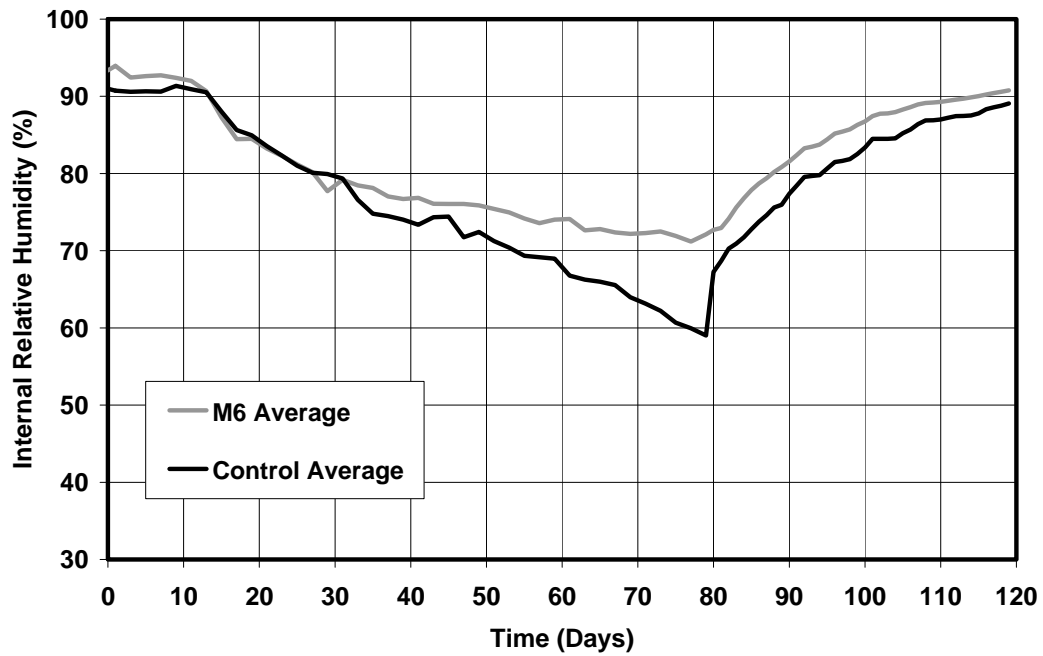
Figure 7.20 Average internal RH of M6 replicates and control replicates at 1.5-in. depth during entire cycle, Confirmatory Tests B

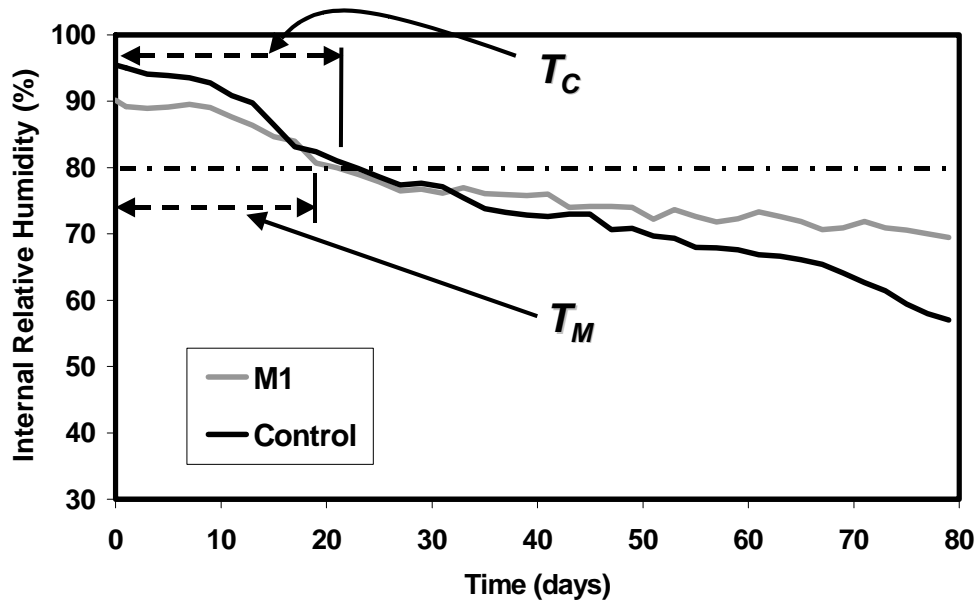
Comparative average drying-stage exposure times for the specimens with Treatment M1 and for the control specimens are shown in Figure 7.21 and Figure 7.22 at depths of 0.5 in. and 1.5 in. respectively. The same times are given numerically in Table 7.1 and Table 7.2.

Figure 7.21 Average drying-stage exposure times for Treatment M1 at 0.5-in. depth, Confirmary Tests B

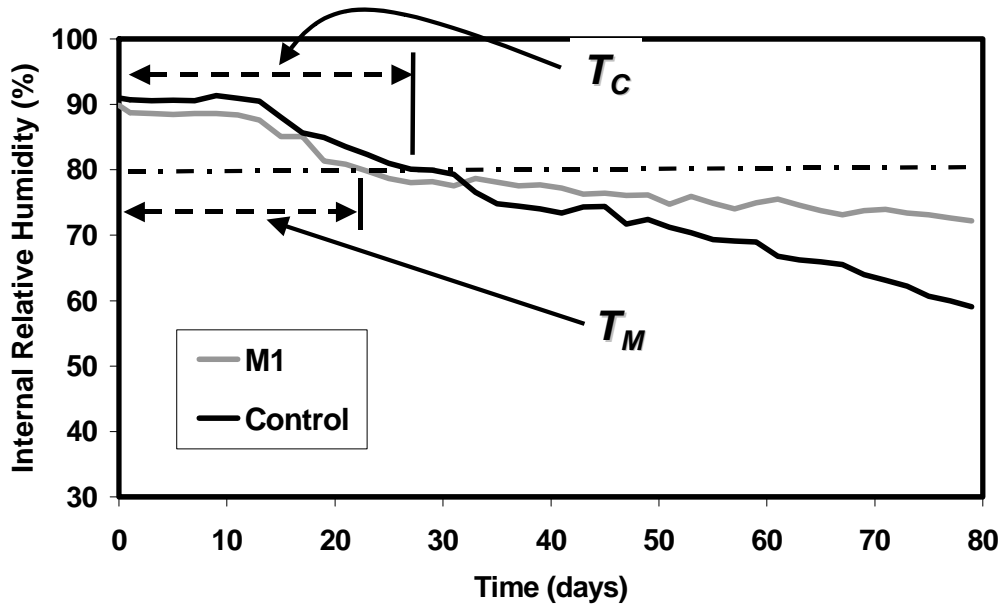
Figure 7.22 Average drying-stage exposure times for Treatment M1 at 1.5-in. depth, Confirmary Tests B

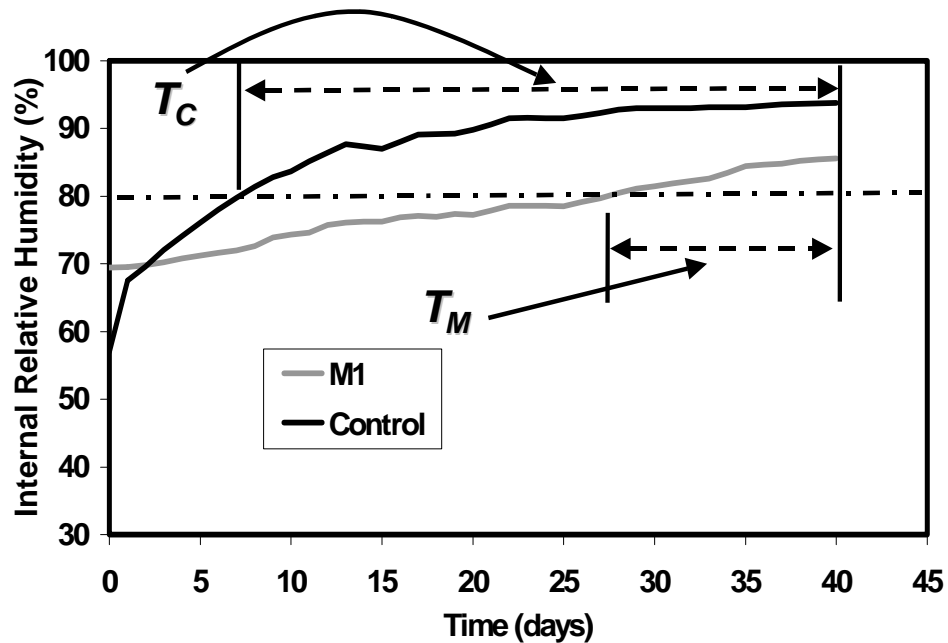
Average wetting-stage exposure times for the specimens with Treatment M1 and for the control specimens are shown in Figure 6.23 and Figure 6.24 at depths of 0.5 in. and 1.5 in. respectively. The same times are given numerically in Table 6.5 and Table 6.6.

Figure 7.23 Average wetting-stage exposure times for Treatment M1 at 0.5-in. depth, Confirmatory Tests B

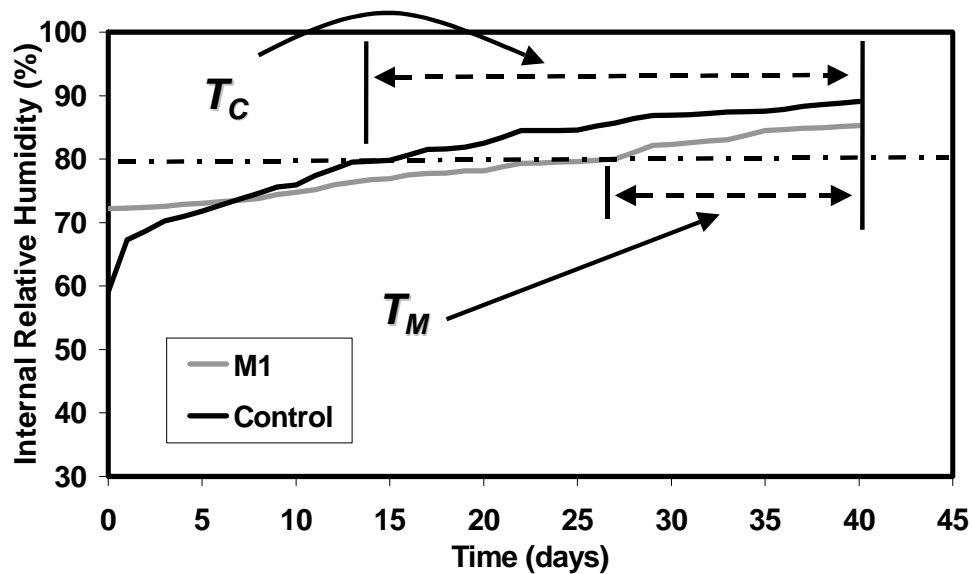
Figure 7.24 Average wetting-stage exposure times for Treatment M1 at 1.5-in. depth, Confirmatory Tests B

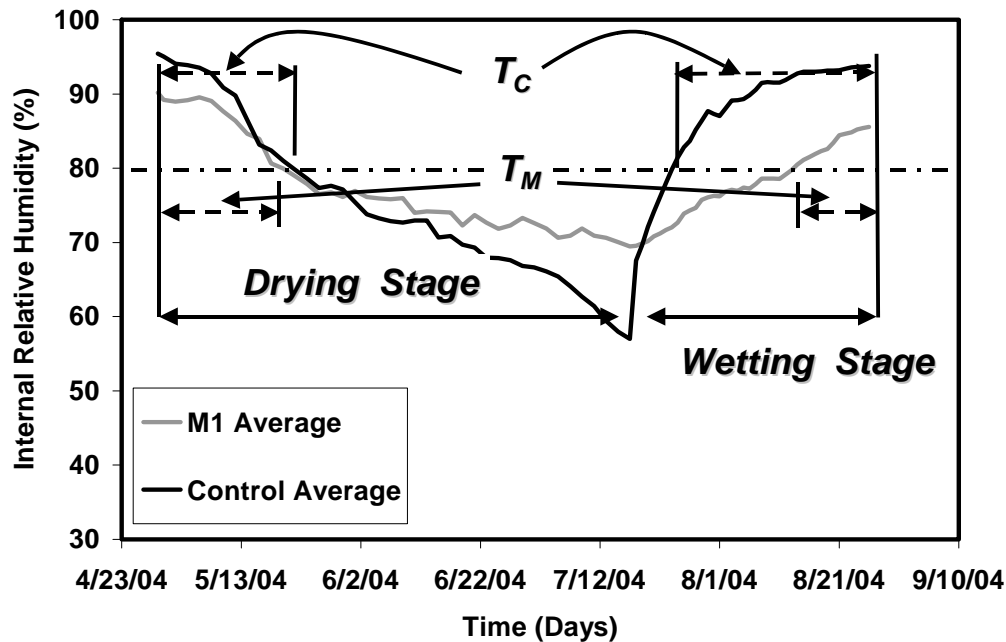
Average total exposure times for the specimens with Treatment M1 and for the control specimens are shown in Figure 7.25 and Figure 7.26 at depths of 0.5 in. and 1.5 in. respectively. Corresponding results are given in tabular form in Table 7.9 and Table 7.10. In each case, the average total exposure time is obtained by summing the average drying-stage and the average wetting-stage times presented in the preceding sections.

Figure 7.25 Average total exposure times for Treatment M1 at 0.5-in. depth, Confirmatory Tests B

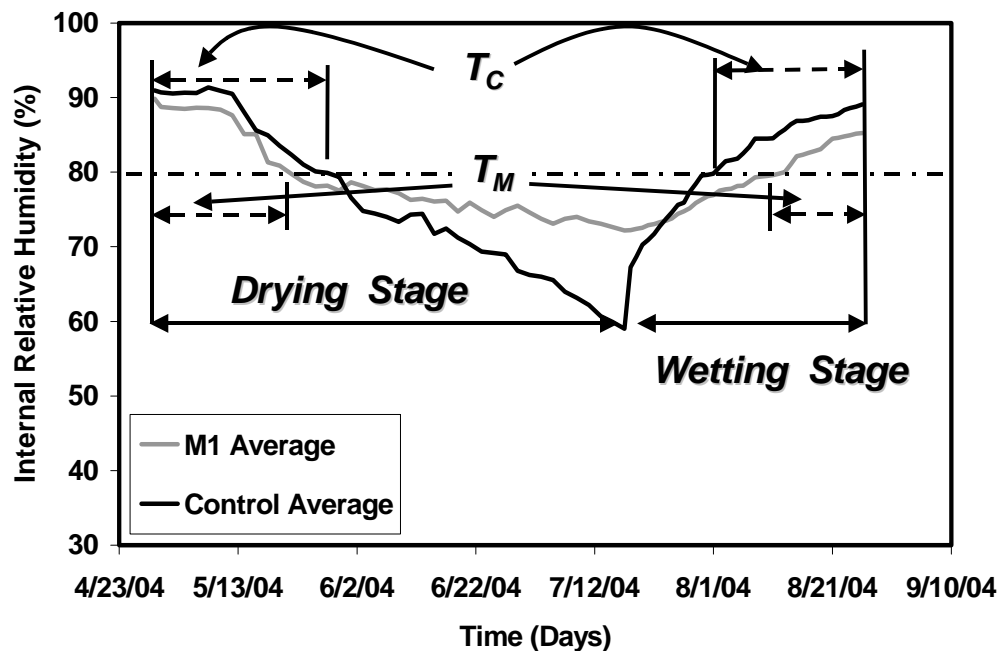
Figure 7.26 Average total exposure times for Treatment M1 at 1.5-in. depth, Confirmatory Tests B
