Fatigue Strength of Signal Mast Arm Connections: A Summary

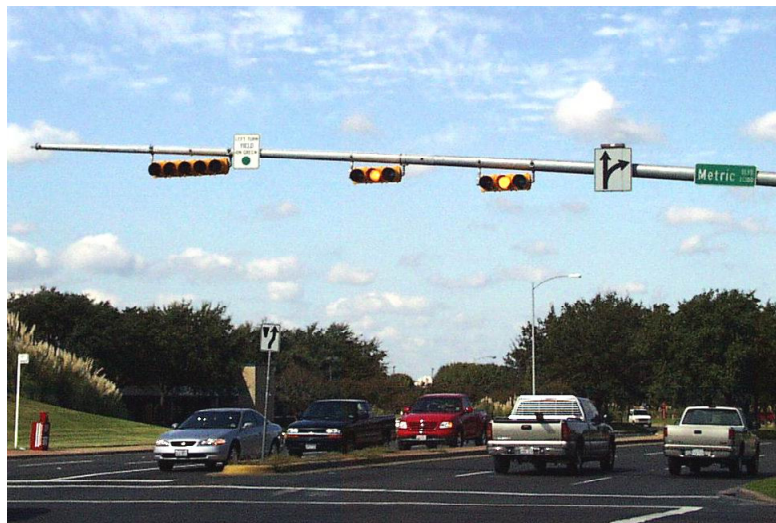
Figure 1. Typical Cantilever Signal Support

This project investigated the fatigue characteristics of traffic cantilever signal mast arms shown in Figure 1. The cantilever mast arm is cost-efficient and relatively simple to design. The overall structure is more aesthetically pleasing than a cable structure or a truss cantilever structure. The same characteristics that make this traffic signal structure desirable also represent the most negative factors of the structure; it is a non-redundant structure and the mast arm is very flexible.

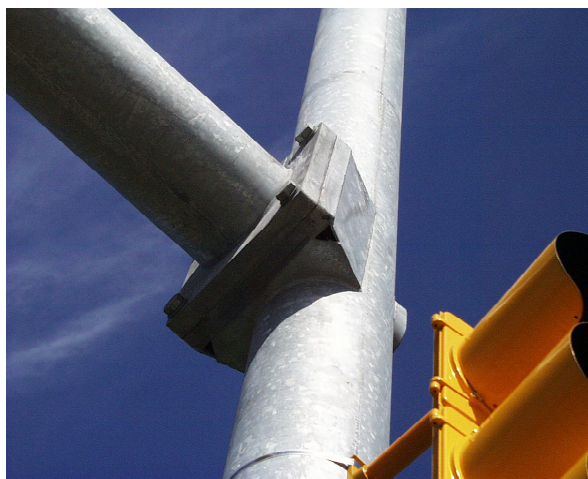
Figure 2. Typical Mast Arm Connection

The details of the typical unstiffened, socketed connection are shown in Figures 2 and 3. This is the most common type of connection between the mast arm and the connection box on the upright mast. The term socketed comes from the socket hole cut into the end plate to accept the mast. The hole allows the drainage of the molten zinc from the interior of the arm during the galvanizing process. An unequal leg fillet weld is used on the outside to connect the arm to the end plate with the interior weld

serving as a seal weld.

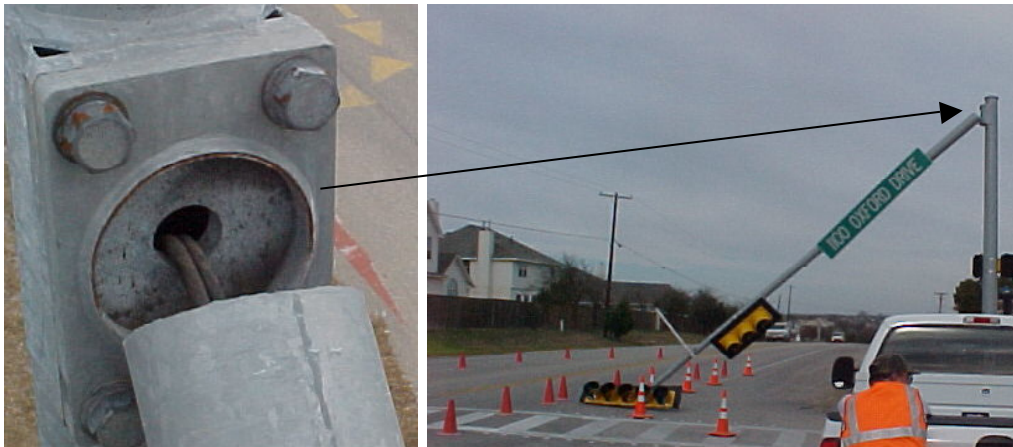
Figure 4. Mast Arm Fatigue Failure

The hole cut into the end plate to accept the mast arm significantly reduces its bending stiffness. A typical service fatigue failure is shown in Figure 4. The failure occurs when there is cracking at the toe of the fillet weld connecting the end plate to the arm. Galloping of the mast arm from steady winds blowing on the back of the signal or gusts from trucks passing under the arm produce the repeated fatigue stresses that cause the cracking.
