# **EVALUATION AND PERFORMANCE MONITORING OF CORROSION PROTECTION BY FIBER-REINFORCED COMPOSITE WRAPPING**

Research Report No. 1774-1

**“Effect of Wrapping Chloride Contaminated Structural Concrete with Multiple  
Layers of Glass Fiber/Composites and Resin”**

**CENTER FOR TRANSPORTATION RESEARCH  
BUREAU OF ENGINEERING RESEARCH  
THE UNIVERSITY OF TEXAS AT AUSTIN**

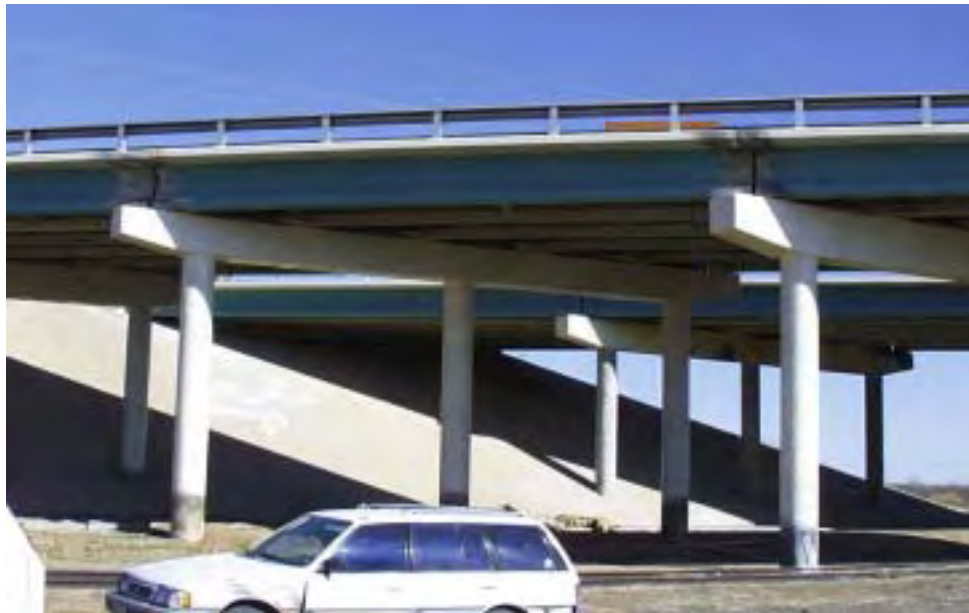
*Figure 1.1 Structure wrapped with FRP*

In recent years, FRP composite wrapping has been considered and implemented (on a few projects) for corrosion protection. Corrosion due to chloride ingress is purportedly arrested by the prevention of further chloride contamination and penetration by the oxygen and water needed to continue a corrosion process that has begun or has caused damage. Figure 1.1 shows a structure that has been repaired with a composite wrapping system.

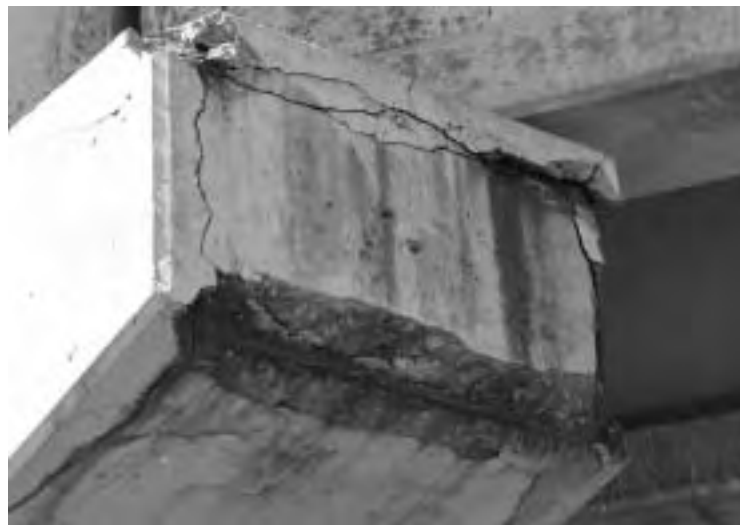
*Figure 1.2 Damage at downstream endcap*

The structures being studied in the field research program are bridge overpass substructures located in and around Lubbock, TX and Slaton, TX. These structures have been in a corrosive environment containing chlorides. Corrosion of the reinforcing steel and spalling and delamination of the concrete cover in areas where the chlorides were allowed to concentrate is evident, as shown in Figure 1.2. Due to the extent of the damage, a project involving repair and FRP wrapping to shield the elements from further chloride penetration was begun. In conjunction with this project, some data collection before and after repair was necessary to evaluate the effectiveness of this repair method.

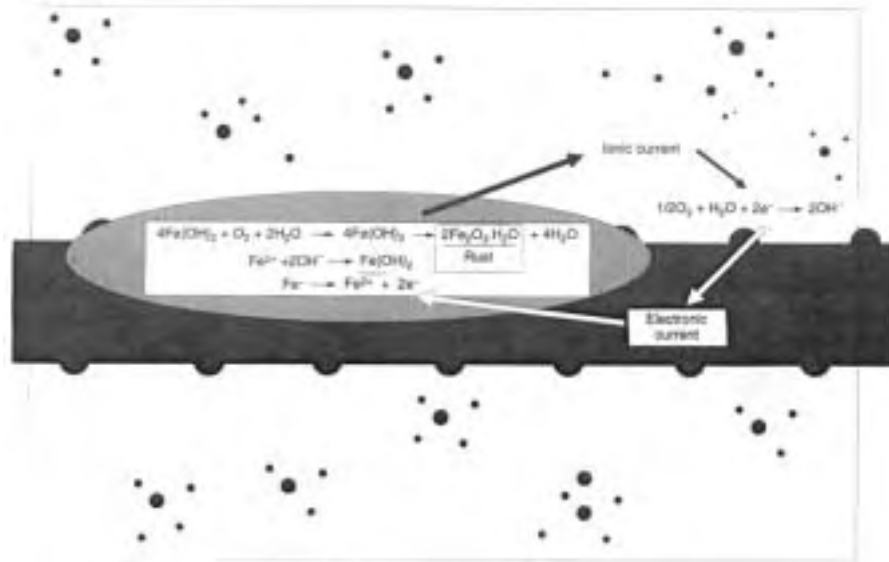
**Figure 2.1 Corrosion reactions and rust formation on the steel surface (Broomfield 1997)**

With the corrosion process underway, the reinforcing steel oxidizes to form ferric oxide ( $\text{Fe}_2\text{O}_3$ ) or rust as outlined in Figure 2.1.

The formation of rust is the most tangible evidence of corrosion and causes many of the problems associated with corrosion damage in reinforced concrete. Hydrated ferric oxide ( $\text{Fe}_2\text{O}_3 \cdot \text{H}_2\text{O}$ ) may have up to ten times the volume of the consumed steel that it replaces (Broomfield 1997). This substantial volumetric increase causes pressures in the concrete, which leads to cracking and spalling of the concrete cover. While spalling is primarily a serviceability issue, delamination at the steel/concrete interface and reduction of the cross-sectional area of the reinforcement can compromise structural integrity.

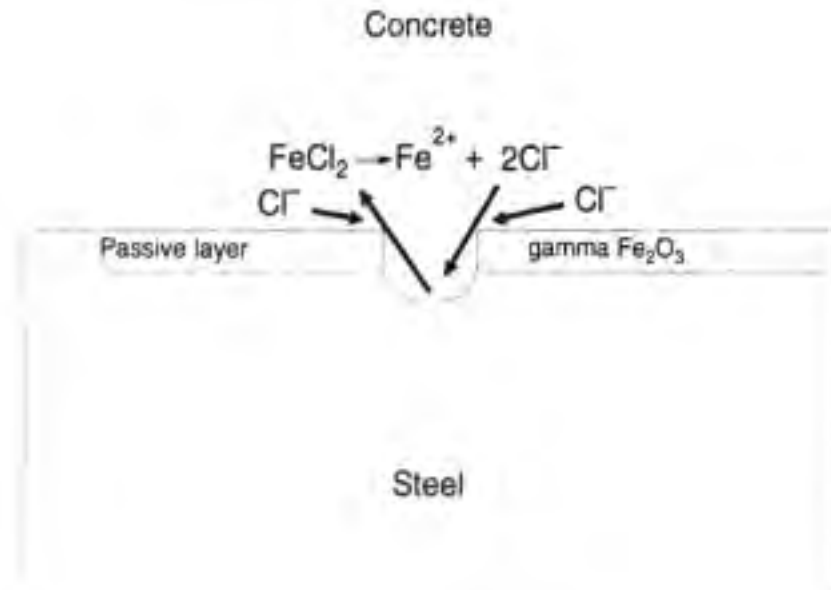
**Figure 2.2 Termination of the passive layer by chloride ions (Broomfield 1997)**

Much of the corrosion evident in reinforced concrete structures is due to chloride ion penetration. Chloride ions migrate through the concrete matrix, reaching the steel reinforcement and breaking down the passive layer. The destruction of the passive film in the presence of chlorides is due more to localized concentrations of free chloride ions, as shown in Figure 2.2, than to the reduction in pH at the bar surface.

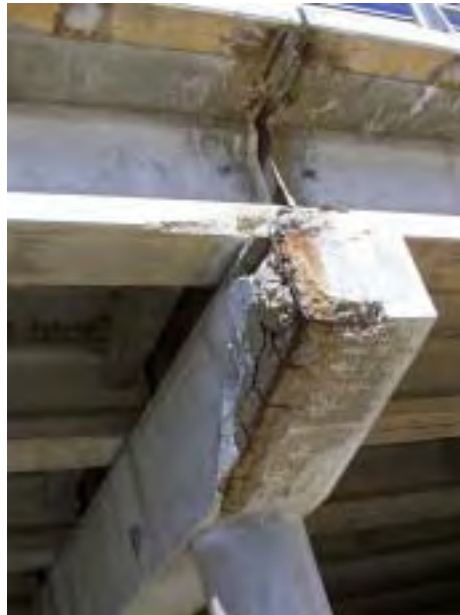
**Figure 3.1 Endcap delamination**

The Texas DOT has wrapped several bridges in Lubbock with composite laminates to protect them from corrosion. The bridges had shown damage in the form of severe cracking and spalling, as seen in Figure 3.1, due to water penetration. Many of these bridge bents were wrapped by Delta Structural Technology, Inc. after concrete in the most damaged areas was removed to the level of the reinforcement and the members were patched.

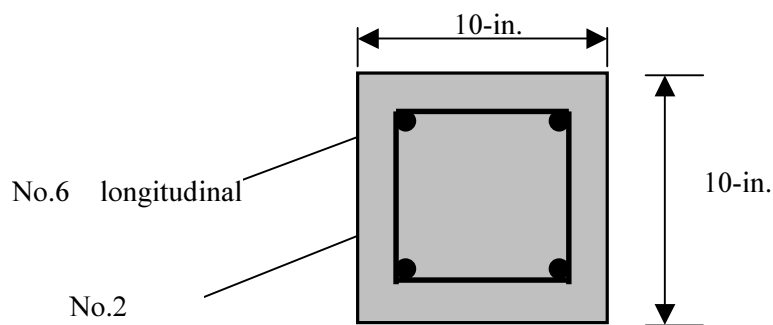
**Figure 4.1 Cross section of beams (1 in. = 2.54 cm)**

Individual forms for the beams were built out of plywood, in compliance with item 420.9 of the TxDOT specifications (TxDOT 1993). They were oiled 24 hours before placing the concrete to allow for easy removal after the specimens had cured.

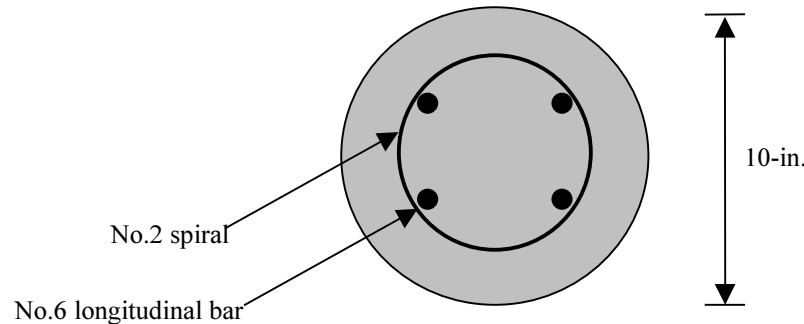
**Figure 4.2 Cross section of columns (1 in. = 2.54 cm)**

The column cages were placed in prefabricated, 10-in. inner diameter cardboard forms. The tubes were attached to plywood and were sealed with silicone.

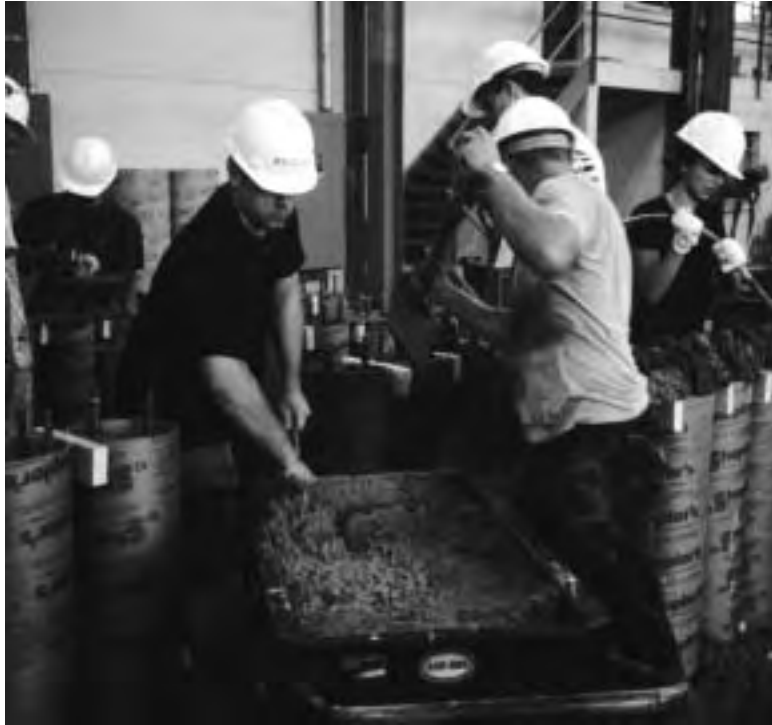
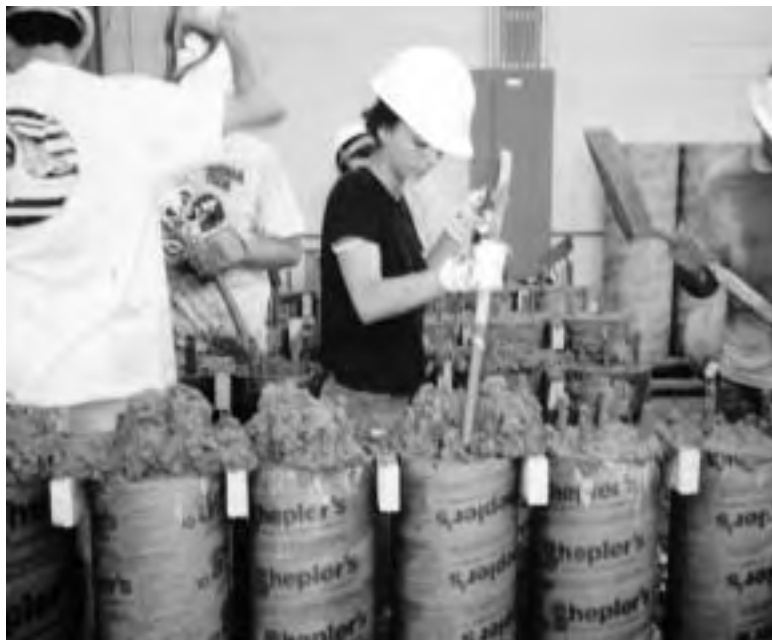
Concrete was placed into the forms in successive layers to minimize segregation. Each layer was consolidated with immersion-type vibrators immediately after deposit as shown in Figures 4.3 and 4.4. Points of vibration were established to ensure complete consolidation and placement of the concrete around the steel cages and into all corners of the forms. For the rectangular specimens, the vibrator was inserted at sloping angles and allowed to penetrate a few inches into each preceding layer. Vibration was more complicated for the columns due to their smaller opening, increased height, and bulky reinforcement. These factors made it difficult to consolidate the lower layers of concrete.

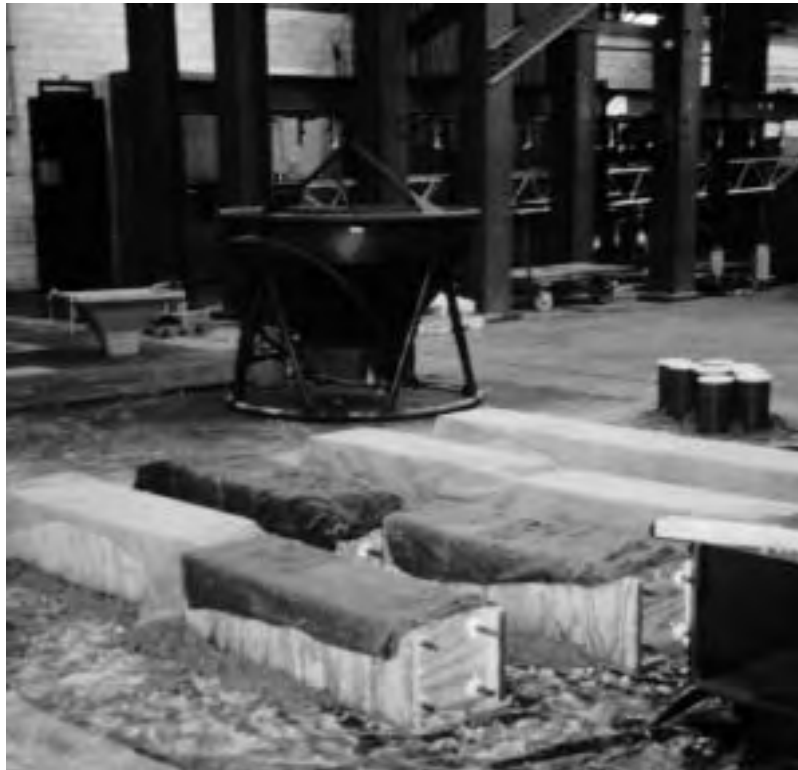
*Figure 4.5 Wet-mat curing of beams*

The specimens were covered with plastic sheets and damp burlap mats for wet mat curing (Figure 4.5). This method kept the concrete continuously wet throughout the curing period. The specimens were cured for 28 days.

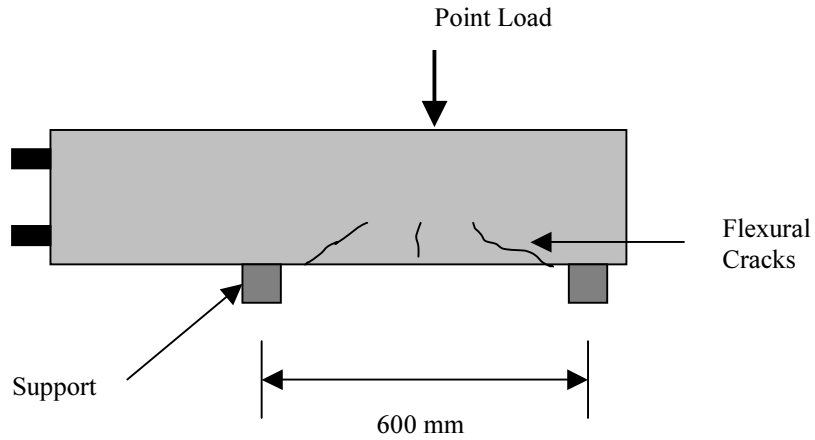
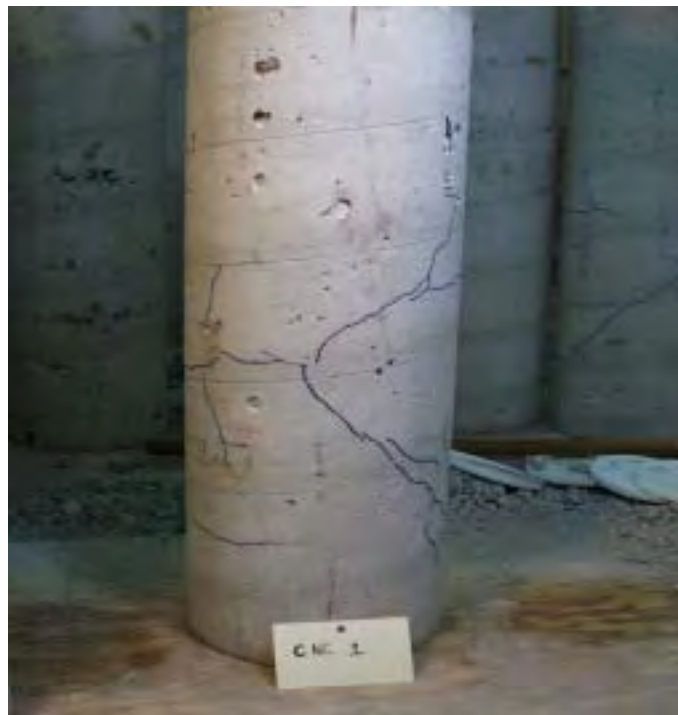
The specimens selected for flexural cracking were loaded until cracks of sufficient width appeared on their surface. The maximum crack width allowable in service is 0.33 to 0.51 mm (13 to 20 mils). Similar crack widths were developed during loading. Figure 4.6 presents the loading configuration and Figure 4.7 shows typical cracks.

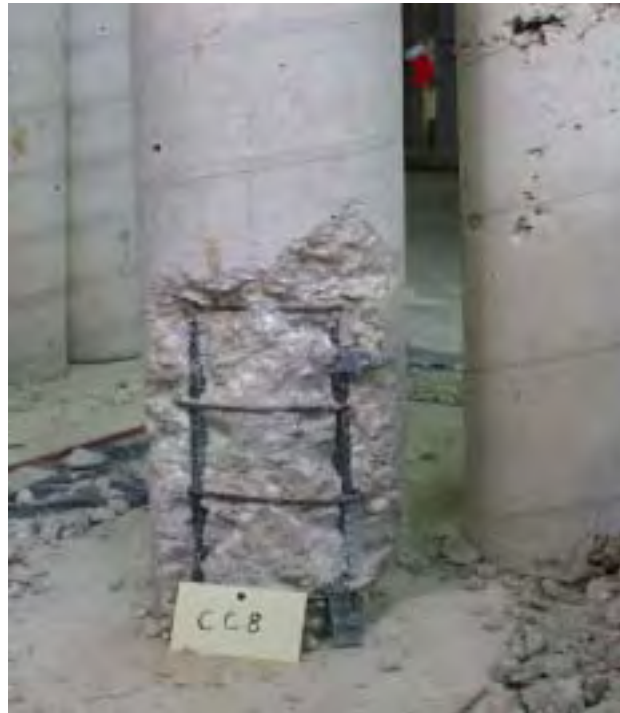
***Figure 4.8 Concrete removed prior to repair***

Concrete on the top surface of beams was removed to a depth of 25 mm. The columns were repaired from the bottom to a height of 400 mm (16 in.), at a depth of about 25 mm (Figure 4.8).

Unsound concrete was removed with a chipping hammer. Care was taken to avoid damage to the reinforcement. Concrete around the steel was removed with a chisel and hammer, and all loose particles were cleaned off with a pressure air hose. All exposed reinforcement was cleaned with a wire brush to remove dirt and any traces of corrosion that may have developed.

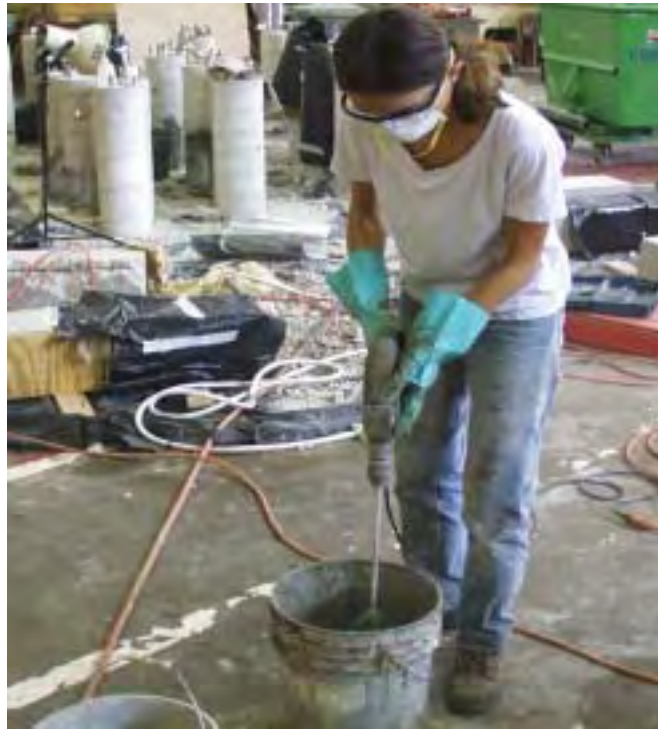
*Figure 4.9 Mixing repair materials*

The separate components for both materials were mixed mechanically with a low speed drill according to Sika specifications (Figure 4.9). Small fractions of the components were held back or added to the mix as appropriate and necessary to achieve a good flow. Materials were poured into the forms (with cups and scoops), consolidated and leveled. The latex-modified concrete had to be scrubbed into the repair zone of the beams, while the epoxy grout poured freely, filling all voids and edges. Both products were made to fill the cylindrical forms. Vibrators were tapped along the side of the metal flashing for the columns (Figure 4.10), and carefully inserted into the repair at an inclined angle for the beams. Small repair areas were patched by drypacking (Figure 4.11). Repairs were covered with plastic and wet burlap, and left to cure for 4 days.

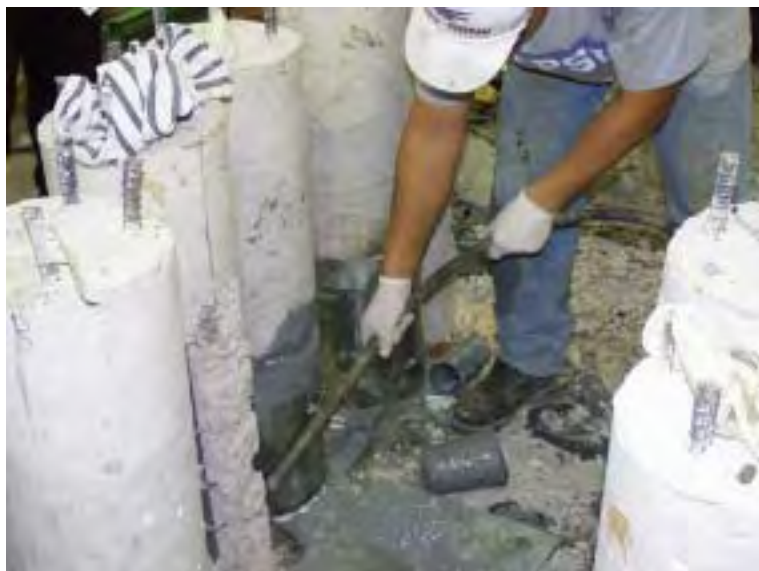
*Figure 4.10 Vibrating columns*

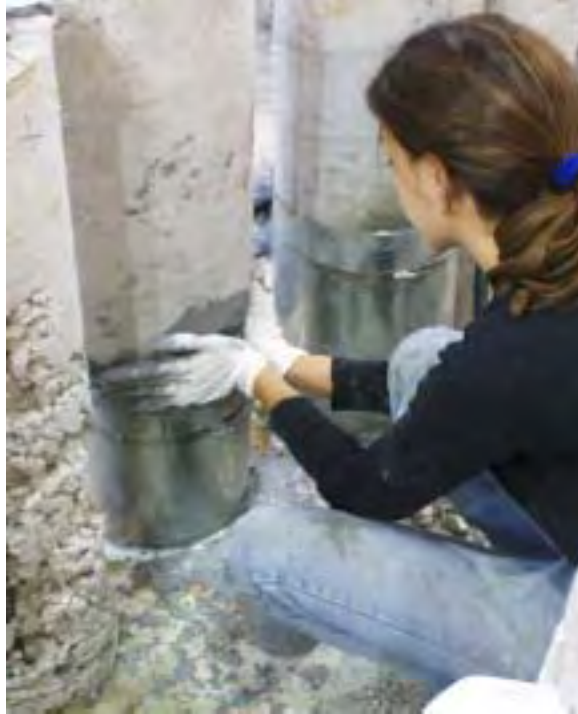
*Figure 4.11 Drypacking procedure*

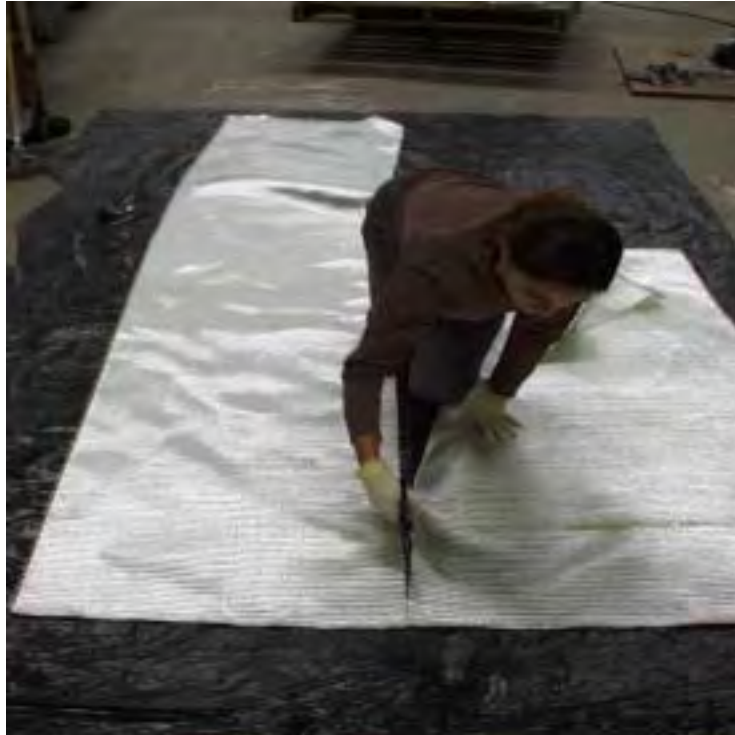
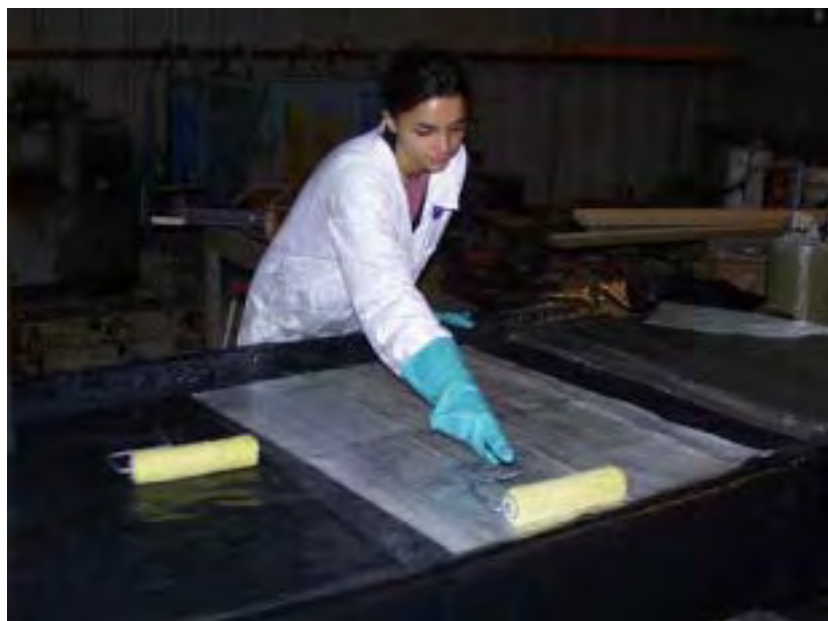
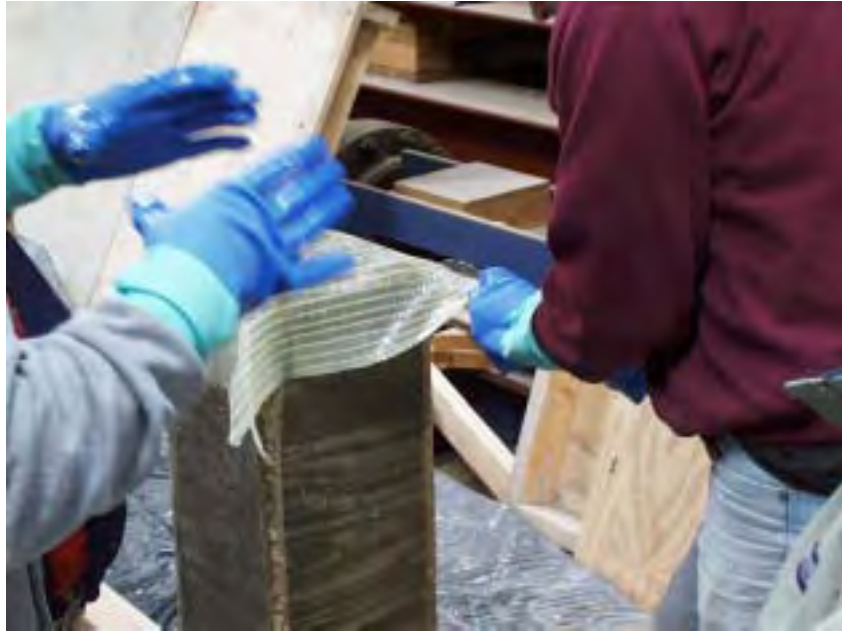
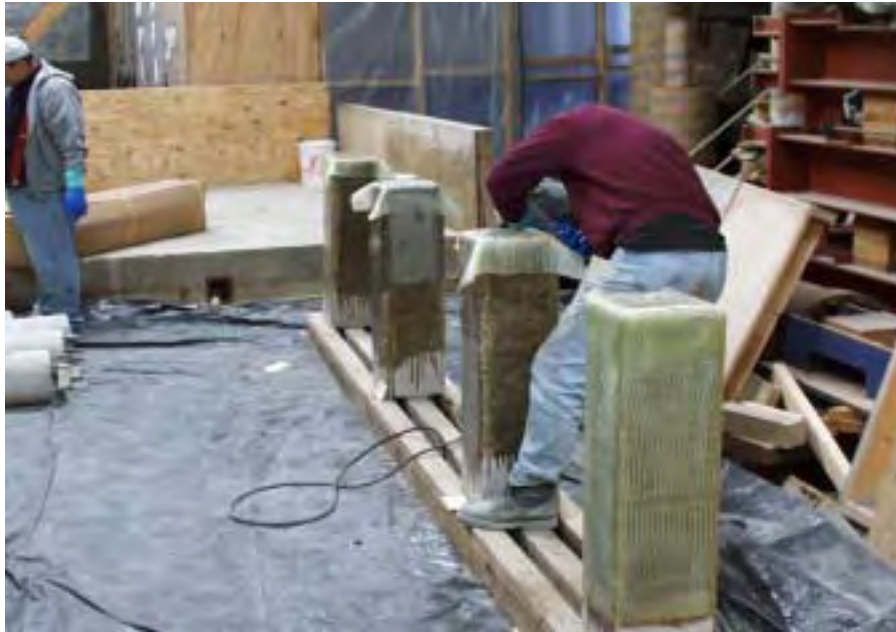
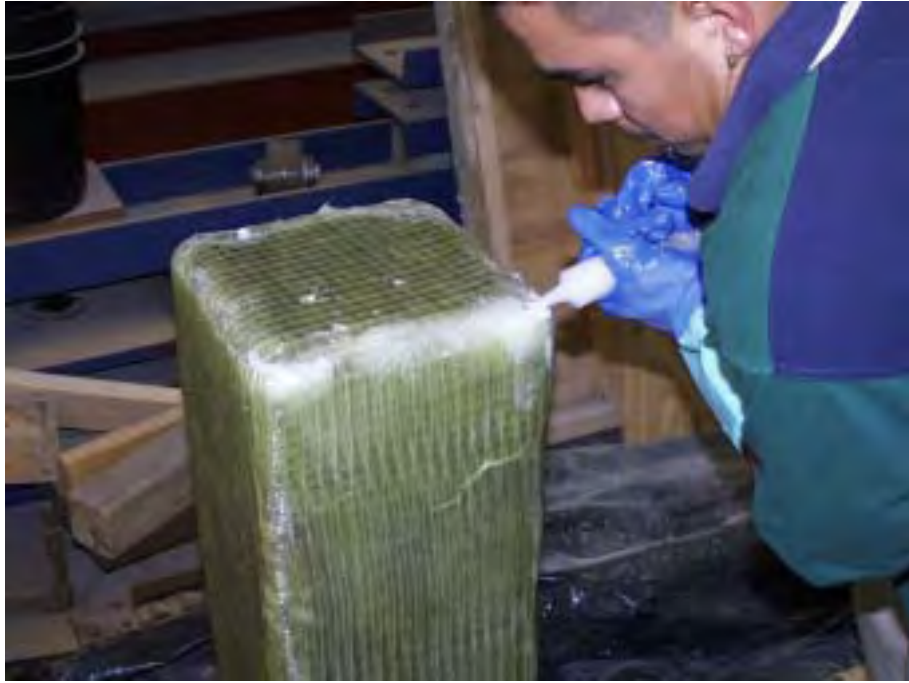
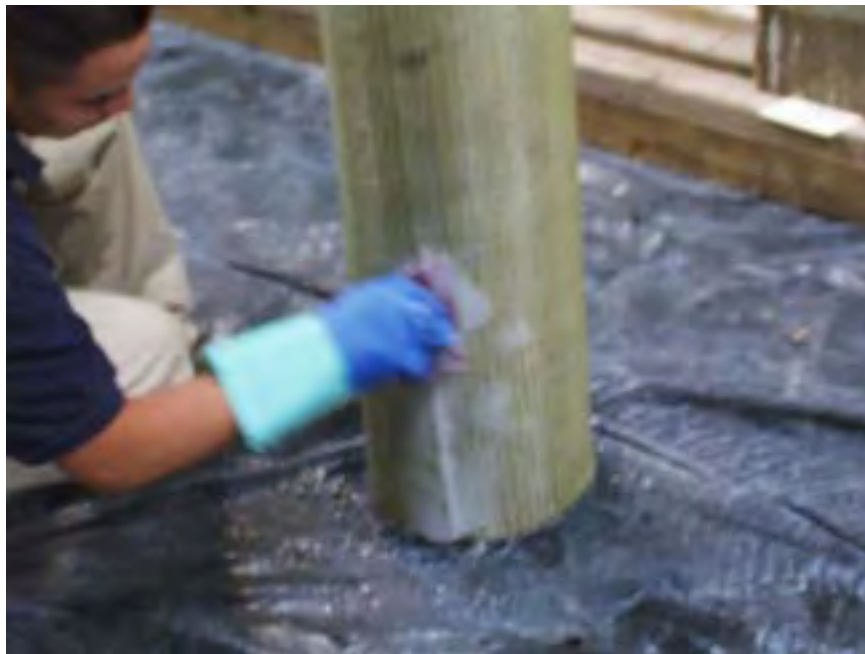
The specimens designated for wrapping were divided into two main categories according to the composite used for wrapping. The composition, material properties, and application methods for both systems are described in this chapter. A photographic record at the end of this section illustrates all steps of the encapsulation procedure (Figures 4.12-4.18).

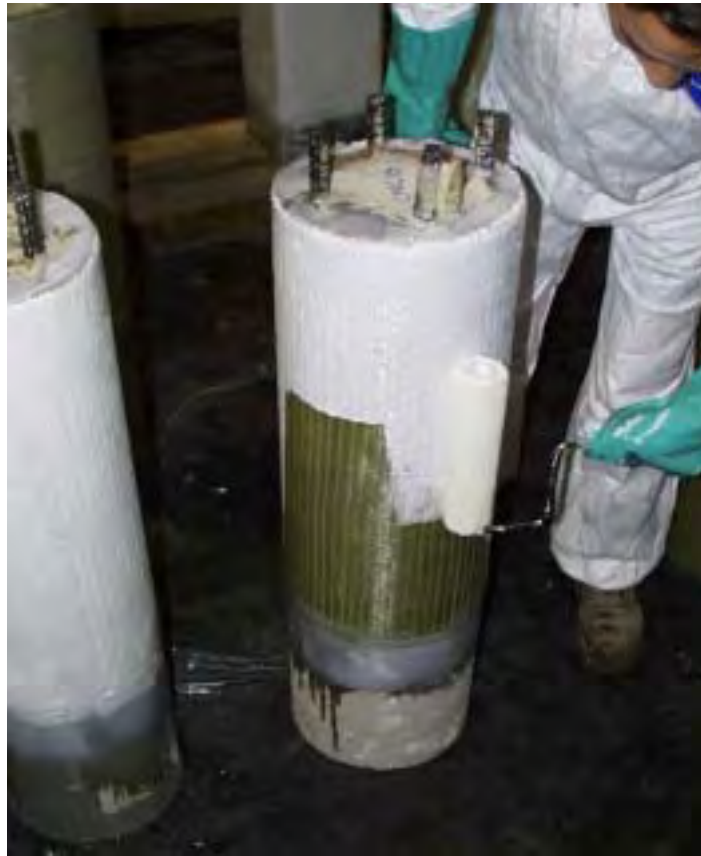
*Figure 4.18 Painting wrapped column*

Within 72 hours of the wrap application, but not before the surface had achieved a tacky feel, each composite was painted with two coats of white Hi Bild Aliphatic Polyurethane from Sherwin Williams (Figure 4.18).

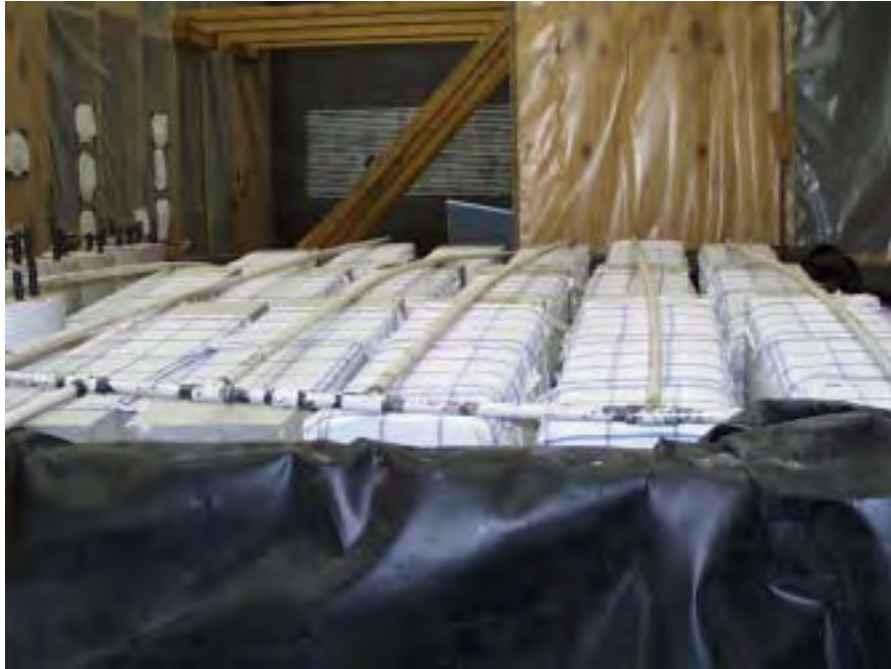
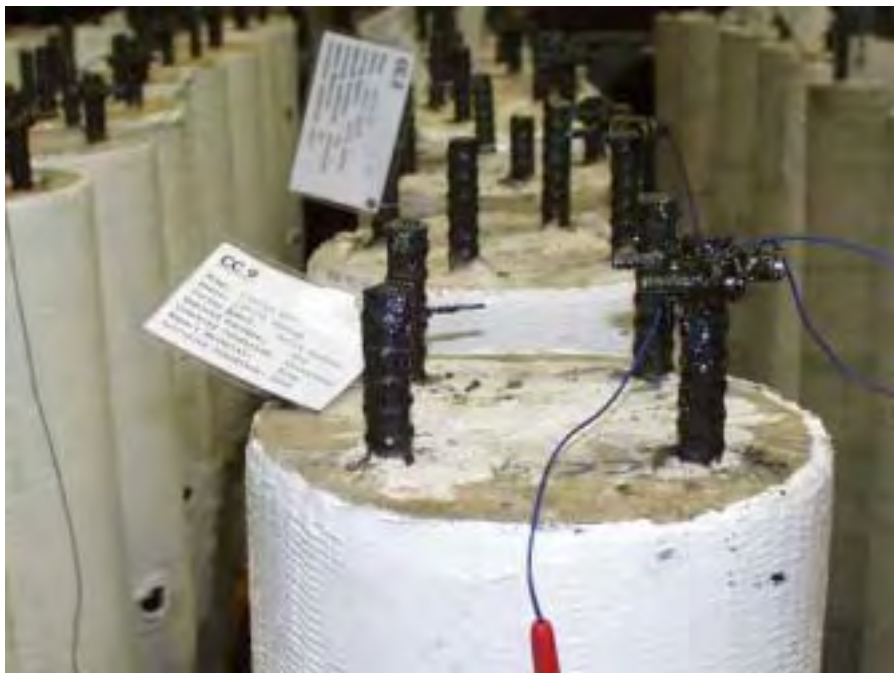
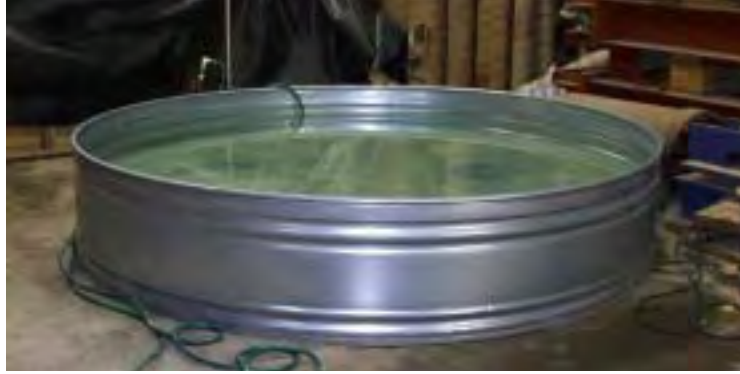
The columns were placed vertically in the pool on small pieces of wood to prevent them from standing in puddles of excess water during the dry cycles. The beams were laid on their side on blocks covered with plastic. The beams were placed at a shallow angle to allow the water to flow across the top surface (Figure 4.19). Laminated identification tags (Figure 4.20) were attached to the exposed steel on all specimens to facilitate data recording and cataloging. A drainage hole in the base of the pool allowed for a connection between the pool and a pump. A 10-ft. diameter galvanized steel storage tank (Figure 4.21) was placed next to the pool, and filled with a saline solution. A 3.5 percent saline solution was created by mixing 136.1 kg (300 lbs.) of salt into the water. The solution is stirred before each cycle to achieve a homogeneous mix. On the first day of each wet cycle, the pump draws water from the storage tank into the pool, to a 300 mm (1-ft.). The pump then circulates the water within the retaining pool through a system of PVC pipes placed over the beams. Holes were drilled into the pipes for water distribution. The beams were covered with cloth to ensure a wet condition throughout the cycle. Upon completion of the wet cycle, the pump is disconnected from the PVC irrigation system and begins to draw water out of the pool and back into the storage tank. A filter attached to the drainage hole prevents dirt and other loose particles from entering the pump and damaging it.

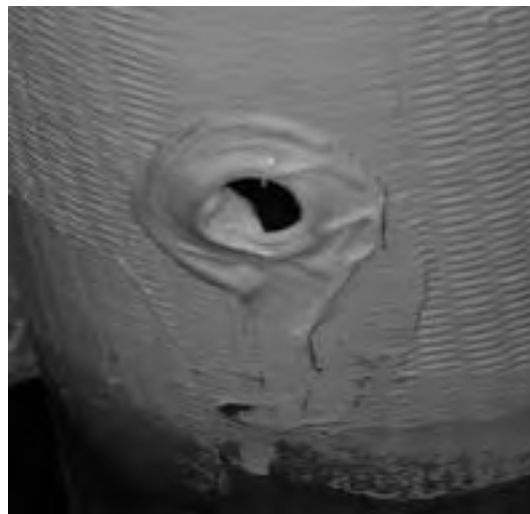
*Figure 4.22 Access hole on wrapped column*

To provide access to the concrete surface, small openings had to be made in the FRP wraps. A circular saw was used to cut 3.8-cm (1.5-in.) diameter holes into the composite. For the columns, this was done directly over a longitudinal bar, 40.6 cm (16 in.) from the bottom of the column to keep the openings from being submerged in the saltwater solution during the wet cycle. On the beams, the circular openings were drilled at the bottom left corner of the ends, directly over the reinforcement. To prevent water penetration during exposure, all holes were covered with removable plastic buttons sealed onto the specimens with silicone (Figure 4.22).

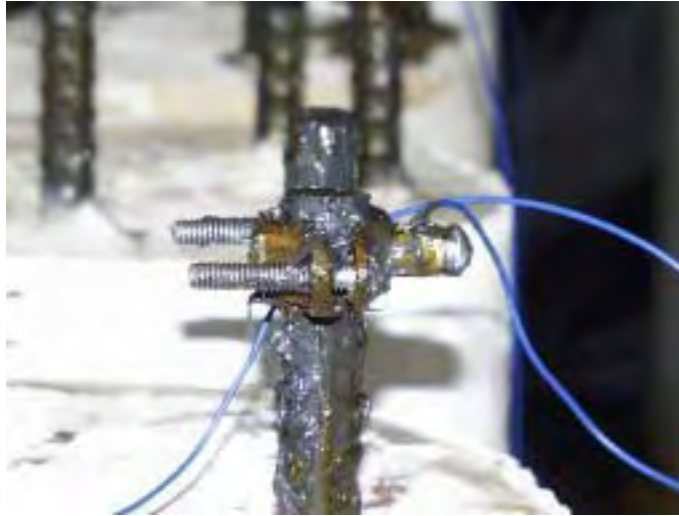
*Figure 4.23 Detail of greased ground clamp*

The connection to the steel was made with lead wire attached to ground clamps. The clamps were then attached to the exposed end of the bar over which the opening in the composite wrap was made. The exposed ends of the bars had all been previously ground to remove any rust that could interfere with the readings. All exposed steel and metal clamps were covered with grease to prevent corrosion (Figure 4.23).

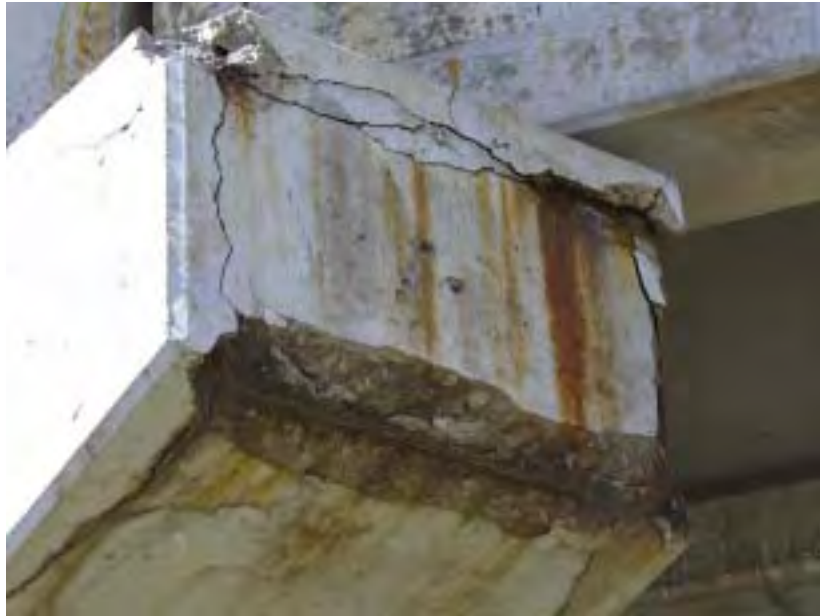
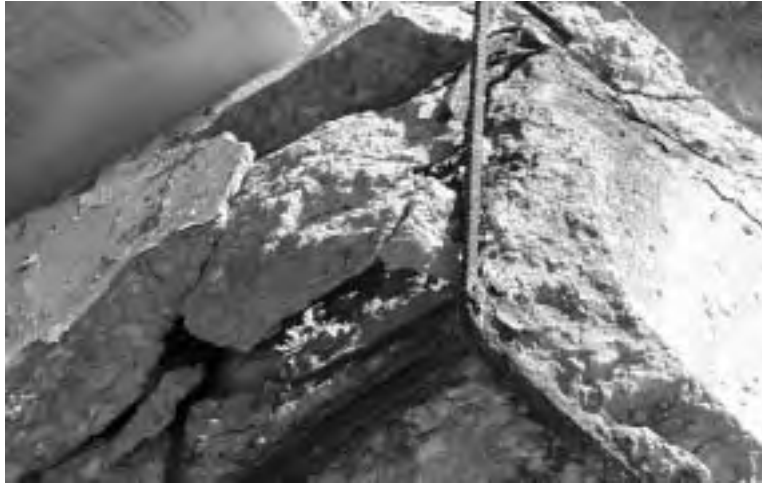
Figures 5.1 and 5.2 show typical corrosion damage to bent endcaps. The project specifications call for cover removal back to sound concrete for the damaged portions of the downstream endcaps. The reinforcement is to be cleaned and/or replaced as necessary to remove all previous corrosion products. Welding of the reinforcing steel is not permitted on this project. Figure 5.3 shows an endcap with the steel exposed and the preparations made for repair. During the period of structural repair, the structures are supported and bridges are not open to traffic.

The repair material used is Shotpatch® 21F, a material made by Master Builders Technologies®, Inc. The specifications for this material are listed in Appendix B, and call for the surface to be clean of all materials that would interfere with the bond to the sound concrete substrate (Master Builders Technologies 1999).

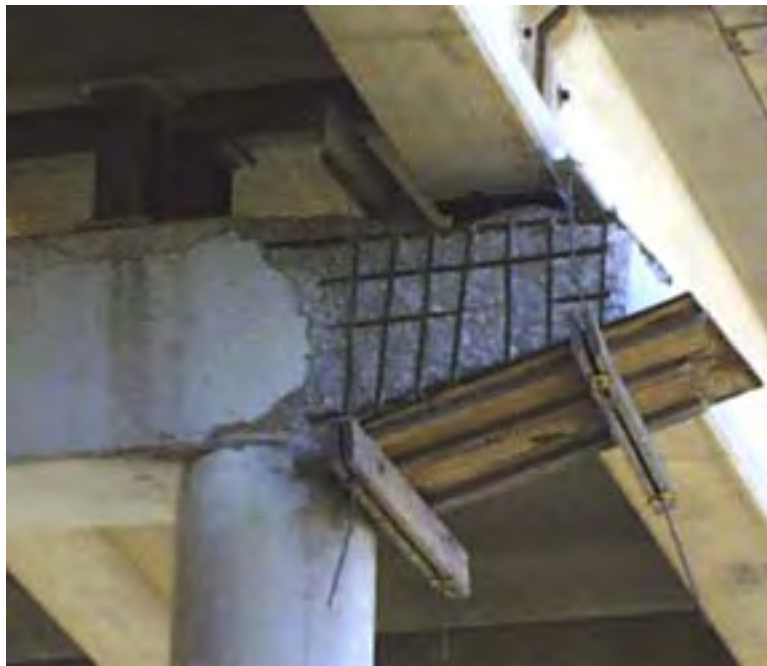
*Figure 5.3 Endcap prepared for application of repair material on Structure #3*

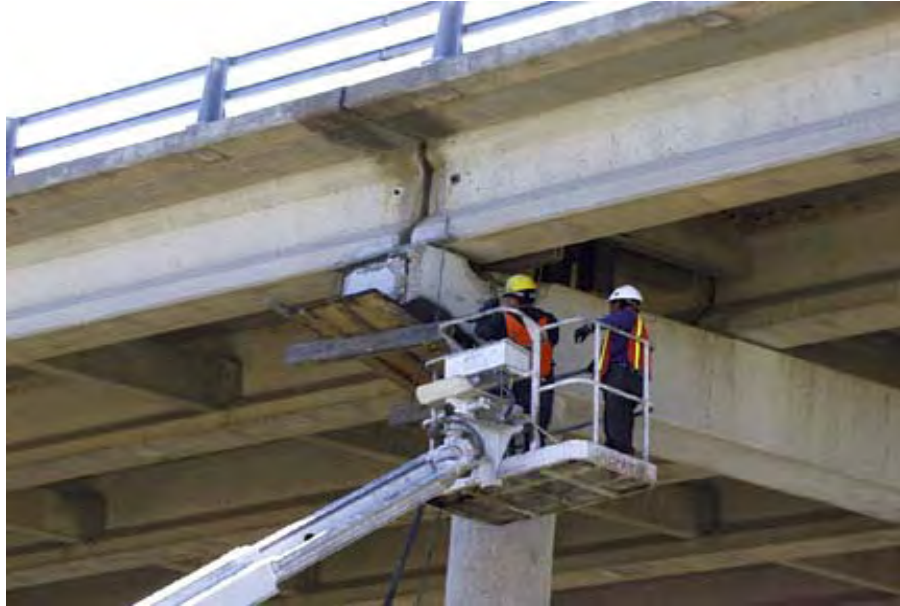
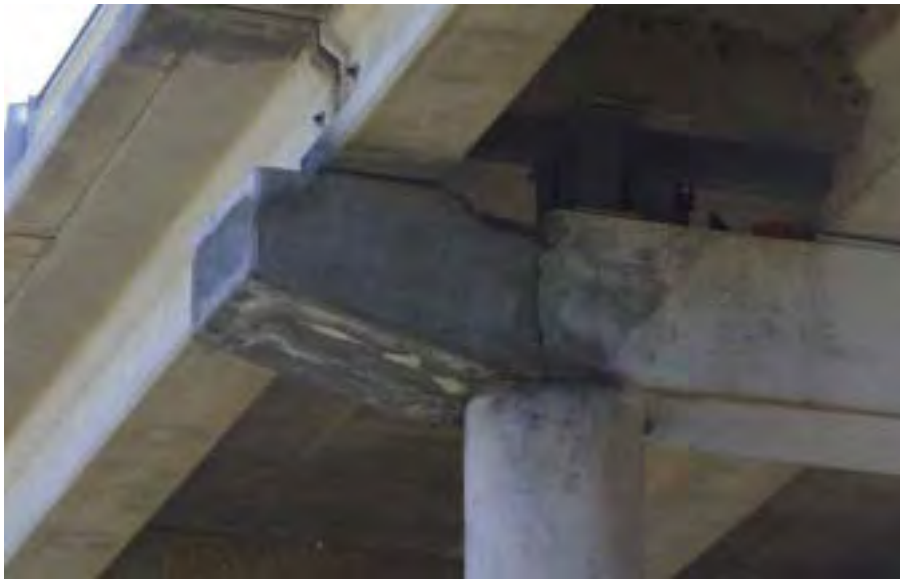
Shotpatch<sup>®</sup> 21F is applied by a shotcrete process. This application and the temporary formwork are shown in Figure 5.4. Figure 5.5 illustrates a typical endcap after the formwork has been removed. It is evident that the concrete cover was removed to just inside the outer column face at this particular location (Structure #3).

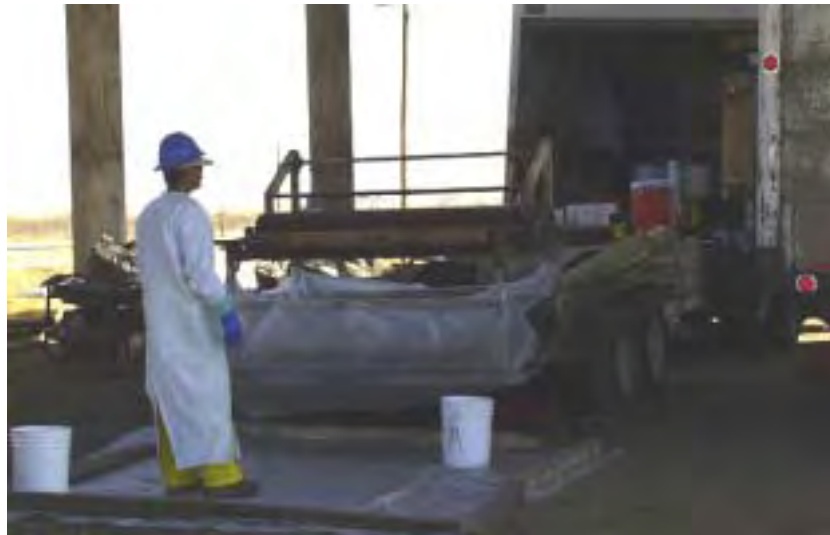
*Figure 5.6 Saturation machine used by Delta Structural Technology, Inc.*

The mechanism used to provide saturated fabric is displayed in Figure 5.6. The epoxy is in effect rolled into the fabric. Once the fabric is saturated, it is applied to the substructure. Figure 5.7 shows the wrap being placed on an endcap of Structure #2. Three layers of wrap are applied in succession, to prevent polymerization of the previous layer. This ensures complete bonding between layers.

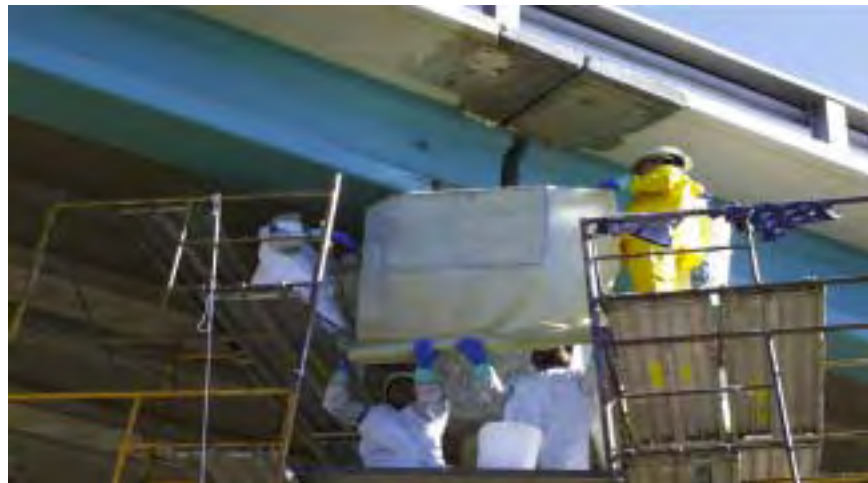
*Figure 5.7 Application of Fibrwrap® to endcap on Structure #2*

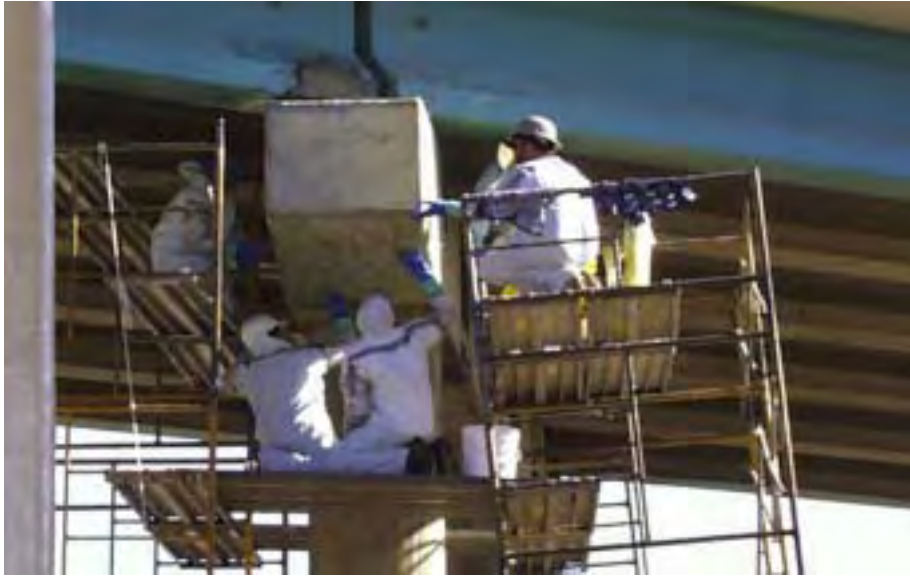
*Figure 5.8 Removal of air pockets beneath a layer of Fibrwrap®*

After each layer is placed, any air pockets (or “bubbles”) must be removed by rubbing or rolling. This is a major construction concern and the process is demonstrated in Figure 5.8. About 24 hours after the final layer is applied, the entire surface is painted with a high-solids paint to provide UV protection for the wrapping system and to match the color to that of the existing structure. An example of a finished and painted endcap is shown in Figure 5.9. The Fibrwrap® system can be applied at a rate of about 2 bents in 2 days on skewed bridges, and a little faster on structures with more orthogonal geometry.

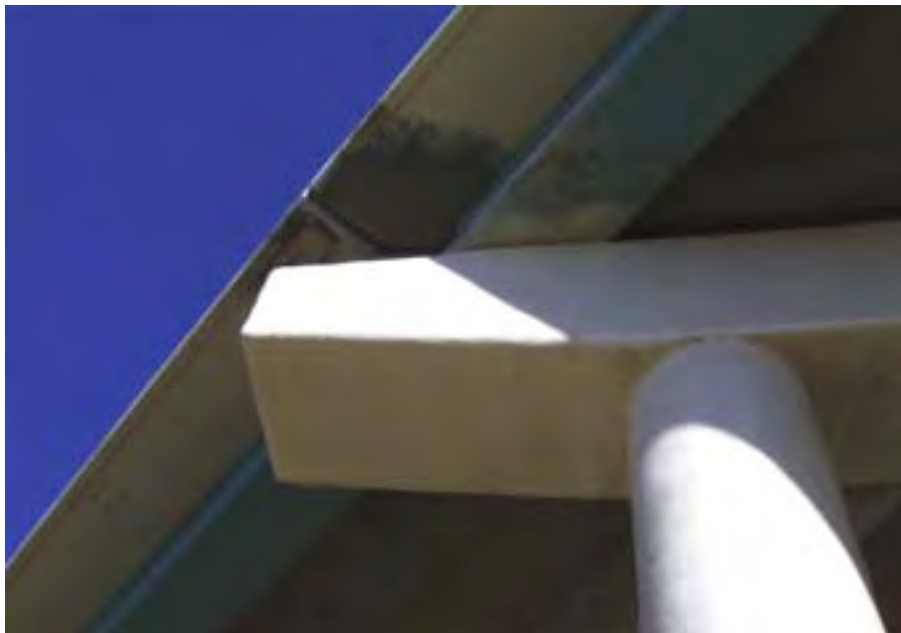
*Figure 5.9 Wrapped and painted endcap on Structure #2*

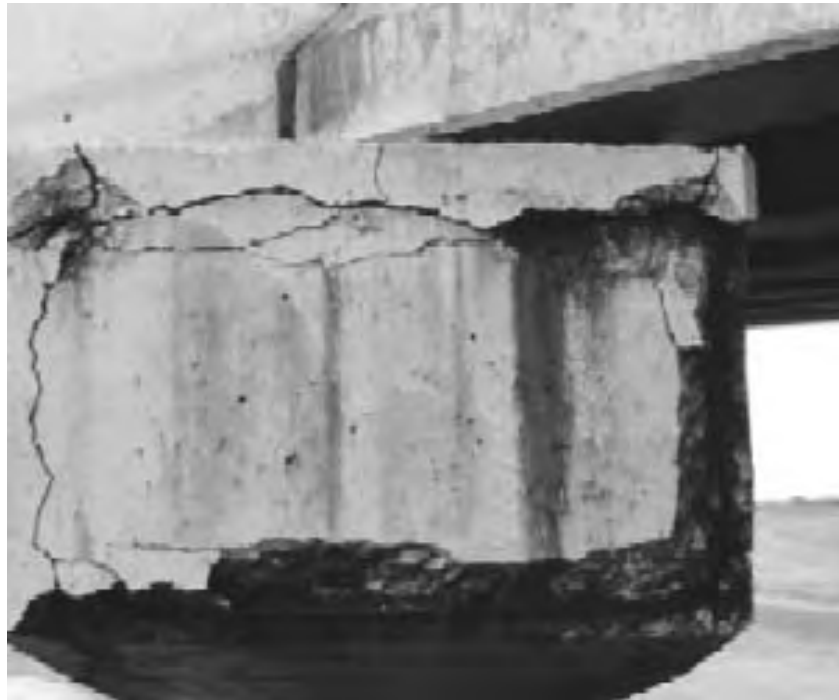
*Figure 5.10 Corrosion damage on downstream endcap*

Many of the corrosion-related problems on the structures being repaired for Project CSR 783-2-66 occur on the low or “downstream” end, toward which all water and water-borne particles are drained. Of particular concern are the end sections on the substructure bridge bents. Many of the downstream end portions of these bents have experienced severe cracking, delamination, and spalling, as shown in Figures 5.10 and 5.11.

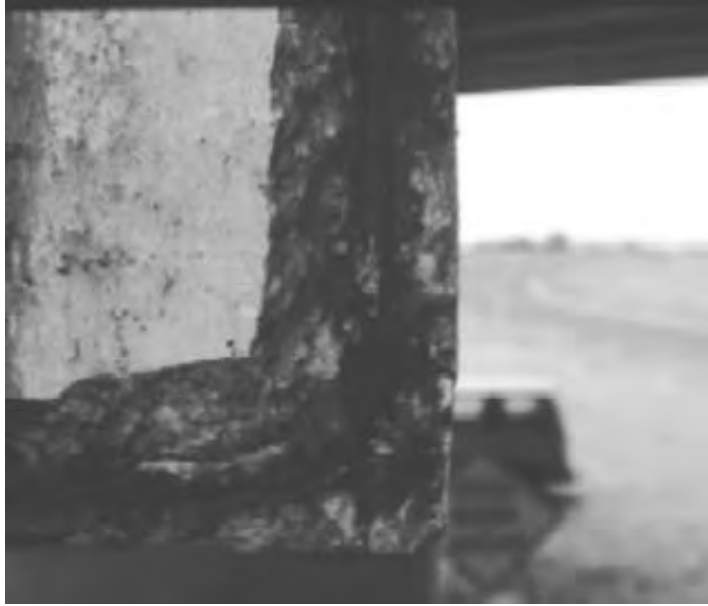
*Figure 5.11 Closeup of area with severe concrete spalling*

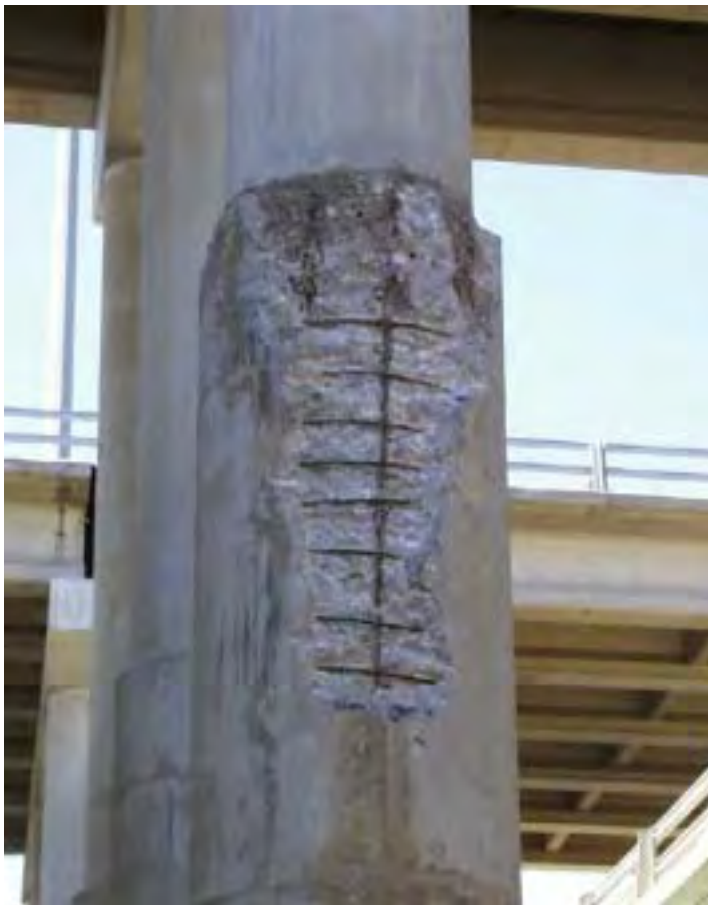
*Figure 5.12 Concrete spalling on a bridge support column*

Just as the substructure beams show distress in the areas subjected to drain water, the columns in the drainage path exhibited cracking and delamination. Figure 5.12 shows the damage on one such column located on Structure #3, at the interchange of US Highways 62 and 82 and Loop 289. There is also some delamination evident on the top portion of the substructure bents near the center and downstream supports, where water drains along the deck beams.
