# **EVALUATION AND PERFORMANCE MONITORING OF CORROSION PROTECTION BY FIBER-REINFORCED COMPOSITE WRAPPING**

Research Report No. 1774-1

**“Effect of Wrapping Chloride Contaminated Structural Concrete with Multiple  
Layers of Glass Fiber/Composites and Resin”**

**CENTER FOR TRANSPORTATION RESEARCH  
BUREAU OF ENGINEERING RESEARCH  
THE UNIVERSITY OF TEXAS AT AUSTIN**

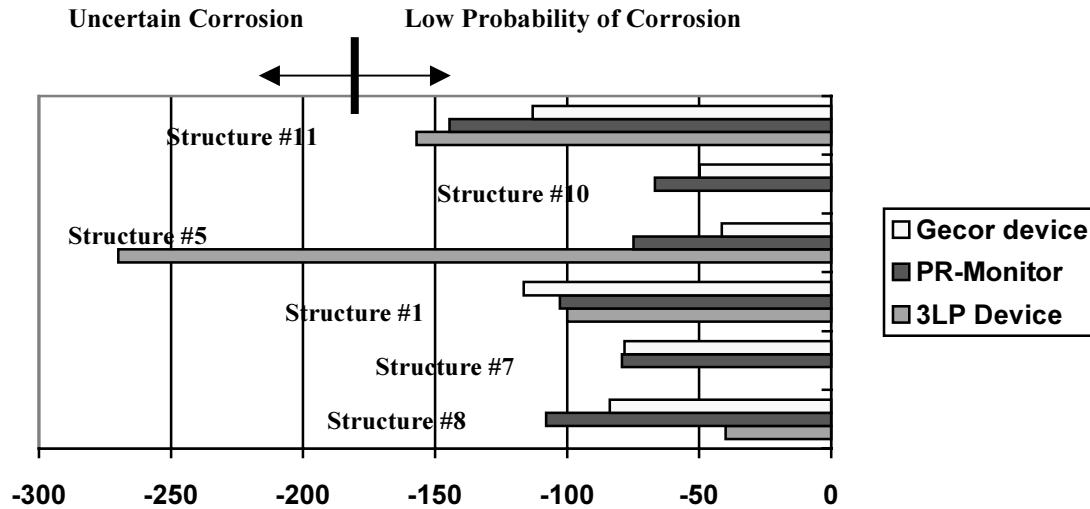
Figure 5.13 Corrosion potential (mV vs. CSE) values from different equipment

The PR-Monitor and Gecor device provided similar corrosion potential measurements as shown in Figure 5.13. The higher the corrosion potential, the more negative are the values. There may be error in some readings from each device due to the difficulty of applying the electrode sponges to vertical surfaces with limited overhead clearance. However, all of the readings were greater than -200 mv vs. CSE, which indicates a low probability of corrosion according to ASTM C 876 (ASTM).

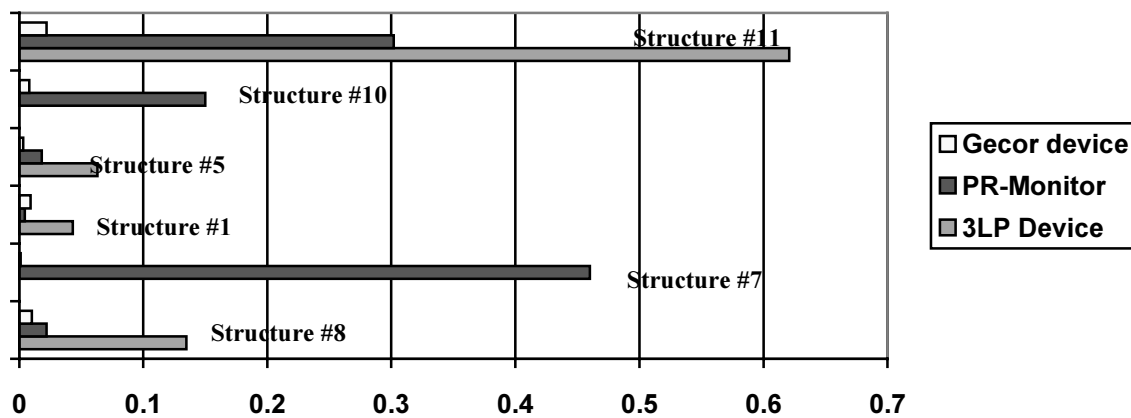
Figure 5.14 Corrosion current density ( $\mu\text{A}/\text{cm}^2$ ) values from different equipment

Each of the devices also gives a value of current density, shown in Figure 5.14. There is large disparity between the output values from each device. Table 5.2 gives some guidelines for corrosion rate evaluation (Scannell, Sohanguwala, and Islam 1996).

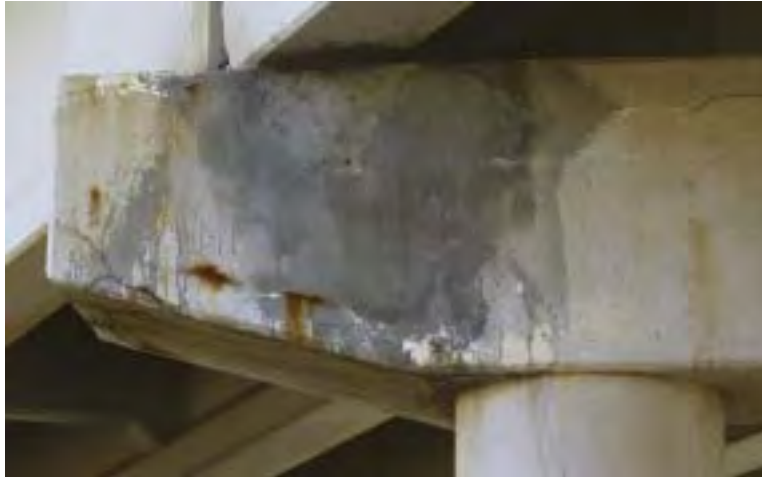
**Figure 5.15** *Delaminations and corrosion stains on a downstream endcap*

The presence of delaminations, such as those shown on Structure #10 in Figure 5.15, made the corrosion rate device difficult to stabilize in some areas. This is because of a high solution resistance caused by the discontinuous medium between the working electrode and the reference electrode.

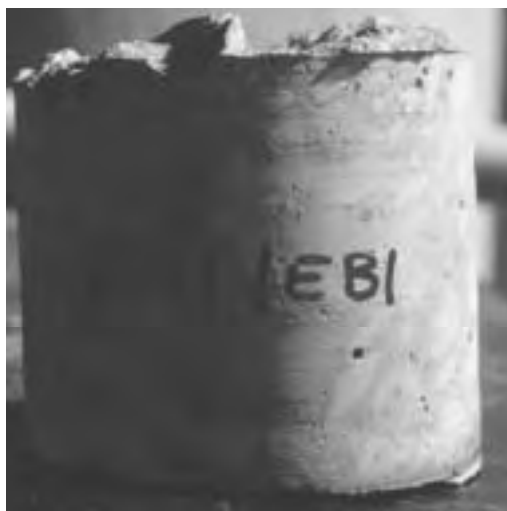
**Figure 5.16 Permeability core taken from Structure #10**

The cores were drilled with a 10.2-cm (4-in.) nominal diameter and then cut to thicknesses of 5.1 cm (2 in.) before being subjected to electrical current according to ASTM C 1202-94. They were then evaluated for chloride ion penetrability based on the amount of charge passed through the sections (ASTM 1994). An example of a core sample (prior to cutting) taken from Structure #10 is shown in Figure 5.16.

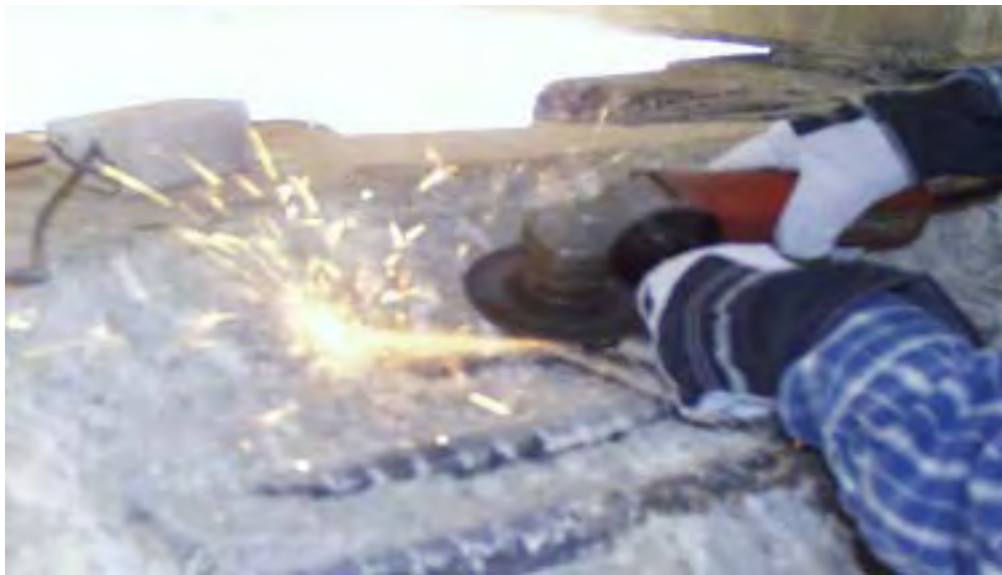
***Figure 5.17 Grinding of the reinforcement to prepare for soldering***

An electrical connection was established by means of silver soldering the copper ground wire from the probe to the reinforcement. To prepare the steel surface for the soldering procedure, the surface was ground as shown in Figure 5.17. Once a length of about 2.5 to 5 cm (1 to 2 in.) of bright steel was produced, a cleaning agent (flux) was applied to all surfaces and the copper ground wire was placed in contact with the steel reinforcement.

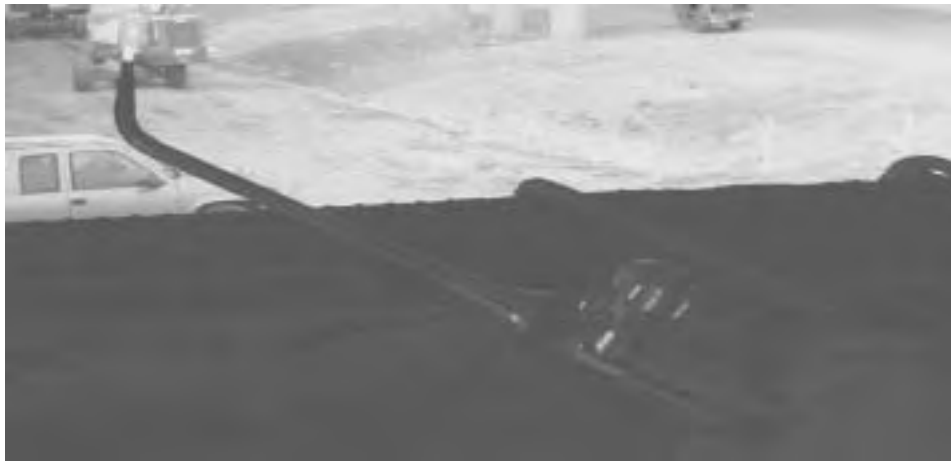
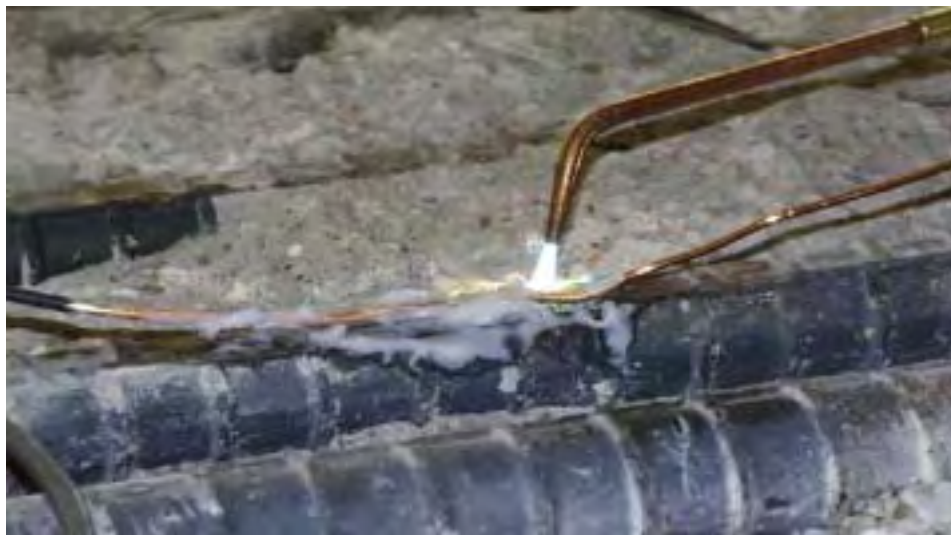
To operate the torch for soldering, the oxygen valve was opened and the flame was started with a striker. The flame was adjusted to the point where no black smoke was emitted. The acetylene was then added to the flame until a small, defined inner cone of flame was achieved near the nozzle as shown in Figure 5.18. The flame was applied to the steel and copper attempting to keep the tip of the inner cone, which was the hottest part of the flame, on the surface as shown in Figure 5.19. When the metals at the interface were sufficiently heated and the flux had melted and cleaned the surfaces, the silver solder was applied to the junction between the copper and steel. A connection of about 2.5 cm (1 in.) was provided to prevent detachment during subsequent construction. A 56 percent silver solder alloy was used for all probe installations and is recommended for connecting copper and steel.

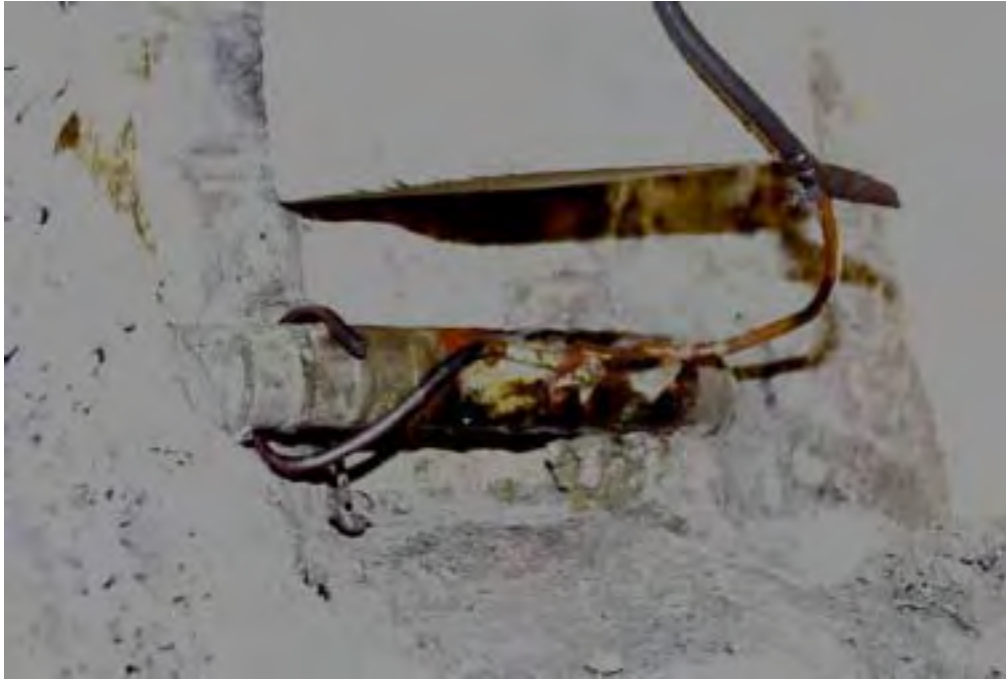
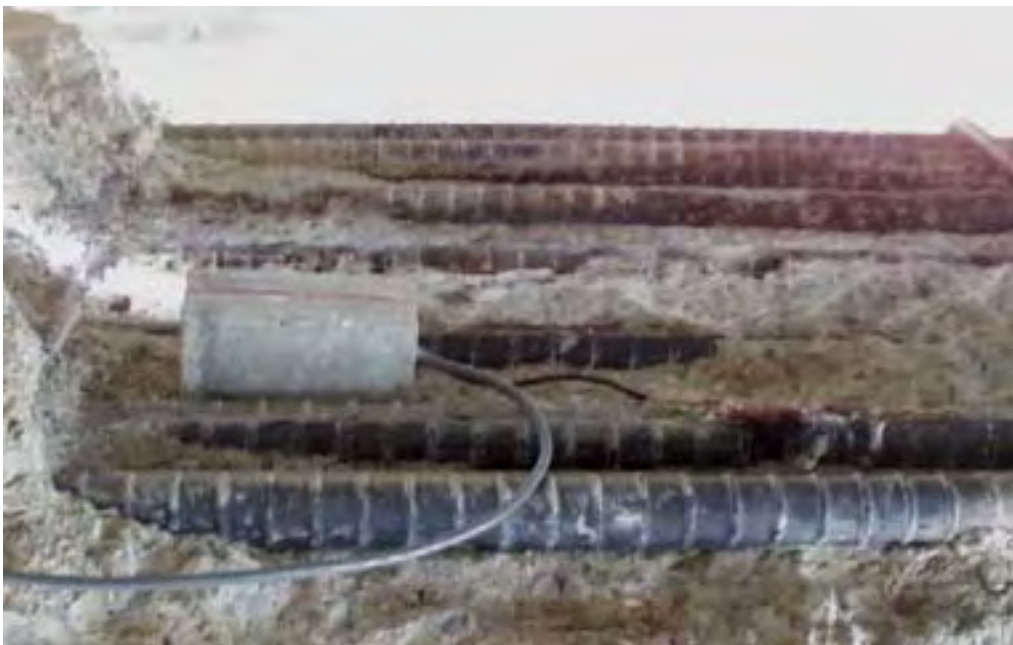
Figure 5.20 shows a typical finished soldered connection. The probe is installed some distance away from the solder point to prevent the erroneous measurement of corrosion due to the other metals and the heat-treated steel. Figure 5.21 displays a fully installed embedded corrosion rate probe.

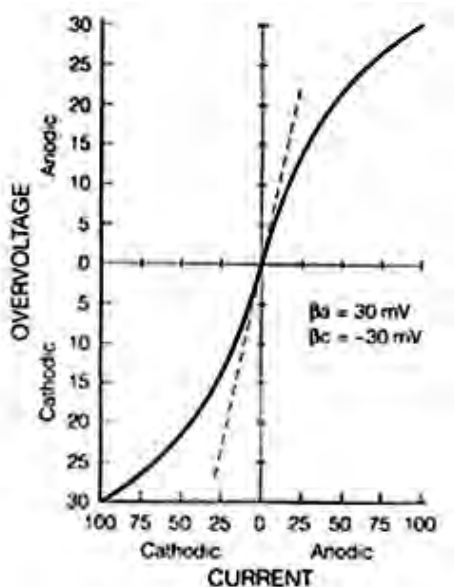
Figure 5.22 Hypothetical anodic and cathodic polarization curves (Jones 1996)

The linear polarization method takes its name from the apparent linearity of polarization curves near their origin. This is the region of low applied current and subsequently low overvoltages (voltages differing from the determined corrosion potential,  $E_{corr}$ ). Figure 5.22 shows a hypothetical polarization curve in both the anodic and cathodic regions. Note that the region of curve linearity is limited to points near the origin. For this reason, the linear polarization method is commonly referred to as the “polarization resistance” method, with polarization resistance defined as the slope of the polarization curve at the origin (Jones 1996).

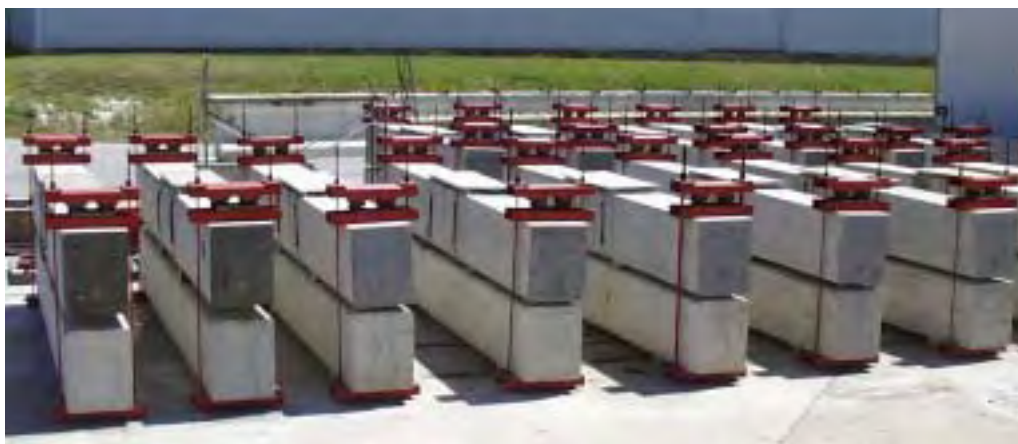
*Figure 5.23 The saltwater ponding beams (from an ongoing project at Ferguson Structural Engineering Laboratory) used for corrosion rate testing*

After the field testing was completed, further tests were conducted with the 3LP device and with the PR-Monitor. These tests were carried out on several beams, shown in Figure 5.23, which underwent continuous wet/dry (two weeks wet and two weeks dry) cycling in a saltwater ponding condition and had previously been examined only with half-cell potential measurements. The Gecor device was not available for this evaluation.

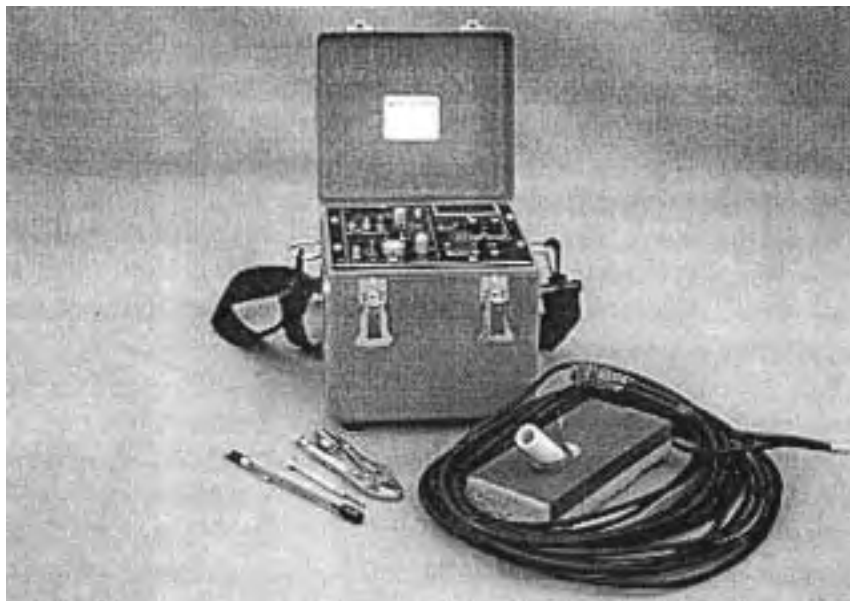
*Figure 5.24 The 3LP device*

3LP device, which consists of a self-contained power source and polarization console connected by wire to the electrodes. A sponge serves as the medium for electrode contact.

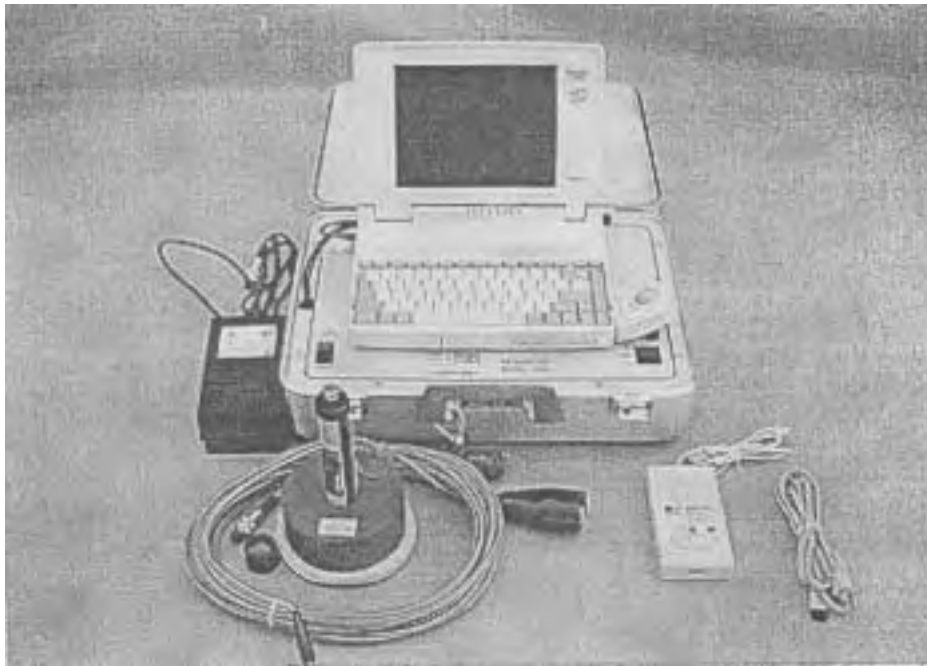
*Figure 5.25 The PR-Monitor device (Scannell, Sohangpurwala, and Islam 1996)*

In addition to the computer console, the PR-Monitor system includes a 120 volt AC power supply and the reference and counter electrodes with the necessary wiring. The PR-Monitor is displayed in Figure 5.25.

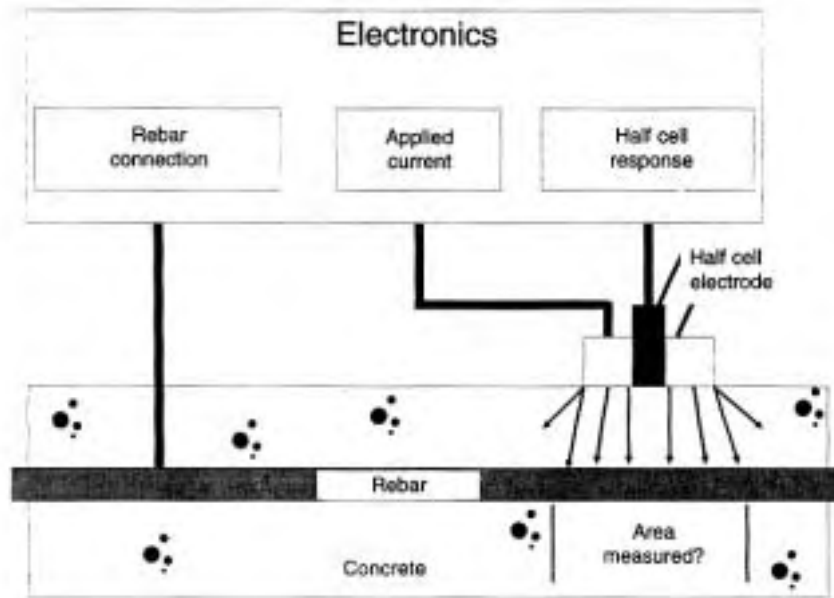
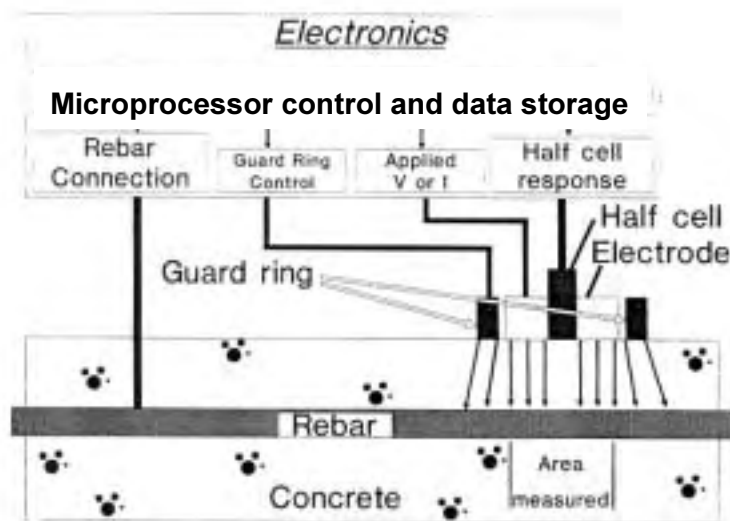
The concept of the guard ring is to focus the current output from the counter electrode (CE). This gives a relatively well defined polarized surface and a more accurate measurement of corrosion rate. Figures 5.26 and 5.27 show schematic diagrams for polarization equipment without and with a guard ring respectively. For comparison, some PR-Monitor measurements were taken with the guard ring deactivated and gave readings much higher than those taken with the guard ring active.

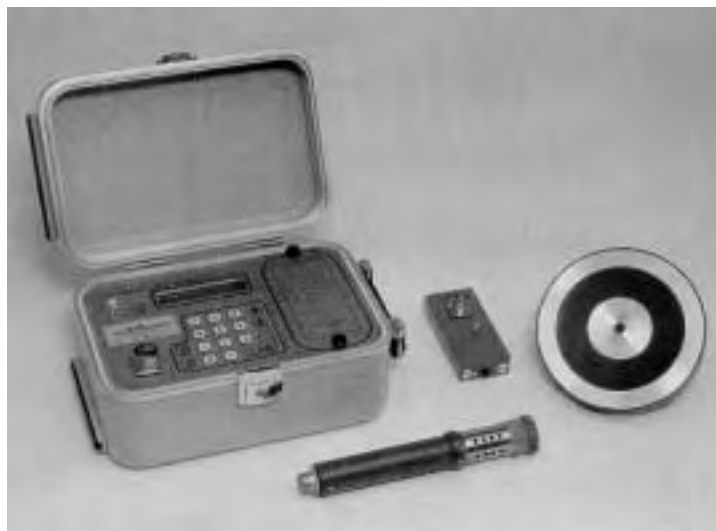
*Figure 5.28 Gecor 6 device – sensors and rate meter (James Instruments)*

The Gecor 6 Corrosion Rate Meter is for use on steel in concrete and is manufactured by James Instruments, Inc. This device uses the polarization resistance method for measurement of corrosion rate. The value used for the proportionality constant is 26 mV. Gecor 6 is shown in Figure 5.28.

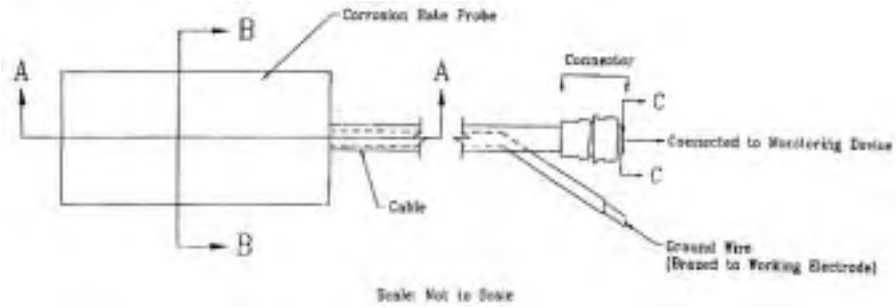
**Figure 5.30** Concorr corrosion rate probe and connection cable (Concorr, 1998)

Embedded probes were considered to be desirable devices for use in Project CSR 783-2-66 because it is important to avoid penetration of the Fibrwrap<sup>®</sup> system. The probes used for this study are manufactured by Concorr, Inc. of Virginia. A schematic diagram of the probes is shown in Figure 5.30.

the graphite reference electrode should not be placed between the counter electrode and the steel. The test area, or the area of polarized steel, is calculated based on the installation. The test area is confined to the length of the probe, with little current “spread” beyond this region. Only reinforcement in close proximity to the probe is affected by the polarization. The connector on the end of the connection cable, displayed in Figure 5.30, is a six-pin connector designed for input to the PR-Monitor corrosion rate device.
