1. Report No. FHWA/TX-09/5-4124-01-1		2. Government Accession No.		3. Recipient's Catalog No.	
4. Title and Subtitle Implementation Project: Strengthening of a Bridge near Hondo, Texas using Post-Installed Shear Connectors				5. Report Date March 2009

## **Implementation Project: Strengthening of a Bridge near Hondo, Texas using Post-Installed Shear Connectors**

CTR Technical Report:	5-4124-01-1
Report Date:	March 2009
Project:	5-4124
Project Title:	Implementation Project: Bridge Strengthening through the Use of Post-Installed Shear Connectors
Sponsoring Agency:	Texas Department of Transportation
Performing Agency:	Center for Transportation Research at The University of Texas at Austin

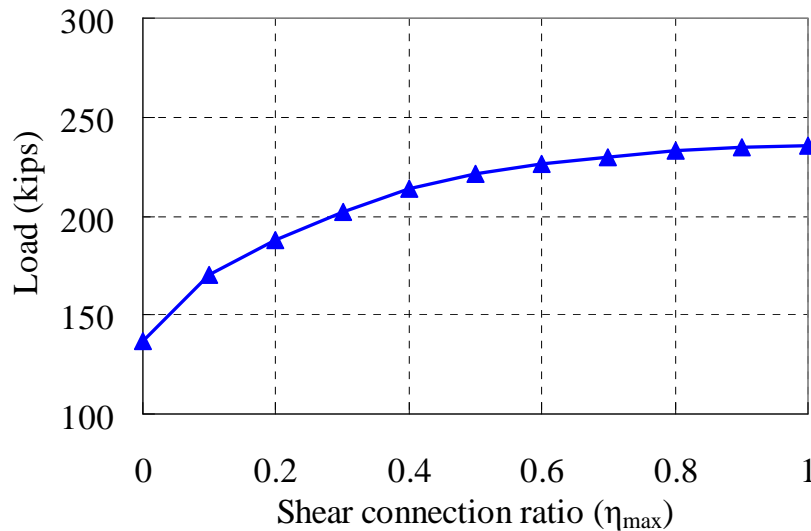
Figure 2.6: Ultimate load-carrying capacity of a composite beam

The ultimate load-carrying capacity of a composite beam with different shear connection ratios is shown in Figure 2.8. The composite beam used in Figure 2.6 has the same geometry as the full scale beam test specimens tested as part of Project 0-4124 (Kwon et al. 2007). For this composite beam, the steel section was a W30x99 with  $F_y = 50$  ksi; and the concrete slab was 7-ft wide by 7-inch thick with  $f_c' = 3$ ksi. A partially composite beam with a low shear connection ratio shows much higher strength than a non-composite beam. For example, a shear connection ratio as low as 30 percent results in a flexural strength increase of about 50 percent.

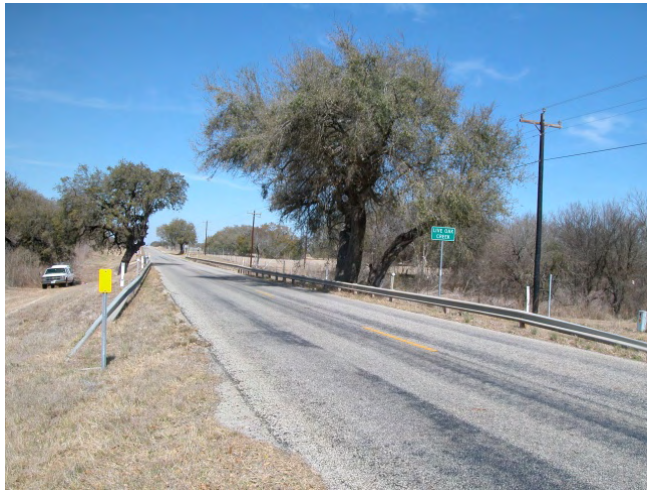
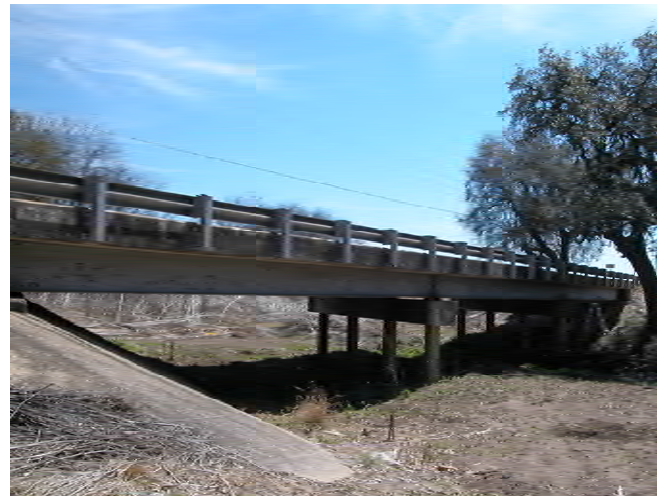
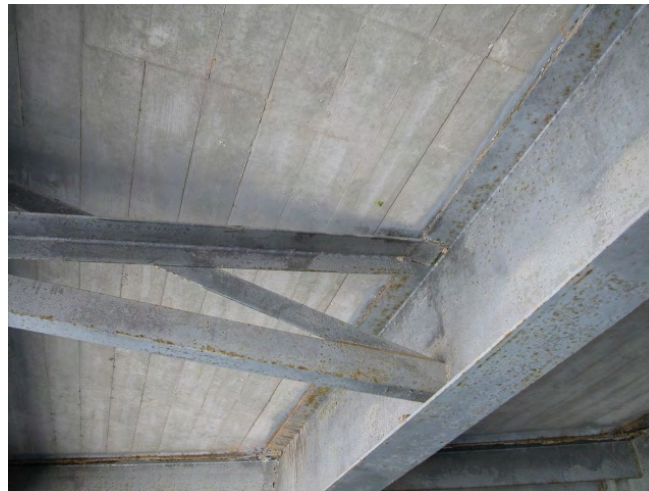
*Figure 3.1: The Hondo case-study bridge*

The material properties of the concrete slab and the steel girders were not reported in the available drawings of the bridge. The *AASHTO Manual for Condition Evaluation* provides recommendations for the yield stress of the steel girders and the compressive strength of the concrete slab based on the year the bridge was built. The recommended yield stress of the steel girders and the compressive strength of the concrete slab for load-rating were 33 ksi and 2.5 ksi, respectively for a bridge constructed in 1950 (AASHTO 2003).

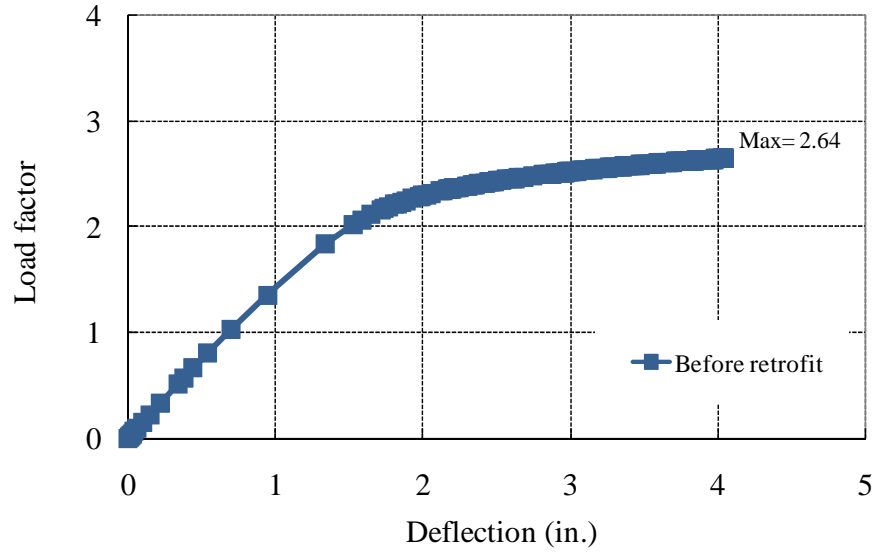
Figure 3.7: Load-deflection relations for the Hondo Bridge (before retrofitting)

From the ABAQUS analysis, load-deflection plots of the Hondo Bridge before retrofitting are shown in Figure 3.7. The deflection was measured under the center wheel of the load-rated girder. The load factor ( $A_2 \cdot (1 + I) \cdot RF$ ) on the vertical axis is the ratio of the applied load to the standard HS 20 design truck load. The load factor 1 means the bridge is loaded with the two standard HS 20 design trucks as shown in Figure 3.6(a). The ABAQUS analysis was stopped after widespread cracking was predicted in the concrete slab elements, beyond which point the solution could not converge. This point was taken as the analytical equivalent of failure. Note from Figure 3.7 that the load-deflection curve was nearly flat at this point.

Consequently, although the finite element solution did not converge beyond the last point shown in the plot, this point likely was close to the actual maximum capacity of the bridge. Longitudinal stresses predicted by ABAQUS are shown in Figure 3.8. As expected, the neutral axis of each girder is located near mid-depth. The maximum load factor is 2.64. The load factor  $A_2$  is 2.17 for the Inventory rating level and 1.3 for the Operating rating level. The impact factor  $I$  is 0.3 for the bridge. Based on the ABAQUS analysis, the load rating results for the AASHTO strength criterion are therefore  $2.64/2.17/1.3 \times (HS20) = HS18.7$  for the Inventory rating level and  $2.64/1.3/1.3 \times (HS20) = HS31.3$  for the Operating rating level.

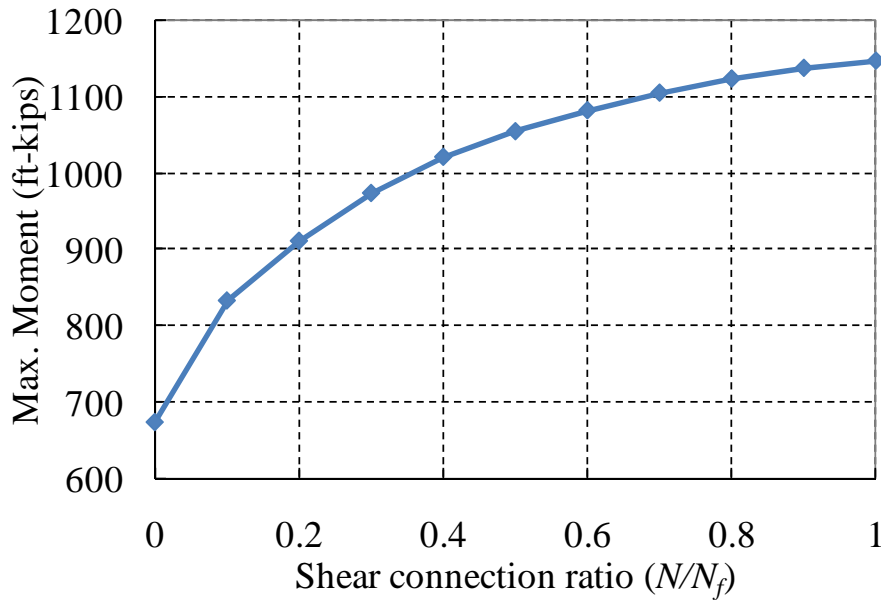
Figure 3.10: Load-carrying capacity vs. shear connection ratio for girder in Hondo Bridge

required for each girder (28 shear connectors in a shear span). For a preliminary design, it was decided to provide a sufficient number of shear connectors to achieve a 50-percent shear connection ratio, and then determine the resulting increase in the bridge load rating. A 50-percent shear connection ratio requires 28 shear connectors in a bridge girder (14 shear connectors in a shear span), and will result in an approximately 55 percent increase in its flexural capacity. The shear connectors will be installed near the supports at a 12-in. spacing to reduce slip at the steel-concrete interface, and thereby increase the ductility of the retrofitted partially composite bridge girders (Kwon 2008). The layout and the numbering of the post-installed shear connectors are shown in Figure 3.11.

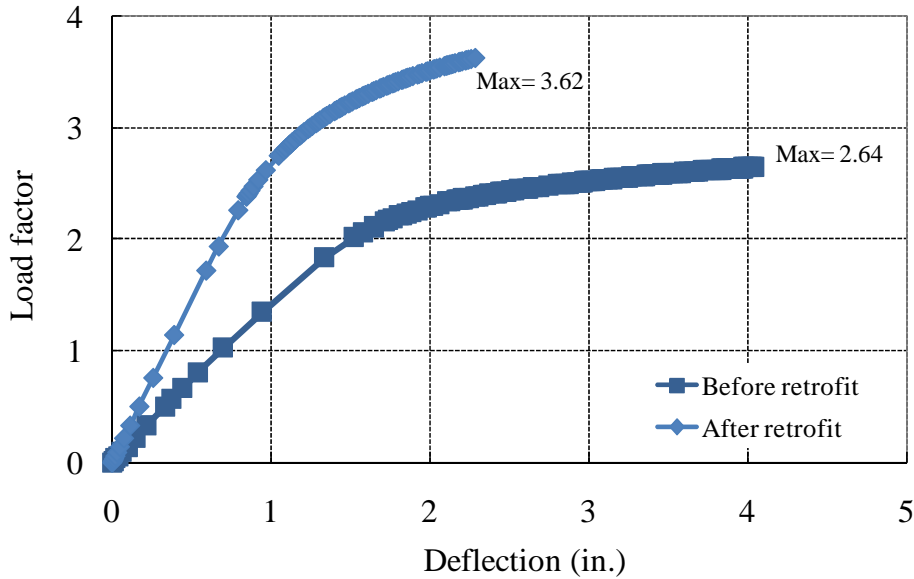
Figure 3.13: Analytically predicted load-deflection relations for Hondo Bridge (after retrofitting)

A load-deflection graph for the strengthened bridge is shown in Figure 3.13 along with the graph of the non-composite bridge before the strengthening. A load factor ( $A_2 \cdot (1 + I) \cdot RF$ ) instead of the applied load value was used in the vertical axis. Failure of the loaded ABAQUS model was also defined as the development of widespread cracks in the concrete slab, resulting in failure to achieve convergence of the solution. No shear connector failure was detected in the analysis model, meaning that the load could have been increased further past the point of non-convergence. As shown in Figure 3.13, the strength of the bridge was improved significantly by installing post-installed shear connectors. The maximum load factor obtained from the analysis was 3.62, which resulted in the rating of  $3.62/2.17/1.3 \times HS20 = HS25.7$  for the Inventory

rating level and  $3.62/1.3/1.3 \times HS20 = HS42.9$  for the Operating rating level. Figure 3.14 shows the longitudinal stress distribution in the composite girders after the strengthening. As expected, the neutral axis is located near the top flange of the beam due to partial composite action.

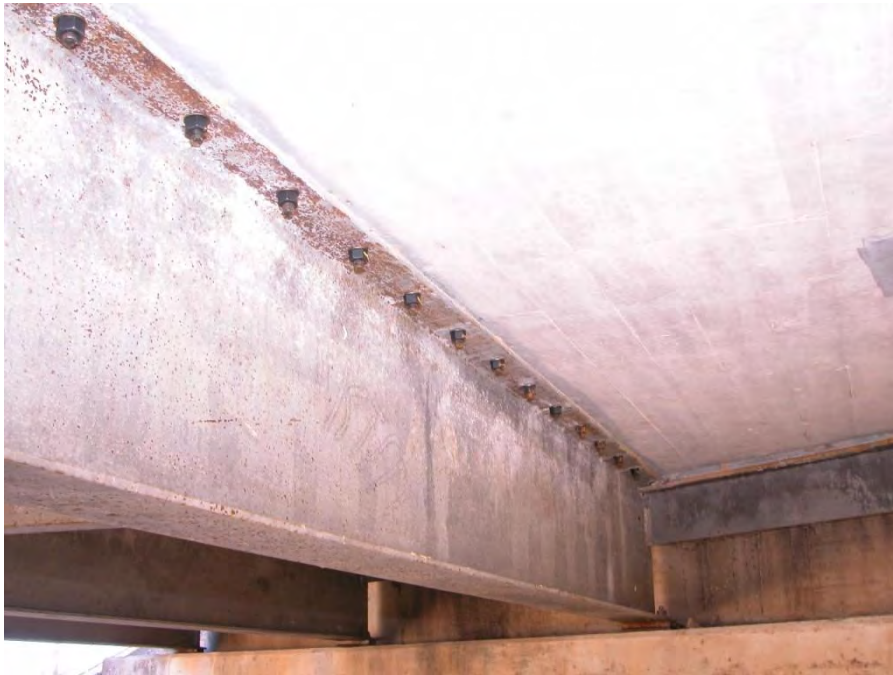
*Figure 3.17: Post-installed shear connectors (HASAA) in an interior girder in south span of Hondo Bridge*

- The HASAA connector requires drilling through the top flange of the steel beam from underneath the bridge. This is normally done using a magnetically mounted drill. When the underside of the top flange is slanted, as was the case at the Hondo Bridge, it may be possible to use taper steel shims between the magnetic mounting surface of the drill and the underside of the flange. These shims can be used to keep the drill bit perpendicular to the top side of the steel flange. This should help reduce wear on the drill bits.

- For the HASAA connector, problems with the adhesive running out of the hole can be reduced by proper selection of adhesive. It should be noted that problems with the adhesive running out of the holes were not encountered in the construction of the large-scale test specimens in Project 0-4124. However, based on discussions with TxDOT personnel, it appears that the adhesive used at the Hondo Bridge was different than that used in Project -4124 and different than was recommended in Appendix B. The adhesive used in Project 0-4124 and recommended in Appendix B was Hilti HIT HY 150 adhesive. While other adhesives are likely acceptable for this application, care should be taken in choosing alternatives, as strength, durability and installation characteristics can vary widely among adhesives.

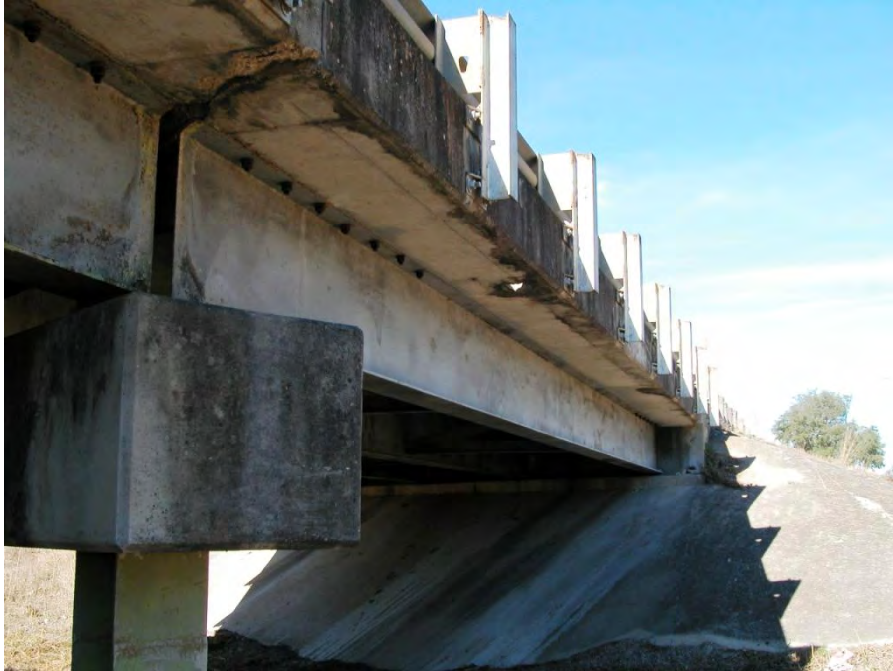
*Figure 3.18: Post-installed shear connectors (DBLNB) in an exterior girder in north span of Hondo Bridge*

- The construction personnel reported that they found the DBLNB connector the easiest of the three methods to install. However, they indicated that they preferred to use a standard high-strength ASTM A325 headed bolt rather than the ASTM A193 B7 all threaded rod which was called for in the recommended installation procedure (Appendix B). The installation procedure called for the use of A193 B7 all-thread rod, with a nut placed near the top to resist uplift of the deck. Two nuts (double-nuts) are also provided directly above the steel flange to reinforce the connector and to prevent rotation of the connector while the nut is installed from underneath. The experience at the Hondo Bridge was that the double-nuts did not prevent rotation of the connector during installation of the nut from underneath the bridge. Consequently, in order to prevent rotation, it was necessary to weld the nut to the top of the threaded rod, so this could be held with a wrench during tightening operations.

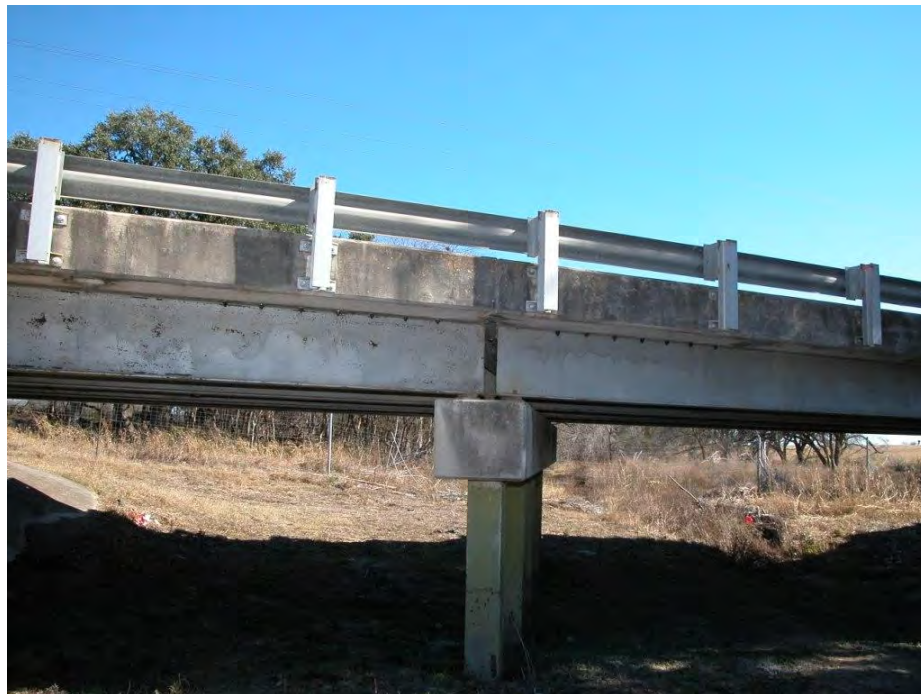
*Figure 3.19: Post-installed shear connectors in exterior girders of north span (on left) and center span of Hondo Bridge (DBLNB in north span; HTFGB in center span)*

- Adding washers to the bottom of the bolts for the HTFGB connector is not expected to have any adverse effects on the structural performance of the connector. However, it is advisable to have extra washers on hand during construction.
- For the DBLNB connector, replacing the A193 B7 threaded rod with an A325 bolt is acceptable, as long as there is sufficient thread length on the A325 bolt so that two nuts can be placed directly above the steel flange. These double-nuts are intended to prevent rotation of the connector when the nut is installed underneath the flange (a feature that apparently did not work well at the Hondo Bridge) and to help reinforce the base of the connector. Eliminating the double-nut may adversely affect fatigue life of the connector.

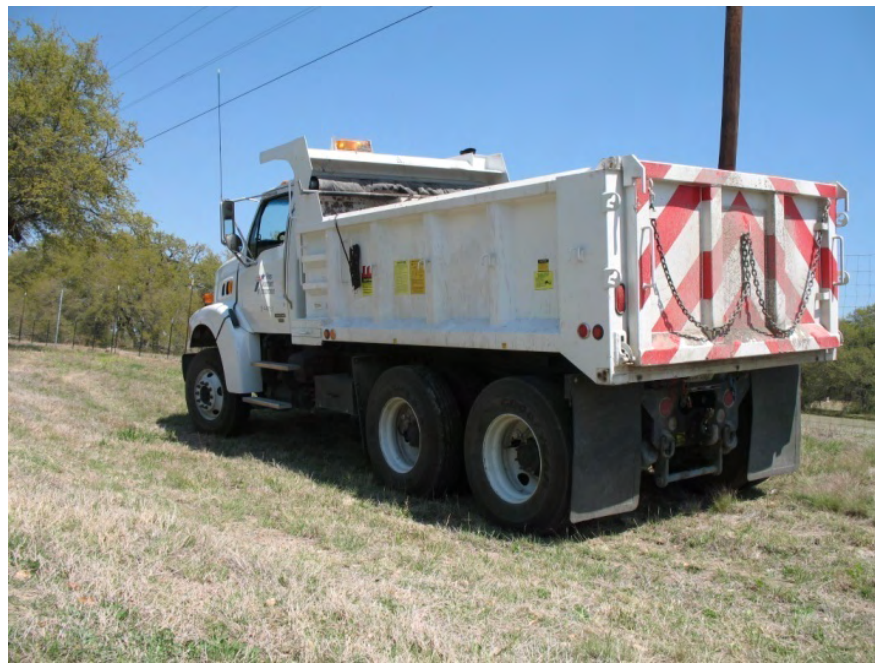
*Figure 4.1: Dump trucks used for the field test*

Two dump trucks provided by TxDOT were used for the load tests (Figure 4.1). The two trucks were loaded with gravel, and the front and tandem axles were weighed at truck scales before the tests. Since the two tests were conducted several months apart, the dump trucks did not have the same weights for the two tests. The configuration and weights of the trucks are shown in Figure 4.2.

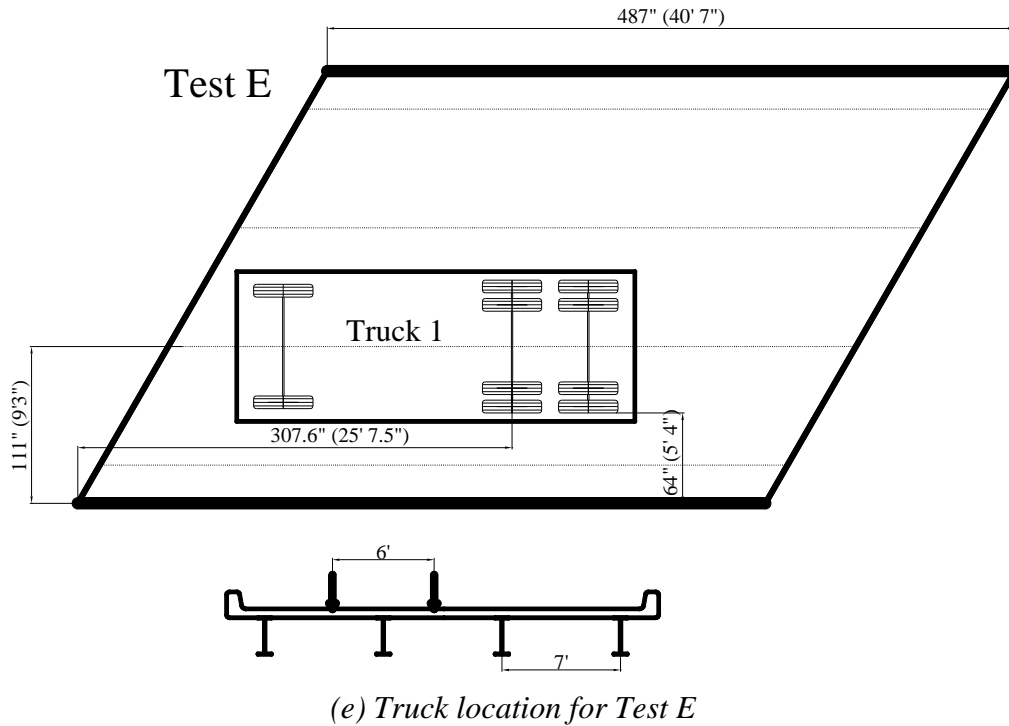
Figure 4.3: TxDOT dump truck locations for field tests

During the tests, the trucks were positioned in various locations on the span and test runs were conducted to measure deflections at mid-span and strains in the bridge girders under the truck loadings. Five different truck locations, identified as Tests A to E, are shown in Figure 4.3. The locations of the trucks were chosen to produce significant strain and deflection response at the mid-span of the bridge girders.

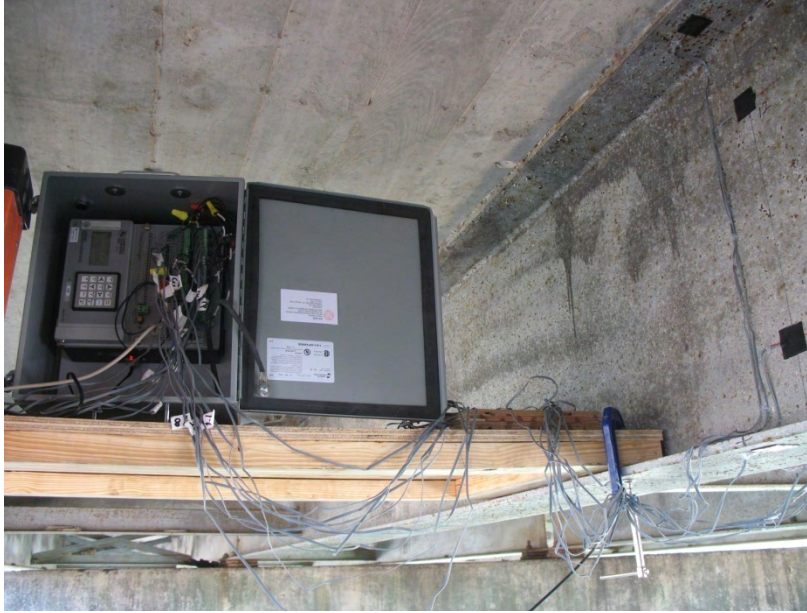
*Figure 4.5: CR 500 data logger used for field tests*

The data acquisition system used for the field tests was a Cambell Scientific Inc. CR 500 unit (Figure 4.5). The data acquisition unit was connected to a laptop. During the tests, the TxDOT dump trucks were located in the predetermined positions (Figure 4.3) and held in place for several minutes while data readings were taken. The data were read at a rate of 1/5 Hz, meaning the strain and deflection data were measured every 5 seconds.

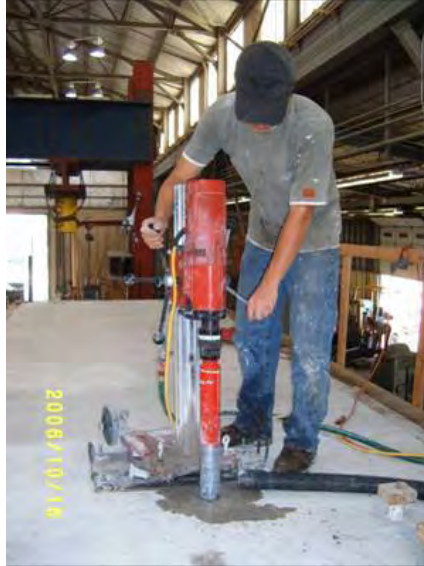
*Figure B.4: Coring using Hilti DD200 coring machine*

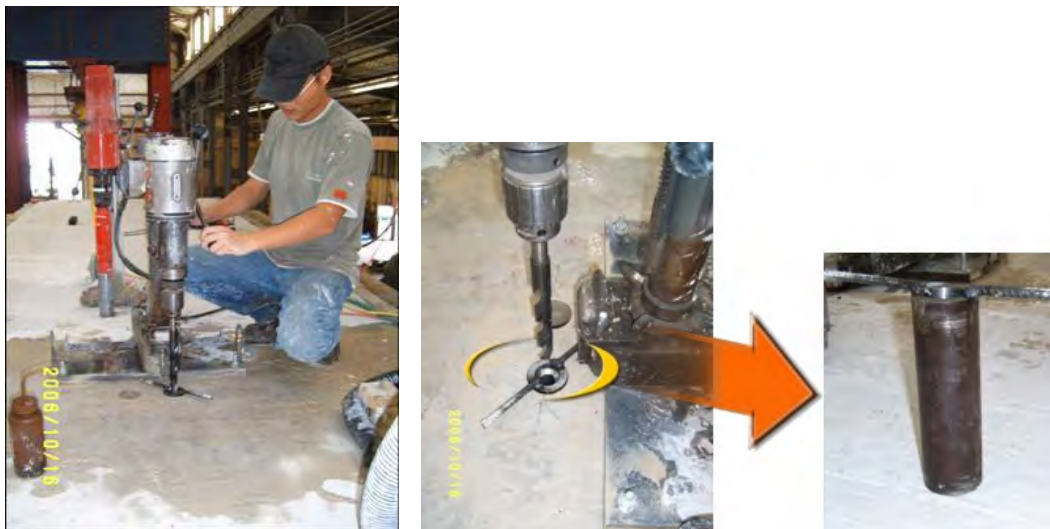
*Figure B.5: Drilling through the beam flange*

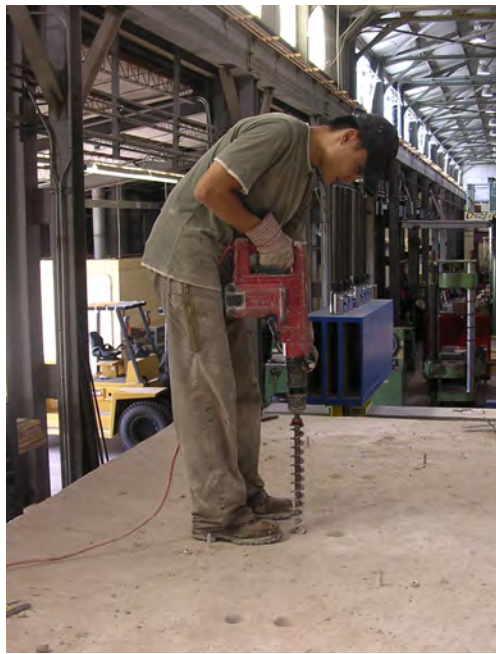
*Figure B.8: Drilling into the concrete slab*
